Flood Risk Assessment 50,000 m³ and landscape impact, winter storage reservoir Church Farm Seething.

Introduction.

The report below details the construction and design aims in relation to flood risk and landscape of the proposed reservoir.

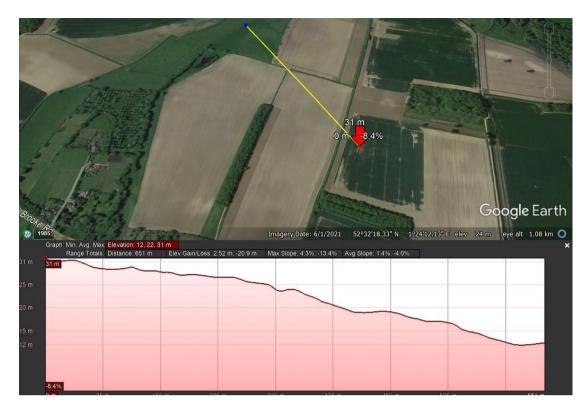
Flood way from theoretical breach in the NW corner, point of highest banks and slope to north west identified by topographical survey- see drawings.

The theoretical, dam break flood will spread out across the flat fields and flow toward the Little Beck and River Chet.
