Heritage Statement

Conversion of barn to a dwelling for visitor accommodation
at Wilcroft Farm, Pecket Well, Hebden Bridge, HX7 8QY

Thornton Architects Ltd

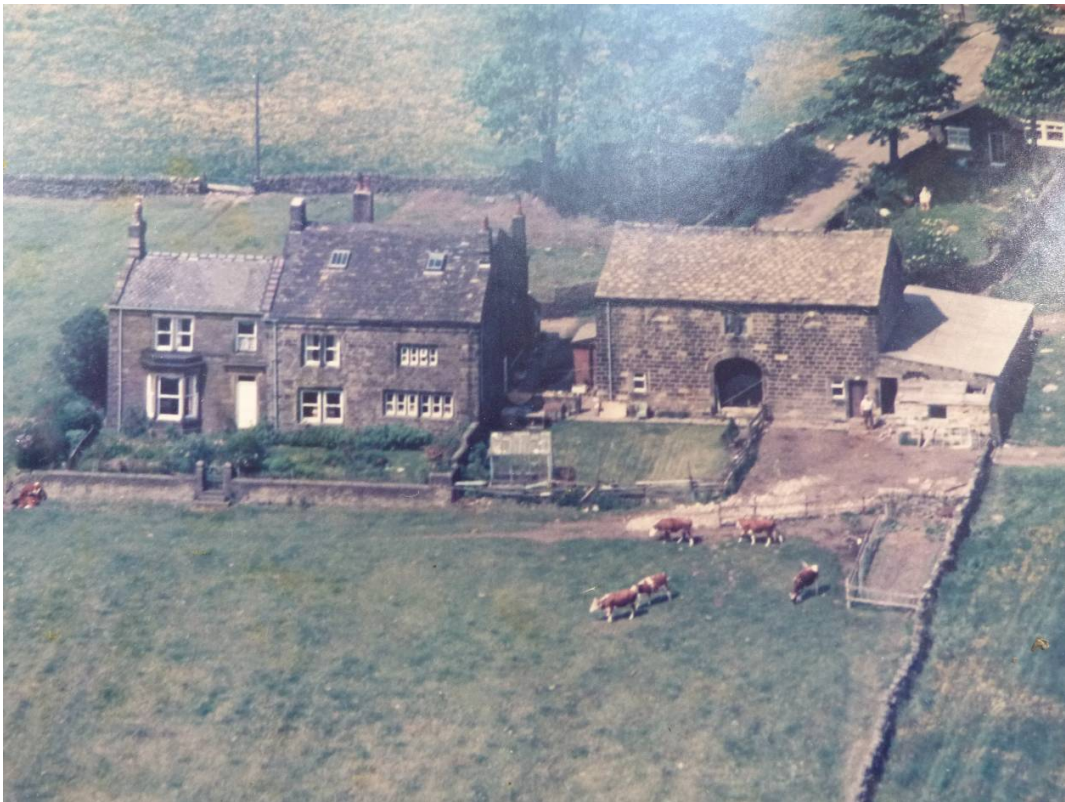
P2 Aerial view of Wilcroft House, Wilcroft Farmhouse and Wilcroft Barn (1982)

4.5. The mid 20th Century lean-to byre on the east side, visible on the 1982 aerial view, remains intact and is used for storage.

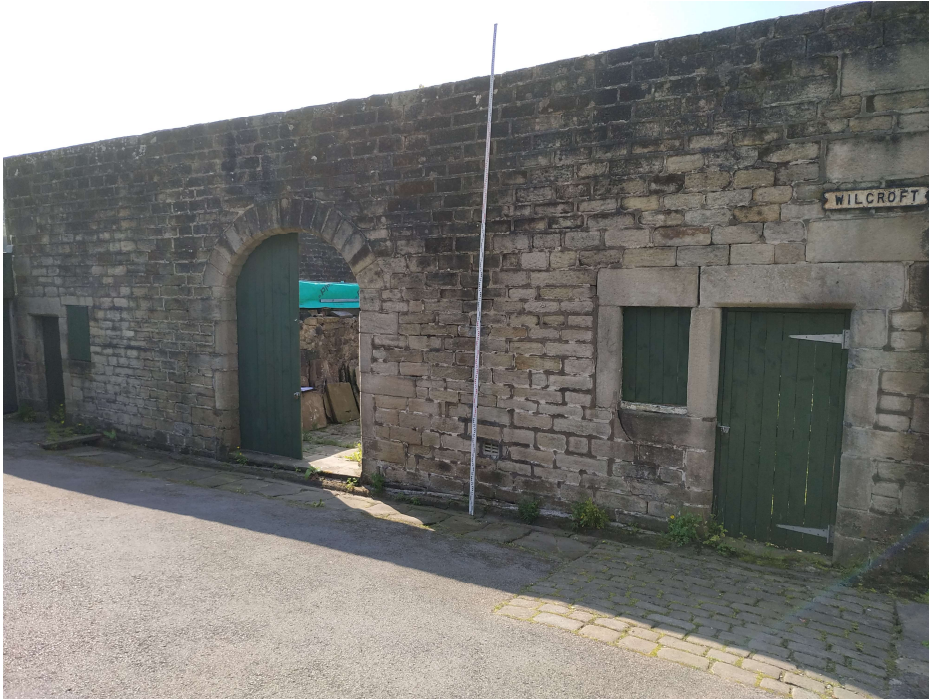
P4 Wilcroft Barn, north side

4.2. The barn has loadbearing coursed sandstone walls. As noted in the listing description, the stonework and dressing of stonework around the openings appears to be older on the north elevation indicating that the barn was rebuilt in the nineteenth century.

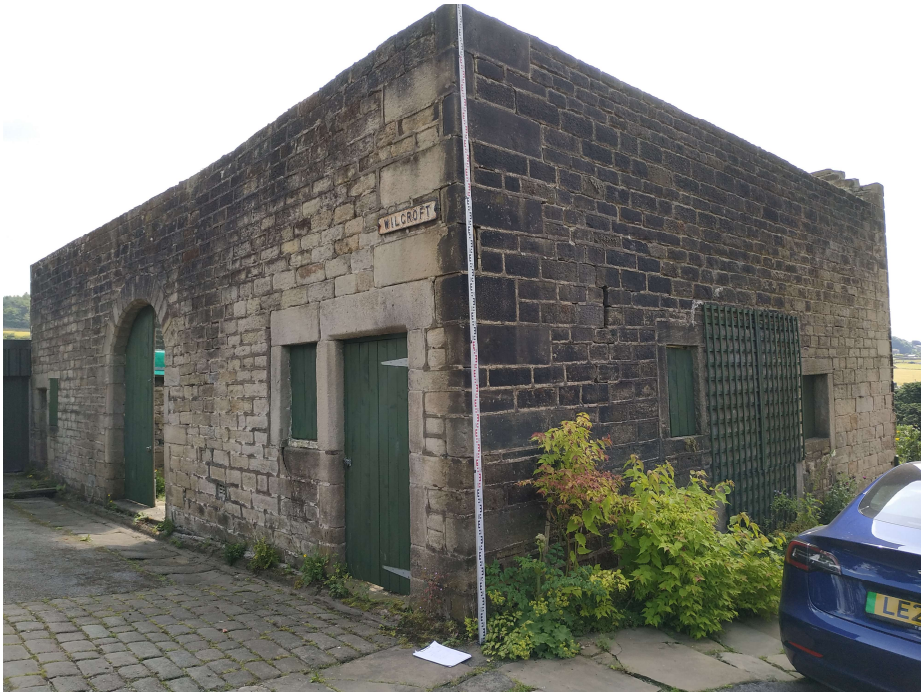
P5 Wilcroft Barn, north and west sides

4.4. The north, west and south elevations of the barn remain as described in the listing except for the gable apex. The owl hole, referred to in the listing, is missing but may be recoverable amongst the stored walling stone within the barn.
