**Mining Searches UK**

**Metalliferous Mining Search**

Dormers Trenance Mawgan Porth TR8 4DB

# Metalliferous Mining Search

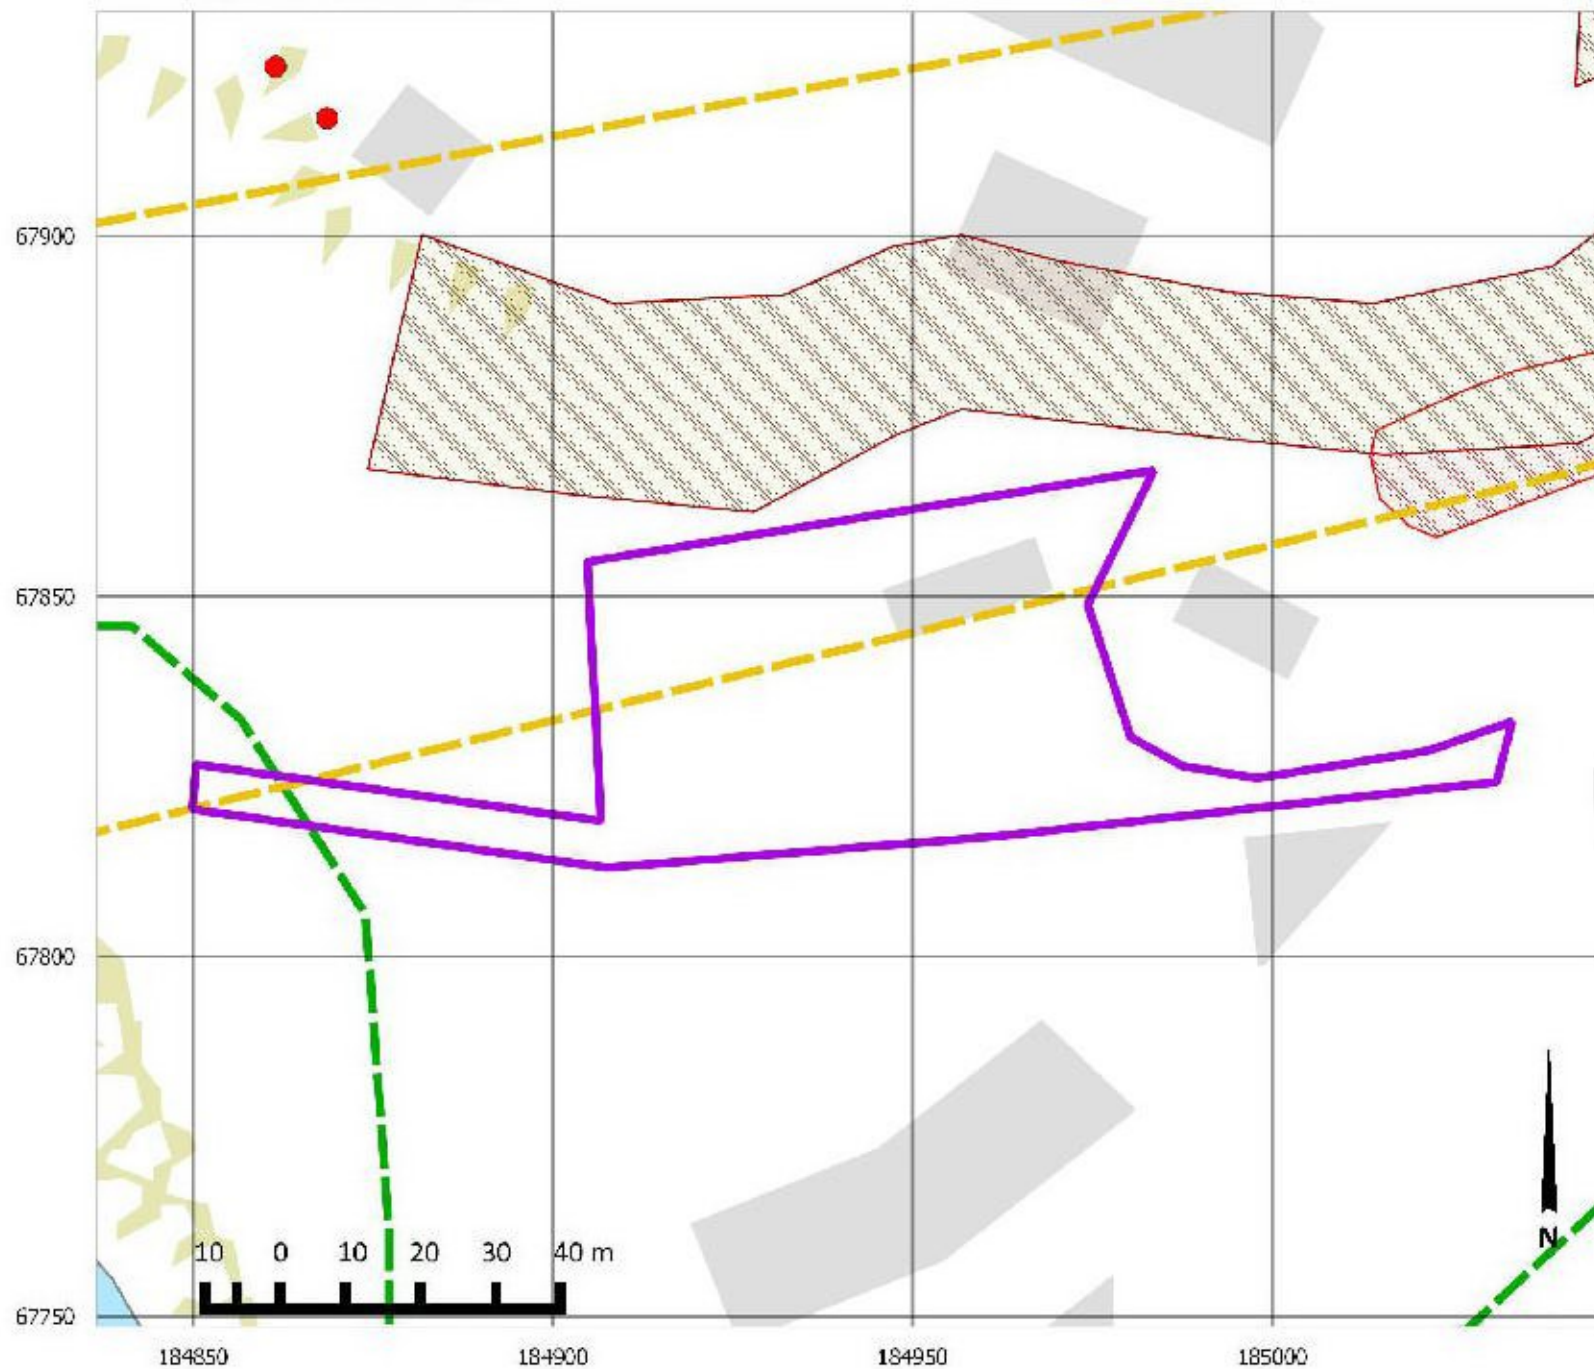
## Map Information

This report provides an assessment of the metalliferous mining risk for the subject property based on the evidence available to Mining Searches UK at the time of production. The opinions outlined are only relevant to the subject property shown in purple on the attached search plan.

Reference: 66553  
 Author: R.Sinkins  
 Date: 2014-08-04  
 Scale: 1:1,500

A poorly recorded mineralised vein passes through the subject property at an undefined elevation of plot. This mineralised vein follows a WSW-ENE alignment. Mining Searches UK have no evidence that this mineralised vein has been observed or worked at surface within the area covered by the search plan.

An old quarry is recorded to lie approximately 30 metres to the ENE of the subject property.

The nearest recorded mine shaft lies approximately 70 metres to the north west of the subject property.
