STEDCOMBE HOUSE

Heritage Statement and Impact Assessment

Prepared by
Stuart Martin, Architect
November 2021

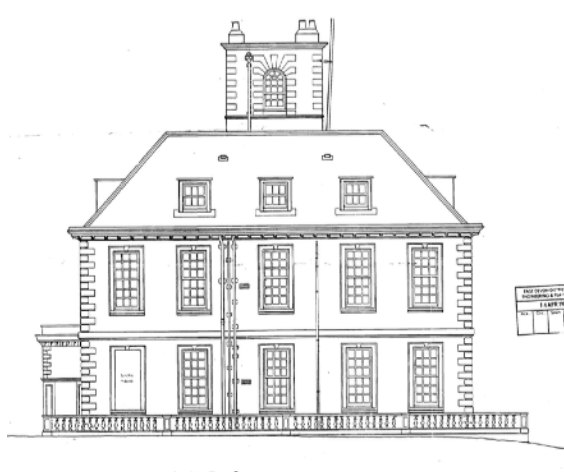
The north elevation of Stedcombe in 1988. This shows the surviving original 9 over 9 sashes, as well as the other later features described above. These sashes were used as the pattern for the replacement of all the later sash windows on the main floors.

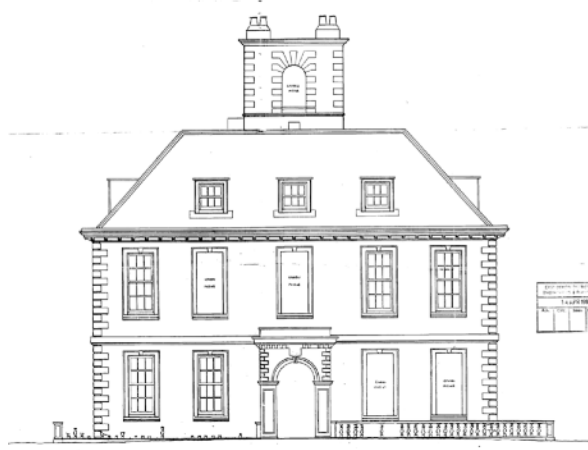
The east elevation of Stedcombe in 1988. This shows missing sashes, as well as the other later features described above. It can be seen that the stone balustrade was damaged and incomplete. In addition this elevation shows the late 19th century porch that was removed in 1988-90.

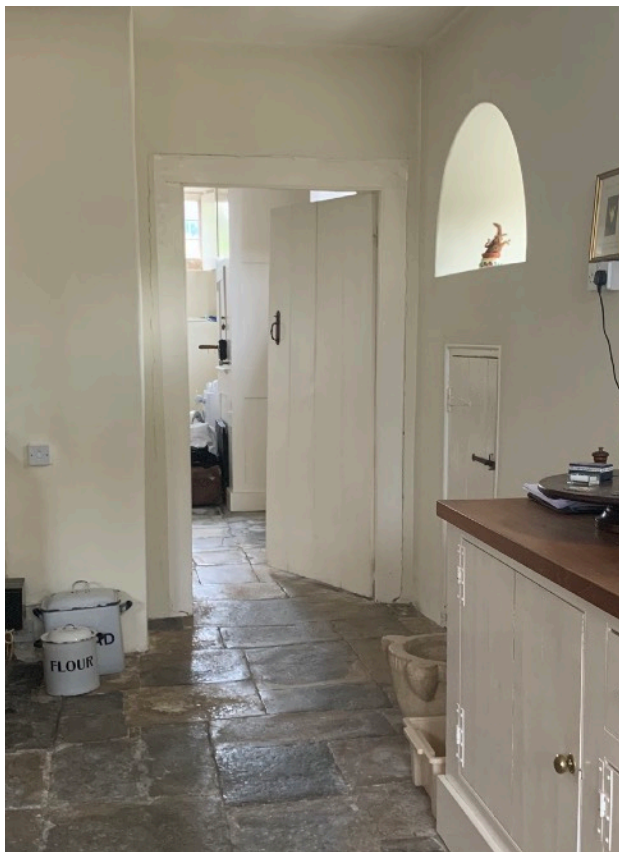
Looking towards the utility room door in the kitchen. The arched window visible at right was reinstated c.1990 within an original archway, below which straight joints and a change in the brickwork suggest was originally an external doorway. Removal of the infilling later brickwork and reinstatement of a door is proposed here, to improve circulation from the kitchen and aid with ventilation.

carried out limited removal of modern plaster finishes in this area, which have confirmed that the brickwork infill below the existing arched window is later - probably late 19th/early 20th century - and which has straight joints to the adjacent older brickwork. The extant arched window joinery dates from the 1988-90 works, apparently being introduced during the course of the project, as it is shown neither on the 'as existing', nor on the 'as proposed' drawings. Nonetheless it is fitted within a pre-existing and obviously much older archway in the brickwork which by the evidence of the straight joints in the brickwork below was originally a doorway. Externally it can be seen that the render has been altered around the arched window, further evidence for a recent change here. The reinstatement of this door would be very useful to the owners, providing a means of direct outside access to the kitchen without passing through another room, and adding ventilation to the kitchen, which currently lacks any openable windows.

- **Assessment** - There is evidence for a door in this position, in the form of the historic plan and the alterations in the fabric. The much later infilling brickwork is of no great importance, and this alteration will have practically no effect on the appearance of the house from ground level views, being set below ground and behind the area railings - see the elevation drawings as proposed - drawing 1233-04. The impact is considered to be **low** in terms of fabric intervention and **positive** in that a missing feature, for which there is evidence, will be reinstated, replacing a modern window of little intrinsic merit, and improving the environment in the kitchen without detracting from its character or significance.

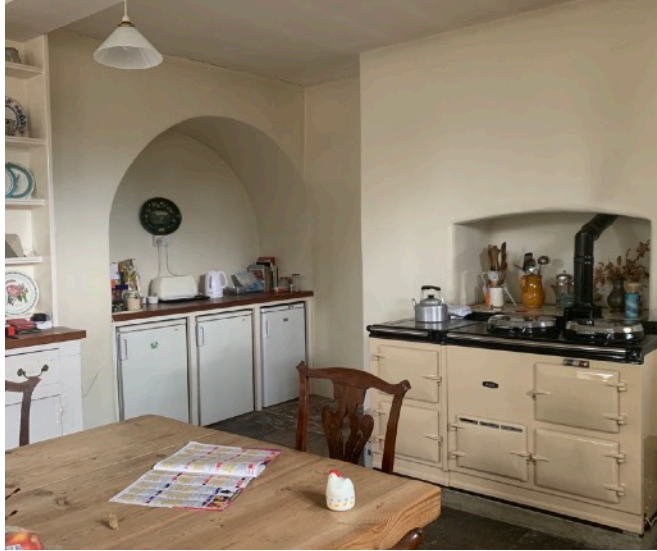
View in the kitchen showing the arched recess in the north east corner. The back wall of this recess is brick, of later date than the original fabric. The proposal is to remove this infill and insert a painted timber half-glazed screen with a door, reinstating the plan-form, improving the circulation and giving to the central basement hall a proper function, as well as improving daylighting and ventilation in both spaces

was blocked later on, for reasons which are hard to fathom, as it makes the circulation much more circuitous and difficult from the kitchen to the back stairs. That this blocking took place later can be confirmed by looking at the brickwork which we have exposed in several places by removing small areas of the modern plaster. The brick has a different character, and lacks proper bonding in to the earlier work. Blocking the archway has made the central corridor very dark at its southern end, where originally it would have benefited from borrowed light from the kitchen through the archway. We consider that the re-opening of this archway will be beneficial in terms of reinstatement of the original plan form, and by making movement through the basement much more practical and convenient, as well as improving the daylighting of the central corridor, reinstating its original function as a main circulation route at basement level, rather than as a low-use and gloomy dead end. We propose to fit the re-opened archway with a half-glazed screen of painted timber, as shown in drawings 1233-08 and 09, in order to form the necessary fire separation for the kitchen from the circulation spaces and stairs, whilst maintaining the daylighting of the corridor and the connection between the various spaces.

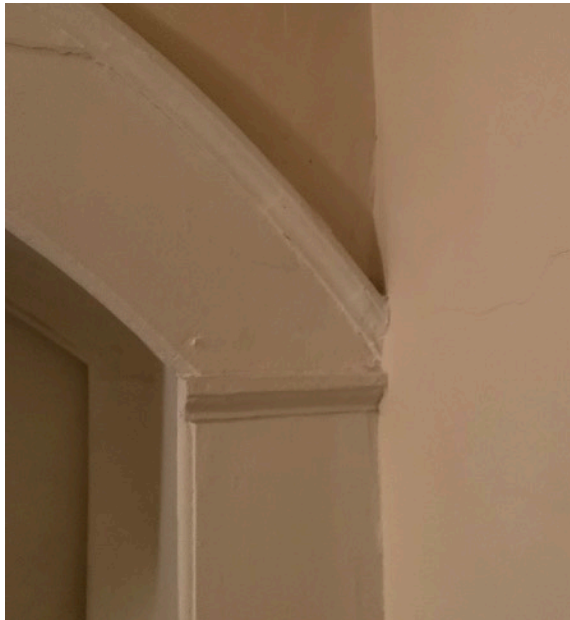
Detail of arched surround to wine cellar door, showing how the later wall has obscured the architrave and impost detail

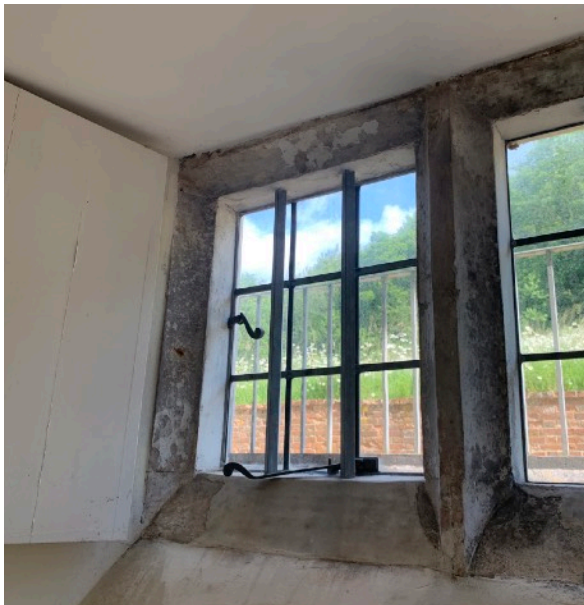
Window in basement room B1, with opening casement. We propose to replicate this detail for the opening lights in the kitchen

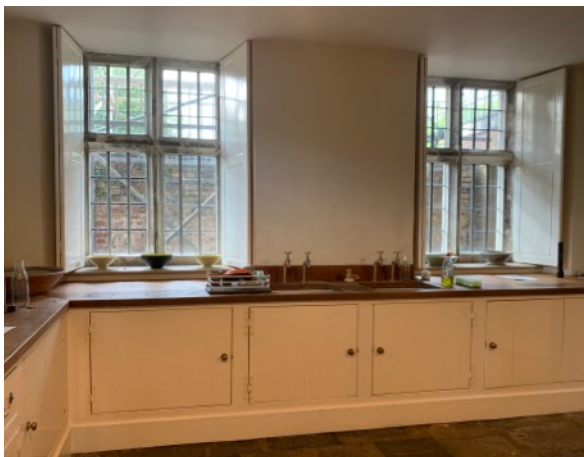
West wall of kitchen, showing the windows in question (WB3 and WB4). One casement in each window will open

- **Discussion:** As noted above, this room has always been the kitchen. It is therefore puzzling that it currently lacks any opening windows, essential for ventilation. Windows WB3 and 4, which are 4-light transomed windows which have lower sills than the others, are easier to reach, and have been selected for this reason. They are also less visible from ground level. There is a pattern we can use for openable windows: WB13, 14 and 16 in room B1.

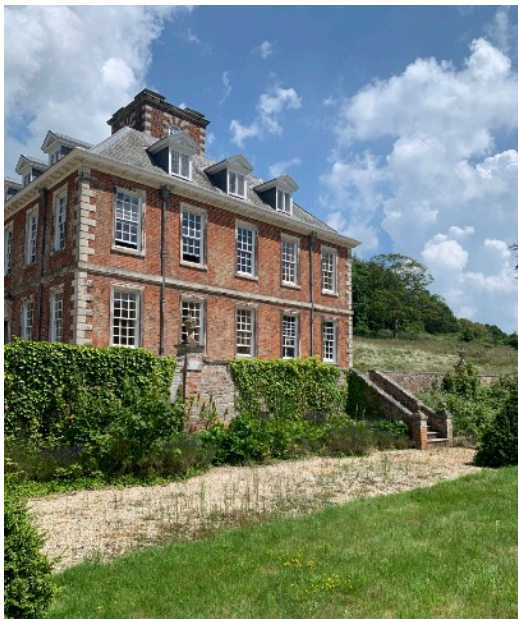
The south side of the house, showing the retaining wall to the upper walled garden, and the flight of steps. It is proposed to widen these steps and adjust the very steep going that was created c.1990, rebuilding the sides walls to the same details and reusing the bricks, whilst replacing the damaged brick and stone steps like-for-like with reduced rise and lengthened going

Whether these works returned the garden walls to their original configuration is unclear. The steps now existing are very narrow in proportion to the size of the house and garden, and too steep in pitch for external steps. The stone has not performed well and is in need of replacement. The proposal is to widen these steps to 2400mm between the side walls, which will be taken down and rebuilt using the same bricks set in lime mortar (as opposed to the cement mortar which was used in 1988-90) to suit the new width and shallower pitch of the flight. The stone treads will be Purbeck stone, which is traditional, reasonably local, softer in colour and more durable.

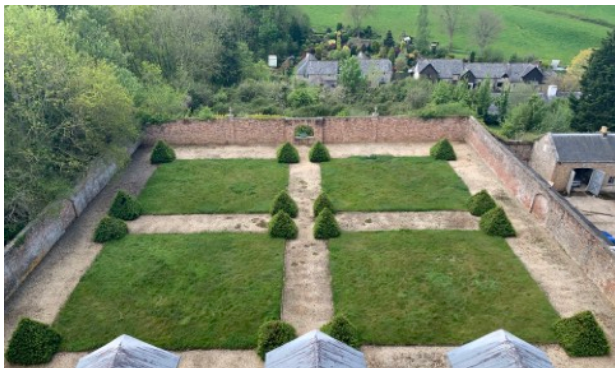
View from the roof of the upper walled garden, looking south. Most of the south wall was rebuilt c.1990, including the piers with urns (relocated from the north side of the garden) and the central elliptical archway.

- **Discussion** - The south wall to the upper walled garden was repaired and modified in 1988-90. According to the documents the wall was previously somewhat lower and lacked the central archway. It is believed that Kit Rae-Scott built up the wall between the piers from approximately waist height, and repositioned the urns on the piers, relocating them from their previous position on the north garden wall closer to the house.

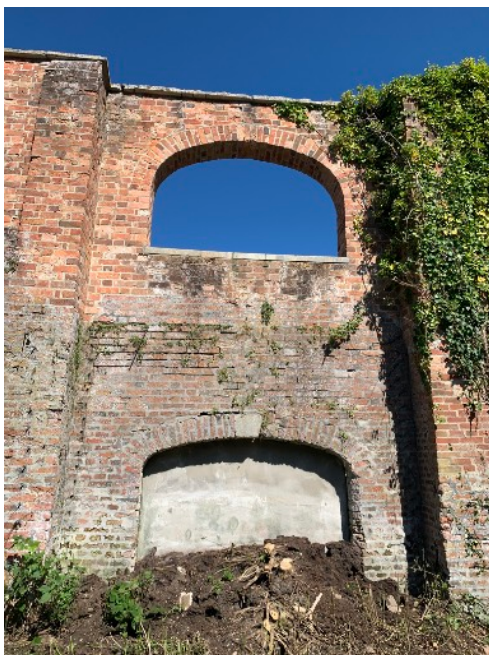
Looking up at the wall from the lower walled garden. The junction between the old brick and the more recent rebuilt work is clear. The proposal is to modify the upper opening to form an archway through which people will be able to access new steps to the lower garden. The lower archway will not be damaged or removed.

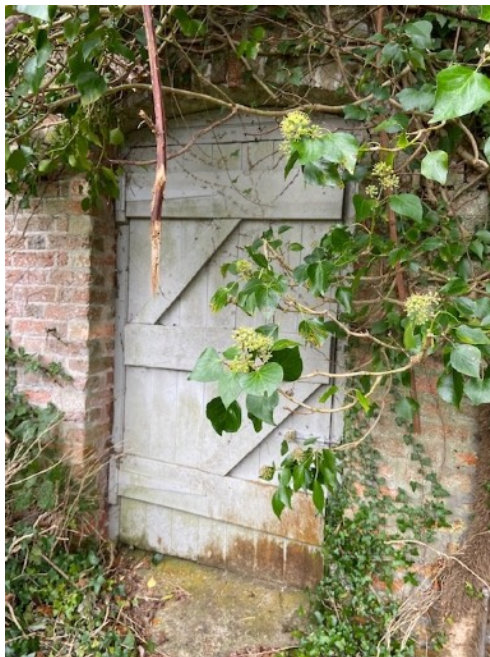
The existing opening and gate in the east wall of the lower garden. The opening is older, the joinery is modern

- **Assessment:** The proposal is to form a new double-gate, matching the details of the existing gate, but within a modified wider opening in the masonry wall. This is a modification of old brickwork, with the wider gate providing a much needed wider access to the lower walled garden. The existing gate in the opening is believed to date from c.1990. This improved access will give access for maintenance where currently there is none. As a result there will be greater use of this area, which was until recently completely overgrown. The impact is deemed to be **low** on historic fabric and significance, and the consequent improved access and greater use of the area is **positive**.
