WARRENS, BRAMSHAW, HAMPSHIRE

Heritage Statement

Statement of Significance

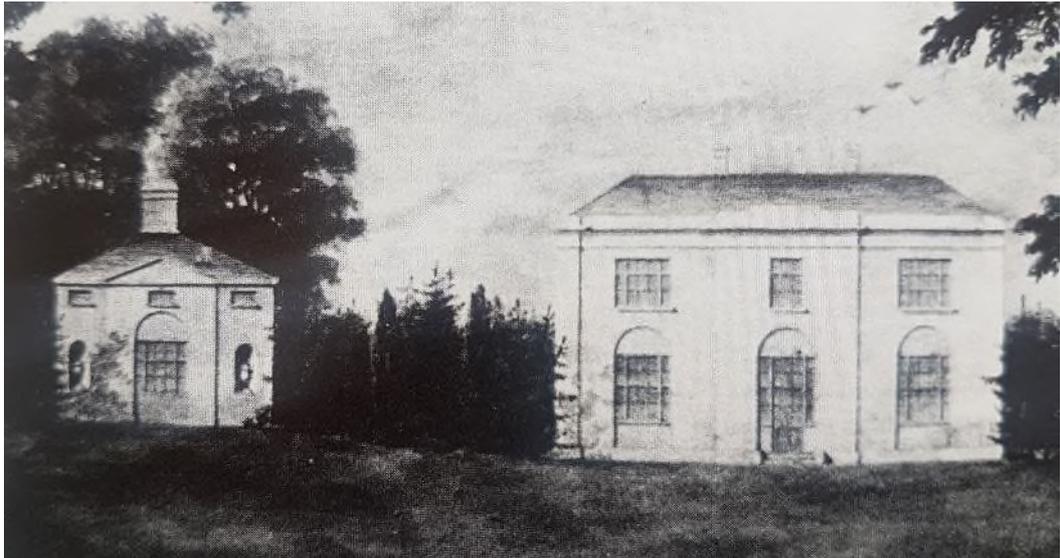
Figure 1 One of Plaw's watercolours of proposed designs for Warrens, 1799. (Reproduced from Temple 1993, 40).

- 2.1 In 1798 George Eyre purchased an estate in Bramshaw called Warrens from Samuel Orr. Eyre intended to immediately replace the existing house and commissioned the Southampton architect John Plaw to prepare sketches of various designs for this new house (e.g. Figure 1). Despite producing at least four different schemes, Eyre discarded Plaw and chose to employ John Nash as his architect (Temple 1993, 40).

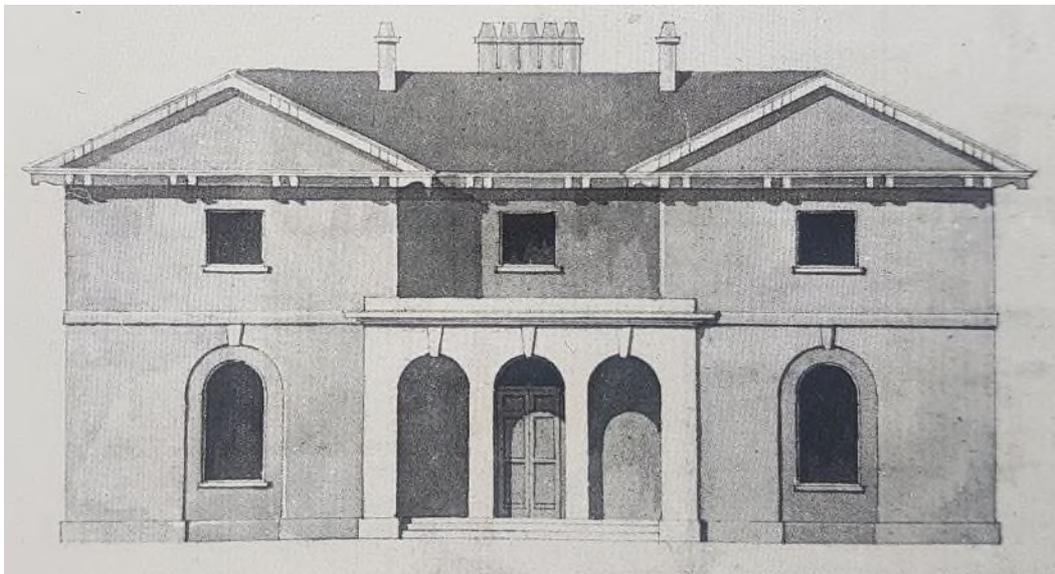
Figure 2 Front elevation of Warrens drawn by George Repton. (Reproduced from Temple 1993, 179).

- 2.4 Plan and elevation drawings of the Nash house, dated 1805 by George Repton (son of Humphry and who worked with Nash) are published within the *Pavilion Notebook* (Temple 1993, 178-9) (Figures 2 and 3). A further illustration of the entrance elevation within George Repton's sketchbook in the RIBA Library (SKB246/4) differs slightly from that in the *Pavilion Notebook* by having four urns upon the parapet of the entrance loggia. Repton's plan of the house, also of 1805, indicates that the library was in the front left-hand room rather than it being the drawing room, as was the case when the list description was written up, and that the drawing room was in the rear left-hand room and the dining room to the rear right. Nash's house was a modest building constructed for a bachelor containing just these three principal rooms with the main entrance hall staircase, an anteroom between the drawing room and the 'eating room' and a small room projecting from the north-east elevation of the library which was described as a 'Dressing Room'. To the right of the main stair was the butler's pantry off a corridor to the services and to the front right was the servants' hall. At the end of the passage from the entrance hall and staircase to the service wing there was a stair, possibly to the cellars, with the house-keeper's room beyond. North of these spaces was a 'covered way to kitchen' which was located beyond the edge of the plan. This covered way did not have a wall to the north-west which seems to suggest that the link between the dining room and kitchen was literally a covered walkway open to the north. To the south-west of the servants' hall was a room which appears to have had a glazed elevation facing into the service court concealed behind a wall set at an angle to the principal elevation of the main block of the house following a similar general line to the curved wall which exists today. On the garden front facing south-east there was a conservatory attached to the south-west

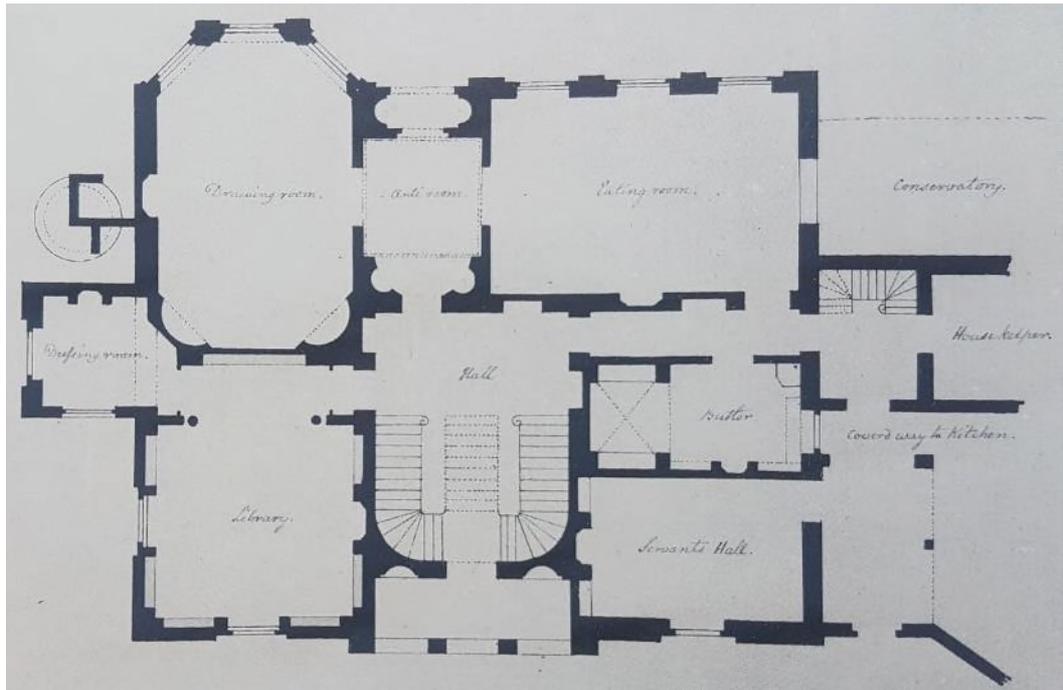
Figure 3 Ground floor plan of Warrens drawn by George Repton. (Reproduced from Temple 1993, 178).

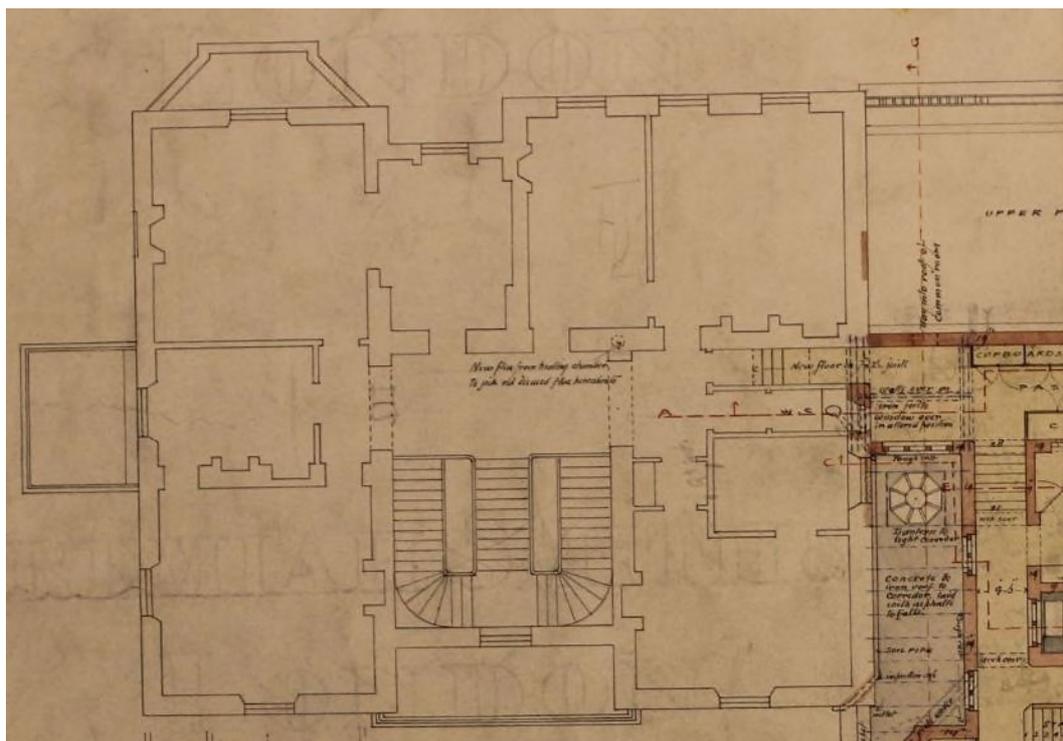
Figure 4 Philip Webb's first floor plan showing the Nash part of the house in 1898. © SPAB Archive.

There is no contemporary first floor plan available; the earliest plan of the upper floor of the Nash house comes from a plan by Philip Webb drawn in association with his major works on the service element of the house and the area of the conservatory dated 1898 (Figure 4). This plan shows that along the north-east side of the house there were two square bedrooms to the corners with a small inner room between. From the landing there were two doors, one to an ante-room to the bedroom to the east, a wide opening connecting the two rooms. The second door gave access to a small room divided from a larger room to the west by a partition which had a rather awkward relationship to the windows suggesting it was a later insertion. To the north-western corner was a further bedroom, smaller than those to the north-east side of the house, with a small inner room, a closet and a passage into the new Webb service block.

- 2.9 The 1877 1st edition Ordnance Survey 25" map (Figure 8) shows the house in much the same form as today, particularly in relation to the south-west end where the single bay pavilion (shown in Figure 4) can be seen projecting forward of the central, five bay section of the elevation. By this date this block had been extended to the south-west, also with a canted bay to match that of the Nash element at the north-east end. Extending back off the north-west elevation of this narrow range to the south-west was part of the service wing

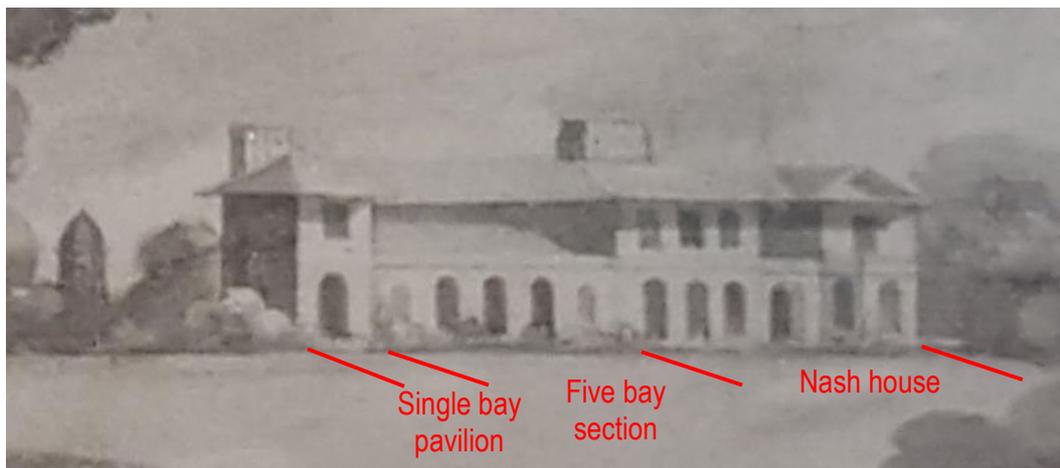
Figure 5 Undated but possibly early 19th century painting of the south-east front of the house (copy within the Temple research archive RIBA Library (TEN/5/1)).

Temple states that almost immediately after its completion the house was doubled in size but the architect for this phase of work is unknown. A watercolour view of the south-east elevation looking across the parkland of probable early 19th century date (a copy of which is within the Temple research archive) seems to show the enlarged house, but the picture presents some difficulties in interpretation (Figure 5). The main part of the Nash house is

clear with its pedimented cross-wing to the north-east and the three-bay element to the south-west. Notably, the canted bay was only at first floor level (in the documents referring to Nash's design there is a reference to a 'balustrated bow' which must refer to this canted bay element which is now of two storeys). The three-bay south-western part of the Nash house is shown with a shadow to its south-west elevation at first floor level indicating this wall was exposed whilst at ground floor level, continuing the line of the elevation is a five-bay section with three central arched openings with arched niches to either side, reflecting the existing arrangement rather than the conservatory shown on Repton's plan. The difficulty in interpretation relates to the roof over the element south-west of the main part of the Nash house; the hipped corner to the south-west part of the Nash house is clearly visible but there is no valley for the roof plane to return to the south-west although the eaves line appears to continue to the south-west up to a two-storey single bay element, casting a shadow over what appears to be a blank wall at first floor level. The single bay element to the south-west had a hipped roof with an arched opening at ground floor level and a square-headed window at first floor level, behind which was a large block of chimney stacks. No building behind this single bay element is visible in the painting. To the left and beyond the house, a tall pepper pot-type structure can be seen.

- 3.18 It is clear from the Webb drawings that the south-east wall was existing and that he utilised the existing openings as shown on the early 19th century painting of the house (Figure 5, above). However, the north-west wall of this room was newly constructed as part of Webb's plans and he either created or enlarged, the doorway link into the main part of the Nash house in the north-east wall. To the south-west wall an existing opening set to the left of the present opening was blocked-up and the current doorway inserted to the left of which is a tiled area at lower level; this was where a radiator was originally positioned. Radiators are now set within the window recesses.

- 3.21 The kitchen is located to the rear of the earlier single bay pavilion of the south-western block and has two separate fireplaces side-by-side on the south-east wall. These fireplaces are served by a large block of flues which features in the early 19th century painting of the south-east front (Figure 5). Webb's plan shows that this was the kitchen prior to his remodelling of the servant's quarters and that his work resulted in some alteration due to the change in the position of the north-west wall of the common room and new door openings were formed. Internally, other than the fireplaces, there is little of interest that helps understand the development of the house.

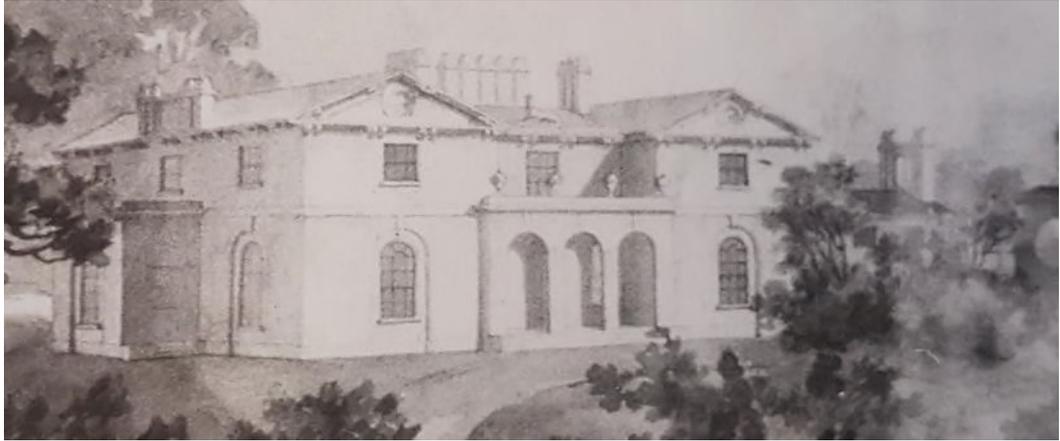
Figure 6 Undated but possibly early 19th century painting of the north-west entrance front of the house (copy within the Temple research archive RIBA Library (TEN/5/1)).

- 2.7 A further watercolour, also undated, is within the Temple research archive (Figure 6) which he refers to in the commentary in the Pavilion Notebook and describes as being 'of some precision' shows keystones above the windows, four urns upon the parapet of the loggia and a sphinx set on a parapet to the recessed section between the gabled cross-wings. Temple suggests that perhaps the watercolour was a visualisation made at some intermediate stage but it is clearly not an accurate depiction of the house as built; there is no parapet for the sphinx to the front elevation, there are no projecting keystones to the arched window openings and the stacks to the north-east elevation are set to the left of the elevation, not centrally as shown in the painting. Behind the roofline a massive block of chimney flues is shown which cannot relate to the position of the services and does not reflect the number of fireplaces required for the rooms to this part of the house.

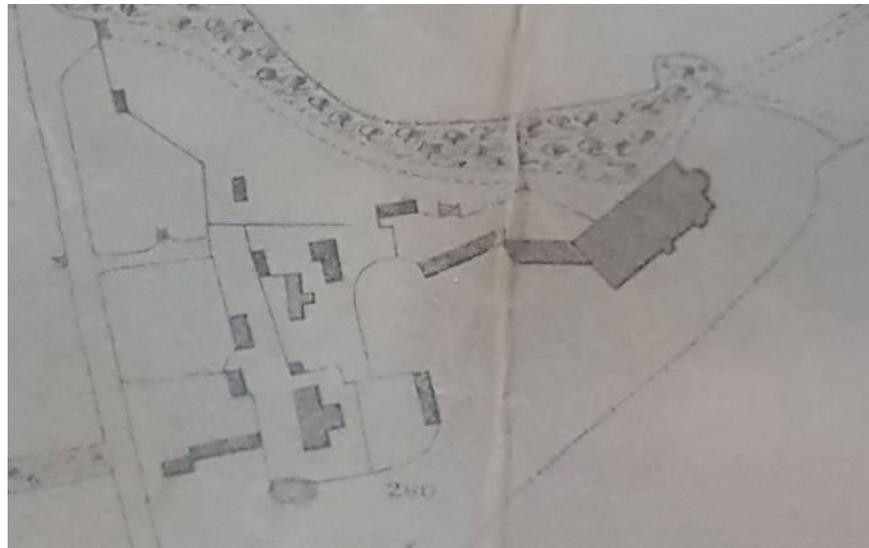
Figure 7 Bramshaw Tithe map, 1843.
© WSRO

- 2.8 The Tithe map of Bramshaw of 1843 is relatively unhelpful in understanding the form of house that at that date. (Figure 7) the map shows a large rectangular block with the small dressing room, extending off the north-east elevation and two small protrusions on the south-east elevation which do not accord with the canted bay of the drawing room whilst the one to the south-west does not relate to any feature shown on any of the earlier drawings or plans. Extending at an angle from the south-west elevation was a narrow range which extended as far as the stable and coach house range. The accuracy of this map is questionable but if the service range to the rear was in its present position, it is difficult to see how a range at right angles to the house and extending off the north-west elevation could be shown at such an angle extending off the south-west elevation.

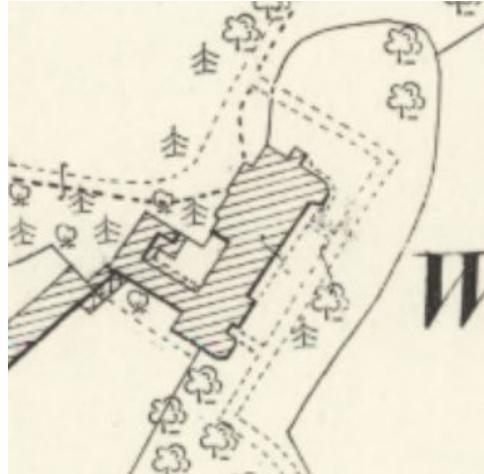
Figure 8a
Ordnance Survey 2nd
edition 25" map, revised
1895, published 1897

which returned to the north-east and with a further short and narrow return back to the south-east enclosing the service court. The 2nd edition 25" map of 1897 (Figure 8a) shows no change from the 1st edition map. The possibility that the 2nd edition map had effectively re-used the survey from the 1st edition map and did not reflect minor changes at Warrens has been considered and so evidence for the site having been resurveyed was sought. The fact that there are changes shown to ancillary buildings around the house between the 1st and 2nd edition maps, for example, some small buildings at the north-east end of the stable and coach house range (now the estate office) was present in 1877 (circled on Figure 8) but had been removed by 1897. This indicates that there had been a resurvey of the site after 1877. The 1909 OS map (Figure 9) shows that some small additions had been made to the south-west elevation of the service wing – one of these being a bread oven enclosure.

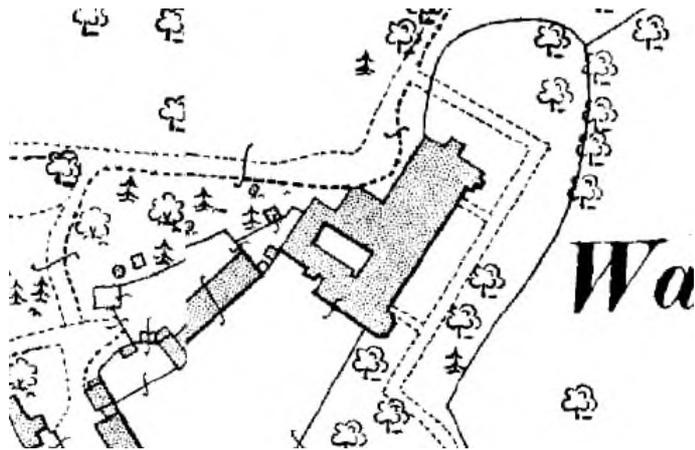
Figure 9
Ordnance Survey 3rd edition
25" map, 1909

- 2.10 George Edward Briscoe Eyre (1840-1922), George Eyre's grandson, employed the architect Philip Speakman Webb for extensive works undertaken to the service elements of the house and the remodelling of the area of the former conservatory to form a 'common room', Webb preparing drawings dated 1898. The new block was built on the north-east side of the service court, partly infilling the yard. This addition is shown on the 3rd edition 25" map of 1909 (Figure 9). Monica Giles, George's granddaughter, states that:

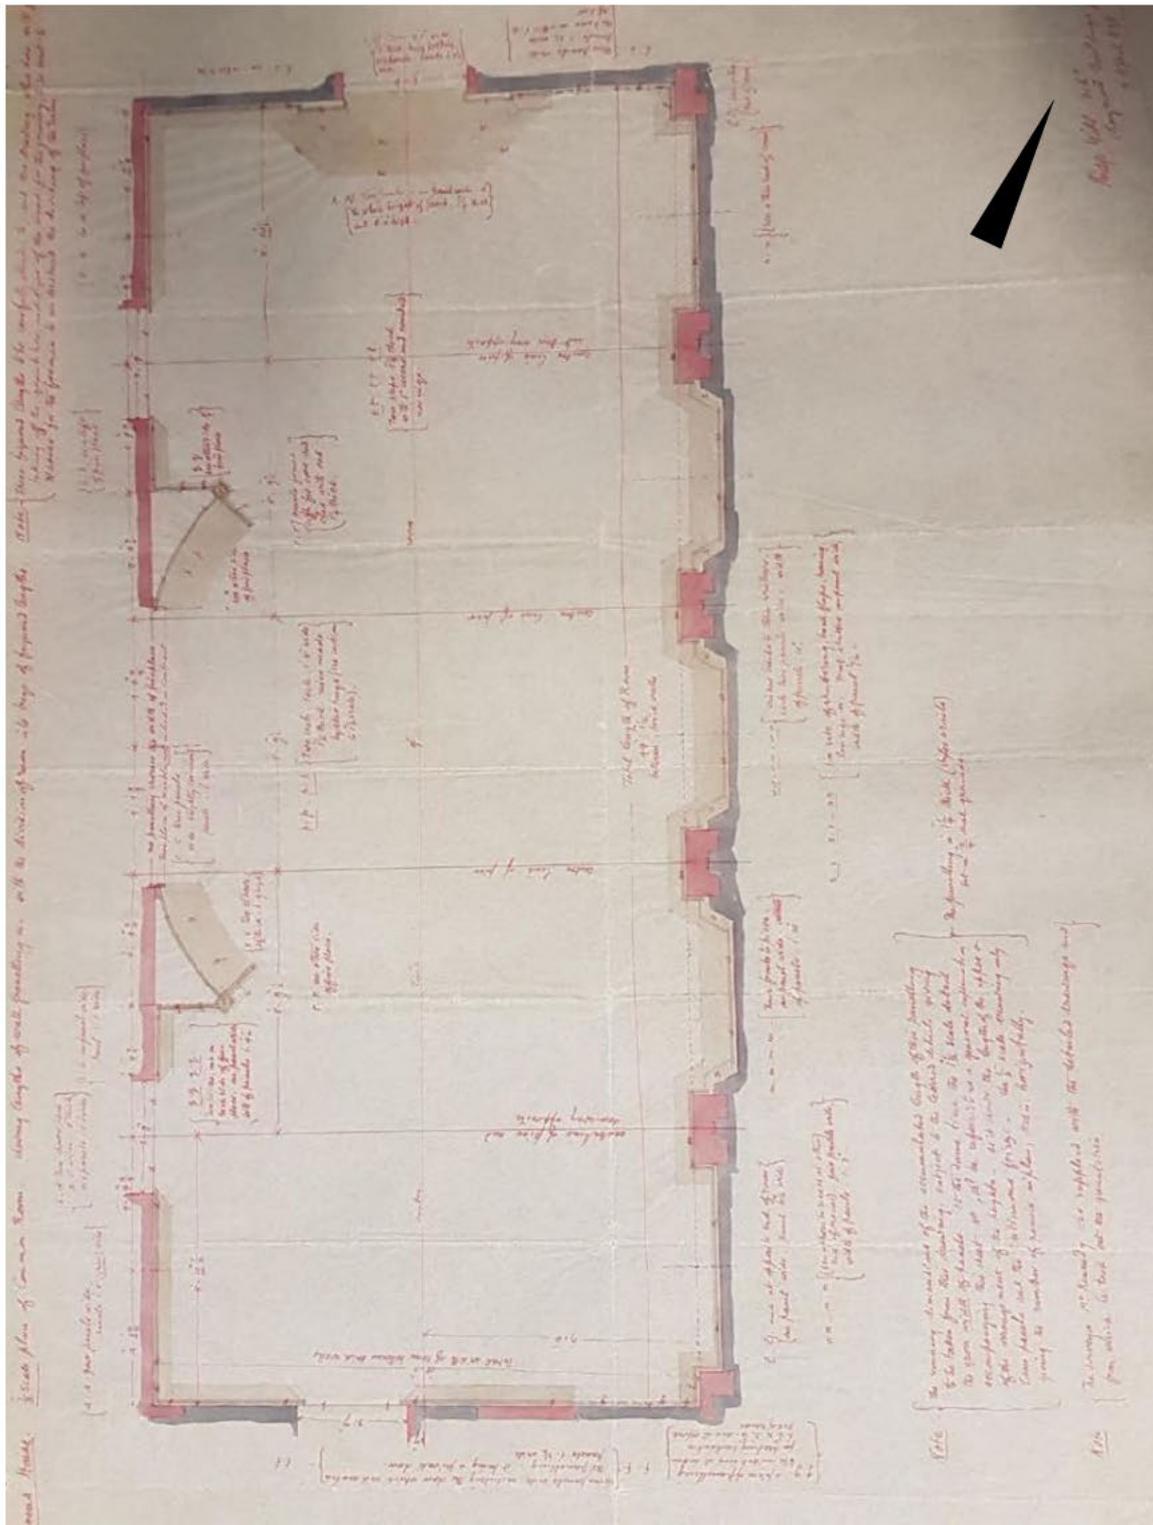
Figure 11 Plan of the remodelling of the 'common room', now the dining room by P.S. Webb, 1898.

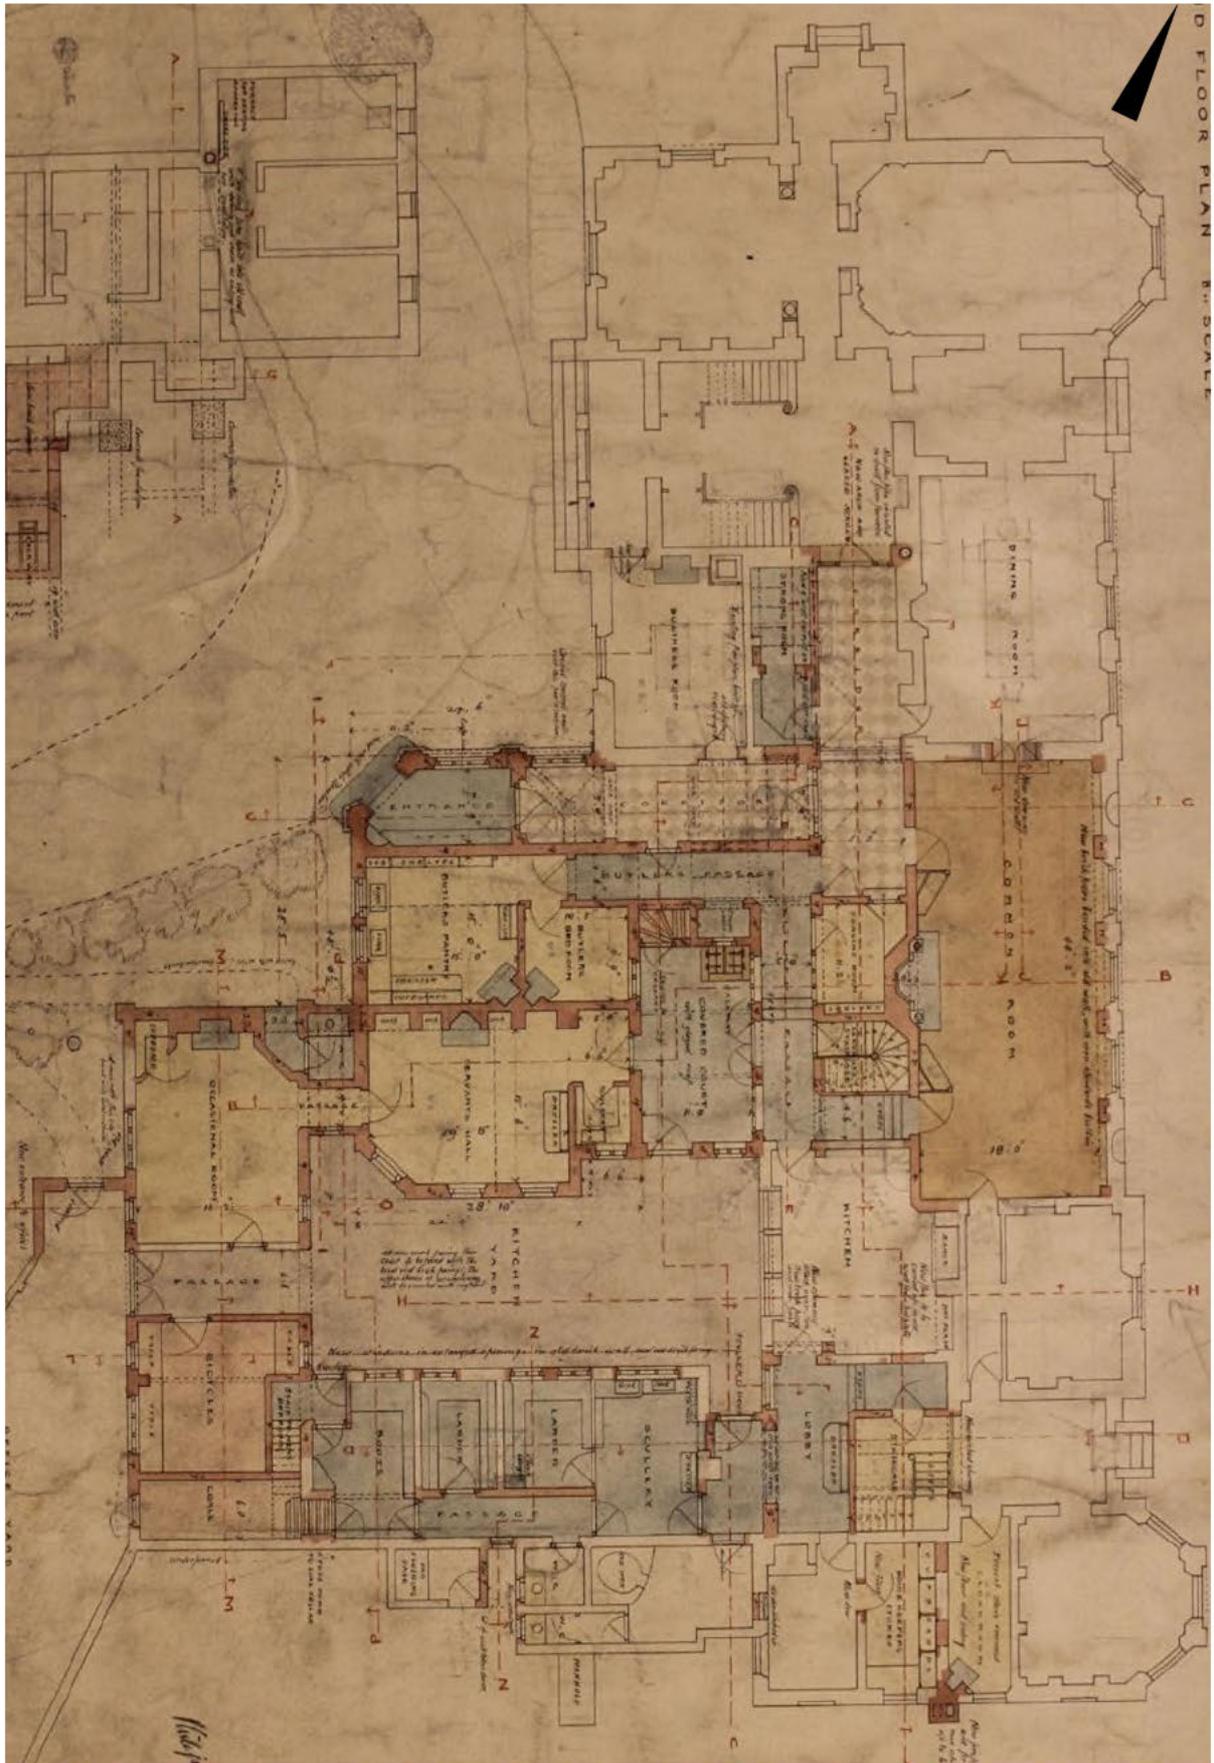
Figure 12 Philip Webb's ground floor plan, 1898, showing the proposals for the remodelling and enlargement of the service elements of Warrens. © SPAB Archive.

- 2.12 Webb's main work at Warrens was related to the provision of a new and considerably larger block for the servants, presumably replacing servants' accommodation which must have previously been largely within the south-western range accessed by a stair within what is now an entrance hall from a door in the south-west elevation (Figure 12). Webb retained the kitchen of the earlier house with some alteration but much of the existing service element was remodelled. The Webb scheme resulted in the erection of a three-storey block taking up a large part of the service yard in which there was a new servants' hall and butler's pantry at ground floor level with a new access to the cellar being formed leading from a covered court and also providing a new main entrance to the house. The present range along the north-west side of the service yard are remnants of Webb's scheme which provided an 'occasional room' and a bicycle store. The new block also incorporated a new principal entrance to the house, the access being along a corridor within the new building and leading to the corridor off the main entrance hall (Figure 14). Webb's only interventions into the Nash part of the house were within the former servants' hall and butler's pantry, a wall to the latter being repositioned to form a strong room, and the fireplace to this space being blocked up. Webb's plan of 1898 shows that he proposed to make some alterations to the building including the creation of the existing door to the oven room from the service area, replacing a doorway in the south-east wall. He also took down a short section of wall that linked to another small block which is visible on the 1909 map (Figure 4), which has since been demolished. The function of these smaller elements is not known. Webb inserted two small windows to serve two WCs in the north-west wall. Webb's plan shows that the oven was present in 1898 and the recent paint analysis indicates that it is contemporary with the enclosure building.

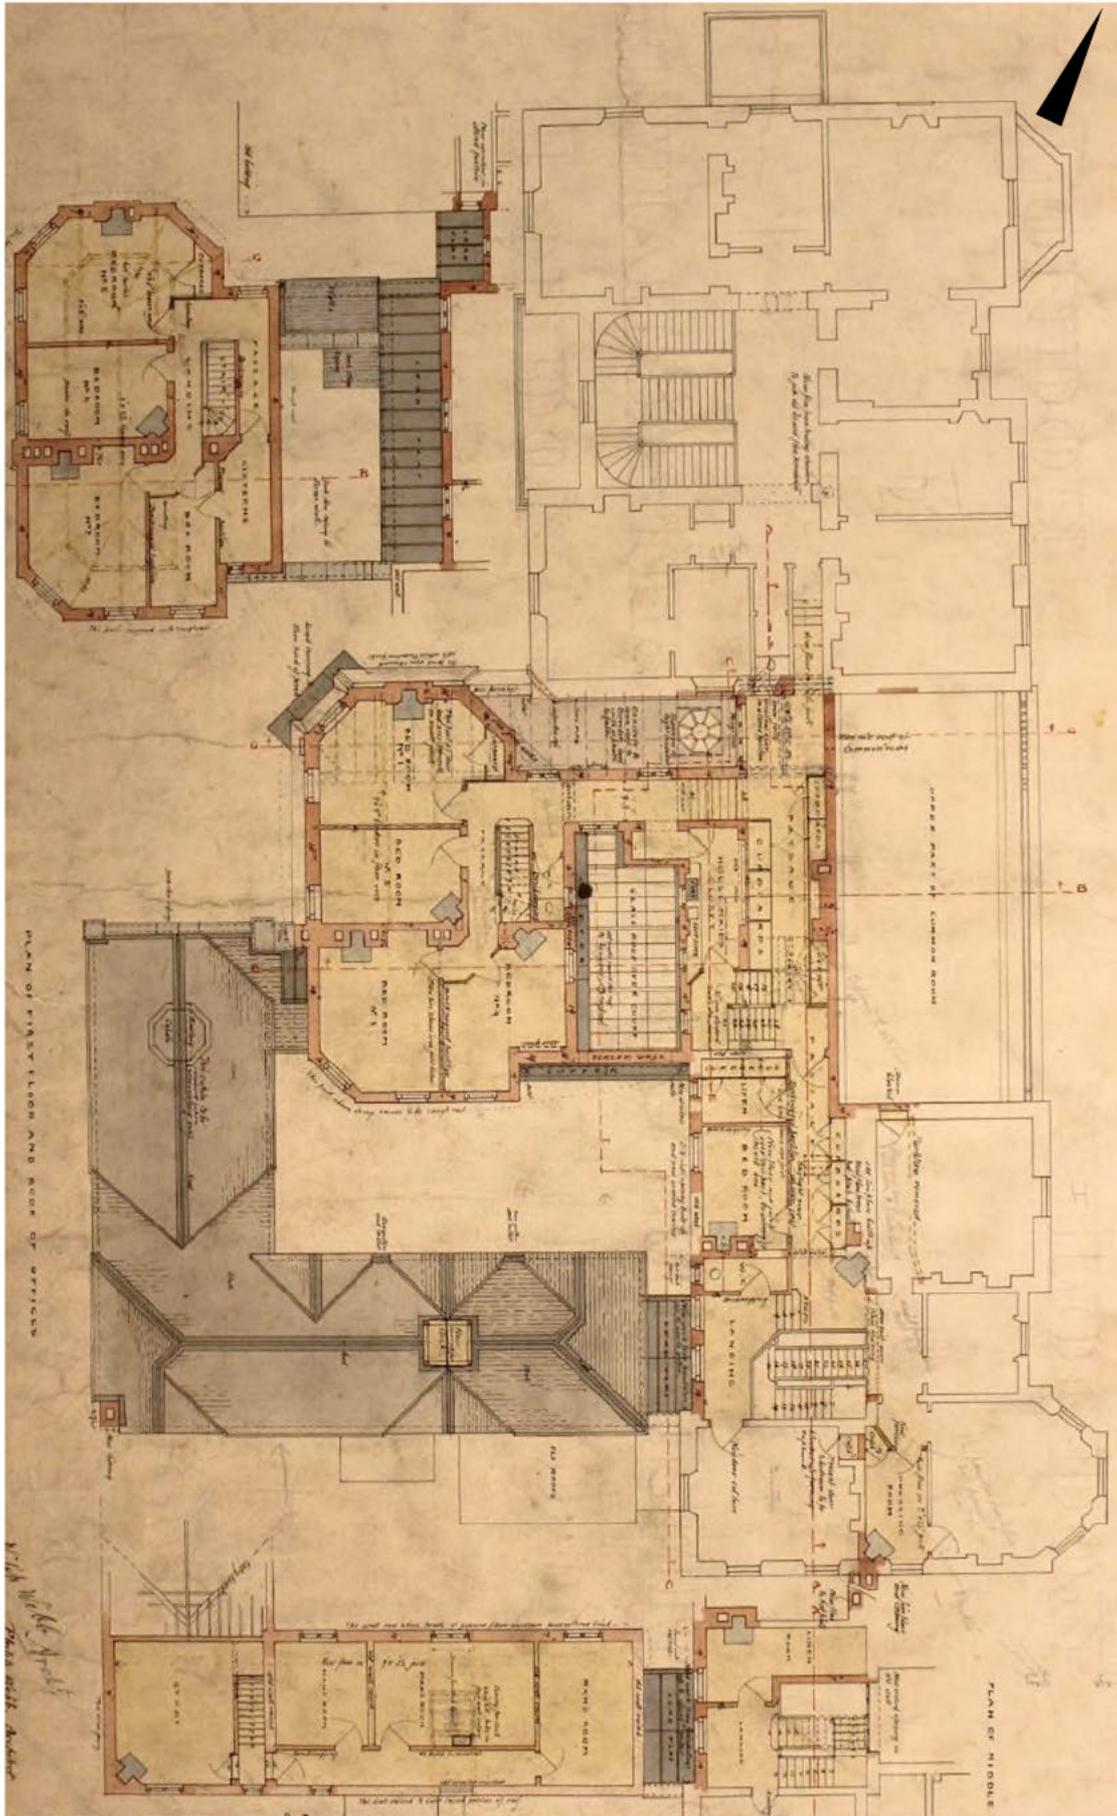
Figure 13 Philip Webb's first floor plan, 1898. © SPAB Archive.

- 2.13 The first and second floor levels of the new block provided bedrooms and further bedrooms for male staff were formed above the existing service range along the south-west side of the service yard (Figure 13).

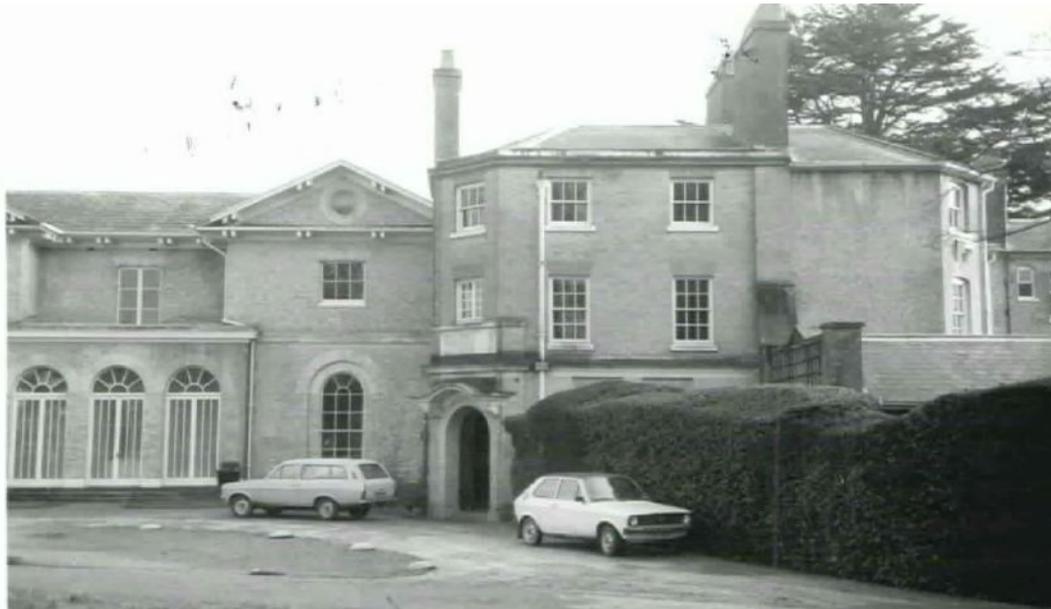
Figure 14 Photo of service block projecting forward of the main front of the Nash House taken before its demolition in 1980. The principal entrance of the house was relocated within this addition.

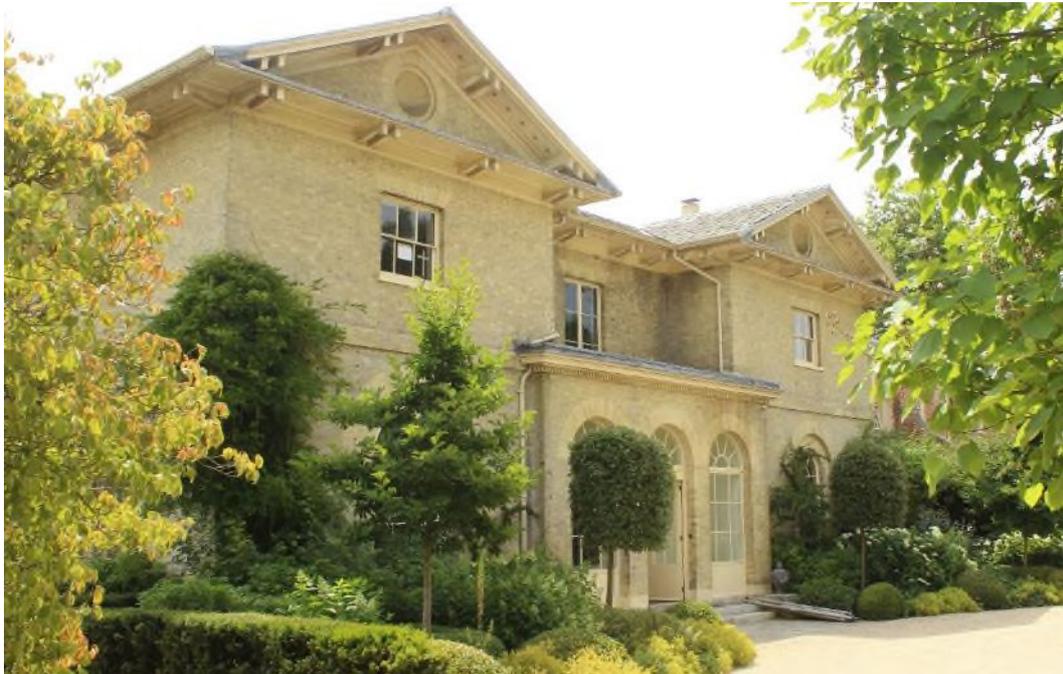
Figure 15 Front, north-west facing main entrance elevation of the Nash element of the house.

- 3.1 The front, north-west elevation of the house consists of two 'cross-wings' with pedimented gables with deep over-hanging eaves and large arched windows to the ground floor, three-over-three sash windows to the first floor and blind roundels within the pediments (Figure 15). A plain plat band runs across the elevation at storey height. Between the cross wings is a recessed section with a large casement window and at ground floor level, projecting forward of the cross-wings, is a single-storey flat-roofed porch having three arched headed openings, the outer two infilled with glazing with a door to the central opening. The list description suggests this porch is a slightly later addition, but it is shown on the Repton drawings when the openings were unglazed. An open porch like this is seen on some other Nash designs and is almost certainly part of the original house.

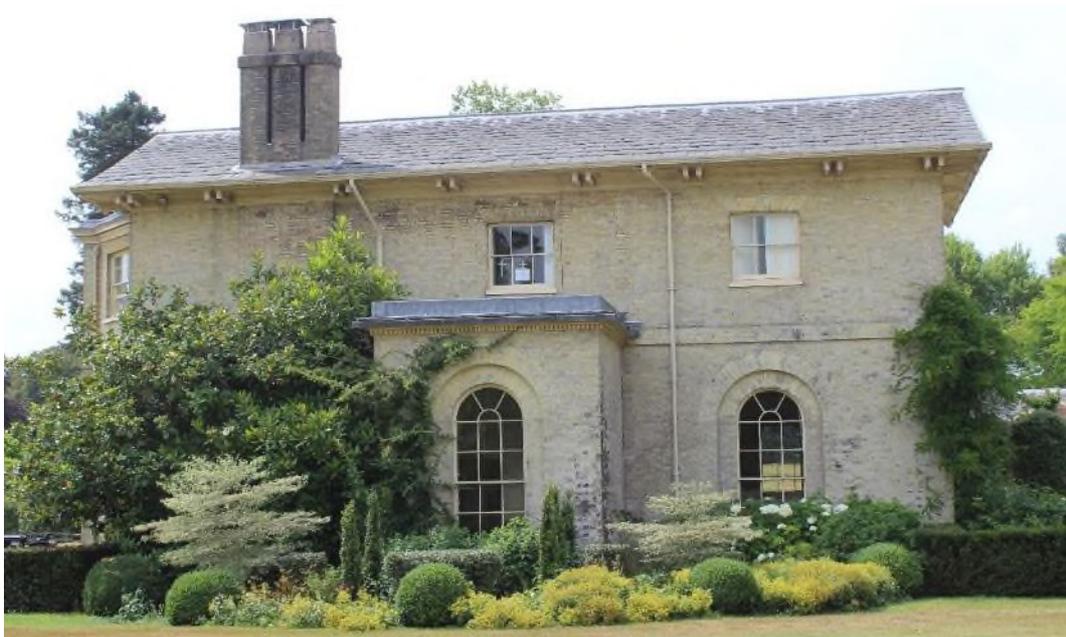
Figure 16 North-east elevation of the Nash house.

- 3.2 The north-east elevation has a small single-storey projecting element to the centre with a large arched window, which is matched by a similar window to the right (Figure 16). At first floor level there are two small square windows with three-over-three sashes. The plat band continues around this flank wall. To the left part of the elevation there is a large triple

chimney stack, the three flues rising as individual stacks from just above the roofline. The presence of the stack here means there are no windows to this part of the elevation.

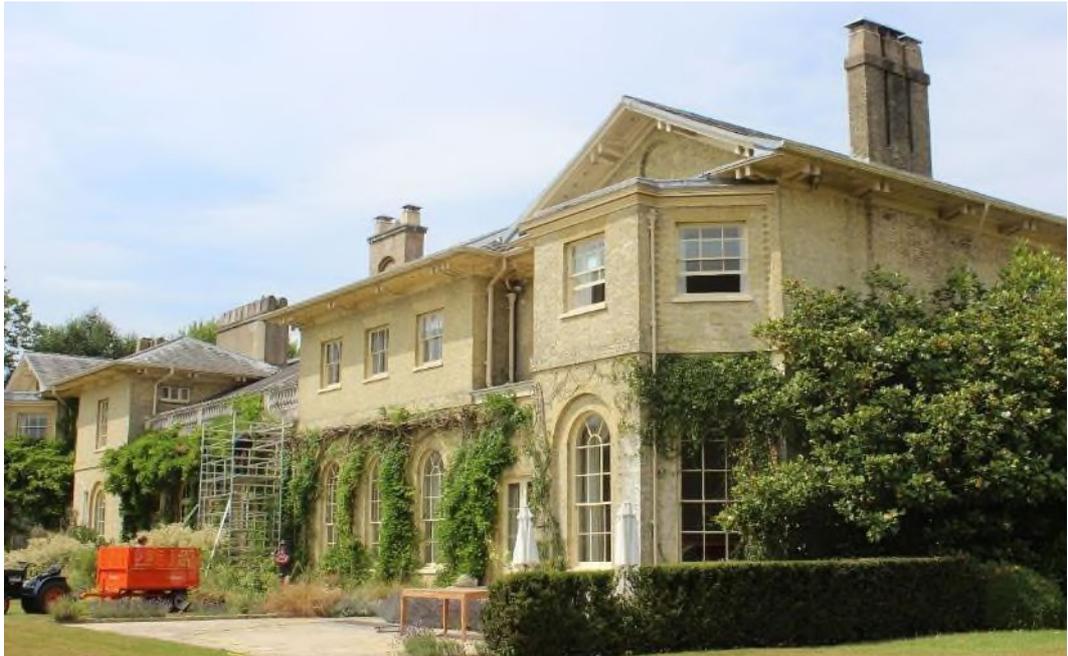
Figure 17 The garden front with the Nash house closest to the camera.

- 3.3 The south-east elevation is the main garden front and consists of a long elevation of several phases of development. To the right is the Nash house; the northern of the two cross-wings of the front elevation continuing through on the right-hand side with a blind roundel within the pediment (Figure 17). Below eaves level there is a canted bay with large arched window openings to the ground floor and three-over-three sash windows at first floor level. From one of the early 19th century illustrations of the house it appears that originally this canted bay was only at ground floor level and that it has been raised to two storeys where it rather crashes into the bottom of the pedimented gable. To the left part of the Nash house there is a wider, three bay section, the roof of the southern cross-wing returning to the north-east to form a hipped roof over this element. The fenestration pattern continues that seen elsewhere with large arched windows to the ground floor and three-over-three sash windows to the first floor. Between this section and the canted bay is a slightly recessed single bay with a doorway at ground floor level and a single window at first floor level. On the south-west flank wall of the Nash block a short section of the rubbed brick arch of a first window is visible where the opening has been largely concealed by the roof of the attached range.

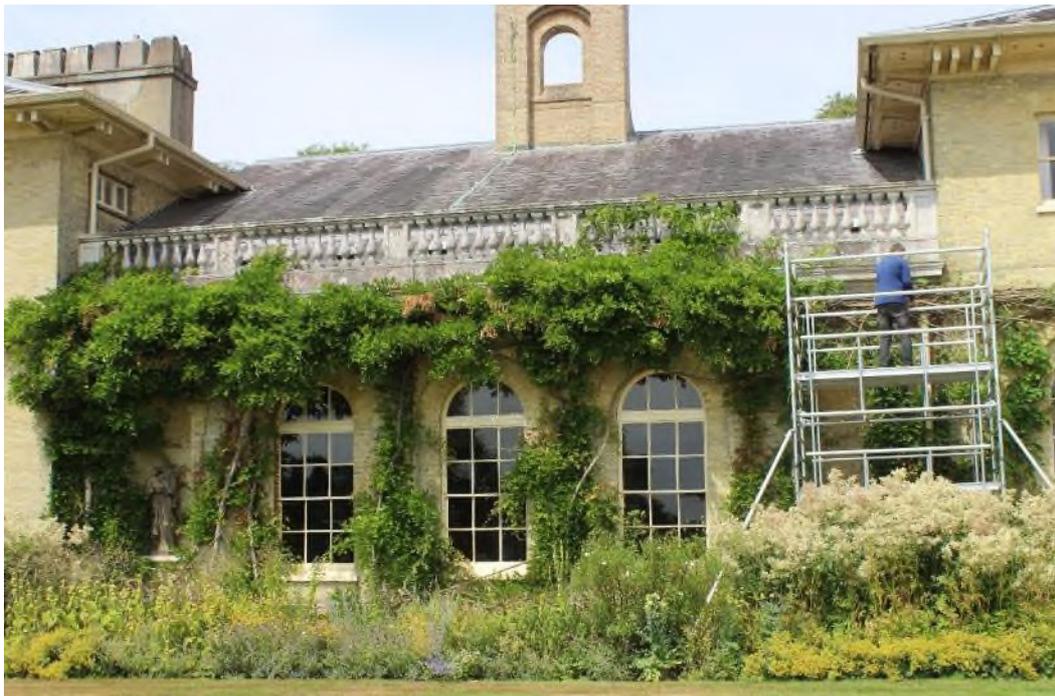
Figure 18 South-east elevation, central single storey element remodelled by P.S. Webb in 1898/9.

- 3.4 Attached to the south-west of the Nash house is a slightly lower five bay range with three arched-headed sash window openings with dome headed niches either side (Figure 18). This element is expressed as a single-storey building on this elevation with a stone balustrade concealing the eaves of the roof. From the ridge rises a large stack of two flues with an arched opening piercing the wide stack. Whereas the round-headed windows elsewhere on the house have radiating glazing bars, the glazing bars to the upper part of these windows are vertical and there is a heavy cross-member marking the division between the sash window below and the 'fanlight' above which means they lack the finesse of the other round-headed windows.

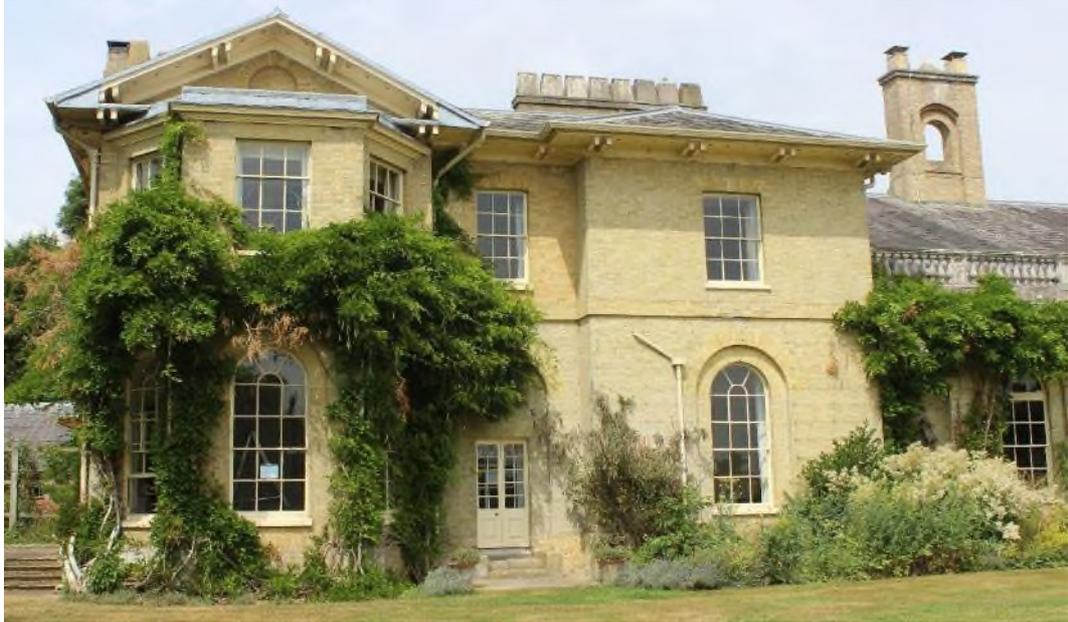
Figure 19 The south-western section of the south-east elevation.

The next section to the south-west initially appears to be of a single build, reflecting the Nash element to the north-east, with a canted bay to the left below a pedimented gable with a blind roundel, a slightly recessed section with double doors at ground floor level and a single window above and a single bay with a large round-headed opening to the ground floor and a sash window above (Figure 19). The sash windows to this single bay and the slightly recessed bay are six-over-six sashes without horns whilst to the canted bay the first-floor windows are three-over-six sashes without horns. Behind the single bay element to the right of this block there is a massive block of a chimney stack seemingly containing 12 flues;

eight in line on the south-east side and a further four on the north-west side. Whilst this element of the house initially appears to be a single phase, examination of the brickwork at the junction between the single bay to the right and the recessed bay to the centre indicates that there are two phases of brickwork with a distinct the join between the two which has been rather crudely infilled with mortar and the horizontal joints in the brickwork do not match up.

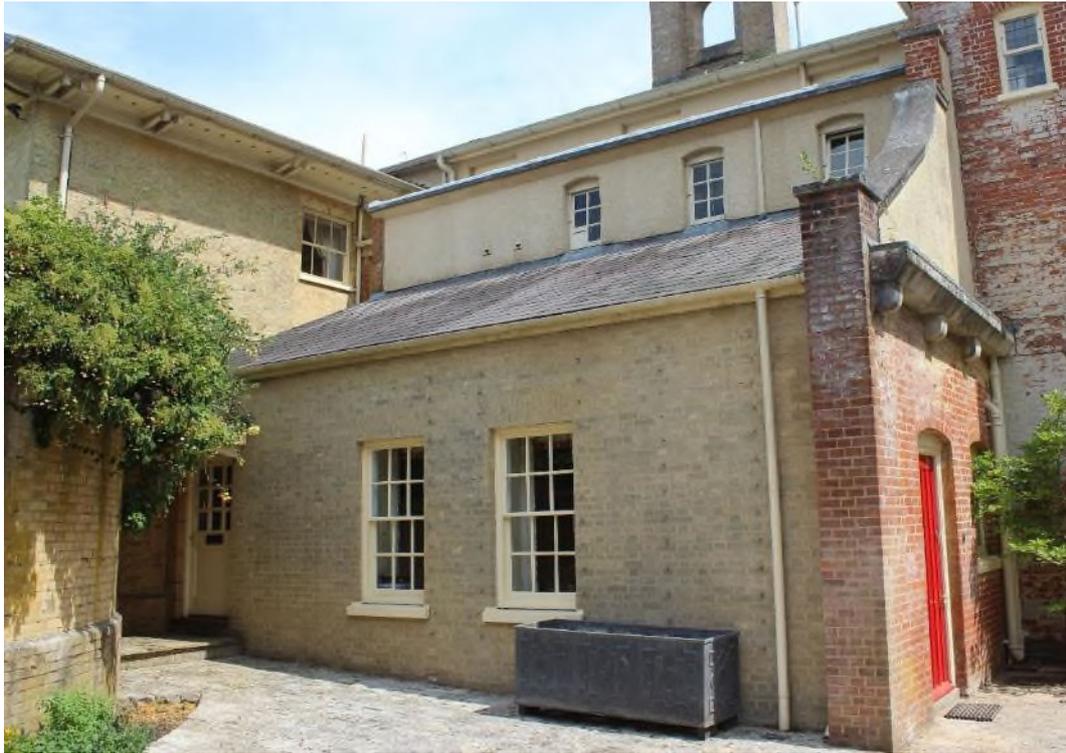
Figure 20 Modern mono-pitched roof addition adjacent to the main part of the Nash house.

- 3.8 The north-west elevation of the later elements attached to the Nash house form a rather muddled combination of elements which have been subject to considerable alteration. Most of this element also stands in contrast to the rest of the house in that it is mainly constructed in red brick. Adjacent to the flank wall of the Nash house is a single-storey block with a mono-pitched slate roof constructed in a buff brick, above which is a rough cast render wall with three small six pane centrally pivoting windows topped by a flat or shallow mono-pitched lead roof above which are a further three window openings (Figure 20). The north-west wall is modern brickwork which runs up to a taller wall constructed in red brick with a very heavy stone cornice supported on three rounded brackets, above which the wall has roughcast render and topped by stone copings. This is part of Webb's work, this element being the covered courtyard that had a glazed roof.
