WARRENS, BRAMSHAW, HAMPSHIRE

Heritage Statement

Statement of Significance

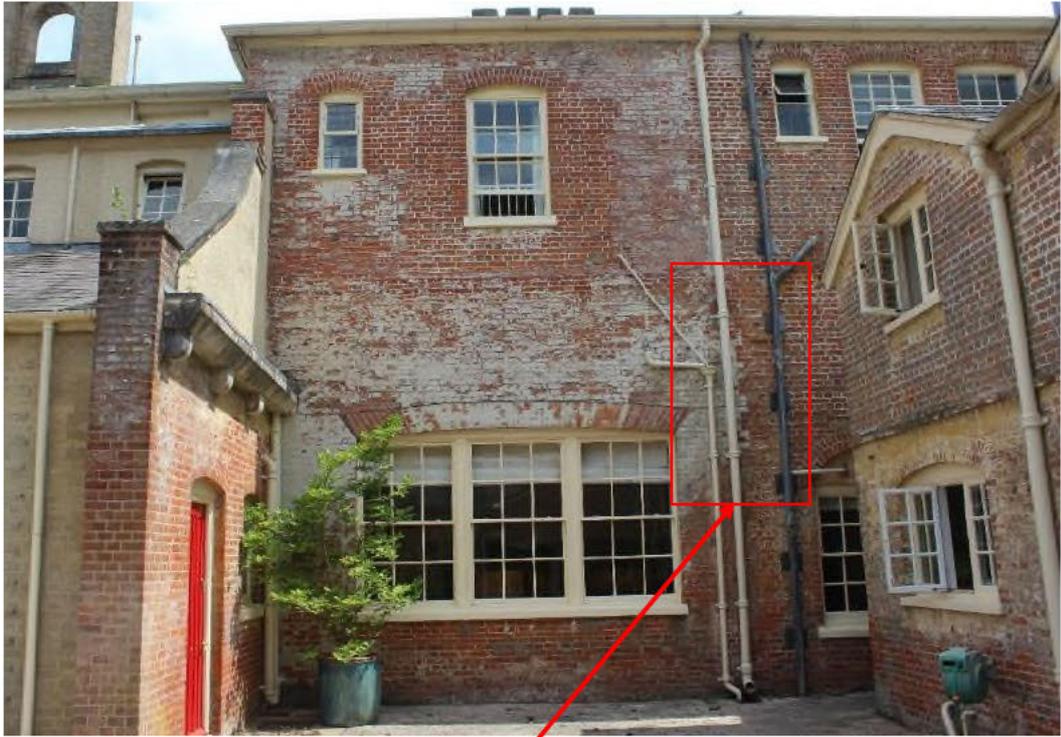
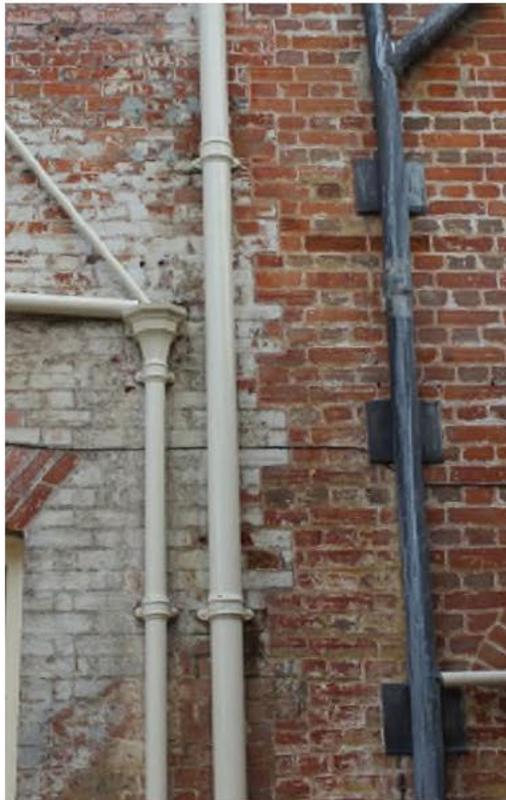
Figure 21
North-west elevation of the service range with a detail showing the keyed junction between the two phases of construction.

- 3.9 To the south-west the range is a taller two-storey block; the first section has a very large window consisting of three six-over-six sash windows set side-by-side under a shallow segmental brick arch lighting the kitchen with a six-over-six sash and a small leaded light window at the upper level (Figure 21). To the next section to the south-west there are three tiers of openings. These two sections are constructed in red brick and are of different phases of construction marked by a vertical joint in the brickwork, the brickwork being keyed together in blocks of three bricks deep (see inset Figure 18). The section to the left incorporating the large kitchen window is constructed in Flemish bond whereas the section to the right is constructed in English bond. The upper part of the wall of the left-hand section in particular has been altered with a clear section of rebuilt brick (in English bond) around both of the window openings – changes which are shown on Webb's drawings.

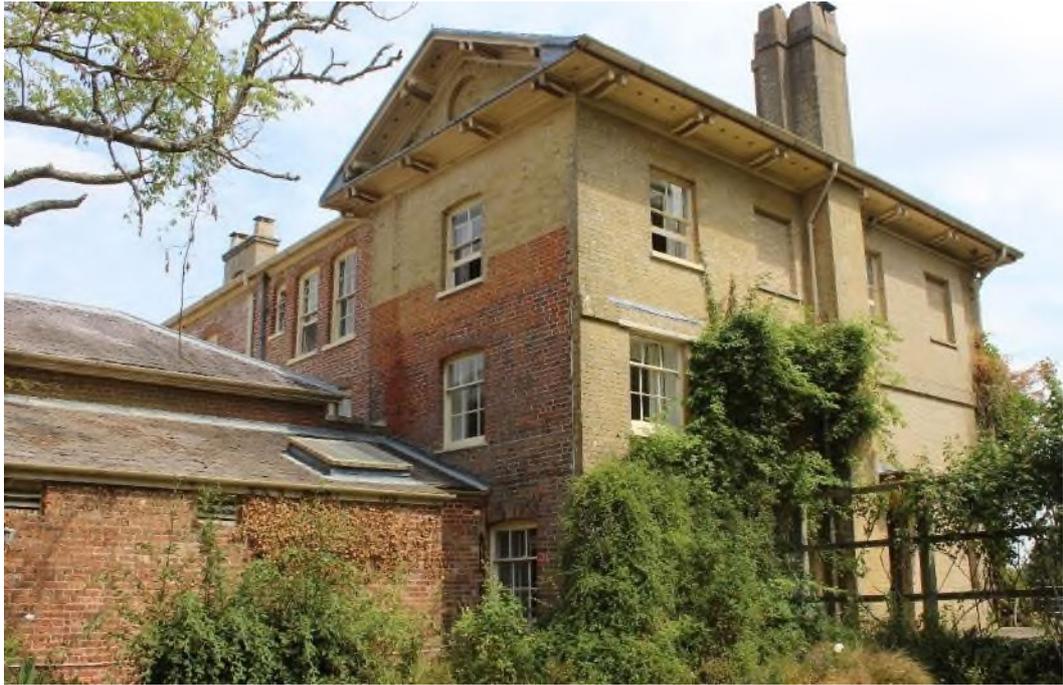
Figure 22 The north-west elevation of the south-western element of the house.

- 3.10 At the far south-west end of this range the single bay 'cross-wing' which has the canted bay to the south-west also has a pedimented gable with a blind roundel within the gable (Figure 22). Only the top quarter of the wall is constructed in buff brick with red brick for the remainder. This change of brickwork is not at floor level; it cuts across the lower part of the second-floor window and suggests that only the upper part of the elevation would have been seen from when approaching the entrance front of the house. The buff brickwork is laid in Flemish bond but the red brick section is laid in English bond. Beneath the first-floor window there is a vertical joint and below the right-hand reveal of the window where a mono-pitched single-storey structure now abuts this section of wall.

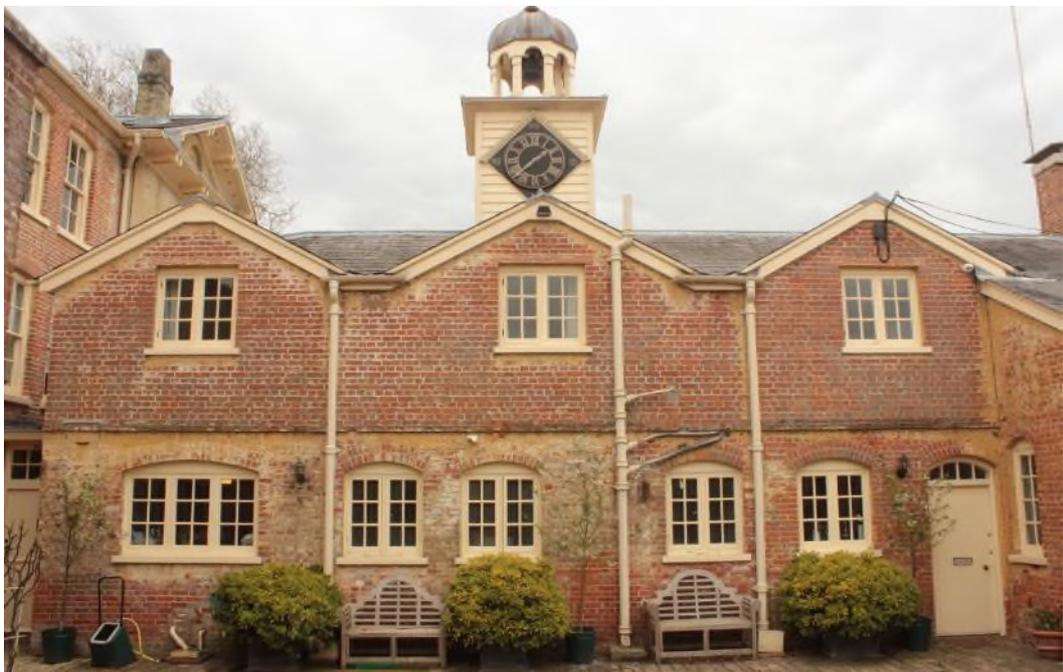
Figure 23 The north-east elevation of the service wing on the south-west side of the service yard.

- 3.11 On the south-west side of the service yard is a two-storey range constructed in red brick of two clear phases indicating that a single-storey building has been raised to two storeys (Figure 23). At ground floor level there is a three-light casement, four 2-light casements and a door, all under segmental brick arches. The upper storey has three gables, each with a two-light casement window extending off the main roof aligned north-west – south-east. To the centre is a clock tower.

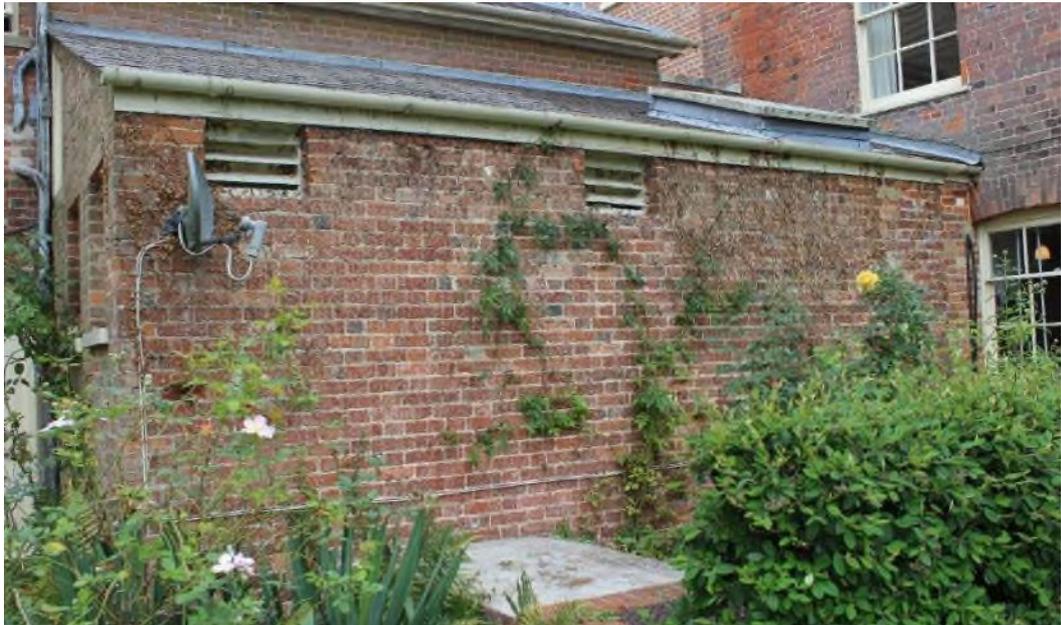
Figure 24 The lean-to housing the bread oven, south-west elevation.

Extending off the back of the service range, which is largely blank at ground floor level, is a single-storey lean-to which encloses the bread oven (Figures 24 and 25). This structure is a simple, brick and slate structure of utilitarian character. The brickwork, which is laid in Flemish bond, is of limited quality and there are only two small vents at high level on the south-east elevation and a small vent at internal floor level – otherwise this elevation is blank brickwork. The mono-pitch roof is covered with slate and has a large modern rooflight which stands proud of the slates above the oven area. The north-west elevation has two windows which were inserted by Webb after 1898 and a hatch to the roof void. To the east there is a narrow section of brickwork which is recessed from the face of the south-east elevation so that it avoids a window in the wall of the main house, but it still has a poor relationship with the window – the brickwork abutting the window frame. This brickwork is of markedly lower quality than the main block of the enclosure building (Figure 26).

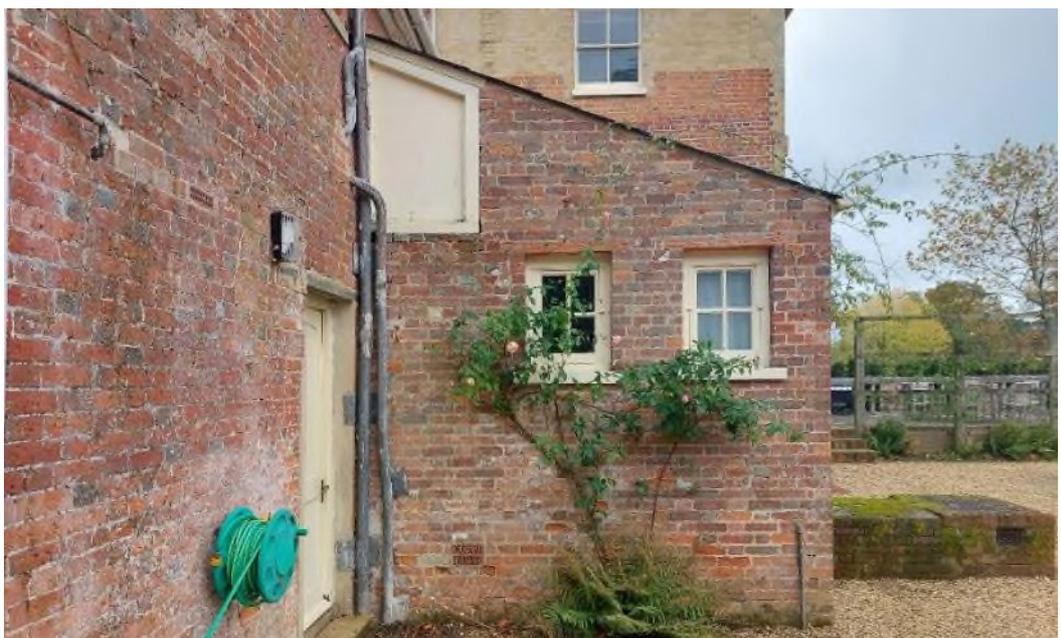
Figure 25 The north-west elevation of the bread oven building.

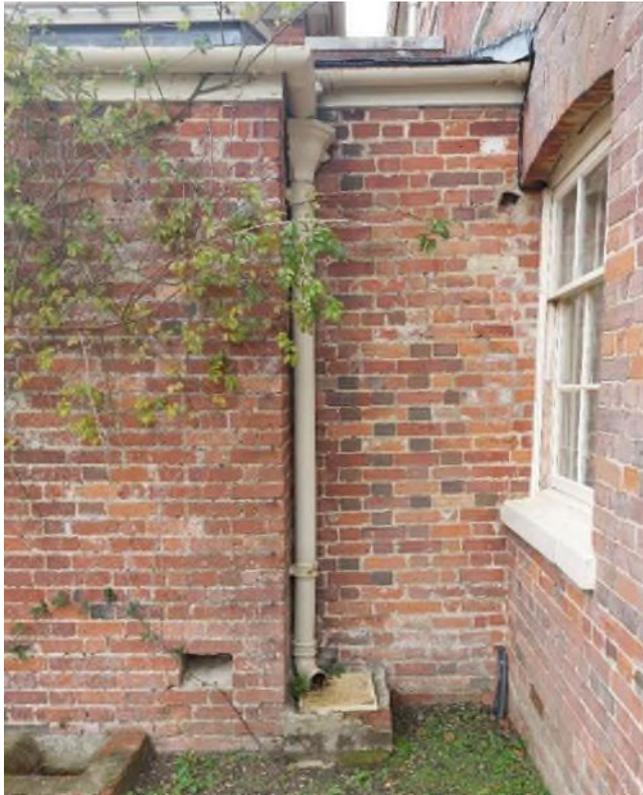
Figure 26
The short section of brickwork which is recessed so that the south-west wall of the oven building avoids the adjacent window to the right. The quality of this brickwork is lower than that of the main block of the oven building.

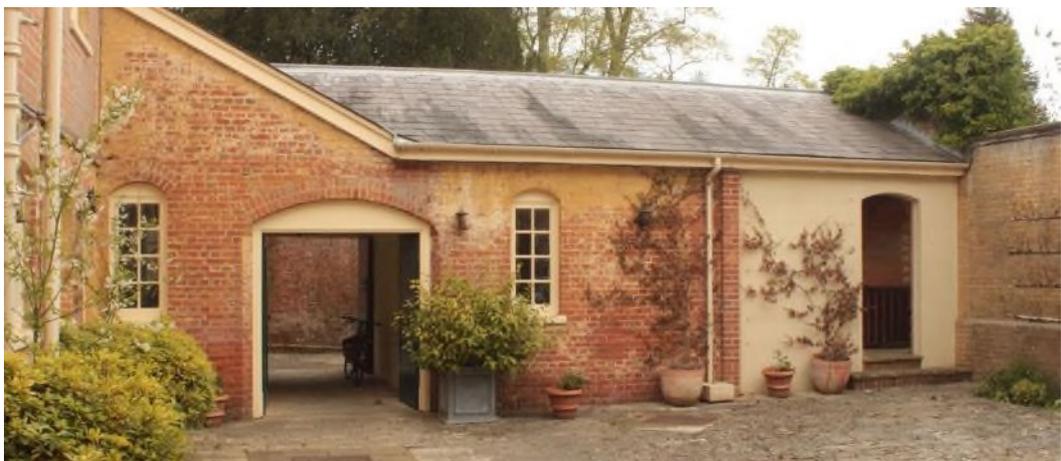
Figure 27 The remnant of Webb's service range, originally a bicycle store to the left of the arch and a space described as 'occasional room' to the right which was accessed through a blocked door now within the rendered section of wall.

On the north-west side of the service yard there is a single-storey range which consists of a lean-to element extending off the two-storey service wing with a slate roofed range attached which was added by Webb and was linked to the servants' block demolished in the 1980s (Figure 27). At the junction of these two elements there is a wide archway leading through to the stables and coach house. There are two single-light windows of eight panes, one either side of the archway. This range was built as part of the Webb phase of works and provided a bicycle store to the left and the room described as an 'occasional room' to the right. The rendered section to the right conceals a blocked doorway which linked the occasional room to the now demolished servants' hall whilst the opening provides a cut through to the forecourt to the front of the house.

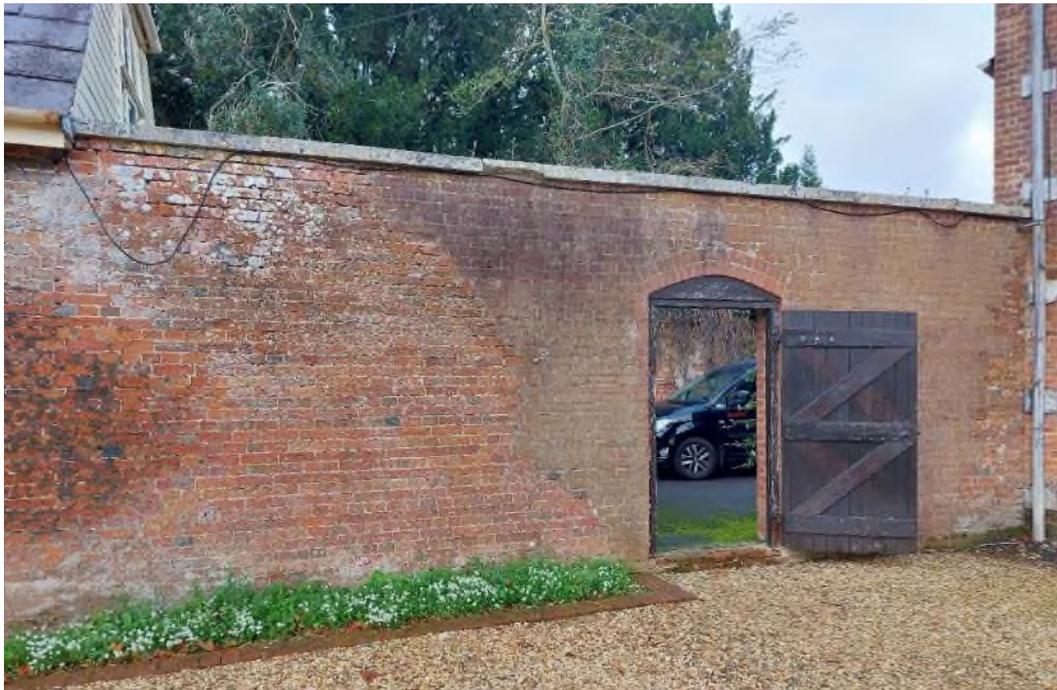
Figure 28 The wall between the estate office and the service range, south-east side.

Attached to the north-west end of the service range and linking to the estate office building, formerly the coach house, is a tall brick wall which closes the gap between the kitchen garden area and the access to the service yard. Over half of the wall is of modern brickwork laid in English bond to match the main section of older brickwork to the south part of the wall (Figure 28). This modern brick is very consistent in colour, unlike the historic brickwork which has a subtle variation in colour but is typical 'Hampshire reds' brickwork. Within this area of modern brickwork, which can probably be dated to the 1980s as there is a commemorative brick relating to the wedding of Prince Charles and Diana Spencer, is a door opening with a segmental arch over and a modern ledged and braced door to the opening. The north-west side of the wall is largely covered by ivy growth. The wall is capped by flat, square-edged coping stones. The wall rises to the height of the eaves of the estate office.

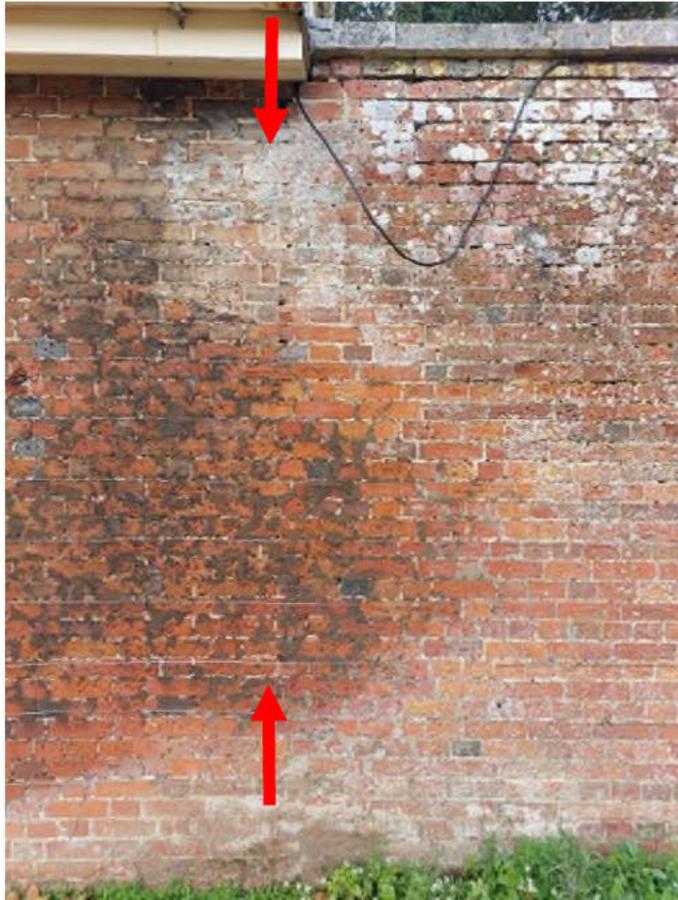
Figure 29
The junction in the brickwork between the estate office (left) and the wall closing the gap to the service wing showing the presence of queen closers which mark the original corner of the coach house. The change in brick bond can also be seen.

The junction between the wall and the estate office is not a straight butt joint but examination of the brickwork shows that the wall is a later phase of construction and not a contemporary continuation of the rear wall of the estate office. This is shown by the presence of queen closers in the brickwork of the estate office which would have closed the brickwork to the corner of the estate office before the wall was constructed, marked on Figure 29. The different phases of construction are also shown by the change in brick bond used – the estate office brickwork is laid in Flemish bond whereas the wall is laid in English bond.

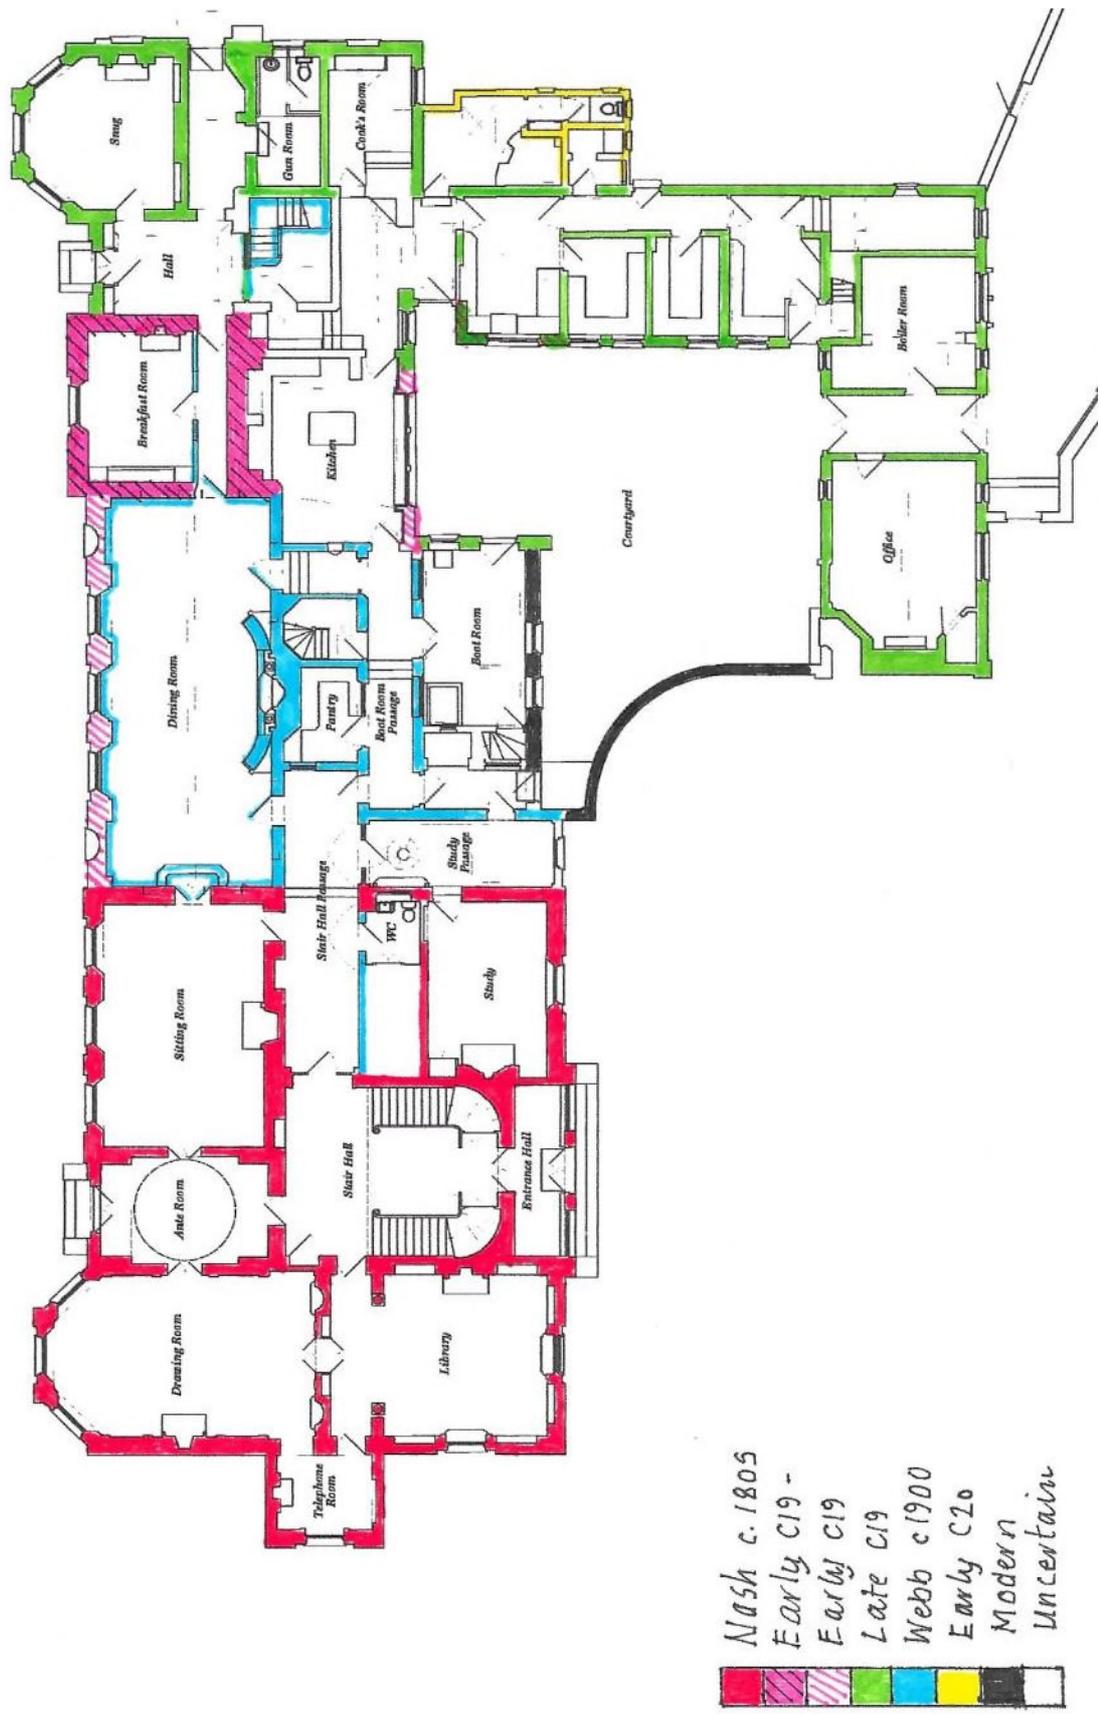
Figure 30 Ground floor plan showing main phases of development

Interior (see ground floor plan, Figure 30)

Internally, within the main rooms of the Nash house there initially appears to have been very little substantial alteration to the fabric; the early 19th century character is strongly represented with original fireplaces and door cases typical of the early 19th century. There are, however, subtle differences between the flower heads which decorate the upper corners of the doorcases that face into the entrance hall compared to those on the room sides (Figure 31). Both of these forms contrast to the form of flower head used in the later parts of the house. Probably the main change in this part of the house is the replacement of the original staircase; the list description refers to a stair of 'polished mahogany', but the present stair is constructed in oak with modern wrought iron balustrades. It is assumed that the reference to a Doric screen in the library in the List description is in error; the screen is of the Ionic order. Other minor changes include the creation of an opening between the drawing room and the small dressing room in the projection to the north-east elevation; an alteration that has been rather clumsily detailed. The drawing room is no longer octagonal (if it was actually built as such); the infill to the north-western corners of the drawing which created the octagonal form have been removed but the cornices cut across the corners reflecting an octagonal form. However, the detailing of features such as the dado rails and skirtings matches exactly that of the side walls so do not offer evidence for change in these corners. The hidden double doors between the drawing room and the library are not shown on Repton's plan and have flower heads of the later form to the upper corners of the door case. There has also been change to the service corridor off the entrance hall and the butler's pantry, the hallway being made wider, and the butler's pantry reduced to a WC (this being a strong room when Webb made these changes after 1898).

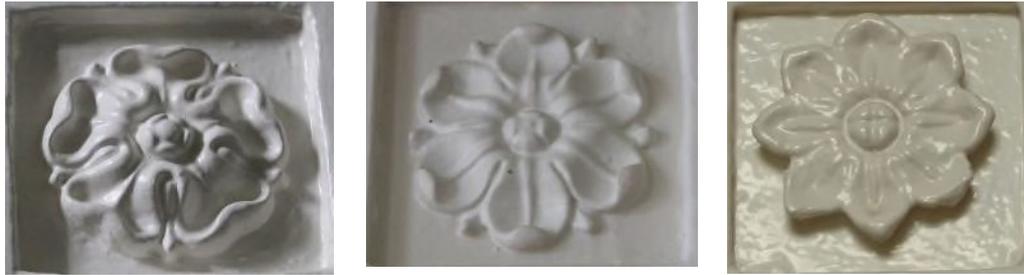
Figure 31 The flower heads used to decorate the top corners of the doorcases; left: main entrance hall/stair compartment; centre: principal ground floor rooms in the Nash part of the house; right: late 19th century addition to the south-west and double doors between the main entrance hall and the drawing room.

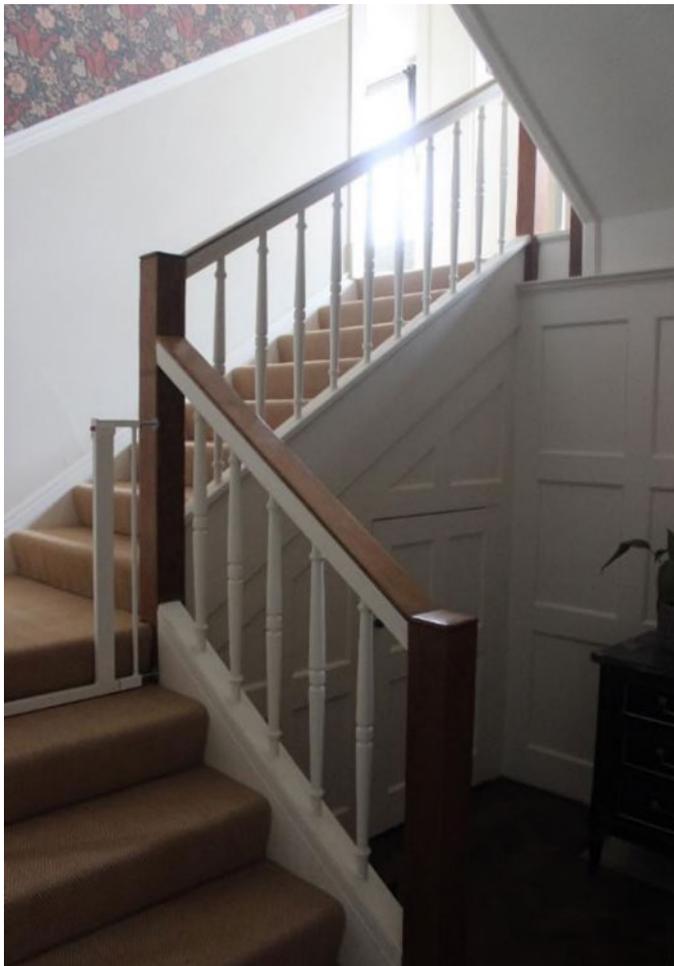
Figure 35
Webb's south stair of 1898
within its panelled compartment.

- 3.20 To the north-west side of the entrance hall within the south-western block is a timber screen, with glazed lights above designed by Webb. This screen separates the hallway from a staircase, described as the 'south stair' by Webb on his drawings for the staircase, the compartment being lined by plain panelling. This is a rather simple staircase, having plain square newel posts and stick balusters; this was not a servant's stair but gave access to

additional family/guest bedrooms one Webb's new servant's block was built, taking the servants accommodation out of the main house (Figure 35).

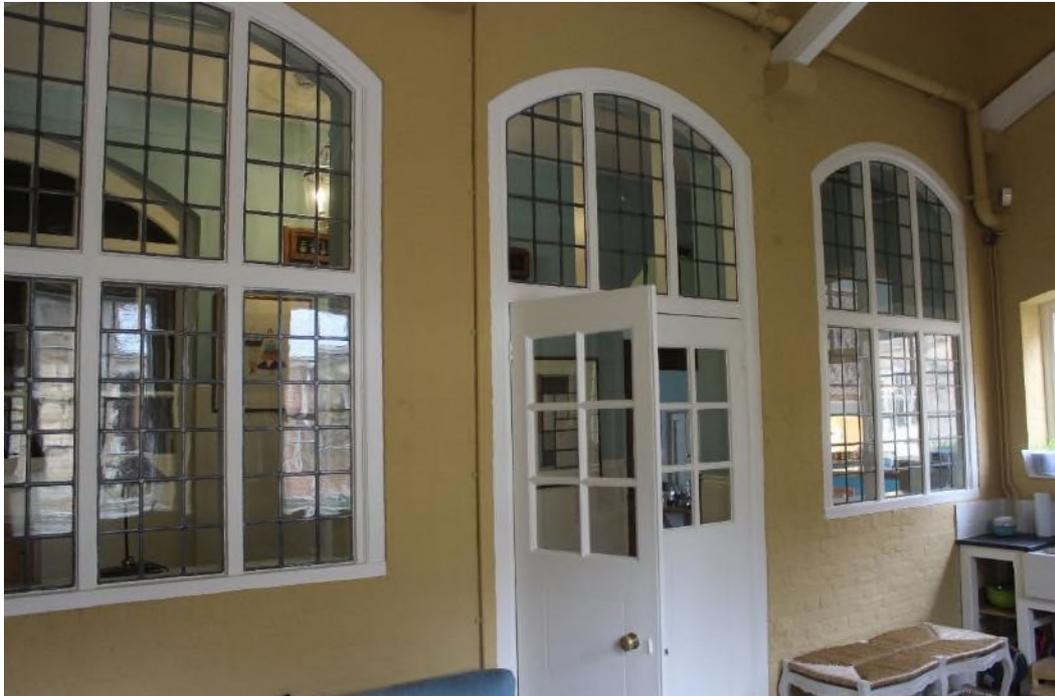
Figure 36 Webb's windows and double doors between the service passage and the former covered yard.

- 3.22 Between the kitchen and the Nash house is a corridor with a newel stair and a small store which was described by Webb a 'serving room'. Two doors give access to Webb's common room. On the north-west side of this service passage is the mono-pitch roofed building standing on the site of Webb's covered courtyard, separated from the passage by a wall with two large leaded light windows and a pair of double doors with leaded lights above (Figure 36).

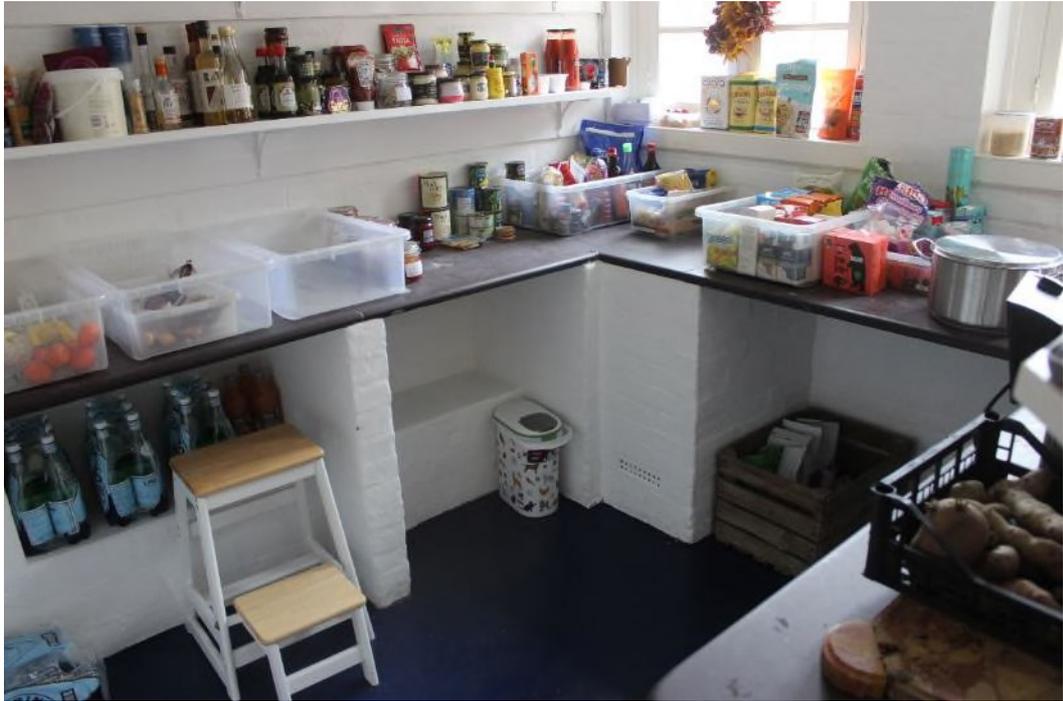
Figure 37 A larder with slate shelves within the service wing.

- 3.23 The area south-west of the kitchen and north-west of the south stair is a relatively large back entrance hall and passage between the kitchen and the service wing on the south-west side of the service yard. Built against the stair compartment is a dresser which is likely to be the dresser marked on Webb's plan.
- 3.24 The service wing is divided into four spaces, the first occupying the full width of the range and being a small back kitchen or scullery. A corridor runs along the inside of the rear wall of this wing from this kitchen giving access to two further small rooms, both of which retains slate shelves supported on low brick walls with the second room having a series of large hooks to the ceiling suggesting that this may have been a meat larder (Figures 37 and 38). The fourth cell of this range also has slate shelves to two walls. A small lobby has been

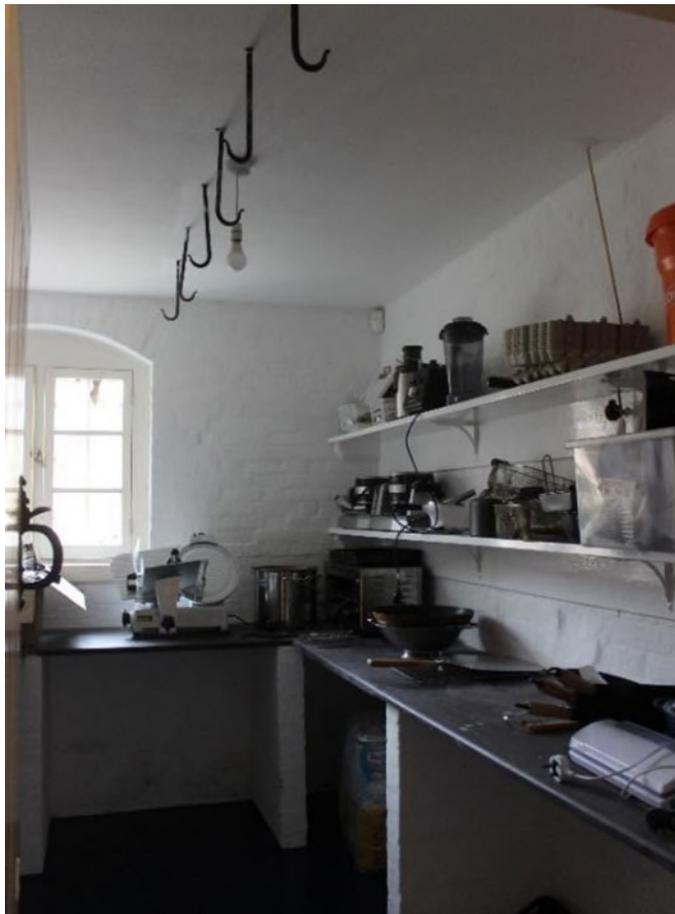
Figure 38
A probable meat larder
within the service wing.

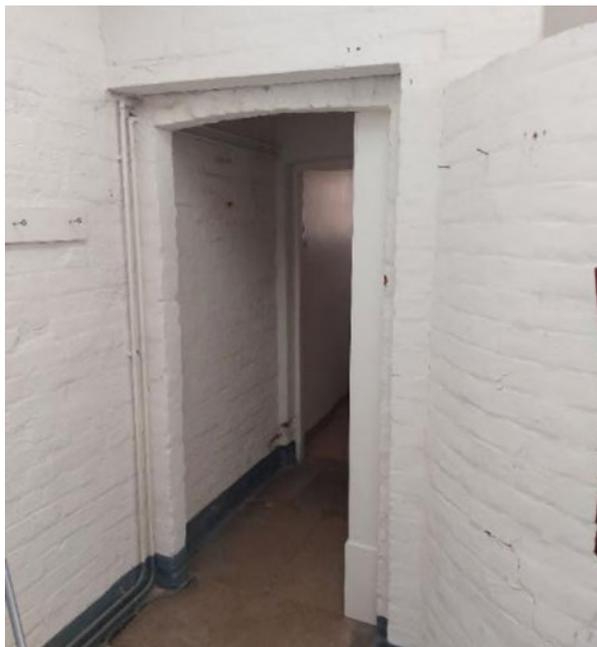
Figure 39
The opening from the oven room to the WC showing the square-headed opening with a segmental arch to the second skin of brickwork, the same arrangement used for the second door to the WC which can be seen in the background.

3.26 The oven is located within a recess to the north-western part of the oven room which has the former external wall of the service range to the north-east, the wall between the oven room and the former WC (now storeroom) to the north-west and a full height wall to the south-west which returns to the south-east to the outer wall of the enclosure building. Within this wall is an opening which leads to the WC to the north-west. This opening shows that the wall is of double skin brickwork with the skin on the oven room side having a square-headed opening with a timber lintel over whilst the other skin of brickwork has a segmental arch over (Figure 39). This arrangement is also seen to the second door to the WC where the square-headed opening is on the WC side and the segmental arched opening to the corridor side. At this opening however, there is a door frame in the square-headed opening but there is no frame in the opening from the oven room. The paint analysis indicates that the brickwork of the segmental arch has always been exposed to the oven room as it has the same paint sequence as the walls and so, whilst the construction of this opening suggests that it was intended to have a door frame, it appears that one was not fitted. Webb's plan, which shows a door opening into the corridor (whereas it would have opening into the oven room) is, presumably, a survey error.

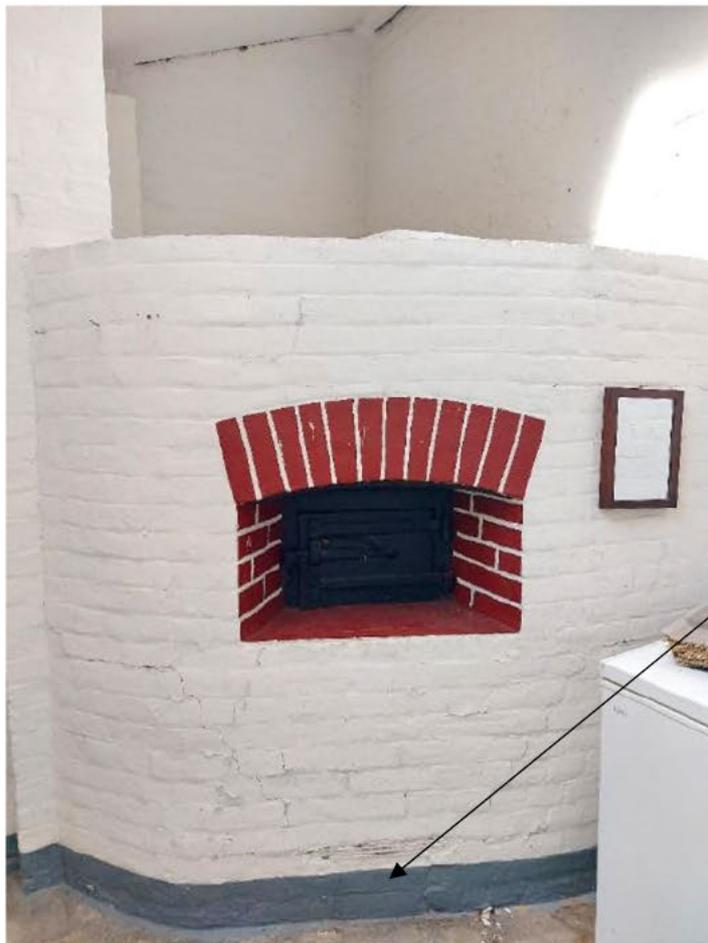
Blocked opening
to ash pit

Figure 40
The oven within the lean-to
structure against the south-
west elevation of the service
wing.

- 3.27 The oven is also constructed in brick which has been painted white with the brickwork of the arch over the oven opening and the reveals to either side painted red (Figure 408). At floor level there is a small, blocked opening which gave access to the ash pit. The oven opening has a cast iron door that does not bear a maker's name (Figure 41). The door has two horizontal straps attached to the face of the door which serve as pintle hinges, and a latch with a spring above which presses against the upper hinge strap. Within the cill of the oven opening there is a blocked opening where the ash being removed from the oven after firing would be deposited in the ash pit below, which has been blocked (Figure 42 and Figure 47). An iron bar forms the lintel above the oven opening which supports the brick on edge arch over. Behind these bricks is the flue where smoke from the firing of the oven could escape (Figure 43). The flue runs over the top of the oven chamber before rising in a chimney set in the corner between the north-west wall and the wall forming the south-west side of the oven (Figure 44). The tiles covering the flue are supported on several iron bars which span the flue (Figure 45).

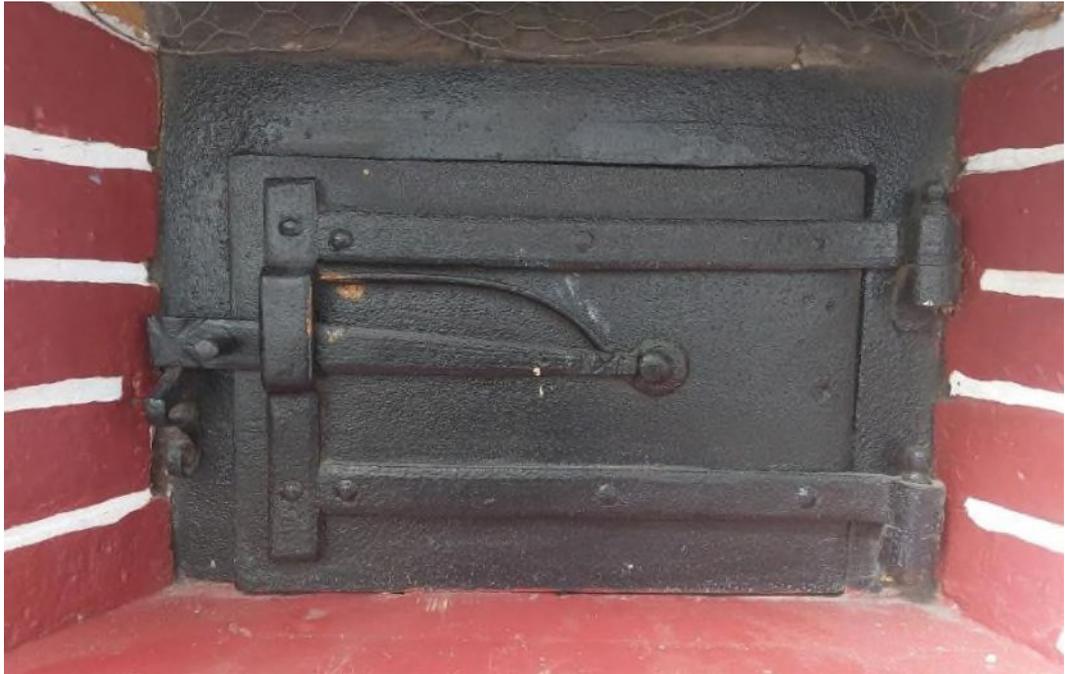
Figure 41 The oven door external face.

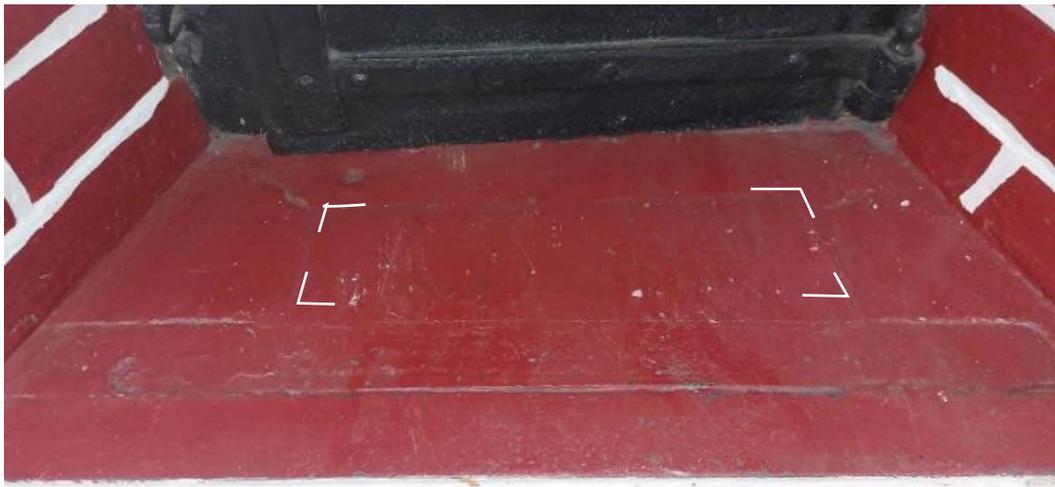
Figure 42 The cill of the oven opening showing the blocked opening (the corners of which are marked) where ash raked from the oven would fall to the ash pit below. In front of this opening is an iron clamp.

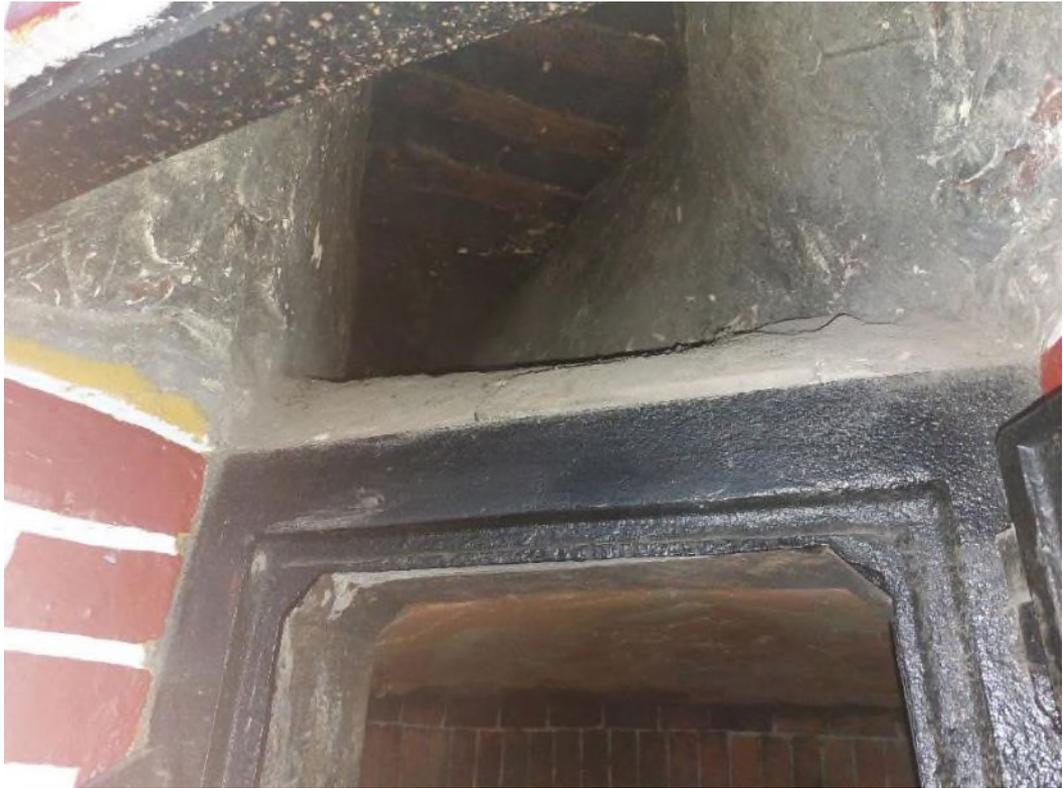
Figure 43 The flue opening above the oven door.

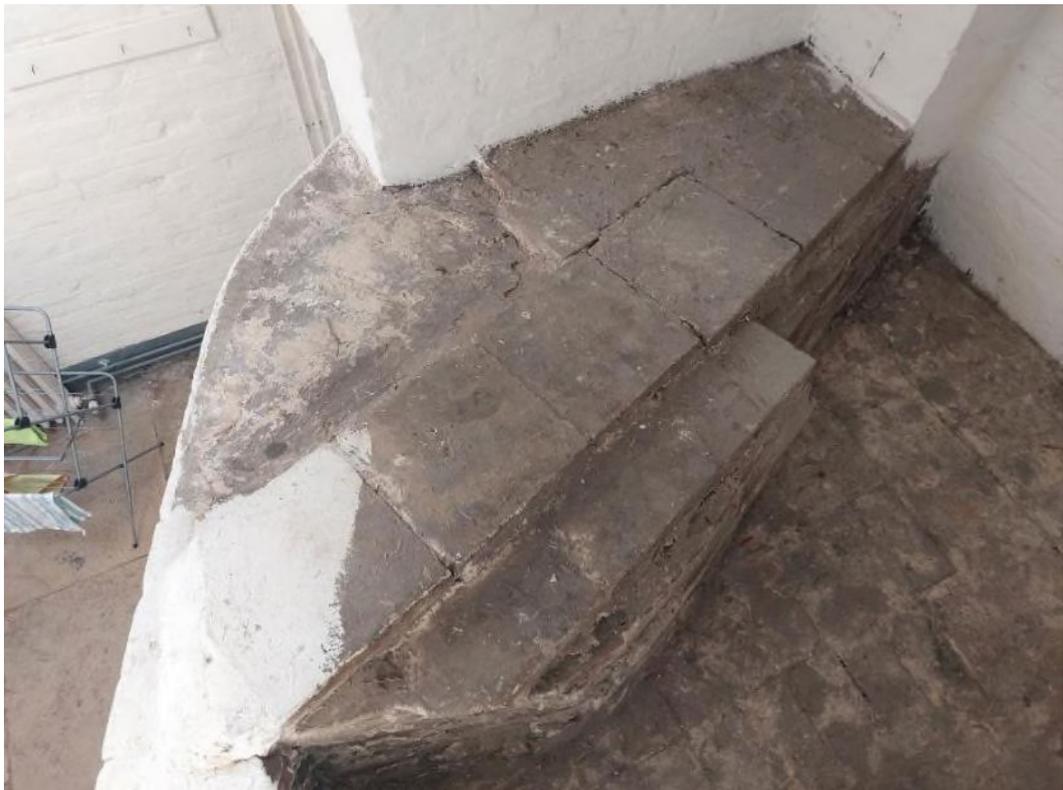
Figure 44 The flue from the oven chamber runs across the top of the oven to a chimney, now capped, on the north-west wall.

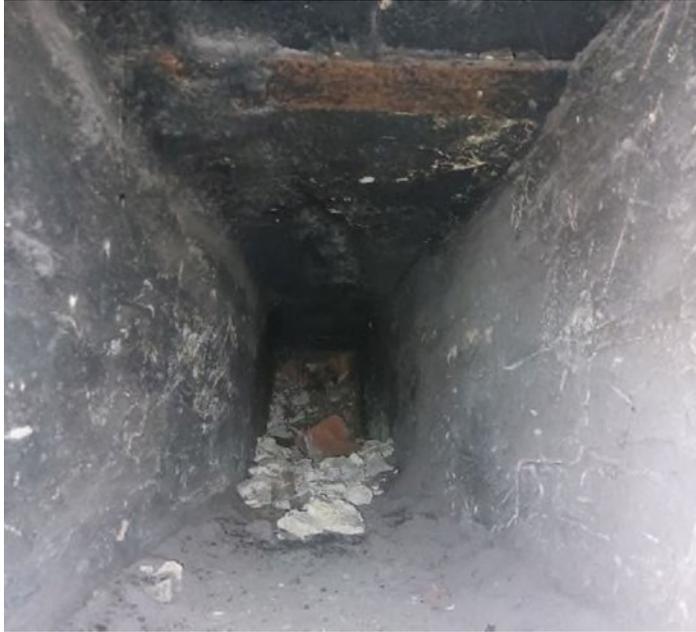
Figure 45
The flue running over the
top of the oven chamber.

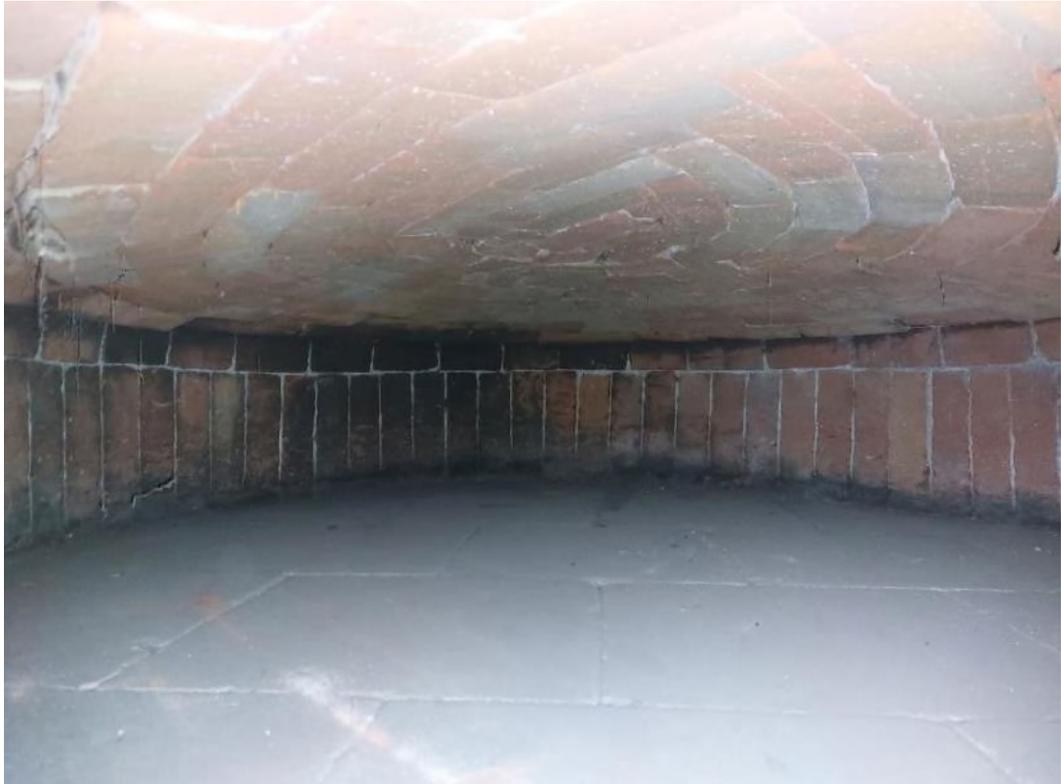
Figure 46 Interior of the oven chamber.

- 3.28 The oven chamber is roughly oval (Figure 48) measuring 1.5m x 1.27m on its axes, and has large square tiles to the base, sides formed with one row of soldier bricks topped by a course of bricks laid flat with a very shallow domed top constructed in brick (Figure 46). This shallow arched form of the oven chamber roof is indicative of later examples of oven; earlier examples have more domed roofs. The change is believed to reflect the appreciation that the lower, flatter roof was more efficient, a development that dates to around the middle of the 18th century (Pollard 2018, 91).

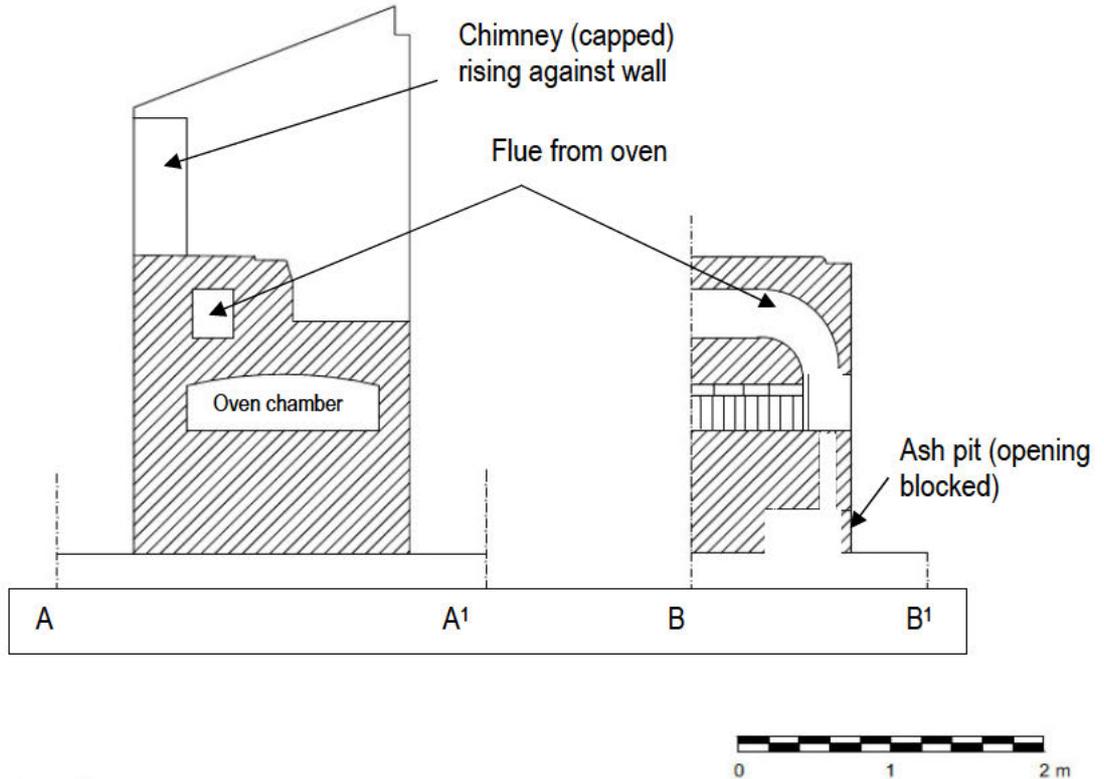
Figure 47 sections through the bread oven. Section A-A1 is taken through the width of the oven chamber. Section B-B1 is through the front part of the oven showing the relationship between the oven chamber and the flue for smoke and the ash pit

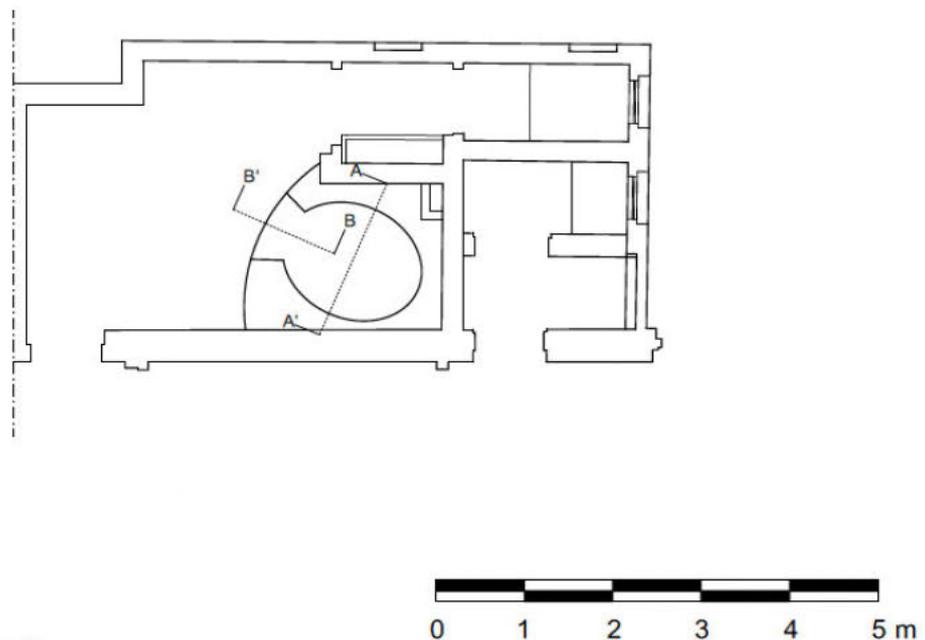
Figure 48 Plan of the bread oven and enclosure with a horizontal section through the bread oven.
