WARRENS, BRAMSHAW, HAMPSHIRE

Heritage Statement

Statement of Significance

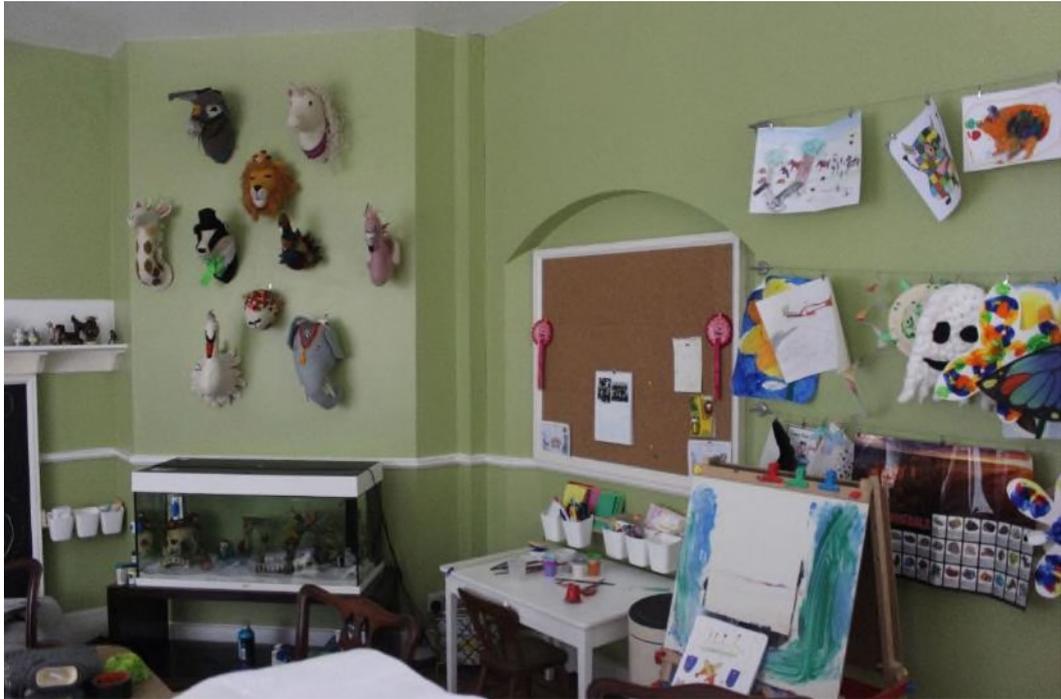
Figure 49 The blocked door that linked the 'occasional room' to the now demolished servant's hall.

decoration. The fireplace is blocked as is the doorway that originally led to the servant's hall (Figure 49).

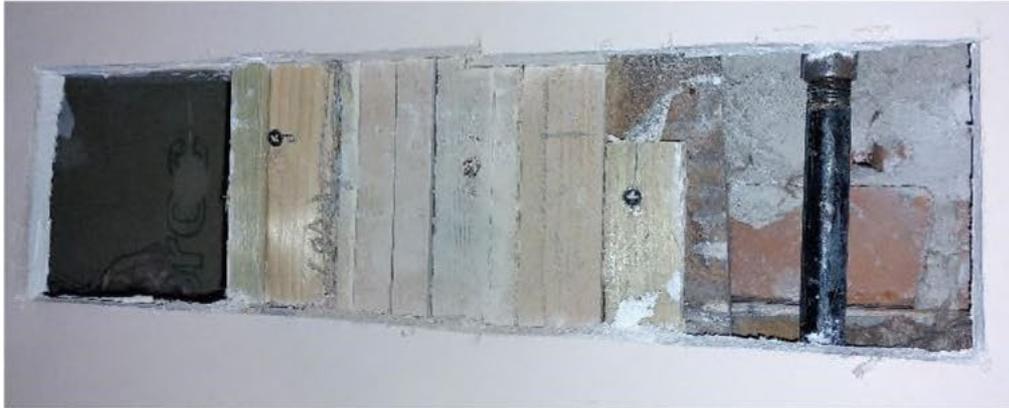
Figure 50 Modern stud infill to the former wide opening between the current master bedroom and bathroom with the original brick reveal to the right.

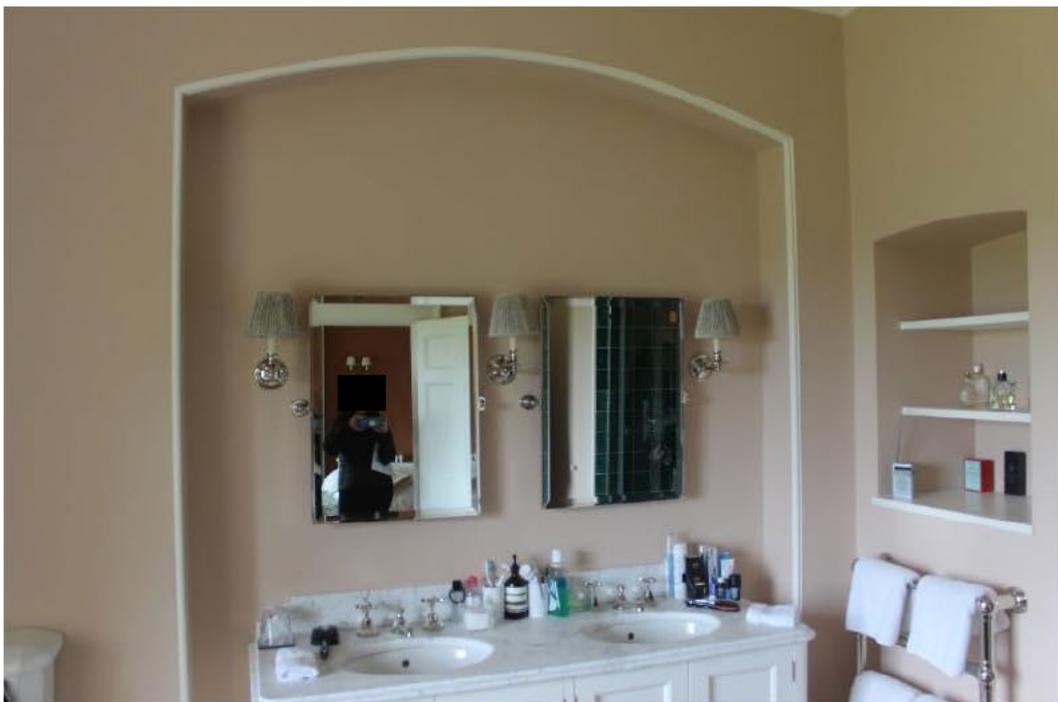
Figure 51 The blind arch ensuite bathroom to the master bedroom which is an alteration to the blind arch shown in Webb's plan.

- 3.31 On the south-east front and there are now four rooms, the larger being bedrooms and the smaller being ensuite bathrooms. The door from the landing which now serves a cupboard is shown by Webb as giving direct access to what is now a bathroom, but which appears to have been an ante-room to the bedroom to the north-east. There is currently a single-width door between the bedroom and bathroom, Webb's plan shows that there was a relatively wide opening between these two spaces. This former wide arch has been infilled with modern studwork and plasterboard revealed by limited opening-up within the bathroom (Figure 50). This wide opening was centred on a blind arch to the south-west wall of the present bathroom. The existing blind arch within the bathroom is not of the same width as that shown on the Webb plan – it is considerably narrower (Figure 51). An examination of the wall within this blind arch shows that a brick partition wall is lined by lath and plaster to both sides.

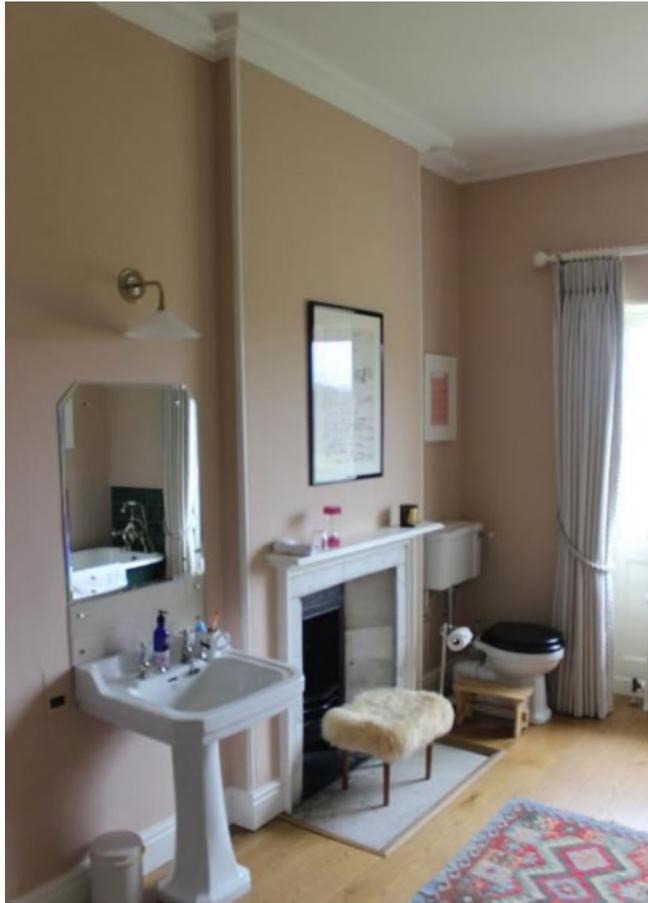
Figure 52
The added fireplace to the bathroom on the south-east front of the Nash house.

added before 1898. The resultant bathroom was provided with a fireplace on the north-east wall where there is no fireplace below (Figure 52).

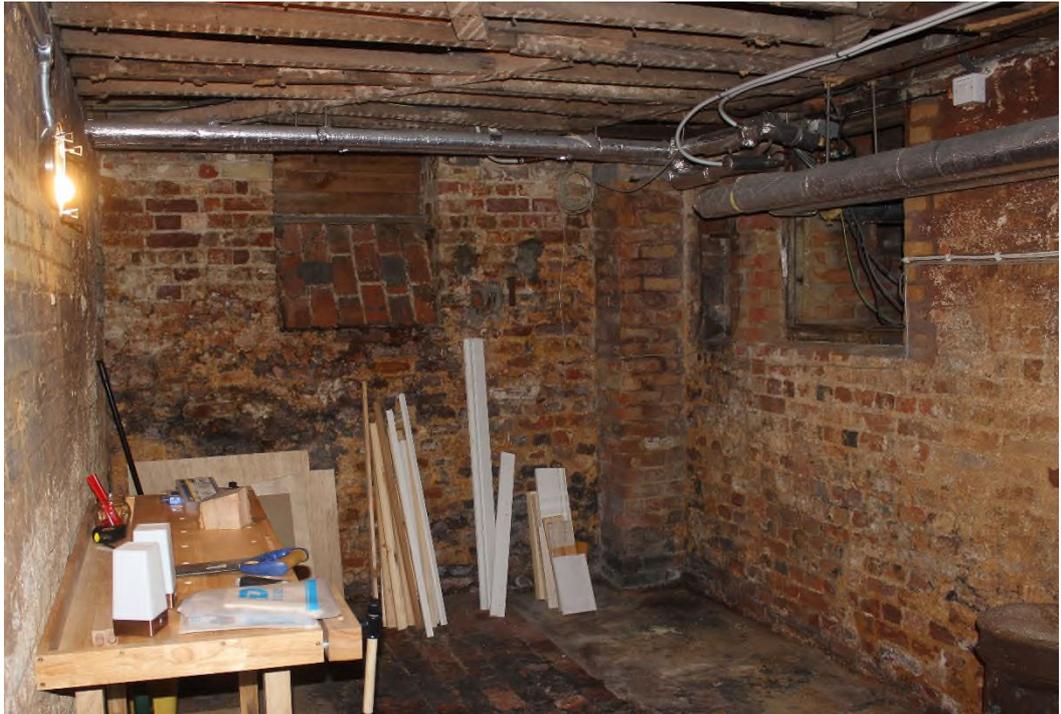
Figure 53 The cellar room adjacent to the floor void of the common room showing the opening to the floor void to the right and the opening where the extractor will vent to the left with the sloping brick cill.

- 6.5 The extraction system will also run beneath the Common room floor, where there is a substantial void allowing sufficient space to install the ducting and other services. The ducting for the extraction will enter the adjacent cellar room through an existing opening and will exit the building at an existing opening in the south-east wall (Figures 53 and 54). There will be no loss of historic fabric and no harmful change to the external appearance of the building.

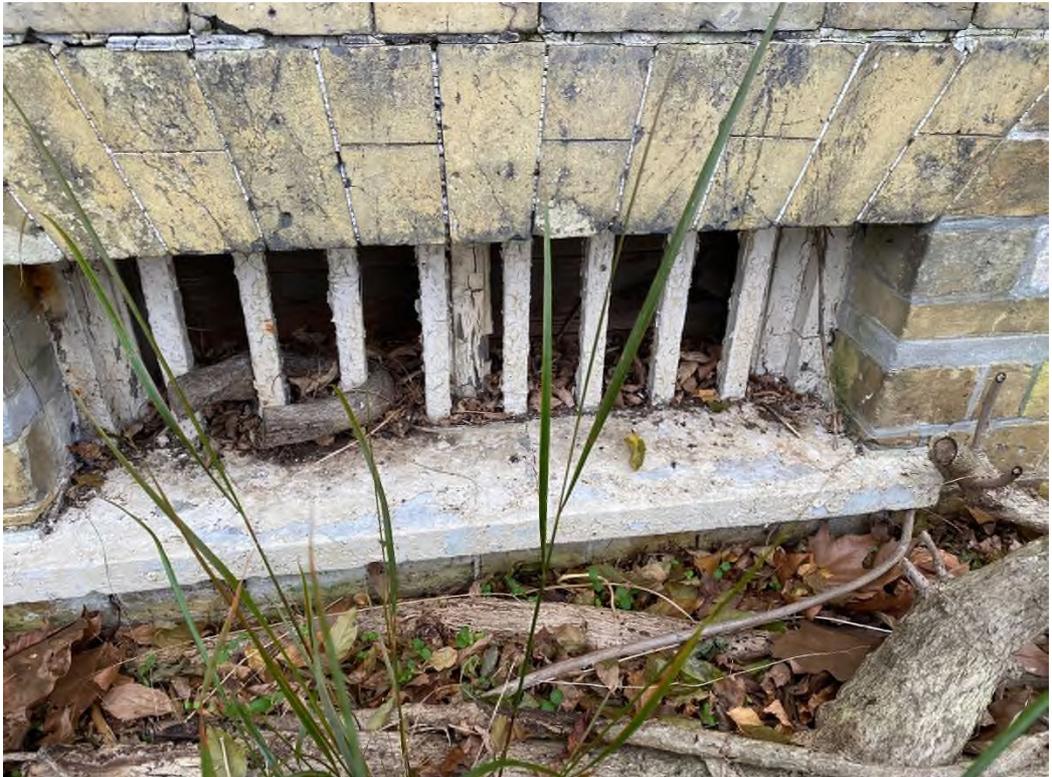
Figure 54 External side of the opening to the cellar room where the extractor will vent – the vent will be set behind the bars and will not be visible externally.

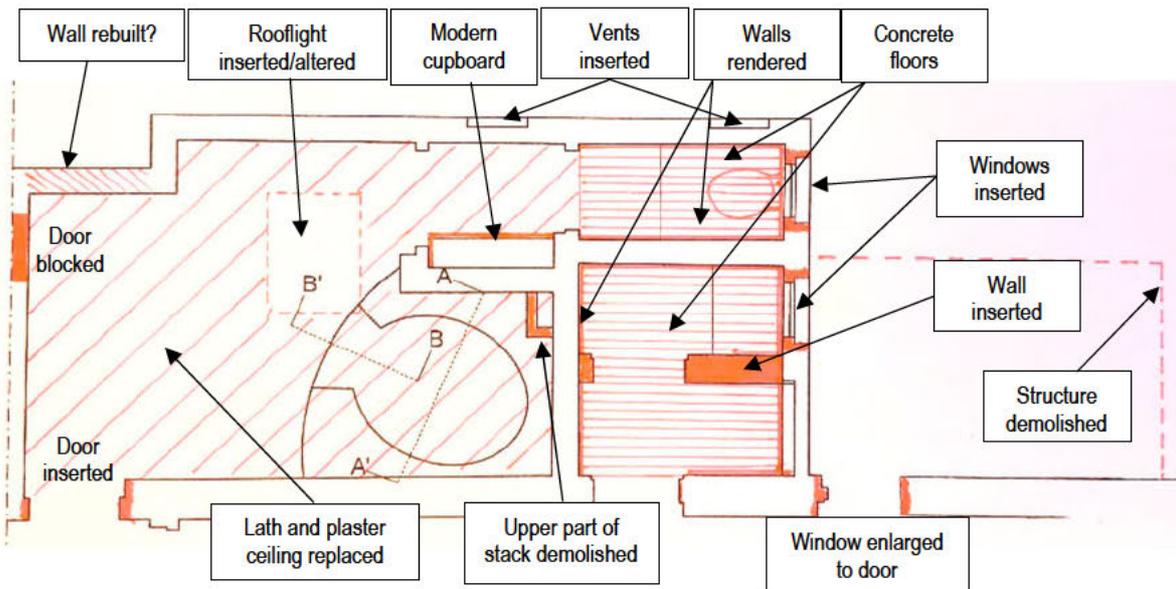
Figure 55 Plan showing the cumulative areas of change to the original lean-to structure built against the side of the service range.

- 6.23 As an area where food was produced, it would have certainly had a lath and plaster ceiling which has been replaced by modern boarding. Otherwise, the paint analysis shows that the enclosure was provided with basic, white limewash finishes to the walls. Clearly, the access to this building was altered by Webb with the insertion of a door and the blocking of the original door in the south-east wall. The chimney stack from the oven, which would have given an indication of the possible use of the building as seen from the outside, has also been taken down to a level beneath the ceiling. As the rooflight is the only source of natural light into the oven room, it may be that it is an original opening but the present rooflight is a poor-quality modern unit which stands proud of the roof surface. The extent of changes that have been made to the enclosing structure are shown in Figure 55.

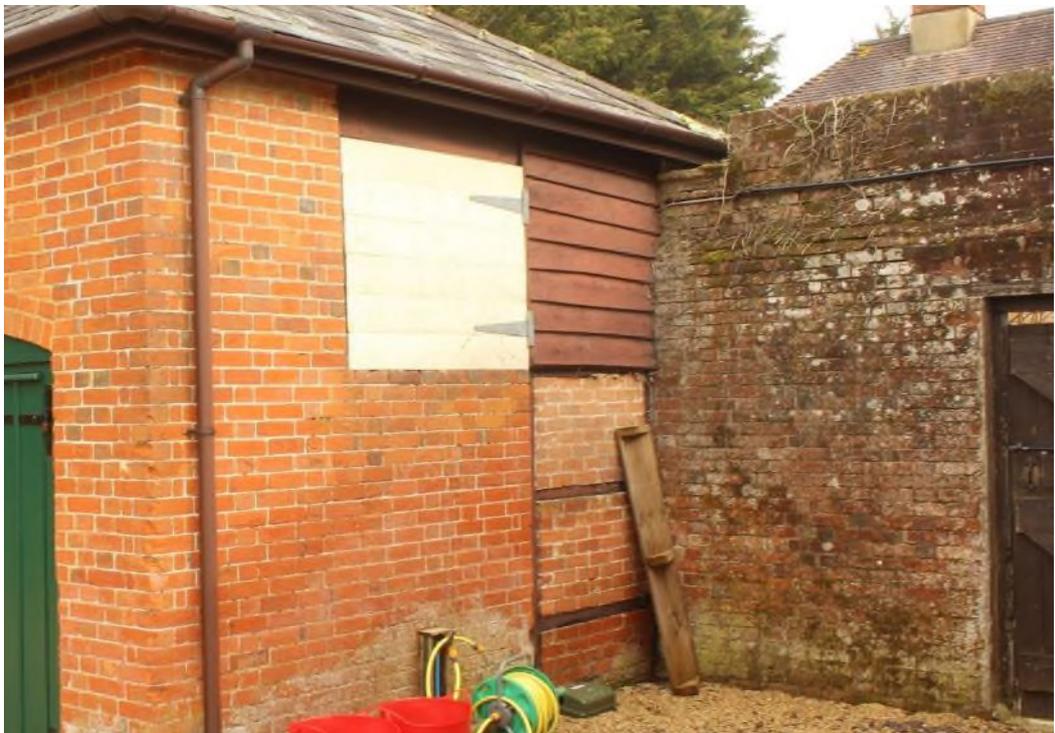
Figure 56 The section of wall between the slaughterhouse and stables on the south-west side of the kitchen garden showing the simple step down in the wall height to respect the eaves of the slaughterhouse.

eaves, and the same detail – a simple step down – will be used for this section of wall (Figure 56).

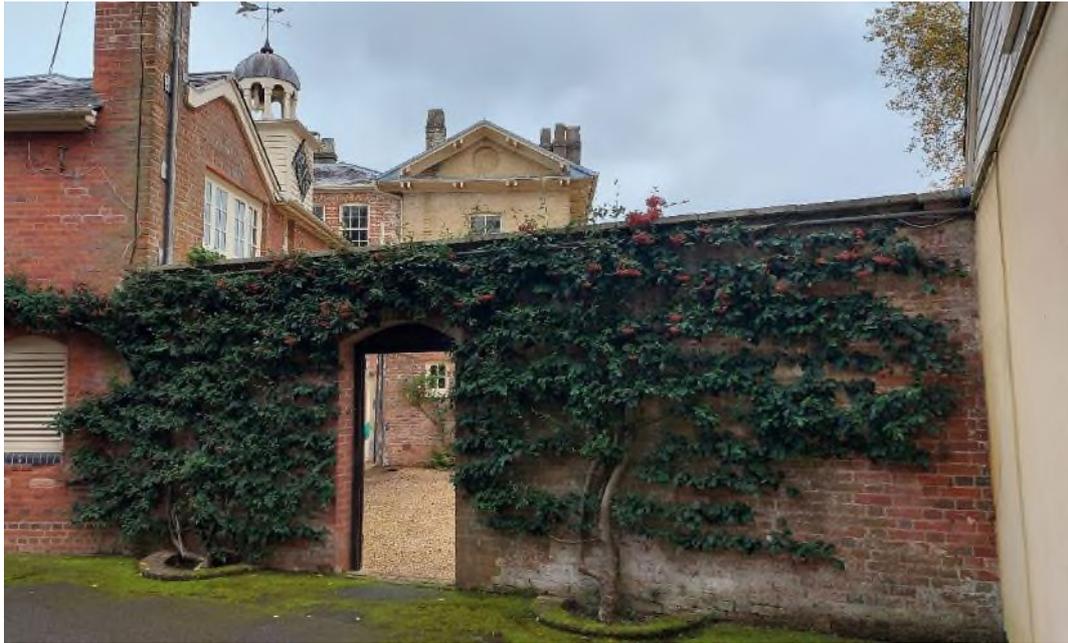
Figure 57 The wall closing the gap between the service wing (left) and the estate office (right) from the yard area adjacent to the estate office.

The raising in height of the wall will not have a harmful impact on the appearance of the main block of the house as seen from the access to the service yard on the north-west side of the wall (Figure 57). The gable to the rear of the later, southern part of the house is constructed in Beaulieu brick to the upper part of the wall and red brick to the lower part which shows that the latter was not intended to be seen whereas the upper would be visible. The increase in height would mean that a relatively small part of the Beaulieu brick section of wall would no longer be visible as one passes the north-east gable end of the estate office, but this would not harm the experience of the main building – the pedimented gable which is the main architectural feature of this element, would still be prominent and indicate that this was part of the main house rather than service. Therefore, it is considered that there would be no harm to the special interest of the listed building.

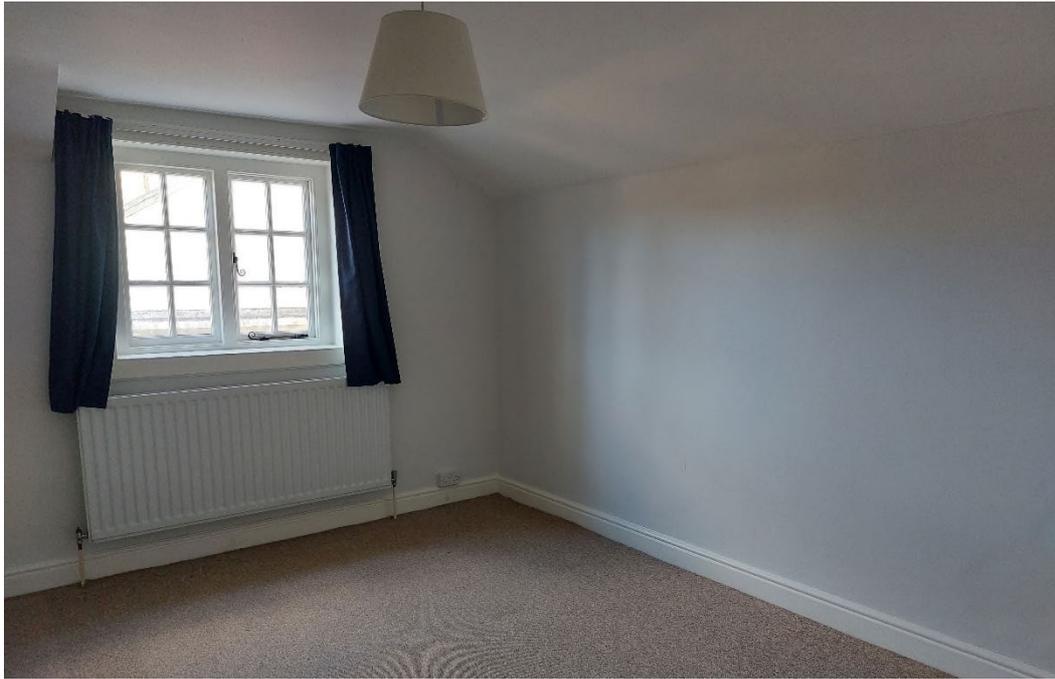
Figure 58 The southern-eastern room at the first floor of the service wing.

- 6.31 At first floor level of the service wing it is proposed to remove the partitions creating the three servants' rooms added by Webb at the end of the 19th century to form a Guest Suite. The clock mechanism, which is within an enclosure to the centre of this area, will be retained with new glass partition walls enclosing it. This will allow an interesting historic clock mechanism to be visible as a feature. The rooms at this level are plain spaces with no features of architectural interest – they have no fireplaces or architectural decoration (Figure 58). It is considered that they do not hold particular significance simply because they are part of the Webb work at Warrens, the majority of which has been previously demolished. A bathroom will be formed at the south-east end and a kitchenette to the north-west. Within the room to the north-west of the stair, a partition will be inserted to form a small bathroom. This will not harm important plan form.
