Drawing title			
Alterations and Repairs			
Job title			
Alterations & Repairs to Listed Farmhouse Blagdon Manor Farm North Tamerton			
Client			
Coleing, Mr & Mrs J			
Drawn by	LR	Stage	PL - Detailed Design
Checked by	DT	Issued for	Preliminary
Date	07/06/2021	Scale @ A1	As indicated
Drawing number		Revision	
08124-TDA-DR-PL-0002		P02	
Revision	Description	Date	Initials
1	Window design amendment	13/08/21	LR

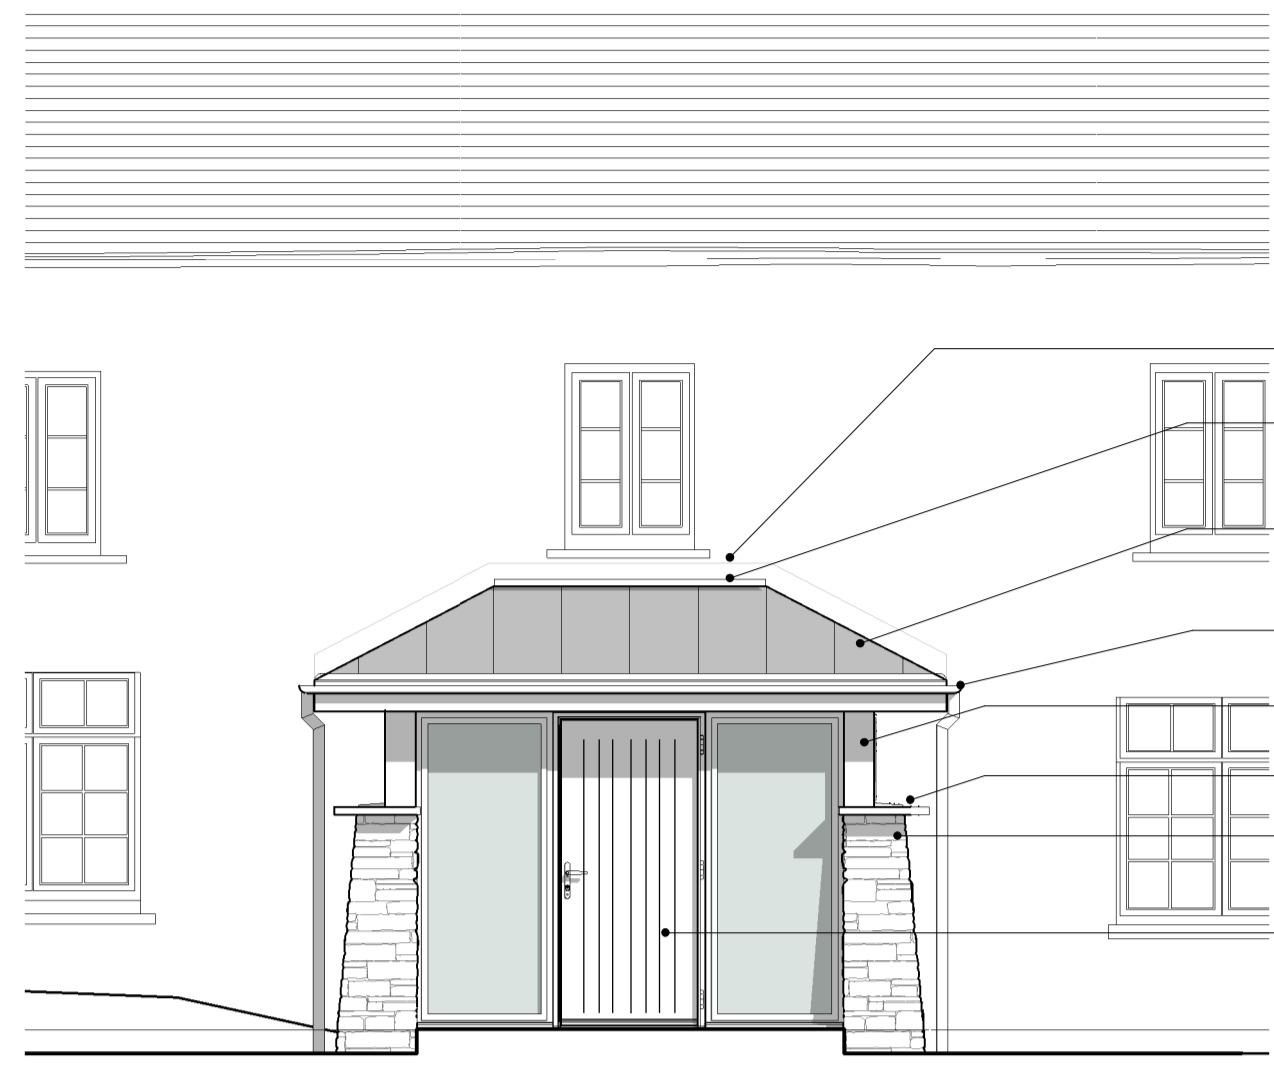
Front Porch Elevation

- Code 4 lead flashing to new roof
- VM Zinc Quartz finish standing seam roof finish
- VM Zinc Quartz finish standing seam roof finish
- Lindab aluminium gutting and downpipes
- Oak framed windows (untreated)
- Cut slate eills
- Natural stone walls
- Oak front door (untreated)

Access points and suitable habitat for roosting crevice-dwelling bats shall be retained. These shall include the provision of small gaps and access measuring 2.5cm in width x 7cm in length underneath at least four ridge lines along both sides of the main ridge. At least one 2.5cm x 7cm gaps shall also be made available underneath wooden fascias carrying gutting at the eastern elevation.

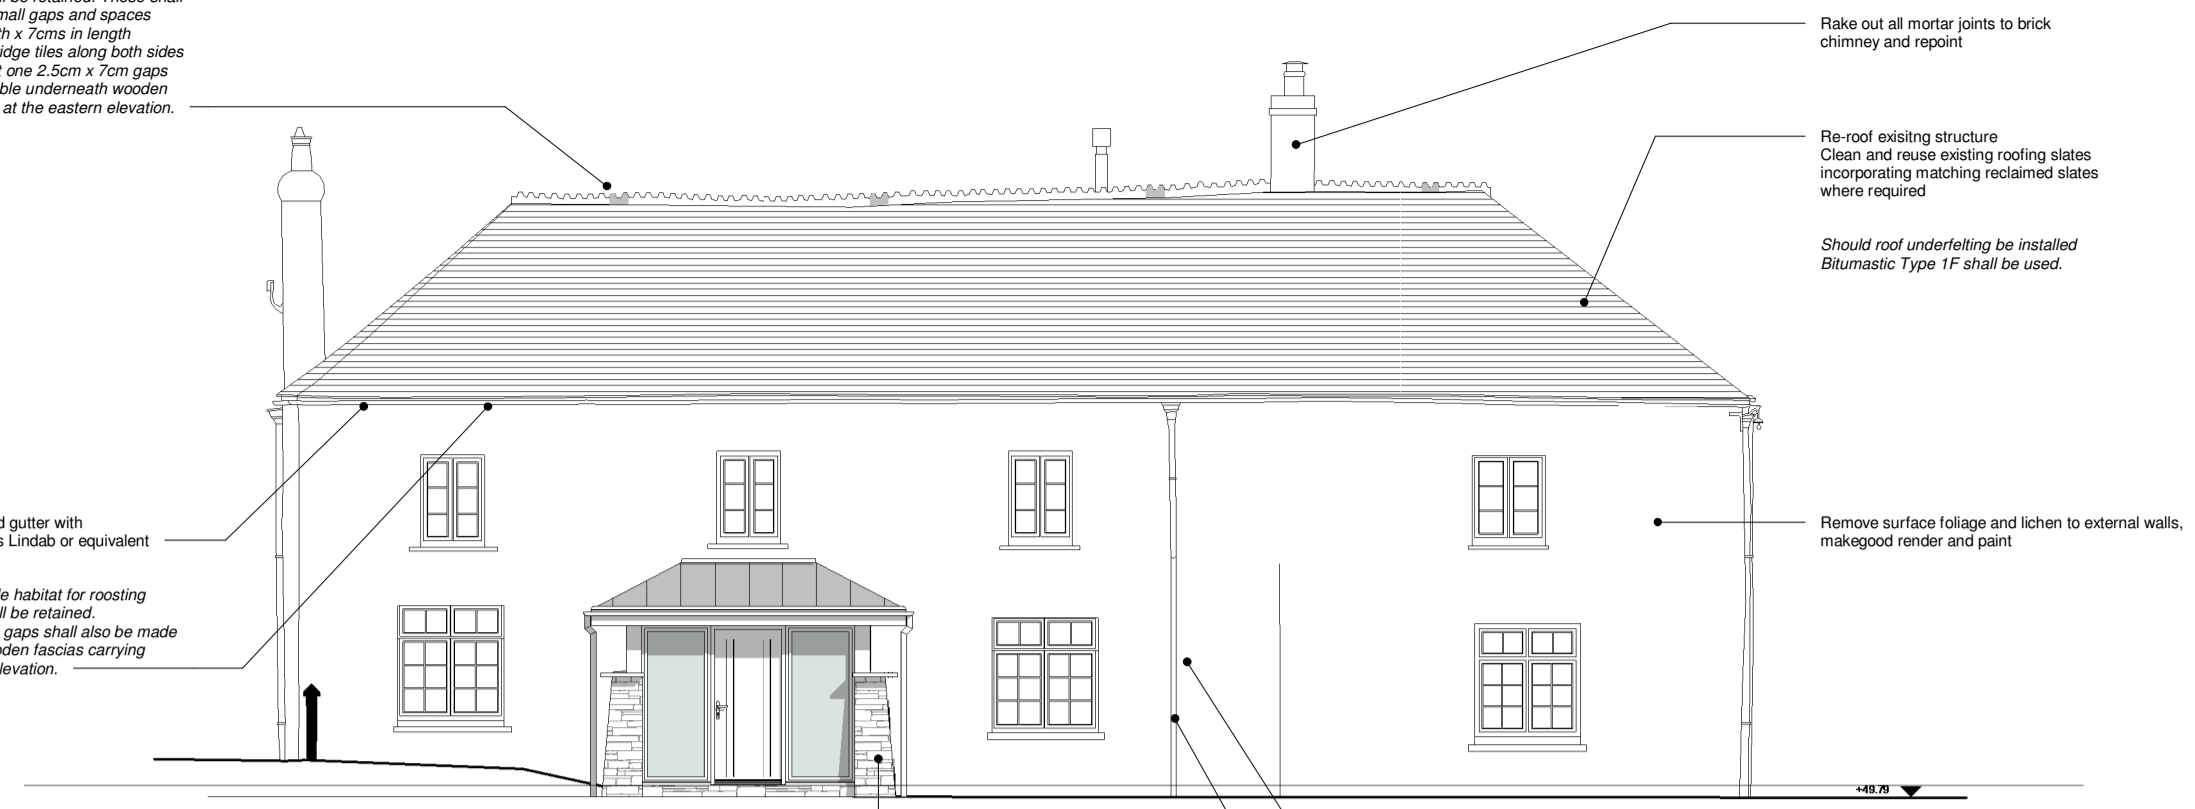
South East Elevation

- Replace all downpipes and gutter with aluminum rainwater goods Lindab or equivalent
- Access points and suitable habitat for roosting crevice-dwelling bats shall be retained. At least one 2.5cm x 7cm gaps shall also be made available underneath wooden fascias carrying gutting at the eastern elevation.

- Rake out all mortar joints to brick chimney and repoint
- Re-roof existing structure. Clean and reuse existing roofing slates incorporating matching reclaimed slates where required.
- Should roof underfelt be installed Blumastic Type 1F shall be used.

- Rake out all existing cracks, repair and make good cracked and damaged render. Strict repair areas of severe cracking
- Replacement downpipe

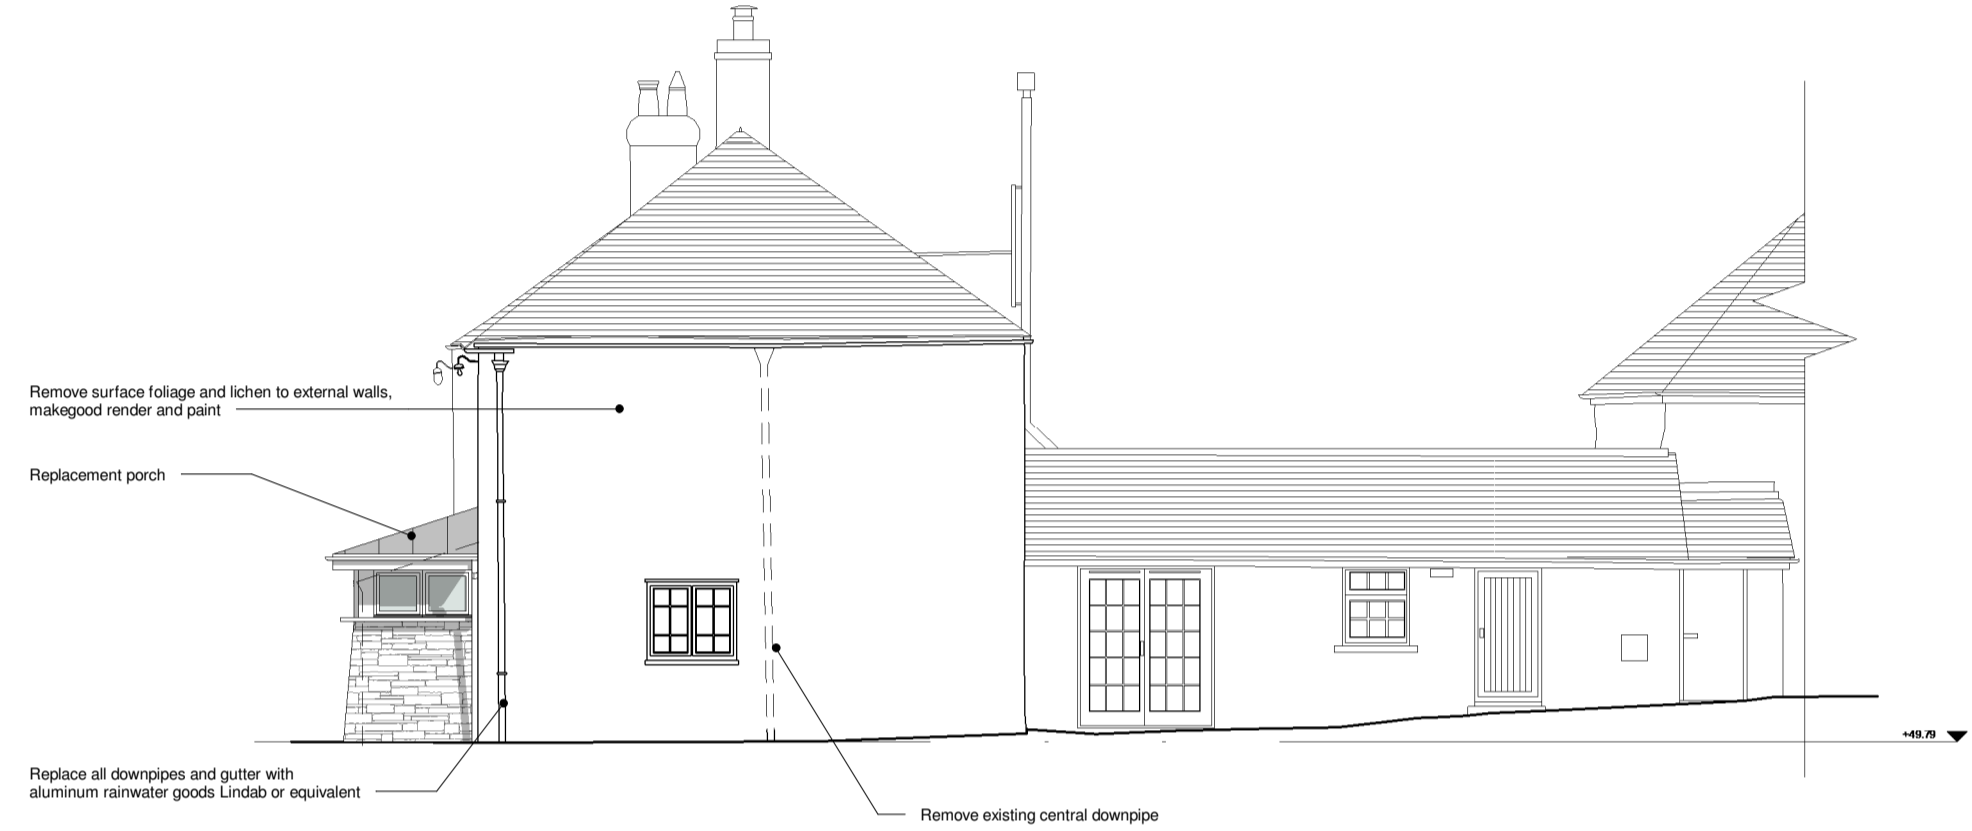
South West Elevation

- Remove surface foliage and lichen to external walls, makegood render and paint
- Replacement porch
- Replace all downpipes and gutter with aluminum rainwater goods Lindab or equivalent

Remove existing central downpipe

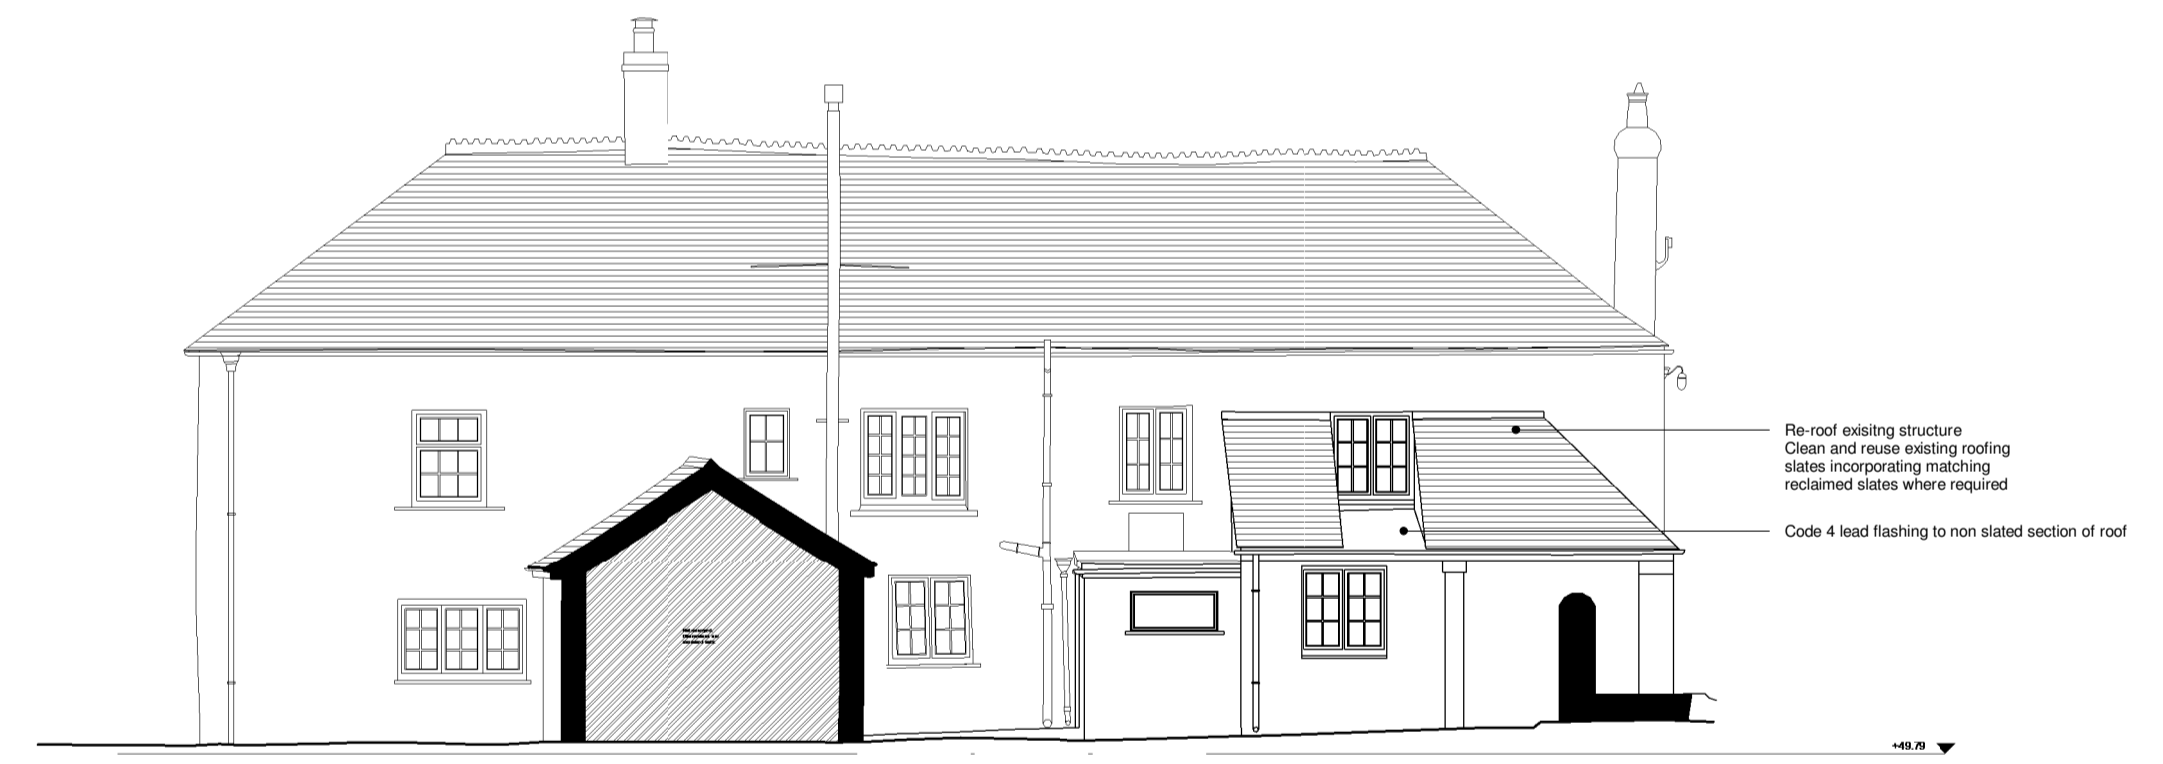
North West Elevation

- Re-roof existing structure. Clean and reuse existing roofing slates incorporating matching reclaimed slates where required.
- Code 4 lead flashing to non slated section of roof

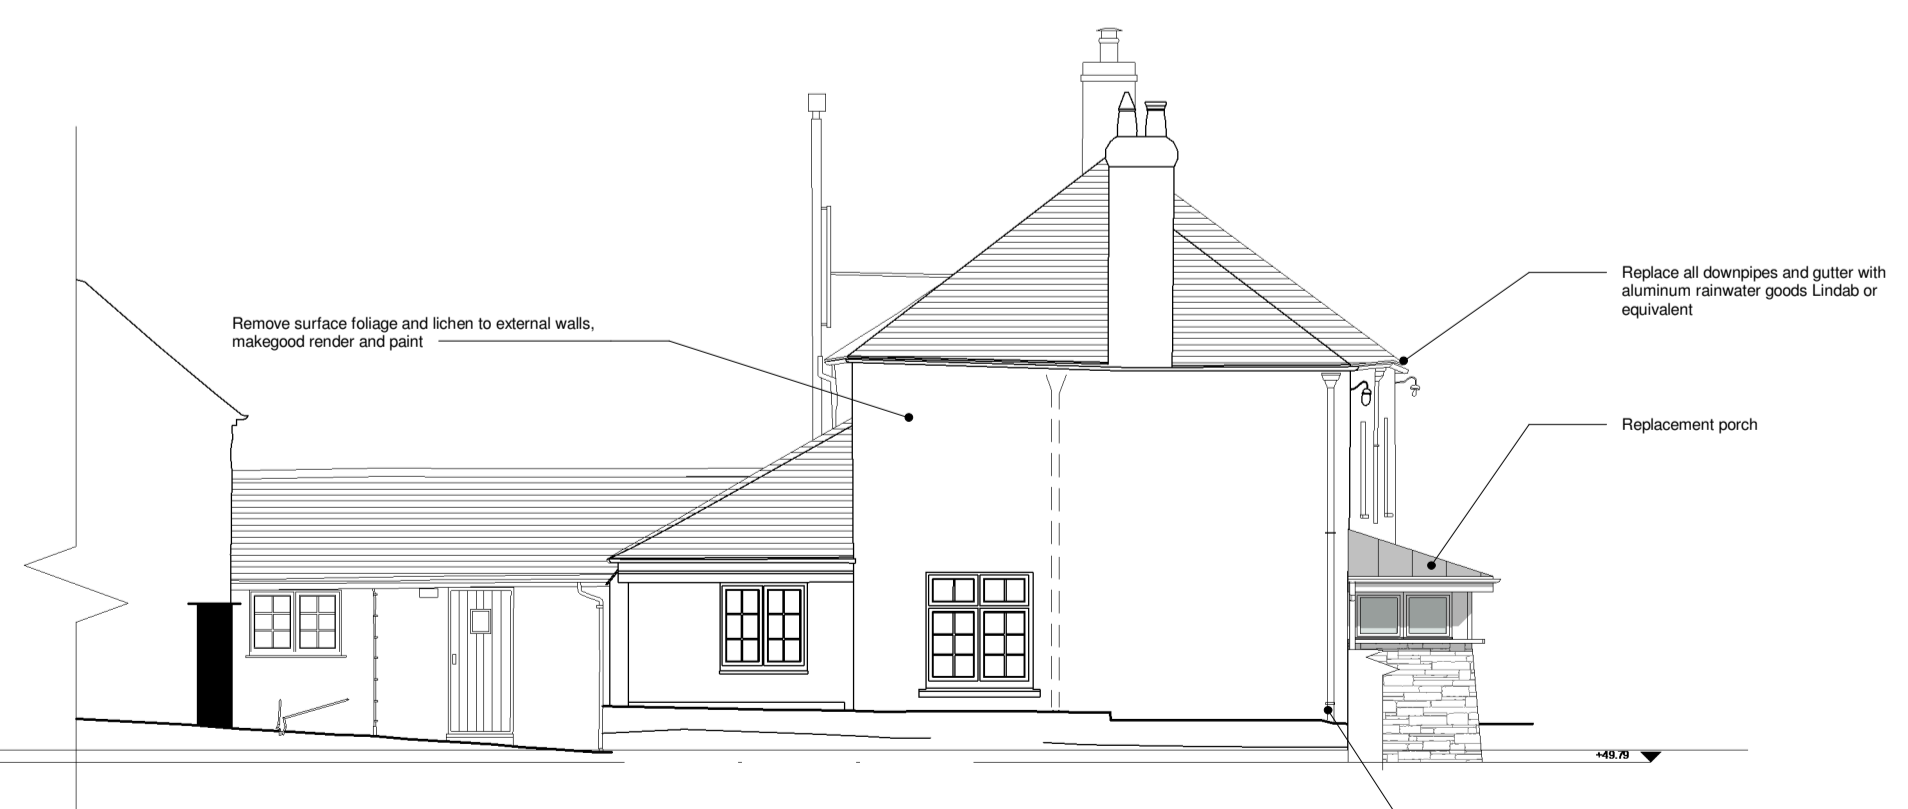
North East Elevation

- Remove surface foliage and lichen to external walls, makegood render and paint

- Replace all downpipes and gutter with aluminum rainwater goods Lindab or equivalent

Replacement porch

Replacement downpipe
