Replacement dwelling of Chandeler cottage, horse shoe corner Design and Access and Refuse, Planning statement and Waste Strategy

Site Address: Chandeler Cottage,

Proposal: Demolition and rebuild of Chandeler cottage

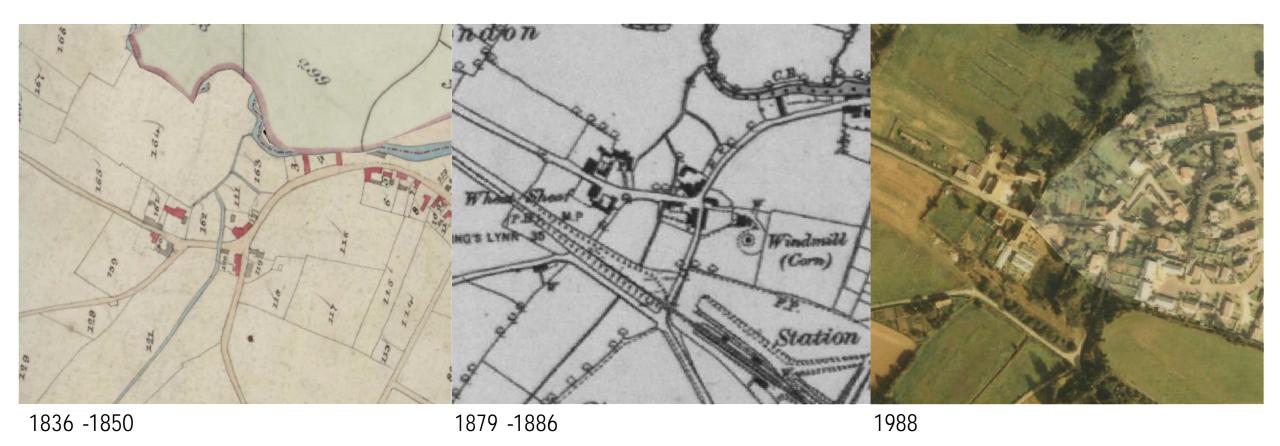
The First evidence of the cottages is the Tithe map dating between 1863-1850 as you can see from the other maps the property hasn't changed too much except extensions to the rear.

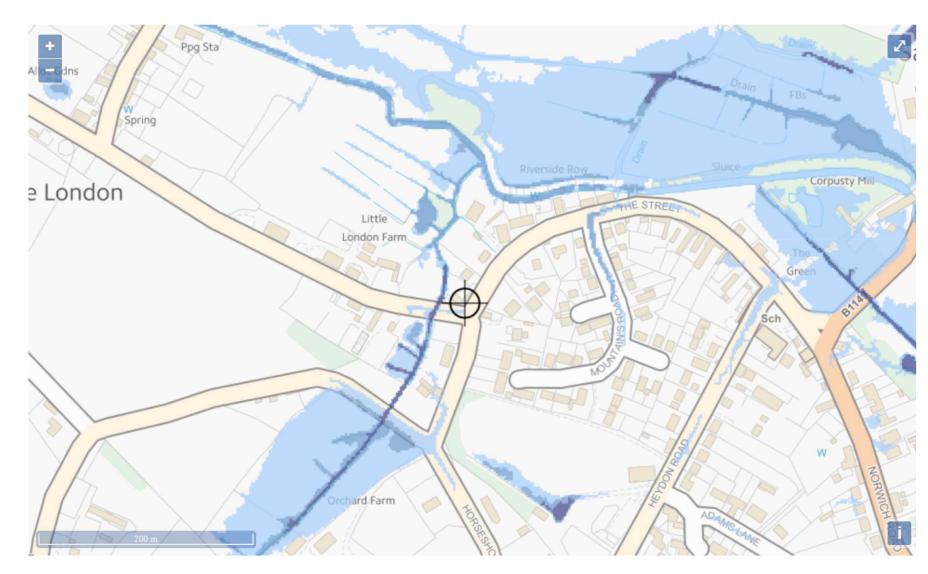
Flood Risk:

I cam confirm that the floor levels to the properties will not be lower than the existing.
