# STAYTS FARM, CHURCH WESTCOTE, GLOUCESTERSHIRE

## HERITAGE STATEMENT

**PROJECT:** Stayts Farm, Church Westcote, Gloucestershire

**DOCUMENT TITLE:** Heritage Statement

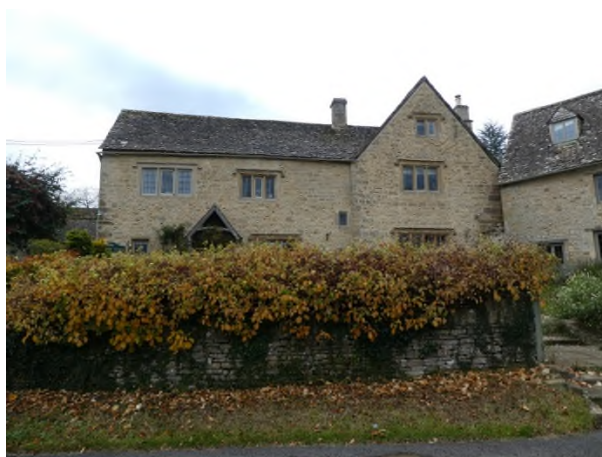
Figure 1: Front elevation of Stayts Farm

- 1.3.1 Stayts Farm was added to the statutory *List of Buildings of Architectural or Historic Interest* at Grade II on 28<sup>th</sup> May 1987. The list description reads as follows:

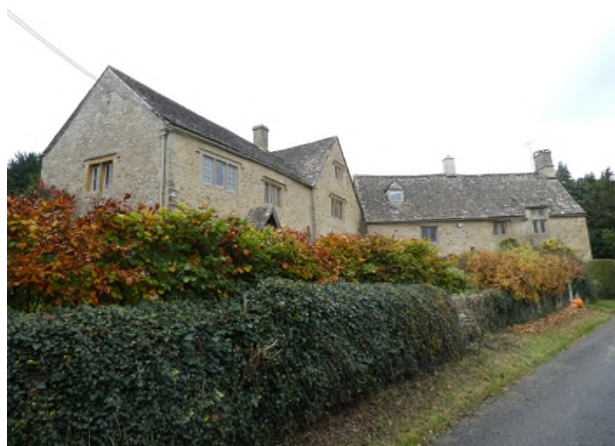
Figure 2: The Close (right of photo)

- 1.3.2 The Close lies adjacent to Stayts Farm. Stayts Farm was added to the statutory *List of Buildings of Architectural or Historic Interest* at Grade II on 25<sup>th</sup> August 1960. The list description reads as follows:

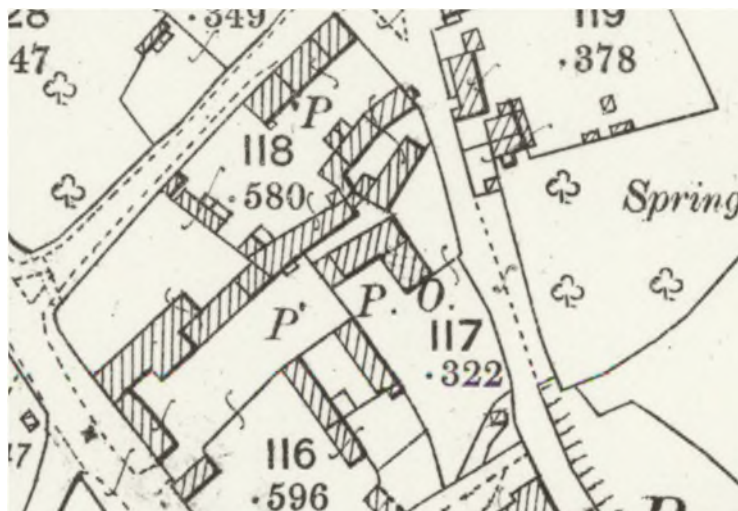
3.1.2 The 2<sup>nd</sup> edition of the Ordnance Survey map (1900) shows that the farmhouse had been extended on the south-west side of the rear wing. The boundary to the garden on the south side of the farmhouse had been removed, along with the greenhouse. The annotation P.O.

suggests that Stayts Farm was used as a post office at this time. The house is sub-divided into three sections which might reflect the residential and commercial functions of the farmhouse.

Figure 4: Extract from the 2<sup>nd</sup> edition of the Ordnance Survey map (1900)

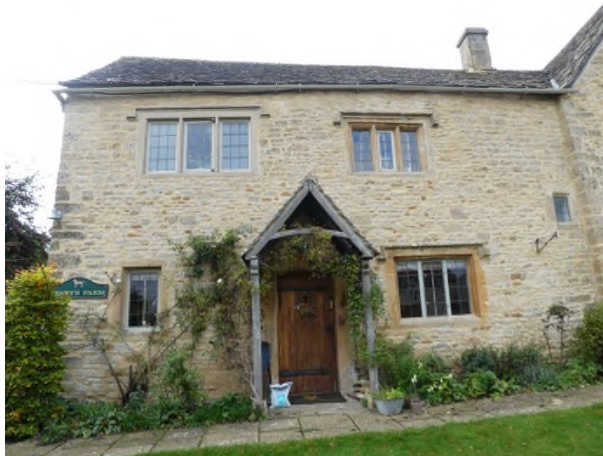
3.2.2 The front elevation (north-east) includes an off-centre entrance with a 20<sup>th</sup> century porch. There is an irregular pattern of windows. The window on the ground floor to the right of the

door includes a stopped drip mould. The character of the stone contrasts with the 17<sup>th</sup> century windows on this elevation and, along with the narrow form of the mullions, suggests a later, possibly 19<sup>th</sup> century, alteration. The first floor window to the left is 20<sup>th</sup> century. There is a small stair window on the far right hand side of the elevation. There is a clear change in the character of the rubble stone walling at first floor level to the right which suggests an alteration or repair.

Figure 6: Front elevation of Section 1

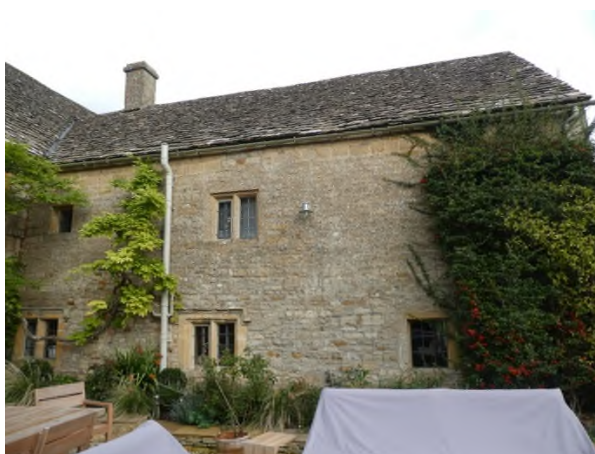
- 3.2.3 The rear elevation includes two courses of squared stones at the top of the wall which demonstrate that the eaves level has been raised. This is consistent with the character of the roof structure which is not original. There two windows with stopped hood moulds. The central 2-light window on the ground floor appears to be largely intact. The other windows appear to be alter replacements or insertions.

Figure 7: Rear elevation of Section 1

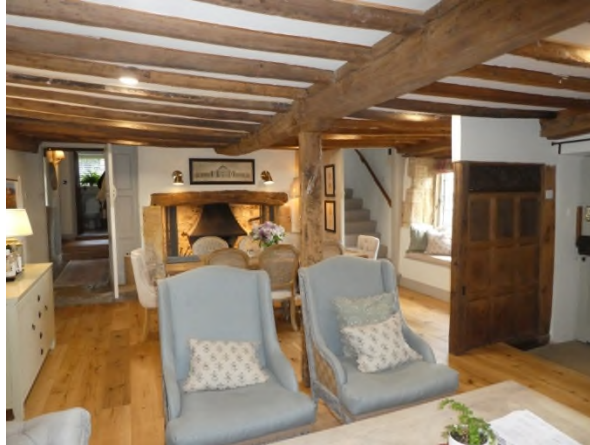
- 3.2.5 The north-west bay includes a plain axial beam with 90mm wide joists with chamfers. The open fireplace includes a timber lintel with an indistinct scroll/curved step stop and stone jambs. There is a seat, or inglenook, to the right and a recess for keeping salt or tinder or for setting a candle. There is a 2-light stone window with a chamfered mullion on the south-west

Figure 8: Ground floor looking north-west

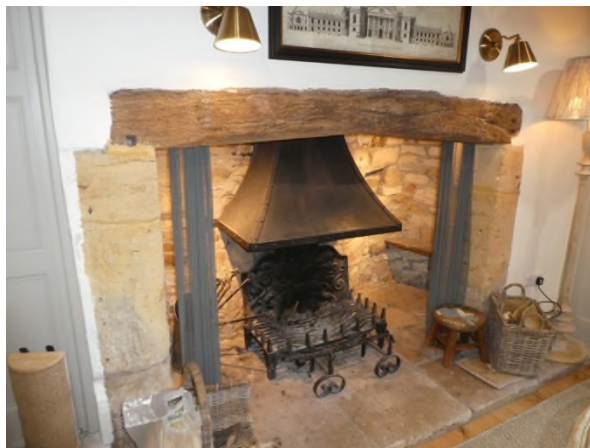
Figure 9: Fireplace with stone jambs and a timber lintel with chamfer and stop details

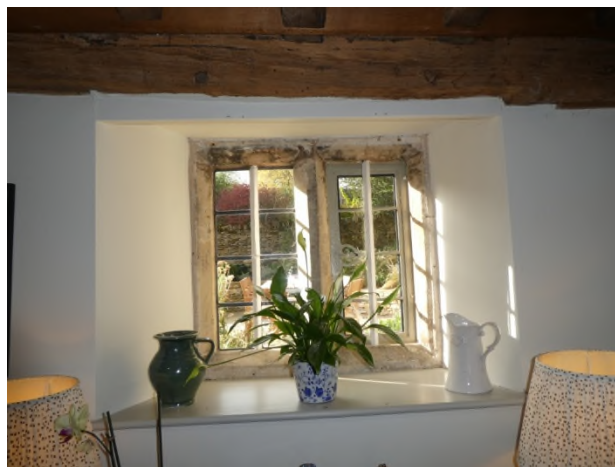
side. This includes iron stanchions. The side opening iron casement is of 17<sup>th</sup> to early 18<sup>th</sup> century date. There is a 3-light window on the front elevation with slender chamfered mullions. The central opening includes an iron stanchion and the flanking openings saddle bars. The central casement is probably 19<sup>th</sup> century. There are longitudinal wall beams on each side of the bay.

Figure 10: 2-light window with chamfered mullions and a 17<sup>th</sup> to early 18<sup>th</sup> century iron casement

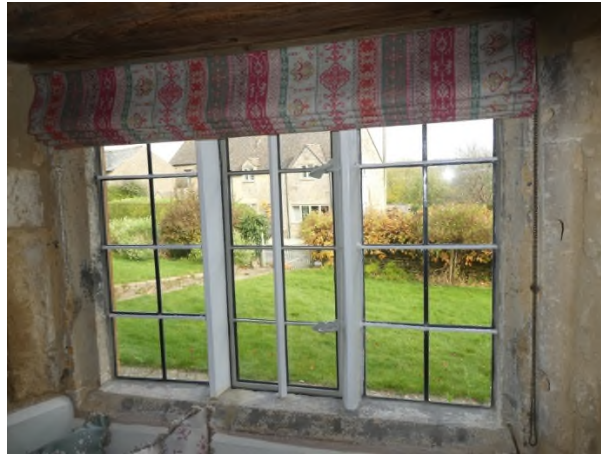
Figure 11: 3-light window with narrow chamfered mullions and a 19<sup>th</sup> century iron casement

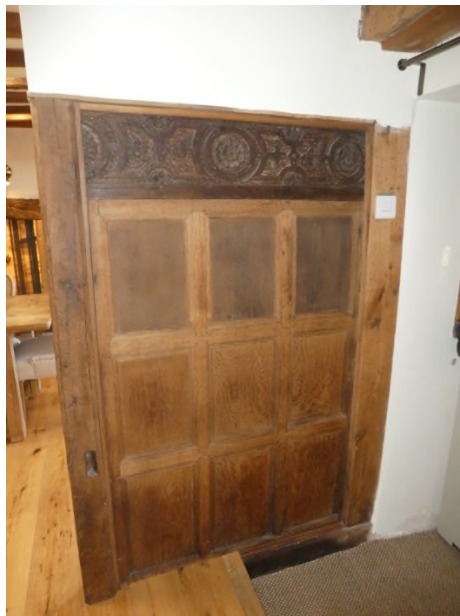
- 3.2.6 The two bays are defined partly by a short section of panelling with part of a strapwork frieze incorporating a sunflower motif at the entrance to the building. This partition lines up with a post supporting the axial beam at the point where there is a scarf joint. The presence of a scarf joint in this position demonstrates that there would have originally been a partition of some form sub-dividing the north-west and south-east bays. The axial beam in the south-east bay is more clearly chamfered (3" wide) and includes a curved step stop at one end. The chamfered joists are 85mm wide and include soffit tenon joints. There are longitudinal wall beams on each side of the south-east bay. There is a single light stone window on the rear elevation. The 3-light window on the south-east gable end elevation includes hollow chamfered mullions. There are two stanchions and a central side opening casement which is of 20<sup>th</sup> century date. There is a single light window on the north-east side of the room with a 20<sup>th</sup> century casement and an iron stanchion.

Figure 12: Section of small square panelling with frieze over

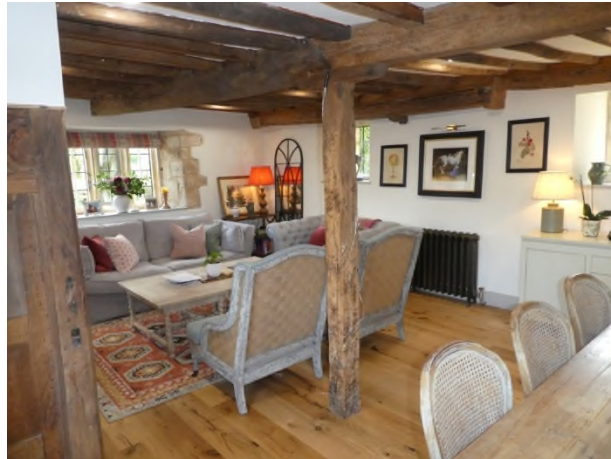
Figure 13: Timber post positioned under a scarf joint in the axial beams

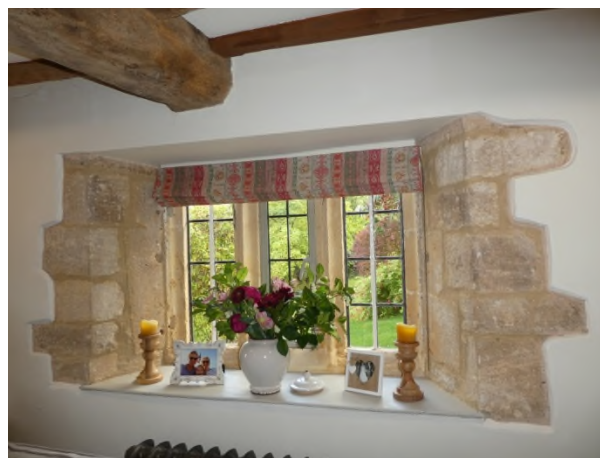
Figure 14: Axial beam with curved step stops and a 3-light window with hollow chamfered mullions on the south-east side of the ground floor

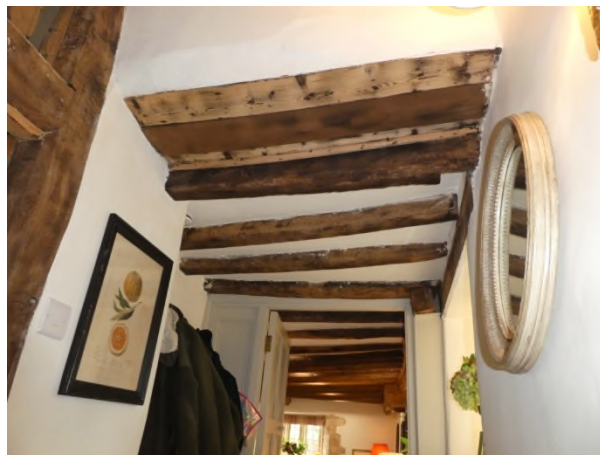
- 3.2.7 There are expressed joists in the passage on the south-west side of the chimney breast. These are chamfered and 100mm wide. The width of the joists is consistent with a 17<sup>th</sup> century date. There is at least one reused timber which includes a joint at one end. There is a 2-light stone window with chamfered mullions on the south-west side of the passage. This includes an iron stanchion to the right. The windows are of 20<sup>th</sup> century date. There is a timber lintel over the opening through the thick north-west wall of Section 1.

Figure 15: Timber lintel and joists on the south-west side of the chimney breast

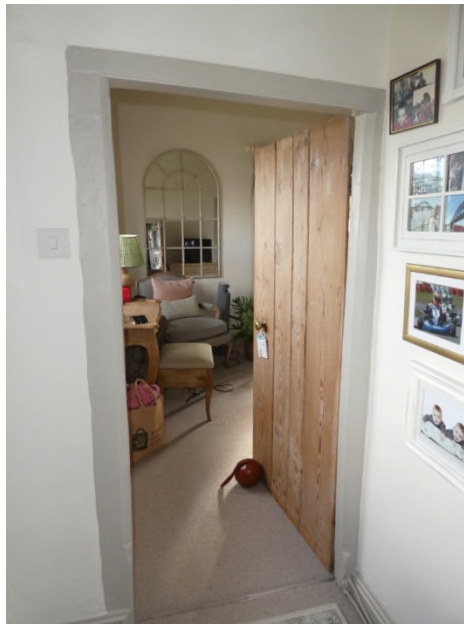
- 3.2.8 The first floor includes a landing and a bedroom with an en-suite bathroom which occupies part of the north-west bay. The bedroom is accessed through a late 18<sup>th</sup> to early 19<sup>th</sup> century plank and batten door in an old frame with chamfer details. There is a chamfered beam with runout stops that is a later alteration. There is a 20<sup>th</sup> century 3-light window with chamfered mullions on the north-east side of the room. The gable end window is of 2-lights with a chamfered stone mullion and 20<sup>th</sup> century Crittal type metal windows. The 3-light window includes chamfered stone mullions, iron stanchions and 20<sup>th</sup> century Crittal type metal windows. The balustrade at the top of the stairs includes replica splat balusters with a relatively modern handrail. The passage leading to the rear wing includes a stud partition with a raking strut. The style of the stud partition is consistent with a later 18<sup>th</sup> to early 19<sup>th</sup> century date.

Figure 16: Plank and batten door and chamfered door frame to the first floor bedroom

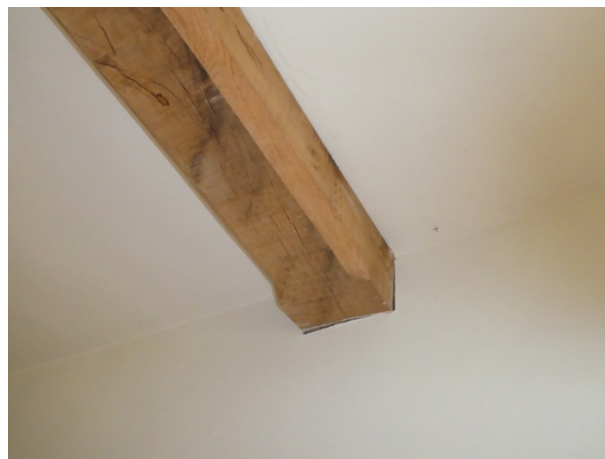
Figure 17: Later machine sawn beam in the bedroom

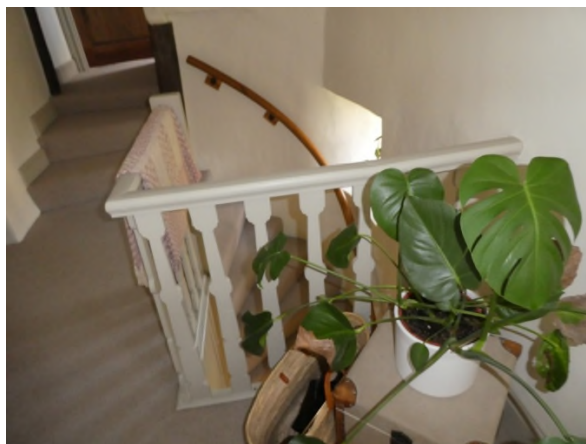
Figure 18: Splat balusters to the first floor balustrade

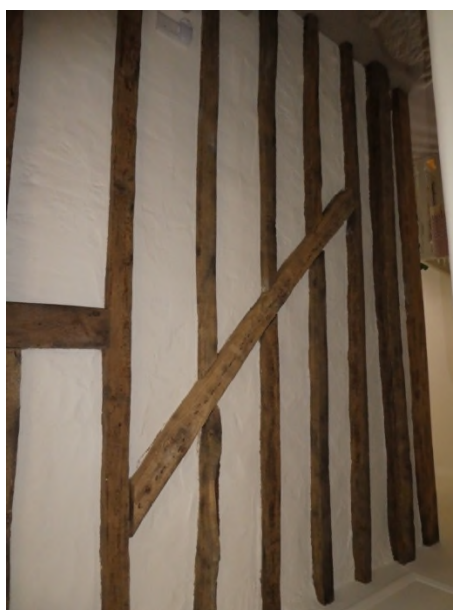
Figure 19: Stud partition in the passage to the rear wing

- 3.3.4 Changes to the layout of the listed building are most clearly demonstrated by the stud with raking strut partitions on the first floor. These are of later 18<sup>th</sup> or 19<sup>th</sup> century date. The latter date appears to tie in with the replacement roof in Section 1 and alteration of the roof in Section 2. This remodelling also appears to be associated with the insertion of or replacement of windows with stone mullioned windows with narrow mullions and using a more honey coloured stone. This appears to relate to the gentrification of the south-eastern aspect of the rear wing.

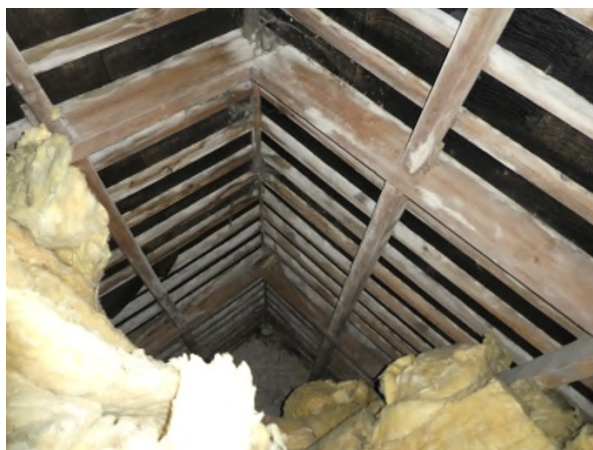
3.2.9 The roof structure includes two rows of butt purlins and a ridge plank. The timbers are regularly sawn. The character of the timbers and the style of roof suggests a 19<sup>th</sup> century date and demonstrates that the original roof has been replaced.

Figure 20: Replacement roof structure

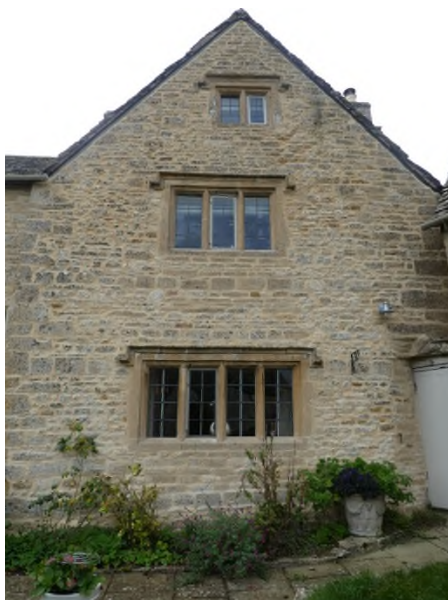
3.2.10 The north-east elevation is gabled and projects slightly from Section 1. The windows on all floors include stopped hood moulds. The original roof profile is preserved by the courses of masonry in the gable apex. This evidence correlates with the modified truss that can be observed internally.

Figure 21: Front elevation of Section 2

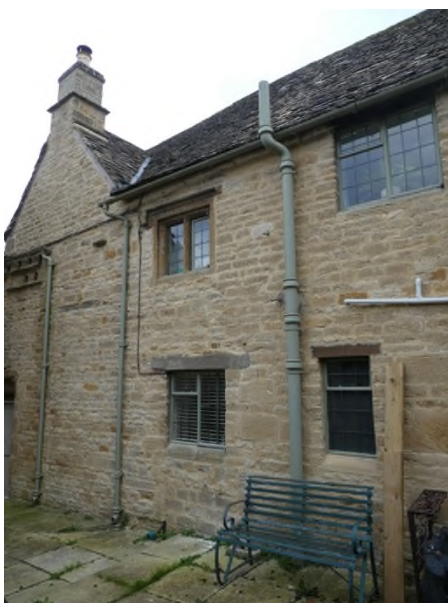
3.2.11 The north-west elevation a cross gable associated with the chimney stack. To the left of the stack there are seven pigeon holes. There is a distinct change in the character of the masonry to the right of the ground and first floor windows which defines the rear wing phase of construction from the main part of the house. The ground floor window opening includes two straight joints for a former door opening below sill level. The lintel is concrete/cement render.

Figure 22: North-west elevation of Section 2

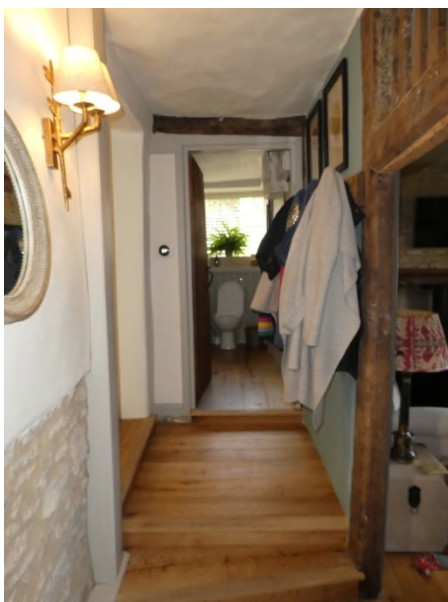
3.2.12 The ground floor of Section 2 includes a room (snug) at the front and a passage to the rear which are defined by a pegged timber partition with adzed finishes to the timbers. The snug is accessed through a reused plank and batten door of late 18<sup>th</sup> to early 19<sup>th</sup> century date. Part of a splat balustrade is positioned over the door. The door frame is chamfered and includes stop details. The snug includes an axial beam with wide chamfers and bar stops with scroll and lozenge. The style of the stops suggests a 17<sup>th</sup> century date. There is a fireplace with a timber lintel and stone jambs on the north-west side of the room. There are short sections of timber in the wall either side of the fireplace which appear to relate to blocked up recesses, possibly for candles. There is a 3-light window with chamfered mullions on the north-east side of the room. There are stanchions for supporting leaded lights. There is one side opening casement with a window catch which may be of 19<sup>th</sup> century date, possibly earlier. The hook stay is 19<sup>th</sup> century. The rear passage includes a modern door leading to a W.C. There is a chamfered beam with ogee stops over the door. This beam is in line with the transverse beam in the study. The style of the stops suggests a 17<sup>th</sup> century date.

Figure 23: Passage on the south-west side of the snug

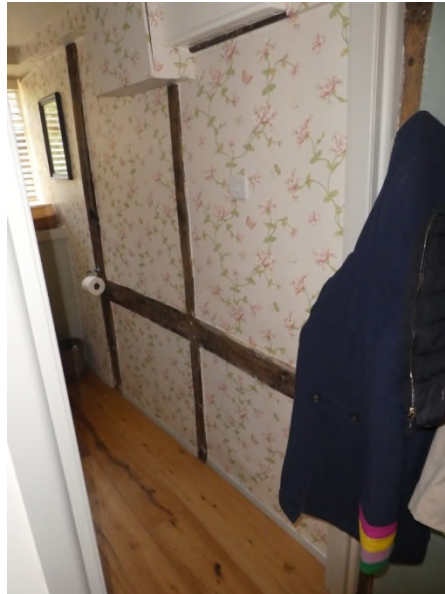
Figure 24: Timber framed partition in the W.C.

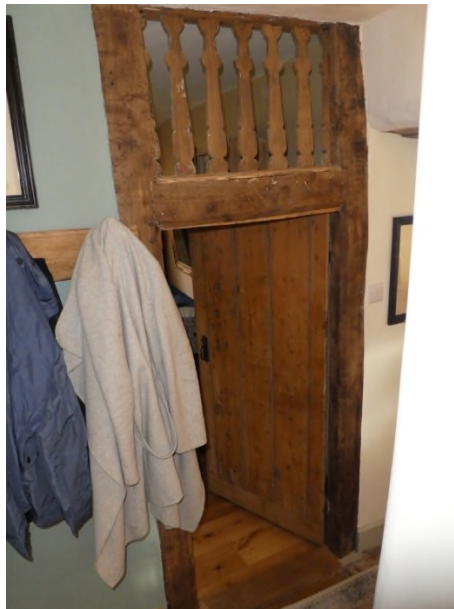
Figure 25: Door to the snug

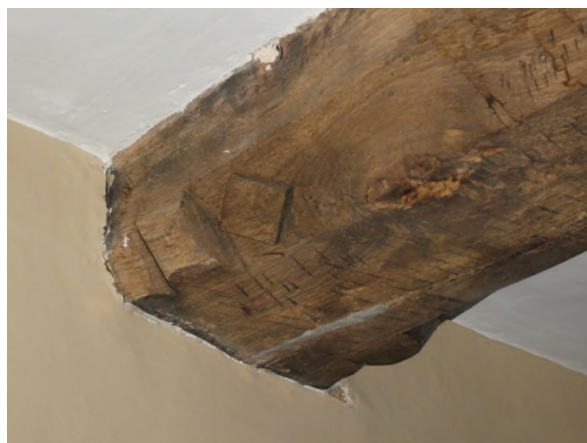
Figure 26: Detail of the transverse beam with bar and scroll stops with lozenge

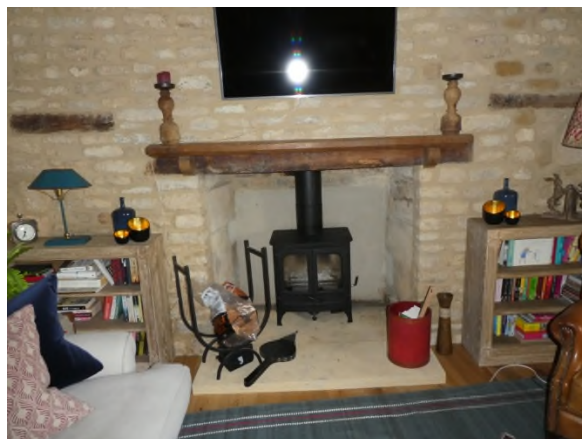
Figure 27: Fireplace with a timber lintel and blocked openings with lintels to the left and right

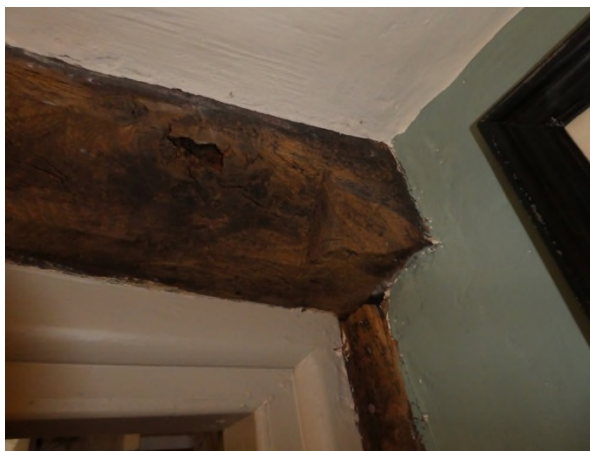
Figure 28: Ogee stop to the chamfered beam over the door to the W.C.

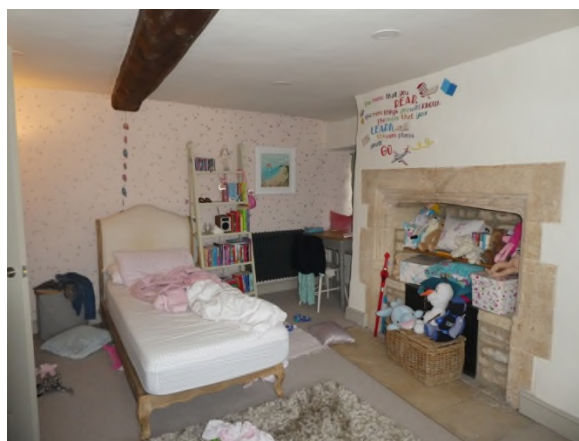
3.2.13 The first floor bedroom is accessed from the landing through a reused late 17<sup>th</sup> to early 18<sup>th</sup> century 2-panelled door. The bedroom includes an axial beam with the same chamfer and stop details as on the ground floor. There is a 17<sup>th</sup> century stone fireplace with a depressed four-centred arch and plain mouldings. An early 19<sup>th</sup> century cast iron hob grate and associated masonry has been inserted into the original open fireplace. There is a 3-light window with chamfered mullions on the north-east side of the bedroom. This includes saddle bars rather than stanchions (as is apparent on the ground floor). The central light is a side opening iron casement with replacement glazing and a bar stay, a later alteration.

Figure 29: Transverse beam and stone fireplace in the first floor bedroom

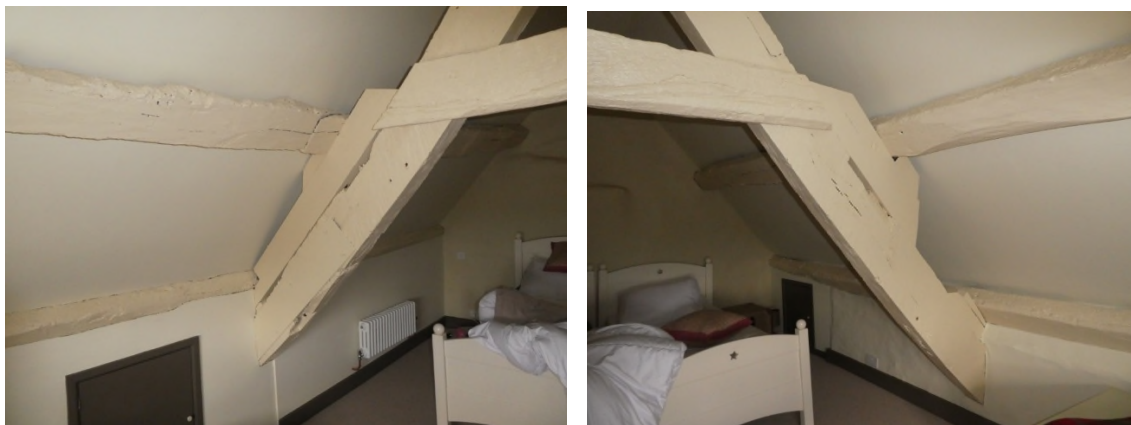
3.2.14 The attic includes a truss with a bridled apex and a collar nailed to one face. There are two rows of purlins which are supported on later blocks of timber with cleats. There is evidence in the form of notches along the top edge of the principal rafters to show that purlins were originally trenched. There is also evidence for struts on the bottom edge of the principal rafters.

Figures 30 and 31: Roof structure in the attic bedroom

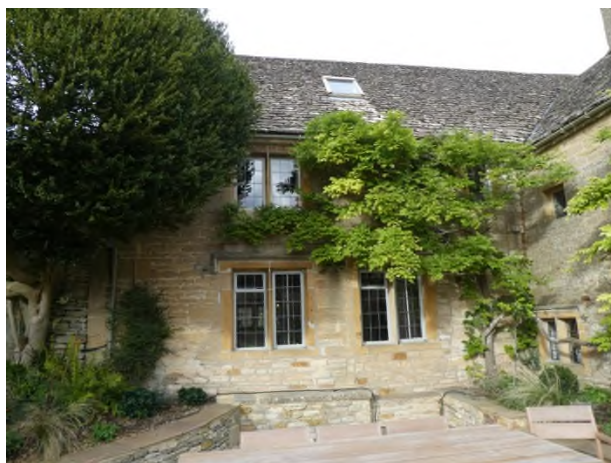
3.2.15 The south-east elevation of the rear wing is characterised by coursed rubble stone construction with quoins on the left hand side. The masonry courses become less regular below the ground floor window to the right as well as along the right hand side margins of this window. The pattern of the masonry in this location is indicative of a former door opening in this location. The ground floor windows include chamfered mullions and stopped hood moulds. These hood moulds extend untidily beyond the edge of the stone window frames which is in contrast with the neatly executed stone windows on the front elevation. The first floor windows also include stone mullions.

Figure 32: South-east elevation of Section 3

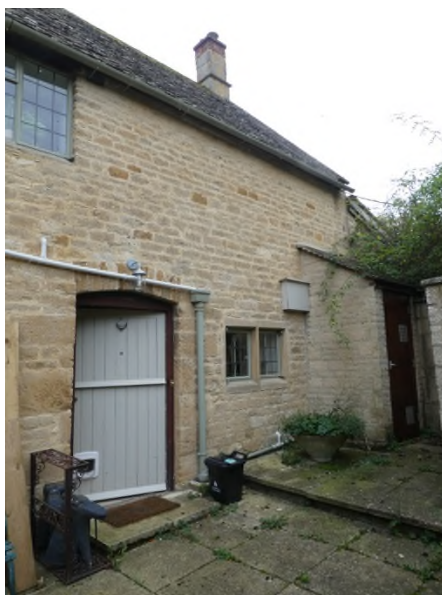
3.2.16 The north-west elevation of the rear wing includes an original door opening with a segmental arched stone head. The plank door is modern. To the right of the door is a 20<sup>th</sup> century stone mullioned window with a Crittal type window. Above the door opening is a window opening with a timber mullion. The window is of c. mid-20<sup>th</sup> century date. To the left of the door is a

single light window opening with a 20<sup>th</sup> century timber lintel and stone sill. There is a distinct change in the character of the masonry on the left hand side of this window. There is no clear straight joint but the change in the character of the coursed rubble stone masonry marks the transition between Section 2 and the rear wing.

Figure 33: North-west elevation of Section 3

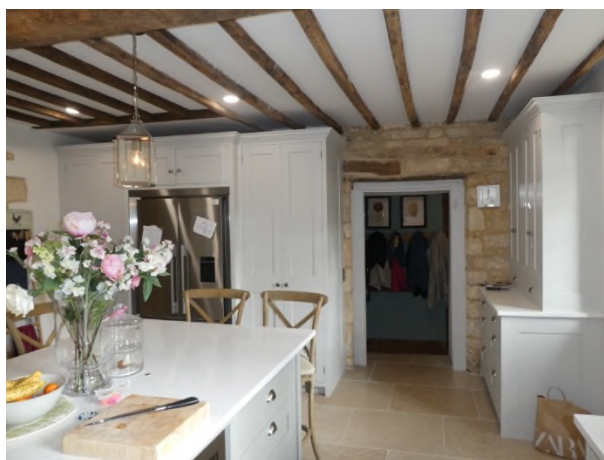
3.2.17 The ground floor of the rear wing is accessed from the passage through a door opening with a timber lintel. The opening is also dressed with stones which, along with the timber lintel, shows that this represents an earlier opening to the rear of Section 2. The kitchen includes a chamfered transverse beam with runout stops. The chamfer is 2 ½". The joists are chamfered and stopped and are on average 80mm wide. There is a break in the pattern of joists and a trimmer on the north side of the kitchen which suggests the position of a former staircase. There is a chimney breast on the south-west side of the kitchen which includes a fireplace with a segmental arched head. There is a bread oven to the right which includes a 19<sup>th</sup> century cast iron hinged door.

Figure 34: North-east side of the kitchen with a door in the rear wall of Section 2

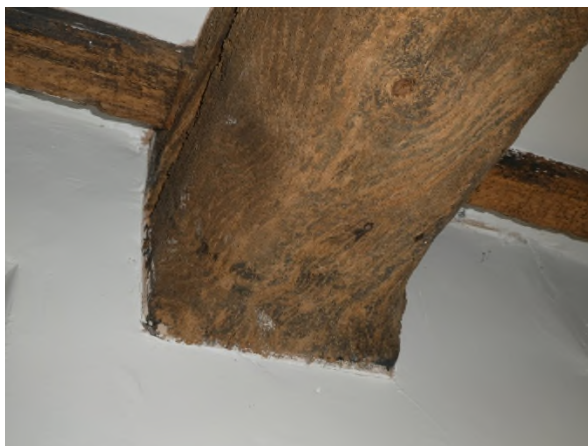
Figure 35: Detail of runout stops on the transverse beam

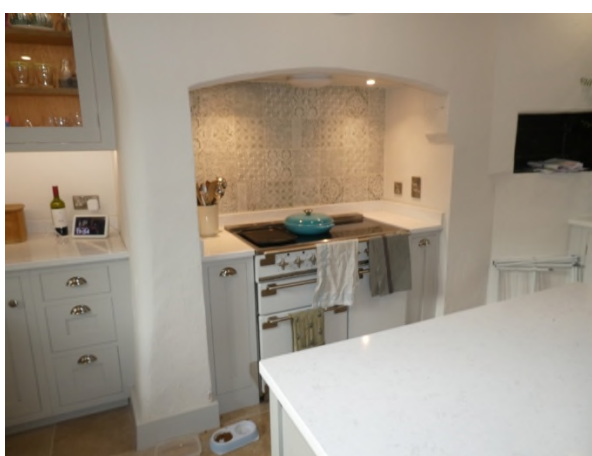
Figure 36: Fireplace on the south-west side of the kitchen

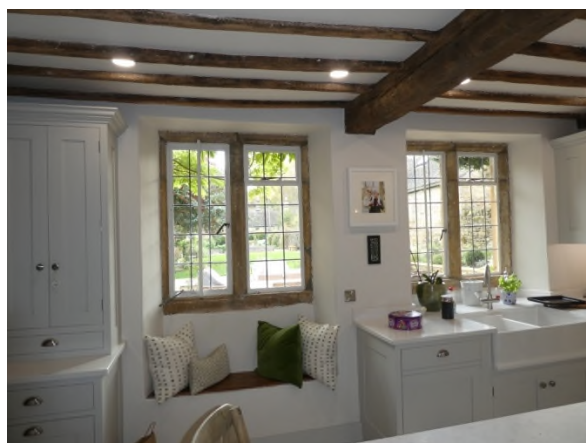
Figure 37: Chamfered mullion windows on the south-east side of the kitchen

3.2.18 There are two stone windows with chamfered mullions on the south-east side of the kitchen. These openings include a single iron stanchion for supporting a leaded light. The current windows are mid-20<sup>th</sup> century Crittal type metal windows. There is a smaller window with a chunky chamfered mullion on the north-west side of the kitchen. This includes two iron stanchions that would have supported leaded lights. The current windows are mid-20<sup>th</sup> century Crittal type metal windows.

- 4.2.1 The proposed access from the kitchen to the garden room requires the modification of an existing stone mullioned window to create a door opening. This window is characterised by a honey coloured limestone which differs from the older 17<sup>th</sup> century examples at the house. The mullion is more slender and matches others that are considered to be later replacements in the original part of the house. The listing description suggests that the rear wing is of late 18<sup>th</sup> to 19<sup>th</sup> century date. Some of the internal details, particularly the beams and joists, suggest an earlier date for construction. The windows on the south-east elevation are of higher status than those on the north-west elevation and appear out of keeping with what is interpreted as a service wing. The stone mullioned windows on the south-east elevation are interpreted as later insertions related to the gentrification of this part of the listed building. This hypothesis appears to be supported by the change in the character of the stone work around the window in question. In particular the change in the character and pattern of the stone courses below sill level suggest that there was formerly a door opening in this position. It is of note that this door is in line with the door from the kitchen into the yard. The windows themselves are Crittal type metal windows of mid-20<sup>th</sup> century and are of low heritage interest.

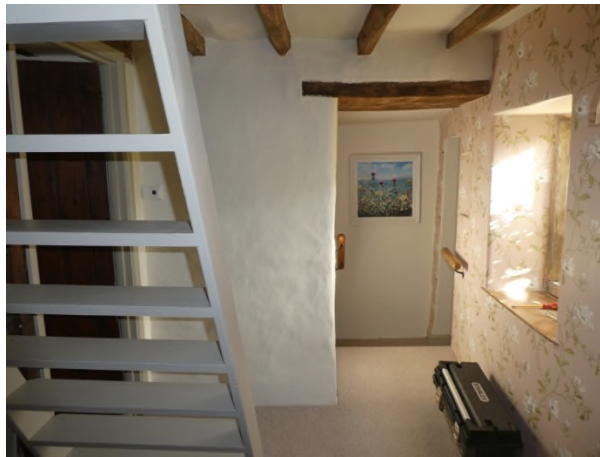
3.2.19 The first floor is accessed through an opening with a timber lintel in the rear wall of Section 2. The first floor is sub-divided to include a bedroom, bathroom and a lobby. There is a transverse beam with a 2 ½" chamfer with scroll stops. The joists are 65mm wide and are also chamfered and stopped. The form of the ceiling suggests that this was originally a single room. The character of the stud partition with raking strut that defines the bathroom suggests a late 18<sup>th</sup> to early 19<sup>th</sup> century date. The character of the partition that defines the bedroom is unknown but is possibly of a similar age. The plank and batten door to the bedroom is of late 18<sup>th</sup> to early 19<sup>th</sup> century date and is probably re-used.

Figure 38: Door opening to Section 3 in the rear wall of Section 2

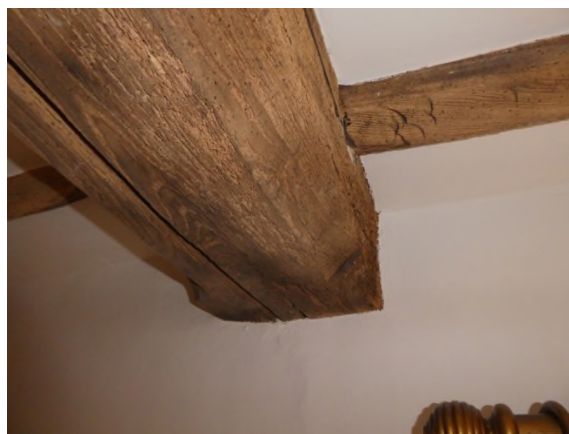
Figure 39: Transverse beam in the bedroom

- 3.3.3 The listing description states that the rear wing is of late 18<sup>th</sup> to 19<sup>th</sup> century date. However, the details of the transverse beams and joists are indicative of an earlier 18<sup>th</sup> century date. The roof structure was not seen but, based on the beams, the rear wing is considered to be slightly earlier than the listing description states.

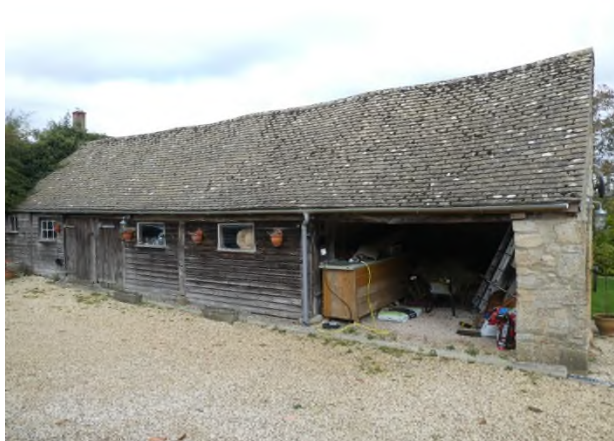
3.2.20 The outbuilding to the south-west of the house is of coursed rubble stone construction with quoins and includes a double pitched roof finished with tiles. The south-east gable end elevation includes a door opening with a timber lintel to the left. The south-west elevation was originally open fronted. One bay remains open but the rest have been infilled with shiplap boards and garage doors. The original posts and bases remain legible along this elevation. The roof structure includes cambered or waney tie beams, a row of butt purlins which are cut back where they are tenoned into the principal rafters and a ridge plank. The style of the roof is indicative of a late 18<sup>th</sup> to early 19<sup>th</sup> century date. The internal partitions are 20<sup>th</sup> century stud and ply board and concrete block.

Figure 42: North-east and south-east elevations of the outbuilding
