DESIGN AND ACCESS & HERITAGE STATEMENT

Hampton Cottage, Milton Street, Fairford, GL7 4BN

PROPOSED WORK:

- Proposed adjustment/ replacement of staircase to second floor to meet safe and usable standards/regulations
- Creation of new bathroom ensuite to second floor bedroom
- Renovation of curtilage listed garden folly
- Creation of new first floor office and ground floor garden room
- Opening of NE facing wall for bifold doors
- Redesign of folly roof for vented warm roof structure
- Associated ground works and wall insulation to provide habitable space

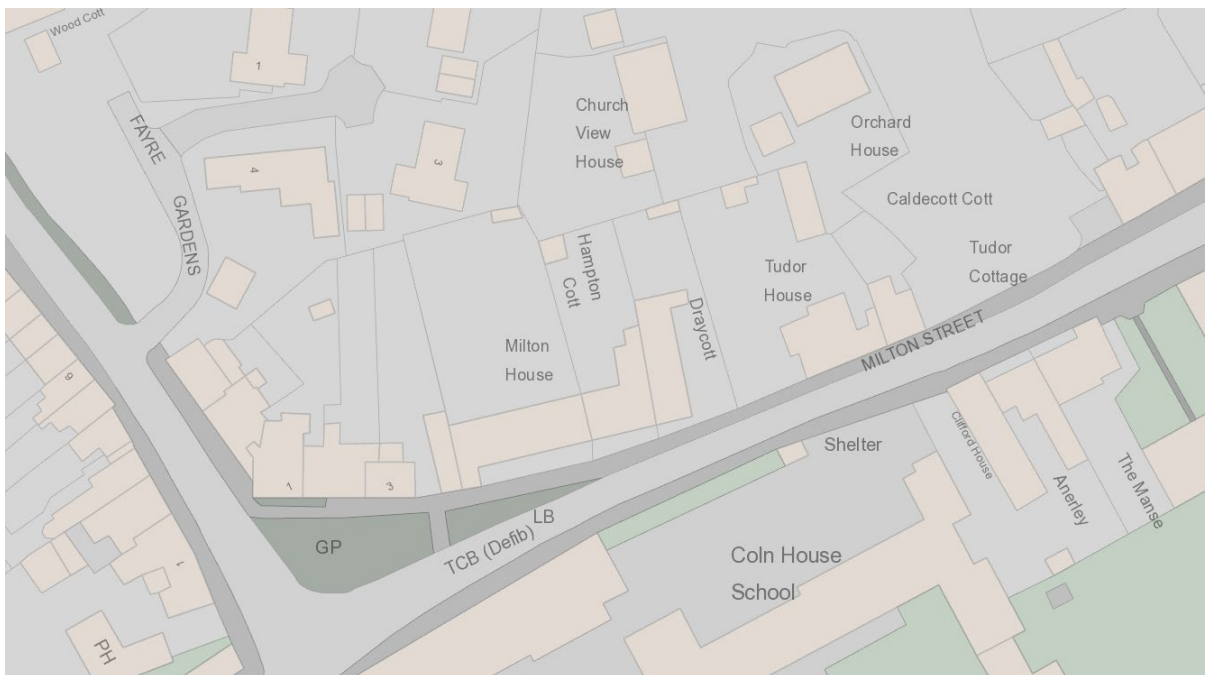
Know your place map: 2019

The additional garden structure is now no longer shown or exists and the folly is shown as currently found in its square form.

What we conclude from this is that the site most likely originally had no rear extensions with those being added around the 1900's. The folly has remained larger unchanged while an additional structure to the rear most likely has been removed over the past century.

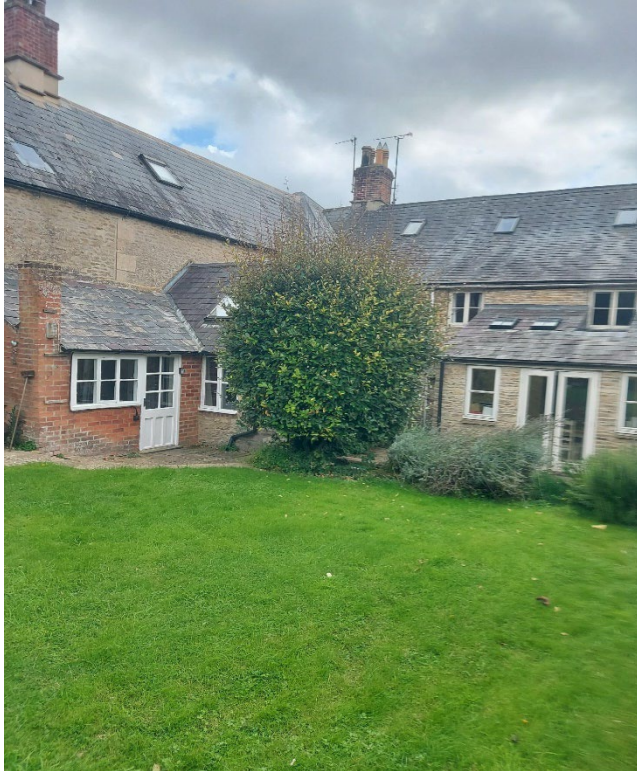
The image above shows the difference between stone used to construct the house in C18 and that used to form the additional recent single storey lean to and the adjacent structures which have been adjusted over the past century. The rubble stone construction is typical of domestic buildings from this period. We would conclude that the significance of the Hampton Cottage lies in the original form of its oldest elements, contemporaneous with the surrounding structures within the site. For this reason, we have not proposed any modifications to the form of the original house.

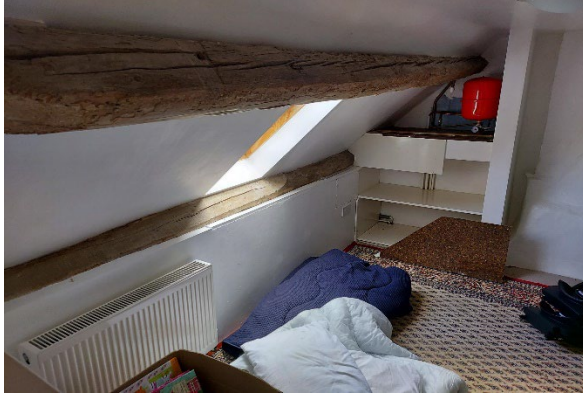
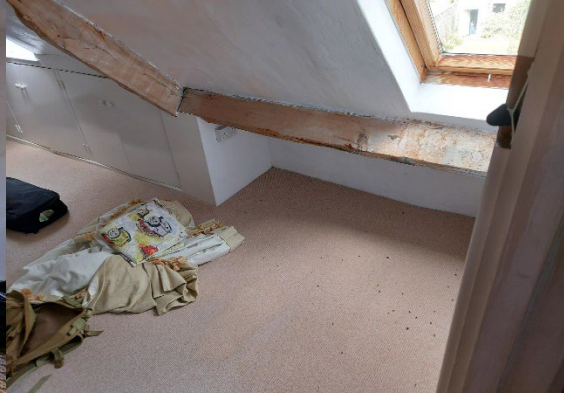
Existing roof window openings

Two cat slide Velux window will be installed into the opposite side of each roof window at first floor and will provide passive through ventilation across the roof space. These additions of would transform this area into a light and useable space, whilst using a detail consistent with the existing building.

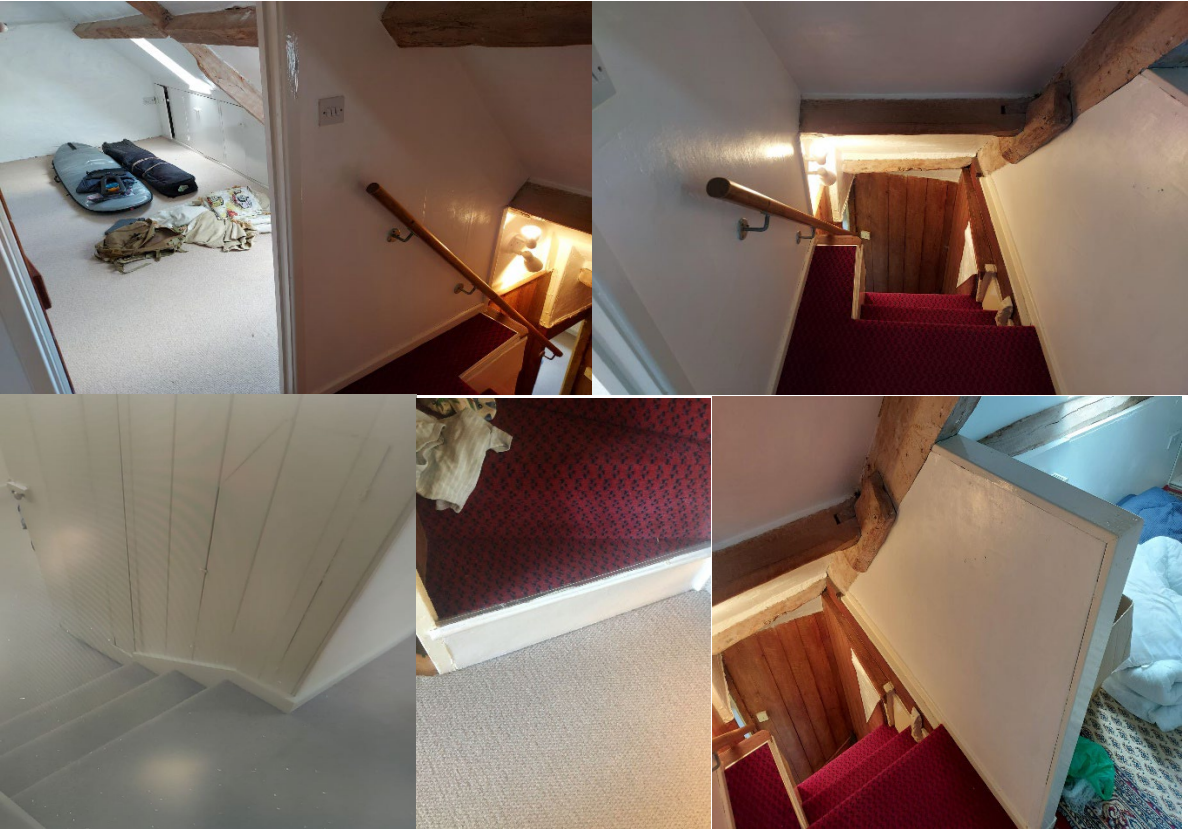
Existing first floor staircase including door opening and internal timber panelling.

As currently found the existing staircase is hugely unsafe and is seen to be unusable. It is seen that the creating of this staircase is not an original feature and was likely introduced after the buildings construction in order to create access to temporary habitable space. In doing so however each riser is different in height and is unsafe to walk along. It is also in pitching distance to the structural beam overhead and any user needs to bend down to use this space. The staircase should not ideally be moved to another location in the house as any work will be detrimental to the surrounding spaces but instead within its existing wall curtilage all steps should be reduced to minimum modern rise size therefore creating a landing that is suggested to be 550mm lower than existing therefore providing clear head room when in use. The reduction in level will not interfere with any ceiling levels below and will therefore sit within the confines of the existing area. All existing details such as the wooden door or panelling will be either reused, retained or respected through the use of matching or suitable materials in order to preserve the C19 detailing.

There are a few areas which are clearly visible that will need to be adjusted in order to meet useable standards while retaining the aesthetic merit of the staircase. The following actions are therefore required to retain this feature where possible and install new where required:

- *Remove all softwood treads, risers, the landing and associated carpeting,*
- *Retain the existing door opening and timber panelling,*
- *Insert a custom build staircase within the structural opening,*
- *Recarpet the structure from top to bottom,*
- *Inspect lath and plaster from above to inspect any laths that have failed.*
- *Cut away defective plaster and investigate.*
- *Where laths have failed, cut back to studs or joists, and replace.*
- *Use like-for-like lime plaster to repair any damage.*

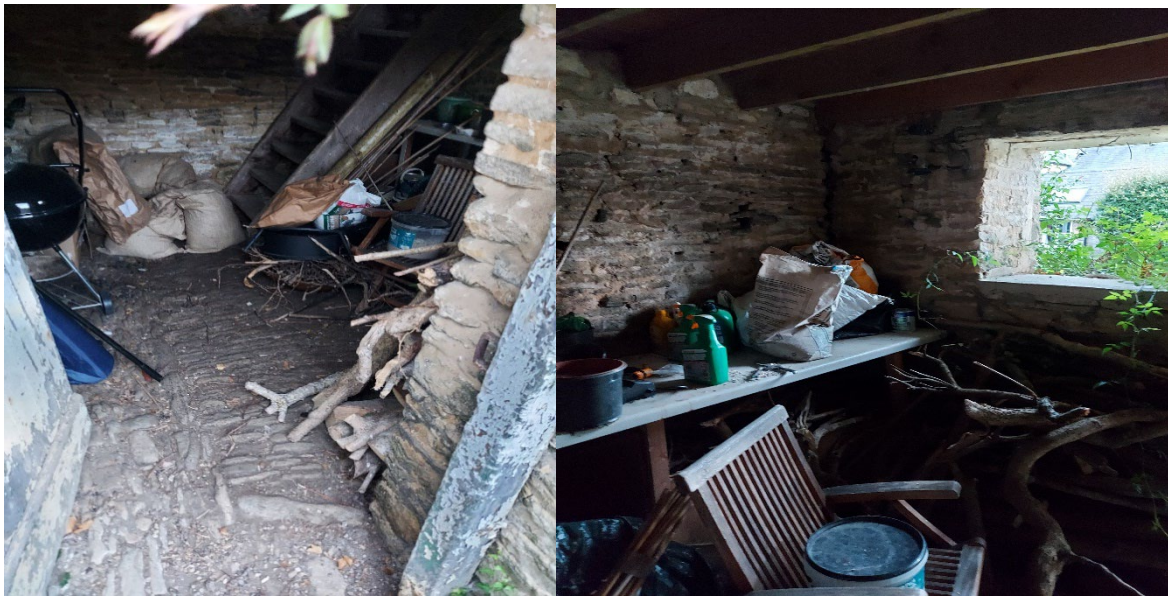
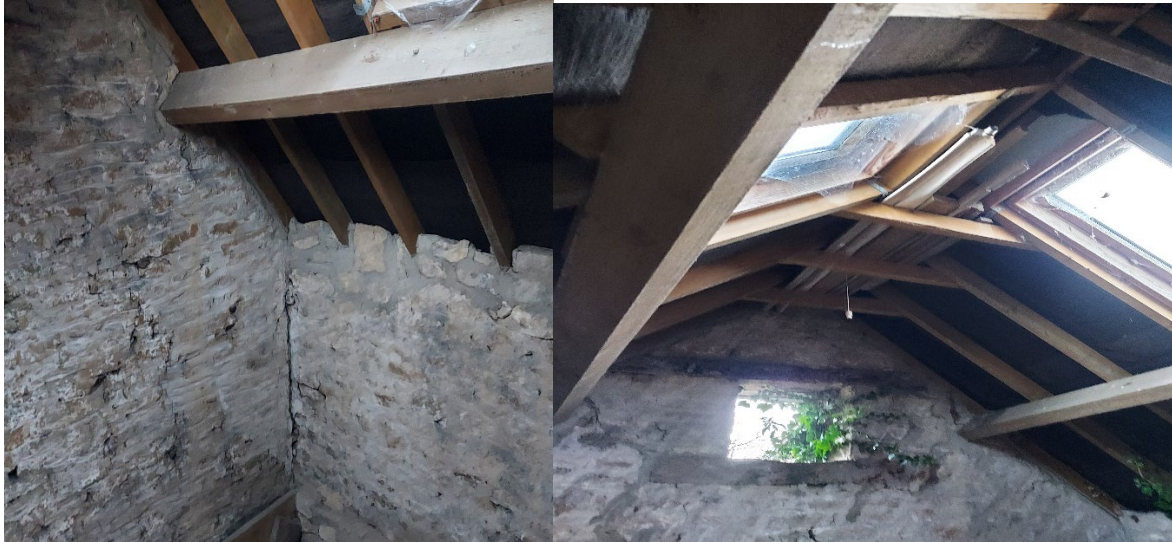
Existing garden folly with exposed openings and no modernisation or updates.

The small, cramped folly is showing clear signs degradation. All openings except for the roof Velux's are without fittings and therefore inclement weather easily enters the folly. This makes the existing structure useable for any means of storage or habitable use leaving the folly to be seen as a detrimental asset to the site.

Behind the entrance door there is original cobbled flooring which although is a traditional feature does cause notable level change from front to back and is unsuitable for day-to-day use. This goes back to its original use as an external store area and therefore this use is intended to be preserved in some form through its connection to its external surrounding. The opening of the NE facing wall for the bifold doors preserves this use aspect while introducing natural daylight from morning to mid-afternoon.

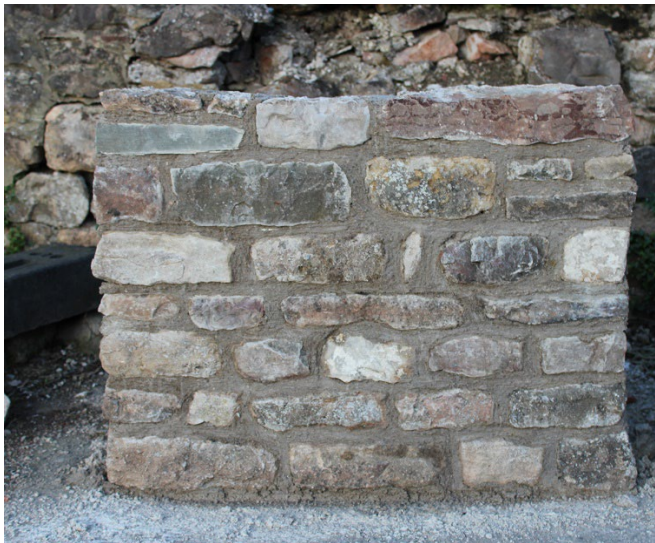
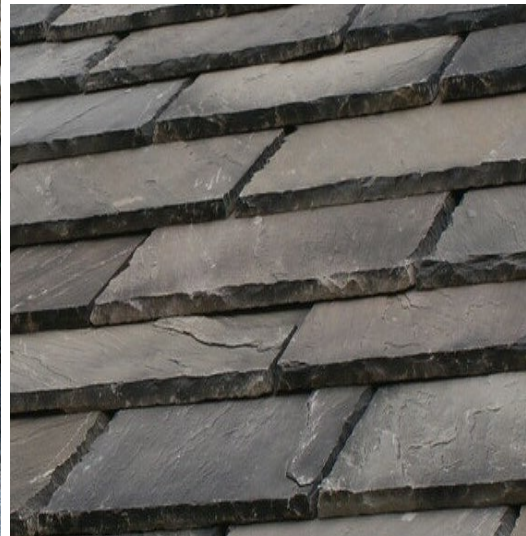
Materials used would consist of random rubble stone laid in irregular arrangements and pointed with a lime mortar mix (as per example sample panel below). Careful stone selection will be undertaken to avoid excessively wide mortar joints. The existing slate tile shape will be continued throughout where needed most likely with Argentinian slate where required.
