Heritage Statement & Impact Assessment

Lamb House, Glasbury

Prepared by Sam Hale on behalf of Place Space Design

April 2022

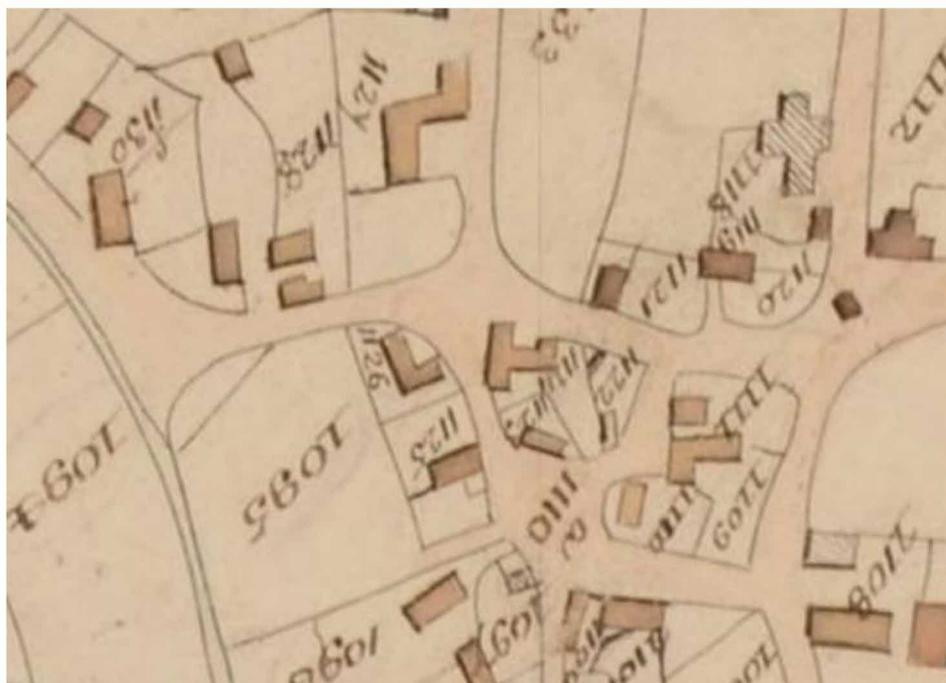
1847 Glasbury Tithe map the landowner was [REDACTED] and occupier [REDACTED]. The link between the house and barn appears to be shown. The yard of the Lamb Inn is shown accessed from the north as well as the south off The Green.

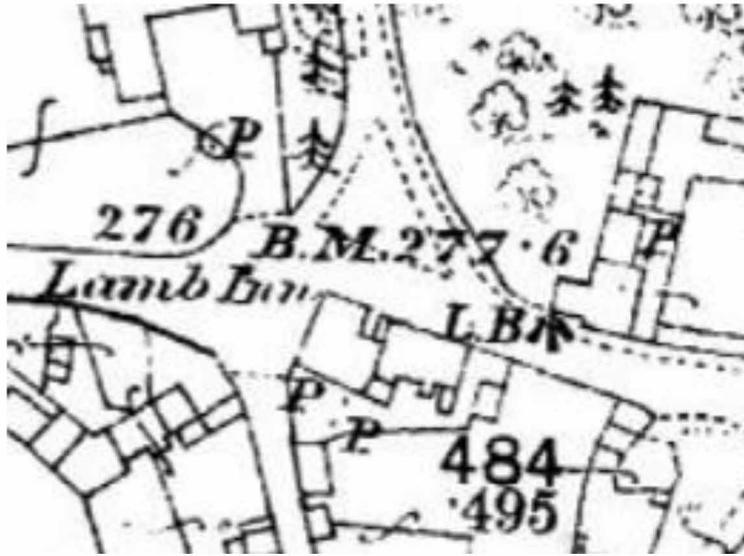
1:2500 OS map extract 1889. The rear kitchen appears to be shown by 1889 as a square plan addition. There are additionally two south projections to the barn which are now non-existent and further buildings in the garden/land to the south and east – these probably comprise the three-stall stable and pigsty referred to in the 1930s – the current 'garage' is shown abutting the side lane. References to a cider mill and cider production in the early 1900s could suggest that either a section of the barn housed a cider mill or one of the outbuildings served this purpose. P indicates a water pump in the garden to the south.

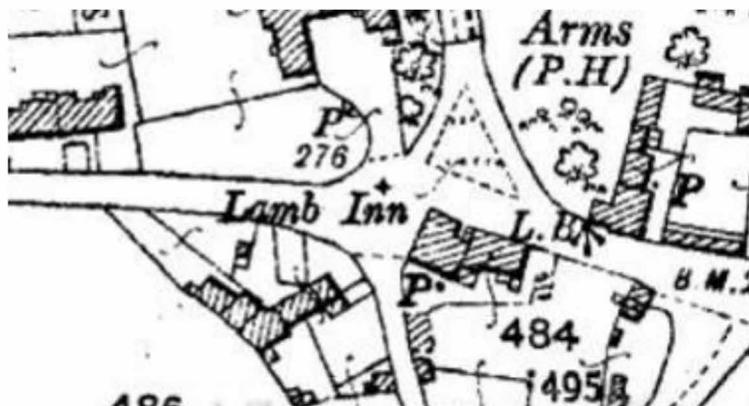
1:2500 OS map extract 1904. The Inn, barn and ancillary outbuildings remain as shown in 1889.

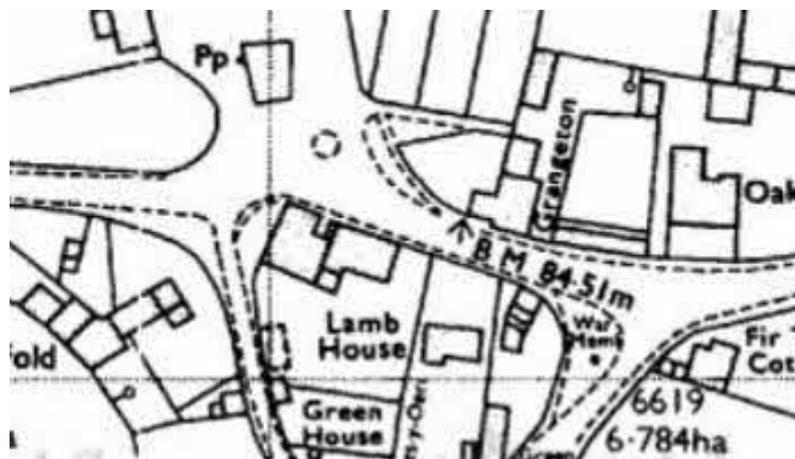
1: 2500 OS map extract 1975. Projections to the barn have now been lost as well as the small outbuilding to the east of the barn. Maes y Deri has been built to the east in the former gorunds of the Lamb Inn truncating the garden.

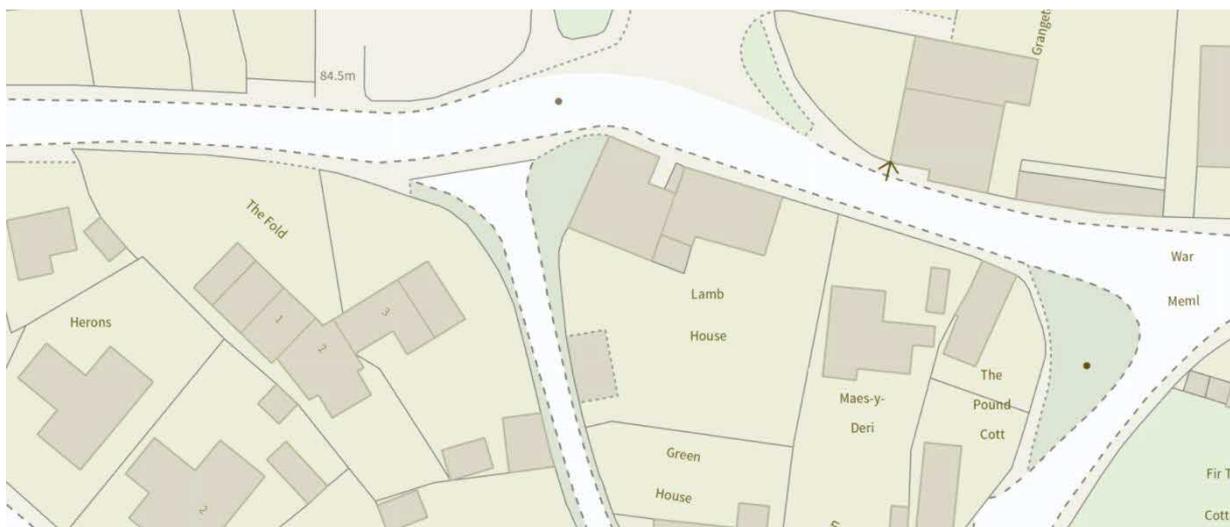
Lamb House with attached barn and detached stone outbuilding, now much altered.

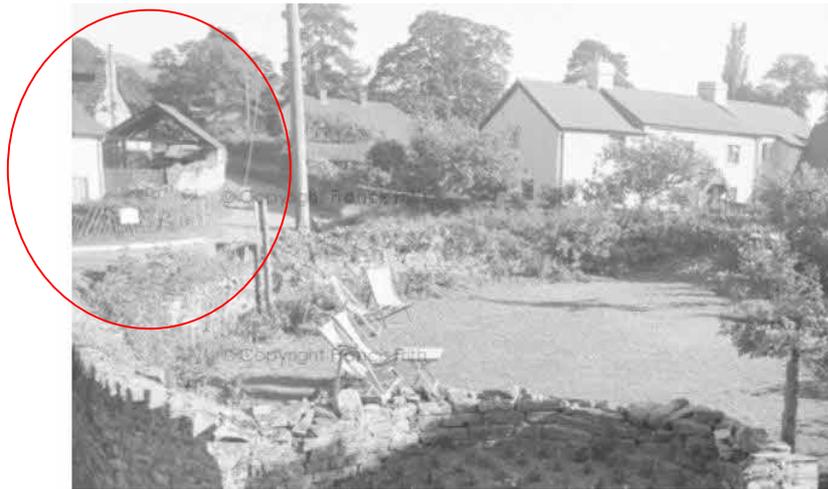
1950 photograph showing the south west corner of Lamb House with the outbuilding behind that appears as an open shelter shed at this time without cladding.

Lamb House is constructed of rubblestone – possibly, but not definitely, replacing former timber-frame. A photograph dated 1957 shows the roadside gable with a ‘bagged’ lime finish. It has been later cement rendered and painted white. A 1950 photograph with glimpsed view of the front elevation may suggest that this was lime rendered.

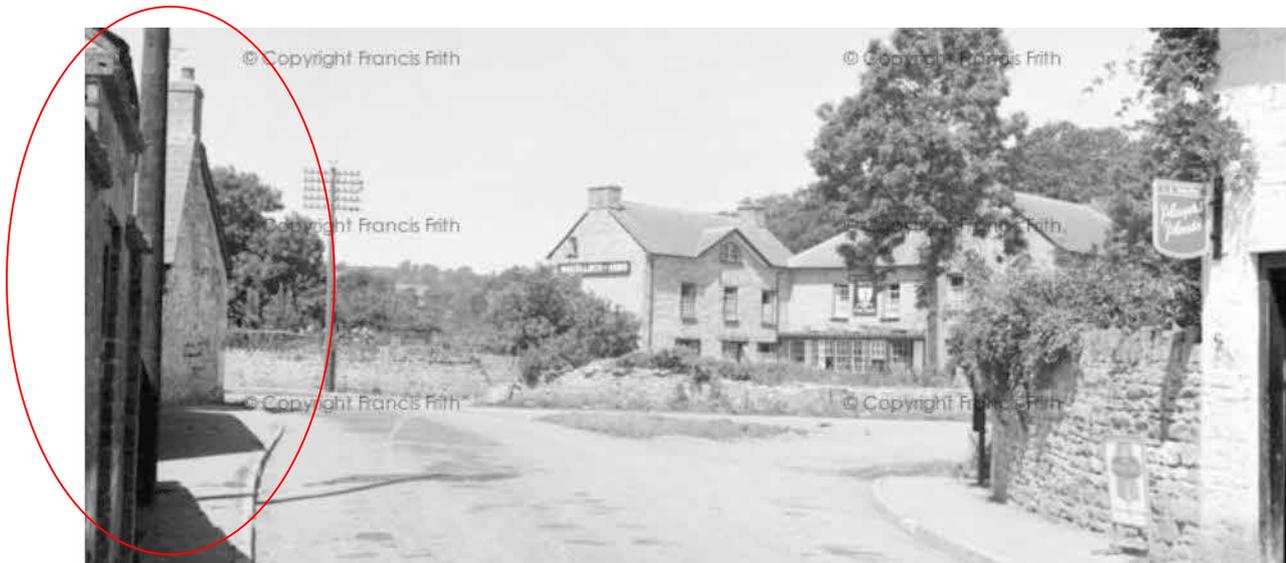
1957 photograph showing the roadside gable of Lamb House with a 'bagged' /'parged' finish.

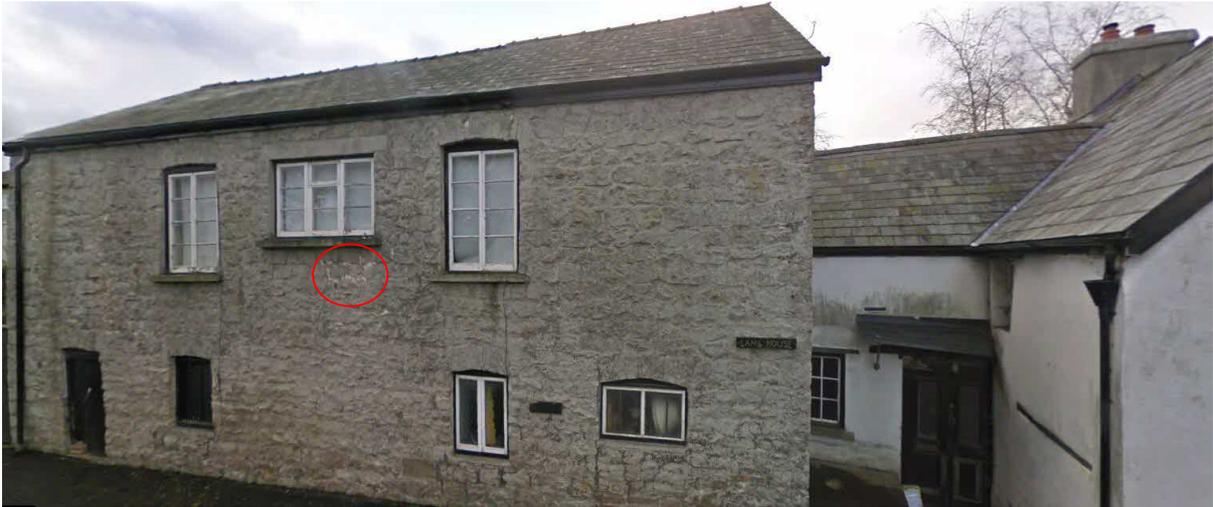
Google Street View 2009 showing the cement slurry finish on the barn although elements of limewash do survive (circled)

The rubblestone barn attached to Lamb House was formerly ‘bagged’ and limewashed. A later cement slurry was applied to the building (seen in 2009) and during renovations it appears as if the majority of the east gable end of the barn and some of the south elevation has been entirely re-built - possibly in concrete block re-clad in stone – see the 2009 image.

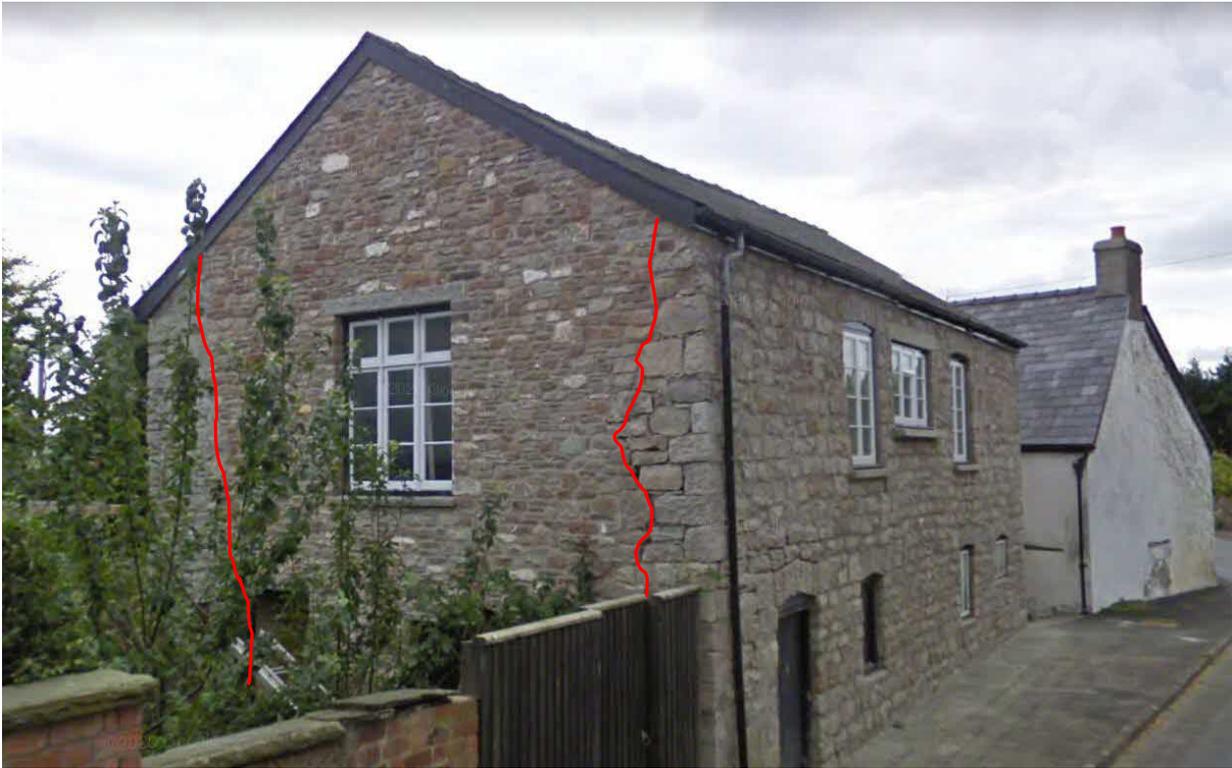
Google Street view showing the re-built gable of the barn between the red lines.

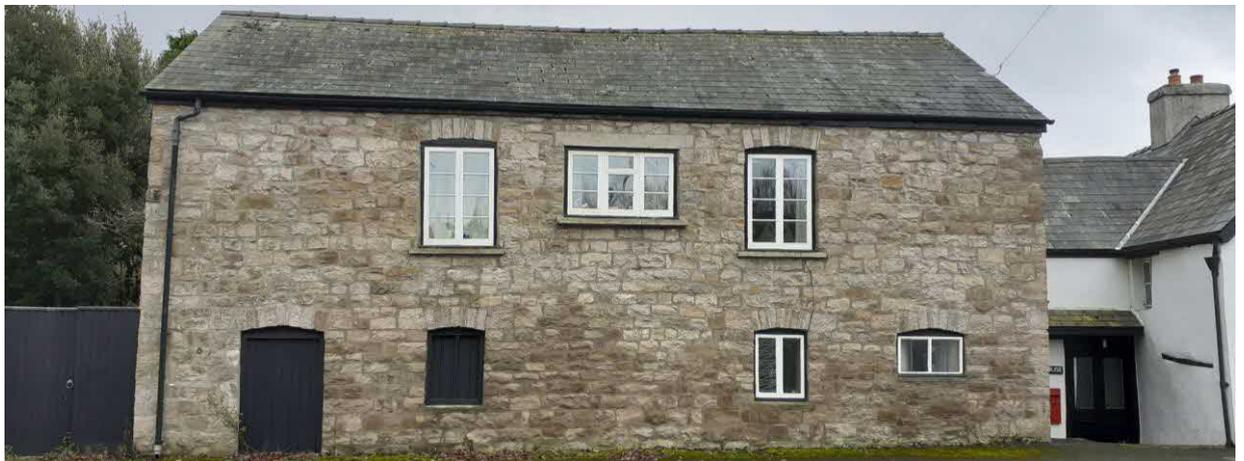
The north elevation of the barn

Currently the plank door and adjacent shuttered window do provide some link back to the former use of the barn and retain agricultural character. It is accepted that the barn is no longer in agricultural use and now forms part of the domestic home. Retaining the plank door is essential to the barn's roadside character. The proposal to retain the shuttered window as is save for fitting plain glazing into the existing frame will retain its essential character and fitting the existing timber boarding as shutters will enable the agricultural character to be read when the shutters are closed. This is will alter the character of the

window but it is designed to have a neutral impact on historic fabric and not adversely affect significance. Removing the 20th century wavy glazing to the other ground floor windows and replacement with plain slim low reflectivity double glazing will improve their current appearance. The glazing is to be specified but could be Histoglass or similar.

8. On the North elevation of the barn it is proposed to open up the boarded window, retaining the boarding to form shutters and installing glass into the existing frame with a simple glazing bead. It is also proposed to replace the glass to the existing Ground Floor windows with low-reflectivity, plain slim double-glazed panels. The existing door within the link is in good condition and simply requires redecoration.

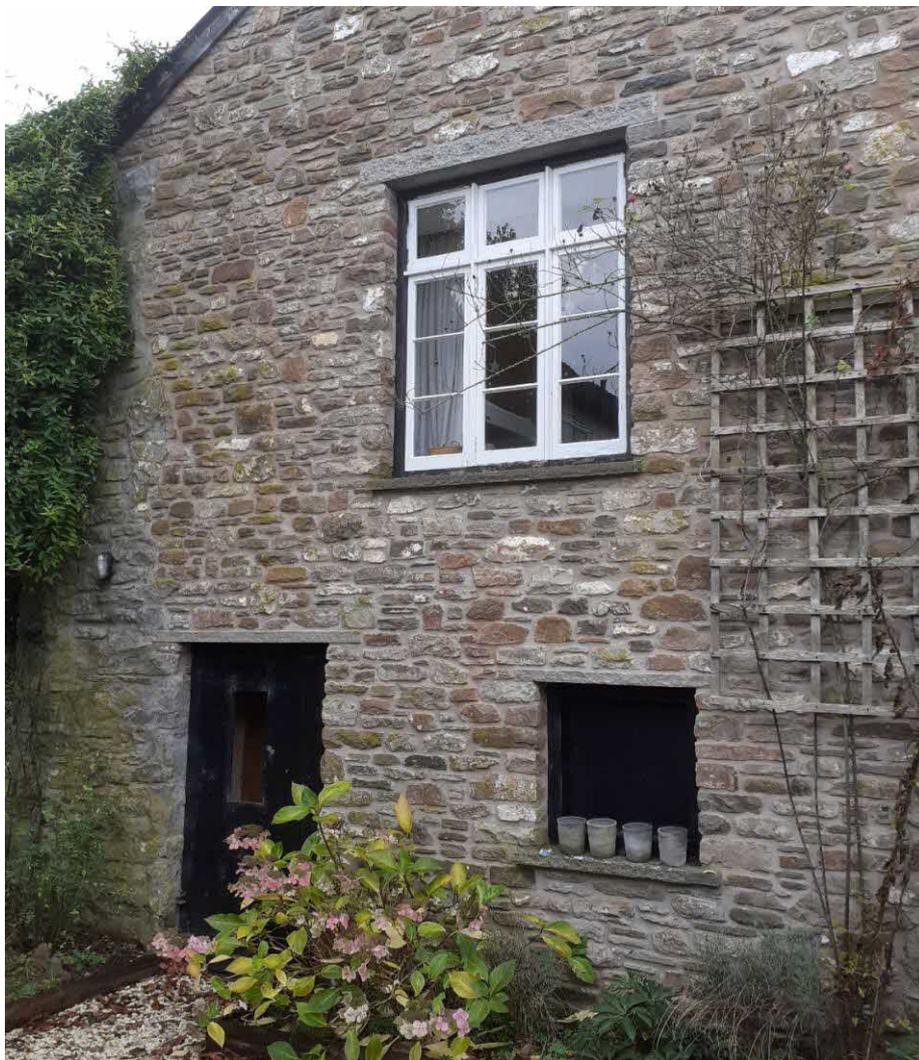
East gable of the barn, substantially re-built and a domestic style window inserted at first floor level.

The east gable of the barn has been largely re-built (it appears to have been re-built in concrete block and re-clad in stone. The door may be 19th century but the boarded window appears to be a replacement. The walls around them have been re-built and the

original window location may have been replicated in the re-building. As with the north elevation the plank door and adjacent shuttered window do provide some link back to the former use of the barn and retain agricultural character. Retaining the door is a positive element in the proposed scheme with simple glazing where there is currently a cut out. The blocked window although having agricultural character does not retain significant historic fabric and its replacement with a new casement to match the roadside W11 would appear to represent an honest alteration reflecting the use of the former barn as domestic accommodation without introducing an inappropriate 'cottage style' window thus retaining some distinction between the barn and the house. This proposed change is deemed to have a neutral impact on the building and not result in the loss of historic fabric or result in the erosion of any significant element of the building important to its listing.

9. On the East elevation of the barn the blocked-up window at Ground Floor level is proposed to be opened up, adding in a simple casement to match the window W11 on the North elevation. The existing external door is capable of repair, with a proposed glass panel inserted in the existing open section.

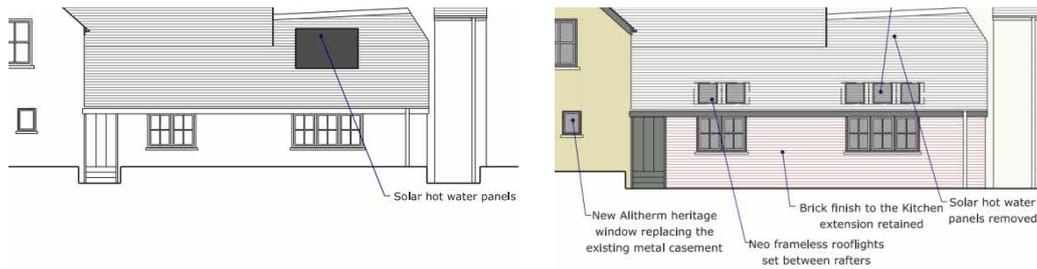
Existing and proposed

The removal of the solar thermal panels and re-siting to be ground mounted to the south elevation of the garage is a positive proposal improving on the current situation. Various options were discussed with the client, architect, heritage consultant and conservation officer regarding a sympathetic solution to get more light into the single storey kitchen. Dropping existing windows to create opening French Windows and options to include large span bespoke rooflights were deemed to have too much impact on the restrained architectural addition of the kitchen and involve too much loss of historic fabric. Instead a solution has been proposed to install modest frameless flush fitting rooflights in banks above the existing south windows. This will be a 21st century intervention but one which will result in limited visual impact and will retain the asymmetric rhythm of the kitchen elevation. Overall it is considered that the proposal will result in less than significant harm.

13. On the Kitchen range it is proposed to remove of the solar hot water panels, to be relocated and ground mounted to the south elevation of the garage. It is proposed to introduce five new flush fitting Neo range Conservation Rooflight Company rooflights to the Kitchen roof above the south window openings.

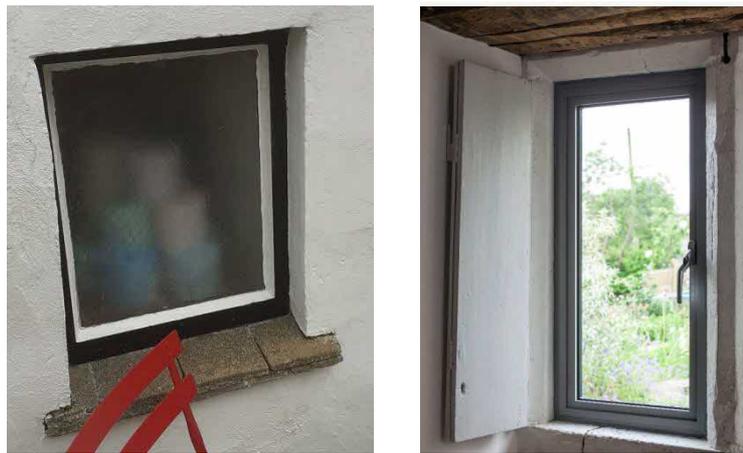
15. On the south gable of the house it is proposed to replace the later 20th century metal window with an Alltherm heritage window, the tile sill replaced in stone. The current window is later 20th century and of no architectural or historic interest. Its removal and replacement with a simple opening light is acceptable in heritage terms and the replacement of the out of character tile sill with a local stone sill is a positive element in the proposal.

The current window and tile sill left, and an example of a simple Alitherm Heritage window right.

15. On the south gable of the house it is proposed to replace the later 20th century metal window with an Alitherm heritage window, the tile sill replaced in stone.

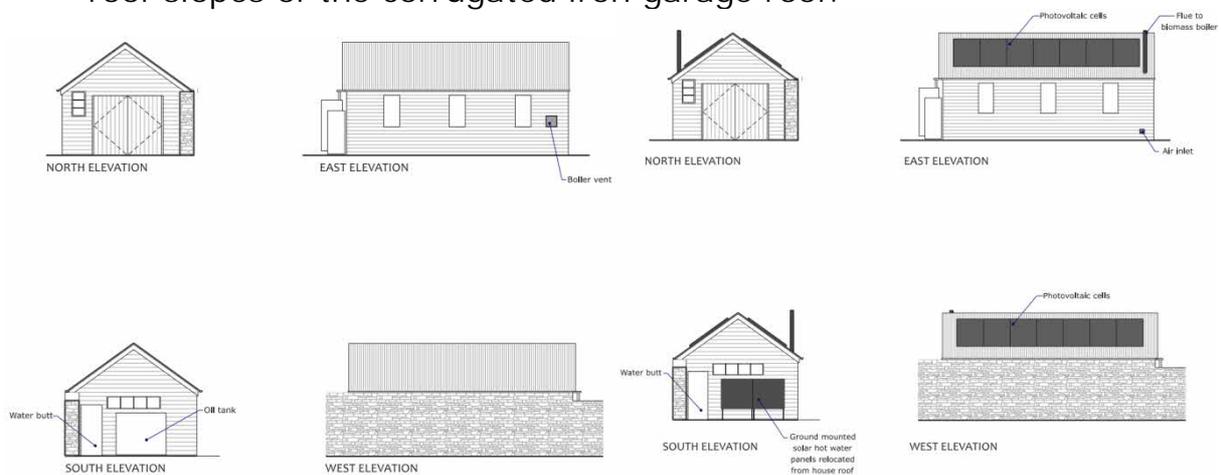
The garage as existing (left) and proposed (right)

Proposals to site new PV arrays on the roof of the garage will offer a solution for sustainable renewable energy while not affecting the fabric of the listed building. The discreet nature of the garage roof and its relatively small roof area combined with the low reflectivity of the panels will limit any impact on the setting of nearby listed buildings (in a more considered way than many recent solar installations on neighbouring buildings, including listed buildings).

17. It is proposed to install an array of Photovoltaic cells to the east and roof slopes of the corrugated iron garage roof.

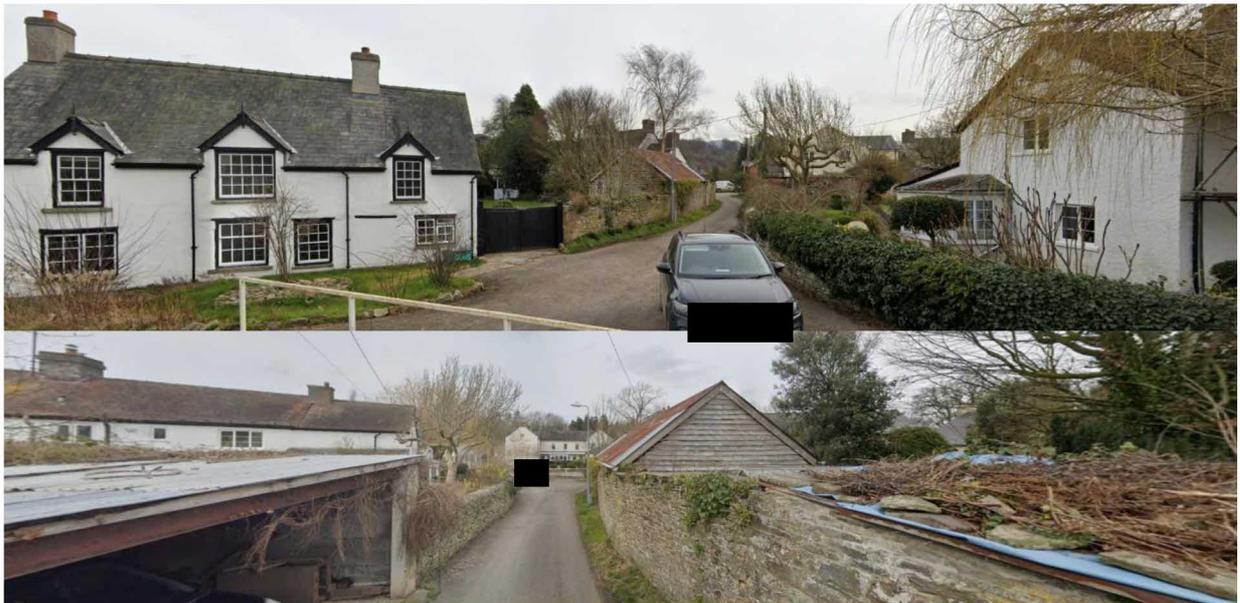
Views of the garage roof from the public realm. While the proposed PV panels will be seen they will not dominate views or have an adverse impact on neighbouring listed buildings or the character of the conservation area. The roof covering to which they are to be mounted is late 20th century.

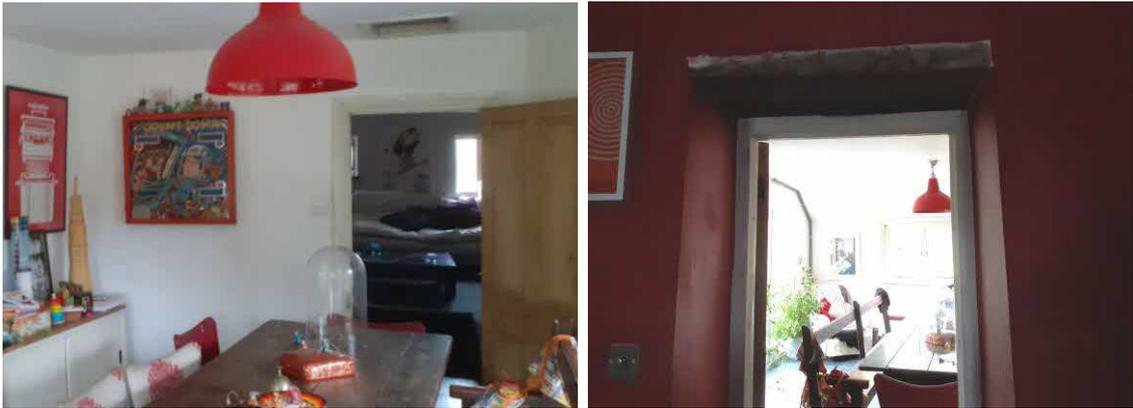
The door between the kitchen/dining room and the barn (living room)

It is likely that this doorway is a later introduction when the kitchen extension was added to the property wrapping around the originally detached barn and not an original opening into the barn. Careful removal of the (later) cement plaster around the doorway may help better reveal the age and construction of the opening. The door, although of some age (pine door of c.late 19th century or early 20th century) appears to have been imported from elsewhere. The door architrave on the kitchen side does appear to be 19th century in date. It is recommended that careful opening up of the cement plaster (that should be removed anyway) on the barn side of the door is allowed to better ascertain the age and significance of the doorway. It has some heritage value in understanding the evolution of the building and the addition of the kitchen range and inclusion of the barn as part of the living accommodation. Suggestions to remove this section of wall entirely were judged by architect and historic building consultant in having a negative impact on the historic fabric and understanding of the building. The current proposal to remove the later (probably imported door) and widen the opening would result in the loss of some historic fabric of the wall and architrave but this would be deemed as less than substantial harm.

22. It is proposed to remove door D16 between the Kitchen / Dining Area and the Living Room and the opening widened by c.300mm.

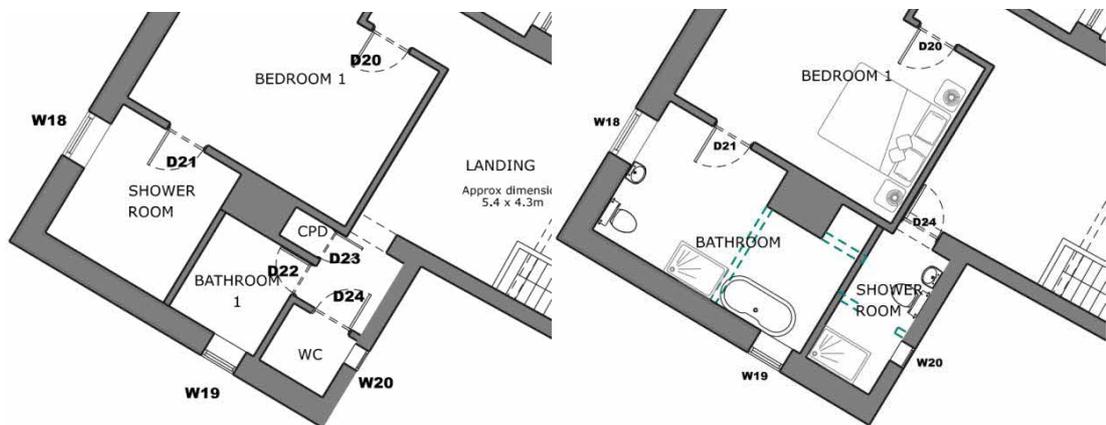
Proposals at the south west side of the house. Existing (left), proposed (right). Dotted green lines indicate proposed removal of walls.

It is understood that the dividing walls to bathroom 1 and the adjacent WC are later insertions and of no historic interest. The plank door to the cupboard D23 is of some age but has been imported into the house and thus has no historic or architectural connection to the building. The proposed rearrangement of the walls to create a separate shower room is deemed to have a neutral impact. The rearrangement of the walls to create a large family bathroom will allow the currently boxed in chimneybreast to be revealed within the bathroom to the positive benefit of understanding the building construction.

27. There are three changes proposed to the First-Floor partitions; To reconnect the existing Bathroom 1 and Shower Room as one Bathroom, To relocate the door to the WC to form a larger room with a shower, To remove a partition wall between Bedrooms 4 and 5 to create one larger bedroom and an en-suite bathroom to Bedroom 3. All of the partition walls for these proposed changes are understood to be modern partitions. However, due to the potential for there to be concealed historic fabric it is proposed to carry out inspection opening up works to ascertain if any historic fabric is found within - work will stop so that this can be recorded and any potential changes to the plans agreed.

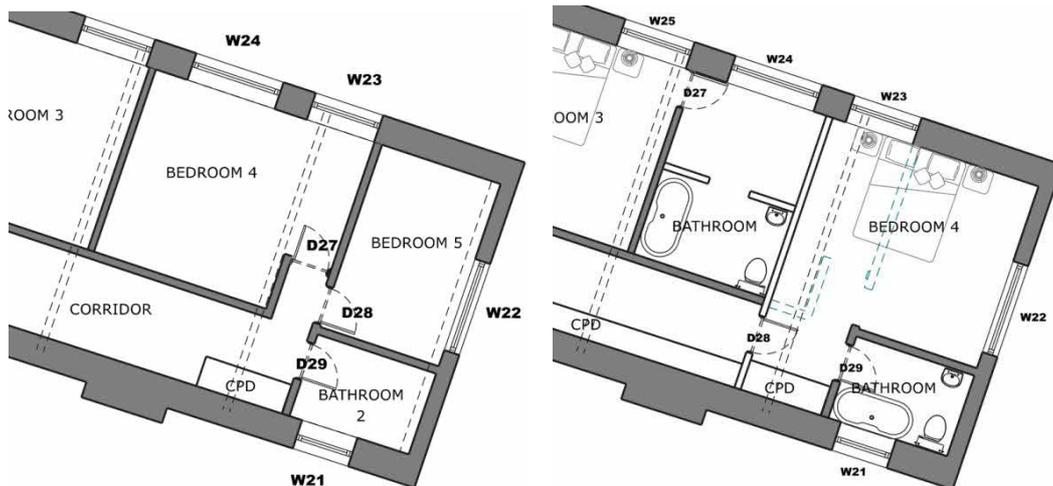
Proposals at the east side of the barn. Existing (left), proposed (right). Dotted green lines indicate proposed removal of walls.

It is understood that the first floor of the barn was a single open space on its original conversion, probably serving as the club room for the Lamb Inn in the early 20th century – as noted by the panelling to external walls and the roof (later hidden by an inserted ceiling). It is therefore extremely unlikely that any historic fabric is present within the walls proposed to be removed/moved. The proposals are therefore deemed to have a neutral impact on the character and significance of the building.

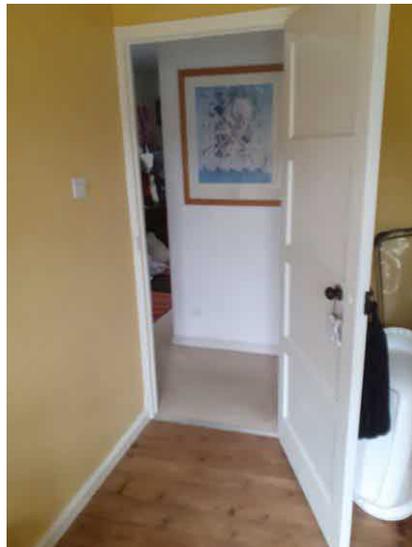
Inserted 20th century wall and door D28

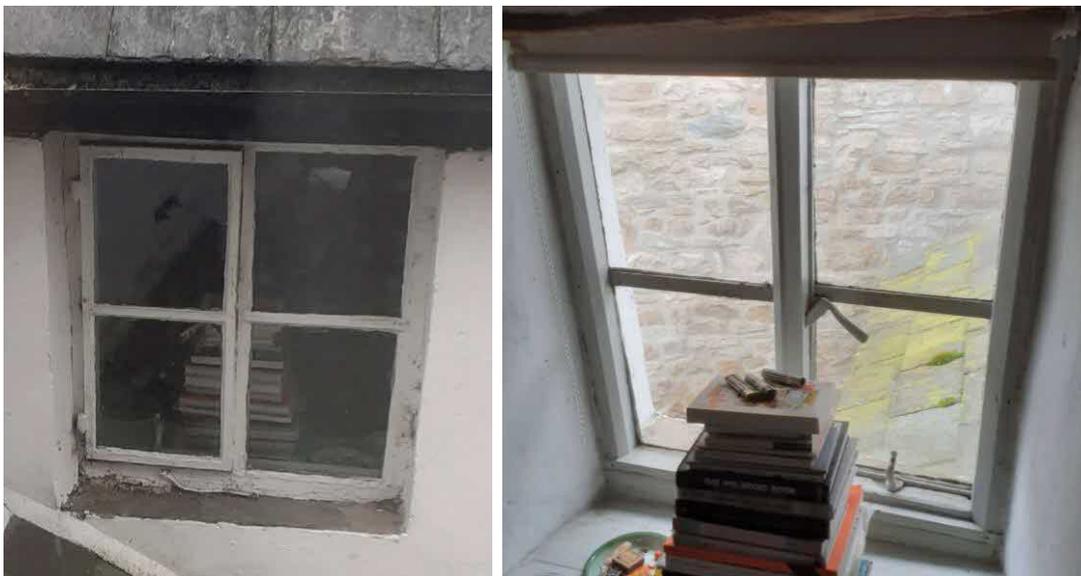
Window W27 is of significant historic value although elements appear to have been replaced over time (the internal frame is very crisp juxtaposed to the opening casement). Dating these windows presents a conundrum. The narrow(ish) profile of the chamfered frame and mullion (accepting that the timber may be renewed) may suggest a late 18th century/ 19th century date as does the window's appearance from the outside with its large panes. The window furniture and opening wrought iron casement present an earlier date or style. The opening casement has a simple knob handle (suggesting an 18th century date rather than the more ornate Tulip or spiral handles of the 17th century). The catch is plain without a decorative base plate. Stylistically this could date anywhere from the late 17th century to the late 18th century. It may be that these windows are indeed 18th century. The large panes are modern replacements. There may have been leaded lights above and below each saddle bar.

The current glass in window W27 is modern (with no historic value) and its careful removal and replacement with a low reflectivity thin double glazed unit (10mm) may be achievable otherwise there are options for improved insulation over traditional single glazing with a single glazed unit such as Histoglass Mono either at 8mm or 4mm. Given the small size of the window there are options to retain single glazing and simply add heavy curtains or internal shutters for reduced heat loss.

29. Most of the windows at First-Floor level are double glazed and in good condition. It is proposed that the windows to the West elevation receive internal secondary glazing along with W19 and W20. Window W27 is proposed for repair and that while this window is removed for such repair, slim double-glazed units are installed (traditionally with putty) in the place of the existing (non historic) glass. A separate window schedule with further information has been provided by Place Space Design. The proposals preserve historic fabric is a positive and necessary step. Secondary glazing is a tried and tested solution to reduce heat loss from single glazed windows accepted on listed buildings and will have limited impact on the character and appearance of the openings. Such secondary glazing systems are reversible without damage to historic fabric. Window W27 is a highly significant historic casement in need of retention and sensitive like-for-like repair with minimal intervention.
