DESIGN AND ACCESS STATEMENT

Alterations and Renovations at Lamb House, Glasbury

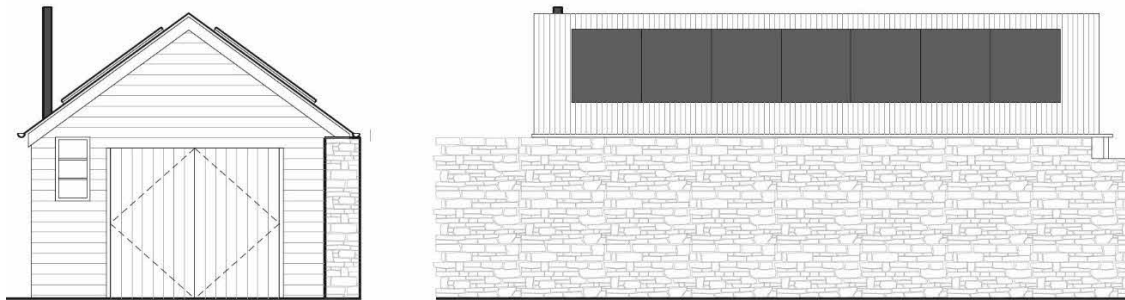
NEW FLUE TO THE GARAGE

With the installation of the proposed biomass boiler, an insulated flue will be needed. This is to be located on the garden elevation of the Garage and should only rise slightly over the ridge of the Garage roof.

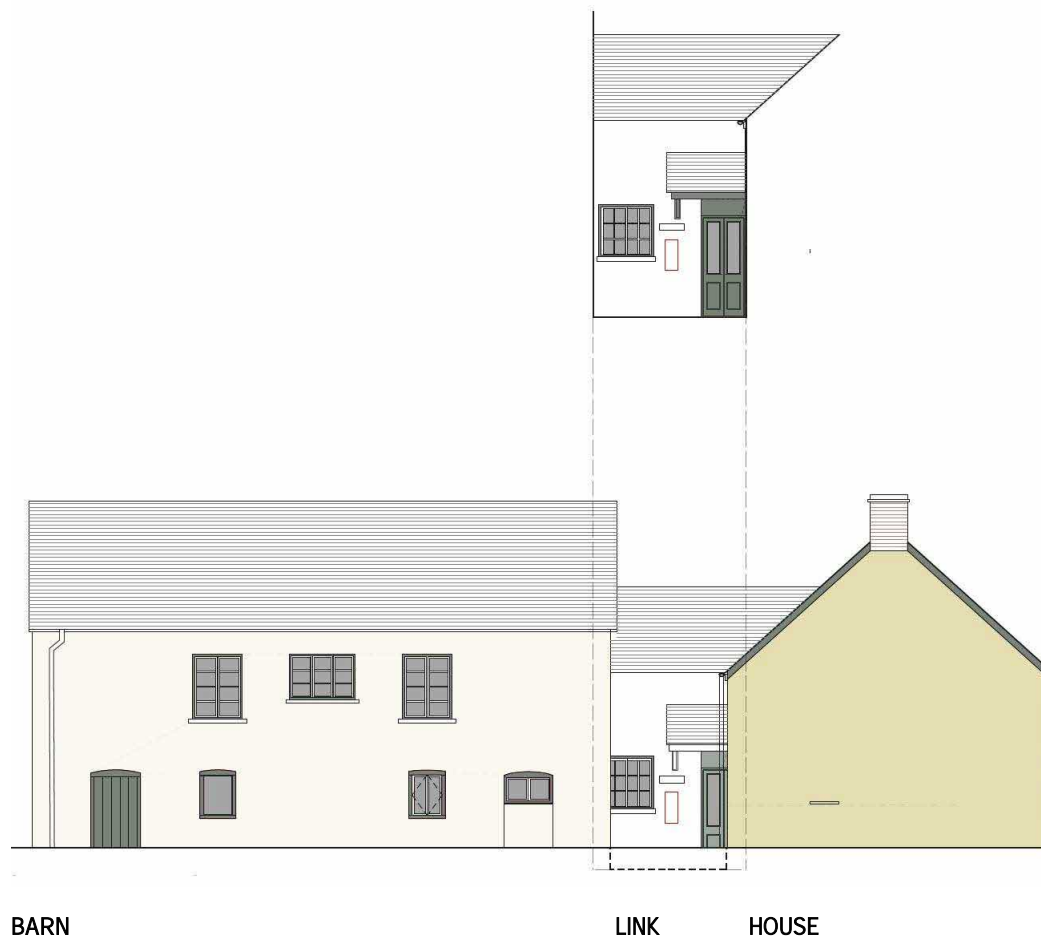
PROPOSED NORTH ELEVATION

In addition to the wall finish, the other work proposed to the North Elevation includes; the opening up of the boarded window, retaining the boarding to form shutters and installing glass into the existing frame with a simple glazing bead. Replacing the glass to the existing Ground Floor windows with plain slim double-glazed panels. The existing door within the link is in good condition and other than decoration, there is no need to change this. It is proposed that the joinery currently painted black is redecorated in a sage green colour. The exact tone can also be agreed following sample areas.

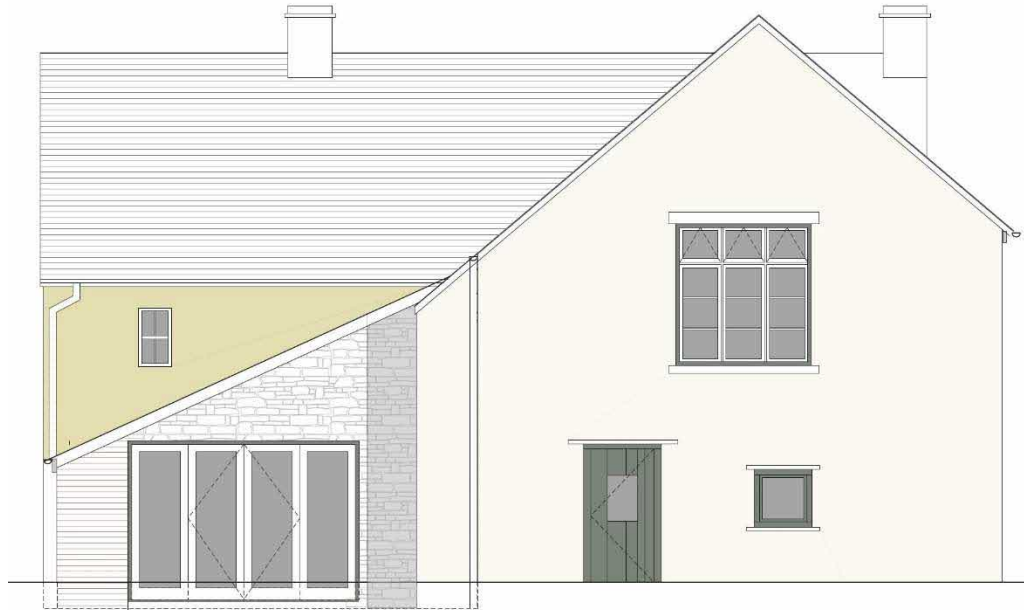
PROPOSED EAST ELEVATION

As with North elevation, the blocked-up window at Ground Floor level is proposed to be opened up, adding in a simple casement to match the window W11 on the North Elevation. The existing external door appears capable of repair, with a glass panel inserted in the existing open section. The existing window surrounds are also proposed to be redecorated in sage green. The Kitchen end elevation is proposed to remain as it is other than joinery decoration. The area of First Floor elevation of the house would have its cement render carefully removed as elsewhere and re-rendered in lime. The window within this section, W20 is an openable metal casement that cannot be closed due to the fixed internal glazing. It is proposed that this casement is repaired and a double-glazed metal casement fitted internally for thermal comfort. The new casement would open inward into the existing window reveal.

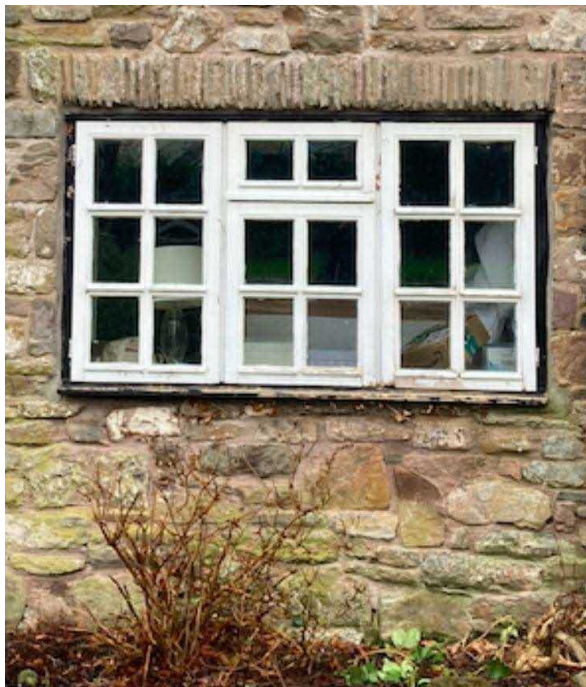
At Ground Floor level is proposed to replace the existing window, W8, with double doors following the style of the existing door D2. Window W8 is a modern window with thick glazing bars and lacks the simplicity of the other openings to this elevation. See image opposite.

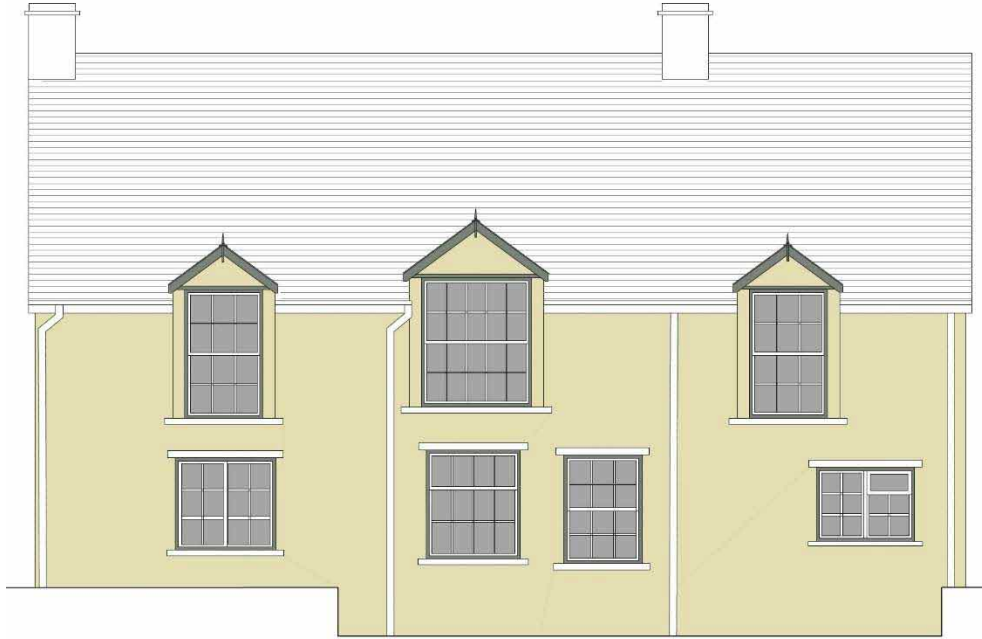
WEST ELEVATION

In addition to the new lime render and the land drain around the perimeter of the perimeter, a new surface water drain is proposed to be added to pick up the discharge from the rainwater pipes. This, along with the land drain would discharge to a new soakaway. A low hedge, in shrub planting creates a low barrier to the lowered ground level. As Elsewhere the joinery is proposed to be in sage green.

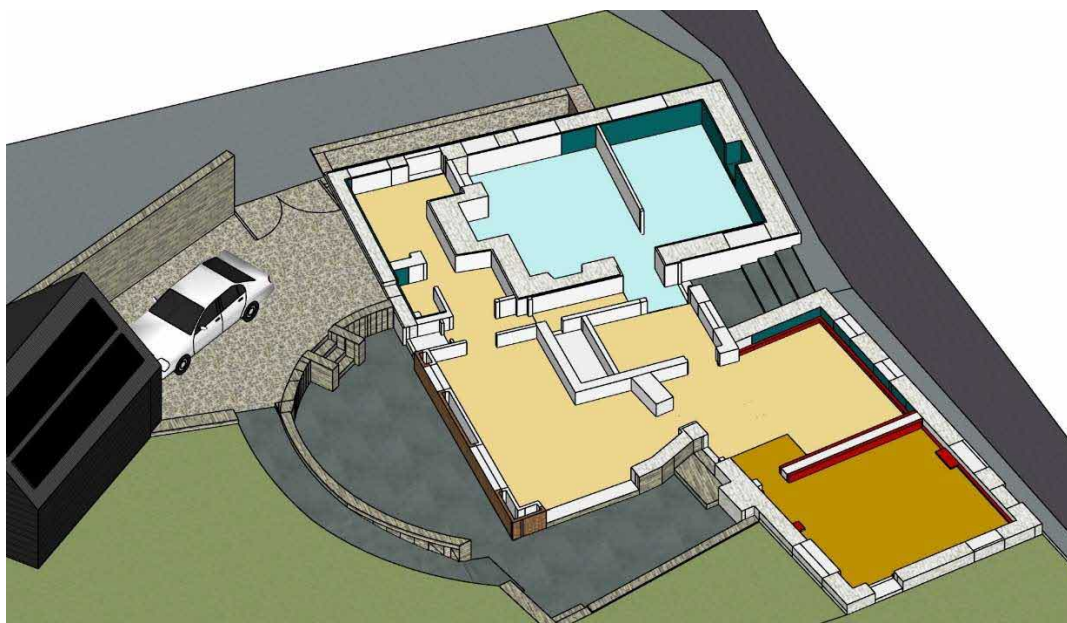
FLOOR LEVEL CHANGES

At present there are multiple changes in level on the Ground Floor. It is proposed to rationalise these to form three zones that respect the various elements of the building. The original house floor is in Aqua, this stays at the existing level of the Sitting Room. The existing step up to the hallway remains forming a common level to the Utility, WC, Kitchen and, following investigatory test pits, the Living Room. The Studio will stay at its current level. The only door that will need to be altered is D16 between the Boot Room and Living Room. This will be raised within the existing opening to allow the existing door to remain.

The alternative is to use the Newton tanking system (shown in green on the illustration above). The technical design for this would be undertaken by Newton. The Newton system includes a base drain around the perimeter of the external walls with a tanking membrane that allows ground water to filter into the base drain. A membrane would also cover the floor, acting to resist the upward movement of rising ground water levels. This system is more usually used with concrete and rigid foam insulation. The Newton membrane along with these other components are by their nature non breathable so their inclusion within an historic building should only be where absolutely necessary. The system does however work with lime plaster, so once applied, should not be obvious to the observer.

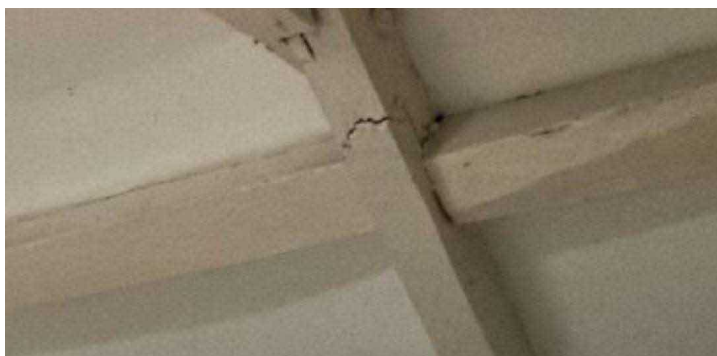
ROOF TRUSS REPAIR

There is an historic crack in one of the roof trusses that we propose to repair with a flitch plate. The exact design of this will be provided by a structural engineer but is likely to be constructed of black painted steel plates to each side of the truss with bolts through.
