CHURCH HOUSE, CHURCH ROAD, HAWSTEAD, BURY ST. EDMUNDS, SUFFOLK, IP29 5NT
DESIGN, ACCESS AND HERITAGE STATEMENT

May 2022

MC/sc/6741

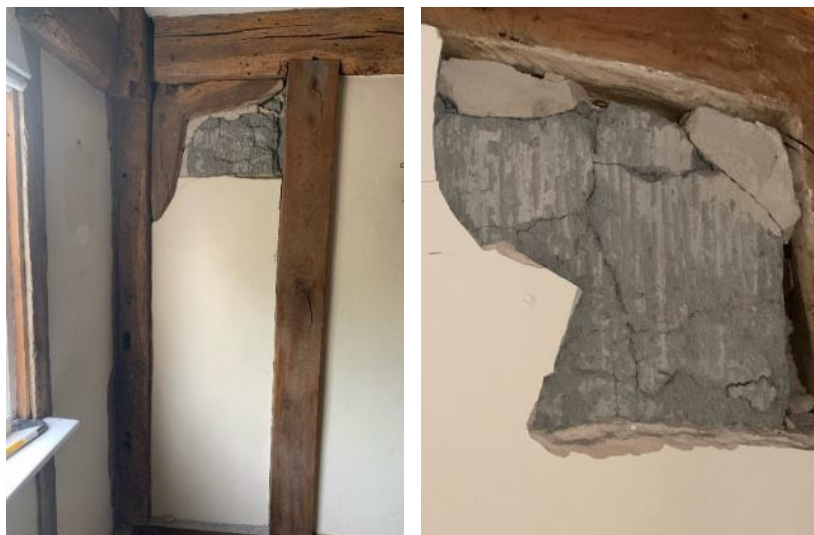
The current wall separating the kitchen and dining room is of mid C20 construction. It is constructed in blockwork, with exposed timber framing and cementitious plaster, sat on a modern brickwork plinth. The photographs depicted below show exposed block work infill between the modern timber framing.

The proposal would aim to remove the modern walling and brick plinth to create an open plan kitchen and living area. The intention is to retain the historic braced beam and timber column that is connected to the South external wall, as well as the central post, with the remainder of wall and the modern materials removed. The historic ceiling beams will also remain, untouched.

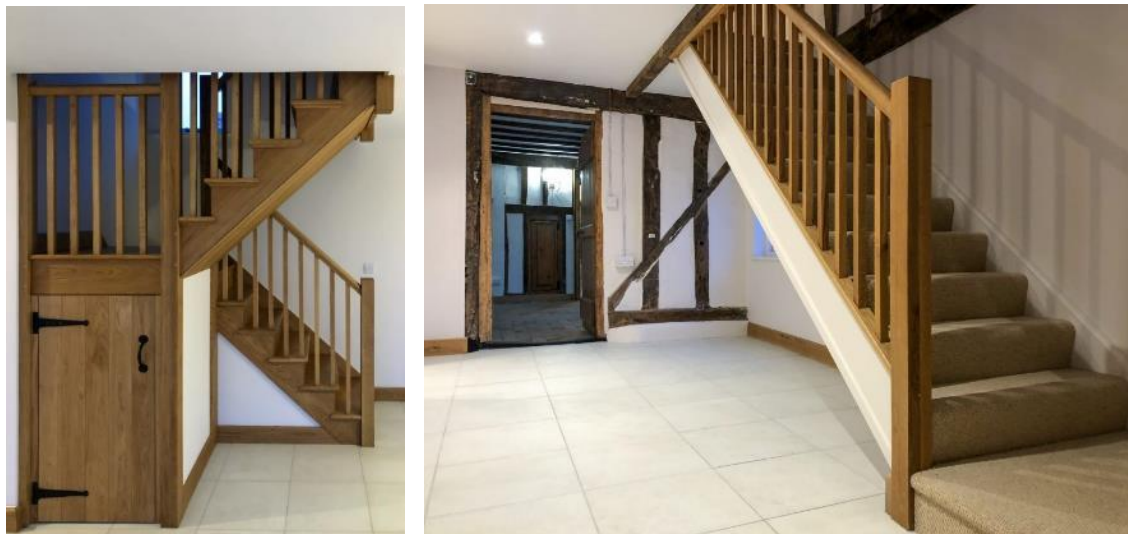
Below, I show an example of the style of baluster we are proposing. This was undertaken on a project Whitworth has recently completed. These will of course, need to comply with current building regulations and be no more than 99mm apart.

The existing primary oak staircase is a modern insertion. It is well crafted and suits the building. However, it is felt that the Victorian style, decorative balusters are too fastidious for this building and that the balusters would be better suited to be plain, square balusters. The rest of the staircase would remain as existing.

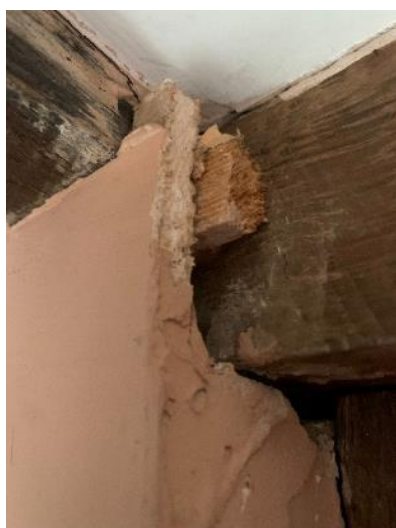
Accessed from the historic staircase within the dining area, there are an additional two bedrooms, a dark, uninviting hallway and a bathroom. This bathroom was likely inserted mid-century, along with an additional oak and plasterboard partition wall, creating a hallway between the bathroom and bedroom areas. Aside from Bedroom 1, all areas within this part of the dwelling have a flat ceiling, with loft space above. The ceiling has thin softwood beams situated on the underside of the ceiling, to give the impression of exposed oak.

The aim is to remove the modern partition between the en-suite and hallway to create a larger bathroom, which optimises and opens out the space; creating a use for the presently bleak, dark hallway area. This bathroom would become a "Jack and Jill" bathroom to both bedrooms using existing door openings.

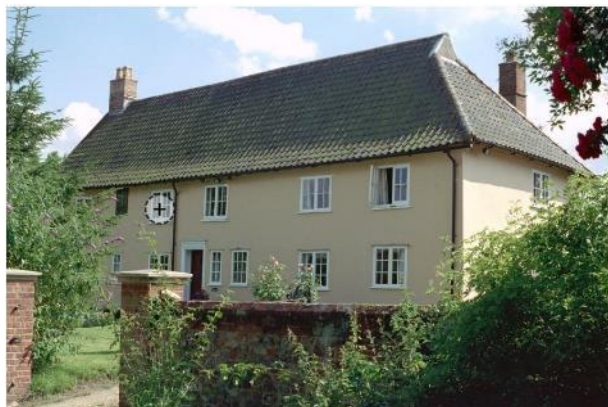
Externally, the proposal includes repainting the exterior render and joinery of the primary dwelling and that of the three outbuildings. In the buildings recent history, we know that the building has been painted cream as shown in the below photos taken circa. 2000, and is currently pink.

Archive image, may not represent current condition of site.

Date: 13 Jul 2002

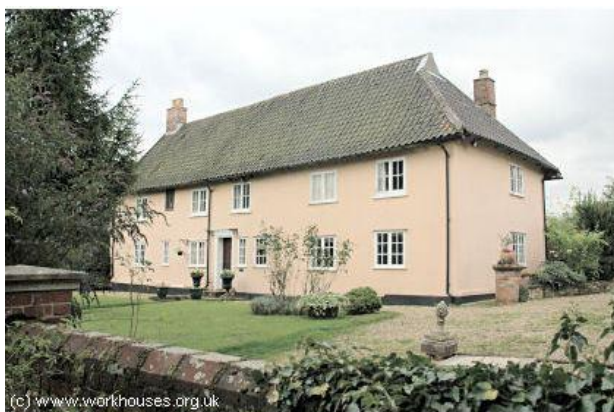
Hawstead former parish workhouse, 2006.

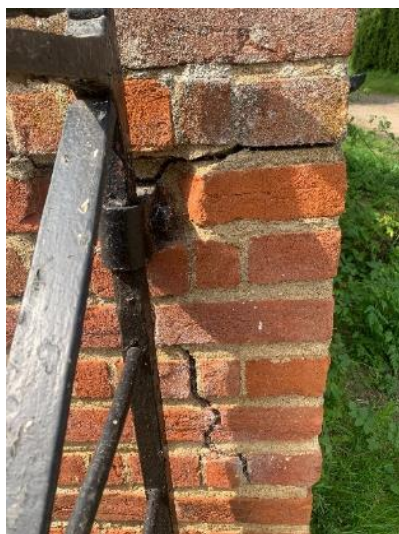
There is also a large structural crack on the Eastern side of the Westernmost pillar, likely to have been caused by how the gate has been fitted into a hollowed-out section of brickwork to allow for the gates full size and hinges. Therefore, this pier would be already in need of re-building.

The gate would be retained and re-used, and the brick piers would be re-built 0.5m further into the property to aid the tight vehicular turning circle. The proposed piers would be spread further apart to ensure that no brickwork would be hollowed out to suit the size of the gate and hinges, making the piers more stable. The existing bricks will be re-used to create the low level brick wall and there is also a collection of matching bricks and capping on site, which can be utilised. The concrete capping will be replaced with a more suitable stone equivalent, matching in style. The new section of wall will be laid in a Flemish bond pattern to match the existing, in a 1:3 NHL 3.5:Sharp sand mortar mix.
