HERITAGE STATEMENT
FOR
**THE REPLACEMENT OF REAR
WINDOWS**
at
**DAIRY HOUSE FARM
DOWNHEAD, BA4 4LQ**

Project Reference HBA 357
Client Sally Whittaker
Date of Issue 6th May 2022

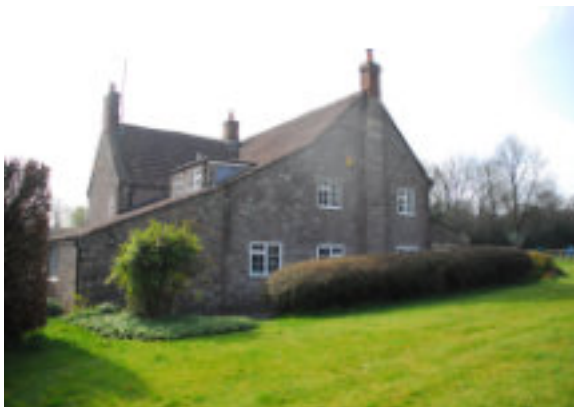
Fig. 3 North east view

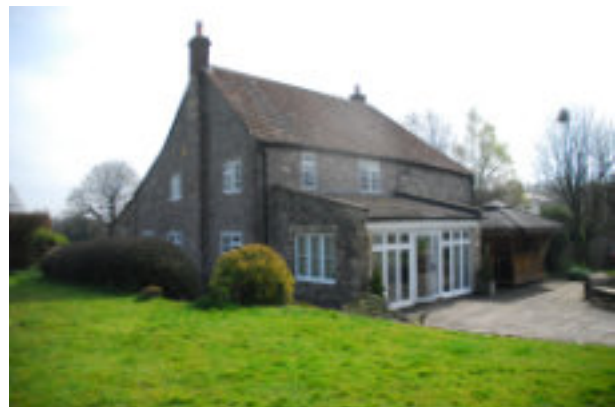
Fig. 4 North west view

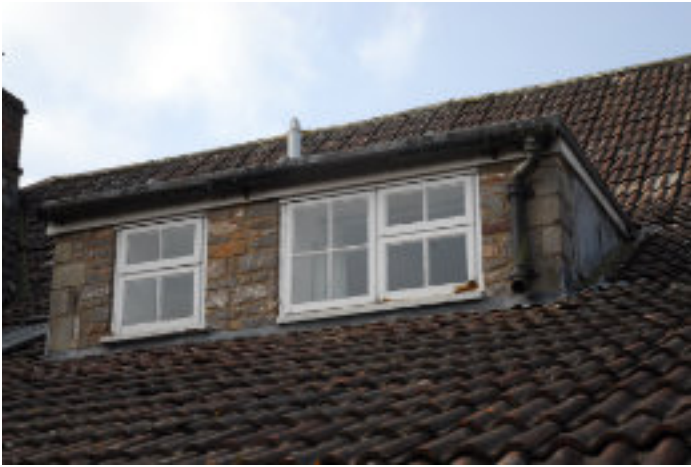
Fig.5 Dormer windows with bird damage

Existing modern windows are decayed and not as energy efficient as they could be. Where the exterior timber is soft it has been attacked by crows causing further damage (see fig.5).

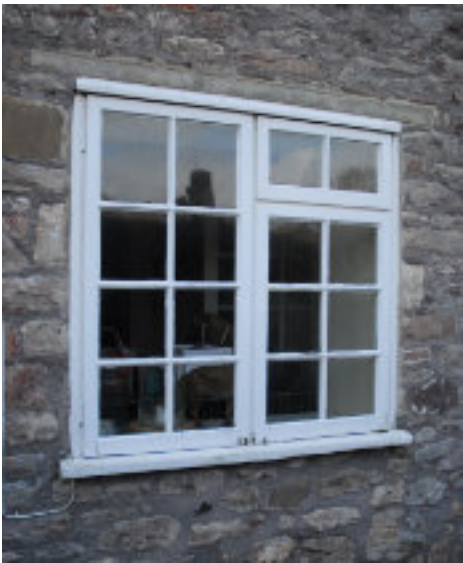
Fig.6 Flush fitted casement windows with concrete lintels and projecting timber cills

It is not entirely clear when the existing timber windows were installed on the north, east and west elevations but they are all modern casement windows with concrete lintels and projecting timber cills externally. They have been fitted flush with the external stonework which makes them vulnerable to decay.

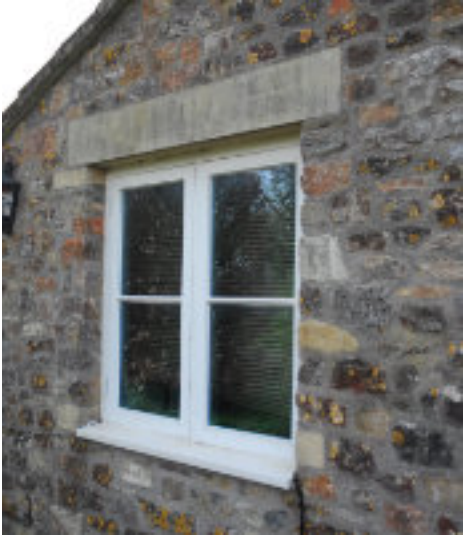
Fig.7 Double glazed casement windows fitted to the 2007 extensions.

In 2007 consent was granted for the erection of a rear single storey garden room which has double glazed French doors and fixed lights without glazing bars on the west elevation. (Ref. 100283/011) This phase of work appears to have also included the addition of a lean-to porch on the east elevation below the dormer window.
