EXISTING BARN
WOODPECKER WOOD
DAMERHAM
FORDINGBRIDGE
HAMPSHIRE

The purpose of this report is to identify the current structural condition of the existing building at Woodpecker Wood and its suitability for conversion to form a new residential dwelling.

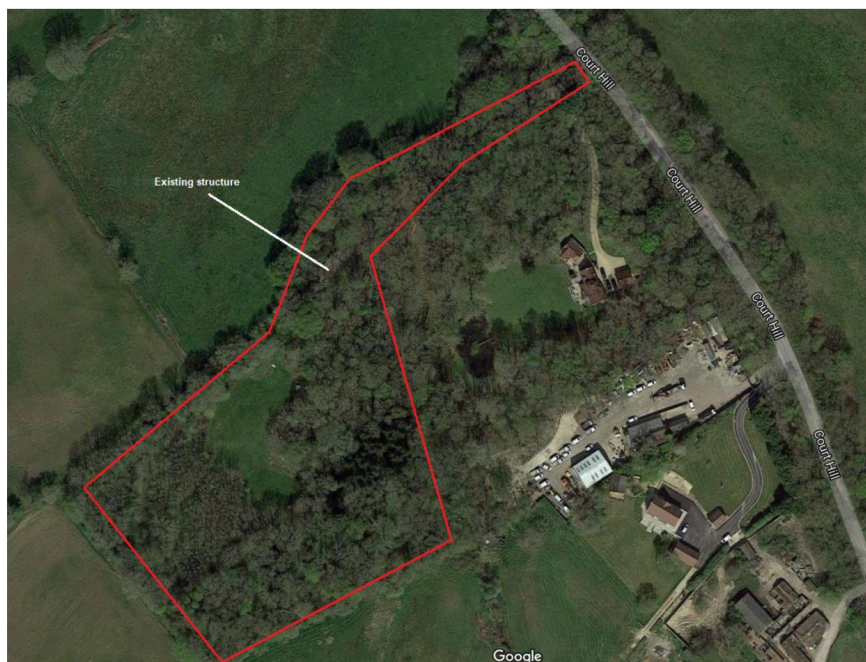
The building has a Gross Internal Floor Area (GIFA) of 60 (M²), or 645 Square Feet (Ft²). Shown in the photo below is the subject building with arrow pointing towards it.

Access to the building is via Court Hill Road, then a part made up gravel track to the building. The area around the building is surrounded by fields, woodlands and other properties. Within the site curtilage there are no other buildings.
