BARTONBURY FARM, DOWN ST MARY, DEVON

Historic Building Appraisal

Document No: ACD2346/1/0

Date: January 2021

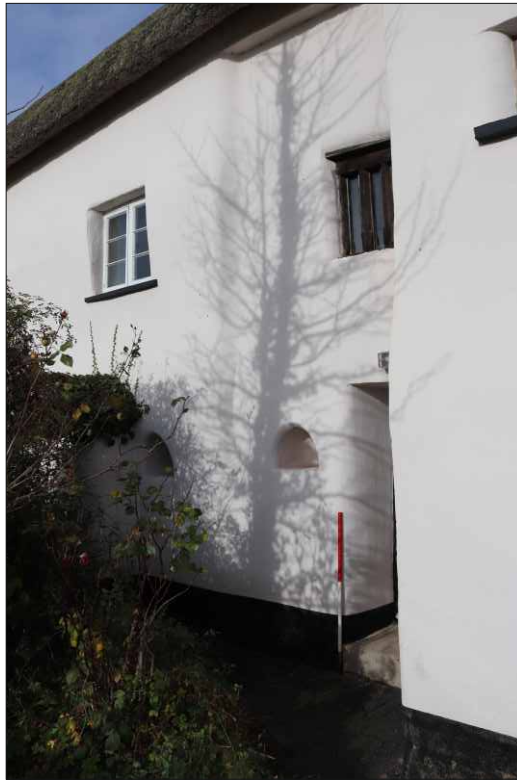
Plate 4: Bee boles in south elevation of the farmhouse, looking northwest, also showing an early window over the cross passage (1m scale)

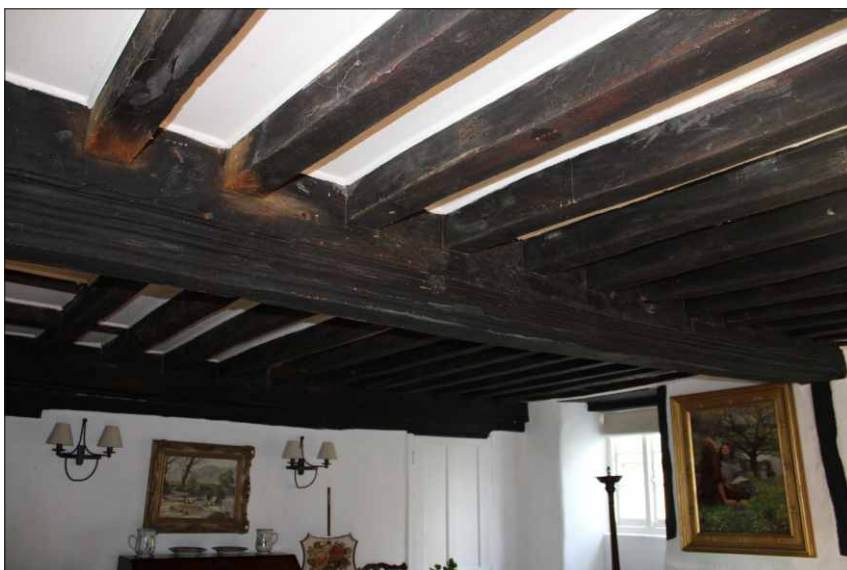
Plate 9: Central bridging beam in the hall, looking northwest with the replaced partition to the cross passage in the background

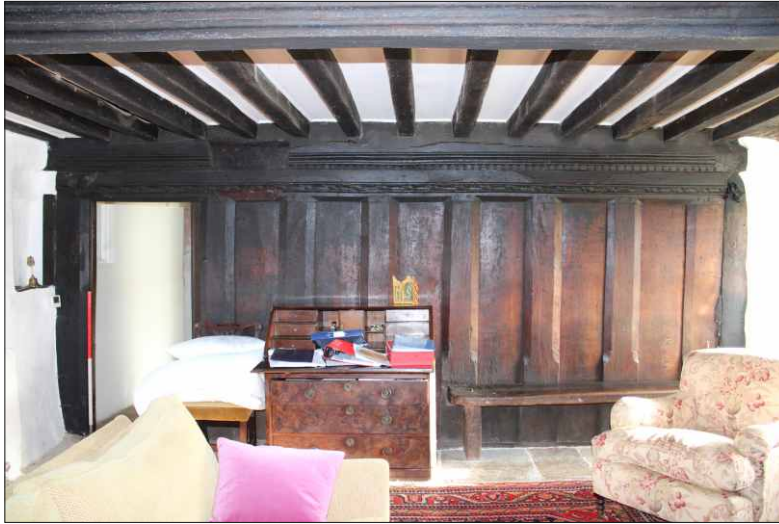
Plate 10: Screen in the hall, looking east (1m scale)

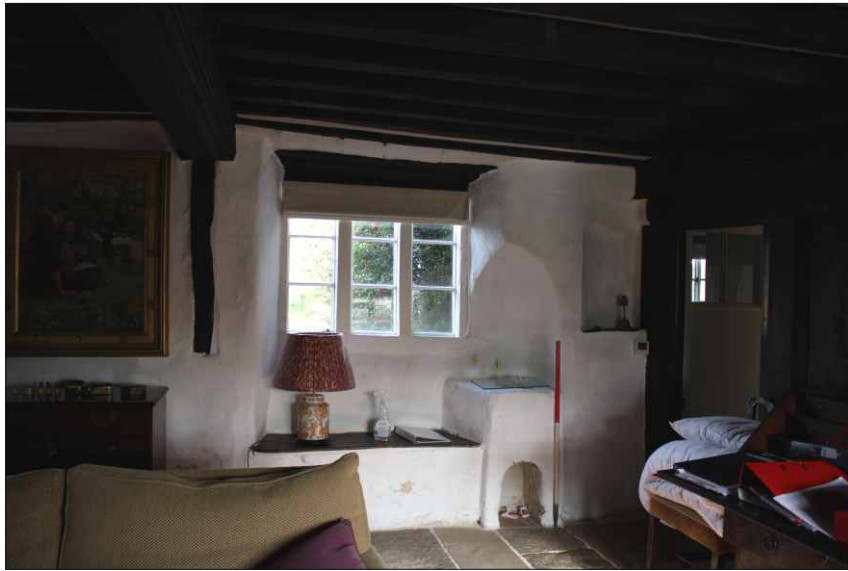
Plate 13: Northeast window and cream oven in the hall, looking north (1m scale)

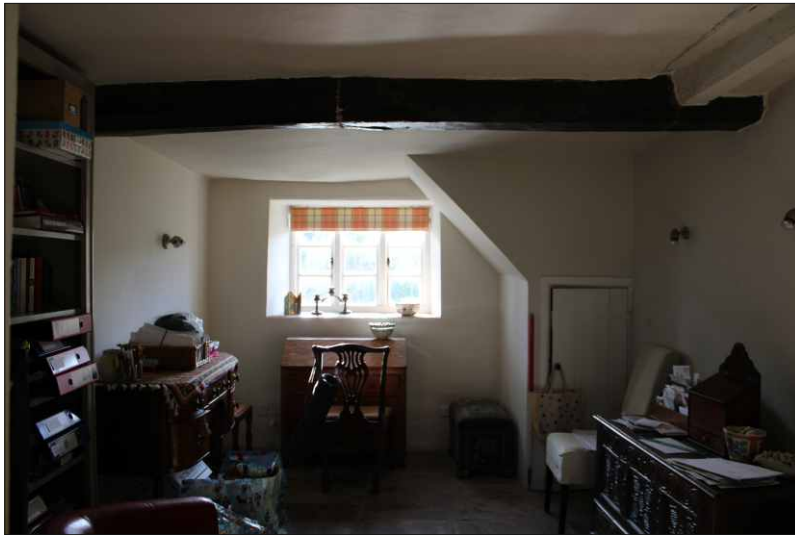
Plate 16: Farm office, looking south (1m scale)

- 6.13** The corridor and flagstone floor extends, up a step, into the farm office; there is an opening at the eastern end into the utility rooms. The office has a single east-west aligned chamfered beam with a smaller beam to the northwest (Plate 16). The understairs cupboard is fitted with a 20th-century plank and batten door.

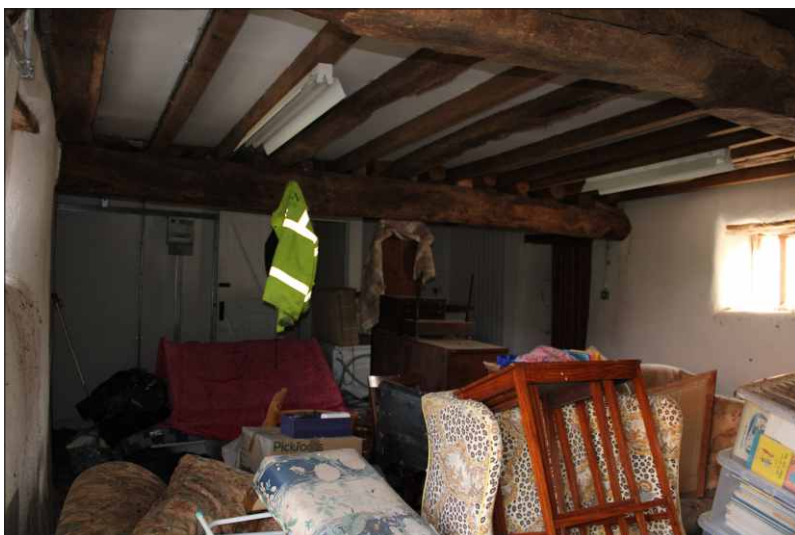
Plate 18: Shippon, looking southeast

- 6.16** The ground floor of the shippon is a single open space with a concrete floor (Plate 18). In the west wall is a mid-level timber, possibly for an infilled fireplace. The wall below is slightly bowed. There is also a small niche at the northwest corner of this wall. The east end of the room has a slate floor between the opposing modern doorways. To the east of this is a utility area raised up a step and fitted with tongue and grooved board finishes to the walls. The south end contains kitchen fittings, and there is a central WC. To the north, the WC in the main house projects into the room.

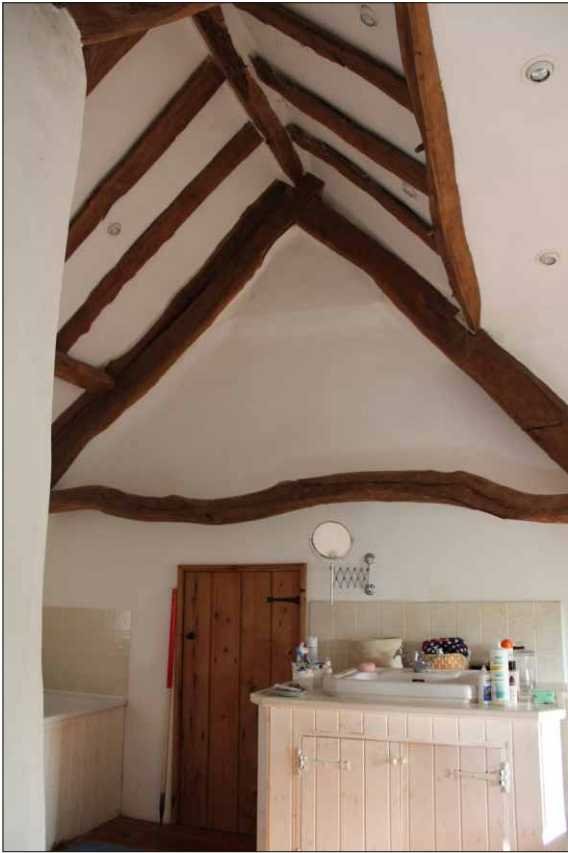
Plate 19: Eastern bathroom, looking northeast (1m scale)

- 6.19** The eastern bathroom is open to the roof, and is dominated by a single A-frame truss with an applied collar (Plate 19). This has pegged joints as does the apex of the rafters. The two rows of purlins are trenched into the back of the rafters, with the secondary rafters pegged to their back faces. On the southern truss there is a further purlin at a lower level. This is only present on its east side with an empty socket beneath for a further purlin that has been removed but would have continued to the west. The fittings including the door from bedroom 1 date to the early-21st century. There is a door in the east wall that accesses a space beneath the rafters. Within this space a lower set of roof timbers forming the hip of the roof are visible. These are all roughly hewn. The current roof is at a higher level than this and is of early 21st-

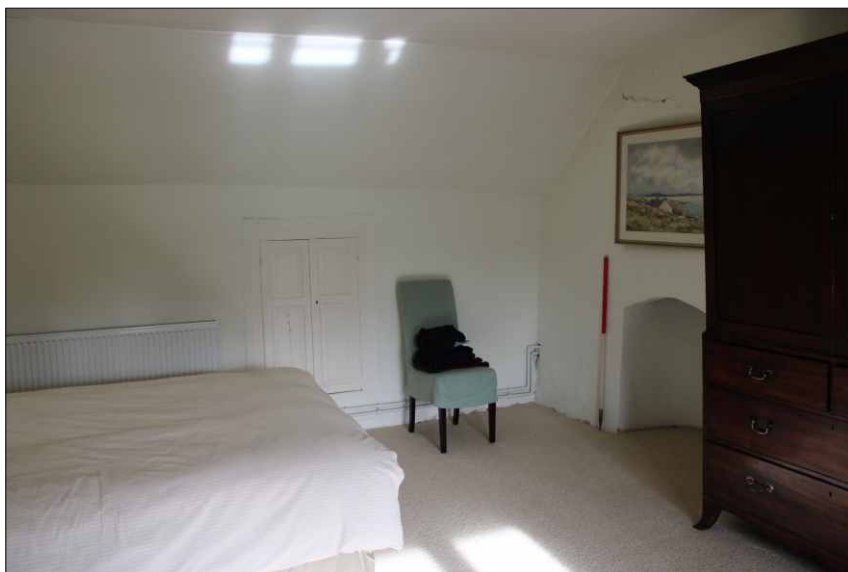
Plate 21: Bedroom 2, looking northeast (1m scale)

- 6.21** Bedroom 2 has two 19th-century four-panel doors connecting with the stair lobby and bedroom 3; the eastern door has a wooden latch and the western door a metal latch. There is a fireplace in the east wall, and a cupboard in the north wall fitted with a pair of 19th-century panelled doors (Plate 21). A ceiling obscures the roof structure above this room, but there is a central timber crossing the ceiling from east to west that has simple chamfered edges.

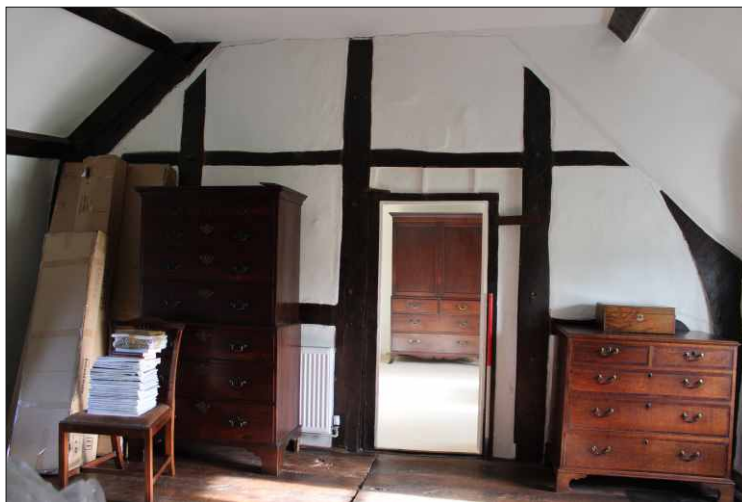
Plate 23: Timber-framed partition between bedrooms 2 and 3, looking east from within bedroom 3 (1m scale)

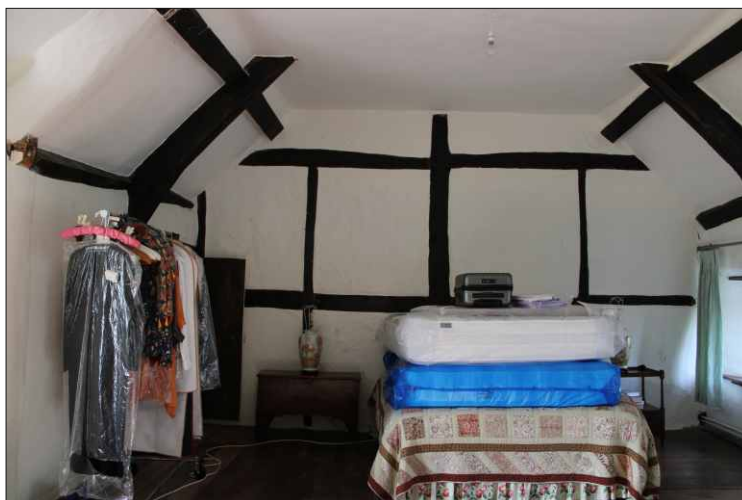
Plate 24: Timber-framed partition between bedrooms 3 and 4, looking west from within bedroom 3, looking west

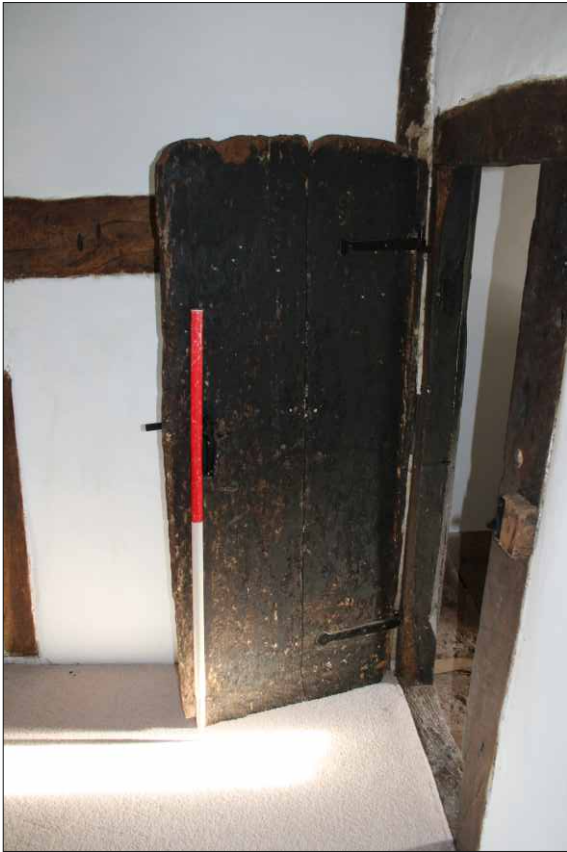
Plate 25: Door to bedroom 4, looking east (1m scale)

- 6.24** Bedroom 4 is entered through an early 17th-century doorway set within a pegged frame with chamfered edges and stops on the exterior face, fitted with a plank door with strap hinges of two designs (Plate 25). The top hinge has an expanded end and the bottom hinge has a spearhead shaped end. It is also fitted with an early metal latch and a late 20th century latch. The window in the south elevation has an internal plank and batten wooden shutter constructed using nails, and attached with strap hinges with expanded ends (Plate 26). The other side of the timber frame partition with bedroom 3 is also exposed within this room. On the lower horizontal beam is a number of scorch marks that may be of a ritual nature (Plate 27). Within the northern central panel there is a small blocked window into bedroom 3. At ceiling height three

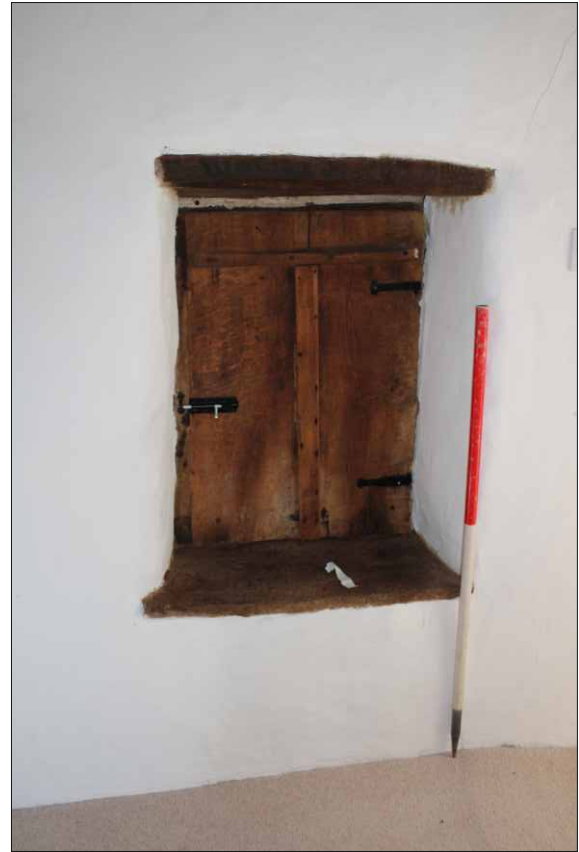
Plate 26: Window shutter in bedroom 4, looking south (1m scale)

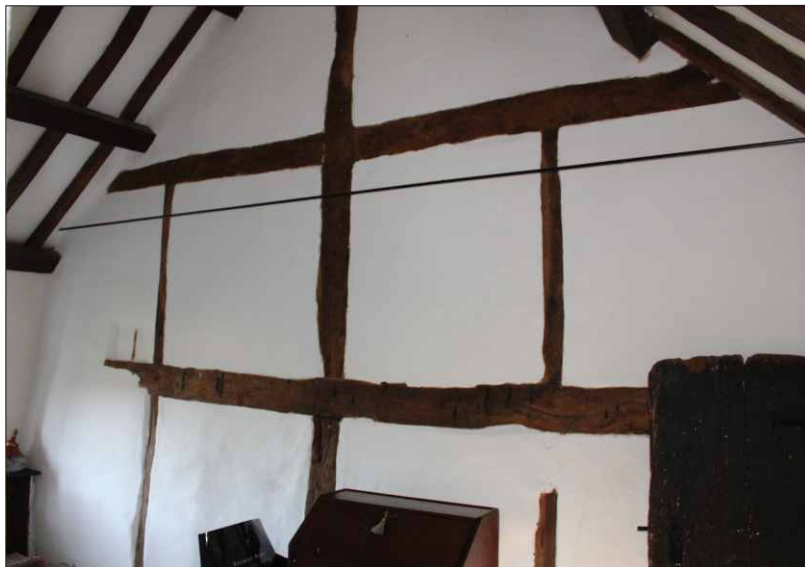
Plate 27: Timber-framed partition between bedrooms 3 and 4, looking west from within bedroom 3, looking northeast from within bedroom 4

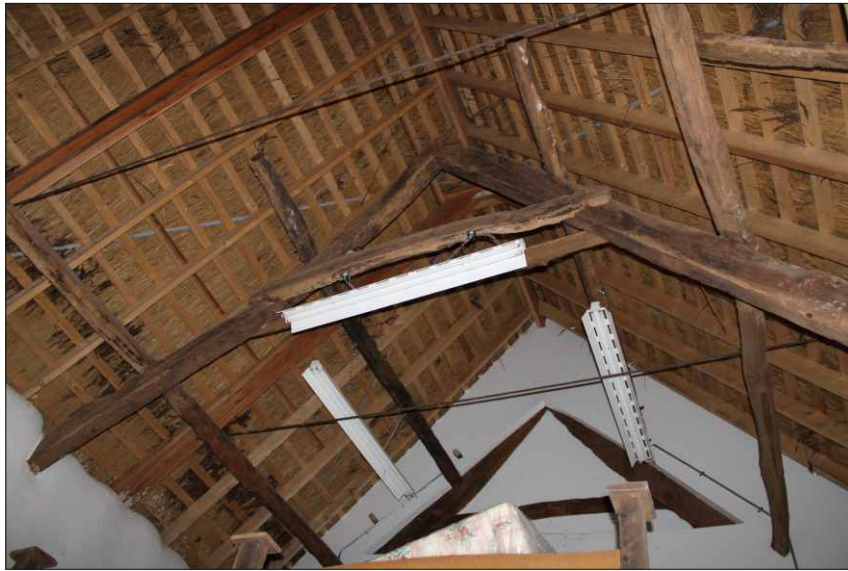
Plate 28: Roof structure of the shippon, looking northeast

- 6.26** The first floor of the shippon has a modern boarded floor, and the fittings at this level are all modern. The current thatch rests on new battens and closely spaced rafters that are independent of the historic roof structure. The earlier structure comprises a single A-frame truss with a second truss incorporated into the eastern wall. These are A-frames with lapped notched collars and halved apexes. The northern rafter has broken and an applied collar has been added for additional support (Plate 28). The principal rafters have been reused, and set back to front as they display (set towards their current outside faces) sockets and pegholes for lapped collars. All joints are pegged and nailed. There are two slightly trenched rows of purlins, which have been partially removed from the west bay. They are scarfed and peg jointed behind the trusses. The secondary rafters only survive in the west bay on the south side below the lower purlin.

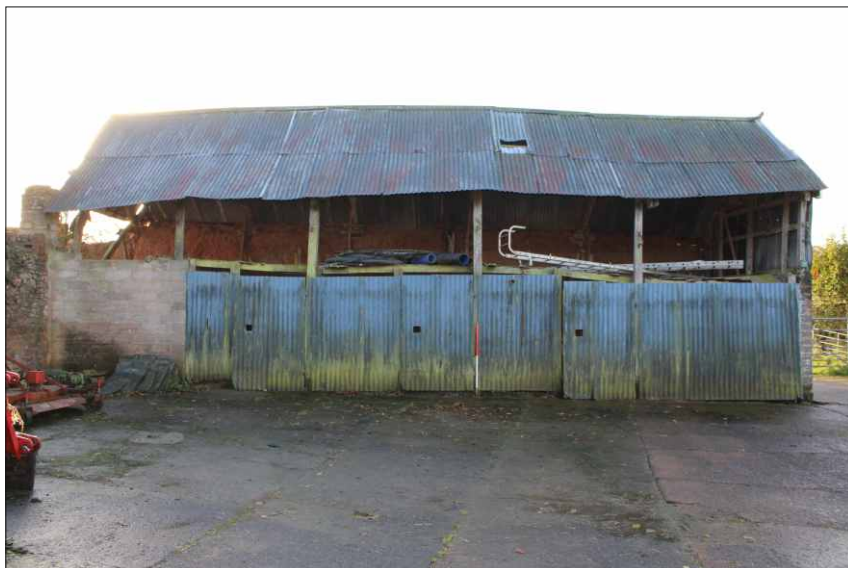
Plate 29: North elevation of the linhay, looking south (1m scale)

- 6.27** The linhay was constructed with a rear, south wall of cob laid on a low plinth of rubble mudstone that continues eastwards beyond the current gable to the line of the western gable of the farmhouse. The west gable, and a short length of the east end of the north wall at ground-floor level, along with a pier at the northeast corner, are built using concrete blocks. The building has a gabled roof covered with corrugated metal sheets. The first floor remains open to the front (north), and the remainder of the ground floor is enclosed with three large doors formed from corrugated sheeting with the same material used to infill the gaps between the openings (Plate 29). The first-floor west gable is enclosed with corrugated sheeting. Abutting the northeast corner of the building is a wall constructed of rubble mudstone blocks laid in rough courses and bonded with a pinkish lime mortar with frequent gravel inclusions. This corresponds with an extension to the linhay recorded on the 1889 First Edition Ordnance Survey 25-inch map.

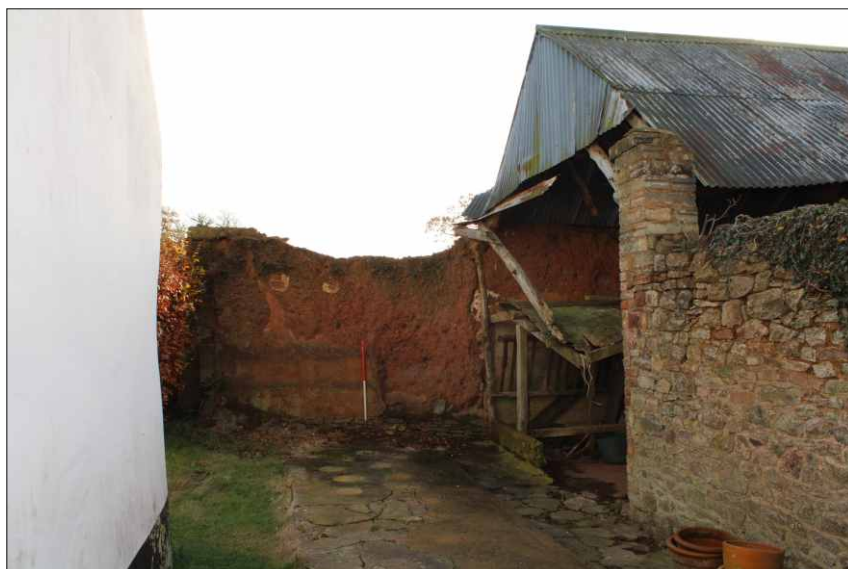
Plate 30: East end of the linhay showing how the south elevation continues beyond the current roof, looking south (1m scale)

- 6.28** The east end of the cob rear wall has been rebuilt in brick and concrete blocks that extend slightly north forming the corner of an extension (Plate 30). At ground level beyond this masonry is the scar of the removed eastern wall of the extension. The current east gable of the linhay is open apart from a very low rubble partial ground-floor wall and some corrugated sheeting in the upper part of the gable.

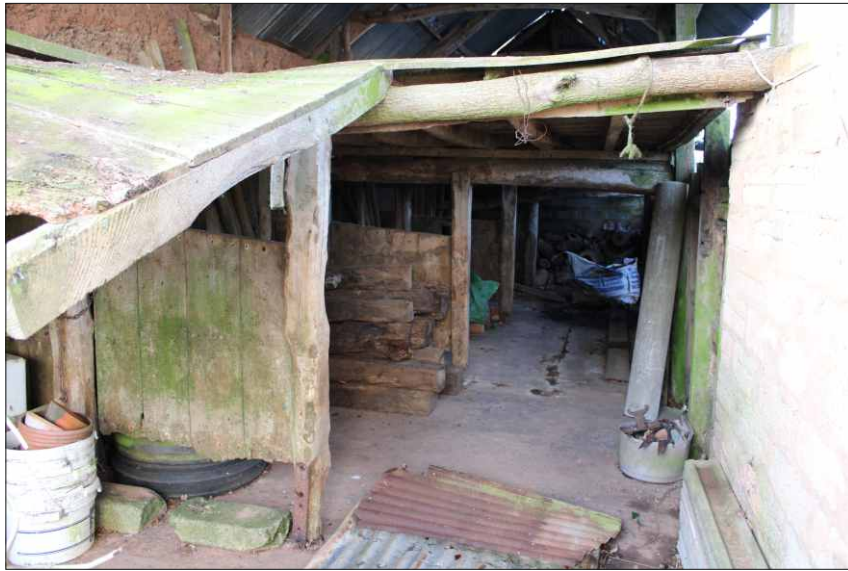
Plate 31: Ground floor of the linhay, looking southwest

- 6.29** The ground floor has a concrete floor, and the inside face of the south elevation has been faced in concrete blocks. The area is divided into five stalls (Plate 31), with the eastern stall retaining a manger. The stall partitions are formed by timber planks nailed to horizontal timbers that are attached to vertical posts suspended from the beams supporting the first floor. These and the floor joists are largely of roughly hewn or unhewn timbers.
- 6.30** The first floor was not accessible but no fixtures or fittings were visible from an external inspection. The roof is supported on six simple trusses (Plate 32). These are nailed at the apexes and four have applied collars. The western truss is a late 20th-

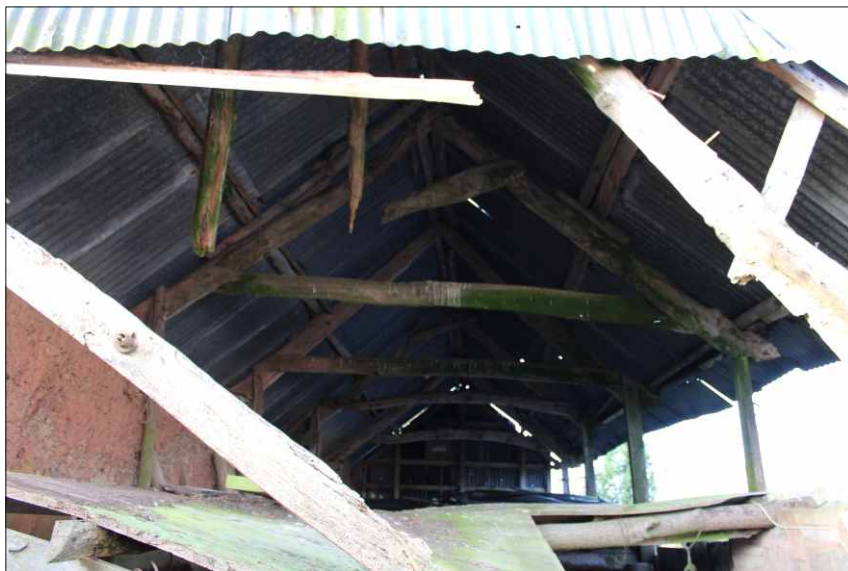
Plate 32: Roof structure of the linhay, looking west
