HERITAGE DESIGN & ACCESS STATEMENT

REPAIRS, ALTERATIONS AND CREATION OF ANNEX TO FARMHOUSE AND ADAPTION OF LINHAY AT BARTONBURY FARM

Down Saint Mary
Credton
Devon
EX17 6EB

Listed Grade II*

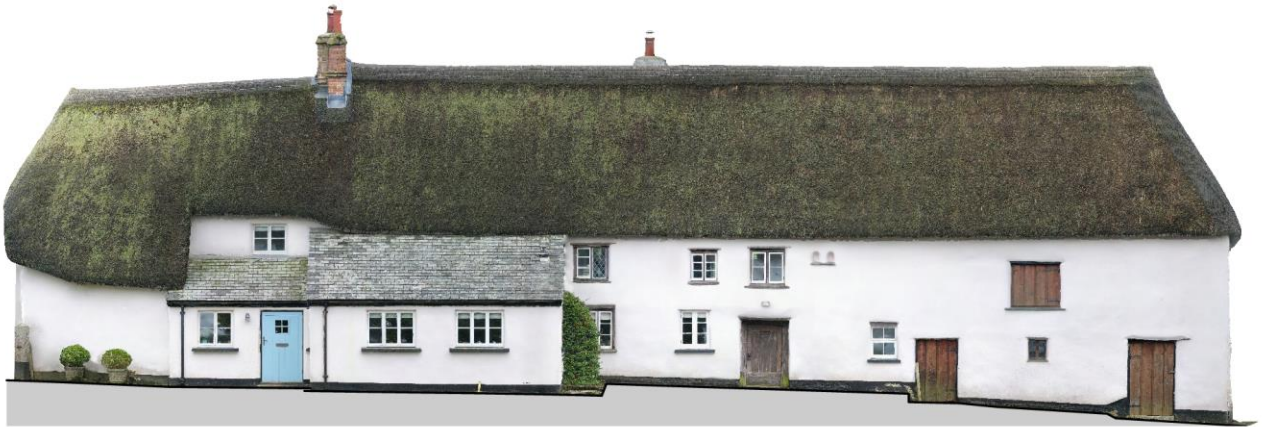
Front elevation – Farmhouse and Former Stable

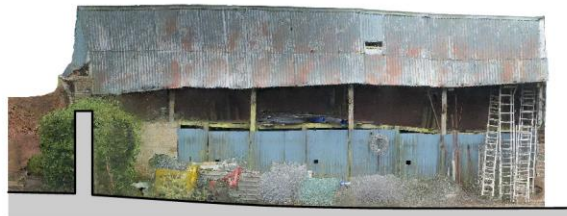
Front elevation – Linhay
Structure

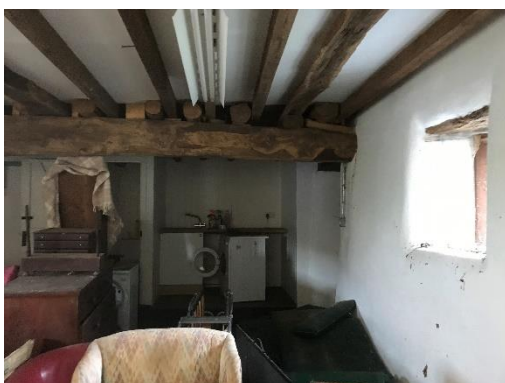
Shippon kitchenette

The proposals will maintain the general form of the whole internal space but closes off the kitchenette niche to provide a small shower room on the ground floor. The mezzanine will be retained as a simple platform for a bed accessed from a stair to replace the existing in the same position. The external internal walls will be lined internally to improve thermal performance and the soffit directly beneath the thatch roof will be ceiled whilst keeping the historic timbers exposed. The ground floor will also receive insulation and a new level slab.

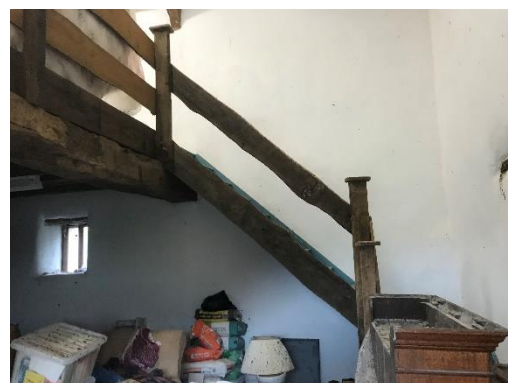
Shippon stair upto mezzanine

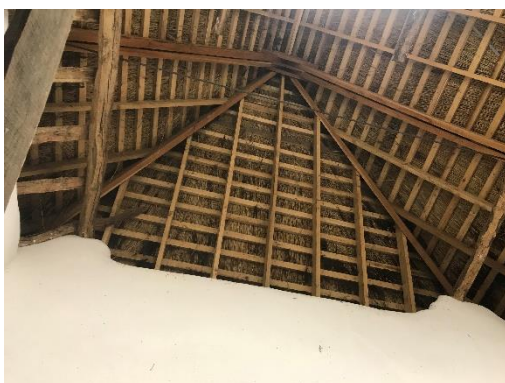
Shippon exposed roof structure

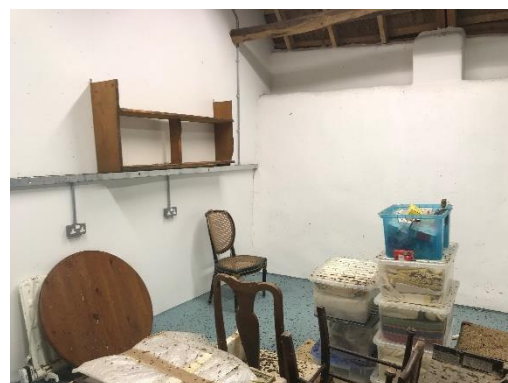
Shippon Mezzanine

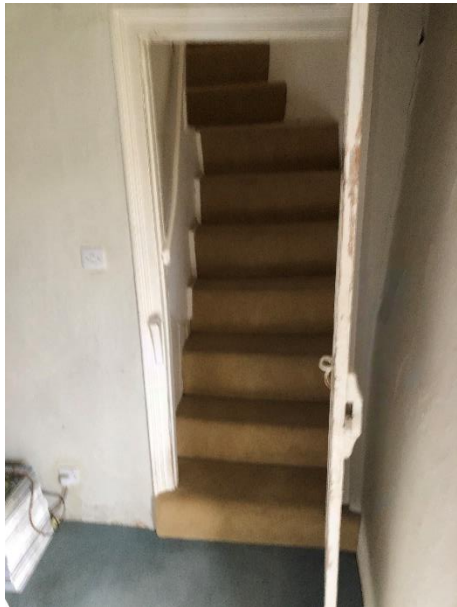
Stair within turret by Living room fireplace

A narrow, steep stair ascends directly from an opening beside the fireplace to the Living space upto a half landing between Bed 1 and 2 to the east end of the house. From the landing, short flights of steps lead into the respective bedrooms. The proposals seek to rearrange the stairs to lessen the severity of its pitch to make it safer as a primary route between floors. It is hoped that the much of the existing materials (including the round handrail) can be reused and the adjustments are slight so as not to affect surrounding structure.

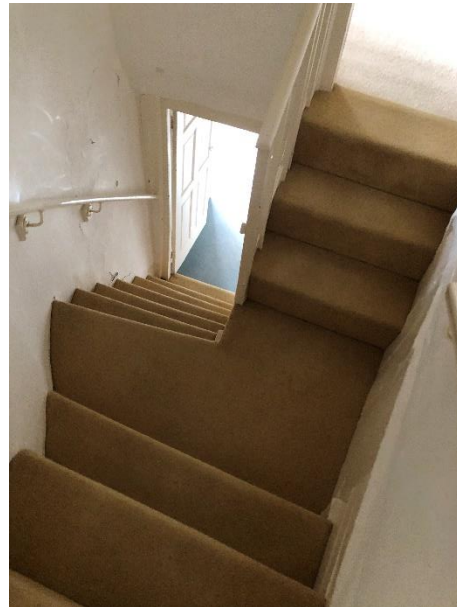
Half landing with steps to bed 1 and 2

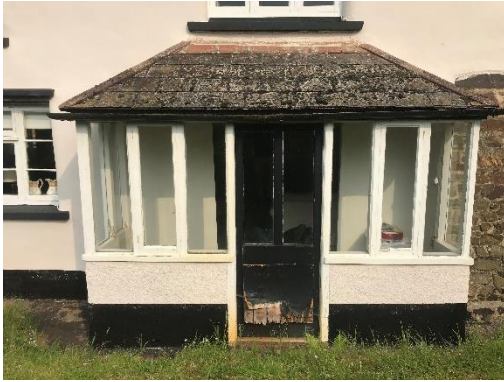
Sunroom Externally

A C20th Sunroom was constructed on the south facing elevation off the Living Room. This features painted timber framework (with simple box profiles), single glazed window units on a block plinth wall and a half-glazed door all surmounted by a concrete tile hipped roof.

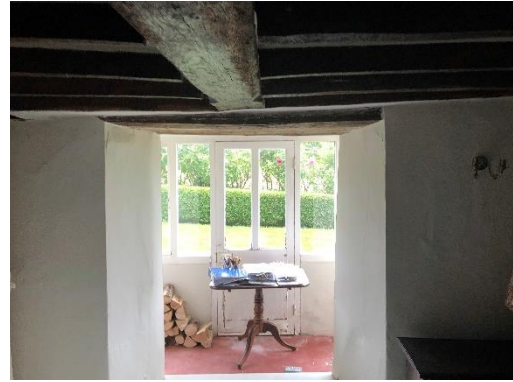
Sunroom seen from Living Room

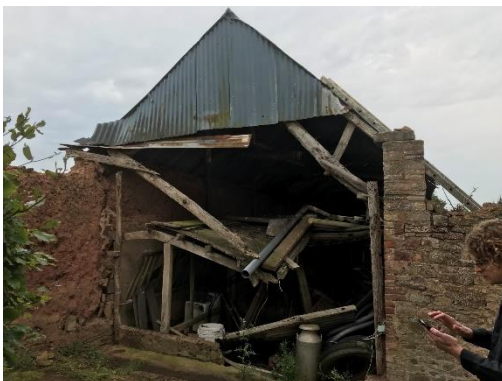
Missing sections of structure and ad-hoc flimsy repairs no longer allow safe use

The Existing Linhay is in a significant state of disrepair. The tallet floors have failed and beams have deflected or split. Trusses are bearing tentatively on their posts. The primary aim will be to repair the Linhay so that it can fulfil its function safely as a farm store whilst retaining the historic fabric which characterises it as an early agricultural structure. Timber will be assessed and retained where possible. The roof will be rationalised and new cladding applied to limit water ingress which has been a significant factor in the timber decay. Primary focus will be on retention of trusses and repair/strengthening. New roofing sheets and structural enhancement will allow the south facing pitch to receive solar panels to raise the sustainability credentials of the property.

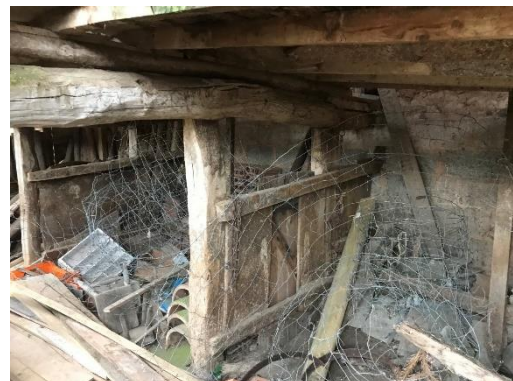
Original livestock bays

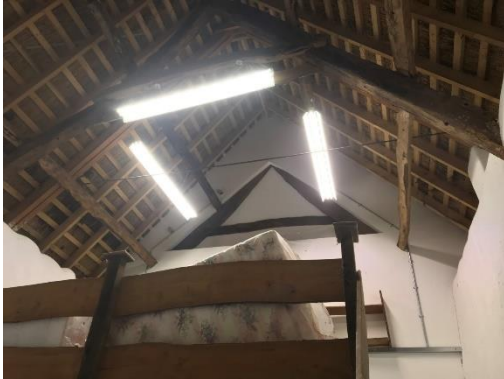
Roof structure over Shippon Mezzanine to have soffit installed below modern rafters keeping the historic timber exposed.

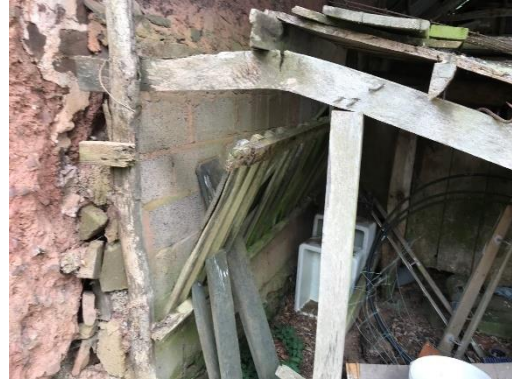
Feeding stall to Linhay with concrete block repairs to cob walling to be retained and cob junction consolidated.

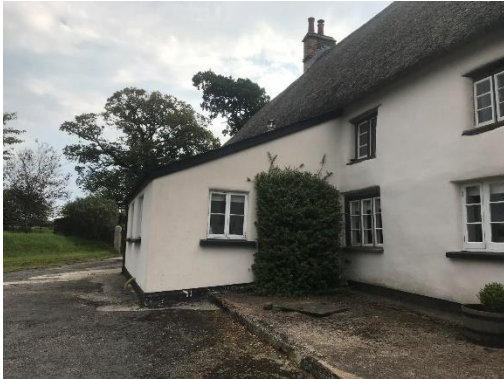
Kitchen block with modern casements to be replaced and concrete platform to be removed and ground made good.

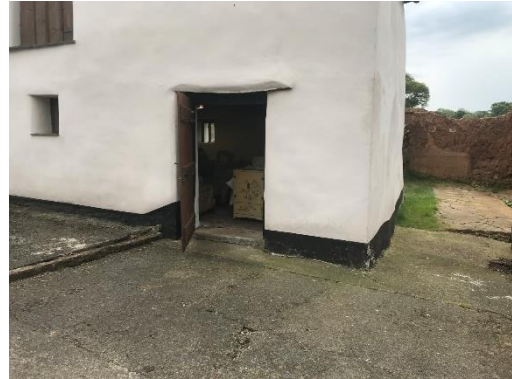
Modern boarded door into shippon to be replaced with 2-part stable doors on extended hinges. Full height fixed glazing unit to be fitted internally within reveal.

The external appearance will be retained but internal glazing is proposed such that the proposed external stable doors (on retained frames) can be opened for additional natural light.

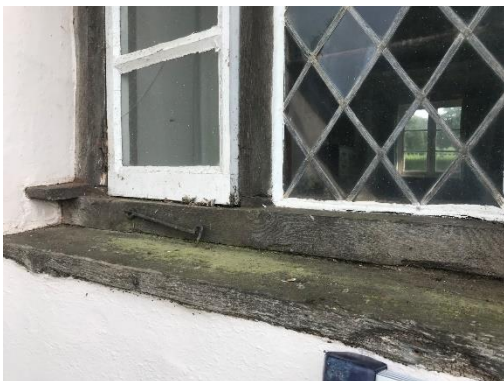
General repairs and decorations to historic frames and casements

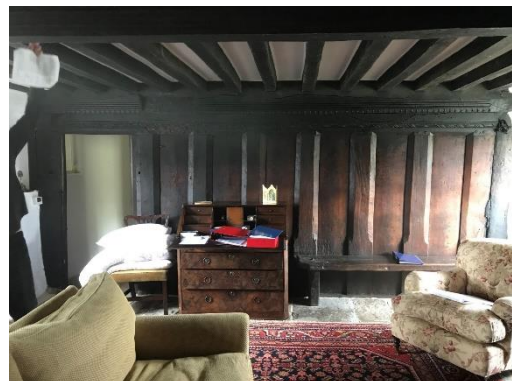
Careful removal of inappropriate finishes to historic timbers and like for like conservation repairs to internal features.
