Heritage Statement & Design and Access Statement

PHASE I ALTERATIONS

Mellifont Abbey
Mr Simon Parks

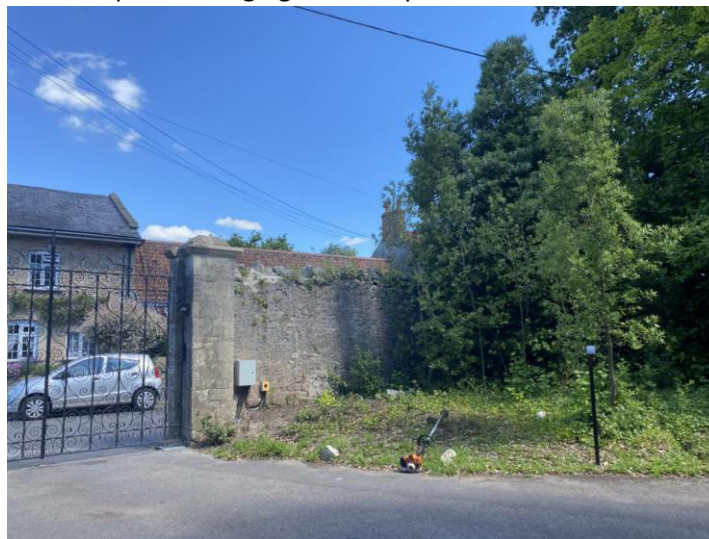
proposed oil tank location

- 4.4.2 The new oil tank is to be situated to the east of the main gate. The reason this location has been chosen is that it can be sited here without disturbing the existing, protected trees in any way. It can be easily screened, and has the significant advantage of allowing re-filling with the oil lorry remaining in the street. A good deal of damage has been caused to the gate pillars in the past by the regular passing of small lorries through this gate entrance, in particular when they turn in and out of what is a very narrow street with on street parking significantly reducing the effective road width. The proposed oil tank will be sat on a concrete pad in accordance with the latest regulations and manufacturer's instructions. It will be hidden by new native species hedging. See site plan.

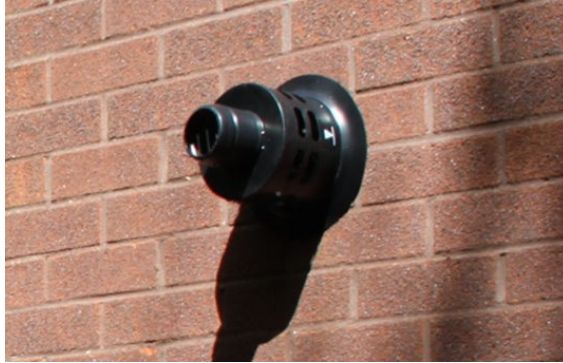
- 4.6.2 No cage will be required over the flue at this height. This location is possible because it is proposed to fix GW5 closed. This is an image of the proposed flue:

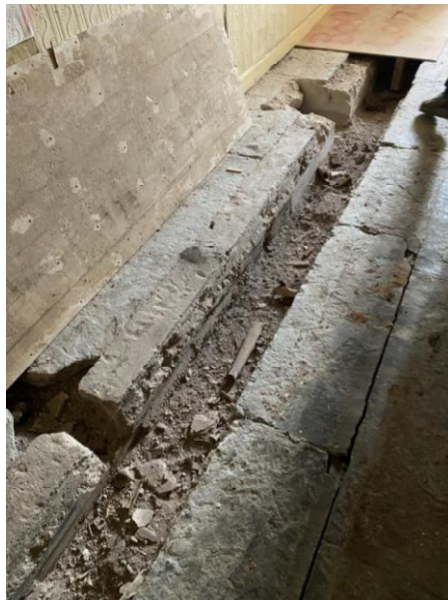
service trench with connections to G. 04

- 4.6.3 Heating pipes will pass from the boiler room into the existing service trench in the service corridor G. 09:

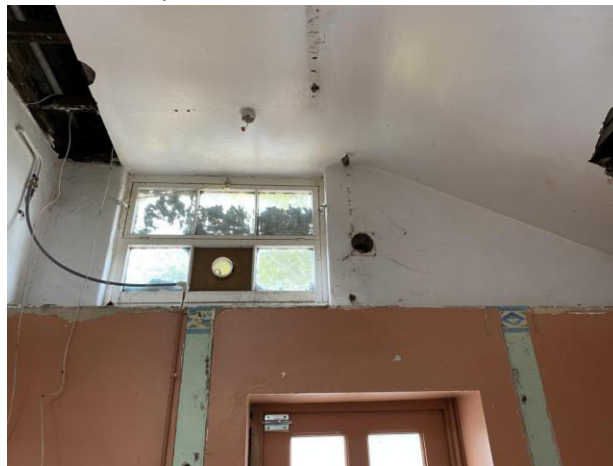
shelf above GD3 (white)

- 4.8.5 Utility room walls: In room G. 07 Boiler room there is a blocked external door. This has been bocked using a single skin of bricks. It is proposed to dry line this eastern wall in order to preserve heat generated by the boiler. The dry lining is to be made from treated timber studs sat on dpc, with PIR insulation in between and plasterboard and skim to finish. Similarly, there is an area of very thin wall above the door GD3. It is proposed to treat this in the same way.

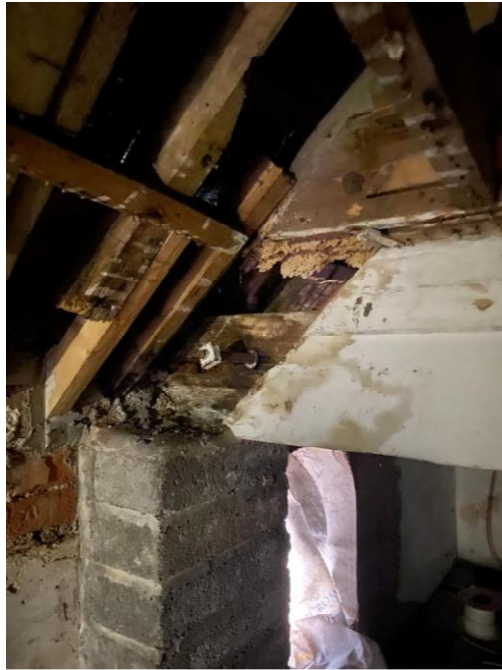
East truss foot

There is an extensive amount of rot in each of these truss feet, along with a design fault in the historic roof which has led to significant deflection in the tie beam spanning across to the east truss foot shown above. This has been remediated in the past using an additional timber beam. When the end of the truss and the timber beam rotted out, a dense block pier was built under in an attempt to support it. This was built off the floor boards and a beam end. The floor boards have since rotted out, leaving the masonry pier unsupported. The historic principle truss foot and tie end is proposed to have new sections scarfed in below the purlin and the whole treated for beetle. All new timber to be oak with the exception of packers between the steel and the underside of the existing historic tie which are proposed to be softwood.

It is proposed to remove the masonry pier along with the additional timber beam and replace it with a new steel beam, bedded into the masonry on either side and resting on precast concrete padstones.

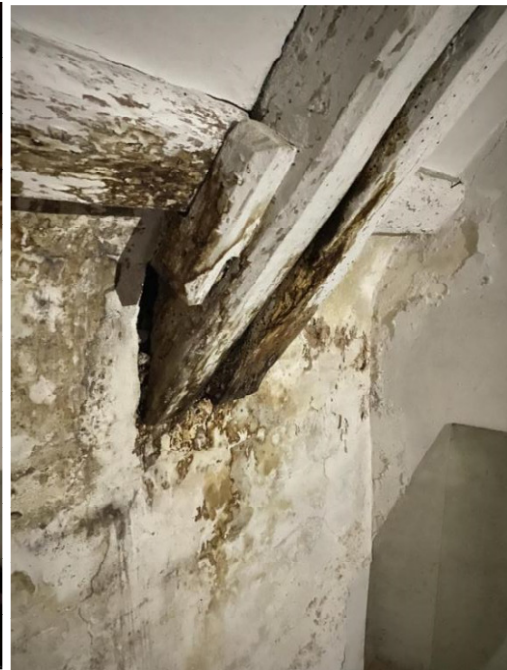
West truss foot

It is not proposed to intervene directly with the west truss foot, but instead to fit an additional purlin above which will take the weight off the truss foot and direct it into the masonry wall adjacent and the new steel beam.

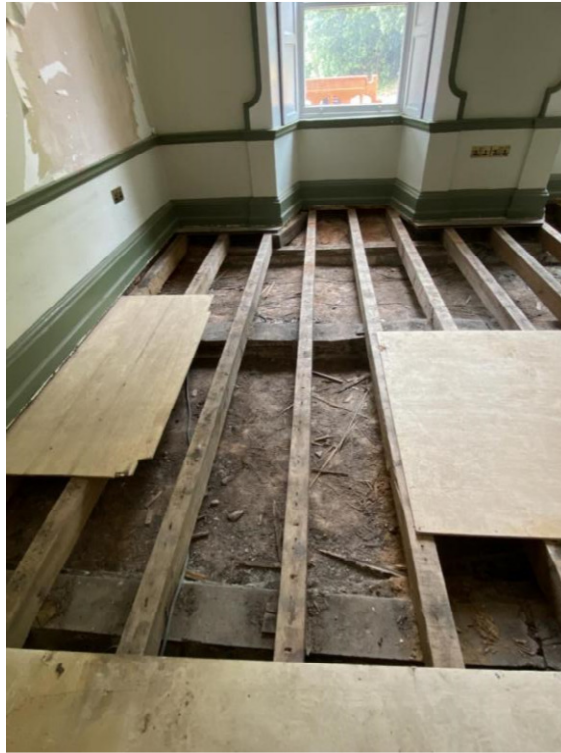
floor void generally

4.10.2 **Floor:** the existing floor is a suspended timber floor. The timber boards are likely to date to the 19th century. These sit on timber joists which in turn sit on timber sleepers. There are two floor vents to the west wall of the house. These have not proven sufficient to ventilate the sub floor and as a result, there is extensive rot in the timber sleepers. A number of the timber joists have also suffered from rot.

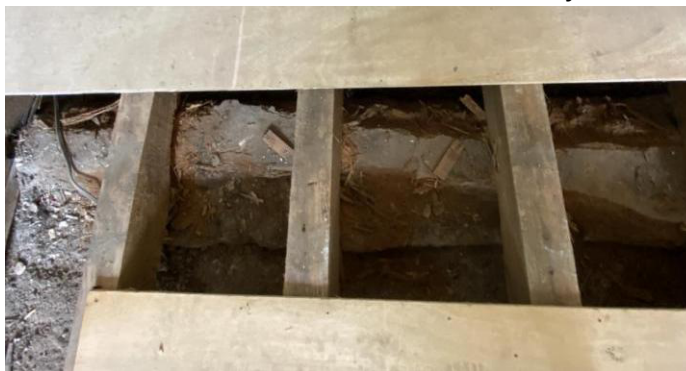
rotten timber

It is proposed to carefully lift and number the timber joists, then replace the sections of timber sleeper with new oak sections. The new sections are to be the same dimensions as the existing, good areas. At the end of each sleeper, a small section of DPC is to be fitted to ensure that the sleeper end is isolated from any damp passing from the masonry wall adjacent. The timber joists are to be re-fitted, with rotten areas supported using new soldier timbers adjacent. The insulation and underfloor heating are then to be fitted as described above, and the floor boards re-fitted using cut nails, lightly sanded, and oiled with linseed oil (sample available for inspection on site).

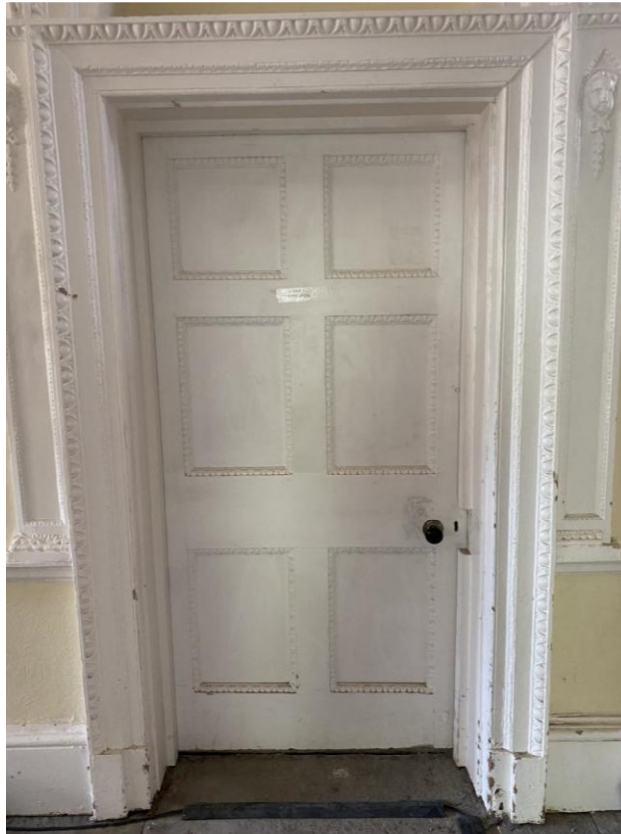
GD5 from the corridor

- 4.10.3 **Door GD5:** It is possible that this door did not sit in this position historically, or it indicates a lower status entry, because it is less ornate than the other doors in the hallway. A large modern fire stop has been applied and it is proposed to carefully remove this. Intumescent strips and a brush have been fitted to the thickness of the door. It is proposed to remove these and make good the timber before decorating. It is proposed to mirror the door swing so that the circulation works better into the kitchen and does not obstruct movement between the two areas of units.

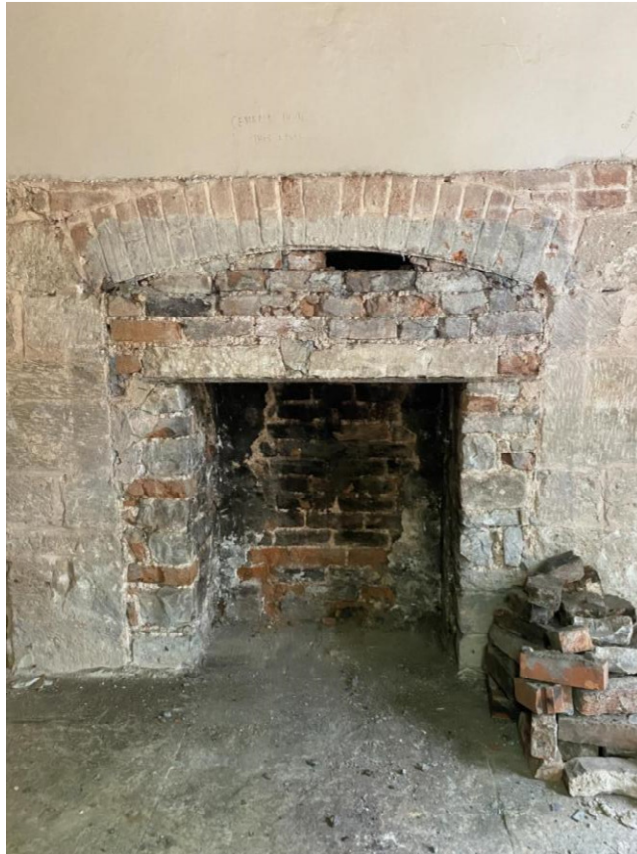
In the photograph below, to the right and left of the fireplace reveals, is dressed stonework, built to be seen, and subsequently keyed to allow a plaster finish. This would indicate an earlier, wider fireplace opening.

Later, the head of this opening was altered, to fit a brick arch and the whole plastered over, including the underside of the arch. It is possible that this work dated to the first phase of the Gothick work mentioned in the Listing. There was a subsequent phase of work which involved fitting infill brickwork, supported over the head of the opening with a metal strap. This work is rather more 'rough and ready' but the lime mortar used for this work, with large lumps of lime, would indicate that the work may be pre-Victorian, corresponding with a second phase of Gothick works. The fireplace recess under was plastered throughout, the remains of which can be seen.

A brick back was fitted to the opening at some time during one of these two phases of work. The floor of the fireplace opening is a mixture of brick and stone which is likely to date to the earlier of the two Gothick phases of work. Finally, a 19th century fireplace was fitted, which was coal burning, and the fireplace opening filled with brickwork to allow the fire basket to be set further towards the room. The fireplace along with its surround has since been lost, and the infill brickwork has been removed and placed alongside the fireplace.

It is not proposed to re-instate the lost 19th century fireplace since there is no evidence of what this may have looked like. Instead, it is proposed to retain the fireplace opening dimensions as shown above in the photo, retaining all the masonry as is, including the hearth. It is proposed to consolidate the existing plaster to the fireplace opening, and complete with new lime plaster. A new stone fire surround is to be fitted to the opening, the design of which is inspired by Strawberry Hill.

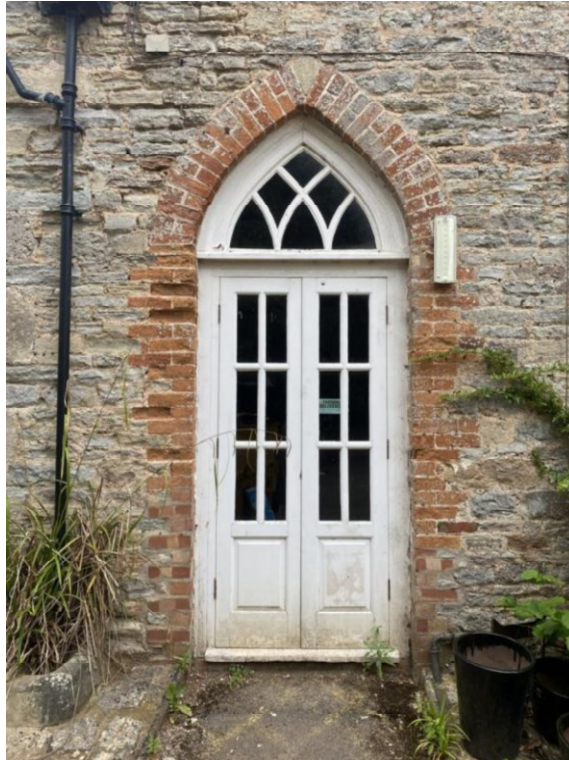
Door GD2

4.11.3 **Door GD2:** It is proposed to change this door back into a window. The masonry surrounding the door surround on the exterior clearly shows that this used to be a window. Externally, this will help the rhythm of the

windows on the external elevation read better. The 1750's window head is still in situ. For this reason, it is proposed to complete the sash window below with the same smaller panes as the north and south windows of the tower first floor.

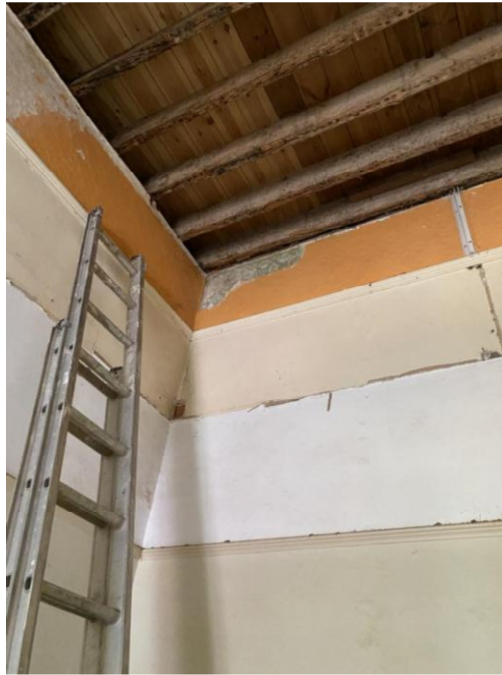
underside of first floor joists, showing embossed wallpaper (orange) above picture rail along with the modern ceiling height (ceiling since removed) and modern picture rail. The modern picture rail is to be removed.

- 4.11.4 **Ceiling:** It is proposed to fit a false ceiling, approx 200mm below the bottom of the existing ceiling. This will house the soil stack from the en-suite above and enable it to run internally, thus tidying up the external elevation. No cornice is proposed. The structural engineer has proposed incorporating a steel support into this ceiling to carry the hearth to bedroom F. 13 above. There is currently a temporary support to this hearth since there was none previously. The new ceiling is proposed to be constructed from timber sections and finished in plasterboard and skim. The existing picture rail and embossed wallpaper is to remain in its existing location and is not to be disturbed.

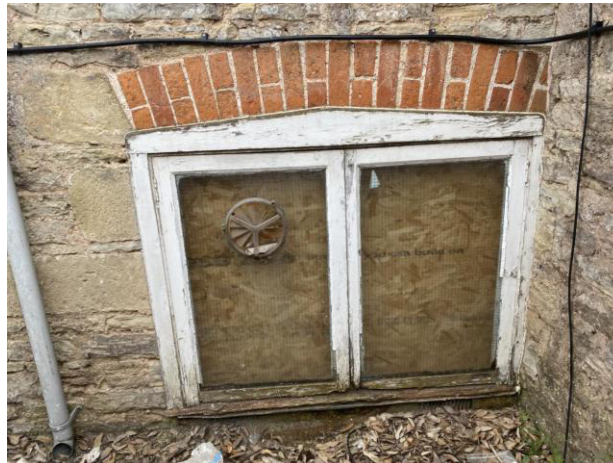
GD9 as existing

4.14.1 It is proposed to remove the existing modern window GD 09 since this window is modern and in poor condition. It is likely that this opening was historically used for deliveries. For this reason, it is proposed to install a pair of robust boarded timber doors.

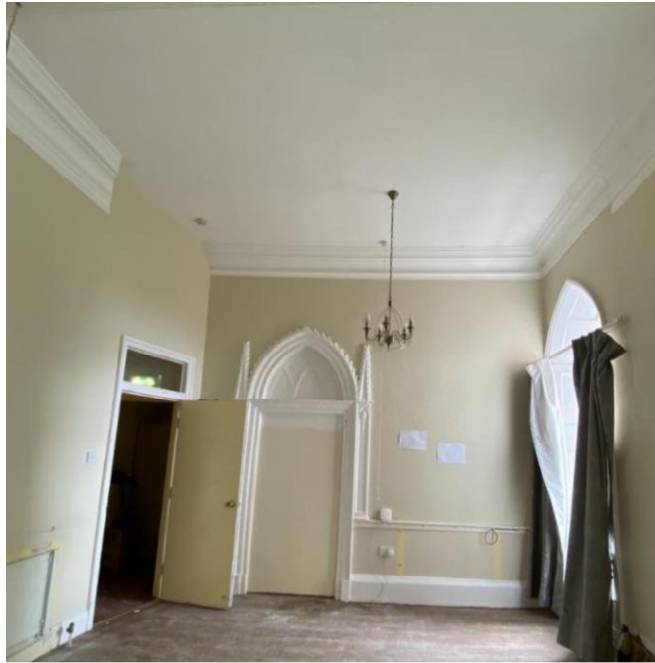
Existing disruptions to cornice indicating location of former partition

4.15.2 It is proposed to reinstate the partition between rooms F. 10 and F. 11. It is clear from the existing cornice and scarring on the external wall that there was an earlier partition in this position. The existing angled piece of partition which currently sits across this corridor is modern and is proposed to be removed.

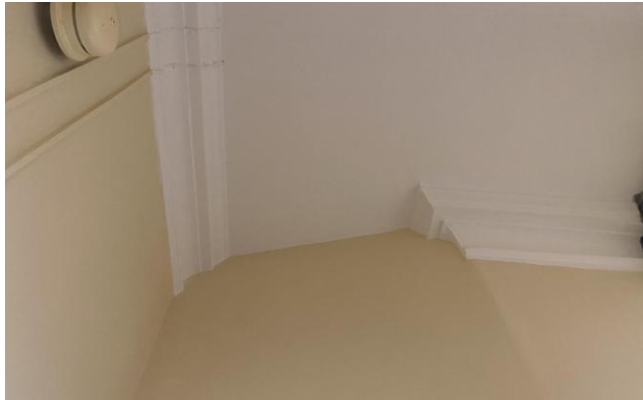
view of cornice return from corridor. Modern angled partition to the centre.

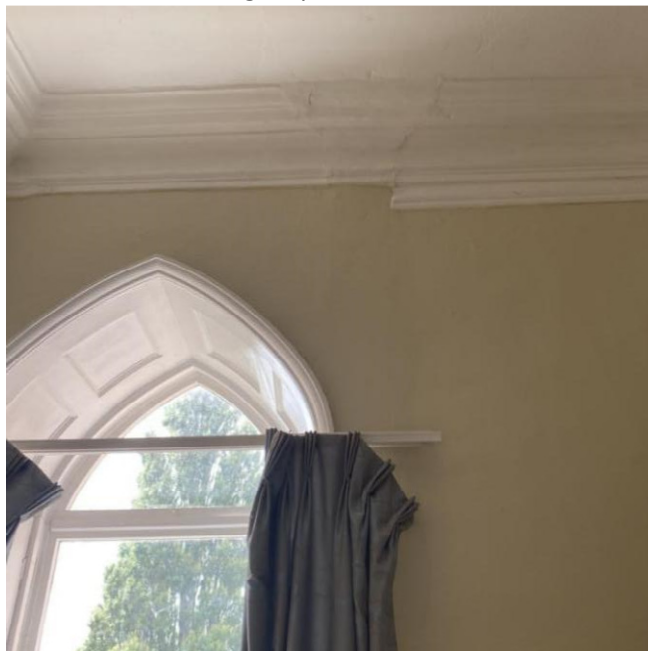
window FW3. wall scar where partition sat previously; scar in cornice. Also, modern picture rail addition to the right.

4.15.3 The resultant corridor creates a visual link back to the front of the house via window FW3, allowing daylight into the top landing of the grand stairwell

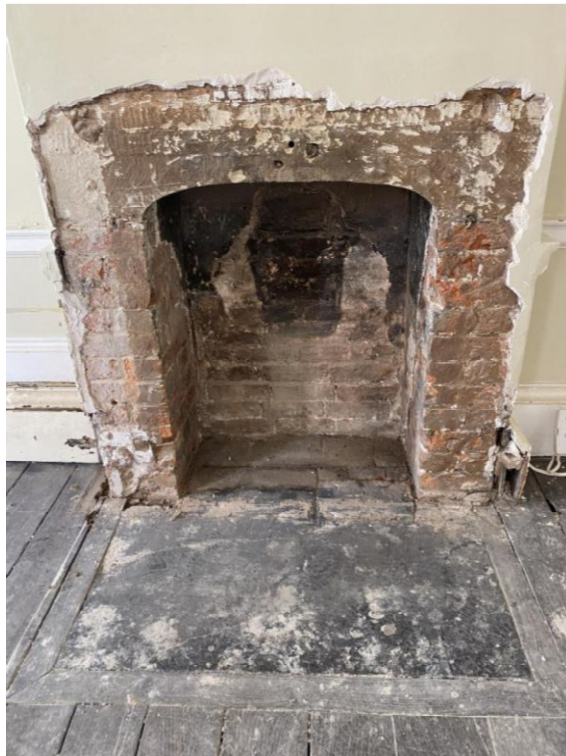
This fireplace has been opened up in consultation with the Conservation Officer to remove modern plasterwork covering assumed 19th century rubble infill into the

fireplace opening. This has revealed an opening formed with brickwork, similar to that used elsewhere in the gothic phase(s) of work. Of particular note with this fireplace is the stone head of the fireplace opening which is formed from a single piece of stone with a basket handle arch.

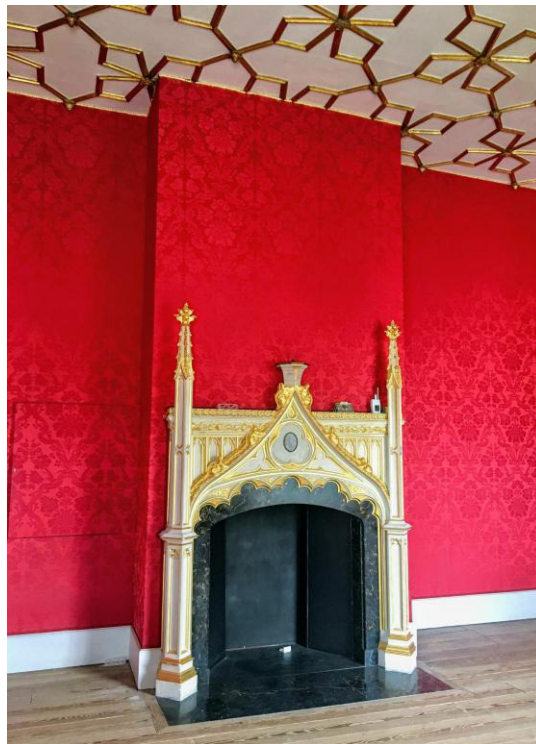
Fireplace at Strawberry Hill

It is possible that the effort put into carving an arched stone head was countered by the savings in cost and effort gained by applying a non-structural fireplace surround. This would lead one towards a similar method of construction as the existing ornate door surrounds, so building up the surround in timber and plaster to create the desired effect. The fireplace below at Strawberry Hill, although much more elaborate than is required here, would be a good influence for the design.

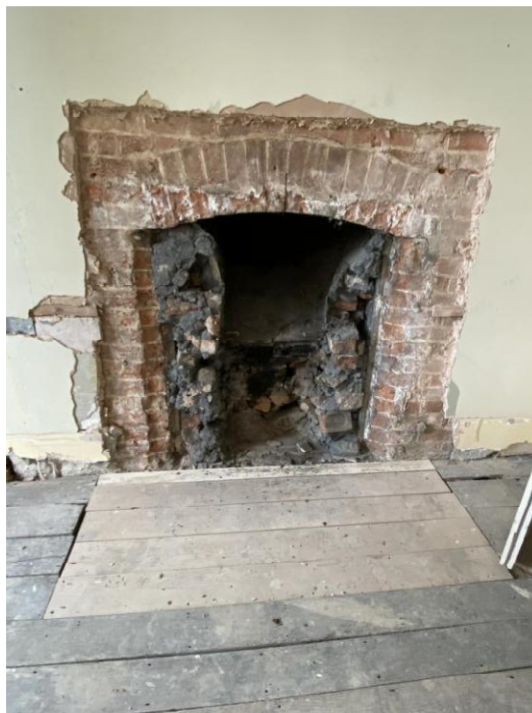
- 4.17.6 **Fireplace:** This fireplace is similar to the opening in bedroom 4. It has a brick arch and surround, indicating that it is of similar date to the other gothic work.

The hearth has been removed and boarded over, leaving a clear indication of its size. It is likely that it was a Douling stone hearth similar to that in bedroom 2 and the attic rooms.

A later coal burning fireplace has been fitted, now lost, the fitting of which required hacking back the brickwork on either side of the fireplace opening. The fireplace was filled with rubble in order to fit this type of fireplace.

The earlier fireplace opening can be seen to have been plastered. Behind the plaster on the side of the opening can be seen the timber support to an earlier dado rail.

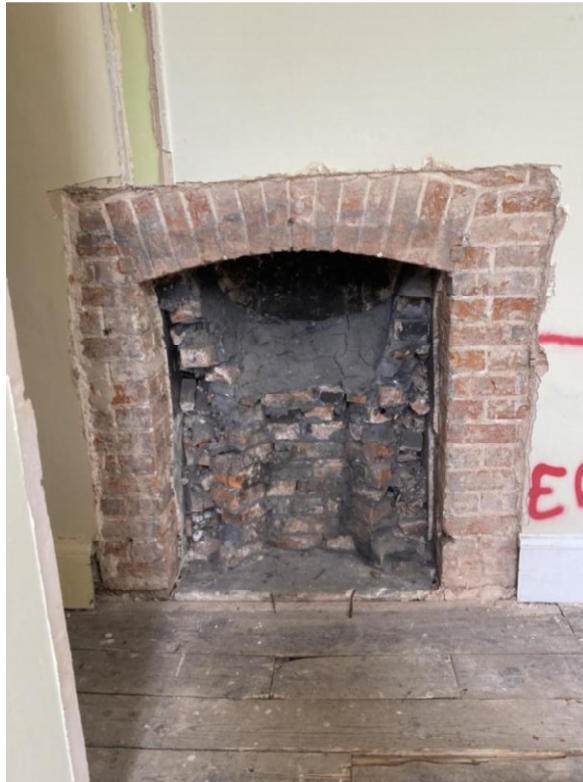
4.18.3 Fireplace: This fireplace is similar to the others described here, with a brick arched head and brick reveals and back. There are remains of plaster to the fireplace surround internally. The floor of the opening is finished with stone.

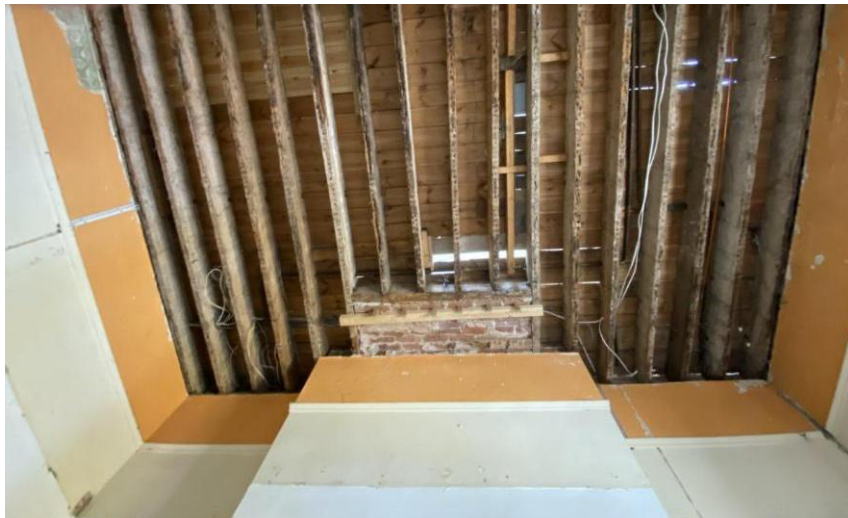
Unfortunately, the hearth has been removed but when seen from underneath, the brick support to the hearth can be seen. From this, the size of the former hearth can be approximated.

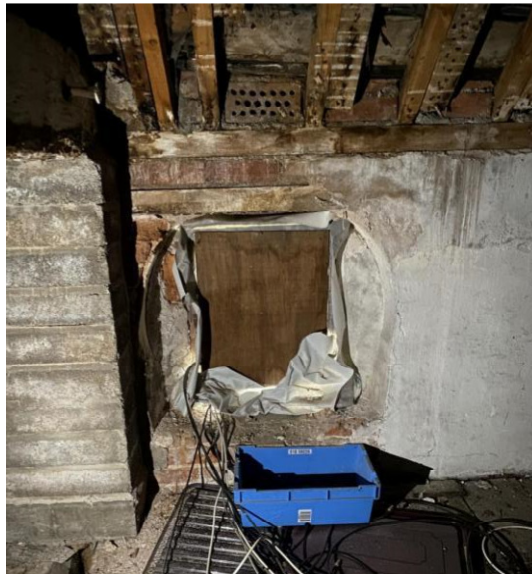
Internal view of AW3

- 4.19.1 It is proposed to make good window opening AW3 which is currently boarded over.
