View of proposed corner of 97-101 Trongate

Holmes Miller (HM) has been asked by Dean Engineering to prepare repair/restoration proposals for the building at 97-101 Trongate. The footprint of the building is outlined on the historical maps on these pages and is located on the corner of Trongate and King Street.

This document has been prepared to support the grant application to Glasgow City Heritage Trust (GCHT) as well as the planning and Listed Building Consent applications. It should be read in conjunction with HM's drawings and specification.

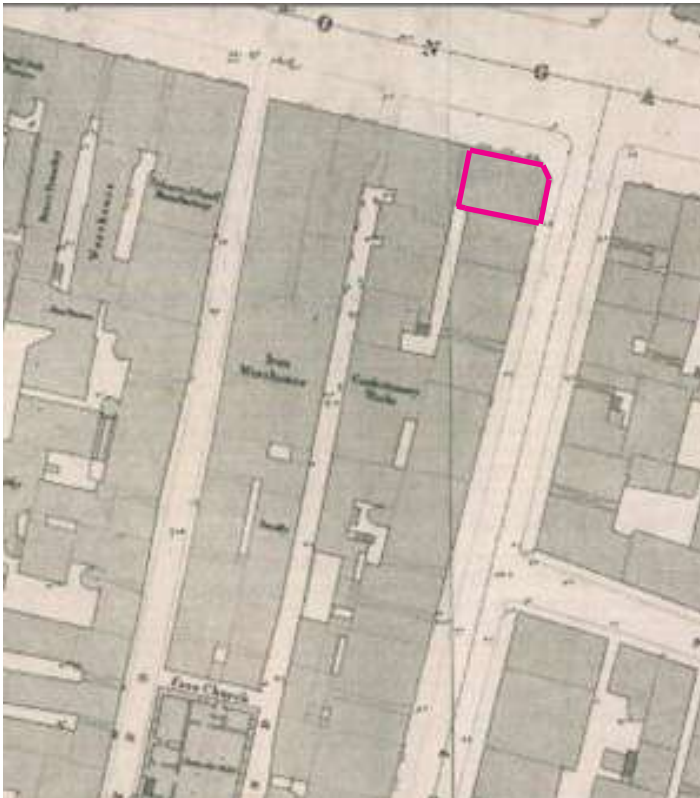
O.S Map: 25 inches to a mile series, published 1857. This map shows the area prior to the works initiated by the City Improvement Trust (CIT). These earlier buildings occupy a very similar urban form but many of the streets are much narrower. This was widened as part of the CIT health works.

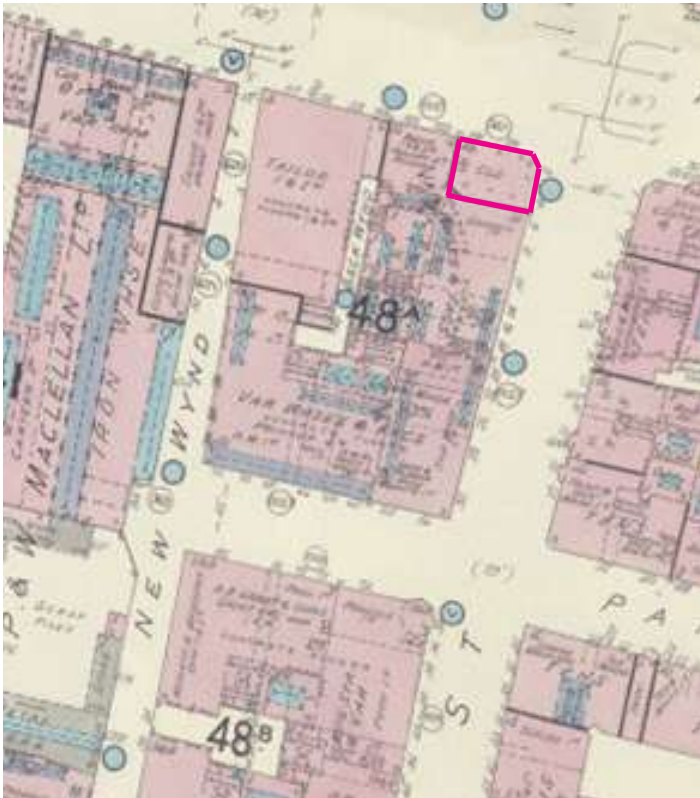
Excerpt from Goad's Streetmap of Glasgow Map, published 1929.
Copyright National Libraries of Scotland

The building in question forms the north-east portion of a city block bounded by the Trongate, King Street, Parnie Street and New Wynd. This block was built in 1849 and was designed by J T Rothead.

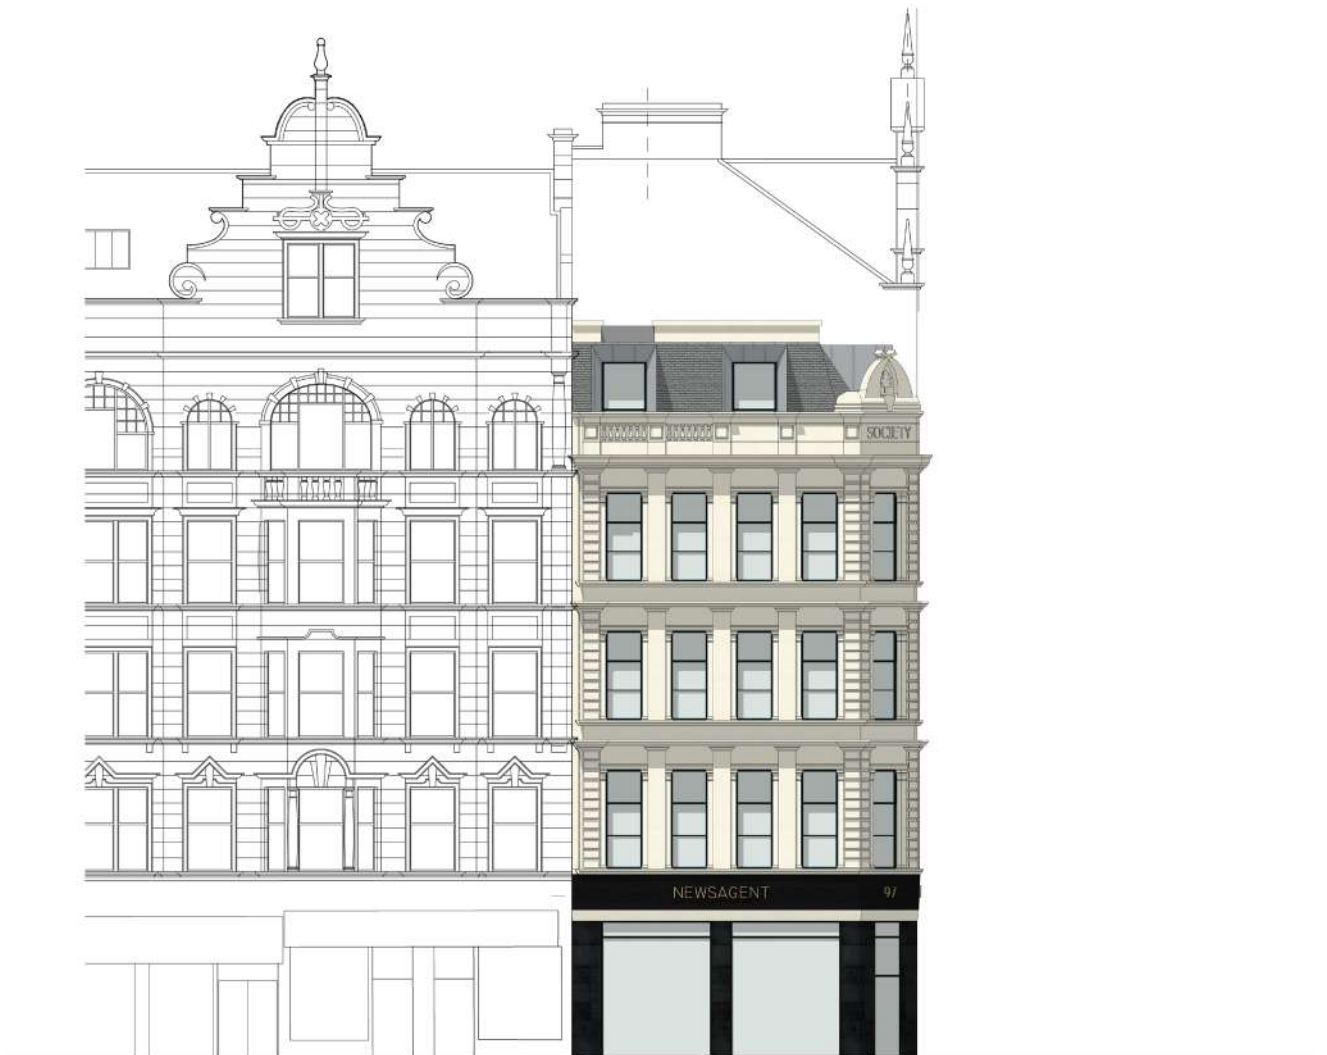
Proposed Elevation on King Street

The Proposal is for the upper floors to be converted into flats whilst the ground floor is refurbished externally and will remain a retail unit.

An additional storey of accommodation will be created within the roof zone to create another flat.

The windows are single glazed and are in a poor state of repair. New double-glazed windows, matching the design of the existing are to be installed.

The Applicants are keen to have the new main entrance brought back to standard befitting the quality of apartments. New black granite cladding will clad the ground floor. The ground floor works will also include the removal of existing advertising canopies and vinyl adverts at signage level.

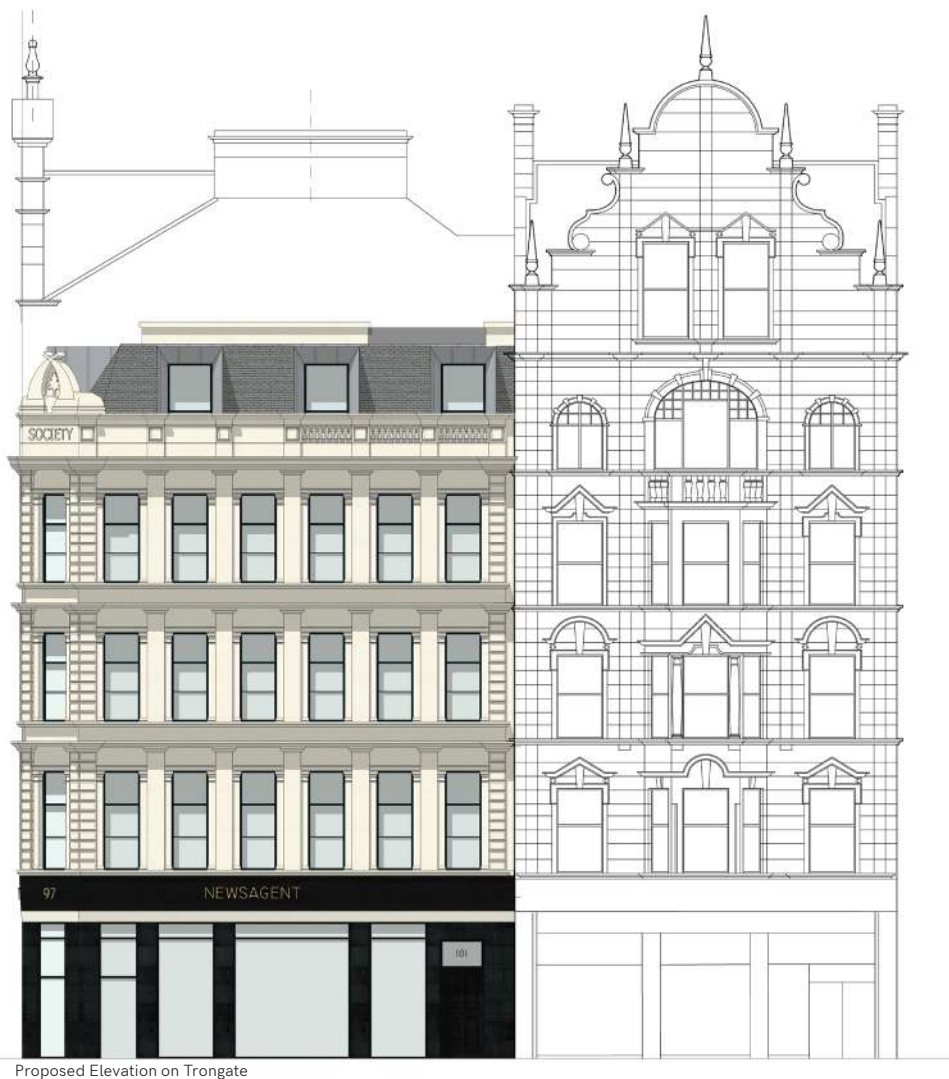
Proposed Elevation on Trongate

Realising the importance of the corner setting, especially given the fine examples throughout the immediate Trongate, wider Merchant City and the Central Conservation Area on the whole, this address offered a unique opportunity for reinforcing a corner that has been negated in some way, by the higher later additions either side.

Coupled with the restoration of the original stonework through paint removal and the revamp of the ground floor, this untidy blight will be restored to the important prominent corner setting it originally was and contribute greatly and positively to the Trongate and Conservation area.

The additional accommodation in the roofspace will result in the existing roof being replaced with a mansard roof punctuated by zinc-clad dormers. The proposed roof level will only be 800mm higher than the existing. The new roof will also be located behind the existing parapet, ensuring that the listed building's prominence is not compromised.

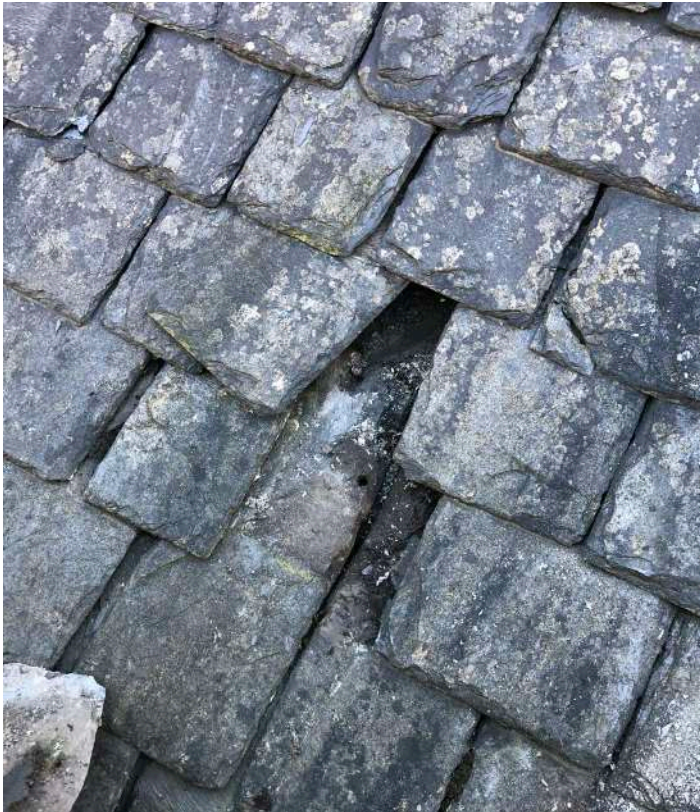
Example of perished slate nails - on High Street

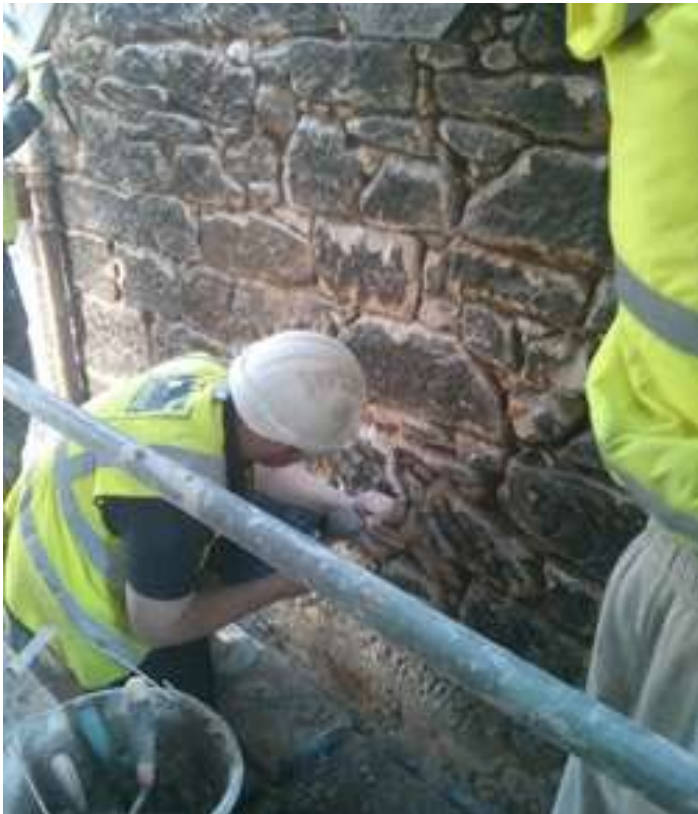
Pointing a rubble wall in a lime-based mortar

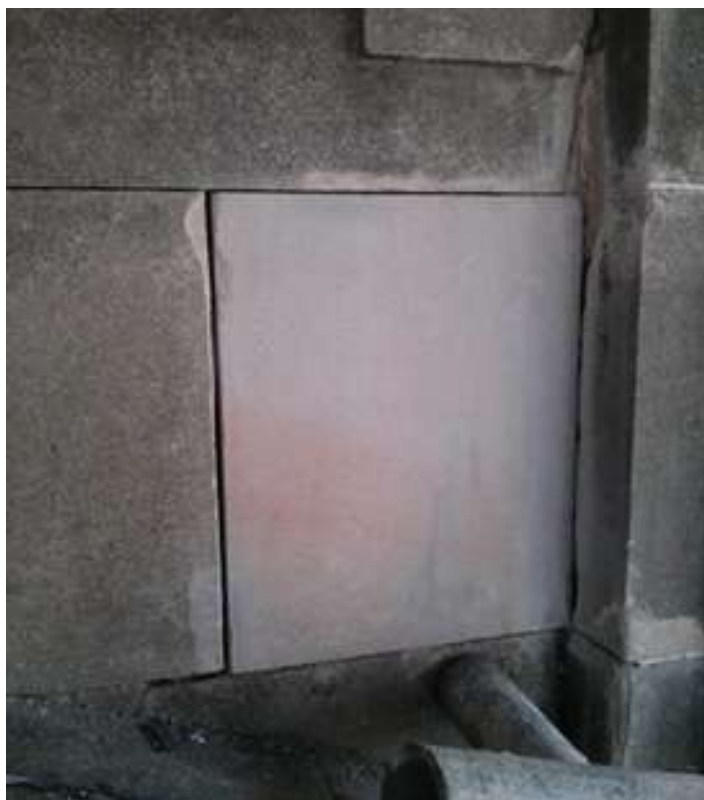
An indented stone having just been inserted in place. Pointing still to be done.

- Indent stonework: Samples of buff sandstone have been sent for analysis. Report from BGS recommends that Blaxter sandstone from the Dunhouse quarry be used. Carefully cut out damaged stone; bed new stone (full course thickness, ensuring indent is wider than tall) in lime mortar; point to finish. **(Grant eligible)**

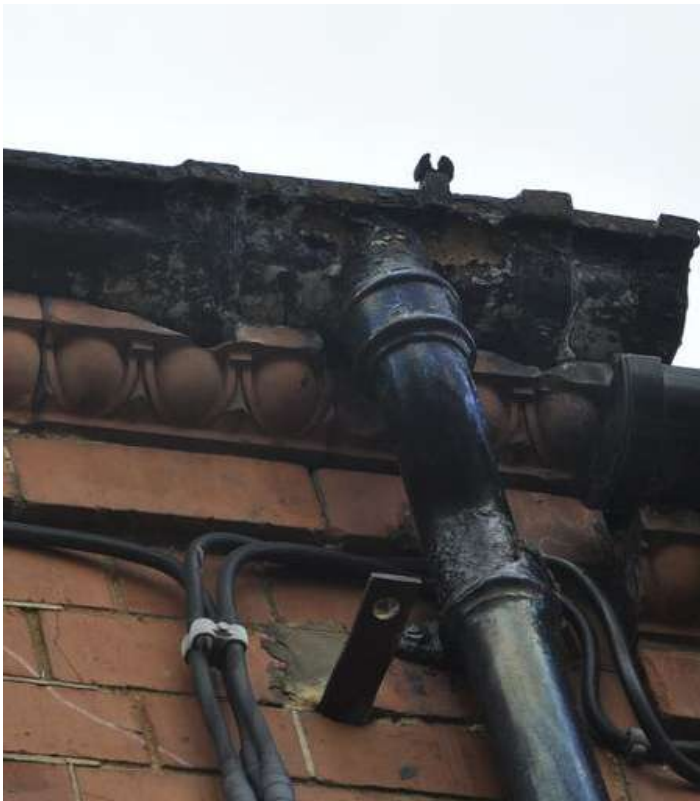
Damaged and leaking cast iron rainwater pipe

- Gutters and downpipes: All downpipes are internal and a mix of cast iron and plastic. Allow for an access panel 300mm above ground. Existing cast iron rainwater goods to be closely inspected and any damaged elements to be replaced in cast iron. The gutter is a lead-lined parapet gutter and this is dealt with above. **(Grant eligible)**
