# **Proposed Extension of Arbour Lodge Care Home, Buxton Lane, Stockport, SK6 7QL**

*Surface Water Drainage Strategy Report*

Project No. CE2882

**Ward Associates (Consulting Engineers) Ltd**

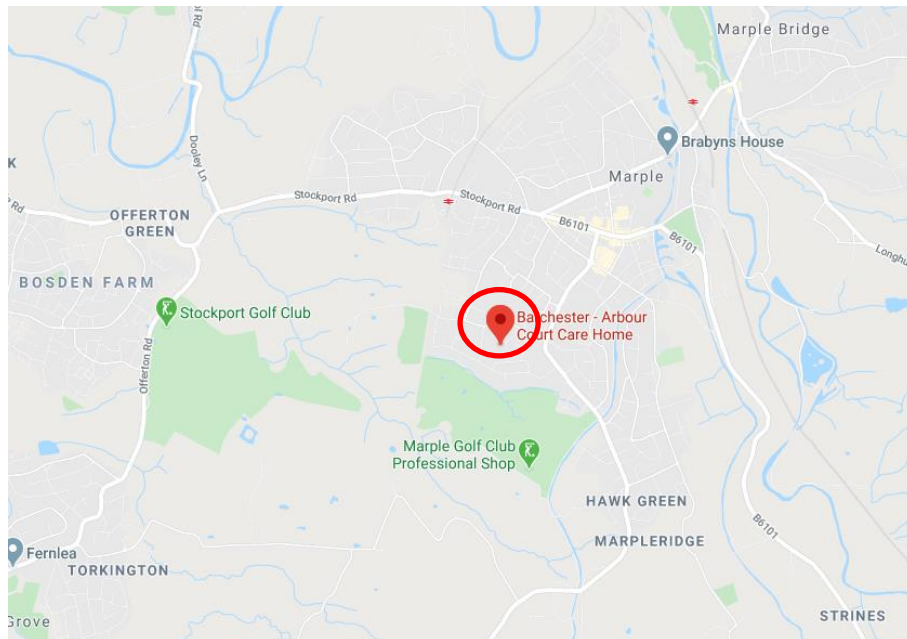
Figure 1.1 Site location plan.

1.1. WARD Associates Consulting Engineers Limited have been commissioned by Barchester Healthcare to prepare a Surface and Foul Water Drainage strategy report reference planning submission for a proposed extension to Arbour Lodge Care Home, Buxton Lane, Marple, SK6 7QL. A copy of the site plan/location is shown in Figure 1.1 and enclosed in Appendix A & B.
