DESIGN STATEMENT INCORPORATING ASSESSMENT OF  
SIGNIFICANCE

FOR  
REPLACEMENT WINDOWS, REDUCTION OF CHIMNEY HEIGHT AND INSTALLATION OF A  
SOLAR PV PANEL ON THE LINHAY ROOF

AT  
CRAMMER BARTON, BROADHEMBURY, HONITON. EX14 3LN

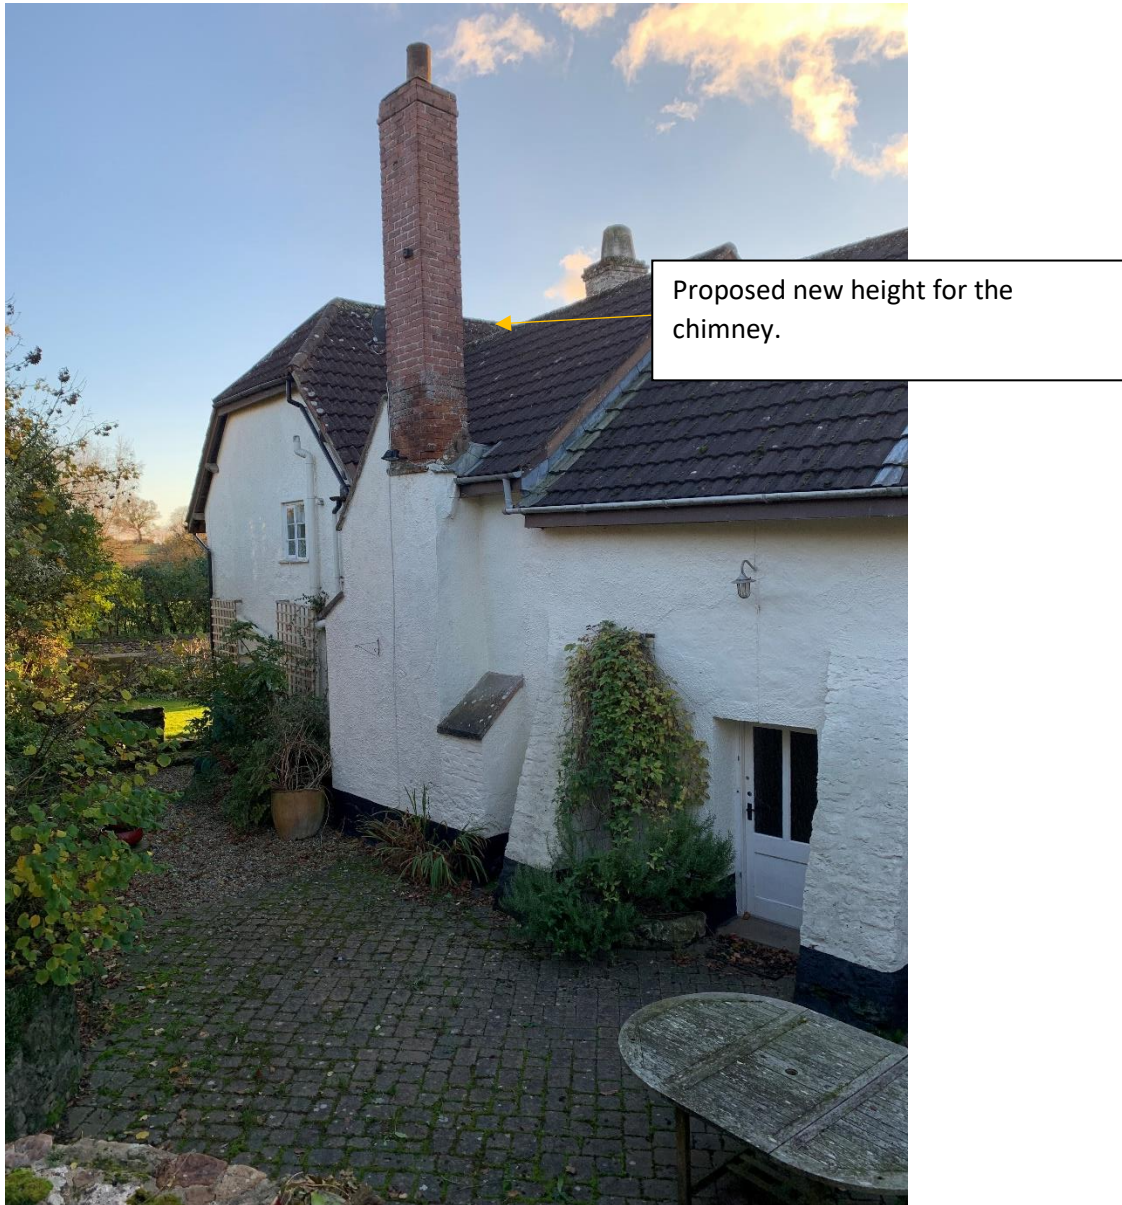
Figure 1: adjusted chimney height

- **Reduction in height of damaged Chimney** In the dining room a 1950's fireplace conceals an earlier fireplace. The 1950's fireplace has been sealed-off for many years and has suffered from water ingress. The chimney, which stands at ~3500mm above pitched roof height, (shown in figure 1 below) has been confirmed by experienced builders as being an unsafe structure and is highly likely to collapse under a high-wind load. It is proposed that the chimney stack height is reduced to the height shown in the below picture, the chimney is sealed at the top with a concrete plinth and the chimney pot reset.

The relevant chimney is largely hidden from view from the road as it's shielded by either the property, the neighbouring property, or trees.

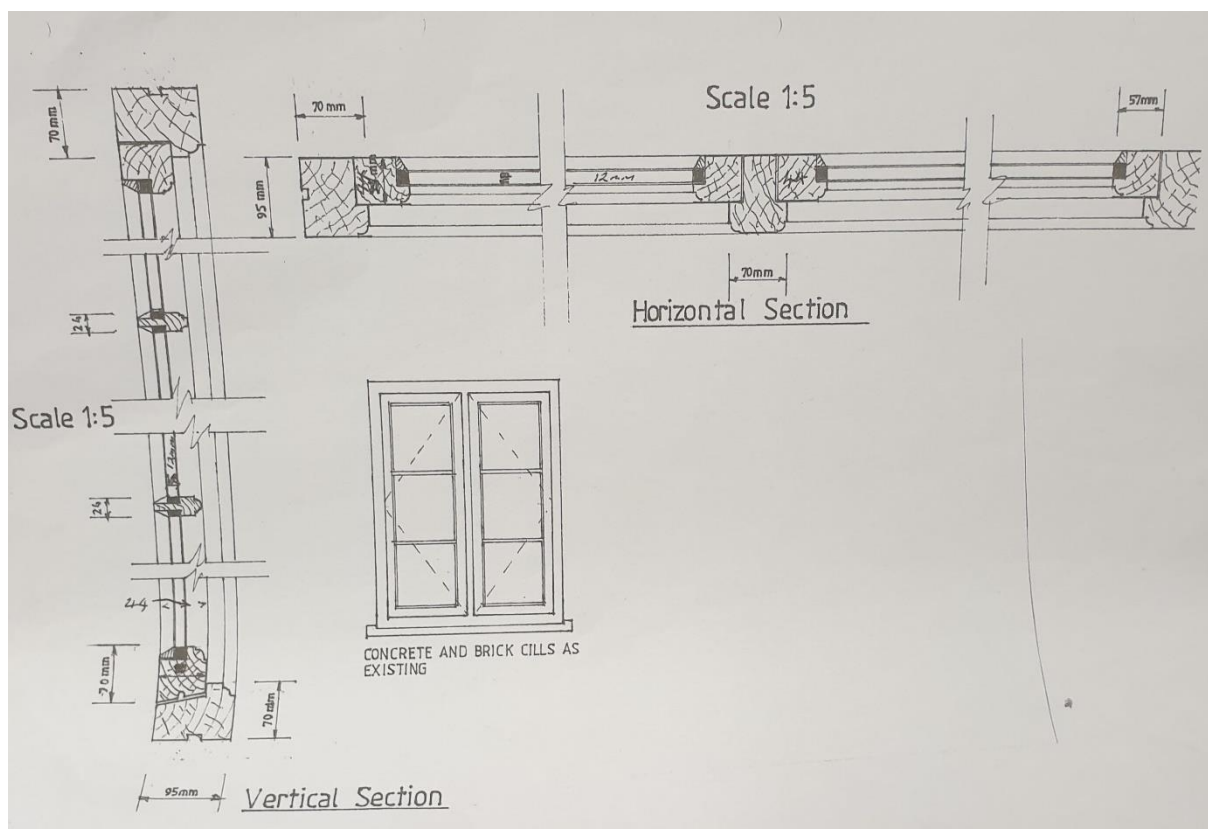
**Schedule 1 – proposed design of replacement Hardwood Casements**

- **Window replacement (Hardwood Casements):** there are 20 casement windows throughout the property that are in poor condition with extensive rot damage to frames (see examples in Schedule 2). The current windows provide little to no thermal efficiency and unhealthy levels of water ingress – several with missing sections to frames. The units are beyond repair and/or repair is not cost effective. It is proposed these casements are replaced with locally made handcrafted hardwood casement windows with slim-line doubleglazed units (alike in design to the current older casements). Where applicable the hardware will be black painted, metal, monkey tail, stays and latches that match that of the existing replacements windows.

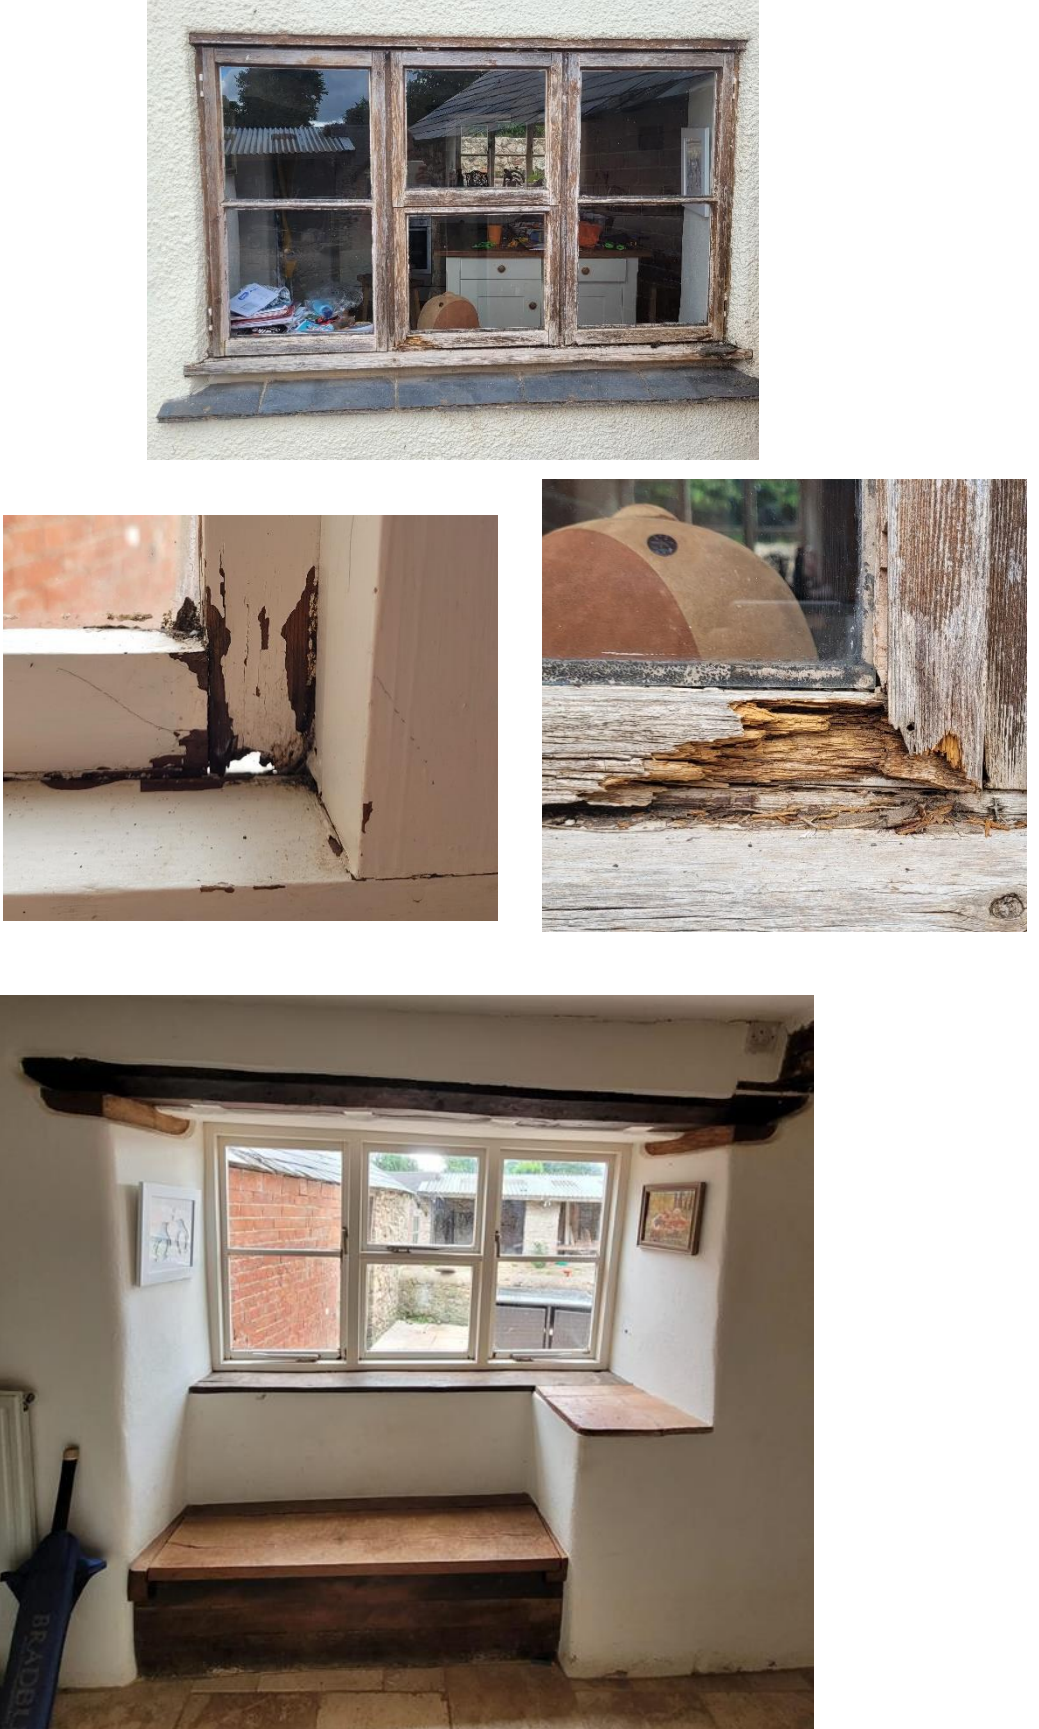
Window	Picture
A

- **Replacing Kitchen Casement with Hardwood Double Doors:** the westerly facing kitchen Window (Window A schedule 2) is set on what is believed to be plastered early C20 single brick as well as a small section of thicker cob. The current casement is in a dismal state with a large finger sized hole in the frame. To improve the natural light and thermal efficiency of the kitchen the wall below the window shall be removed as well as the integrated bench and replaced with hardwood double doors with a consistent design to the replacement windows. No structural changes are required.

<p>The image displays three distinct window-related scenarios. The top photograph shows a traditional wooden window with a dark, possibly stone or slate, sill. The window frame is heavily weathered and shows signs of age. The middle-left photograph is a close-up of a window's base, showing significant peeling paint and structural rot where the window meets the wall. The middle-right photograph is another close-up, focusing on a wooden sill that has a large, irregular hole and is surrounded by extensive rot and splintering wood. The bottom photograph shows a modern window with a white frame, set within a white wall. Below the window is a built-in wooden bench and a wooden ledge, suggesting a well-maintained or newly finished interior space.</p>

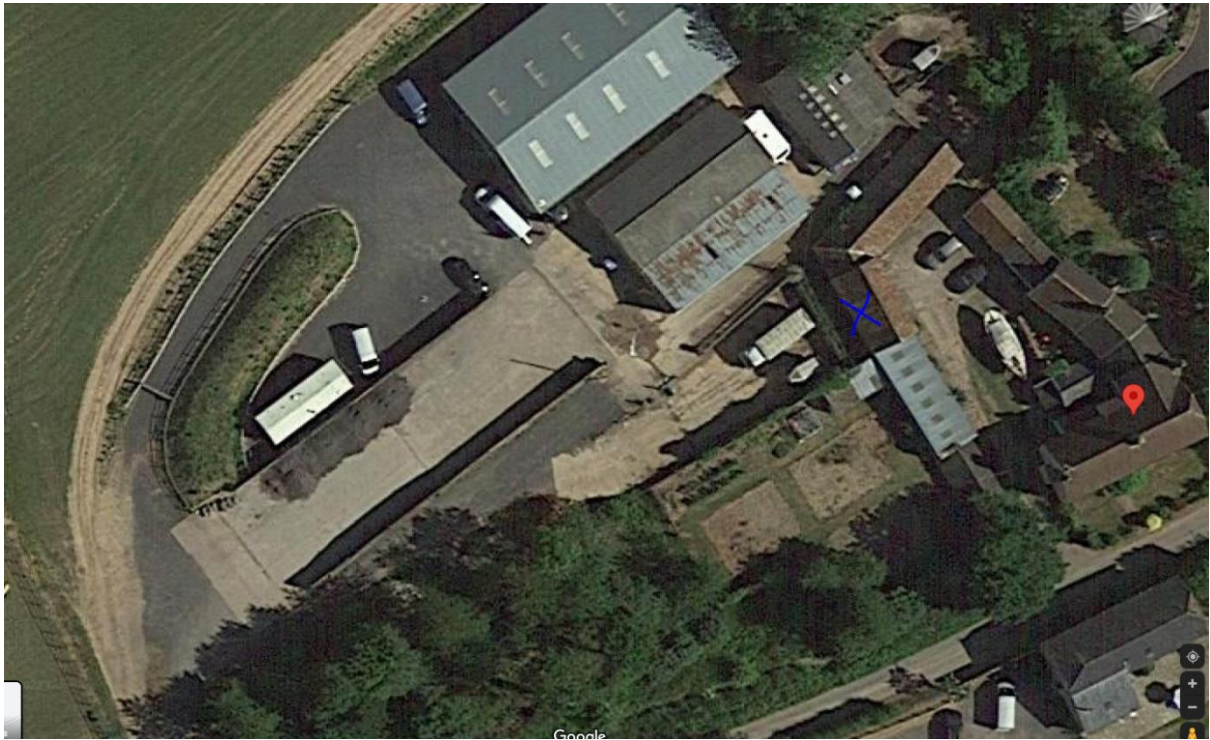
Schedule 3 – Location of proposed 4 KW solar panels (see blue cross)

- **Solar panel installation on Linhay:** instal a 4KW Solar PV panel on the Westerly facing roof of the linhay (See Schedule 3). This roof faces the commercial units used for self-storage and other commercial businesses.
