HERITAGE STATEMENT FOR

QUINCE HALL FARM
CHELMSFORD ROAD
BLACKMORE
CM4 0PZ

Corrie Newell BA Arch Hons RIBA ARB IHBC

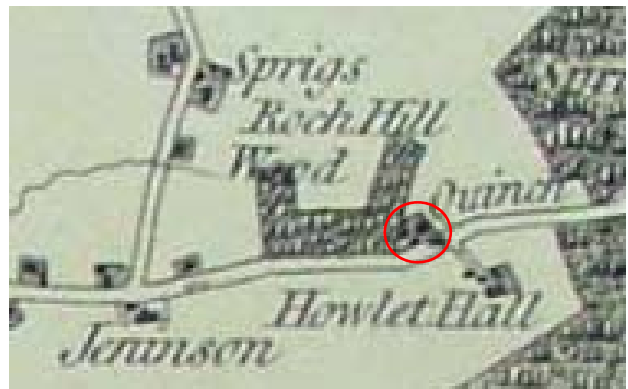
Figure 1. 1777 Chapman and André Map

- 5.17 Quince Hall Farm is shown as 'Quinch' on the Chapman and André map of 1777. This shows at least 3 substantial buildings within a rhomboidal enclosure on the north side of the road. The farmstead abutted Roch Hill Wood to its west.

- 5.18 The position of the 3 large buildings correspond with the farmhouse and Barns 1 and 2.
- 5.19 In 1789 a Deed records the property being surrendered from Helen Lane to the Lord of the Manor of Fingrith Hall *"all that capital messuage or tenement with the orchard garden appurtenances AND all that toft of land called Quinteshall AND that messuage and croft called Capscroft otherwise Robjeants containing 44 acres ...late in the occupation of Peter Bright"*.³
- 5.20 An inventory of 1820 described Quince Hall as a Freehold Farm (still of 44 acres), being sold by Michael Mason to Christopher Preston (of Jericho House, Blackmore), and tenanted by Joseph White. The inventory⁴ described it as:

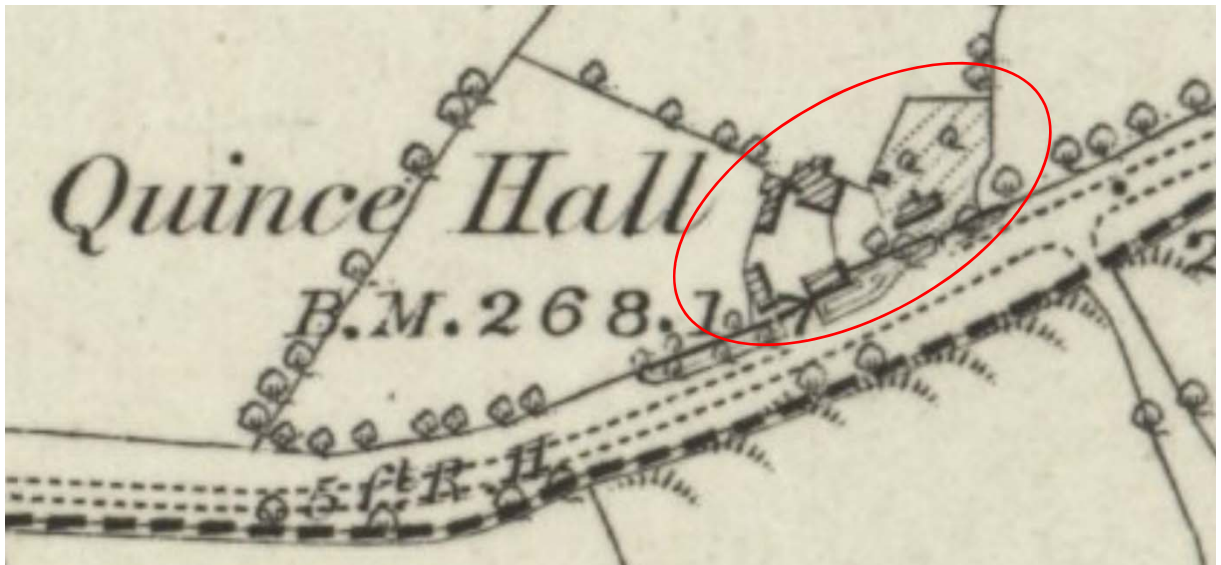
Figure 5. 1881 OS Map surveyed 1873. This shows the differentiation between garden around the house, and the more utilitarian use of the new yard.

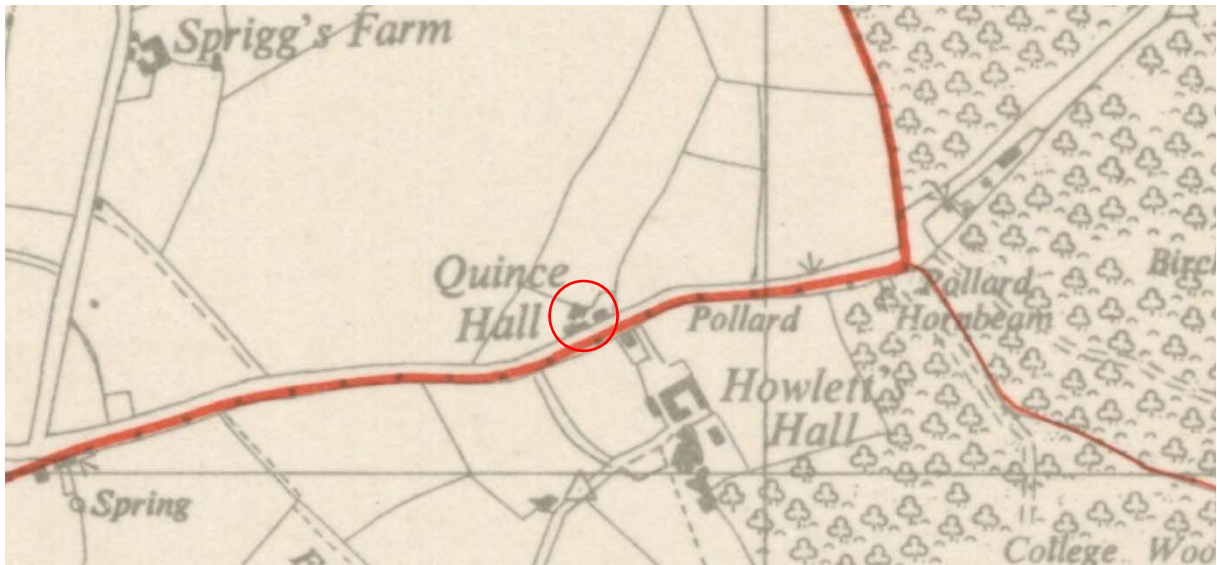
5.39 There is no map that exactly corresponds with the Planning Act of 1948, but the National Trust Map of 1949 gives an indication that it was similar to the 1920 map:

Figure 8. 1949 OS National Trust boundaries map showing farmstead and field boundaries at that time.

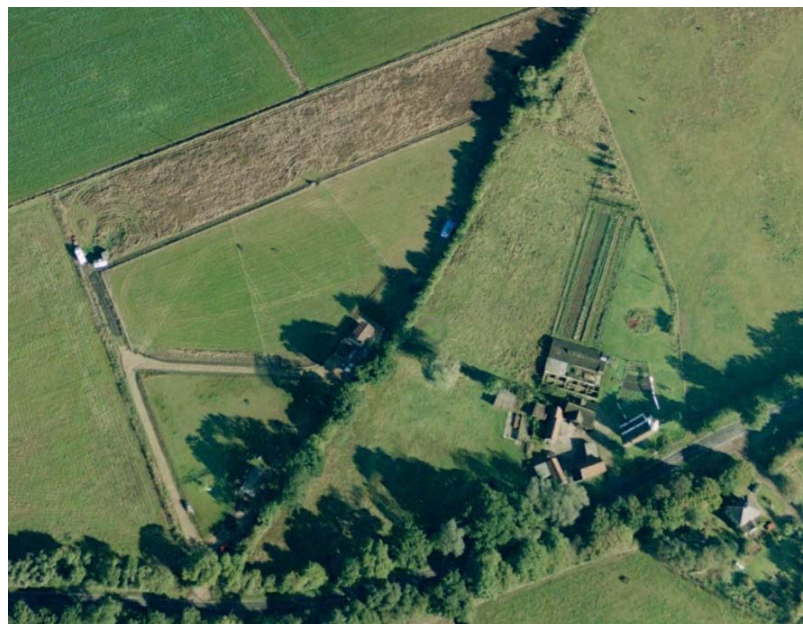
Figure 13. 2000 Google Aerial showing the extent of garden, Piggeries building and enclosures to the north of the main farmyard.

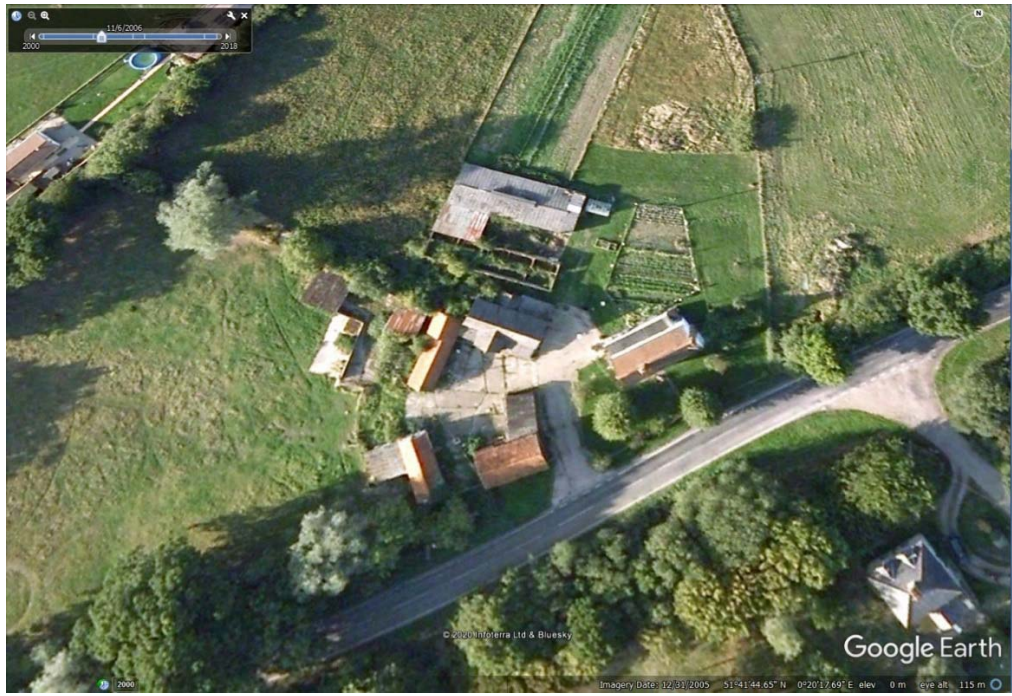
Figure 14. 2005 Google Aerial showing the extent of the farm building group.

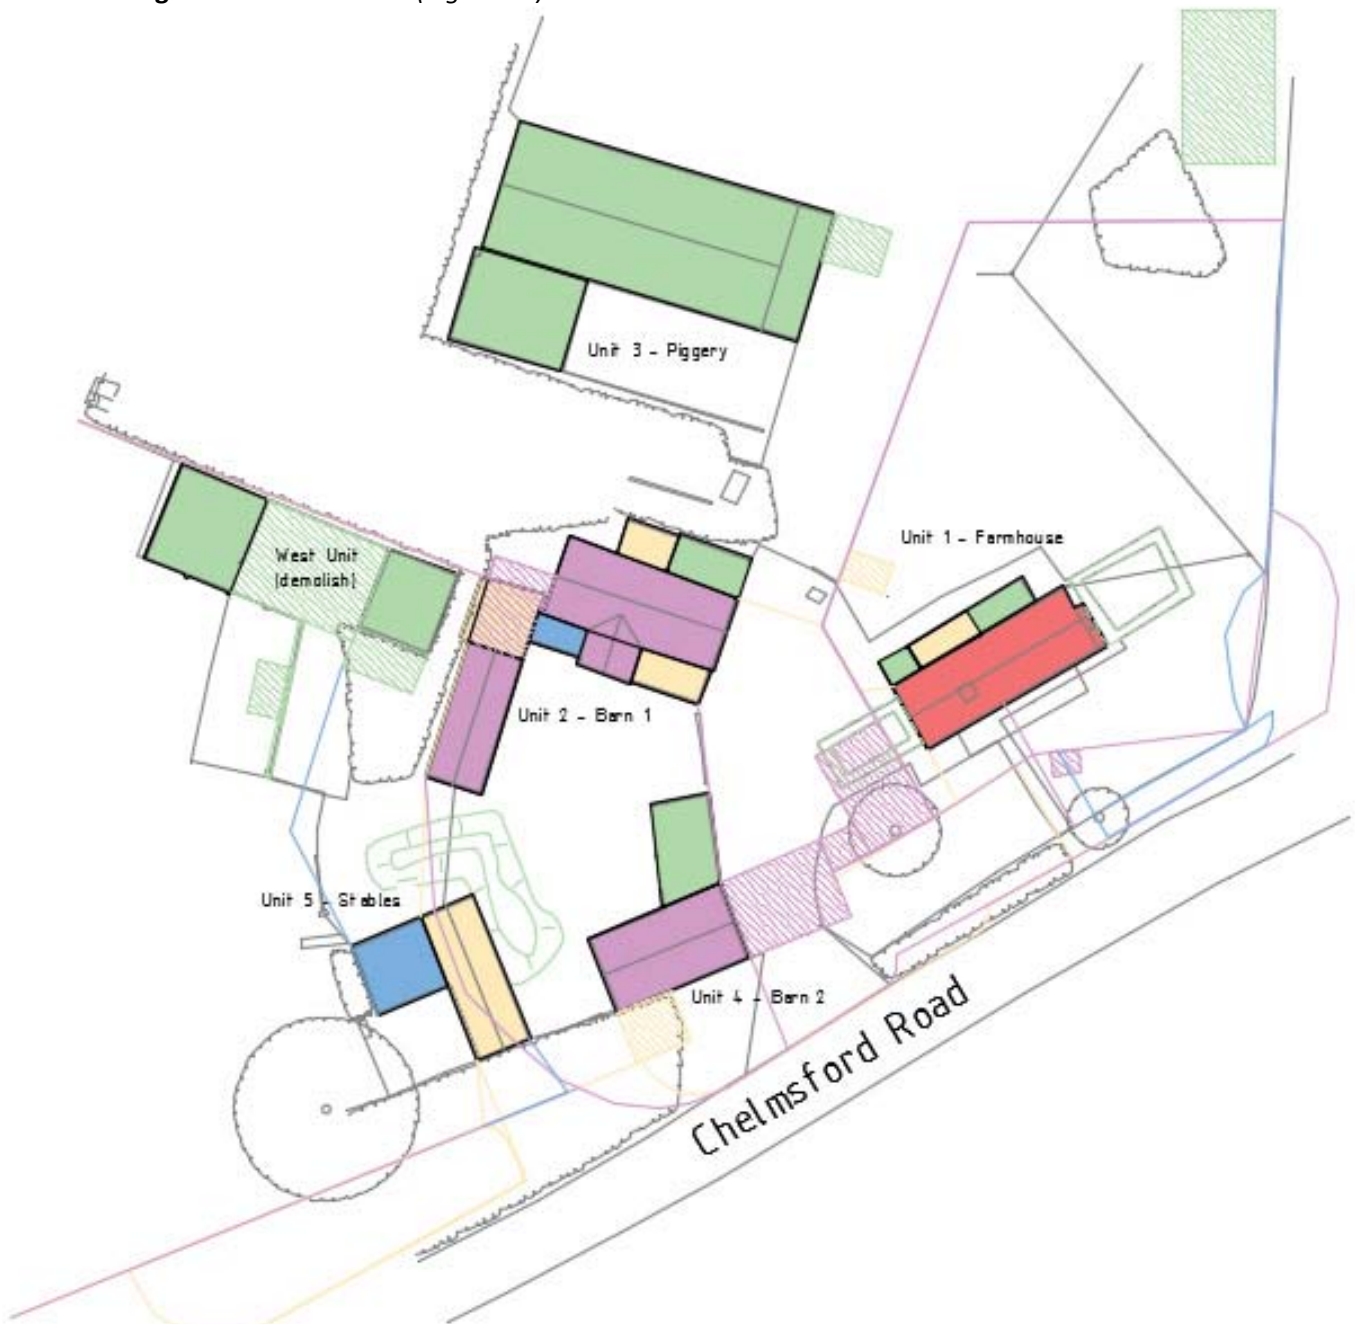
Significance Block Plan (Figure 16)

- High C18
- Medium
early C19 / mapped 1847
- Medium
mid C19 / mapped 1873
- Low
early C20
- Neutral
mid C20 onwards

Hatched areas are previous buildings shown on the historic maps / aerials of the same period

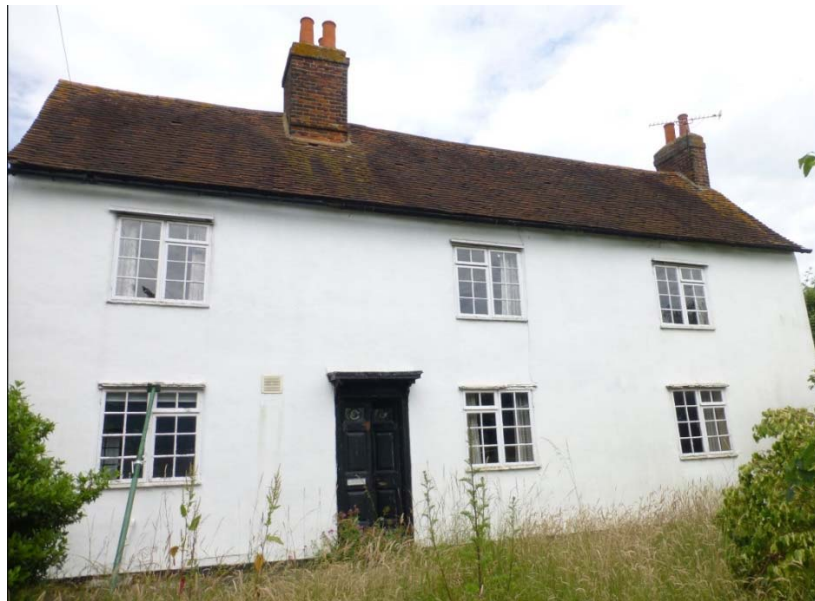
Figure 18. Front elevation 2016 List Entry photograph (windows now blocked).

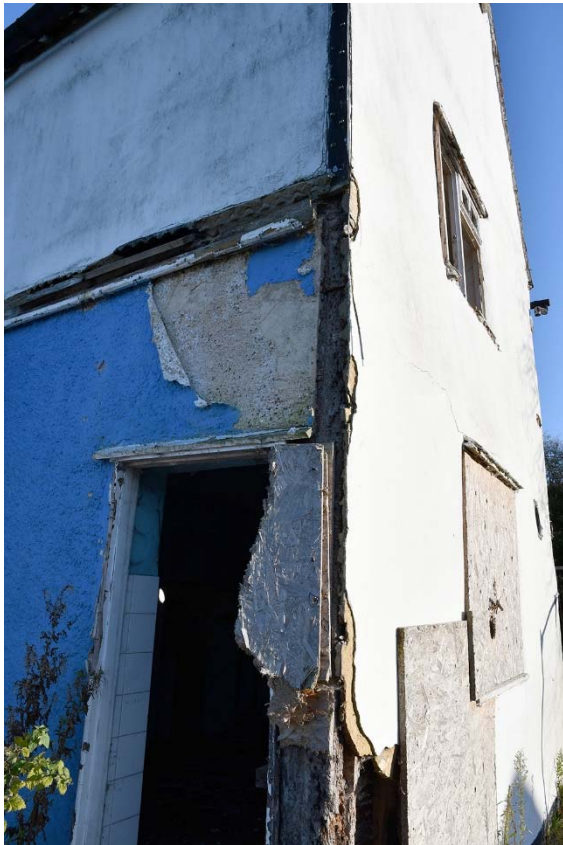
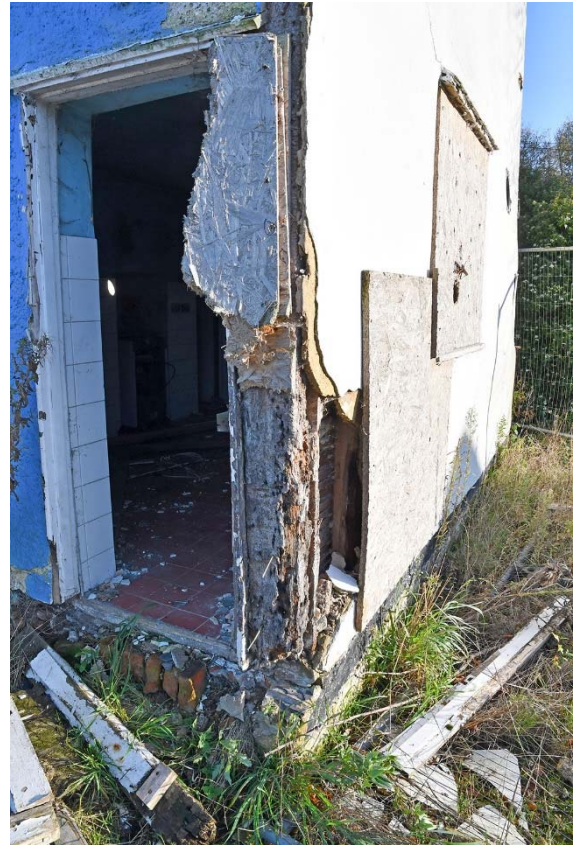
Figures 27 and 28 above. Condition of NW corner frame, following removal of C20 Entrance Lobby

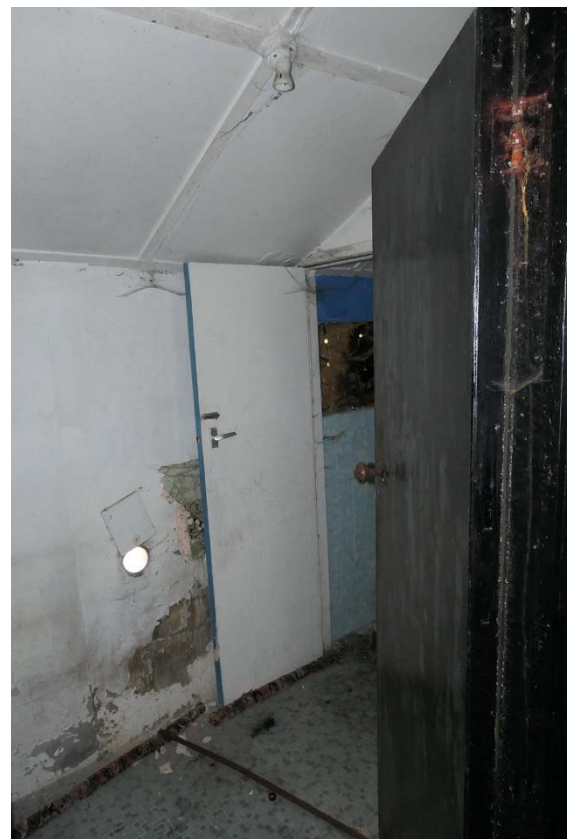
Figure 29. Interior of Lean-to. Fibreboard finishes and C20 flush doors.

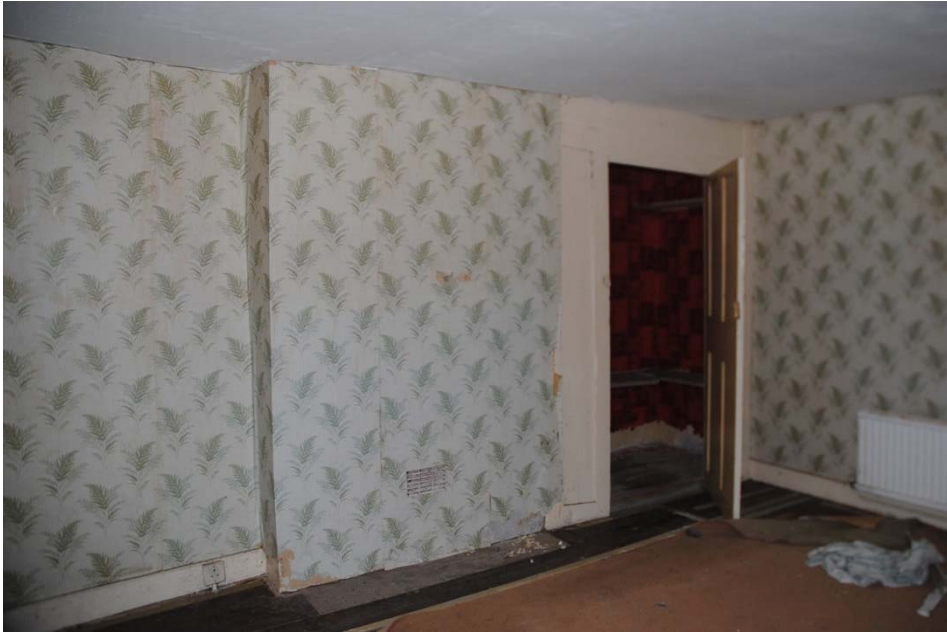
Figure 30. Bedroom 1 with typical simple details and blocked fireplace. C18 cupboard.

- 5.5 The layout of the first floor is original, and retains the 3 bedrooms described in the inventories. They were all heated chambers, but all the fireplaces are now blocked, but ventilated. Some small investigative opening up within Bedroom 2 indicates that this at least may be a good C18 open brick fireplace with curved reveals, which would benefit from being re-opened and repaired. Allowance is therefore made for all fireplaces to be investigated and re-opened if practical.

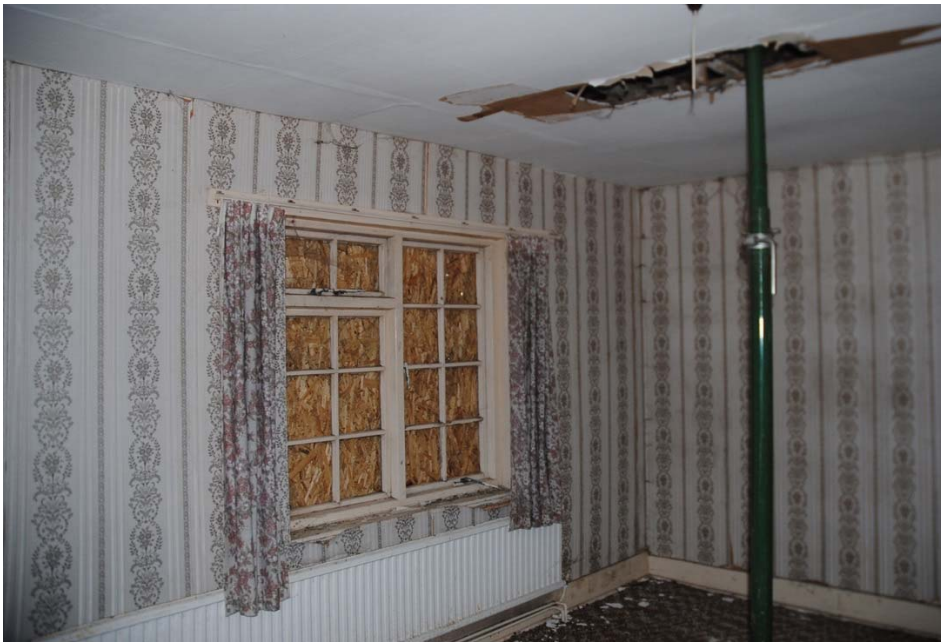
Figure 31. Bedroom 2 with typical C20 window.

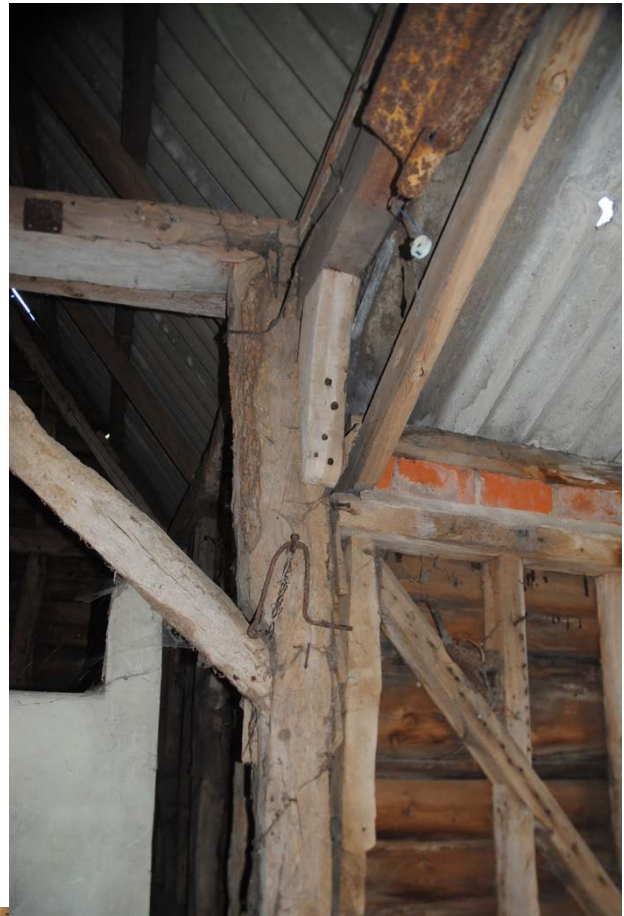
Figure 44 (below). The front midstrey is pegged, so is earlier than that to the rear, but it does not line up with the main frame and the top rail is later and discontinuous.

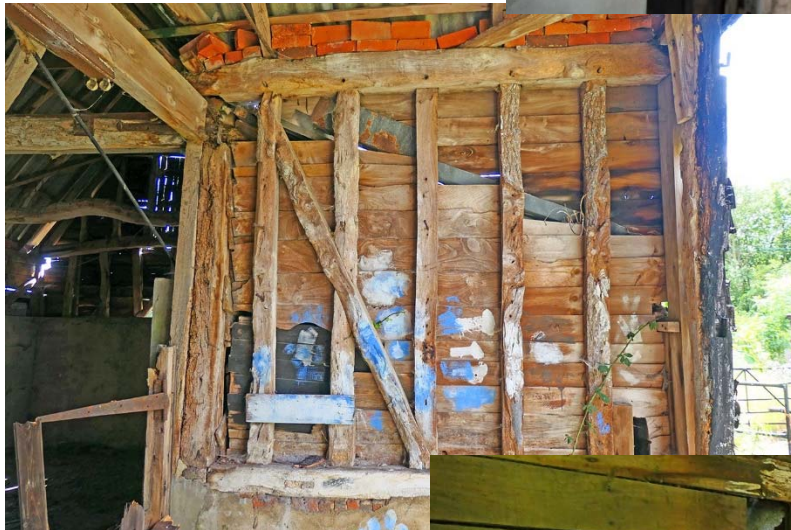
Figure 45 (right). Damage in one of the areas of where there have been longstanding water leaks. High brick plinth using C17 bricks. The C20 blockwork internal casing can be seen beyond.

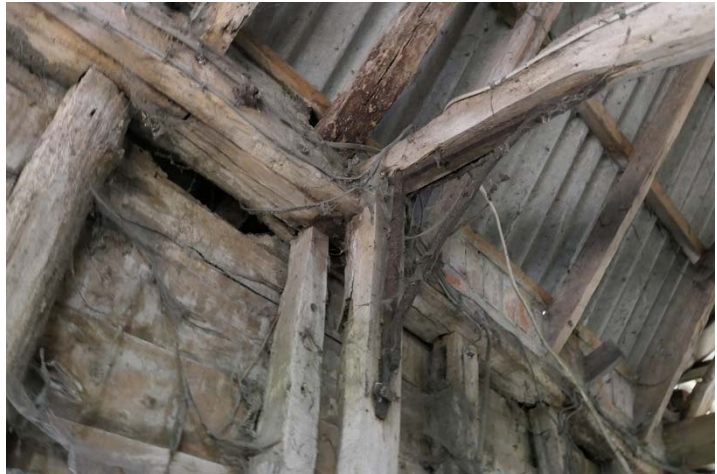
Figure 47 (left). Former Stable within late C19 lean-to. This is in fair condition and the best of the surviving former stables.

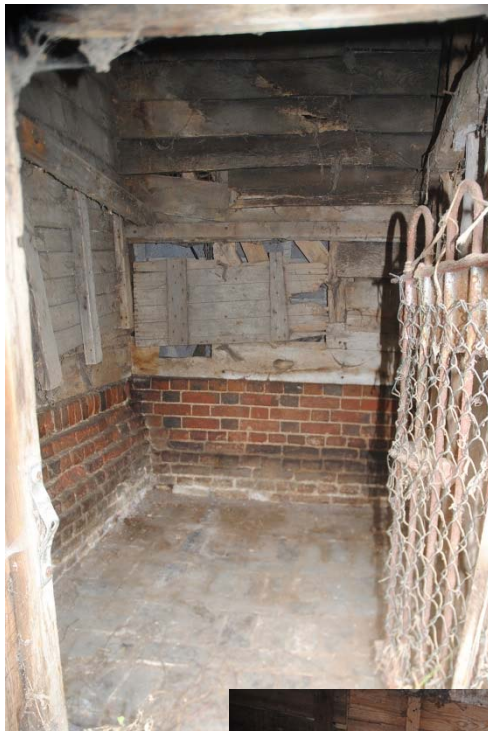
Figure 48 (below). The long C19 stable range, converted for use as calf pens by 1898. The structure where not covered by concrete block and boarding, appears lightweight. (see left).

- Carry out investigation once safe access is possible, to establish the condition of the late C19 range. Subject to advice from the Structural Engineer and agreement with the Conservation Officer, assume this is to be reconstructed unless found to be sound.
- Carefully demolish the unsympathetic poor quality C20 rear range and construct a single storey rear extension.

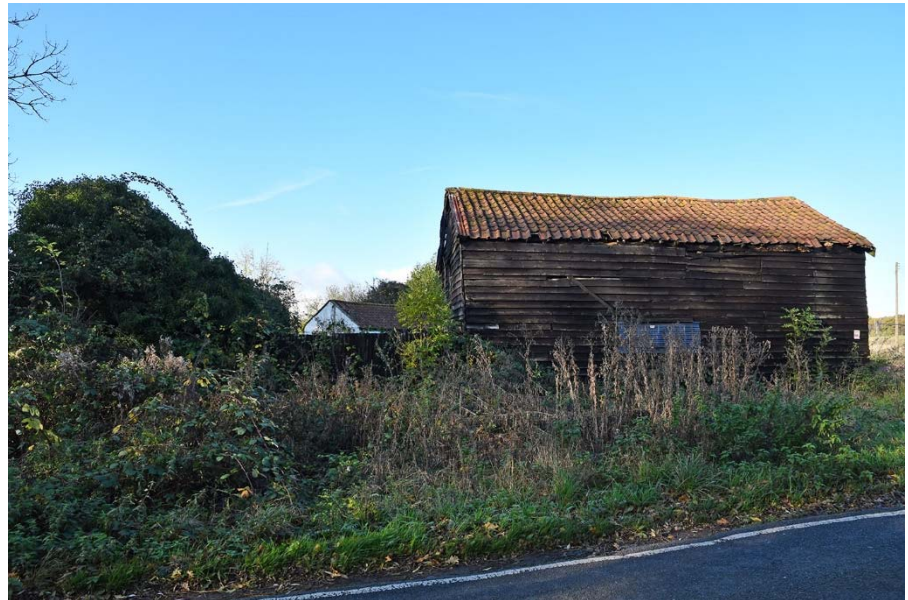
Figure 49 (above). Front (roadside) Elevation. Now blank boarding, the framing above the concrete indicates possibly a blocked midstre opening.

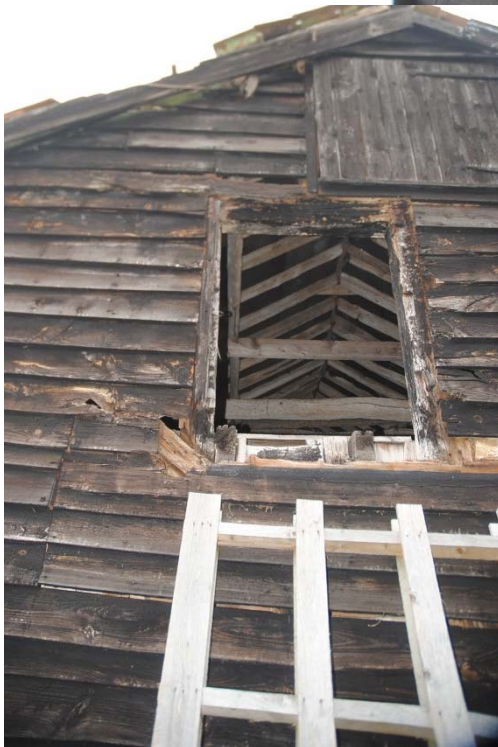
*Figure 54 (left).
First Floor hatch in West Gable, showing roof
structure.*

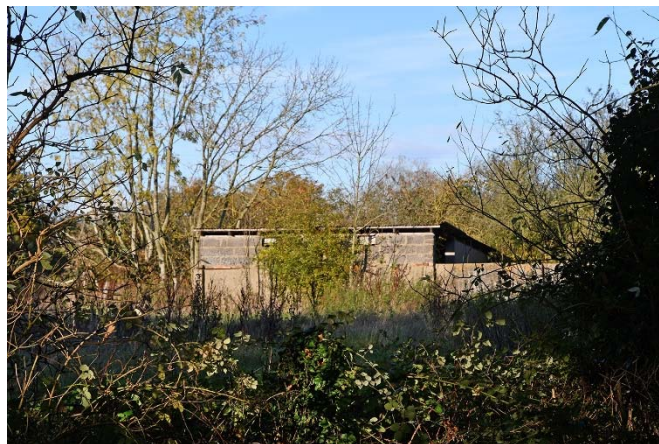
Figure 62. View across the Western field from Chelmsford Road, showing these mid-C20 blockwork units.
