WYNDING HOUSE, BAMBURGH

DESIGN AND ACCESS STATEMENT

21100-HL-00-XX-RP-A-0003-S4-P02

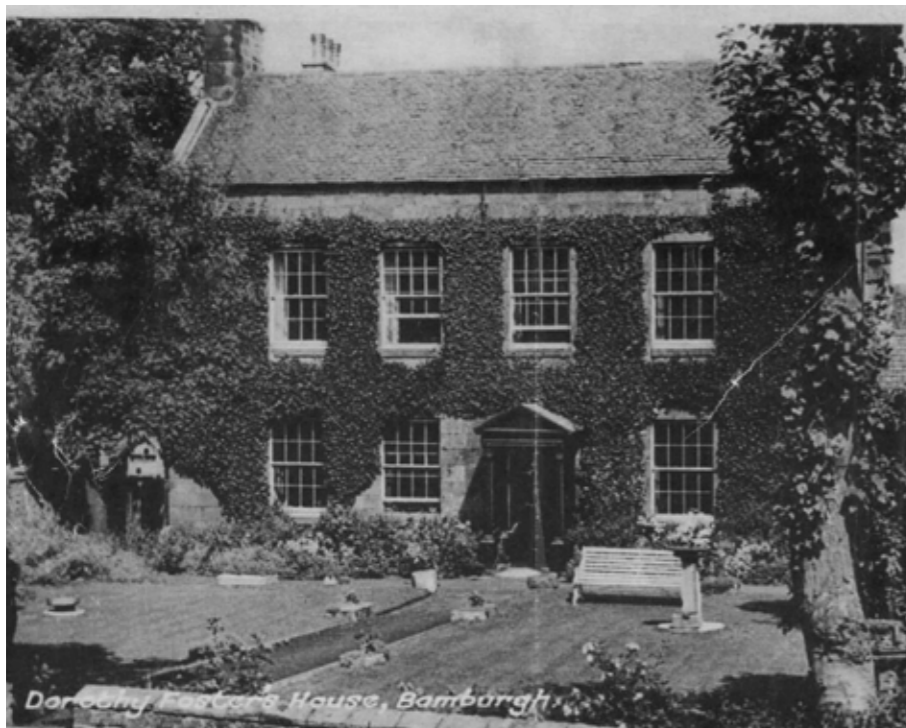
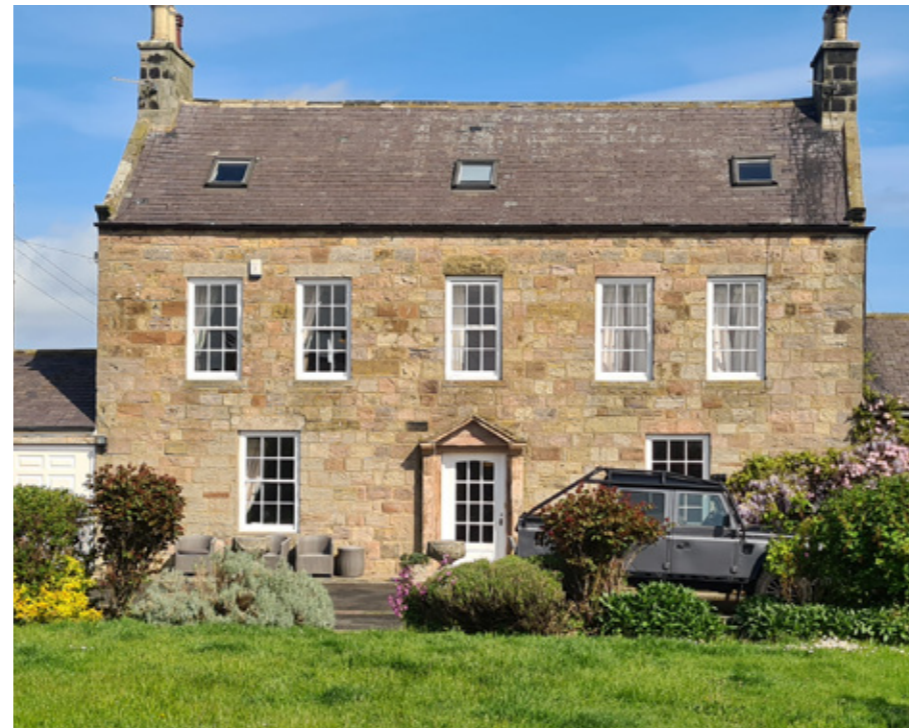
Figure 8. A historic postcard showing the historic windows arrangement and central pathway leading to the front door of the Wynding House. Precise date unknown, 1900s. Elevations compared side by side.

- The front façade has been completely replaced, most likely in the early 20th century, as evidenced by a photograph from 1900 which shows the original Georgian façade (Figure 8).

- The front façade has been completely replaced, most likely in the early 20th century, as evidenced by a photograph in Figure 8 from the 1900s which shows the original Georgian façade.
- Three uPVC roof lights were introduced to provide daylight to the rooms within the roof space.
- The adjacent single-storey to the East is separate and has been extended further east onto the Castle green with a stone Gabled Dormer.

While the stone portico is not original (as evidenced in the photograph from the 1900s - Figure 8), its classical pediment on square rustic piers is of quality. It is likely that the portico has been painted and will require careful restoration.

The internal partitions on the ground floor are not original, as evidenced by the historic photograph in Figure 8 showing the positions of the original windows. The exact period where the changes occurred is unknown, however, it can be assumed that the interiors are either late Victorian or Edwardian.

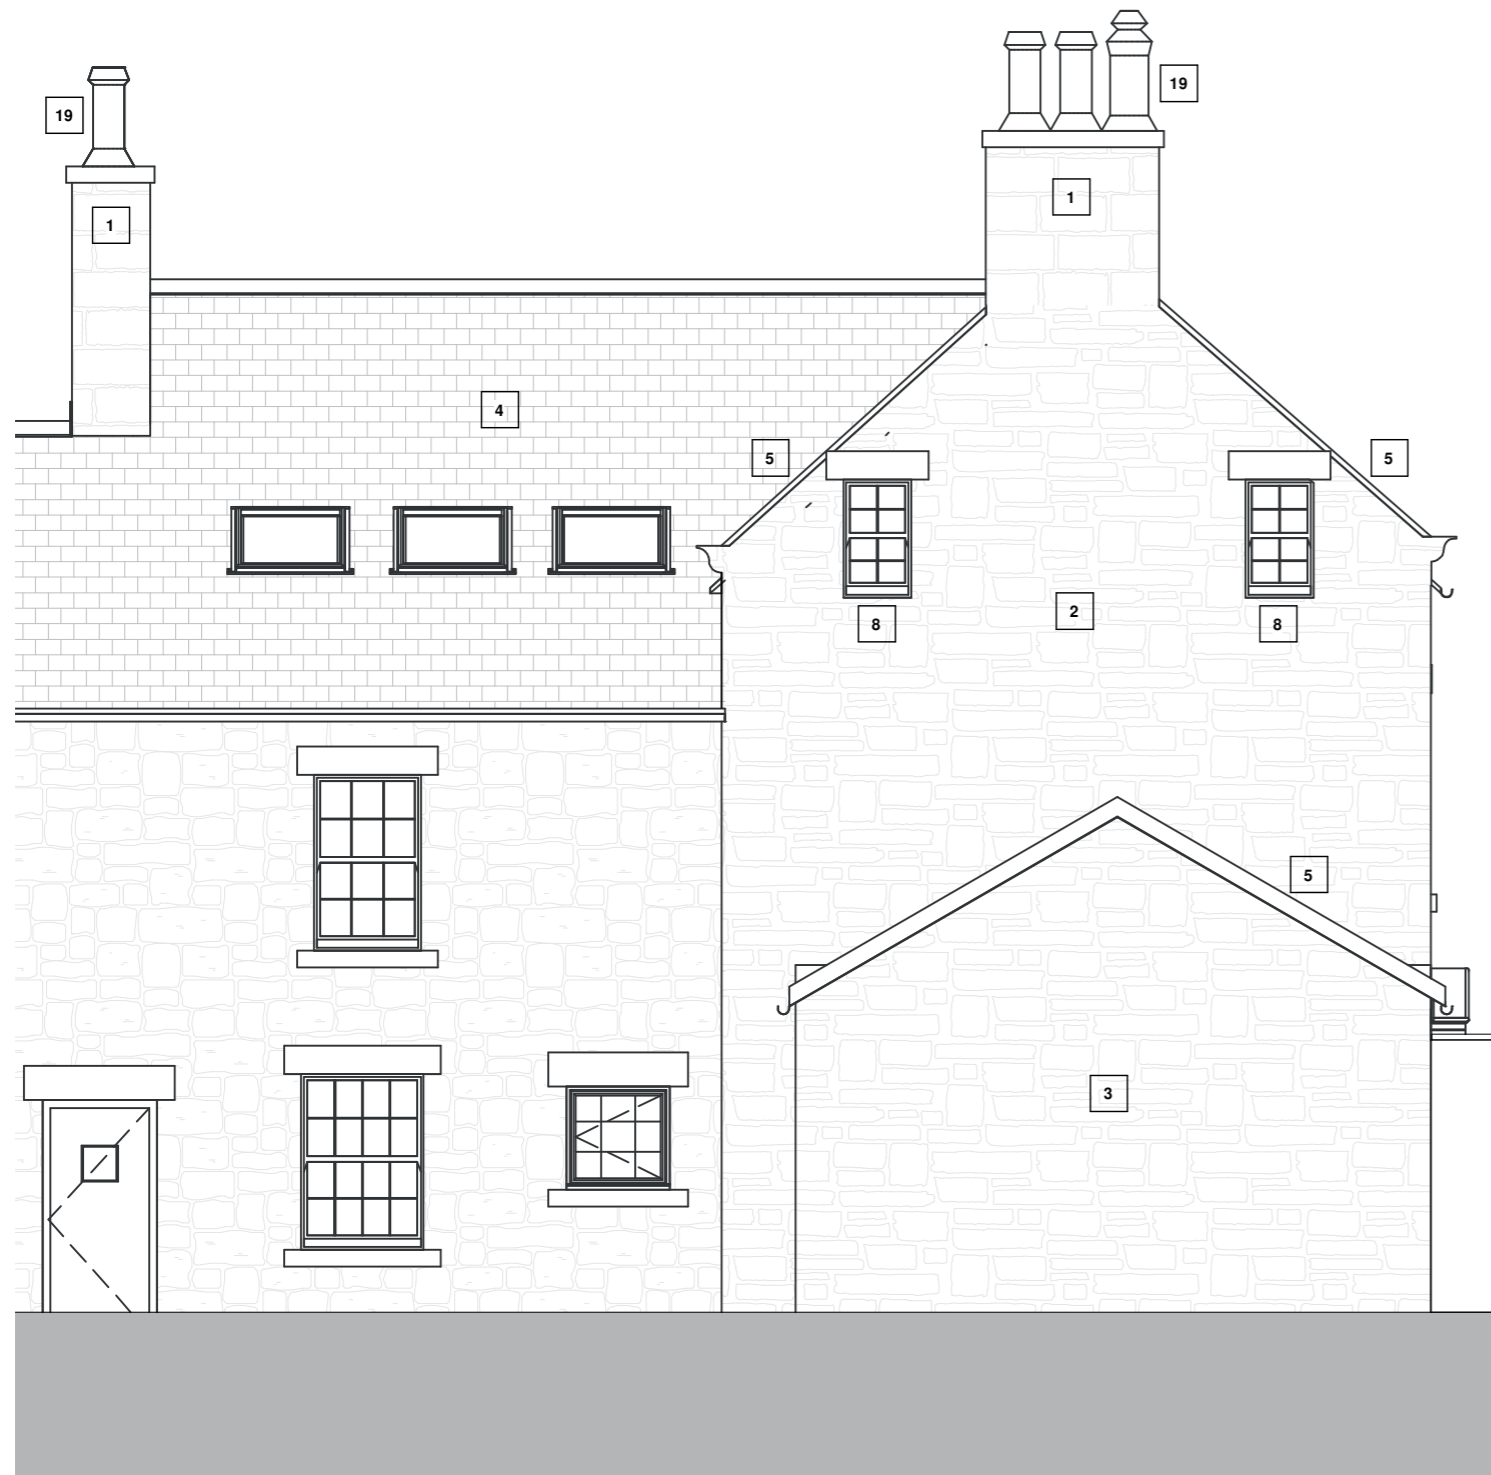
Figure 10. Existing West Elevation

- The single-storey to the west, originally a farm building is now a garage, in poor condition with deteriorating stonework and evidence of arrow list windows for ventilation.

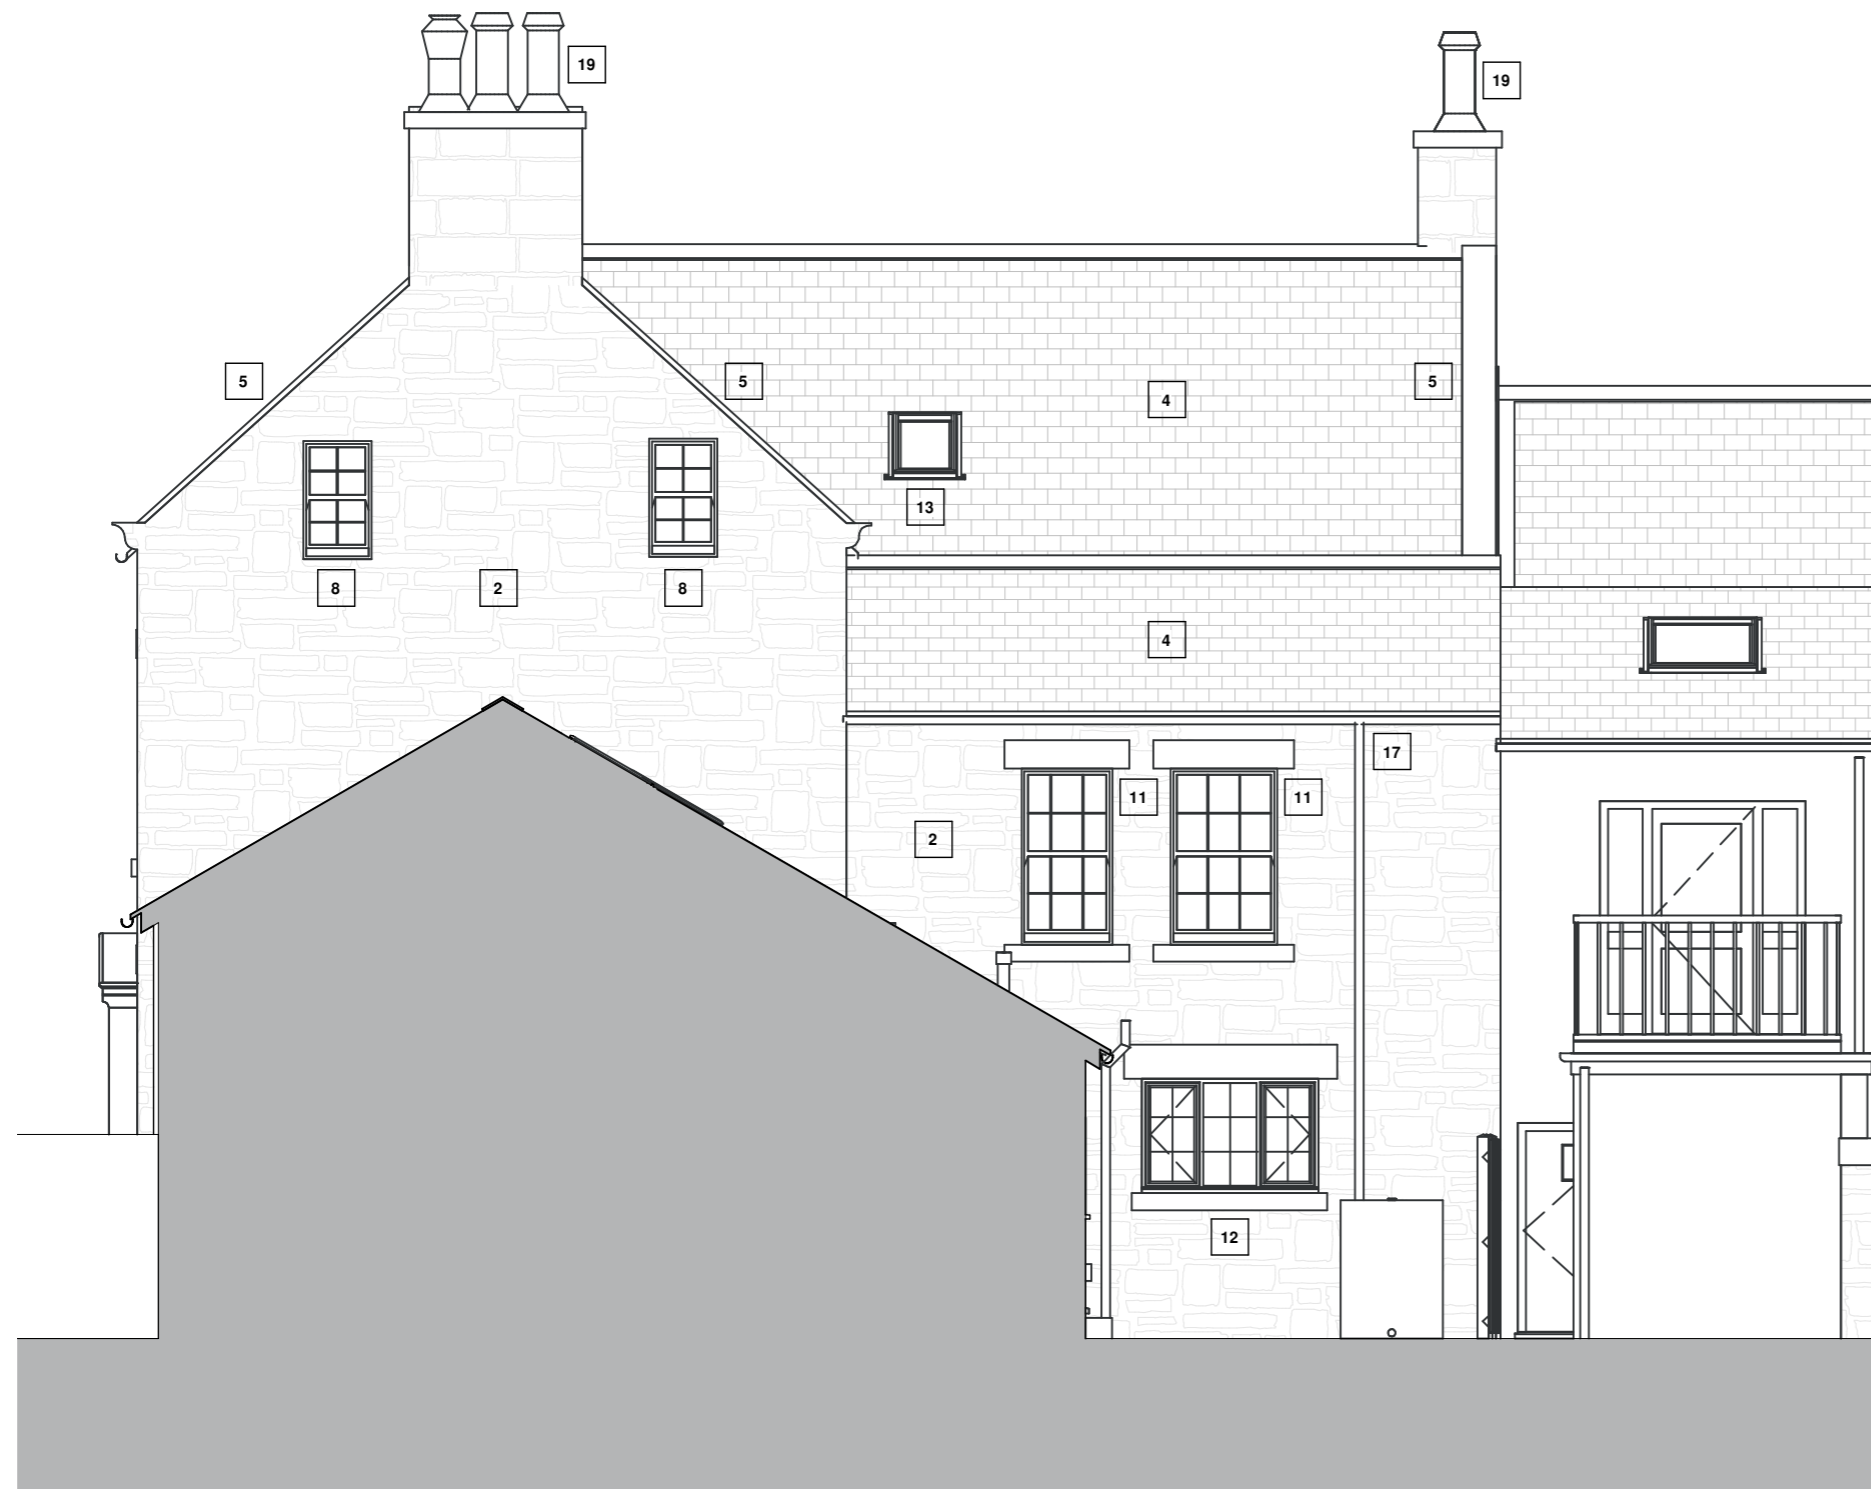
- Windows and rainwater goods to the rear and gable elevations have been replaced with uPVC substitutes.
- While the rear elevations of the property are stone, the adjacent buildings have been rendered, reducing the historical significance of the setting.
- The house has been subdivided over the years so that properties to the North are separated and part of the original house is now no 8.

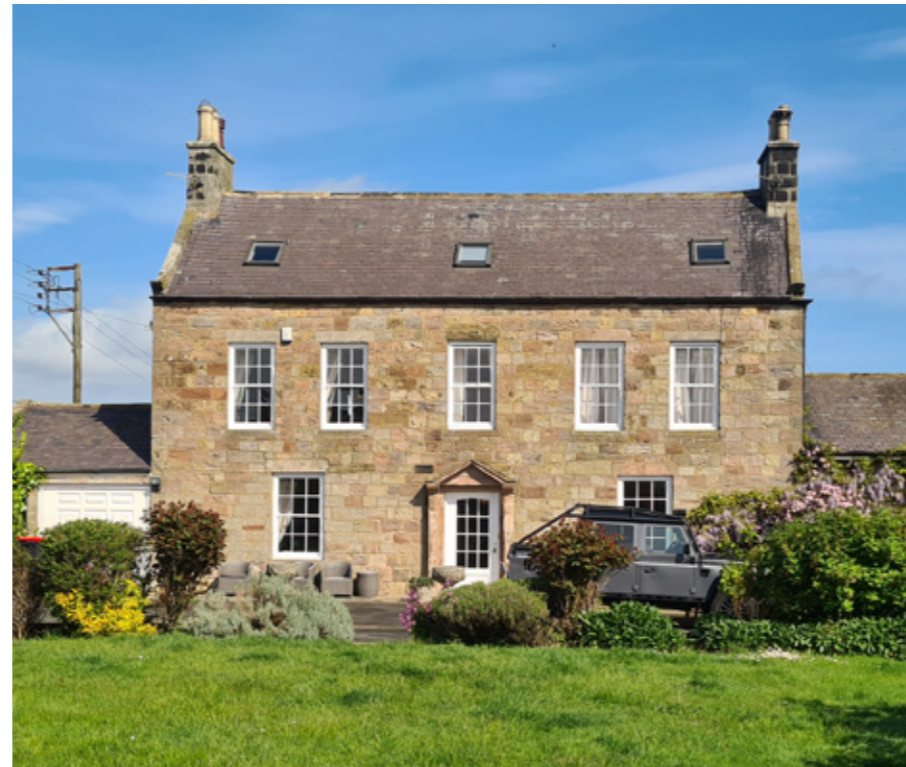
Fig 22. Proposed lime mortar repairs and removal of cement mortar.

Following a specialist survey, the stonework on the elevations will undergo lime mortar repairs and removal of any cement mortar.

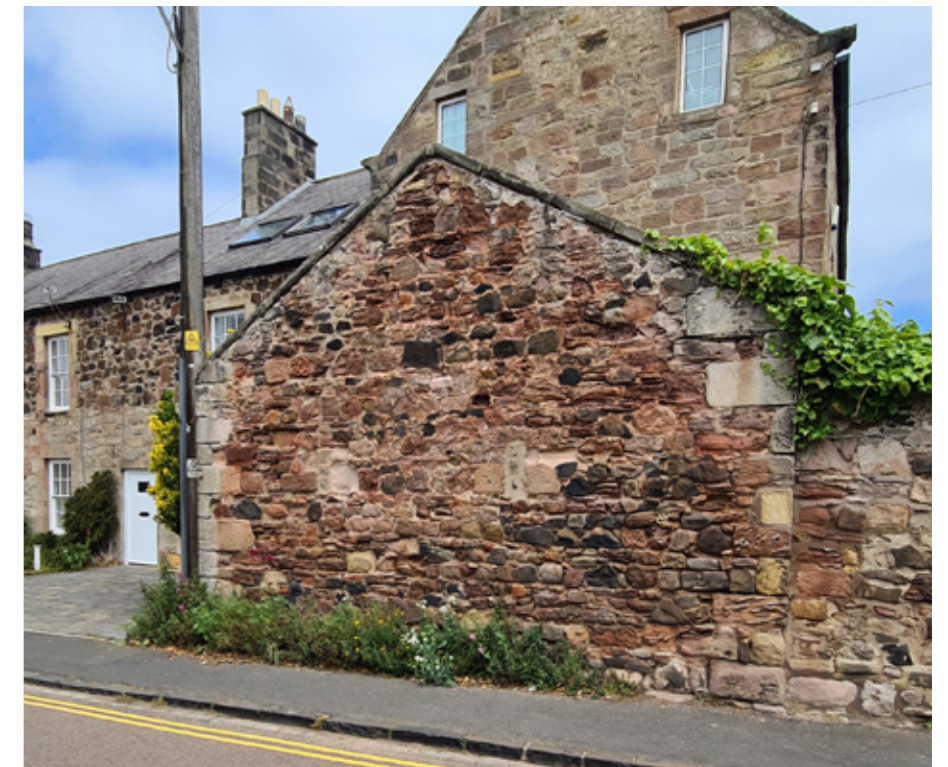
Fig 23. Significant deterioration to the rubble wall of the garage.

The random rubble stone external walls of the garage, especially the western gable, have significantly deteriorated. Stone decay was most likely accelerated by the building's proximity to the coastline. The stone walls will need to be rebuilt with replacement stone and lime mortar.

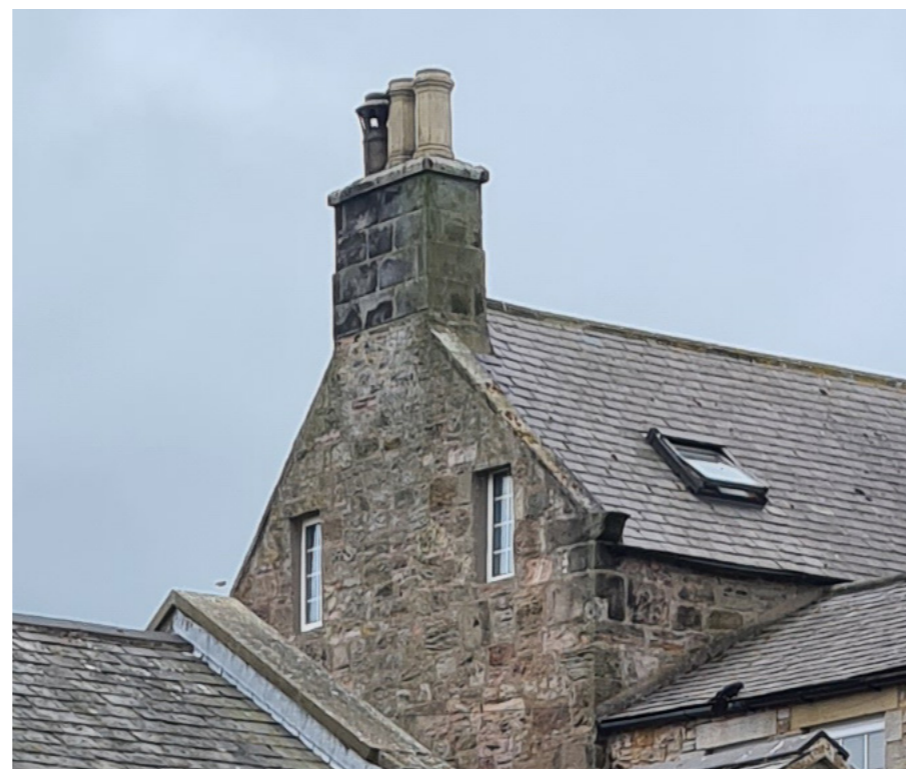
Fig 24. Proposed repairs to the stone water tables and kneelers.

Following a specialist survey, stone water tables and stone kneelers are proposed to be repaired where required.

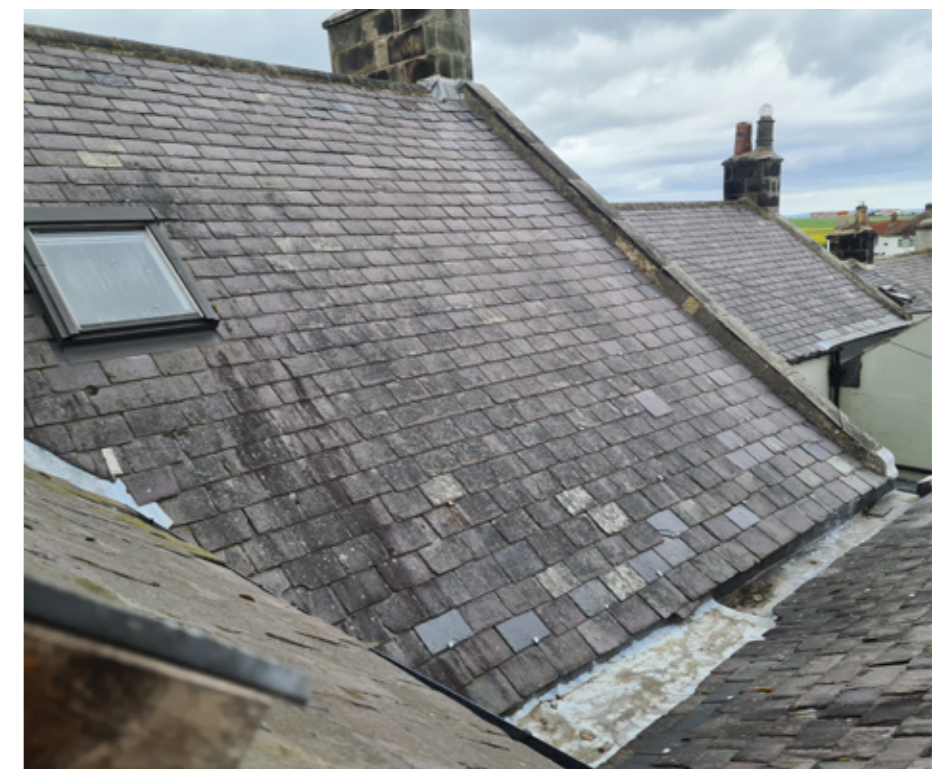
Fig 25. Proposed Welsh slate roof to be removed and replaced to match existing with aim to re-use the original slate.

It is proposed for the Welsh slate roof to be removed and replaced with an aim to re-use 50% of the original slate and the remainder replaced with a second-hand slate. The replacement of the slate with the original slate is proposed to be prioritised on the southern

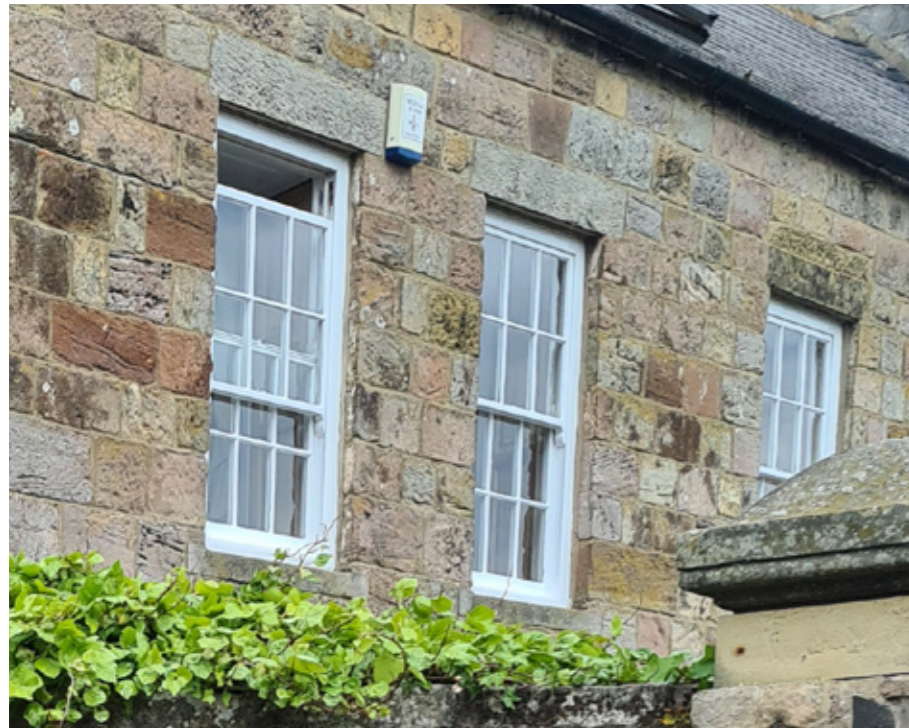
Fig 26. Unoriginal timber windows to be replaced with operational timber sash windows with double glazed conservation type units.

The current sash windows to the front elevation are not original and were replaced in the 20th century. Similarly, the late 20th century uPVC windows are replacement ones, therefore a consistent approach across all facades is proposed to replace the windows with operational timber sash windows with double glazed conservation type units to improve the overall environmental properties of the building.

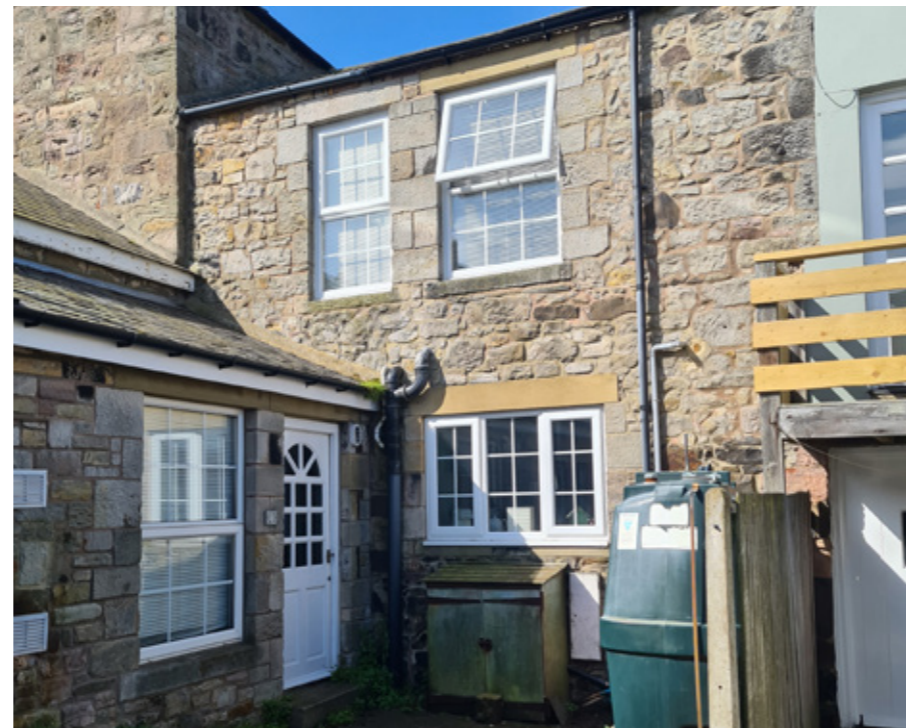
Fig 27. Unoriginal uPVC windows to be replaced with operational timber sash windows with double glazed conservation type units.

The project seeks to remove all the uPVC windows to the rear of the building and end gables, in order to replace them with operational timber sash windows appropriate to the Georgian period.

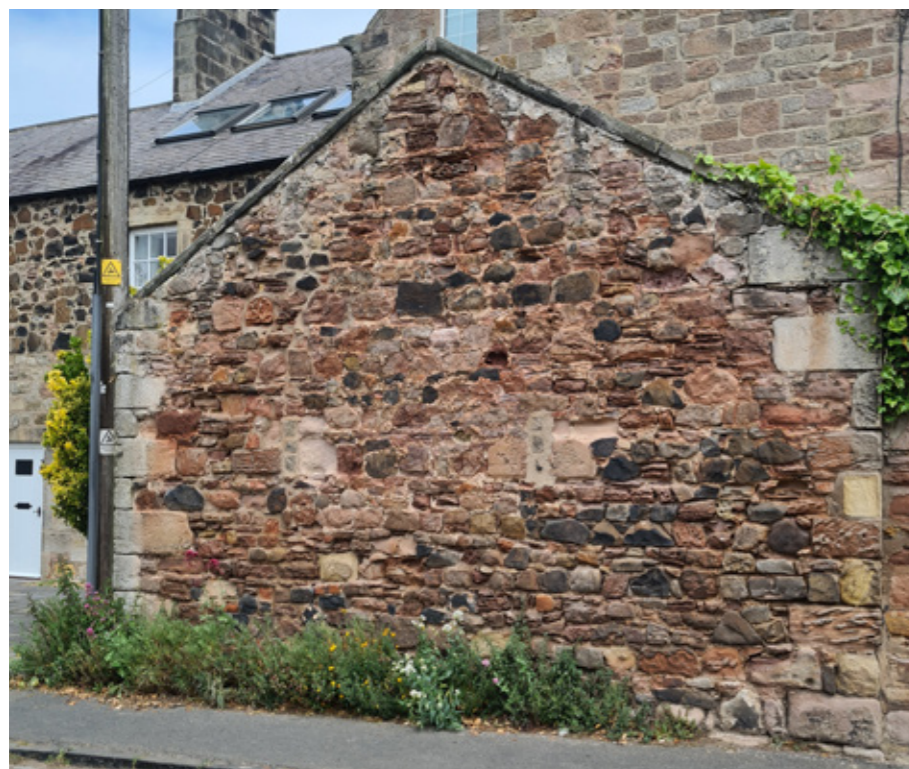
Fig 28. Infilled arrow slit windows to be reinstated - External view.

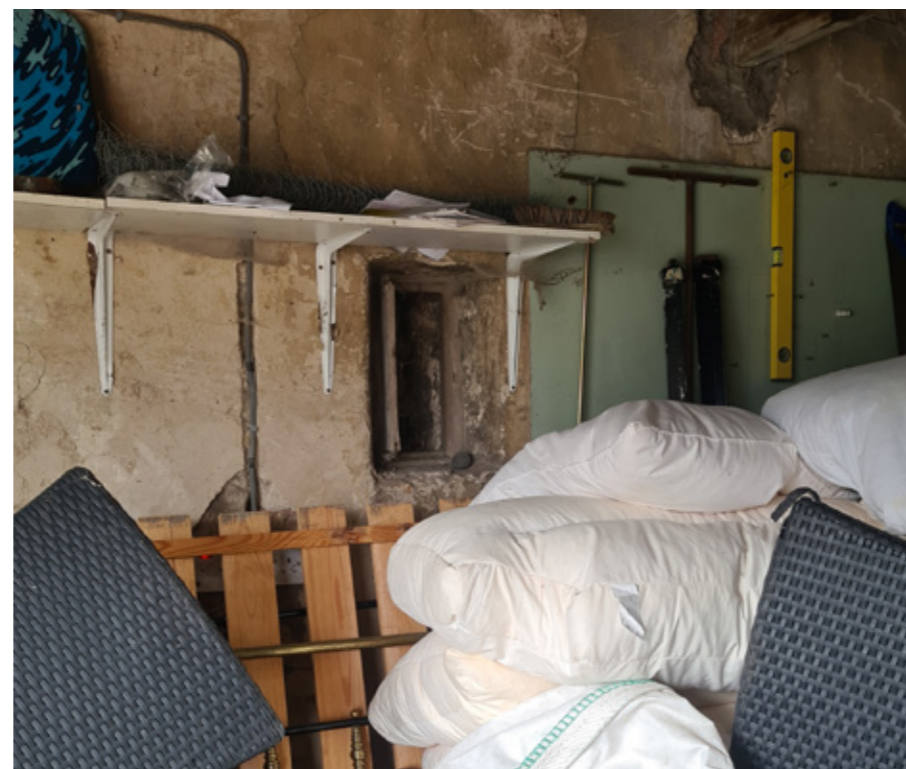
Fig 29. Infilled arrow slit windows to be reinstated - Internal view.

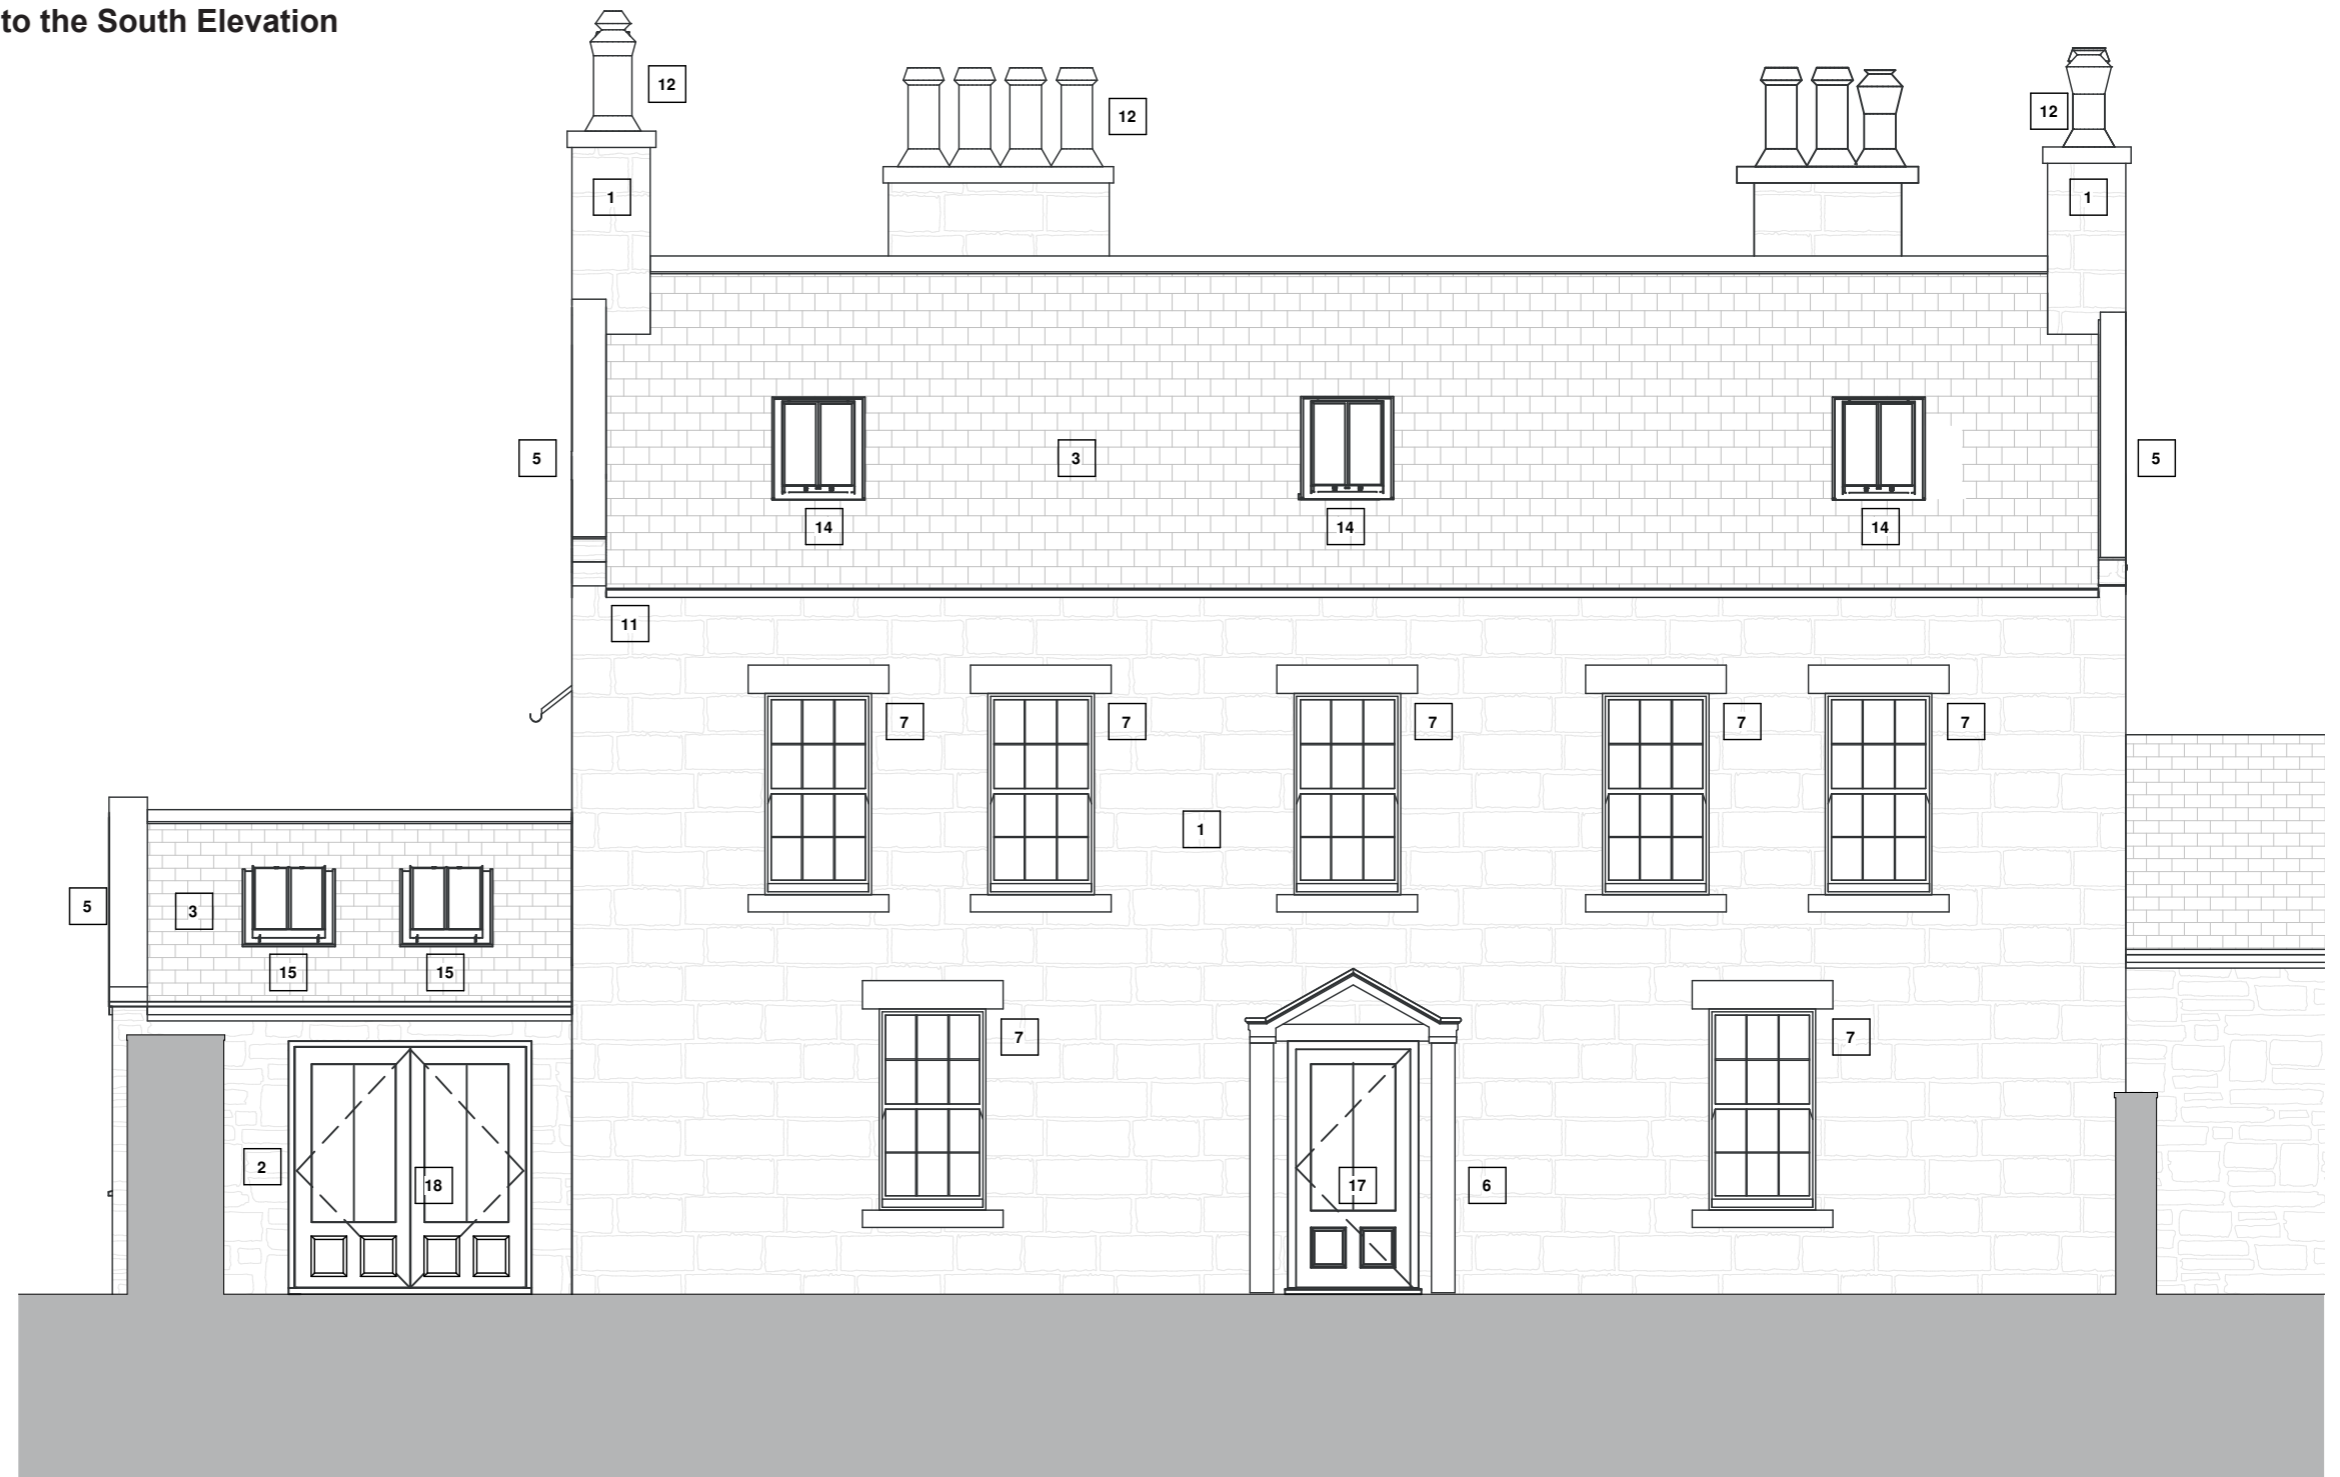
Figure 30. Proposed South Elevation

- 1 REPAIRS AND MAKING GOOD TO THE EXISTING MASONRY INCLUDING LIME MORTAR REPAIRS AND REMOVAL OF ANY CEMENT MORTAR. SUBJECT TO SPECIALIST SURVEY.
- 2 RECONSTRUCTION OF THE MASONRY WALLS WITH REPLACEMENT STONE AND LIME MORTAR. SUBJECT TO SPECIALIST SURVEY.

- 3 REMOVAL AND REPLACEMENT OF THE EXISTING WELSH SLATE ROOF WITH AIM TO RE-USE 50% OF THE ORIGINAL SLATE AND THE REMAINDER BEING REPLACED WITH SECOND-HAND SLATE TO MATCH EXISTING. SUBJECT TO SPECIALIST SURVEY.

- 4 NEW WELSH SLATE ROOF TO MATCH EXISTING.
- 5 EXISTING STONE WATER TABLE AND STONE KNEELERS TO BE REPAIRED WHERE REQUIRED. SUBJECT TO SPECIALIST SURVEY.

- 6 STONE REPAIRS TO THE PORTICO. SUBJECT TO SPECIALIST SURVEY.
- 7 EXISTING TIMBER WINDOWS REPAIR OR REPLACEMENT WITH OPERATIONAL TIMBER SASH WINDOWS WITH DOUBLE GLAZED CONSERVATION TYPE UNITS. SUBJECT TO SPECIALIST SURVEY.

- 8 EXISTING uPVC WINDOWS TO BE REPLACED WITH OPERATIONAL TIMBER SASH WINDOWS WITH DOUBLE GLAZED CONSERVATION TYPE UNITS.
- 9 BLOCKED UP ARROW SLIT WINDOWS TO THE GARAGE GABLE END TO BE REINSTATED, WITH NEW WINDOWS SET BACK WITH INTERNAL SHUTTERS. EXACT WINDOW POSITION TO MATCH INFILLED OPENINGS, SUBJECT TO SITE SURVEY.

- 10 EXISTING LOUVRE VENTS TO BE FILLED IN WITH STONE MATCHING THE EXISTING.
- 11 uPVC RAINWATER GOODS TO BE REPLACED WITH BLACK PAINTED CAST IRON GOODS.

- 12 CHIMNEY POTS TO BE REPAIRED IF REQUIRED. SUBJECT TO SURVEY.
- 13 NEW CHIMNEY POTS TO MATCH EXISTING.
- 14 EXISTING uPVC ROOF LIGHTS TO THE FRONT ELEVATION TO BE REPLACED WITH CONSERVATION ROOF LIGHTS.

- 18 NEW TRADITIONAL DOUBLE DOOR TO MATCH THE PROPOSED FRONT DOOR IN PLACE OF THE EXISTING GARAGE DOOR.
- 19 NEW TRADITIONAL DOOR IN PLACE OF THE EXISTING uPVC REAR DOOR.

- 20 NEW DRESSED STONE DETAIL BAND
- 21 NEW SASH DORMER WINDOW TO PROVIDE LIGHT, VIEWS AND HEIGHT TO THE PROPOSED EXTENSION. DRESSED STONE WITH LEAD CHEEK WALLS.

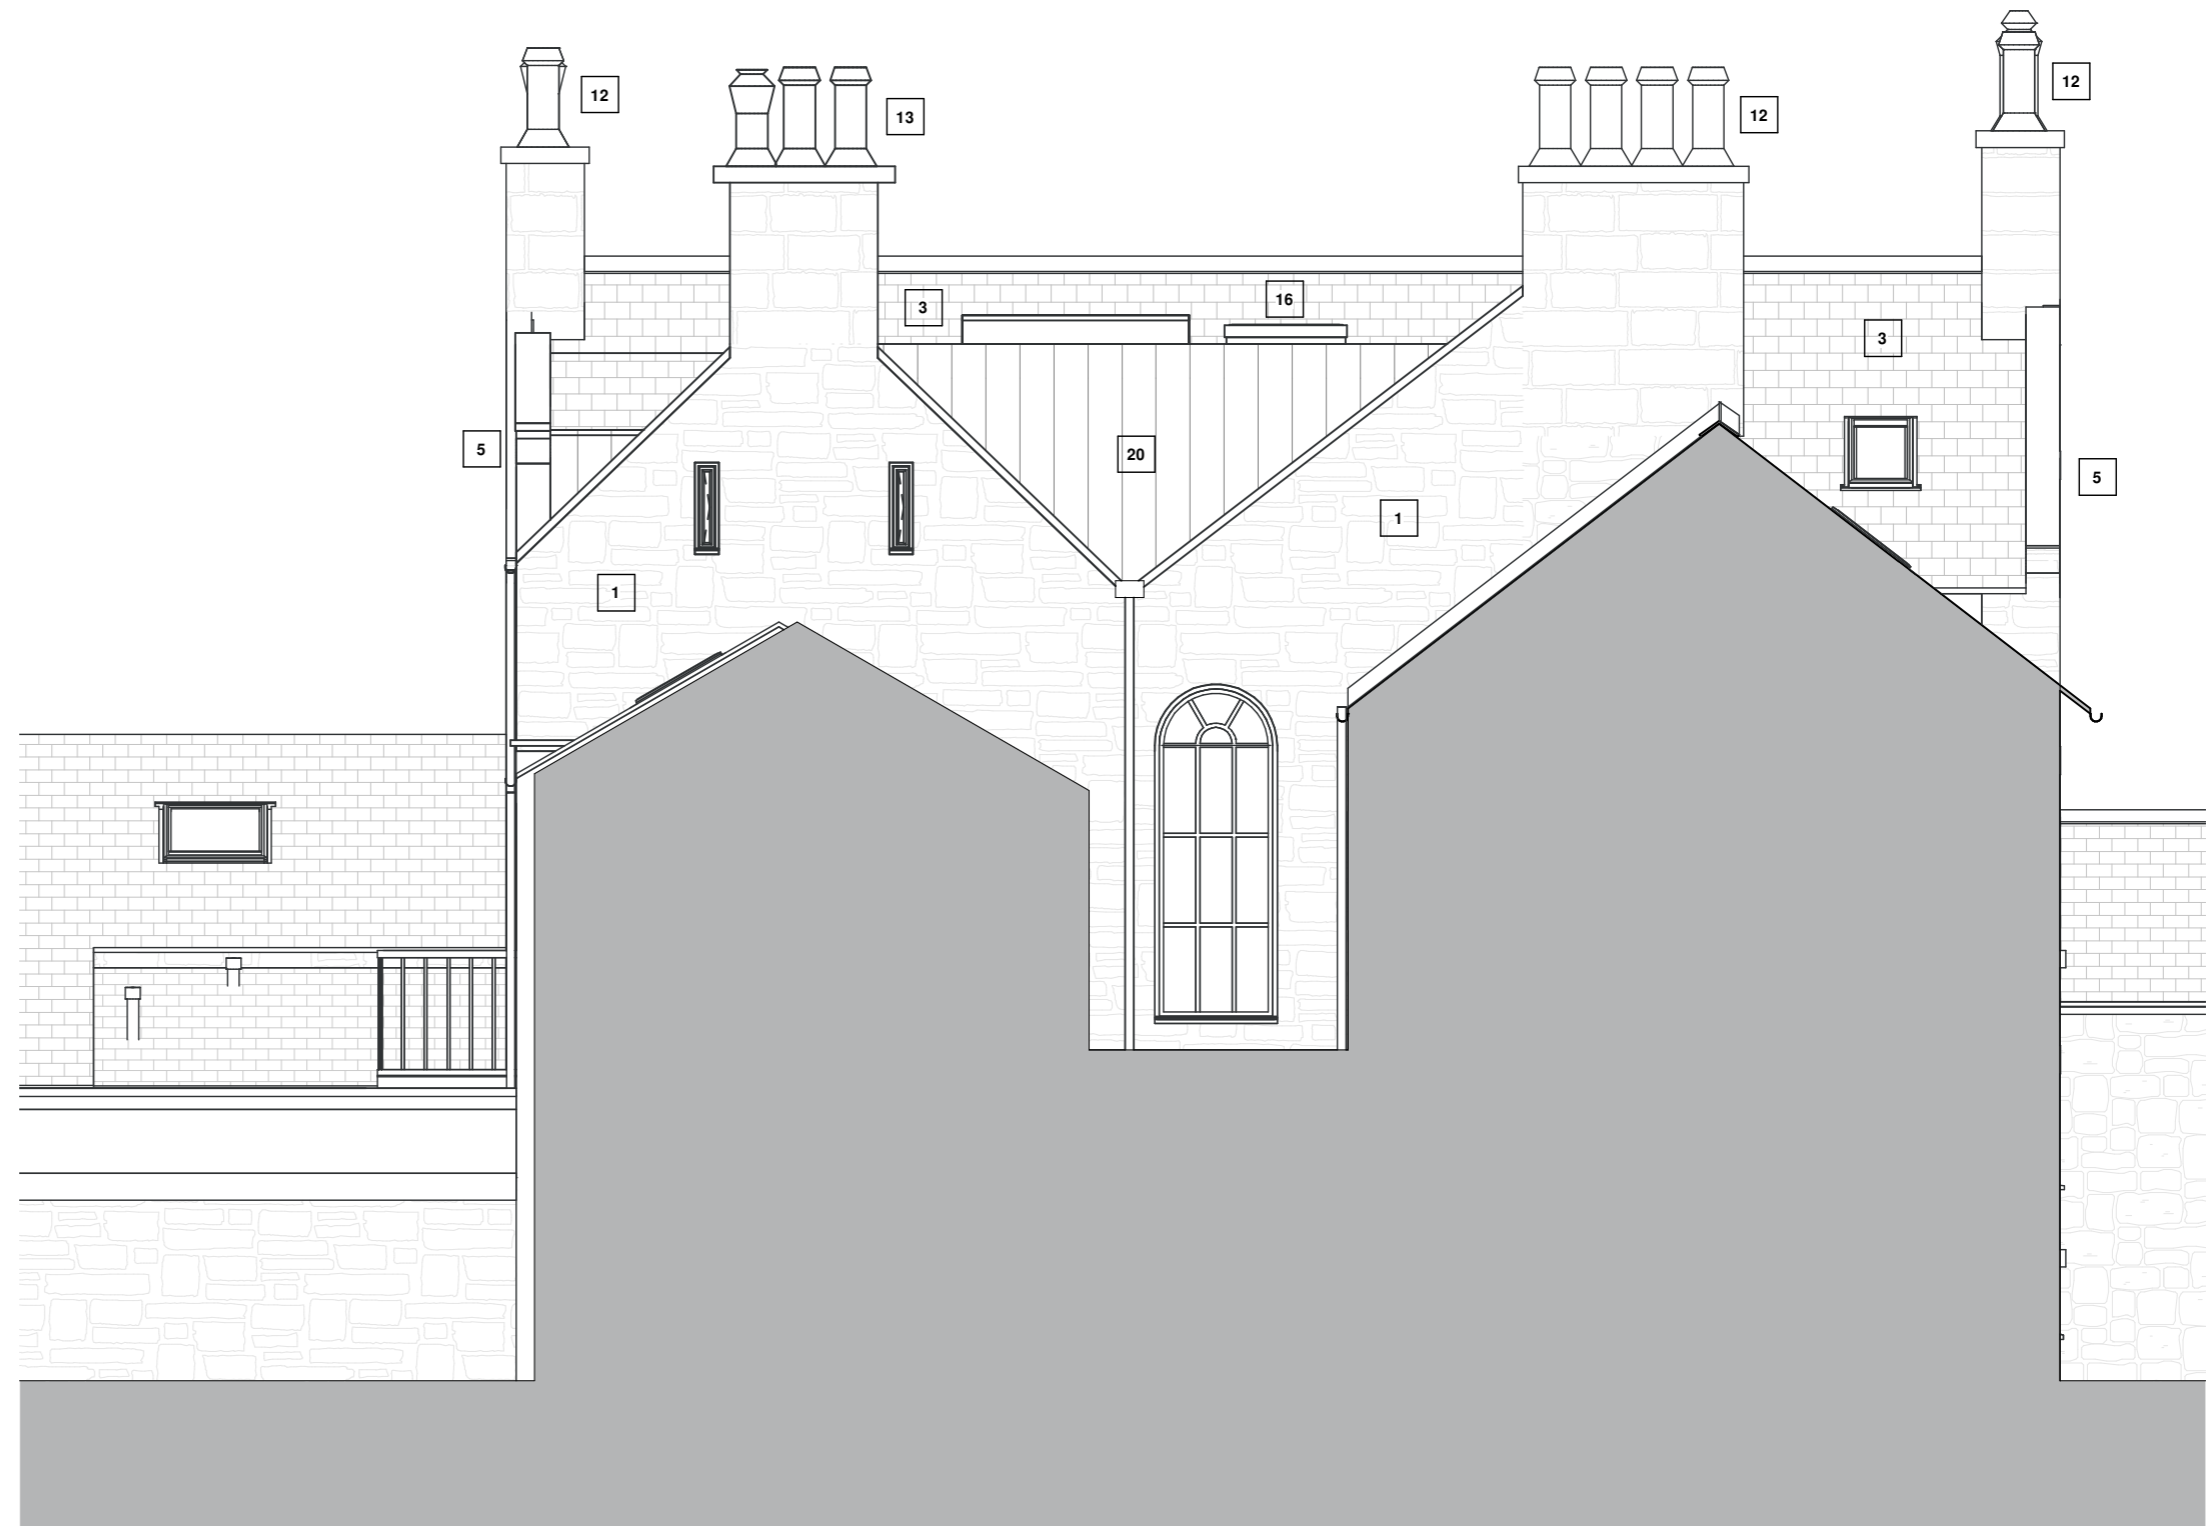
Figure 33. Proposed North Elevation 2

- 1 REPAIRS AND MAKING GOOD TO THE EXISTING MASONRY INCLUDING LIME MORTAR REPAIRS AND REMOVAL OF ANY CEMENT MORTAR. SUBJECT TO SPECIALIST SURVEY.
- 2 RECONSTRUCTION OF THE MASONRY WALLS WITH REPLACEMENT STONE AND LIME MORTAR. SUBJECT TO SPECIALIST SURVEY.

- 3 REMOVAL AND REPLACEMENT OF THE EXISTING WELSH SLATE ROOF WITH AIM TO RE-USE 50% OF THE ORIGINAL SLATE AND THE REMAINDER BEING REPLACED WITH SECOND-HAND SLATE TO MATCH EXISTING. SUBJECT TO SPECIALIST SURVEY.

- 4 NEW WELSH SLATE ROOF TO MATCH EXISTING.
- 5 EXISTING STONE WATER TABLE AND STONE KNEELERS TO BE REPAIRED WHERE REQUIRED. SUBJECT TO SPECIALIST SURVEY.

- 6 STONE REPAIRS TO THE PORTICO. SUBJECT TO SPECIALIST SURVEY.
- 7 EXISTING TIMBER WINDOWS REPAIR OR REPLACEMENT WITH OPERATIONAL TIMBER SASH WINDOWS WITH DOUBLE GLAZED CONSERVATION TYPE UNITS. SUBJECT TO SPECIALIST SURVEY.

- 18 NEW TRADITIONAL DOUBLE DOOR TO MATCH THE PROPOSED FRONT DOOR IN PLACE OF THE EXISTING GARAGE DOOR.
- 19 NEW TRADITIONAL DOOR IN PLACE OF THE EXISTING uPVC REAR DOOR.

- 20 NEW DRESSED STONE DETAIL BAND
- 21 NEW SASH DORMER WINDOW TO PROVIDE LIGHT, VIEWS AND HEIGHT TO THE PROPOSED EXTENSION. DRESSED STONE WITH LEAD CHEEK WALLS.
