WYNDING HOUSE, BAMBURGH

DESIGN AND ACCESS STATEMENT

21100-HL-00-XX-RP-A-0003-S4-P02

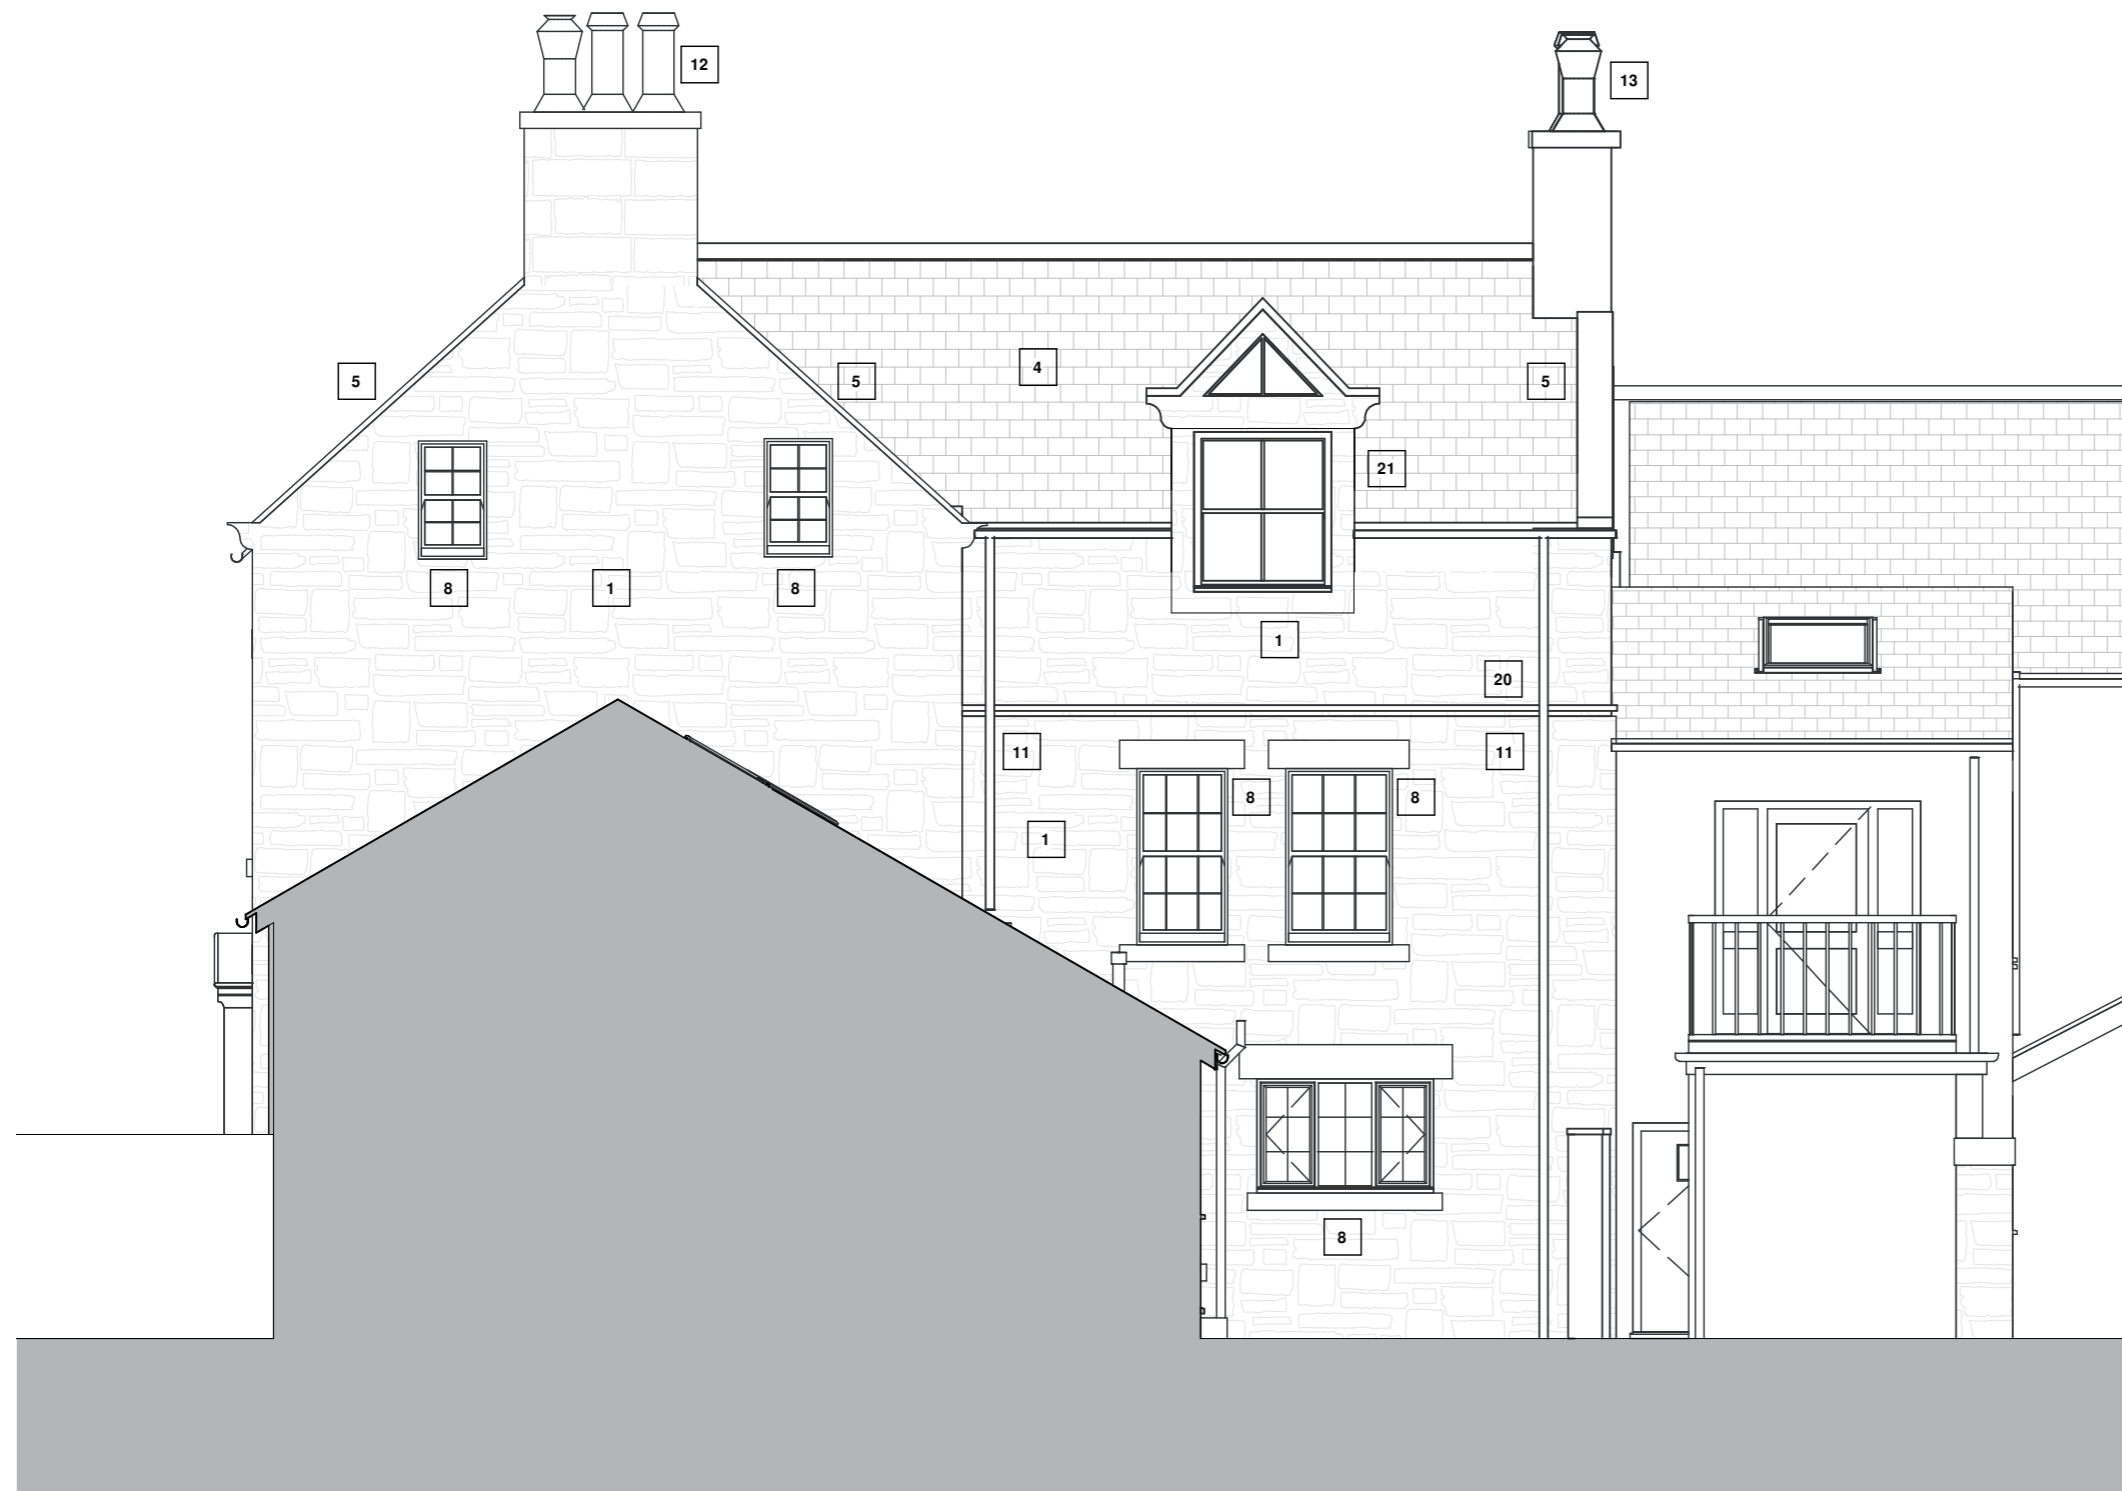
- 1 REPAIRS AND MAKING GOOD TO THE EXISTING MASONRY INCLUDING LIME MORTAR REPAIRS AND REMOVAL OF ANY CEMENT MORTAR. SUBJECT TO SPECIALIST SURVEY.
- 2 RECONSTRUCTION OF THE MASONRY WALLS WITH REPLACEMENT STONE AND LIME MORTAR. SUBJECT TO SPECIALIST SURVEY.

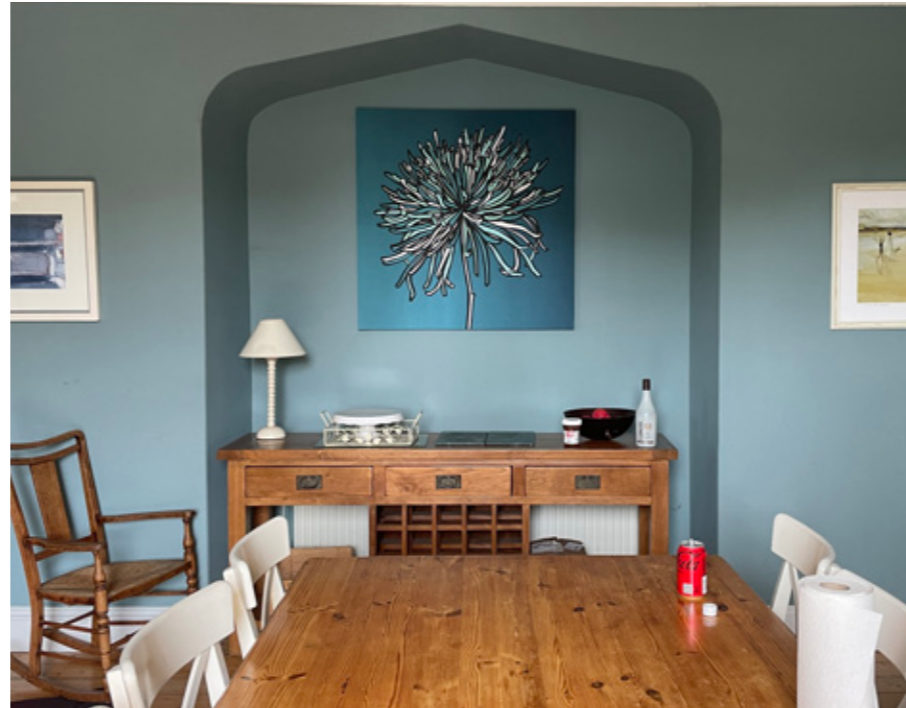
Fig 35. The blocked off opening between the dining room of the Wynding House and the living room of 4A The Wynding.

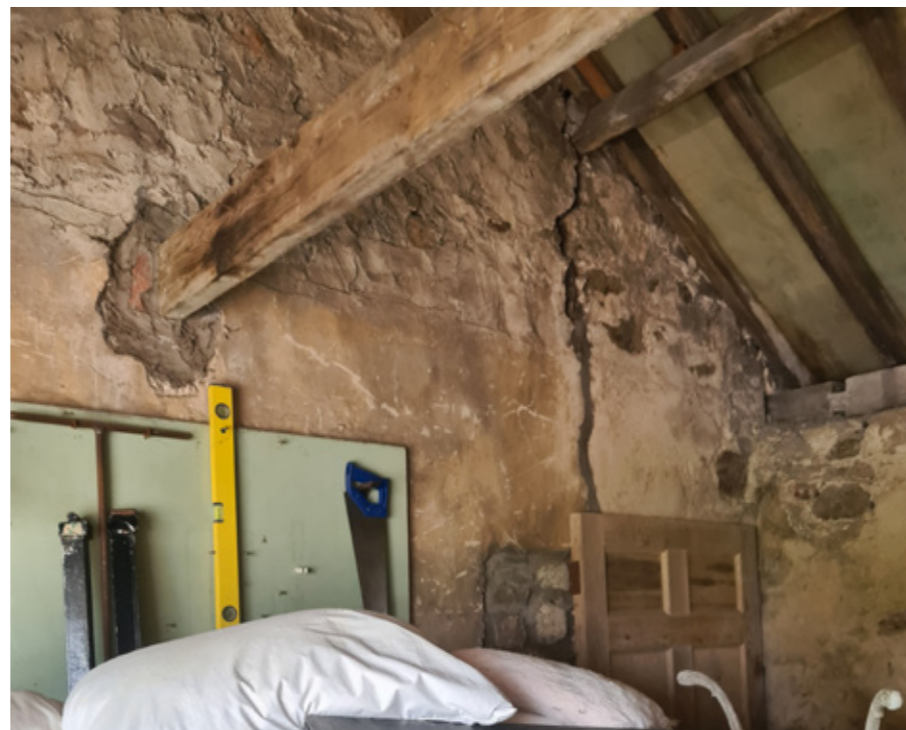
Fig 37. The existing exposed roof trusses in the garage

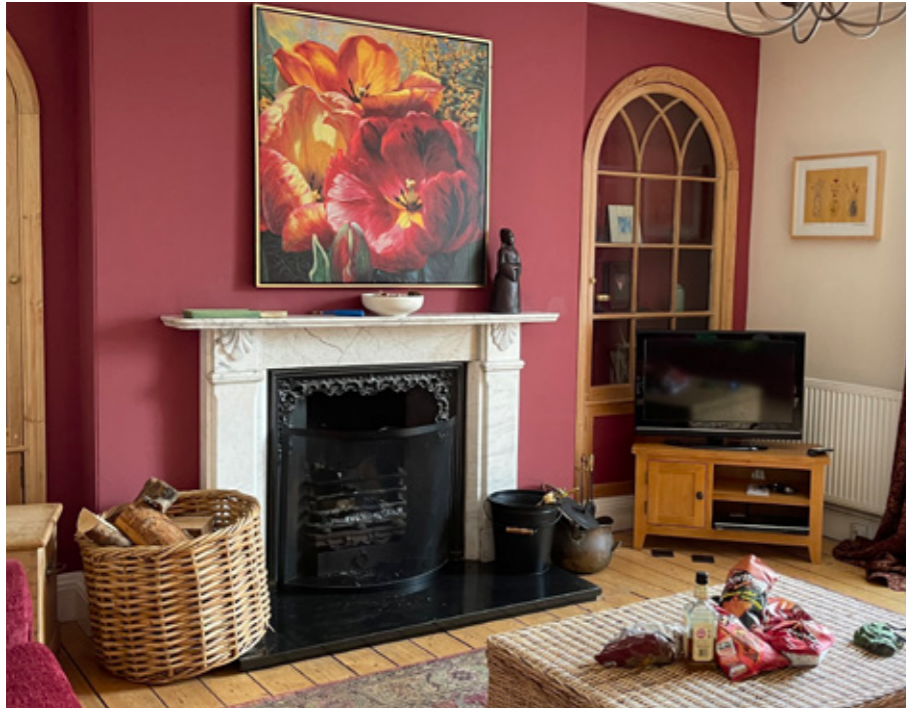
Fig 39. The chimney in the living room is unaltered with Victorian cabinets built-in to the sides.

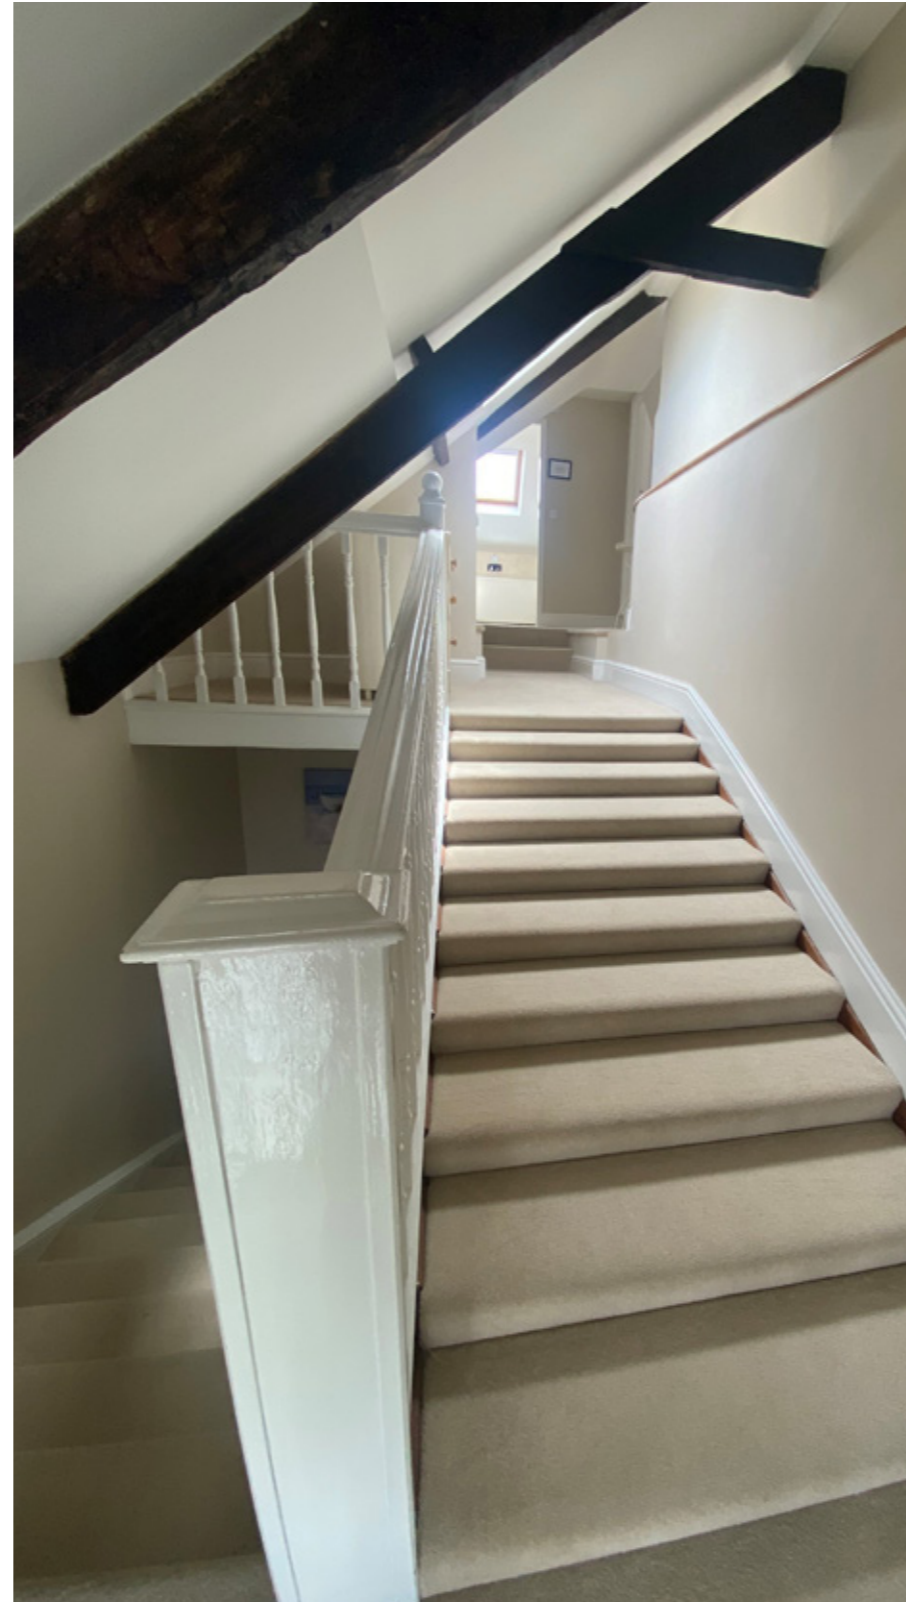
Fig 41. The staircase between the first floor and the roof space (now second floor) was introduced with uncomfortable low risers and long goings, likely due to the height constraints with heights of the beams being very low.

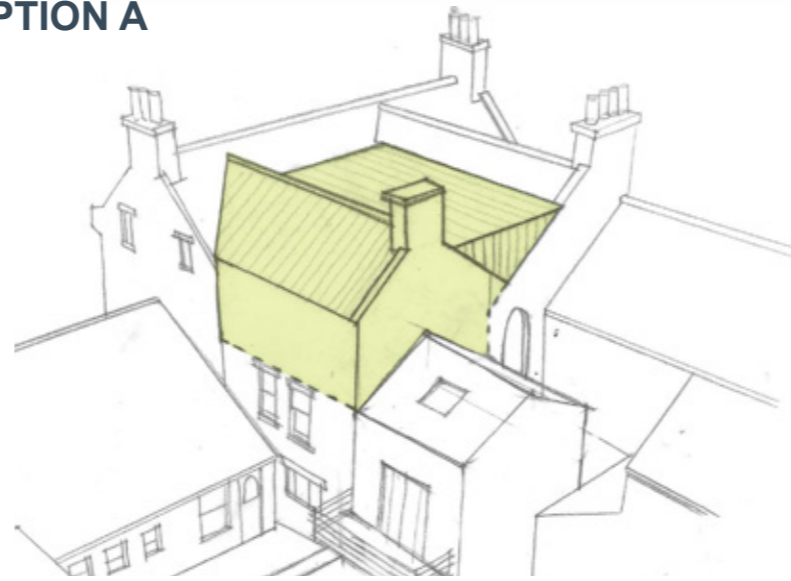
OPTION A

Option A proposes an extension with a gable facing north-west towards Bamburgh Beach and roof infill above the existing staircase that provides adequate height to access the existing loft.

In the early design stages, four options for the second-floor extension were explored (Figure 46):

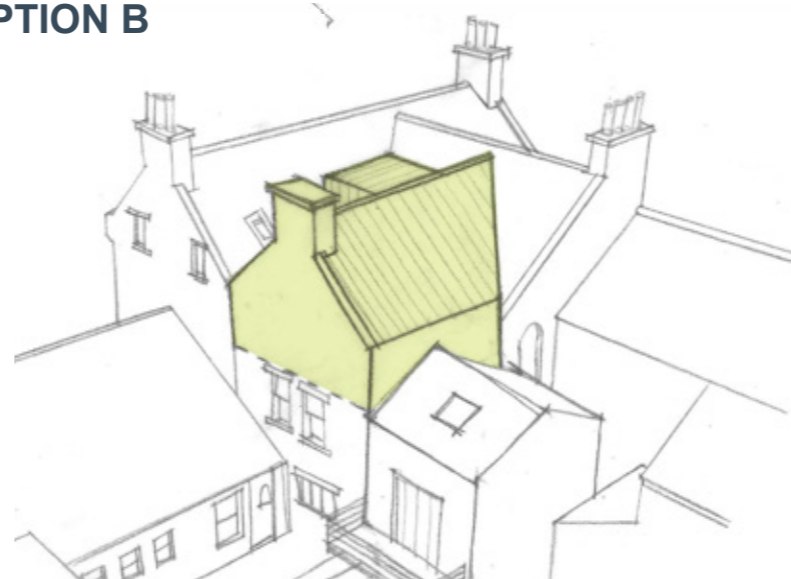
OPTION B

Option B proposes an extension with a gable facing north-east towards Bamburgh Castle and roof infill above the existing stairwell that provides adequate height to access the existing loft.

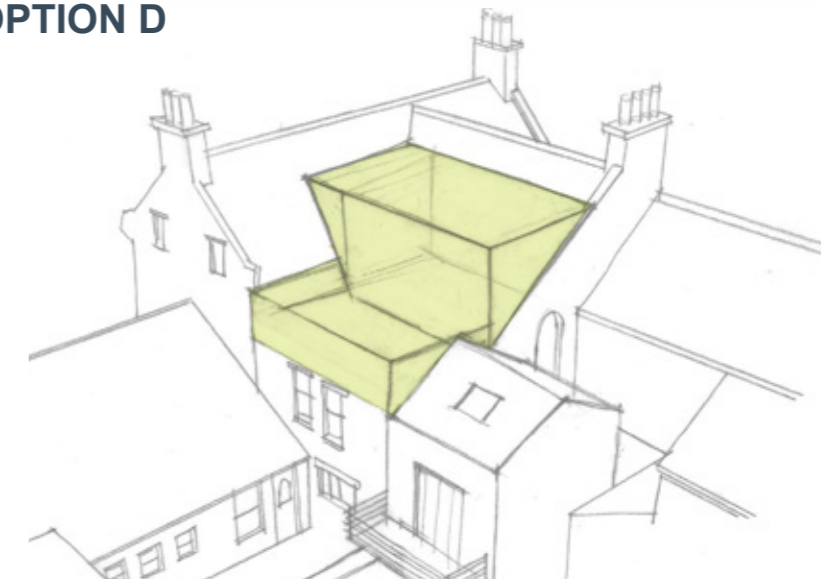
OPTION D

Option D proposes an extension over the existing staircase to provide adequate height to access the existing loft with an outdoor terrace facing north-west towards Bamburgh Castle. An outdoor space so close to the adjacent neighbouring properties will provide little privacy to the house and the neighbours.
