STATEMENT OF SIGNIFICANCE

**Flood Street Farm,
Breamore, Hampshire**

AHC REF: 9943

Date: April 2021

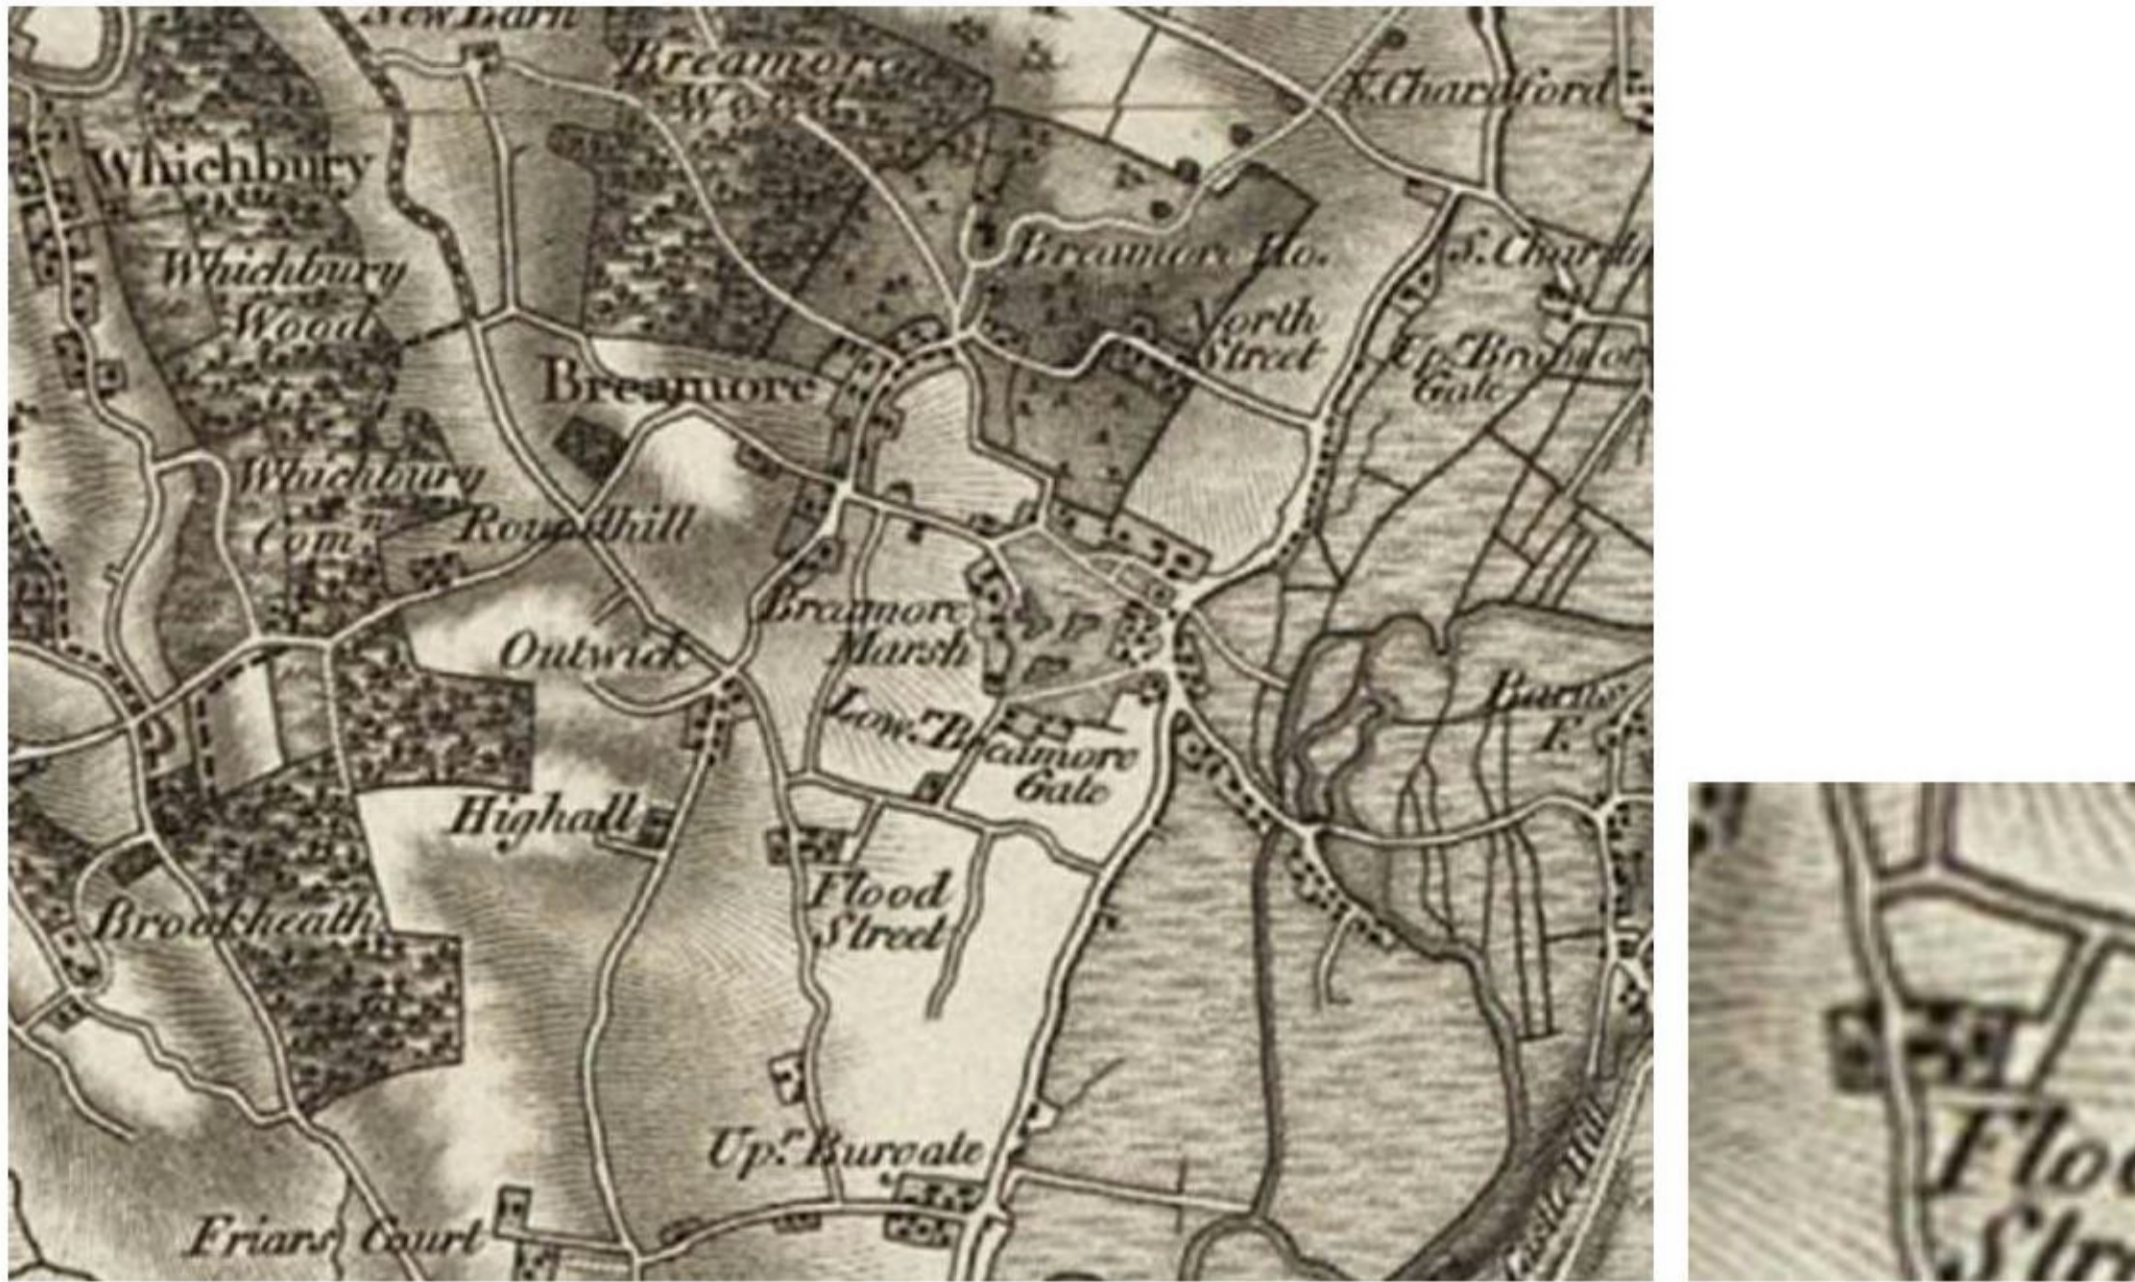
Fig.1: OS First Series map, 1811 (Sheet 15)

- 2.10 The Ordnance Survey (OS) First Series map of 1811 (**Fig.1**) is at a small scale but quite clearly shows a group of buildings at the Flood Street Farm site, which is labelled 'Flood Street' in the same manner as the similarly small 'Highall' to the west, and the slightly larger hamlet of Outwick to the north. This suggests it had some mark or status as a place in itself. Breamore proper is labelled in the location of Upper Street to the north, with Breamore Marsh (the large manorial green) clearly shown between it and the second focus of settlement east and south-east of the marsh. Lower Breamore Gate is marked south of the marsh.

2.22 The reference to it being a manor house is curious, but may just have been an 'affectation' based on the evident age, size and appearance of the house. While it has already been noted that Flood Street is named in the manner of a hamlet on the 1811 OS map (**Fig.1**), no such separate manor is referred to elsewhere.

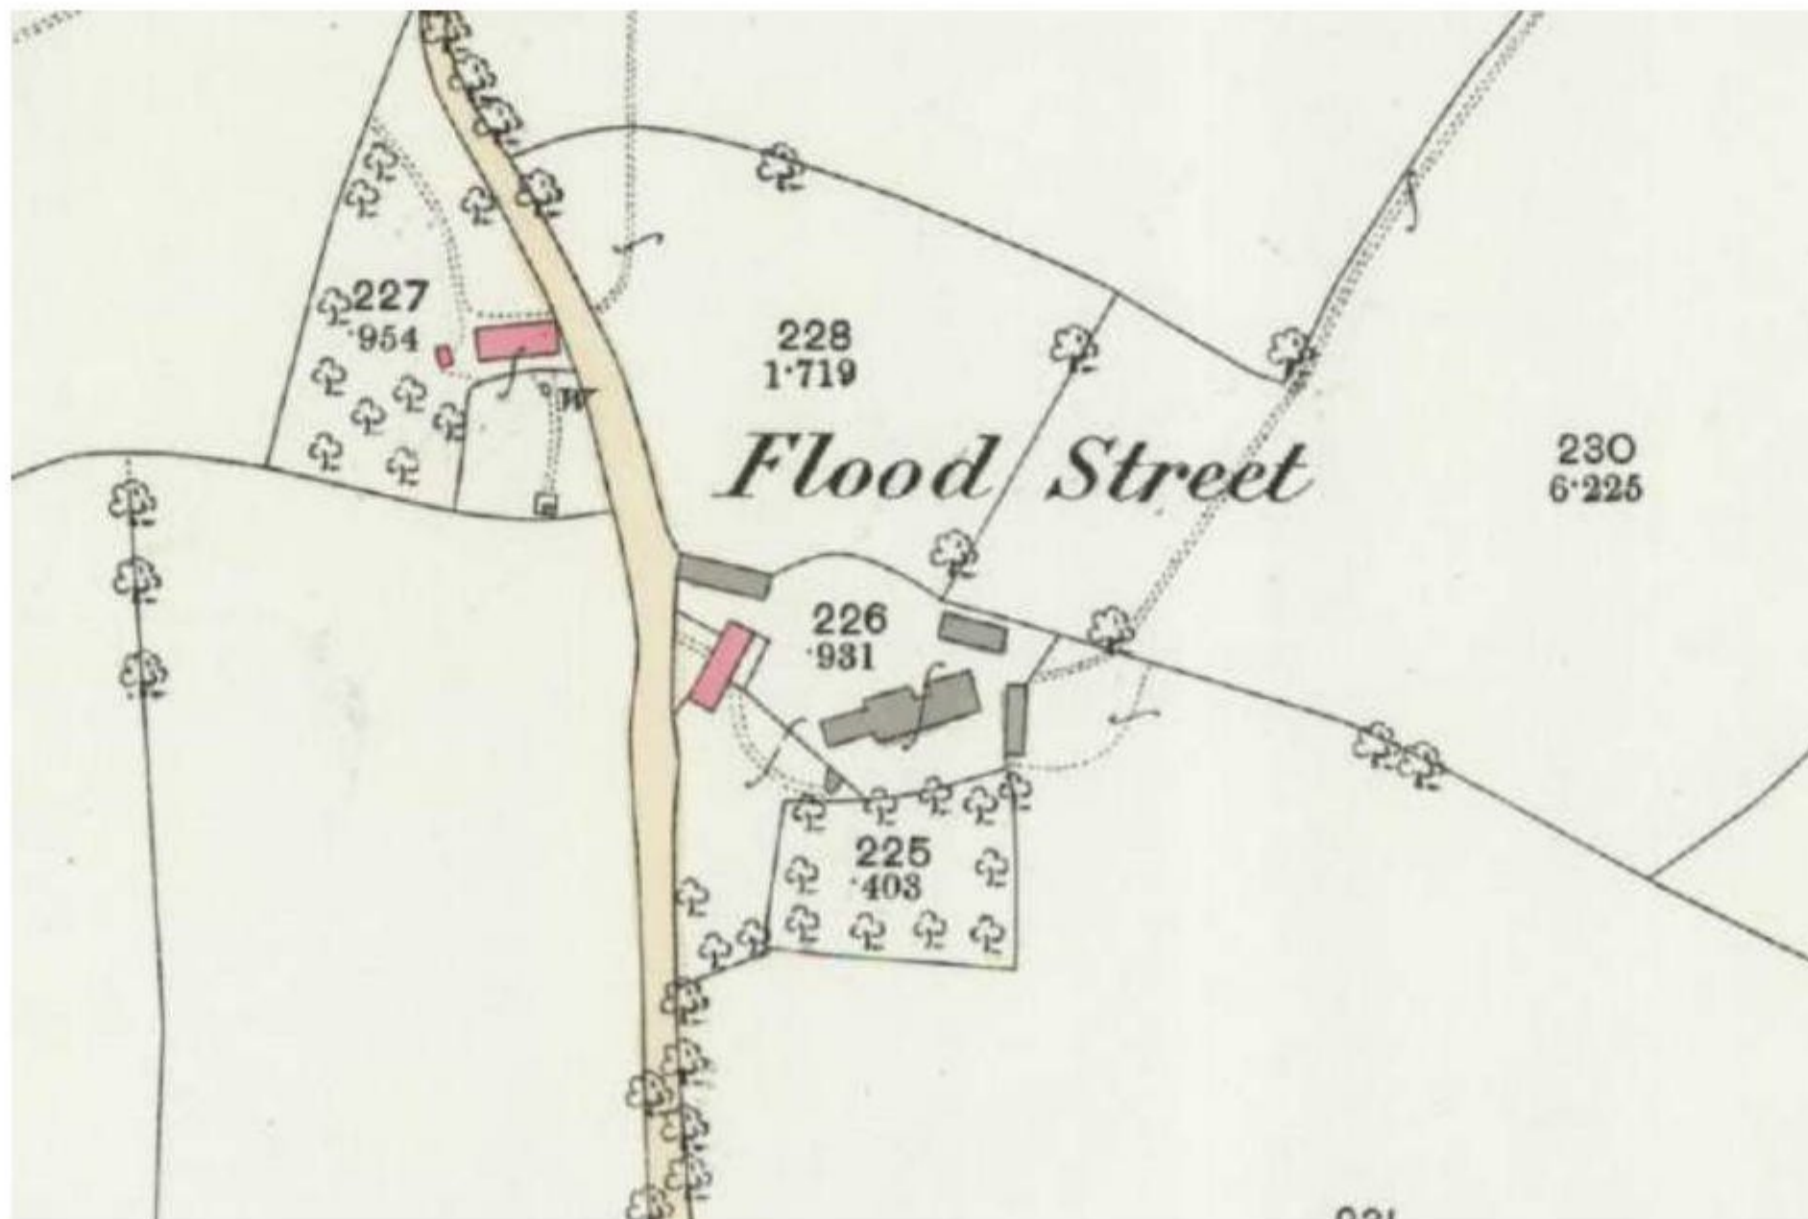
Fig.3: 1878 OS map (surveyed 1870)

- 2.15 The 1878 OS map (actually surveyed in 1870; **Fig.3**) shows the same arrangement of buildings. The pink colouring for the farmhouse indicates a solid masonry structure, while the grey shading for the farm buildings around it indicates construction in wood or iron. It is evident from the surviving Buildings A and D (both present on this and the tithe map), that they were of timber construction. The positions of the buildings and boundaries are essentially as shown on the tithe map. There was a small enclosed front garden with footpath to the front door and an enclosed yard against the rear north-east end of the farmhouse. The rear garden enclosure is shown partly divided to form an orchard in the south-east. The pond depicted on the tithe map is not shown here.

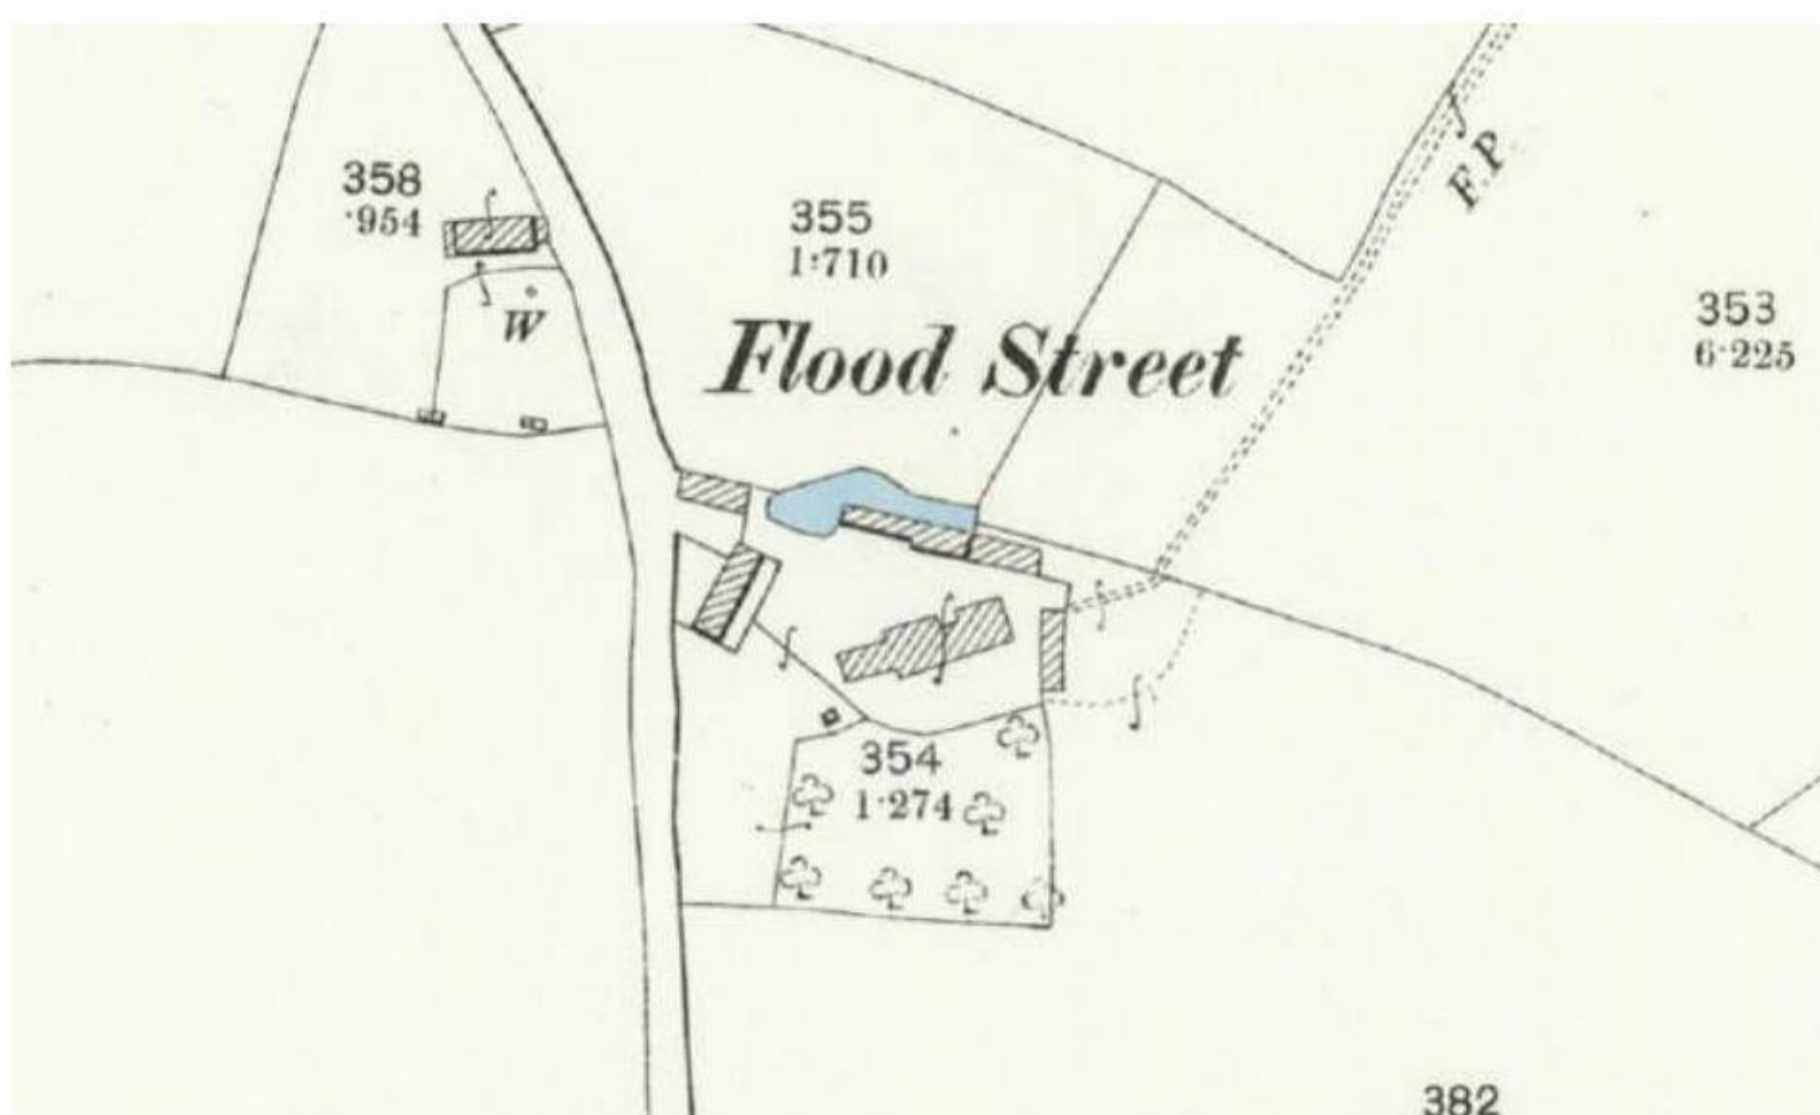
Fig.4: 1897 OS map (surveyed in 1895)

2.16 The 1897 OS map (surveyed in 1895; **Fig.4**) shows that the enclosed yard against the rear of the farmhouse had been extended across the whole of the rear elevation. The cart-shed (Building A) had been truncated at its eastern end, and a wall or fence erected across the driveway access from Building A's new south-eastern corner to meet the north-west corner of the house. The southern boundary of the front garden had been realigned. To the rear, Buildings B and C had been constructed against the west end of Building D and the pond had reappeared, larger than shown in 1838 and extending along the backs of Buildings B and C.

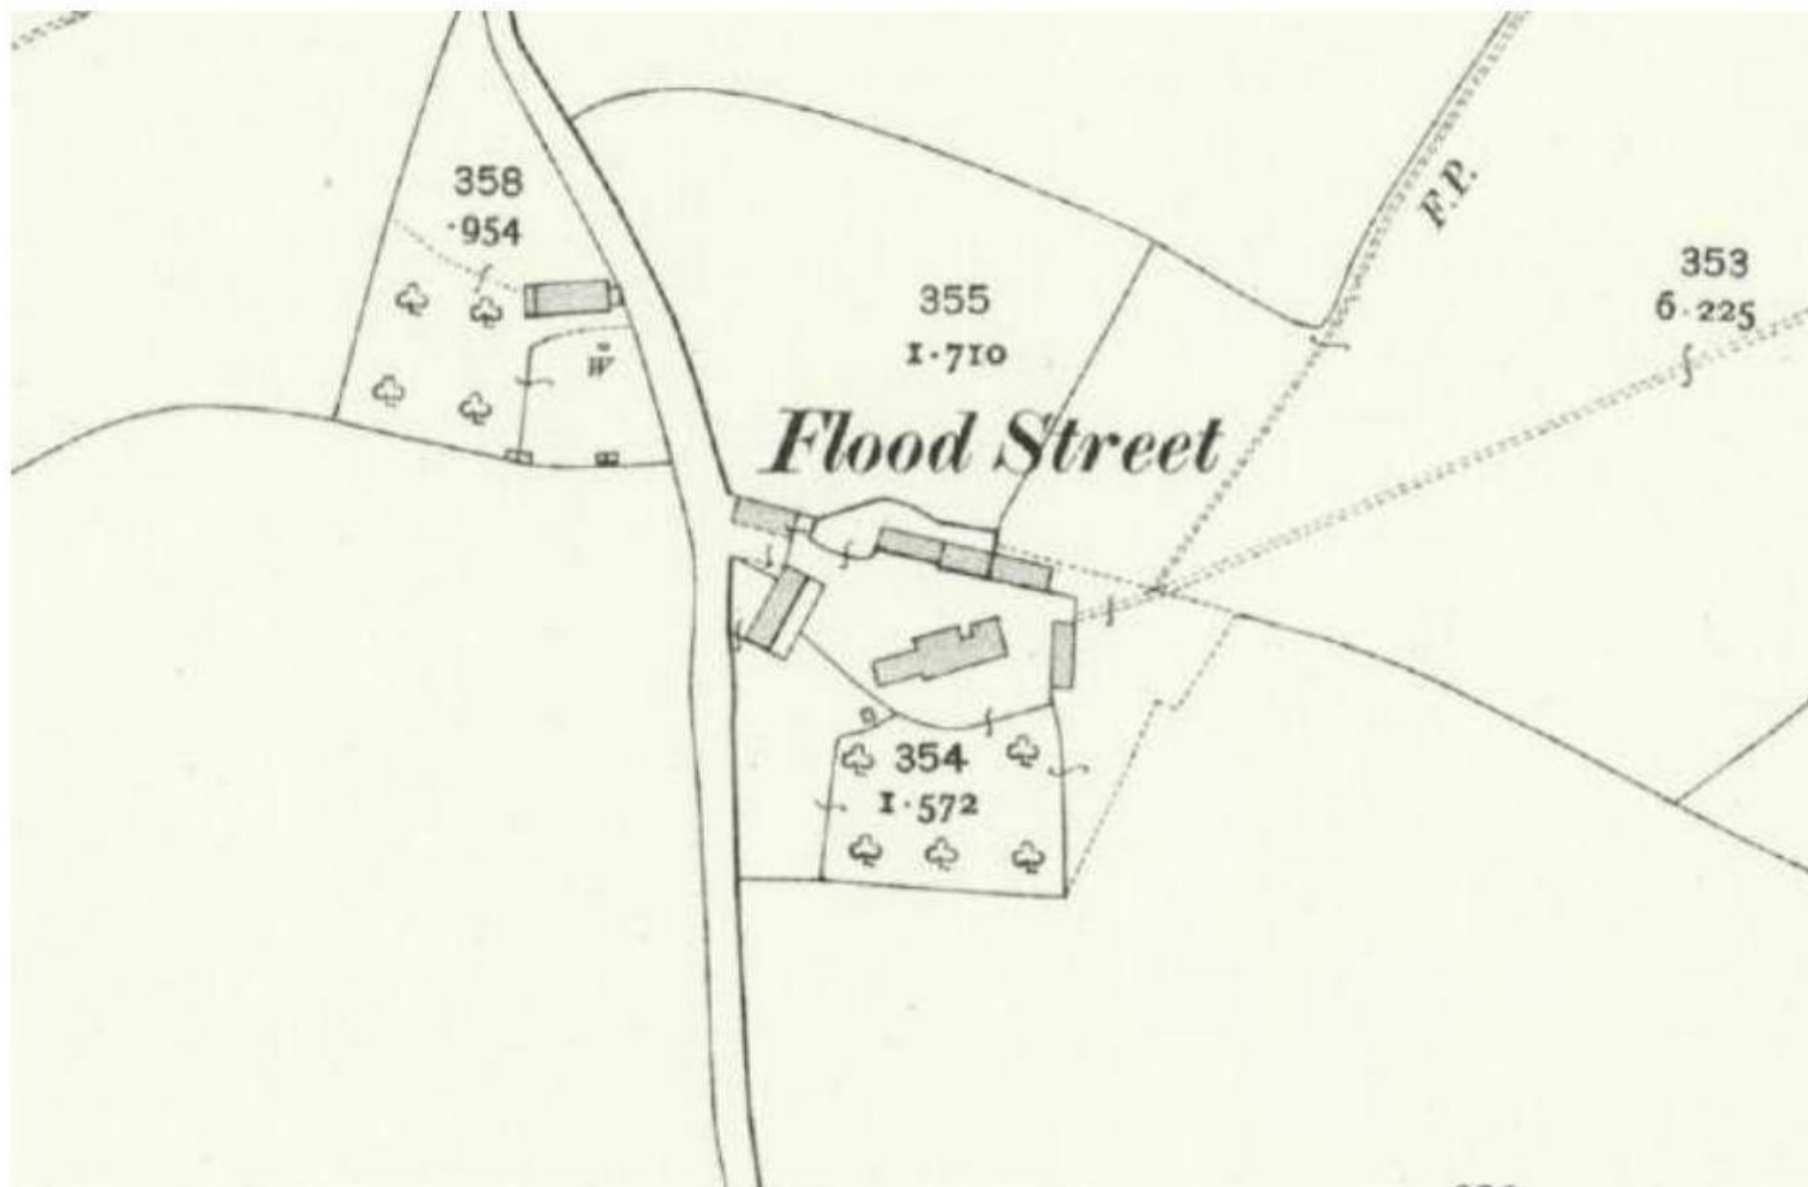
Fig.5: 1909 OS map (surveyed in 1908)

2.17 The 1909 OS map (surveyed in 1908; **Fig.5**) shows the same arrangement of buildings and spaces as the 1897 map. The cart-shed (Building A) is here shown with an open-sided front to the south.

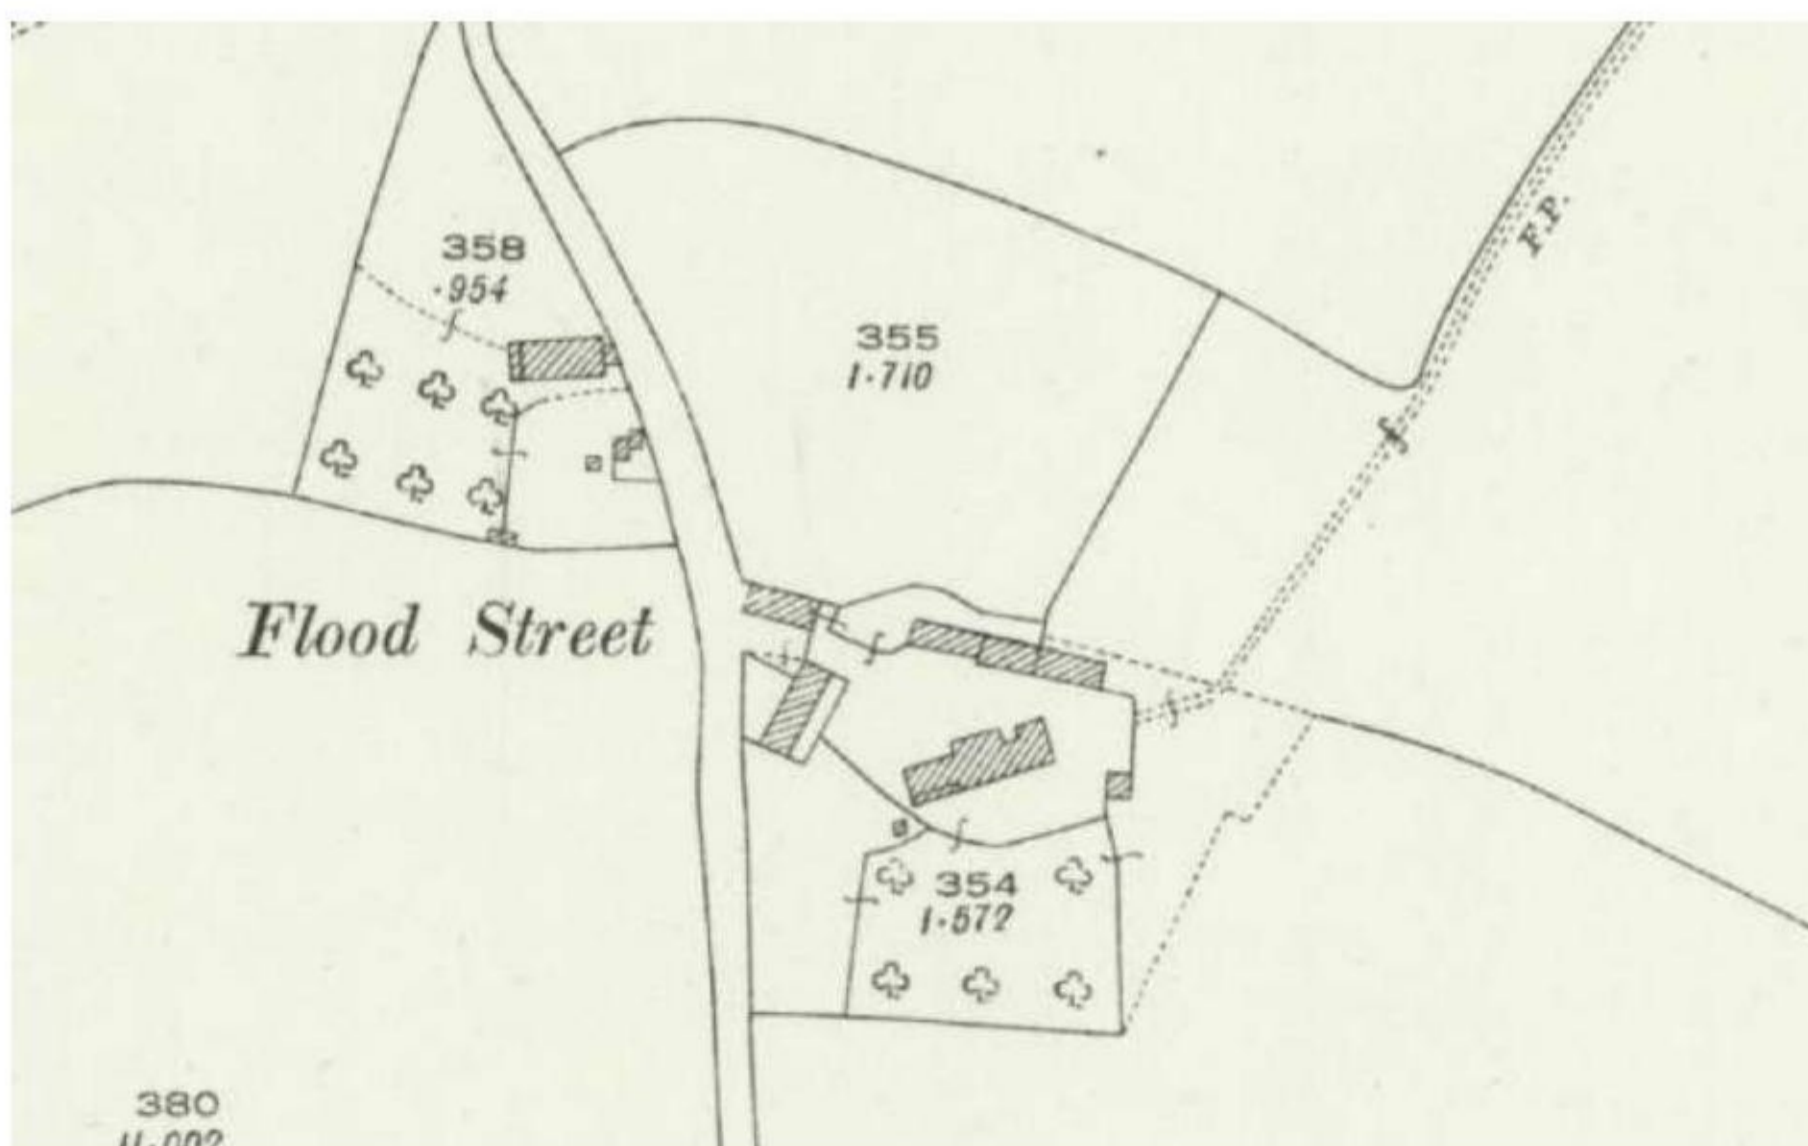
Fig.6: 1926 OS map (surveyed in 1924)

2.18 The 1926 OS map (surveyed in 1924; **Fig.6**) shows the removal of the easternmost of the farm buildings -or possibly its significant truncation, leaving only the southern end of it standing. There is still a small square shed of timber construction with thatched roof in this location (Building E).

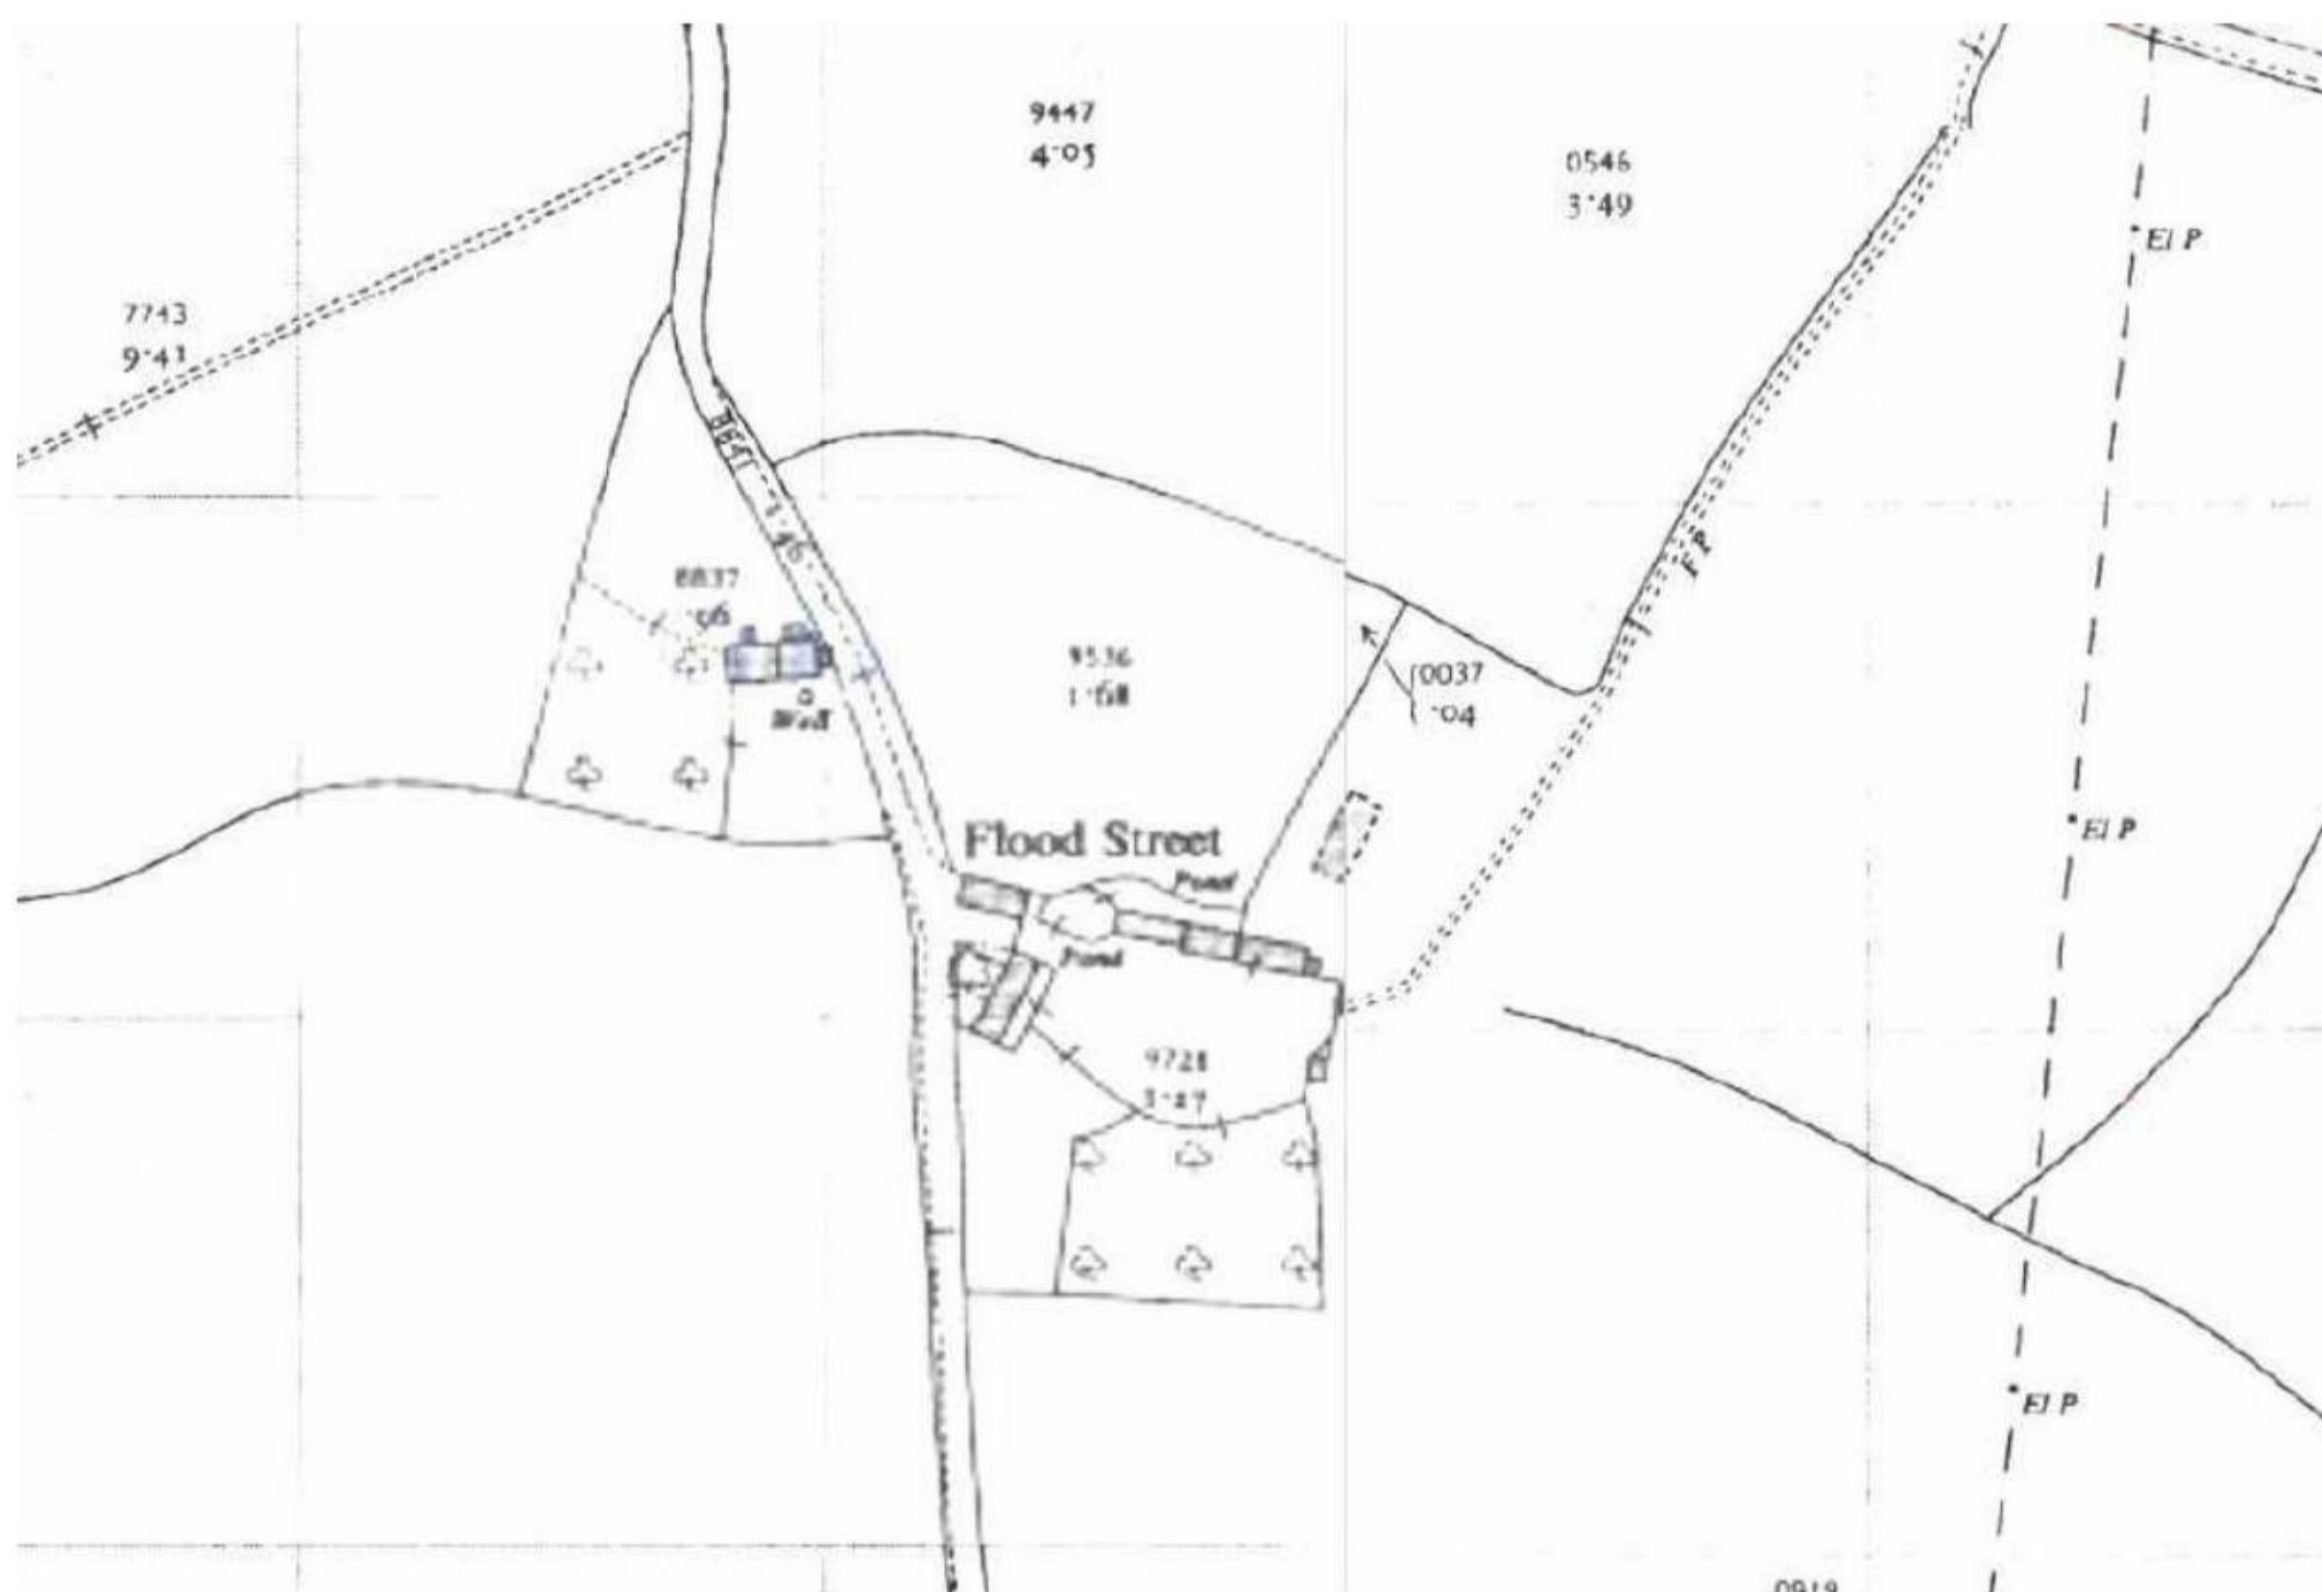
Fig.7: 1957 OS map

2.20 The 1957 OS map (**Fig.7**) shows that the large barn had been demolished. The year 1957 was a transformational one for the farmhouse, when it was purchased by Guy Henley Dodgson and his wife Janet Frances Marion Dodgson. The couple were to undertake a wholesale 'restoration' of the building, which had lain empty for four years and was, apparently, in a parlous condition.

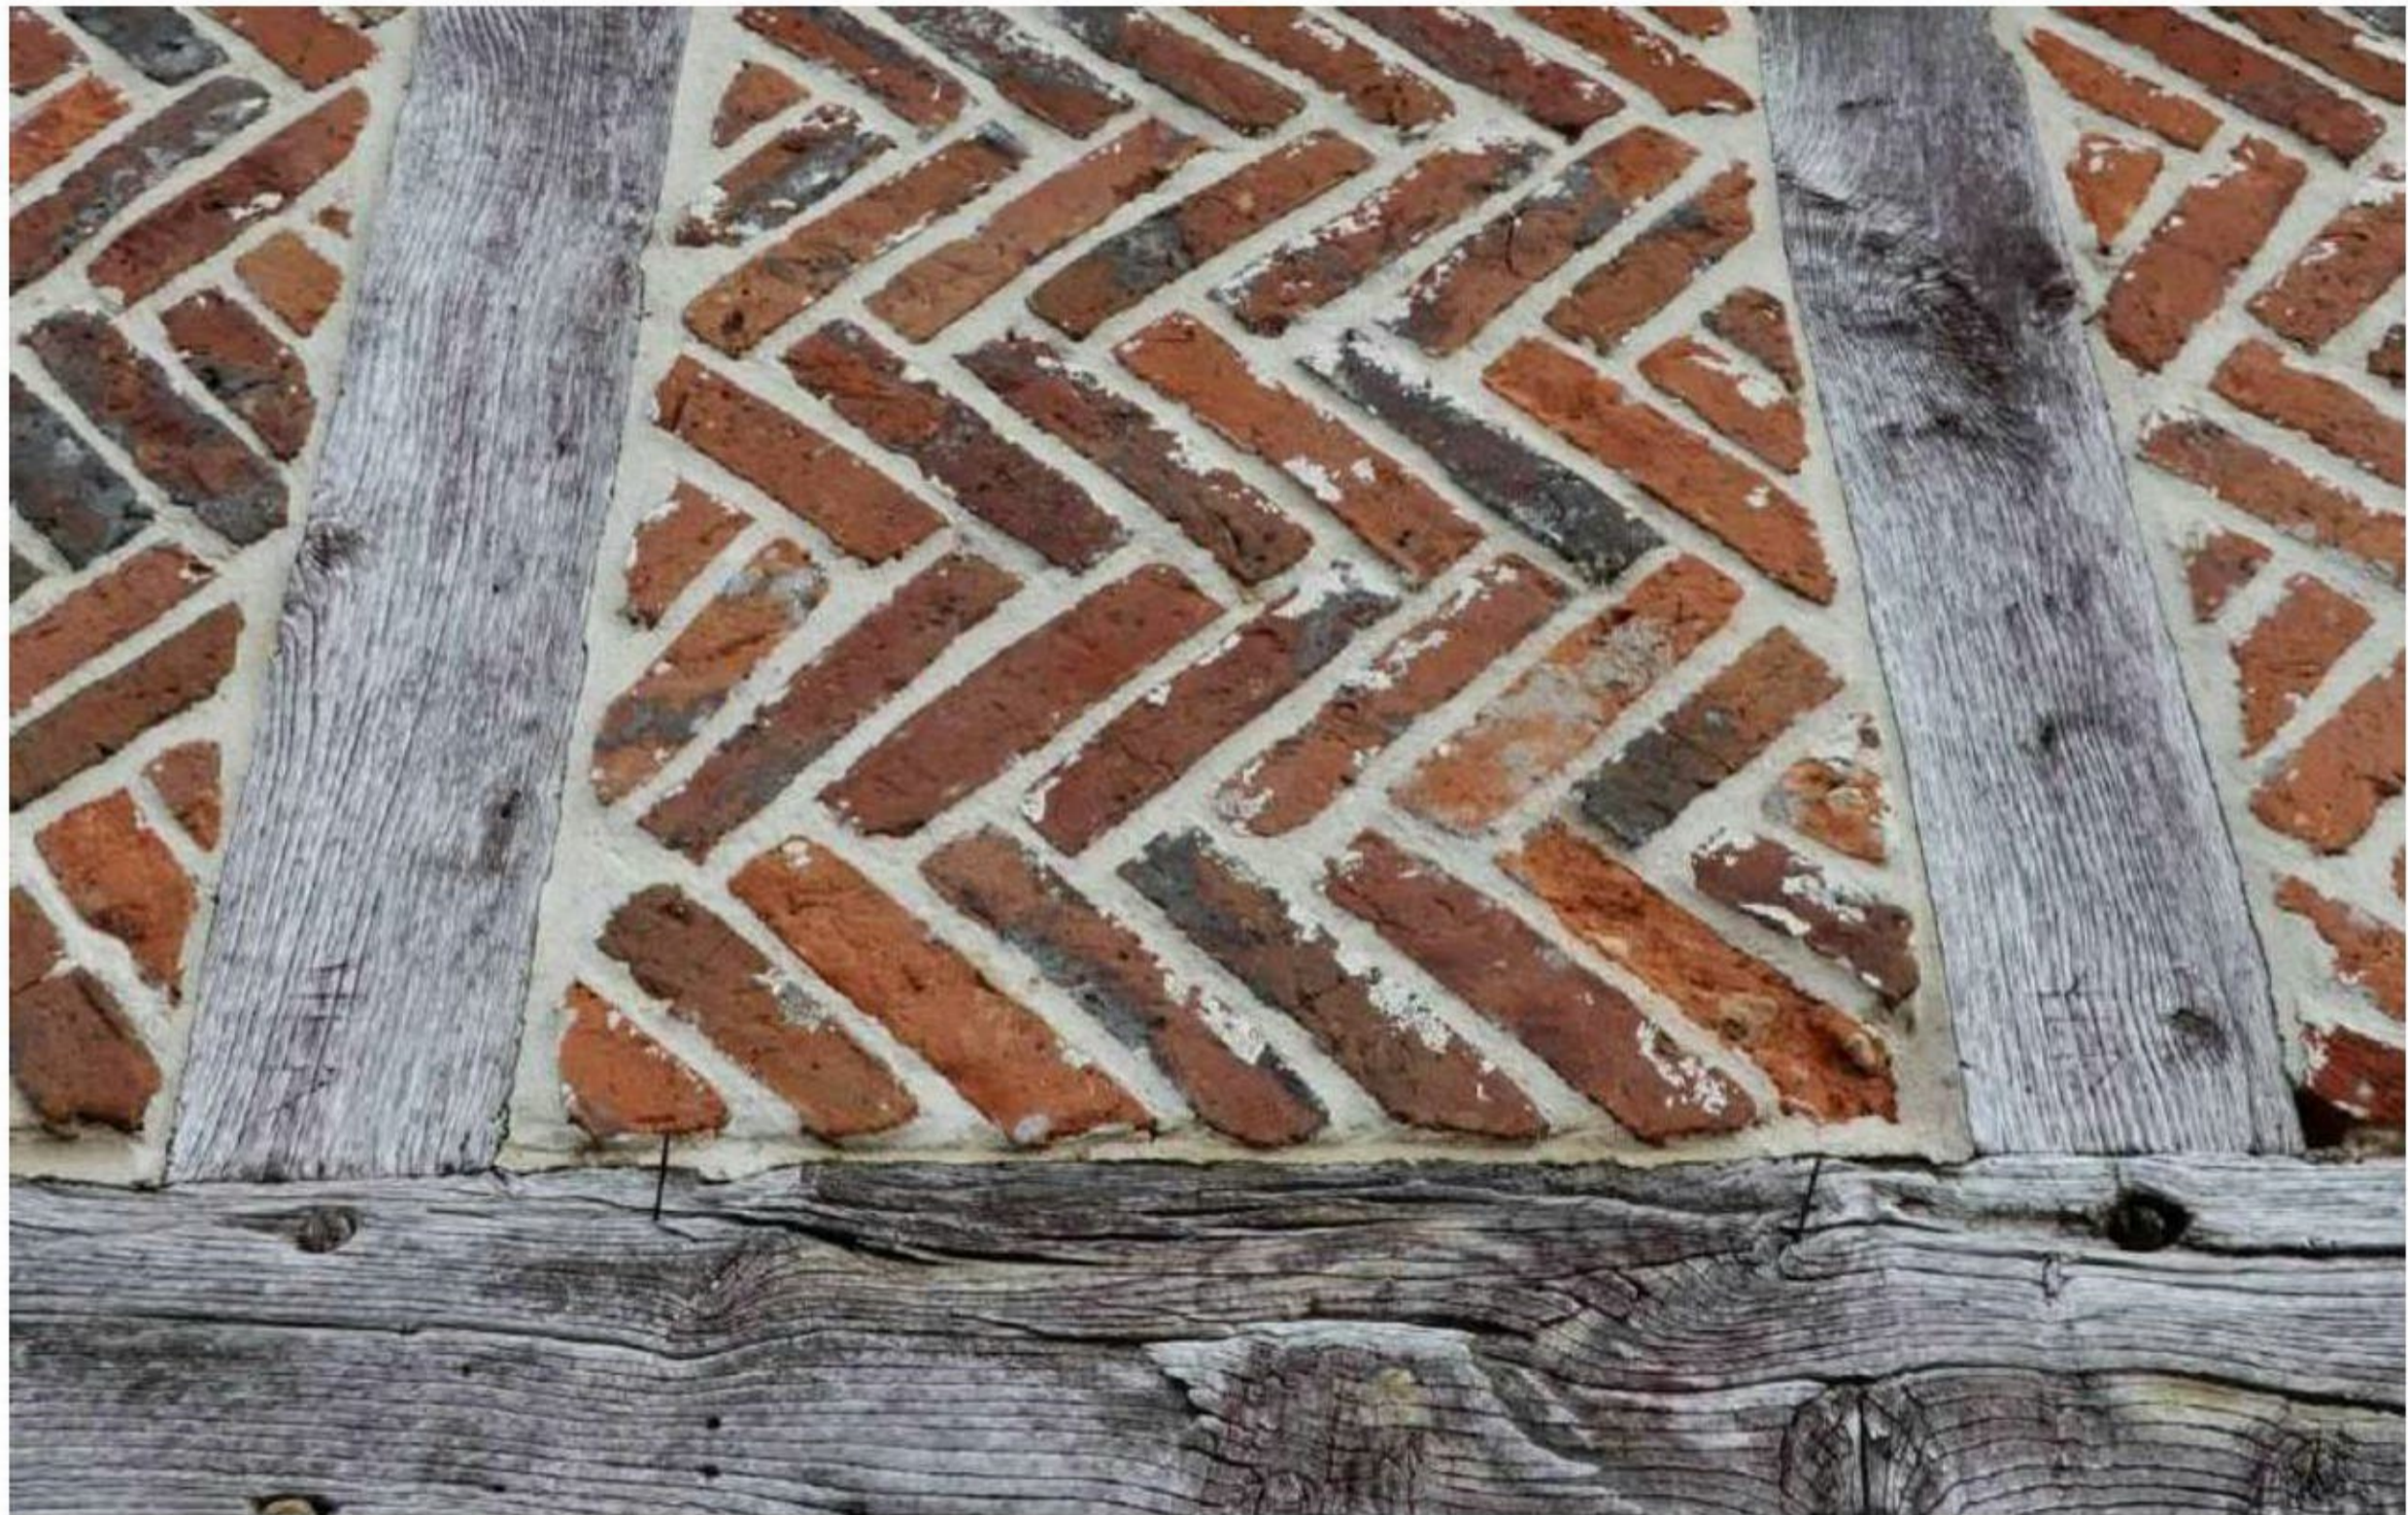
Plate 3: Examples of carpenter's marks on posts to front elevation: VIII to left and VII to right
