STATEMENT OF SIGNIFICANCE

**Flood Street Farm,
Breamore, Hampshire**

AHC REF: 9943

Date: April 2021

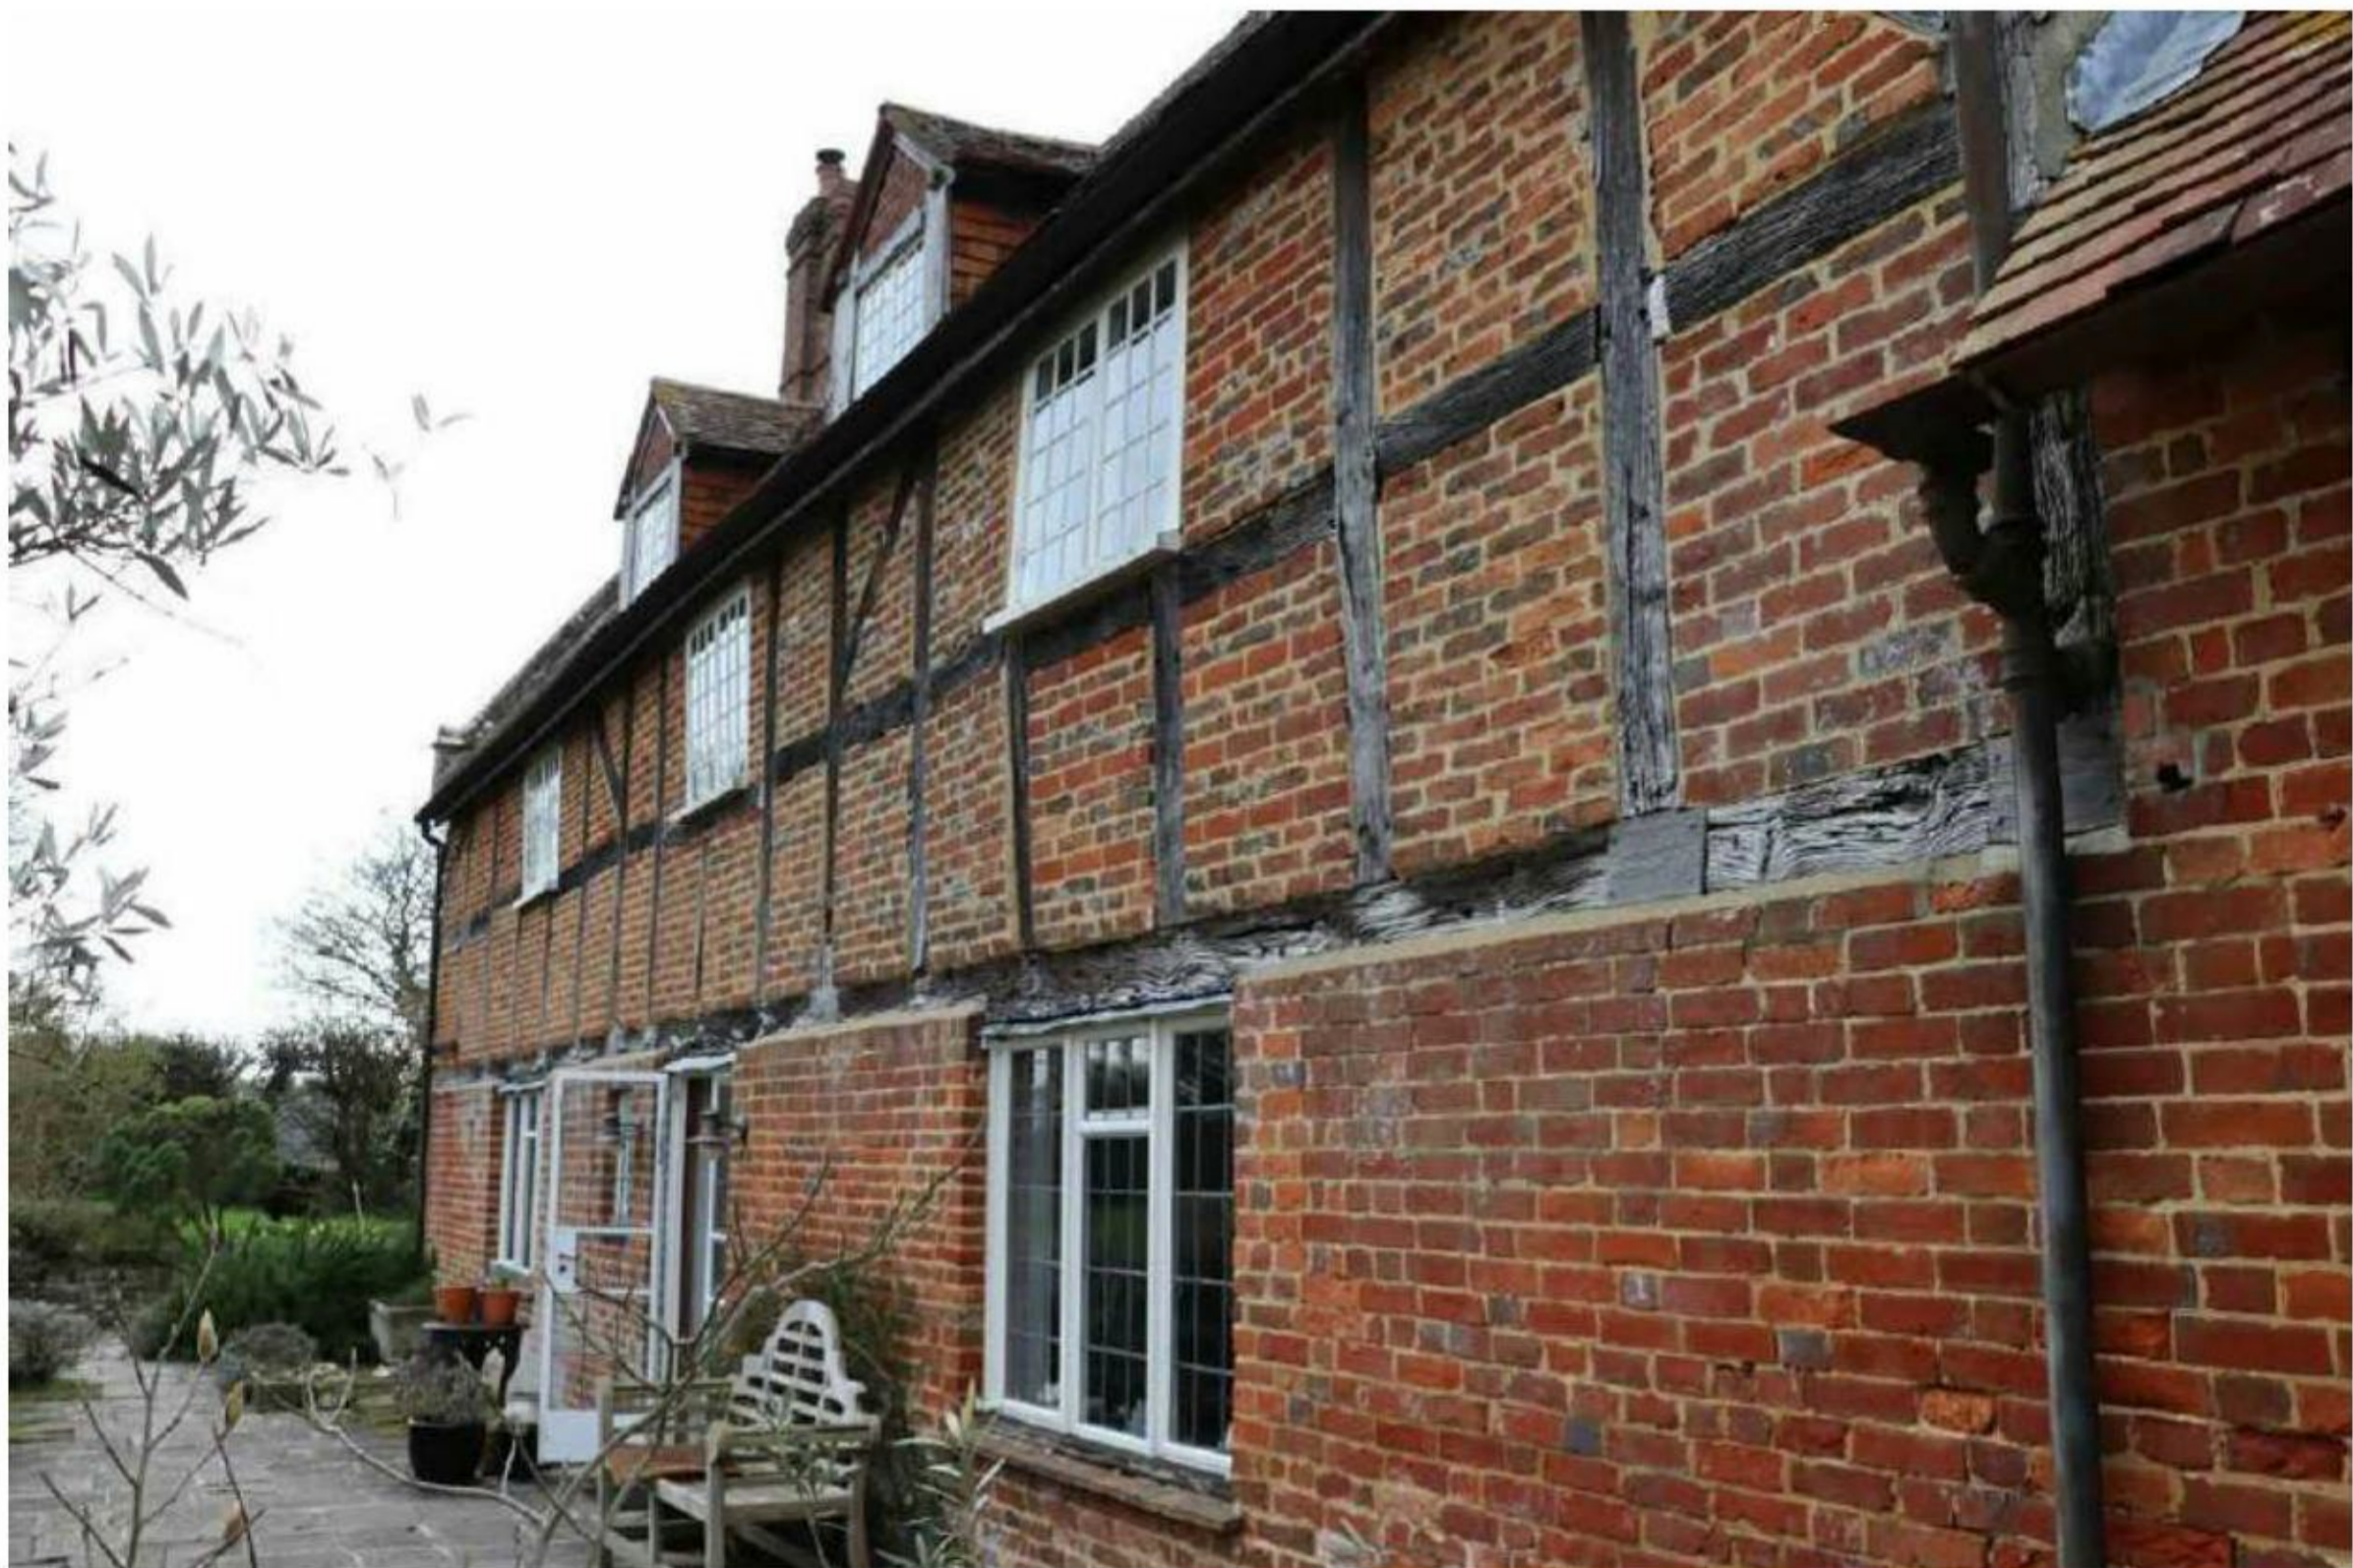
Plate 8: Rear elevation; note projection of ground-floor brickwork from the original building plane, with enlarged window opening in foreground and French doors

front. The two ground-floor window openings were enlarged by the Dodgsons and new windows with leaded lights in Crittall frames were inserted. They also replaced the central entrance with French windows in Crittall frames and a new window was inserted to the left of this (**Photo U** shows it being put in). The three gabled dormers were largely rebuilt at this time too. On this elevation, the projection of the rebuilt brick ground floor from the upper plane of the wall is very apparent (**Plate 8**).

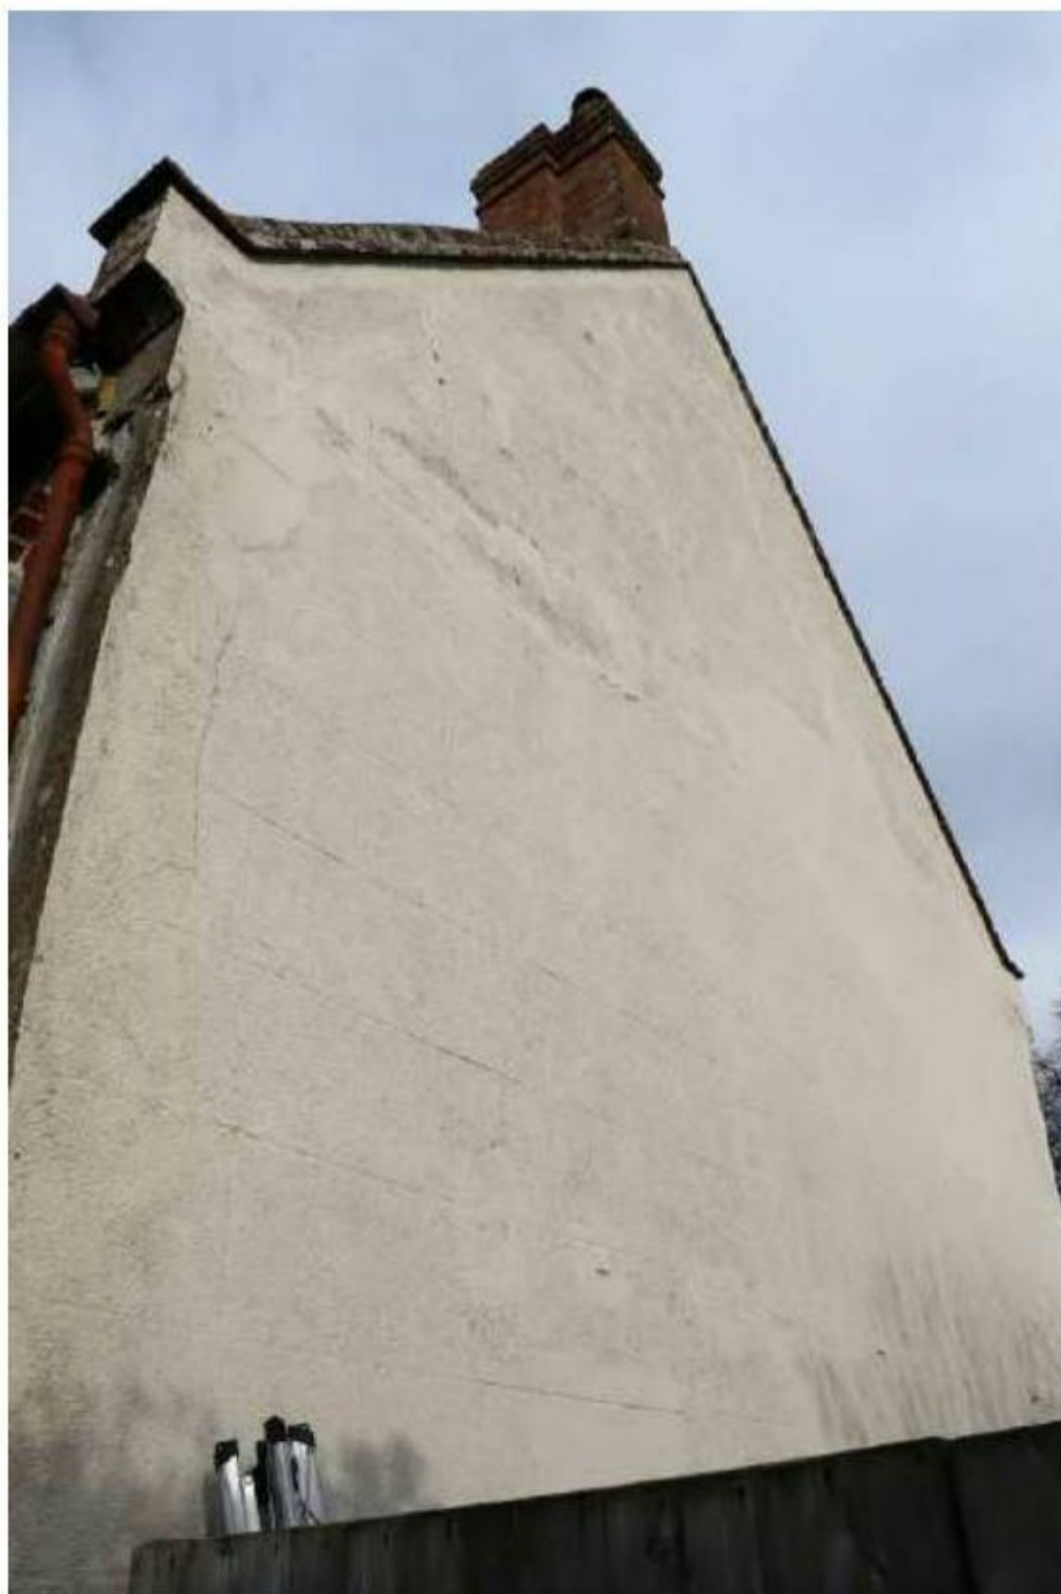
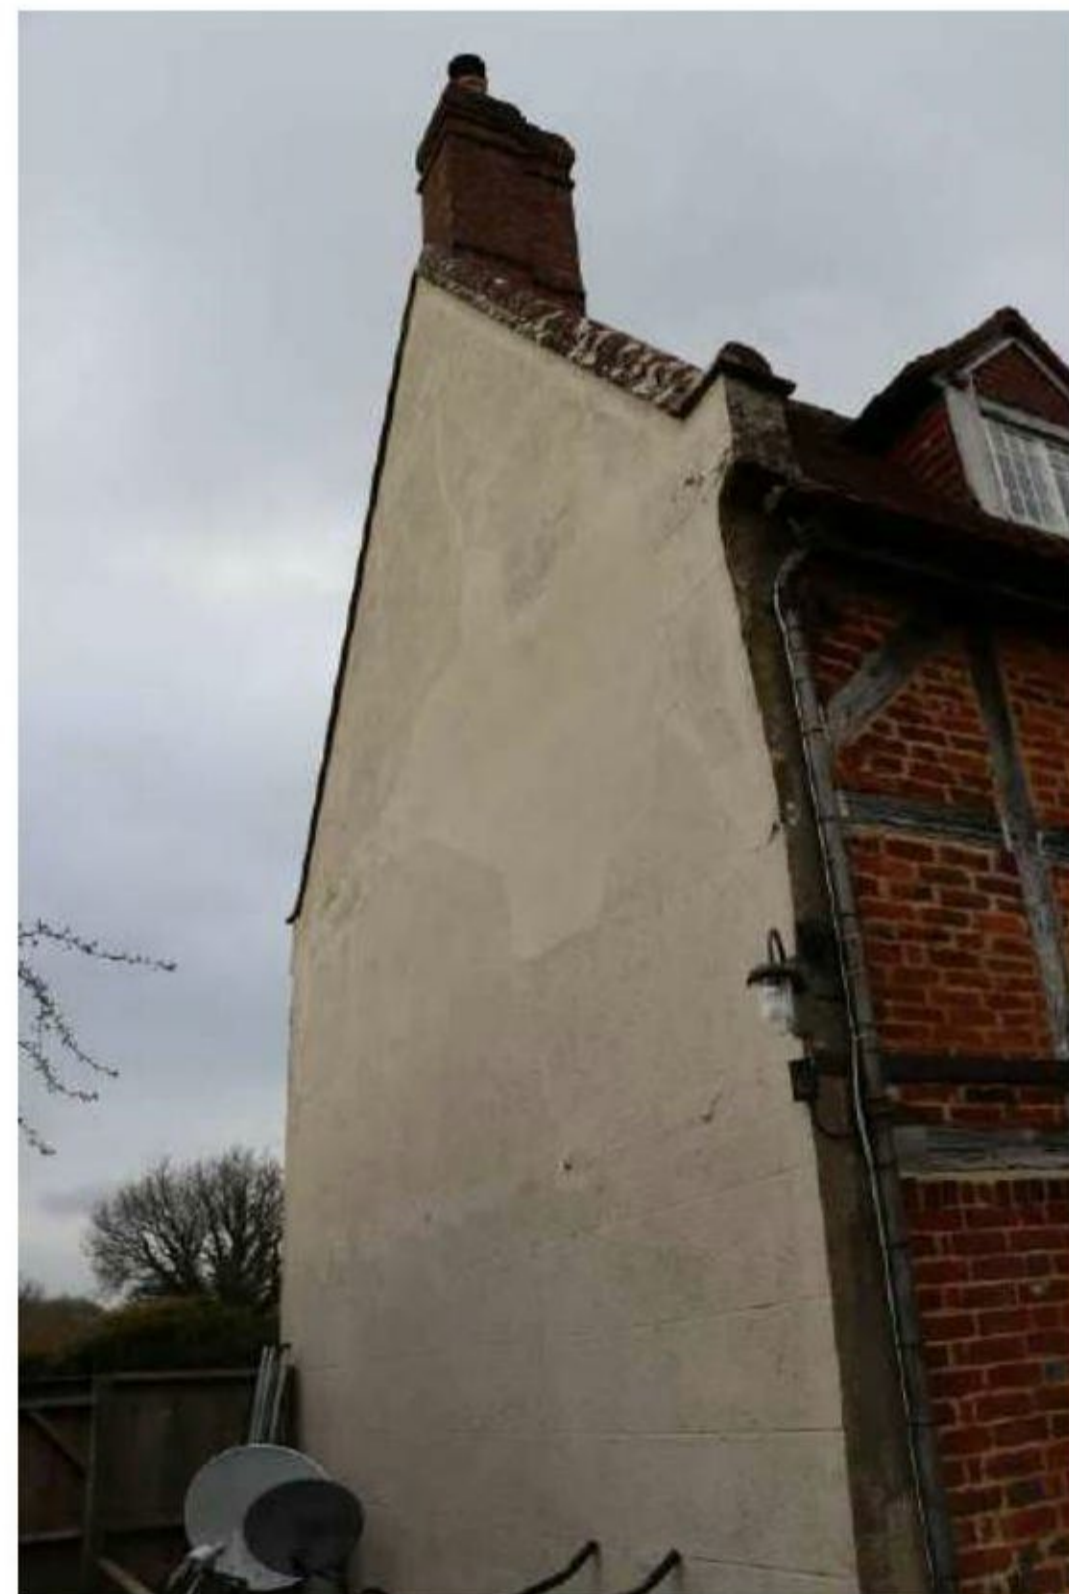
Plate 10: SW gable end

3.3.1 The south-west gable end is entirely covered in render with incised lines. The Dodgsons say that this was the case in the 1950s and that they left it as it was. A comparison of **Photo X** with **Plate 10** suggests the old render has been repaired and repainted if not entirely renewed since that time. The Dodgsons also refer to their removal of an earth bank from the base of this wall – the extent of this removal can be gleaned from **Photo Y** and see **Plate 11**. The condition of the wall fabric beneath the render is unknown.

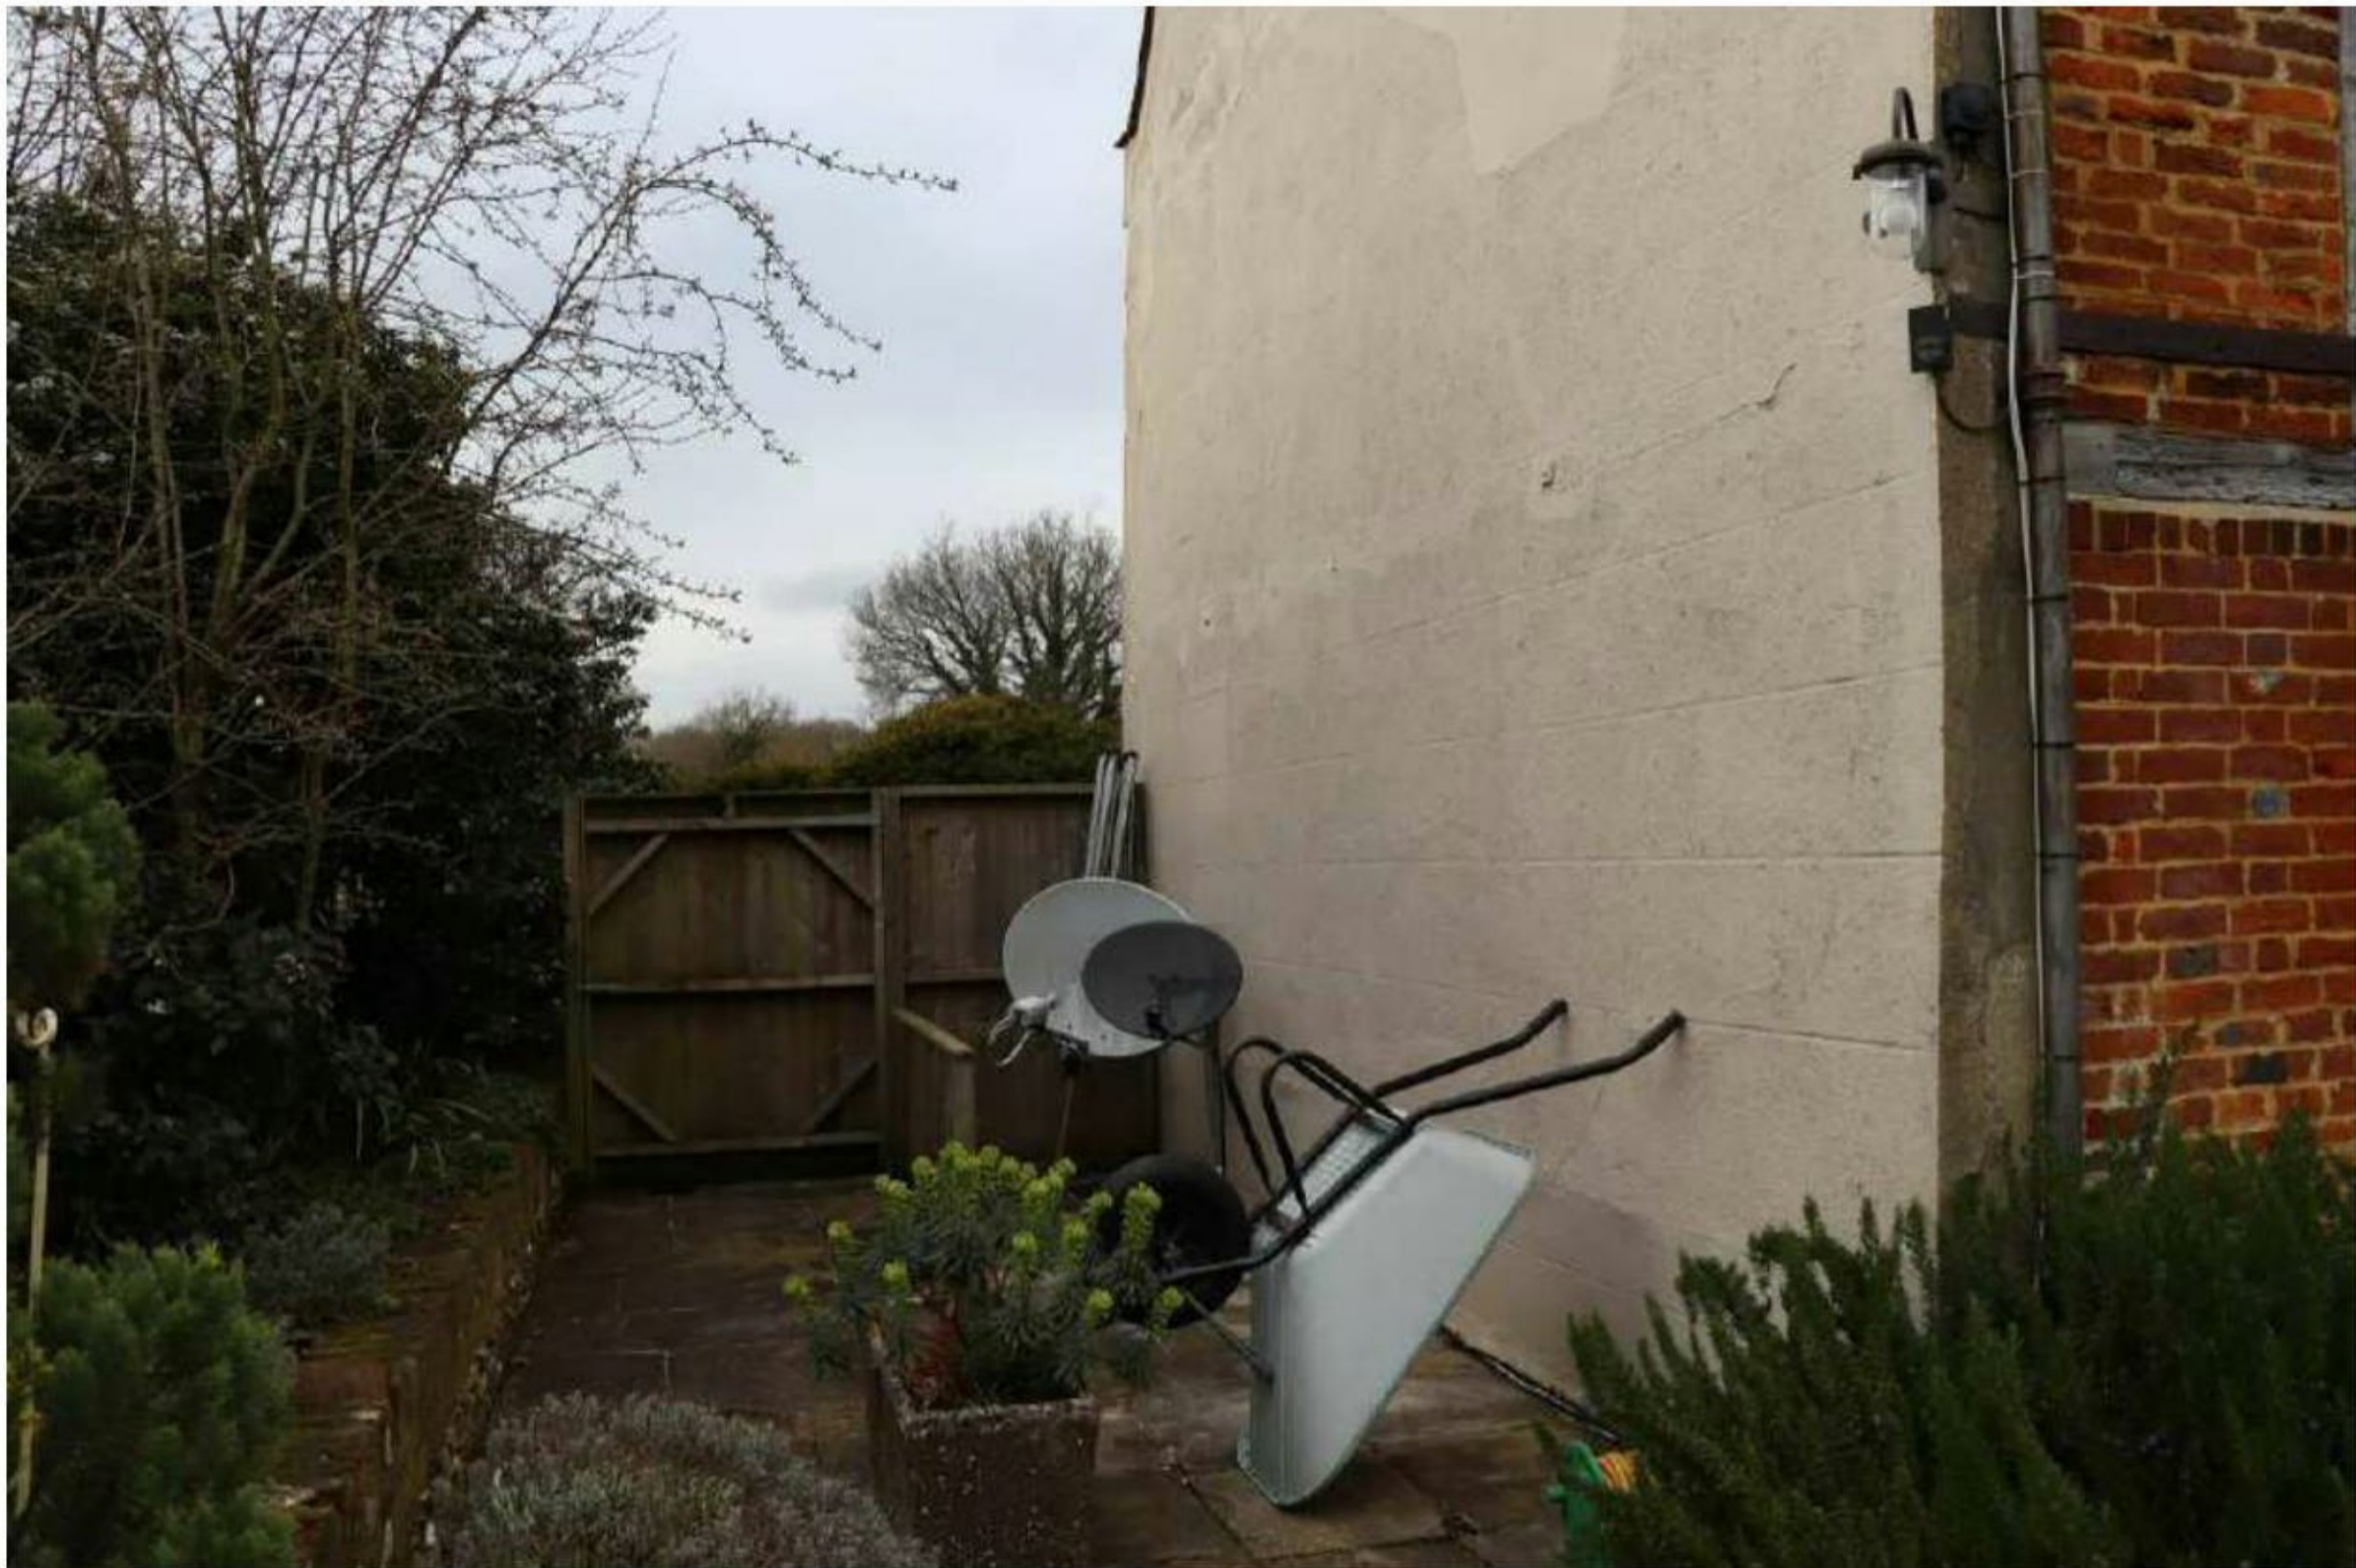
Plate 11: Base of the SW gable end, from where an earth bank was removed in 1957

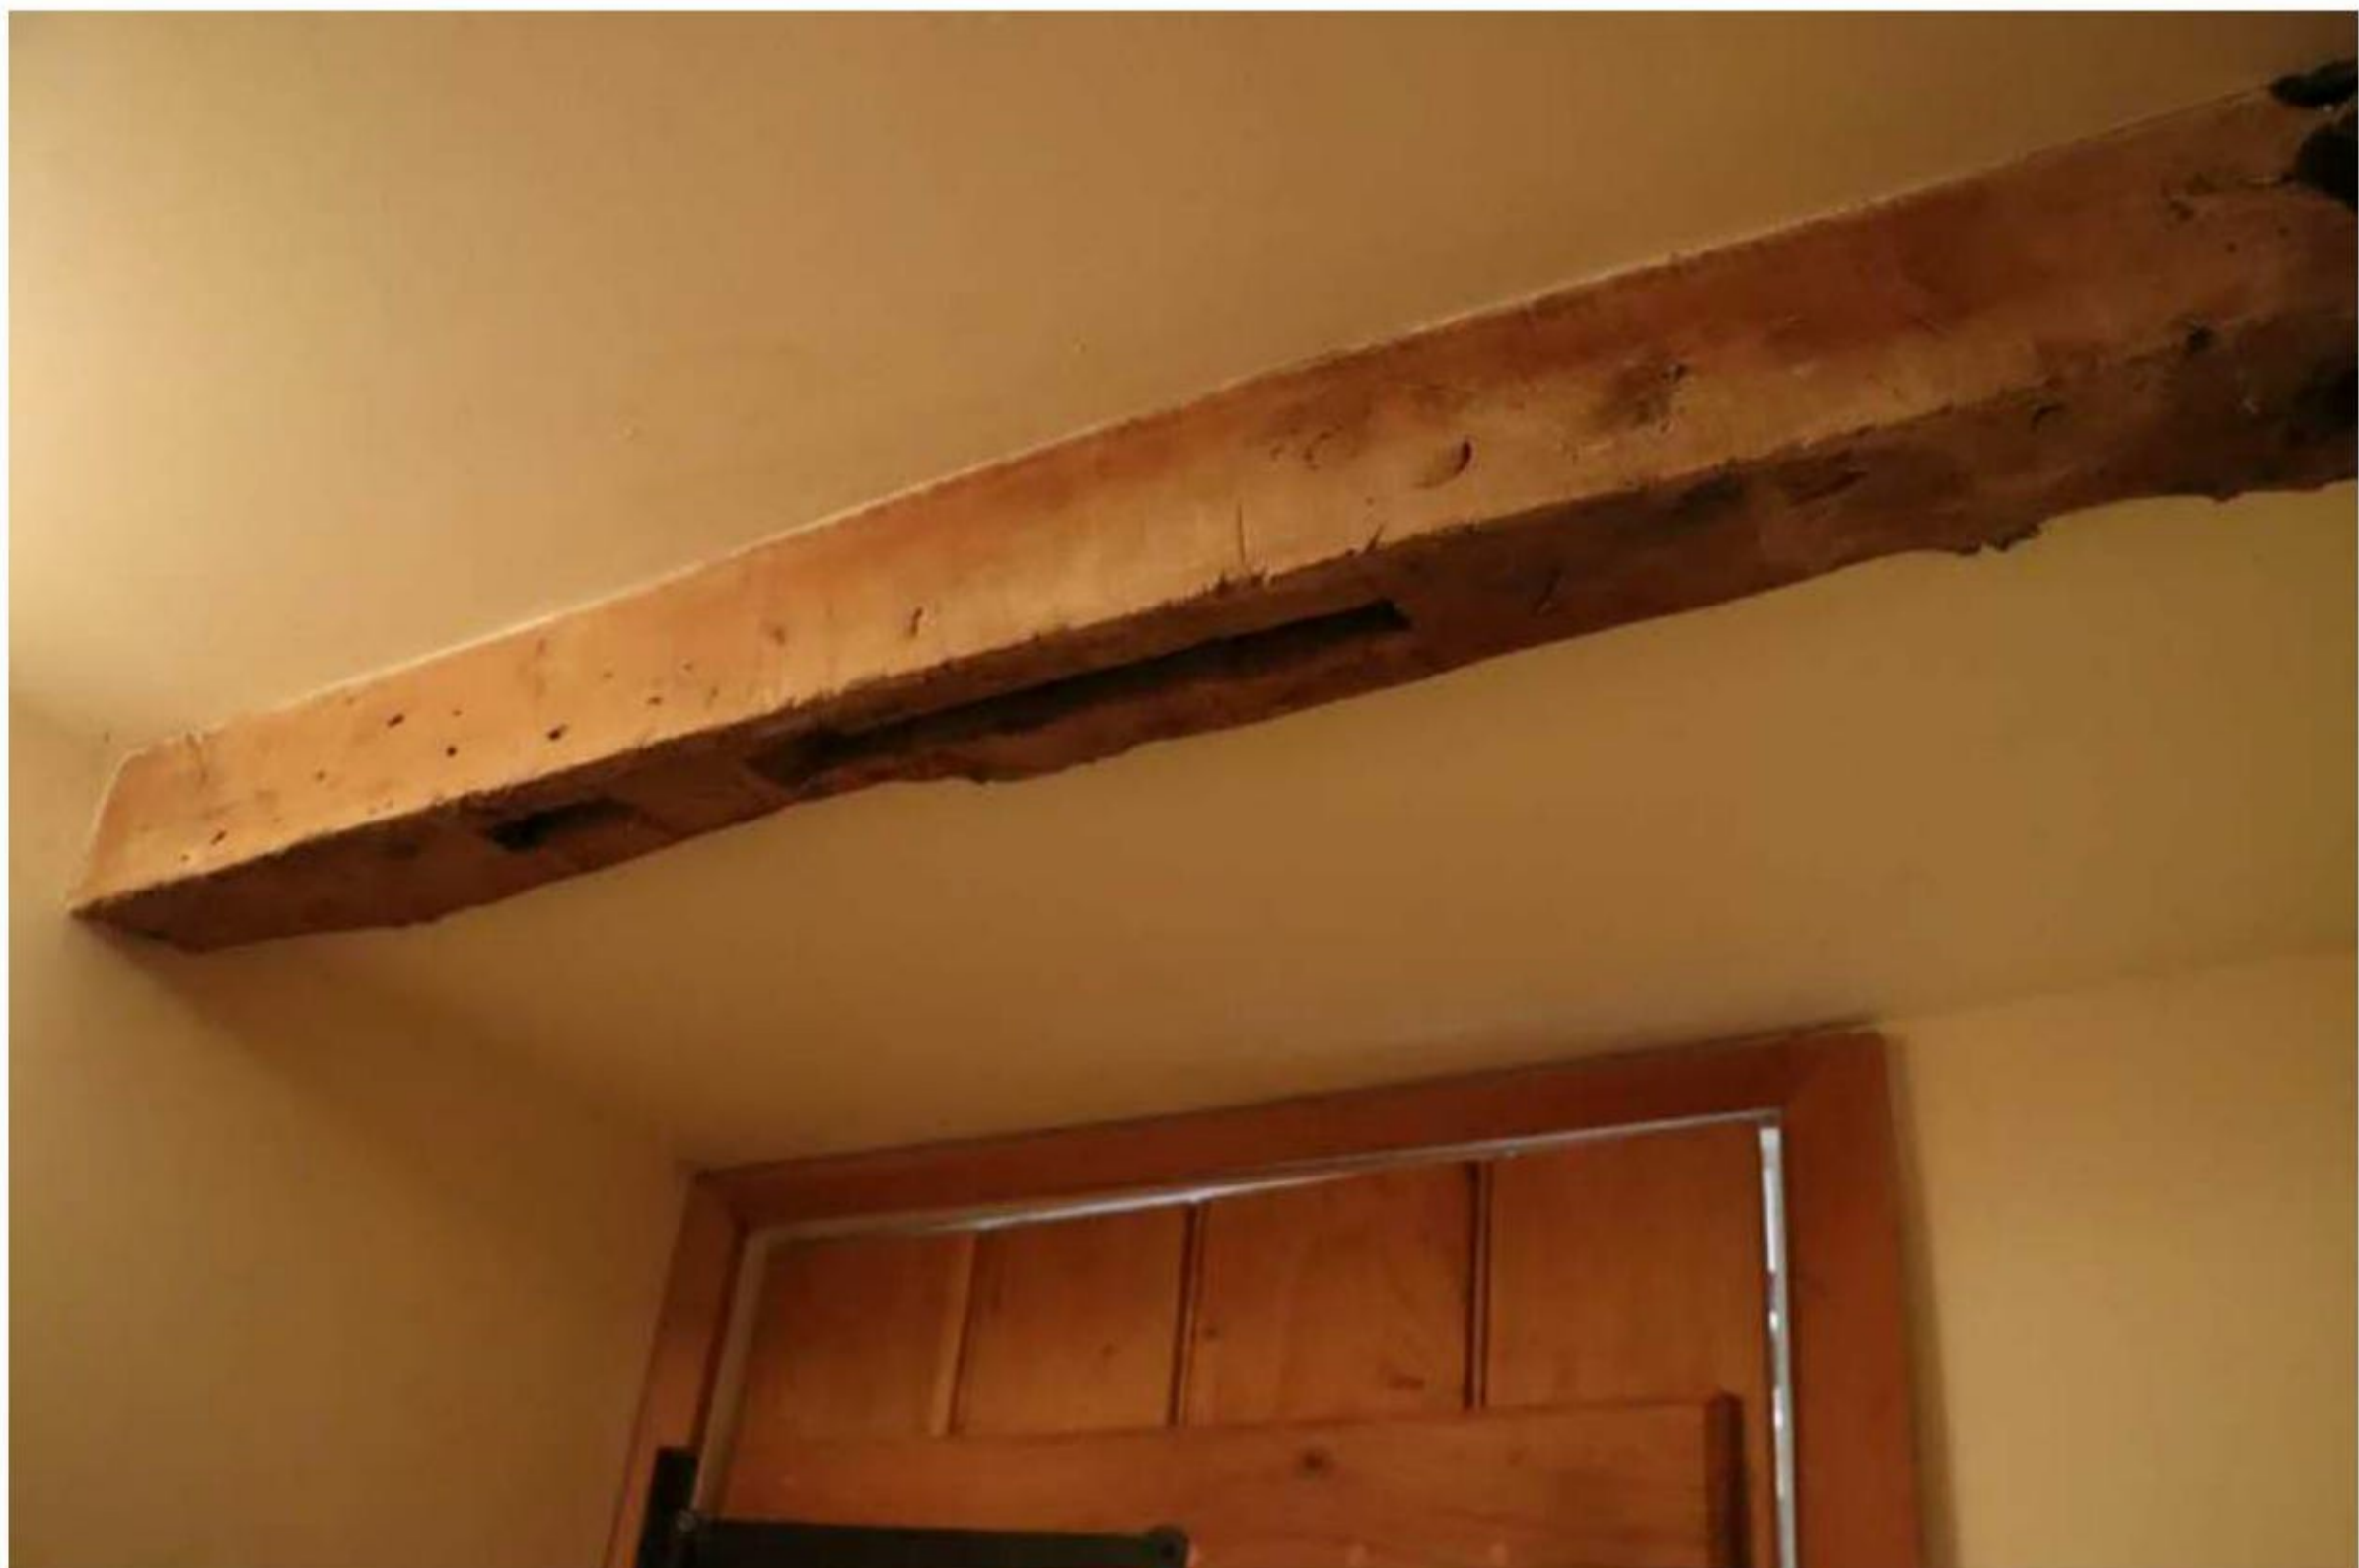
Plate 12: G1: original beam with empty mortises from the removal of the timber-framed wall dividing the northern from the central bay

- 3.1.14 In G1 (and continuing through G2 and G4), a ceiling beam with empty mortises marks the line of the timber-framed wall originally dividing the northern from the central bay (**Plates 12 & 13**; and see **Photos E1 & G1**).

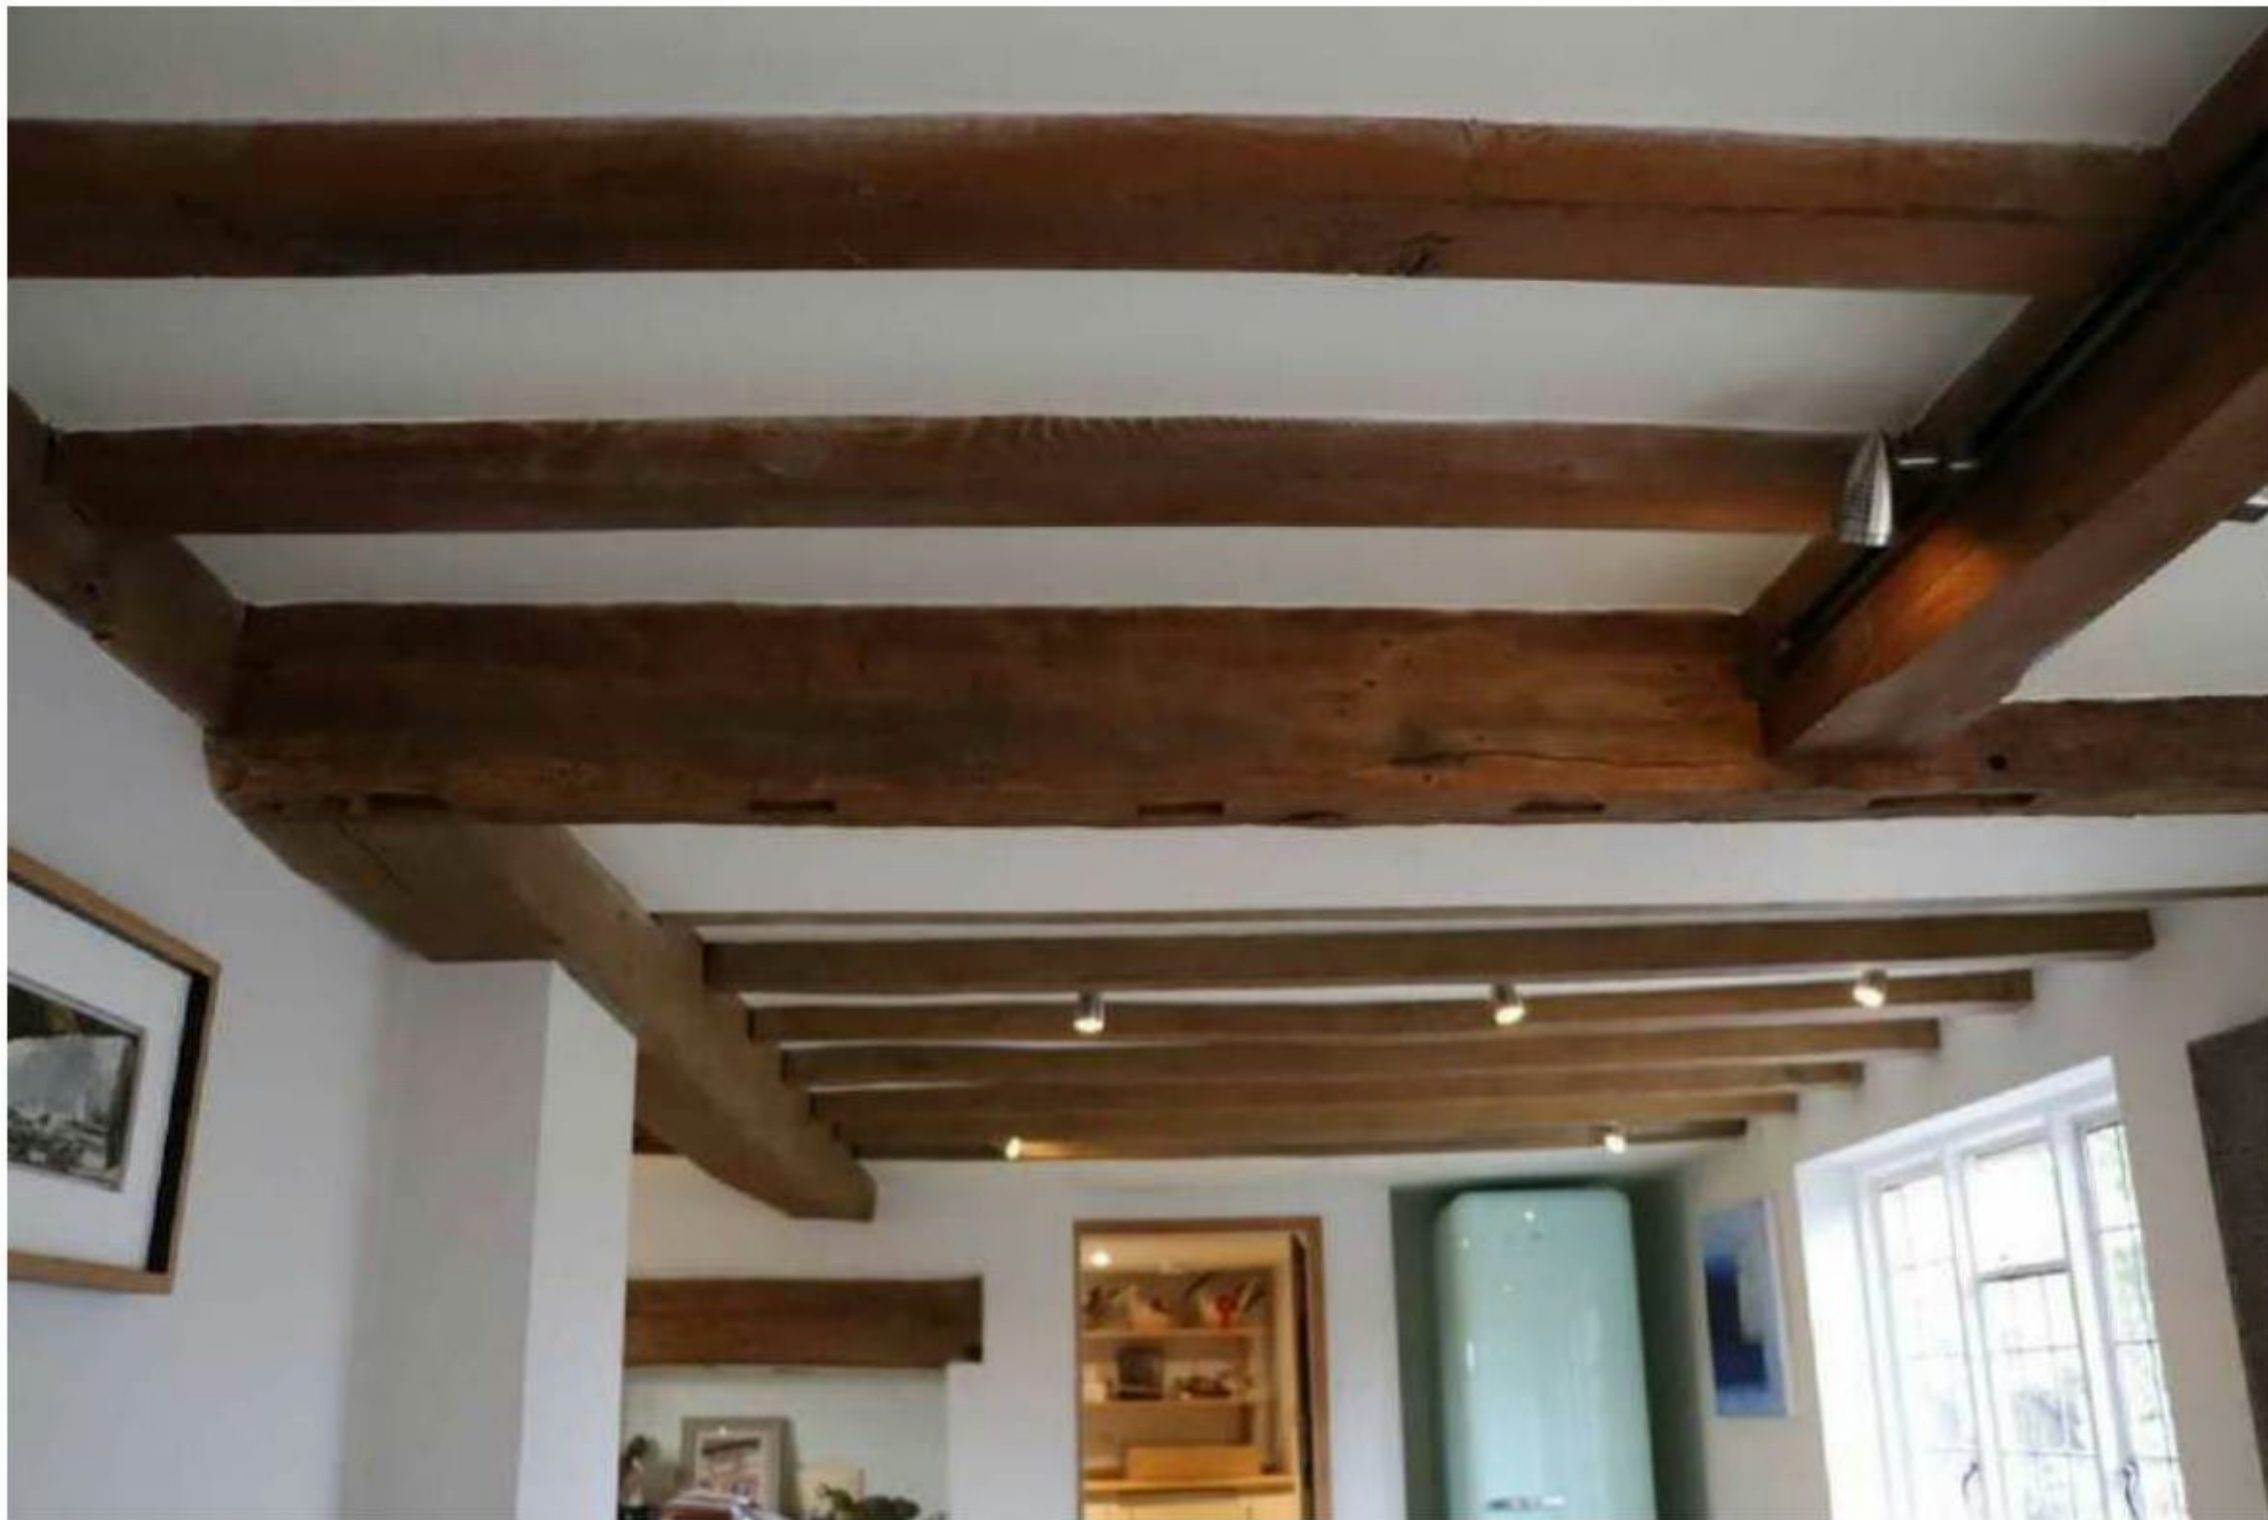
Plate 13: G4, looking NE from central bay into NE bay: the beam with empty mortises across the centre of the image marks the position of the original timber-framed wall dividing the bays; the chamfered and stopped beam joining it to left marks the original extent of the space in the NE bay, while the chamfered beam to right was inserted in the 1950s

3.1.17 In G4, the chamfered and stopped beam across the main part of G4 (along with the beam continuing from G1 and G2) illustrates the original proportions of the space (see **Plate 13**). The joists running parallel with the beam with empty mortises stop at a modern beam inserted where a brick wall was taken out in the 1950s (**Plates 13 & 21**).

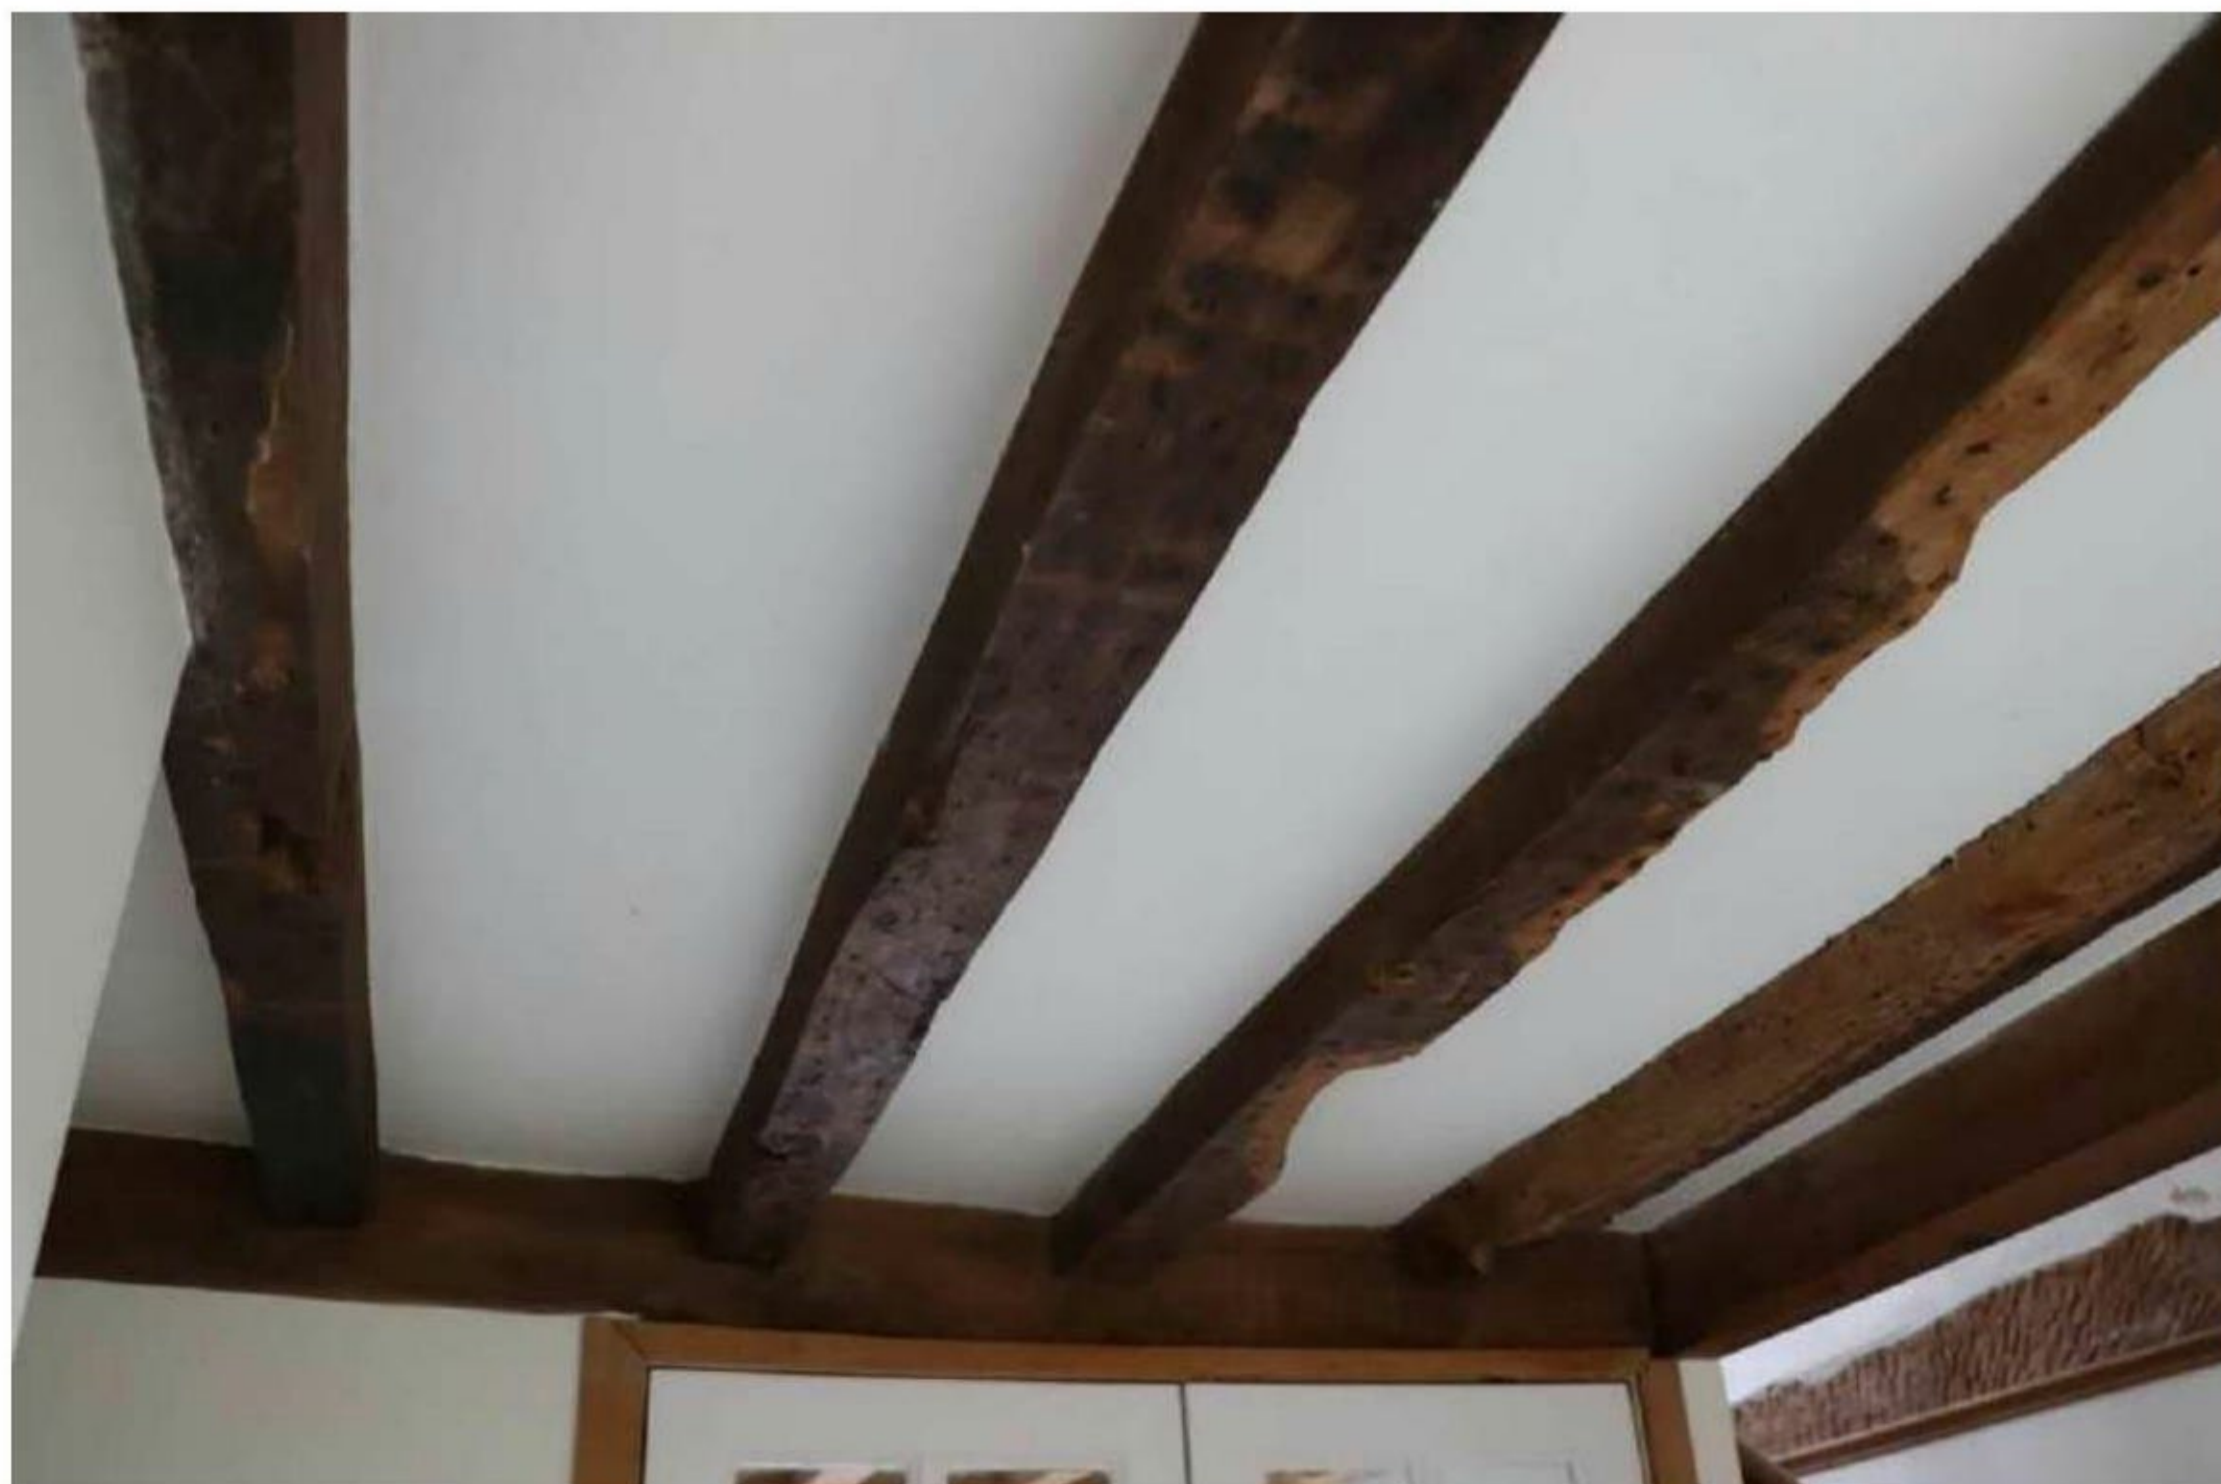
Plate 14: Surviving original joists in G2

- 3.1.15 In G2 and G4, some of the exposed joists are historic and others are 1950s' replacements (**Plate 14**). The staircase, although of the 1950s, reuses the 17th-century thick splat balusters from the original stairhead balustrade (the rest of the staircase was enclosed by brick walls; see **Photos Z-C1 & X1-A2**) and at least one, if not two of the newel posts and a section of moulded handrail, are original. The original newel type is a square profile post with linear moulding to two sides, and a polyhedron finial (**Plates 15-18**).
