STATEMENT OF SIGNIFICANCE

**Flood Street Farm,
Breamore, Hampshire**

AHC REF: 9943

Date: April 2021

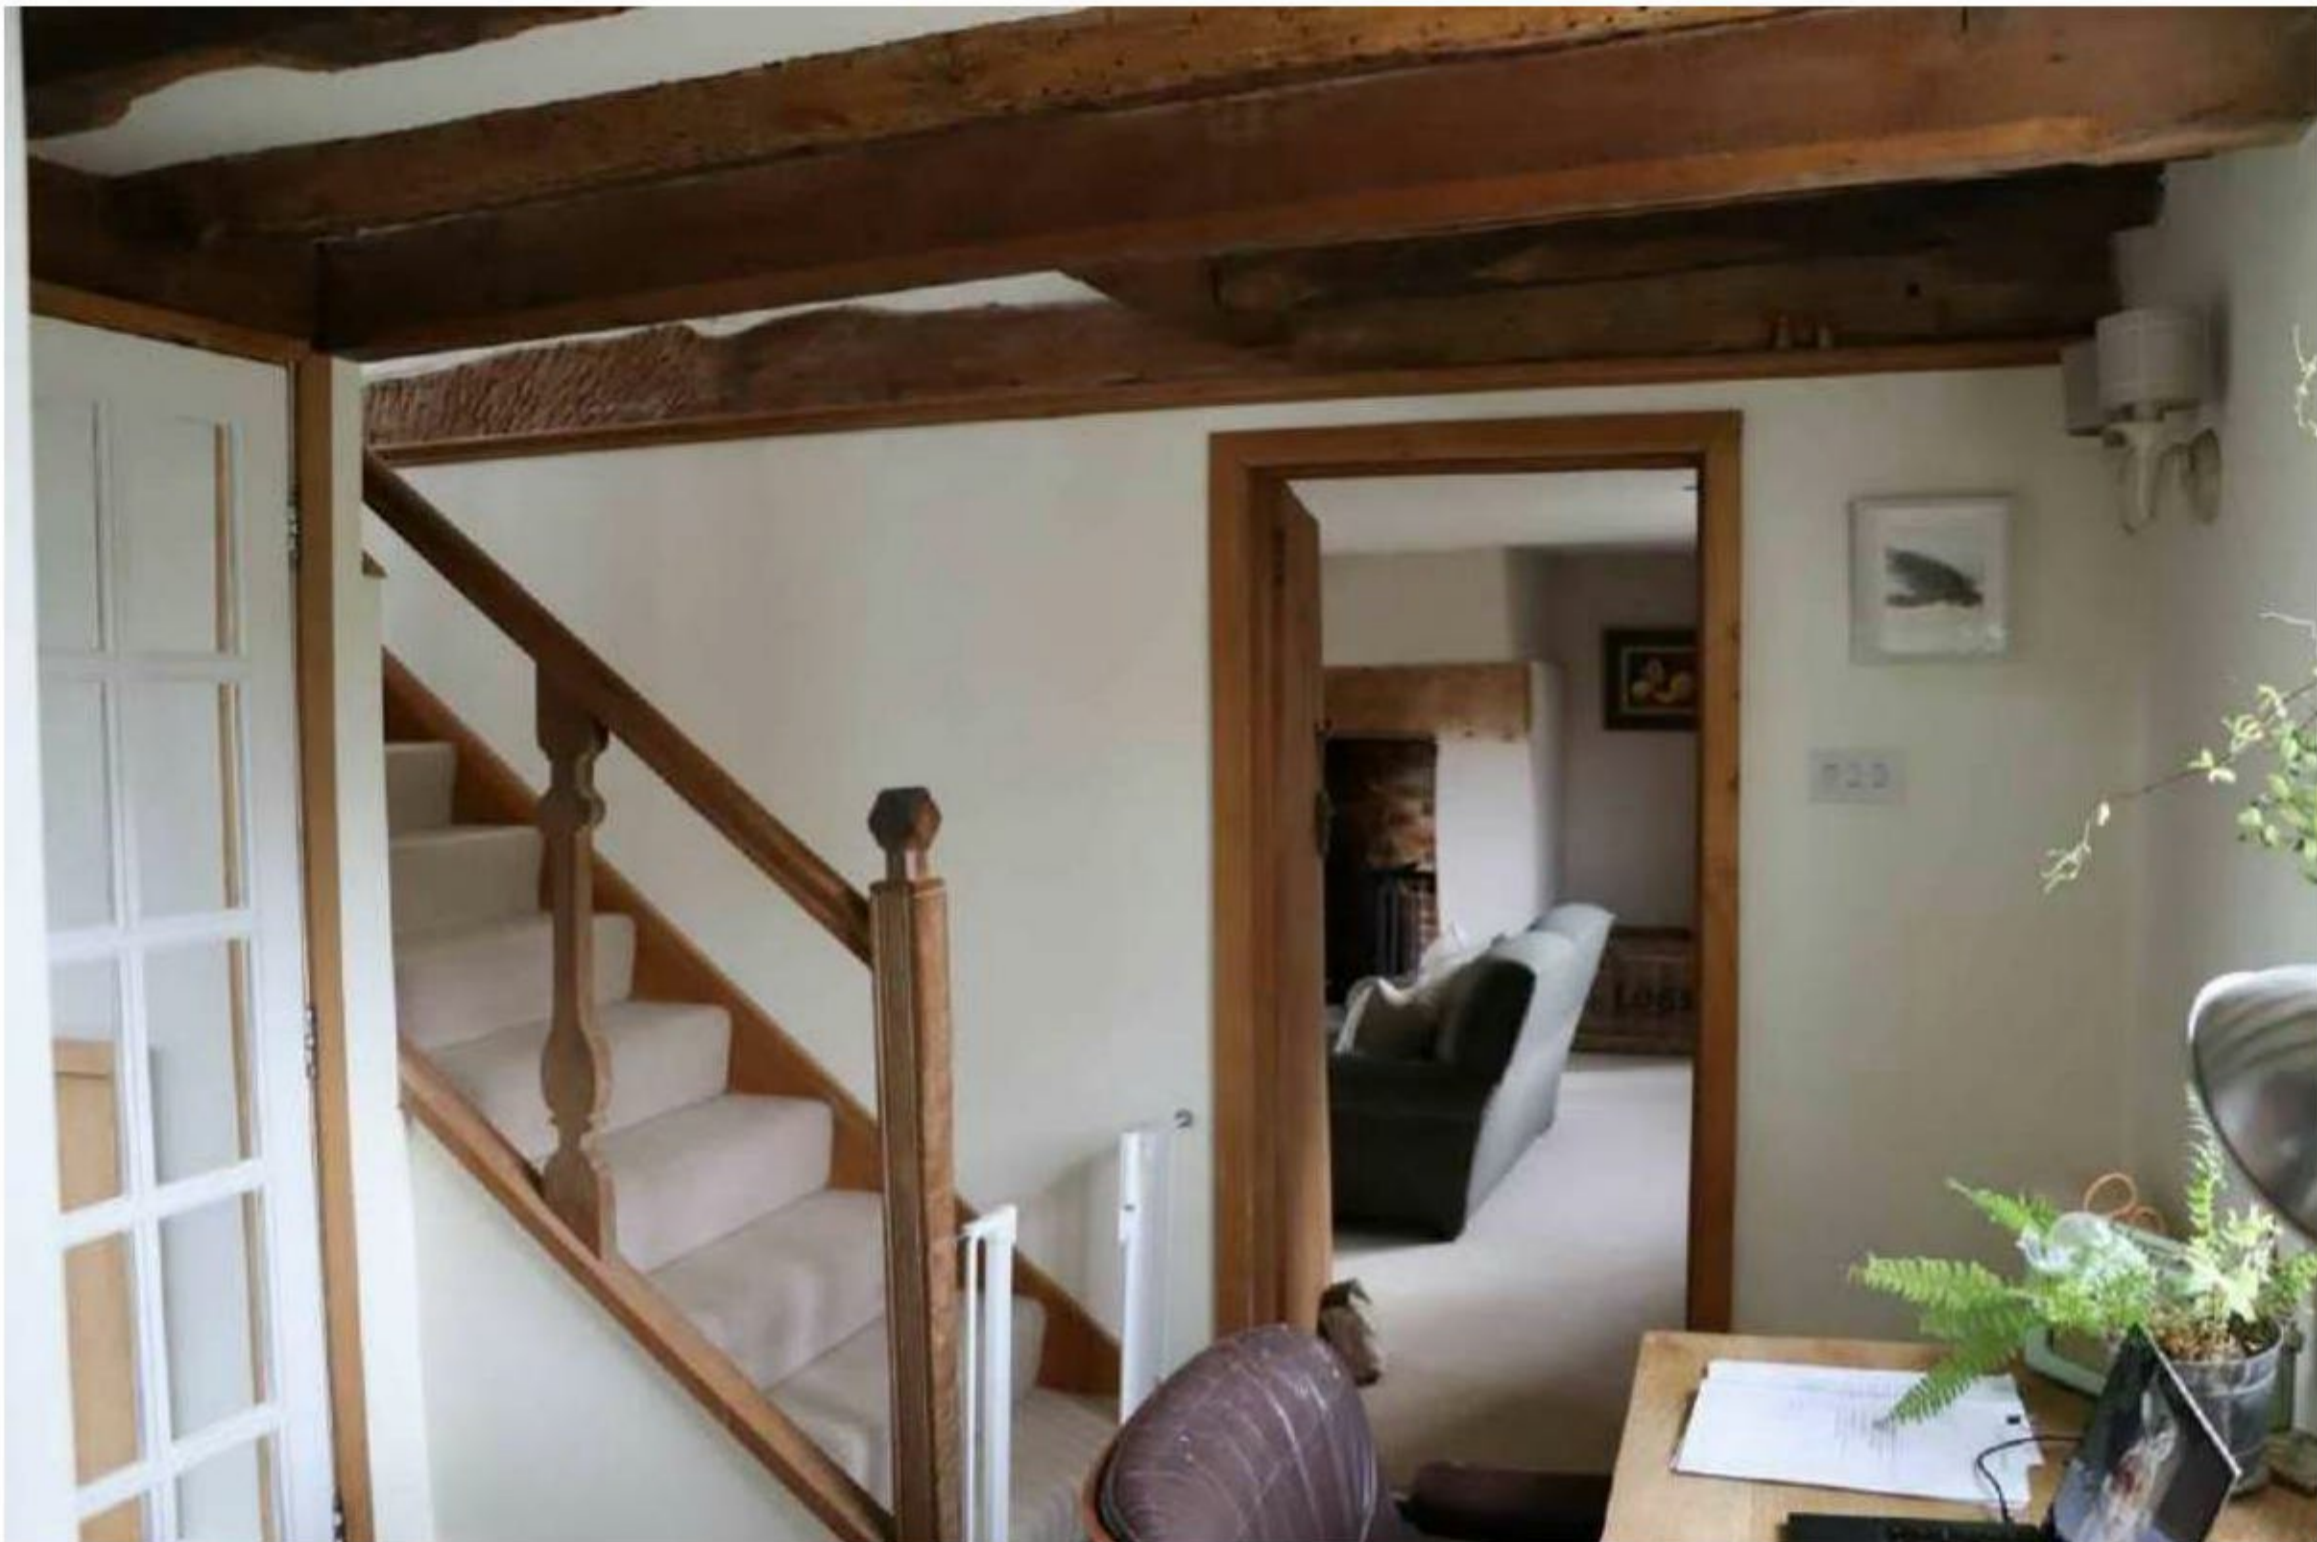
Plate 15: G2, looking towards 1950s' staircase (the newel may be original) and concrete blockwork dividing wall with G3

- 3.1.15 In G2 and G4, some of the exposed joists are historic and others are 1950s' replacements (**Plate 14**). The staircase, although of the 1950s, reuses the 17th-century thick splat balusters from the original stairhead balustrade (the rest of the staircase was enclosed by brick walls; see **Photos Z-C1 & X1-A2**) and at least one, if not two of the newel posts and a section of moulded handrail, are original. The original newel type is a square profile post with linear moulding to two sides, and a polyhedron finial (**Plates 15-18**).

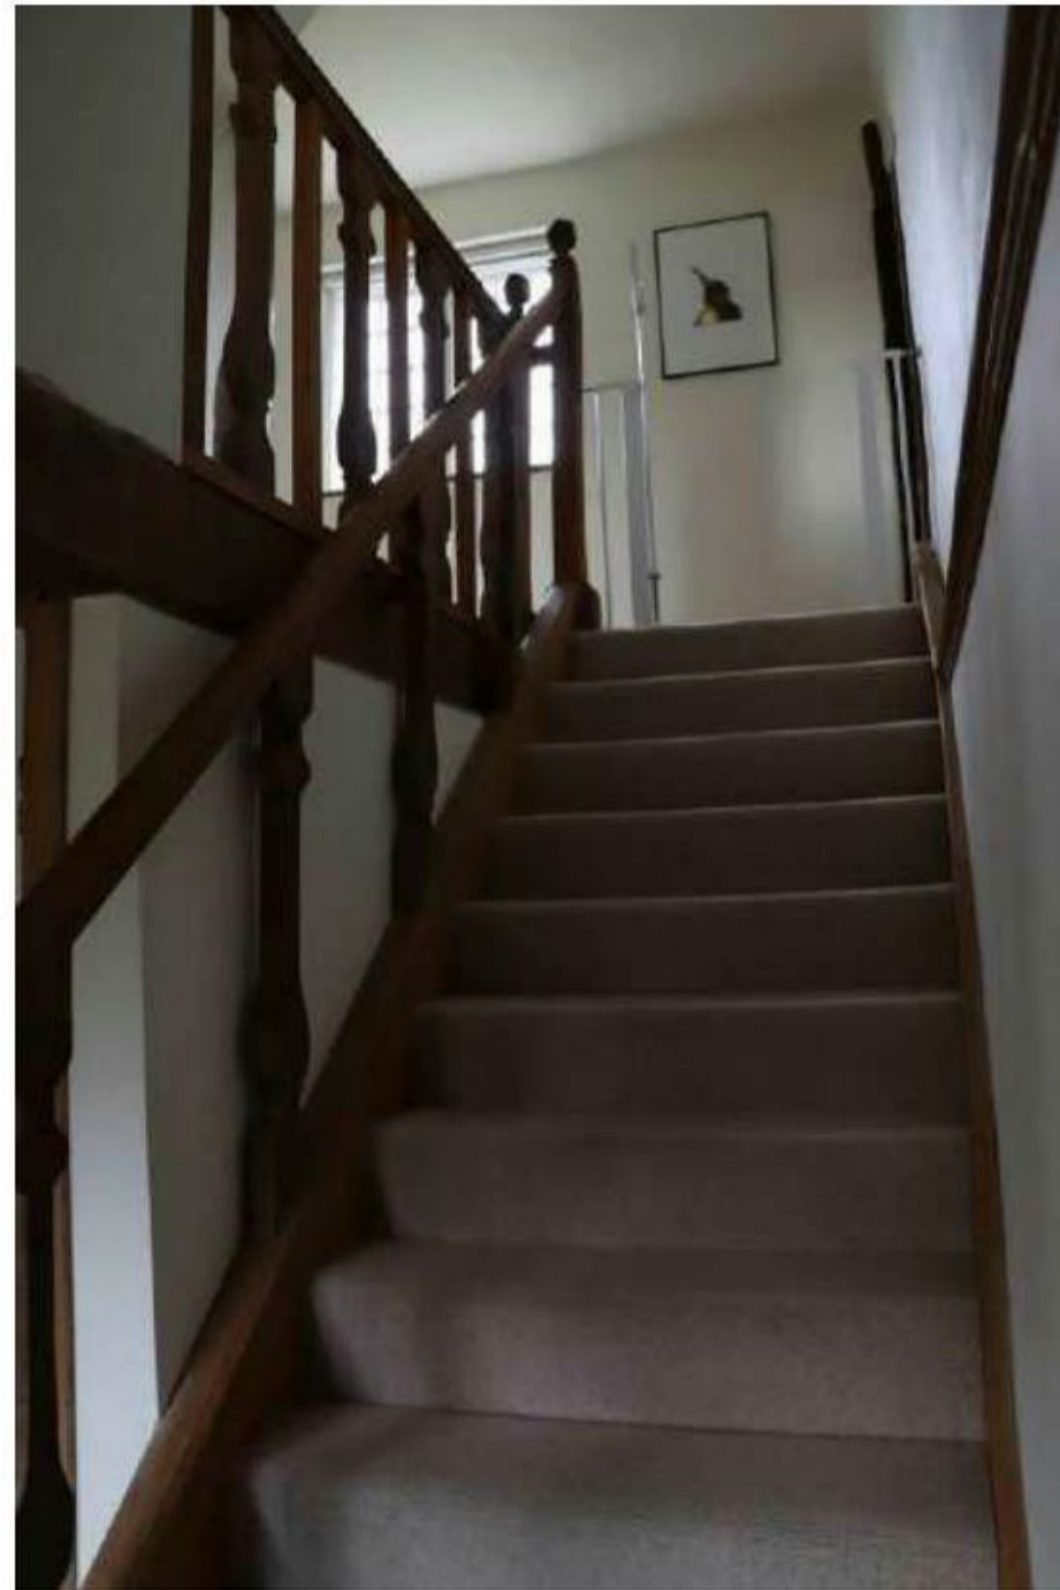
Plate 16: The 1950s' staircase to the first floor; note reused 17th-century splat balusters

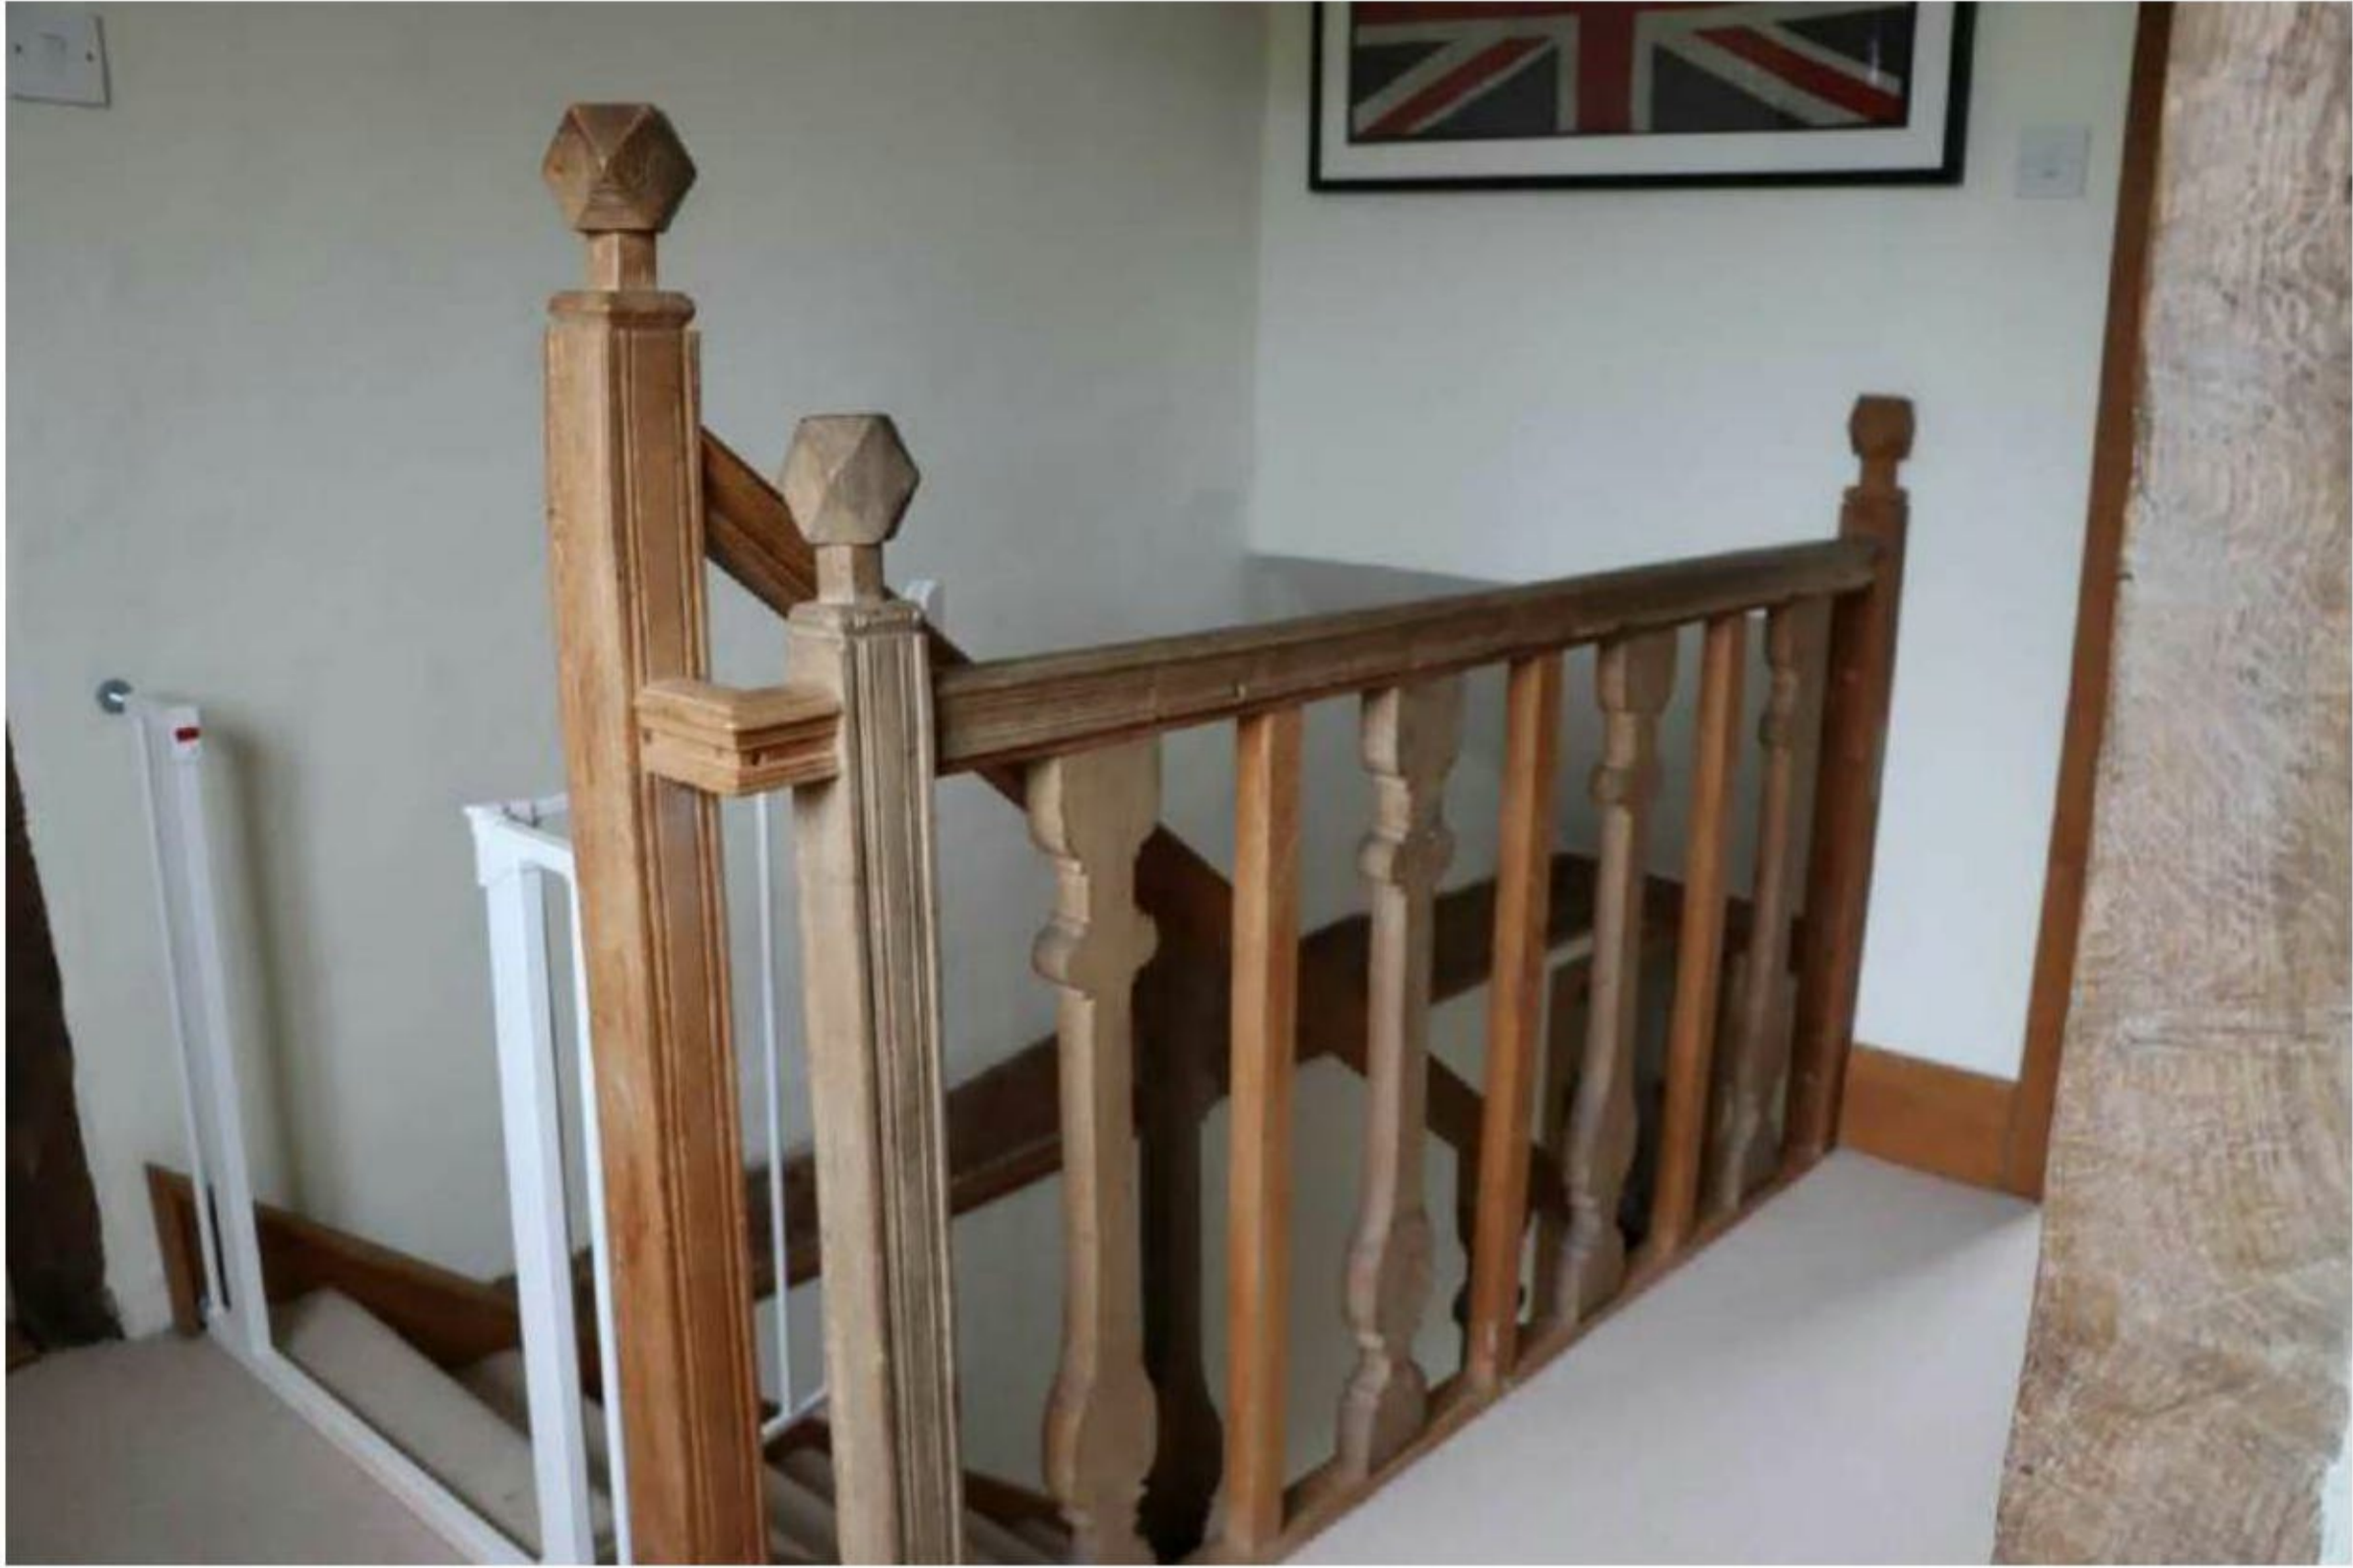
Plate 17: F1 (first-floor landing): note original newel and taller replica, original section of handrail and splat balusters

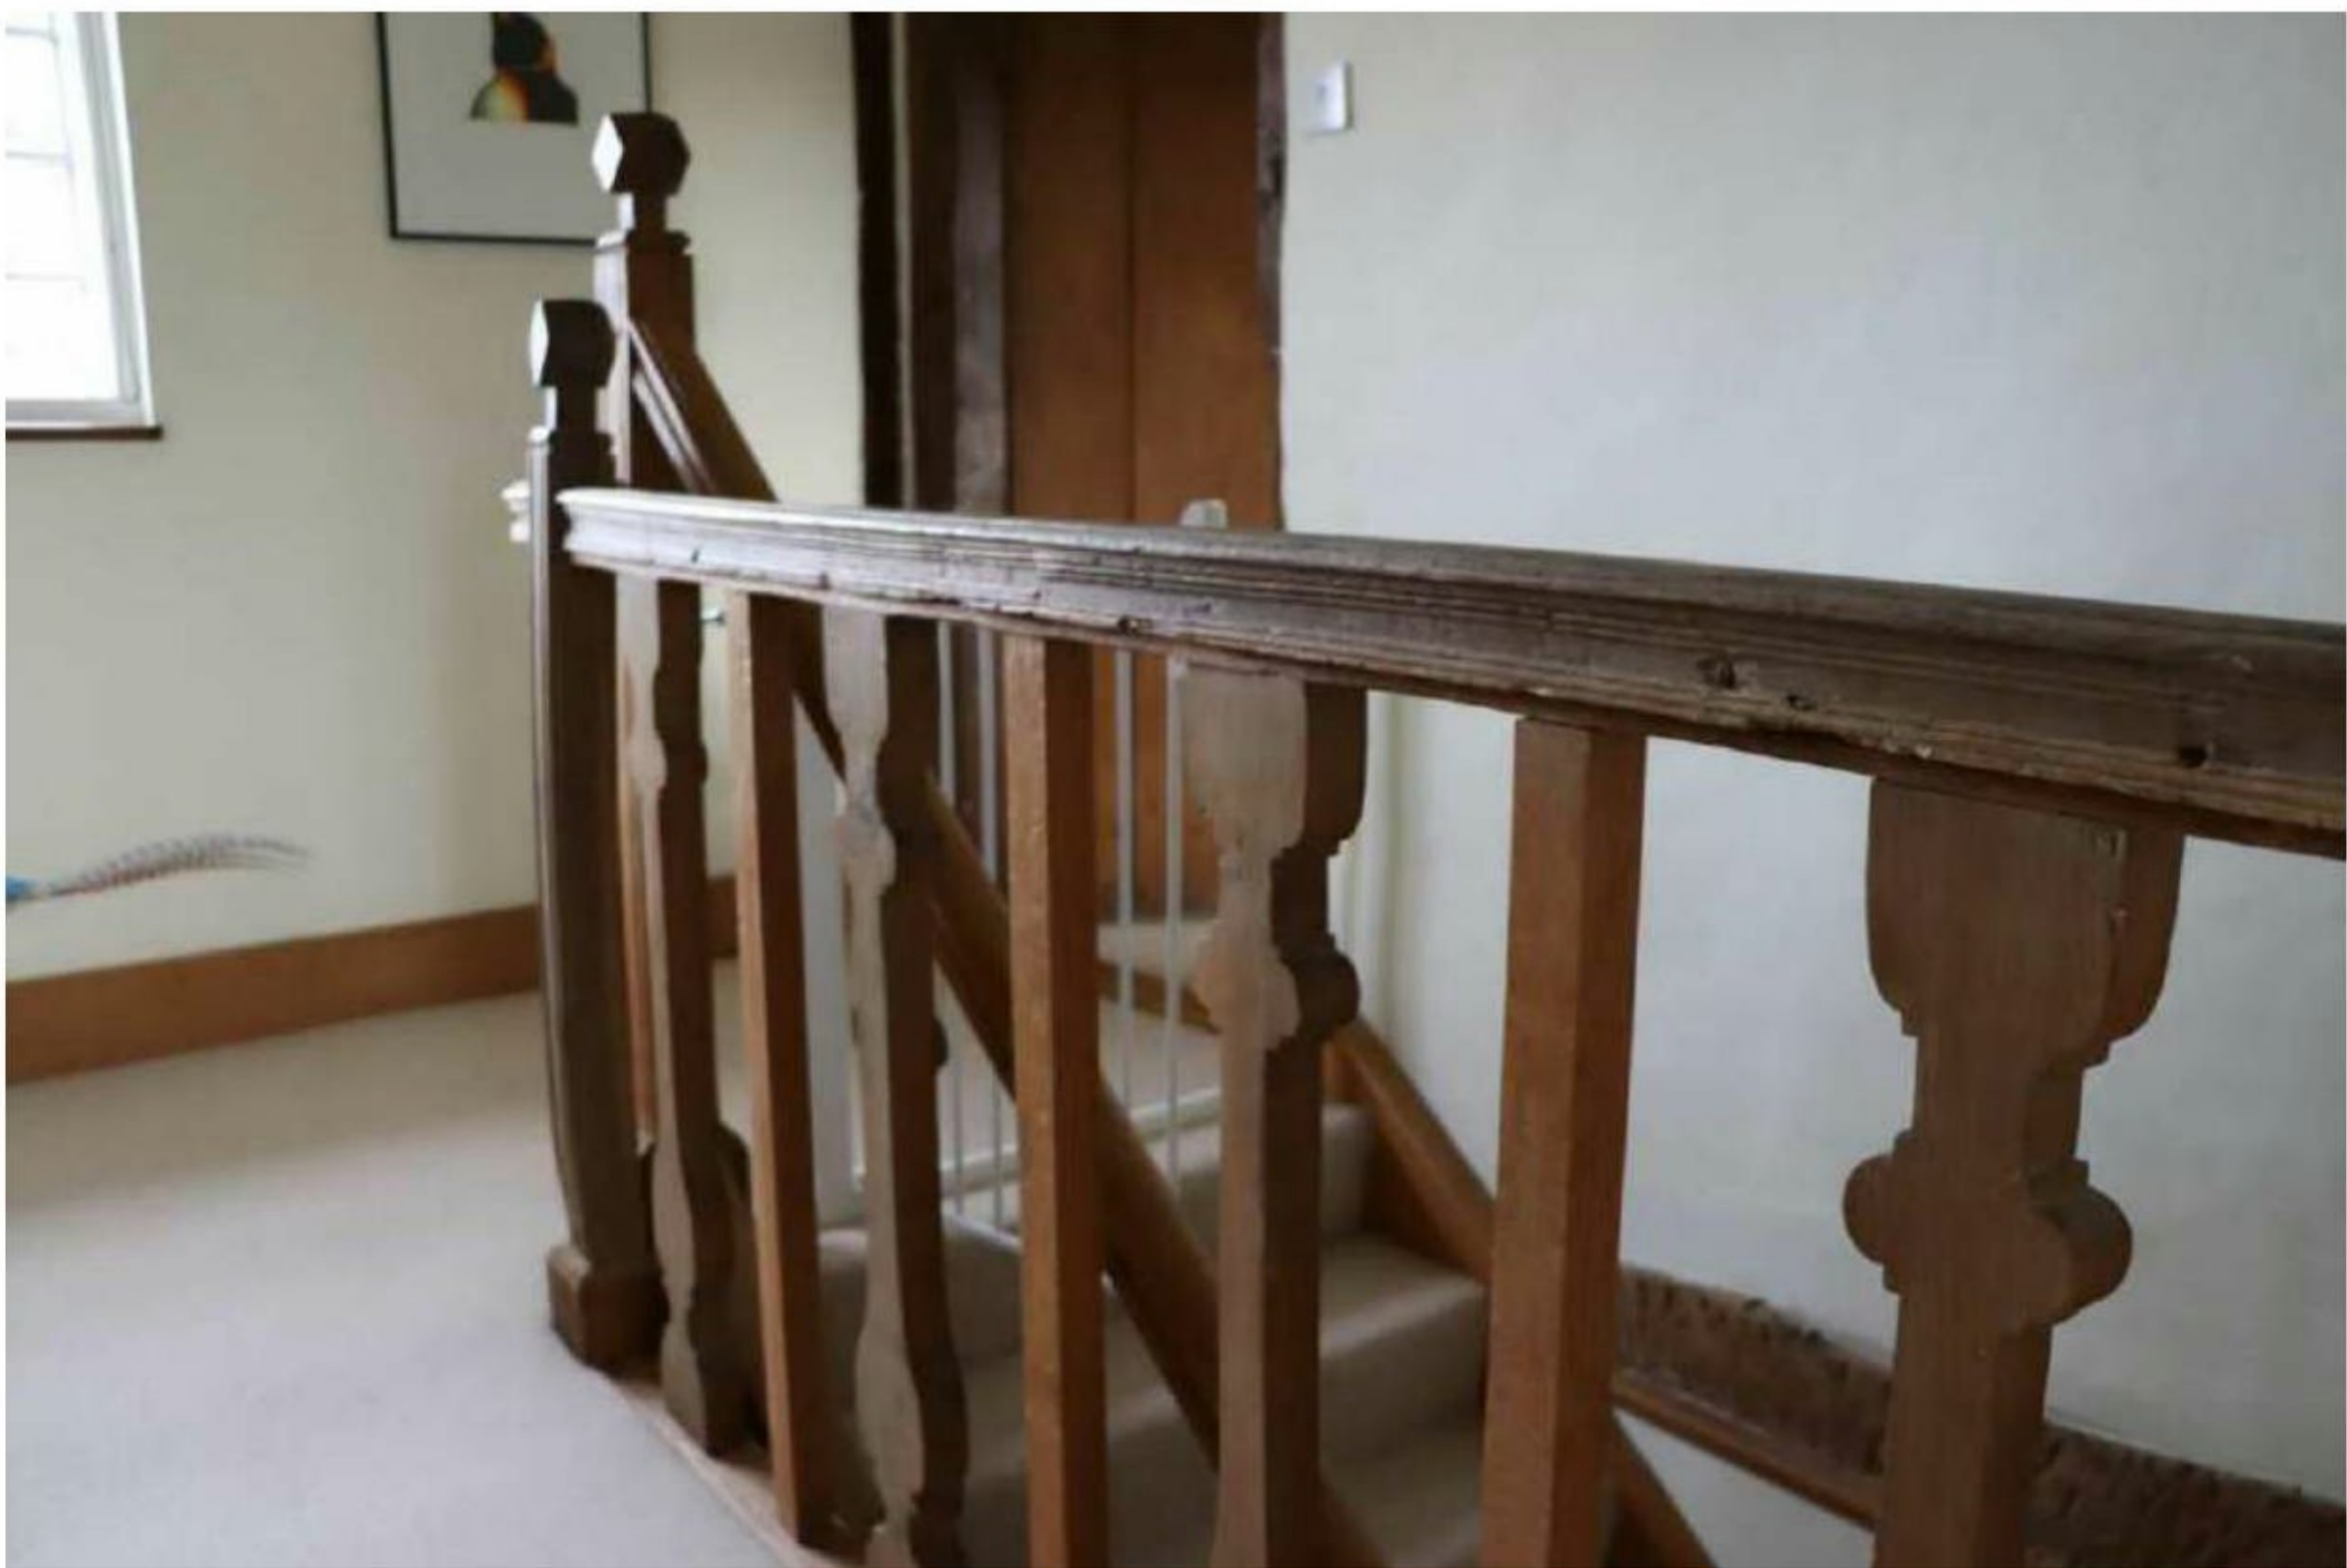
Plate 18: Original section of handrail, newel and splat balusters

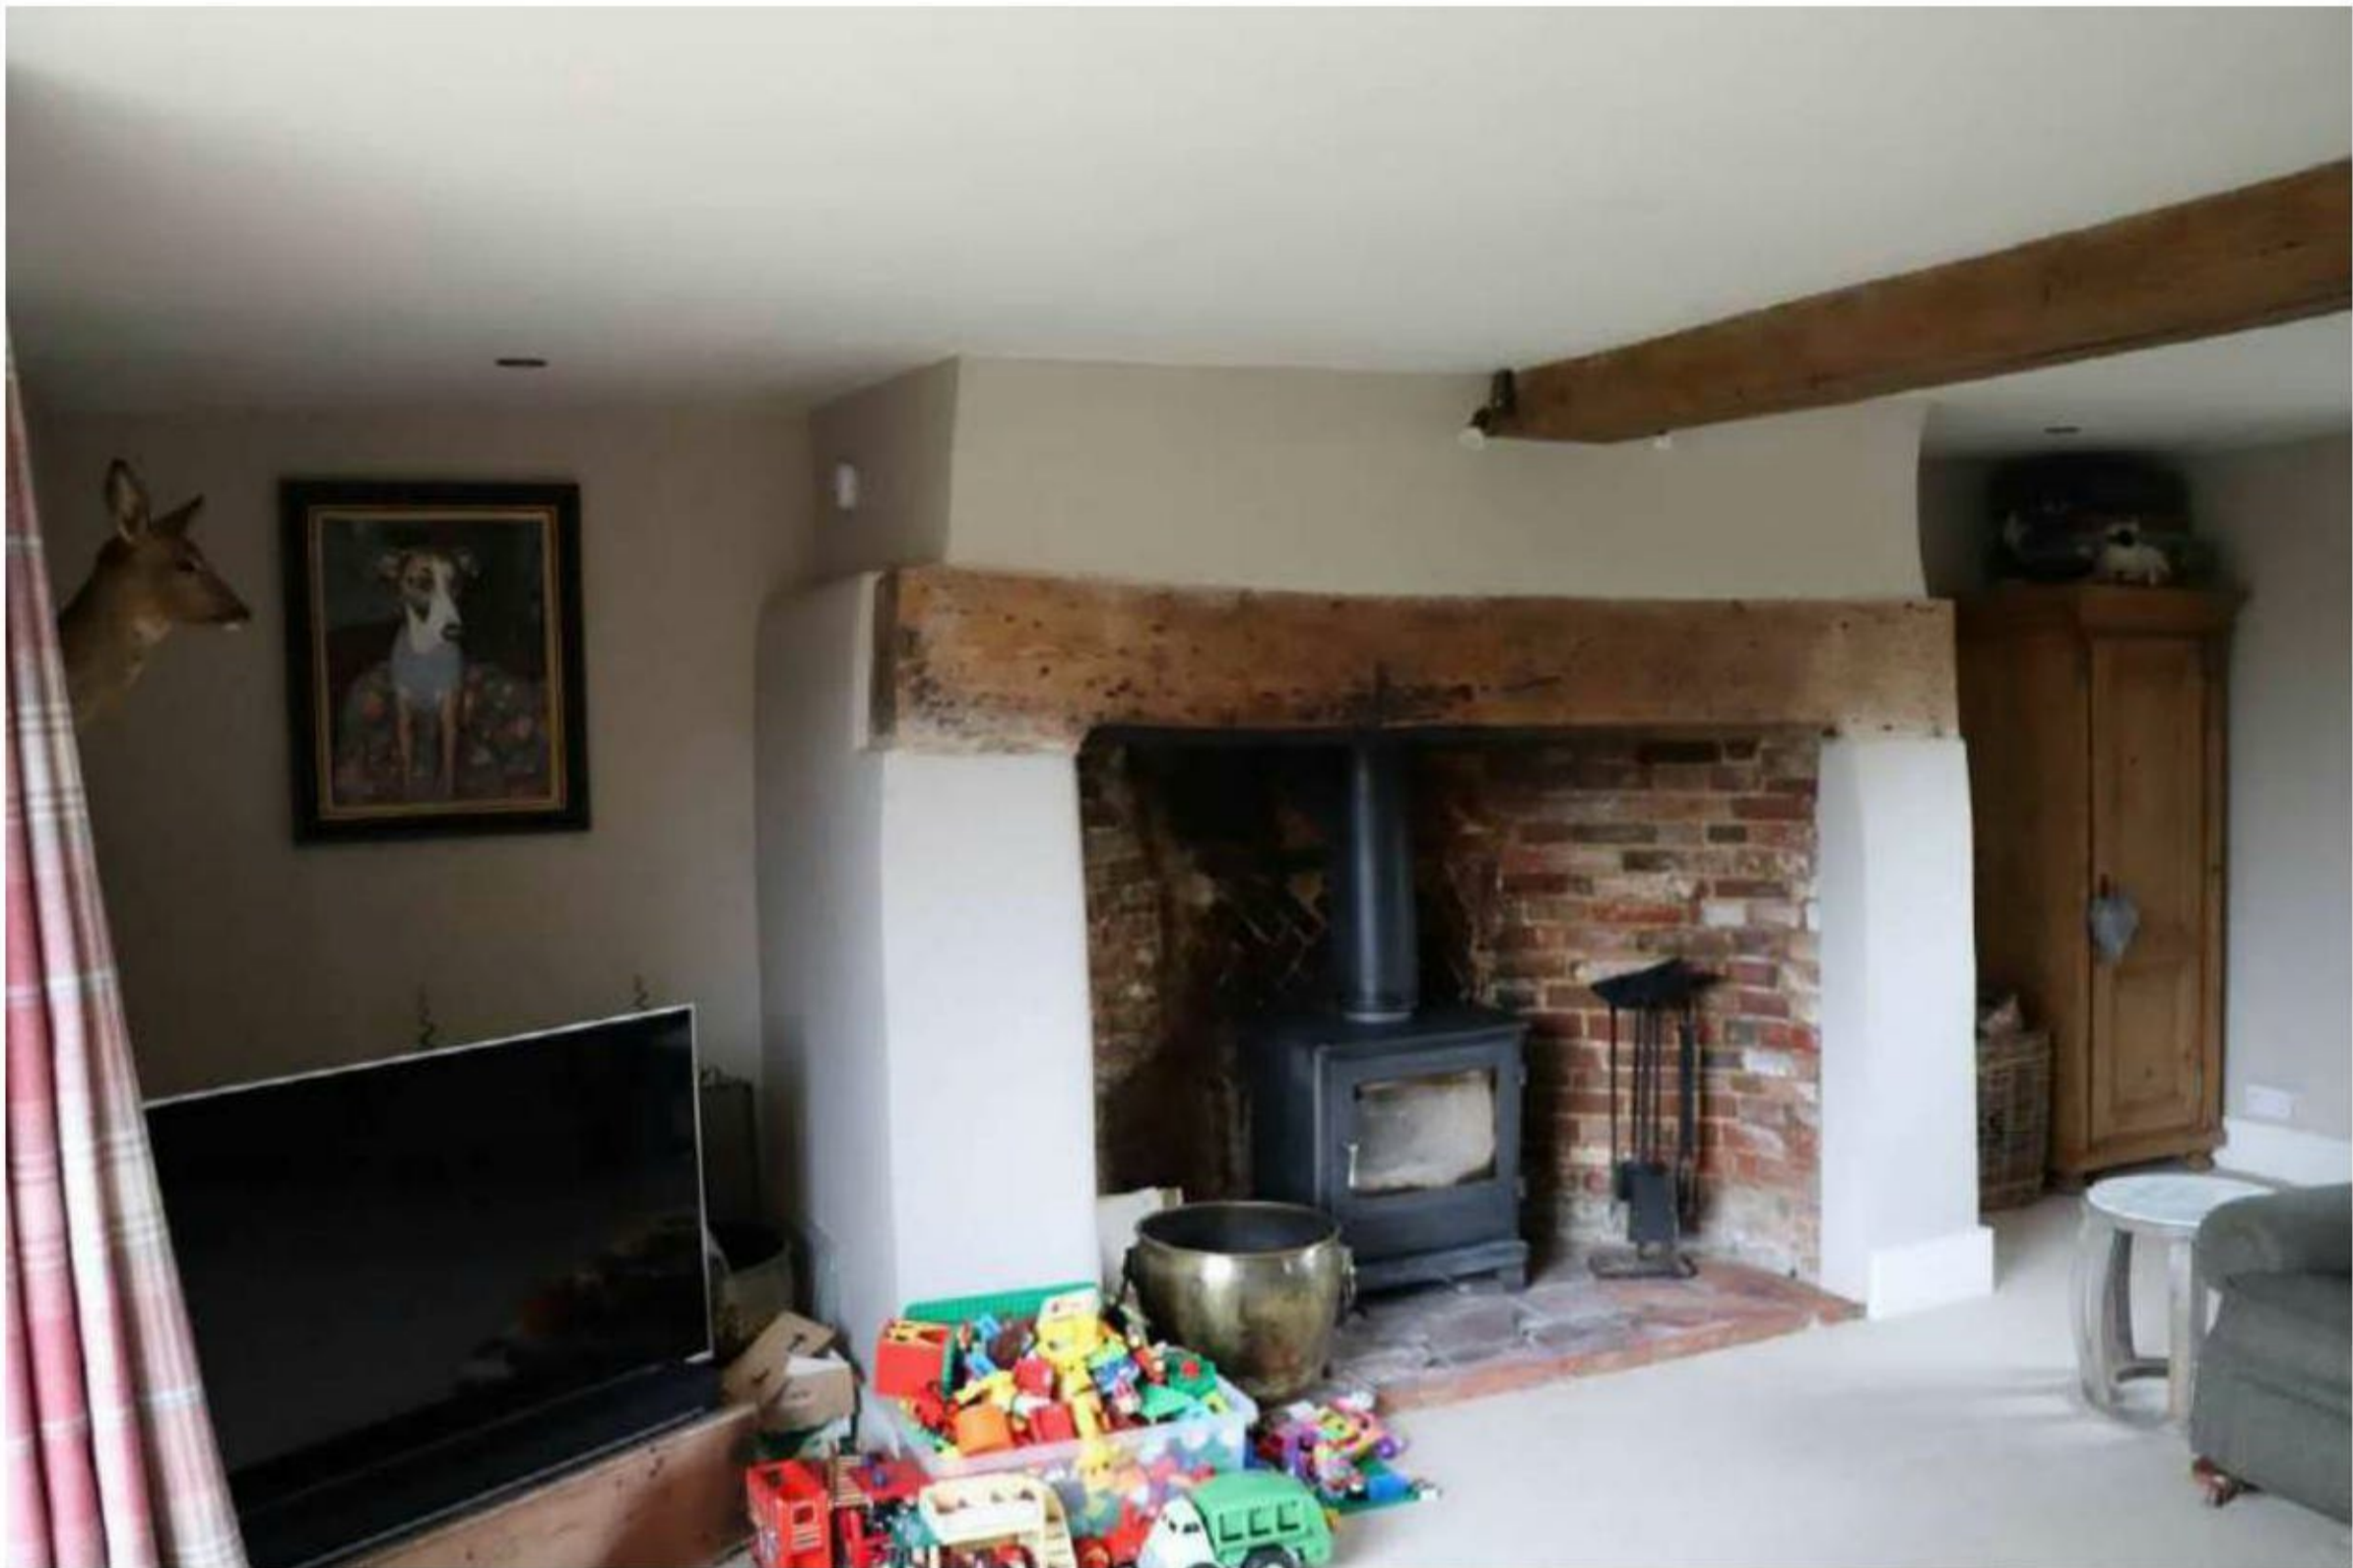
Plate 19: Reopened inglenook on SW wall of G3

up. In 1957, this wall was taken out and the large inglenook fireplace was reopened (**Plate 19; Photos H1-I1**). The chamfered and stopped beam across G3 (**Plate 20**) appears to be original and indicates the original proportions of this room, which were retained even though the wall dividing it from the staircase is a blockwork wall of 1950s' date (**Photos L1 & O1** shows how this beam was supported by a prop during the rebuilding of the wall).

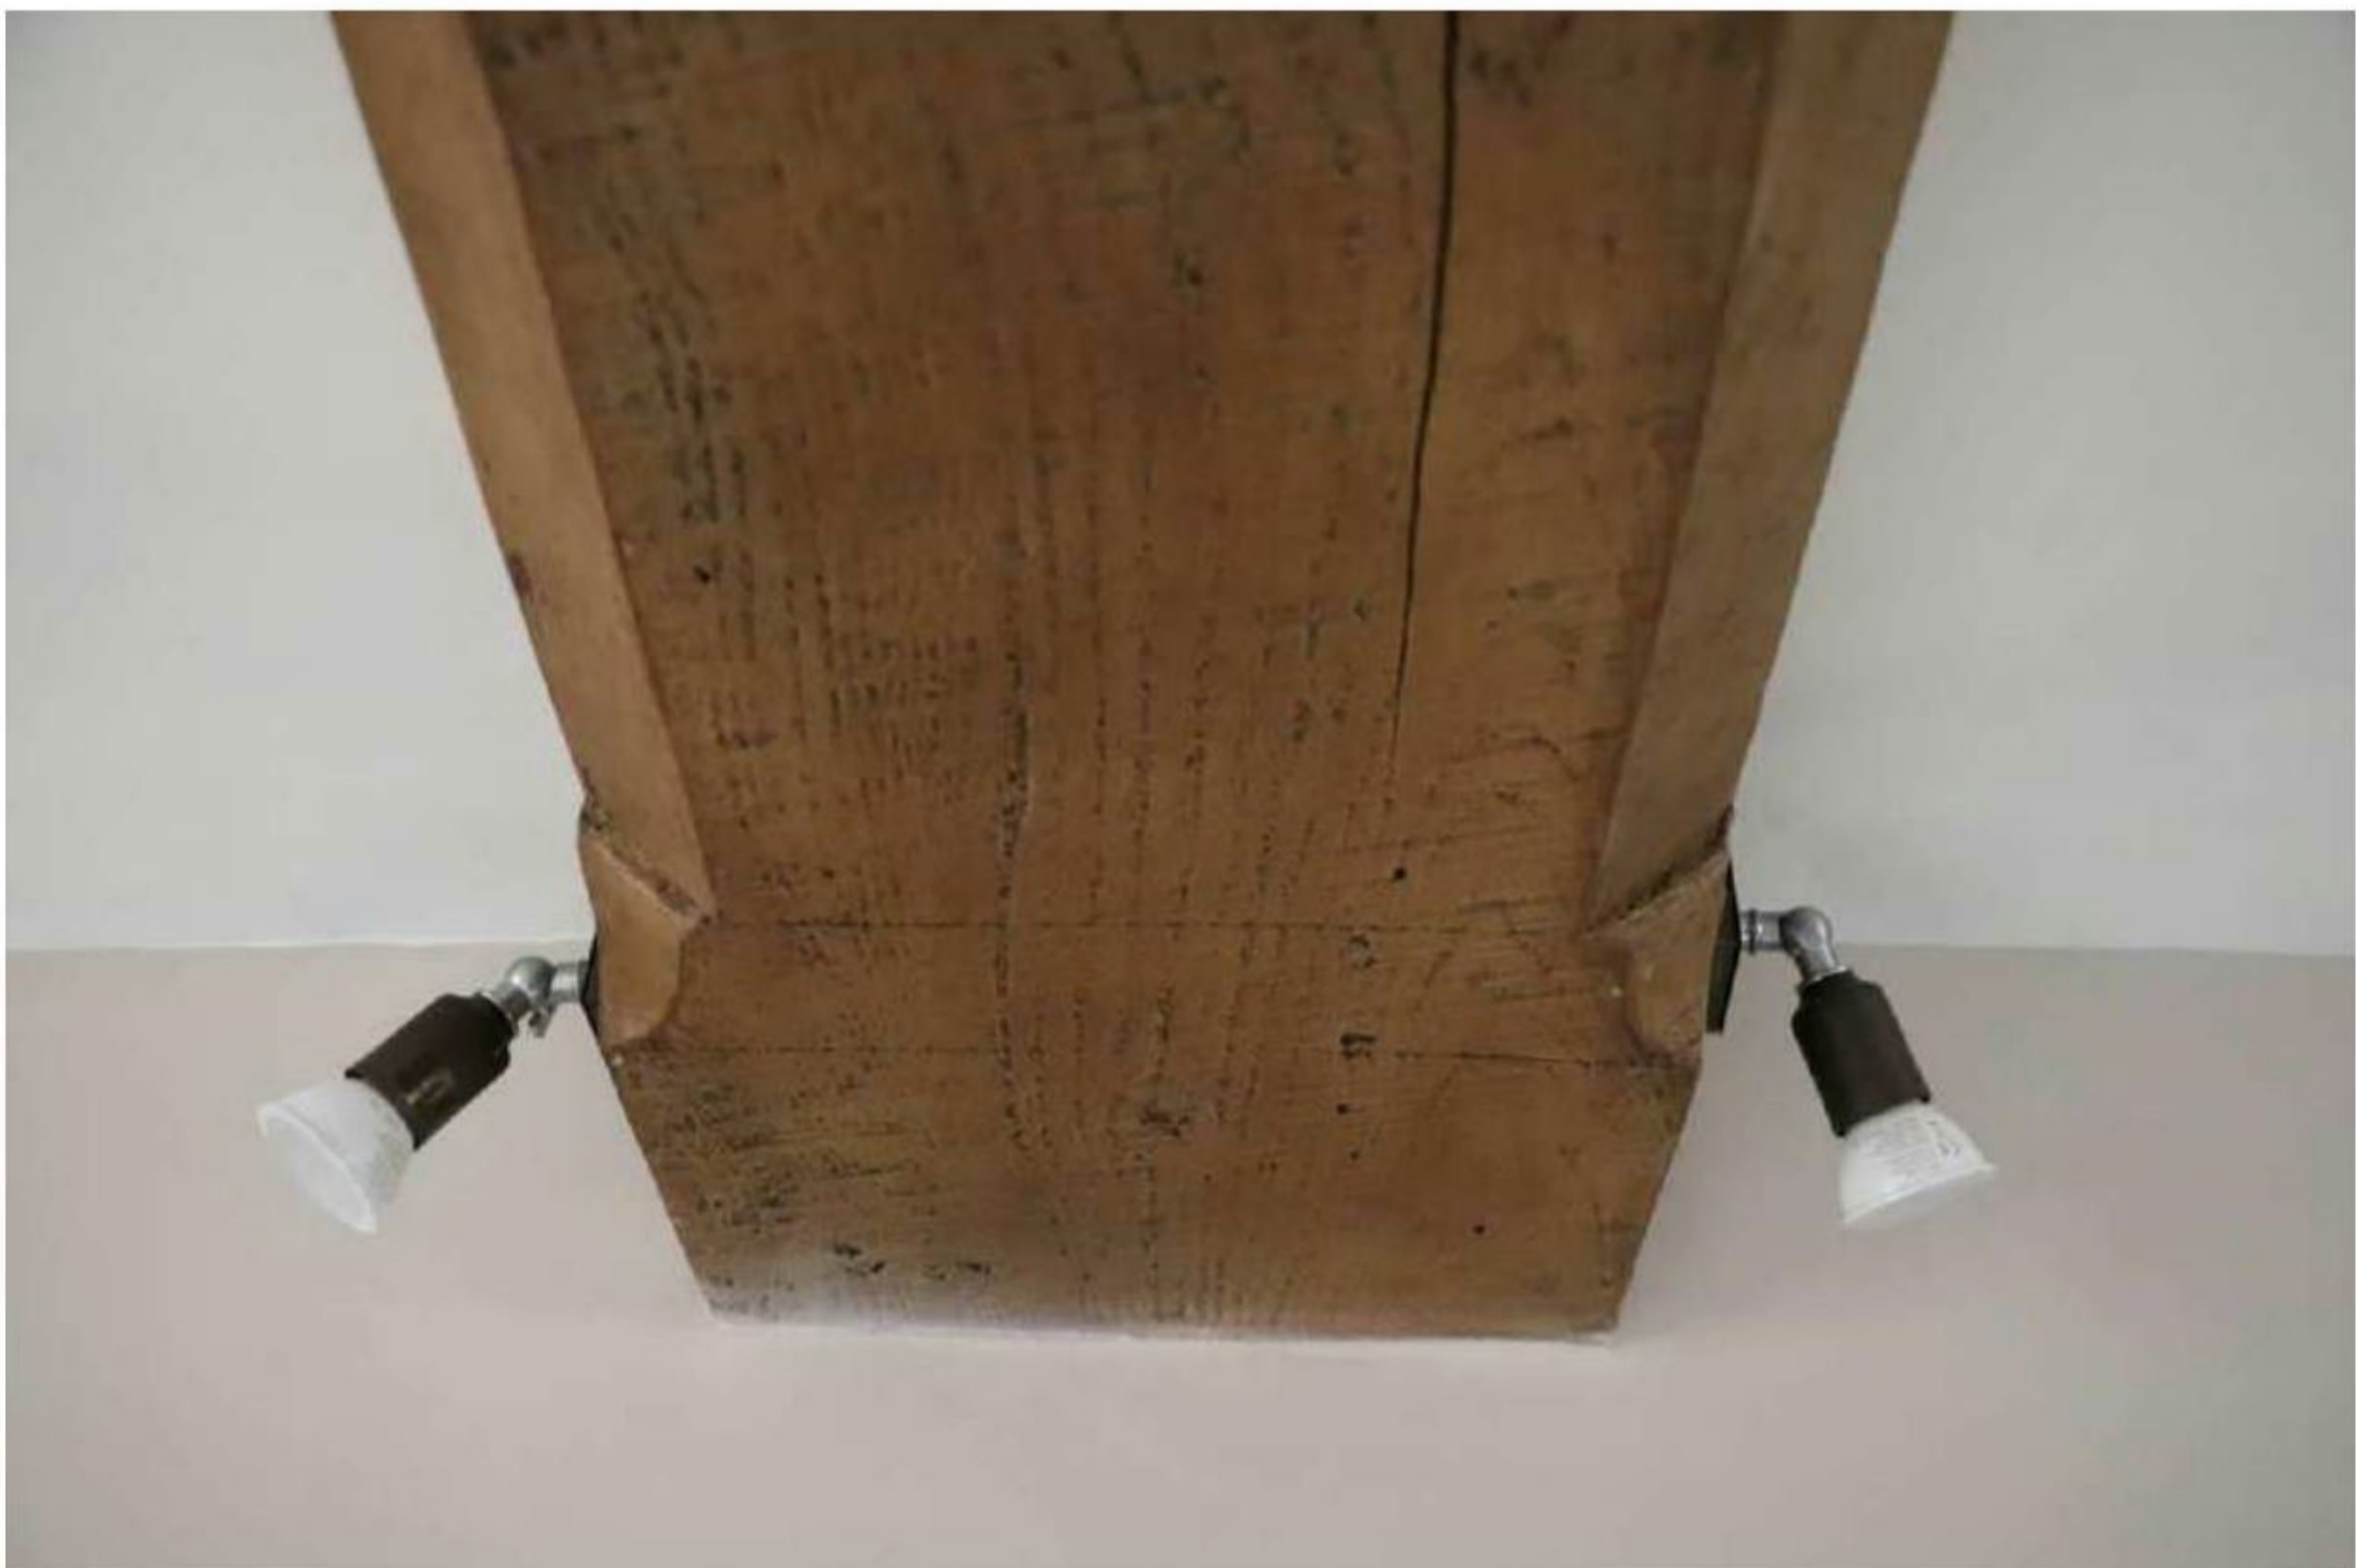
Plate 20: Chamfer stops to beam in G3
