STATEMENT OF SIGNIFICANCE

**Flood Street Farm,
Breamore, Hampshire**

AHC REF: 9943

Date: April 2021

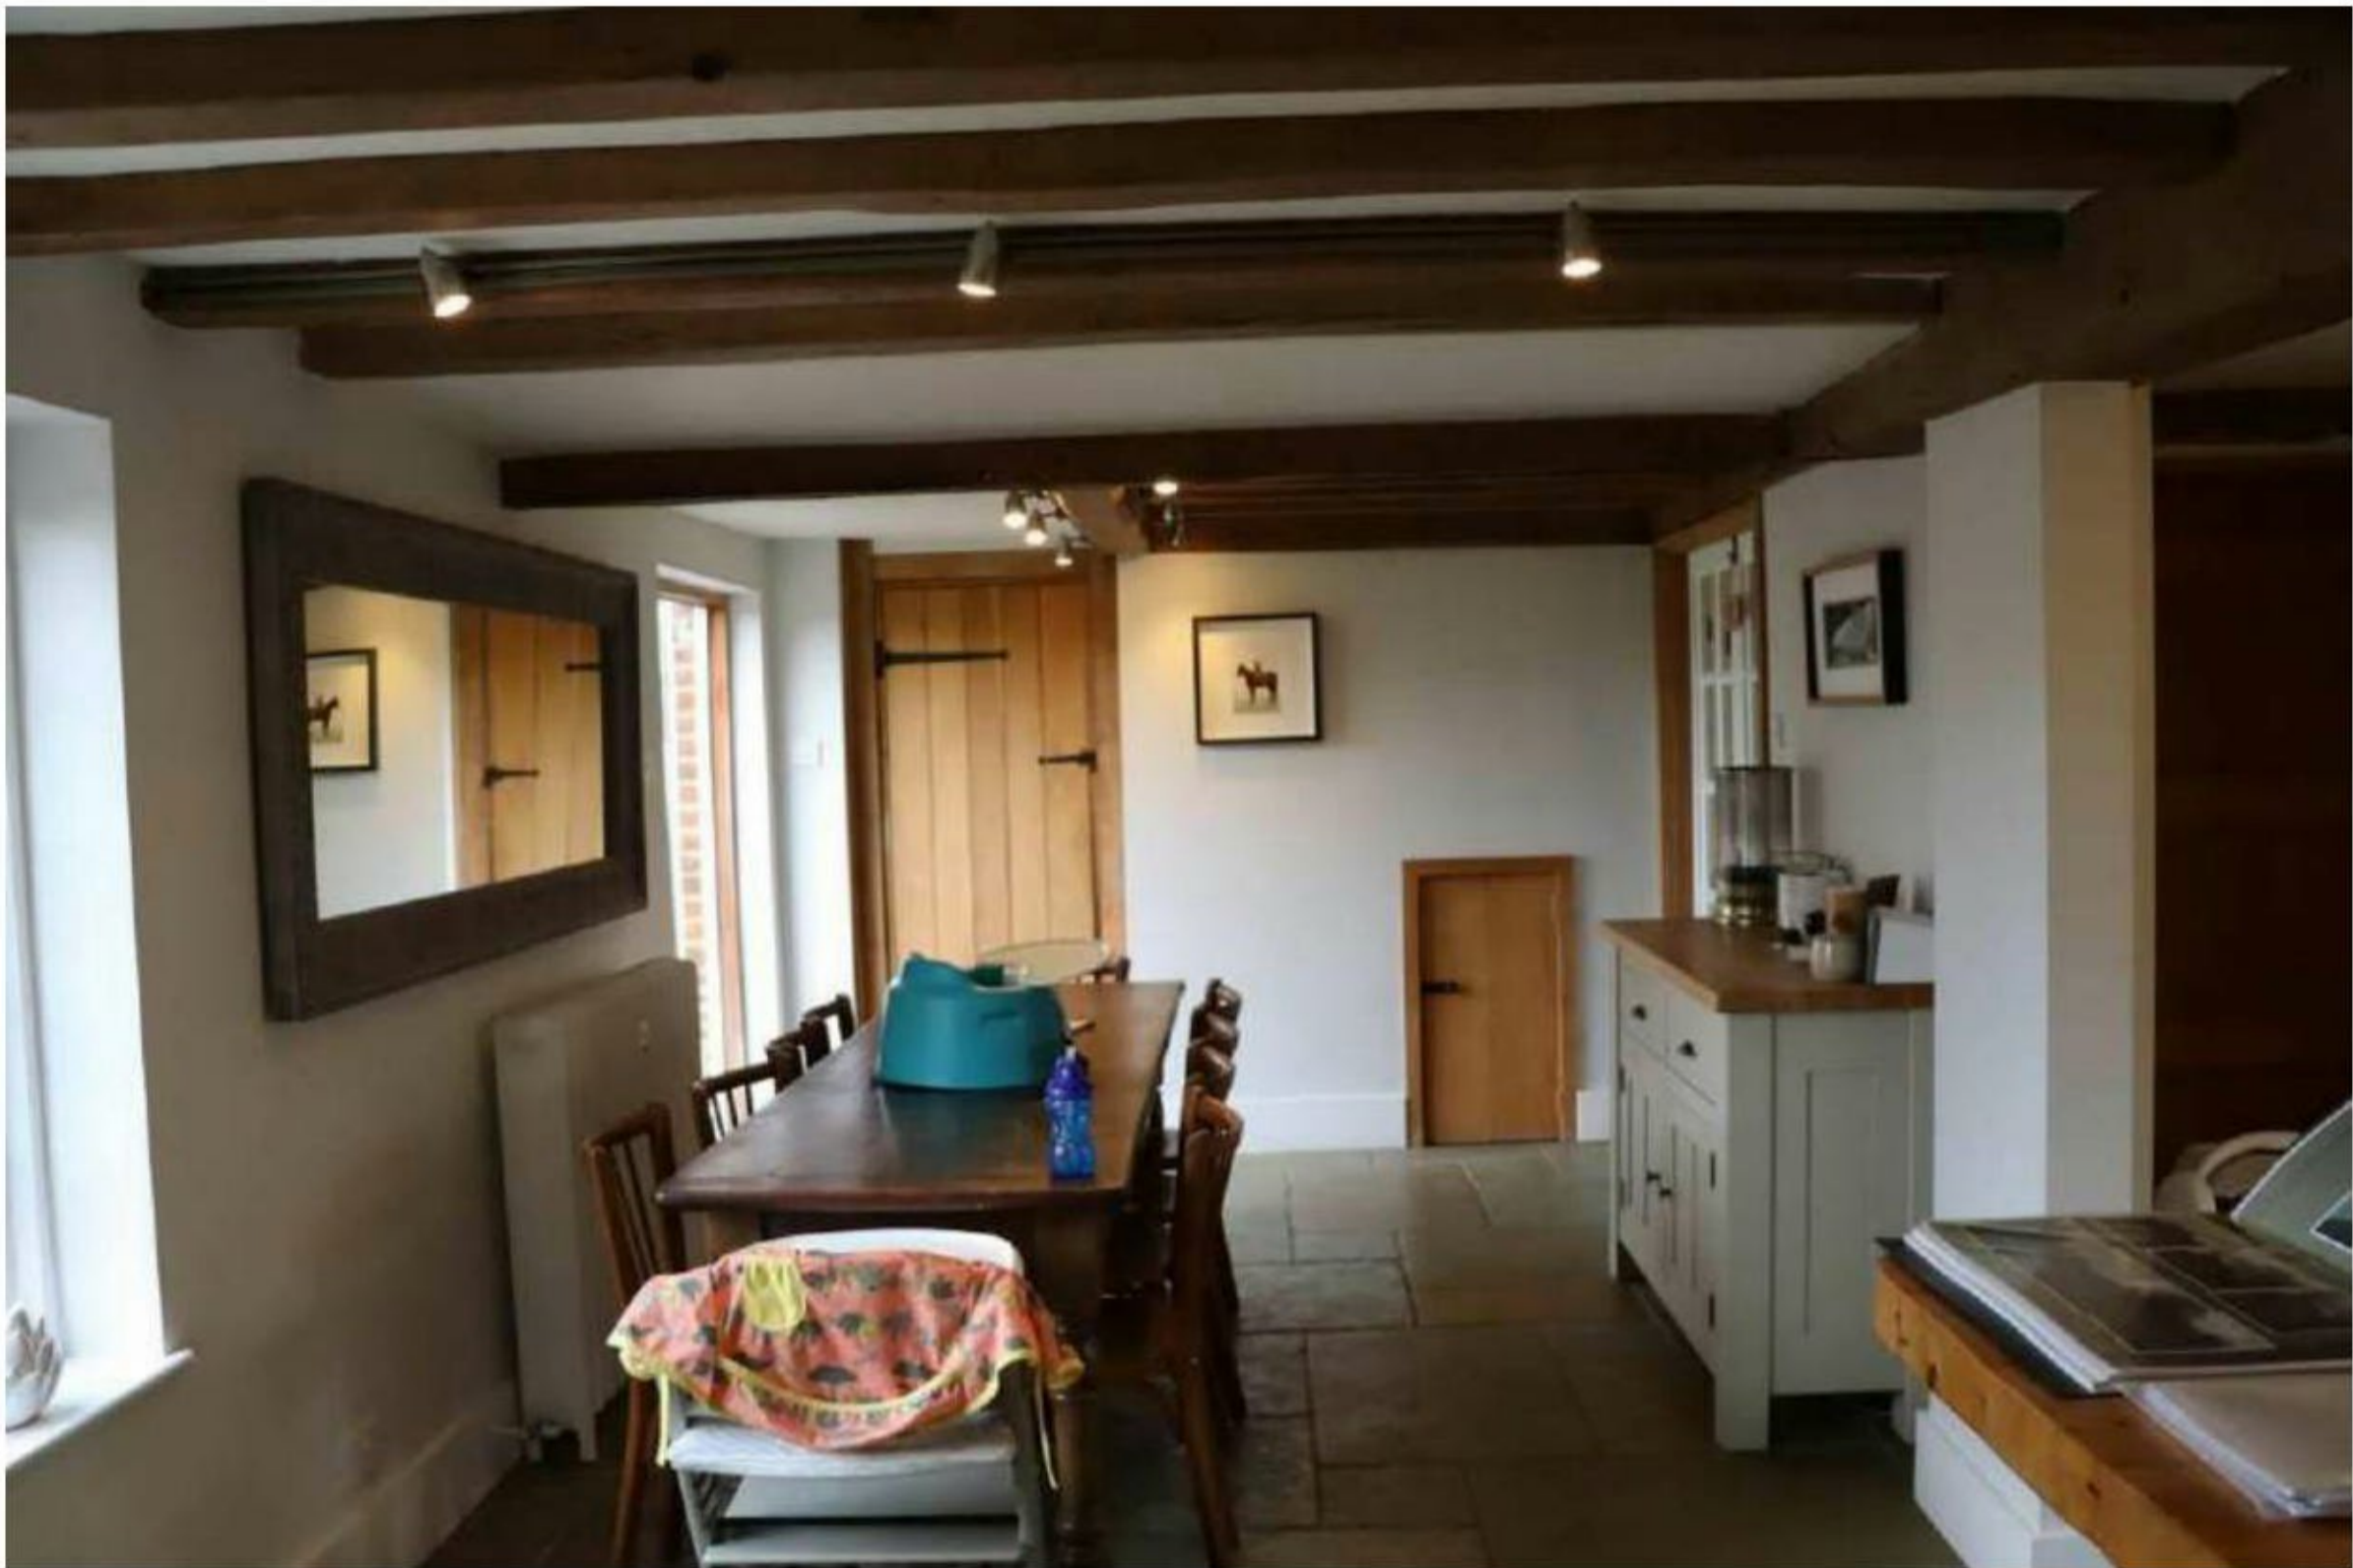
Plate 21: G4, looking SW into area within central bay, formerly divided from G4 by a timber-framed wall

3.1.17 In G4, the chamfered and stopped beam across the main part of G4 (along with the beam continuing from G1 and G2) illustrates the original proportions of the space (see **Plate 13**). The joists running parallel with the beam with empty mortises stop at a modern beam inserted where a brick wall was taken out in the 1950s (**Plates 13 & 21**).

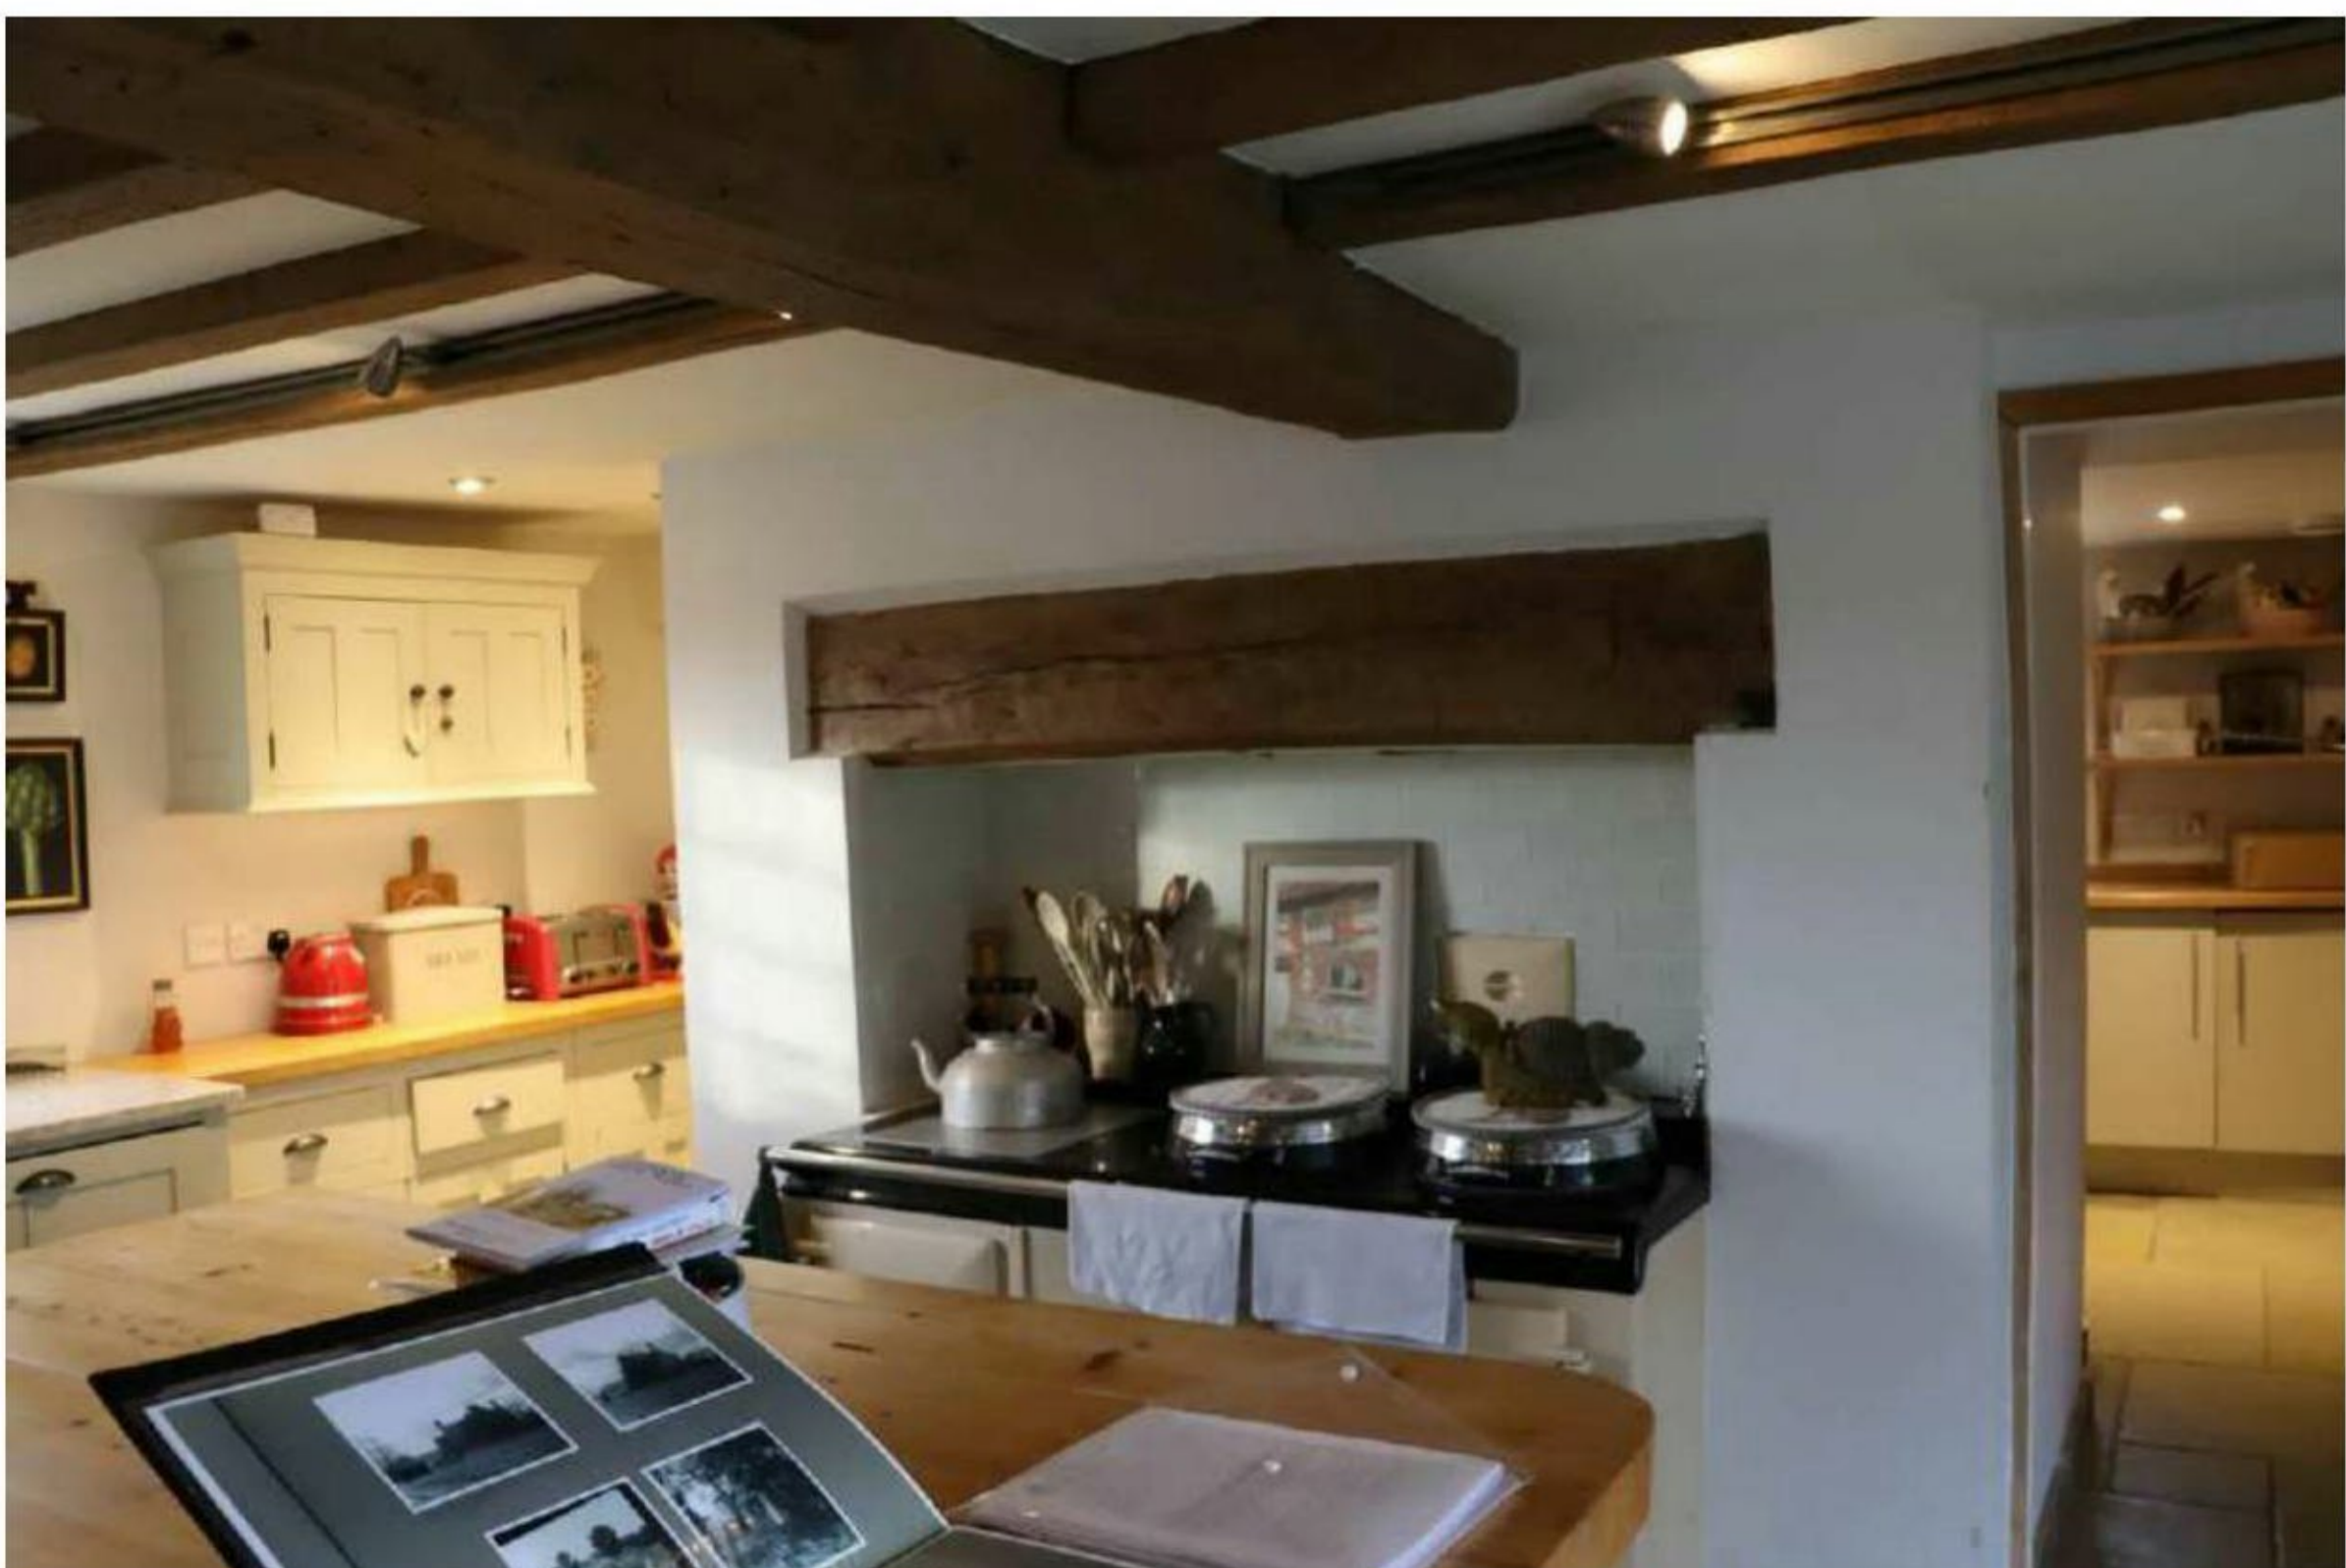
Plate 22: G4, with fireplace on NE wall. Door opening to right formed in 1957

3.1.18 The original doorway into the brewhouse has been infilled to create a recess and cupboard and a new one opened up directly adjoining the fireplace (**Plate 22**). The Aga range appears to be the same one inserted in the 1950s (see **Photo N1**). The bread oven marked on the 1956 plan to left of the fireplace was taken out and a door opening has been made through here into a pantry (G5) in the brewhouse addition (**Plate 23** and see **Photos Q1-U1**). In G6 (also in the brewhouse), the fireplace has survived, but the copper and stone sink referred to by the Dodgsons as being in this part of the building were presumably taken out by them (**Plate 24**).

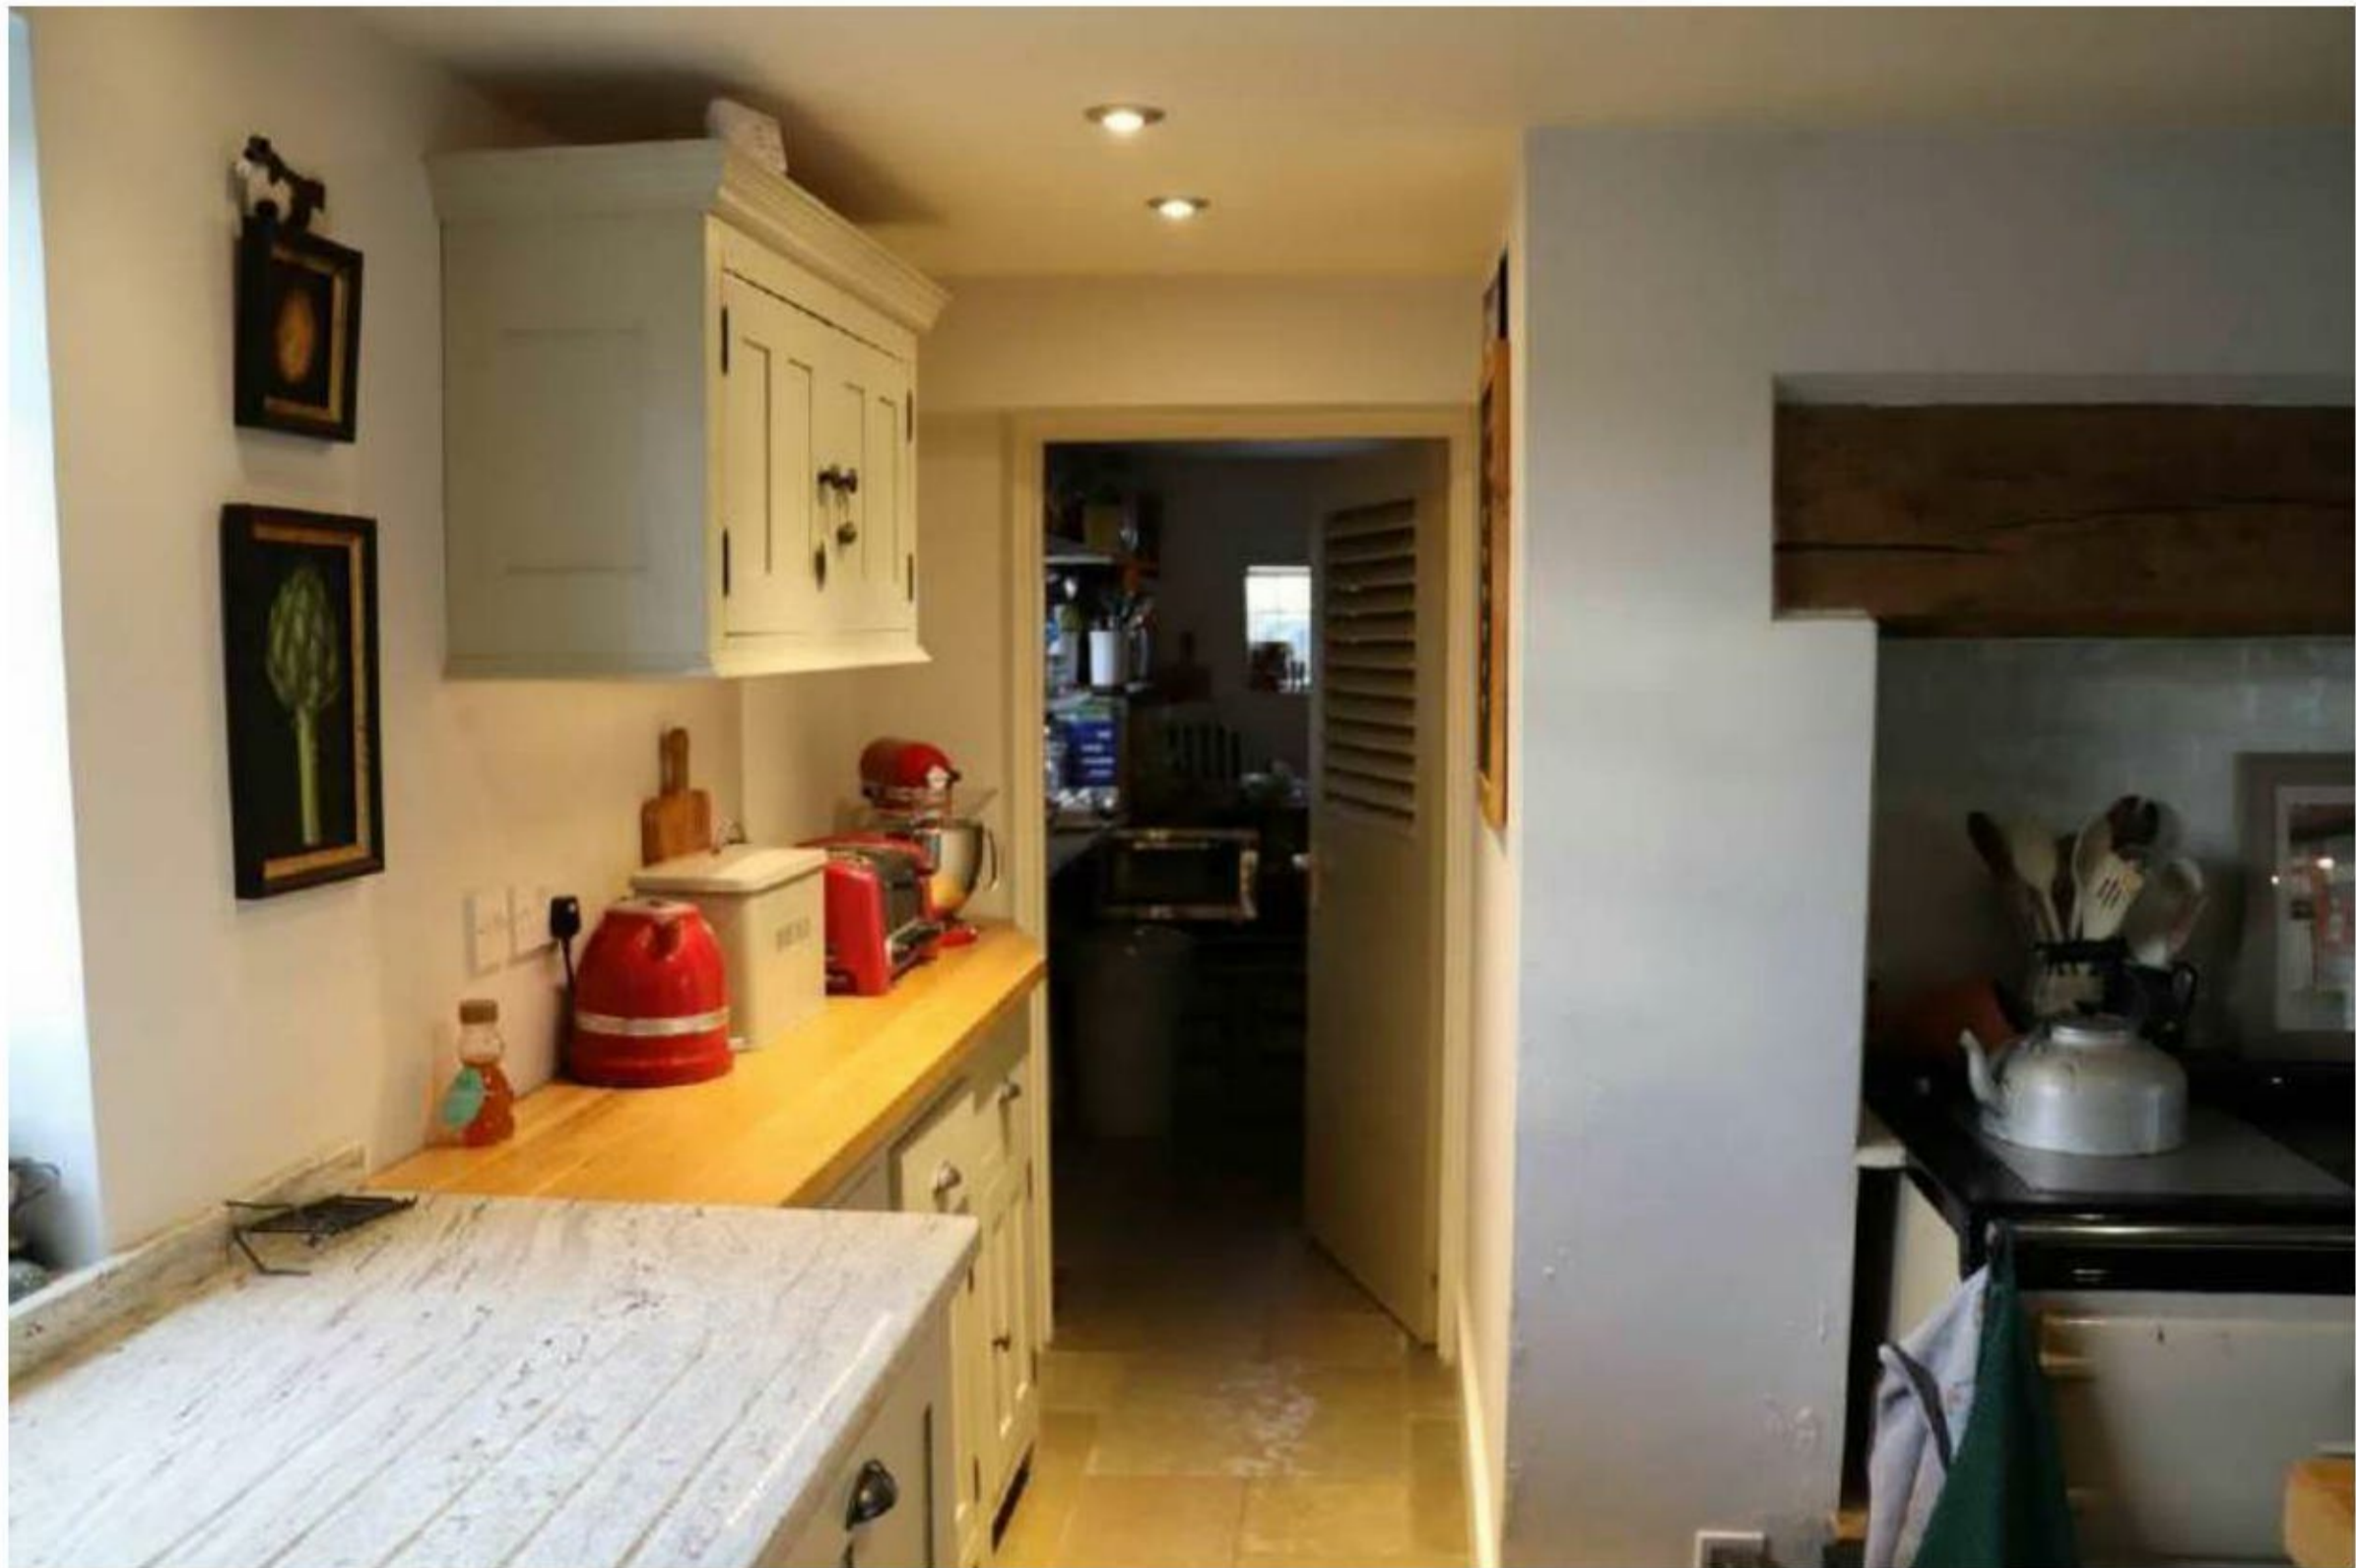
Plate 23: Looking past fireplace in G4 into G5 in the 'brewhouse'; this space was previously blocked by a wall with bread oven behind

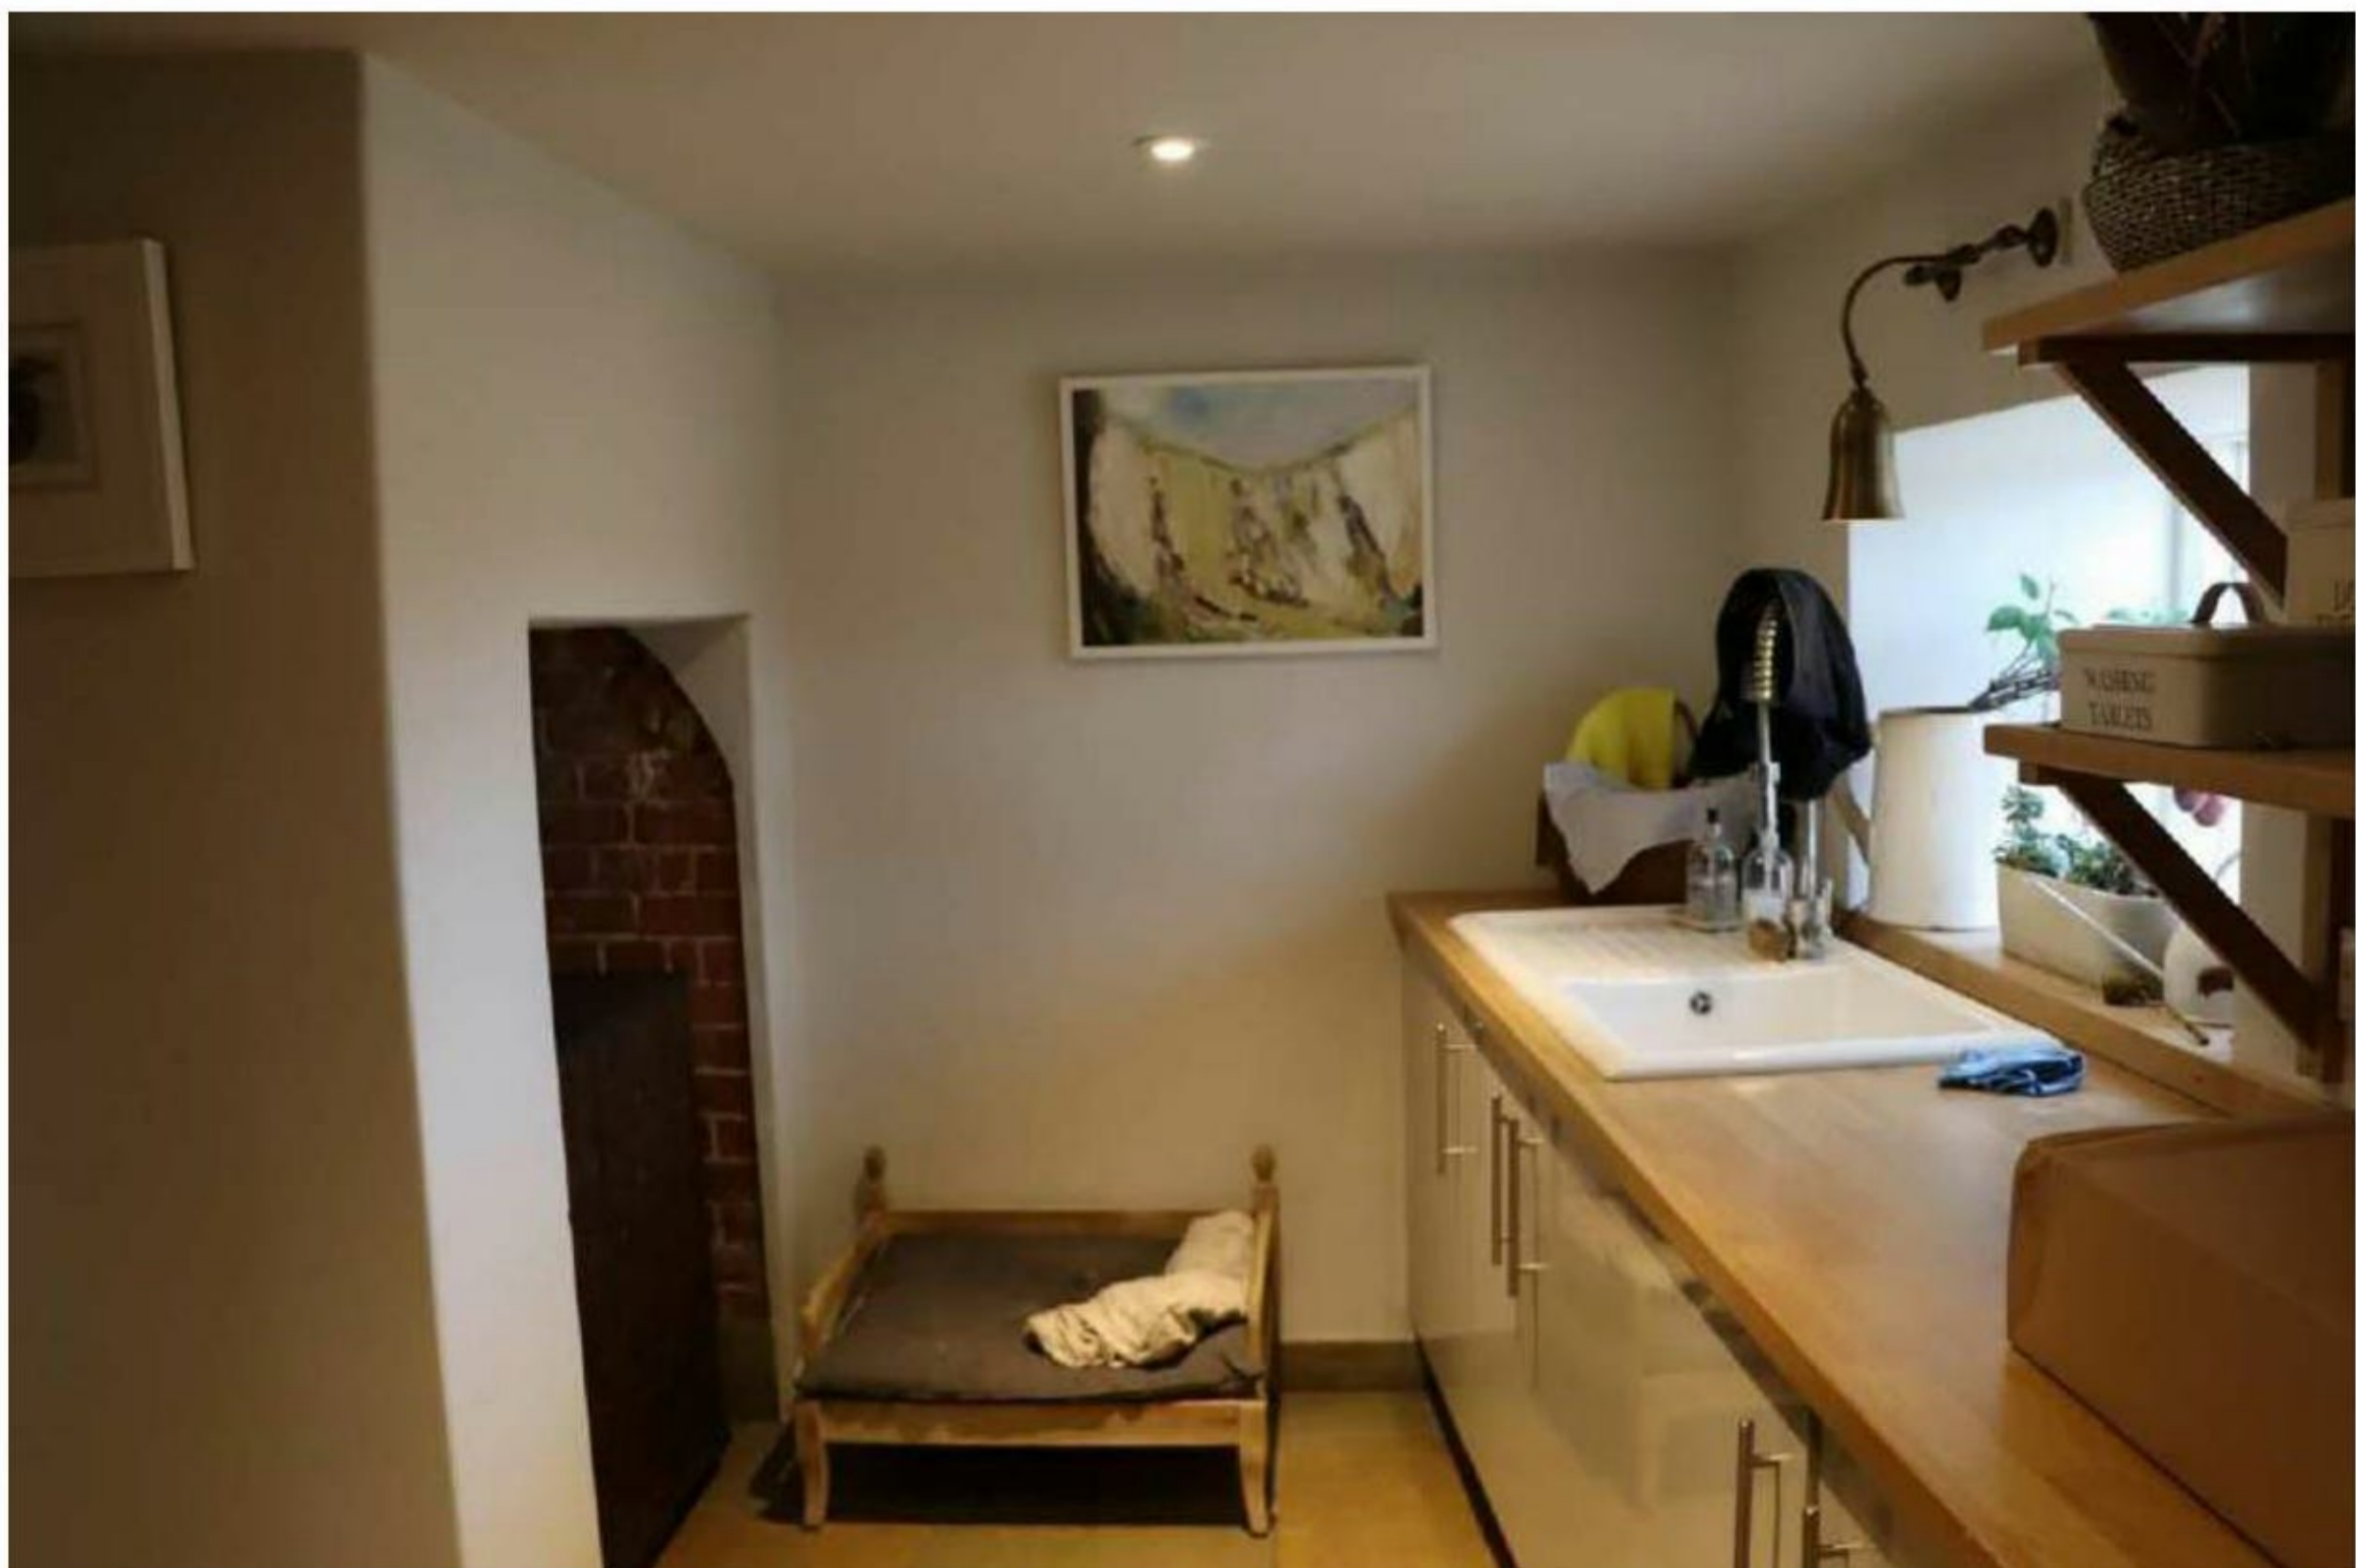
Plate 24: G6, with fireplace on NW wall

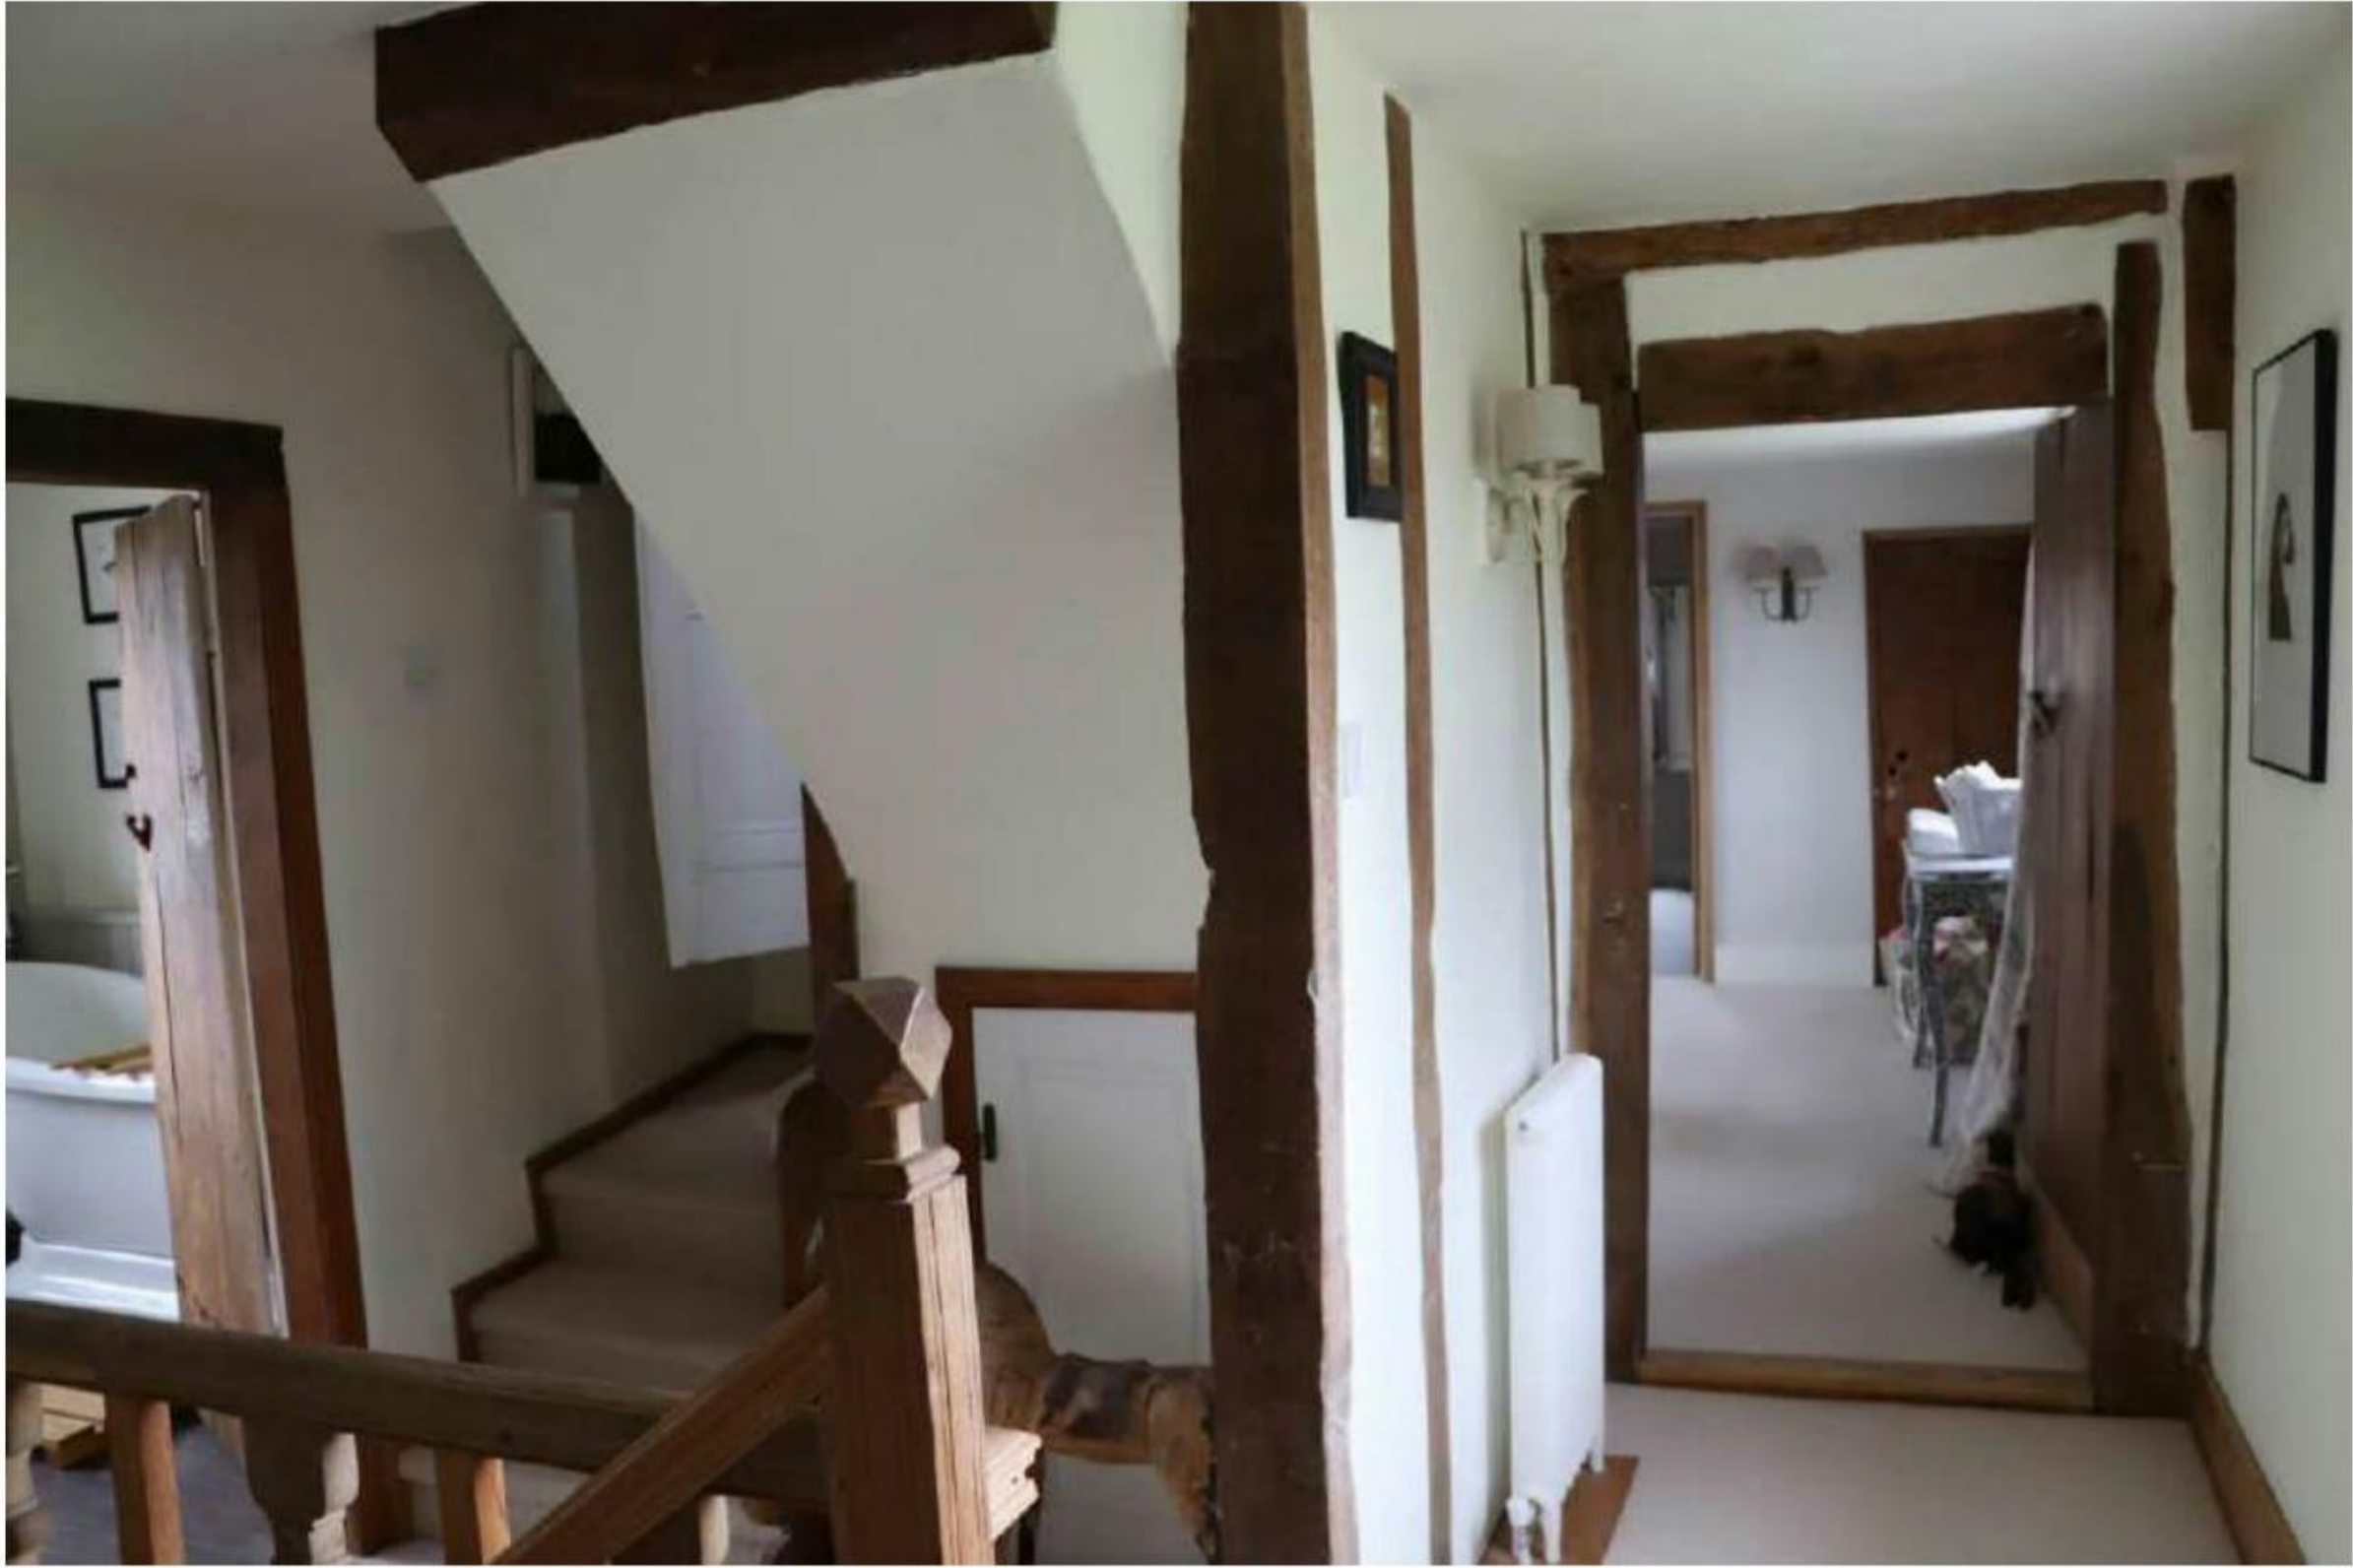
Plate 25: F1 (first-floor landing), looking NE (underside of attic stairs to left)

3.1.20 The landing (F1) was reconfigured to accommodate the new staircase. The original staircase made two 90-degree turns to get to the landing (see **Photo X1**), with the staircase to the attic (which was retained) continuing up from a quarter-landing (**Plate 25**). Because the new staircase was all in one straight flight, the landing floor was levelled off, losing the bottom step of the attic stair. The piece of carved wood that flanks the base of the attic stairs now projects beyond the foot of the stairs whereas before it sat on the bottom step (cf **Plate 26** and **Photo B2**) (another such piece of

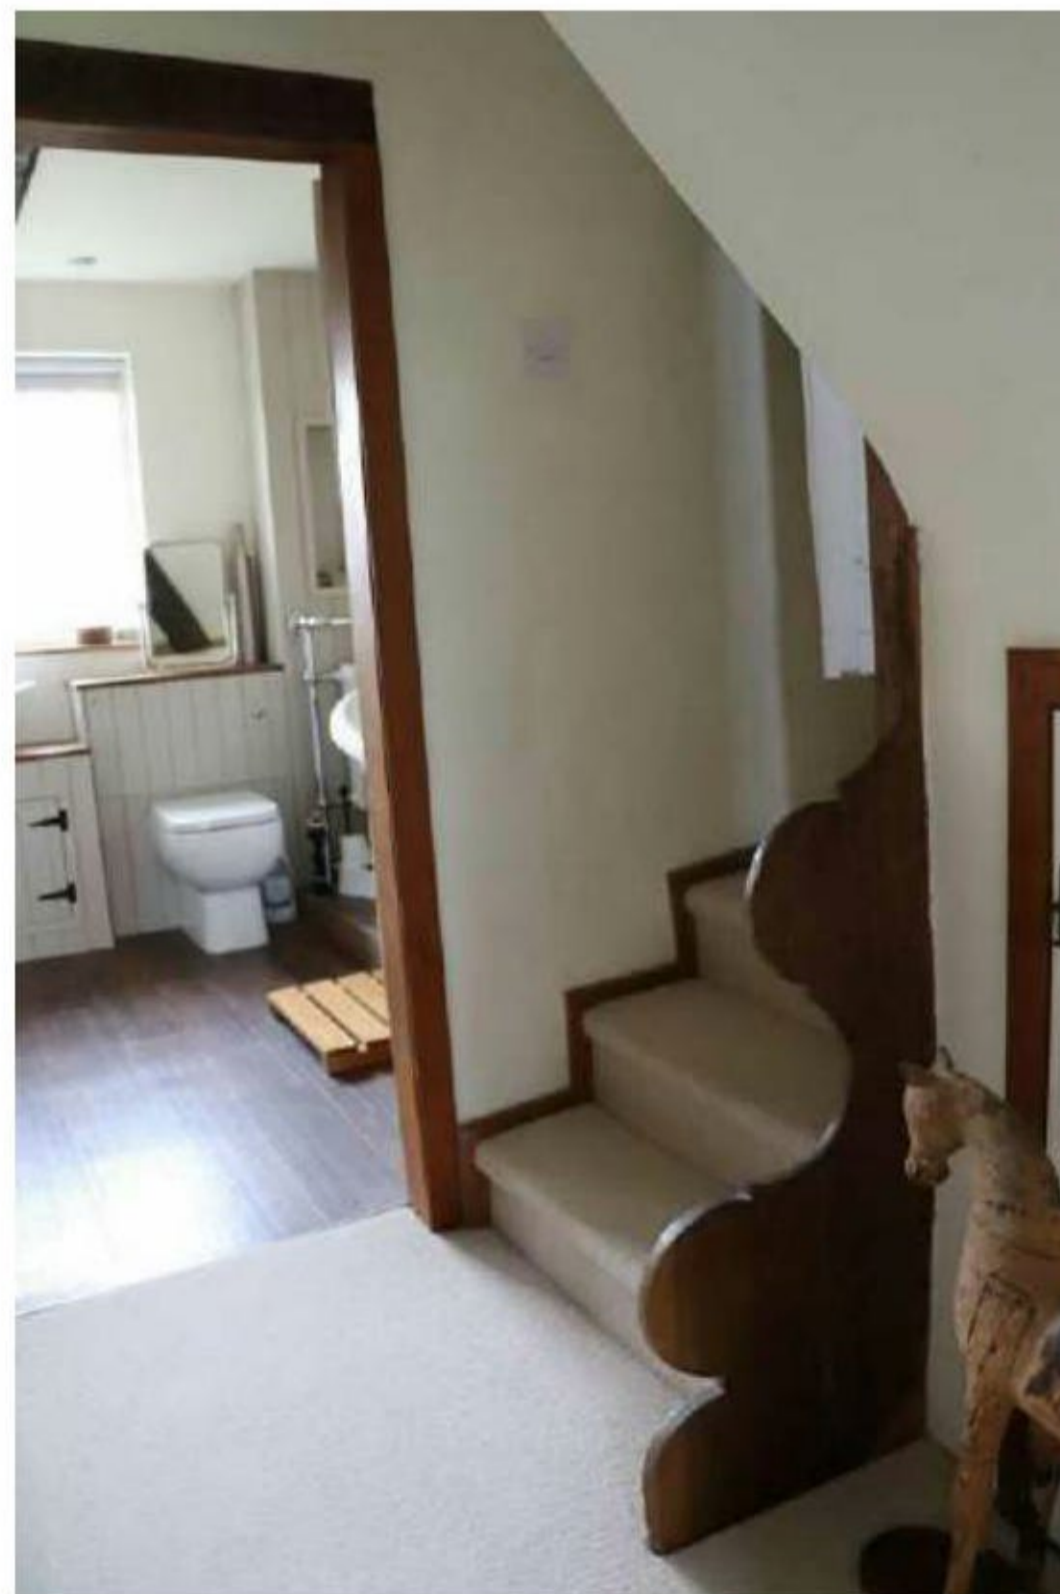
Plate 26: Foot of attic stairs, with door into F2 beyond

- 3.1.21 The door opening into the bathroom (F2) previously opened onto the same quarter-landing with a raised sill but is now level with the landing floor and has a new architrave (see **Plate 26** and **Photo B2**). However, the three-plank door looks original and the lintel incorporates a piece of 17th-century wood carved with arcading (**Plate 28**). The room has a chamfered and stopped ceiling beam.
