STATEMENT OF SIGNIFICANCE

**Flood Street Farm,
Breamore, Hampshire**

AHC REF: 9943

Date: April 2021

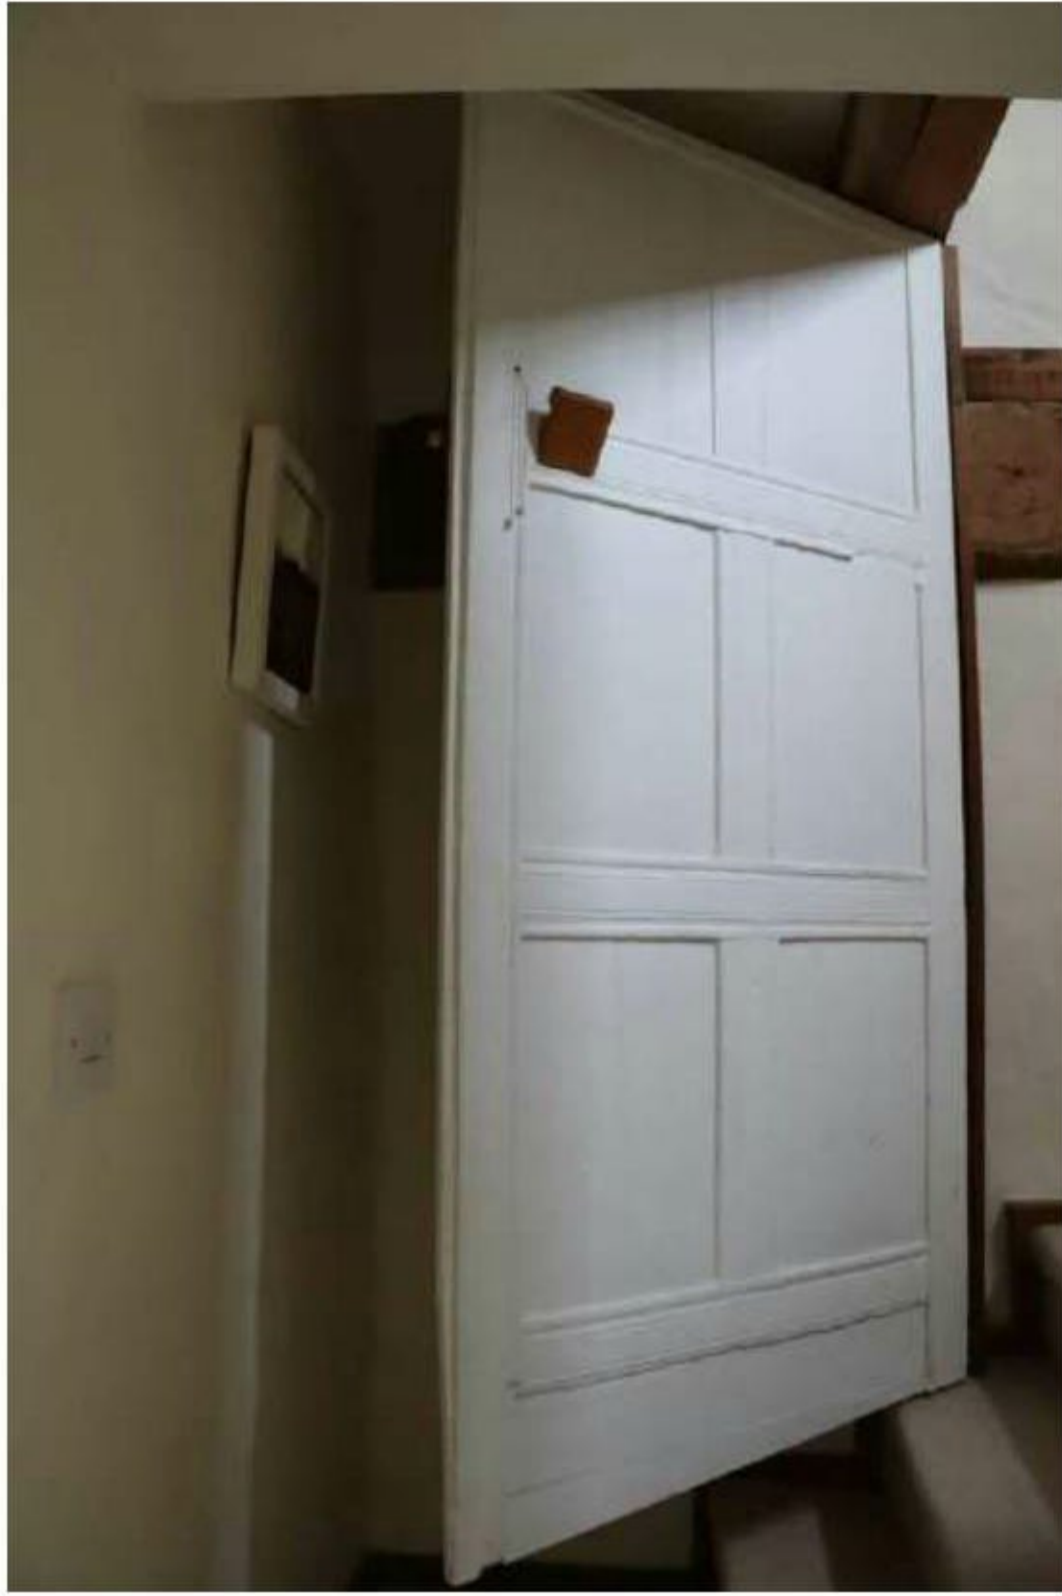
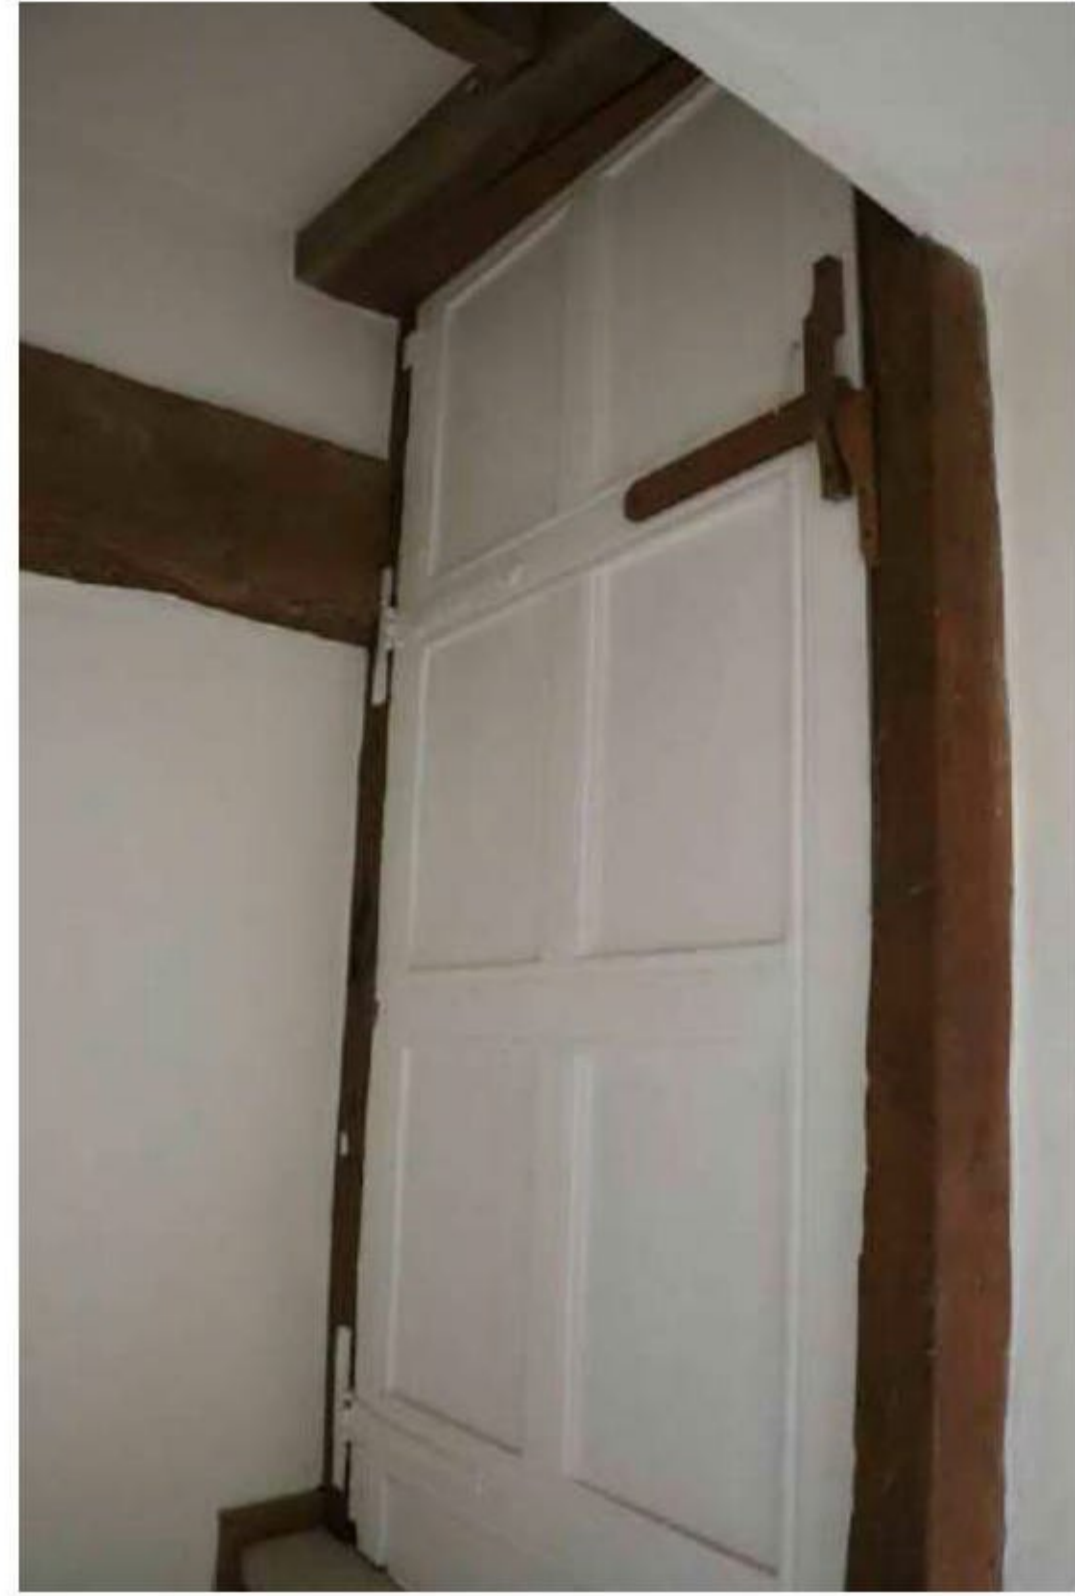
Plate 27: 17th-century door to attic stairs

timber flanking a lower part of the staircase was lost when the latter was taken out; see **Photo Y1**). The 17th-century door to the attic stairs is of six panels with spearhead strap hinges (**Plate 27**).

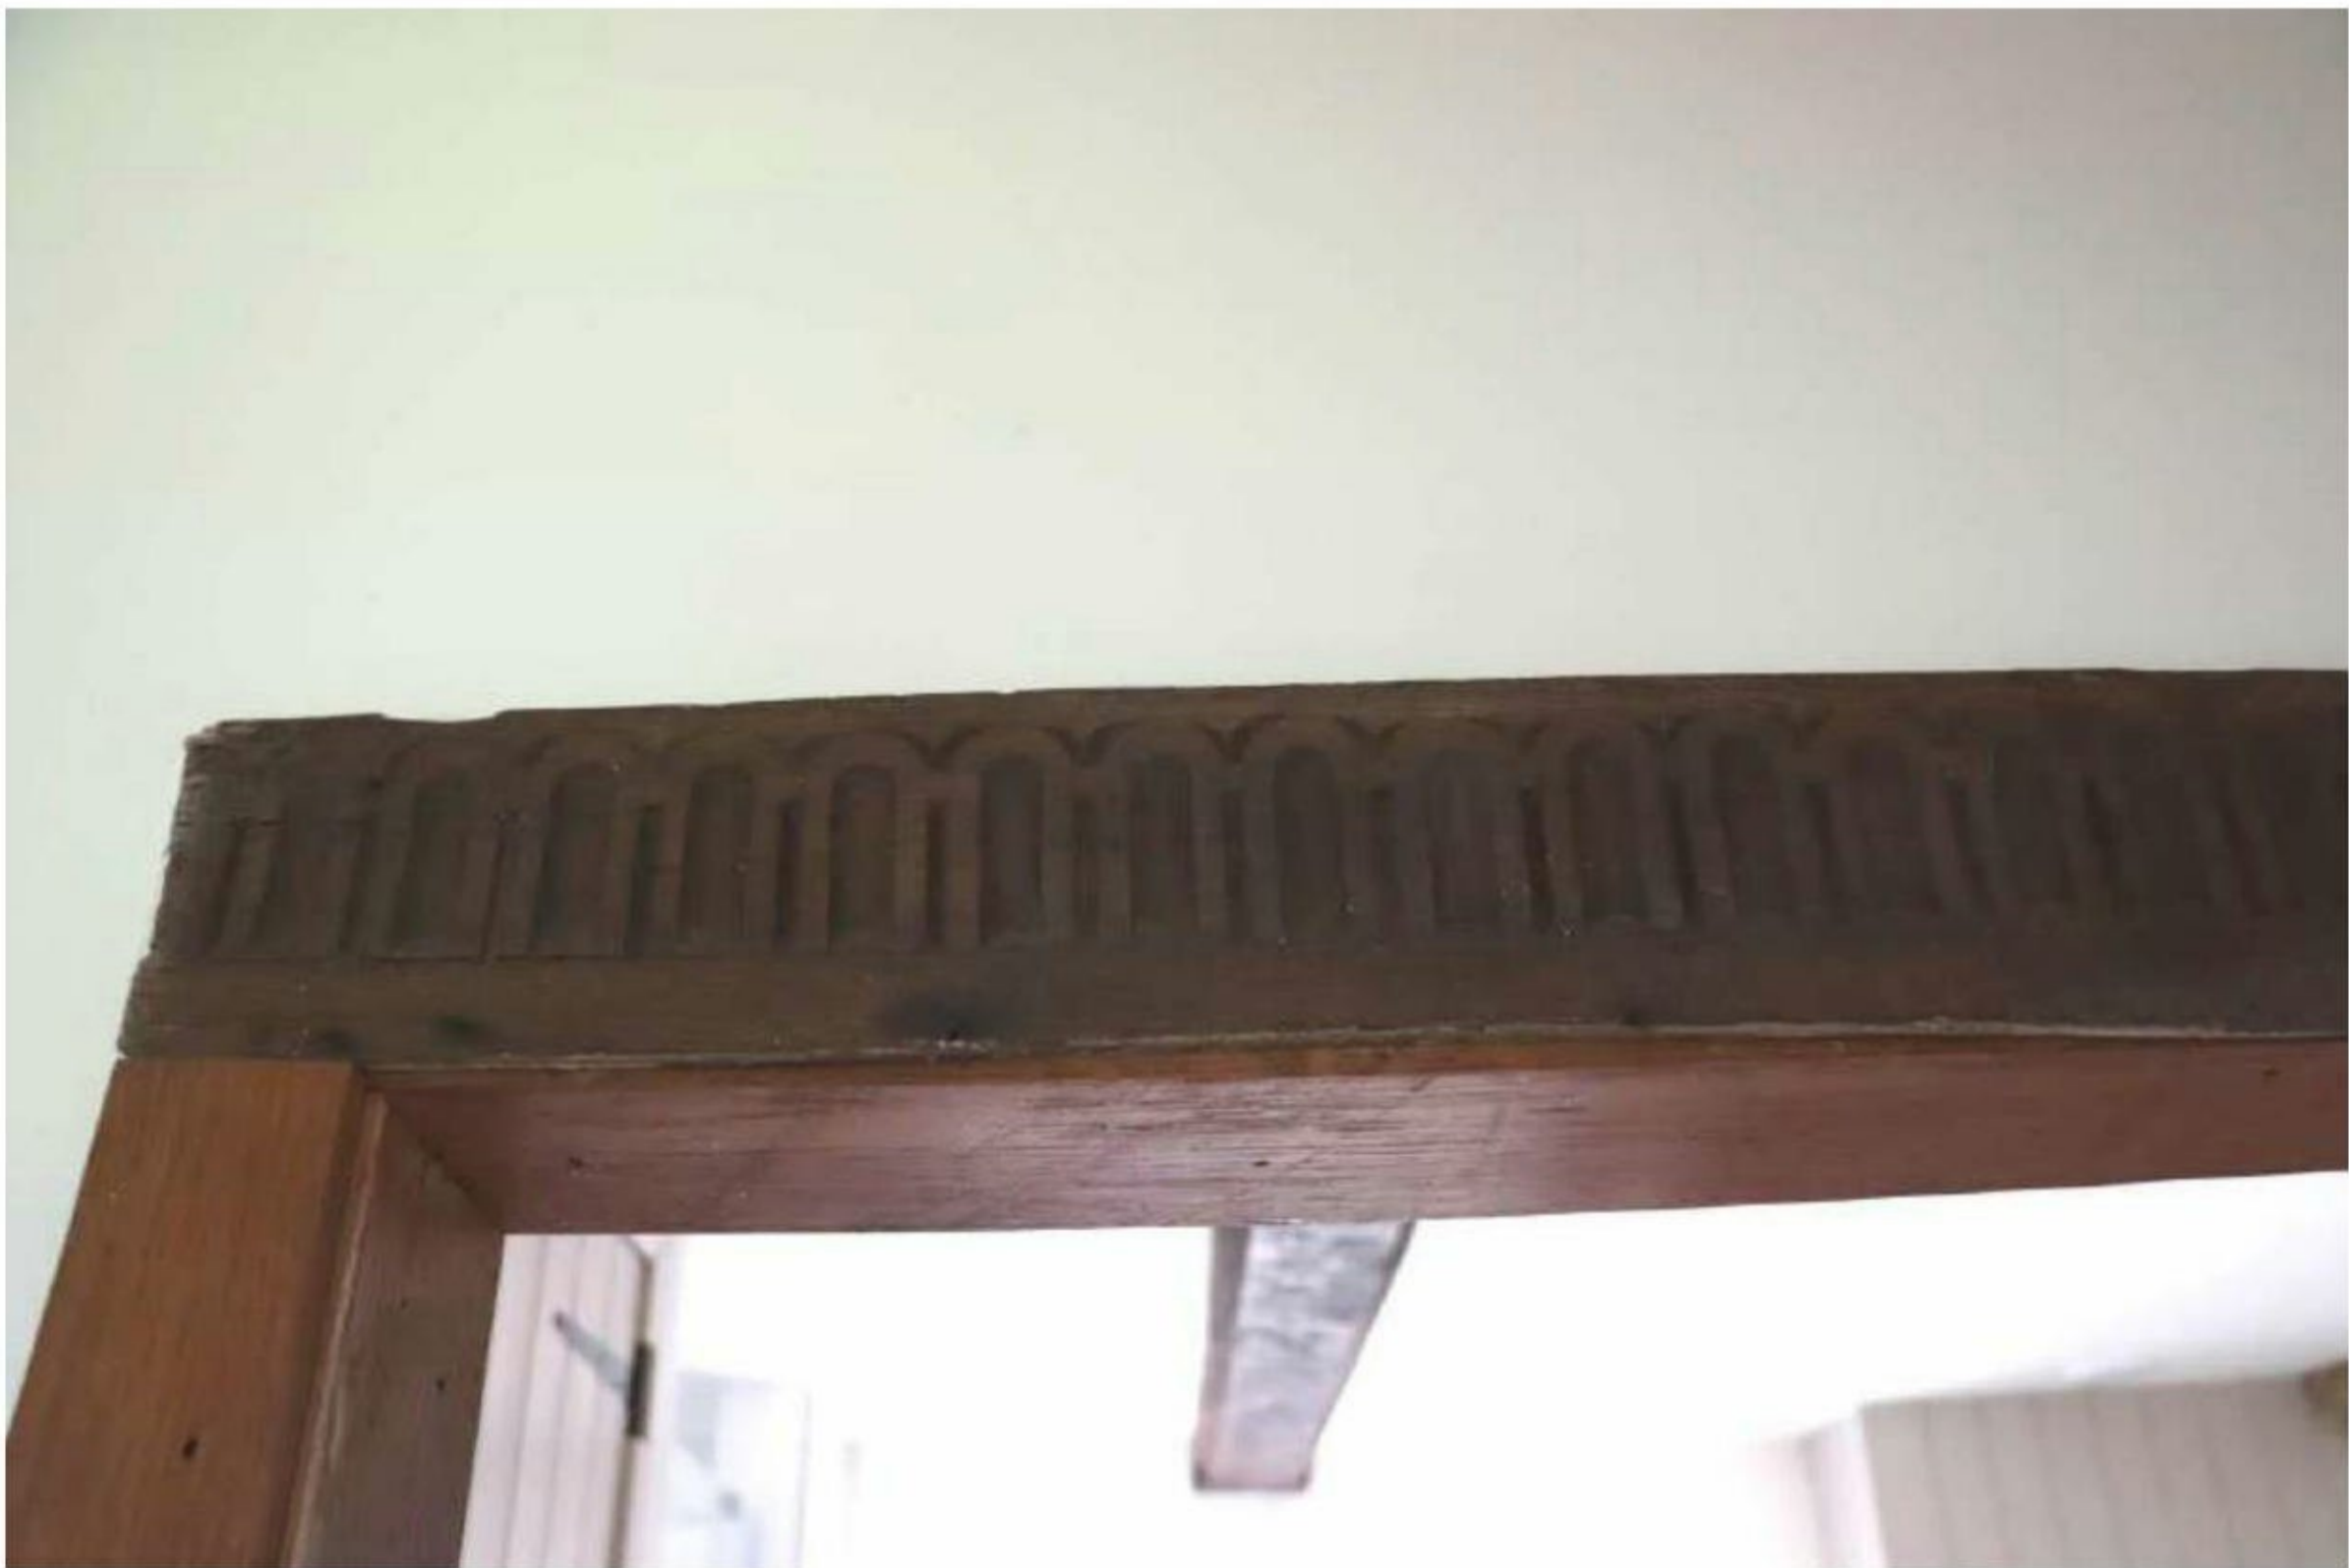
Plate 28: Carved arcading decoration over door into bathroom, F2

- 3.1.21 The door opening into the bathroom (F2) previously opened onto the same quarter-landing with a raised sill but is now level with the landing floor and has a new architrave (see **Plate 26** and **Photo B2**). However, the three-plank door looks original and the lintel incorporates a piece of 17th-century wood carved with arcading (**Plate 28**). The room has a chamfered and stopped ceiling beam.

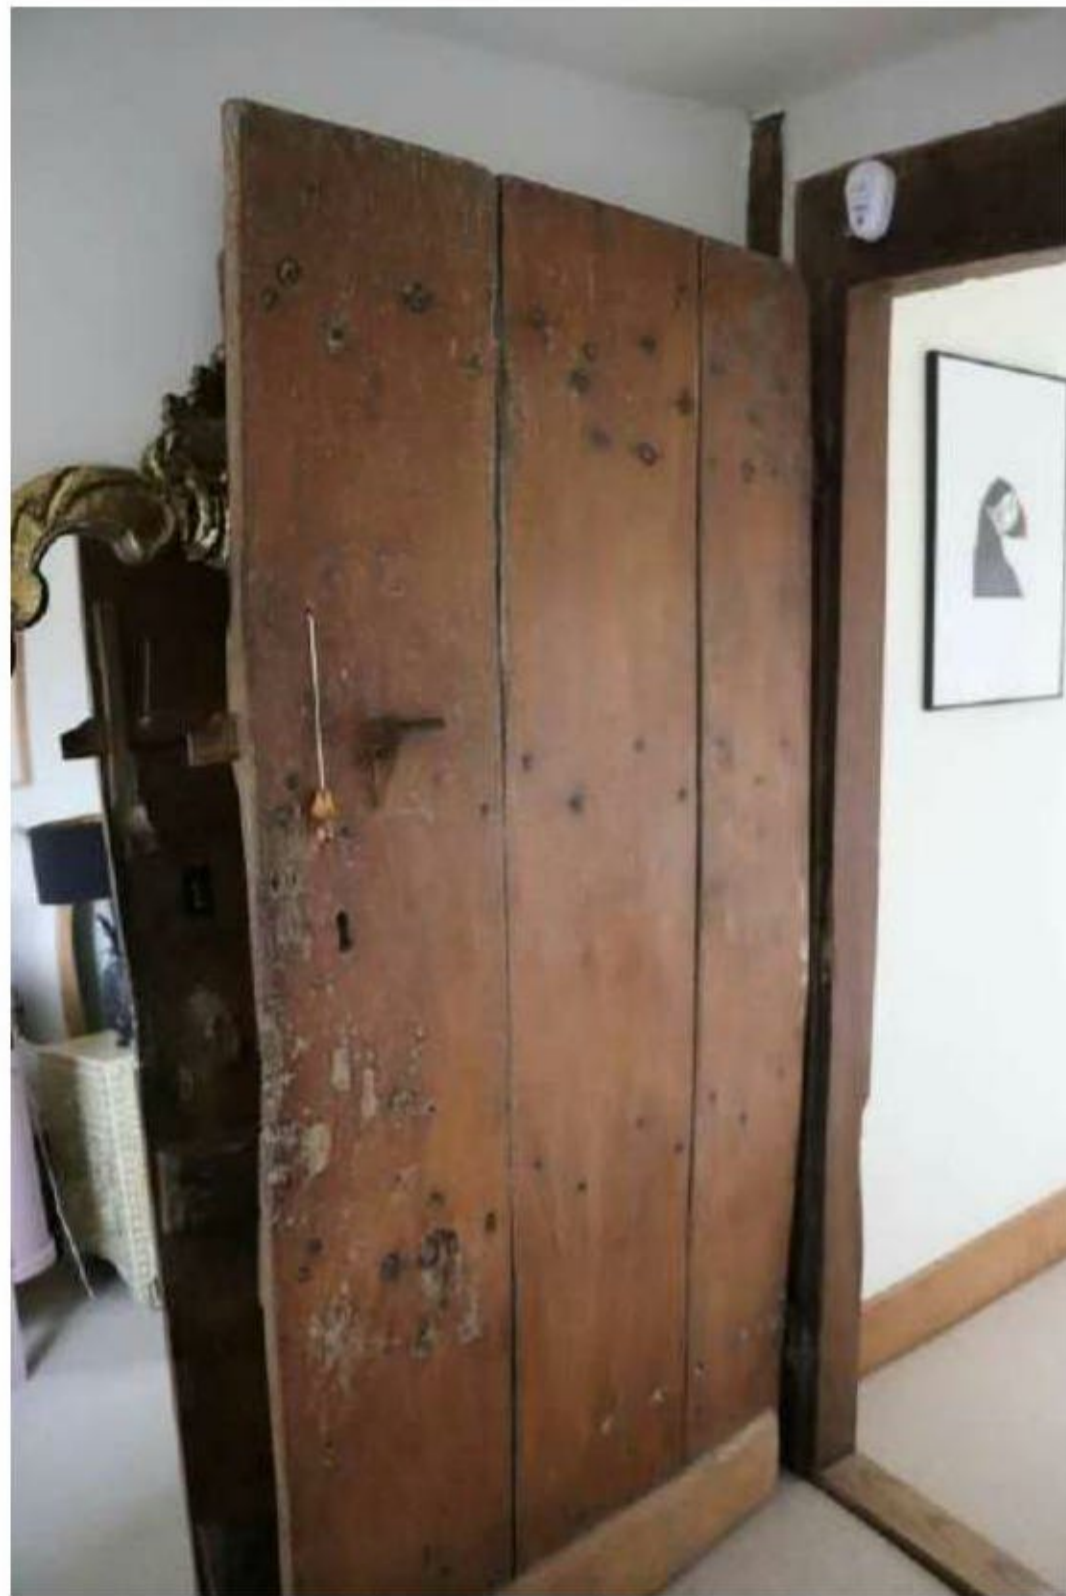
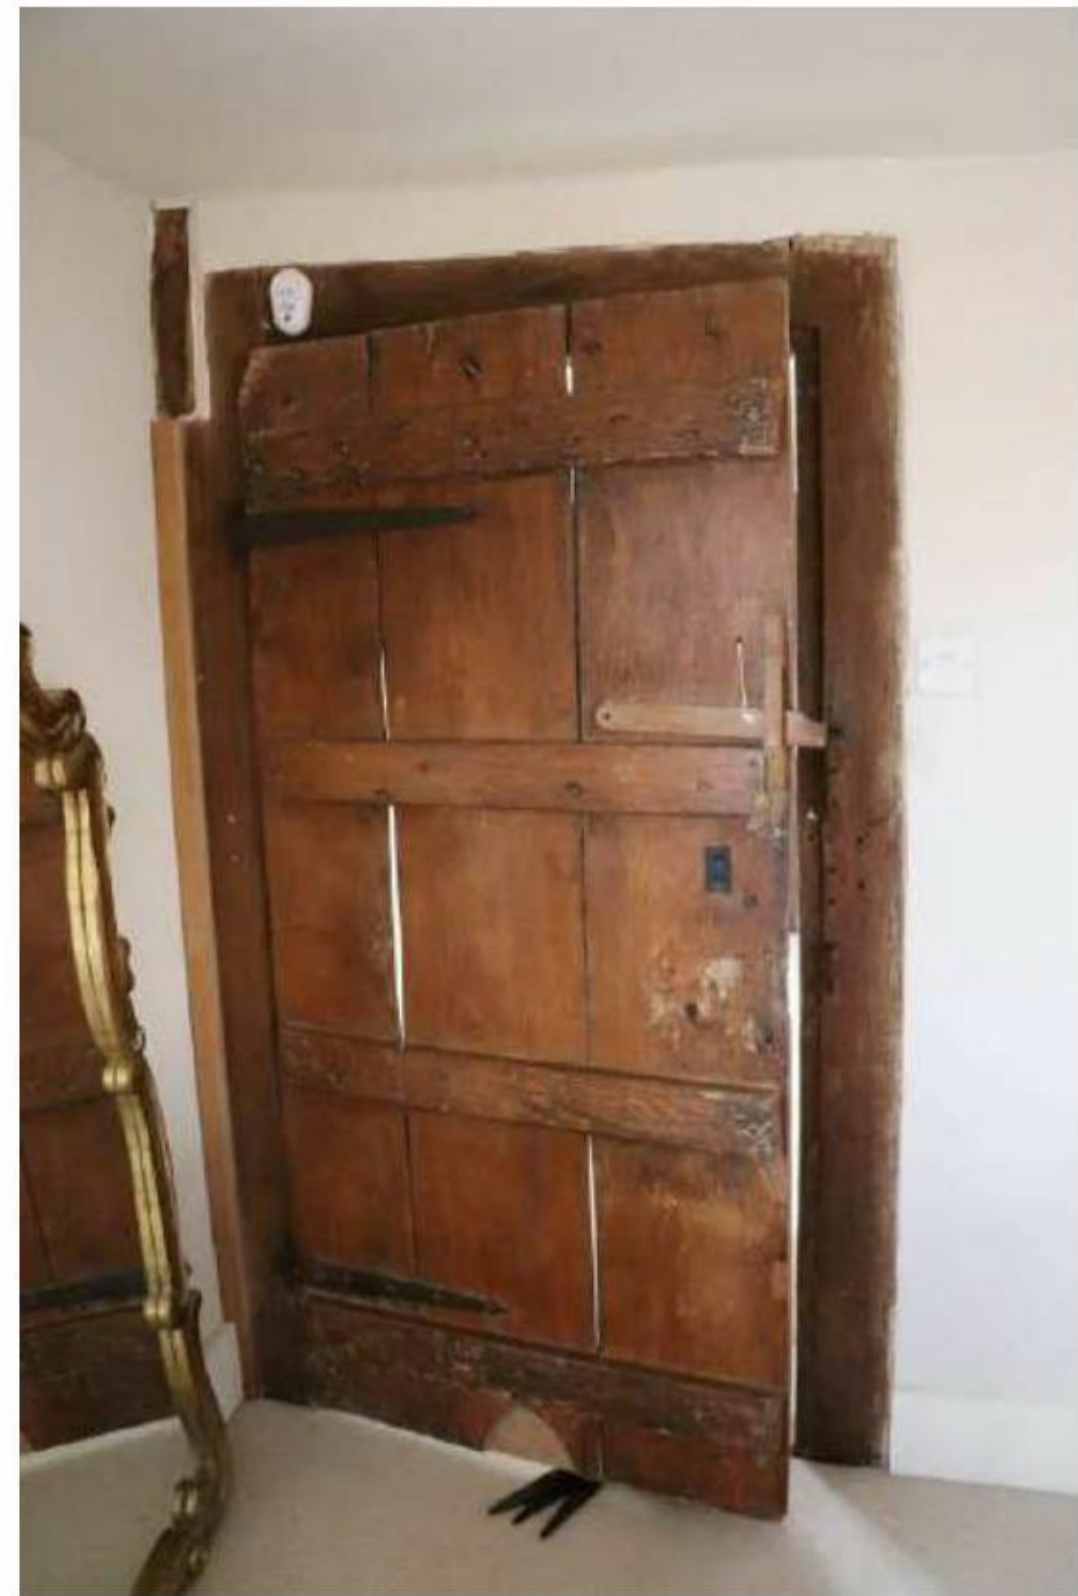
Plate 29: 17th-century door into F3

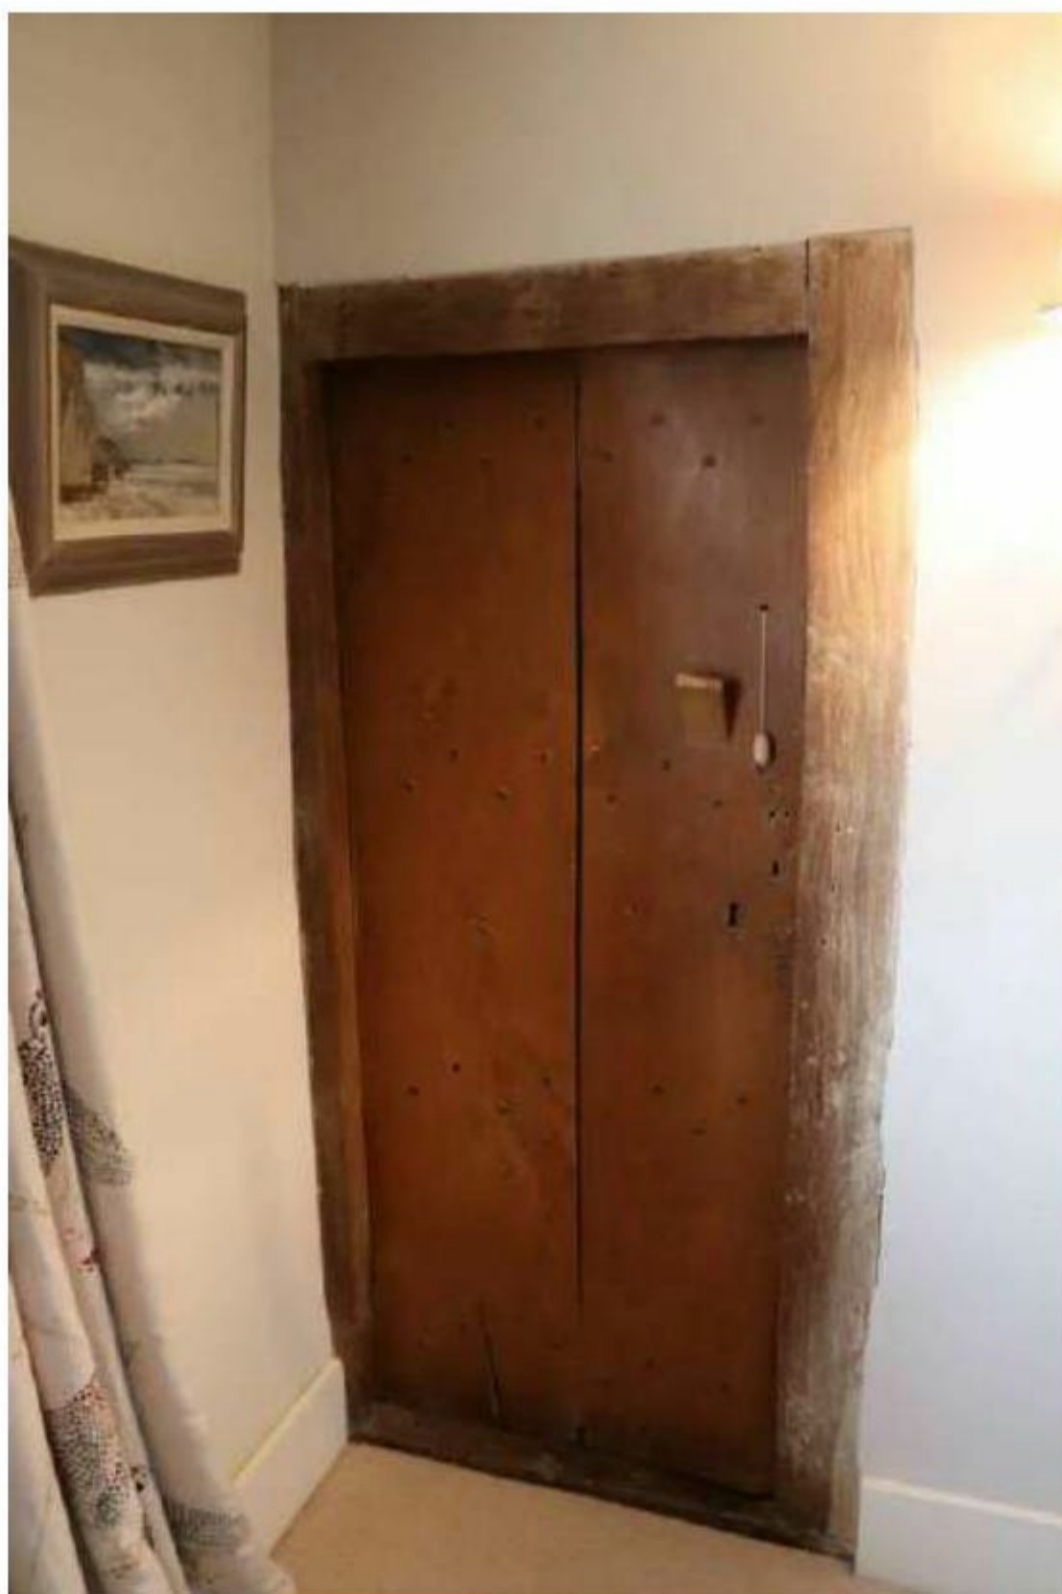
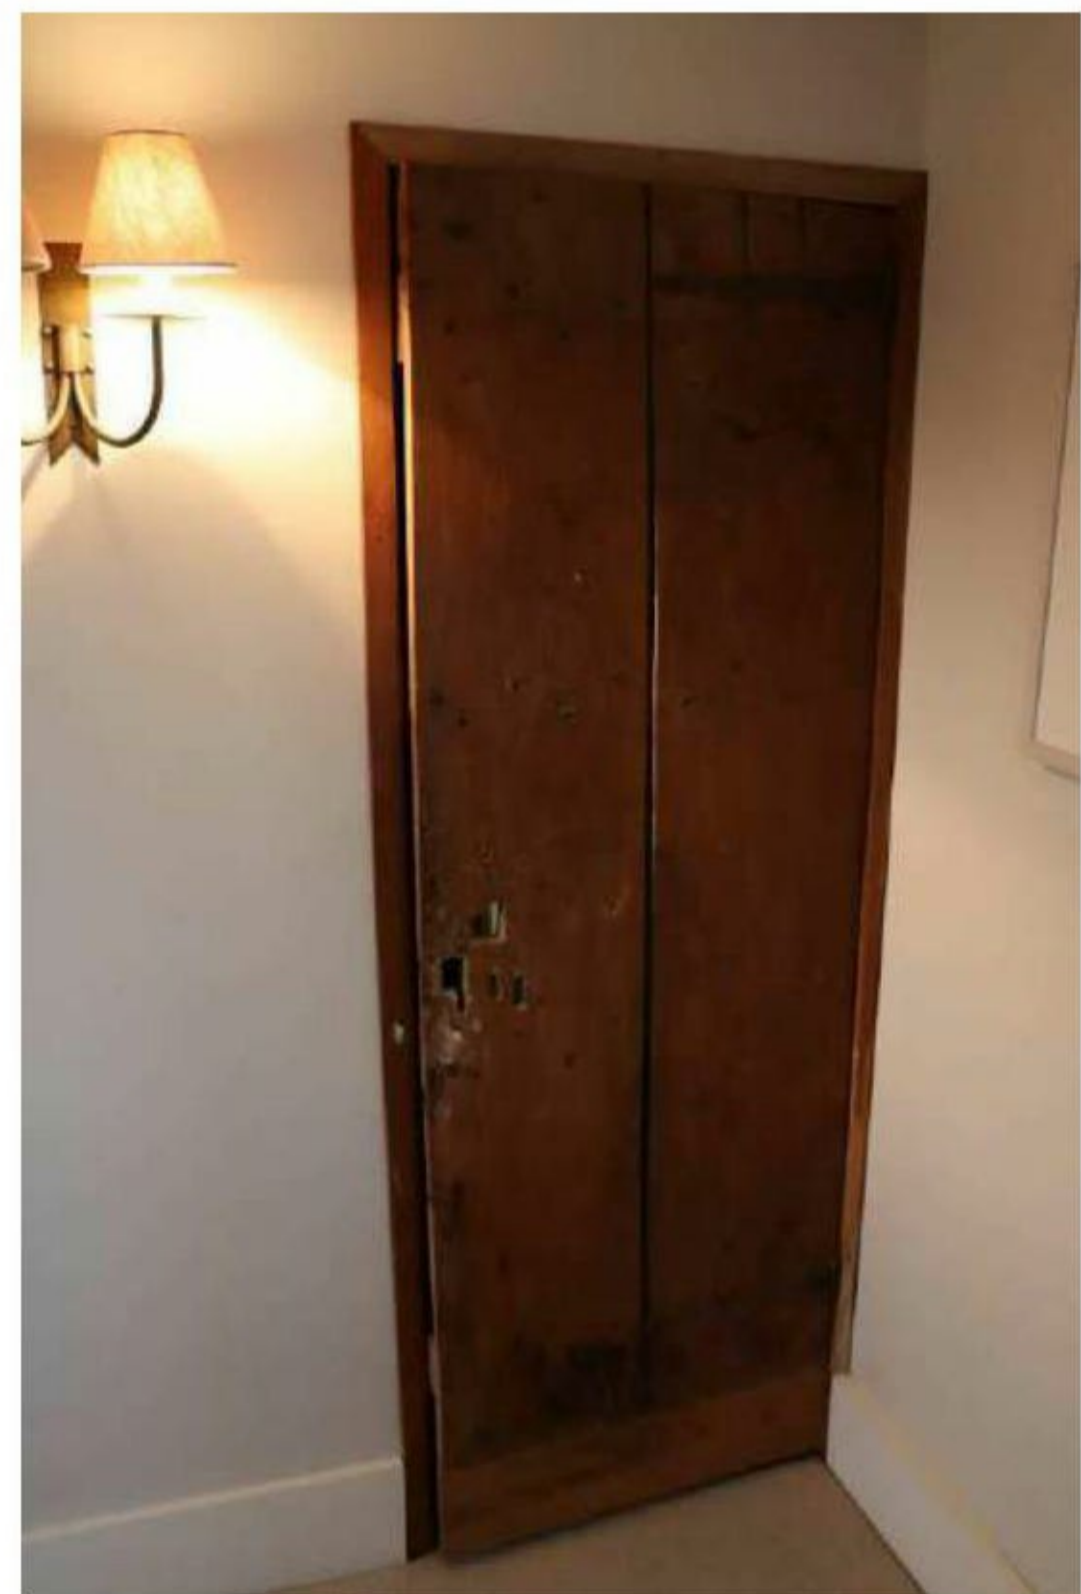
Plate 30: 17th-century doors into cupboards on NE wall of F3

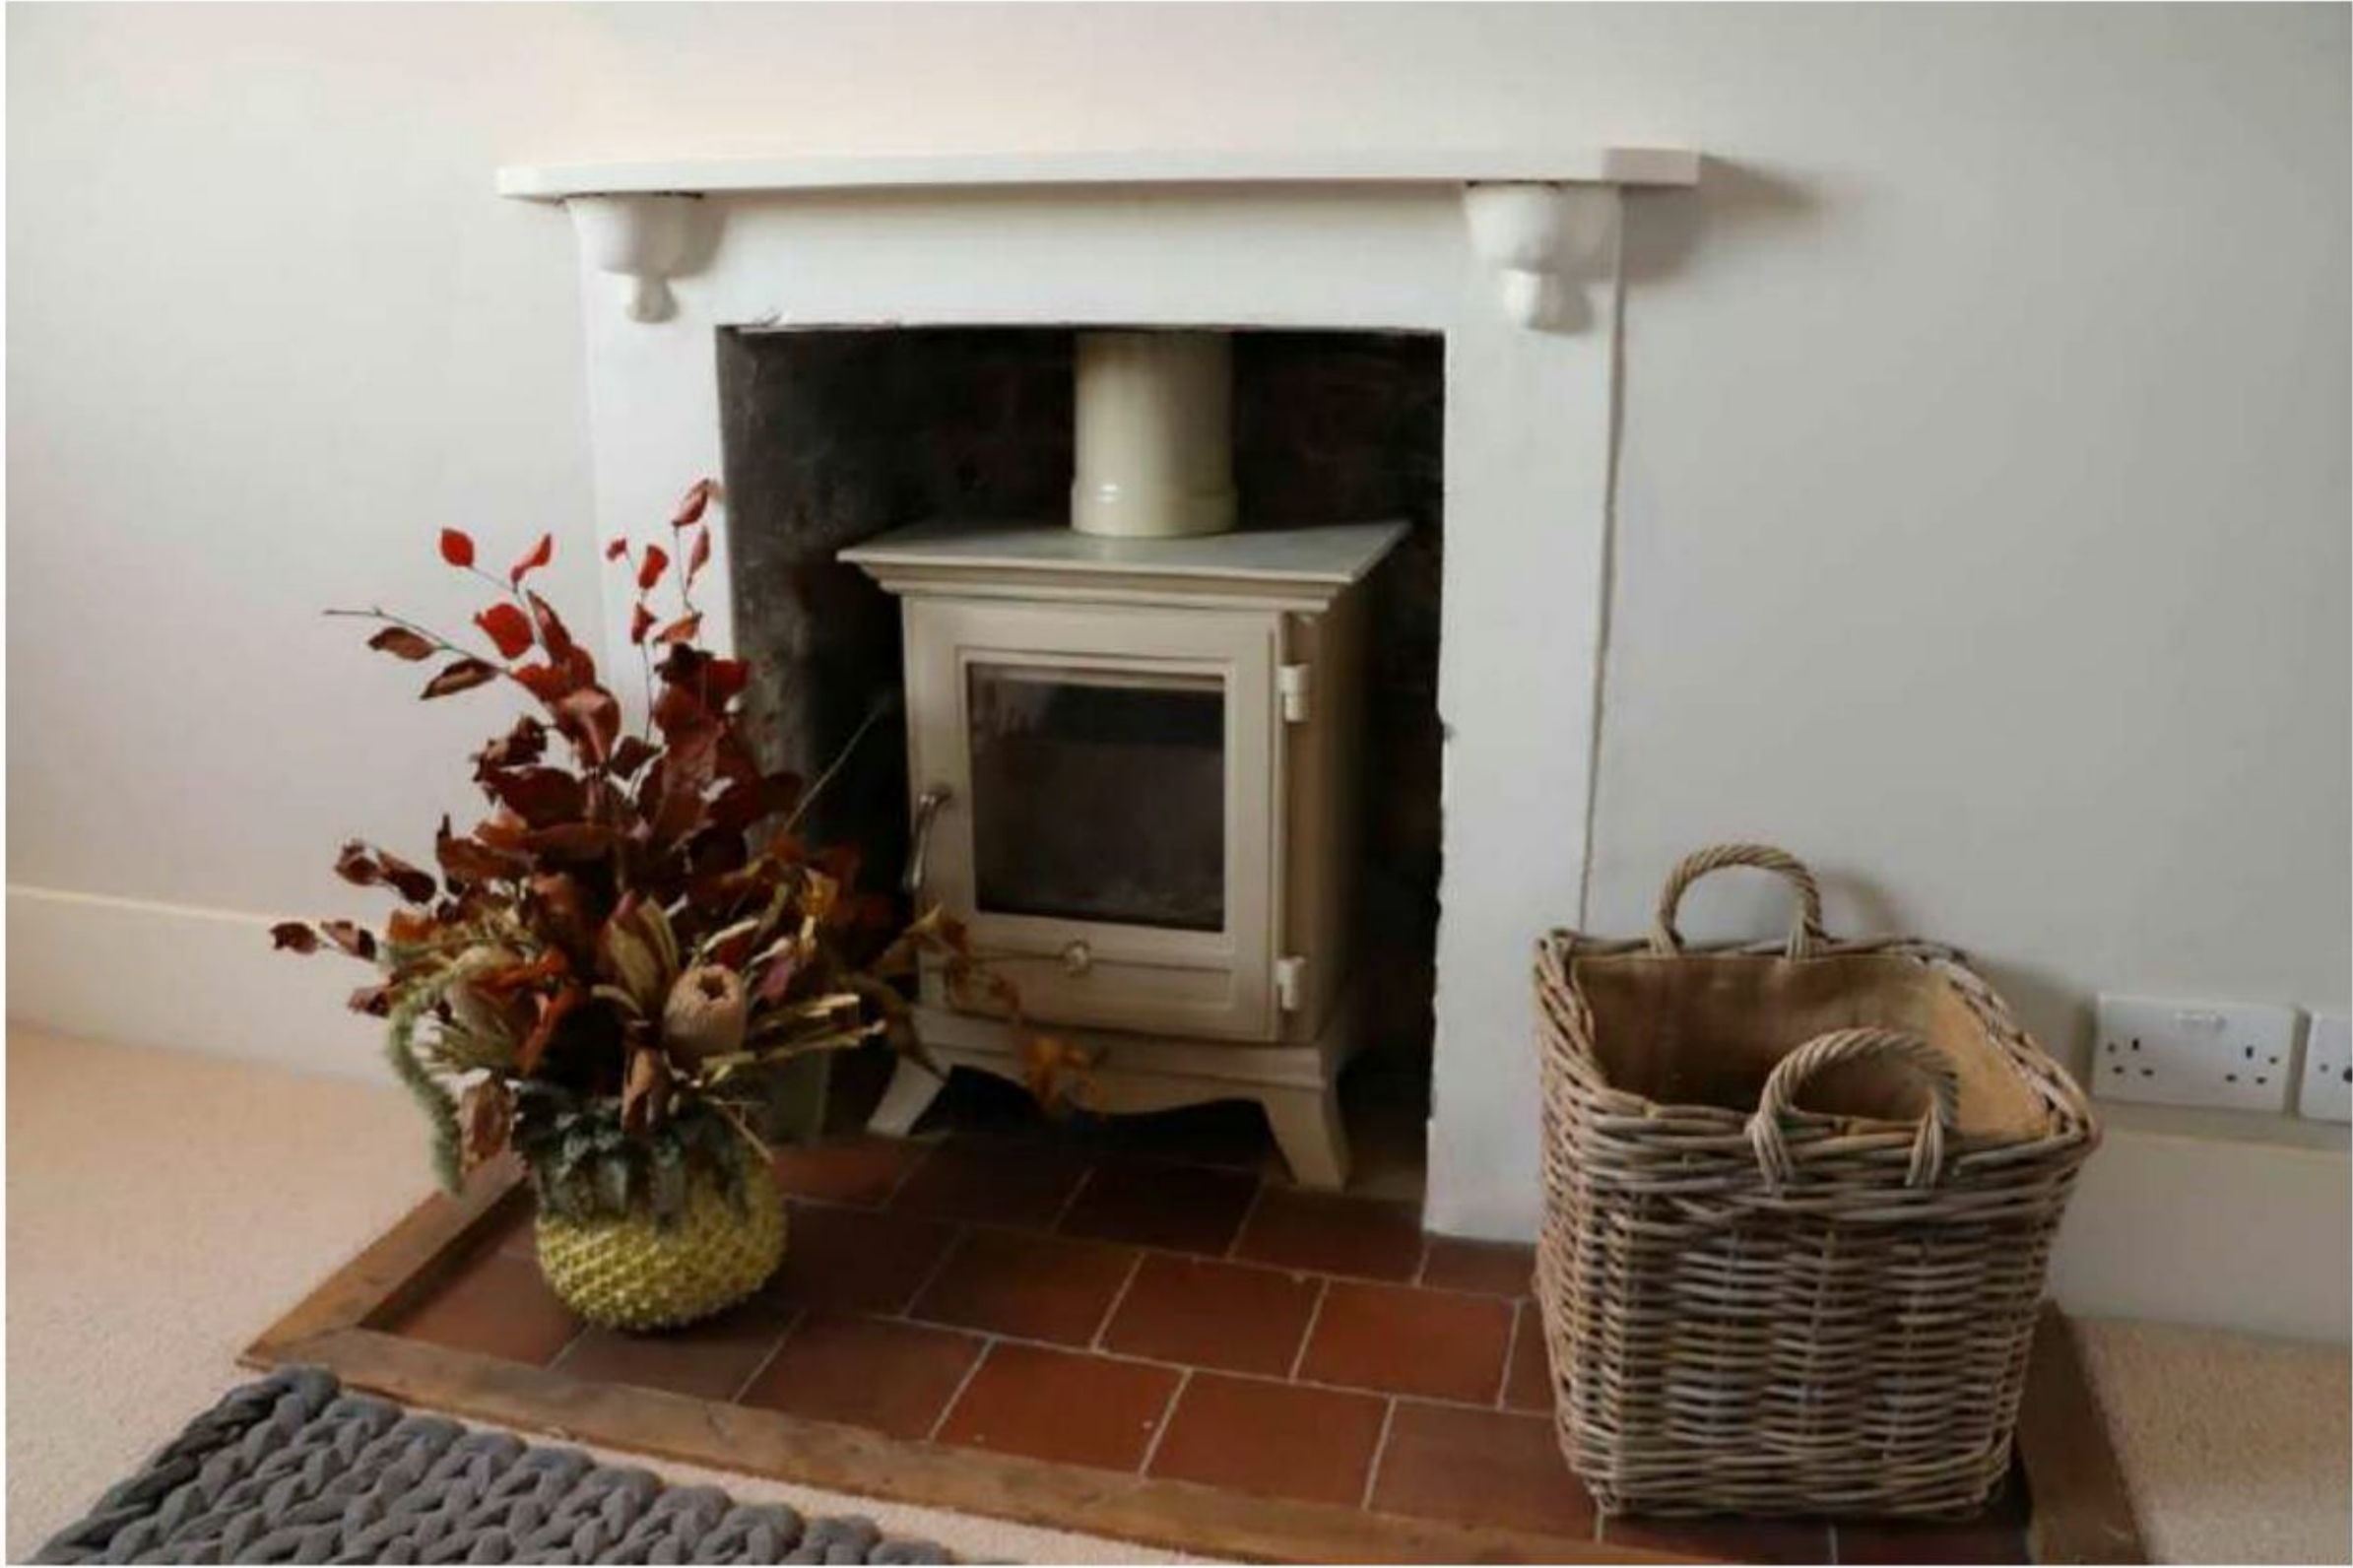
Plate 31: Fireplace on NE wall of F3

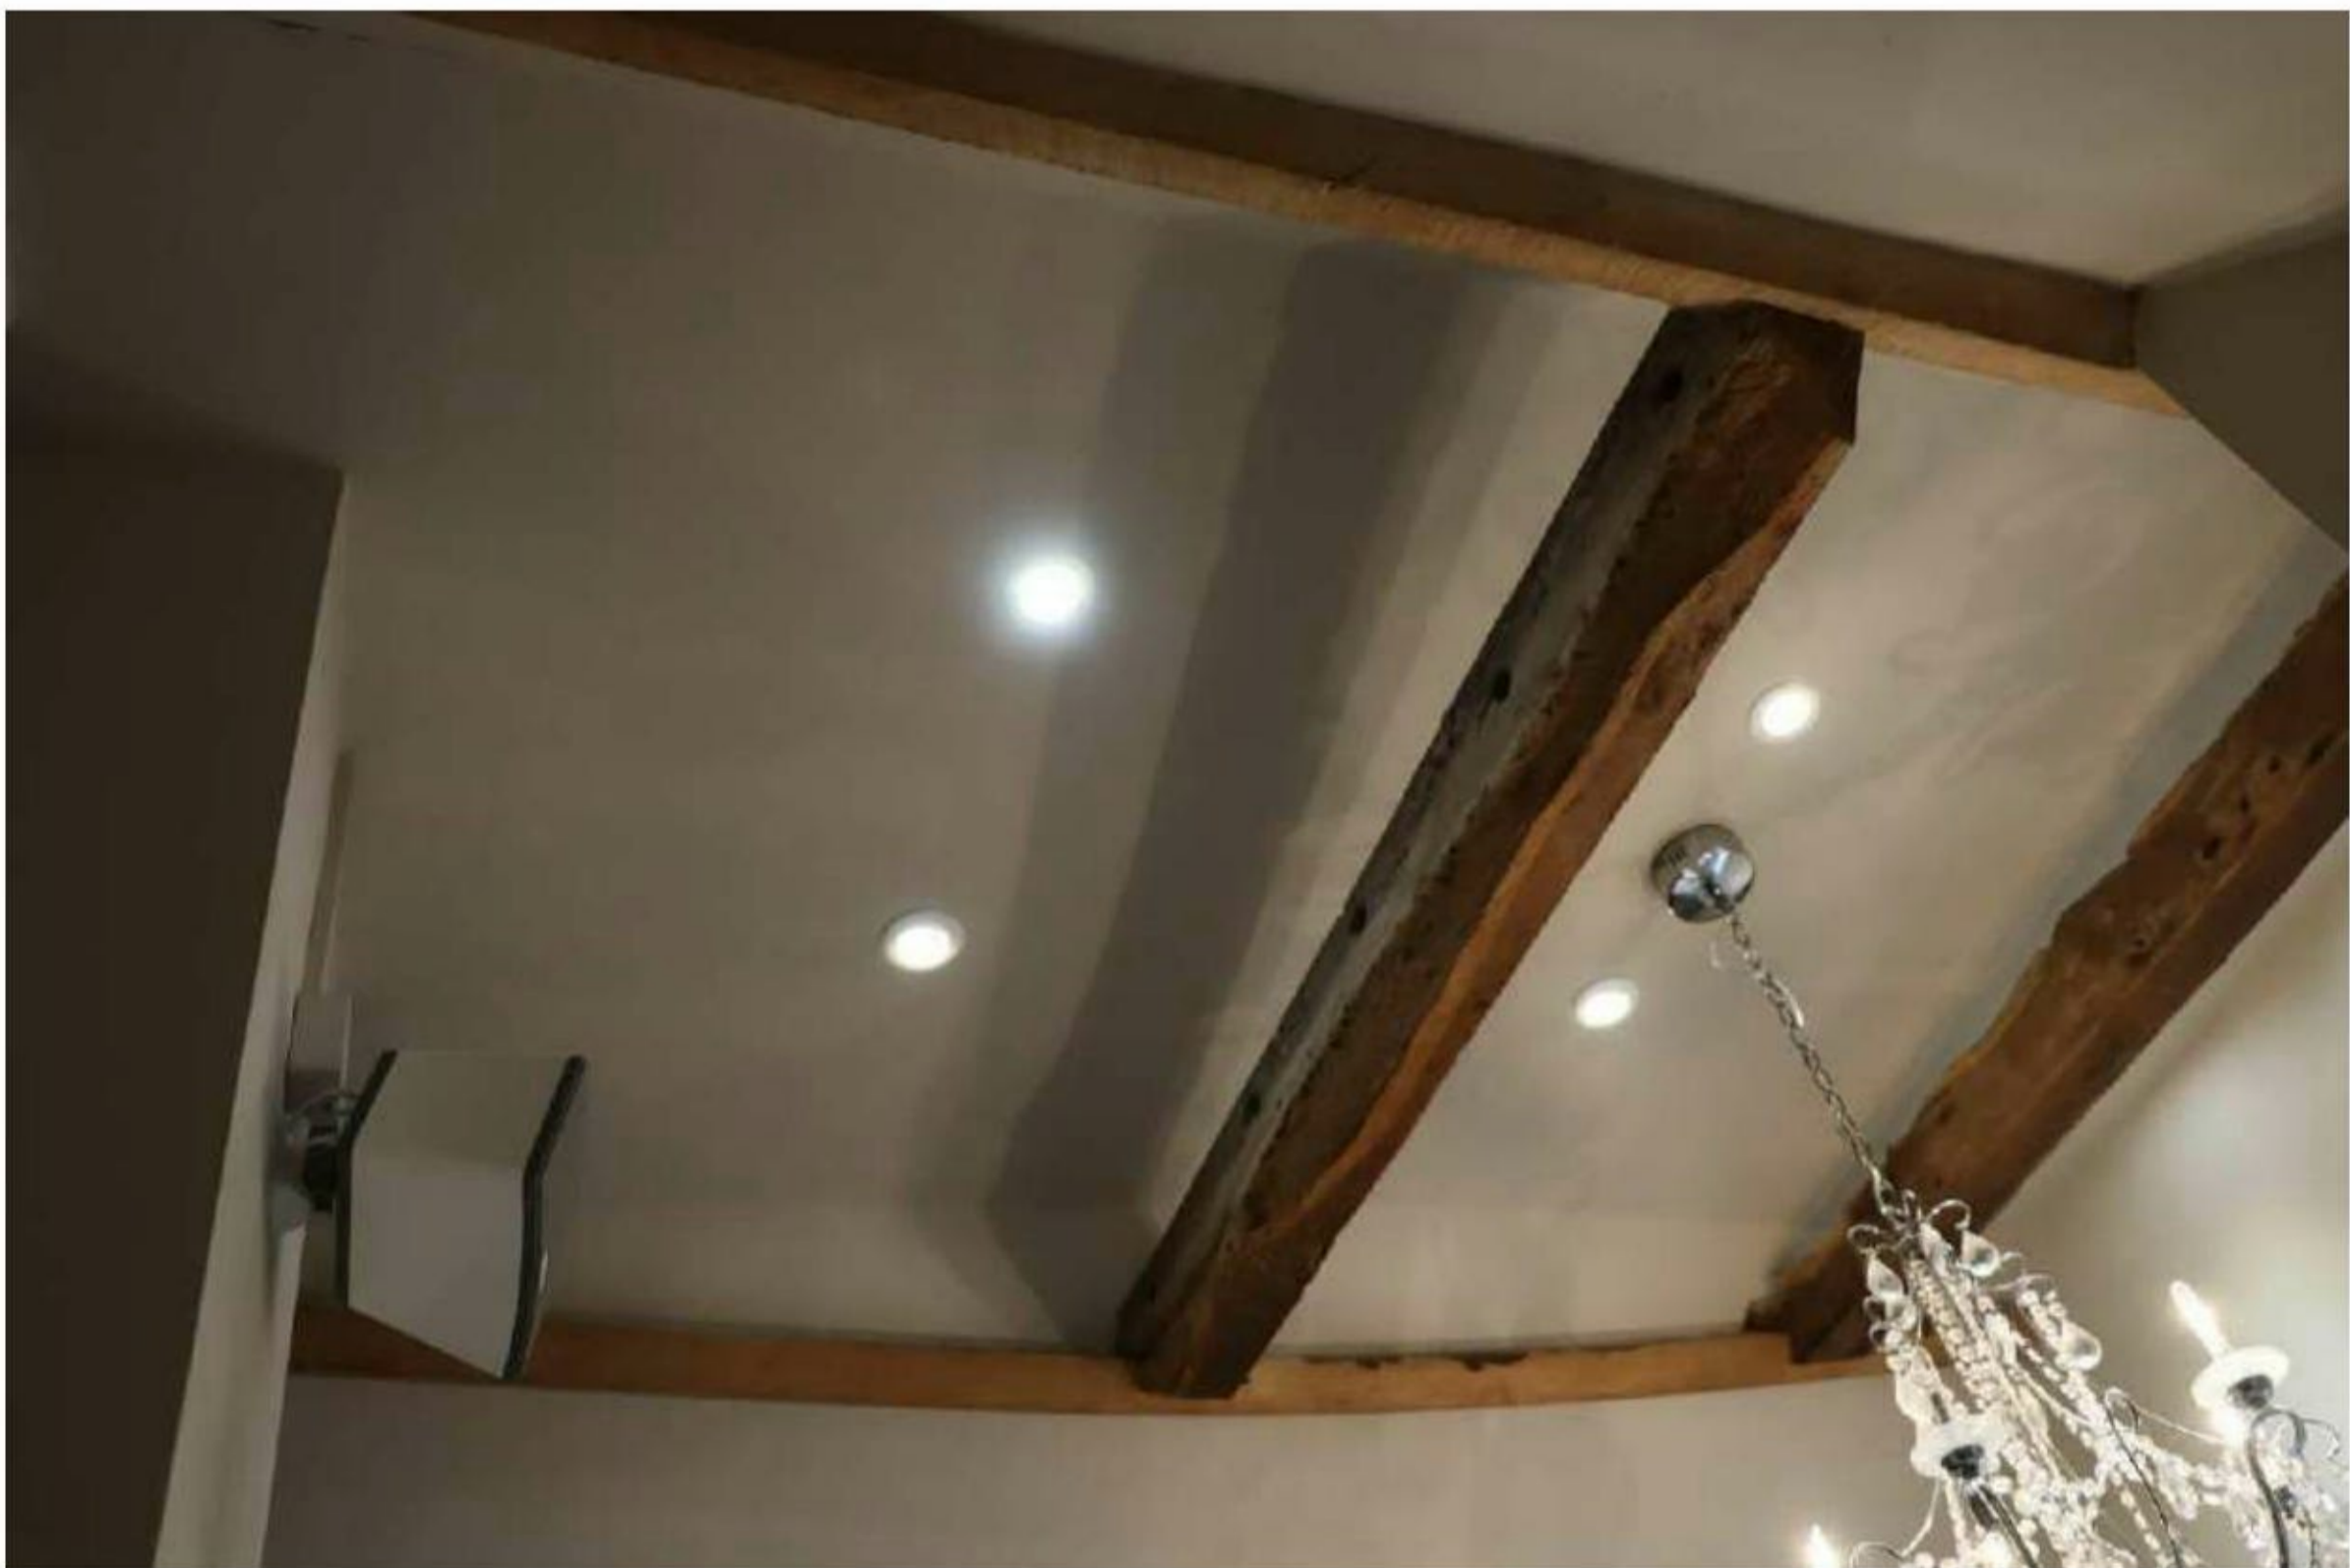
Plate 32: Exposed roof timbers in F4
