STATEMENT OF SIGNIFICANCE

**Flood Street Farm,
Breamore, Hampshire**

AHC REF: 9943

Date: April 2021

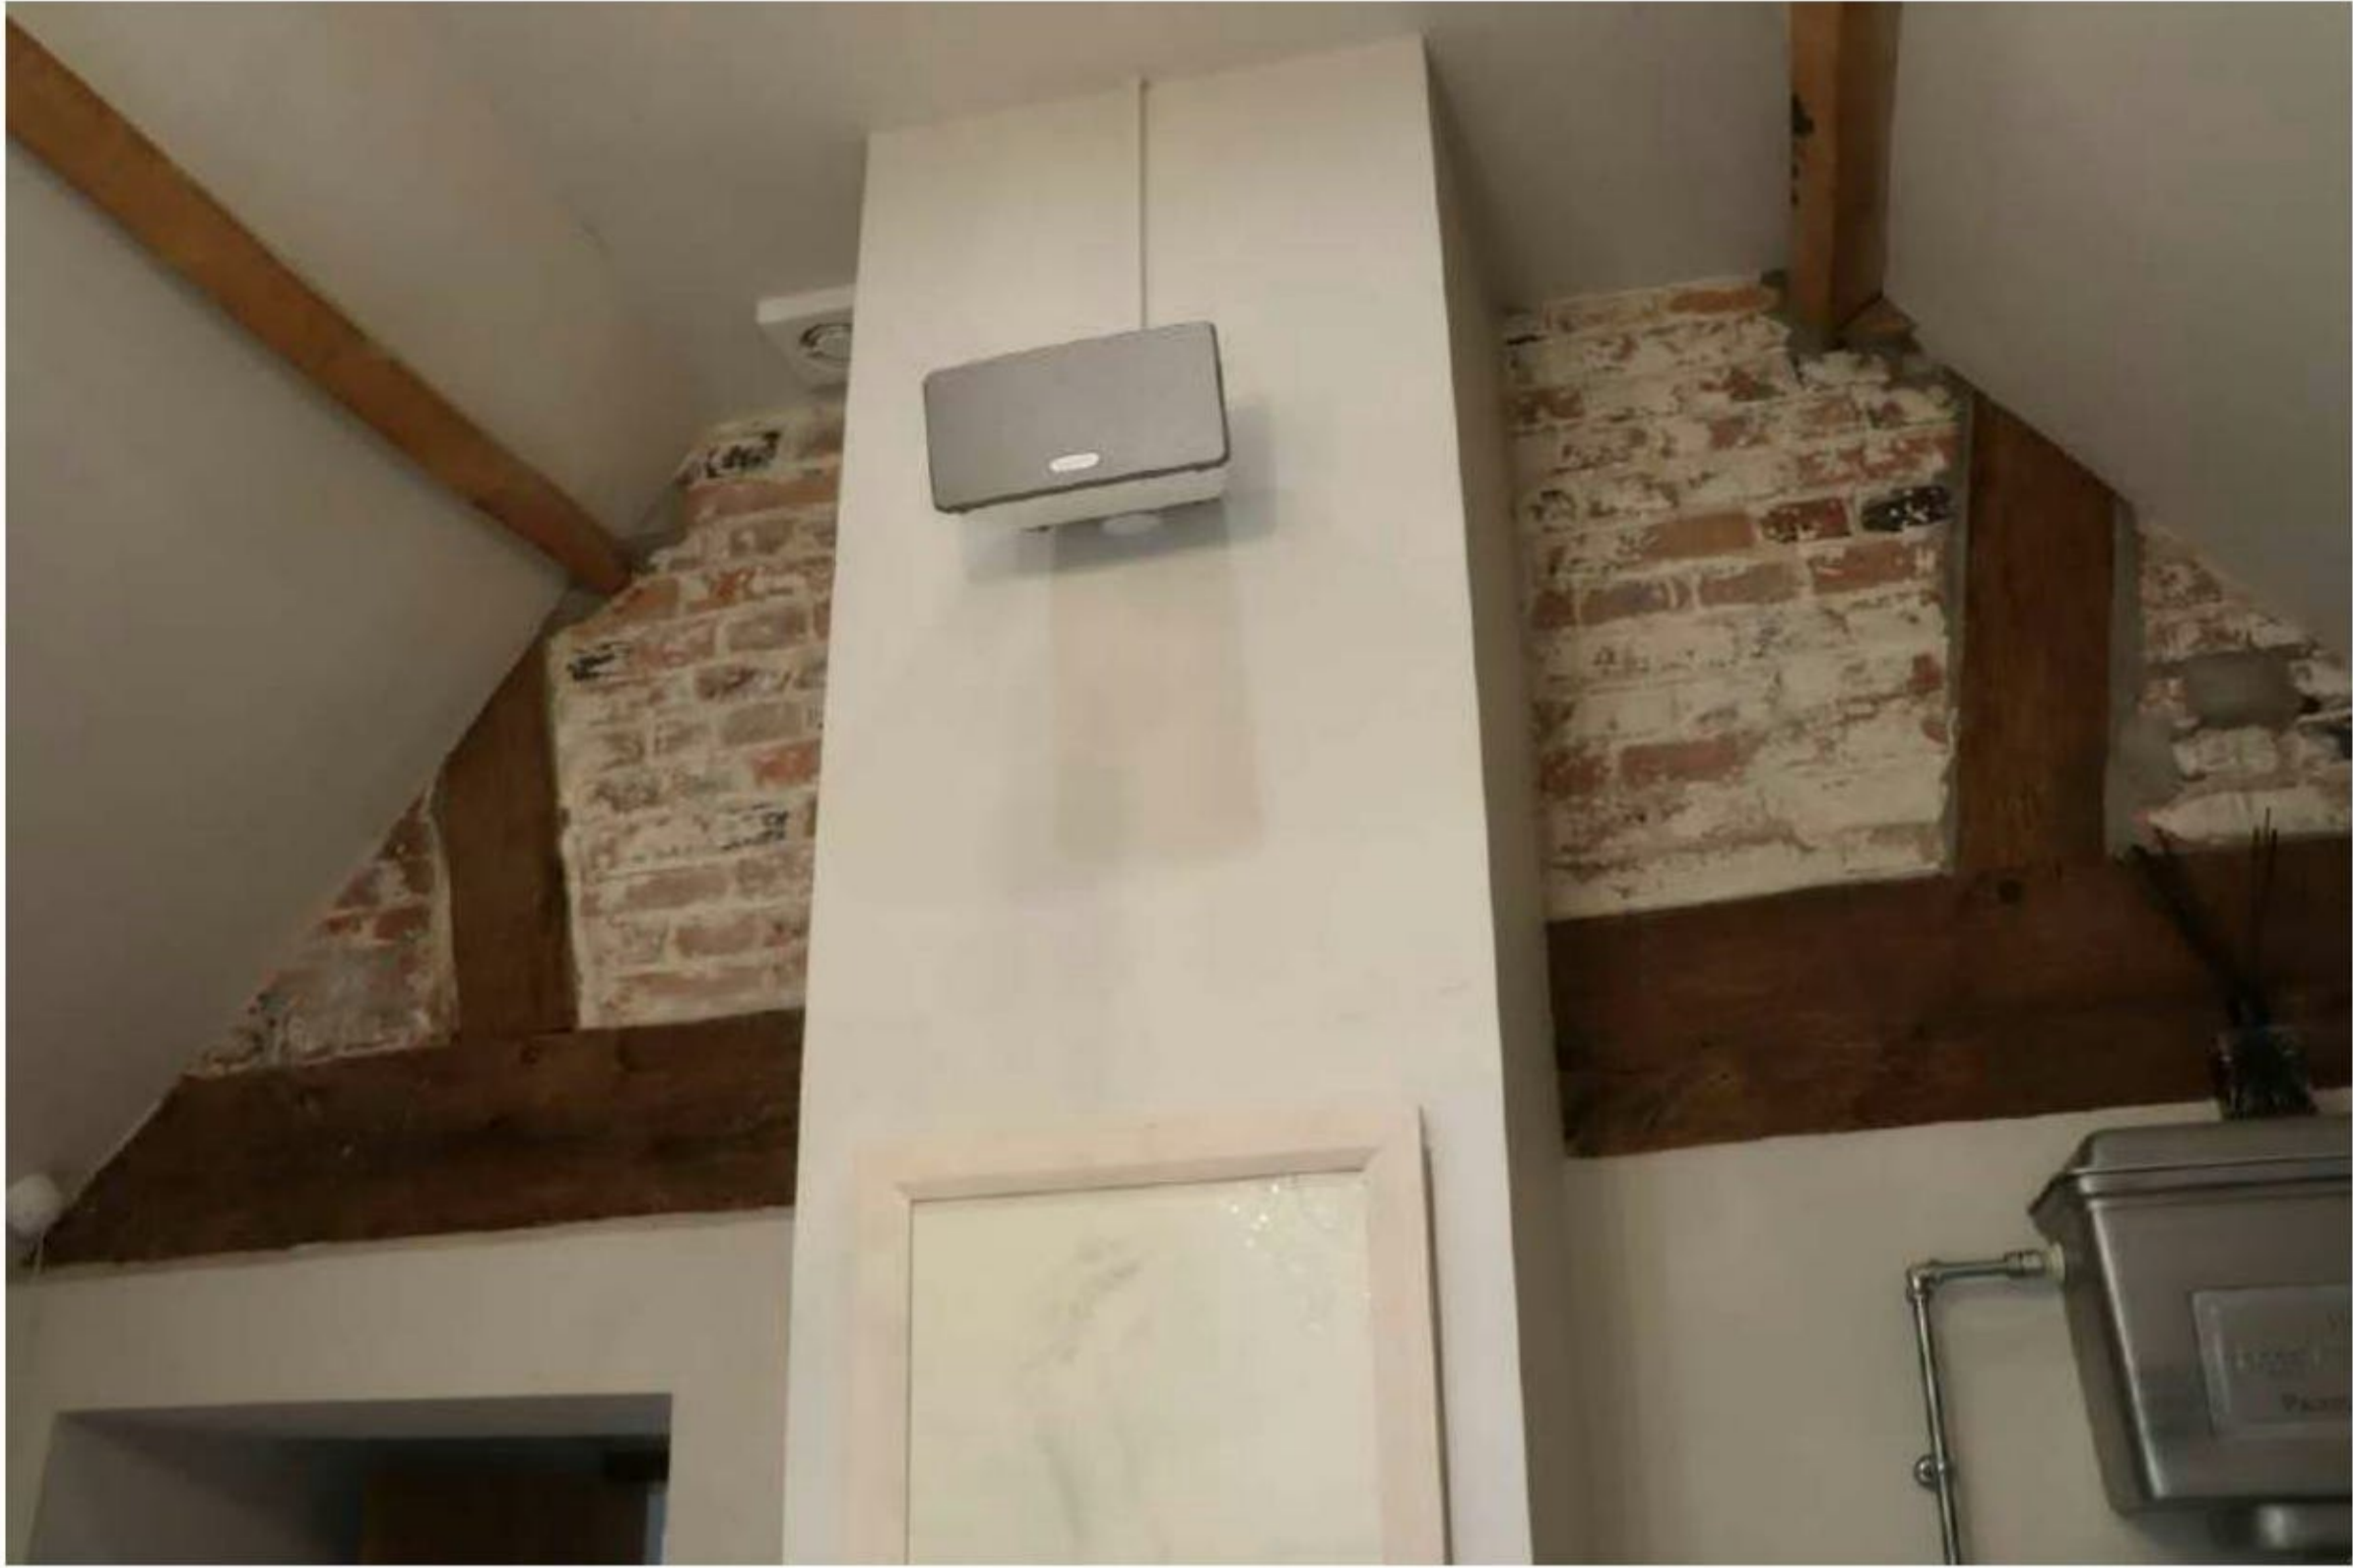
Plate 33: F4: chimneybreast and exposed truss struts in NE gable end of main range

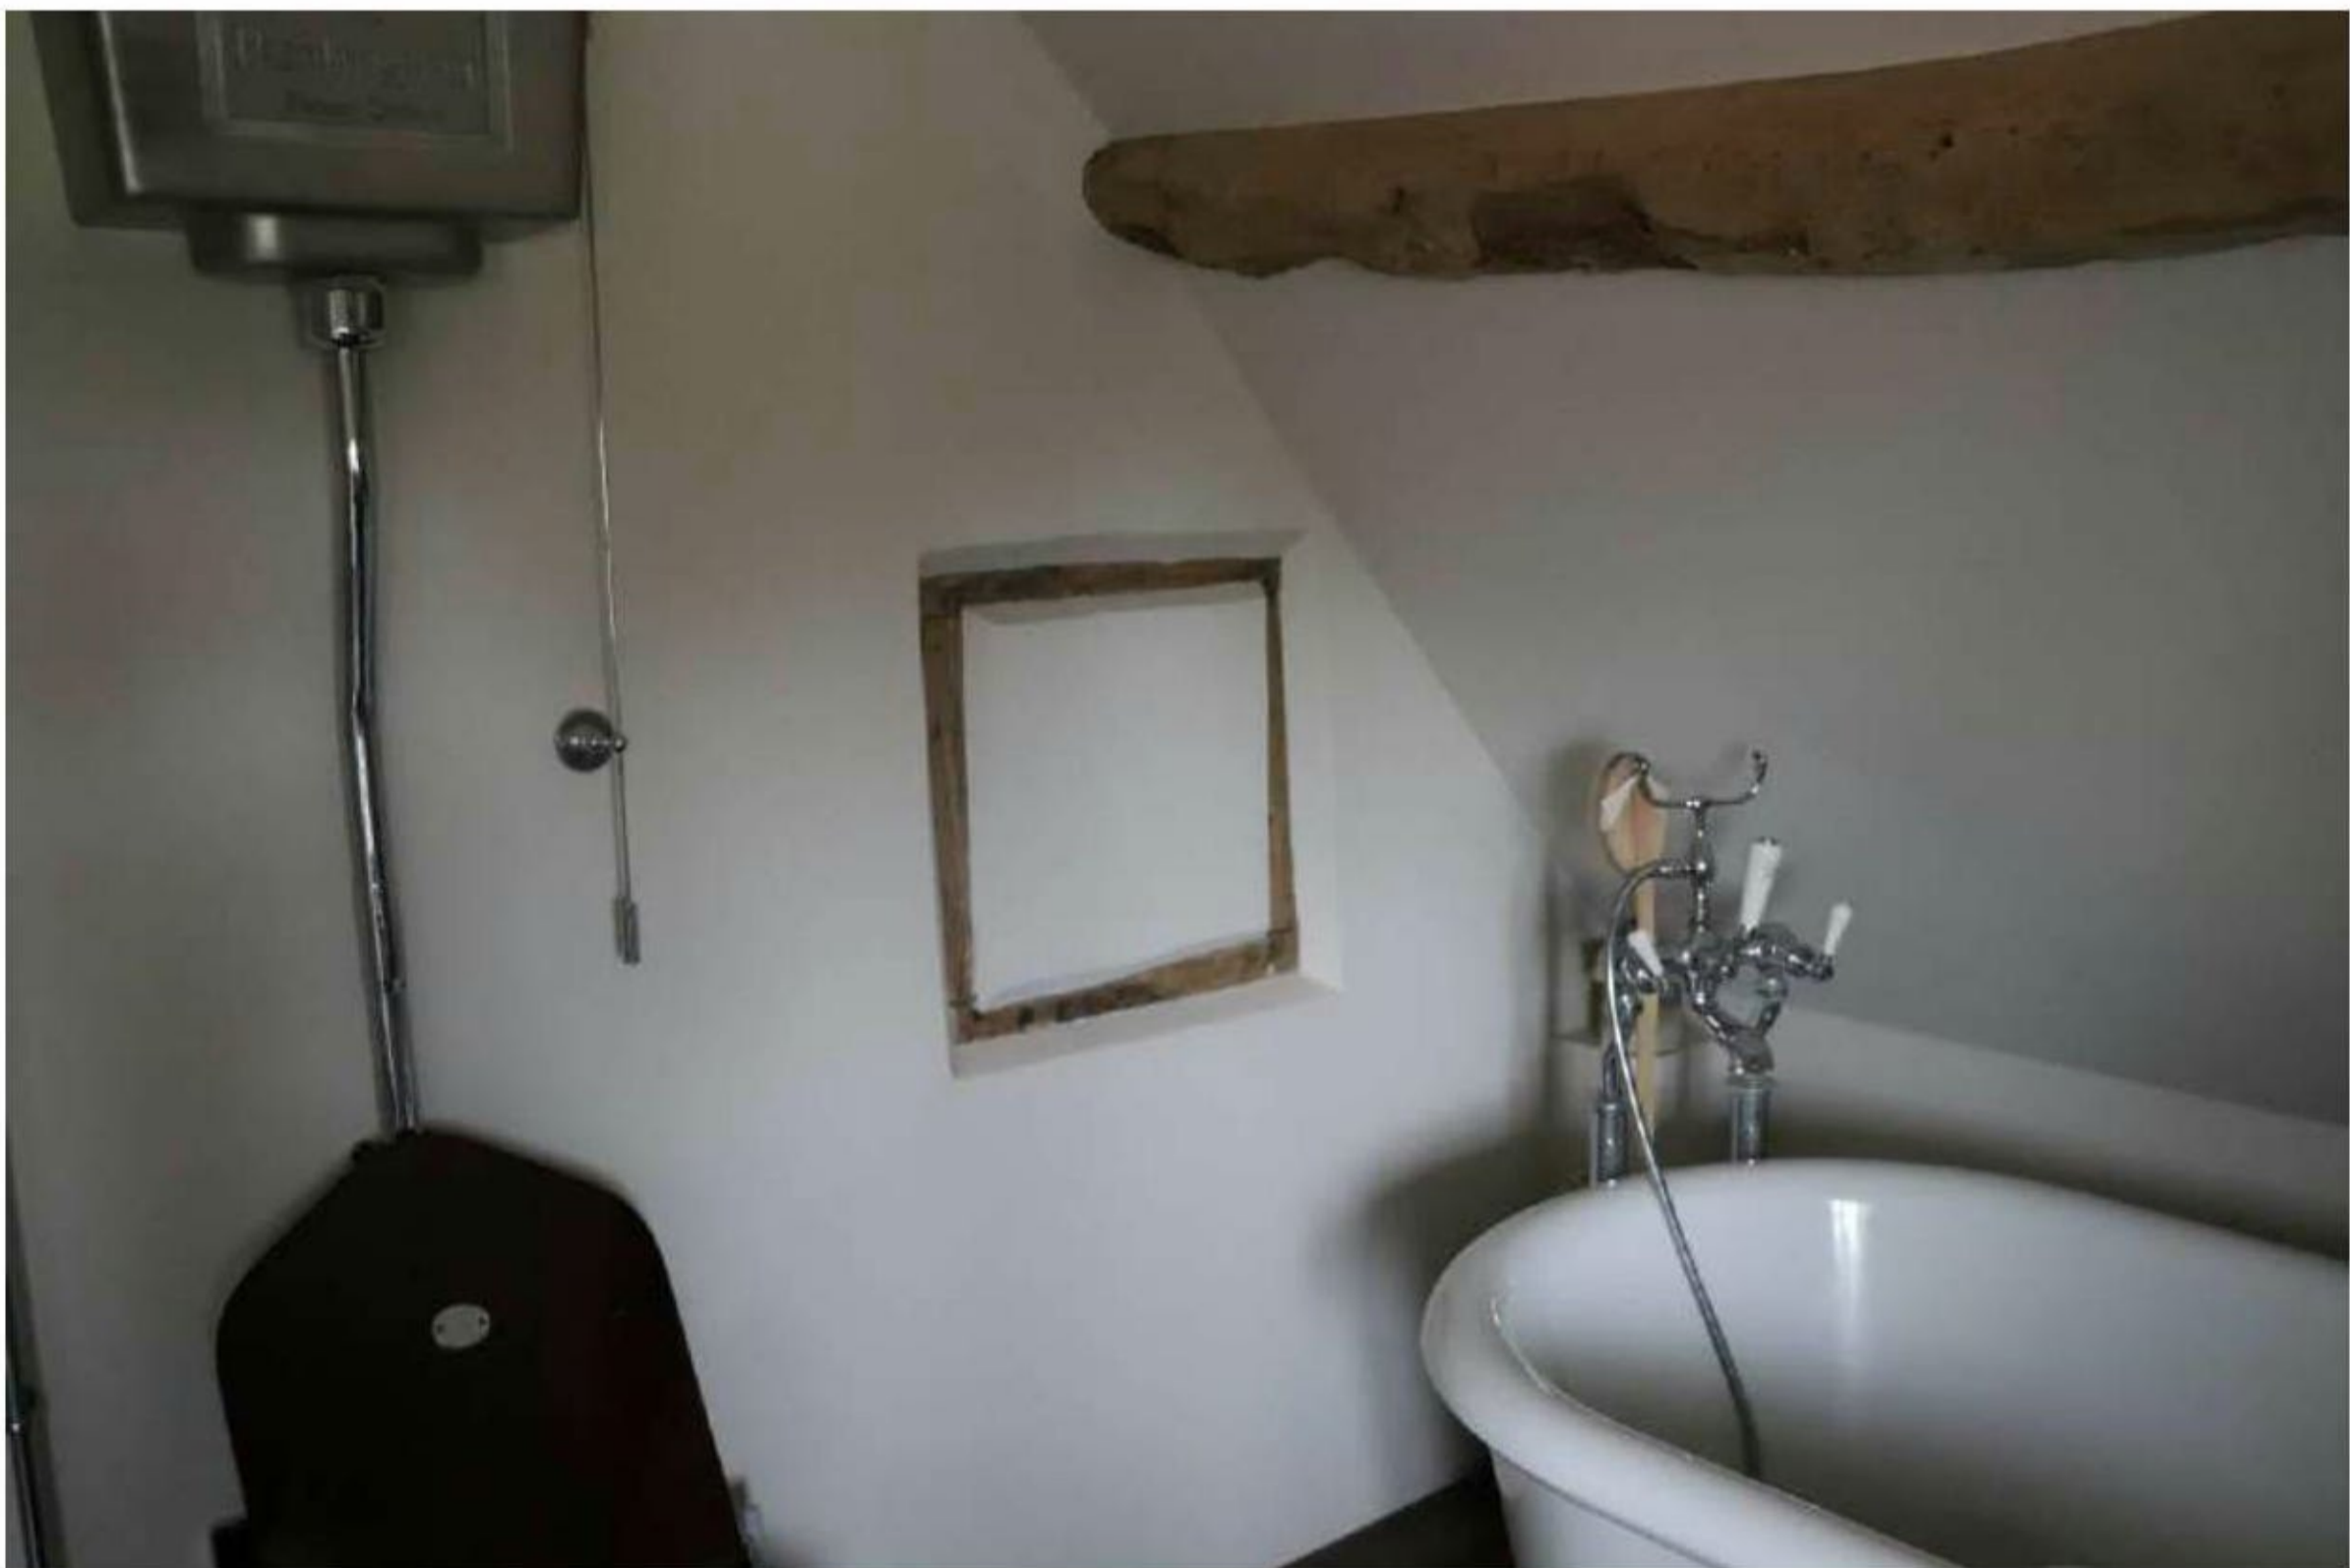
Plate 34: Blocked former window opening in NE gable end of main range, seen in F4

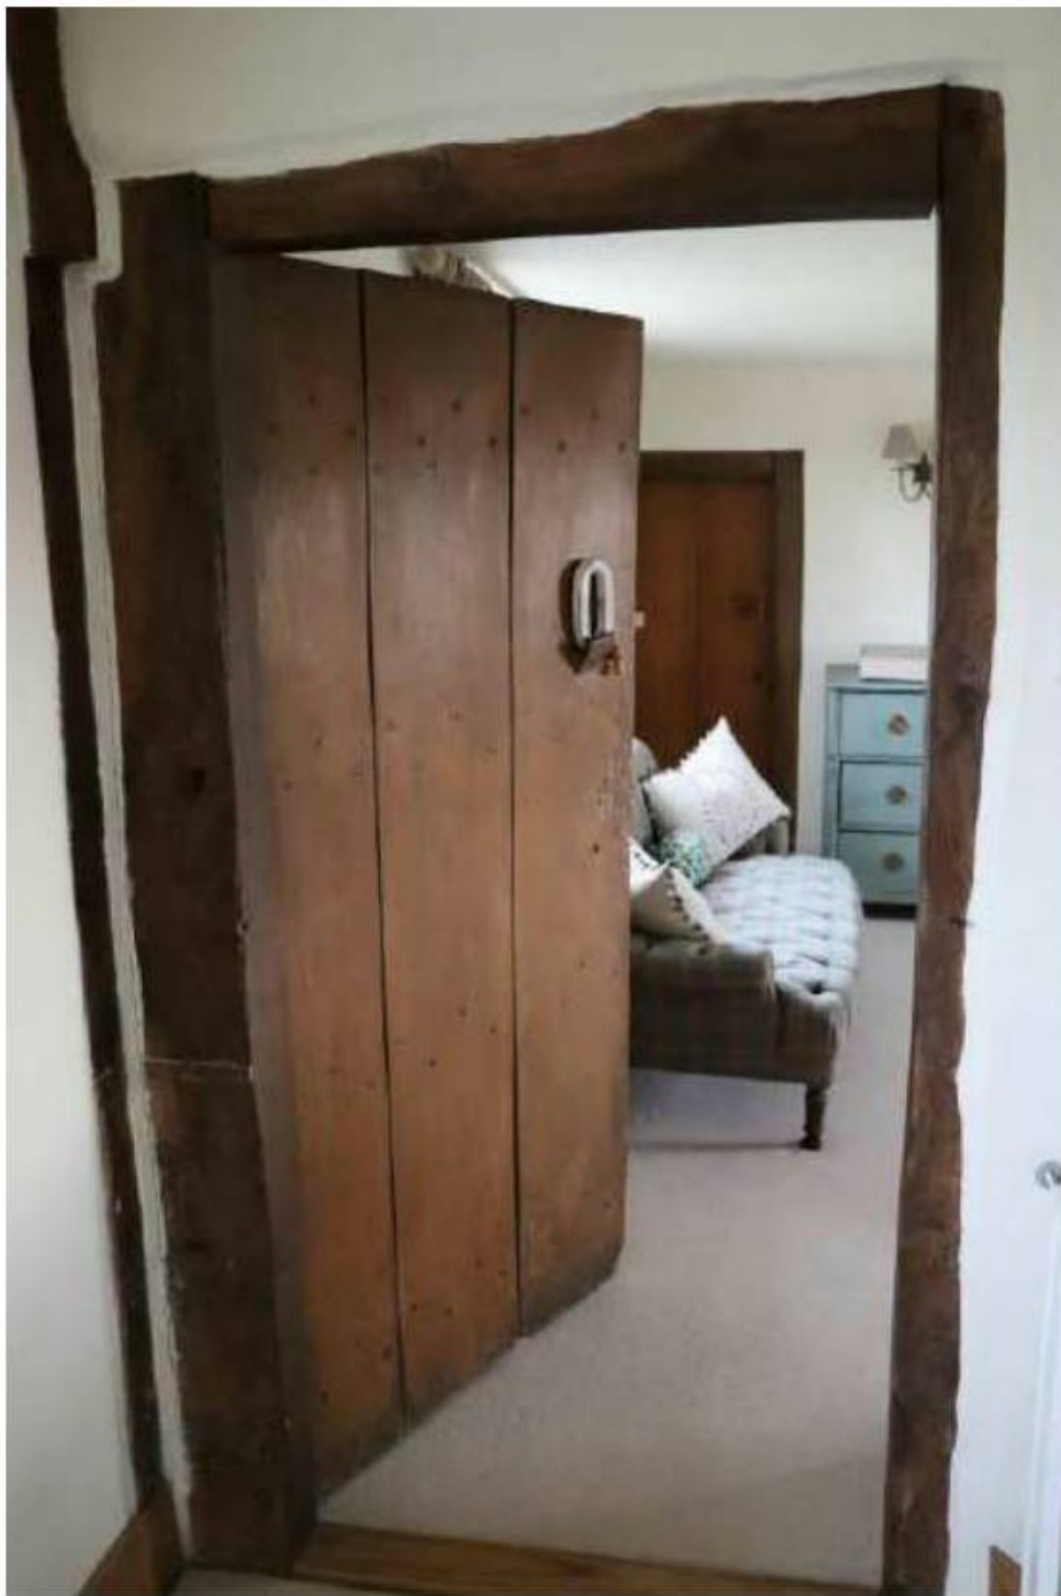
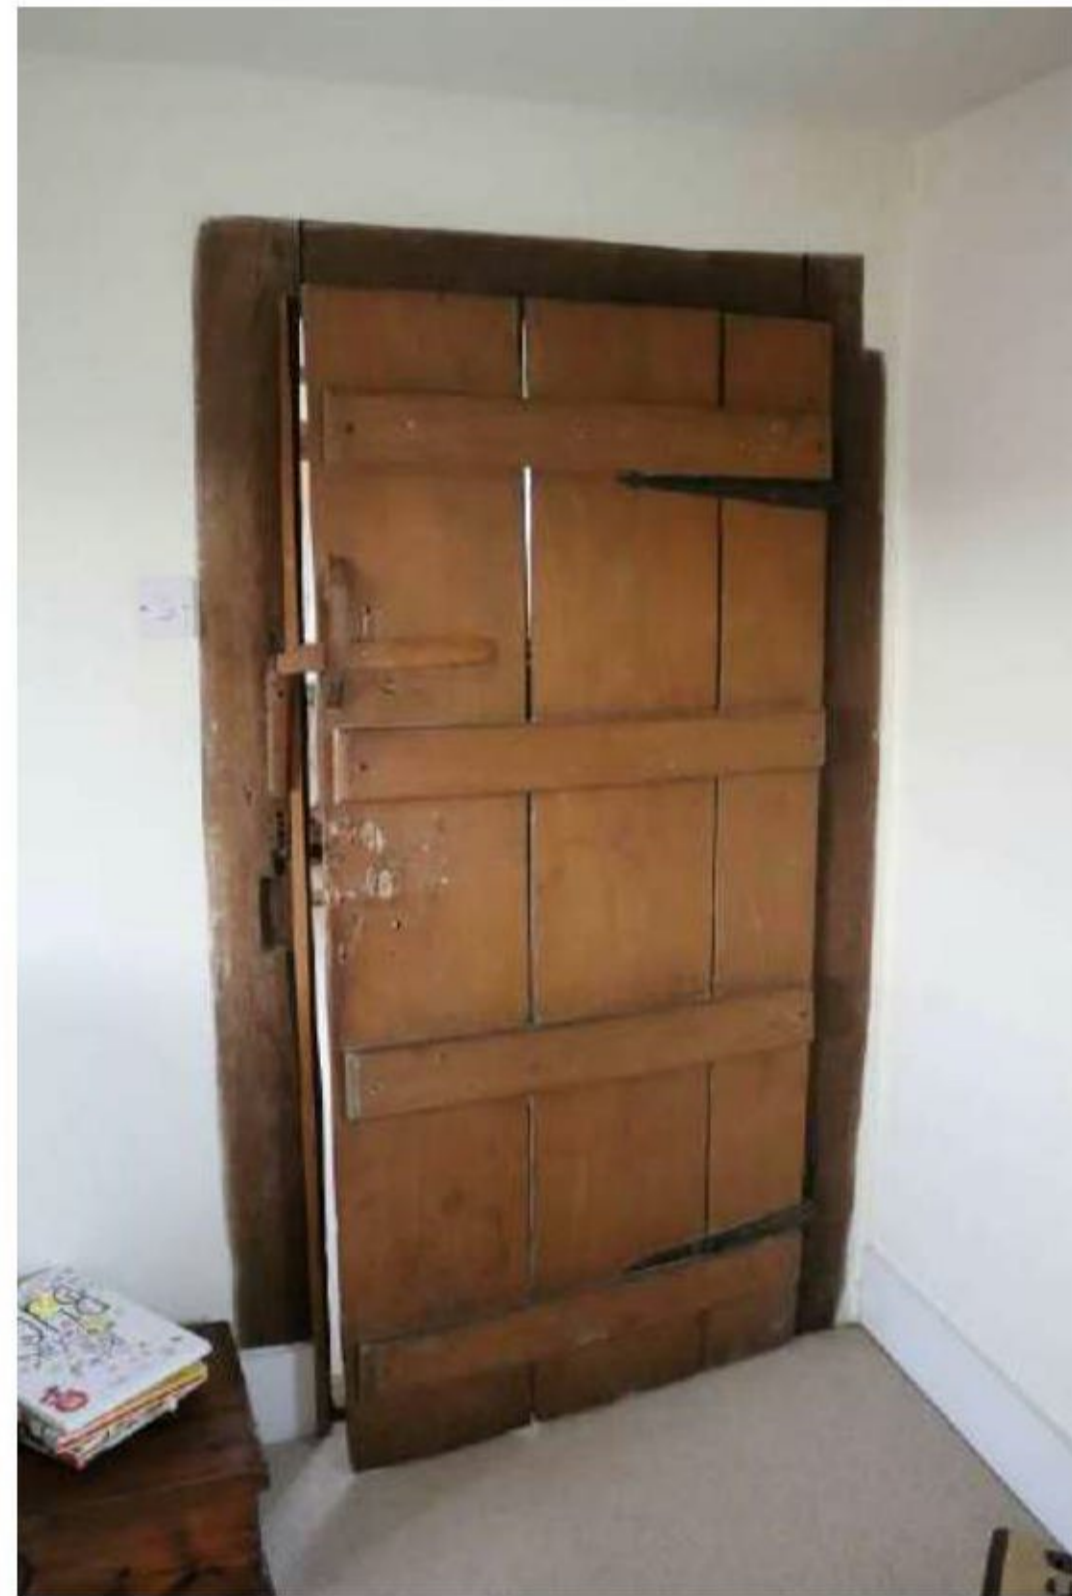
Plate 35: 17th-century door into F5

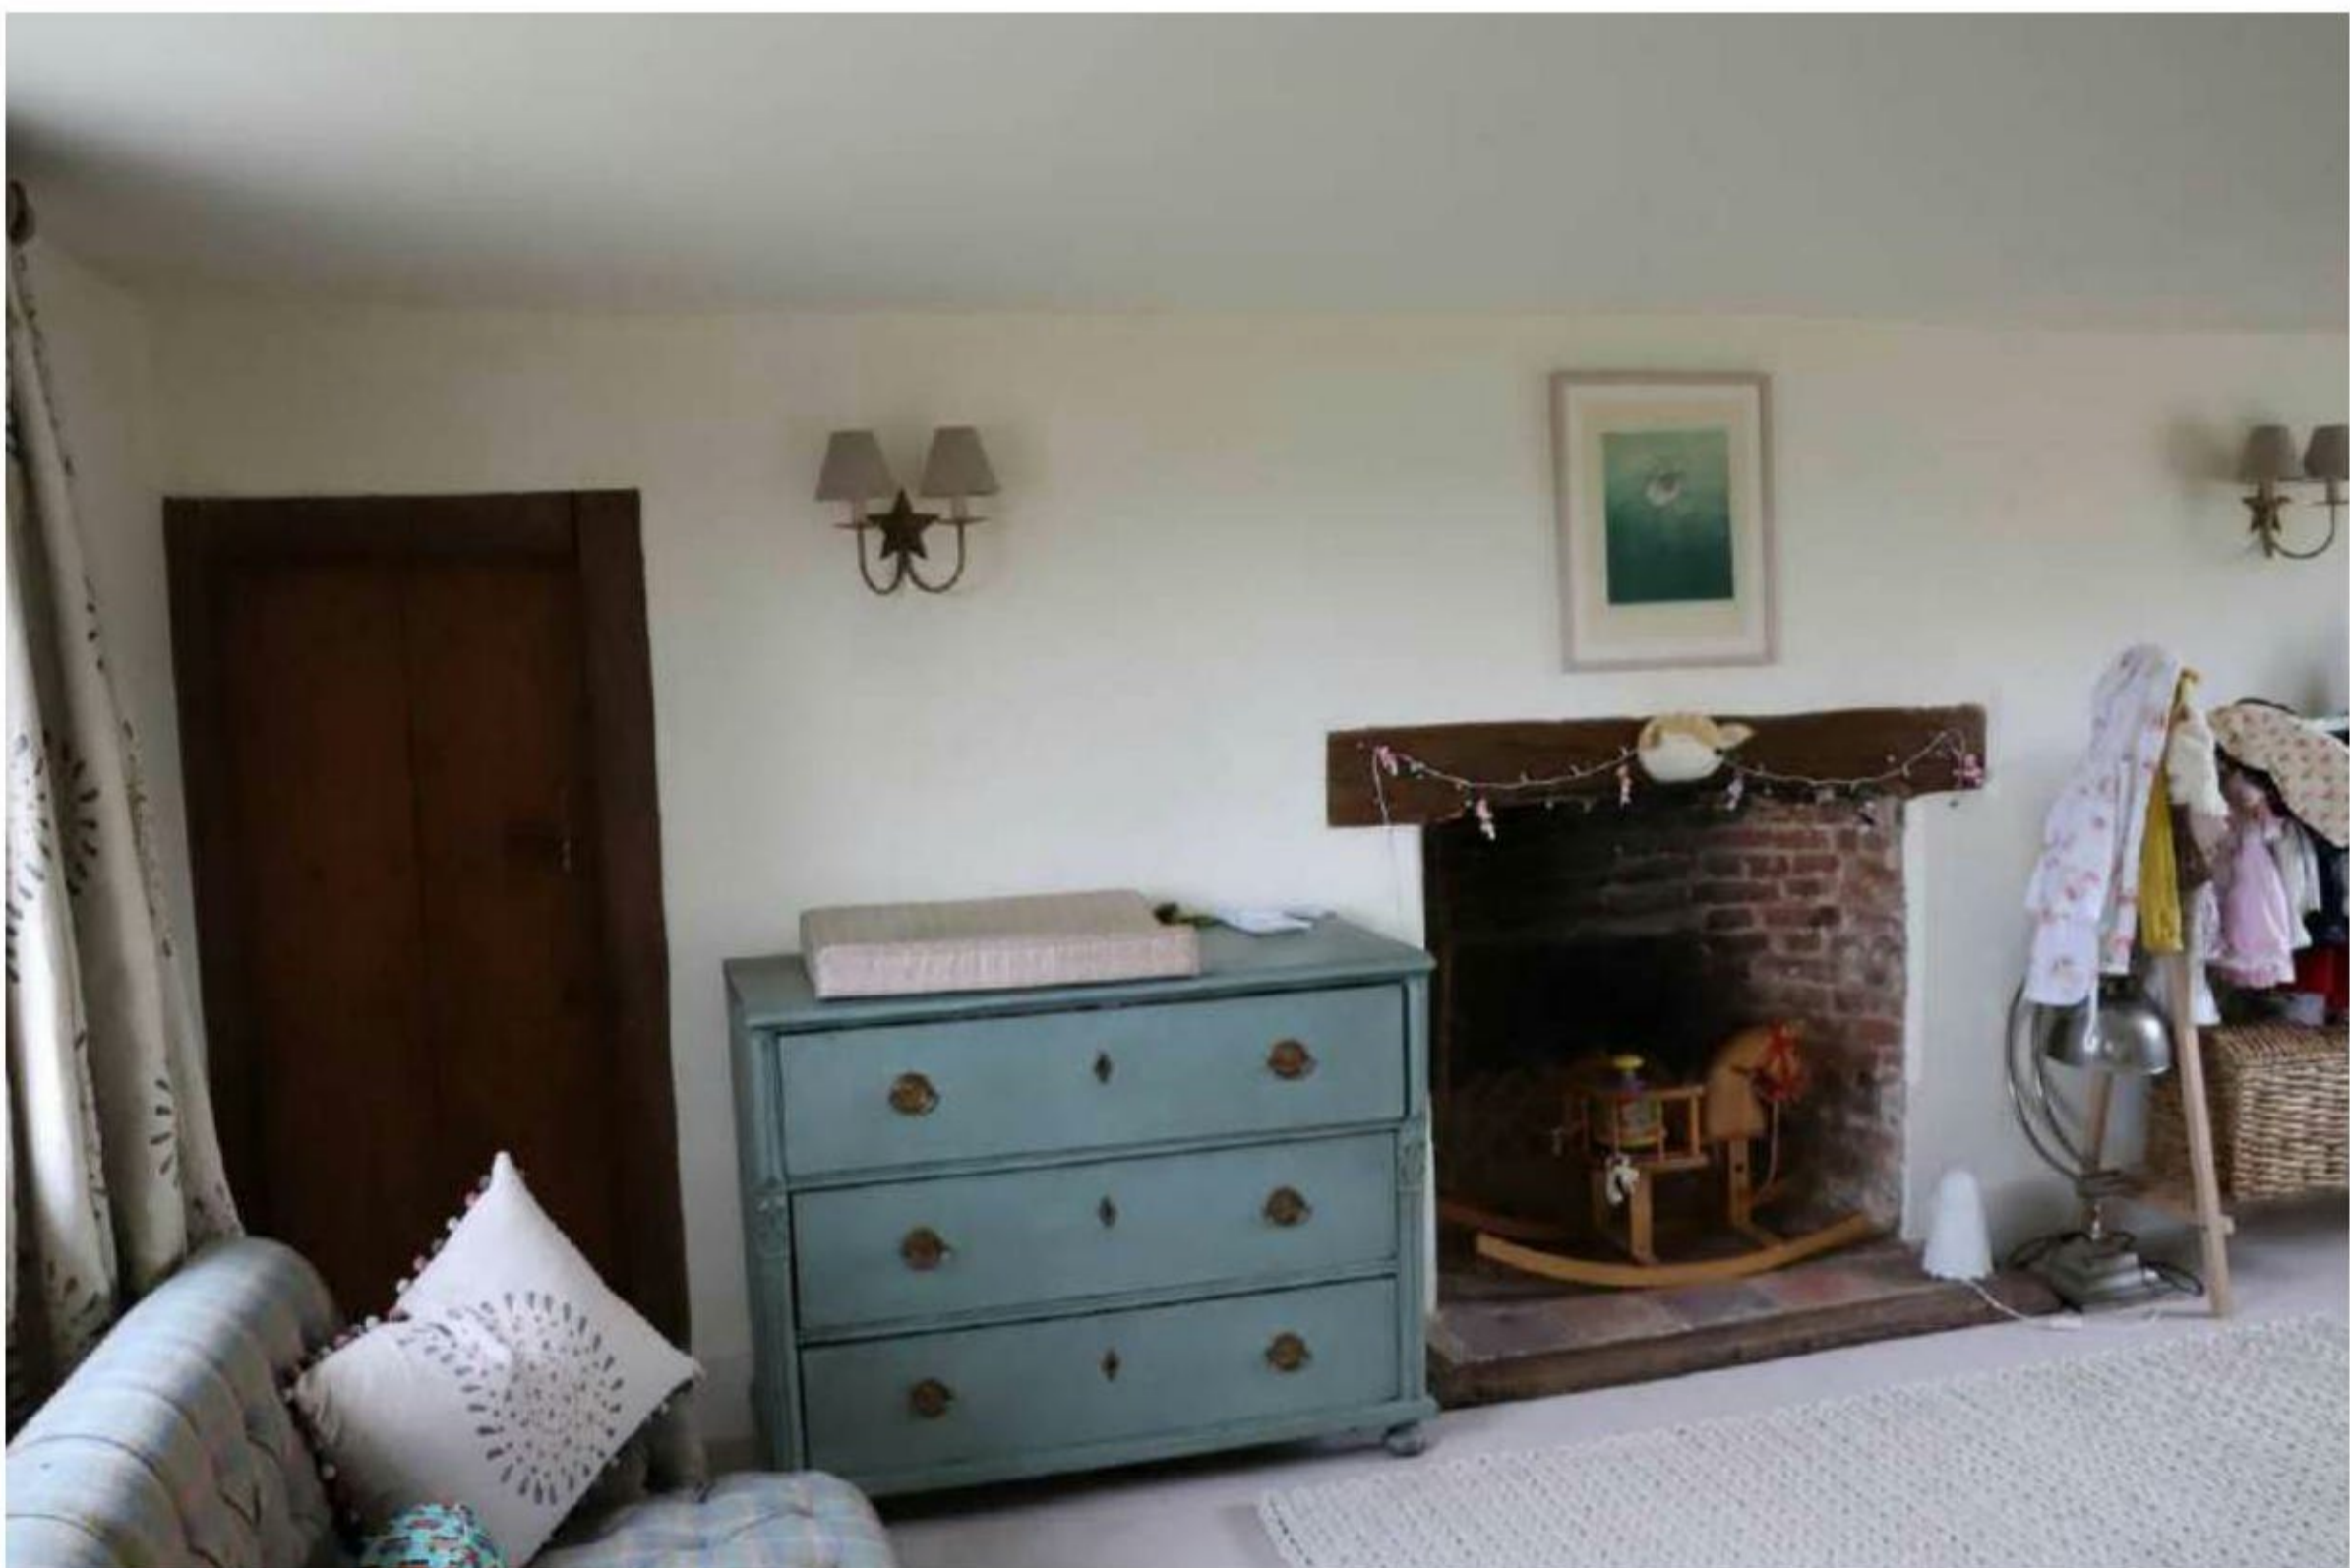
Plate 36: Fireplace in F6

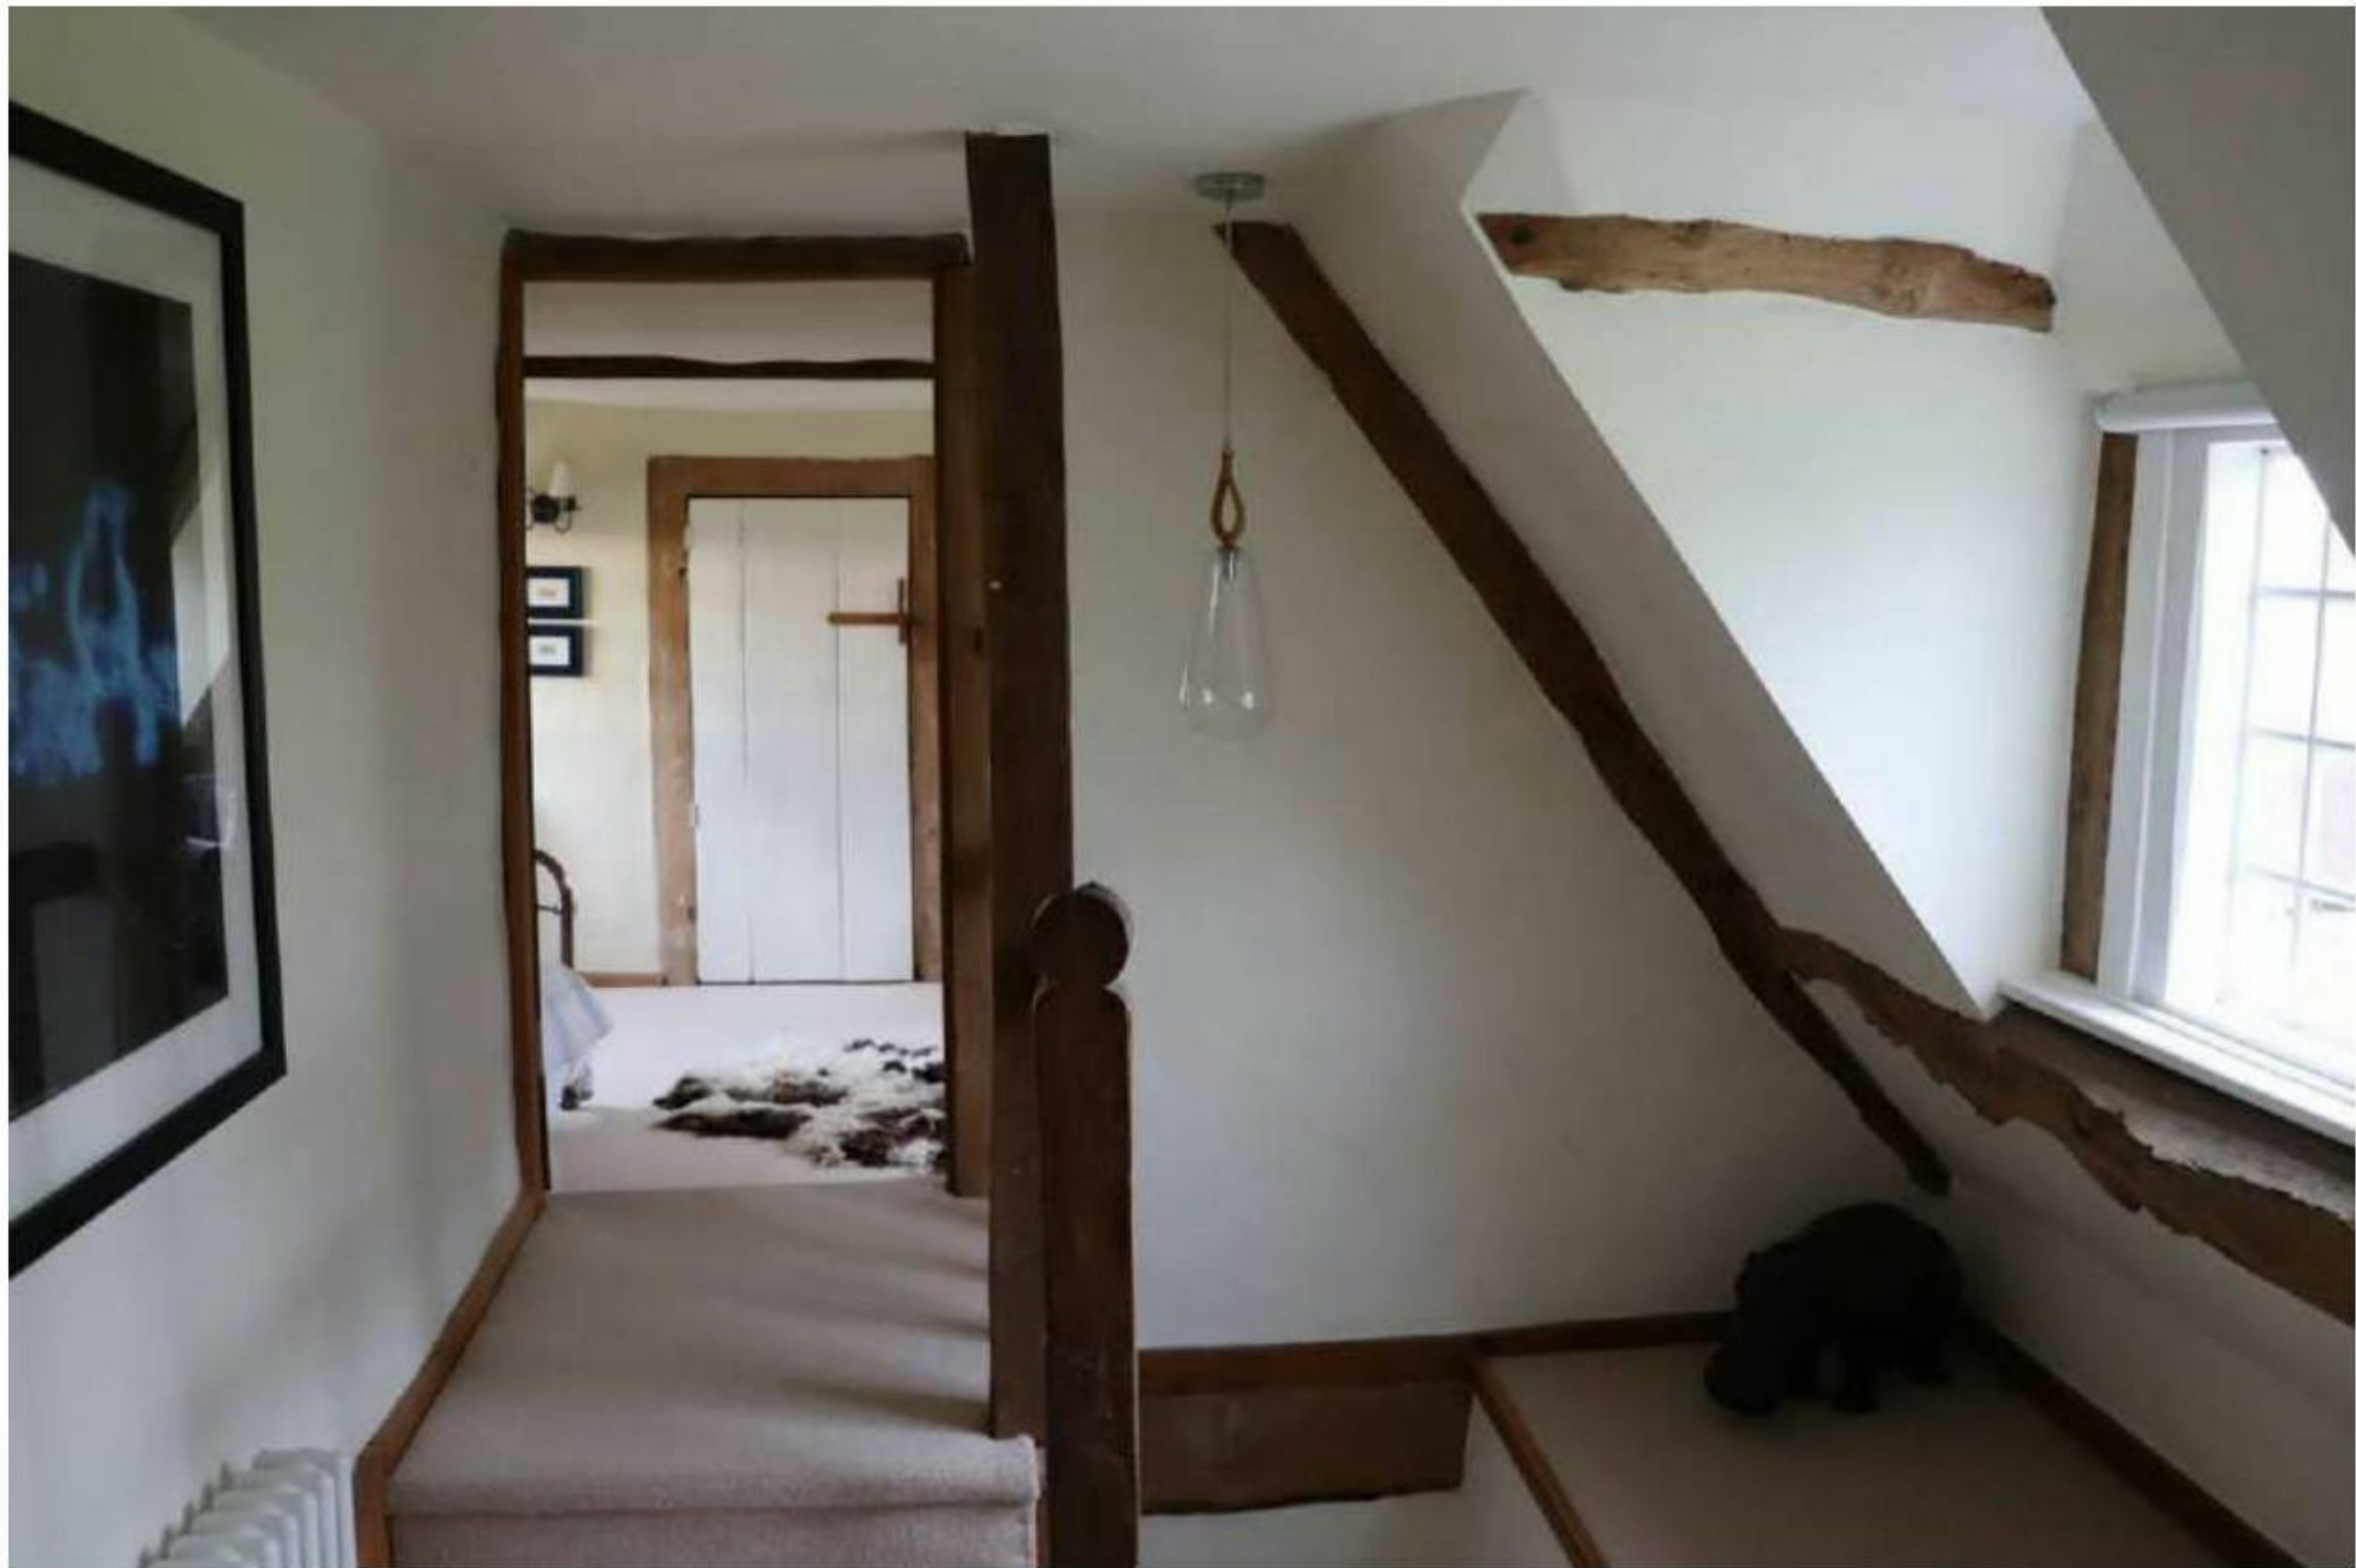
Plate 37: S1, looking NE into S5, with original newel

- 3.1.24 The second-floor landing (S1; **Plates 37 & 38**) looks much as it did in 1956, with an original newel with barrel-shaped finial and plain handrail (with replaced stick balusters) at the stair head (cf **Plate 37** with **Photos J2 & K2**). From the landing, there are two steps up to the door into the northern room and then two steps down from there into the room. This is presumably to allow for headspace and the height of the attic door beneath.

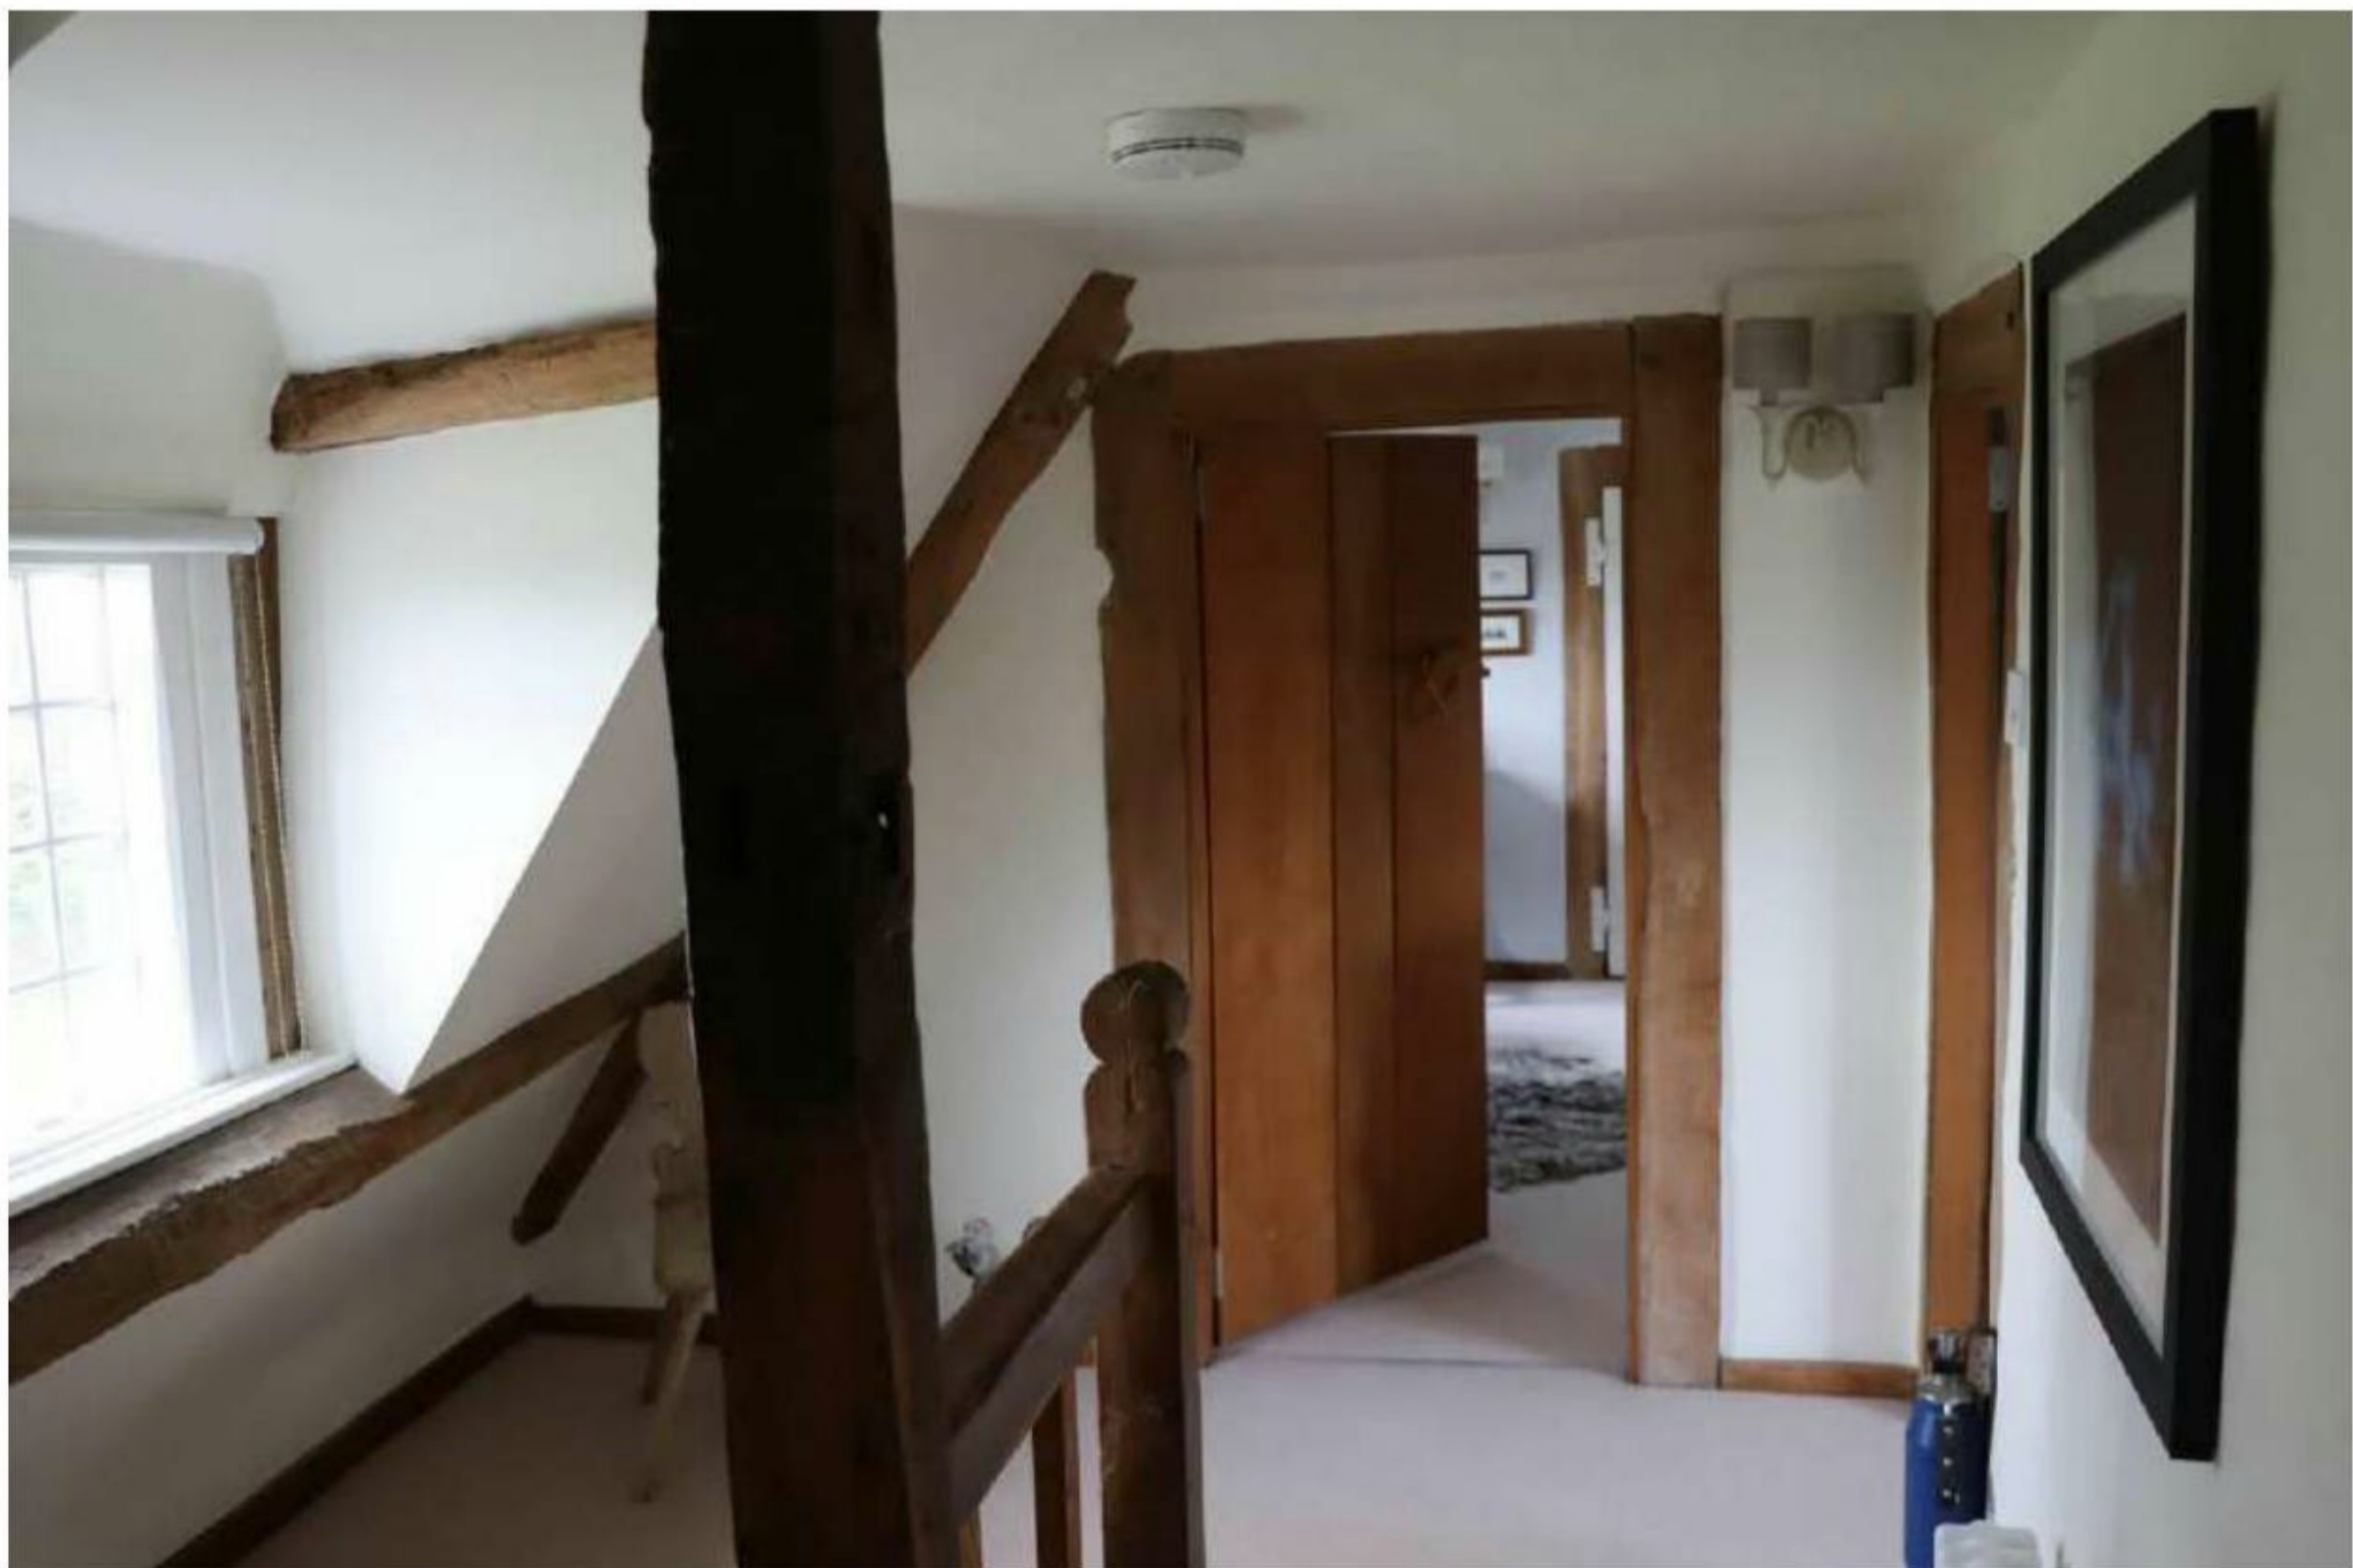
Plate 38: S1, looking SW into S3
