STATEMENT OF SIGNIFICANCE

**Flood Street Farm,
Breamore, Hampshire**

AHC REF: 9943

Date: April 2021

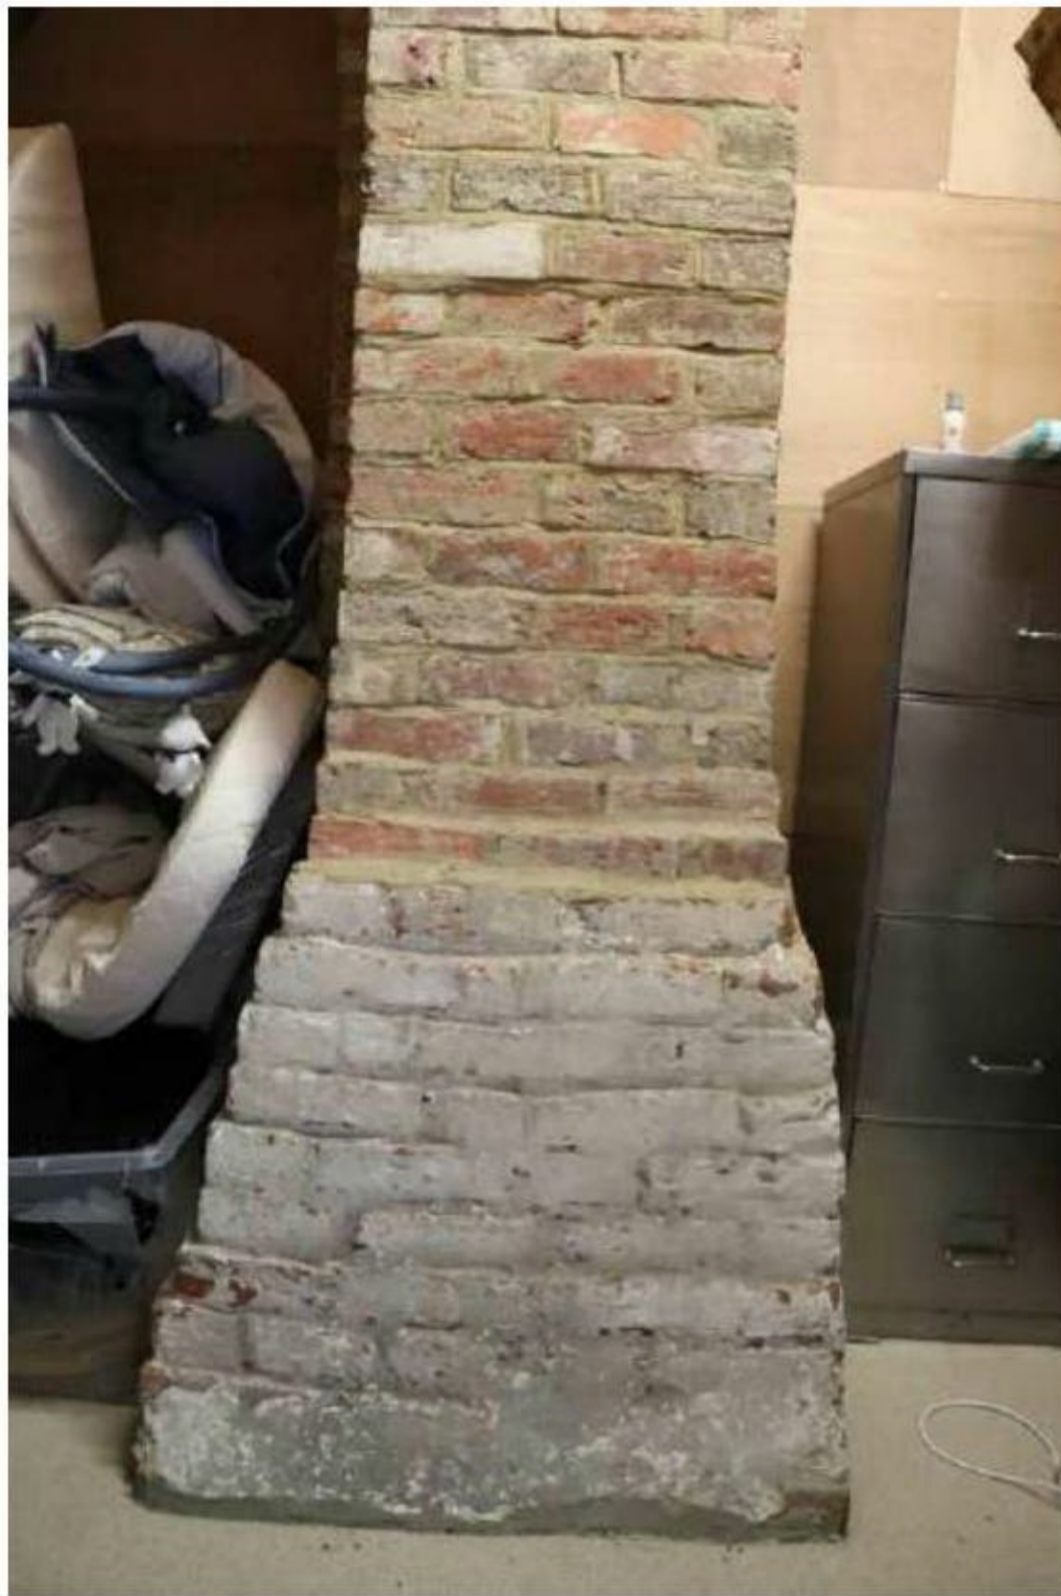
Plate 39: Chimney stack on SW wall of S4; note the rebuilt section above the white brick

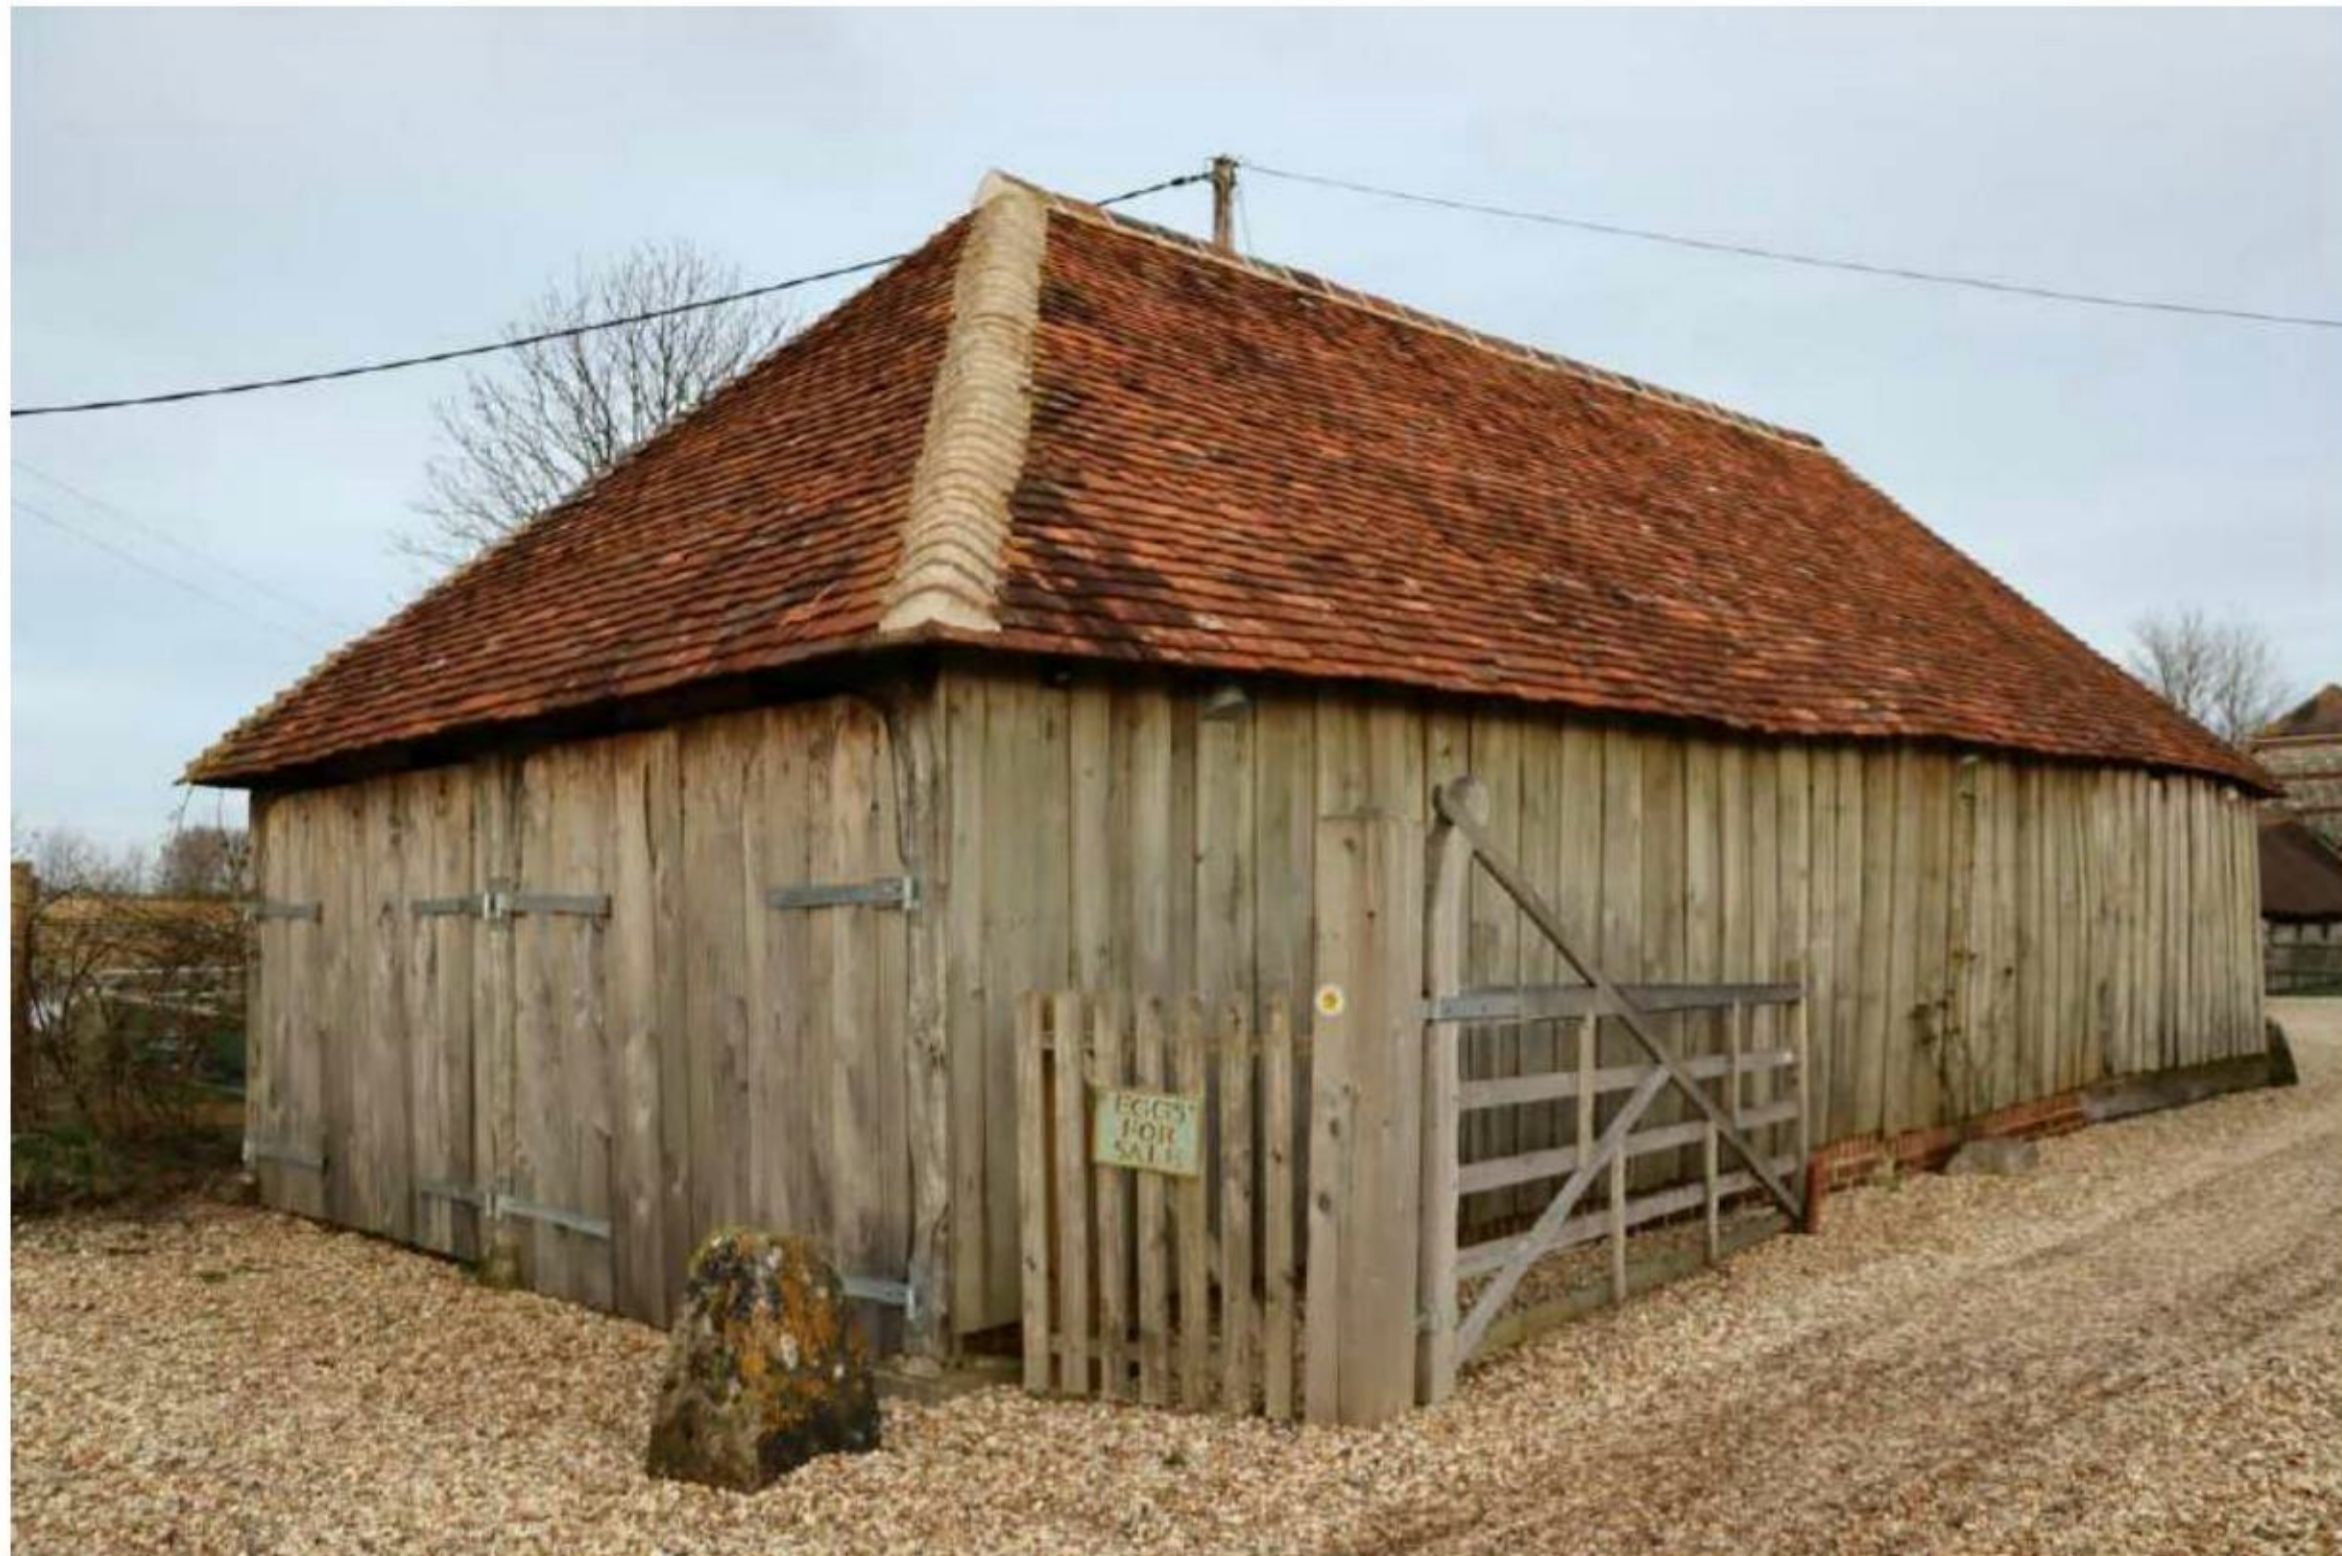
Plate 41: The Grade II listed cartshed restored in 2016 (Building A) – W end with cart entrances and long S elevation

3.2.1 Building A (**Plates 41 & 42**) is not considered in any detail as part of this assessment as it has been subject to a painstaking restoration in recent years. This former cart-shed is listed in its own right, for group value with the farmhouse, at Grade II. The list description describes it as being of 18th-century date and it certainly seems to have been present on the site in 1811. The OS map suggest it was truncated at its eastern end between 1870 and 1895. The building is constructed on a timber frame and clad with vertical timbers to its long sides and horizontal timbers to its eastern end. The western end has two sets of double cart doors. It has a hipped clay-tile roof with scalloped bands. See **Photos A & G**.

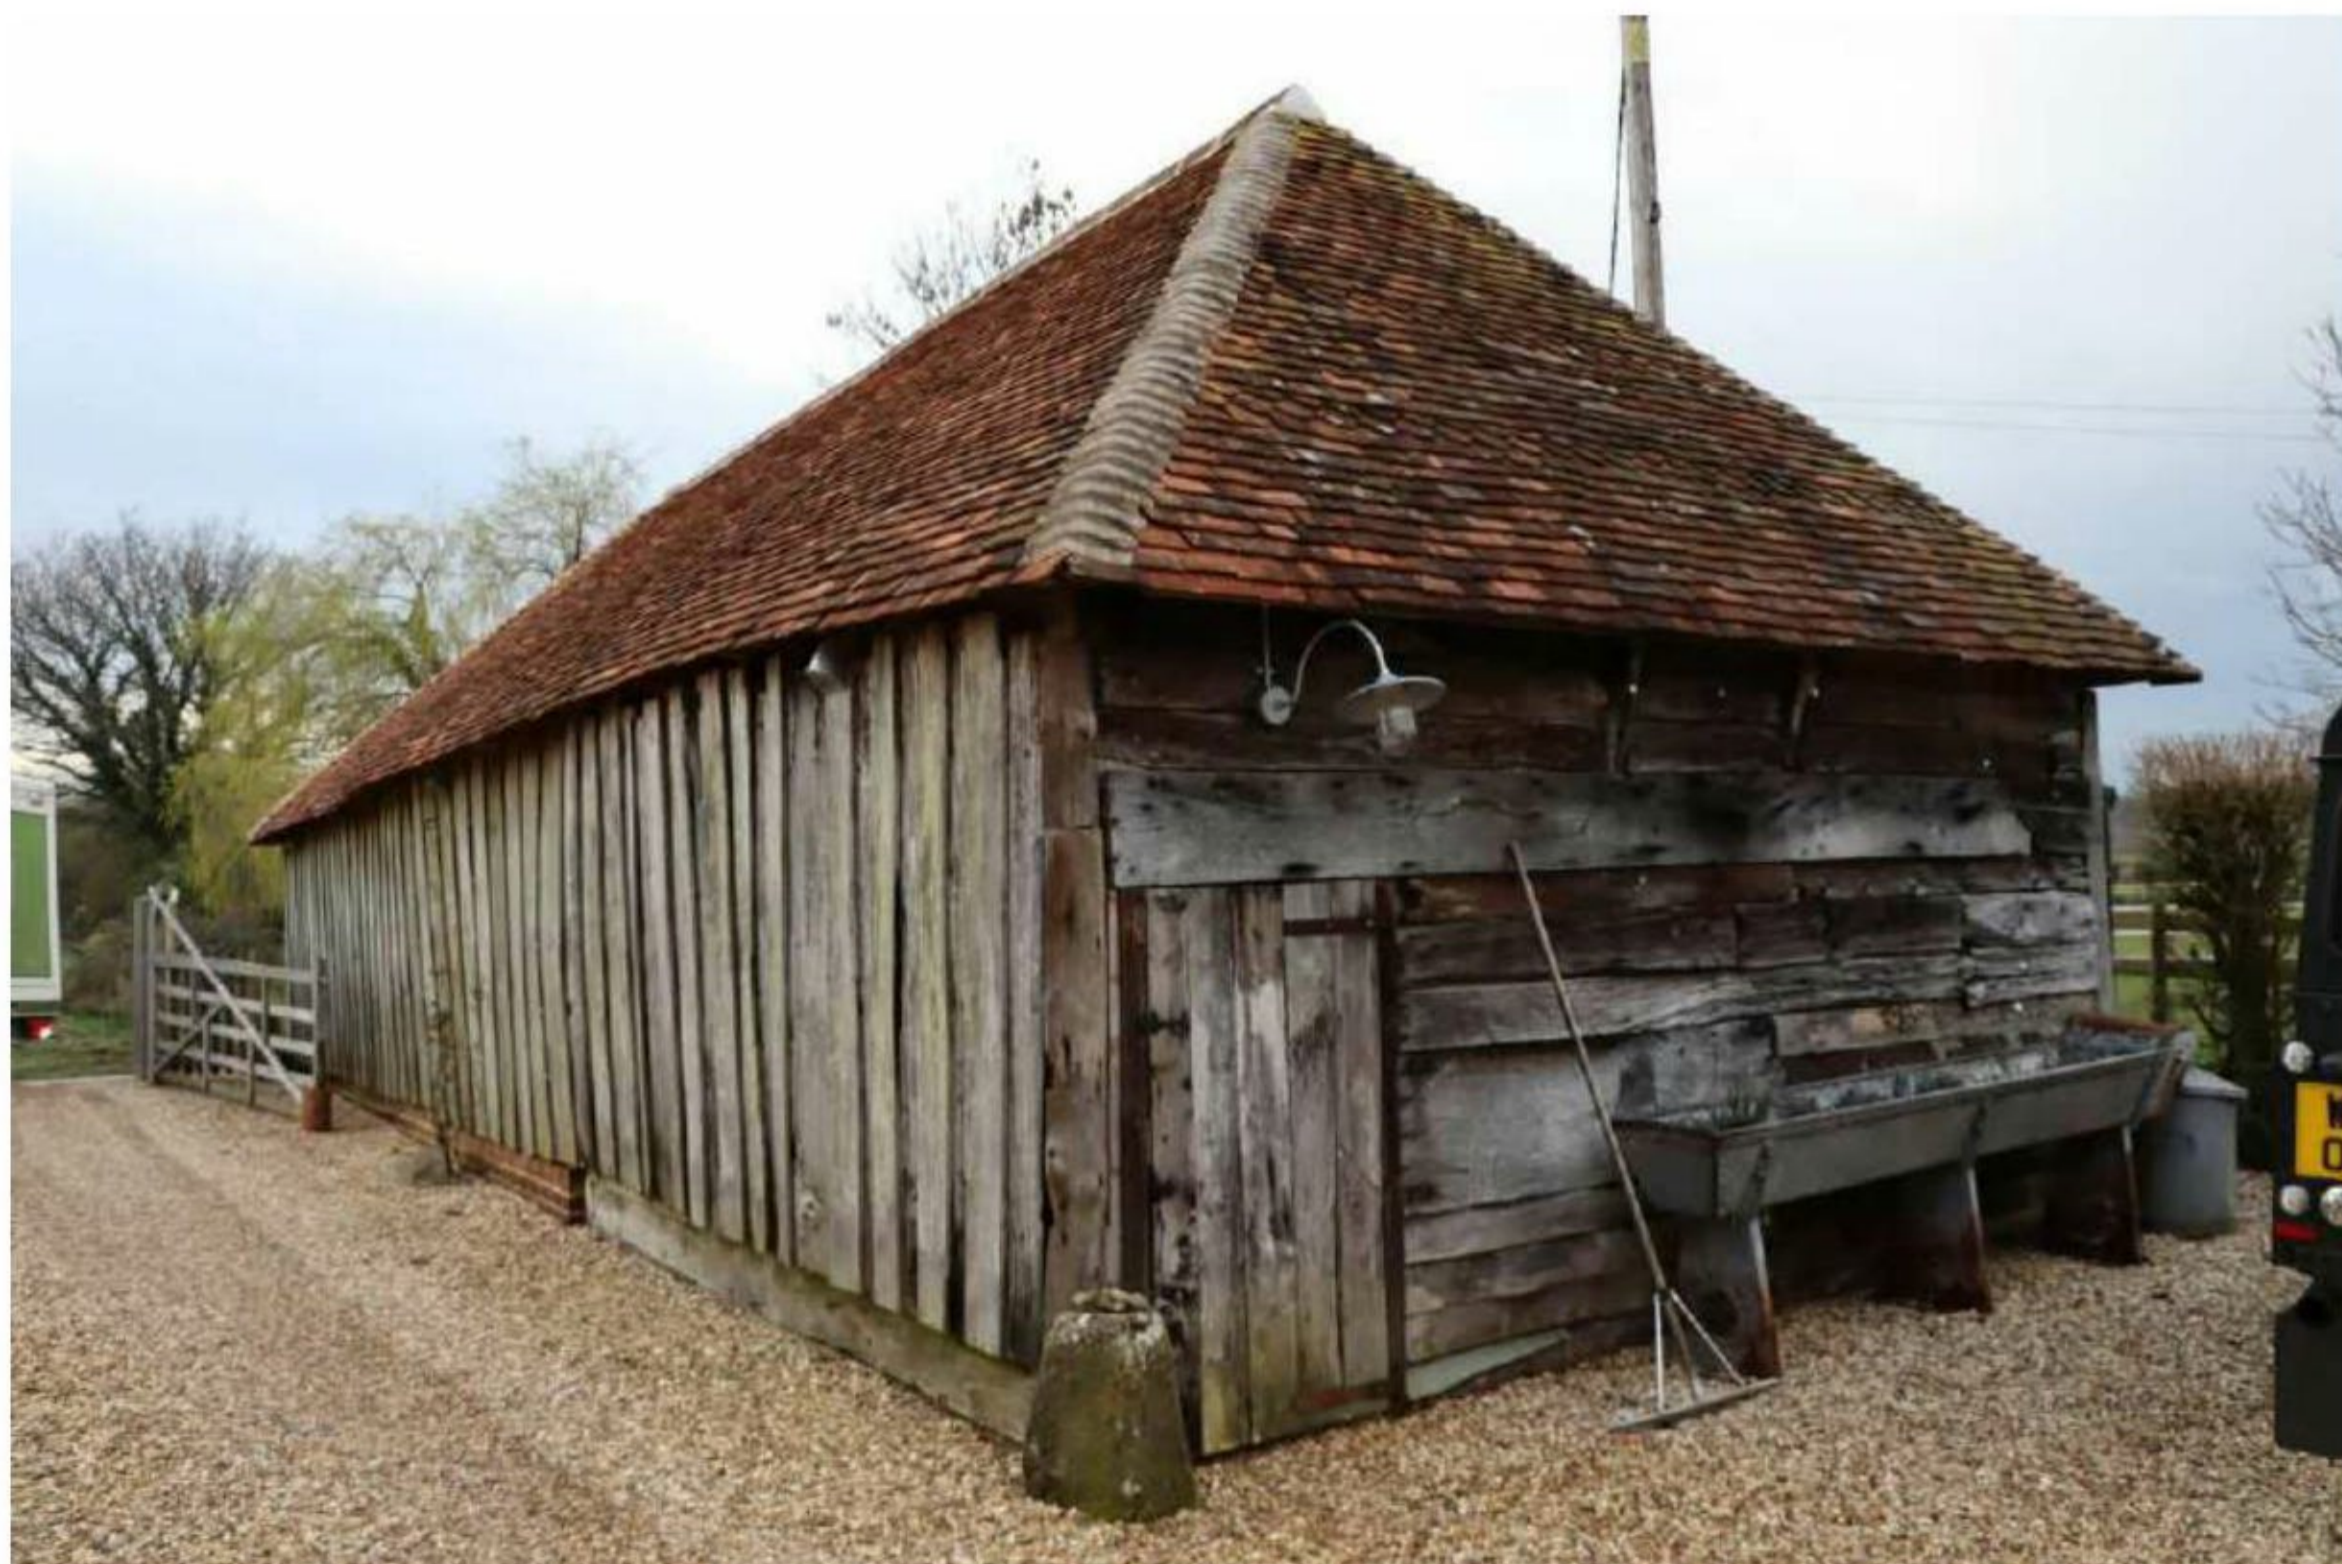
Plate 42: Cartshed (Building A) – long S elevation and E rear end – the building appears originally to have extended further E

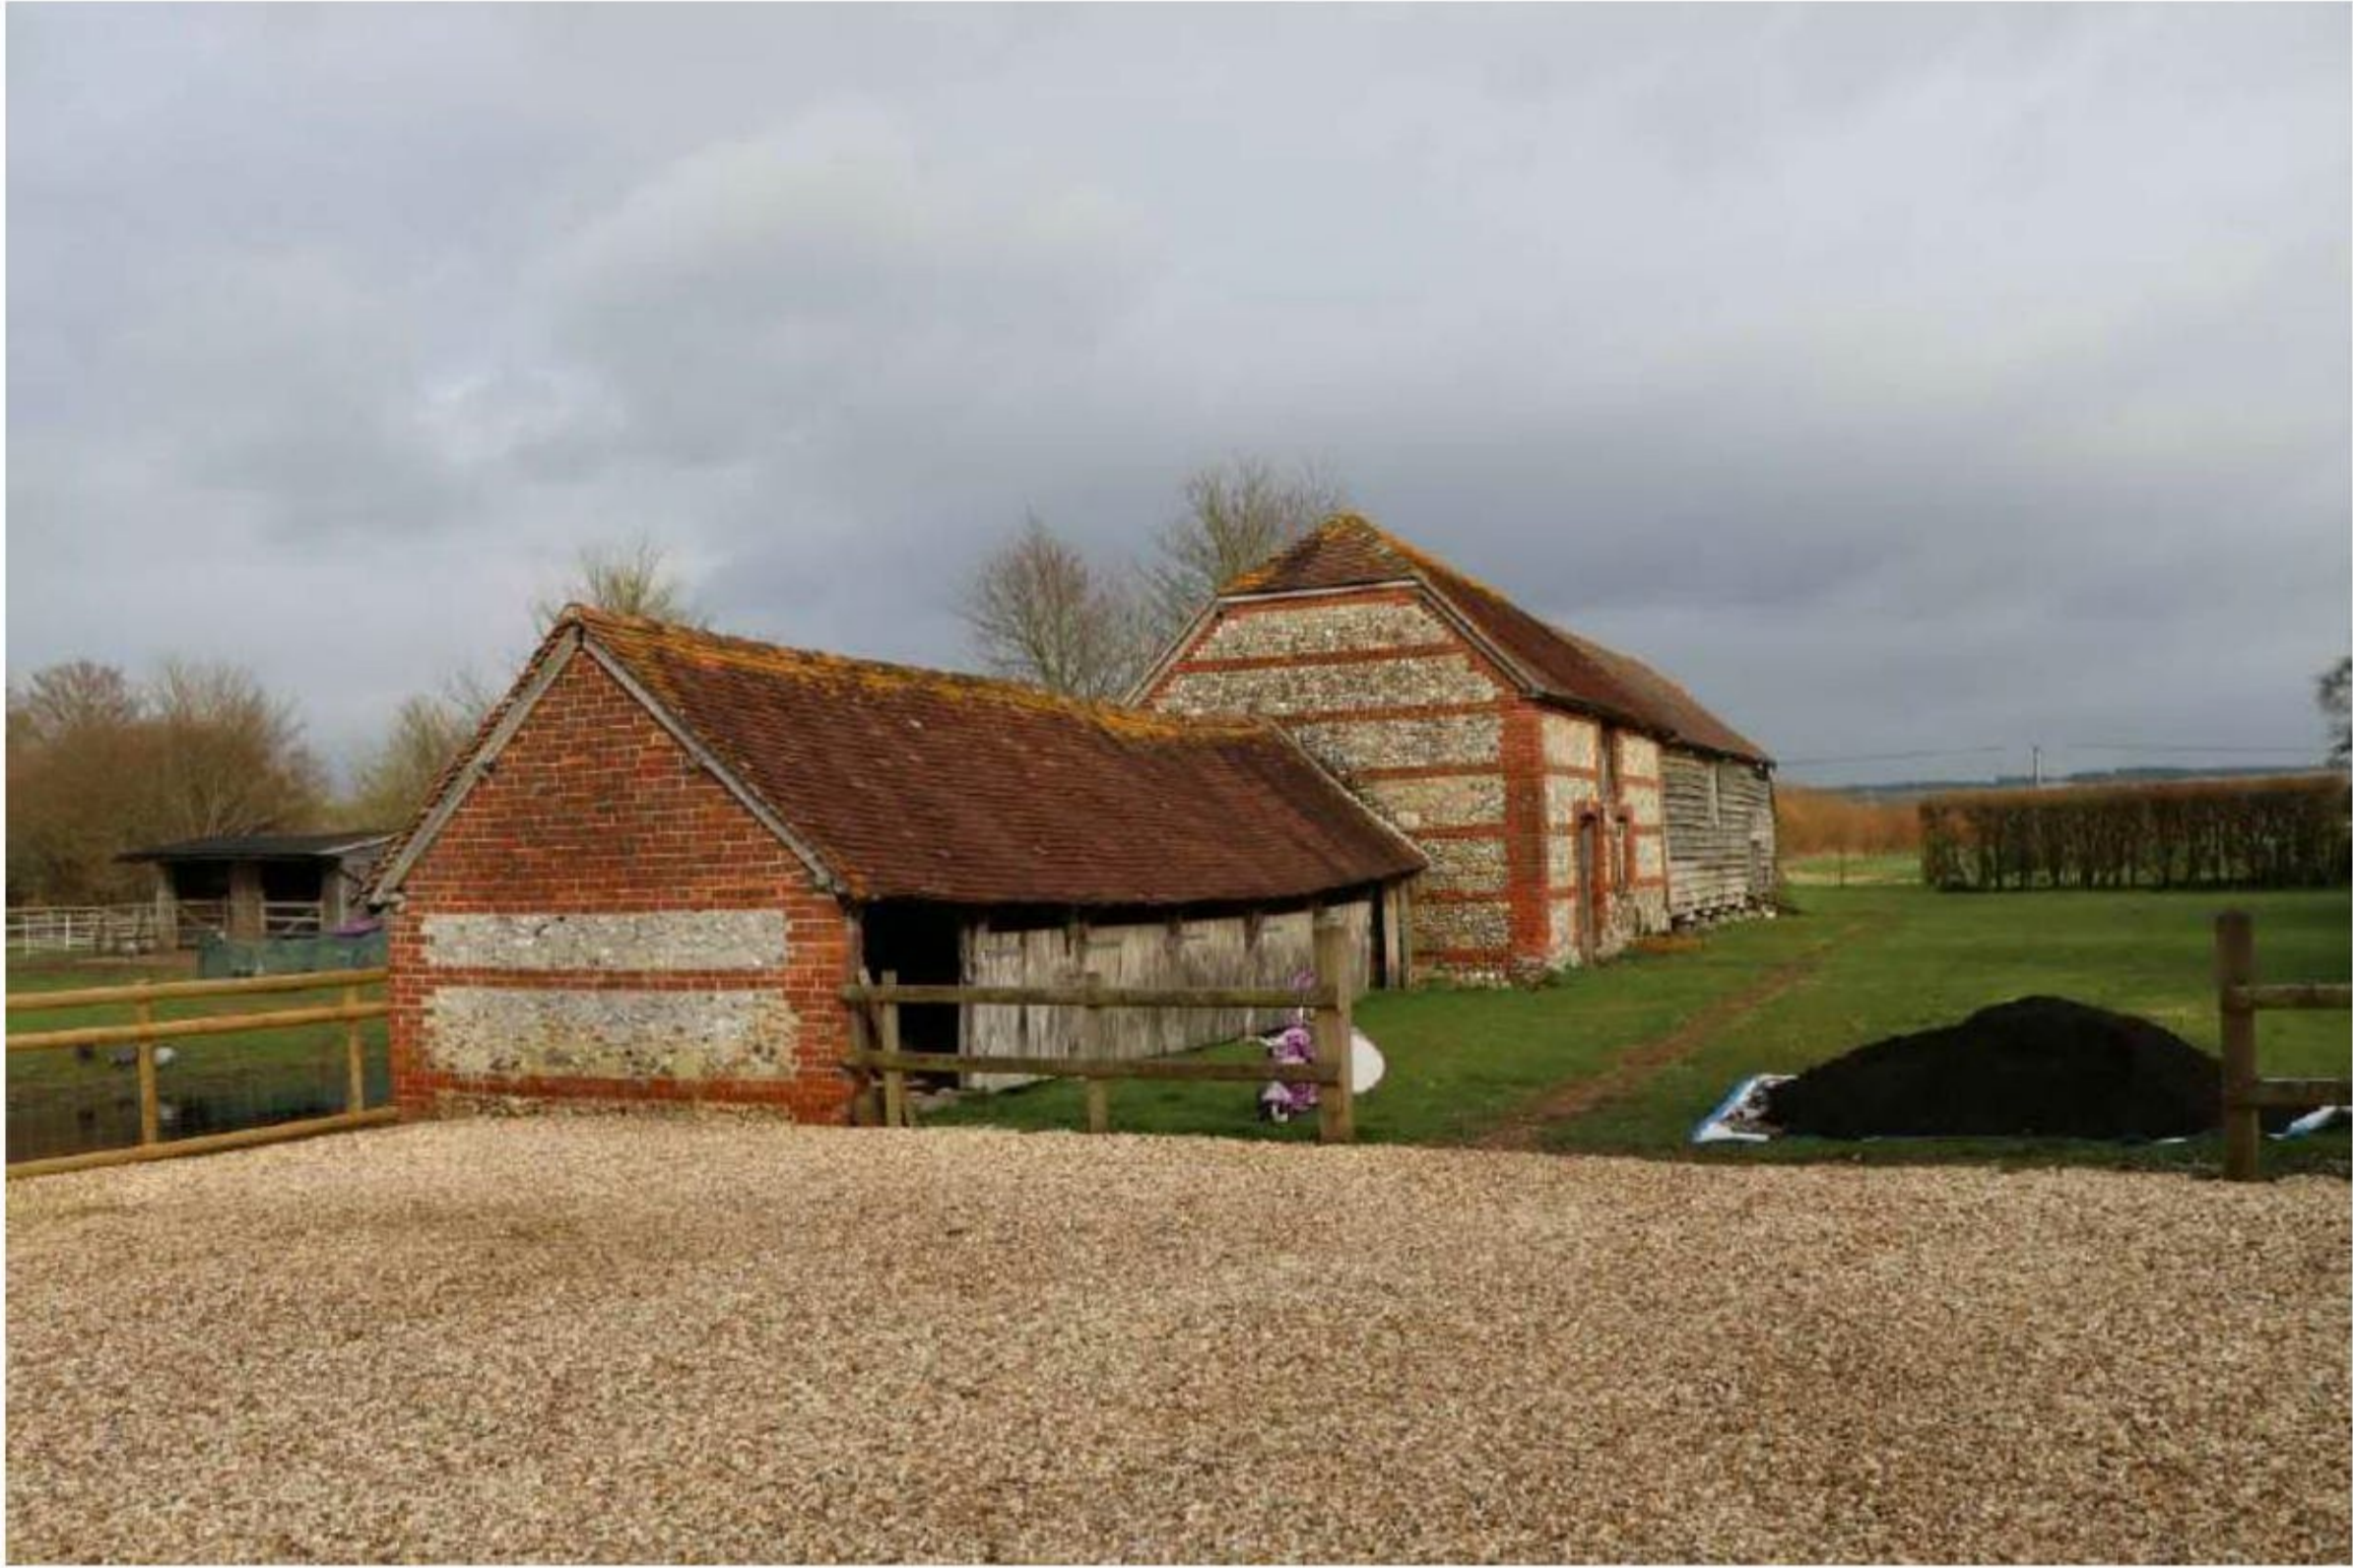
Plate 43: Buildings B (cattle shelter shed), C (stable) & D (granary), looking E

3.2.2 Buildings B, C and D (**Plates 43 & 44** and **Photos B & N-P**) were not sold with the farmhouse in 1957, only coming into the Dodgsons' ownership in July 1988. It is probable that some of the repair work that has evidently been undertaken to the roof structures of these buildings was done after this time.

3.3.2 The close setting of the building is clearly defined by its front and rear gardens and then by the driveway and area containing the outbuildings, although the driveway no longer continues to the outbuildings, with the area in front of them now laid to grass and fenced off from the main garden (see **Plate 43**); this has the effect of slightly divorcing them from the farmhouse and diluting the close relationship of farmhouse and farm buildings. Nevertheless, the outbuildings still have group value in relation to the farmhouse and the whole is legible as a single property (**Plate 62**).

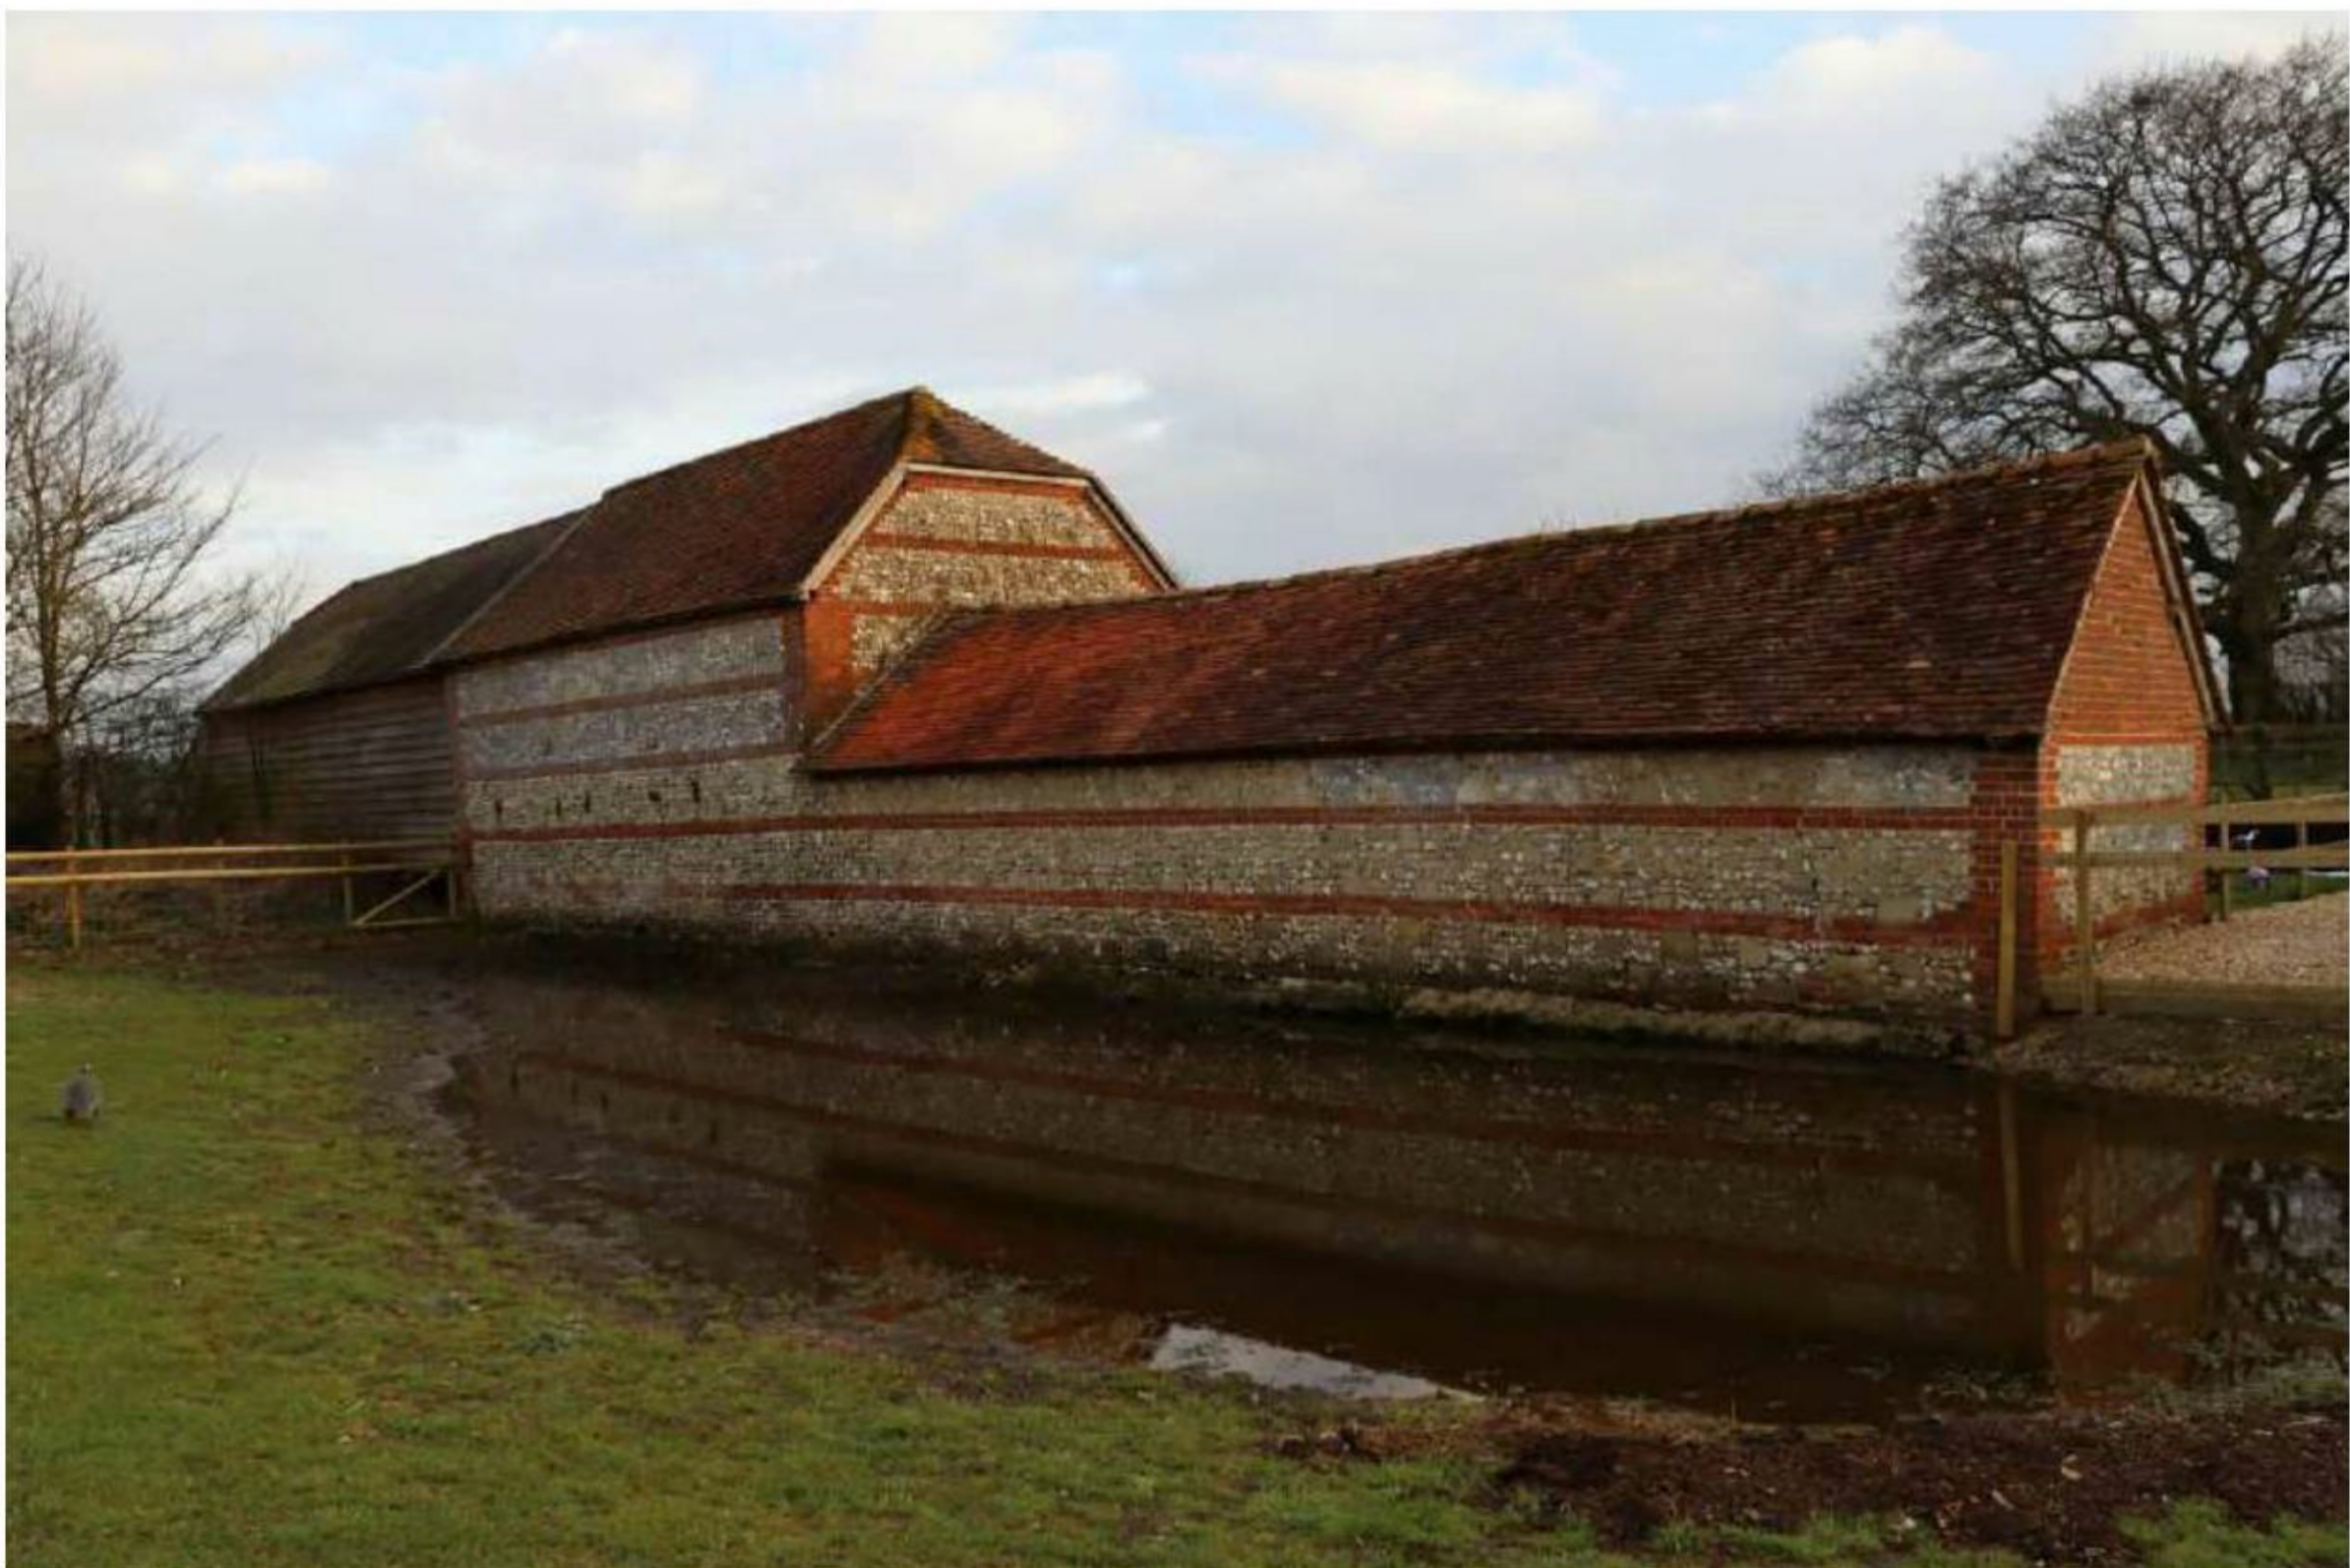
Plate 44: Buildings B, C & D (rear view)

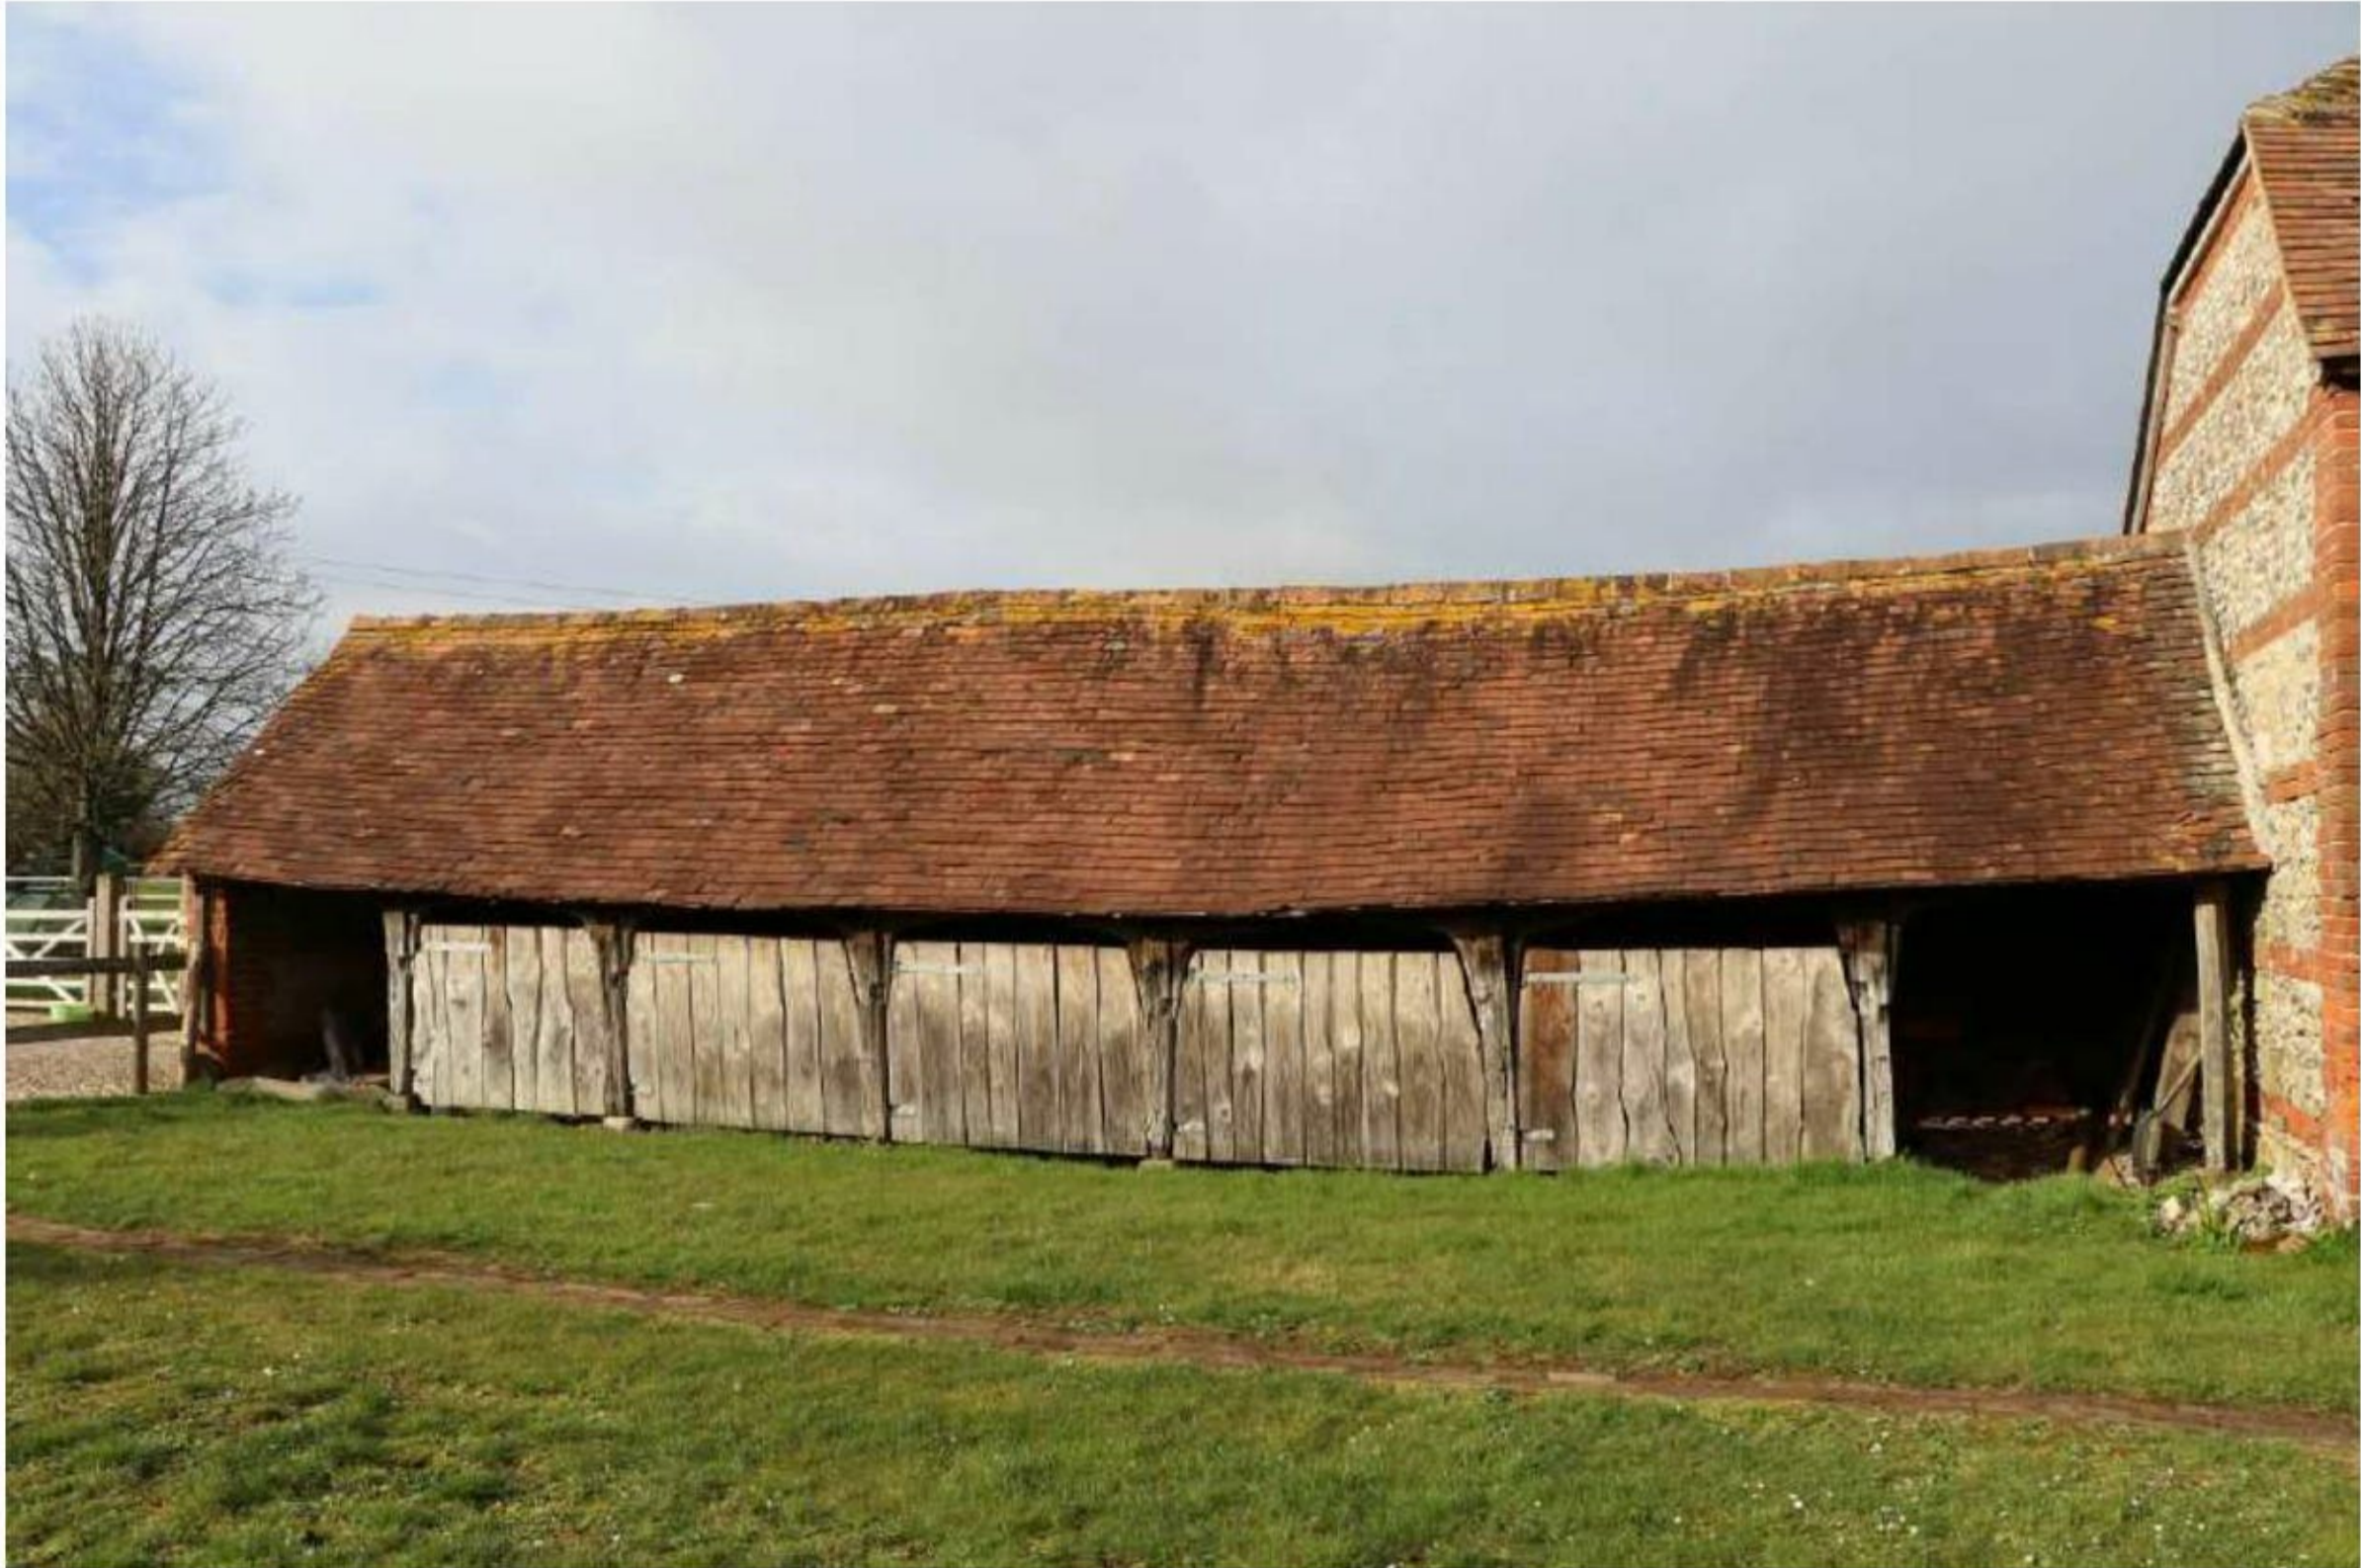
Plate 45: Building B – former cattle shelter shed

3.2.4 Building B is a long, low, open-fronted cattle shelter shed with pitched clay tile-covered roof (**Plate 45**). The west gable is constructed of brick laid in Flemish Garden Wall Bond. The open front to the south is supported on timber posts, with the openings filled with vertically boarded gates. **Photo B** seems to show a similar arrangement. The building has been re-roofed in relatively recent times with new tie beams and queen struts and new battens. Some of the rafters and purlins may be
