STATEMENT OF SIGNIFICANCE

**Flood Street Farm,
Breamore, Hampshire**

AHC REF: 9943

Date: April 2021

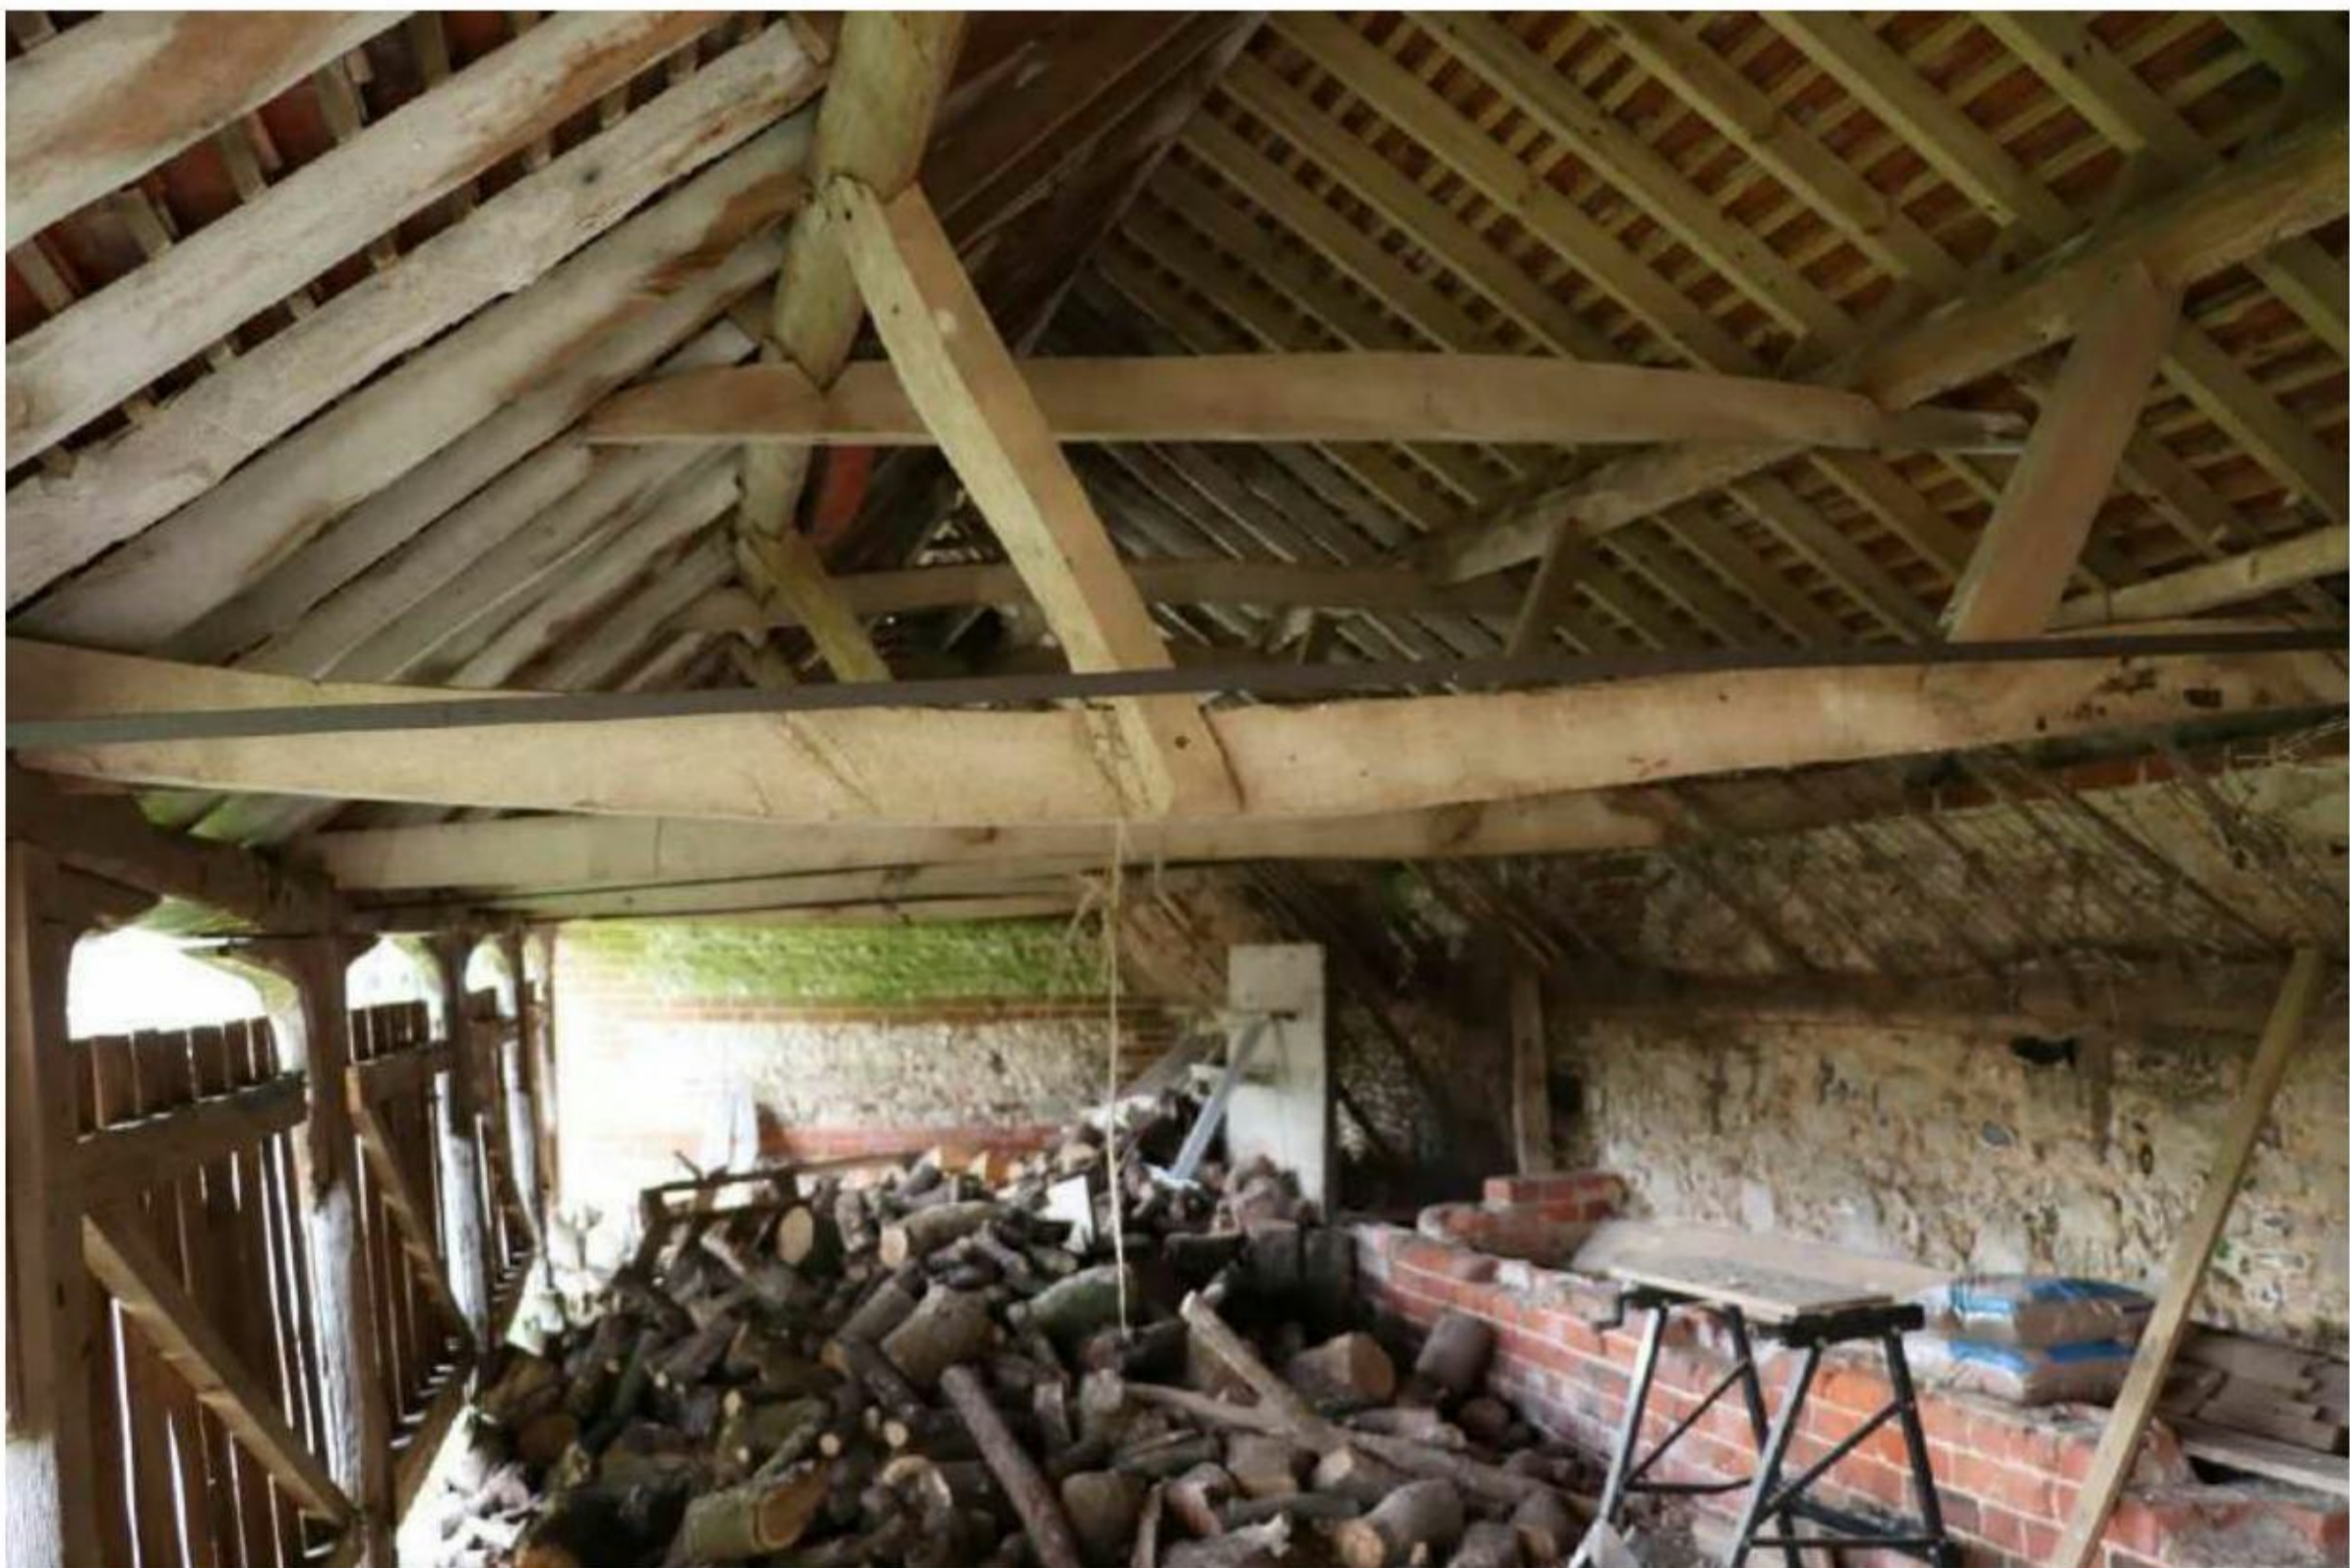
Plate 46: Interior of Building B, looking W

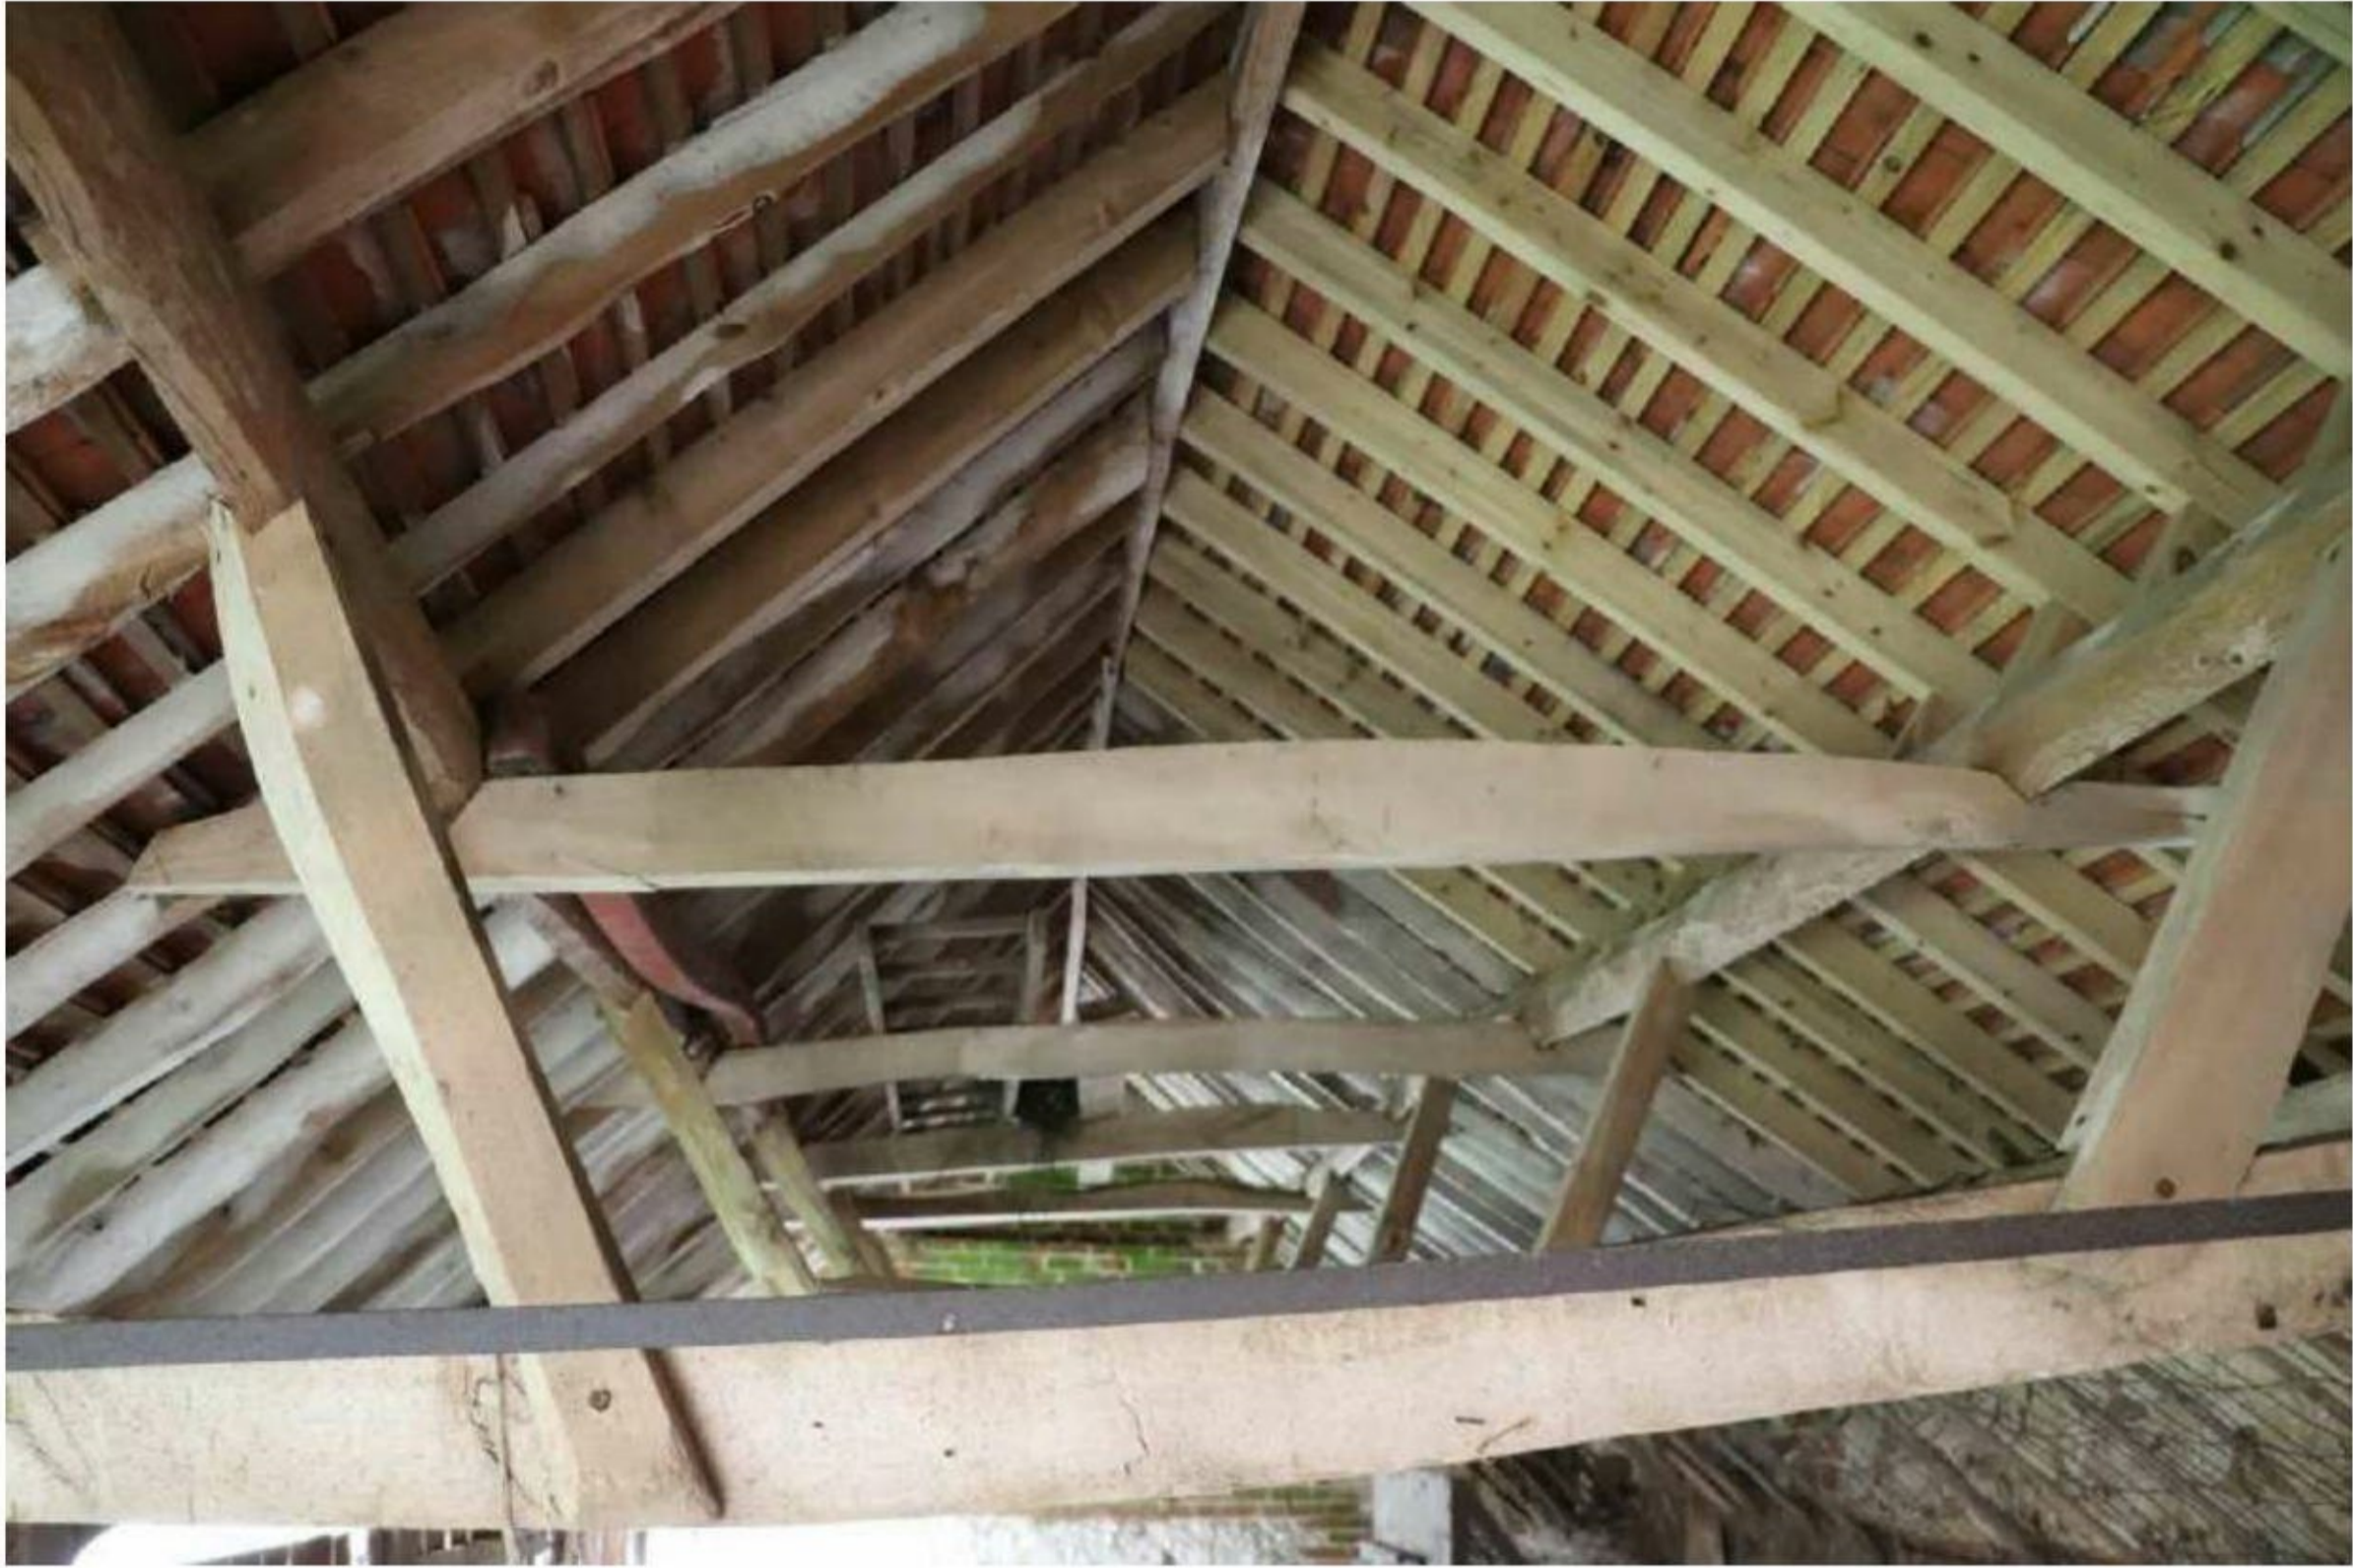
Plate 47: Building B – detail of roof structure

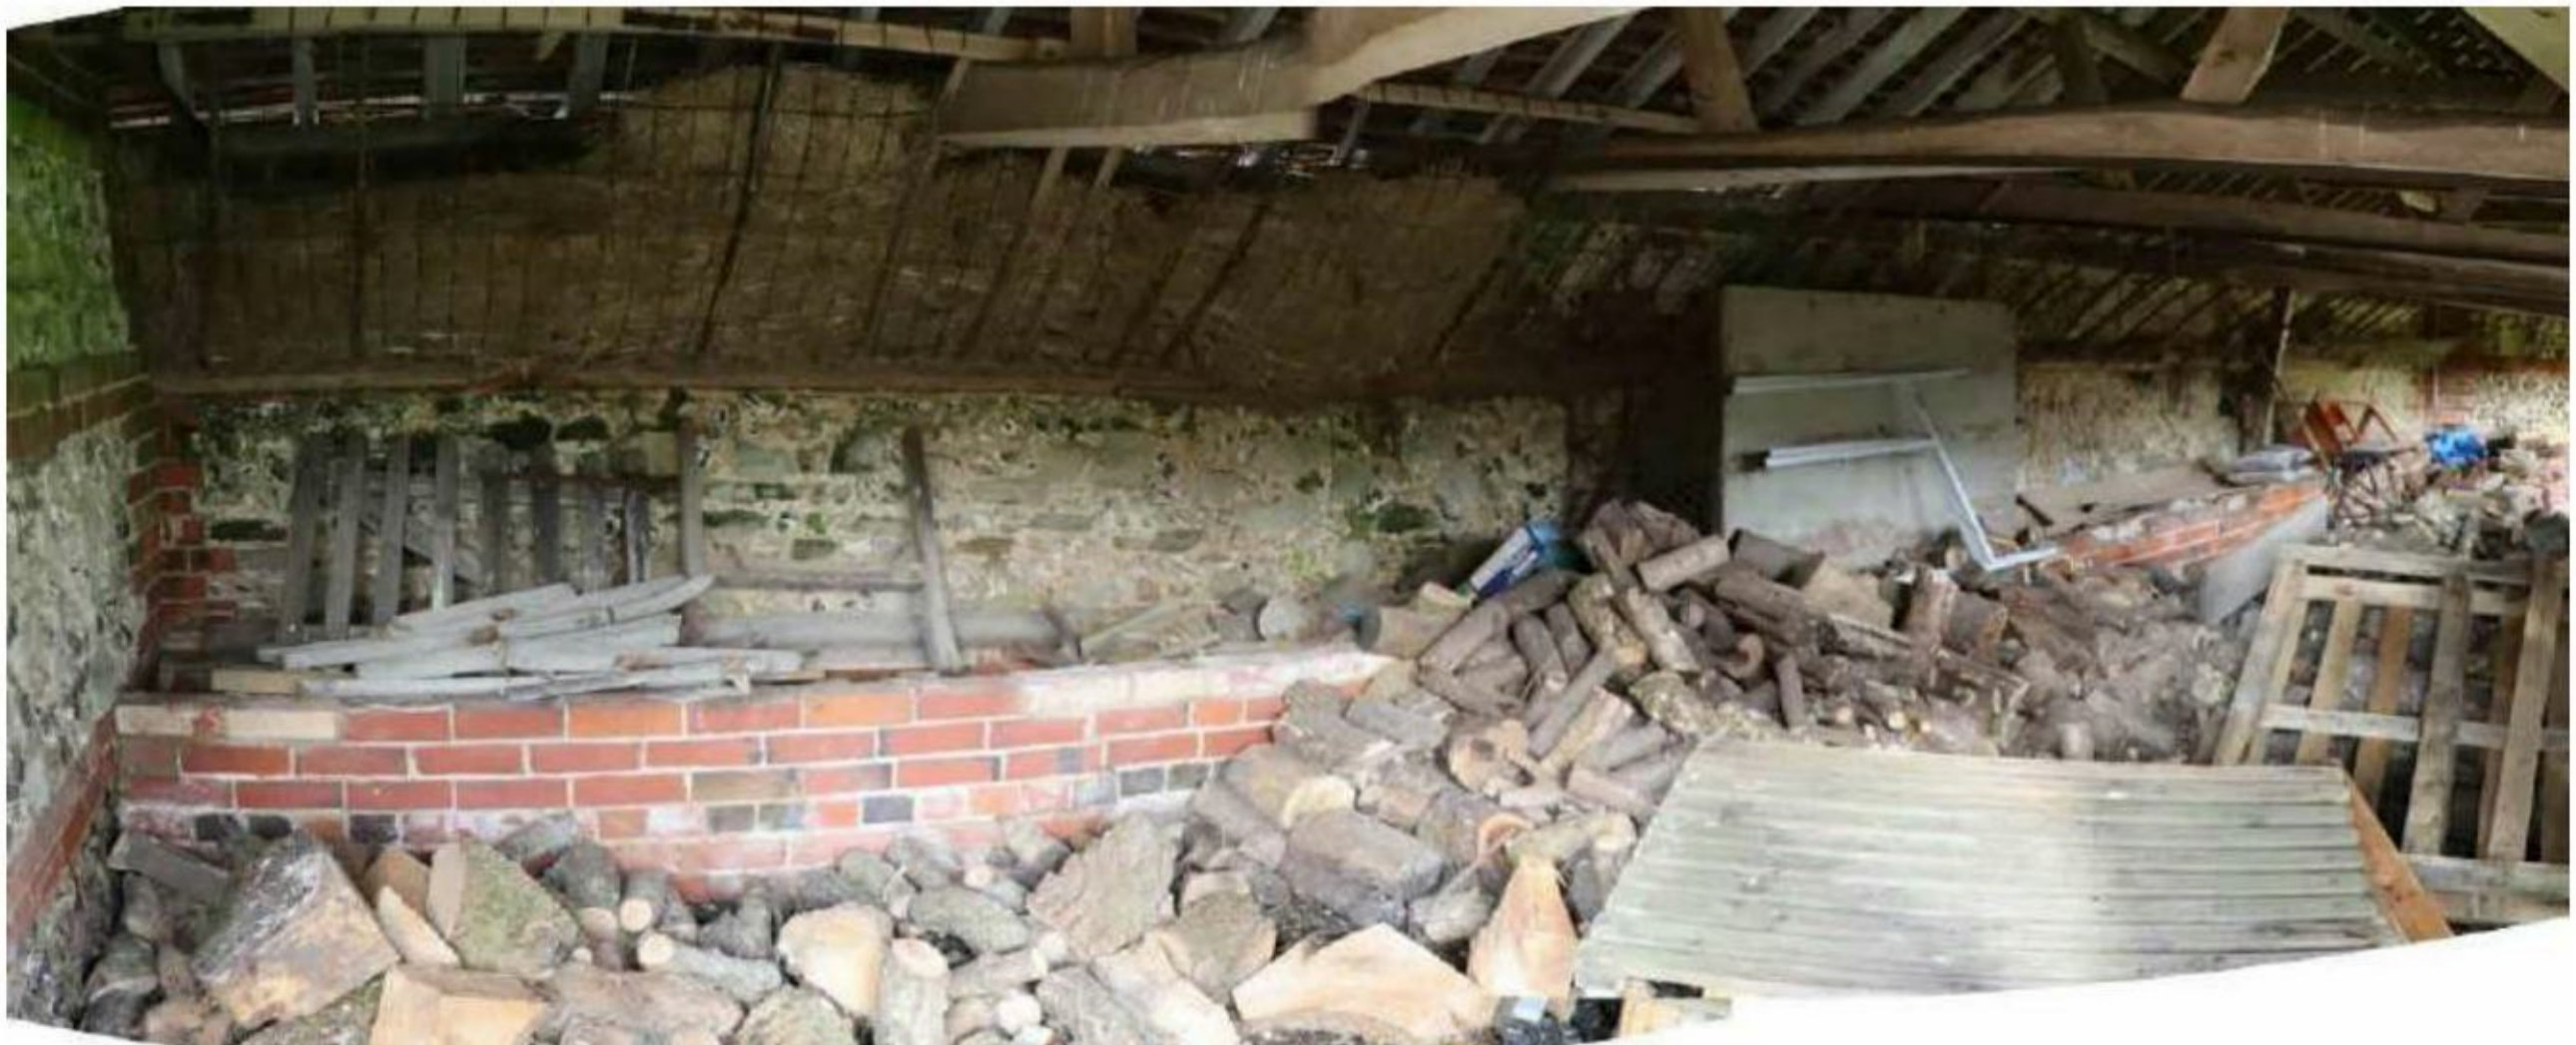
Plate 48: Building B – interior, looking to rear wall with feeding trough and manger

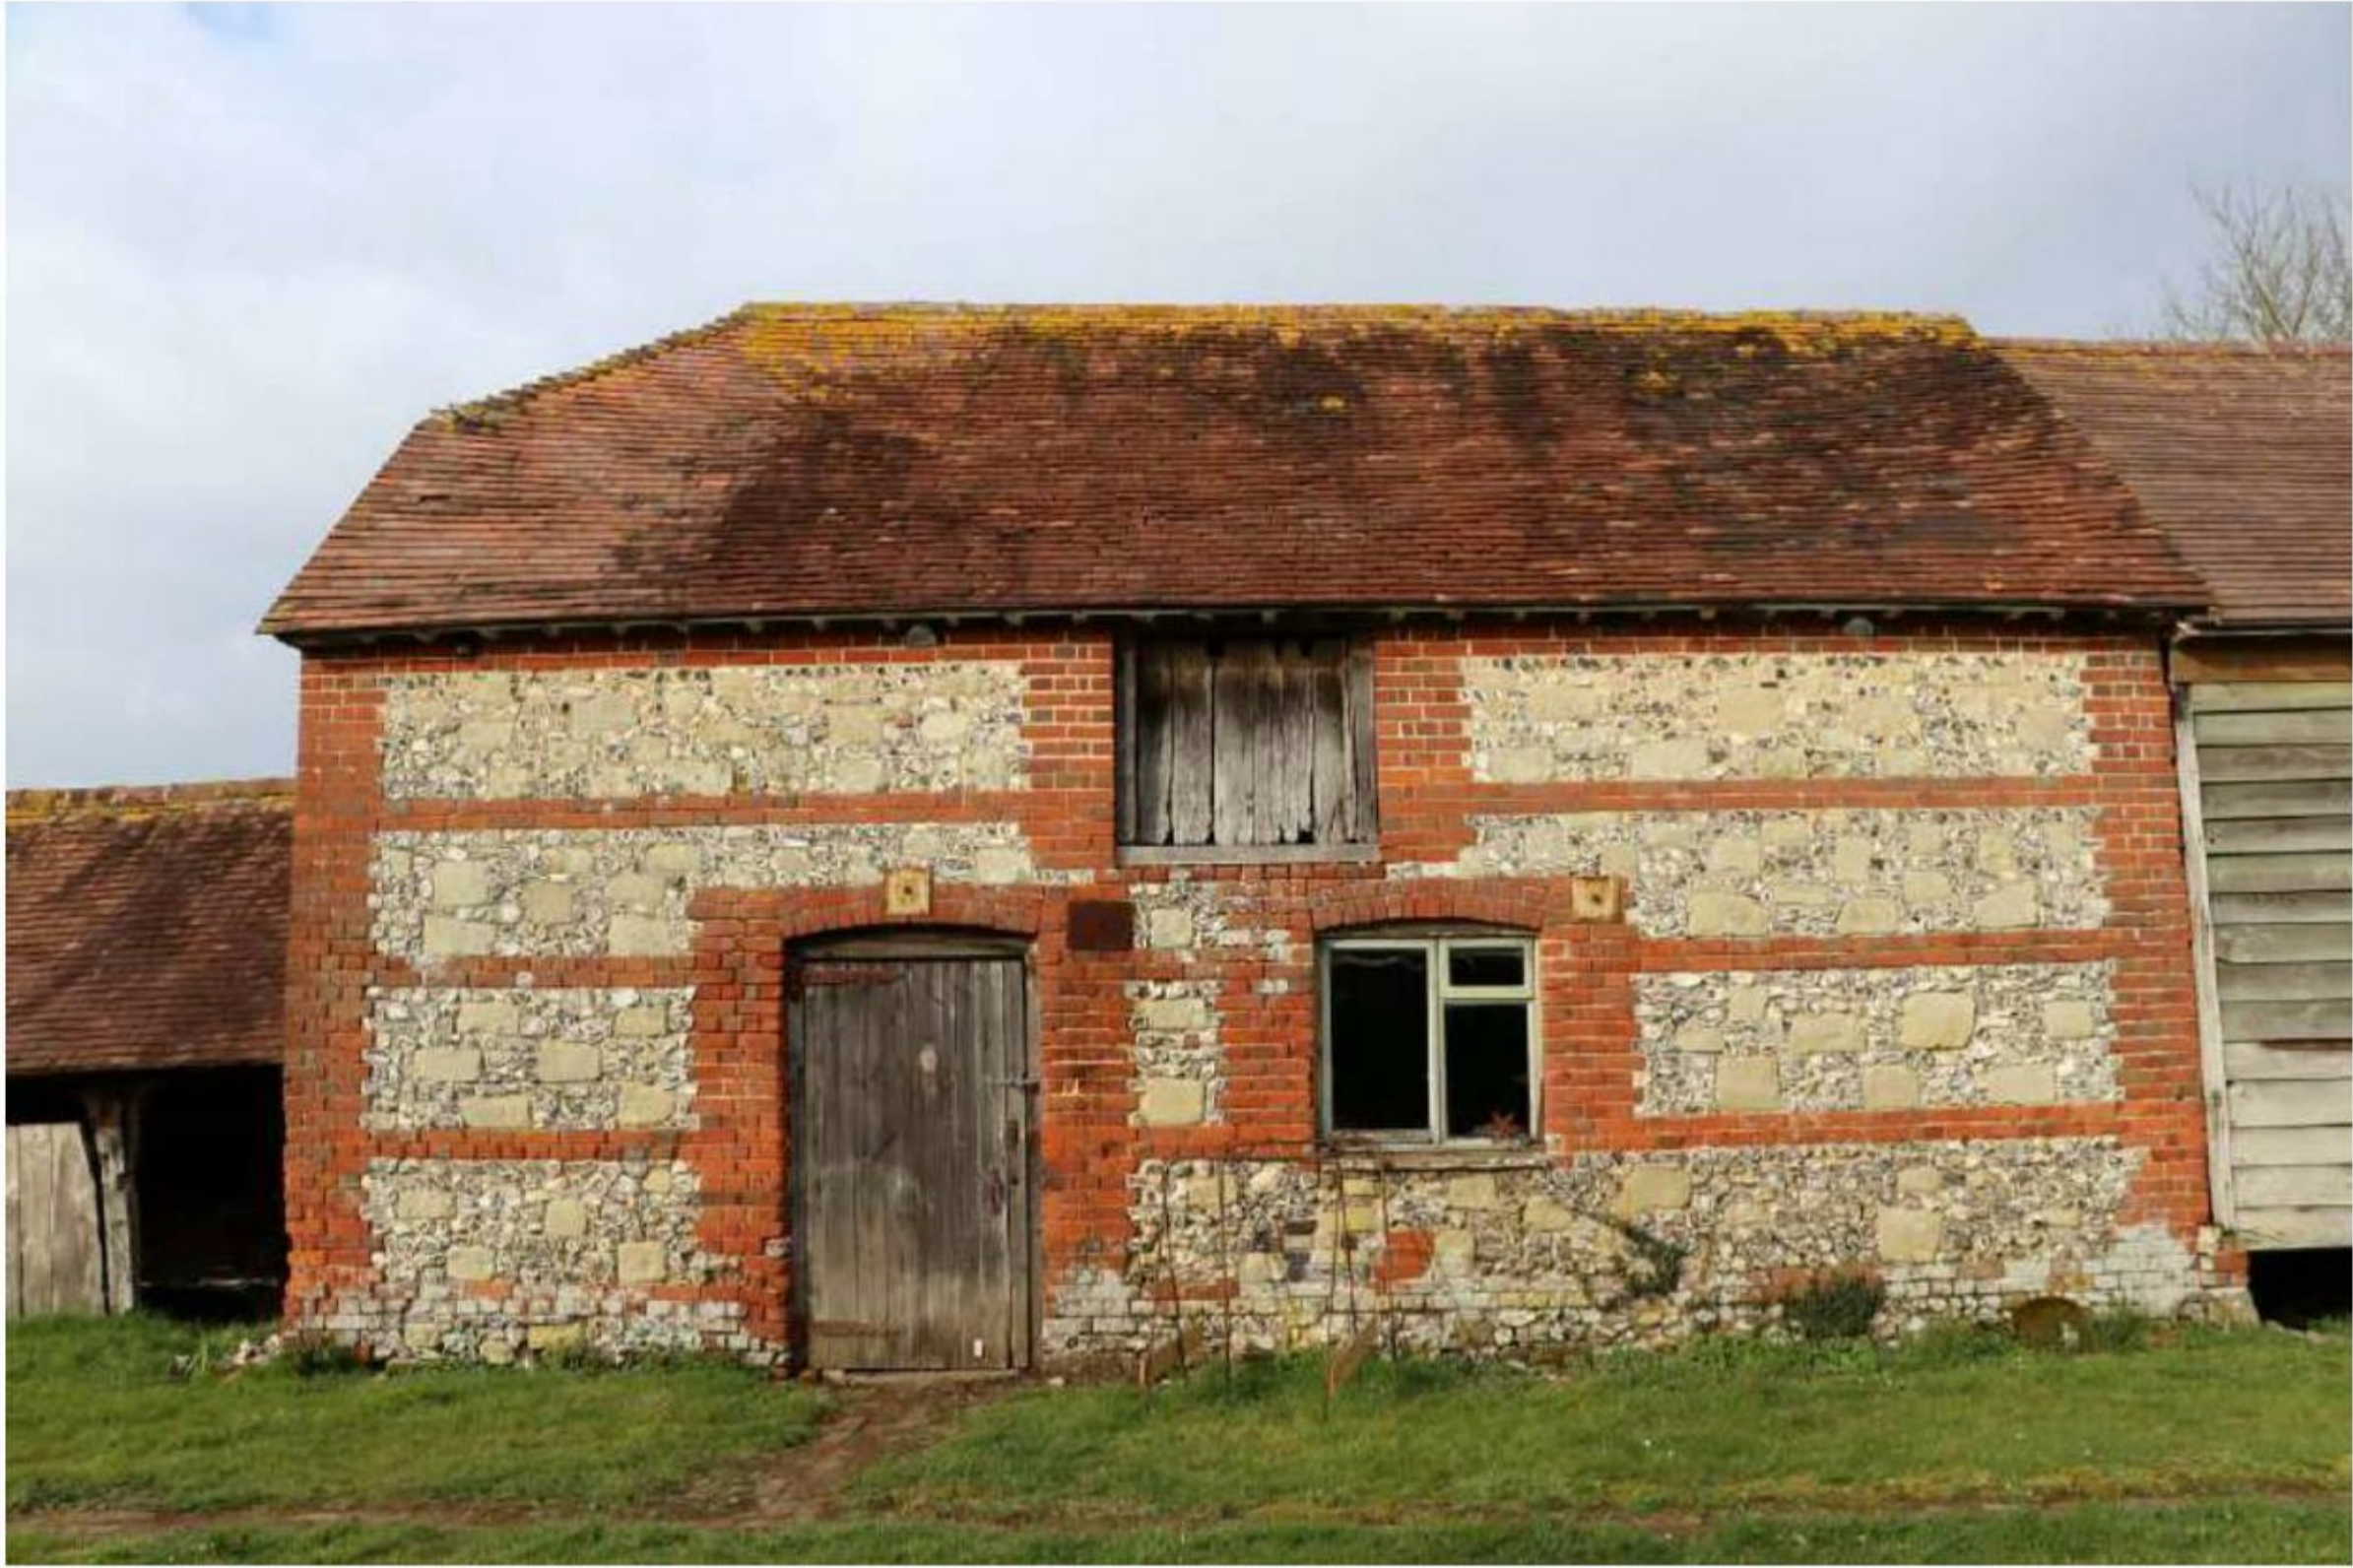
Plate 49: Building C – former stable

- 3.2.5 Building C is a former stable, like Building B constructed of stone and flint with red brick banding and having a clay-tile covered roof, hipped at the western end (**Plate 49**). A number of iron tie bars are present. In the south (front) elevation is an off-centre entrance with segmental-arched head and boarded late 19th-century door with decorative strap hinges and iron handle. There is an adjoining window opening with late 20th-century wooden casement, and a hay loft opening above with boarded door. The rear elevation is blind.

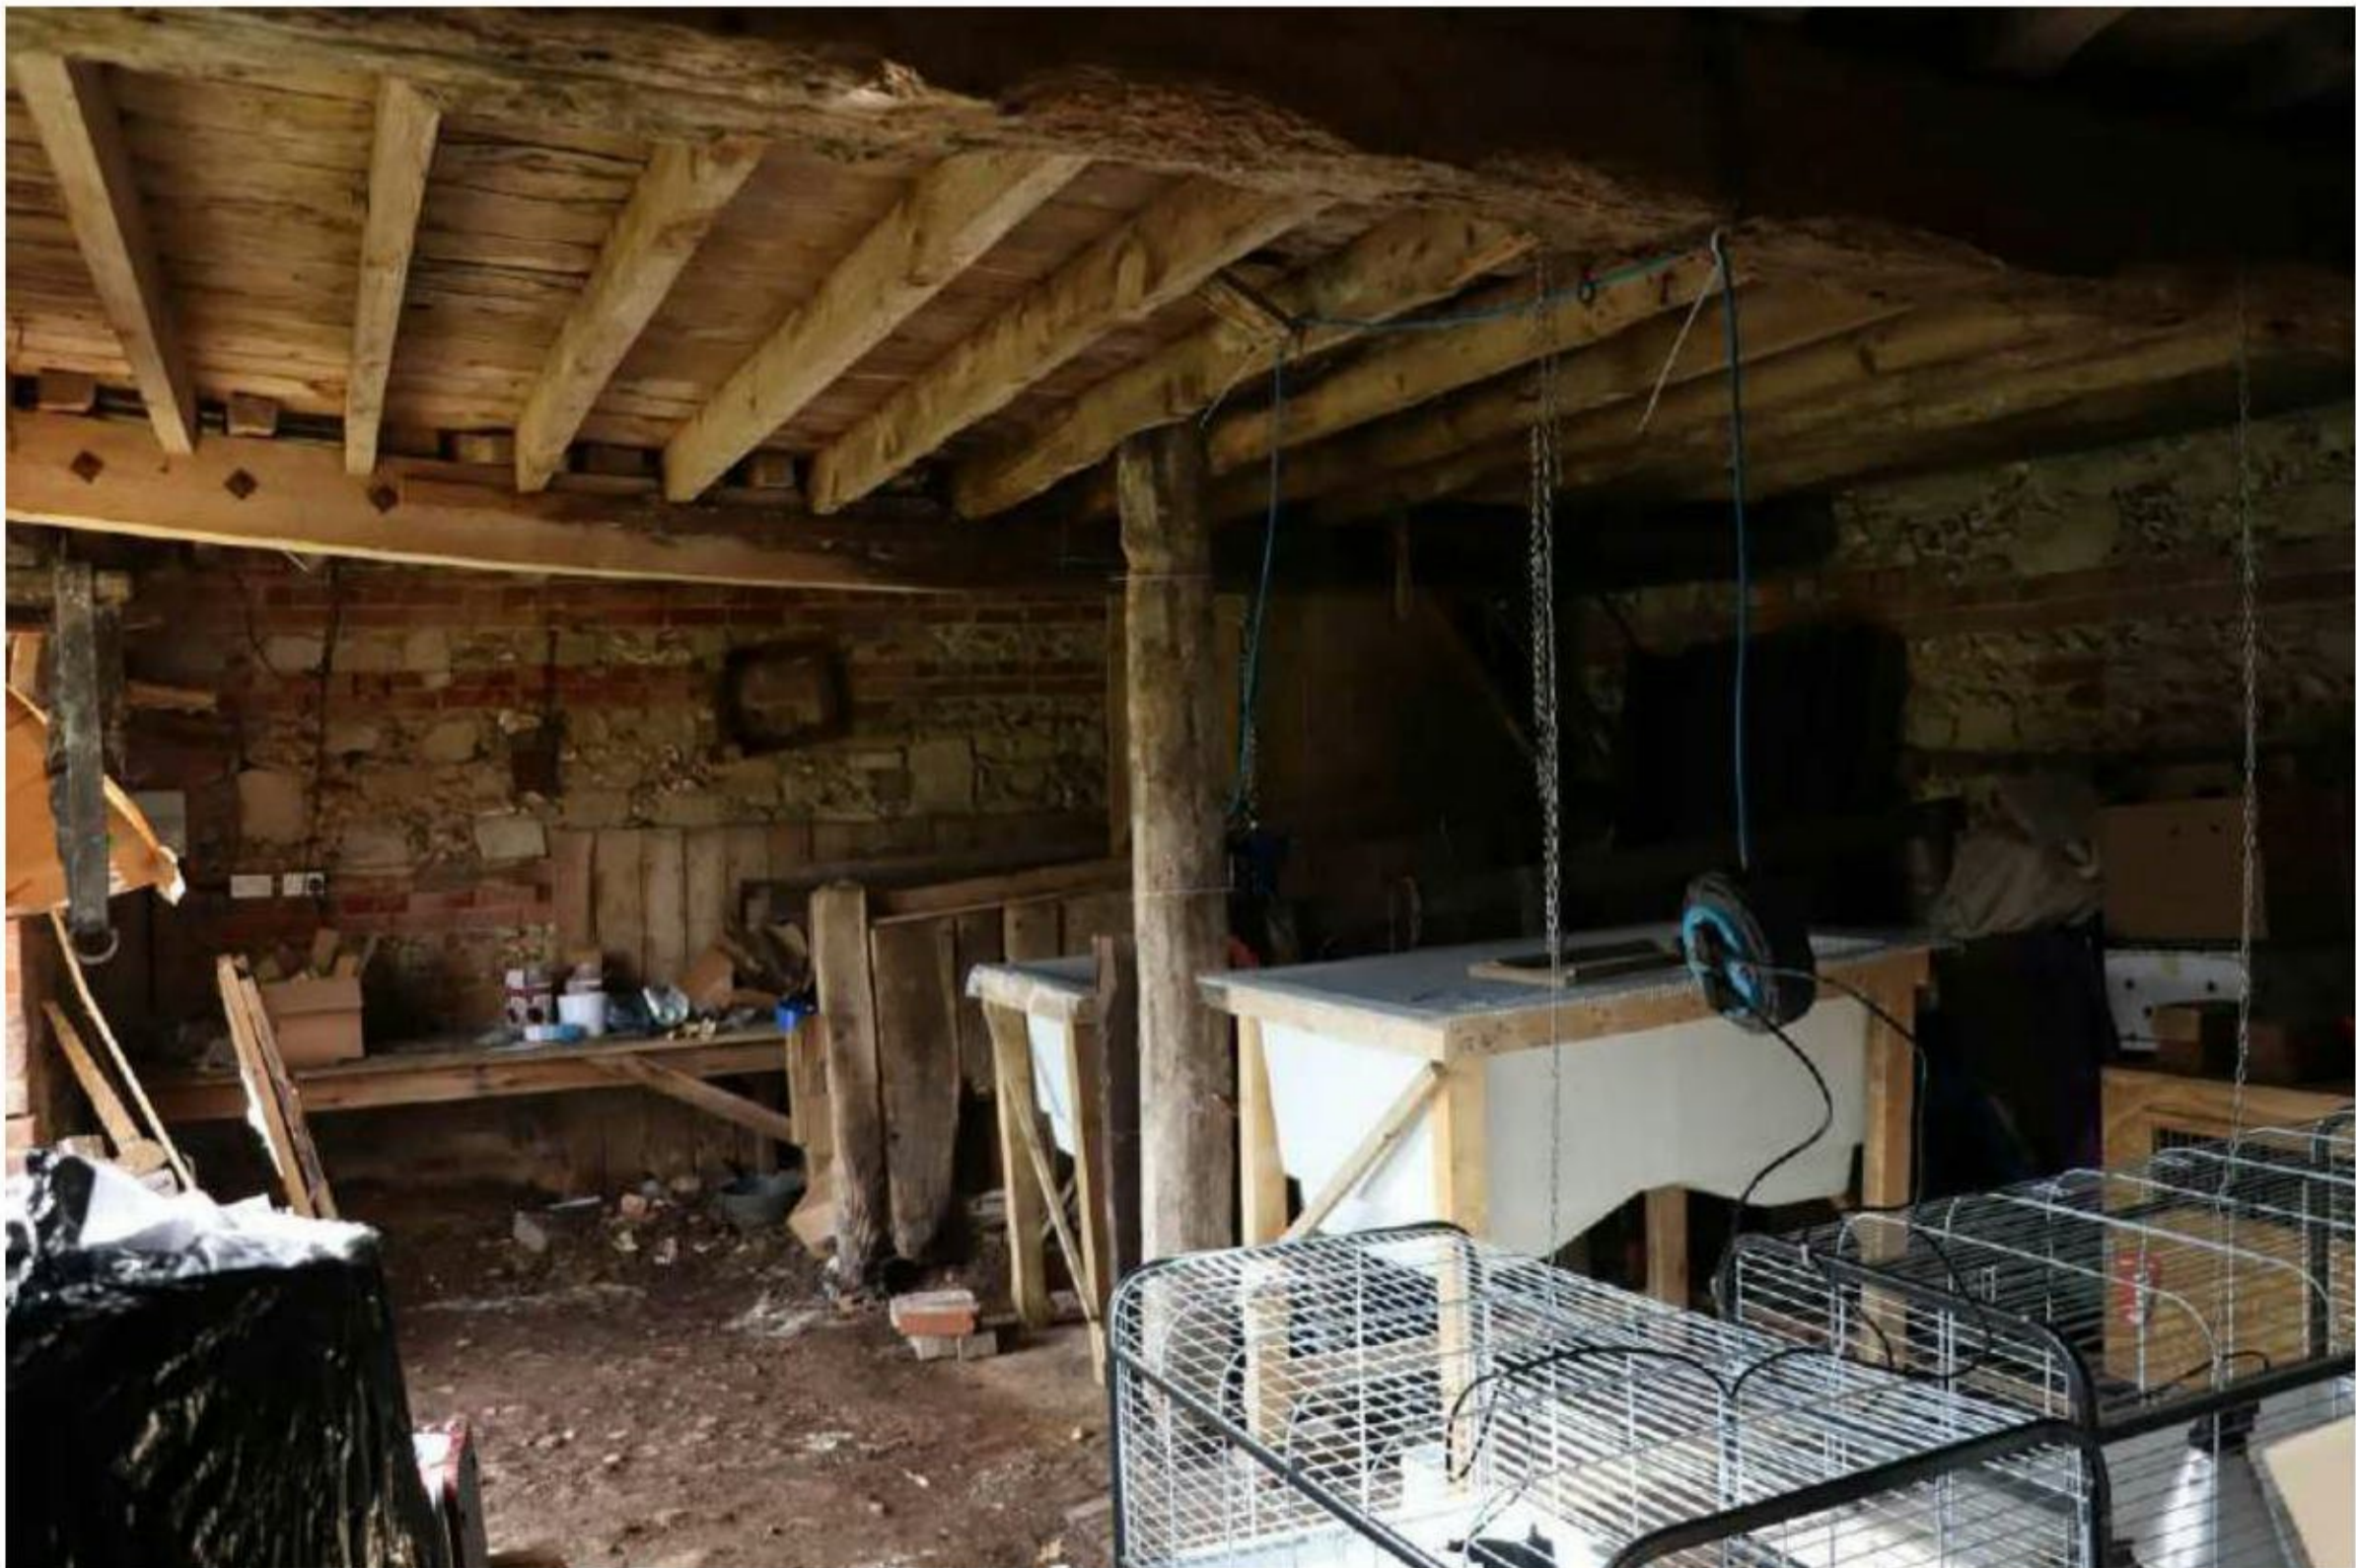
Plate 50: Building C – interior, looking W

- 3.2.6 Internally, the original late 19th-century timber beam, joists and floorboards are still present, though in places the floor has rotted through. A number of the joists are crudely cut timbers with the bark still on (**Plates 50 & 51**). There are some dilapidated remnants of wooden stall dividers and hay mangers, some surviving brick-paved flooring within the stalls area (**Plates 52-54**), and timber studs at the eastern end, presumably once part of a partition dividing off the end bay from the stalls. A ladder provides the only access to the hay loft (not currently safe to access) (**Plate 55**). Elements of the roof timbers (at least one purlin) appear to have been replaced, probably when it was lined, but many of the common rafters appear original to the late 19th-century construction (**Plate 56**).

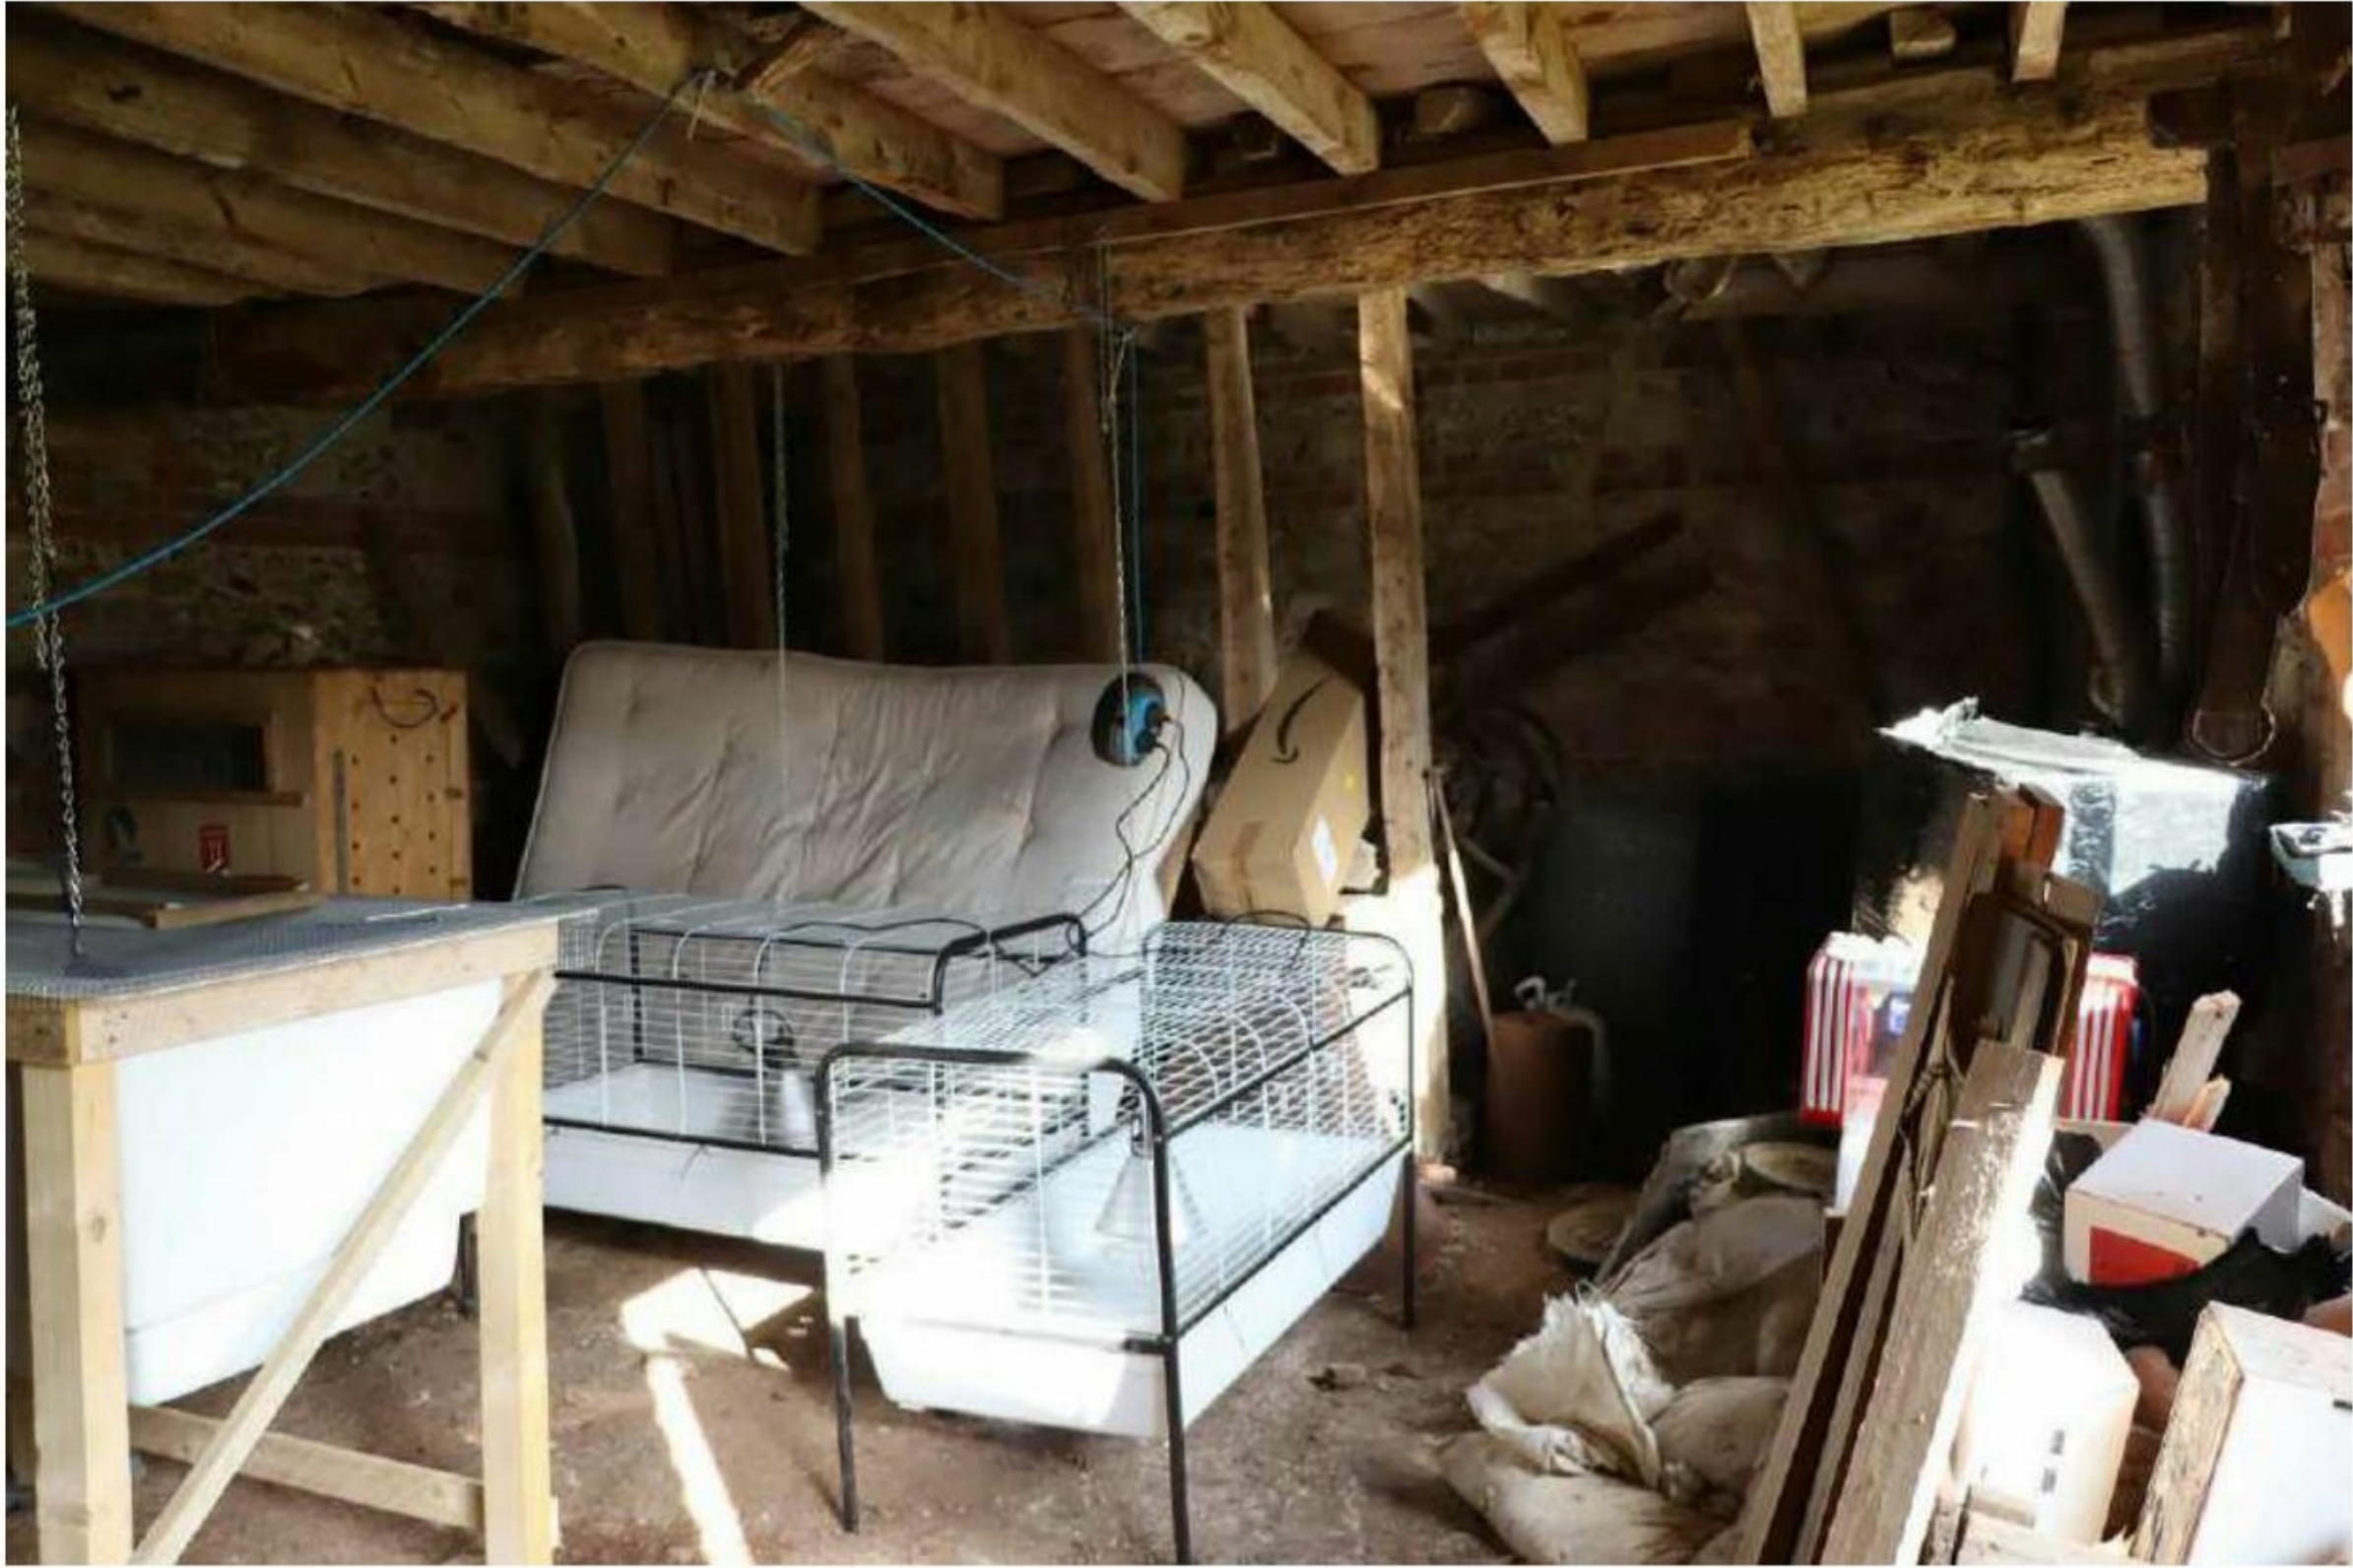
Plate 51: Building C – interior, looking E towards former partition in E end bay, and ladder to hay loft
