STATEMENT OF SIGNIFICANCE

**Flood Street Farm,
Breamore, Hampshire**

AHC REF: 9943

Date: April 2021

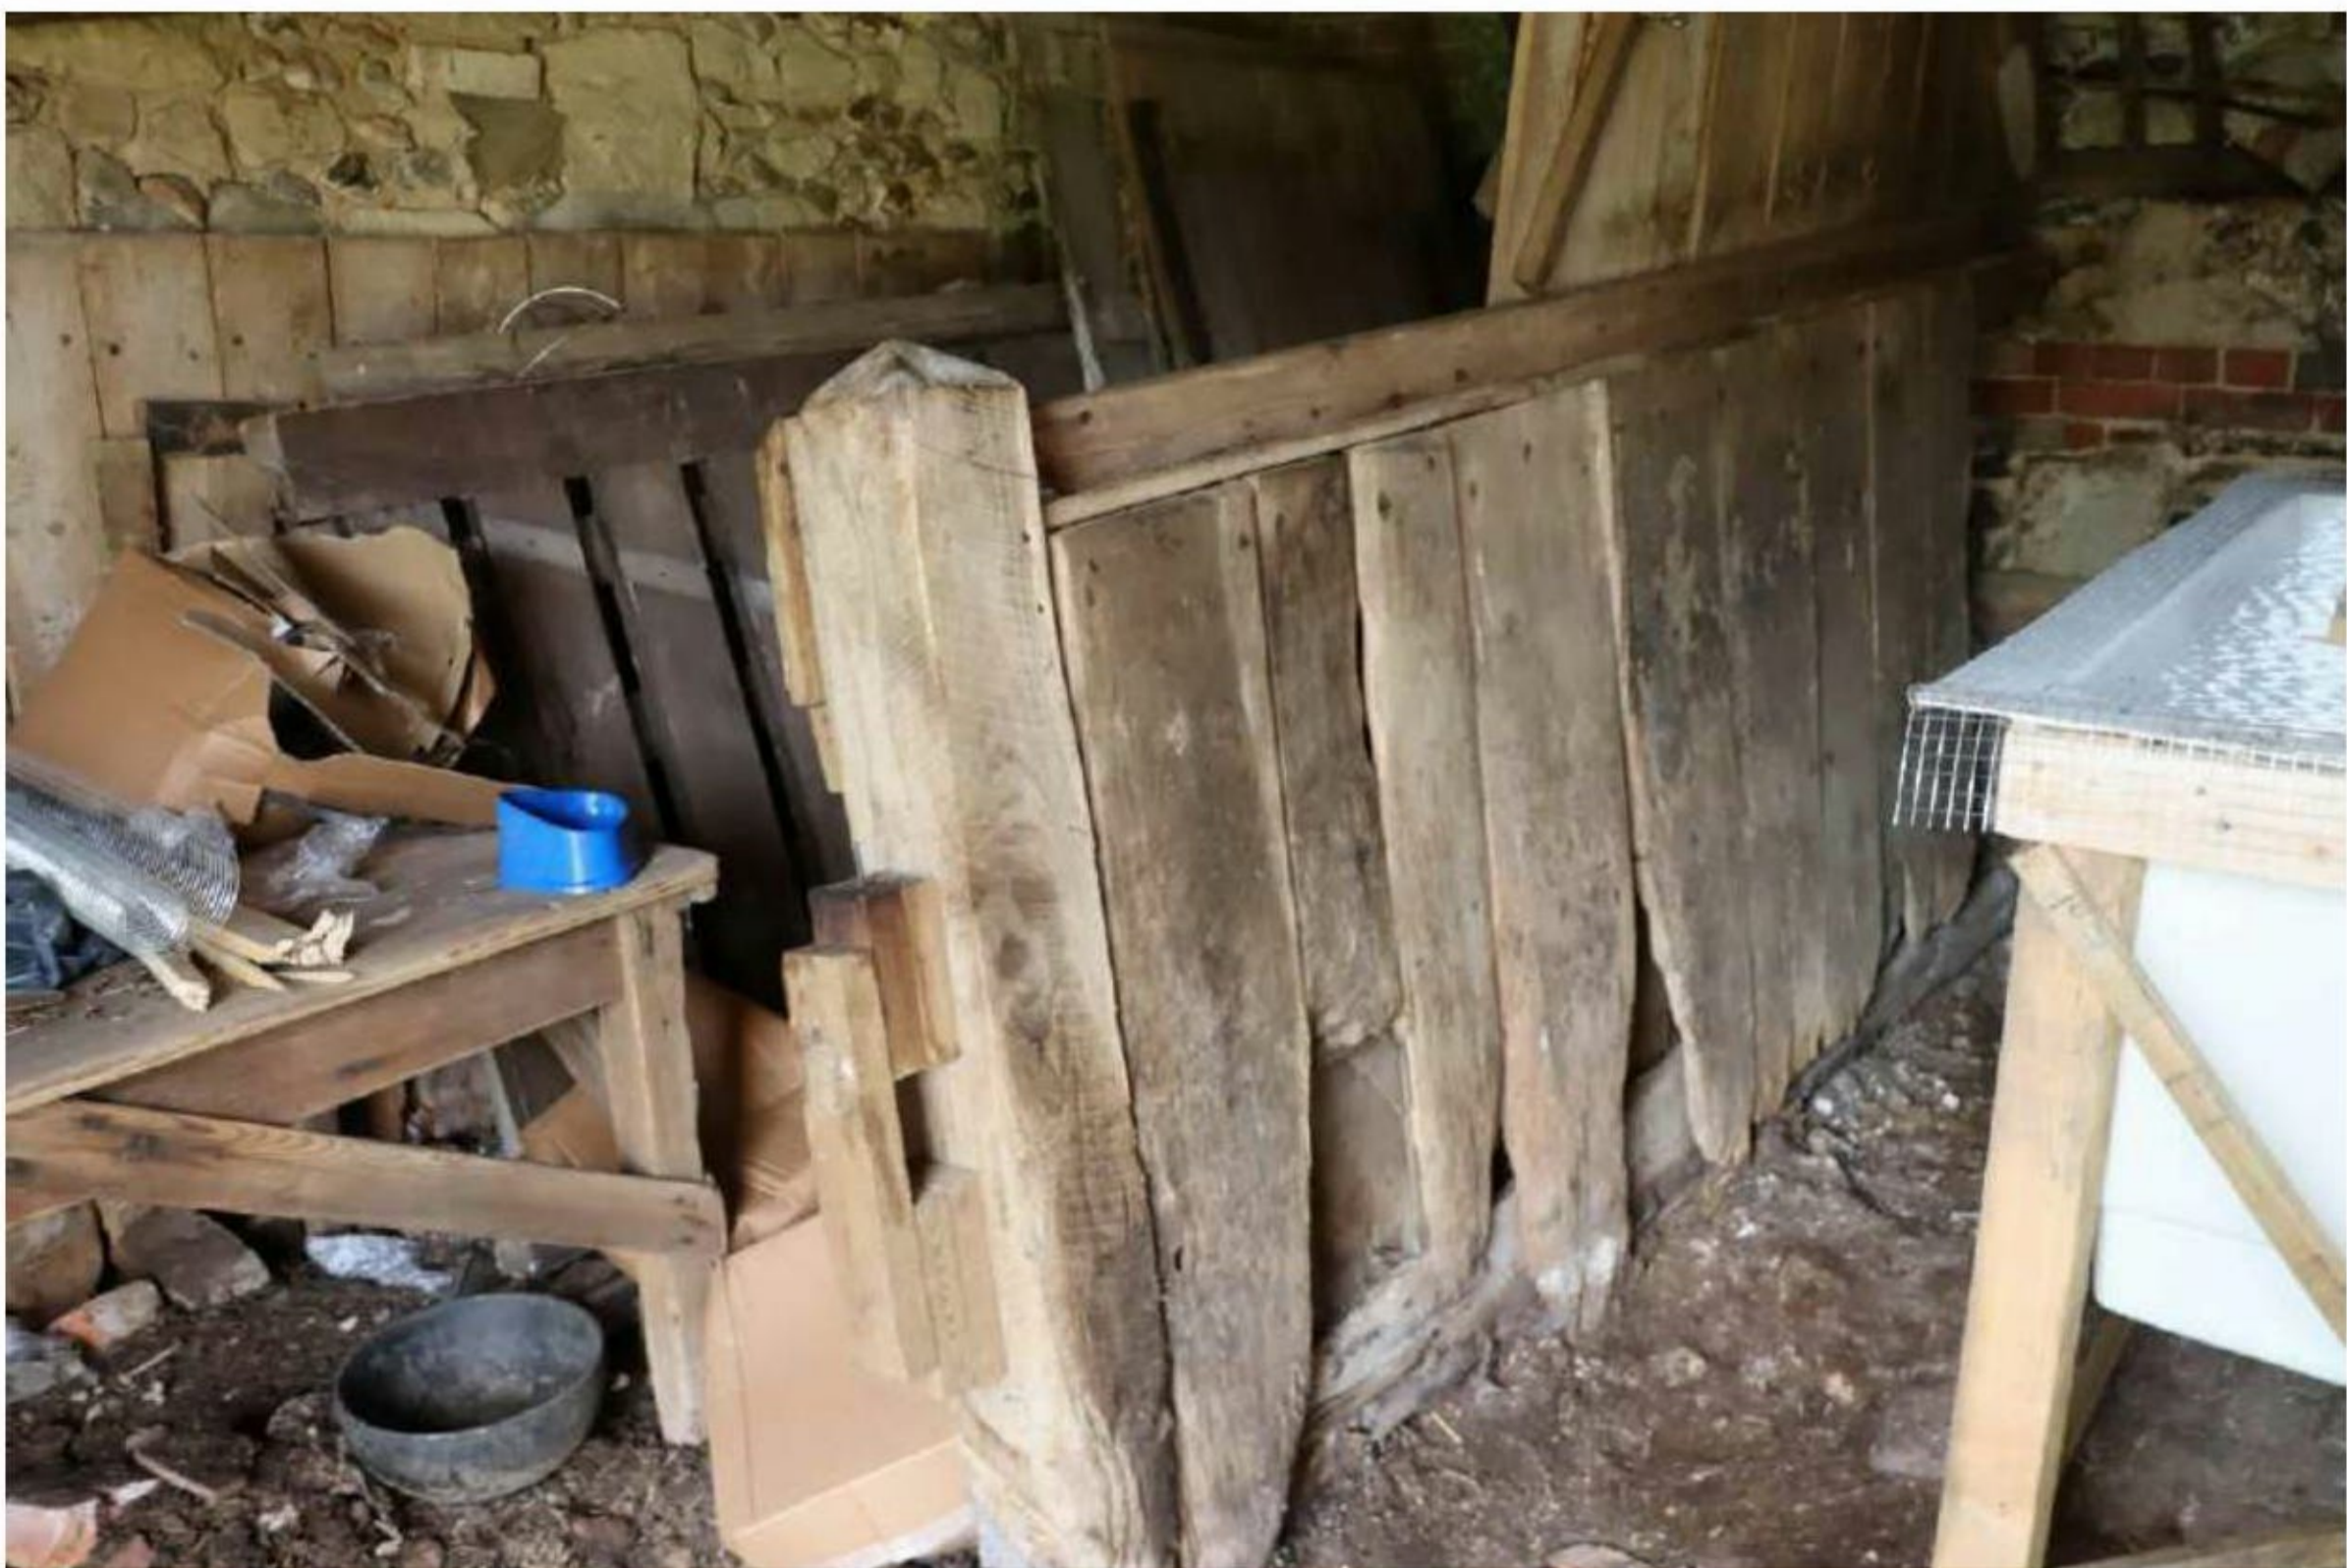
Plate 52: Building C - remnant of wooden stall divider at W end

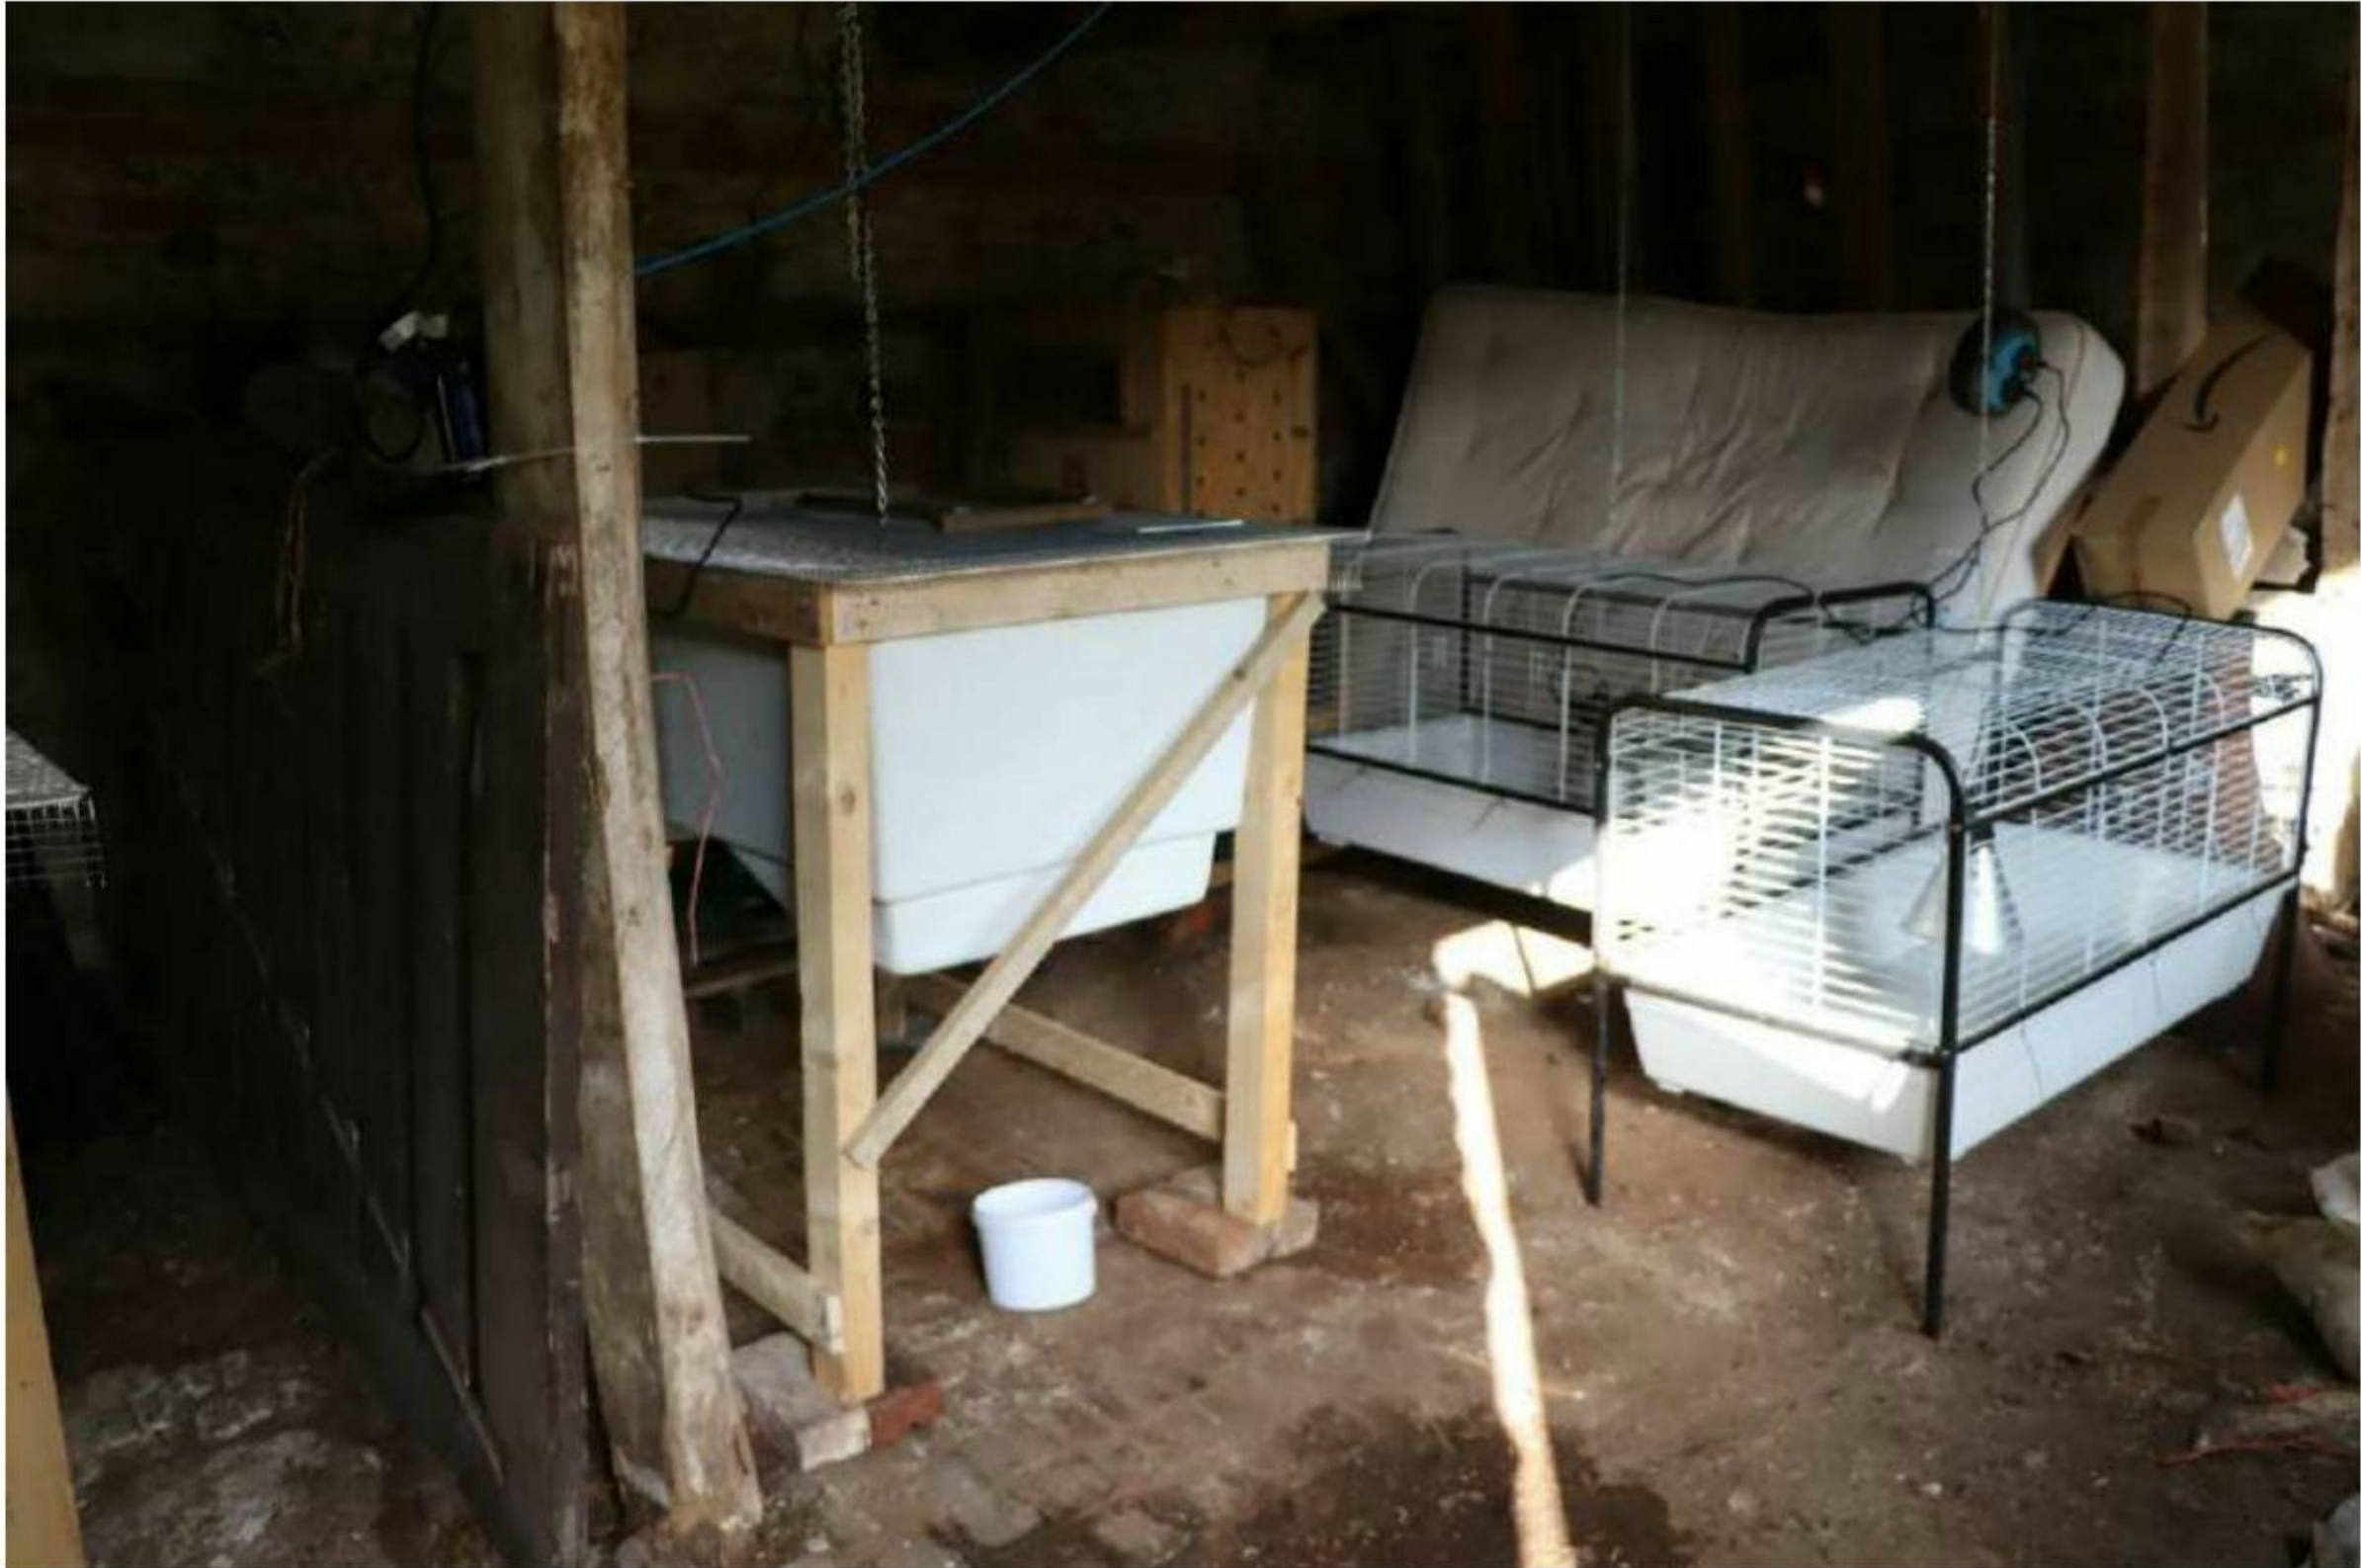
Plate 53: Building C – makeshift later stall divider to left and survival of brick flooring

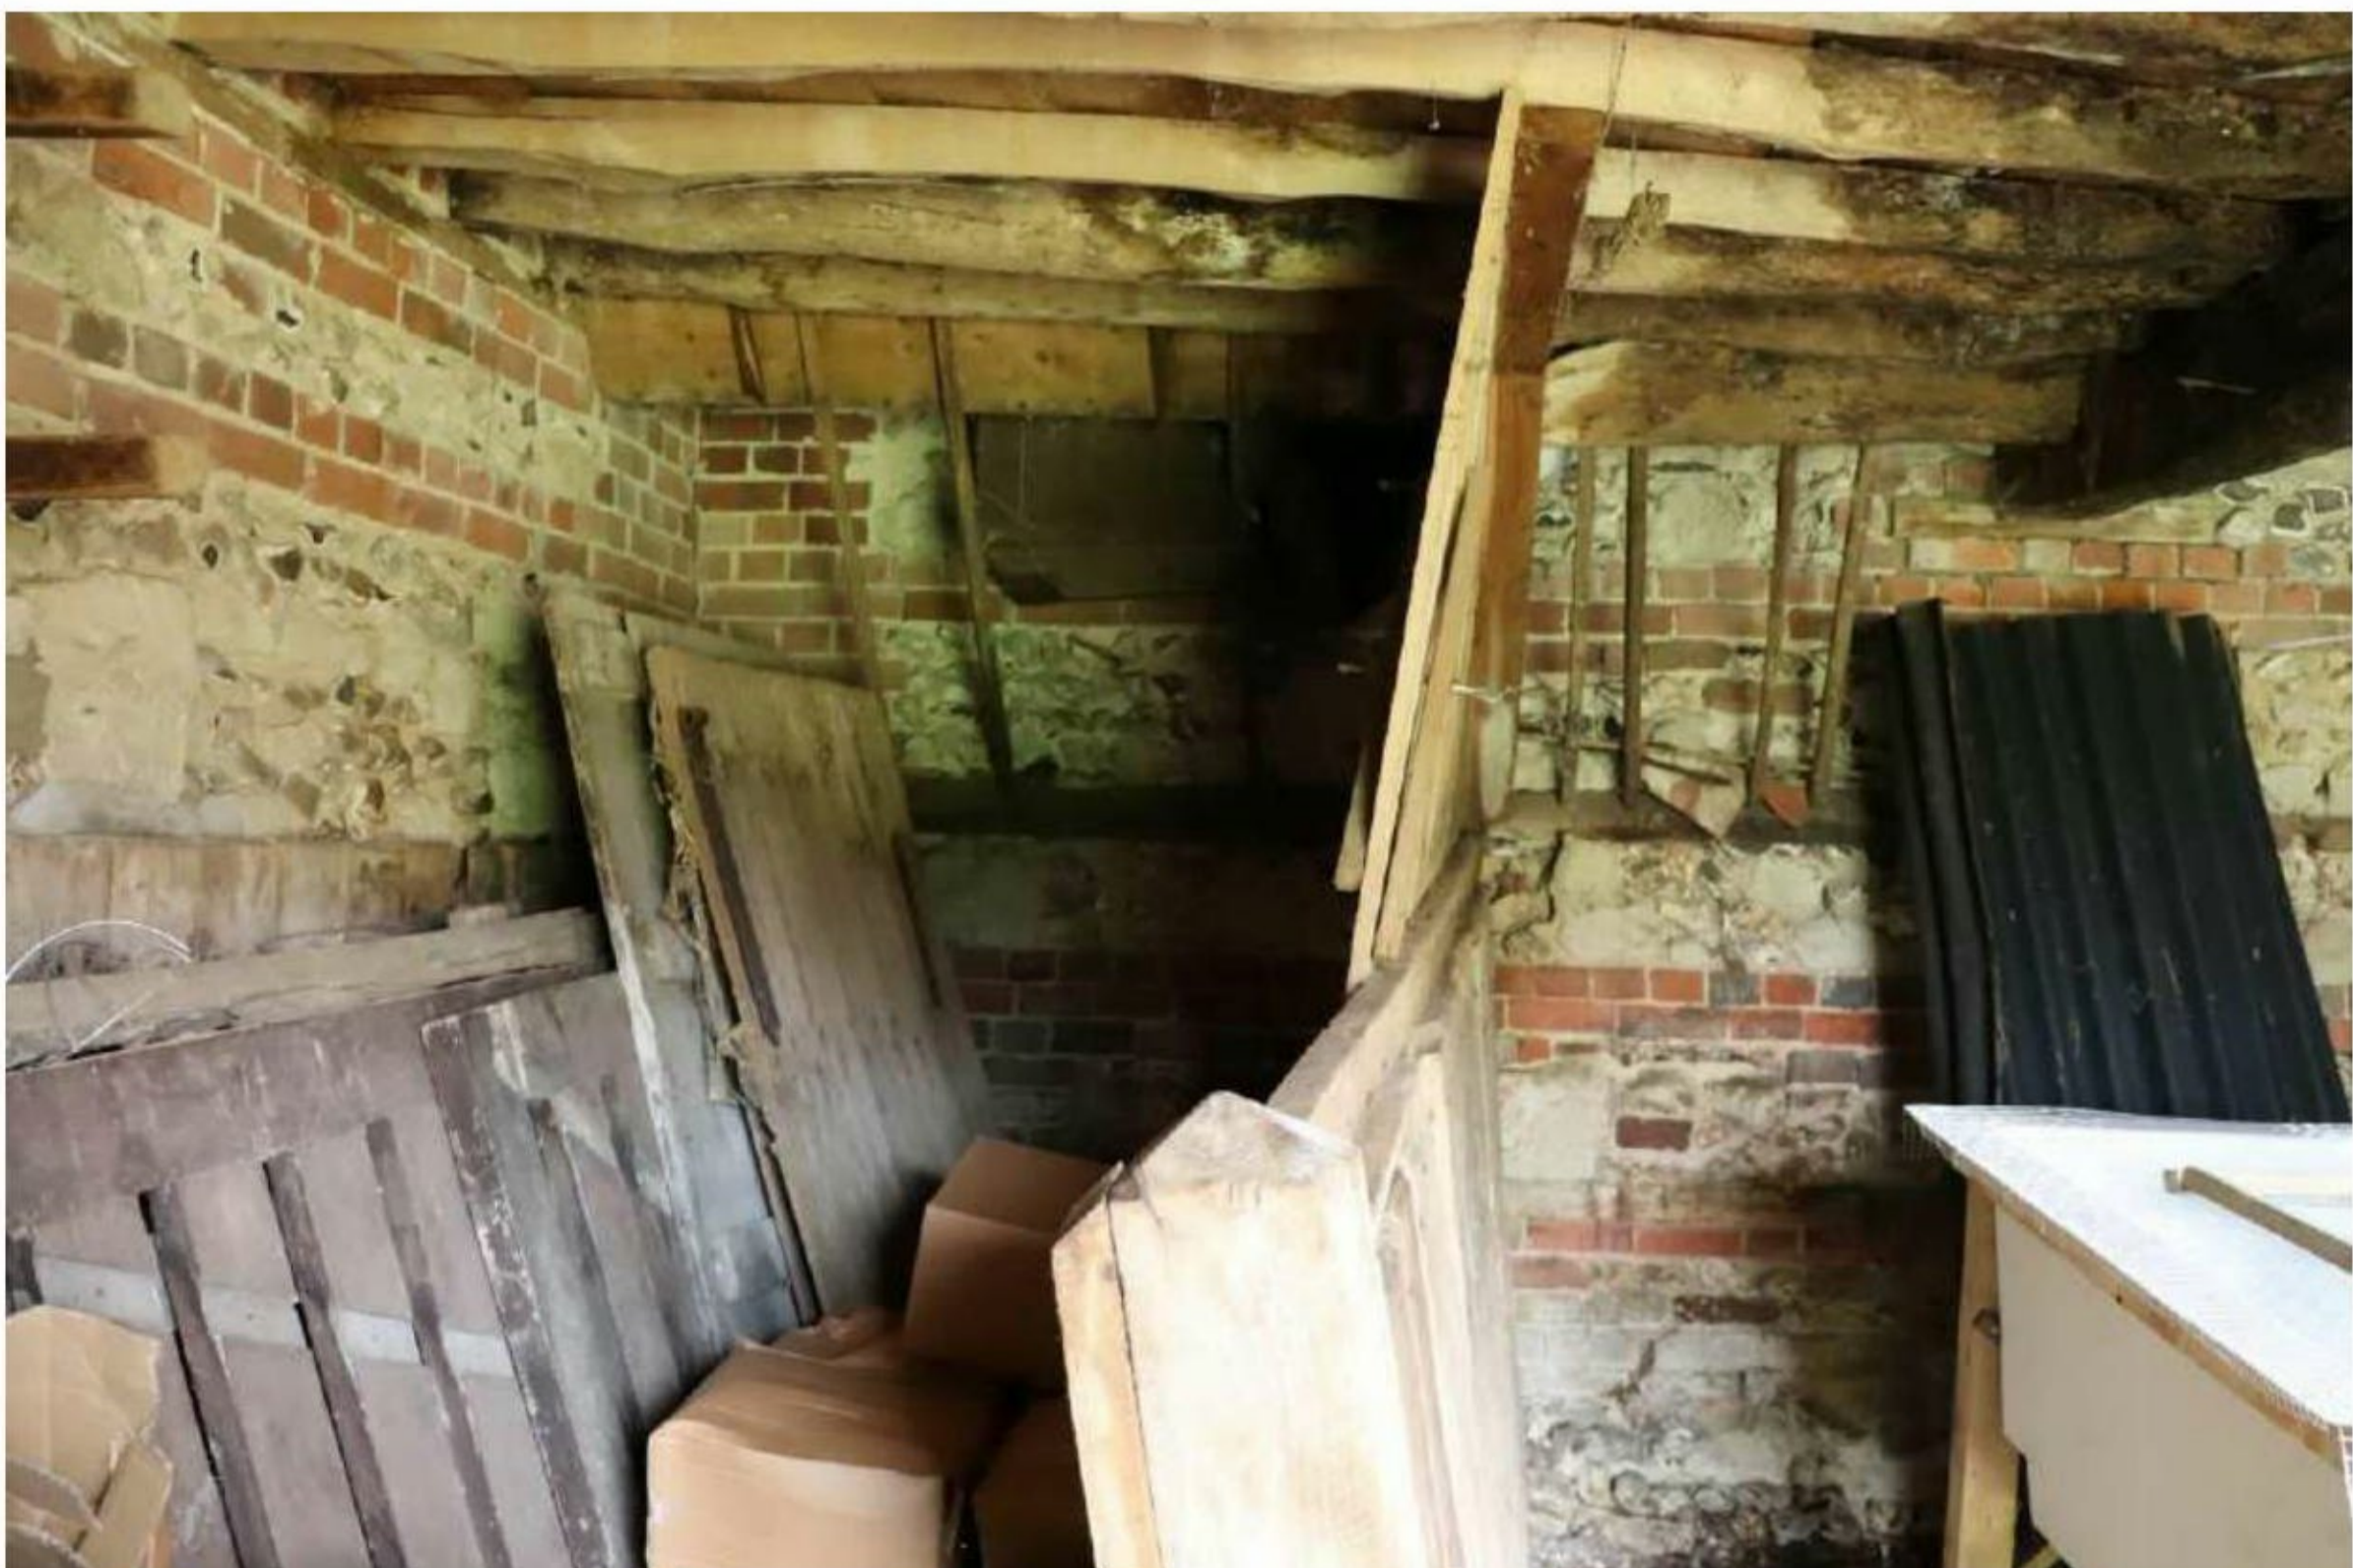
Plate 54: Building C - remnants of wooden manger against rear wall of stalls

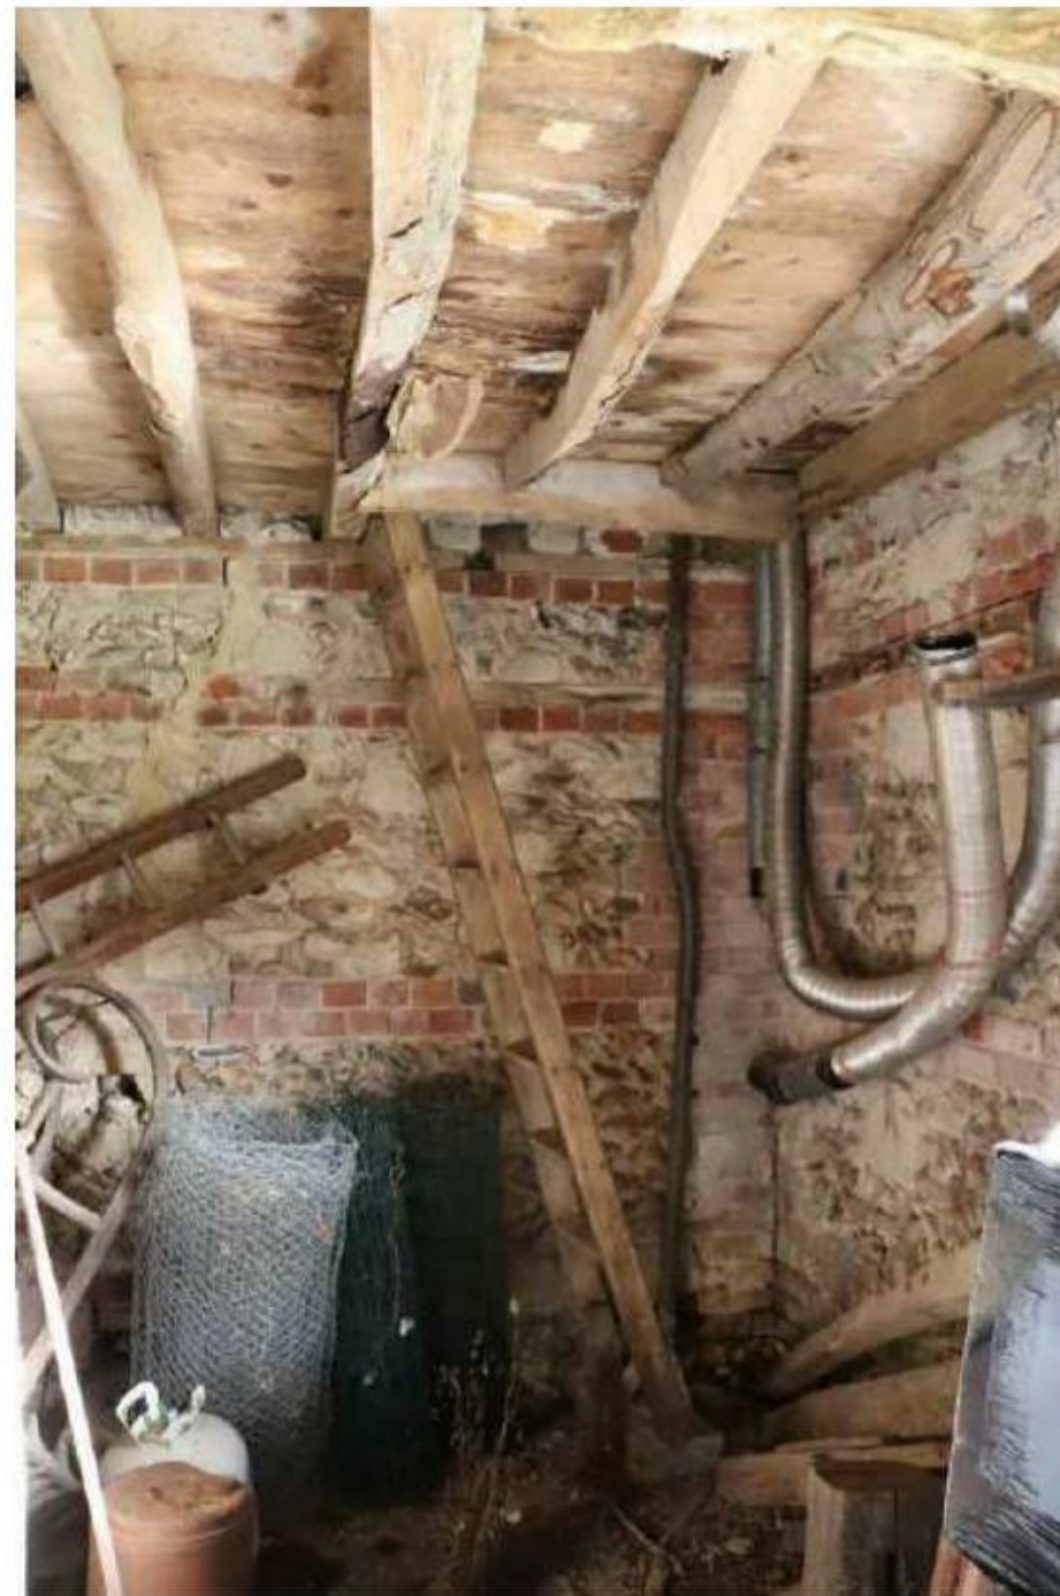
Plate 55: Building C – ladder access to hay loft

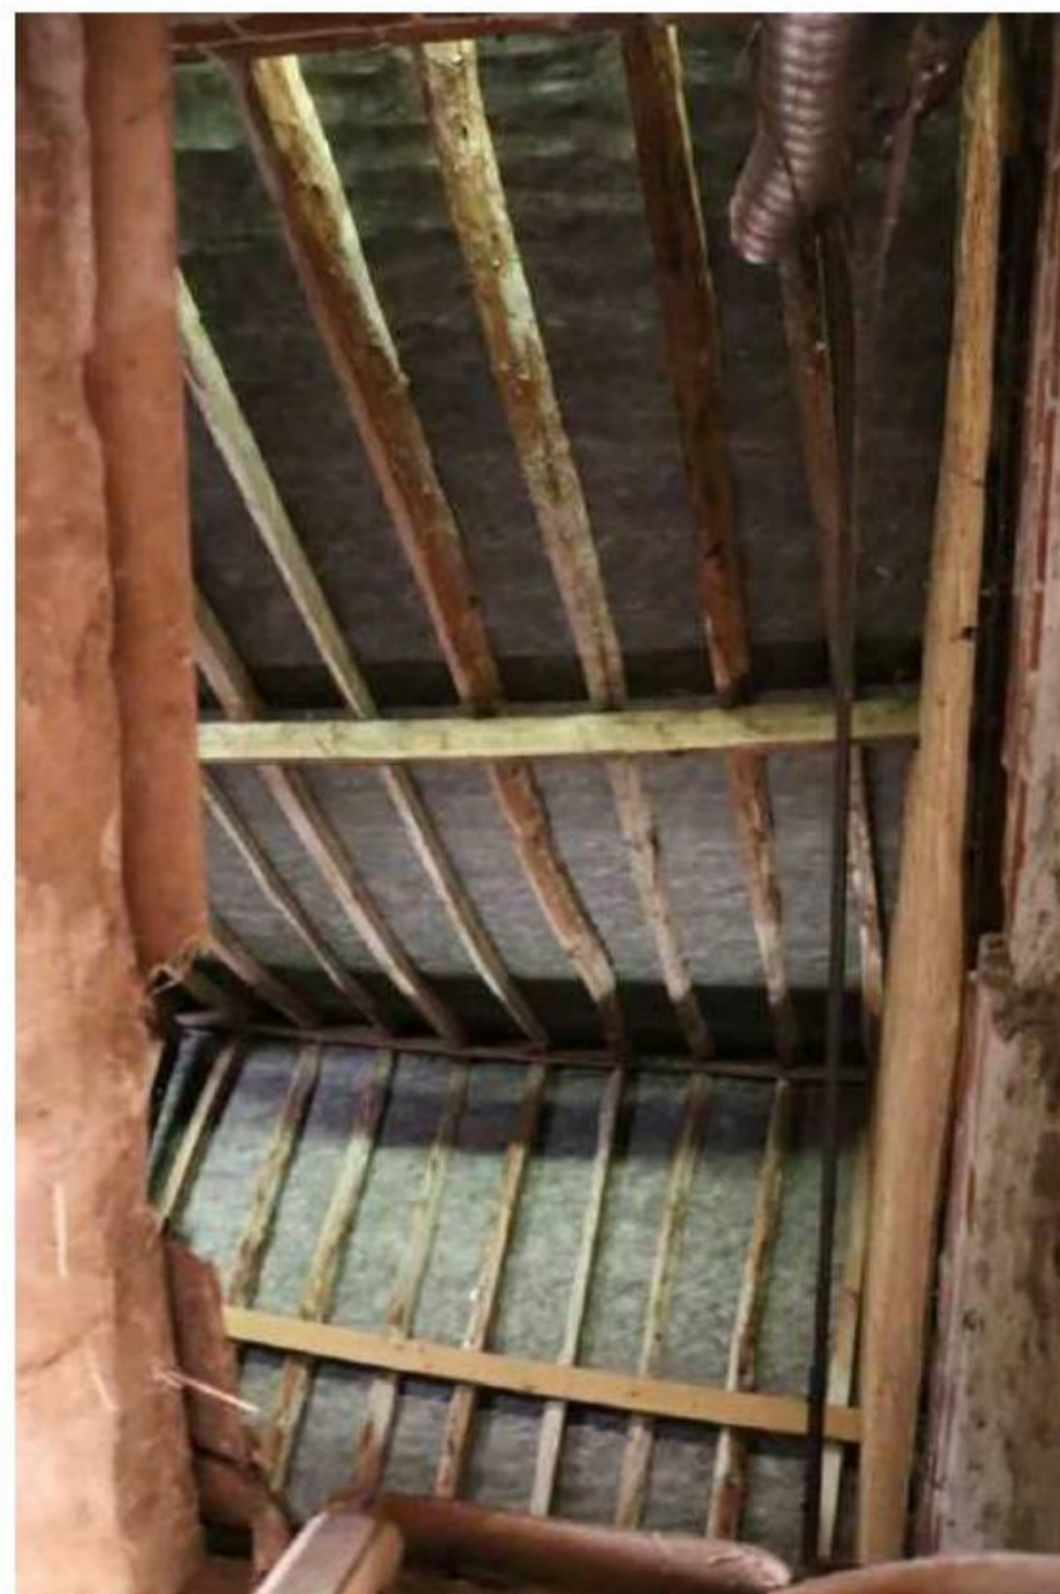
Plate 56: Building C – view into hay loft and roof structure

- 3.2.6 Internally, the original late 19th-century timber beam, joists and floorboards are still present, though in places the floor has rotted through. A number of the joists are crudely cut timbers with the bark still on (**Plates 50 & 51**). There are some dilapidated remnants of wooden stall dividers and hay mangers, some surviving brick-paved flooring within the stalls area (**Plates 52-54**), and timber studs at the eastern end, presumably once part of a partition dividing off the end bay from the stalls. A ladder provides the only access to the hay loft (not currently safe to access) (**Plate 55**). Elements of the roof timbers (at least one purlin) appear to have been replaced, probably when it was lined, but many of the common rafters appear original to the late 19th-century construction (**Plate 56**).

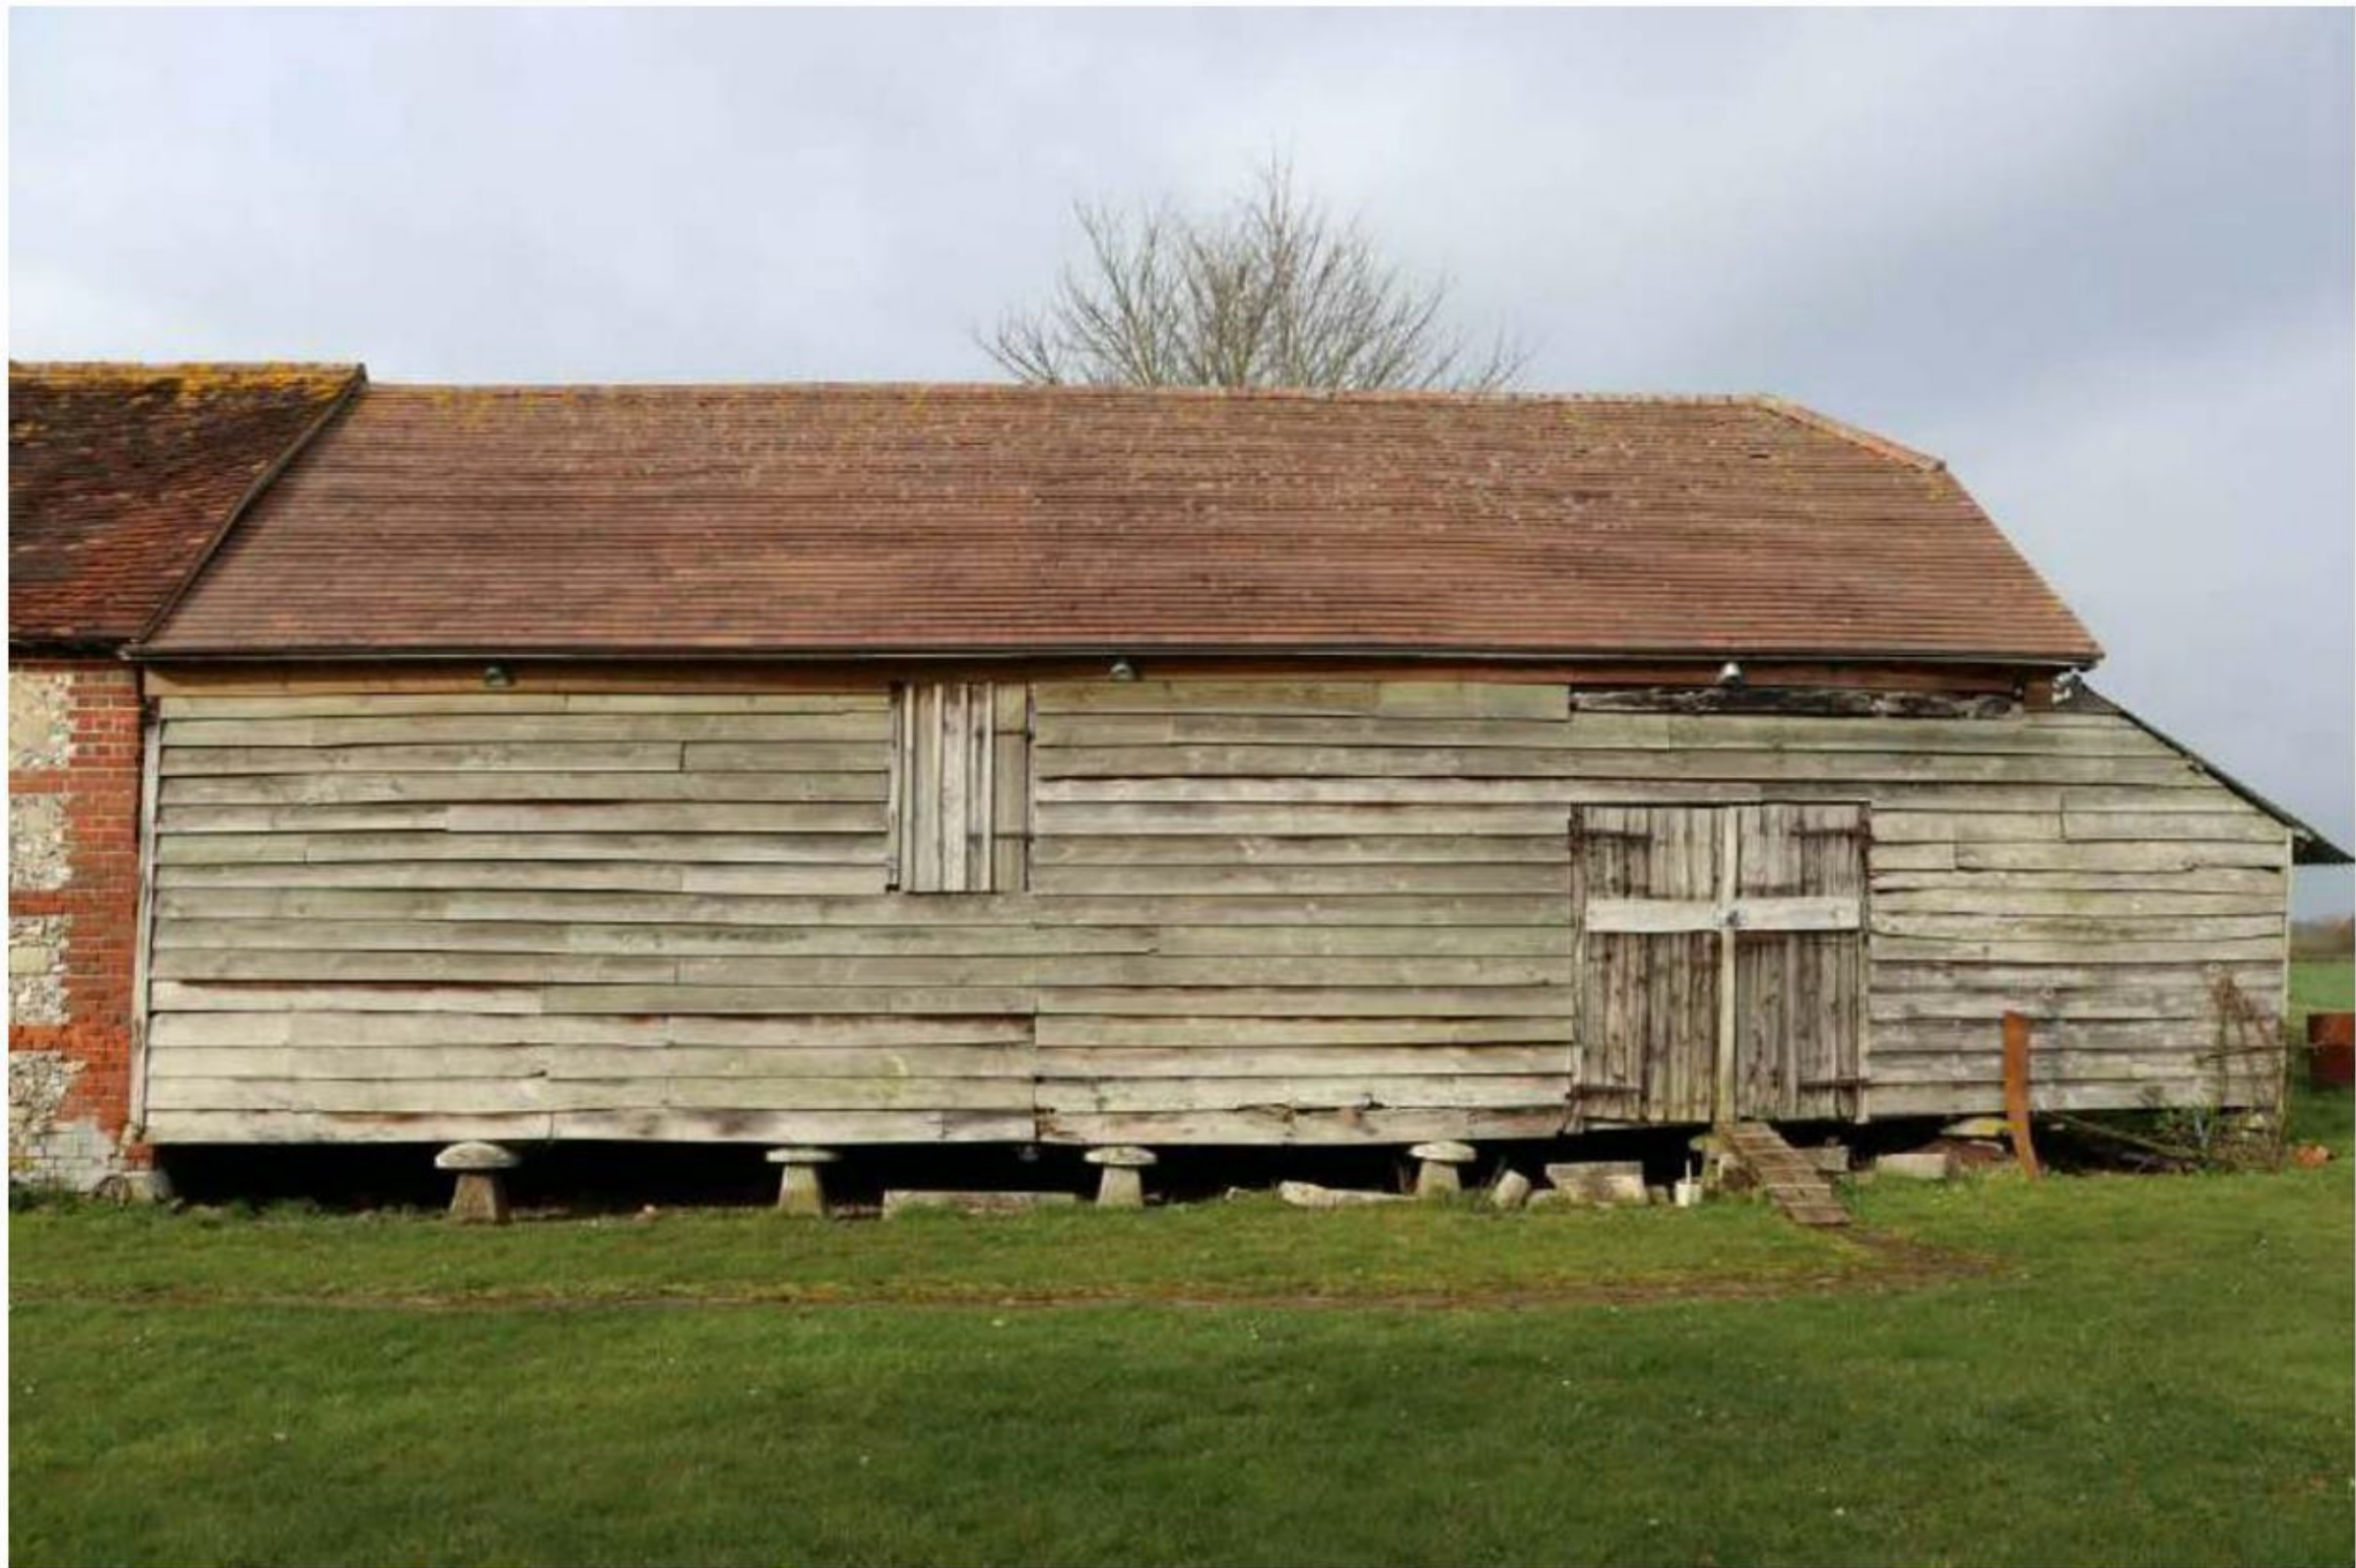
Plate 57: Building D - granary

- 3.2.7 Building D is older than B and C and was present on the site by 1838 and undoubtedly for some time before this, possibly being broadly contemporary with the cart-shed, Building A. It is a timber-framed structure clad in horizontal weatherboarding and raised on mushroom-shaped staddle-stones, which indicates its original use as a granary (**Plate 57**). The structure has a clay-tiled roof, hipped at the eastern end where there is a lower lean-to structure (with recent corrugated metal roof), but the main roof was originally thatched, with an eyebrow cut out over the loading door in the front elevation, as can be seen on **Photo B**. The access is provided by a set of double boarded doors. The roof had been tiled by 1957.

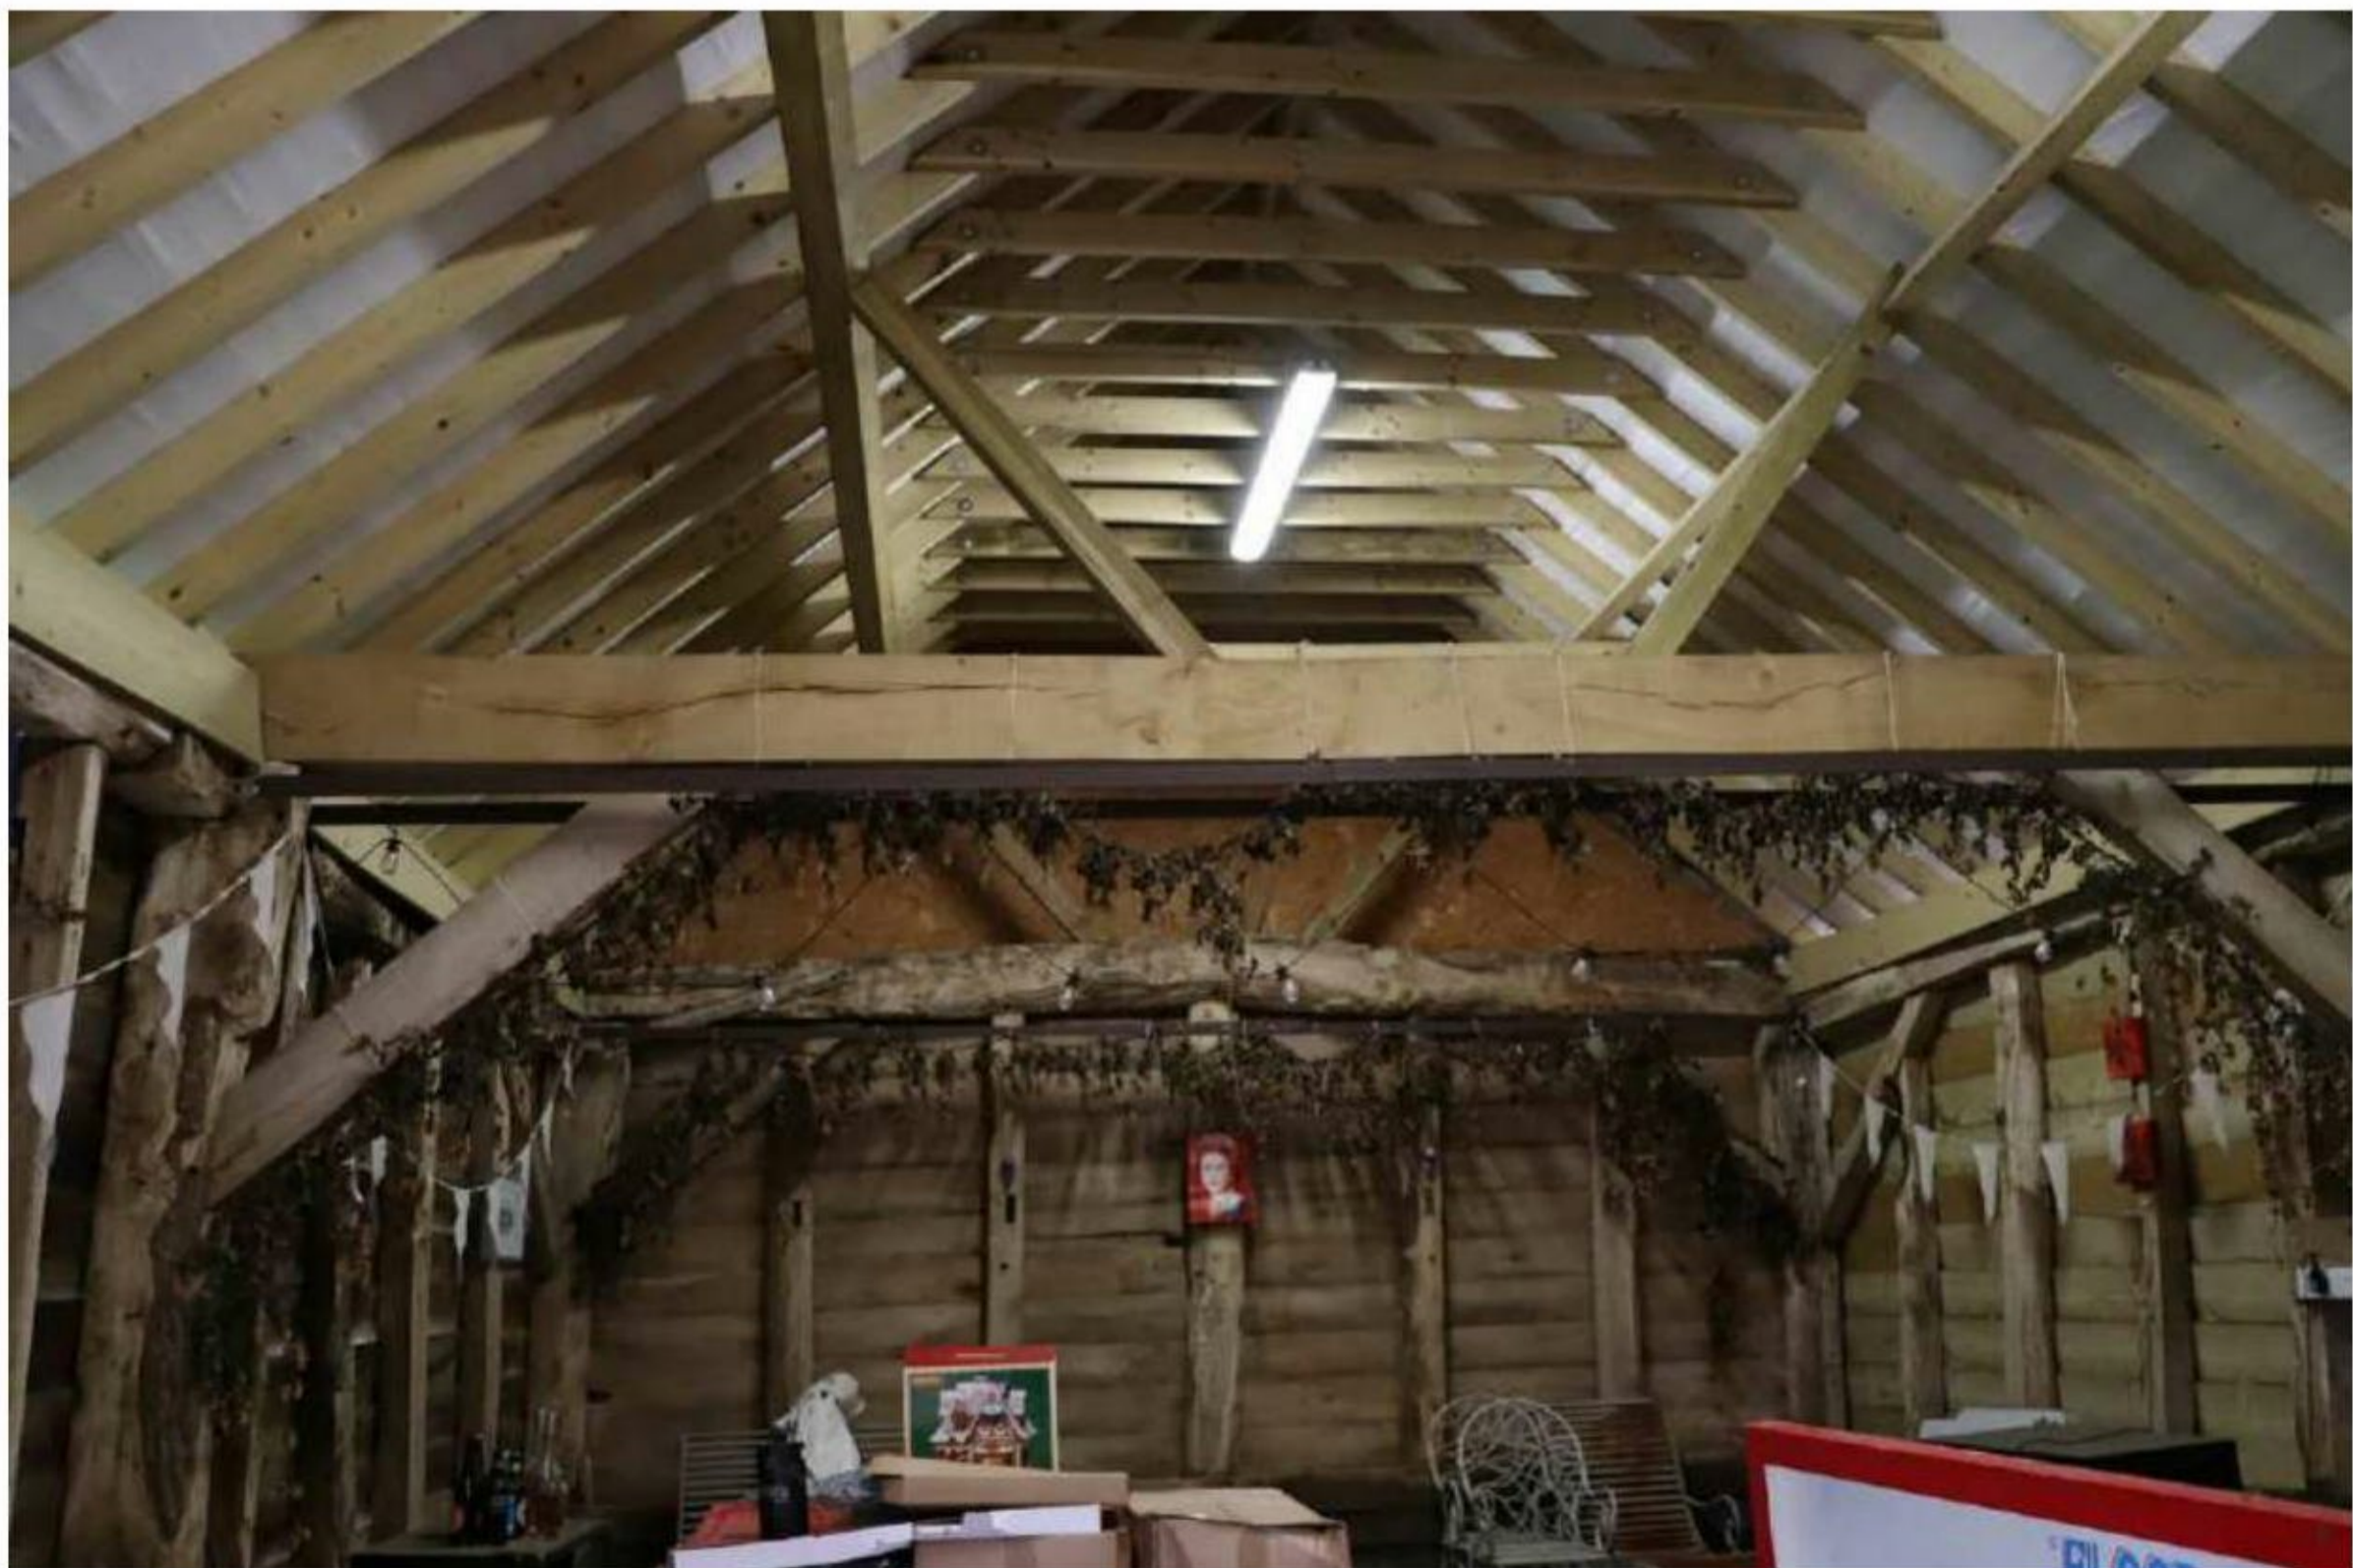
Plate 58: Building D: interior, looking W
