STATEMENT OF SIGNIFICANCE

**Flood Street Farm,
Breamore, Hampshire**

AHC REF: 9943

Date: April 2021

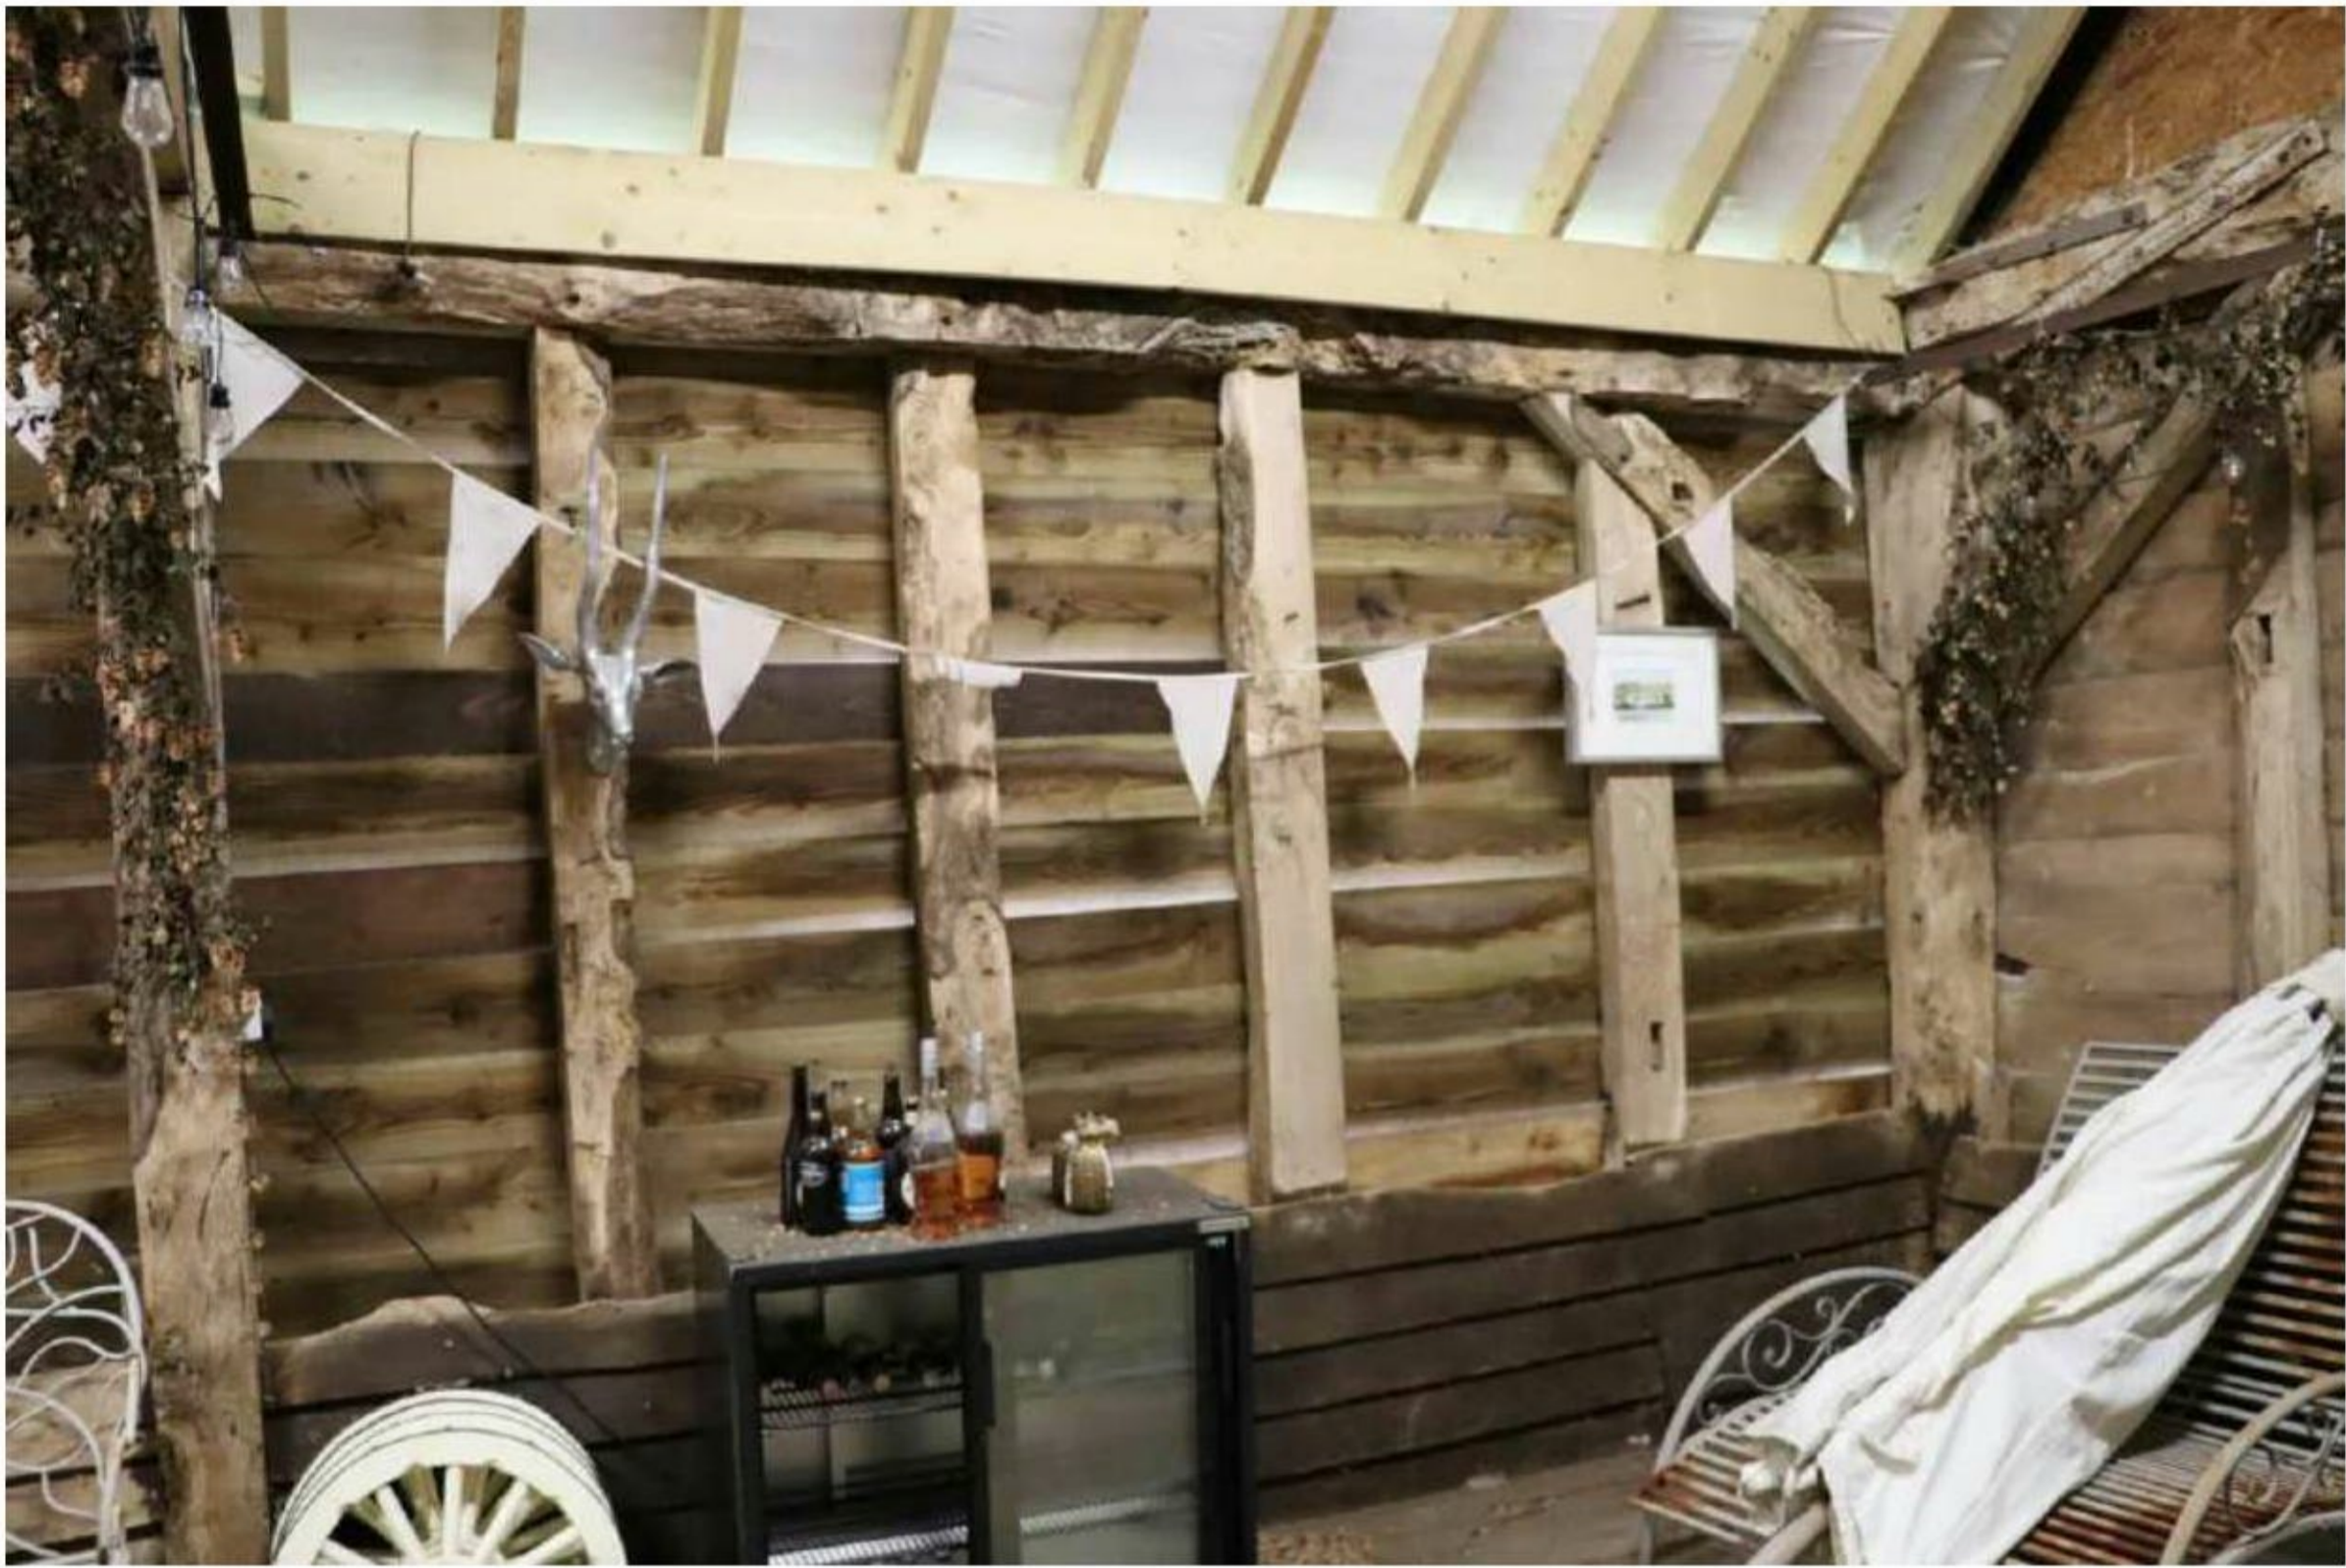
Plate 59: Building D: interior, looking towards S wall

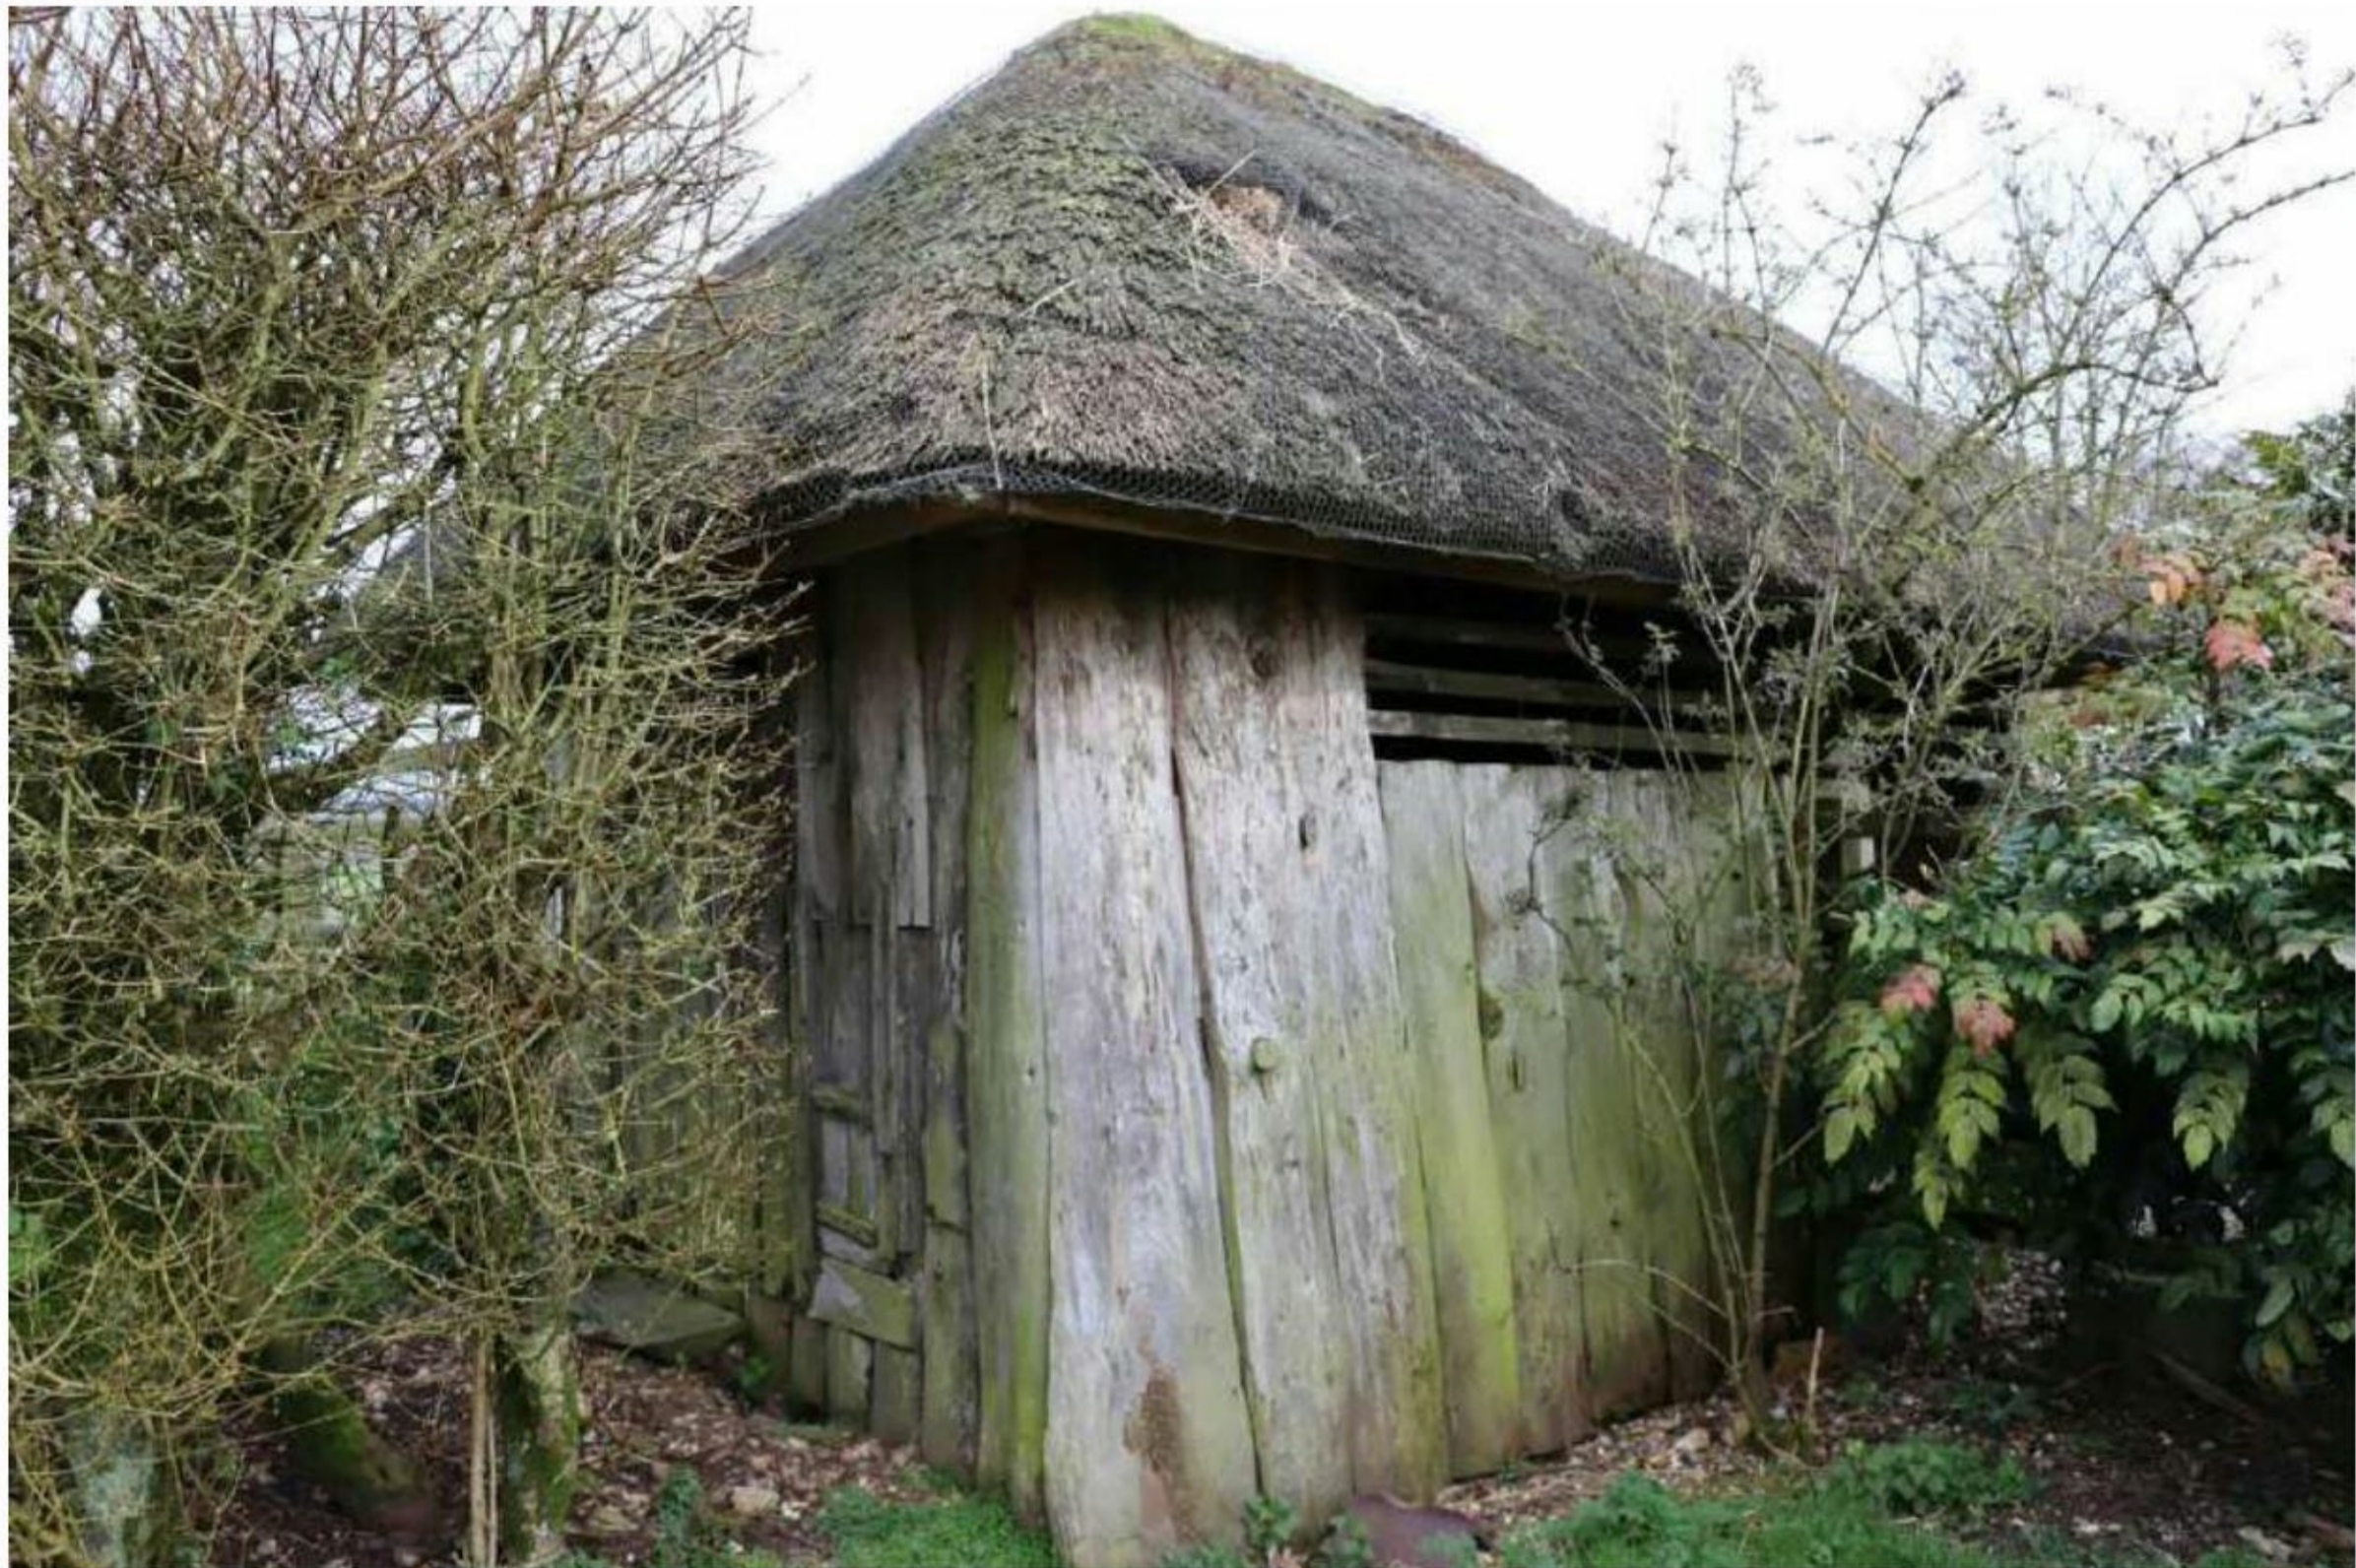
Plate 61: Building E

3.2.9 Building E is a small timber-framed weather-boarded shed with a thatched hipped roof (**Plate 61**). The substantial pegged boards at the corner indicate it of some age but, while it is shown on the 1926 OS map, the building on its site prior to this (including in 1838) was much longer, so what stands now may represent the truncated southern end of that building.

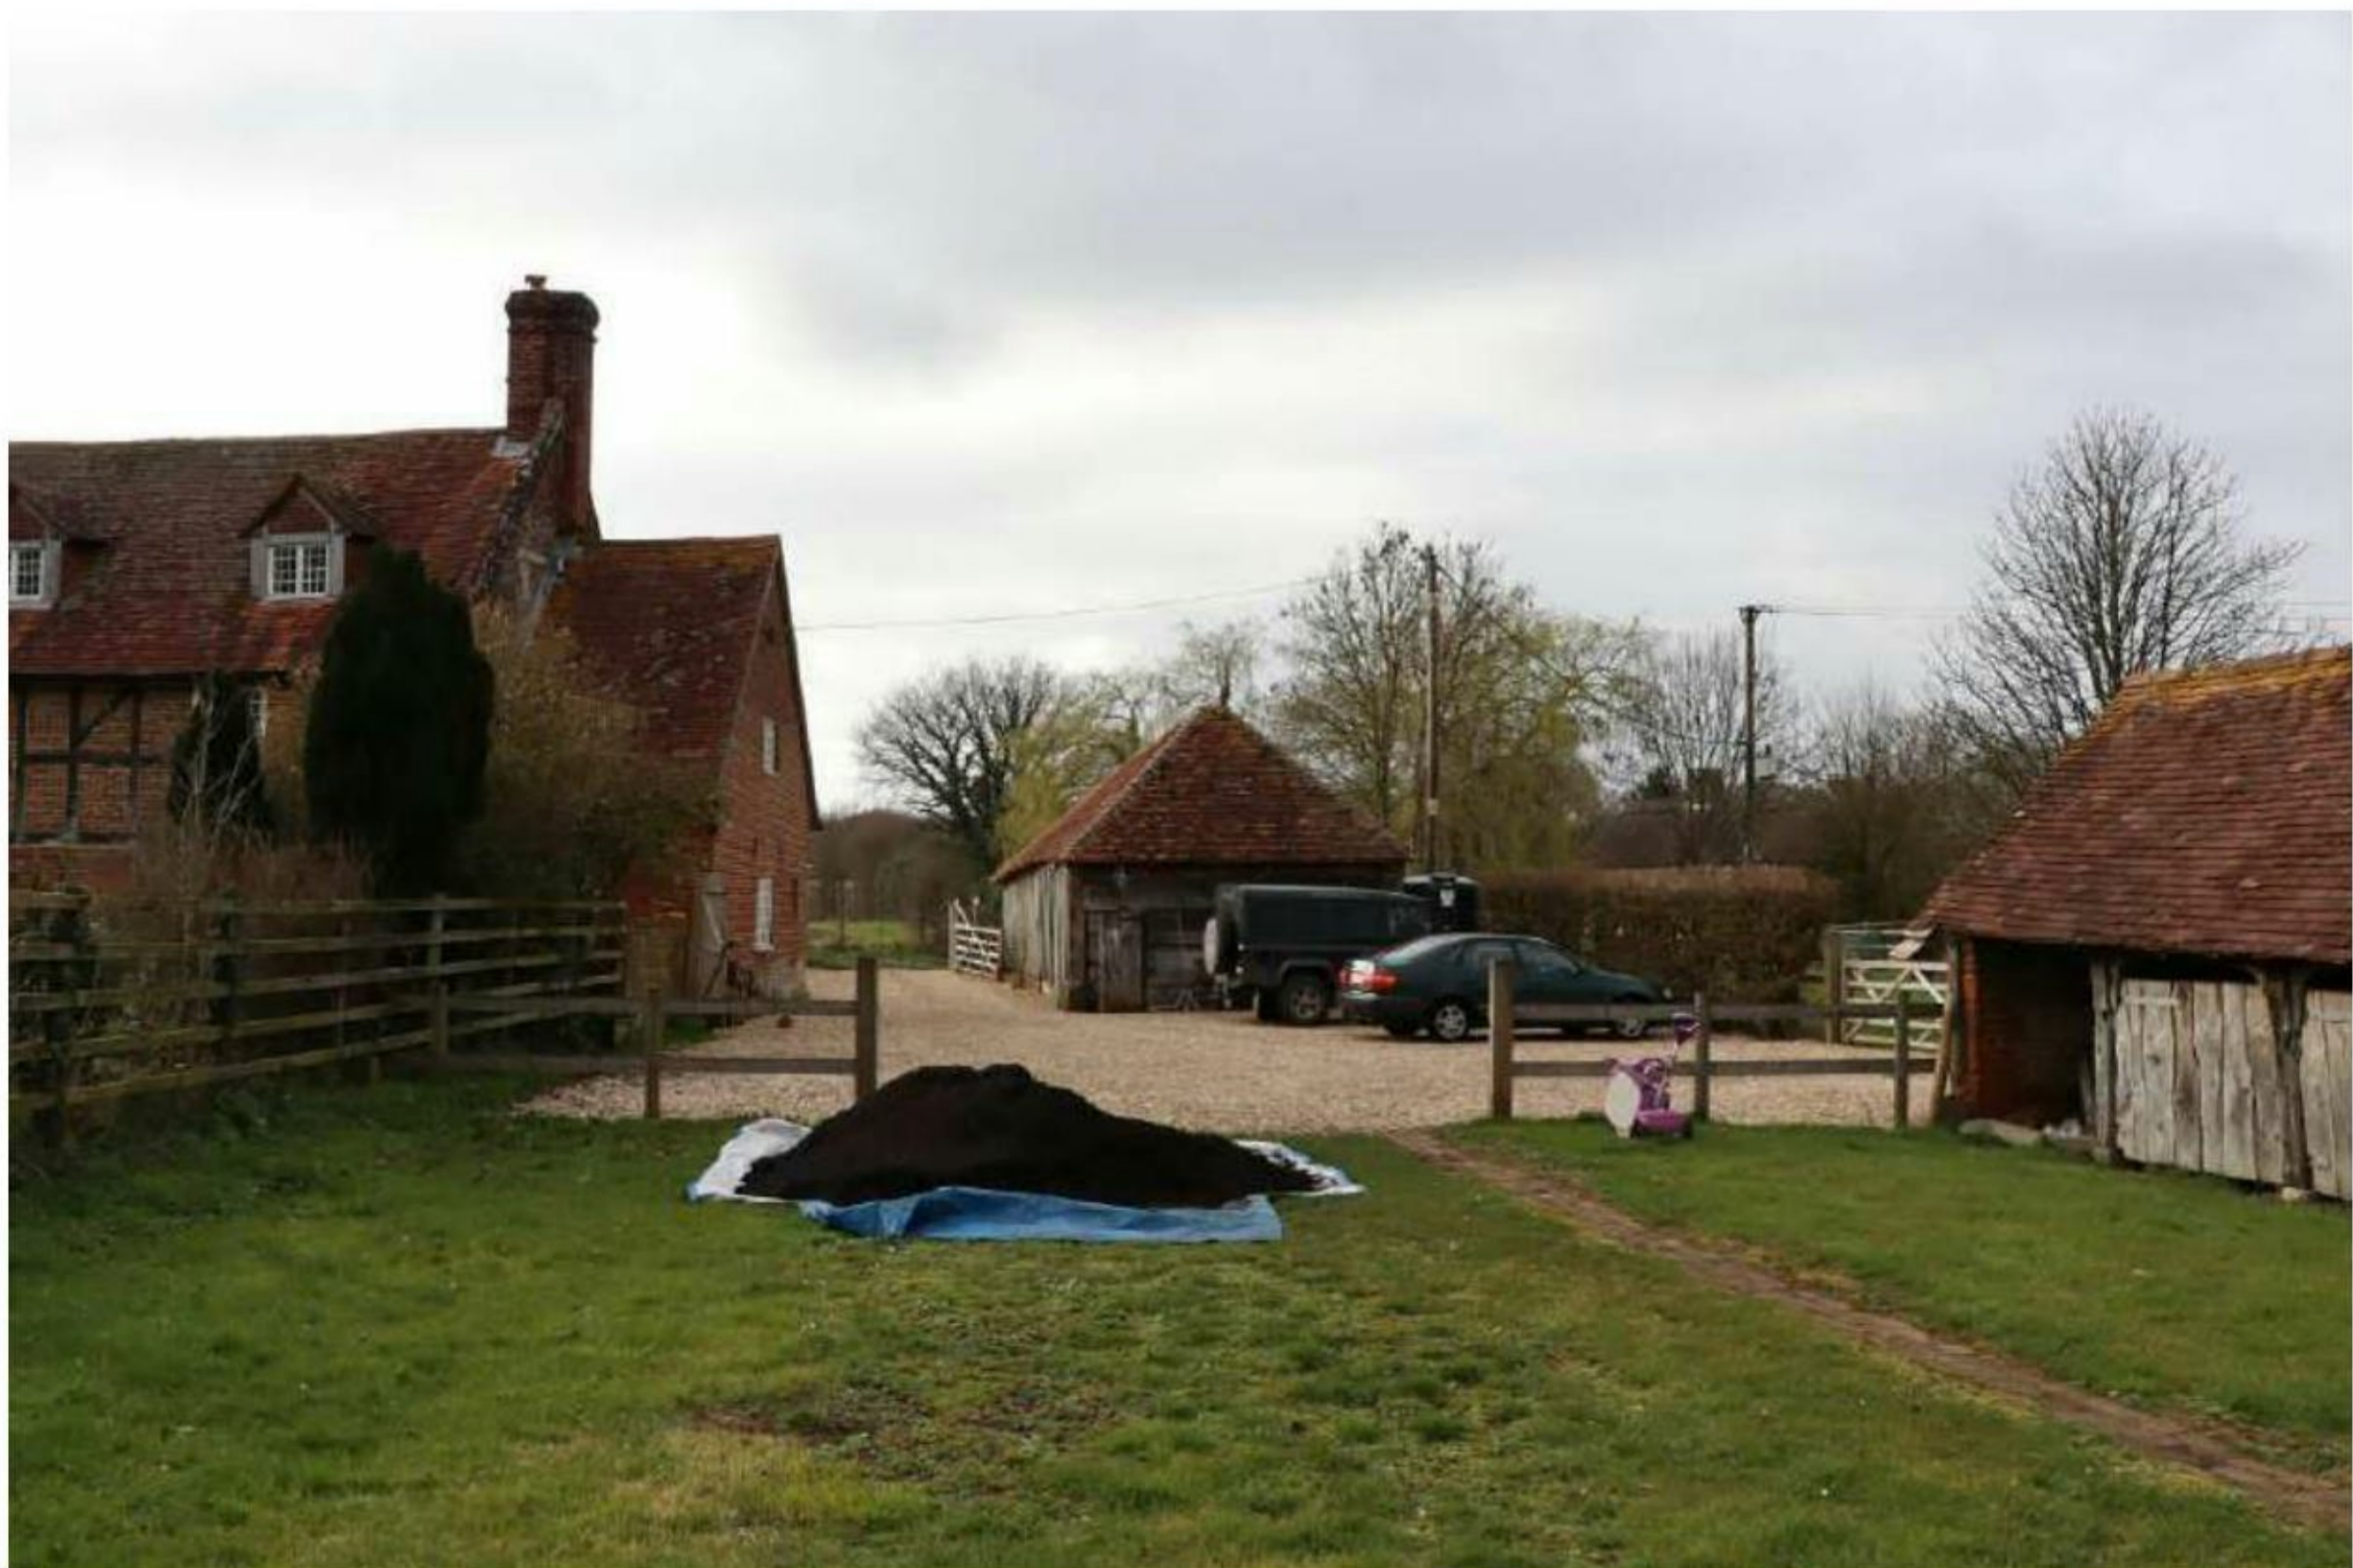
Plate 62: Looking W past Buildings B-D (right) along the historic farm access

3.3.2 The close setting of the building is clearly defined by its front and rear gardens and then by the driveway and area containing the outbuildings, although the driveway no longer continues to the outbuildings, with the area in front of them now laid to grass and fenced off from the main garden (see **Plate 43**); this has the effect of slightly divorcing them from the farmhouse and diluting the close relationship of farmhouse and farm buildings. Nevertheless, the outbuildings still have group value in relation to the farmhouse and the whole is legible as a single property (**Plate 62**).

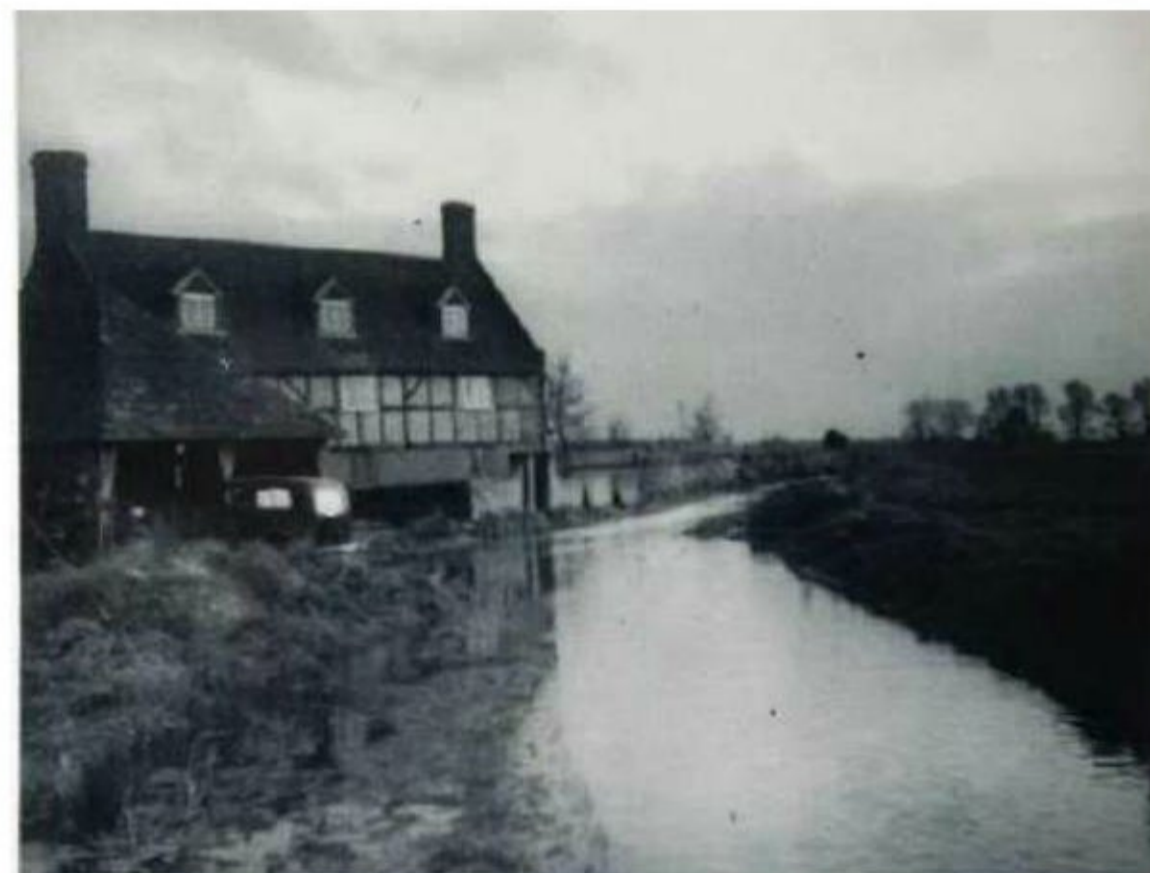
D: Looking S along a flooded Flood Street towards the farmhouse

- 3.3.5 Behind Buildings A-D there is a paddock in the use of the property, containing the pond against the rear of Buildings B-D (**Plate 67**).
- 3.3.6 Flood Street itself is liable to periodic flooding rising from natural springs in the area, (see **Photo D**, which shows a very similar situation to the flooding that was present in March 2021). The lane runs roughly north-south past the farmhouse, which faces it at an angle so that its façade is seen on the approach from the north (from Breamore). Views back towards the building along the lane from the south are precluded by a high dense hedgerow on an earth bank, such that only the south-western gable apex and chimney are visible above the hedge (**Plate 68**).

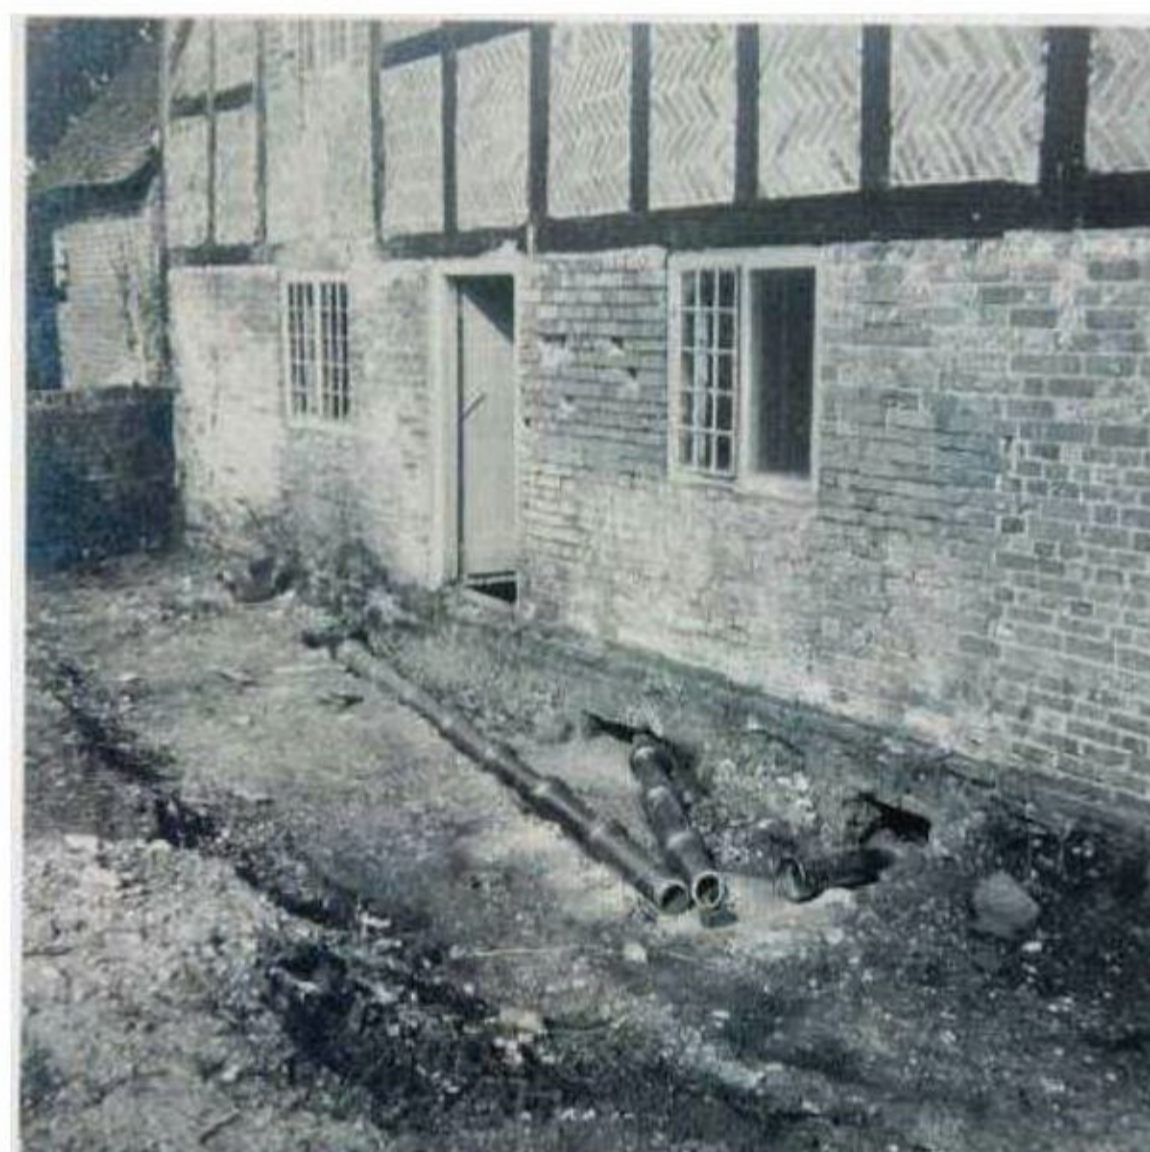
E: Front elevation, drainage works

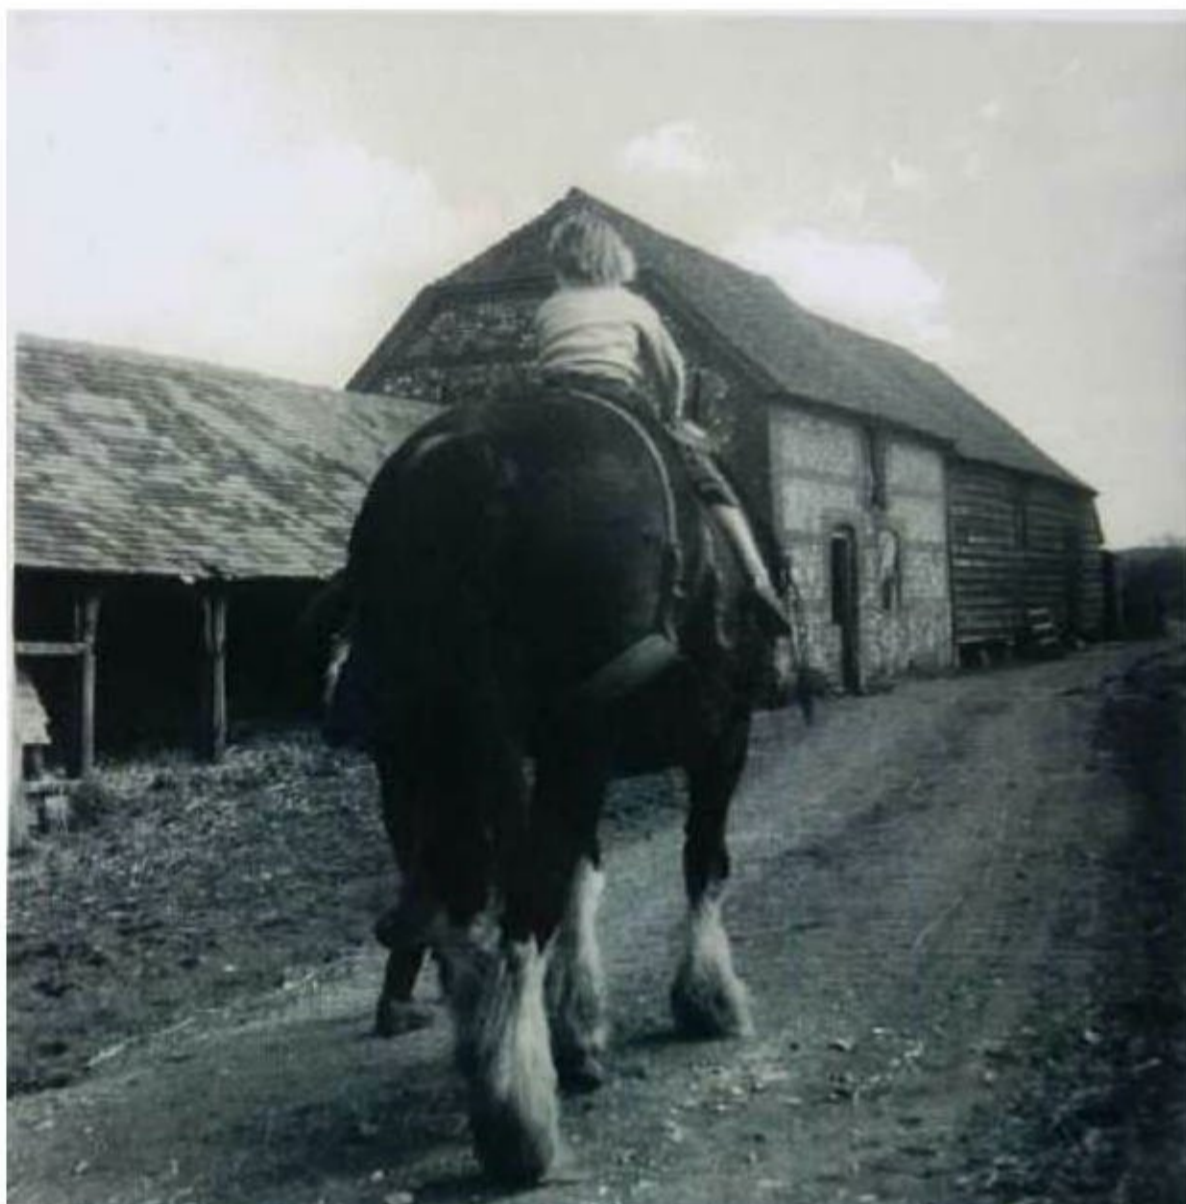
N: Looking E past farm buildings B-D

3.2.2 Buildings B, C and D (**Plates 43 & 44** and **Photos B & N-P**) were not sold with the farmhouse in 1957, only coming into the Dodgsons' ownership in July 1988. It is probable that some of the repair work that has evidently been undertaken to the roof structures of these buildings was done after this time.

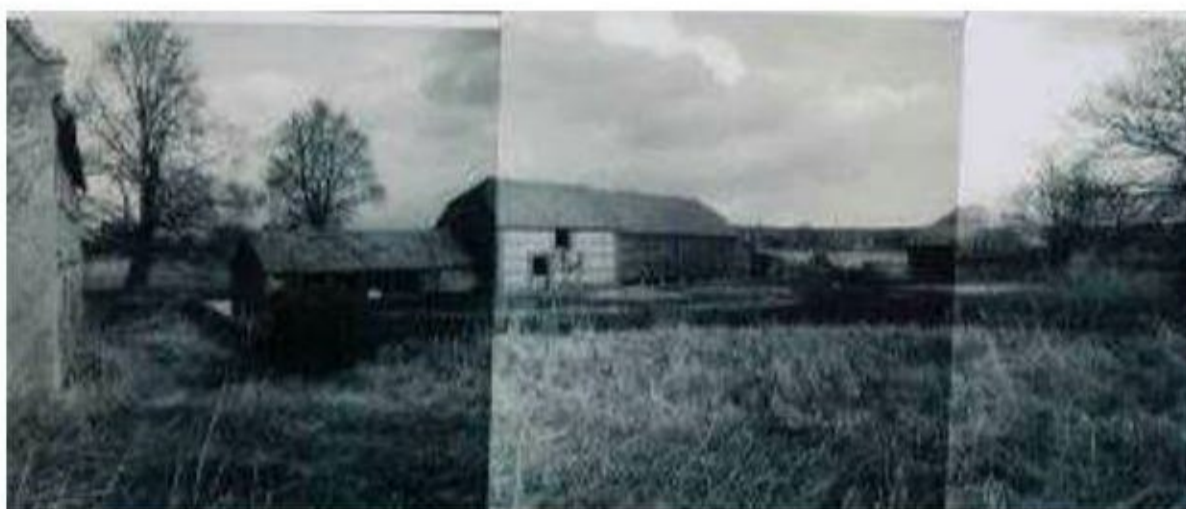
O: Looking N across garden to farm buildings

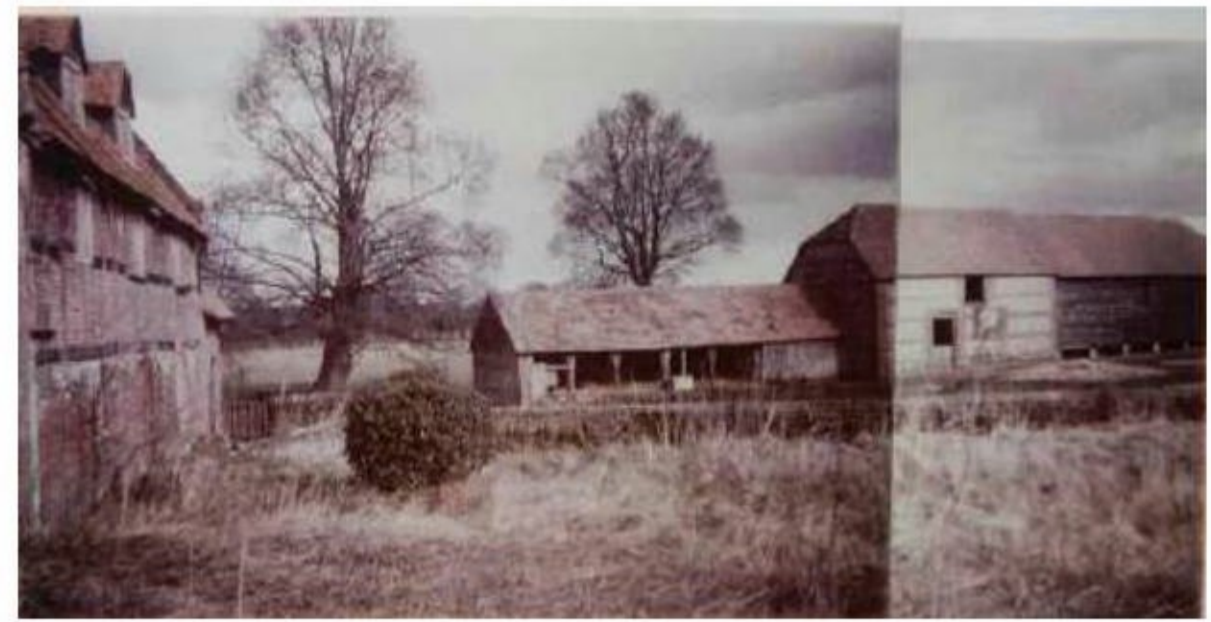
P: Looking N across garden to farm buildings

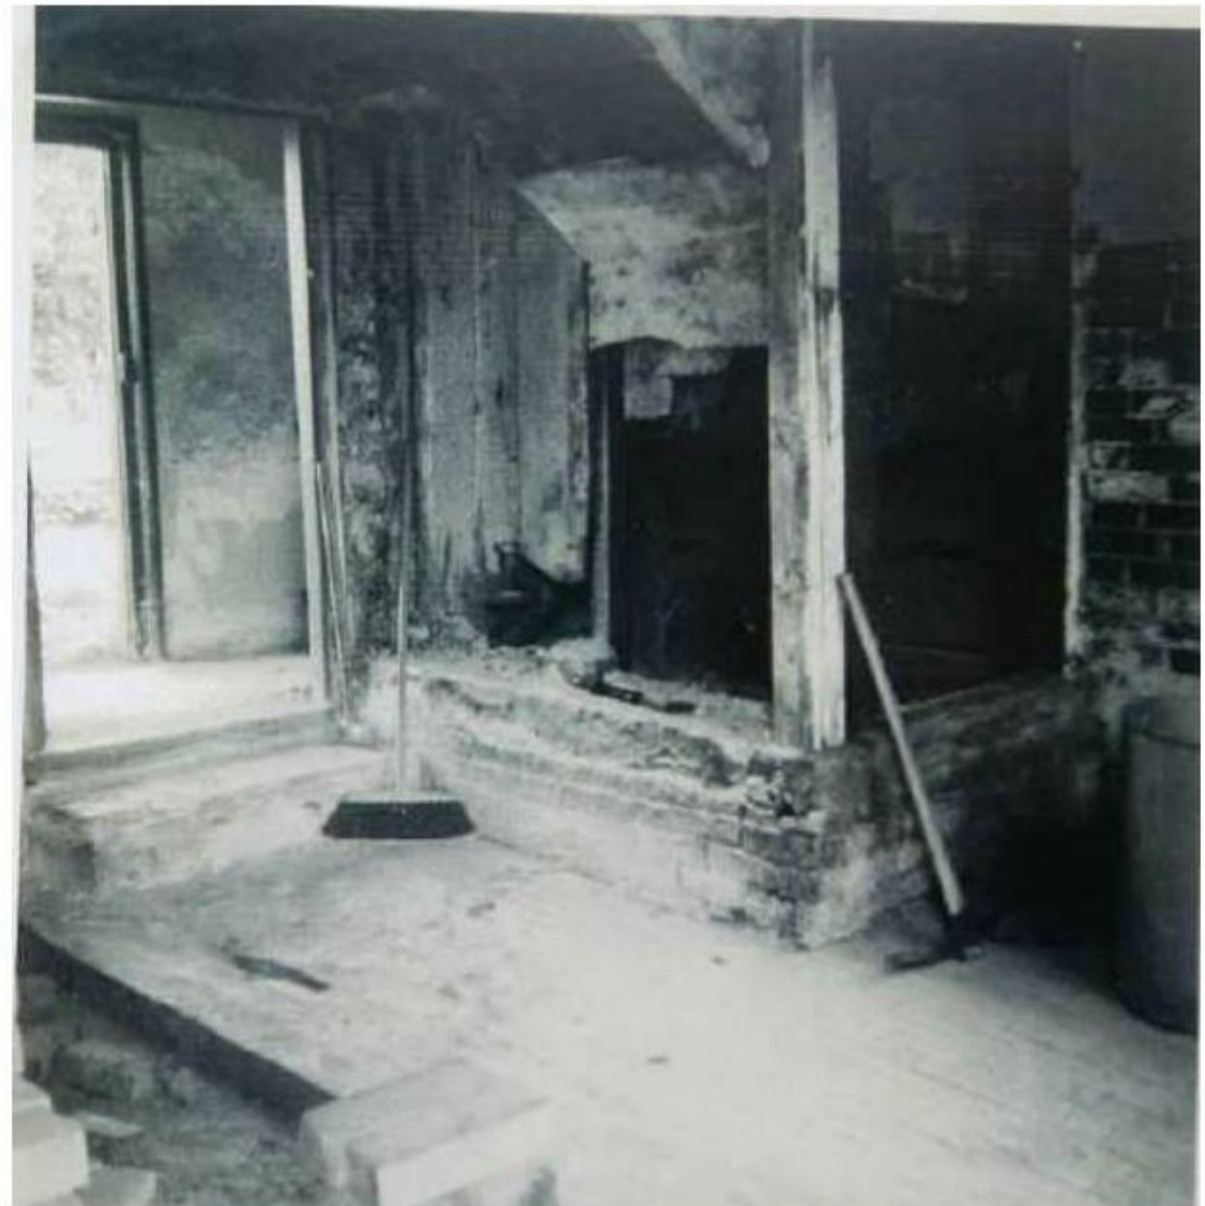
A1: The reverse view of that above: looking NW across rear passage into the central bay

following removal of two internal masonry walls (original staircase to left)

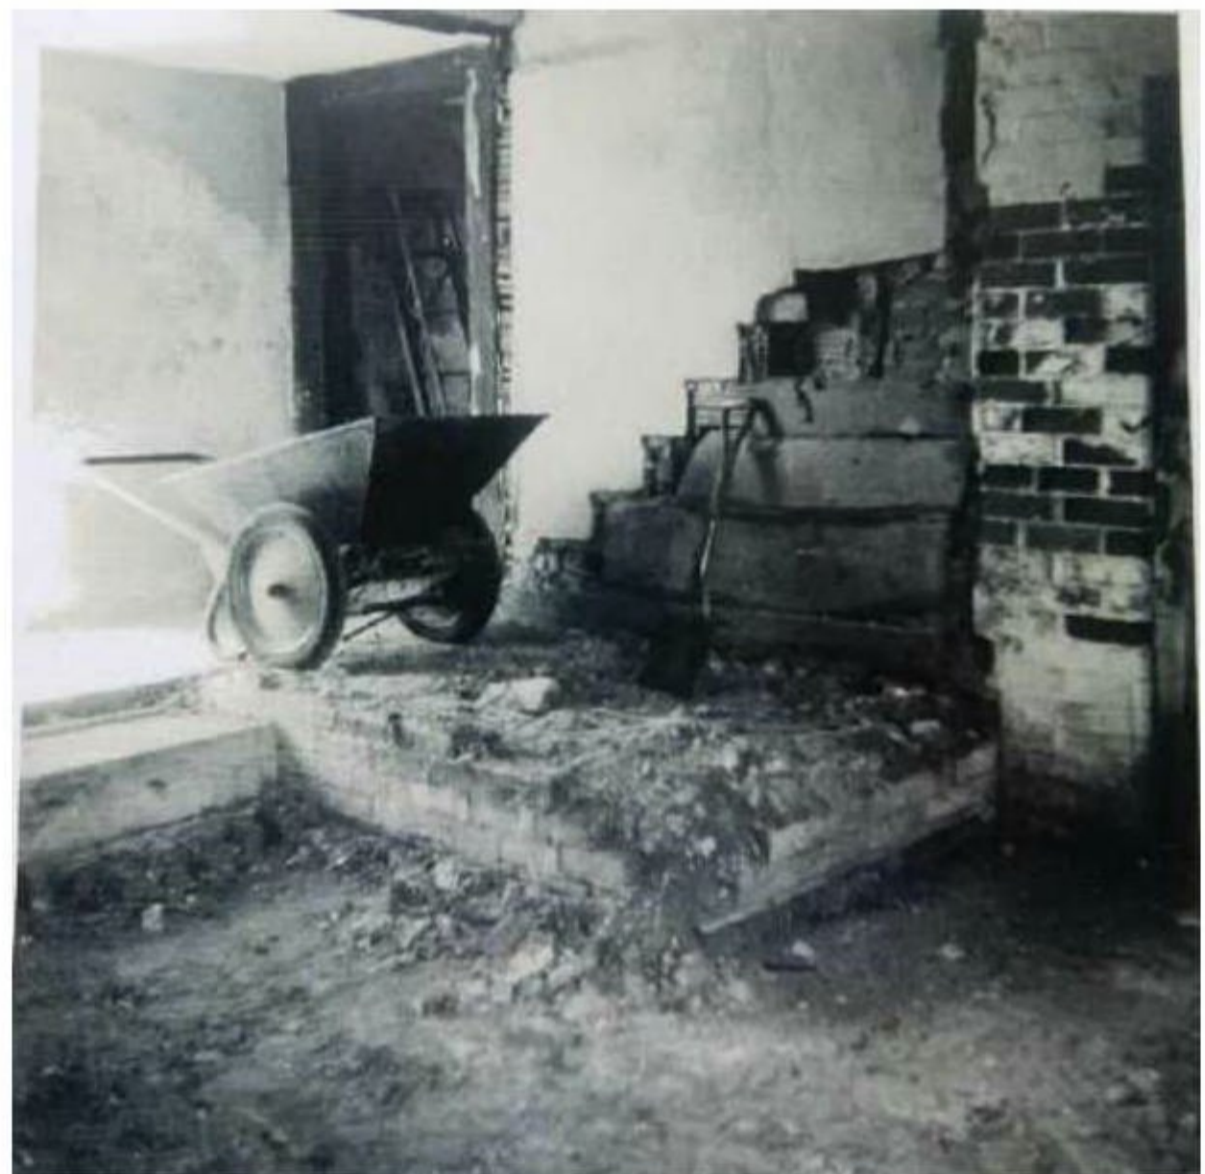
B1: Looking SE across central bay towards partly demolished staircase enclosure (rear entrance to left)

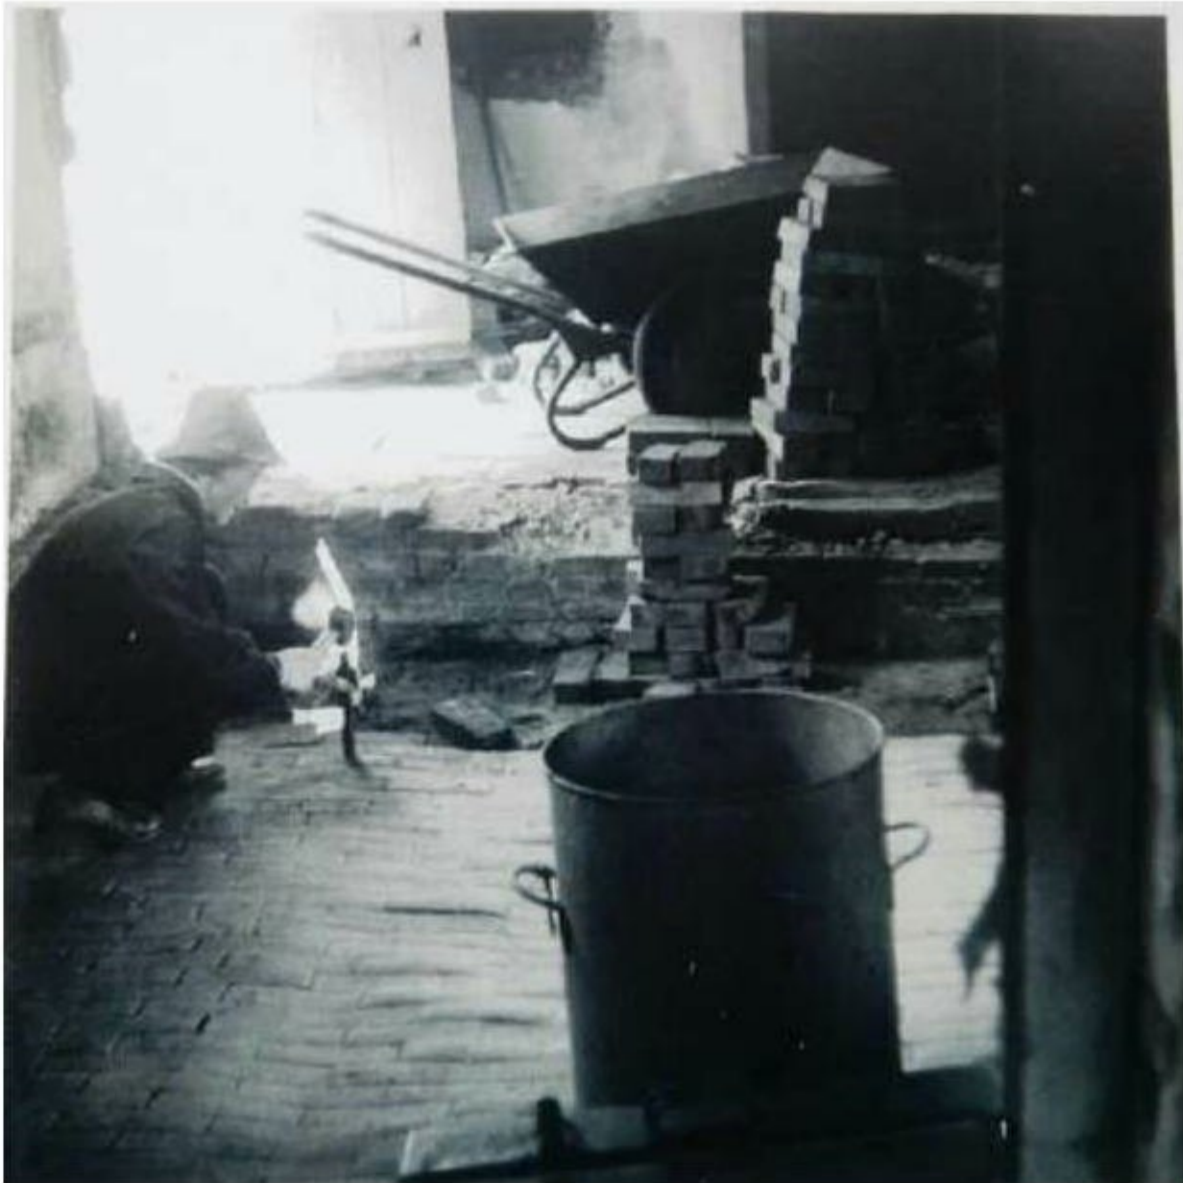
C1: Similar viewpoint to above following further demolition of staircase

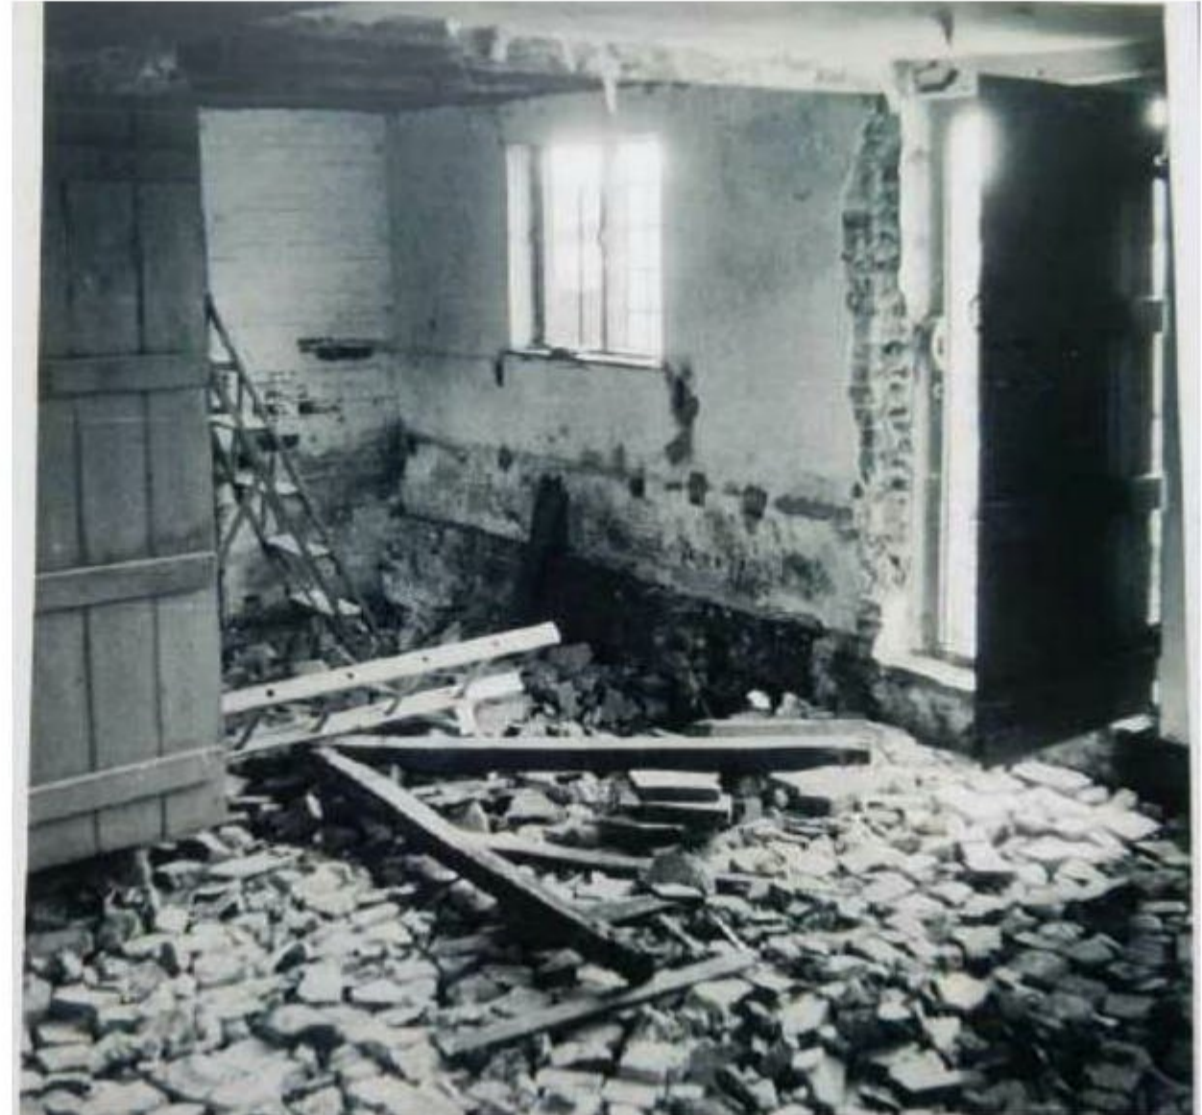
D1: Looking NE from G2; the bricks are on the line of a removed internal wall. The lower brick floor is being dug out
