STATEMENT OF SIGNIFICANCE

**Flood Street Farm,
Breamore, Hampshire**

AHC REF: 9943

Date: April 2021

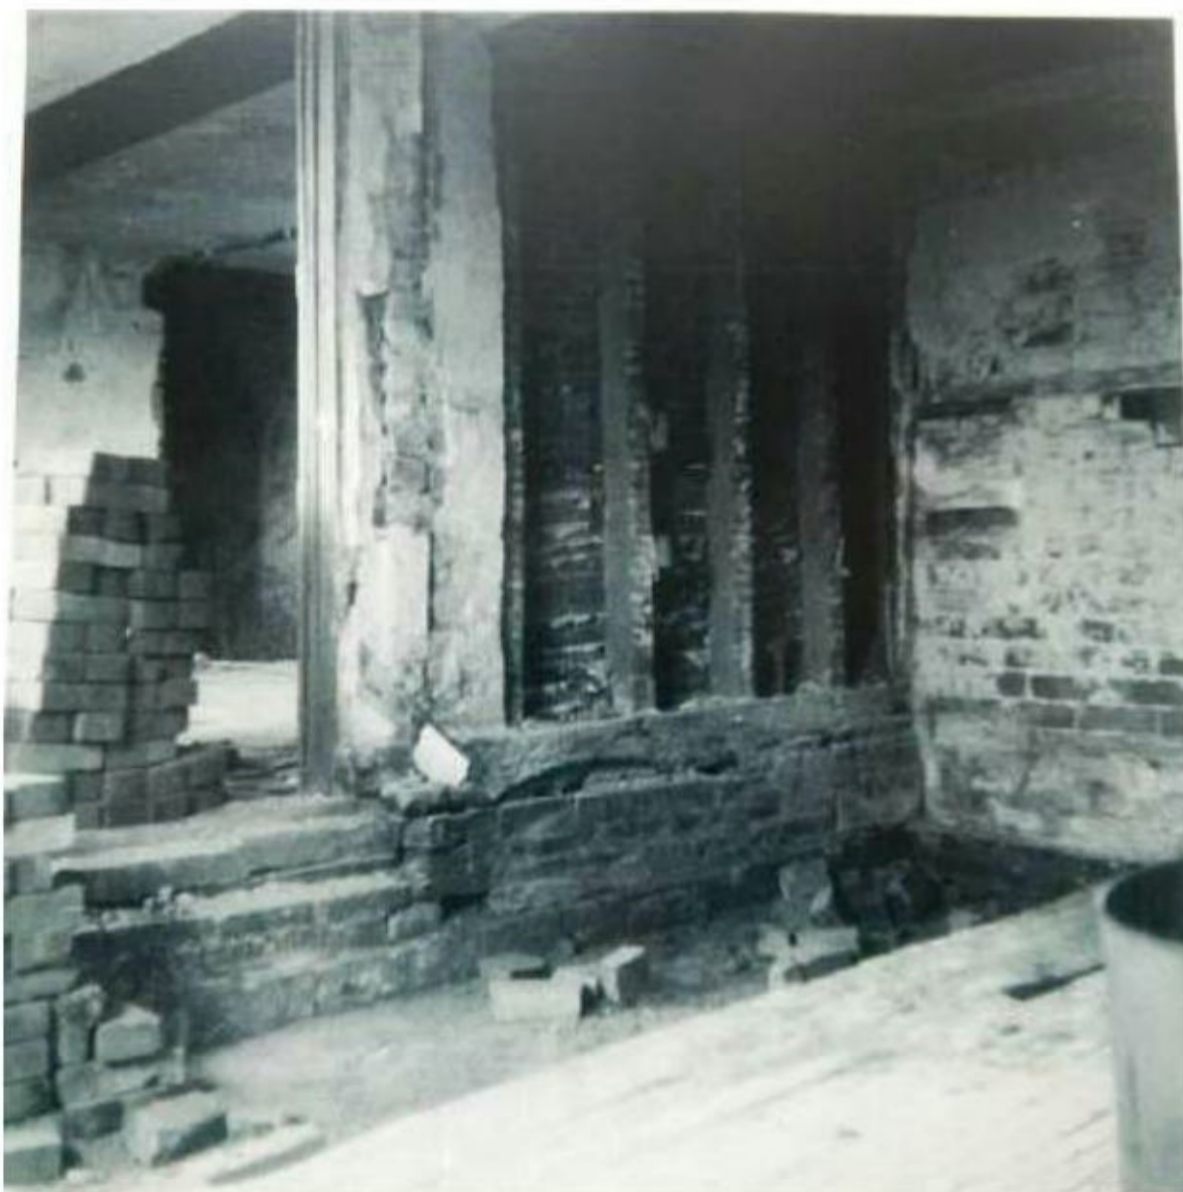
F1: Looking SW from G4 to back door through where demolished wall between G4 & the central bay stood, & into the central bay: the brick floor has been dug out (the person in Photo D1 above is sitting just L of the door in this image)

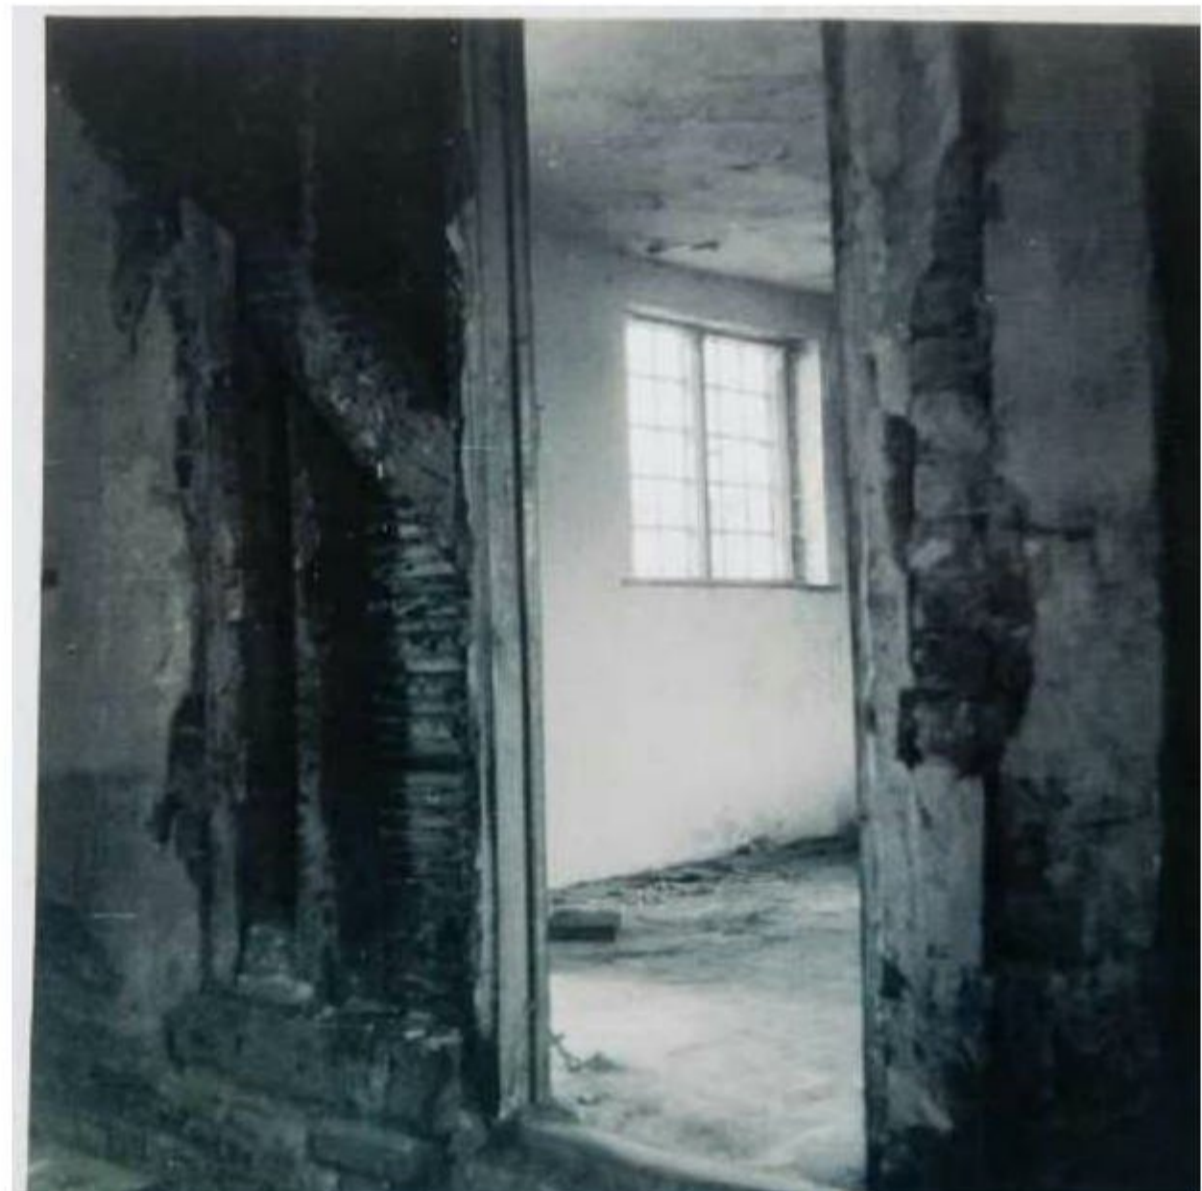
E1: Similar viewpoint as above, further to the right: looking towards remains of timber-framed wall. The brick wall to right was to be removed.

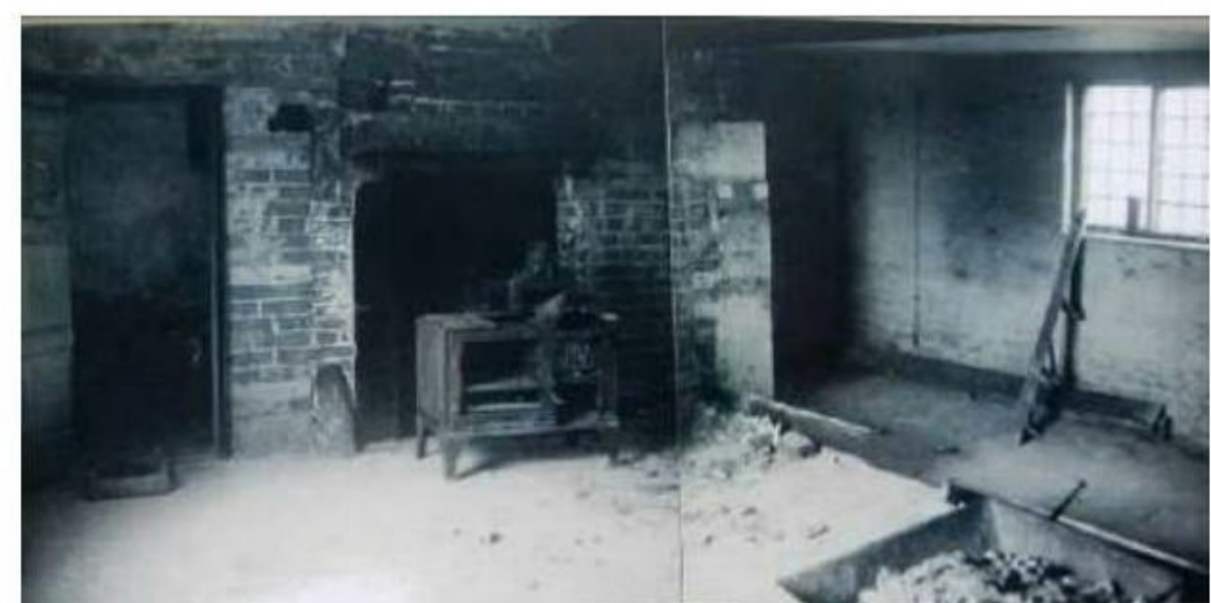
G1: Looking N from central bay into G4 (the timber-framed wall was yet to be demolished)

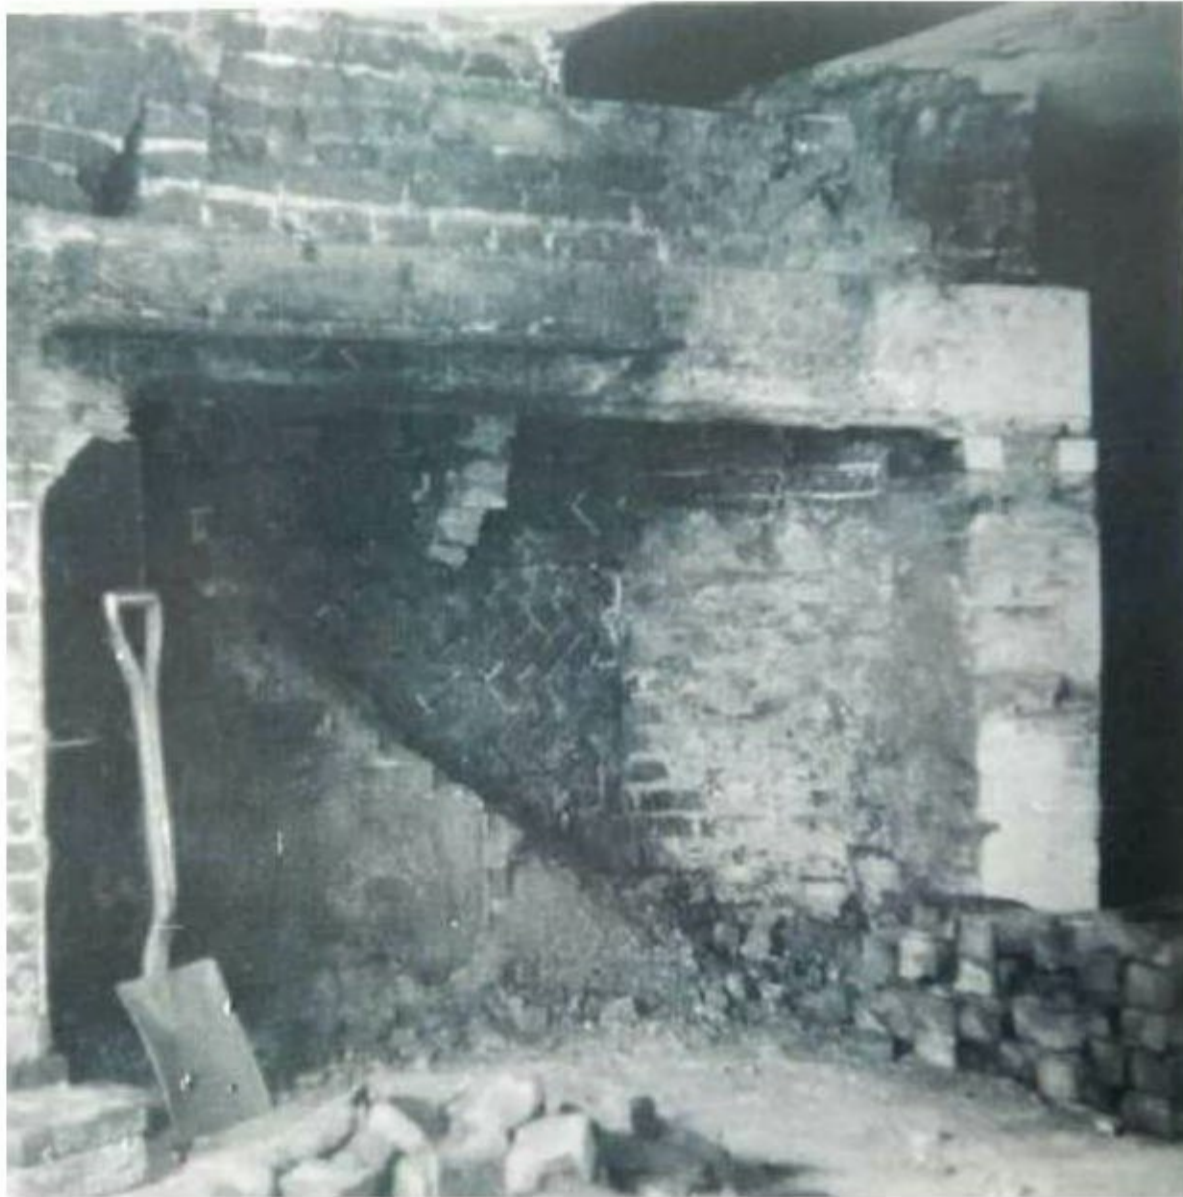
I1: G3: detail of reopened inglenook in G3

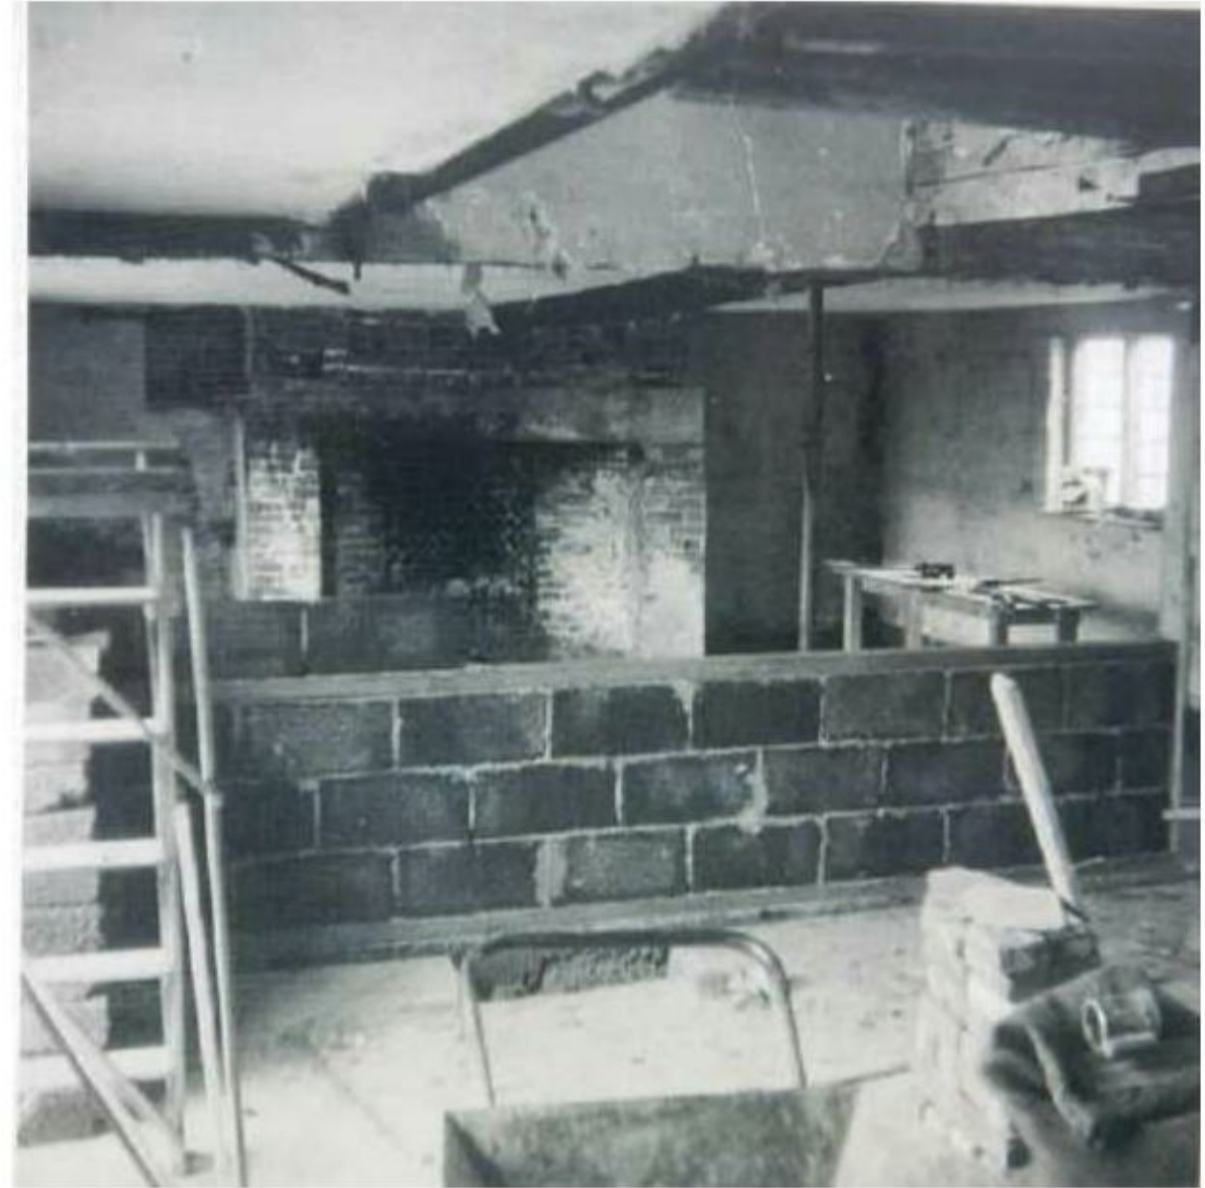
L1: Similar viewpoint to K1 above, looking SW into G3, but from within the central bay: the brick wall is in the process of being replaced with the new concrete block wall

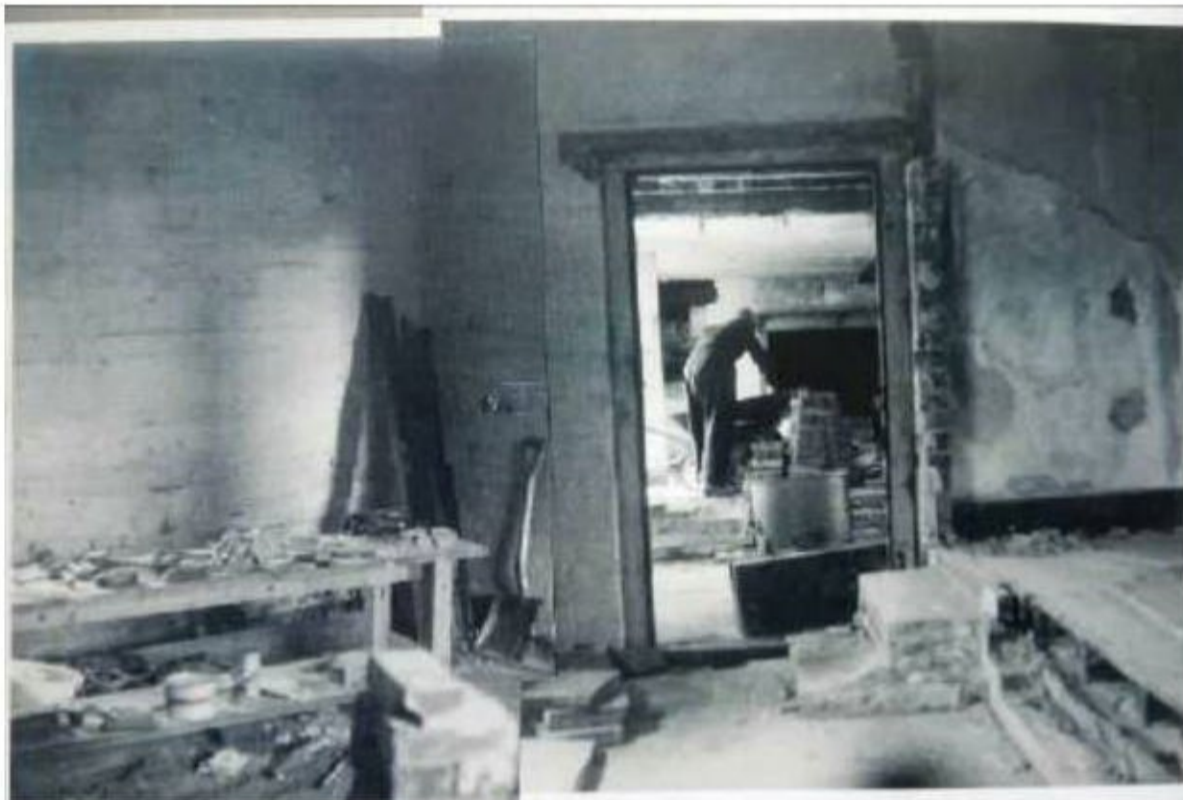
J1: Looking NE from G3 through doorway into central bay and beyond into G4: to the right a wall stood on the alignment of the higher floor level, said to be C19 and dividing the NW part of G3 (dairy) from the SE part (parlour)

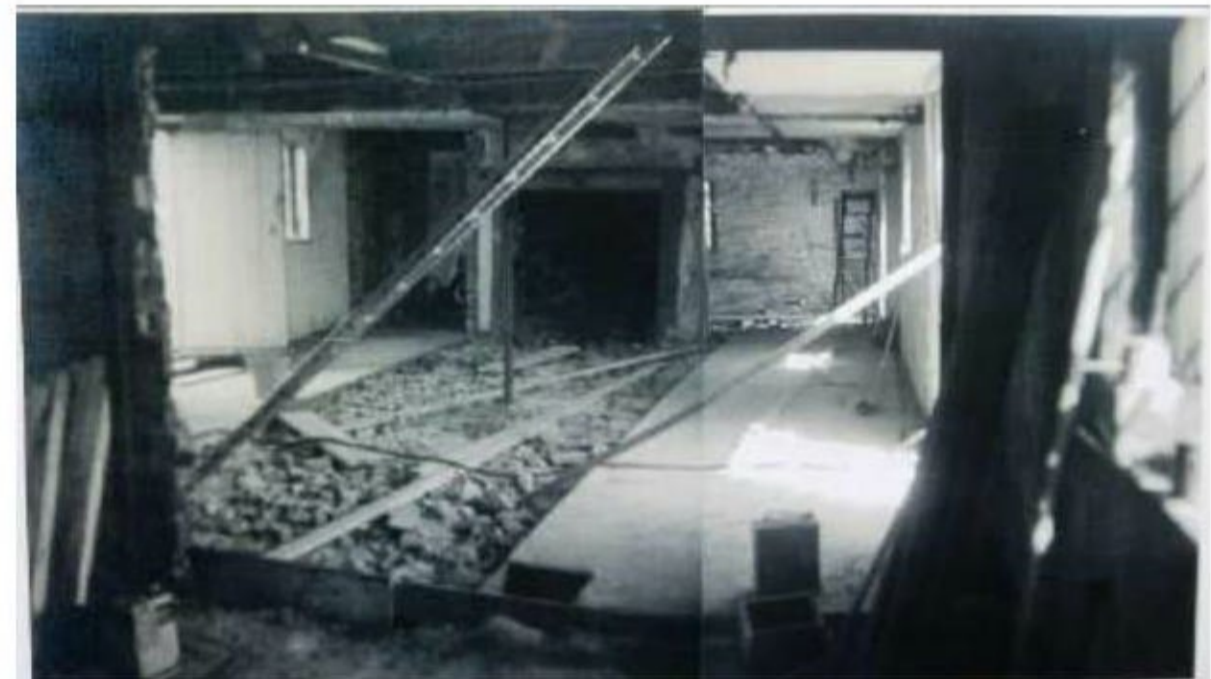
M1: Looking NE from G3 through partially demolished wall where staircase has been removed in central bay across into G4

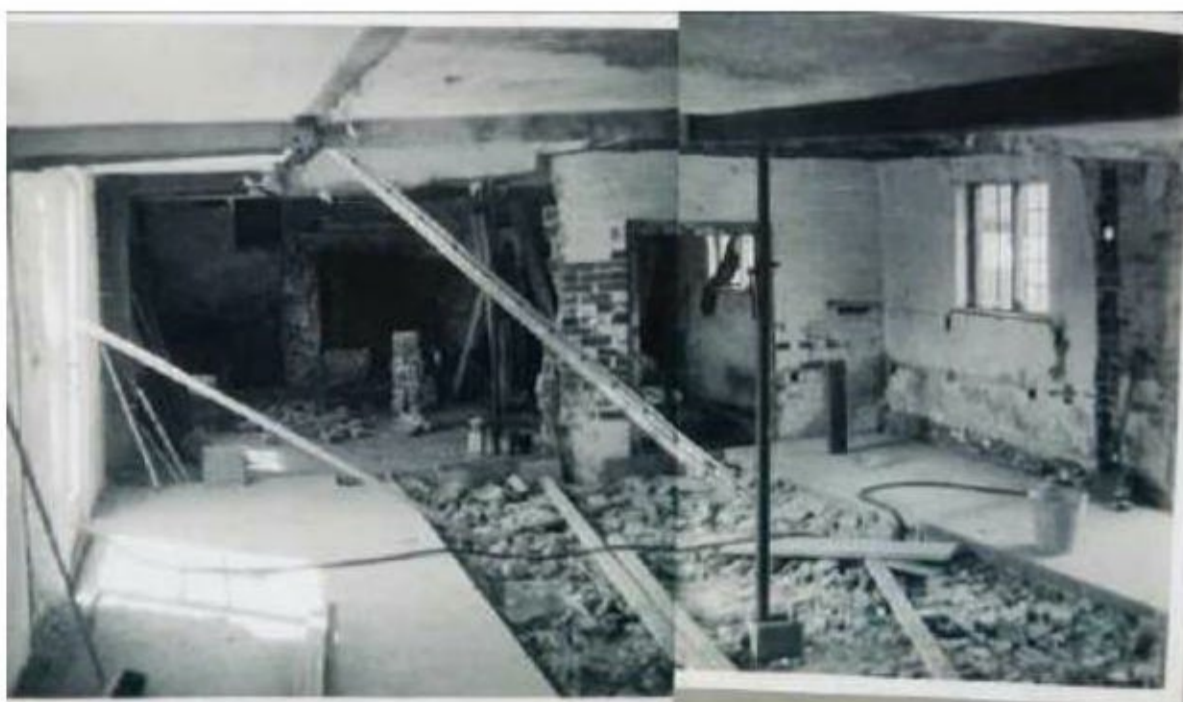
K1: Looking SW from G4 across central bay into G3. A partly demolished brick wall divides central bay from G3. The old staircase (removed) ascended from L to R where the rest of the brick wall has been demolished

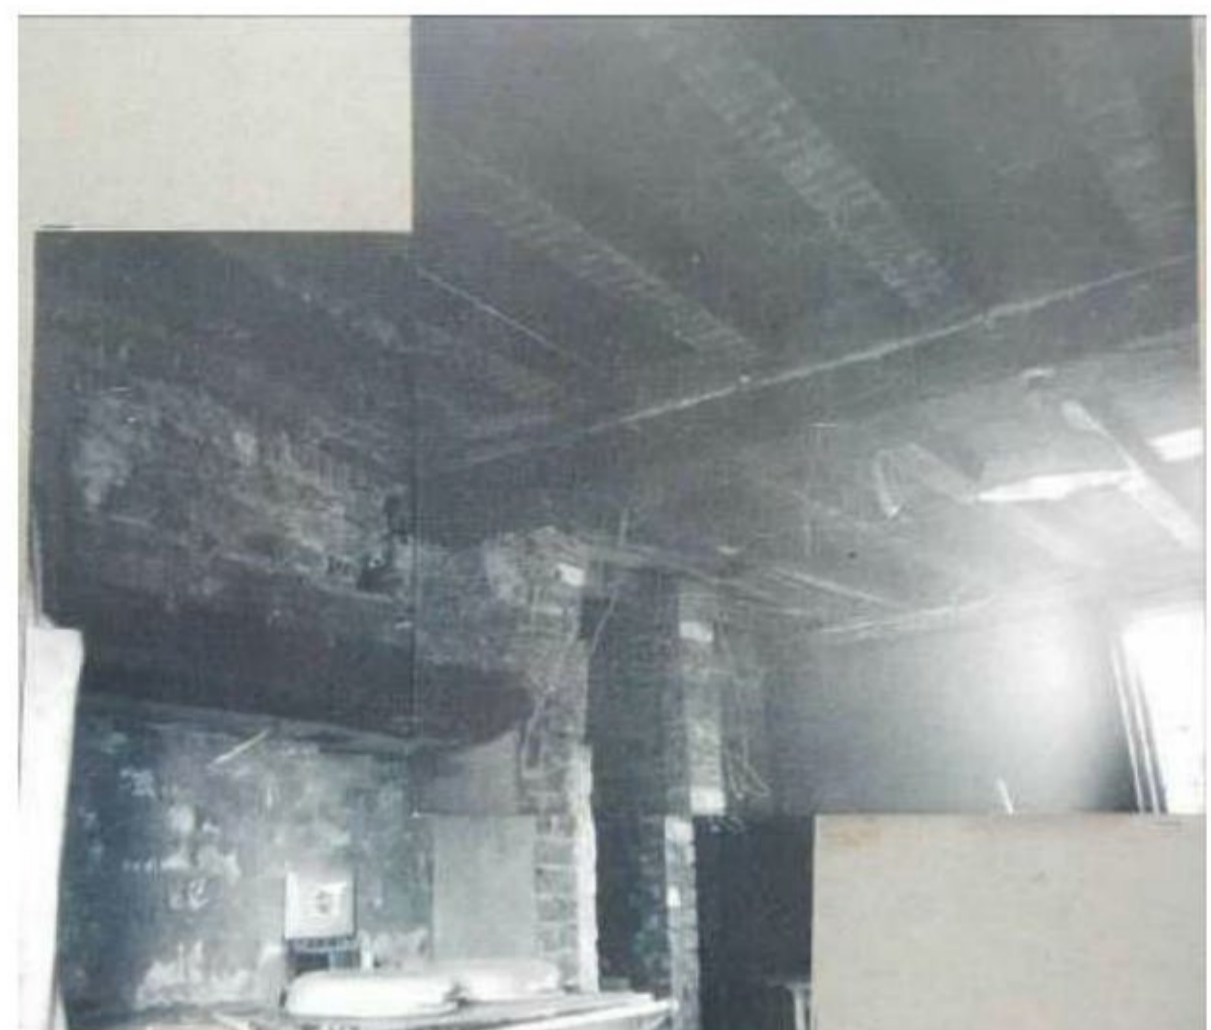
N1: G4, fireplace with newly installed Aga to left

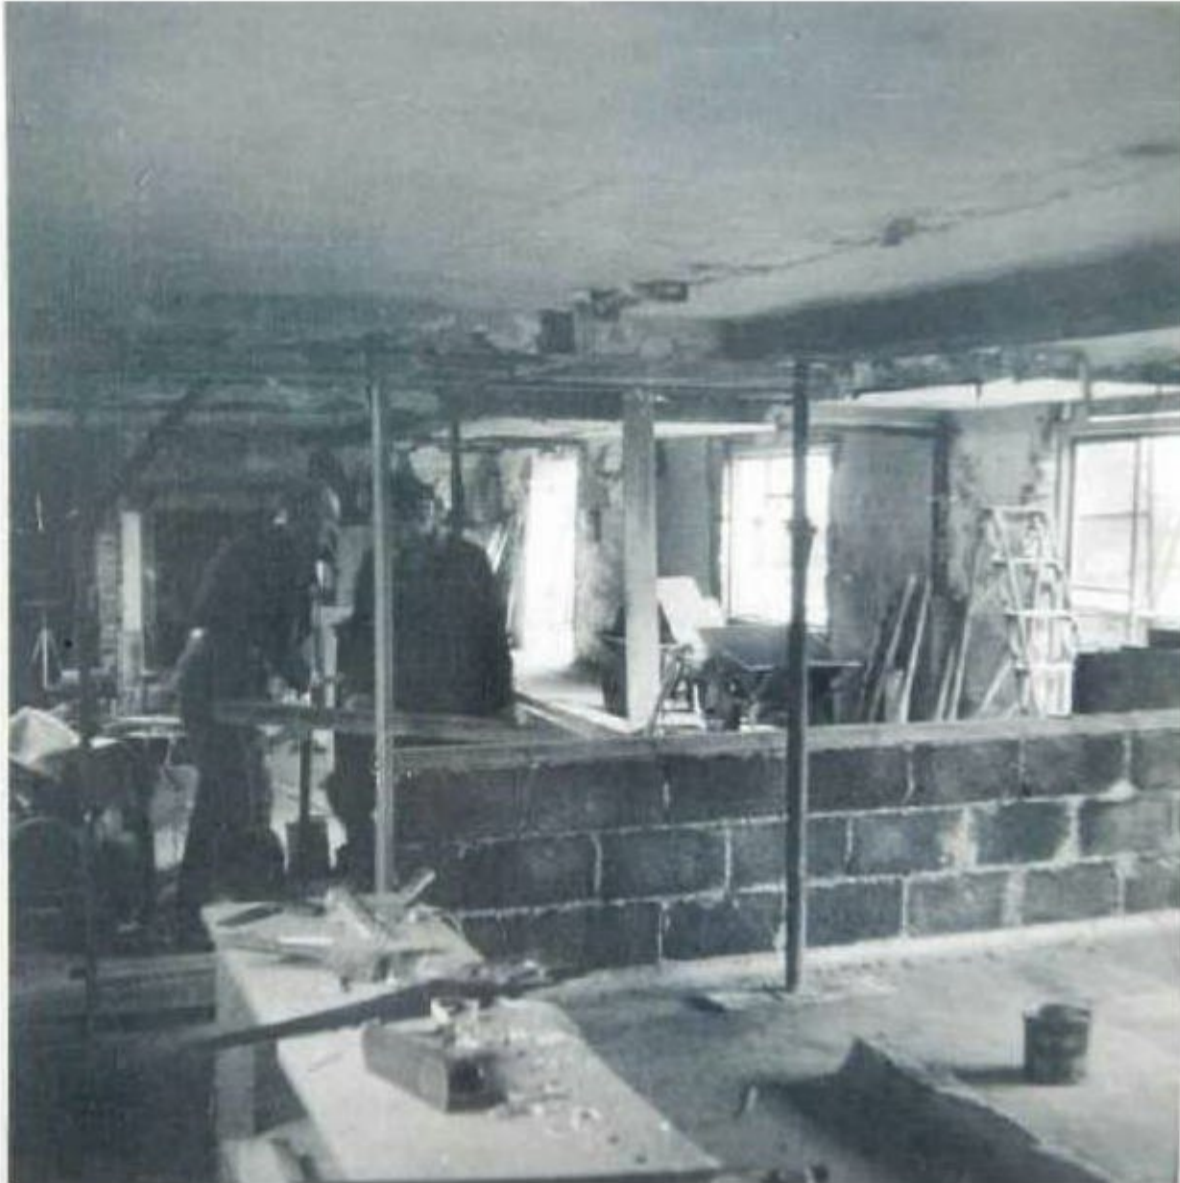
O1: Looking NE from G3 across central bay into G4: new concrete blockwork wall being built to divide G3 from central bay

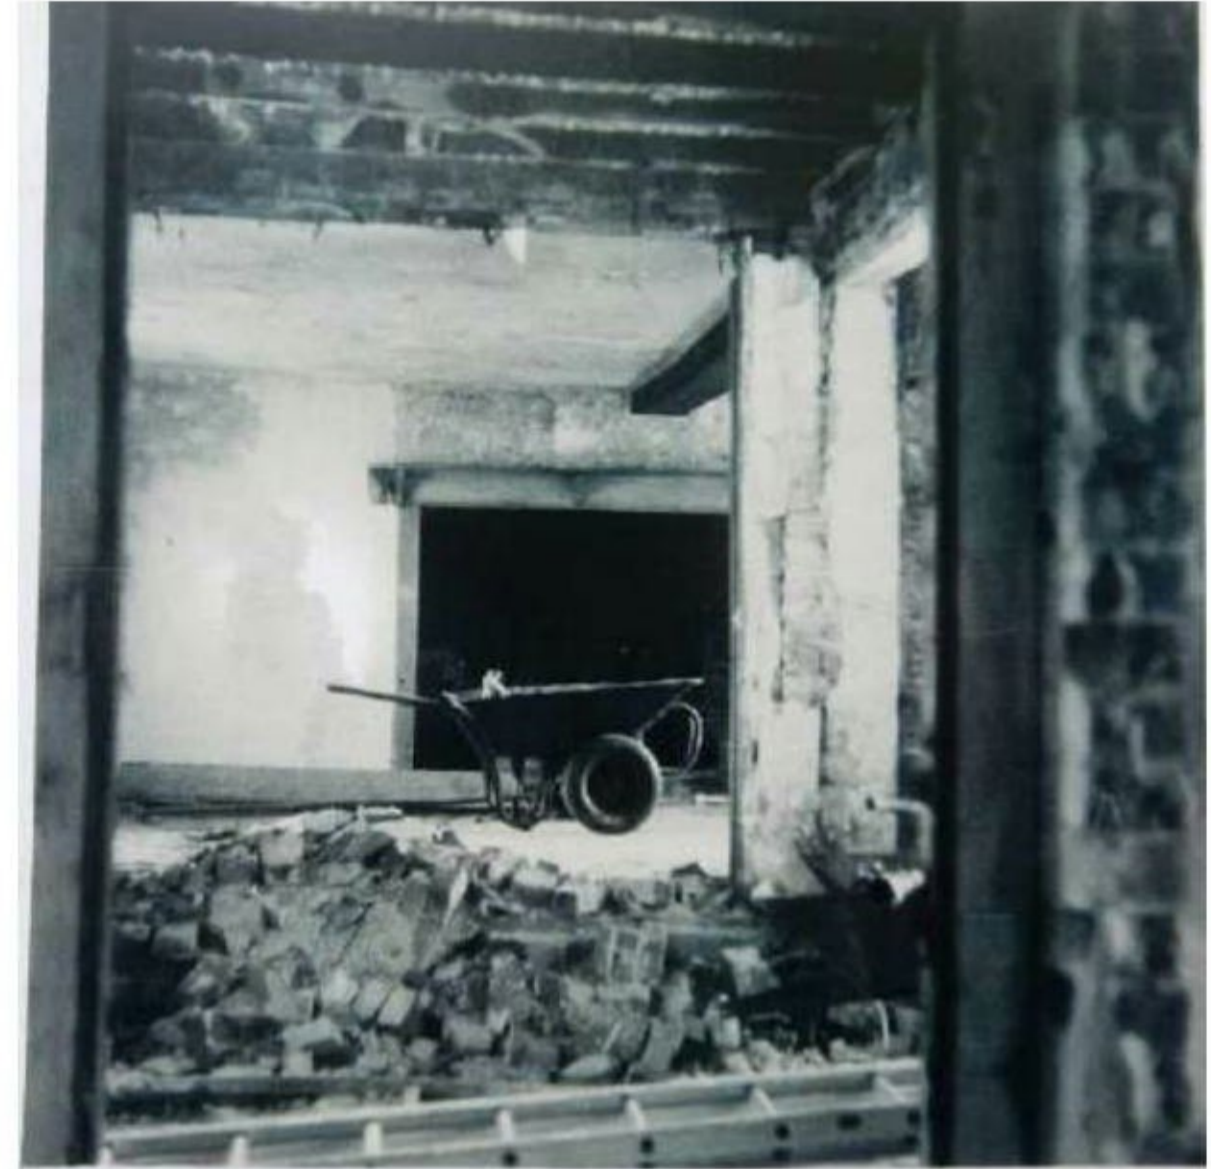
Q1: Looking NE from G3 across central bay into G4; note wall left of G4's fireplace, behind which was a bread oven

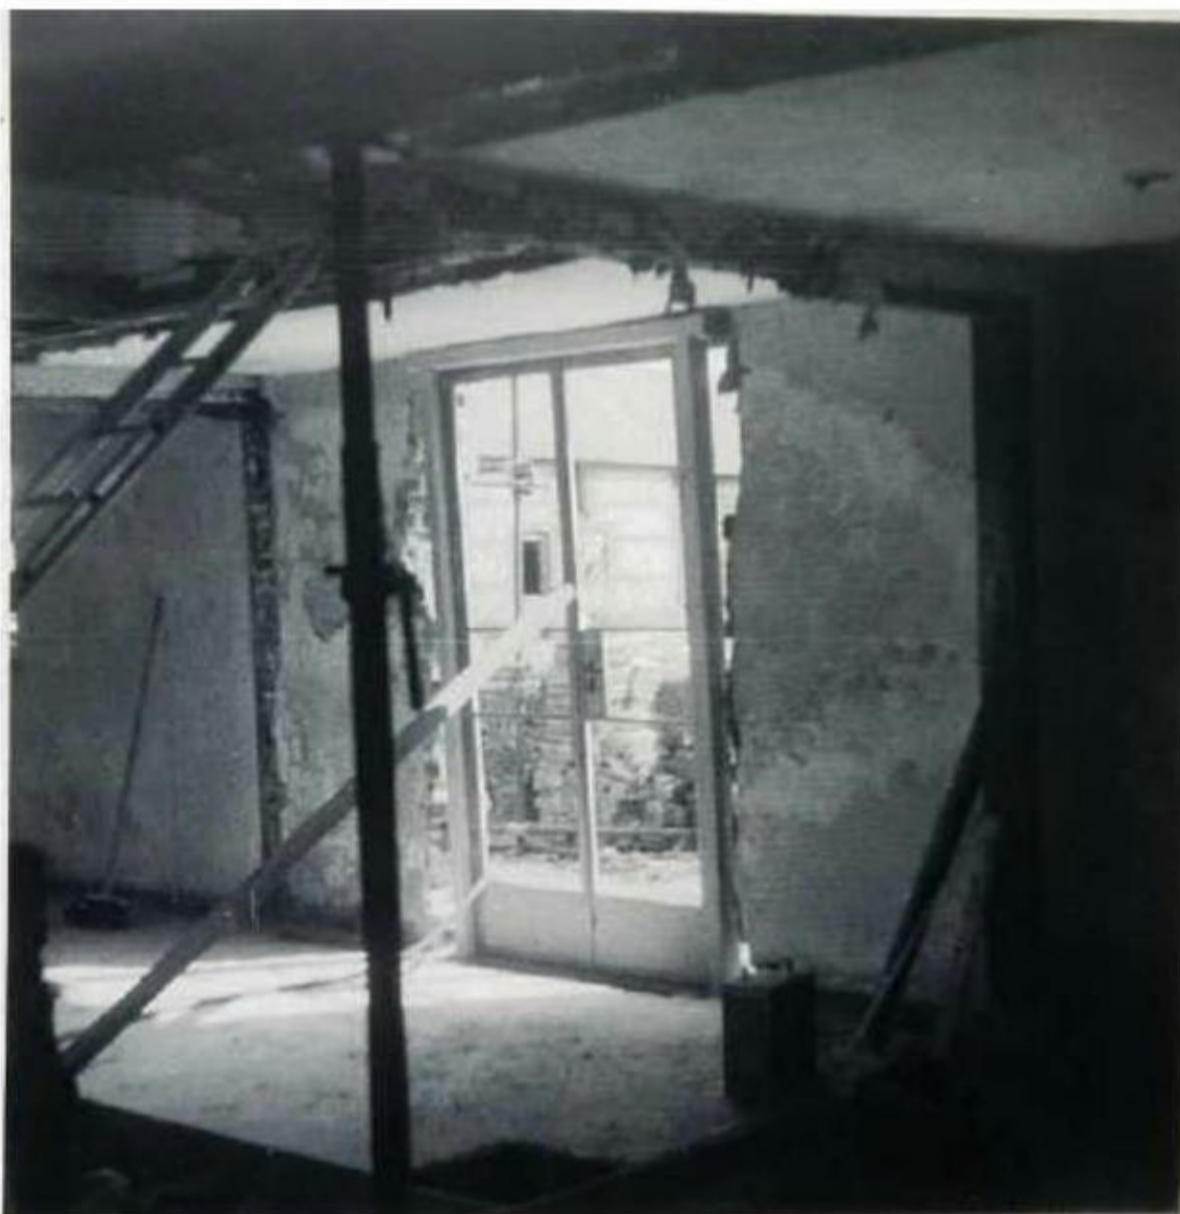
P1: Looking NE towards new rear entrance doors in G4, from G3

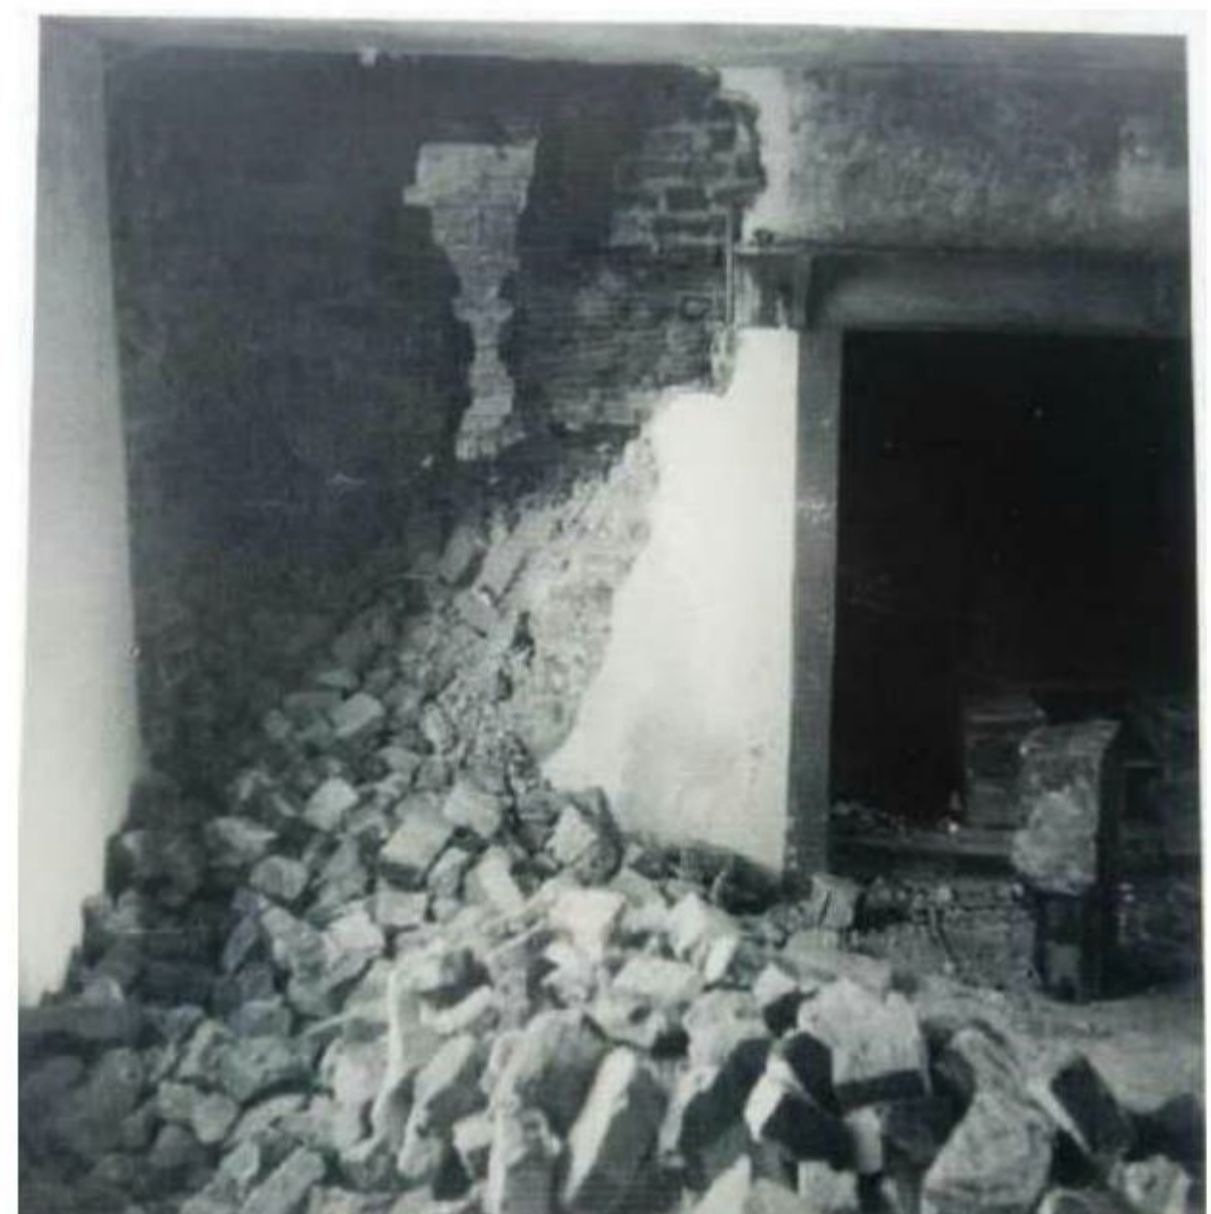
R1: Demolition of wall and bread oven left of G4's fireplace

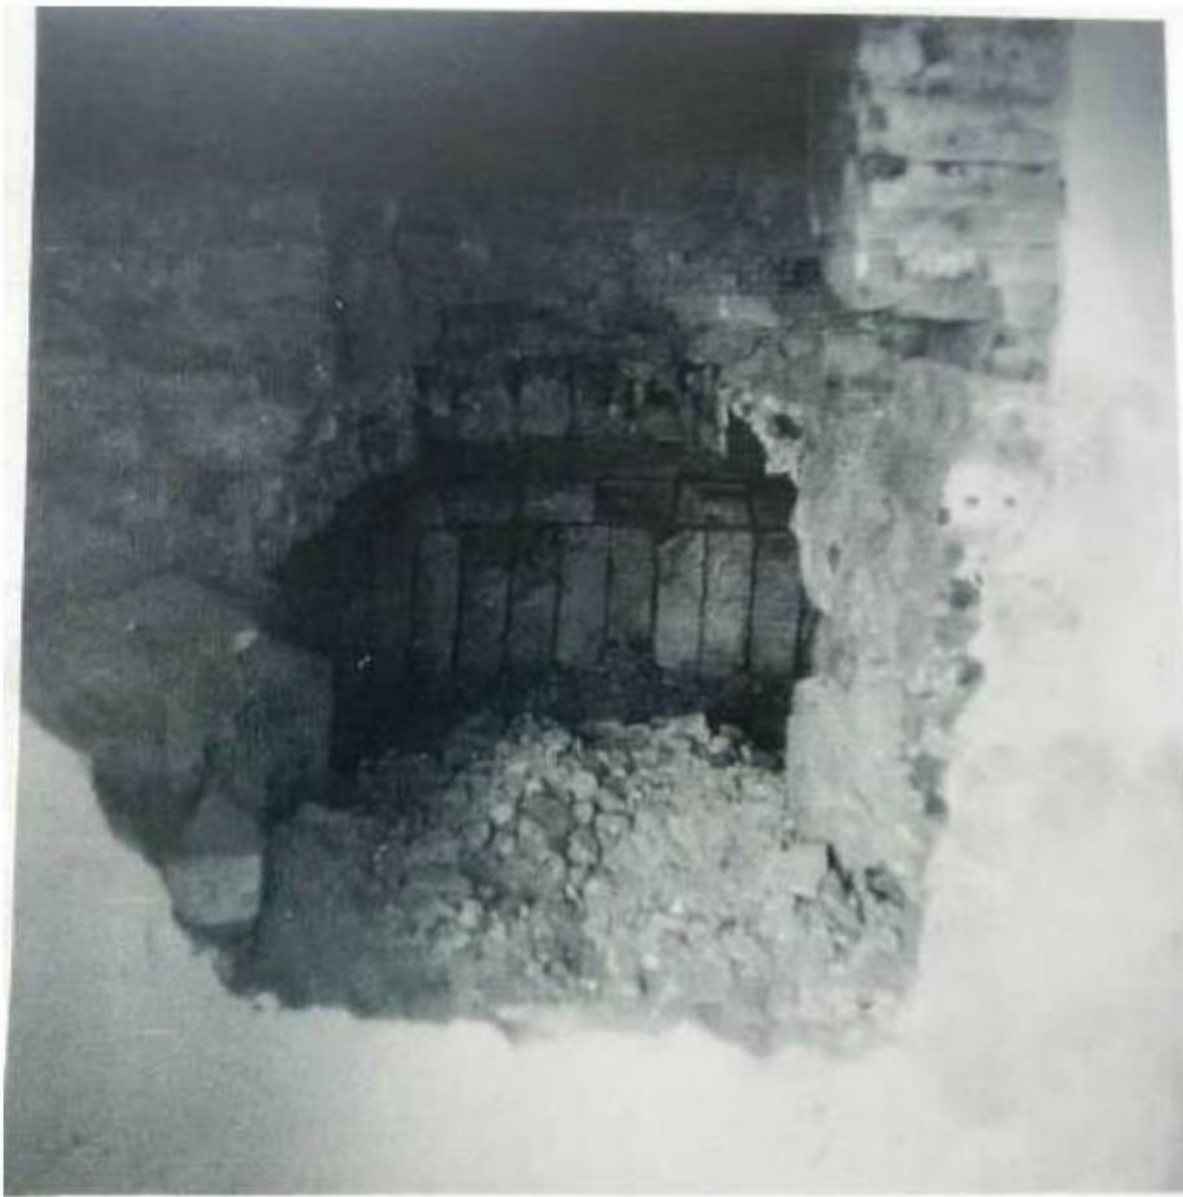
S1: Looking into bread oven before demolition

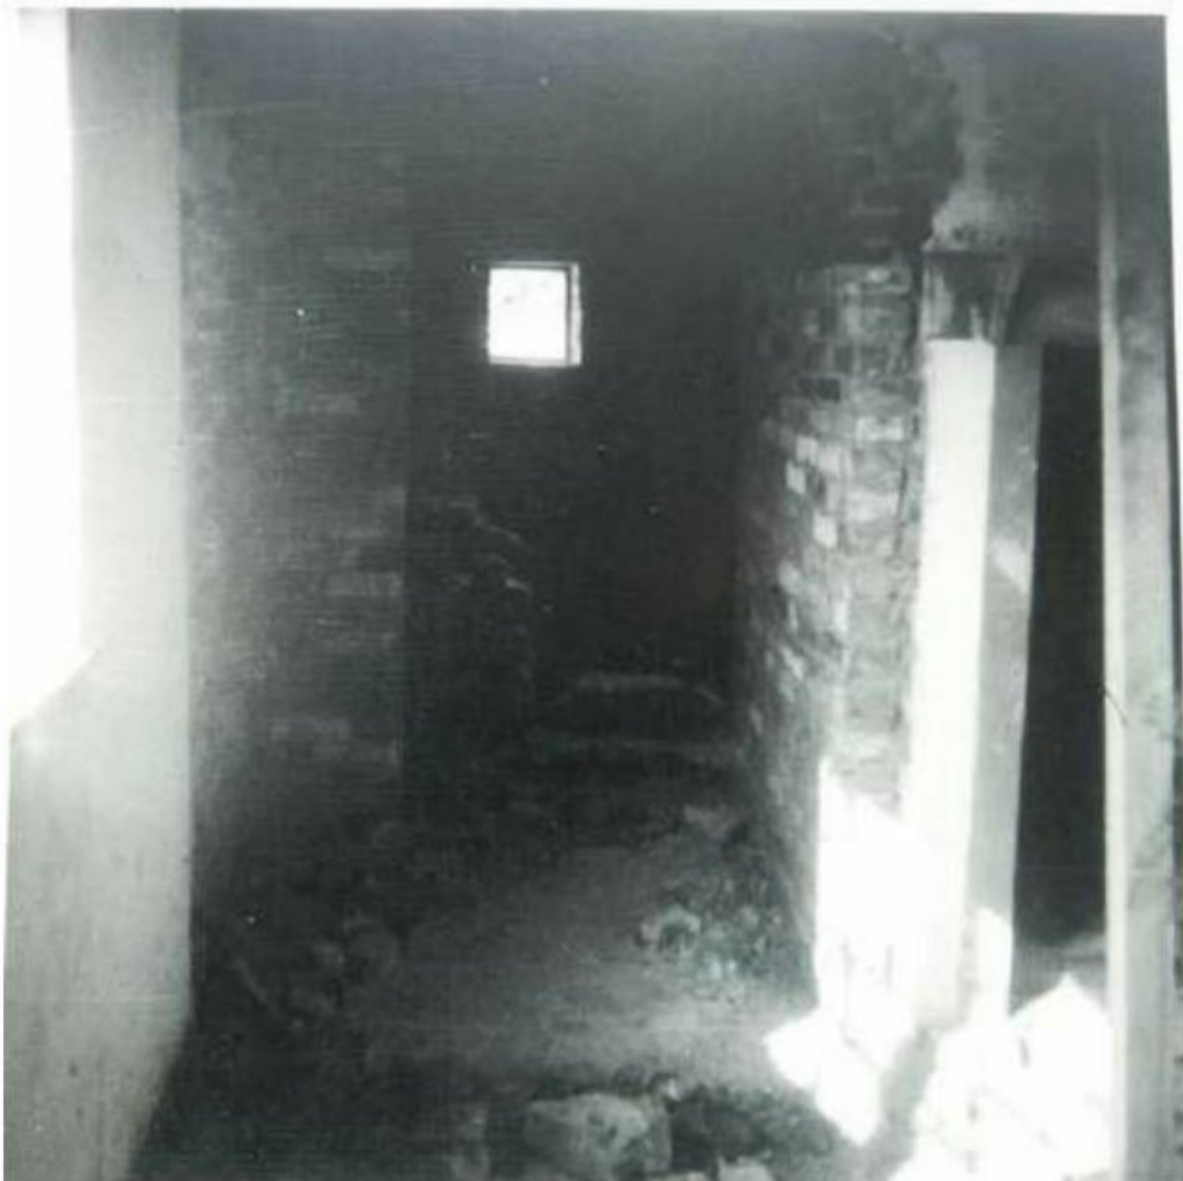
T1: Following demolition of bread oven, looking NE from G4 into G5 in 'brewhouse' addition

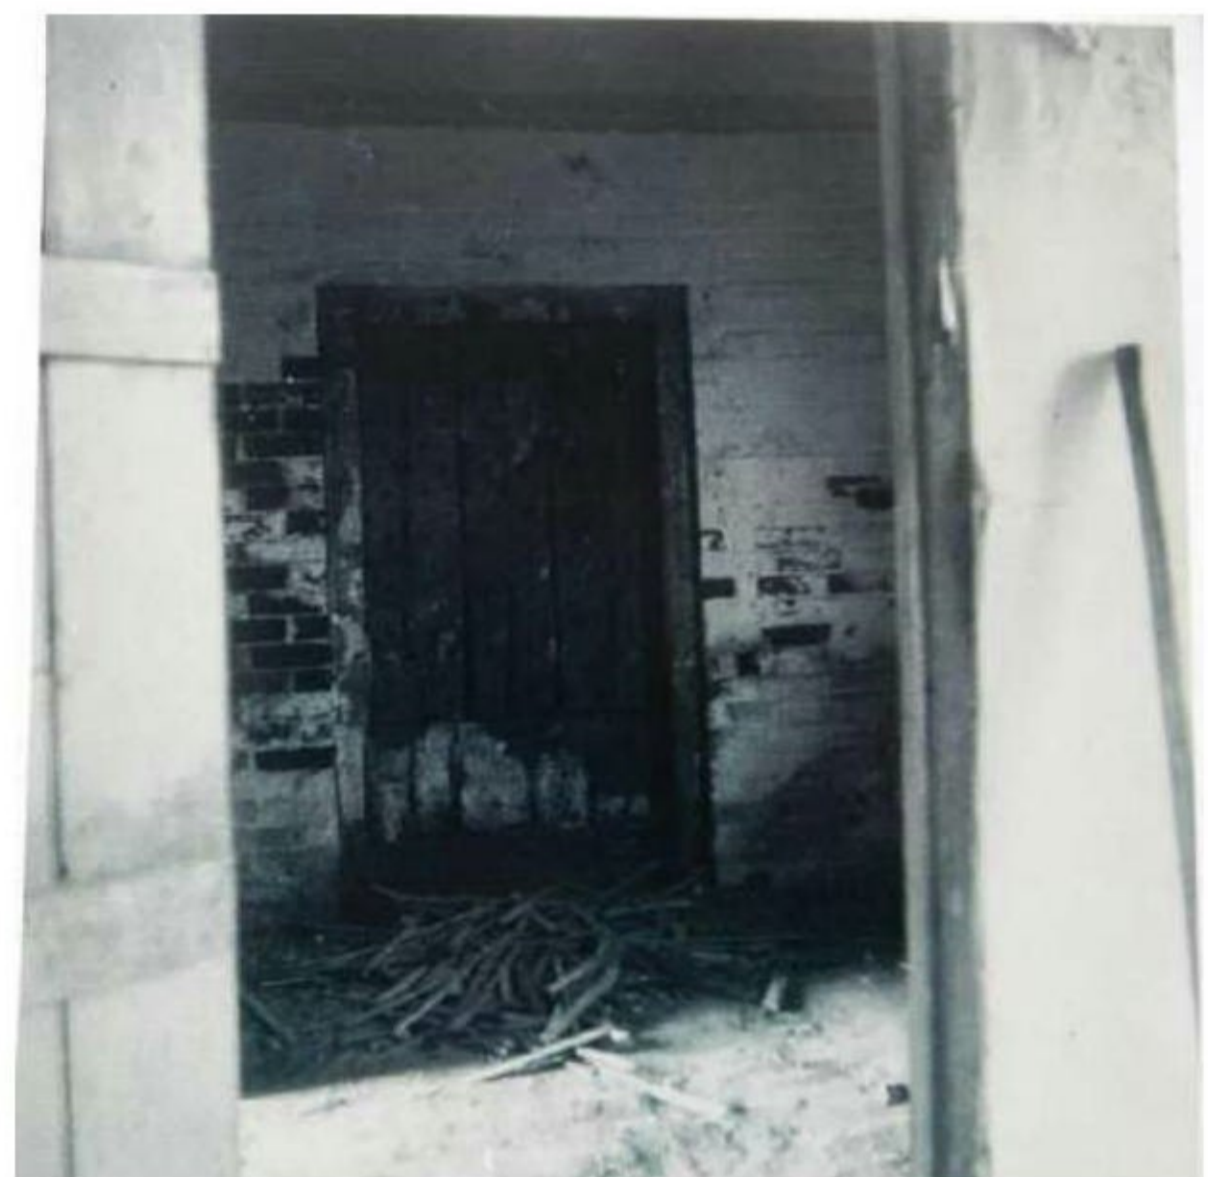
V1: Old double-thickness door in undetermined location. The nature of the brickwork suggests somewhere in the central bay.

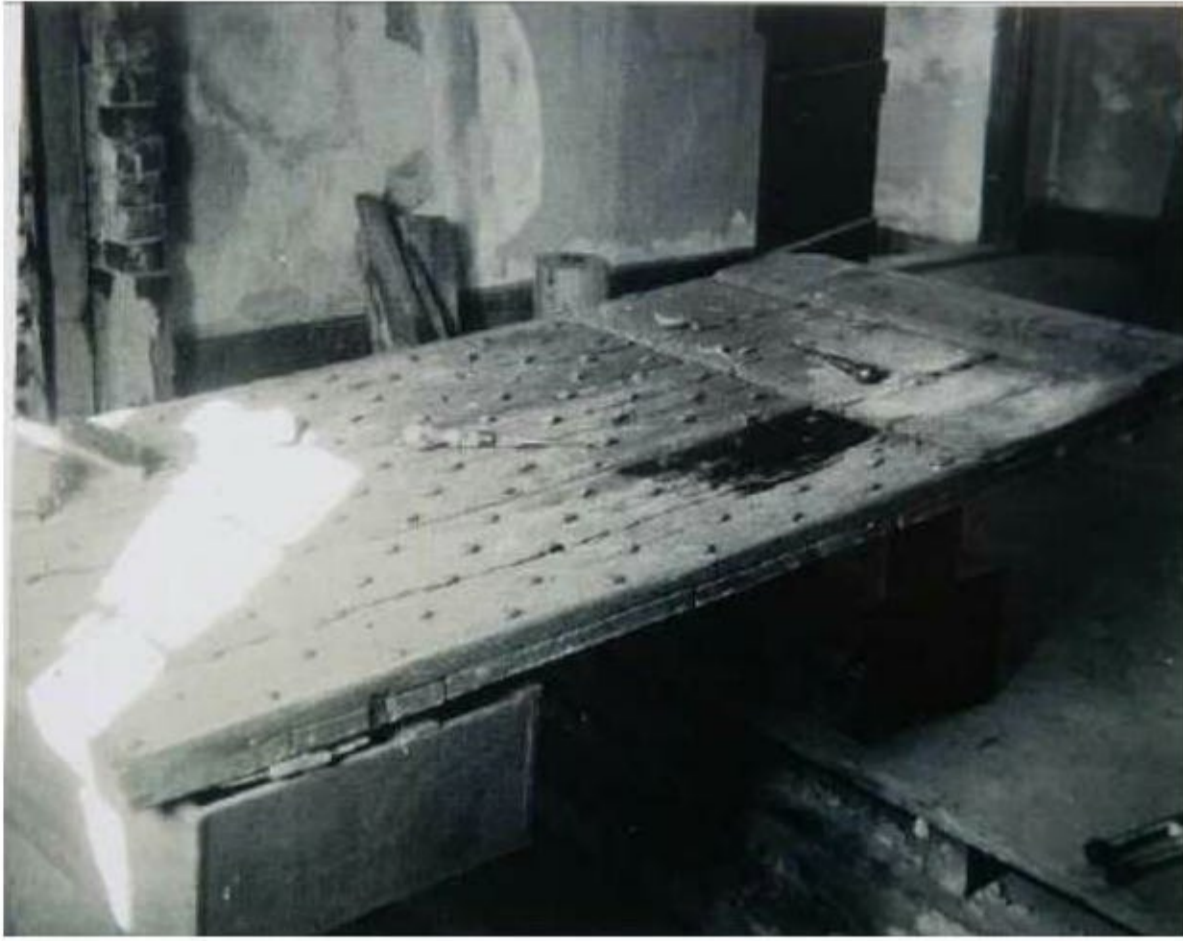
W1: Old double-thickness door, removed and apparently not retained in the farmhouse

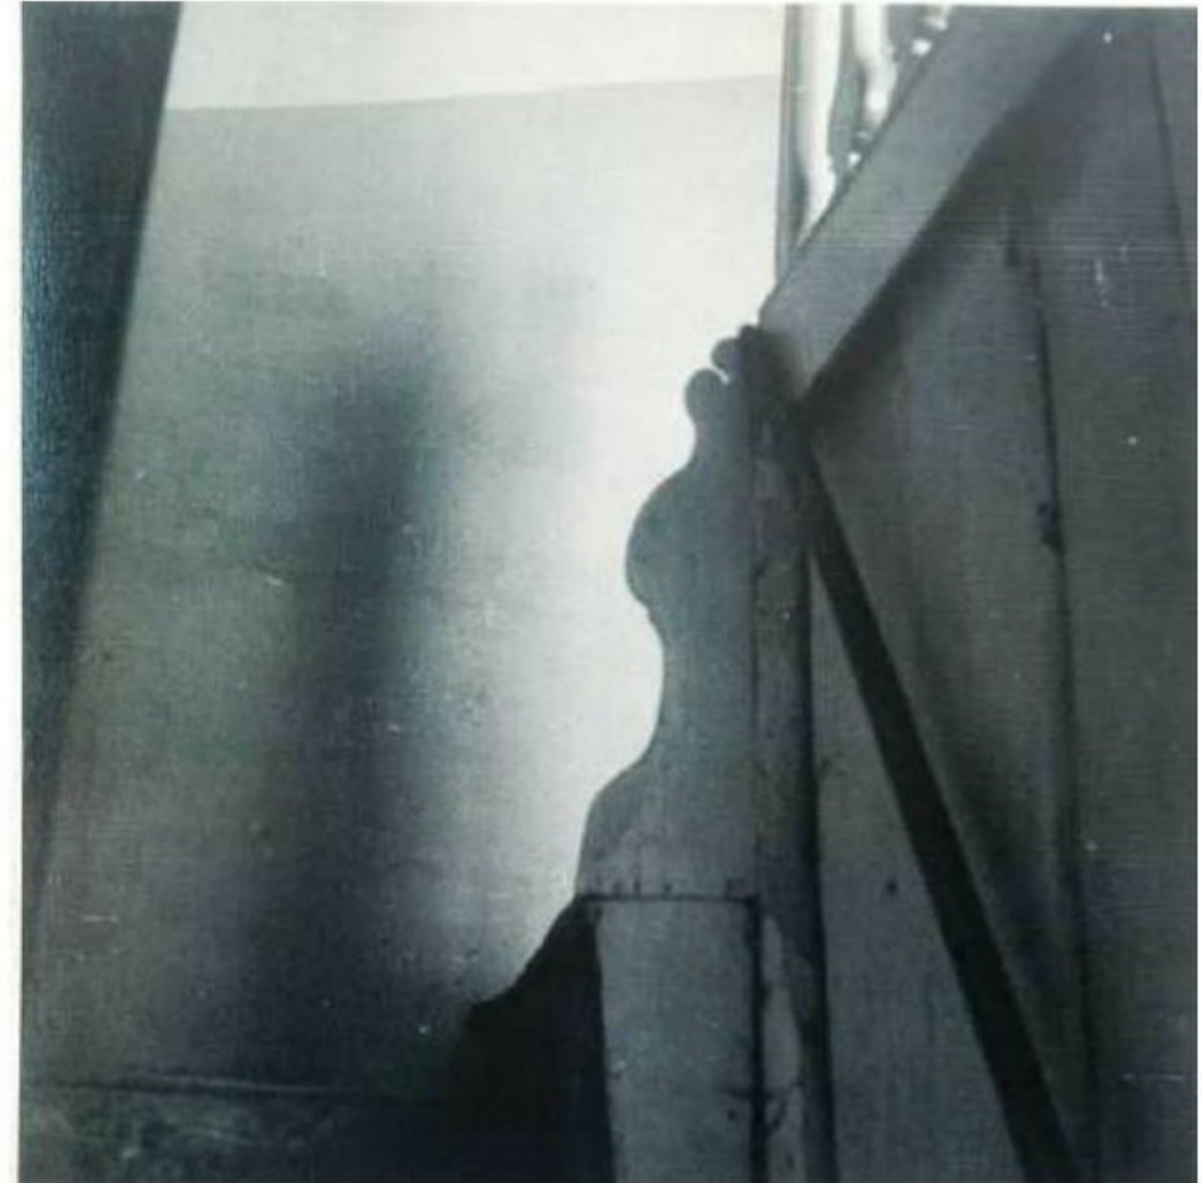
Y1: Detail of carved wooden piece where the staircase turns through 90 degrees up to the first floor (this was not retained)
