STATEMENT OF SIGNIFICANCE

**Flood Street Farm,
Breamore, Hampshire**

AHC REF: 9943

Date: April 2021

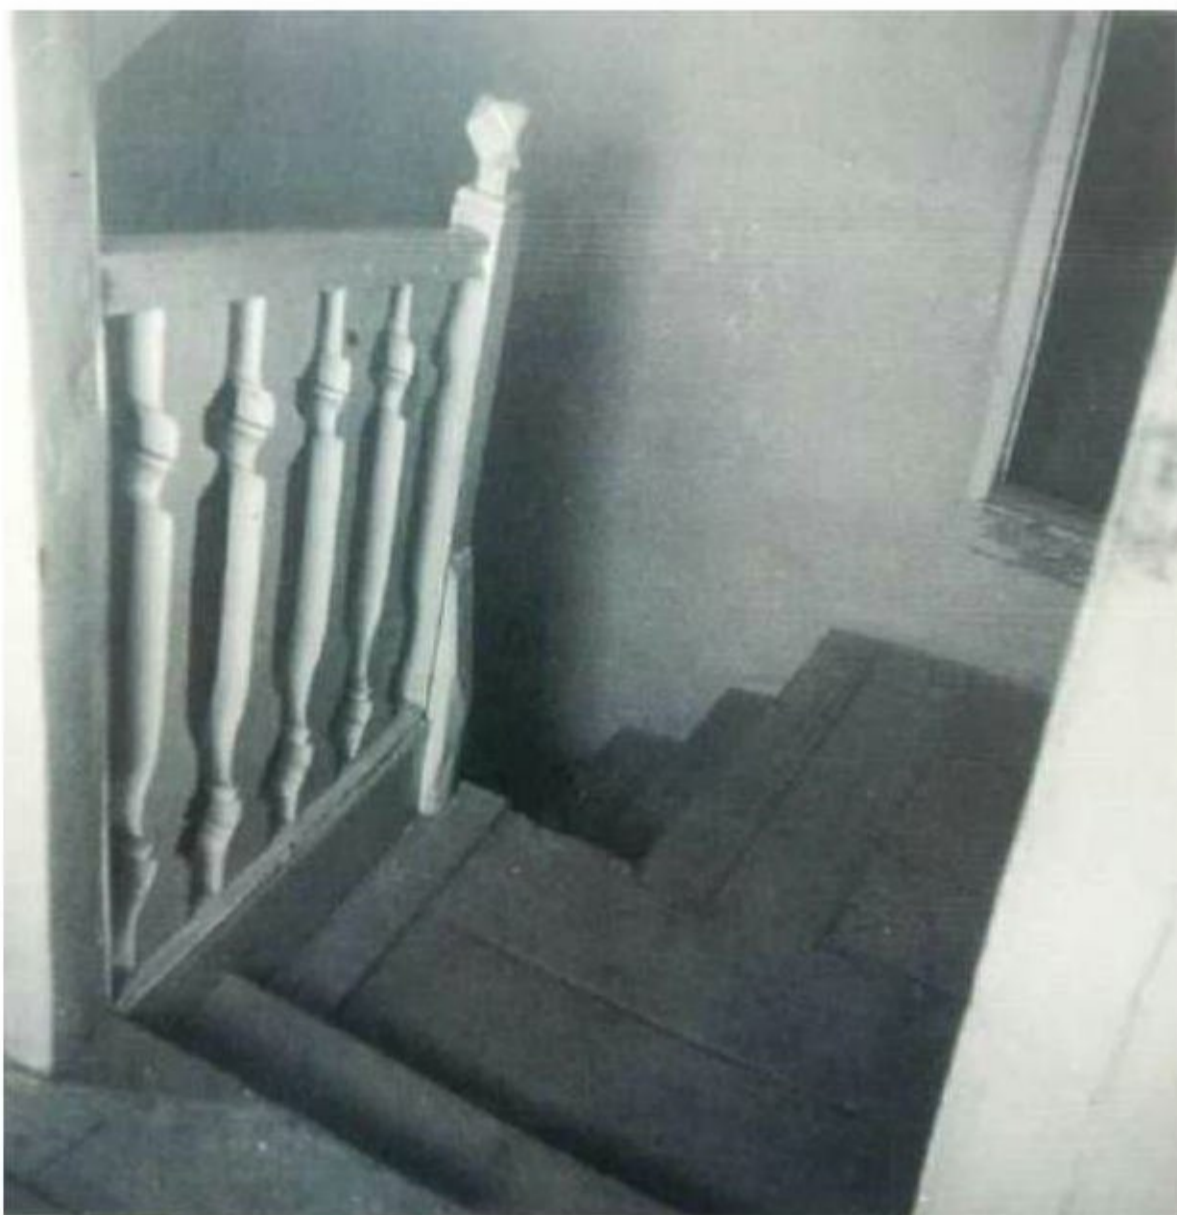
X1: Looking down the original staircase from the first-floor landing (F1). The door opening ahead is into F2. The attic stairs ascend to the right from the quarter landing in front of the doorway (out of shot)

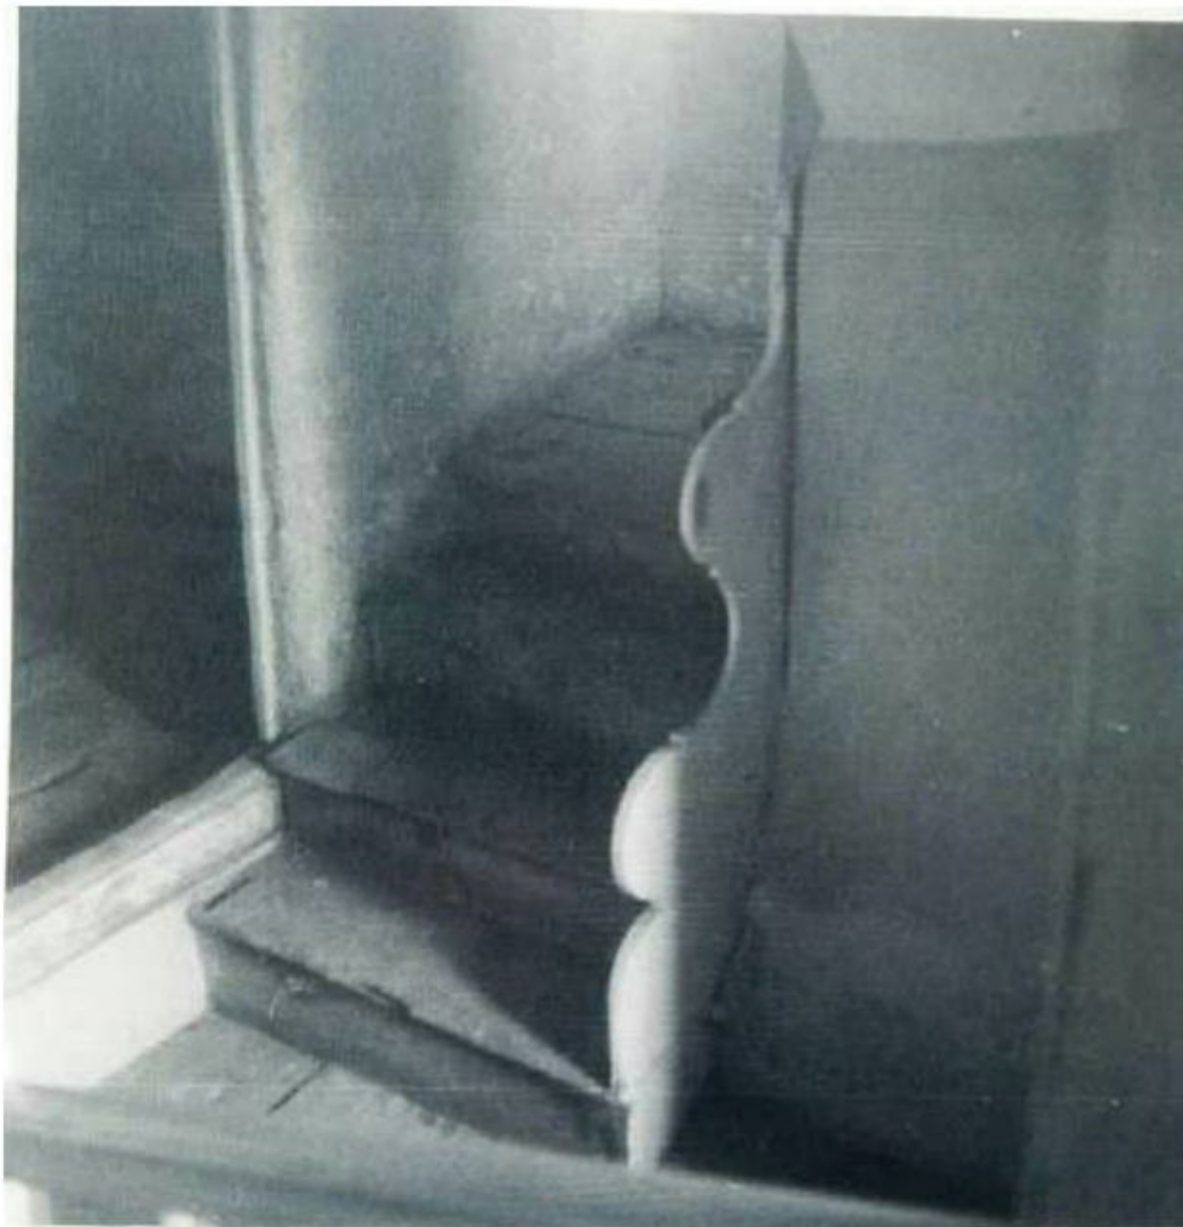
B2: F1 (landing), showing stairs up to attic and carved wooden piece that has been retained in situ (doorway to F2 to left)

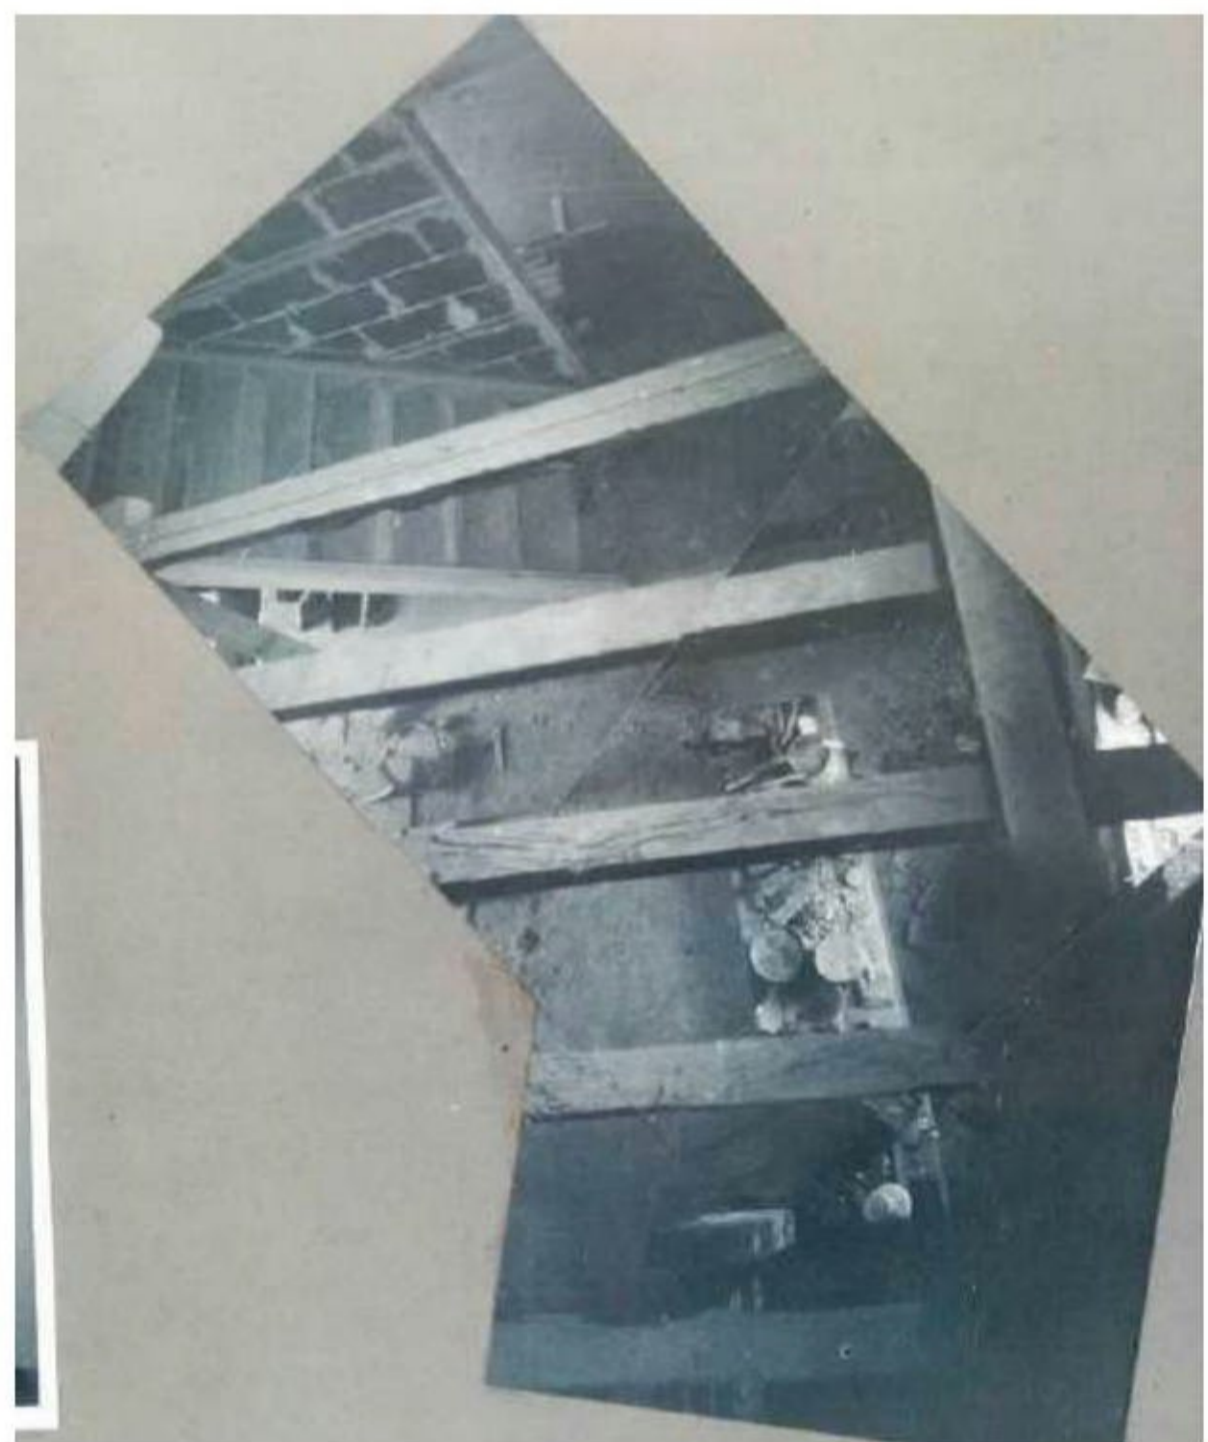
H2: Looking down from F2 into central bay: new staircase, or a temporary one, can be seen against new blockwork wall
