STATEMENT OF SIGNIFICANCE

**Flood Street Farm,
Breamore, Hampshire**

Mr & Mrs Bolt

Date: April 2021

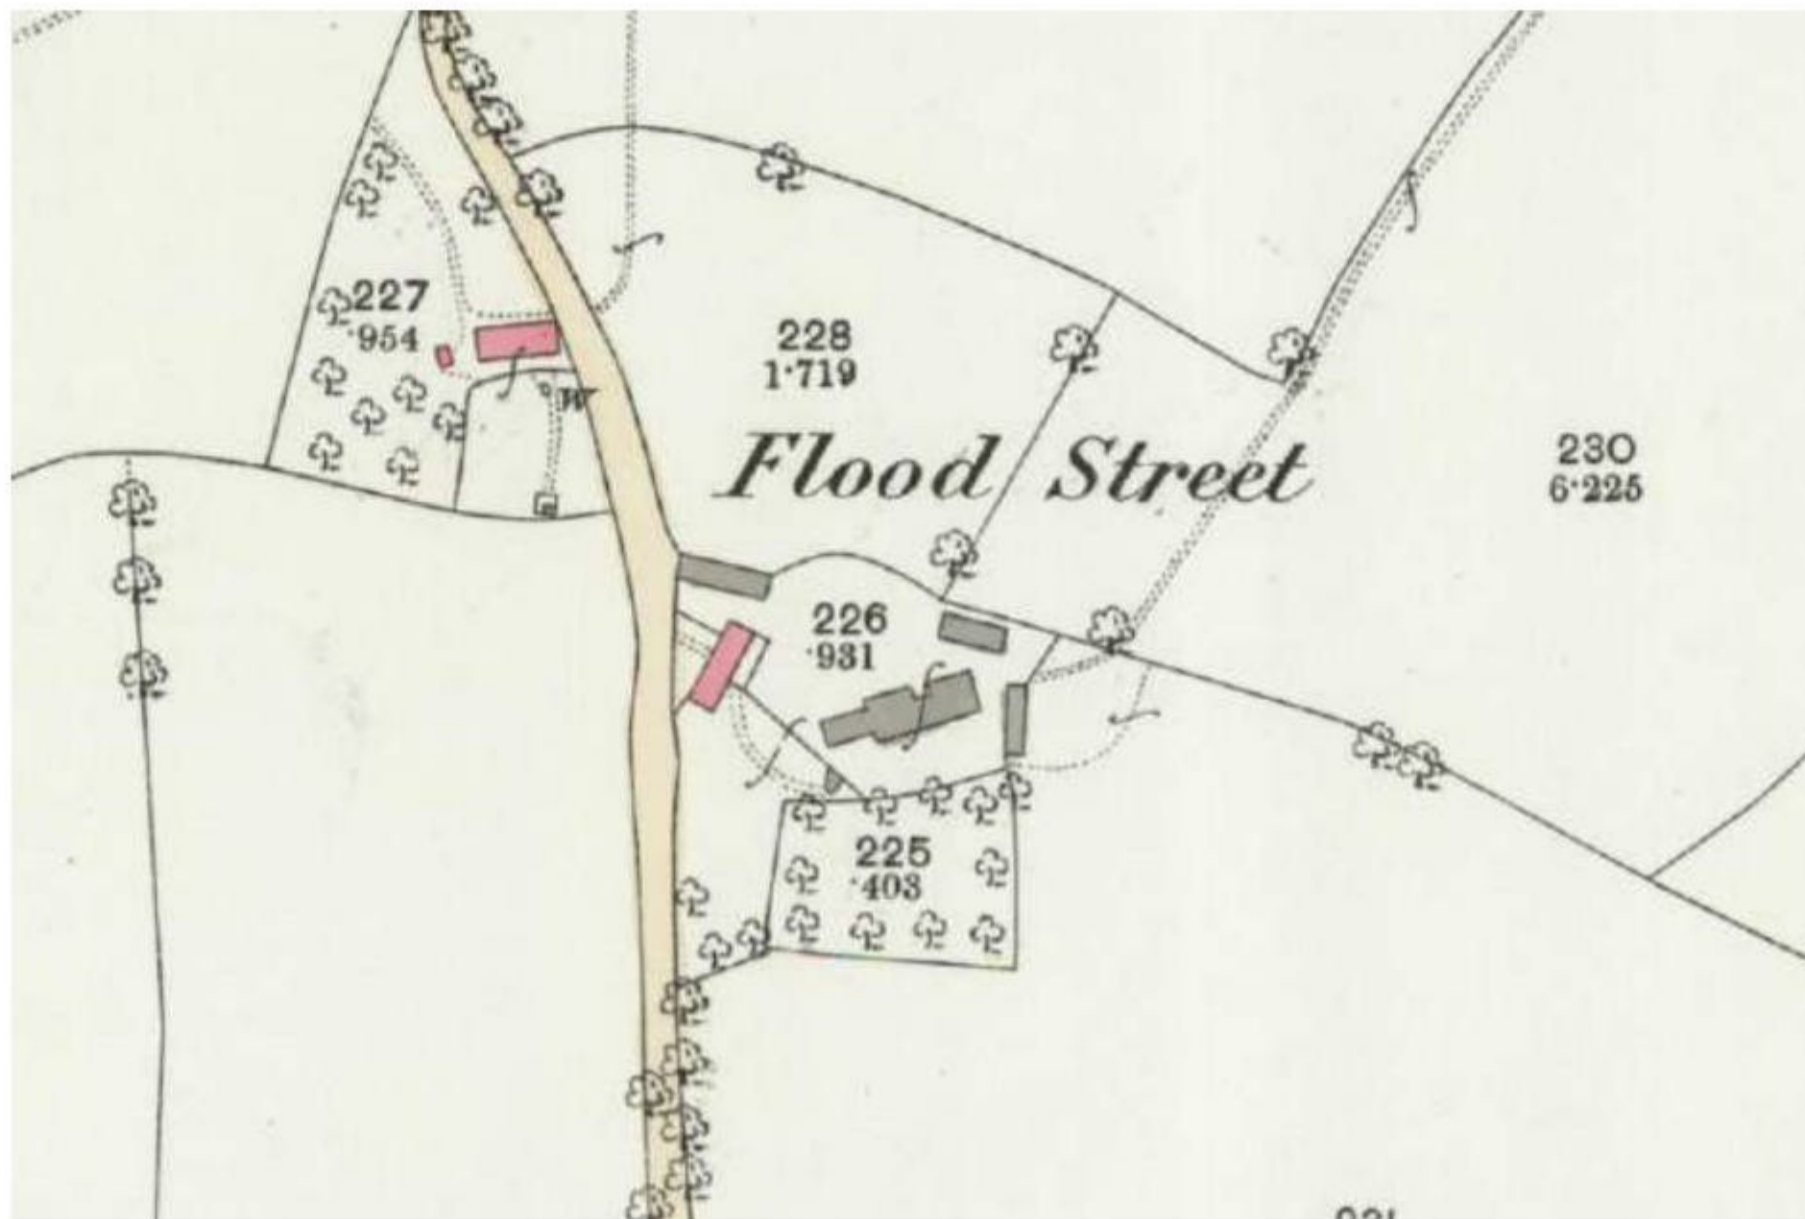
Fig.3: 1878 OS map (surveyed 1870)

- 2.15 The 1878 OS map (actually surveyed in 1870; **Fig.3**) shows the same arrangement of buildings. The pink colouring for the farmhouse indicates a solid masonry structure, while the grey shading for the farm buildings around it indicates construction in wood or iron. It is evident from the surviving Buildings A and D (both present on this and the tithe map), that they were of timber construction. The positions of the buildings and boundaries are essentially as shown on the tithe map. There was a small enclosed front garden with footpath to the front door and an enclosed yard against the rear north-east end of the farmhouse. The rear garden enclosure is shown partly divided to form an orchard in the south-east. The pond depicted on the tithe map is not shown here.

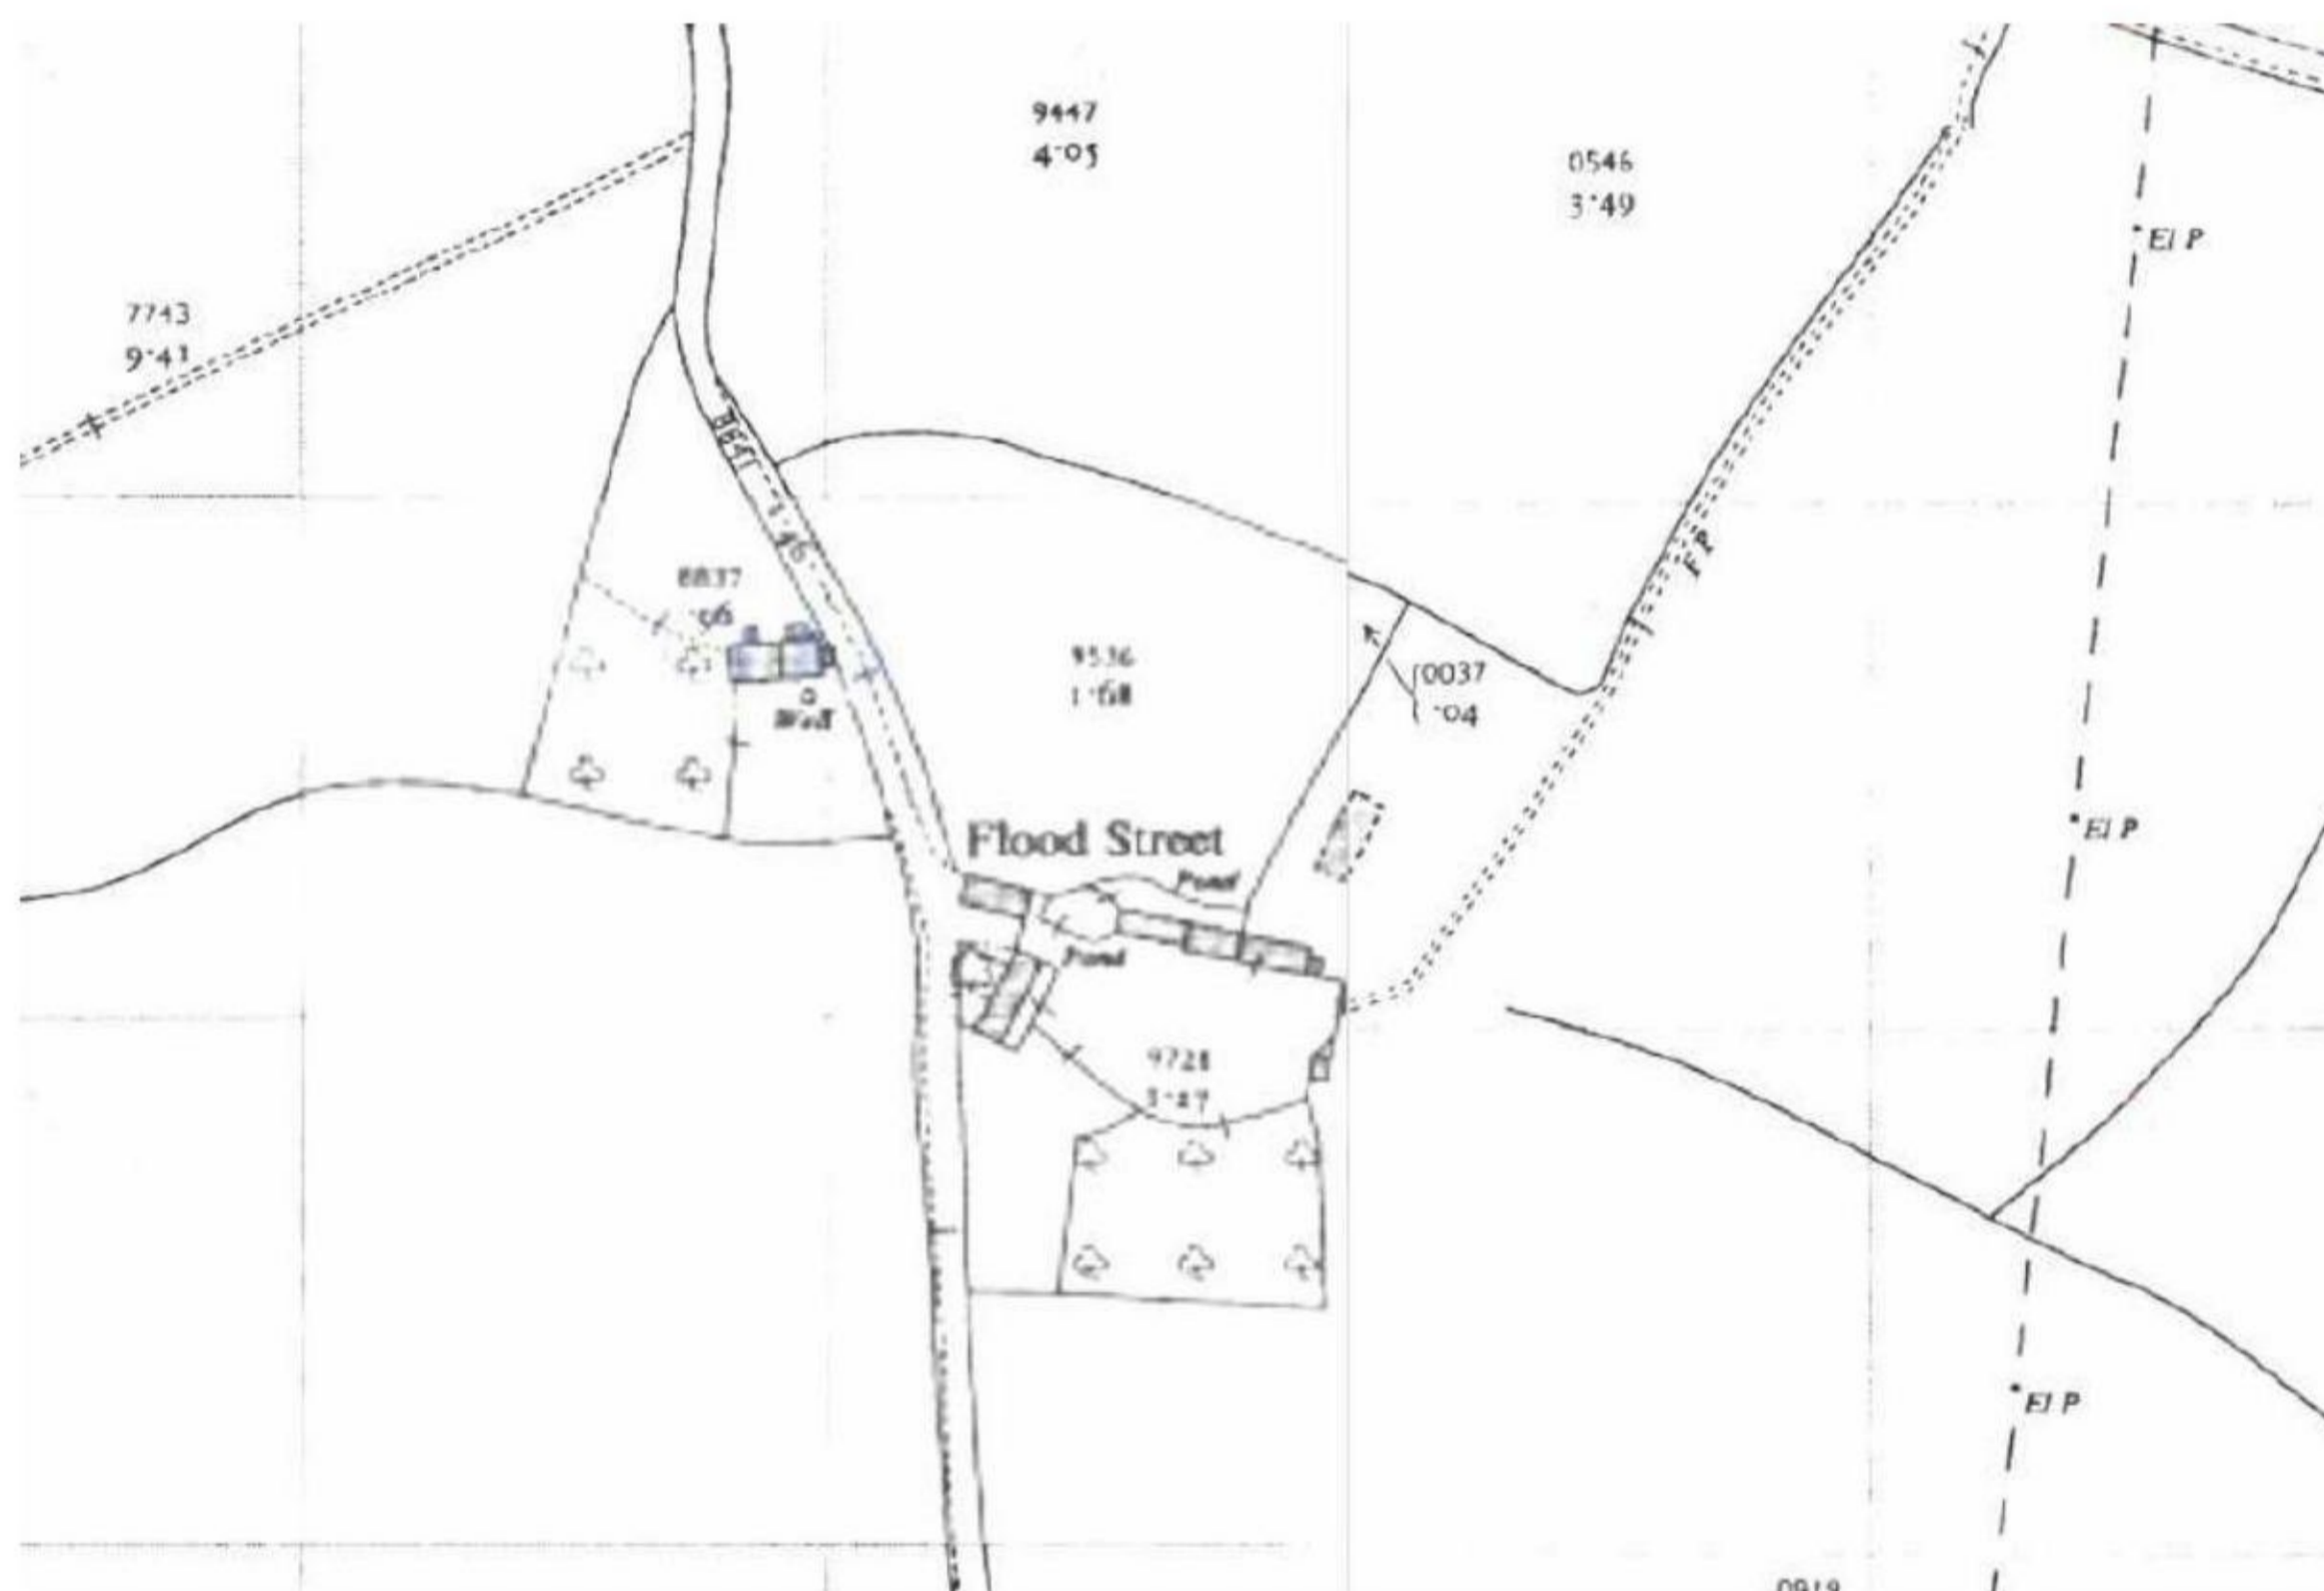
Fig.7: 1957 OS map

2.20 The 1957 OS map (**Fig.7**) shows that the large barn had been demolished. The year 1957 was a transformational one for the farmhouse, when it was purchased by Guy Henley Dodgson and his wife Janet Frances Marion Dodgson. The couple were to undertake a wholesale 'restoration' of the building, which had lain empty for four years and was, apparently, in a parlous condition.

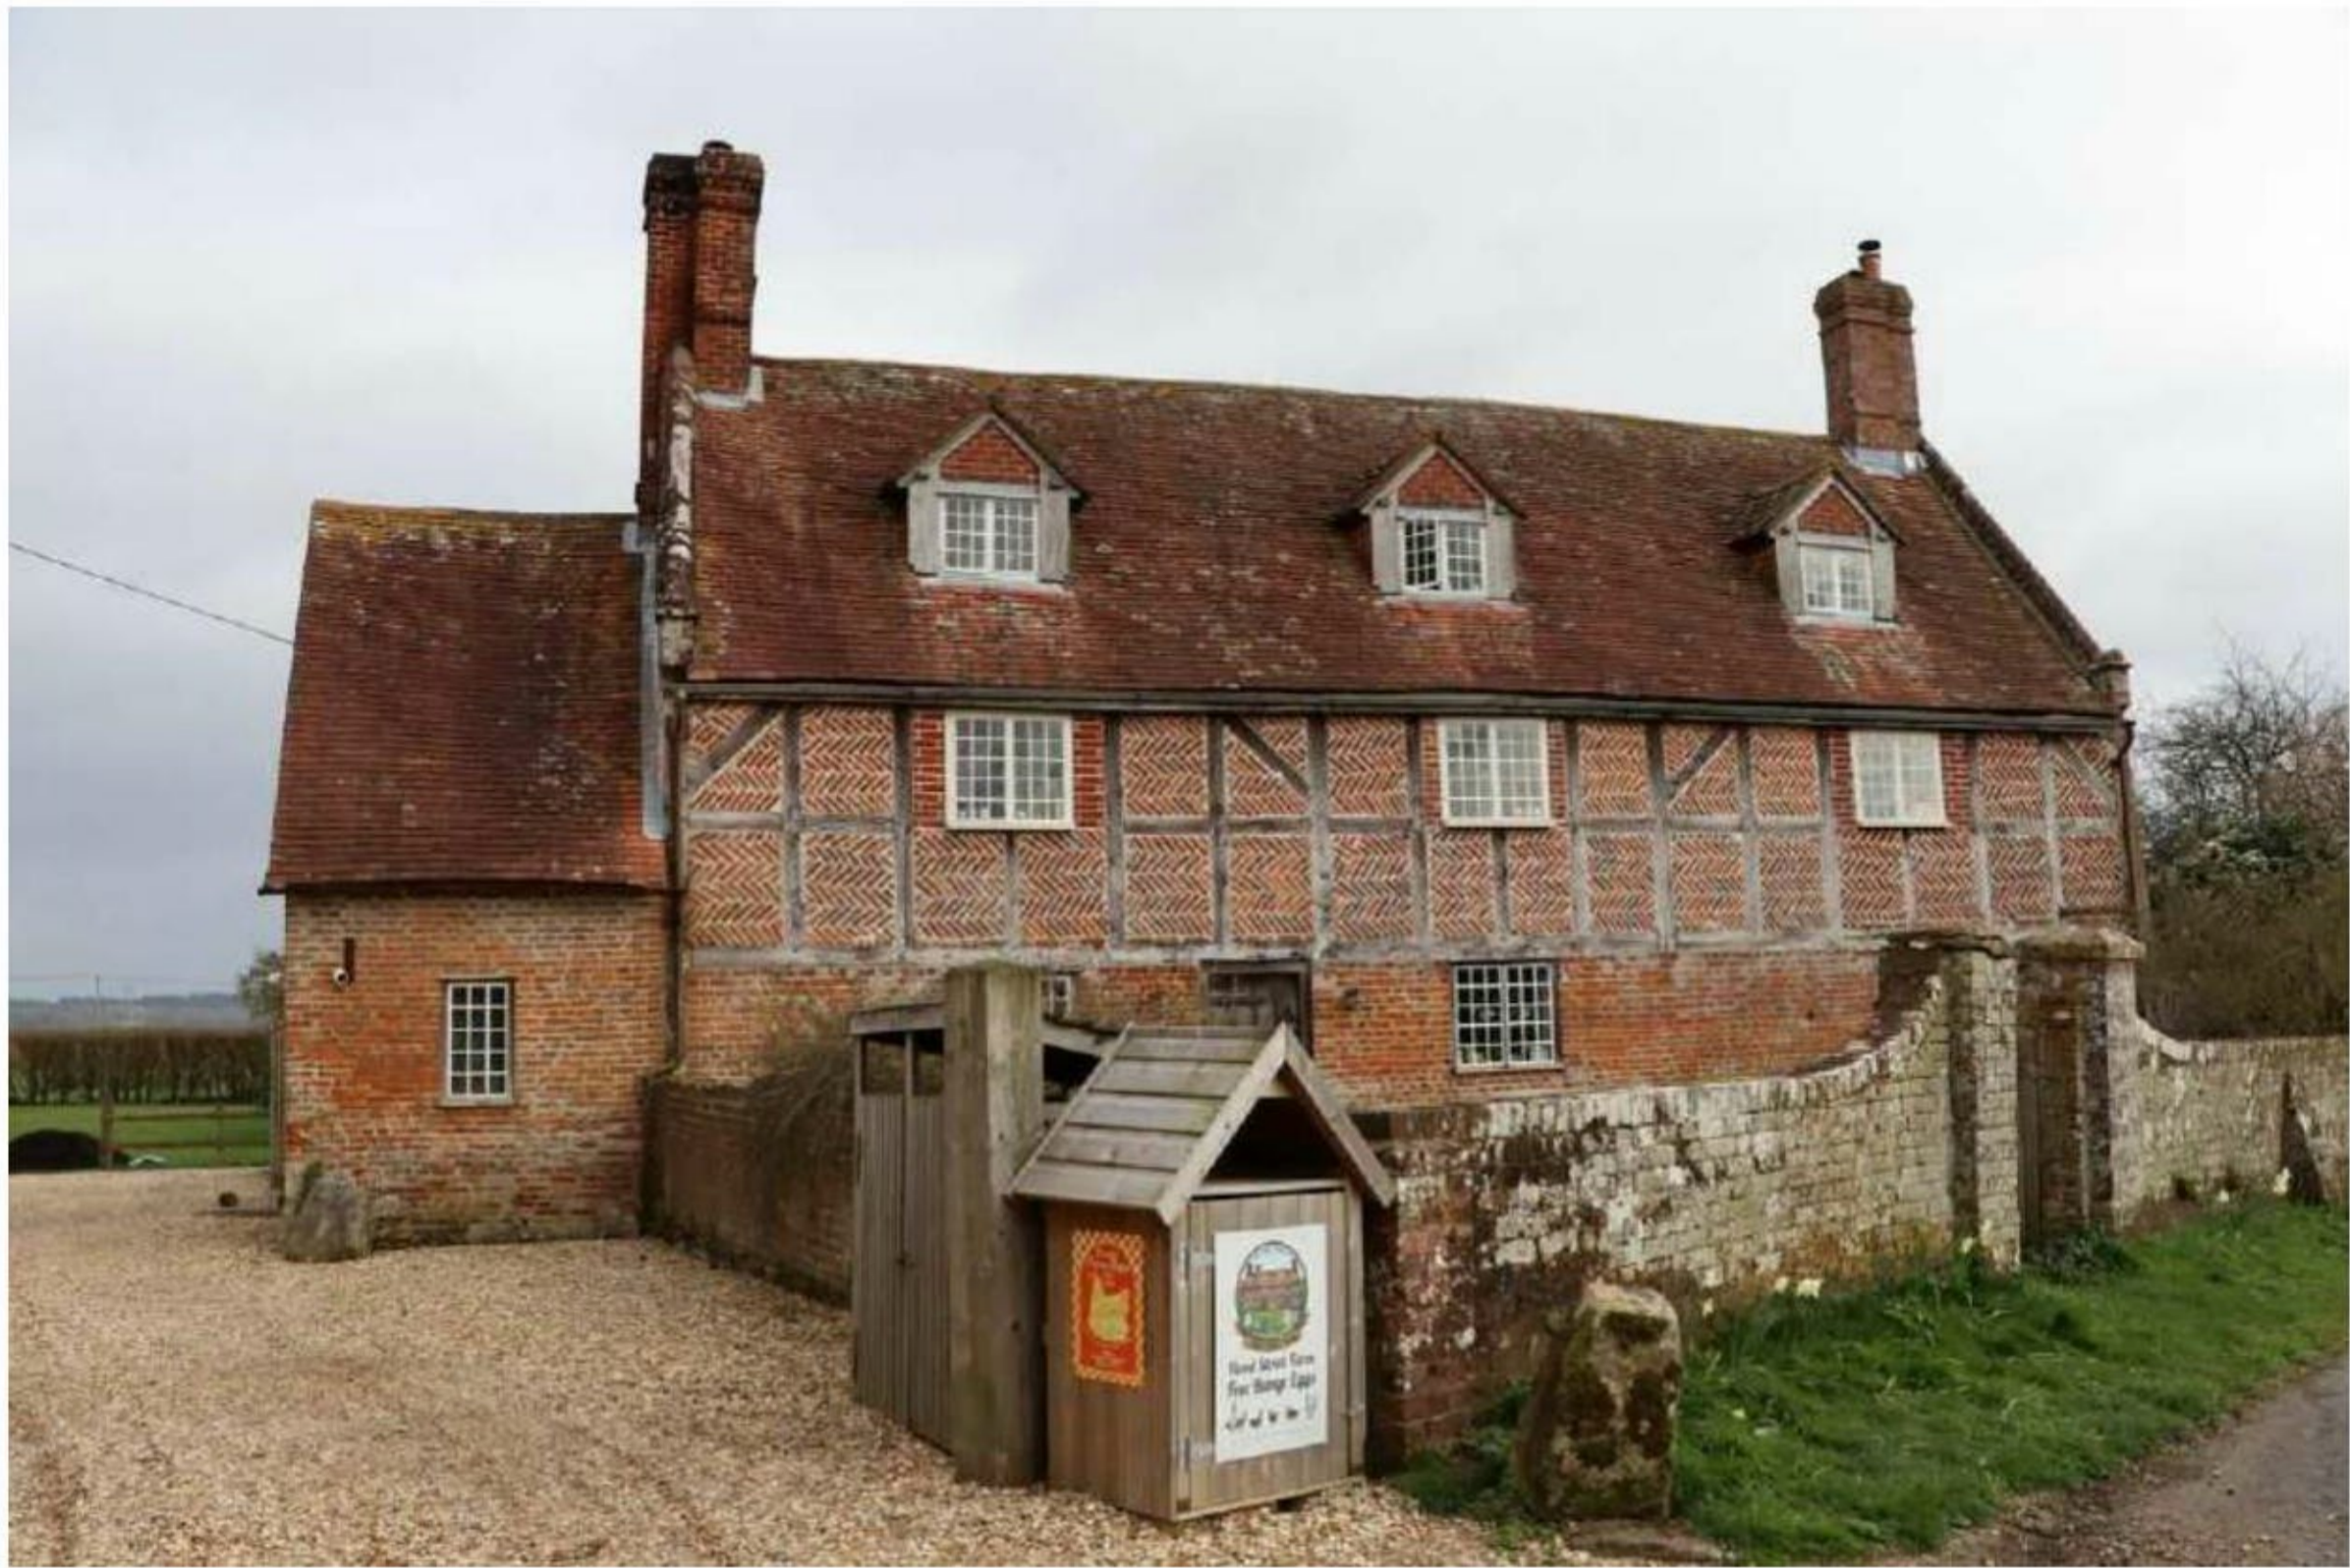
Plate 1: Front (NW) elevation of farmhouse

- 3.1.2 The front (north-west) elevation comprises three wide fenestrated bays (**Plates 1 & 2; Photos A & C-G**). To the timber-framed first floor, the outer two bays are of six square-framed panels each and the central bay of four square-framed panels. The bays are marked by posts into which the mid-rail is jointed (the posts, apart from the corner posts, truncated below the mid-rail) and by diagonal braces. Carpenter's marks are present on some of the studs, for instance III, V, VII and VIII, indicating the count began from the first stud at the right-hand end and moved left (ignoring the principal posts) (**Plate 3**).

3.3.3 The front garden is enclosed by a brick wall which continues around to abut the north-western corner of the main building range where it joins the brewhouse (the latter presumably considered primarily a service building; see **Plate 1**). To the front, the wall profile curves upwards to two taller gate piers flanking a wooden paling gate that was there in 1956. The garden wall should be considered 'curtilage listed'.

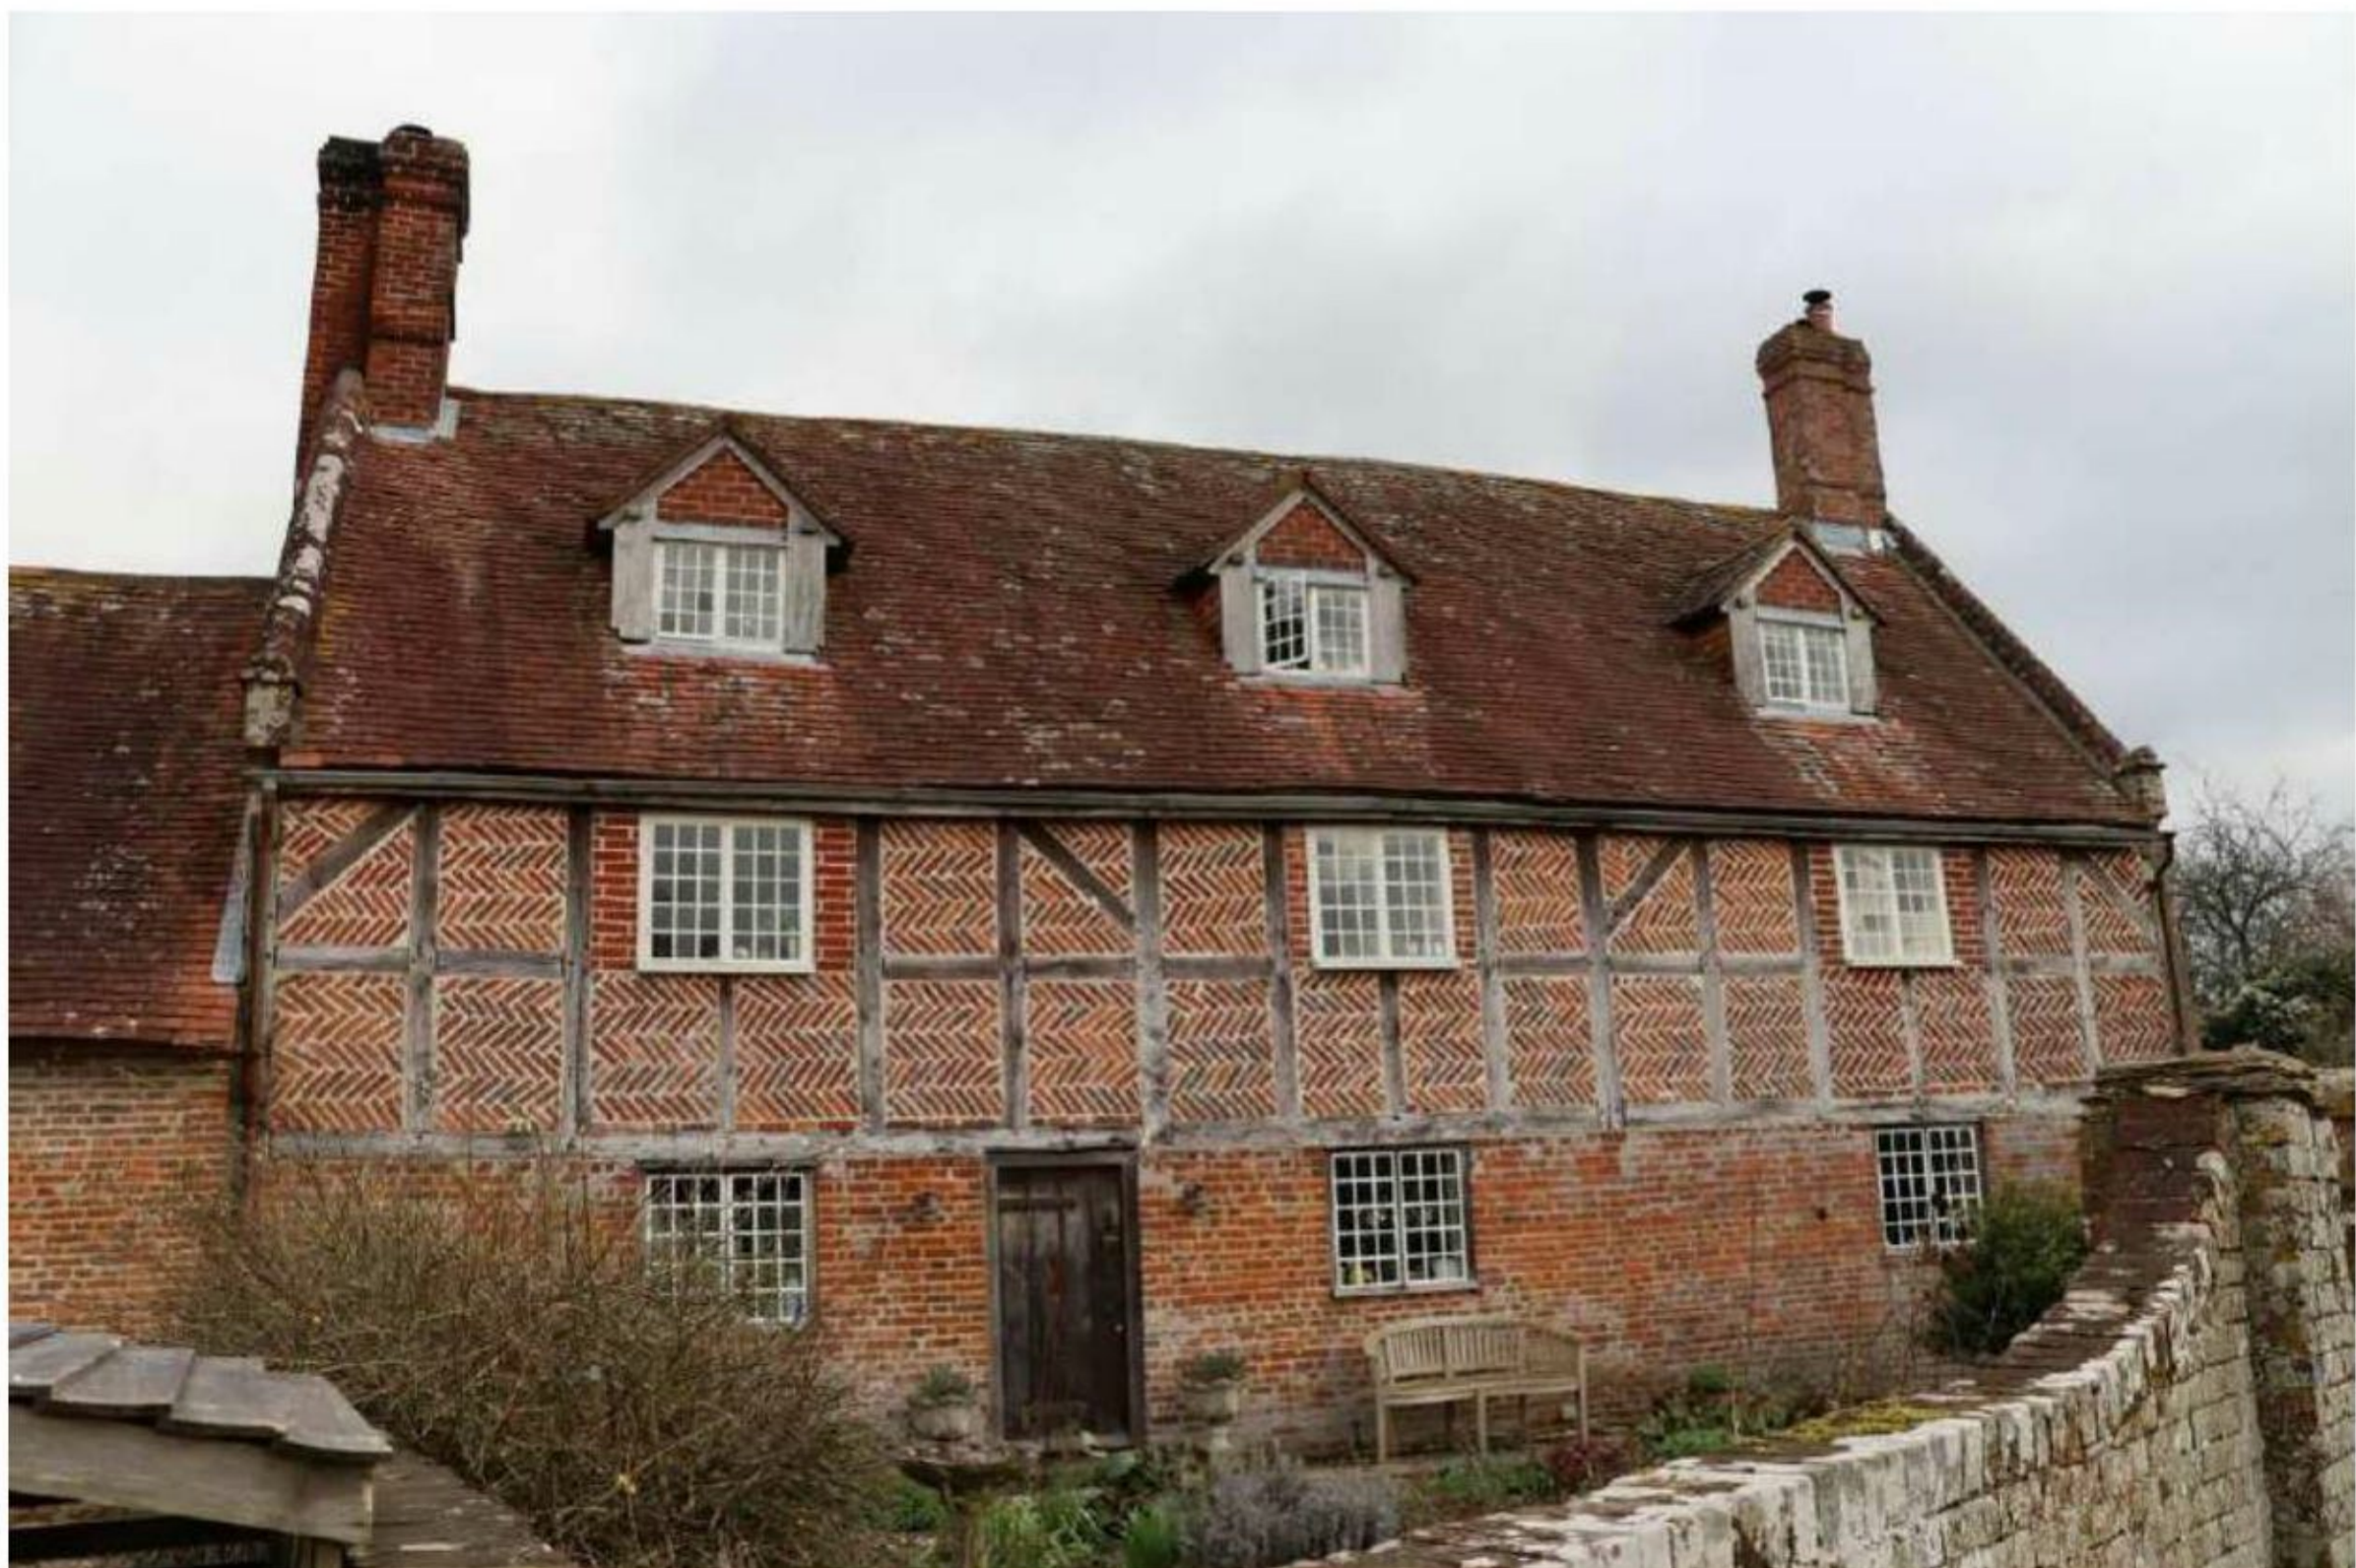
Plate 2: Front elevation

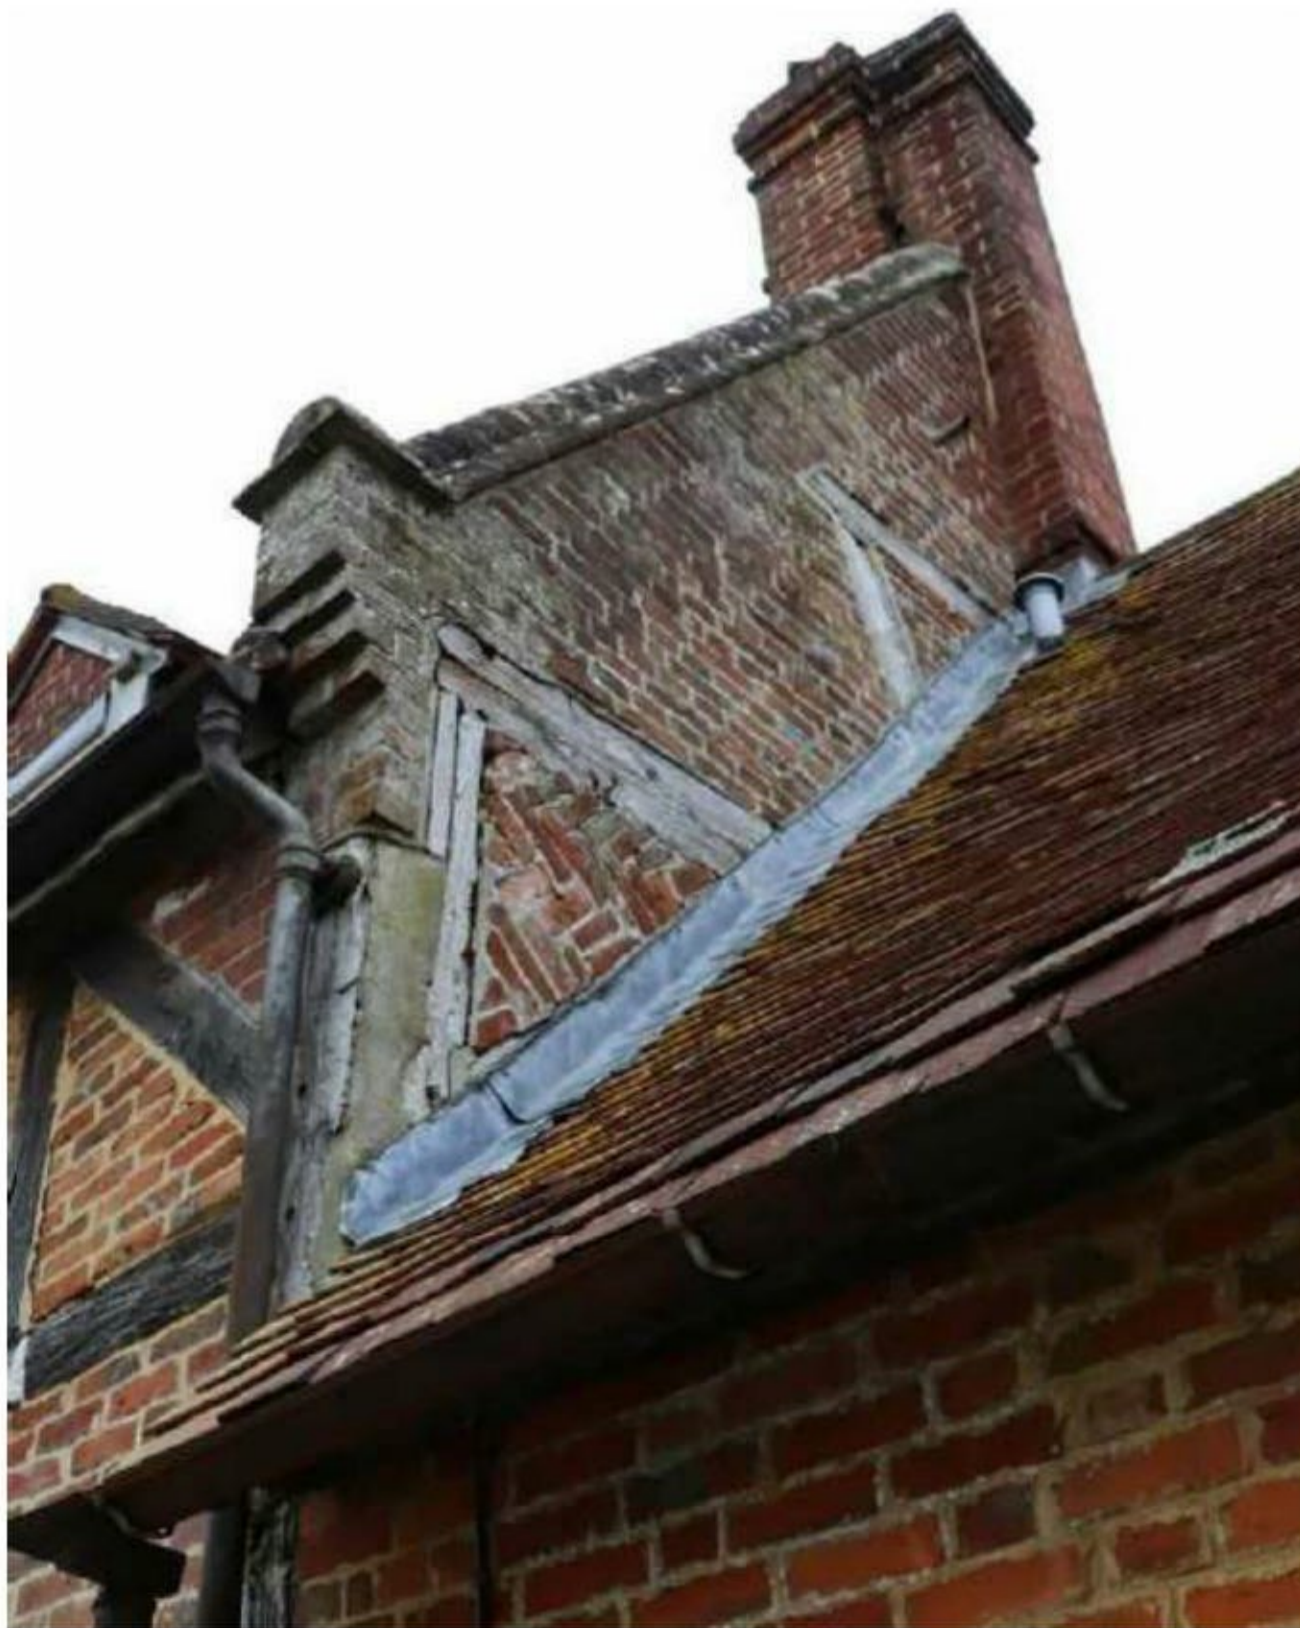
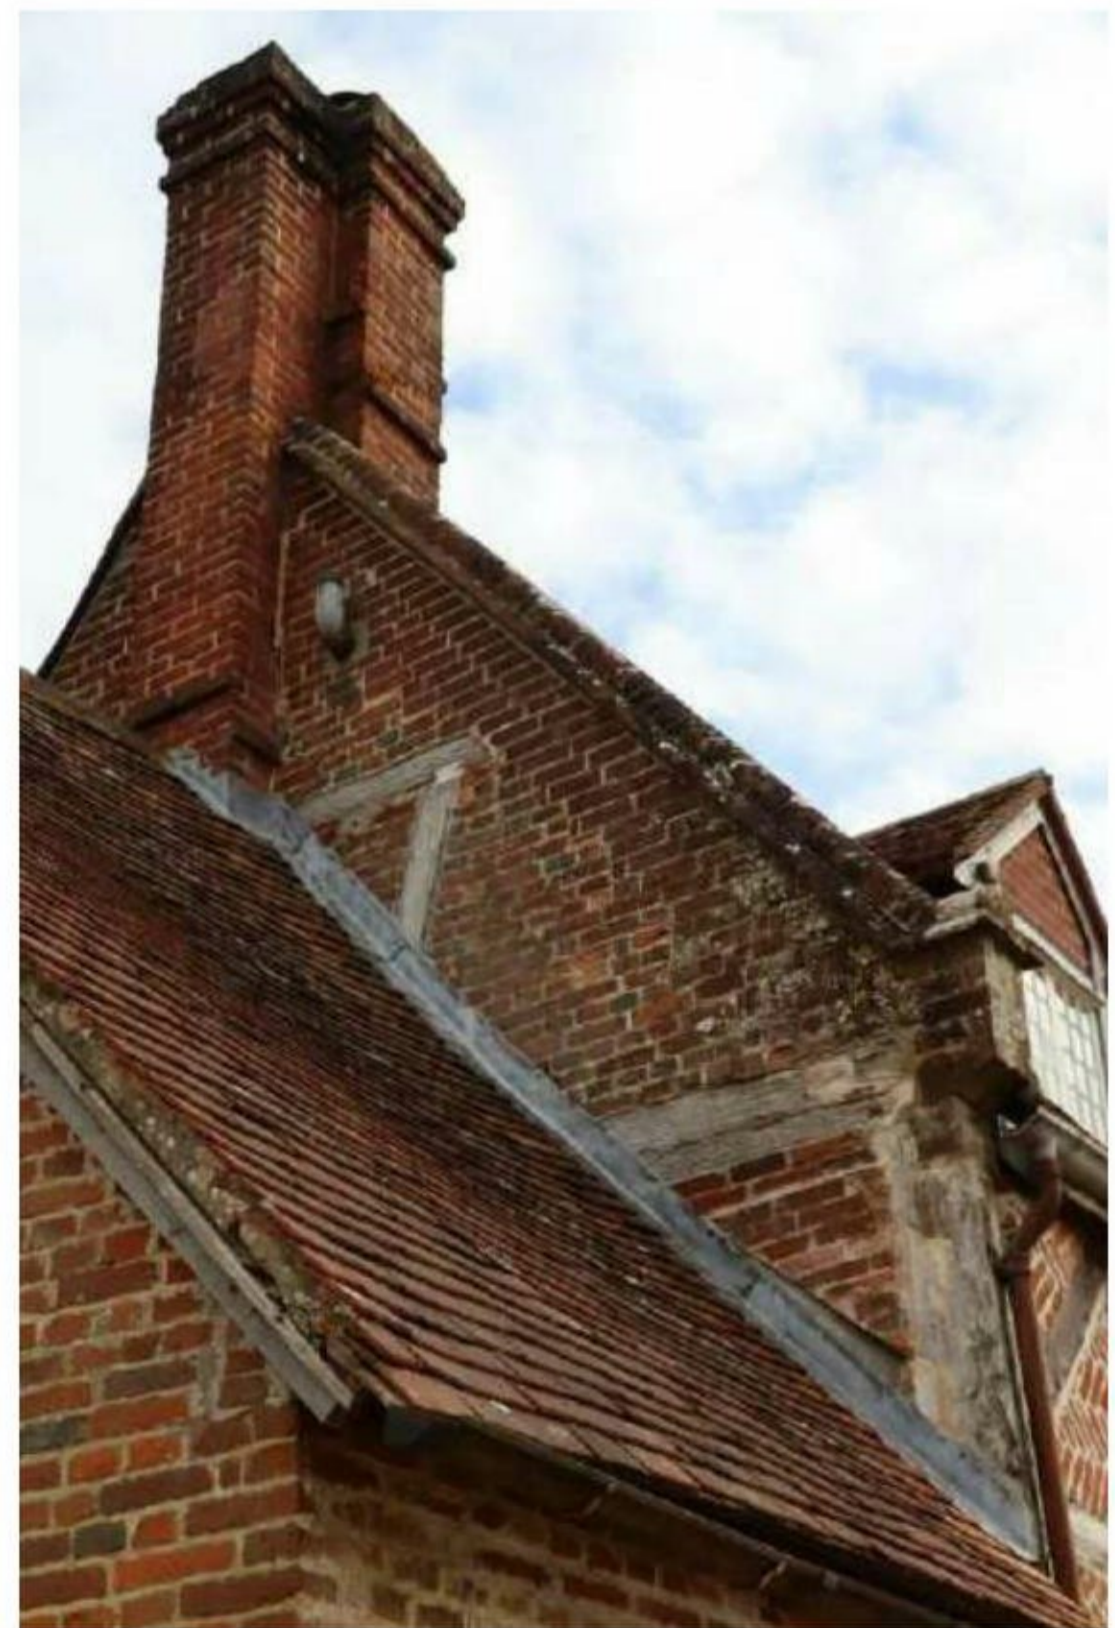
Plate 4: Details of NE gable end of farmhouse

- 3.1.6 Only a very small part of the north-eastern gable end of the main range is exposed to view externally (**Plate 4**). The brickwork has been renewed to the parapet. The earlier brickwork that can be seen is laid in English Bond like the brewhouse addition, a bond generally used earlier than Flemish Garden Wall Bond. Elements of exposed timber frame can be seen, comprising a truss tie and collar and a pair of angled struts between them.

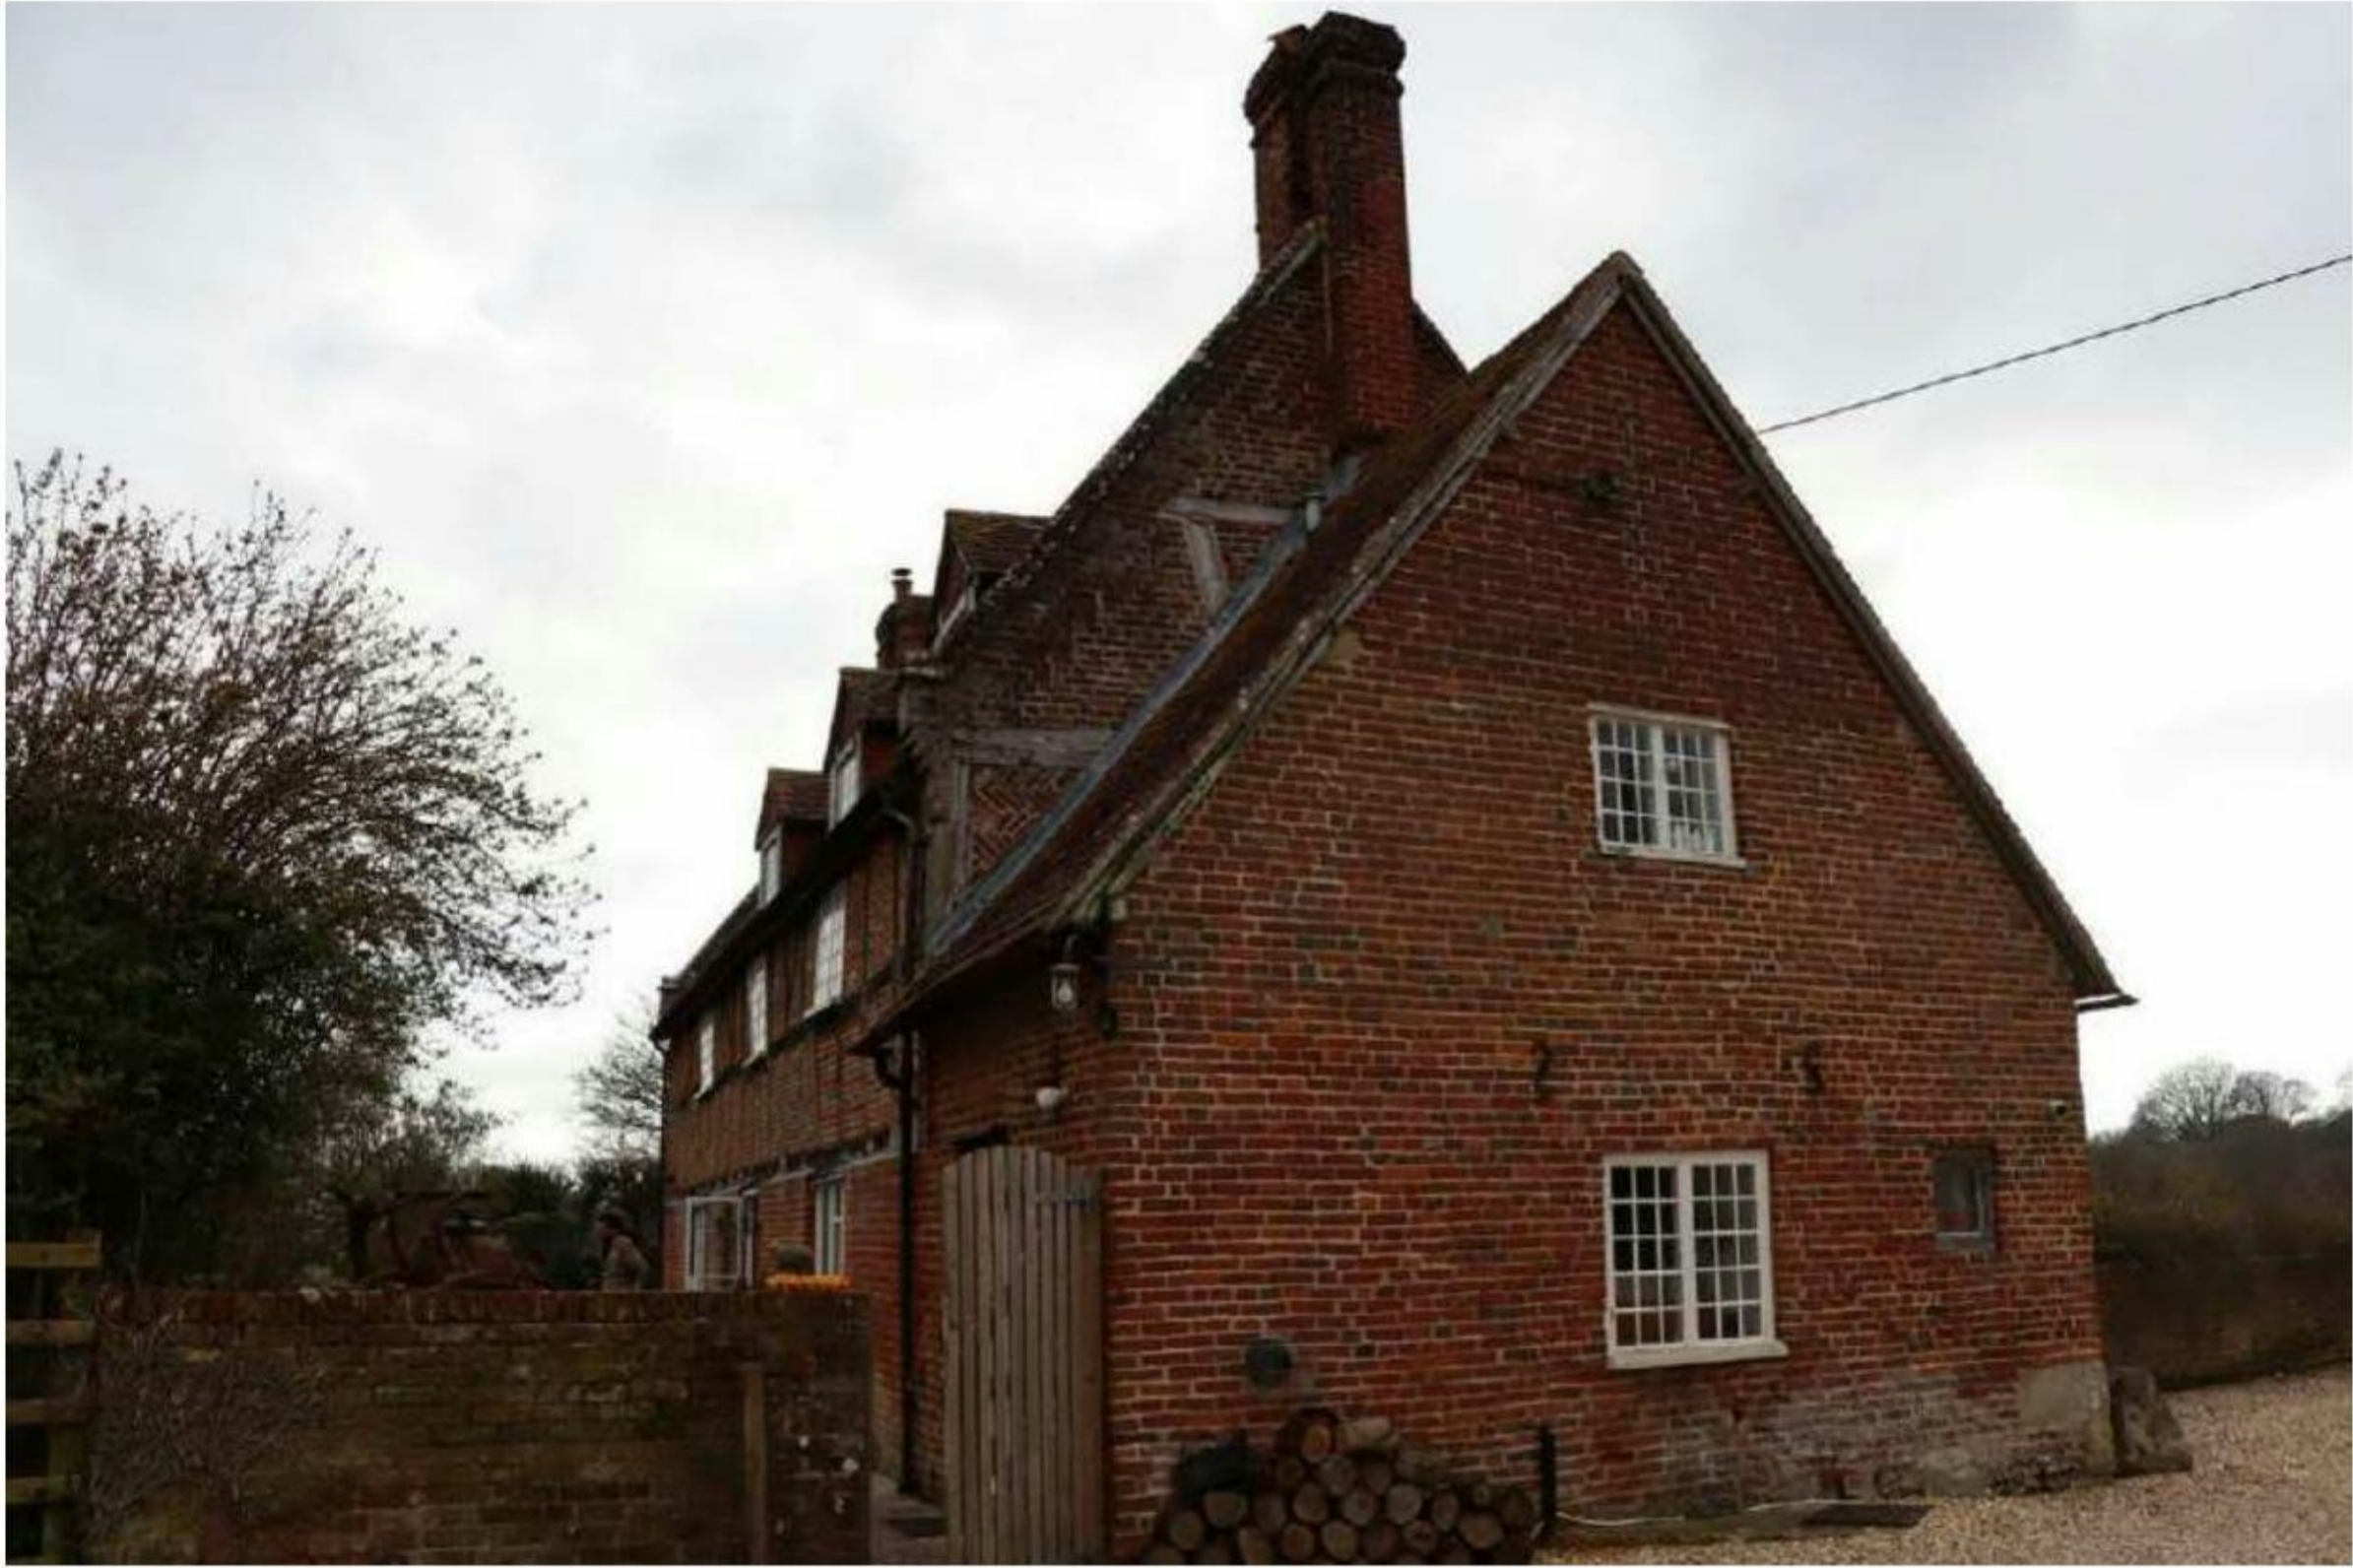
Plate 5: NE gable end of farmhouse and 'brewhouse' addition

- 3.1.7 The gable-end of the 'brewhouse' has been rebuilt in the apex above the attic window (**Plates 5 & 6**). There has also been some earlier rebuilding beneath this window opening. The aligned windows to ground and attic floors are both cast-iron casements in wooden frames. There is also a small high-set square-leaded fixed-light window in a pegged wooden frame to the right at ground-floor level. Two tie bars are evident, both inserted in the 1950s.
