STATEMENT OF SIGNIFICANCE

**Flood Street Farm,
Breamore, Hampshire**

Mr & Mrs Bolt

Date: April 2021

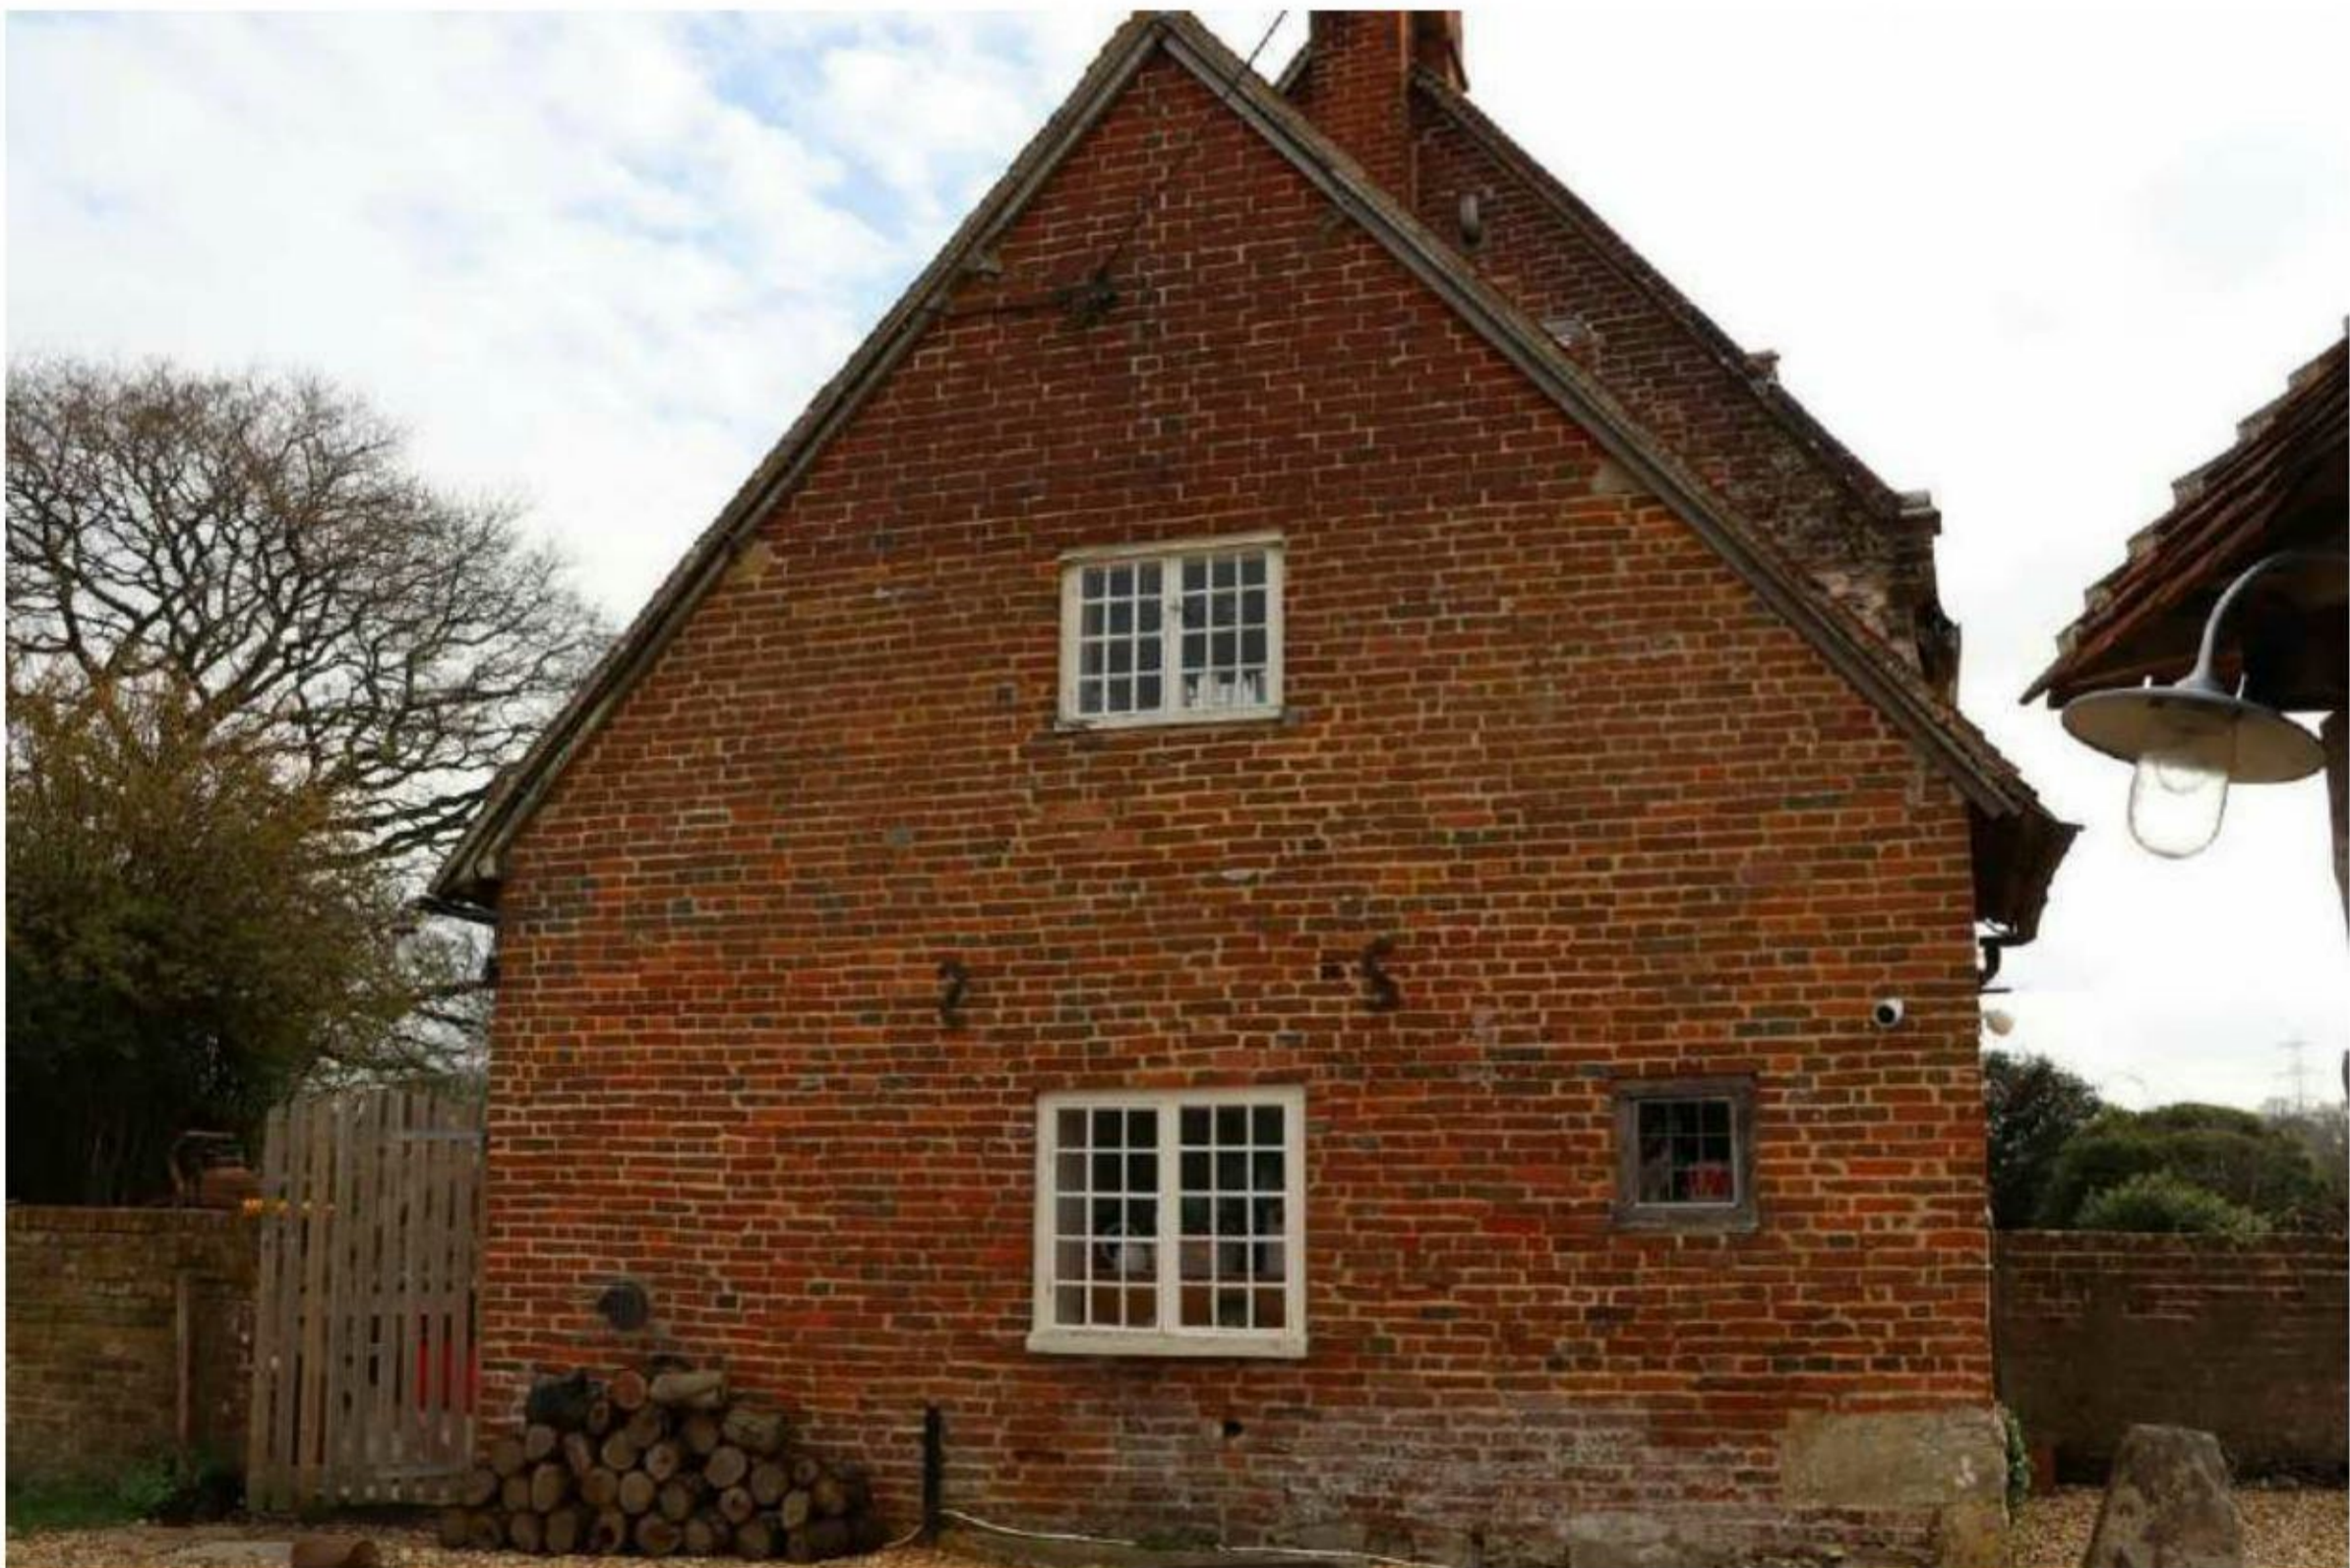
Plate 6: NE gable end of 'brewhouse' addition

- 3.1.7 The gable-end of the 'brewhouse' has been rebuilt in the apex above the attic window (**Plates 5 & 6**). There has also been some earlier rebuilding beneath this window opening. The aligned windows to ground and attic floors are both cast-iron casements in wooden frames. There is also a small high-set square-leaded fixed-light window in a pegged wooden frame to the right at ground-floor level. Two tie bars are evident, both inserted in the 1950s.

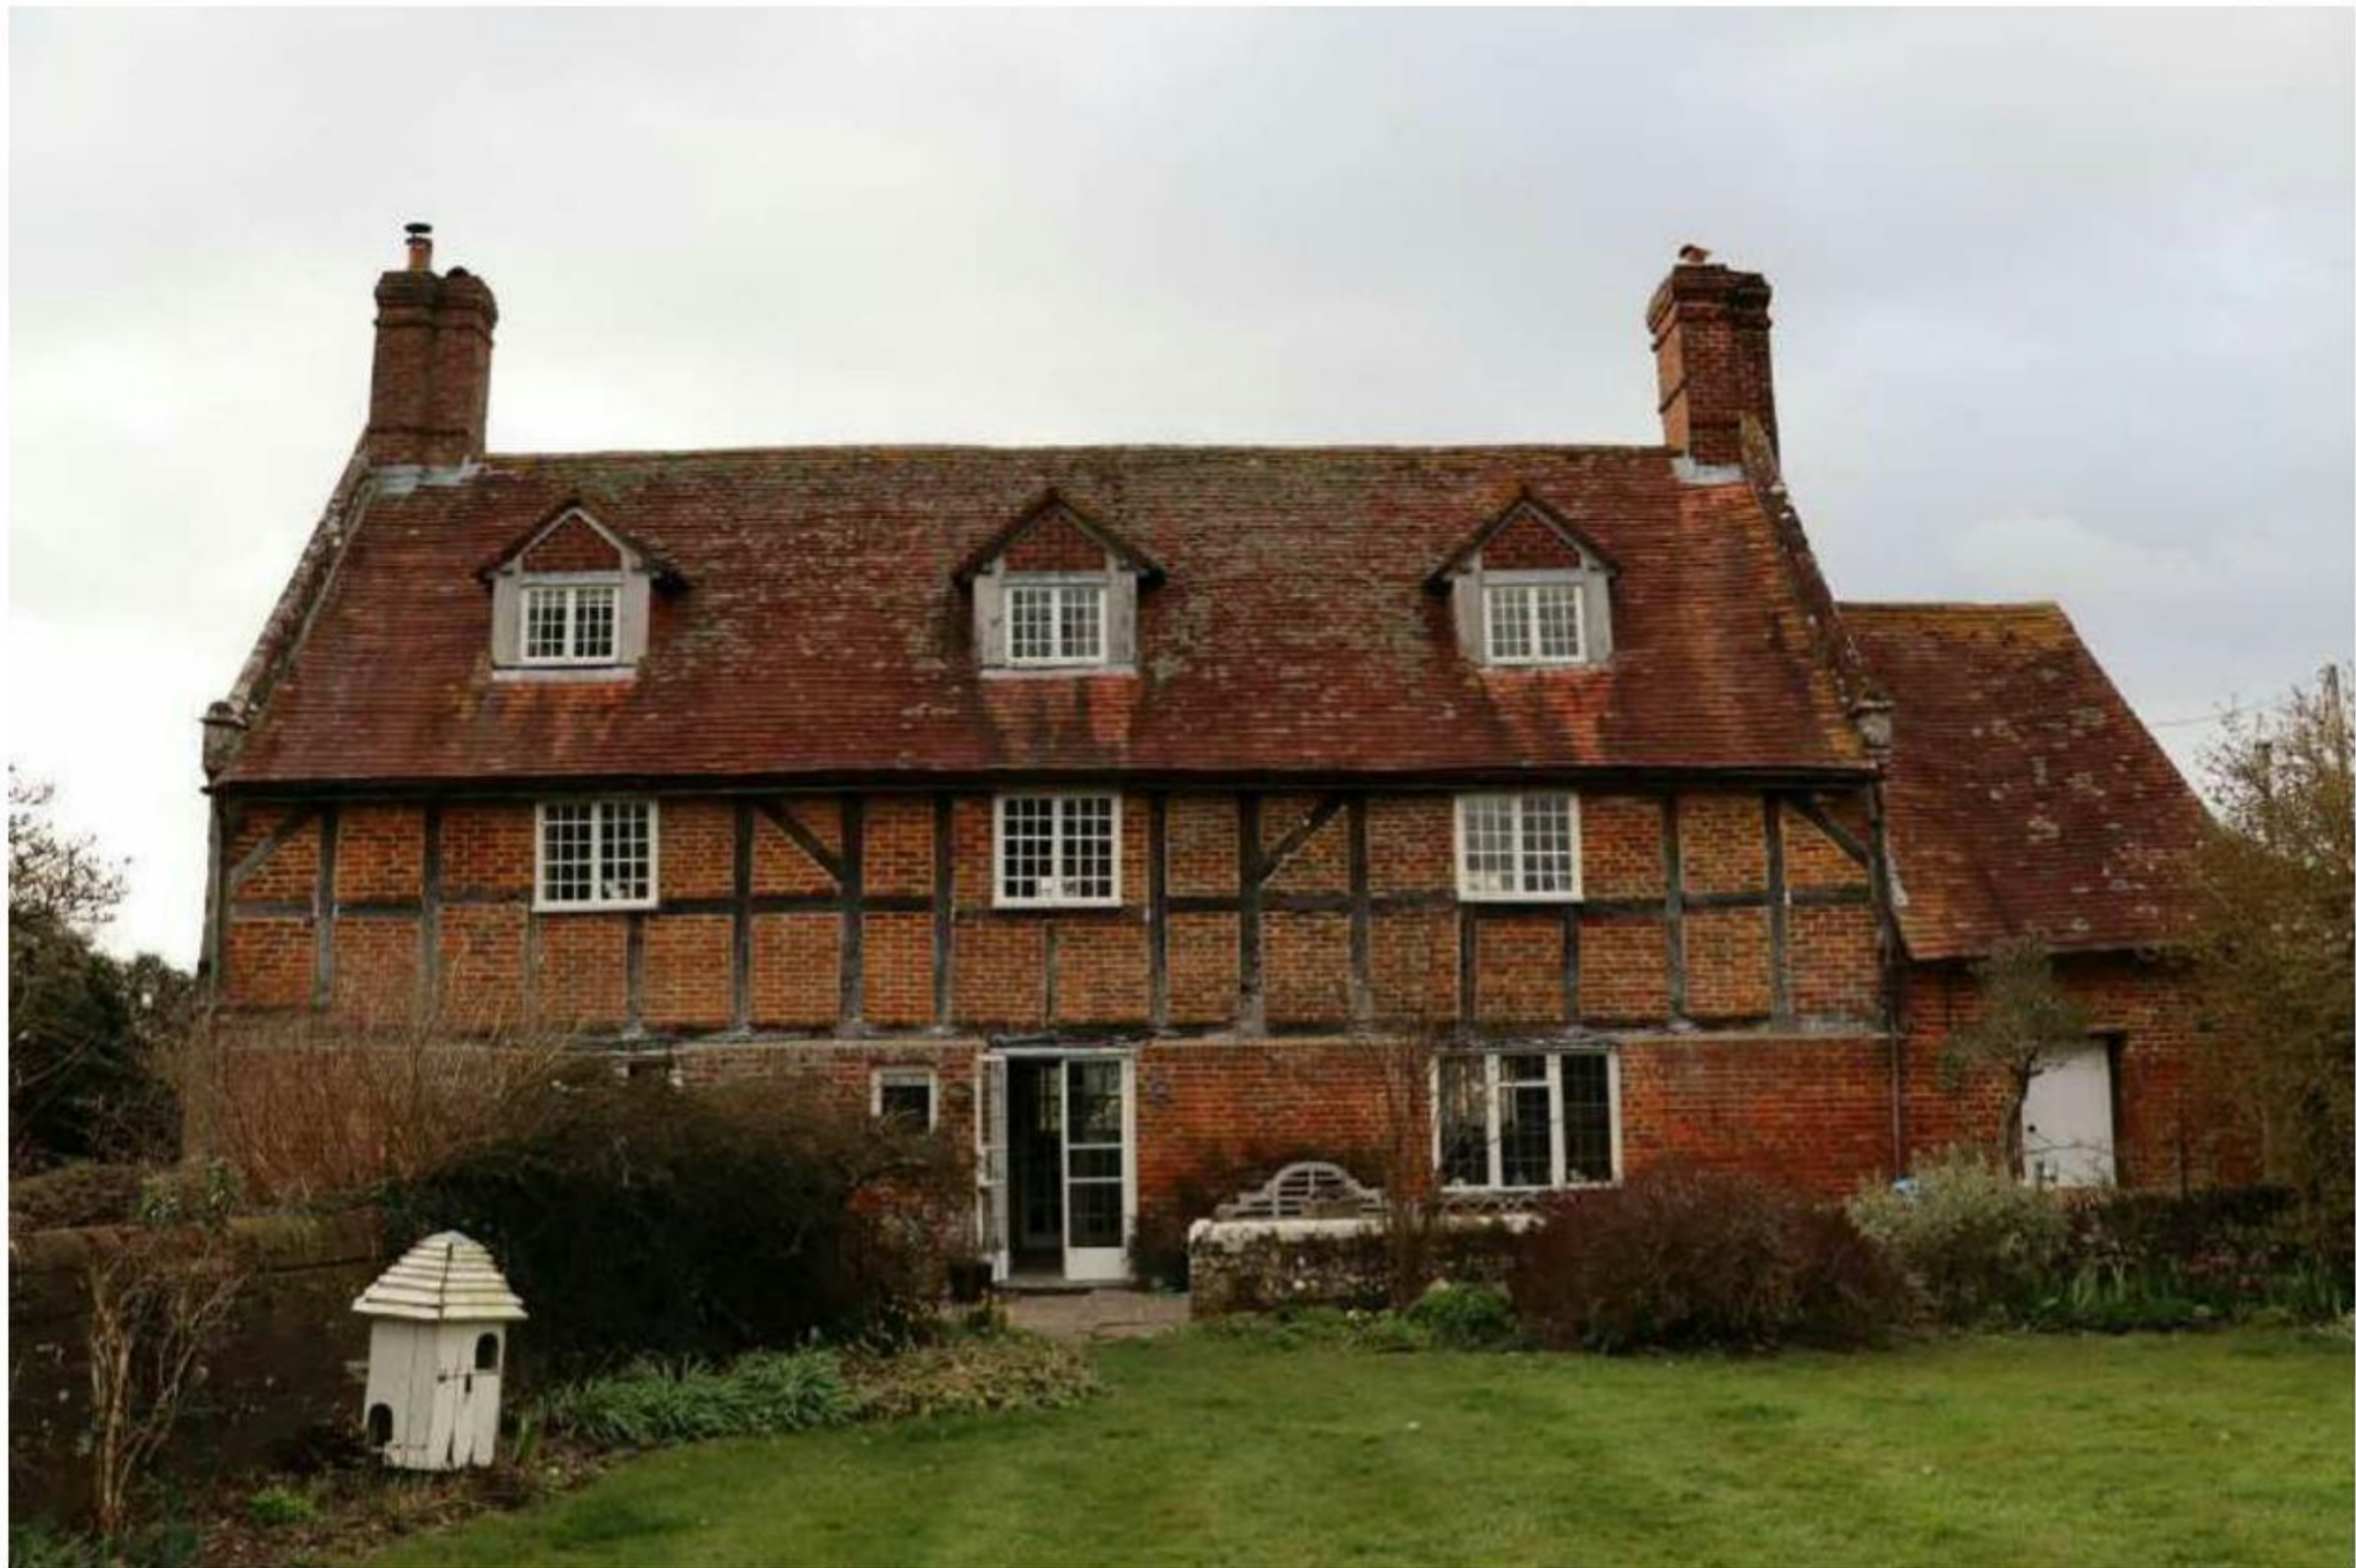
Plate 7: Rear (SE) elevation

- 3.1.8 The rear (south-east) elevation of the main range is arranged in a similar manner to the front, with the timber framing and positioning of first-floor window openings following the same pattern (except that the rails have been retained at sill level) (**Plate 7; Photos H-M & Q-X**). The brick infill to the first floor is laid in straight courses on this rear side of the building, rather than the herringbone pattern of the

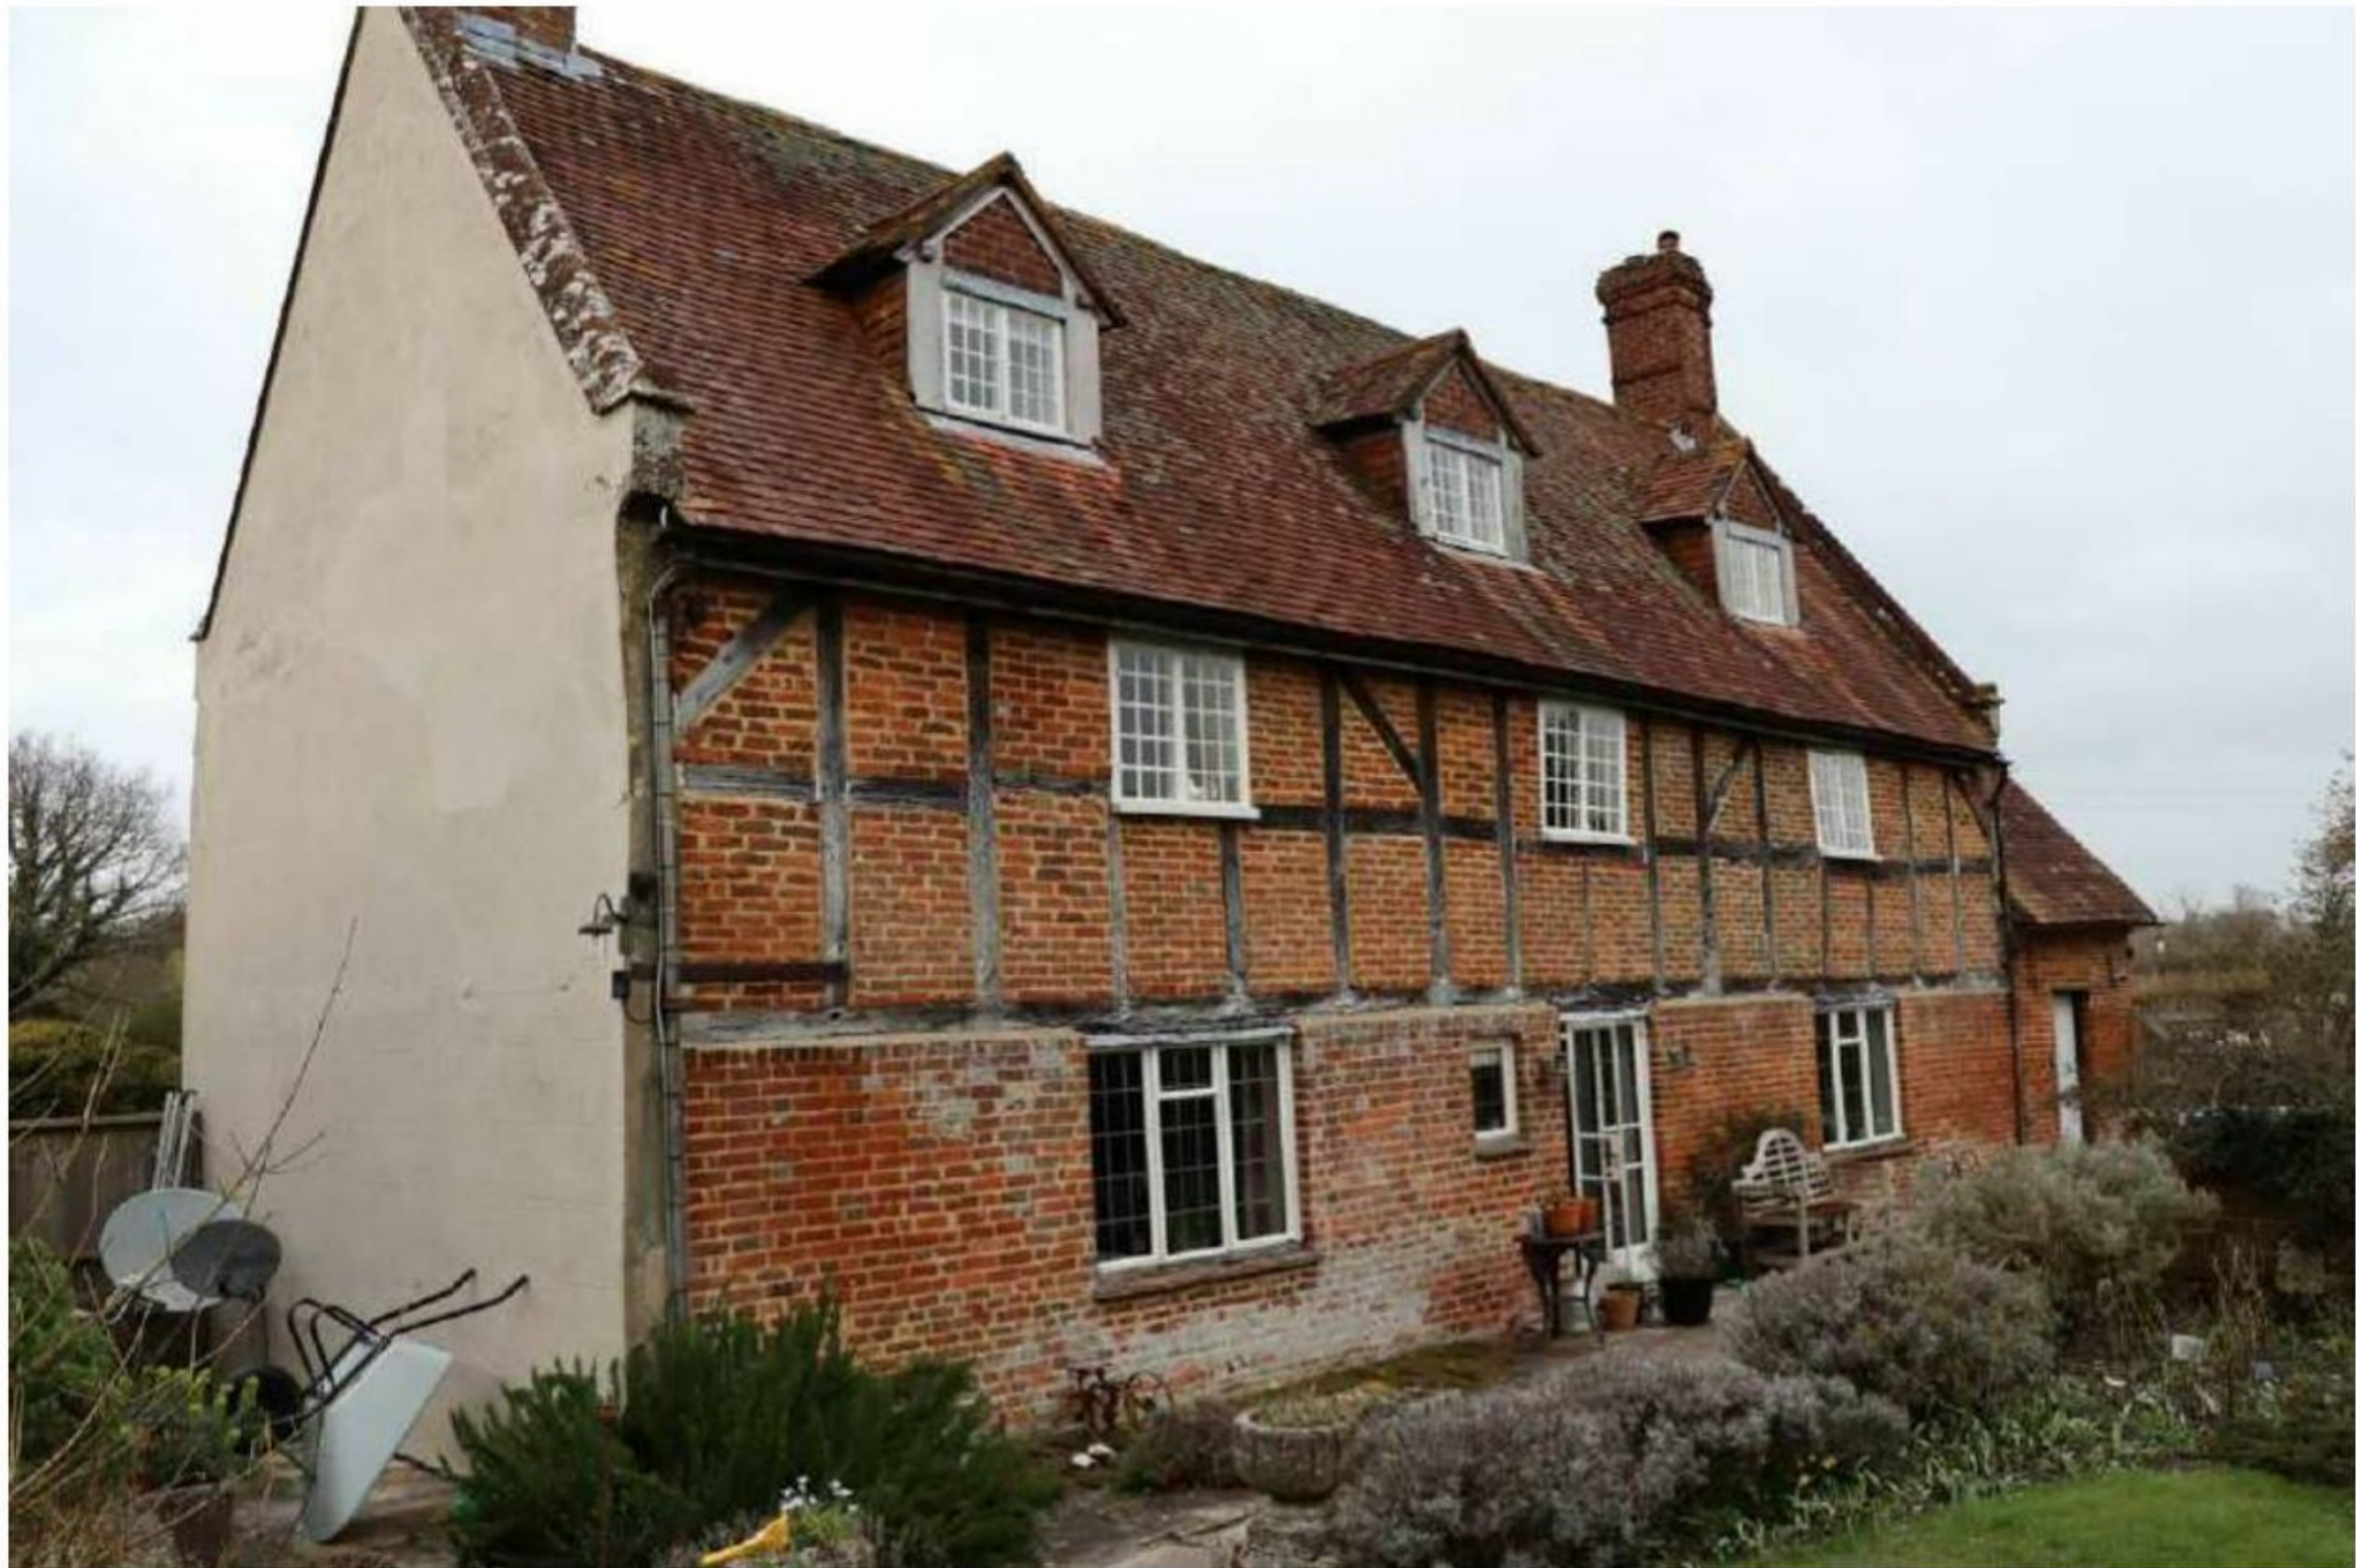
Plate 9: SW gable end and rear elevation

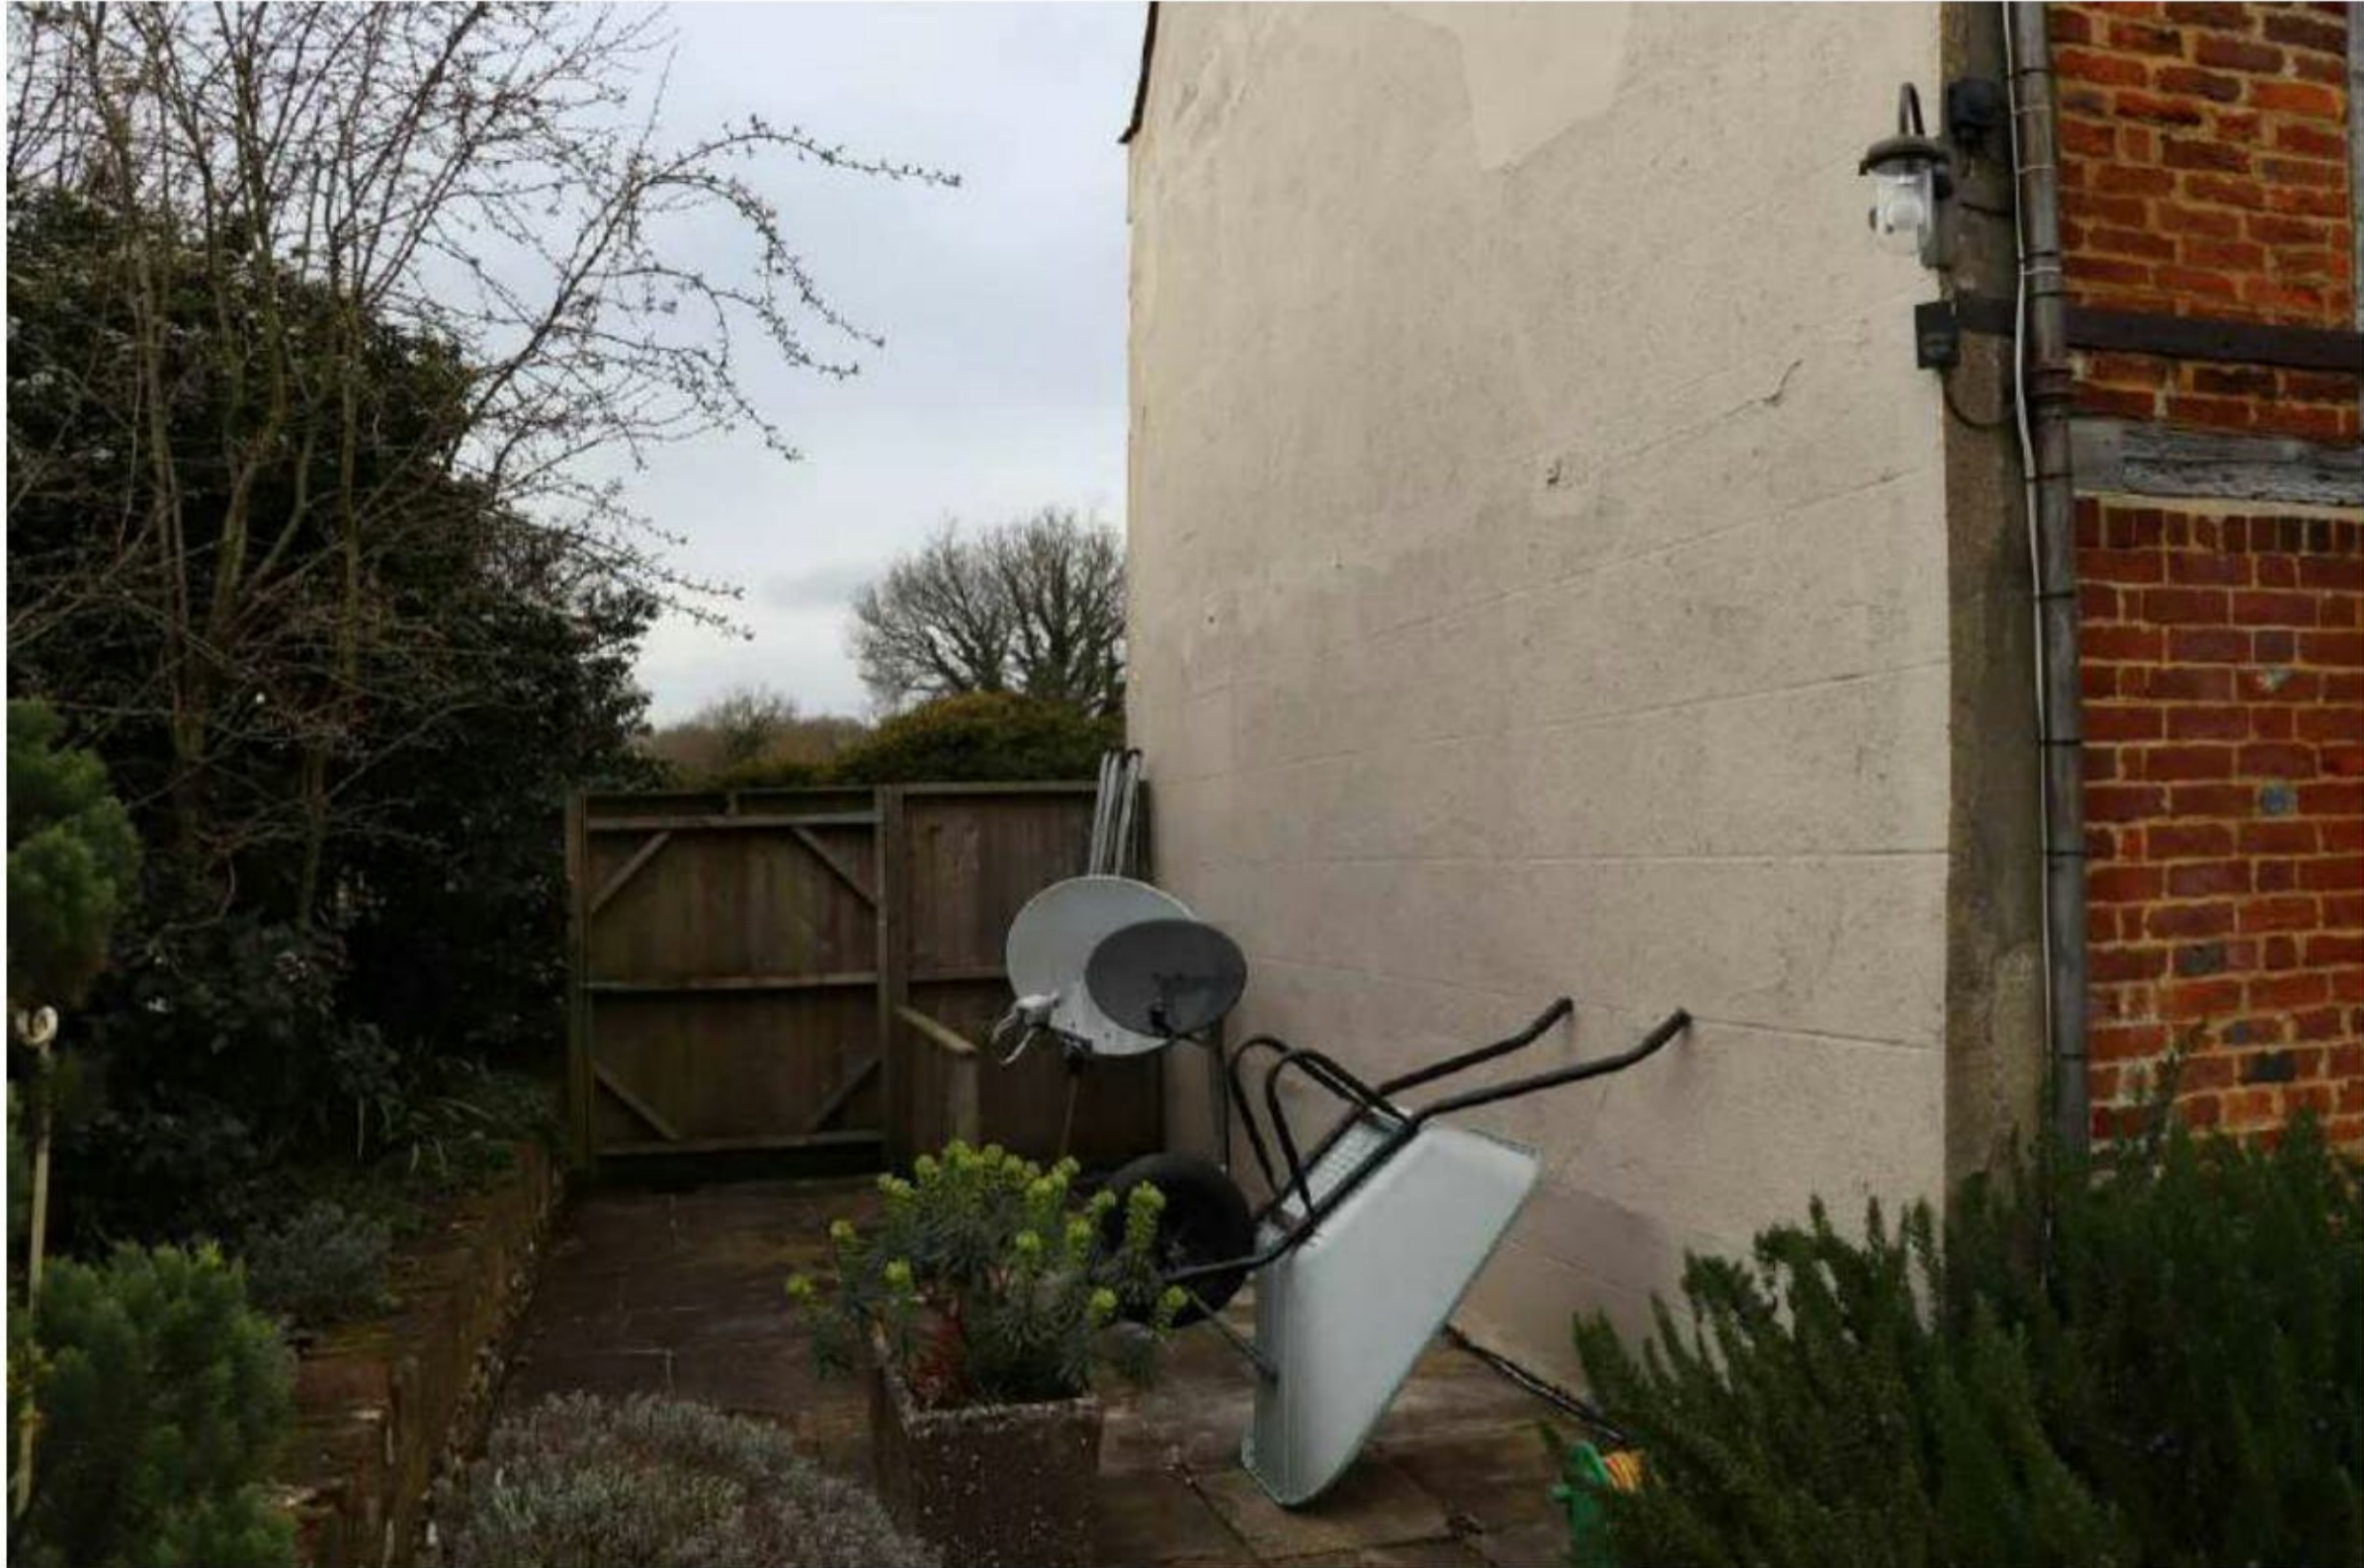
Plate 11: Base of the SW gable end, from where an earth bank was removed in 1957

3.3.1 The south-west gable end is entirely covered in render with incised lines. The Dodgsons say that this was the case in the 1950s and that they left it as it was. A comparison of **Photo X** with **Plate 10** suggests the old render has been repaired and repainted if not entirely renewed since that time. The Dodgsons also refer to their removal of an earth bank from the base of this wall – the extent of this removal can be gleaned from **Photo Y** and see **Plate 11**. The condition of the wall fabric beneath the render is unknown.

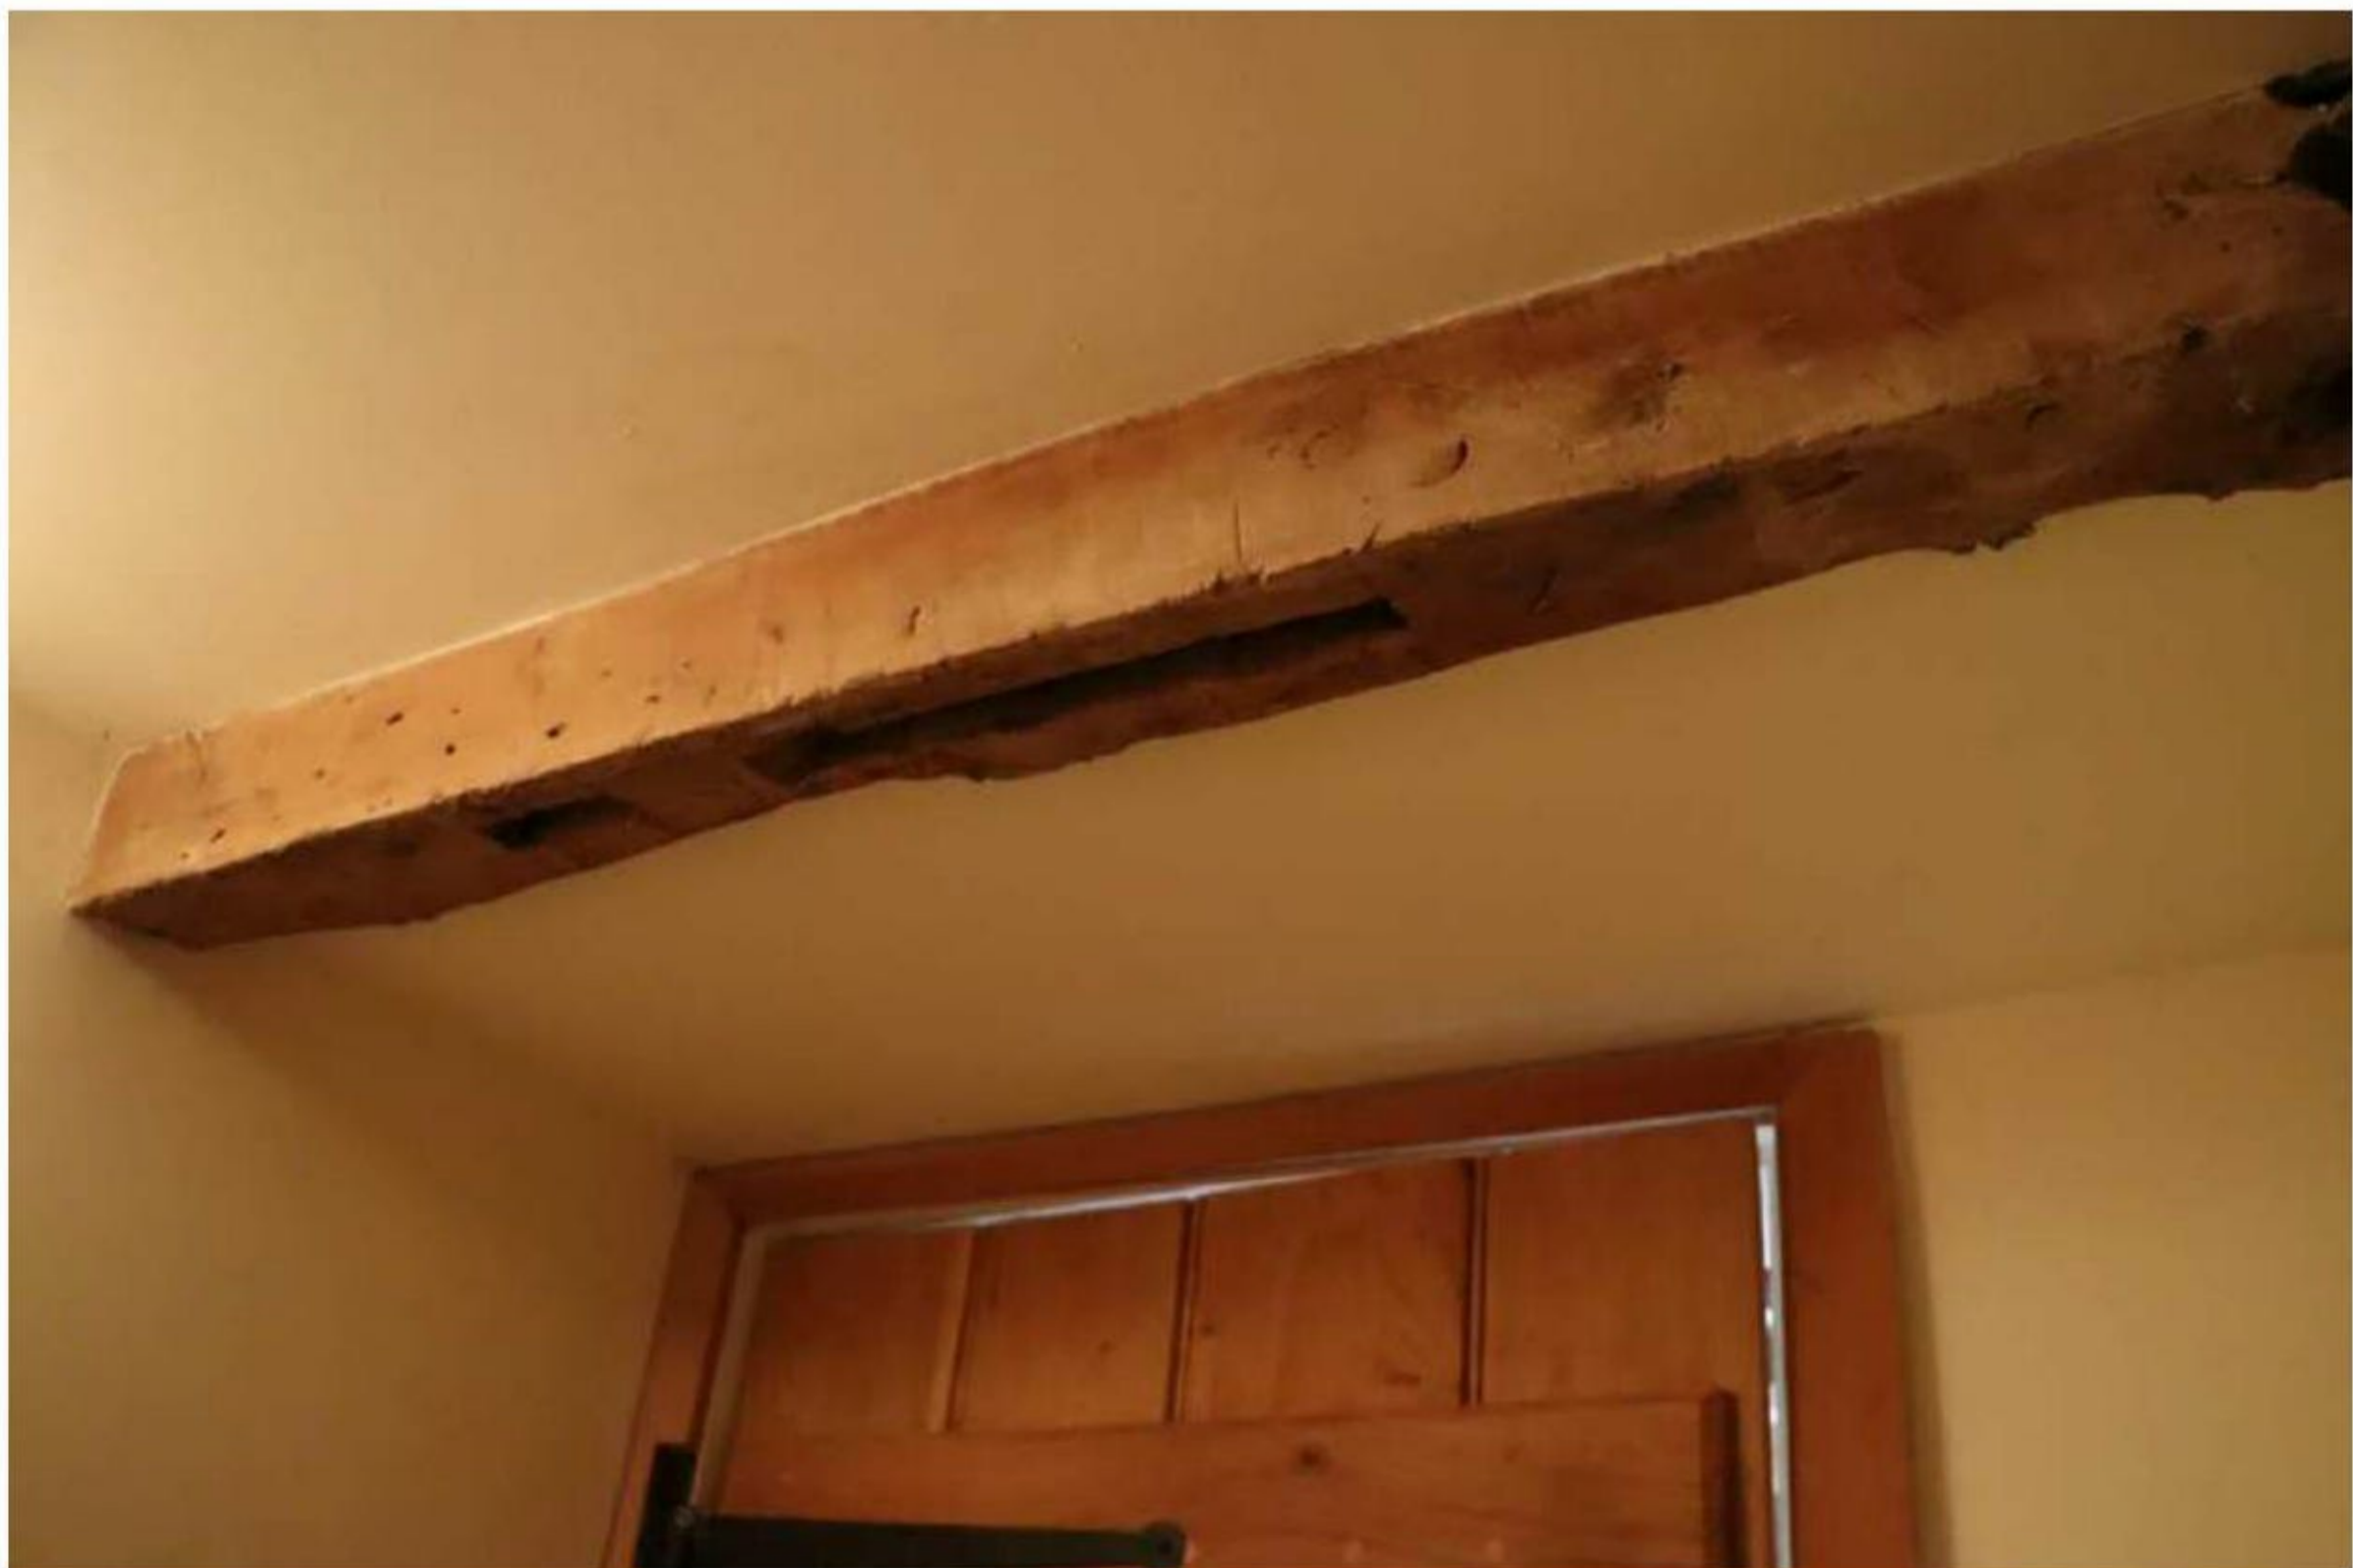
Plate 12: G1: original beam with empty mortises from the removal of the timber-framed wall dividing the northern from the central bay

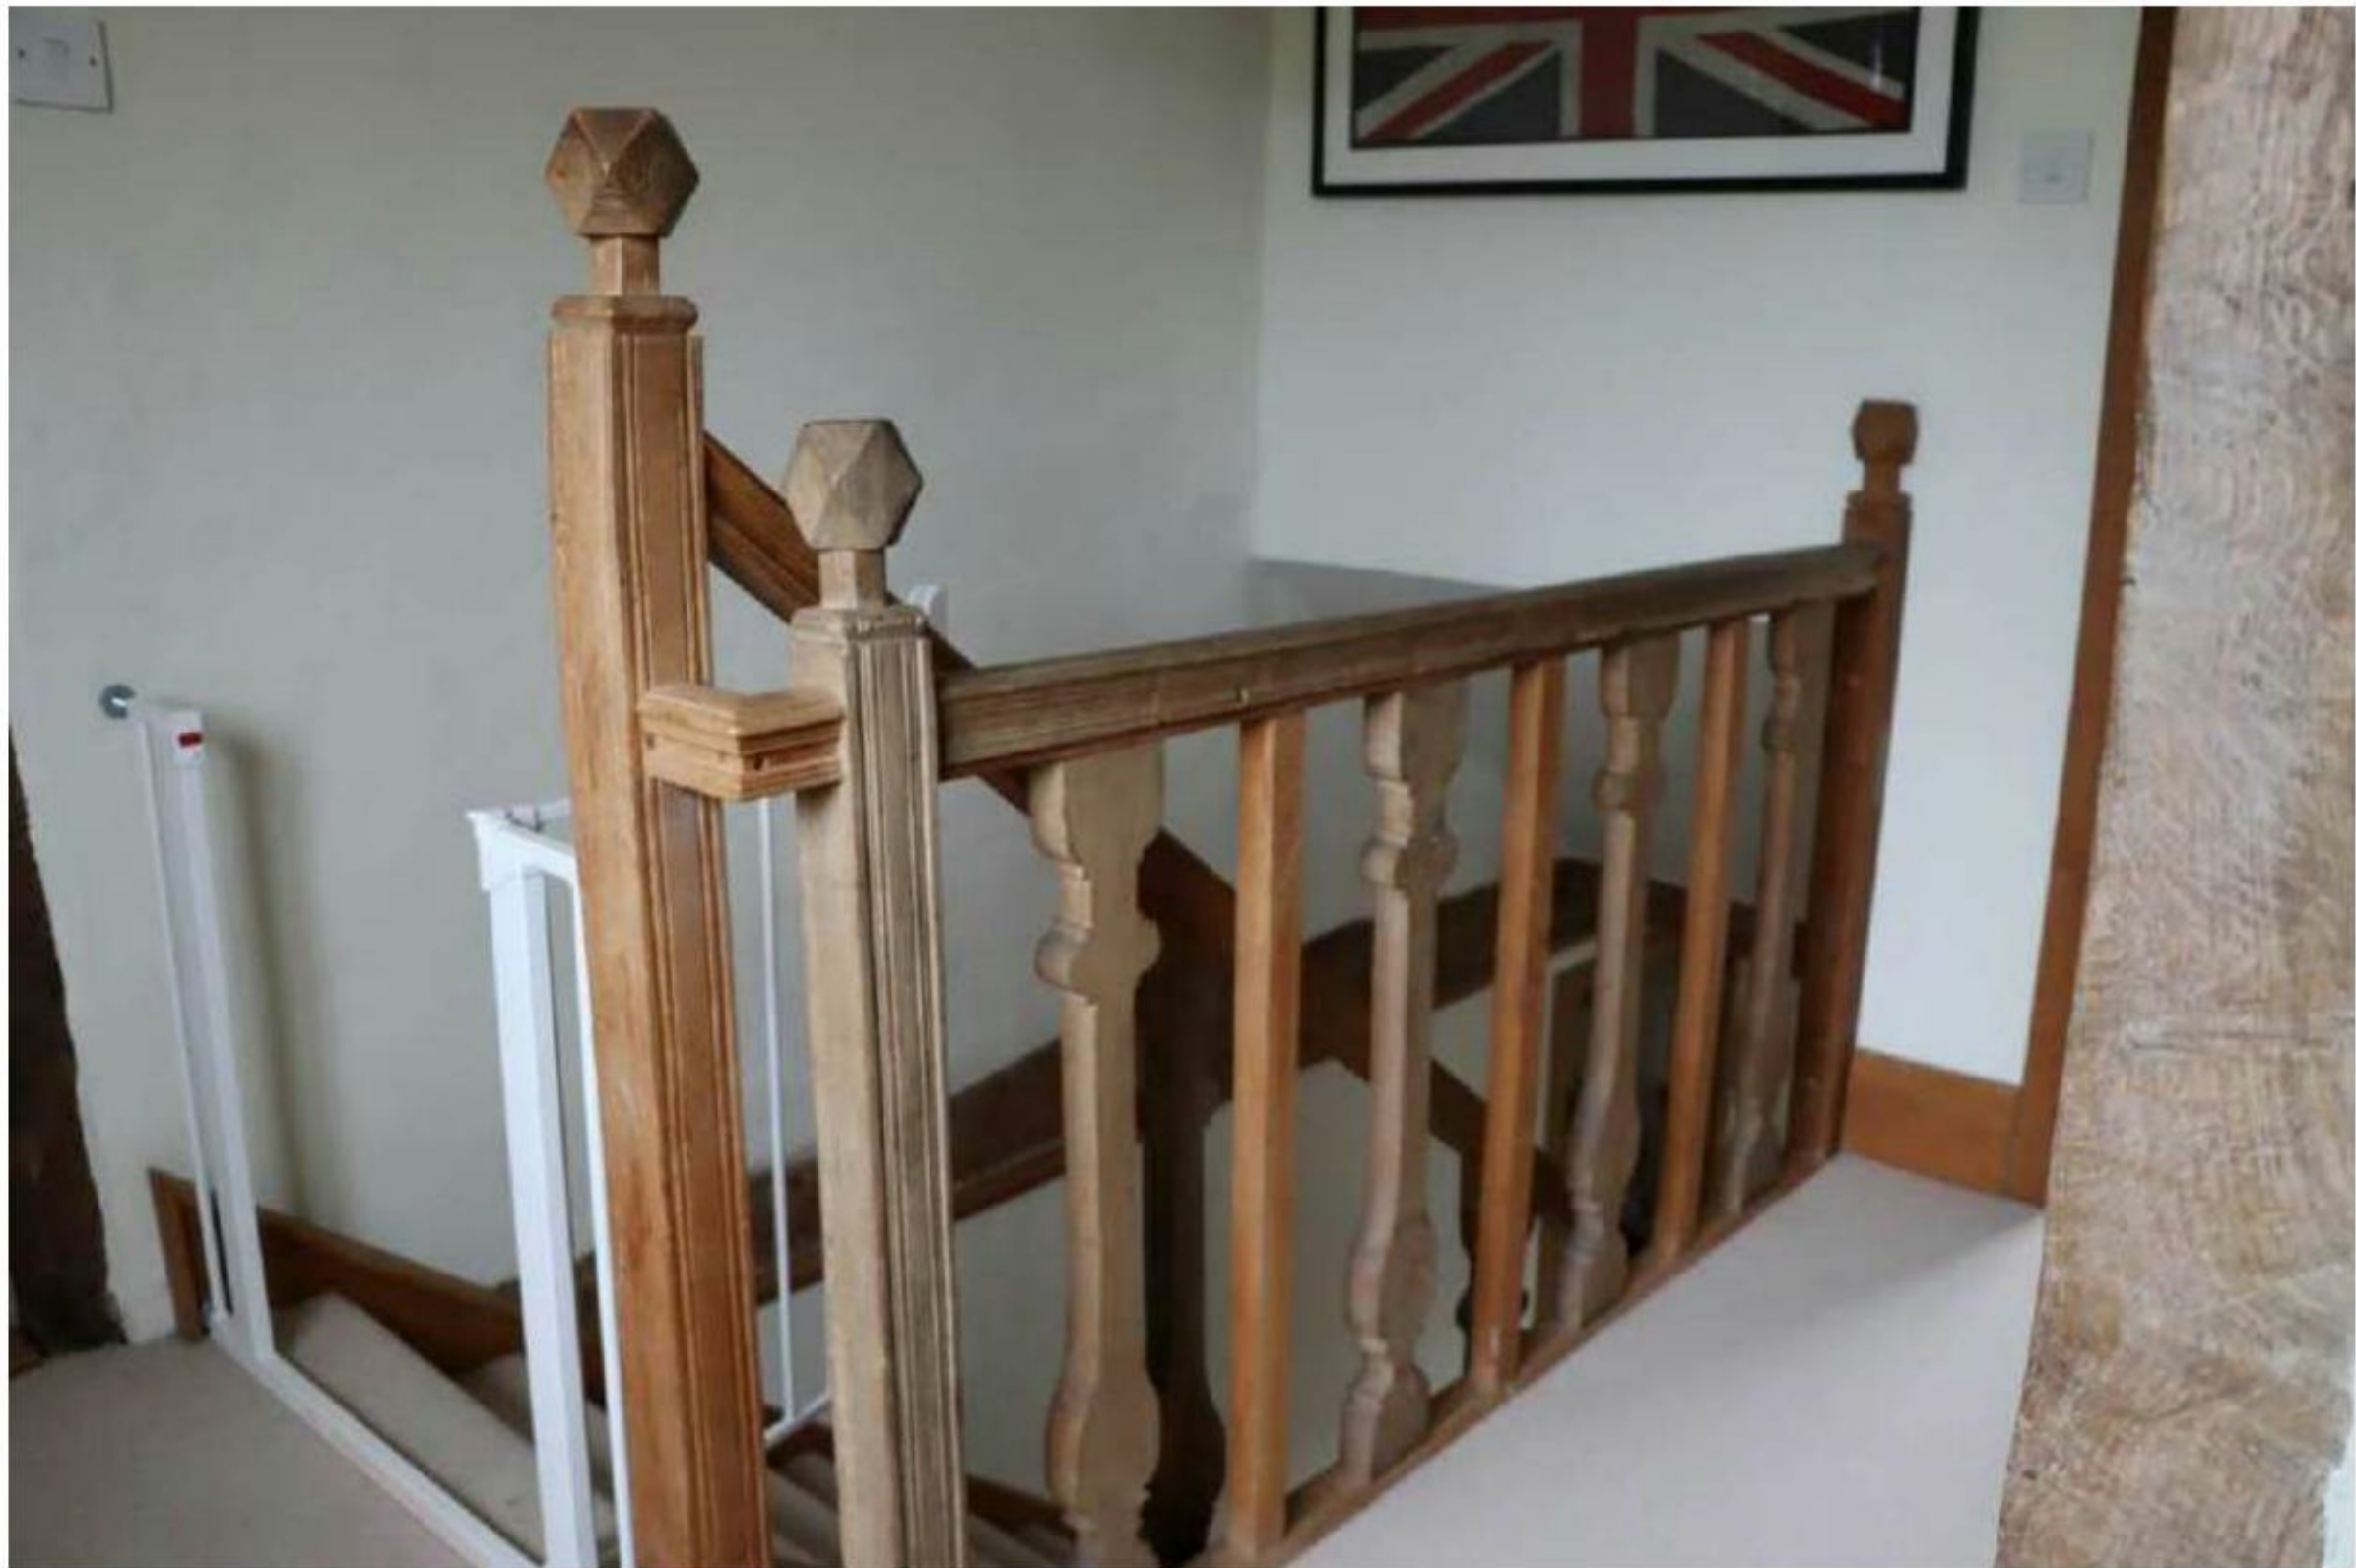
Plate 17: F1 (first-floor landing): note original newel and taller replica, original section of handrail and splat balusters

- 3.1.15 In G2 and G4, some of the exposed joists are historic and others are 1950s' replacements (**Plate 14**). The staircase, although of the 1950s, reuses the 17th-century thick splat balusters from the original stairhead balustrade (the rest of the staircase was enclosed by brick walls; see **Photos Z-C1 & X1-A2**) and at least one, if not two of the newel posts and a section of moulded handrail, are original. The original newel type is a square profile post with linear moulding to two sides, and a polyhedron finial (**Plates 15-18**).
