STATEMENT OF SIGNIFICANCE

**Flood Street Farm,
Breamore, Hampshire**

Mr & Mrs Bolt

Date: April 2021

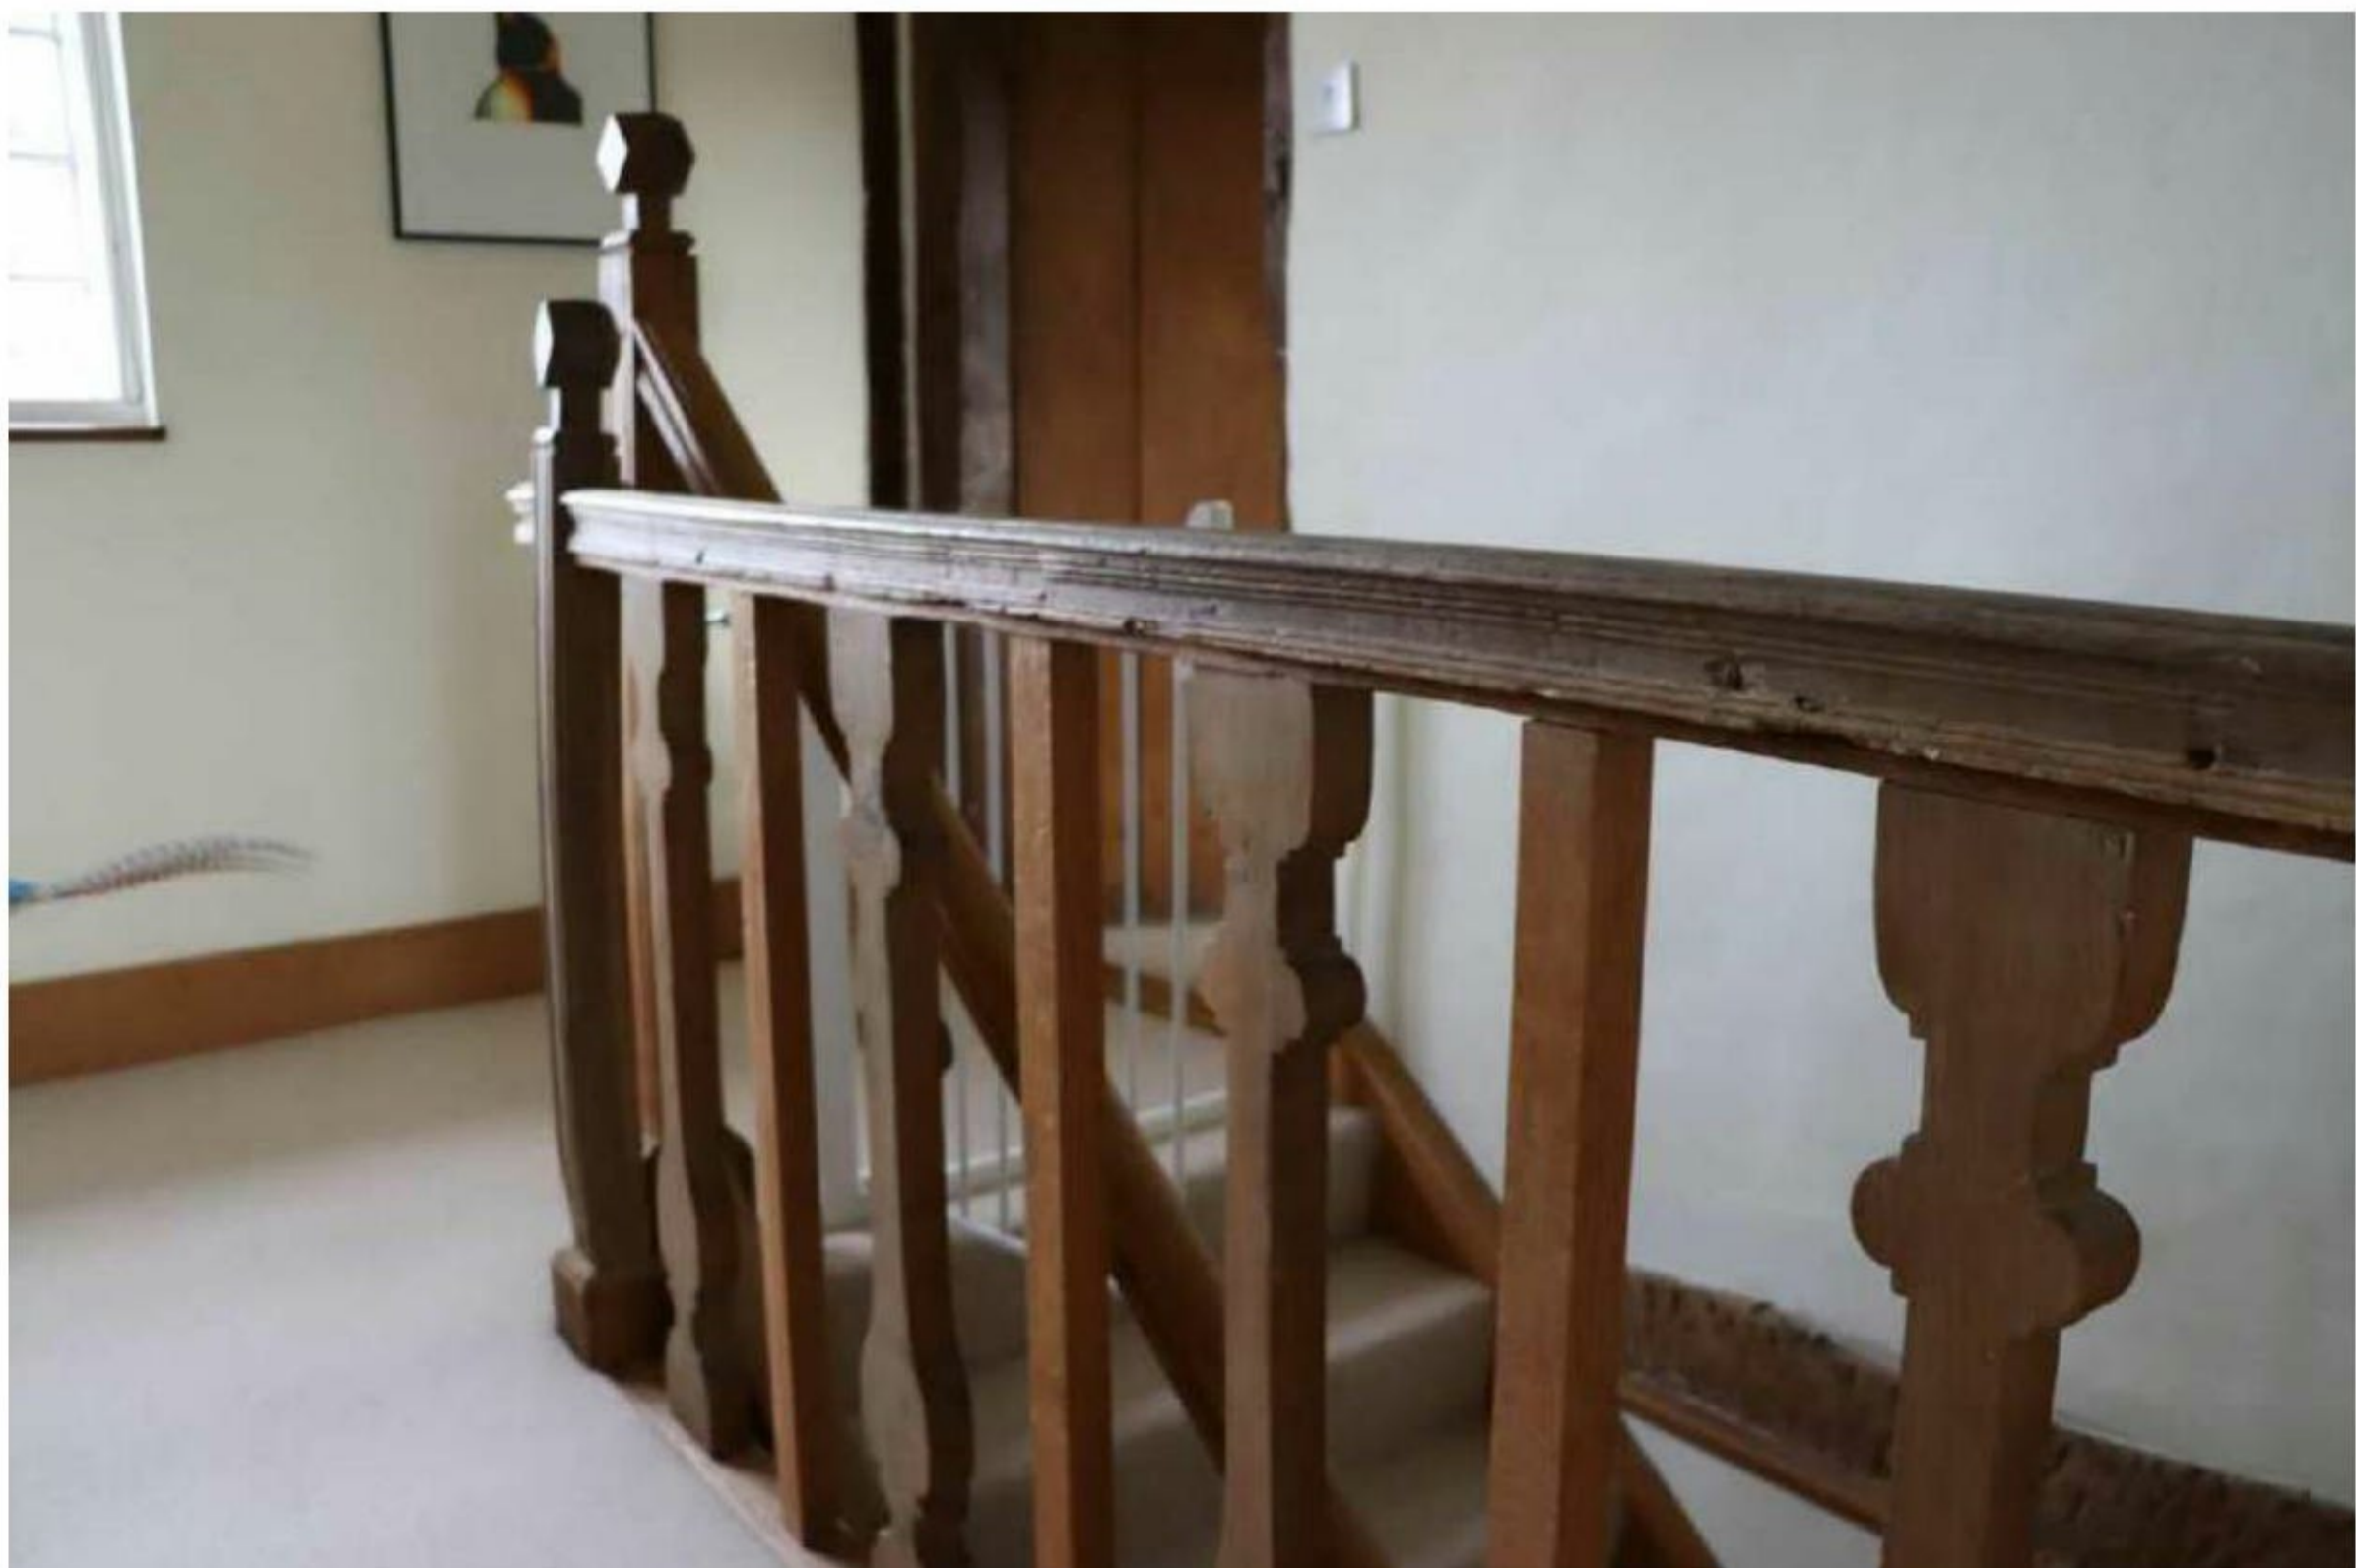
Plate 18: Original section of handrail, newel and splat balusters

- 3.1.15 In G2 and G4, some of the exposed joists are historic and others are 1950s' replacements (**Plate 14**). The staircase, although of the 1950s, reuses the 17th-century thick splat balusters from the original stairhead balustrade (the rest of the staircase was enclosed by brick walls; see **Photos Z-C1 & X1-A2**) and at least one, if not two of the newel posts and a section of moulded handrail, are original. The original newel type is a square profile post with linear moulding to two sides, and a polyhedron finial (**Plates 15-18**).

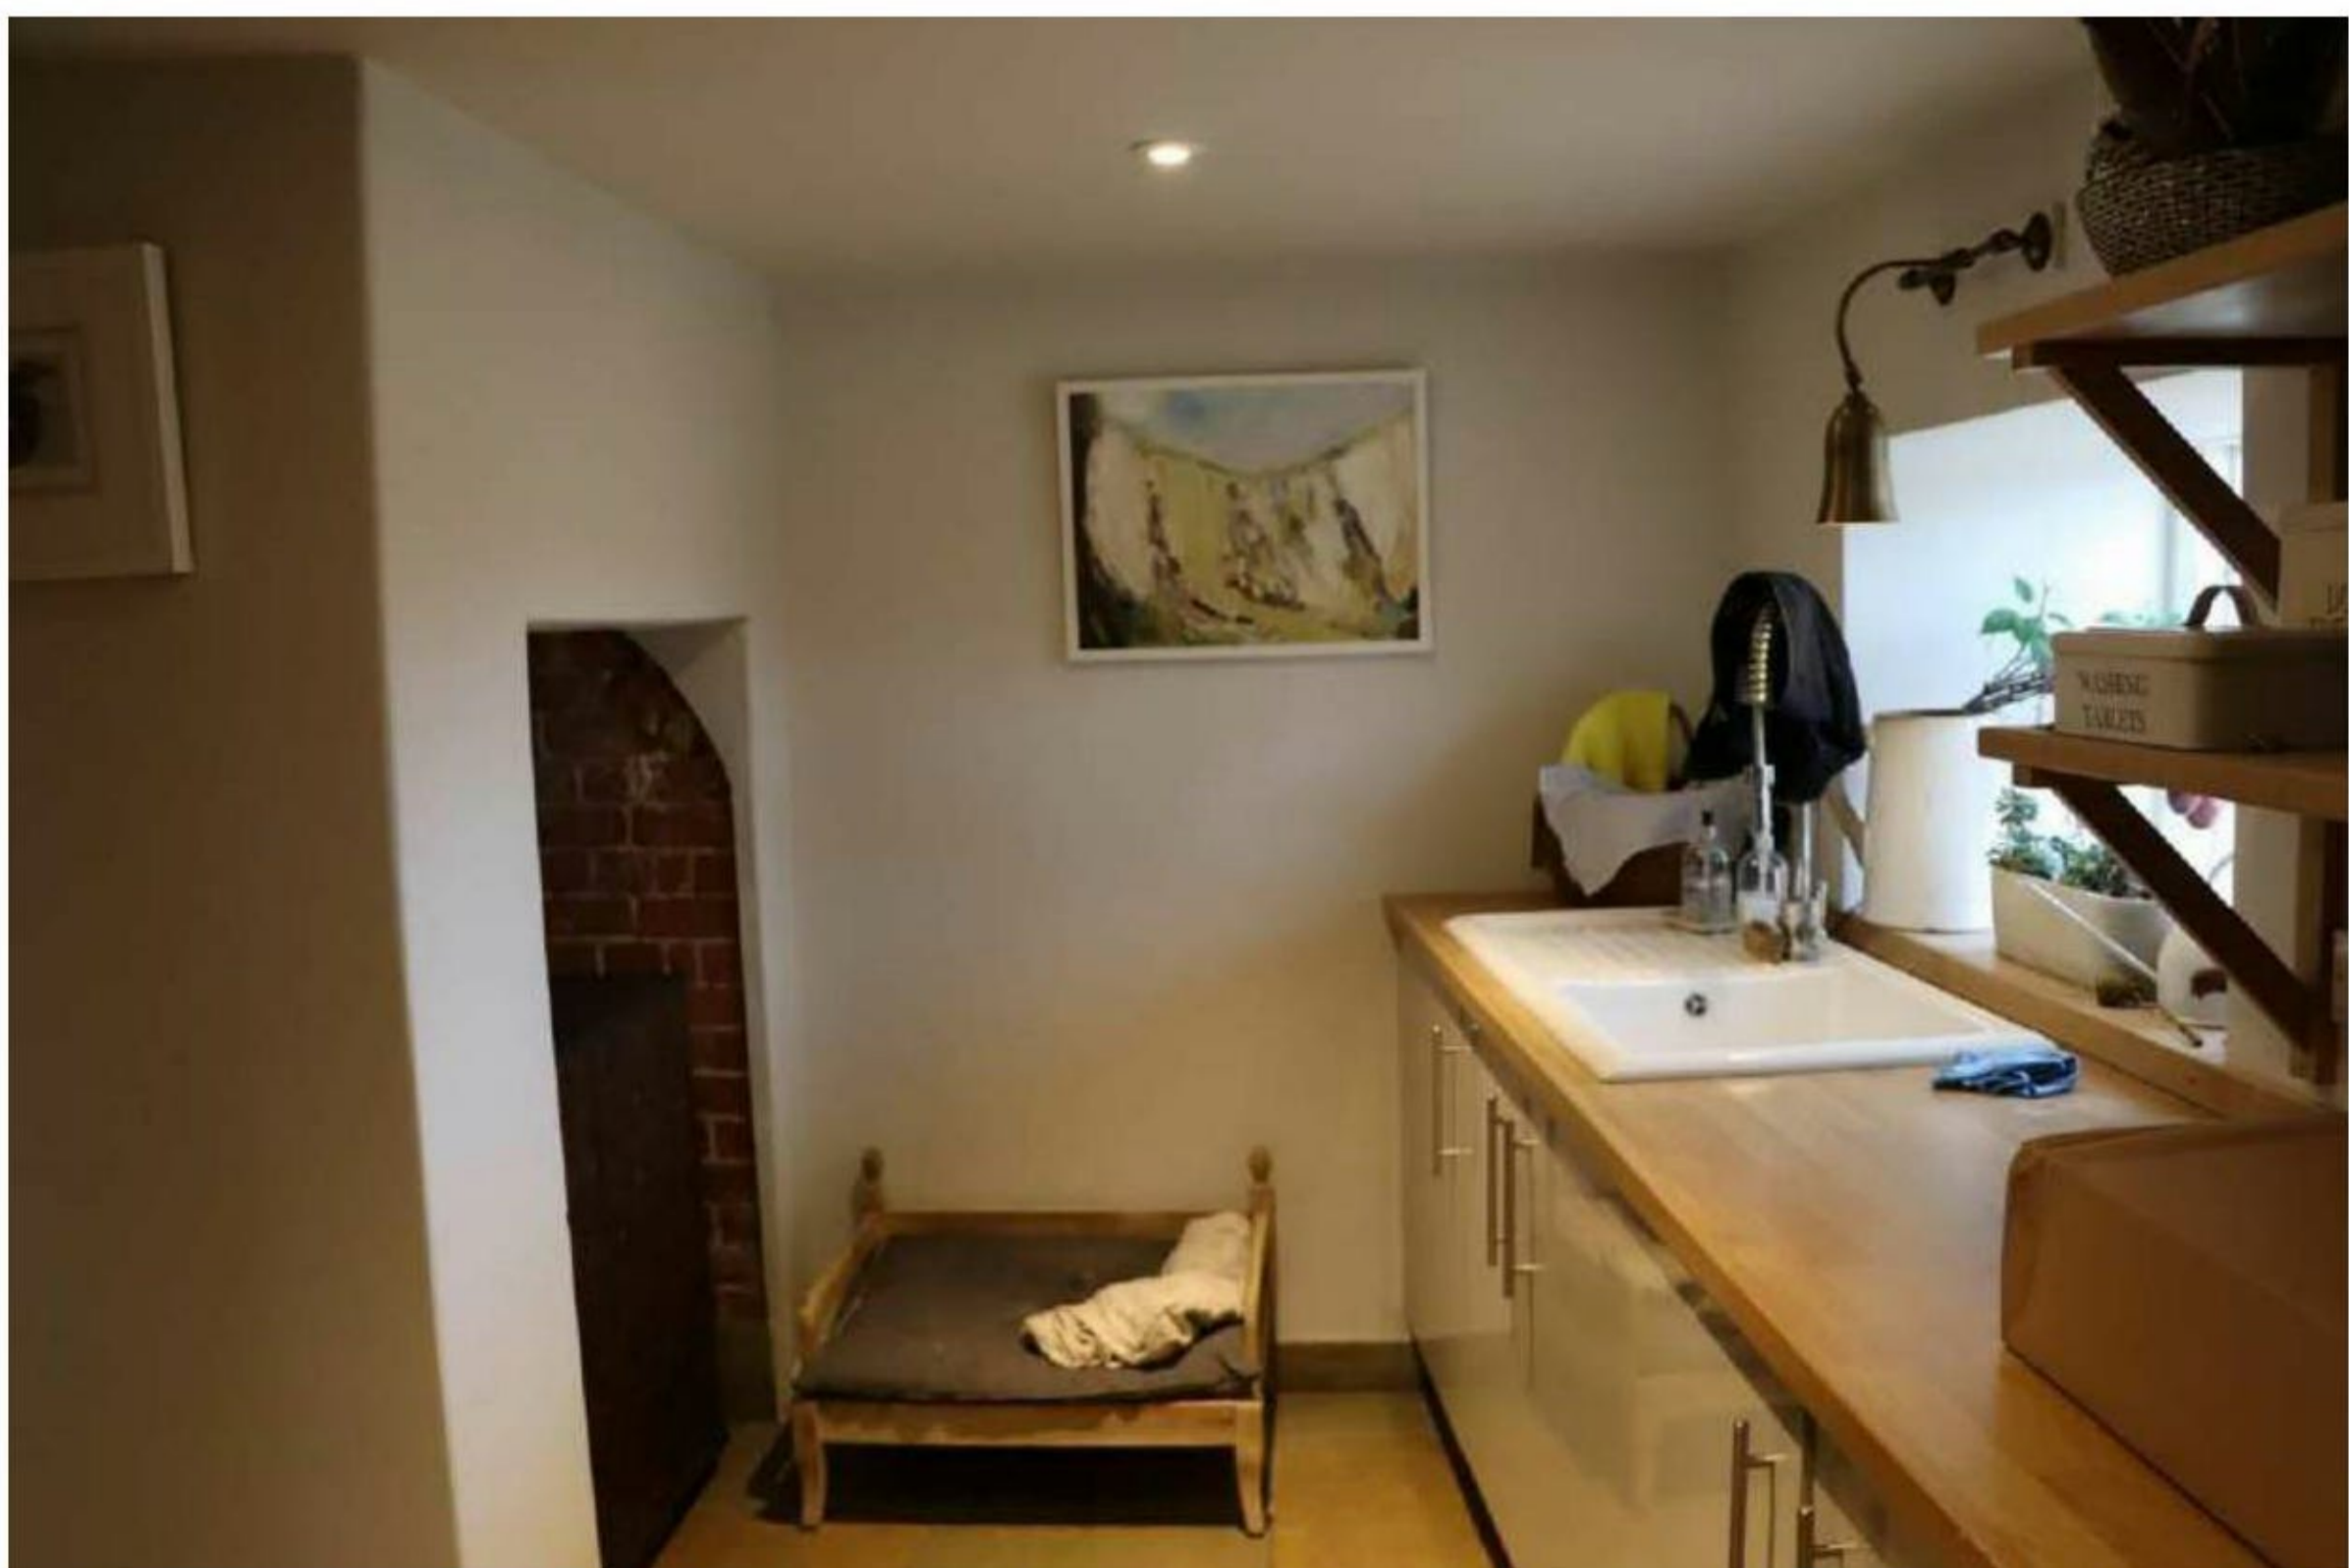
Plate 24: G6, with fireplace on NW wall

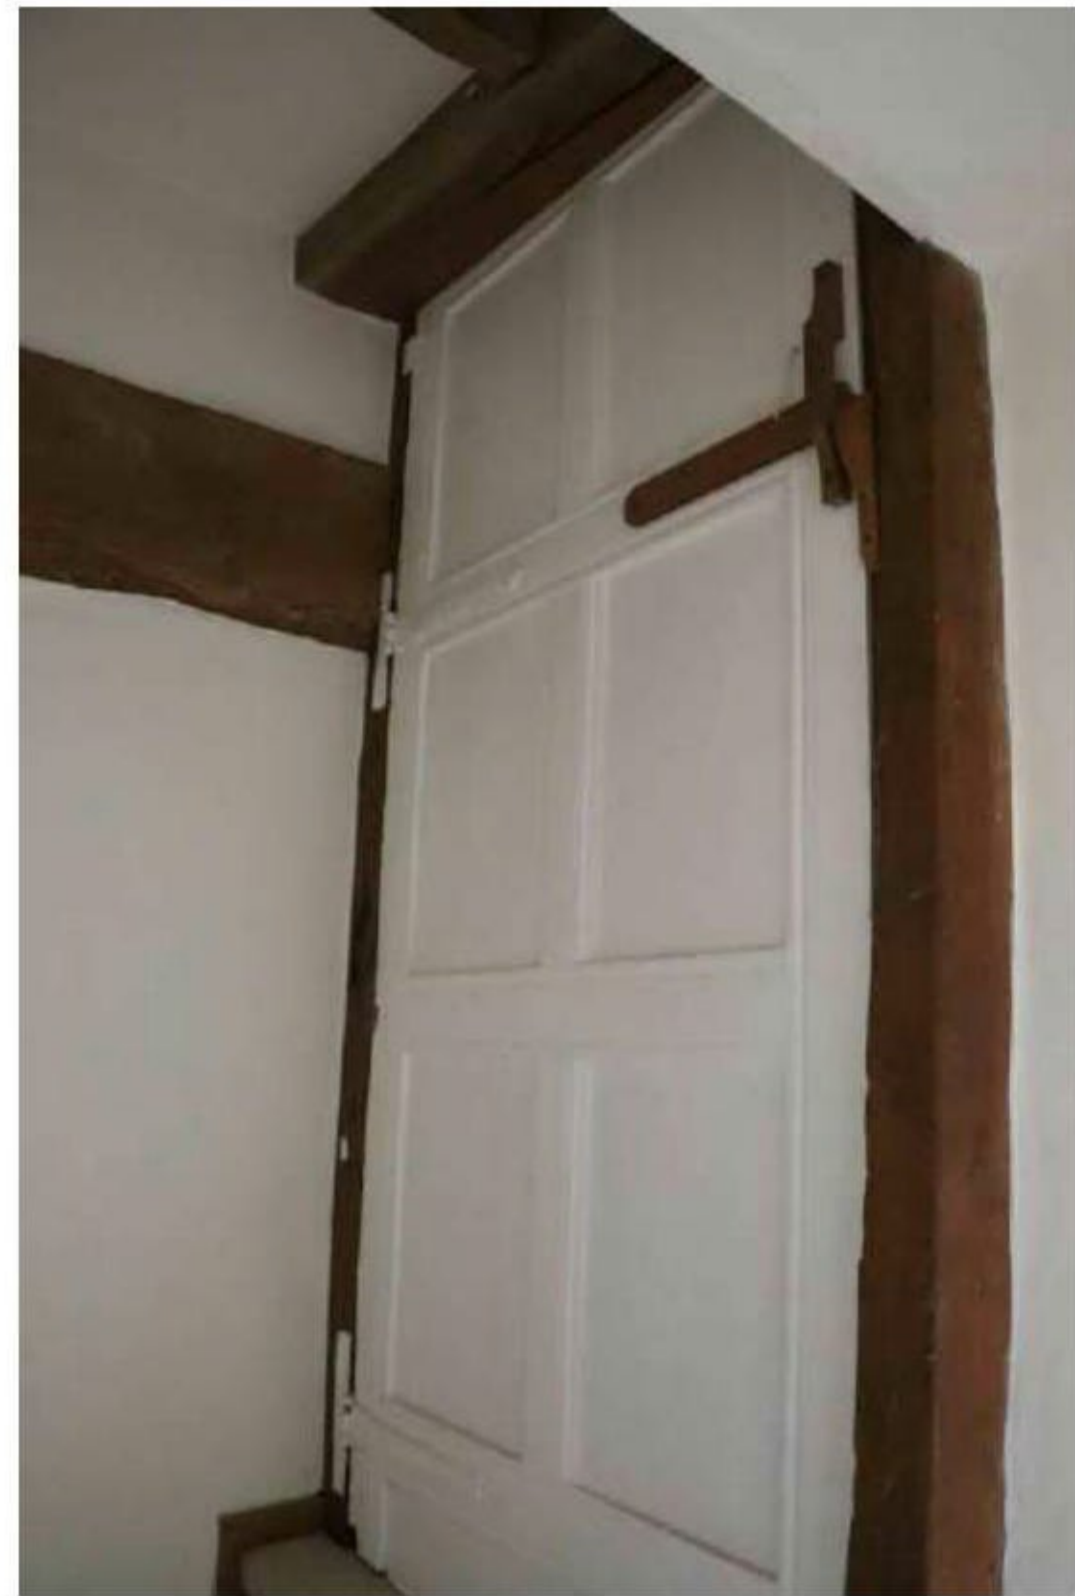
Plate 27: 17th-century door to attic stairs

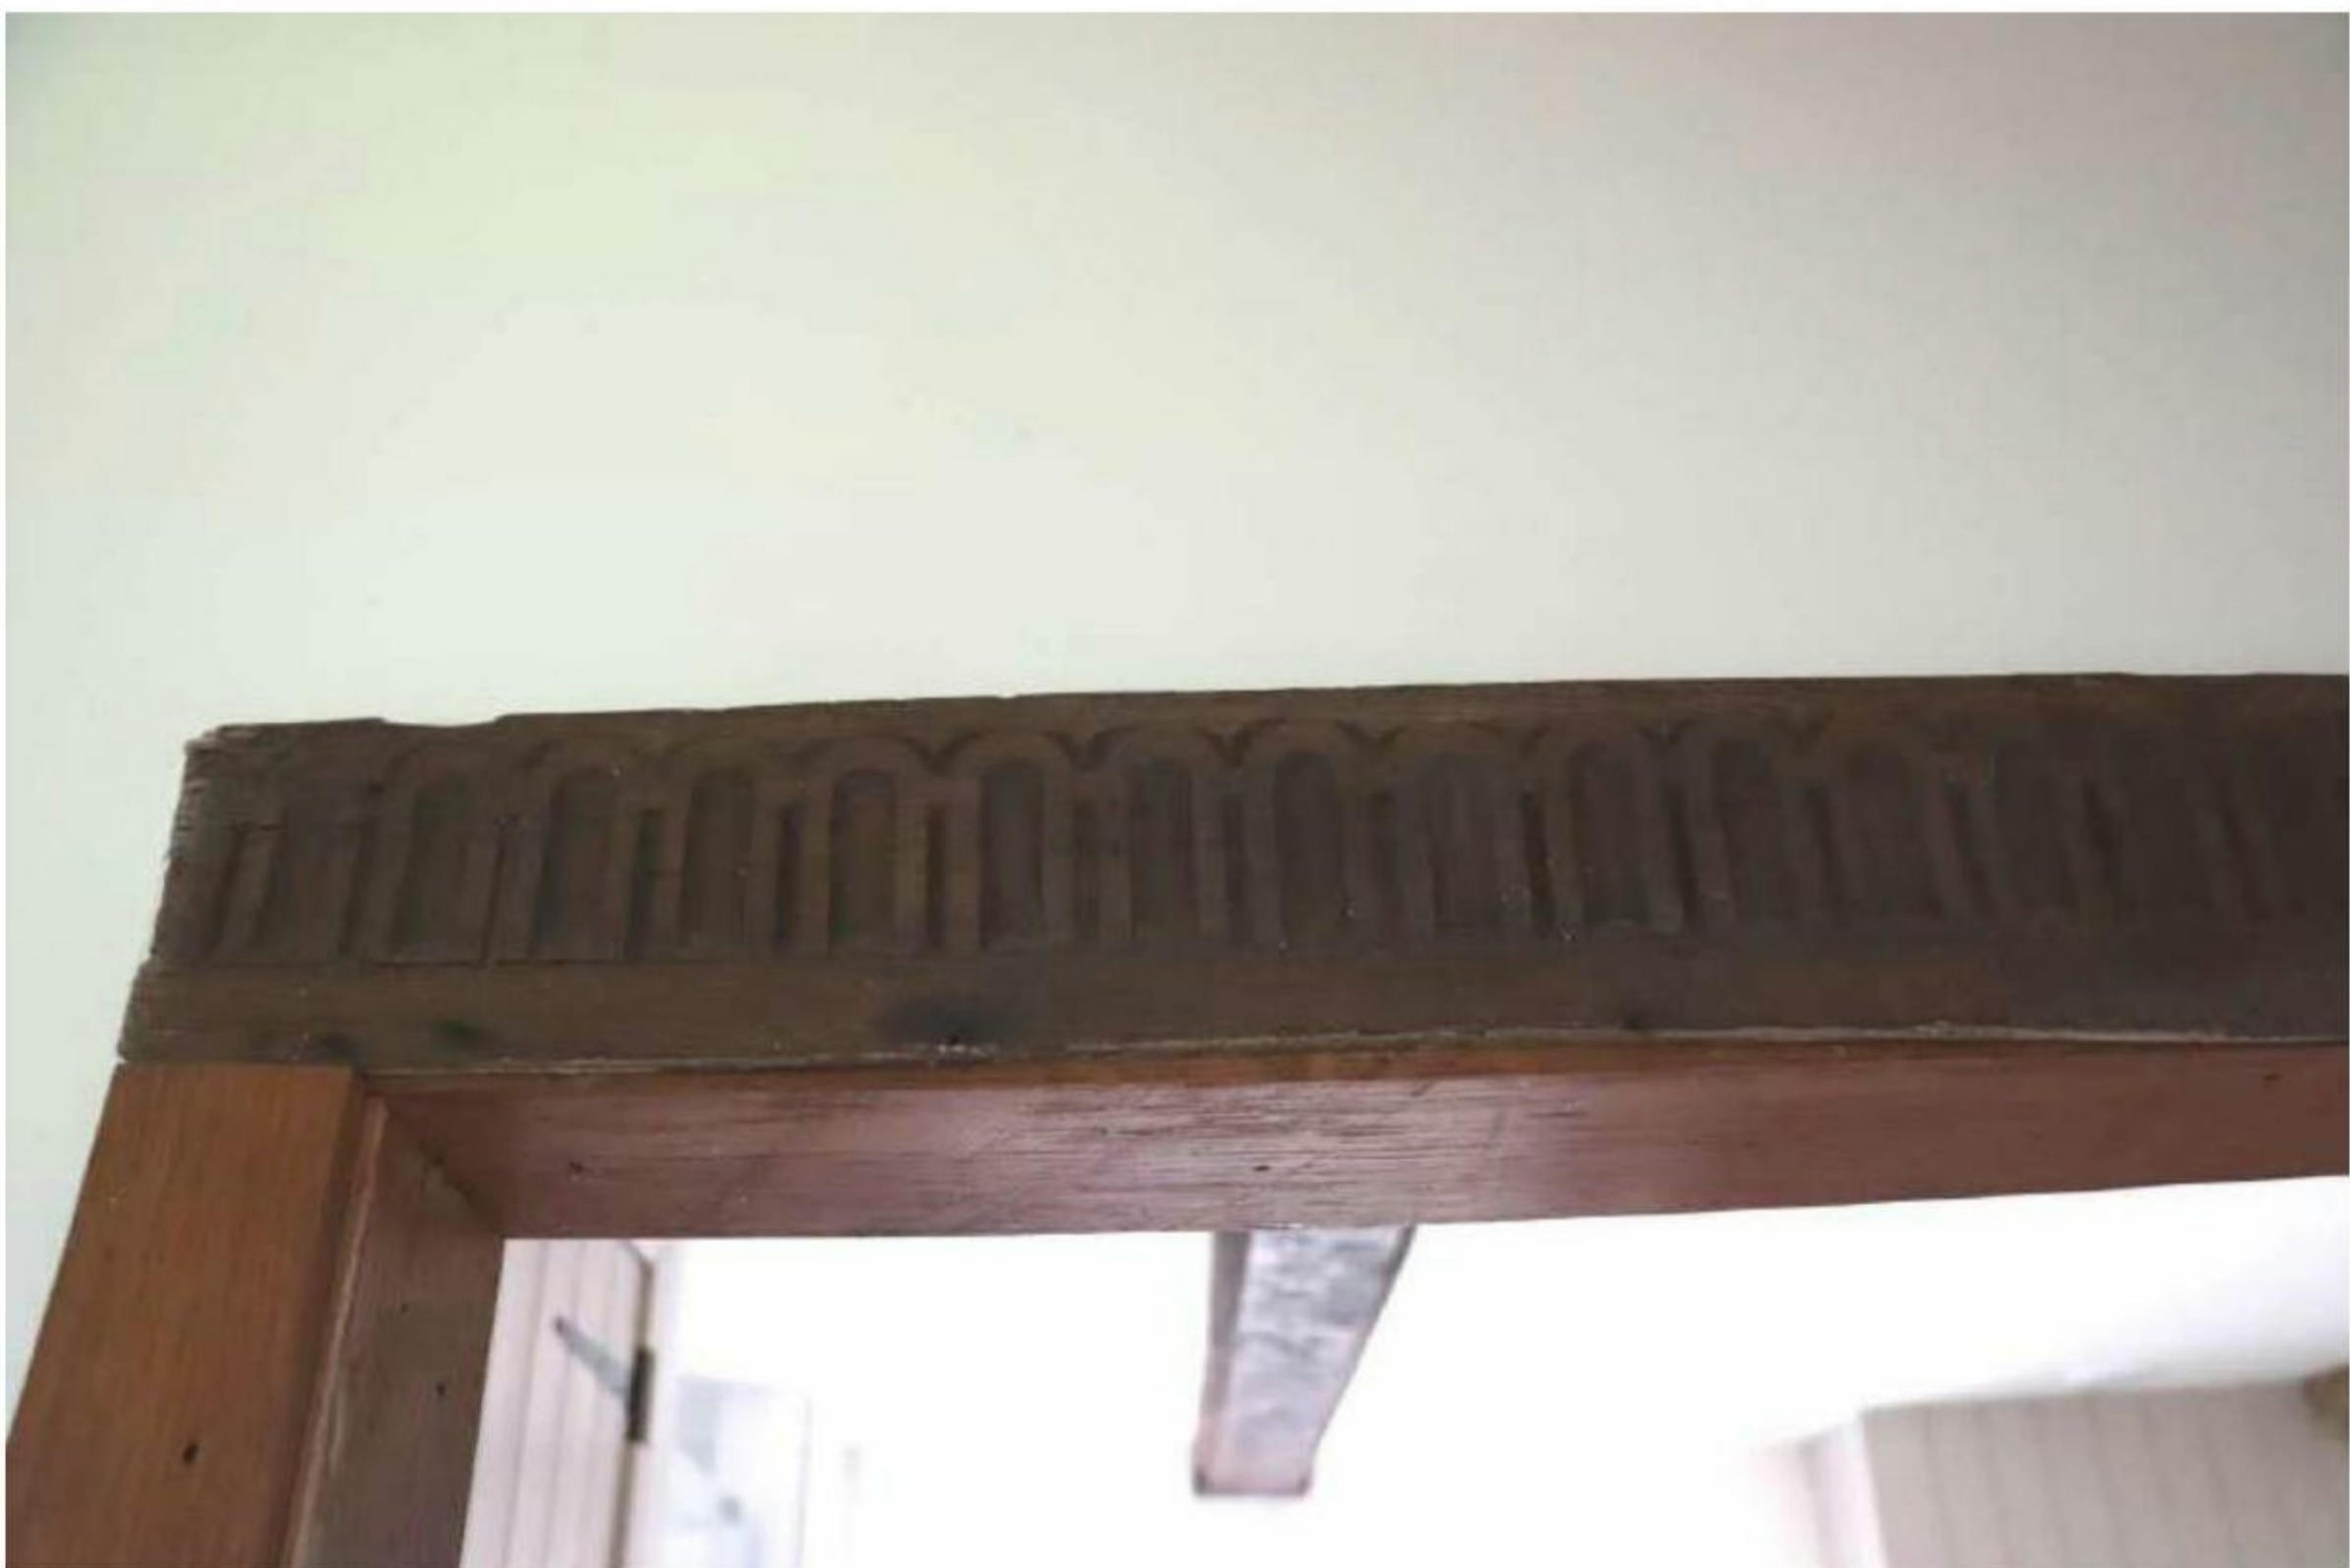
Plate 28: Carved arcading decoration over door into bathroom, F2

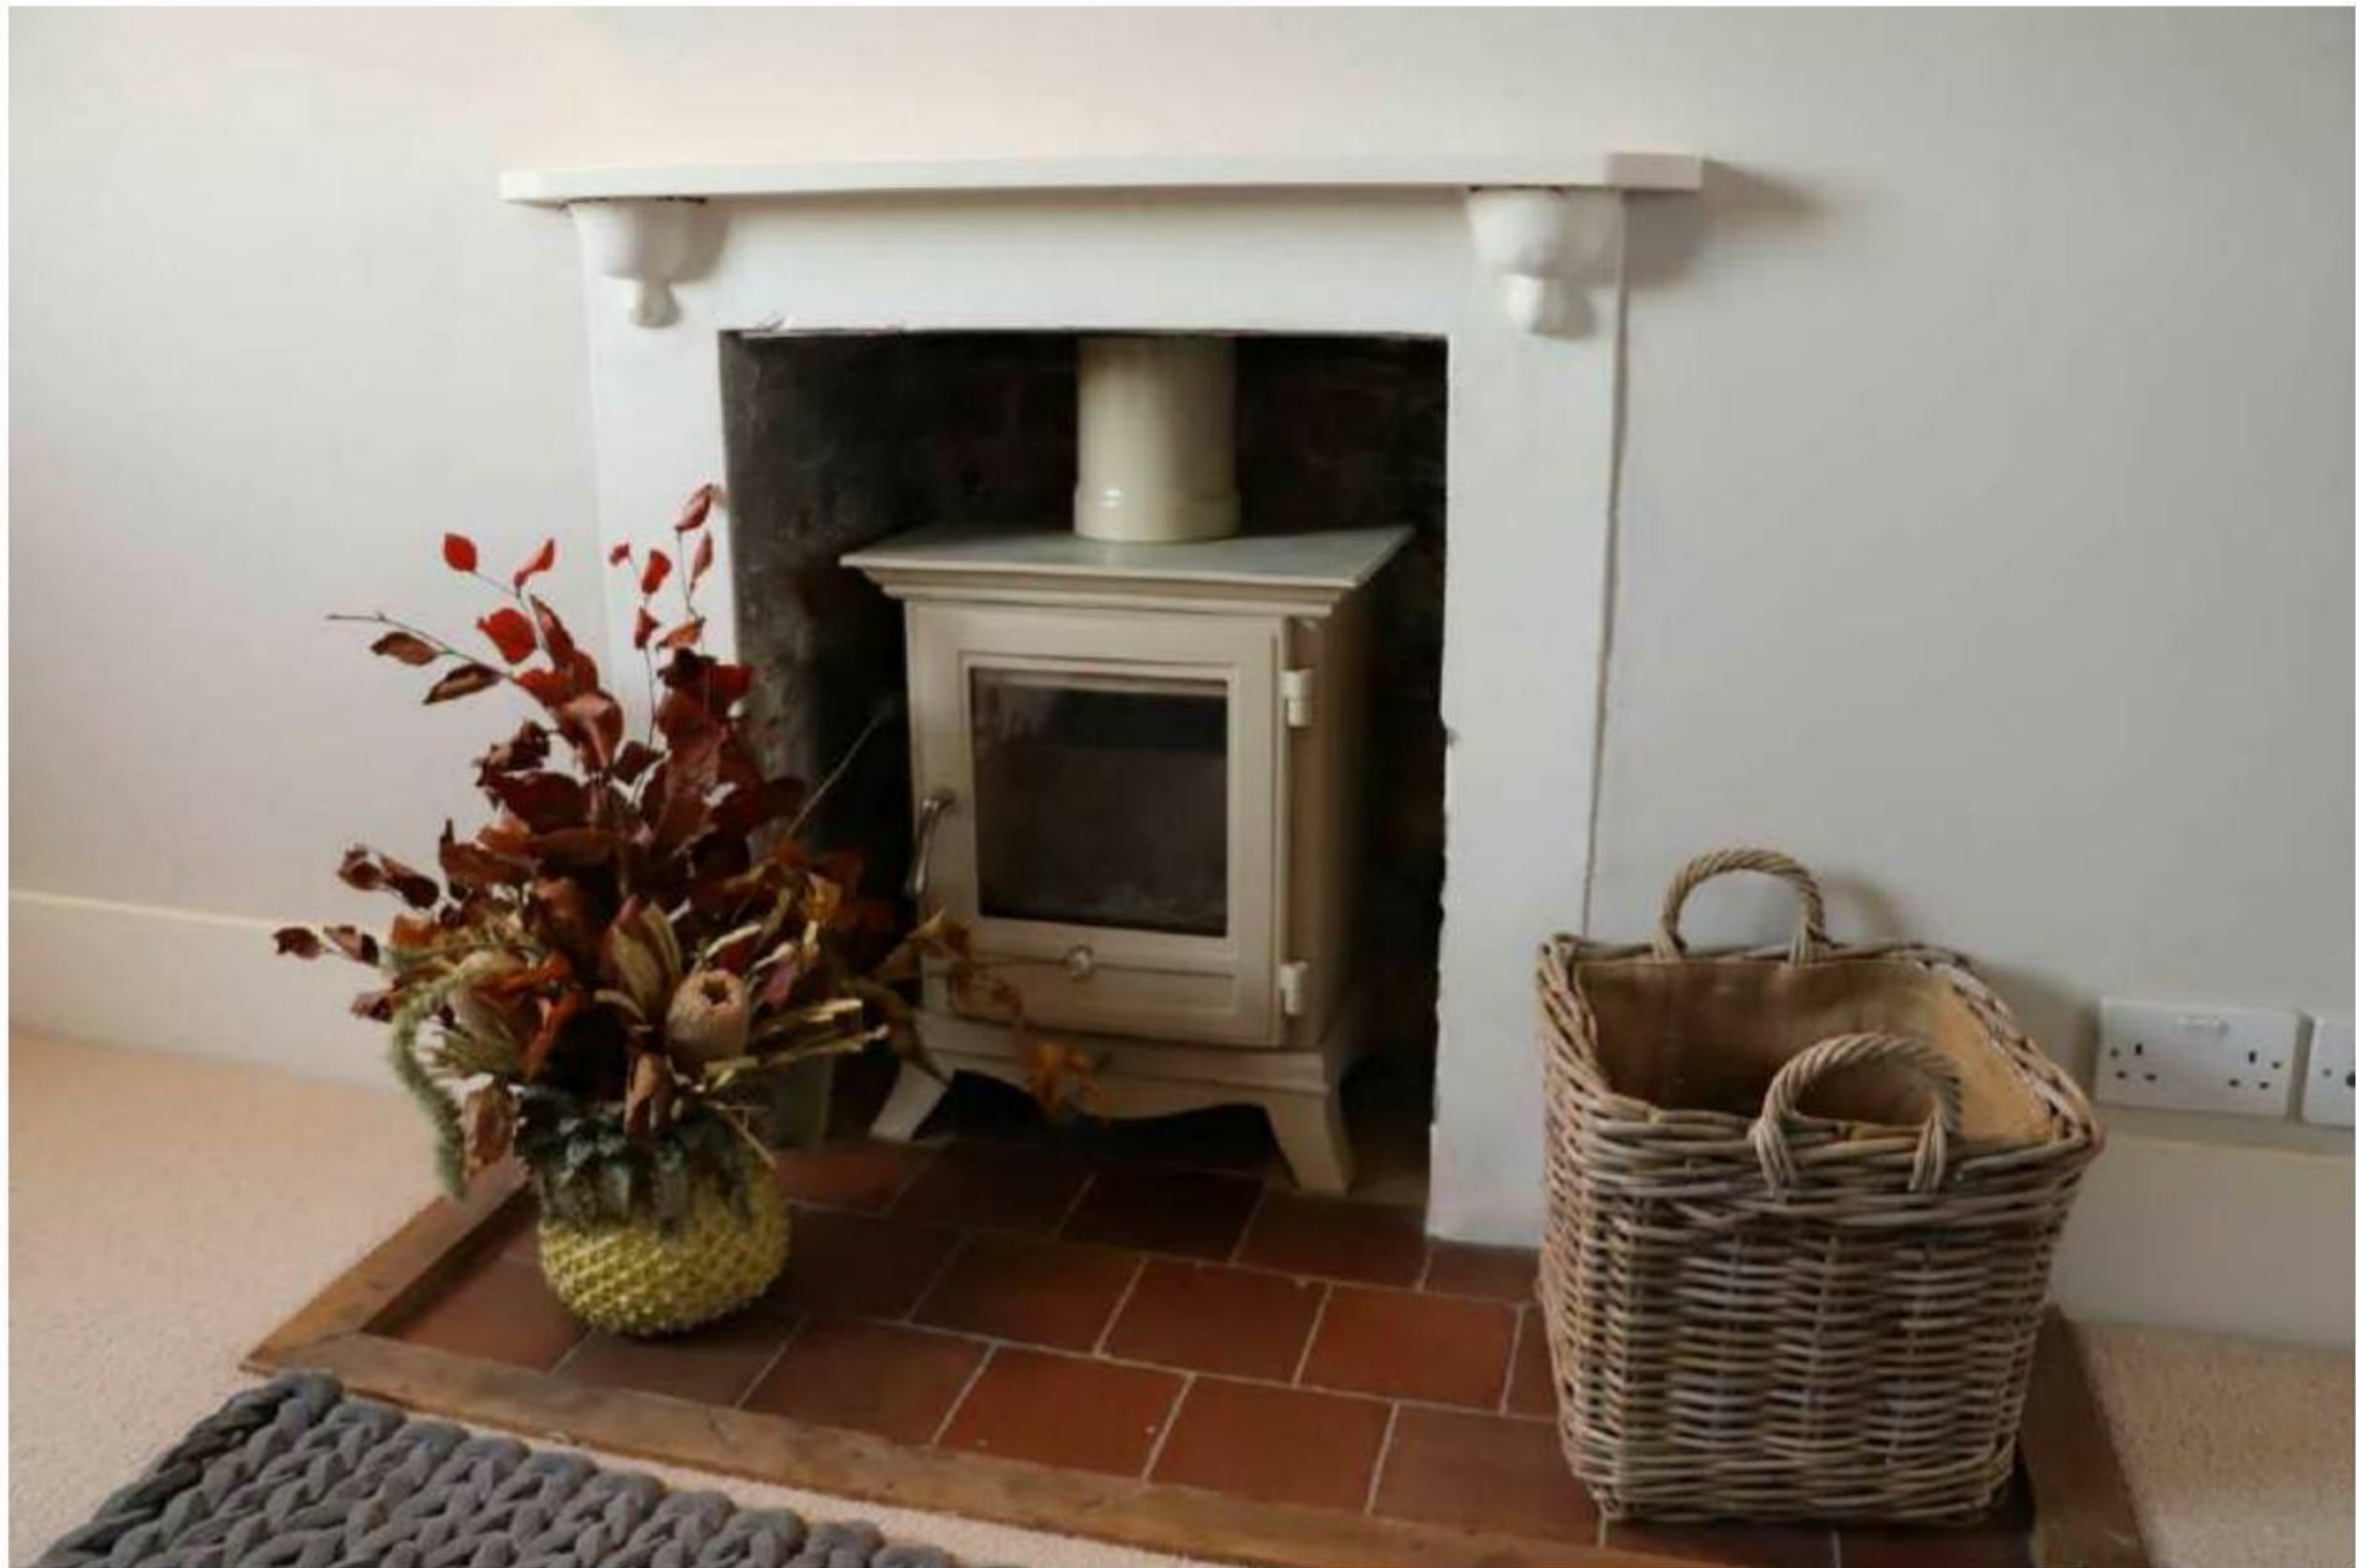
Plate 31: Fireplace on NE wall of F3

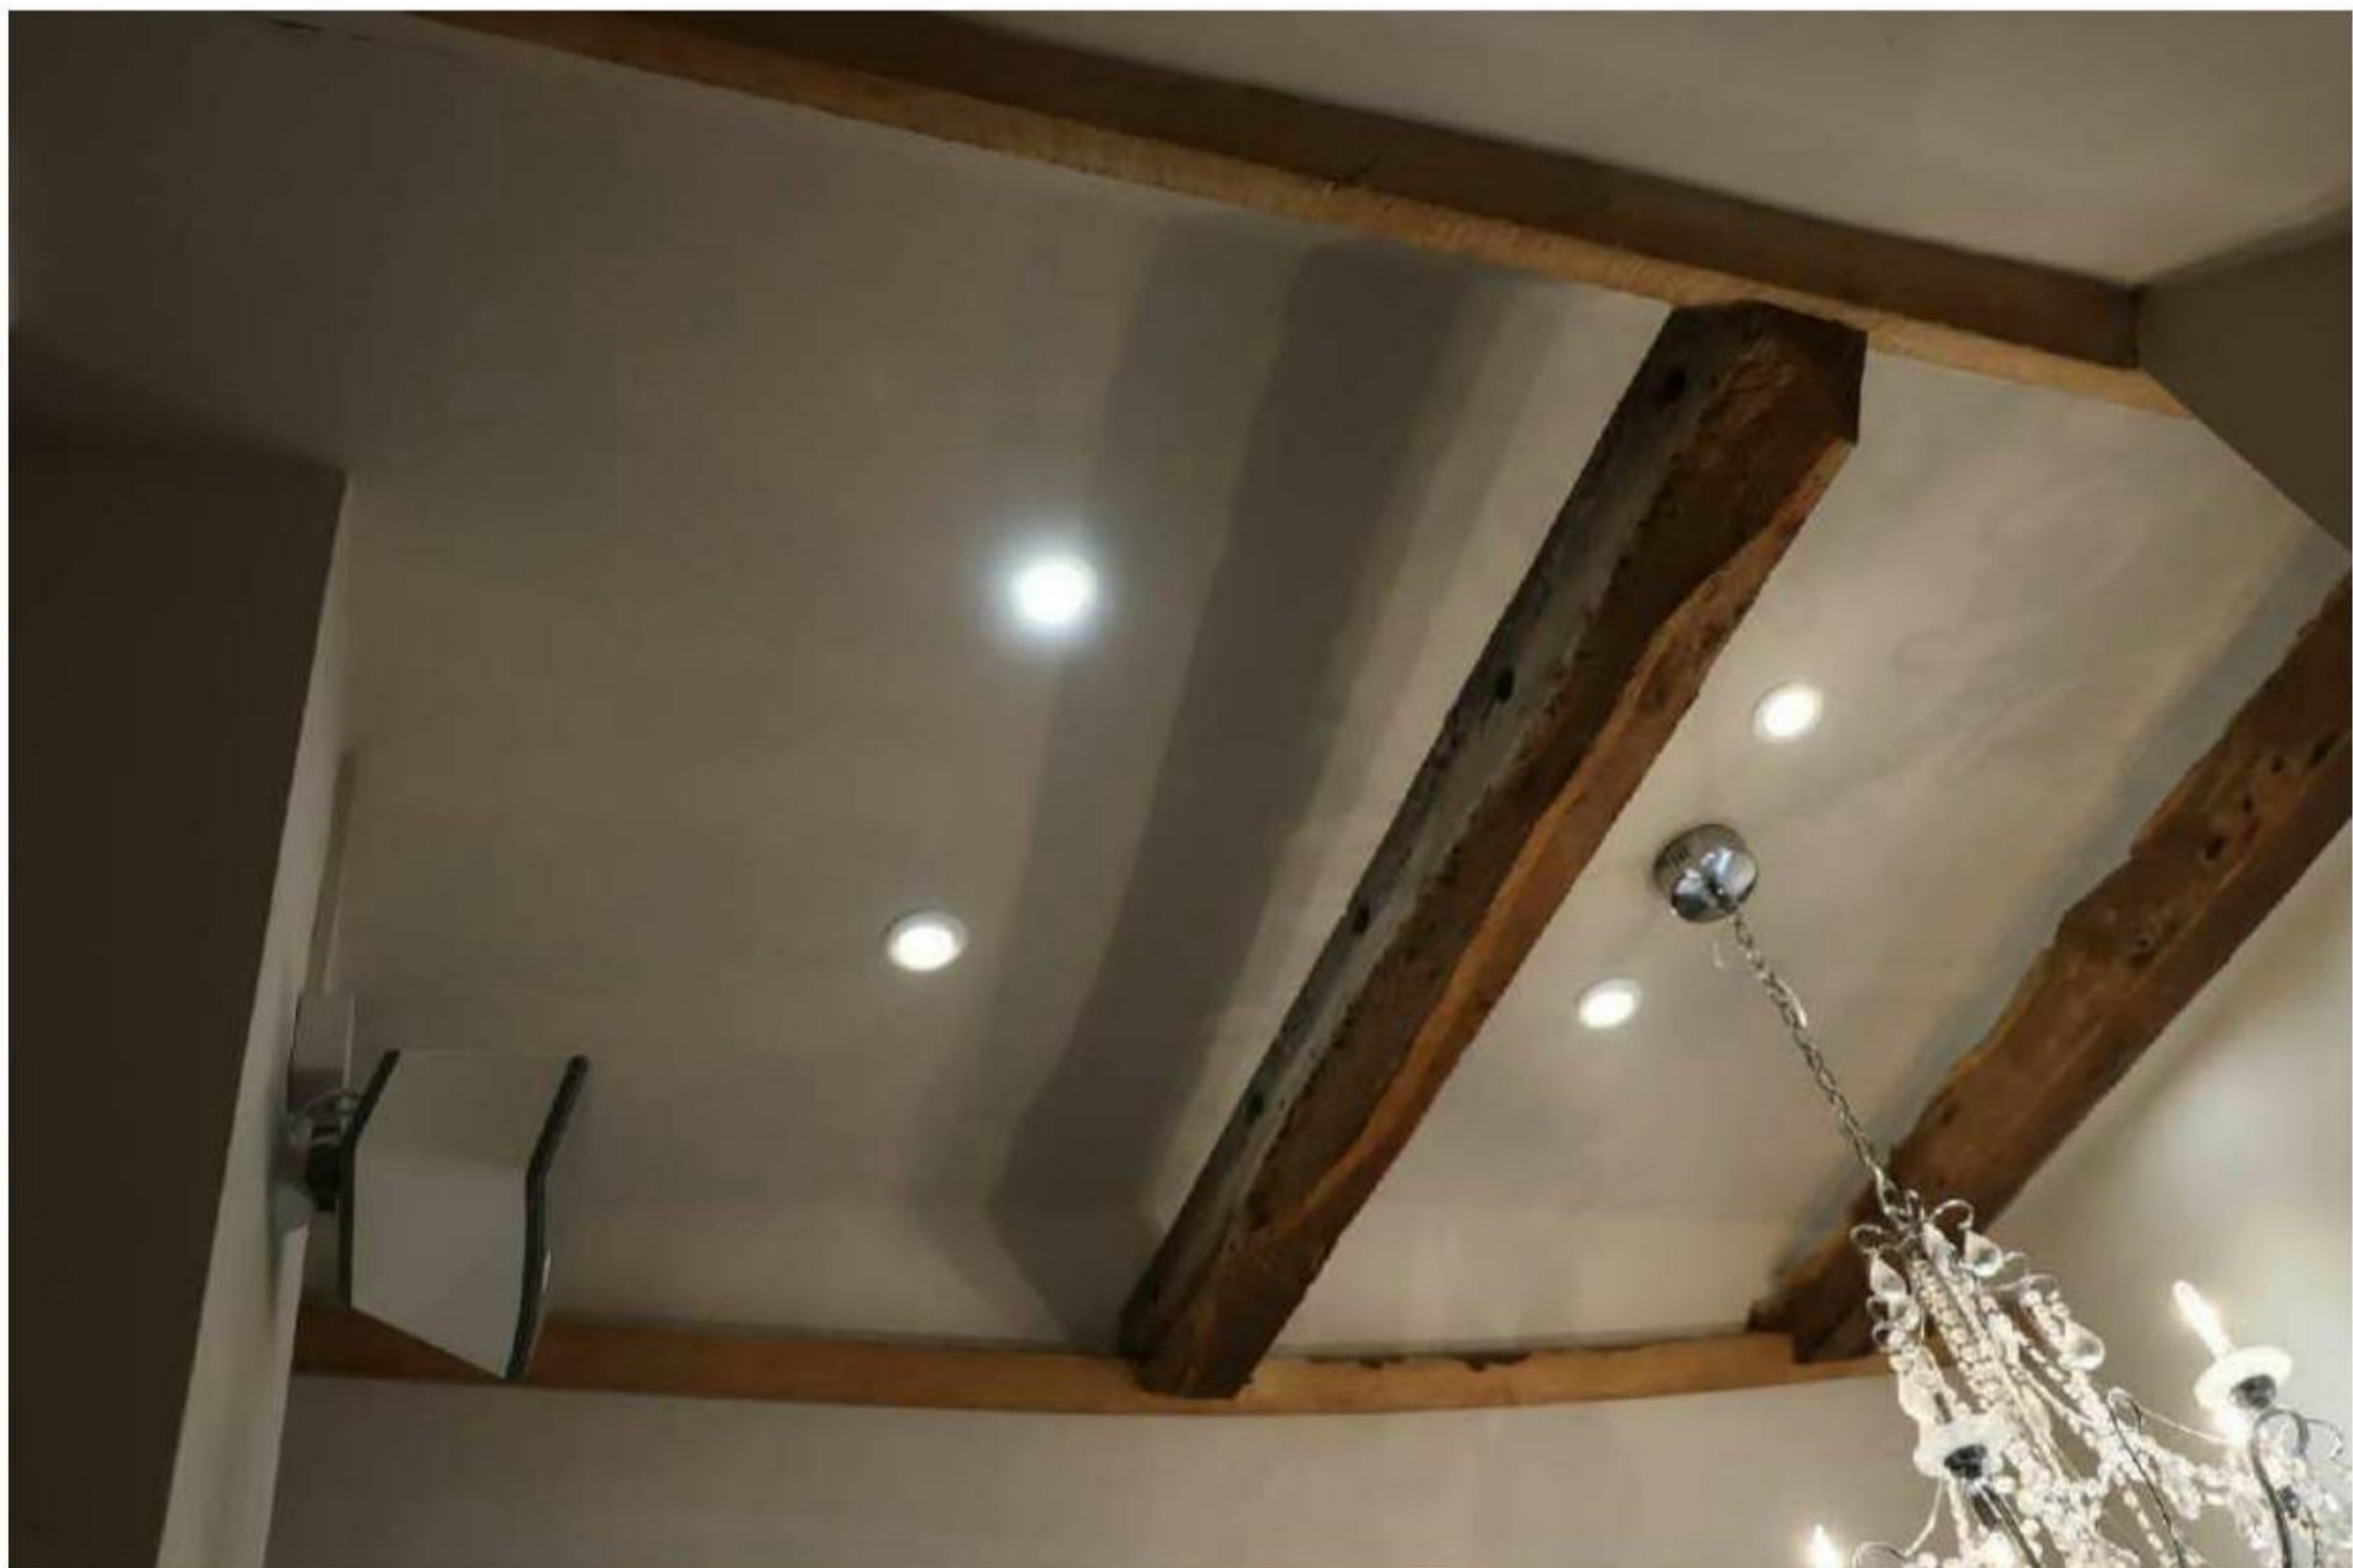
Plate 32: Exposed roof timbers in F4

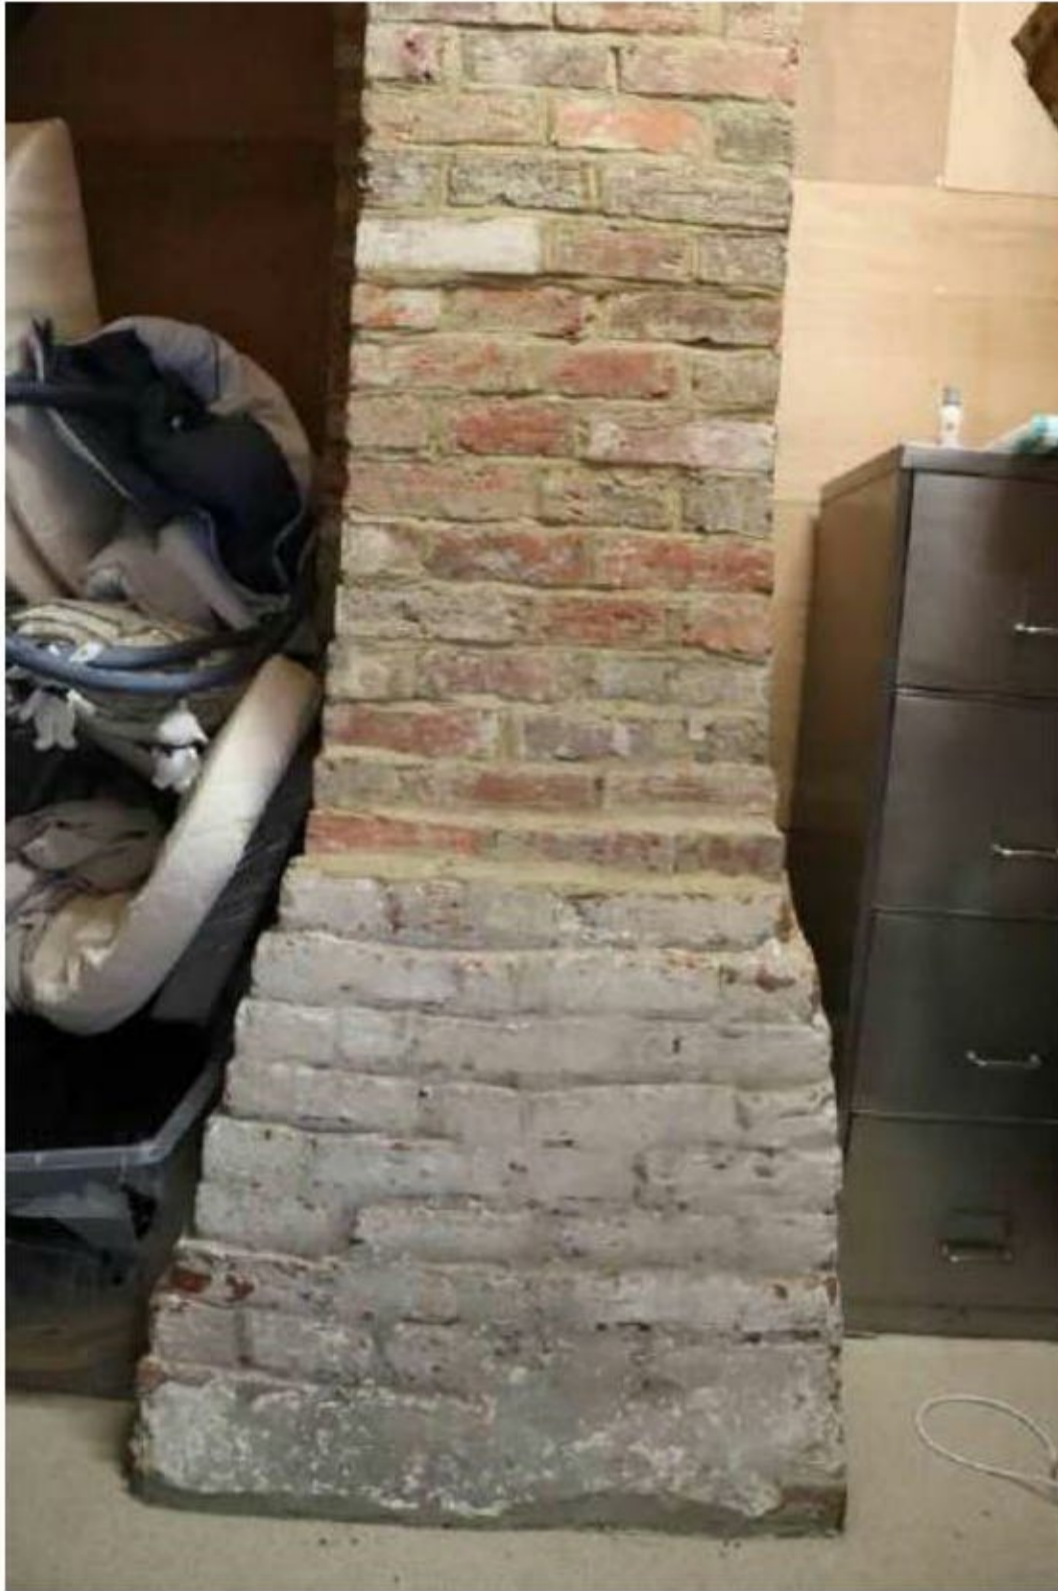
Plate 39: Chimneystack on SW wall of S4; note the rebuilt section above the white brick
