STATEMENT OF SIGNIFICANCE

**Flood Street Farm,
Breamore, Hampshire**

Mr & Mrs Bolt

Date: April 2021

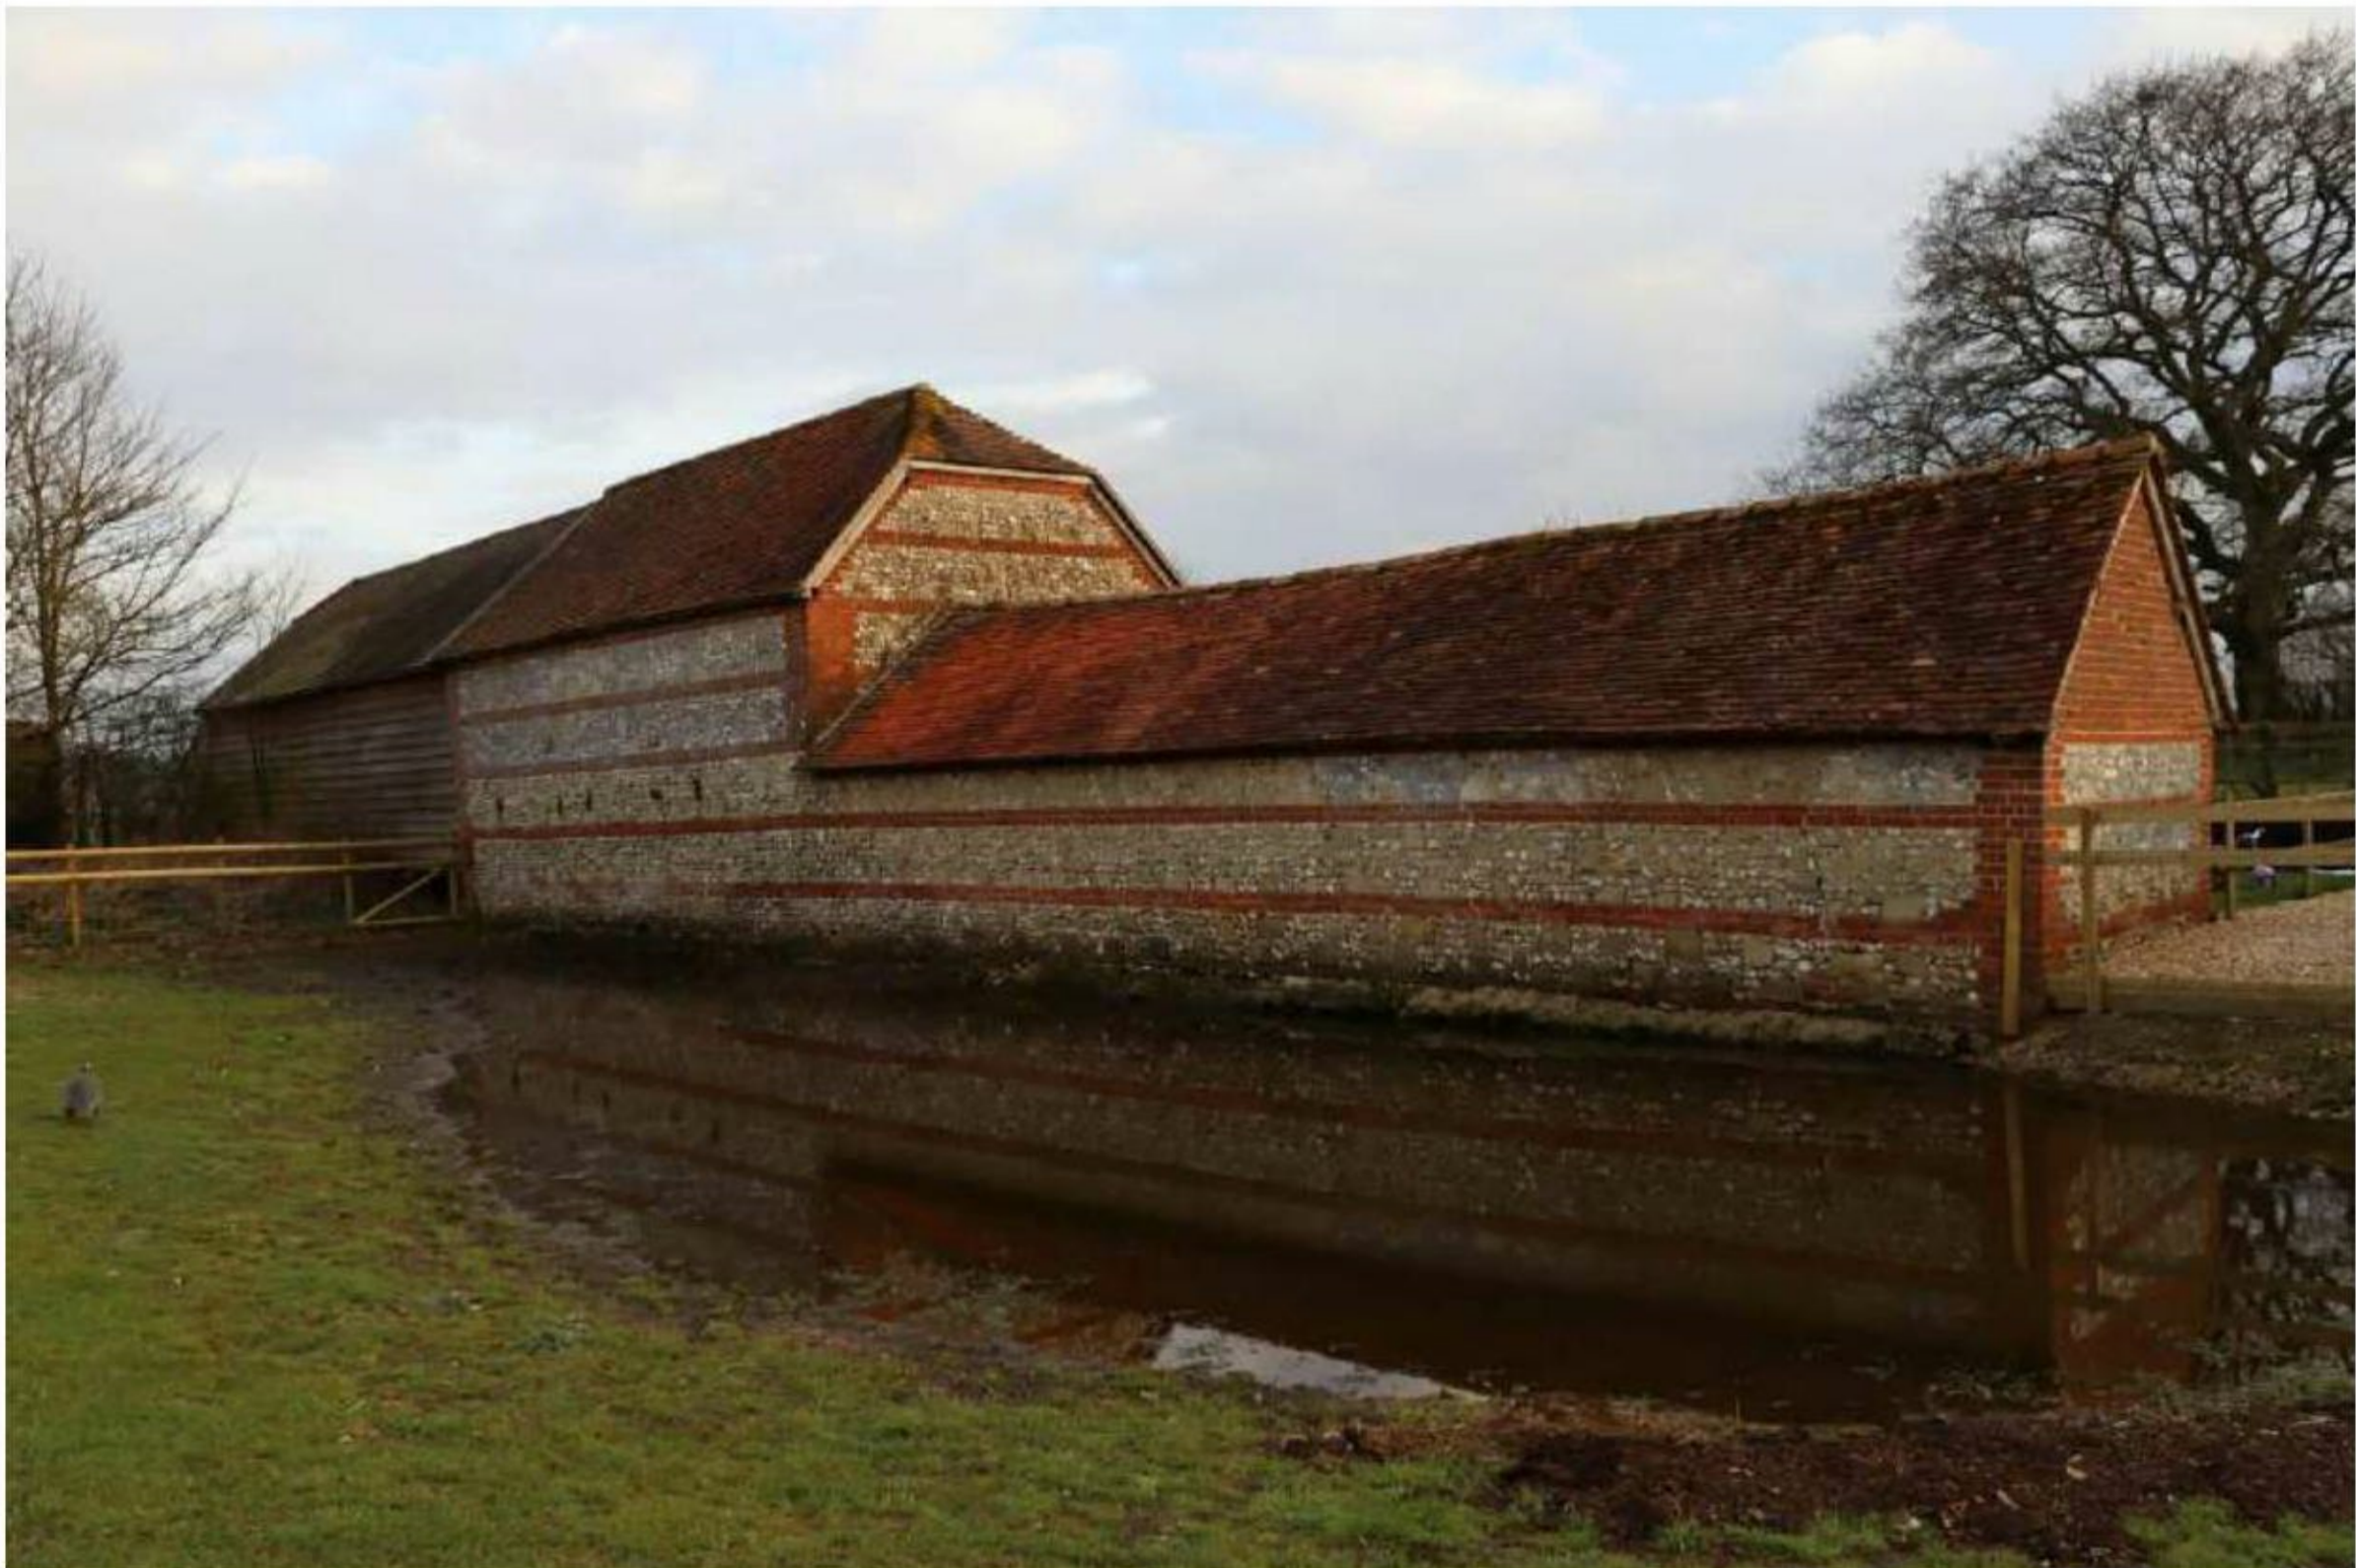
Plate 44: Buildings B, C & D (rear view)

3.2.2 Buildings B, C and D (**Plates 43 & 44** and **Photos B & N-P**) were not sold with the farmhouse in 1957, only coming into the Dodgsons' ownership in July 1988. It is probable that some of the repair work that has evidently been undertaken to the roof structures of these buildings was done after this time.

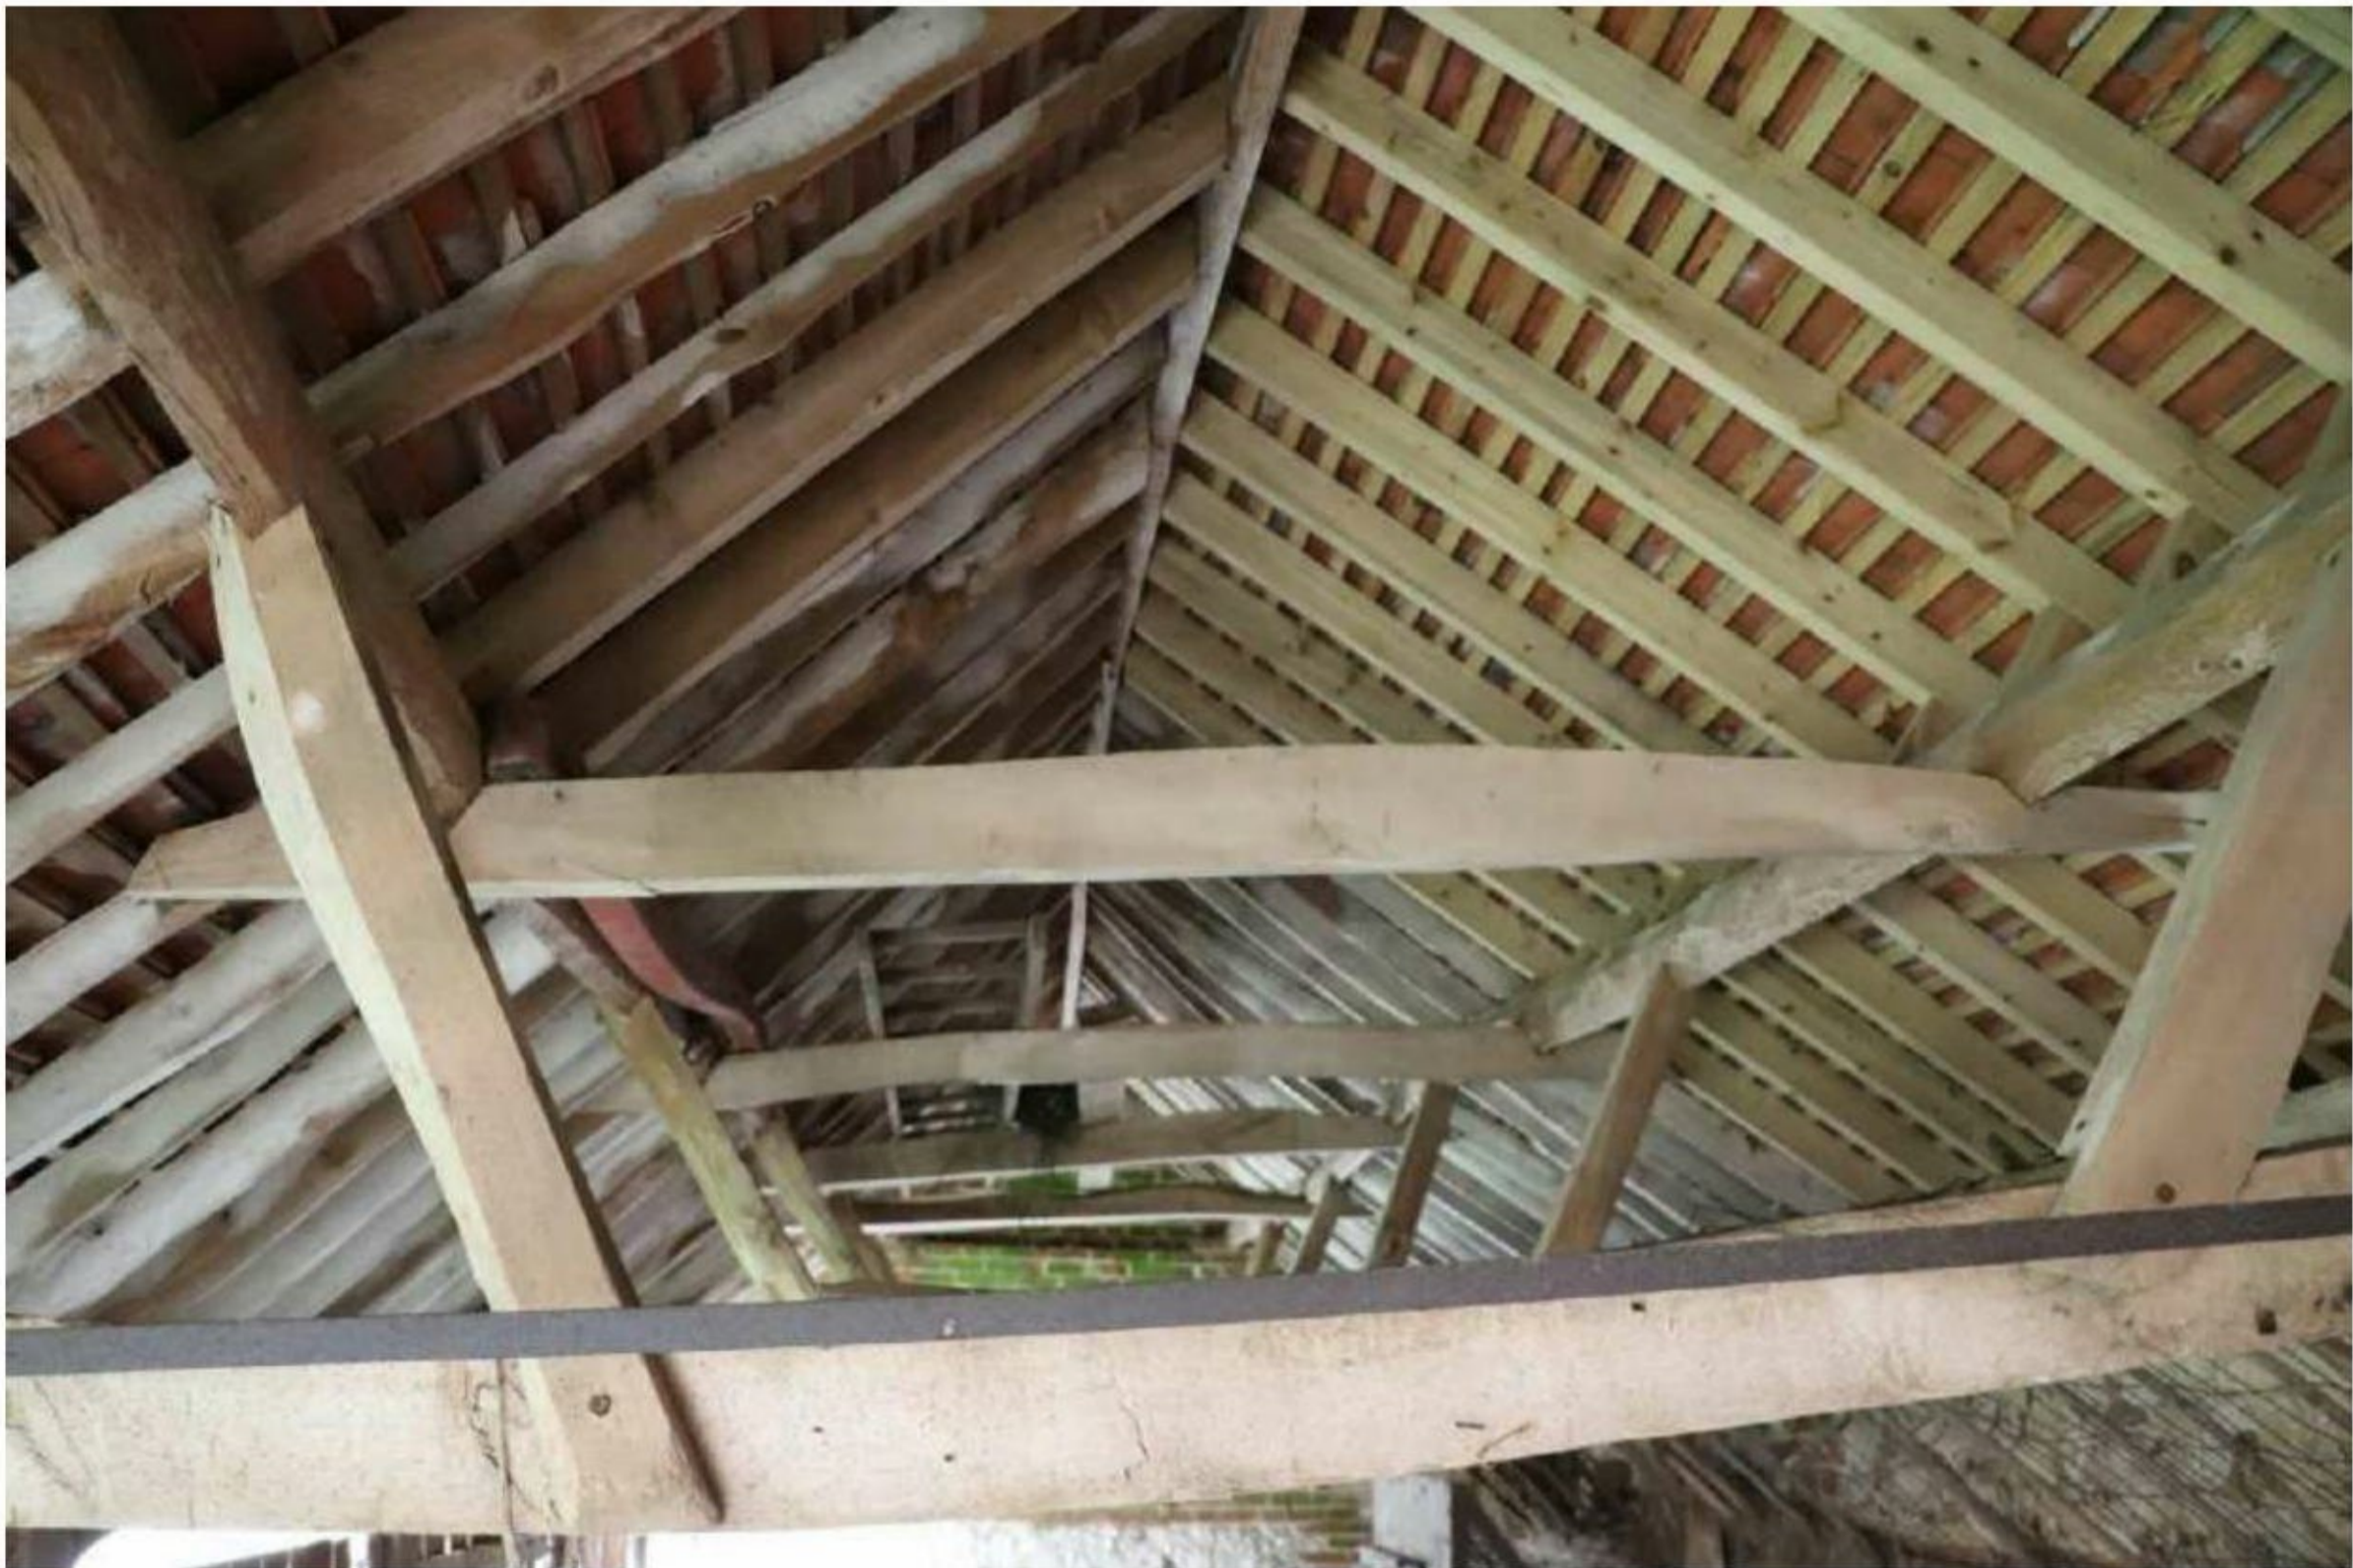
Plate 47: Building B – detail of roof structure

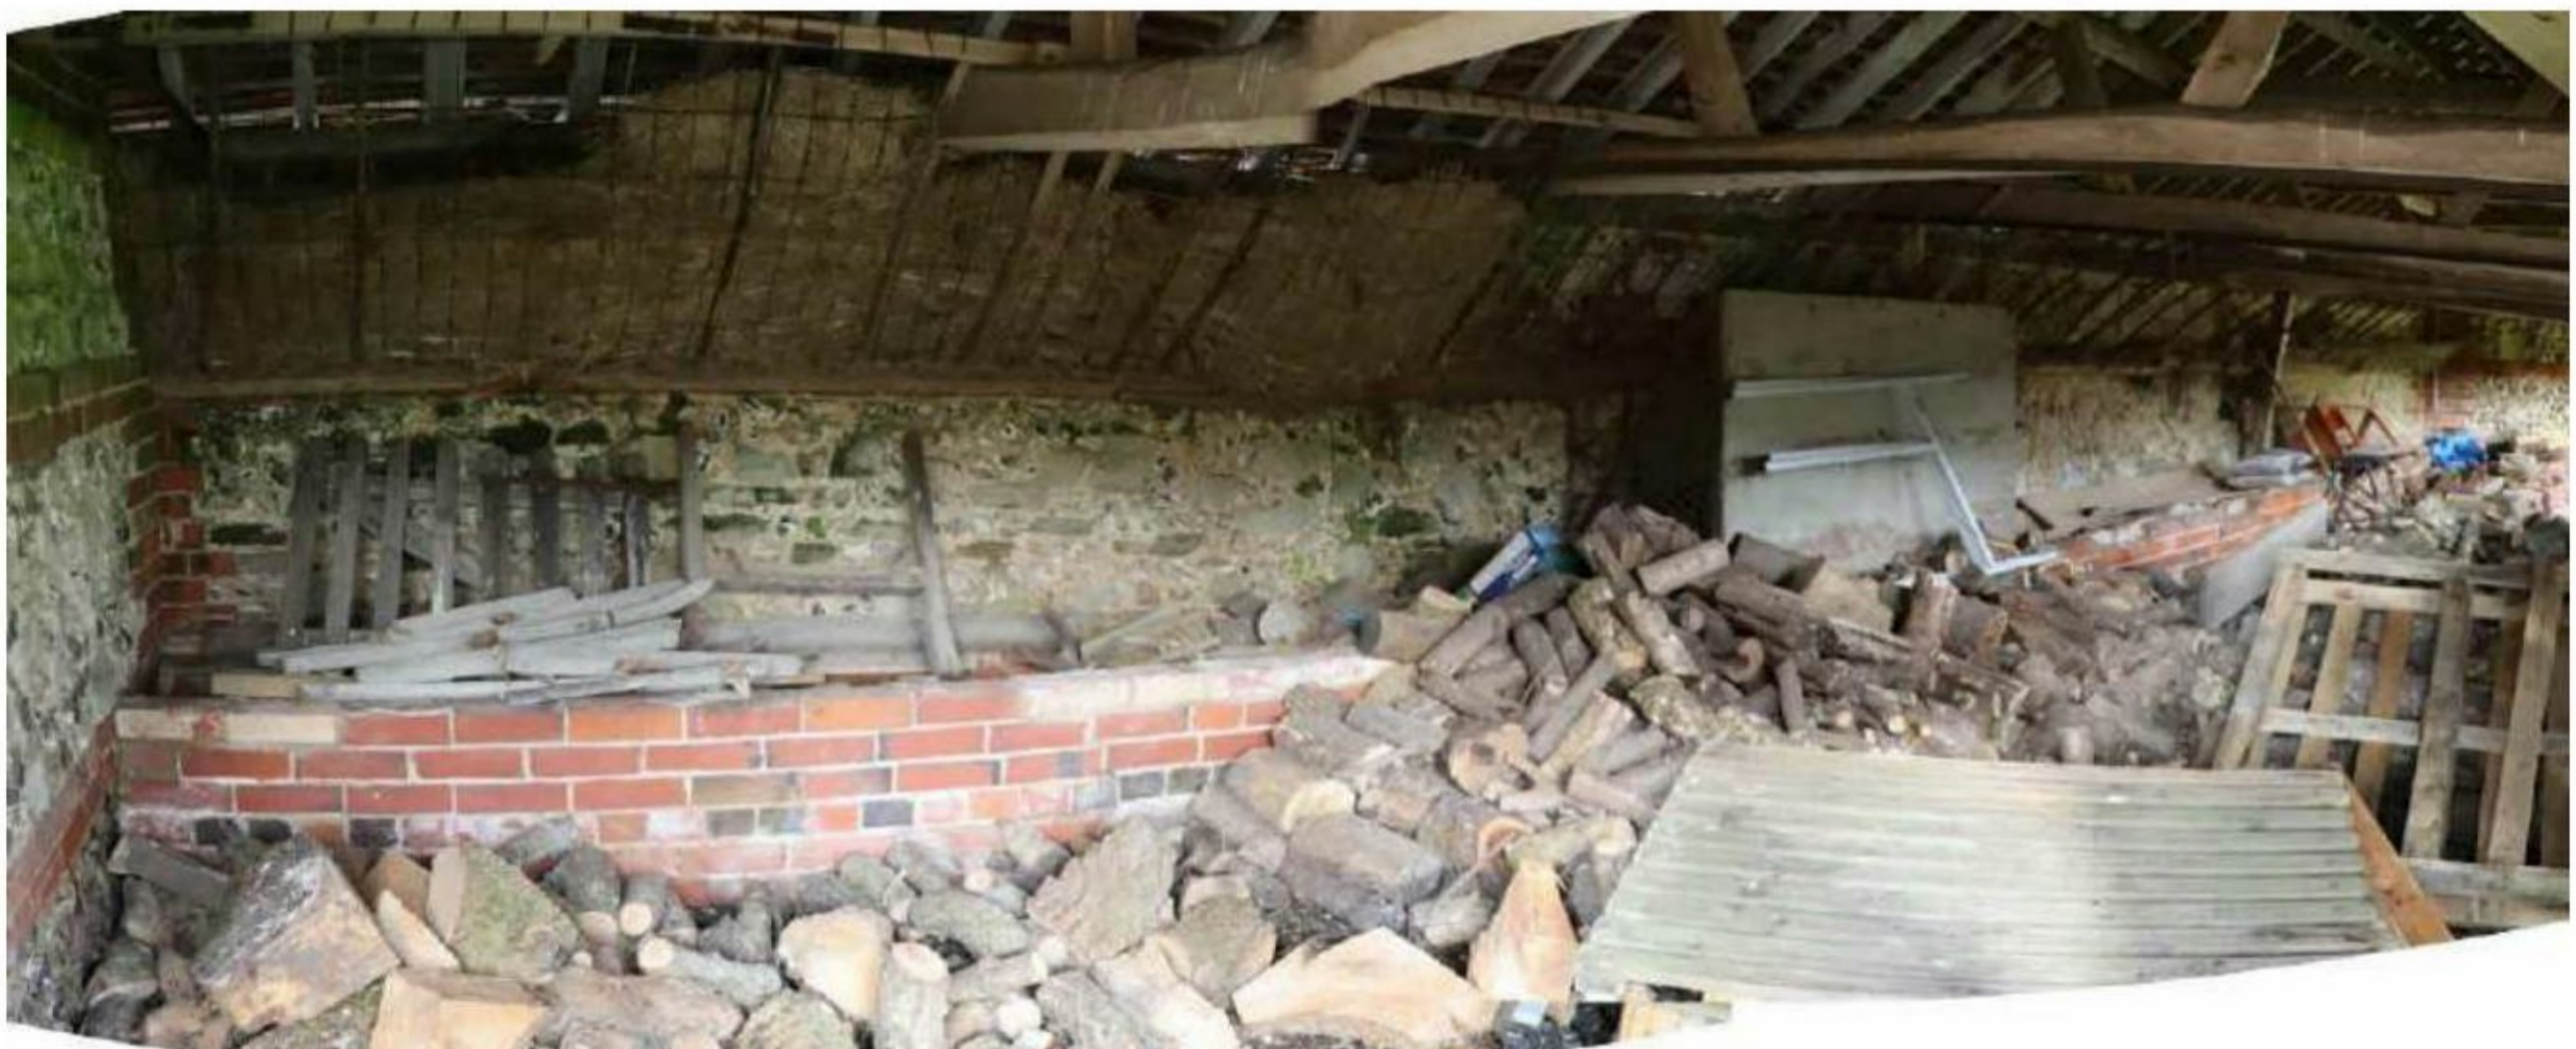
Plate 48: Building B – interior, looking to rear wall with feeding trough and manger

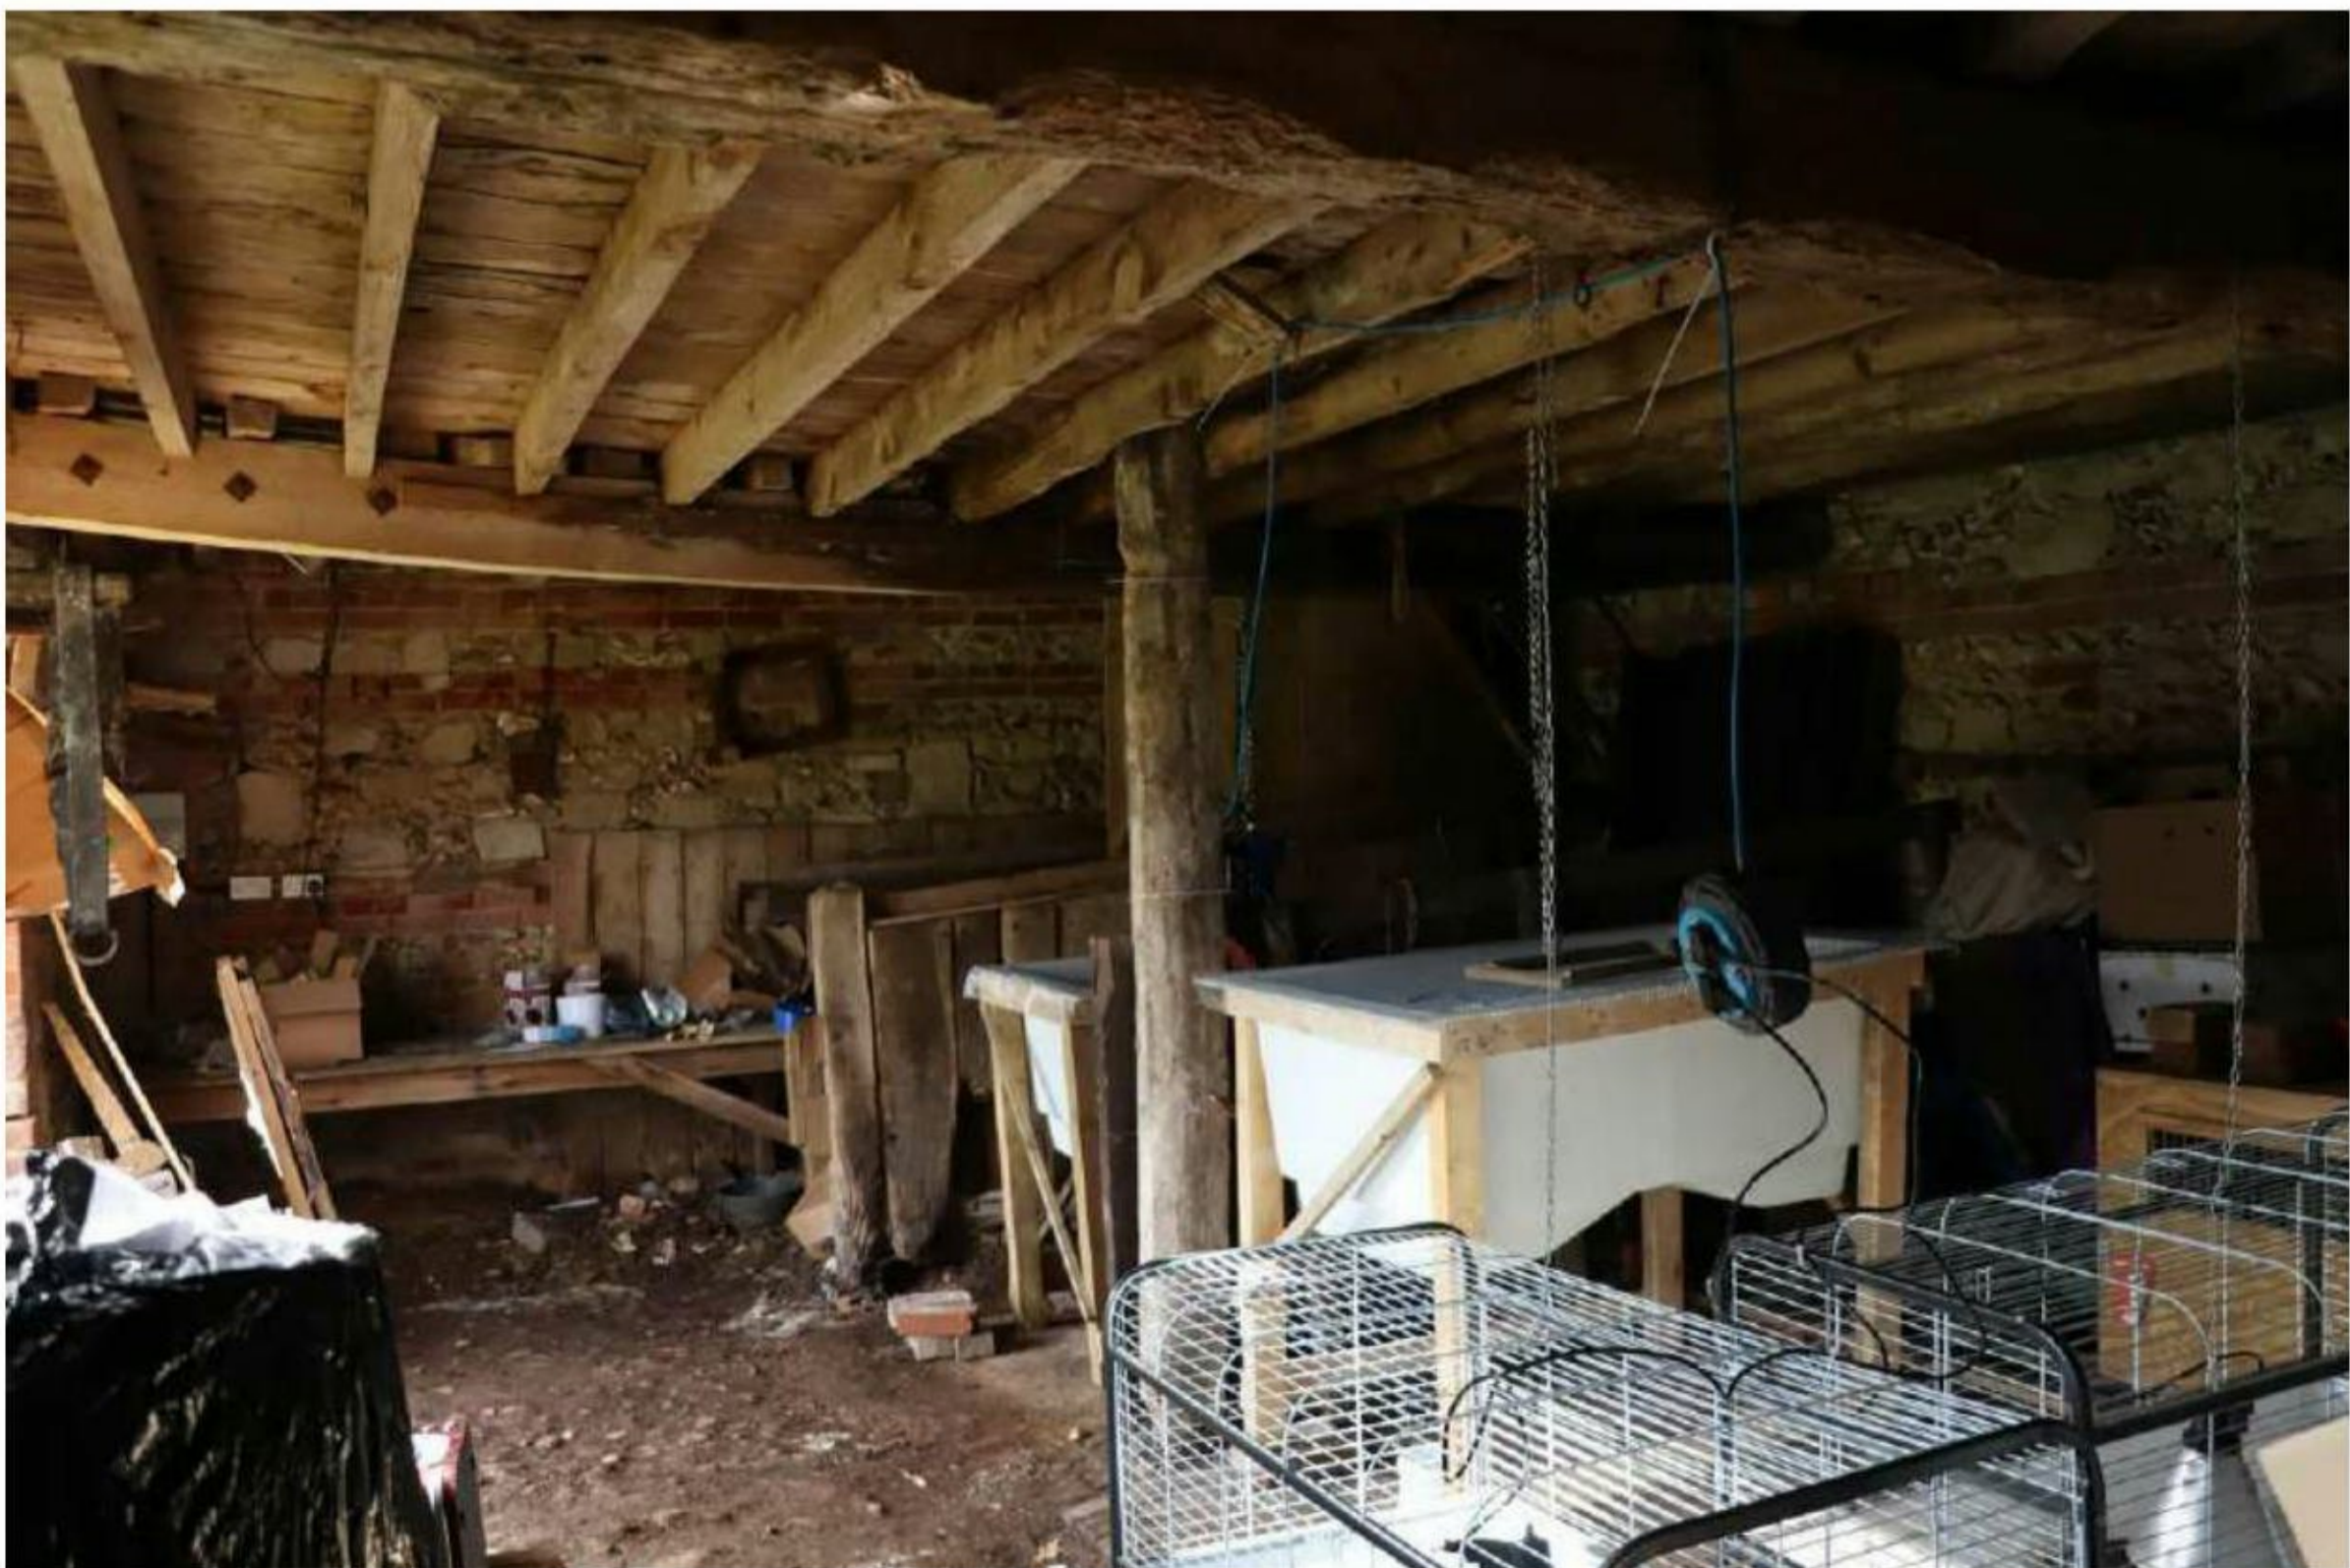
Plate 50: Building C – interior, looking W

- 3.2.6 Internally, the original late 19th-century timber beam, joists and floorboards are still present, though in places the floor has rotted through. A number of the joists are crudely cut timbers with the bark still on (**Plates 50 & 51**). There are some dilapidated remnants of wooden stall dividers and hay mangers, some surviving brick-paved flooring within the stalls area (**Plates 52-54**), and timber studs at the eastern end, presumably once part of a partition dividing off the end bay from the stalls. A ladder provides the only access to the hay loft (not currently safe to access) (**Plate 55**). Elements of the roof timbers (at least one purlin) appear to have been replaced, probably when it was lined, but many of the common rafters appear original to the late 19th-century construction (**Plate 56**).

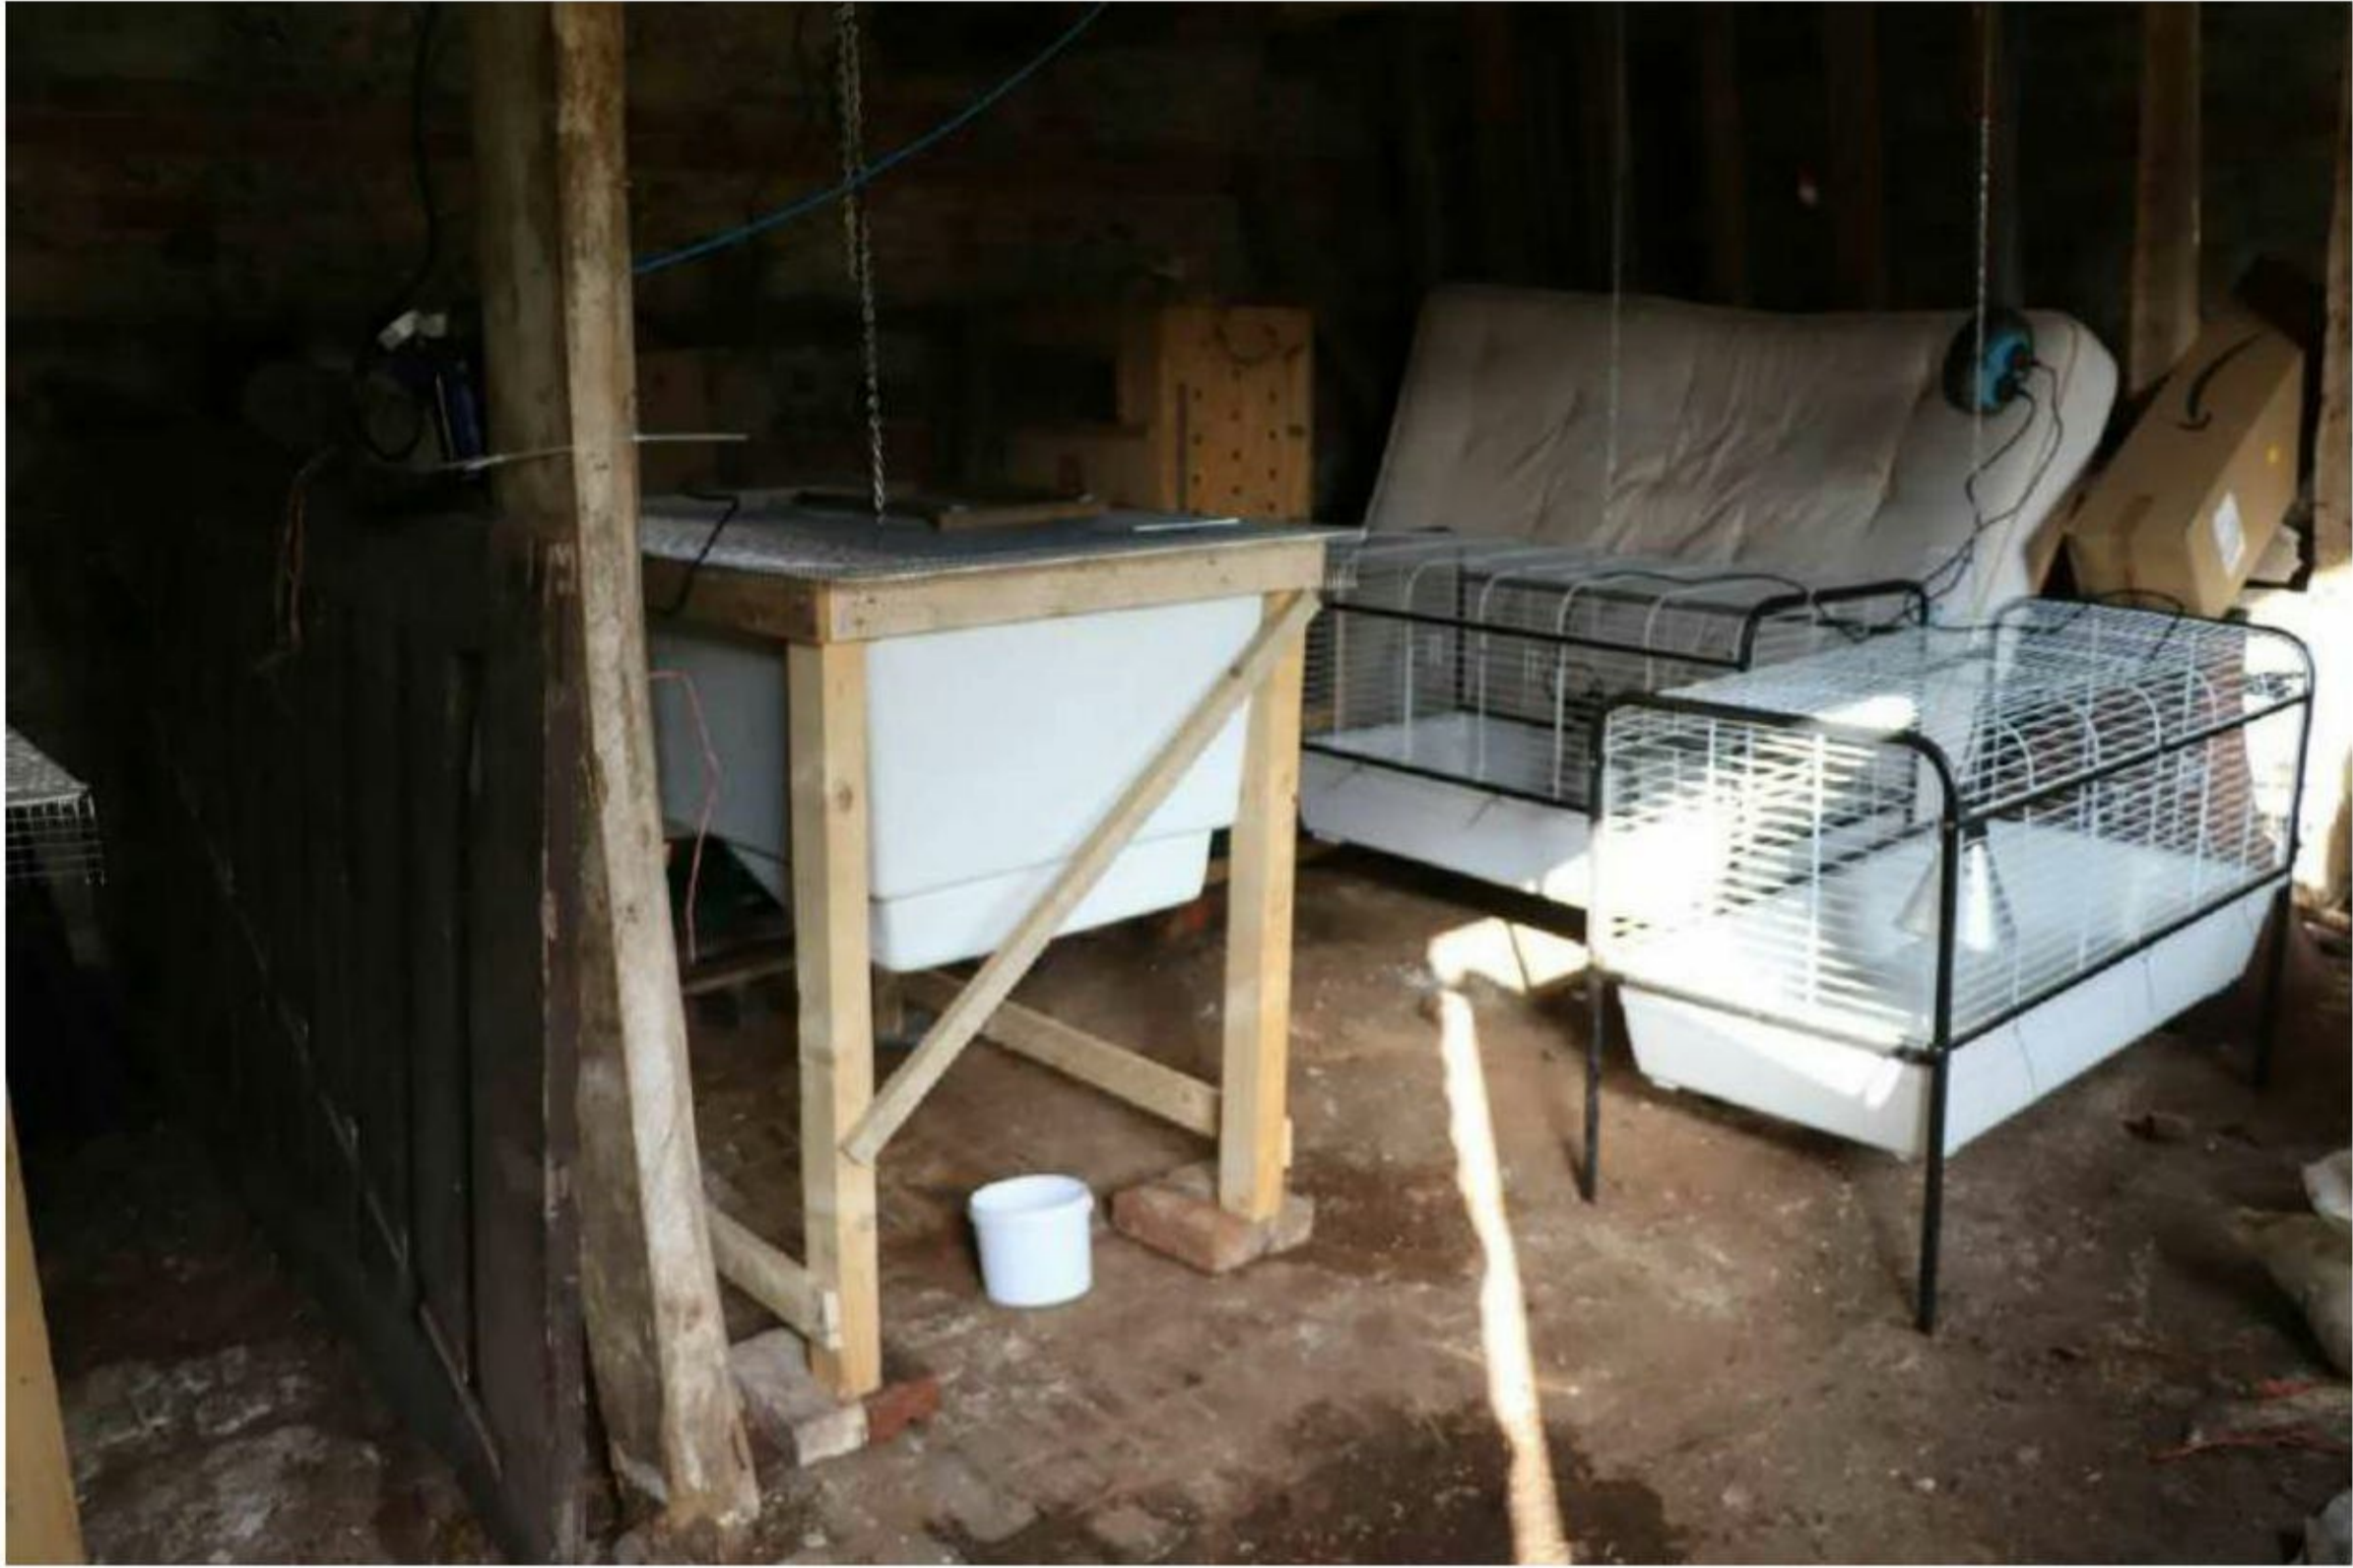
Plate 53: Building C – makeshift later stall divider to left and survival of brick flooring

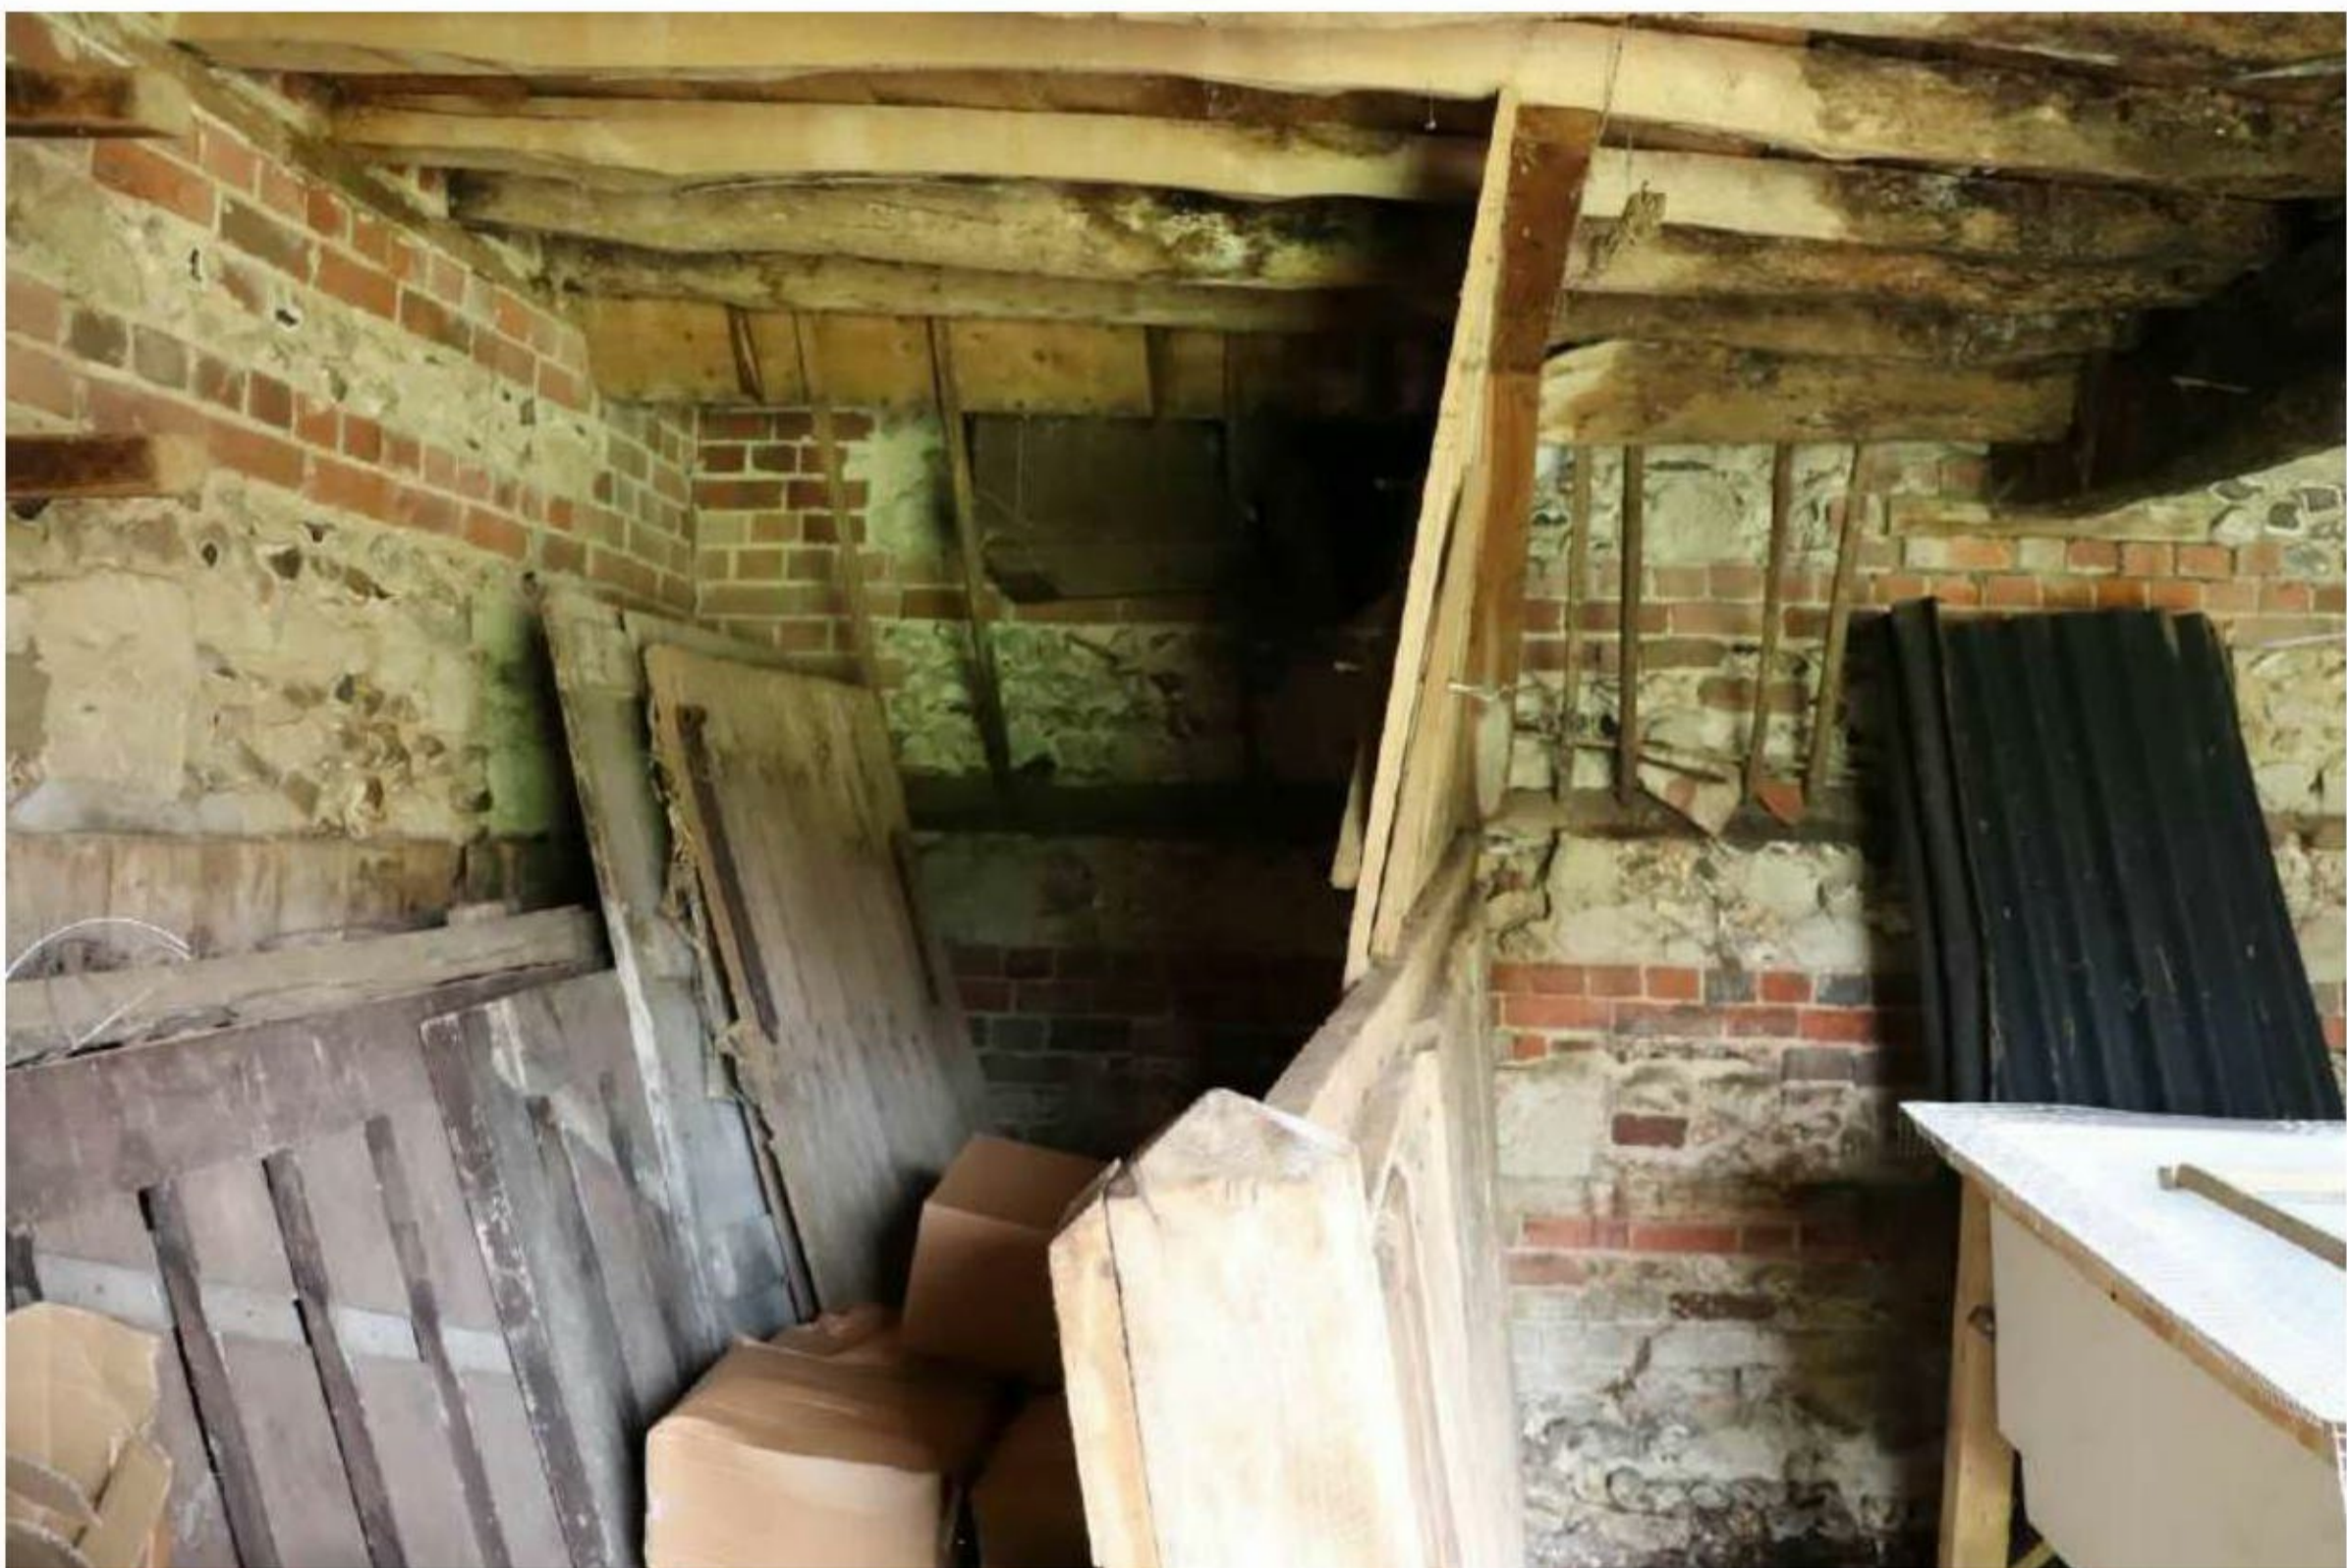
Plate 54: Building C - remnants of wooden manger against rear wall of stalls
