STATEMENT OF SIGNIFICANCE

**Flood Street Farm,
Breamore, Hampshire**

Mr & Mrs Bolt

Date: April 2021

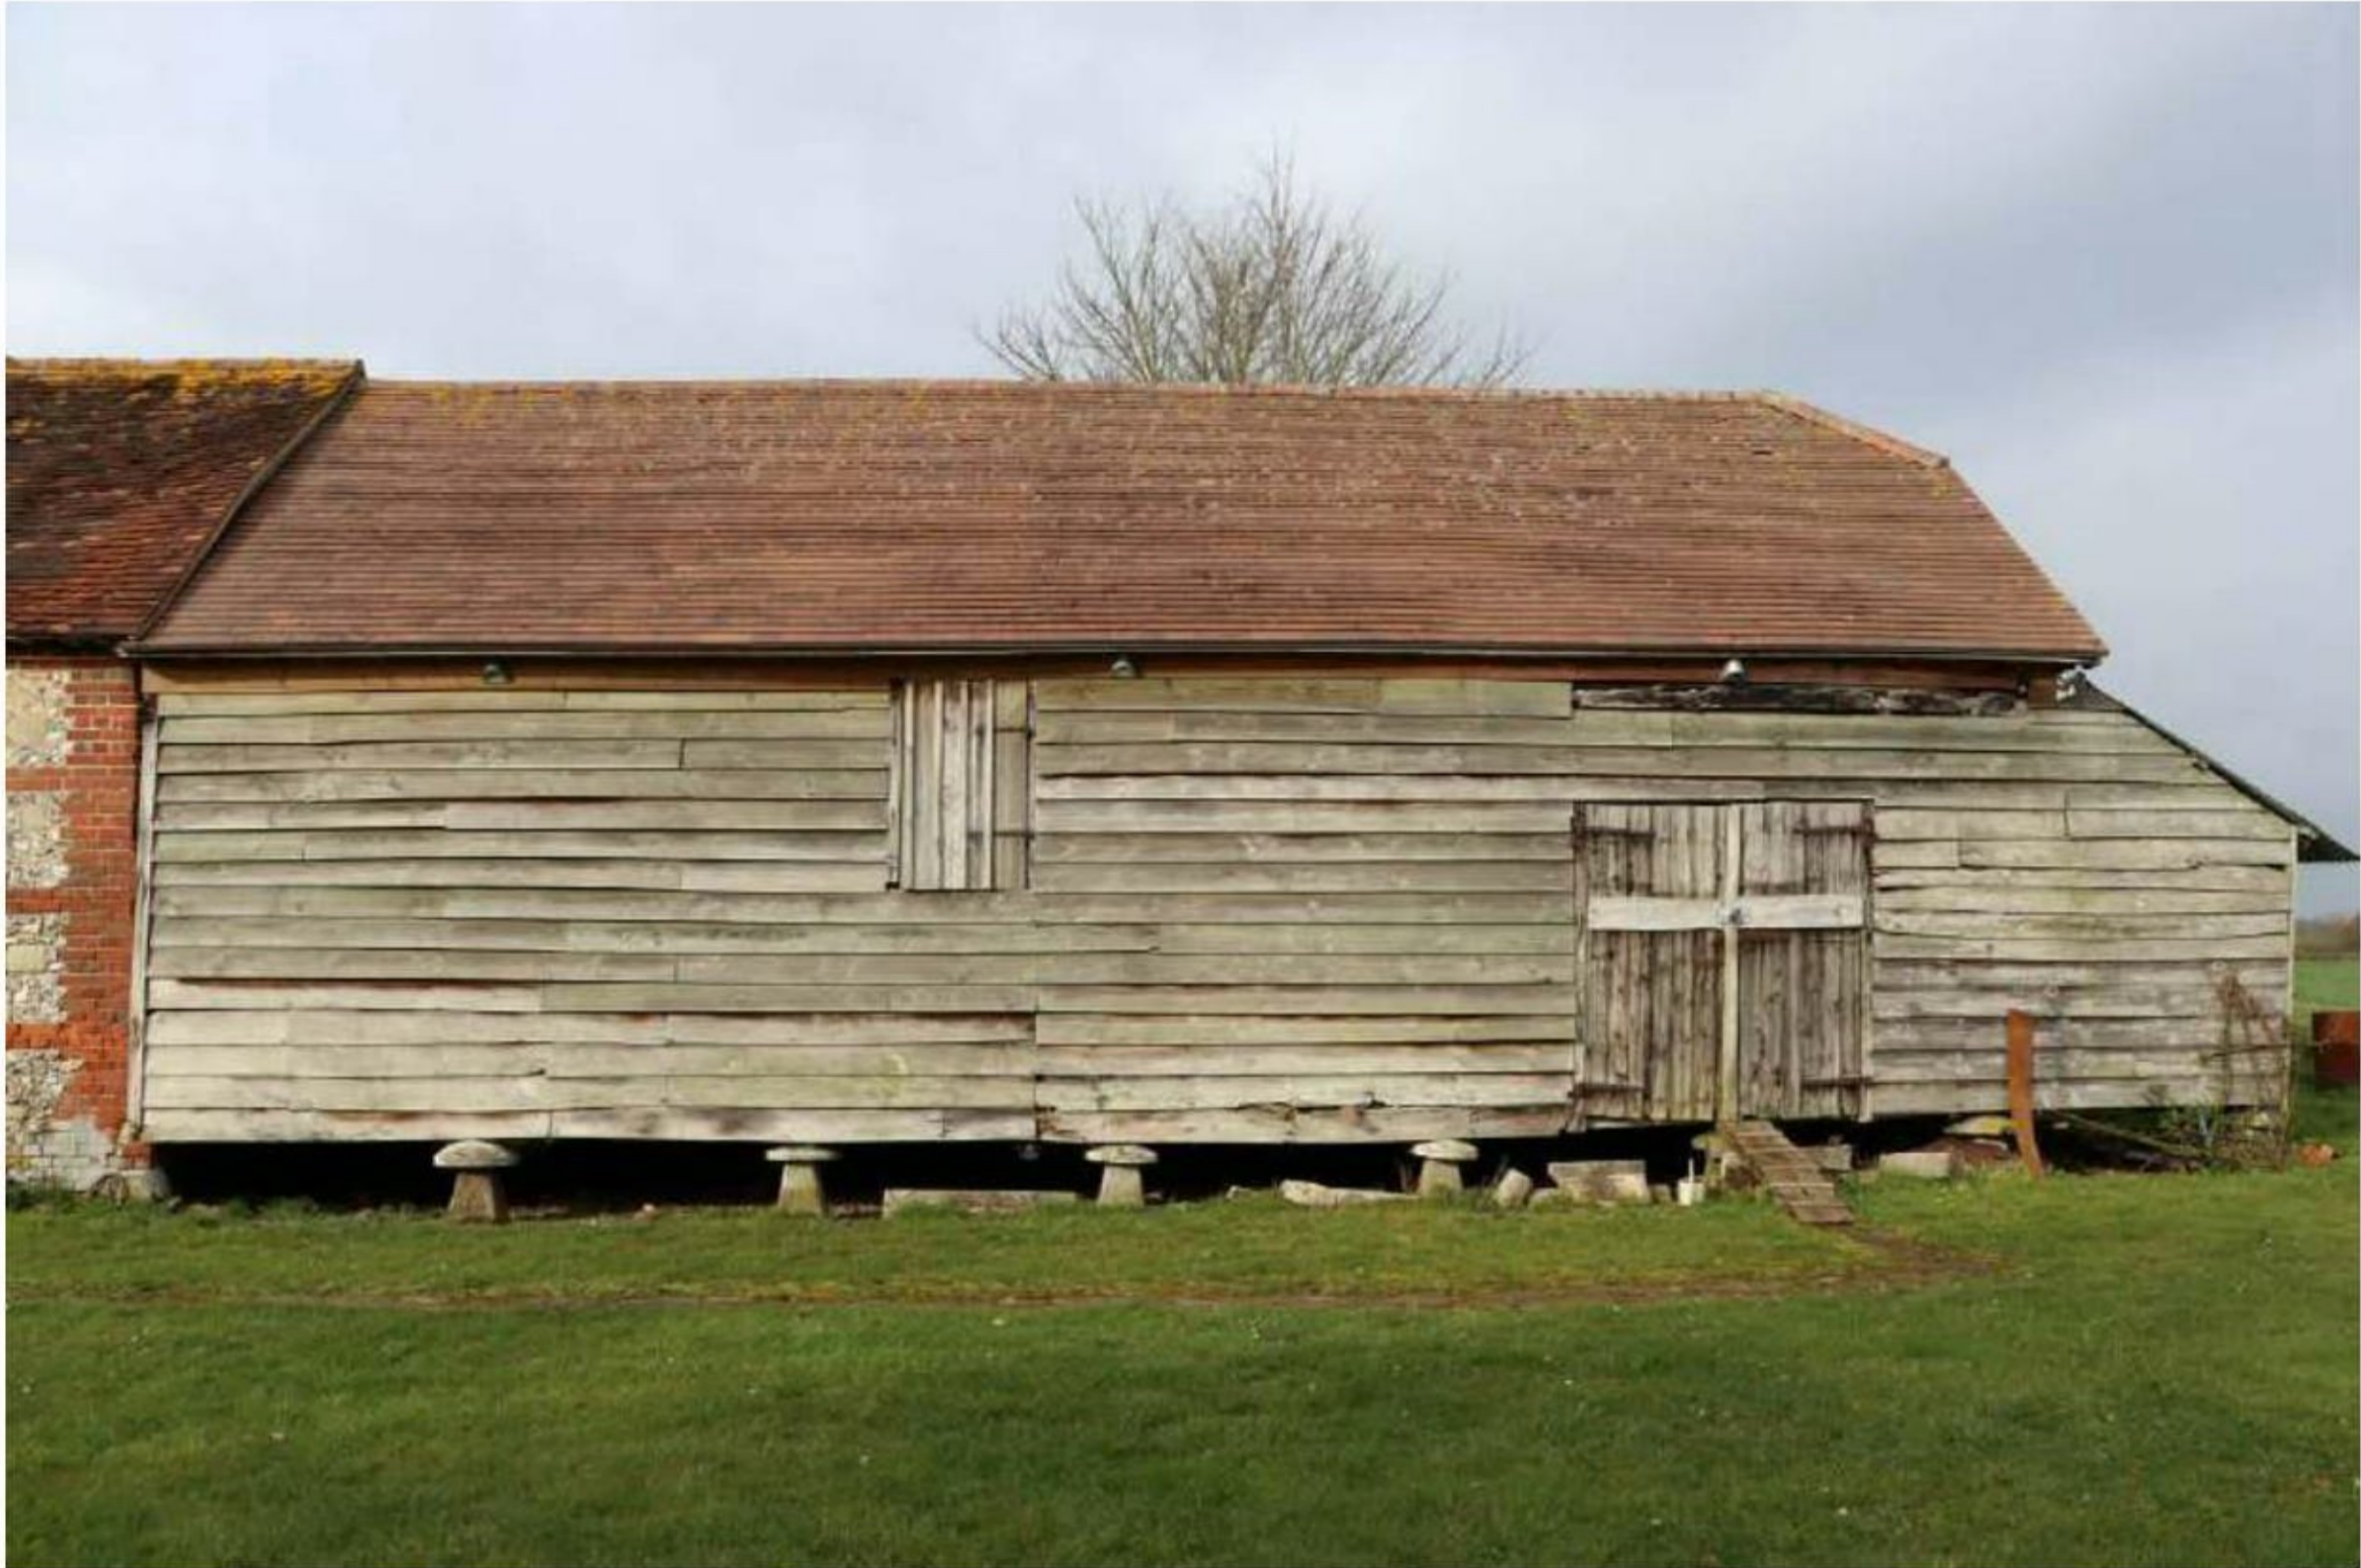
Plate 57: Building D - granary

- 3.2.7 Building D is older than B and C and was present on the site by 1838 and undoubtedly for some time before this, possibly being broadly contemporary with the cart-shed, Building A. It is a timber-framed structure clad in horizontal weatherboarding and raised on mushroom-shaped staddle-stones, which indicates its original use as a granary (**Plate 57**). The structure has a clay-tiled roof, hipped at the eastern end where there is a lower lean-to structure (with recent corrugated metal roof), but the main roof was originally thatched, with an eyebrow cut out over the loading door in the front elevation, as can be seen on **Photo B**. The access is provided by a set of double boarded doors. The roof had been tiled by 1957.

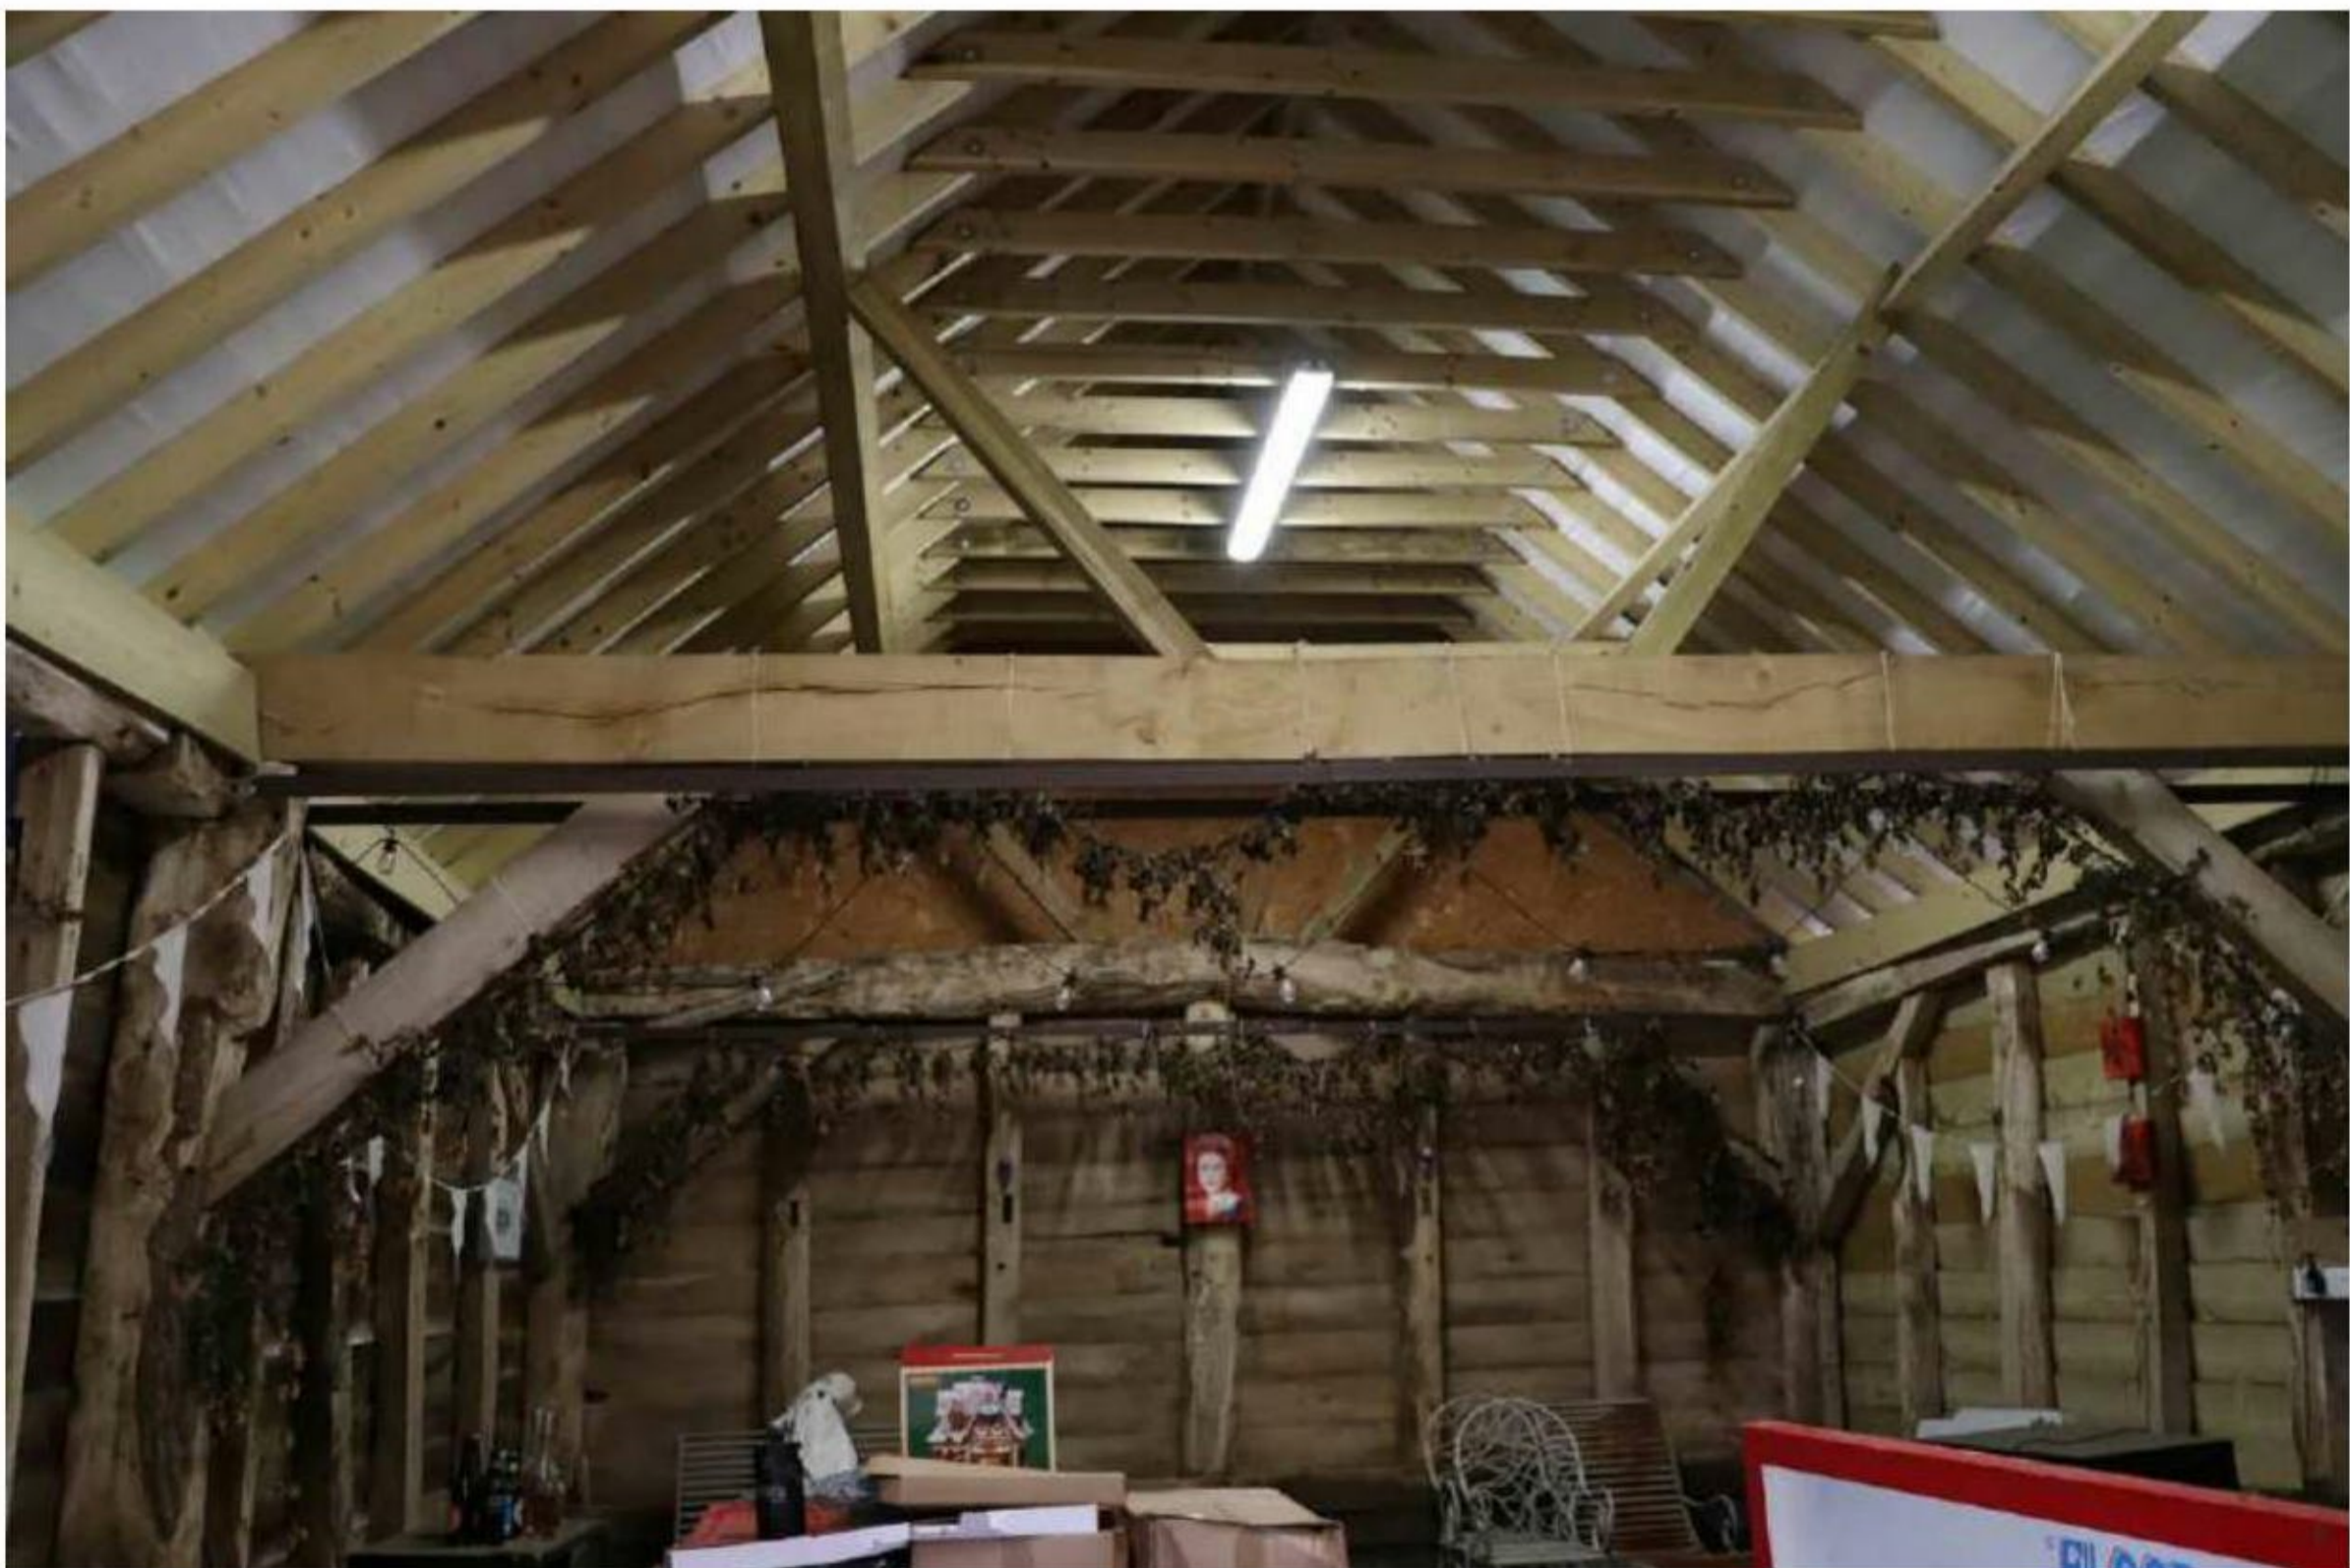
Plate 58: Building D: interior, looking W

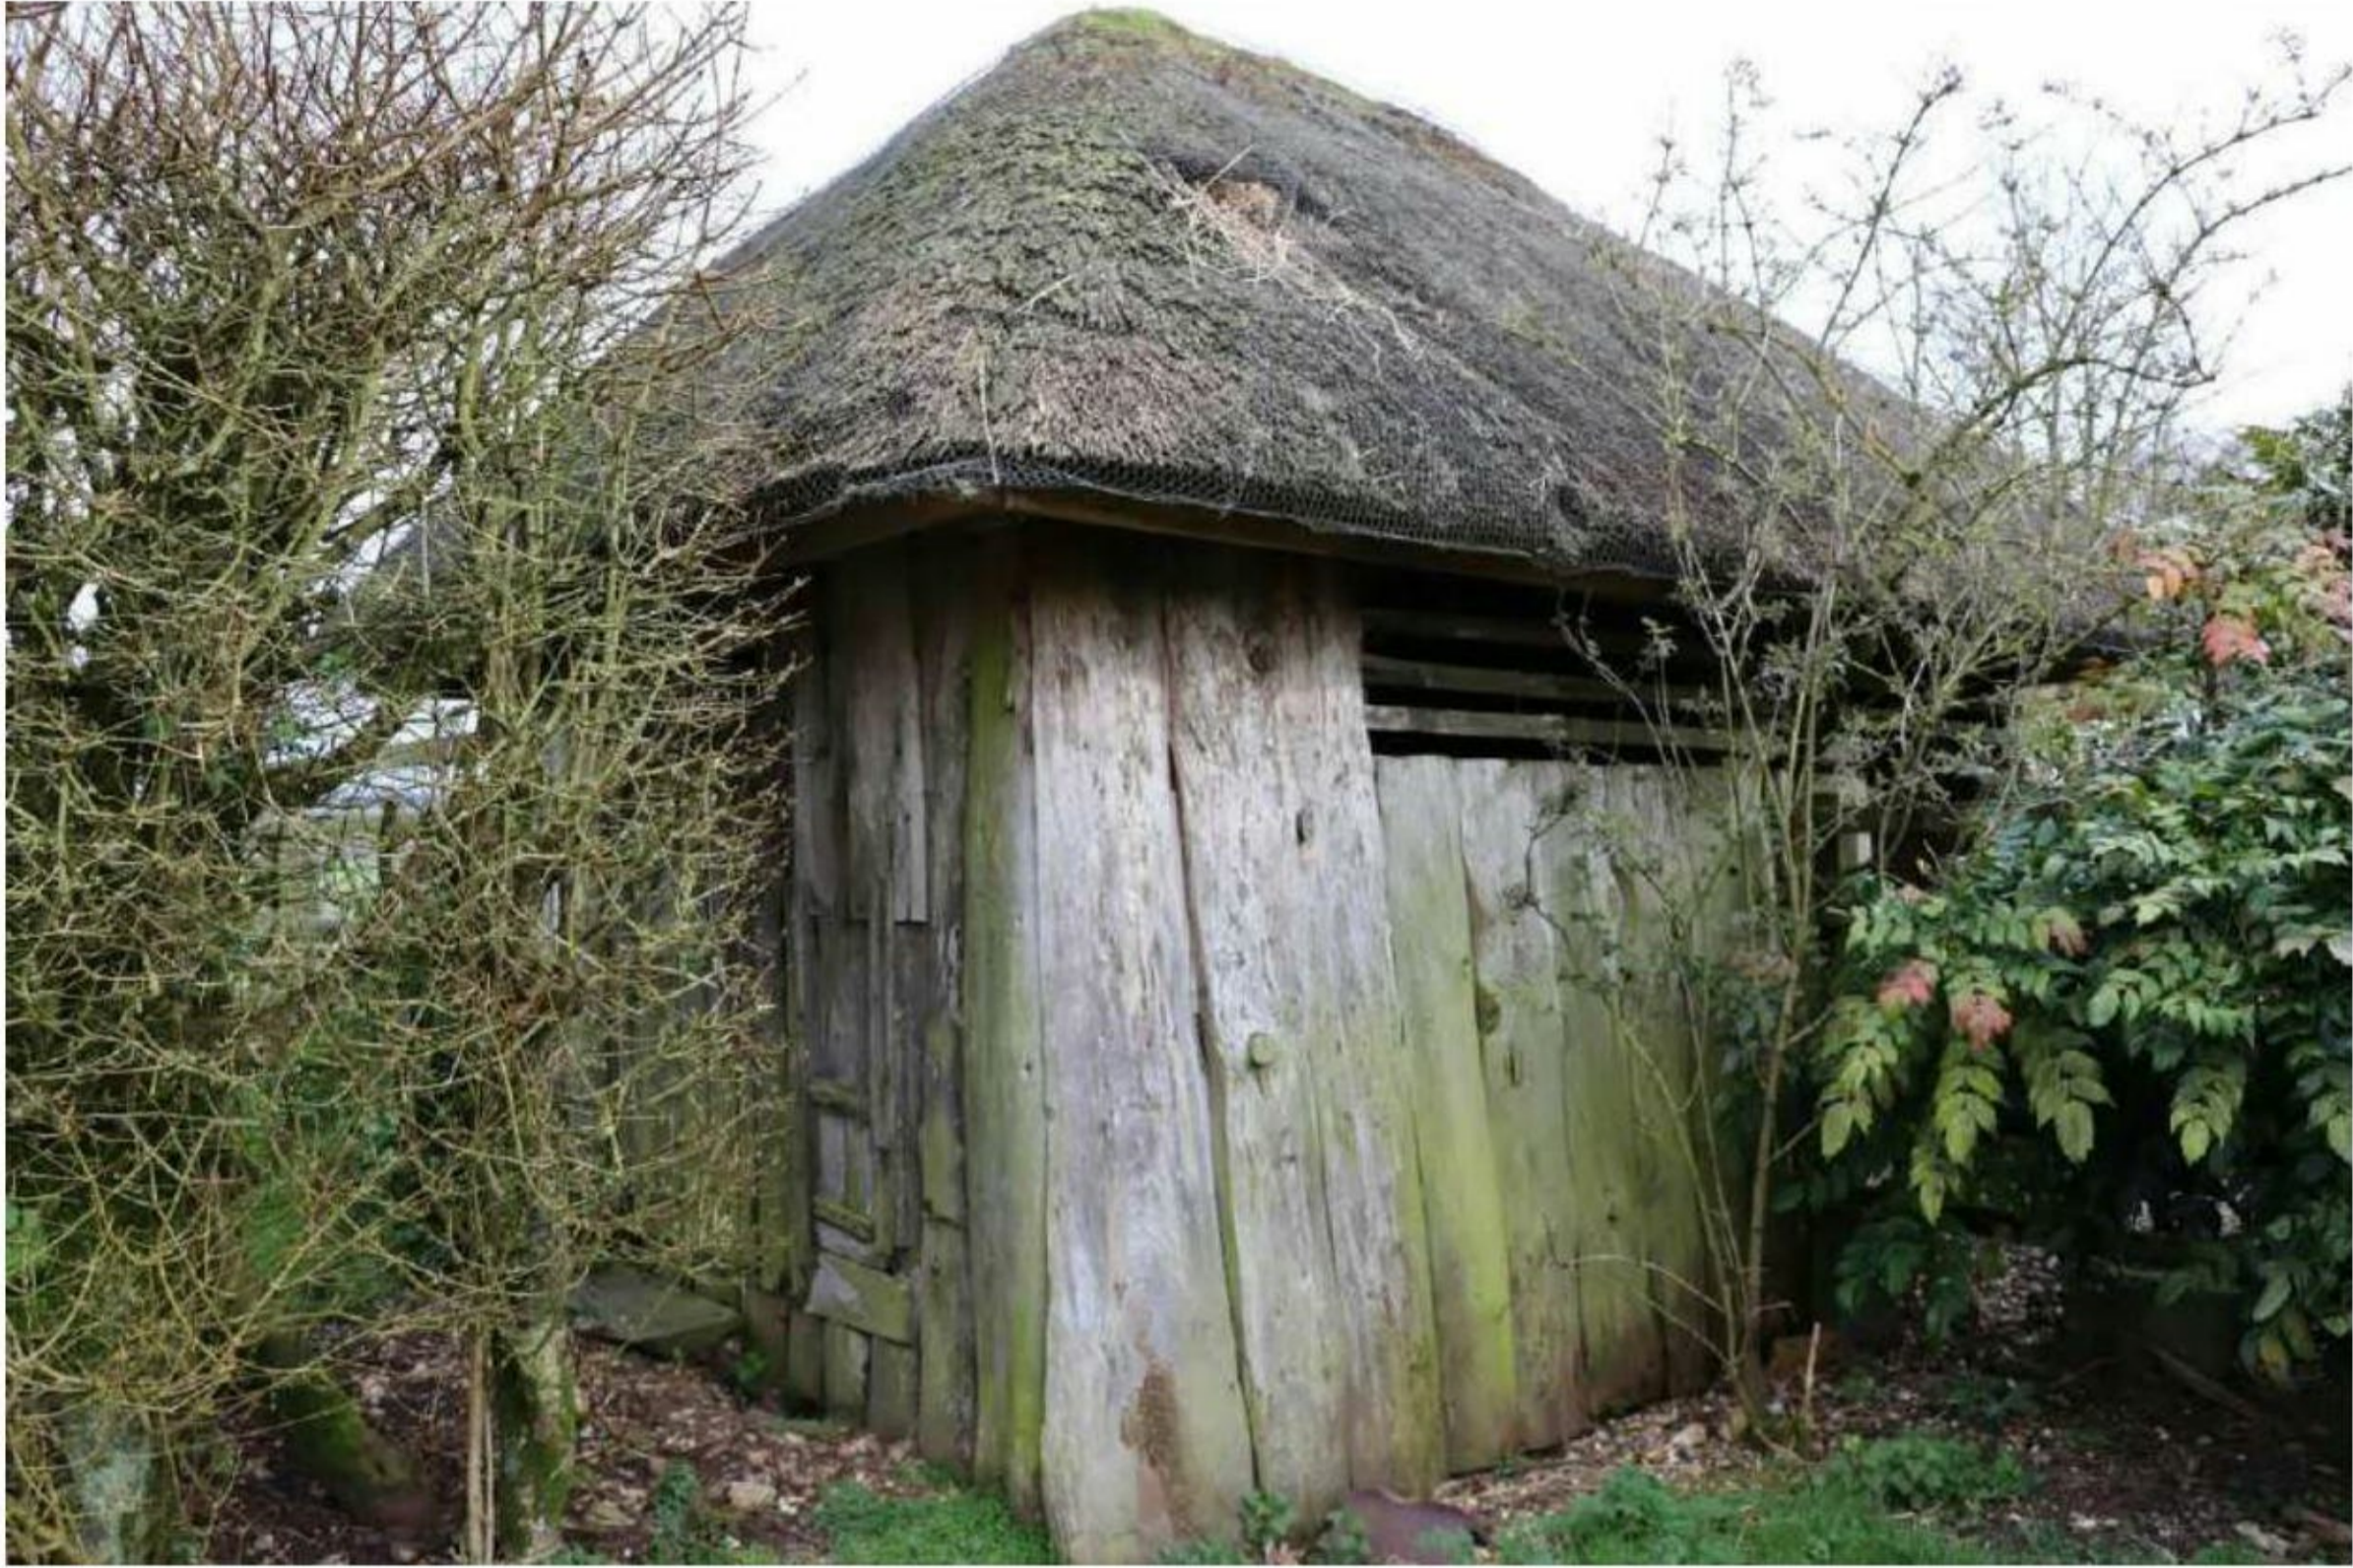
Plate 61: Building E

3.2.9 Building E is a small timber-framed weather-boarded shed with a thatched hipped roof (**Plate 61**). The substantial pegged boards at the corner indicate it of some age but, while it is shown on the 1926 OS map, the building on its site prior to this (including in 1838) was much longer, so what stands now may represent the truncated southern end of that building.

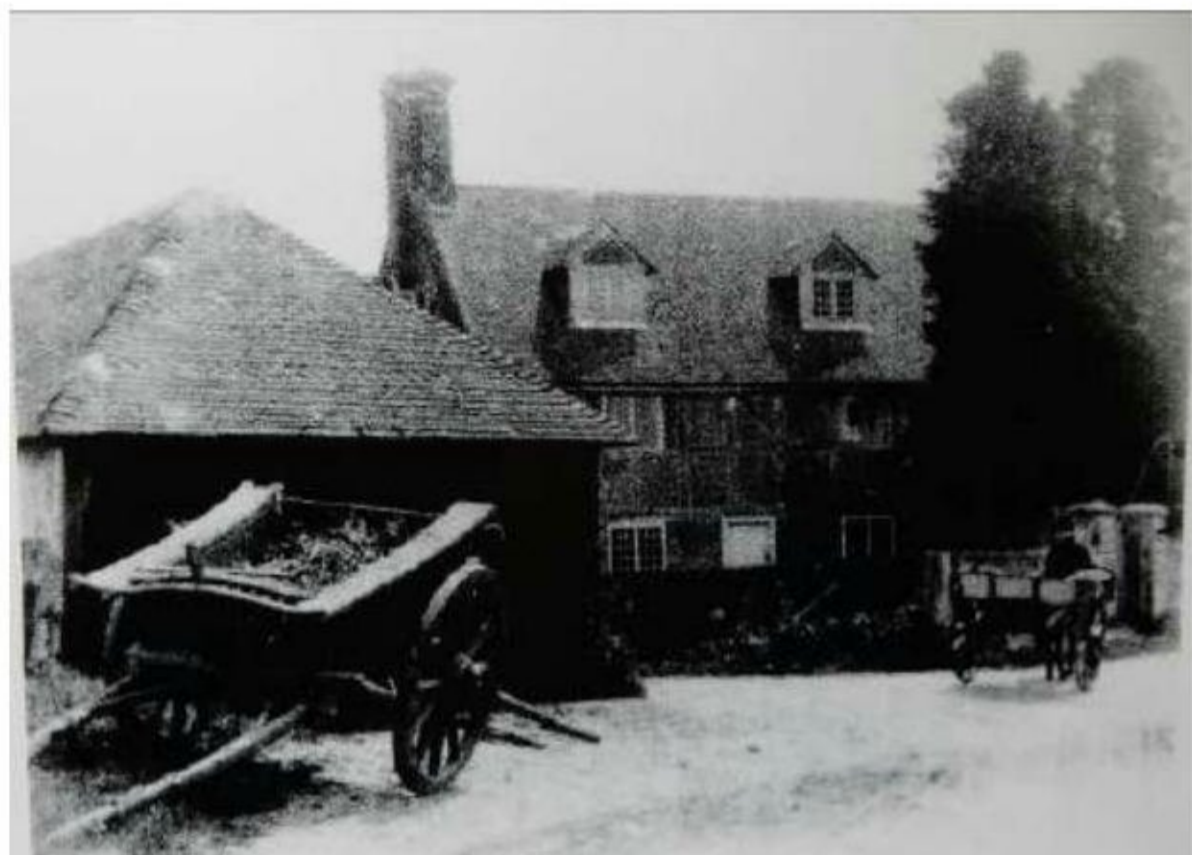
A: Undated, late C19/early C20: front elevation

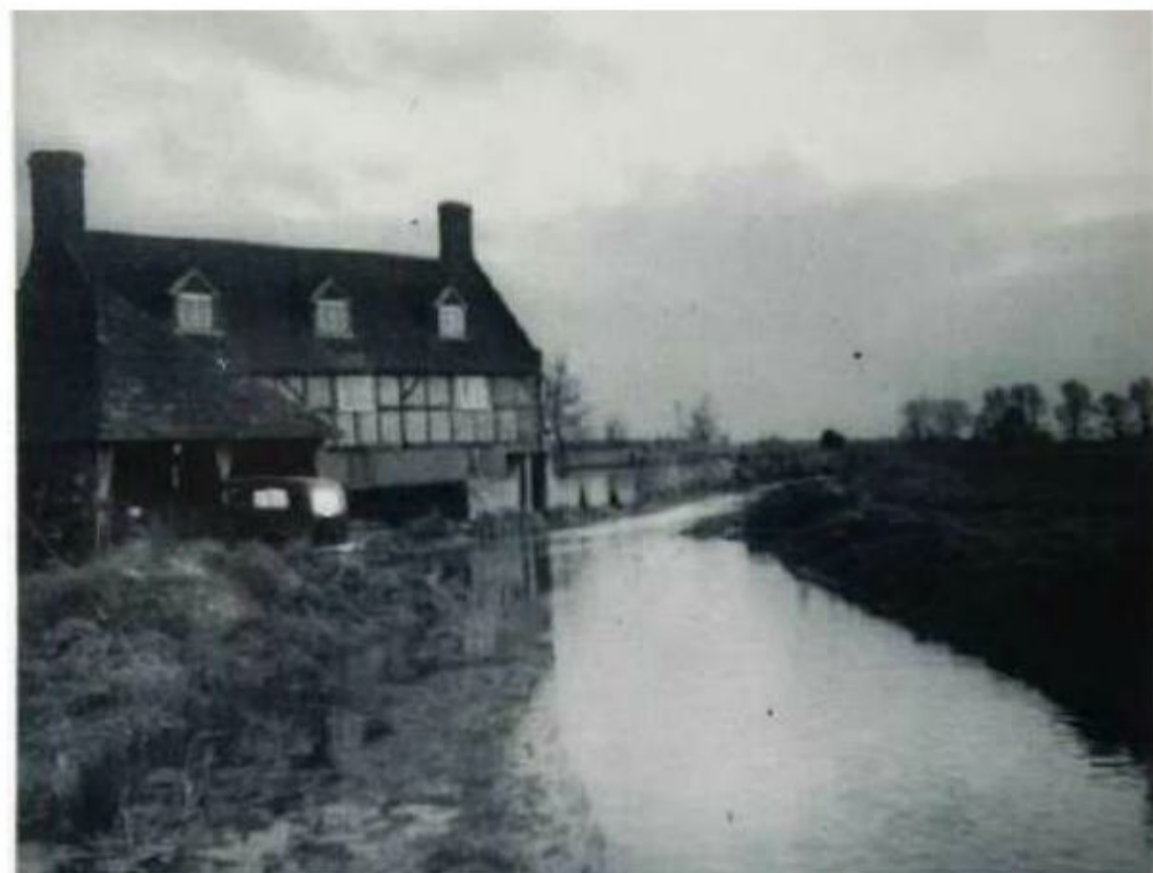
D: Looking S along a flooded Flood Street towards the farmhouse

- 3.3.5 Behind Buildings A-D there is a paddock in the use of the property, containing the pond against the rear of Buildings B-D (**Plate 67**).
- 3.3.6 Flood Street itself is liable to periodic flooding rising from natural springs in the area, (see **Photo D**, which shows a very similar situation to the flooding that was present in March 2021). The lane runs roughly north-south past the farmhouse, which faces it at an angle so that its façade is seen on the approach from the north (from Breamore). Views back towards the building along the lane from the south are precluded by a high dense hedgerow on an earth bank, such that only the south-western gable apex and chimney are visible above the hedge (**Plate 68**).

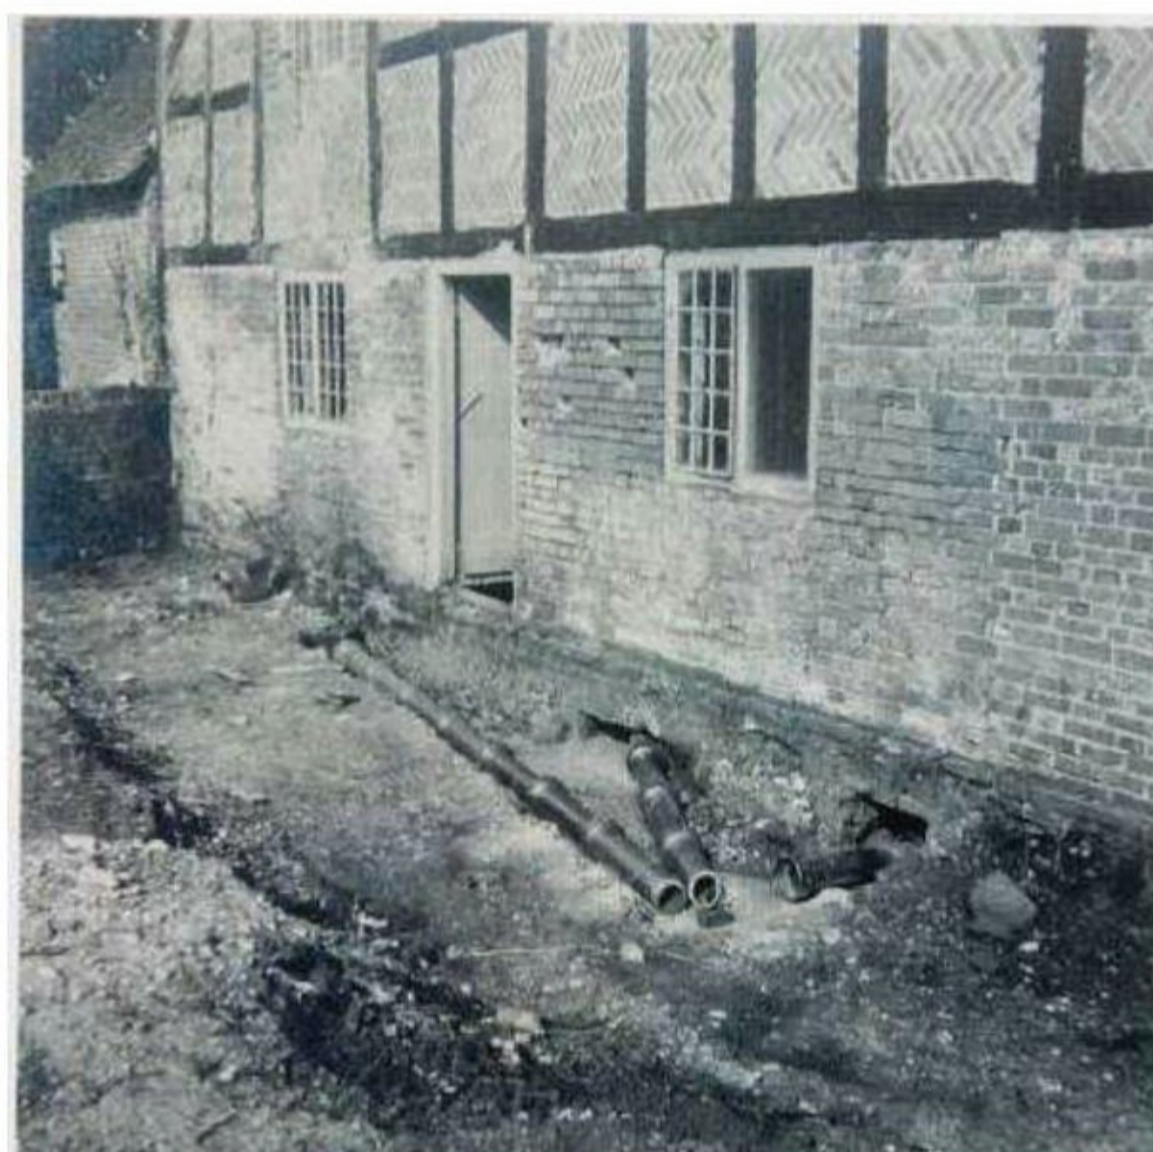
E: Front elevation, drainage works

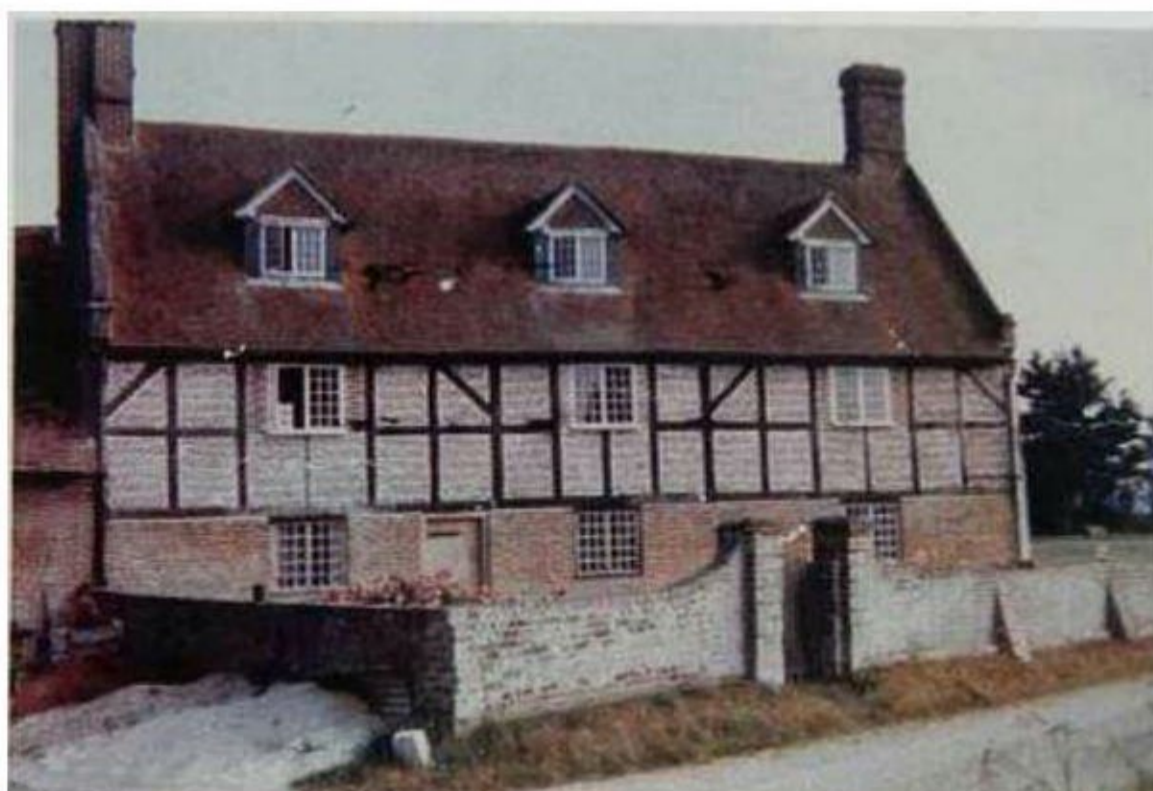
F: Front elevation – September 1959, following works

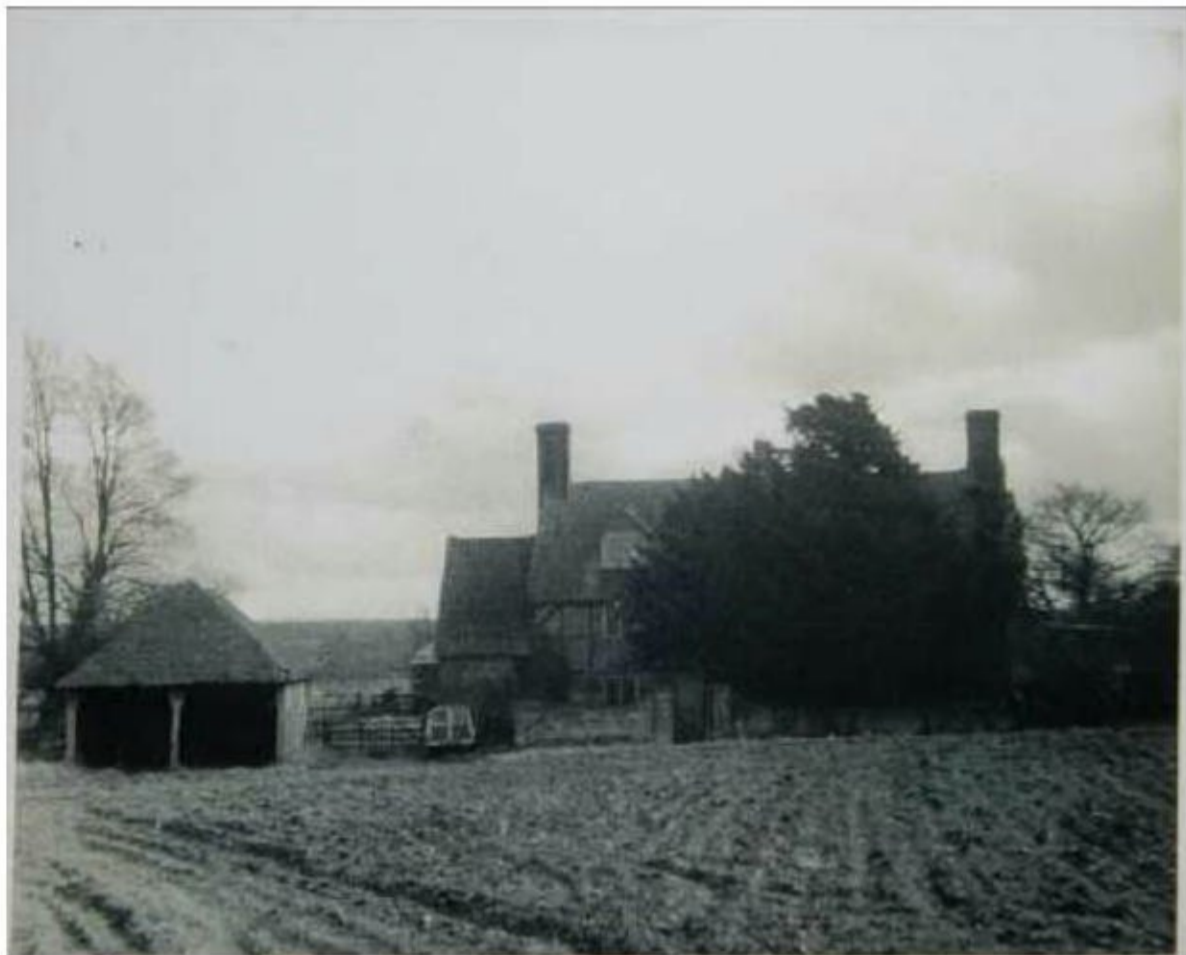
G: Front elevation, largely obscured by tree, and Building A (cart-shed)

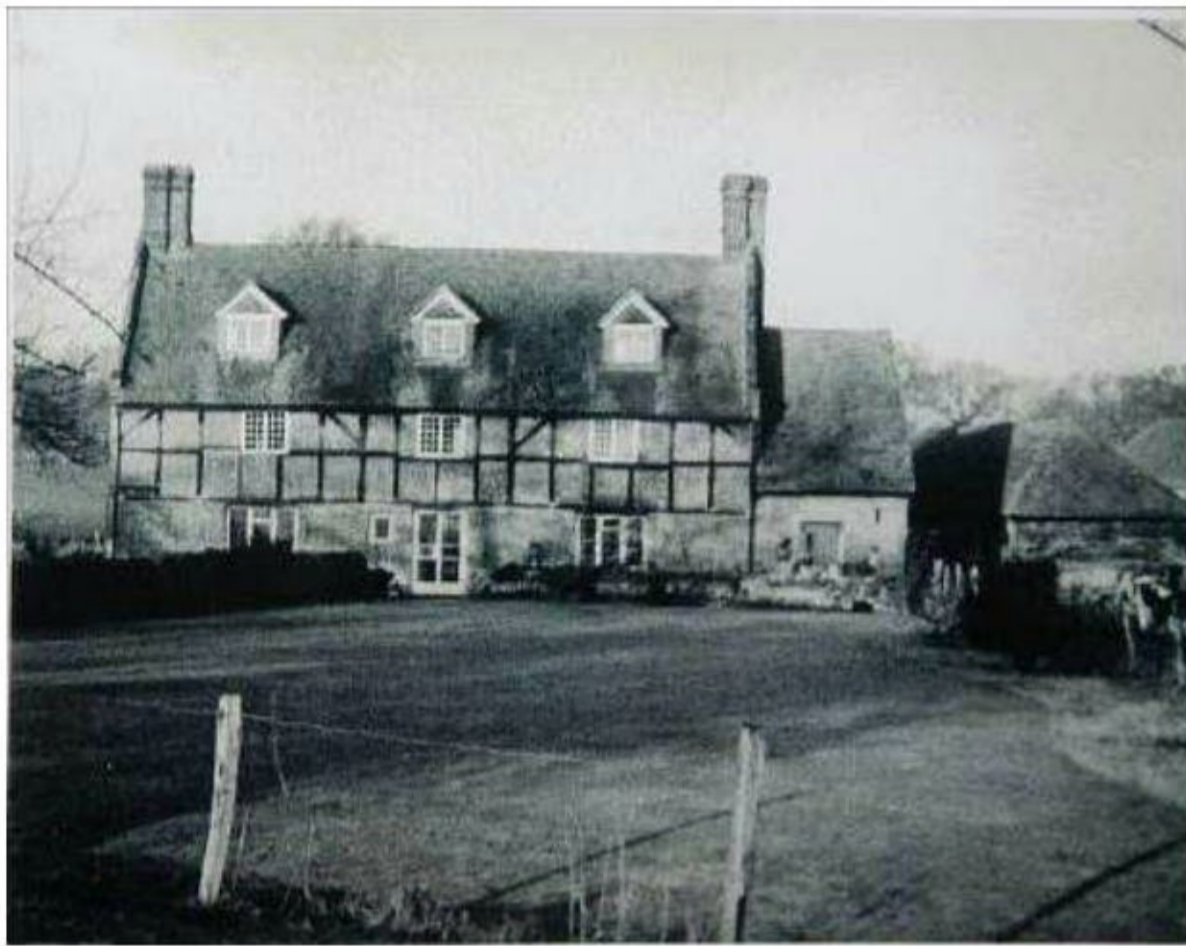
M: Rear elevation after alterations (1966)

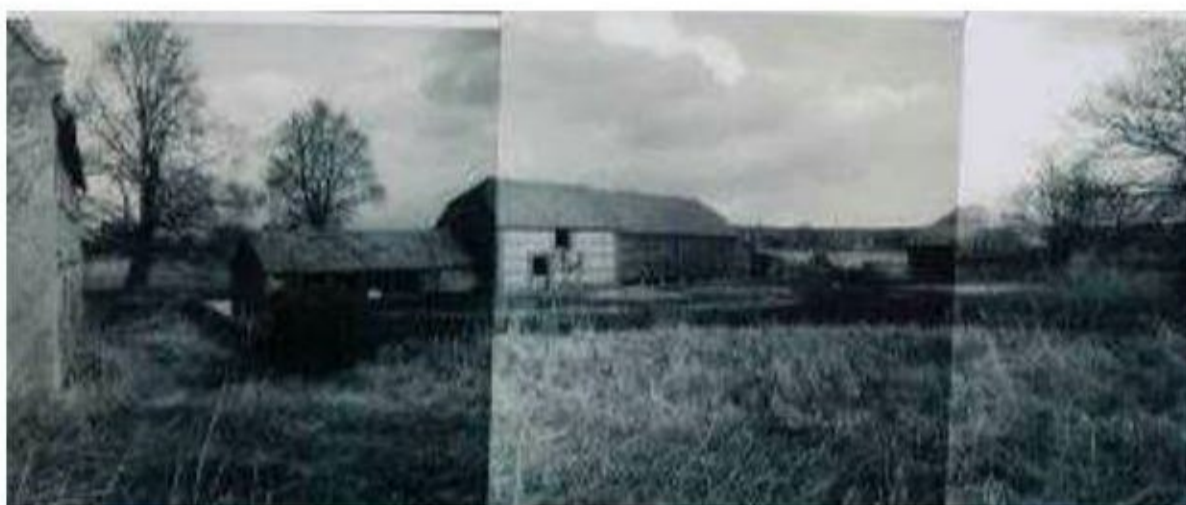
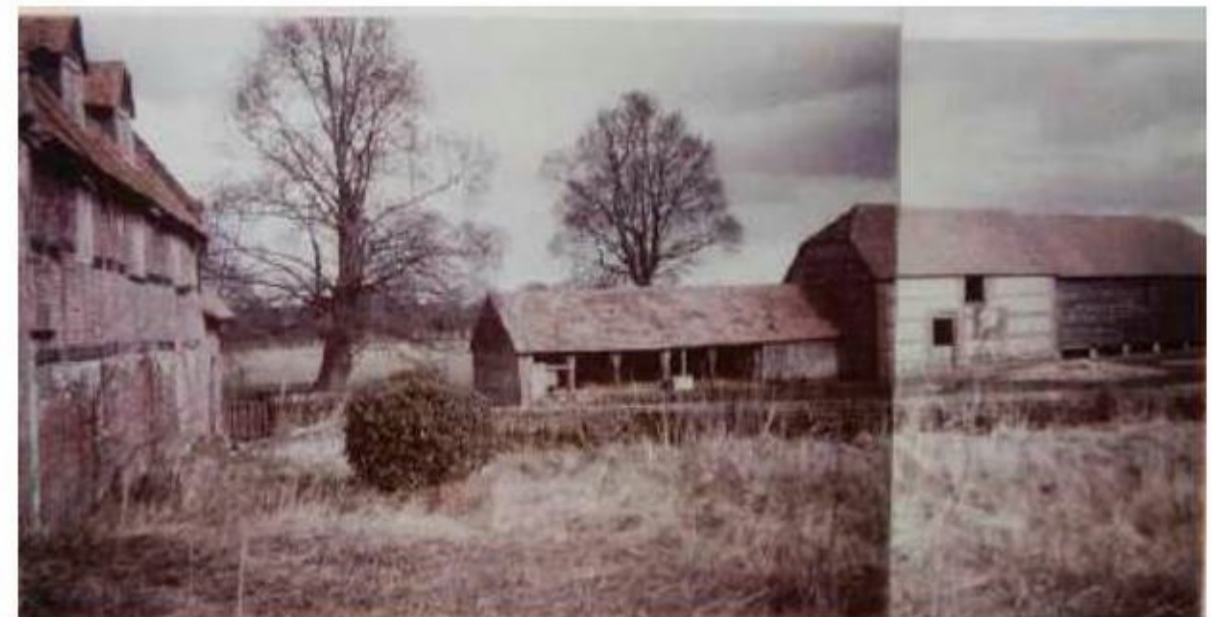
O: Looking N across garden to farm buildings

P: Looking N across garden to farm buildings

3.2.2 Buildings B, C and D (**Plates 43 & 44** and **Photos B & N-P**) were not sold with the farmhouse in 1957, only coming into the Dodgsons' ownership in July 1988. It is probable that some of the repair work that has evidently been undertaken to the roof structures of these buildings was done after this time.

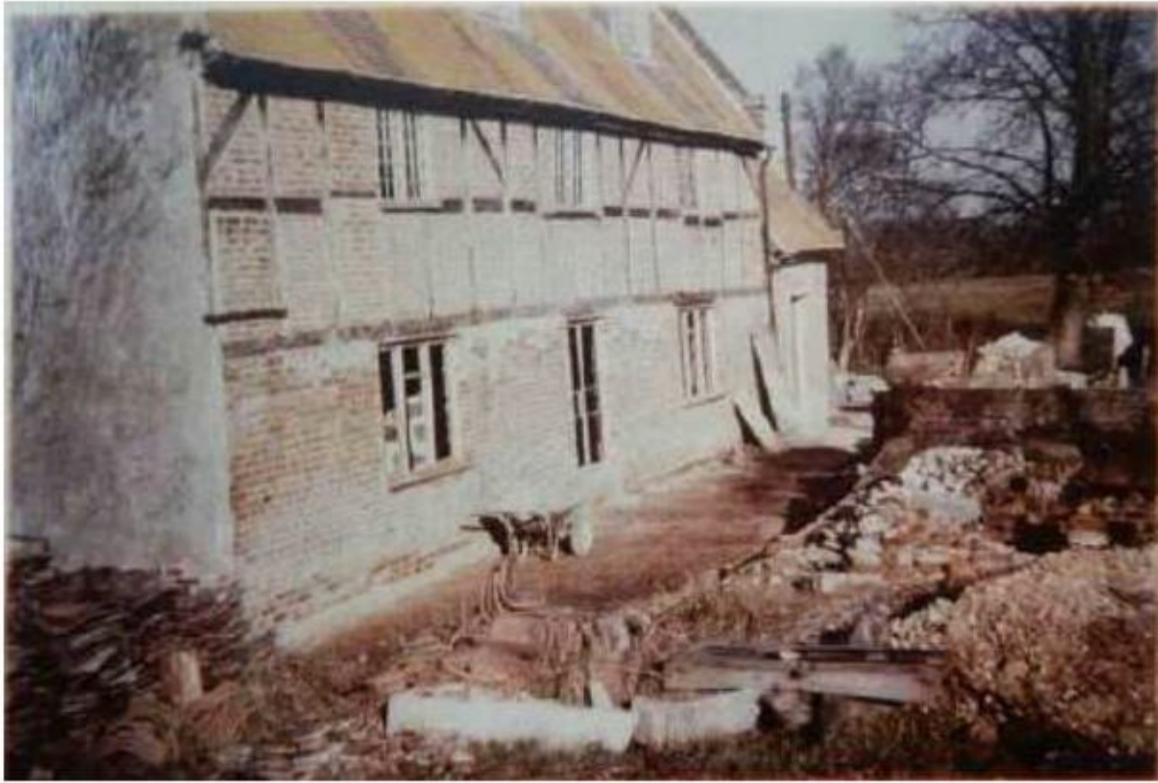
S: Rear elevation with new French doors

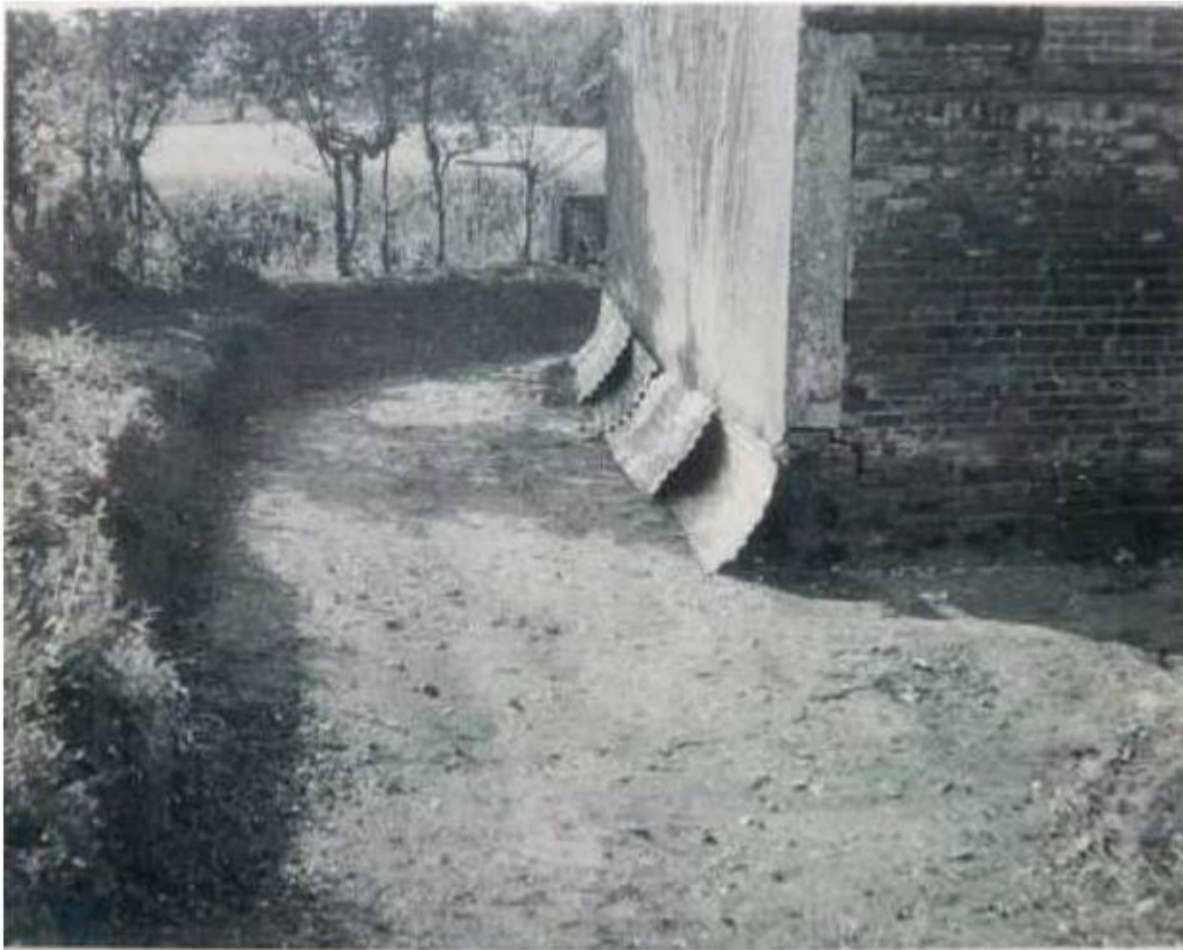
Y: SW gable end, showing where earth bank was excavated away from the side of the building

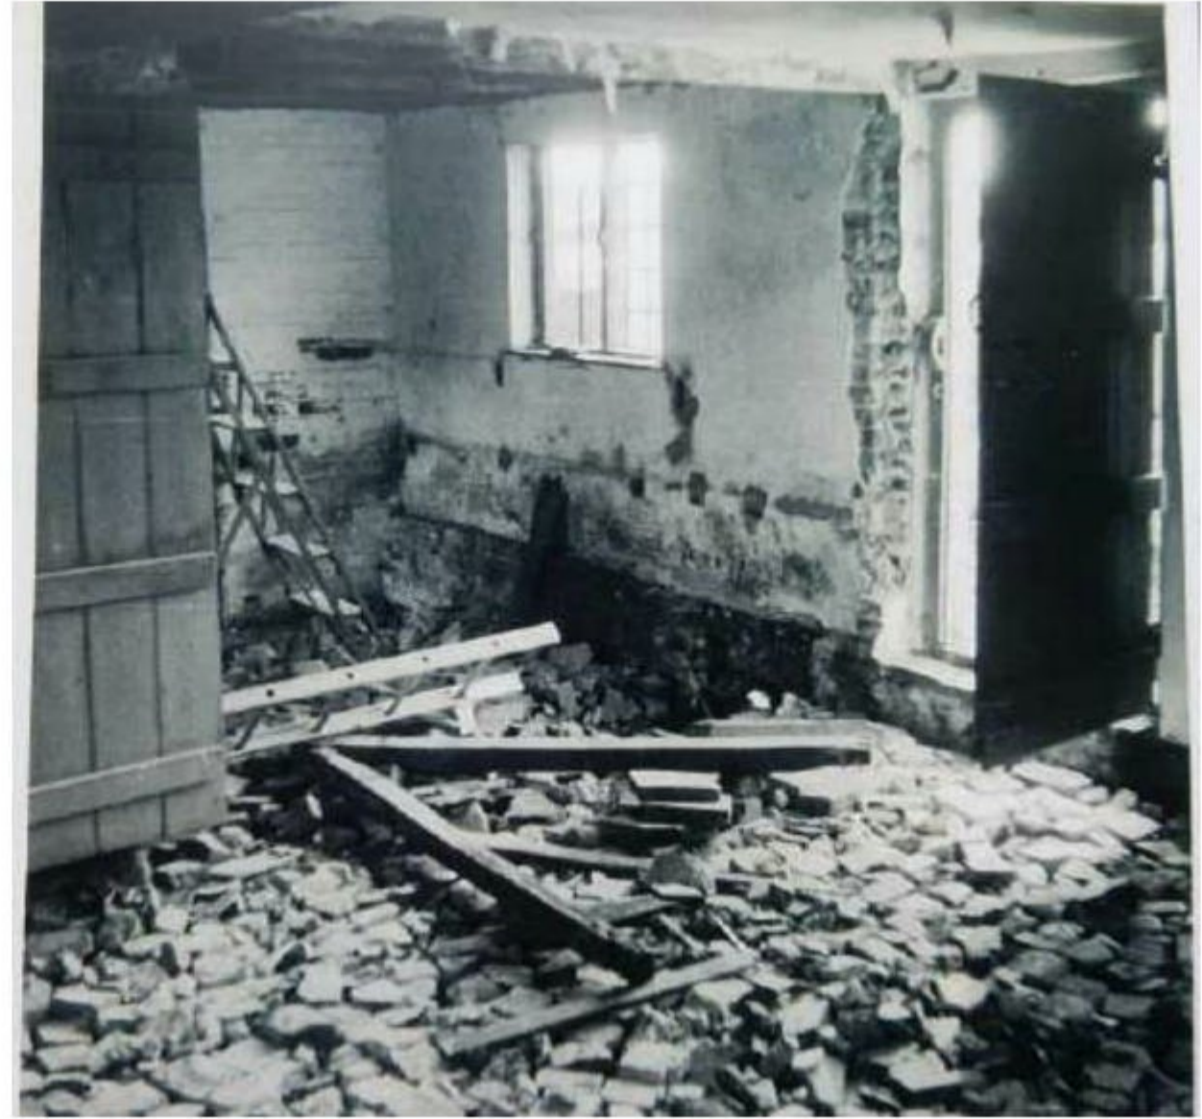
F1: Looking SW from G4 to back door through where demolished wall between G4 & the central bay stood, & into the central bay: the brick floor has been dug out (the person in Photo D1 above is sitting just L of the door in this image)
