STATEMENT OF SIGNIFICANCE

**Flood Street Farm,
Breamore, Hampshire**

Mr & Mrs Bolt

Date: April 2021

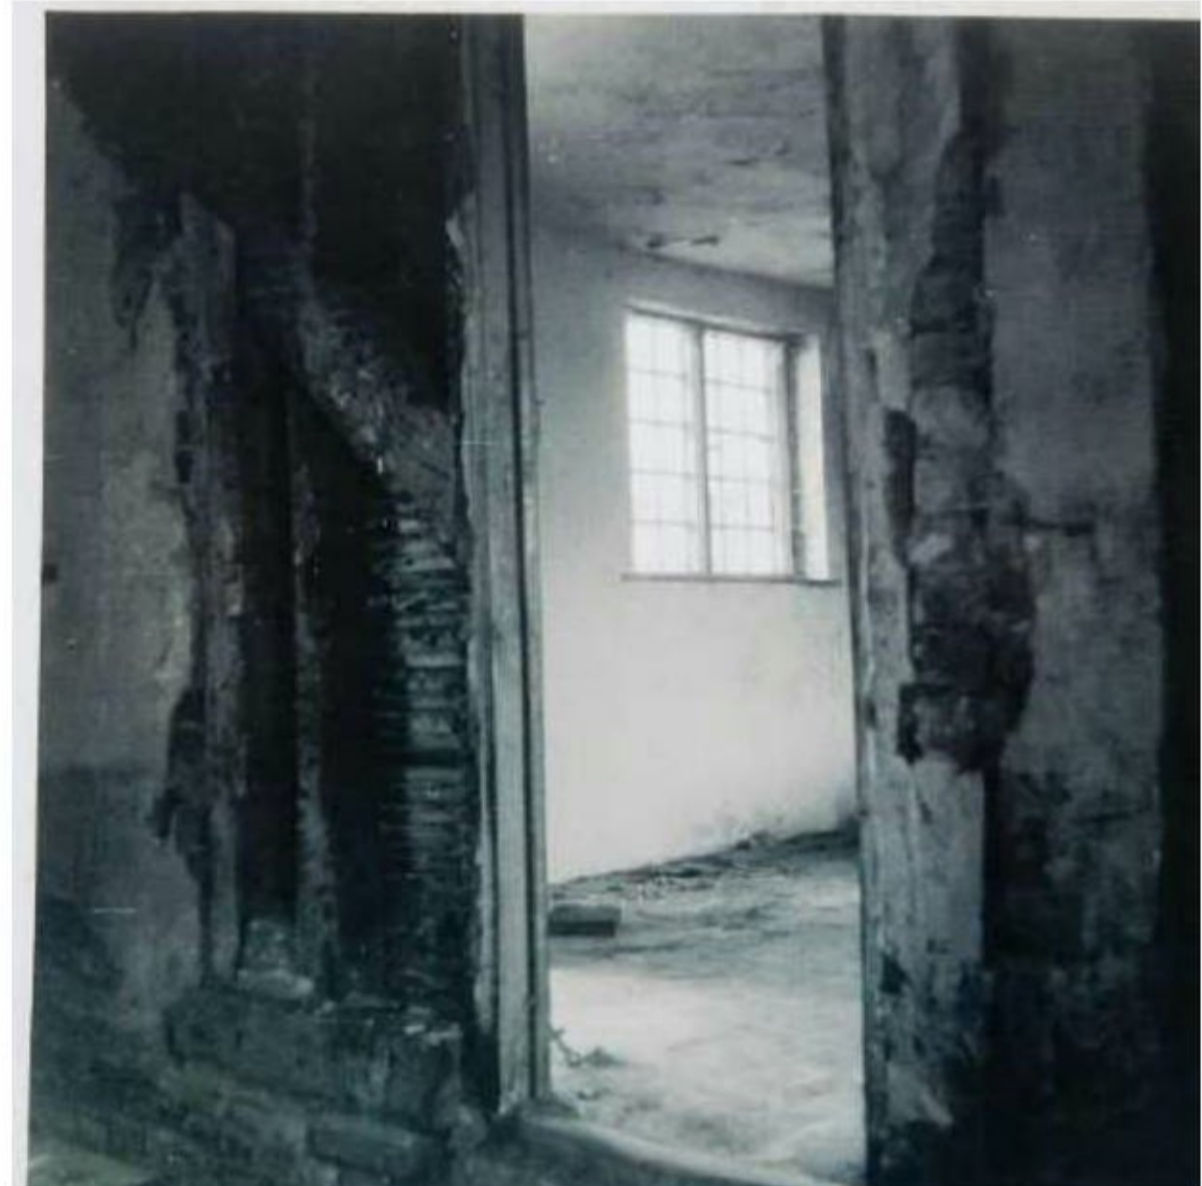
G1: Looking N from central bay into G4 (the timber-framed wall was yet to be demolished)

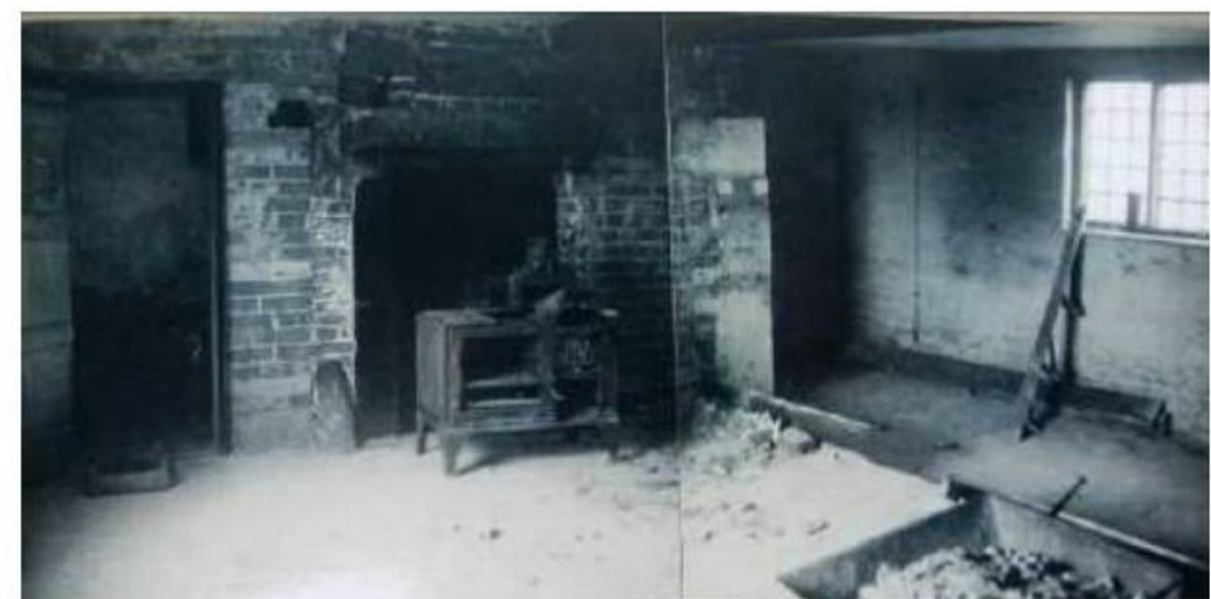
H1: G3, looking SW to partially bricked-in inglenook

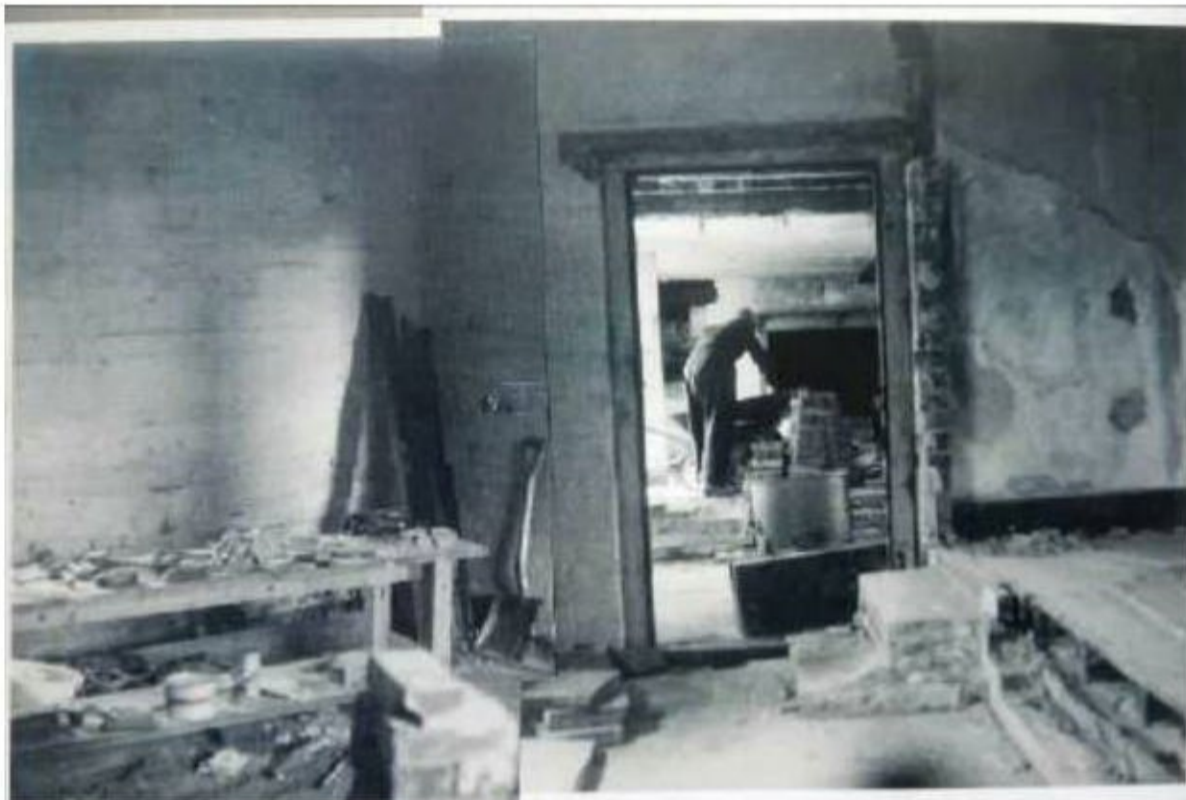
L1: Similar viewpoint to K1 above, looking SW into G3, but from within the central bay: the brick wall is in the process of being replaced with the new concrete block wall

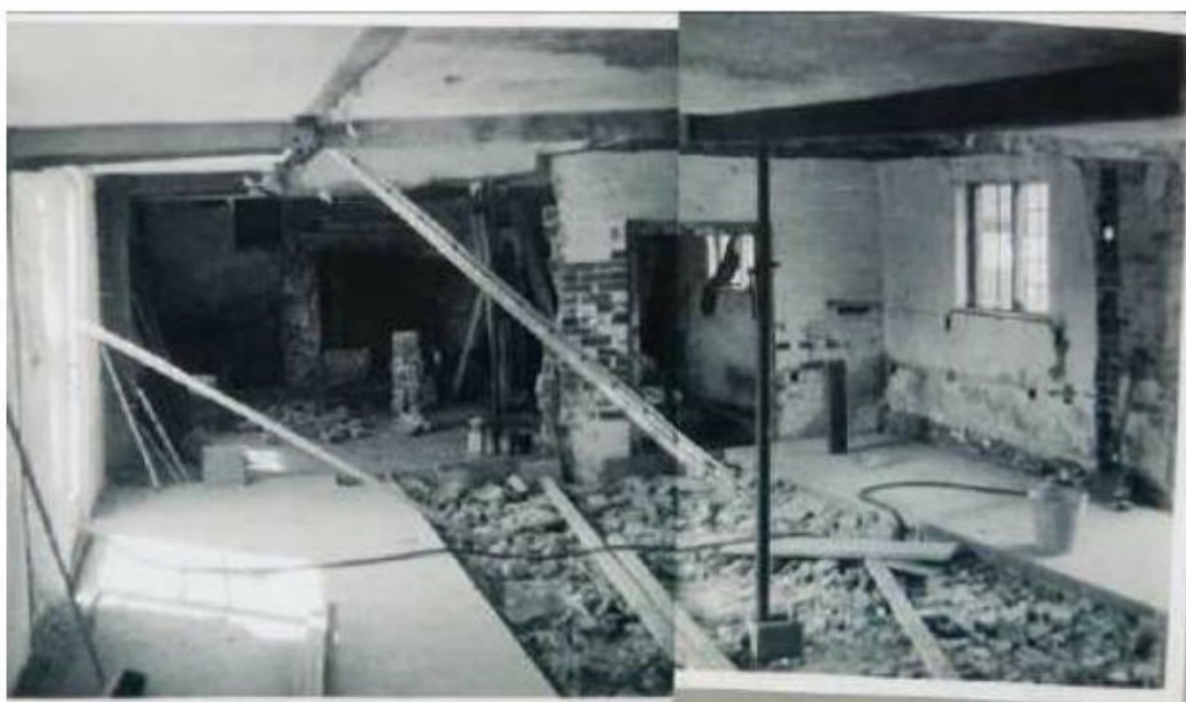
M1: Looking NE from G3 through partially demolished wall where staircase has been removed in central bay across into G4

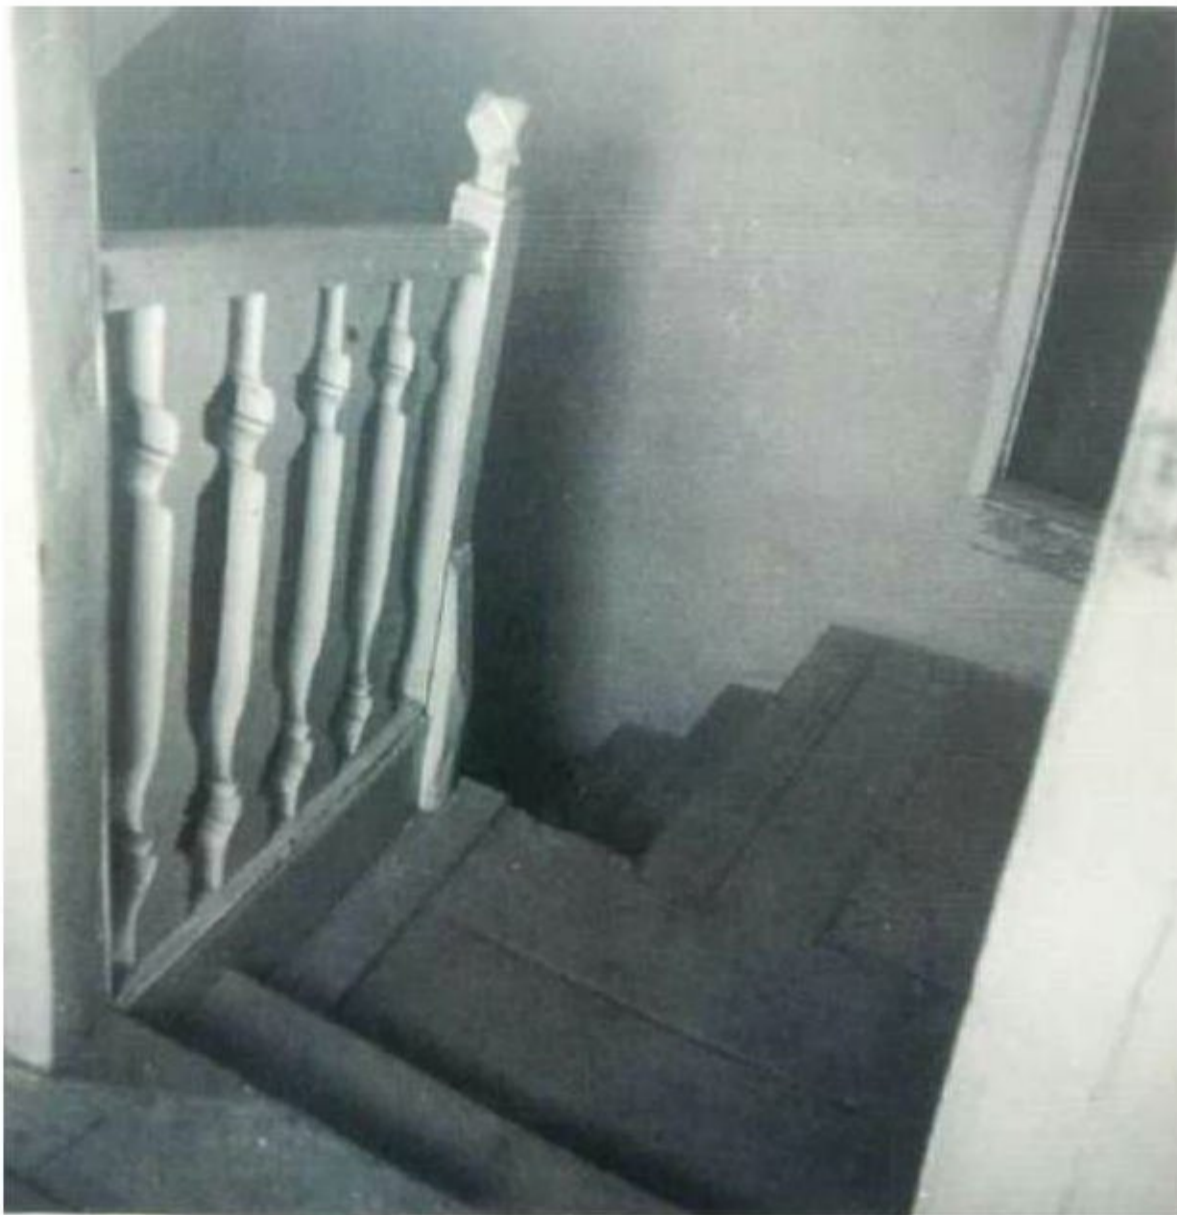
Y1: Detail of carved wooden piece where the staircase turns through 90 degrees up to the first floor (this was not retained)

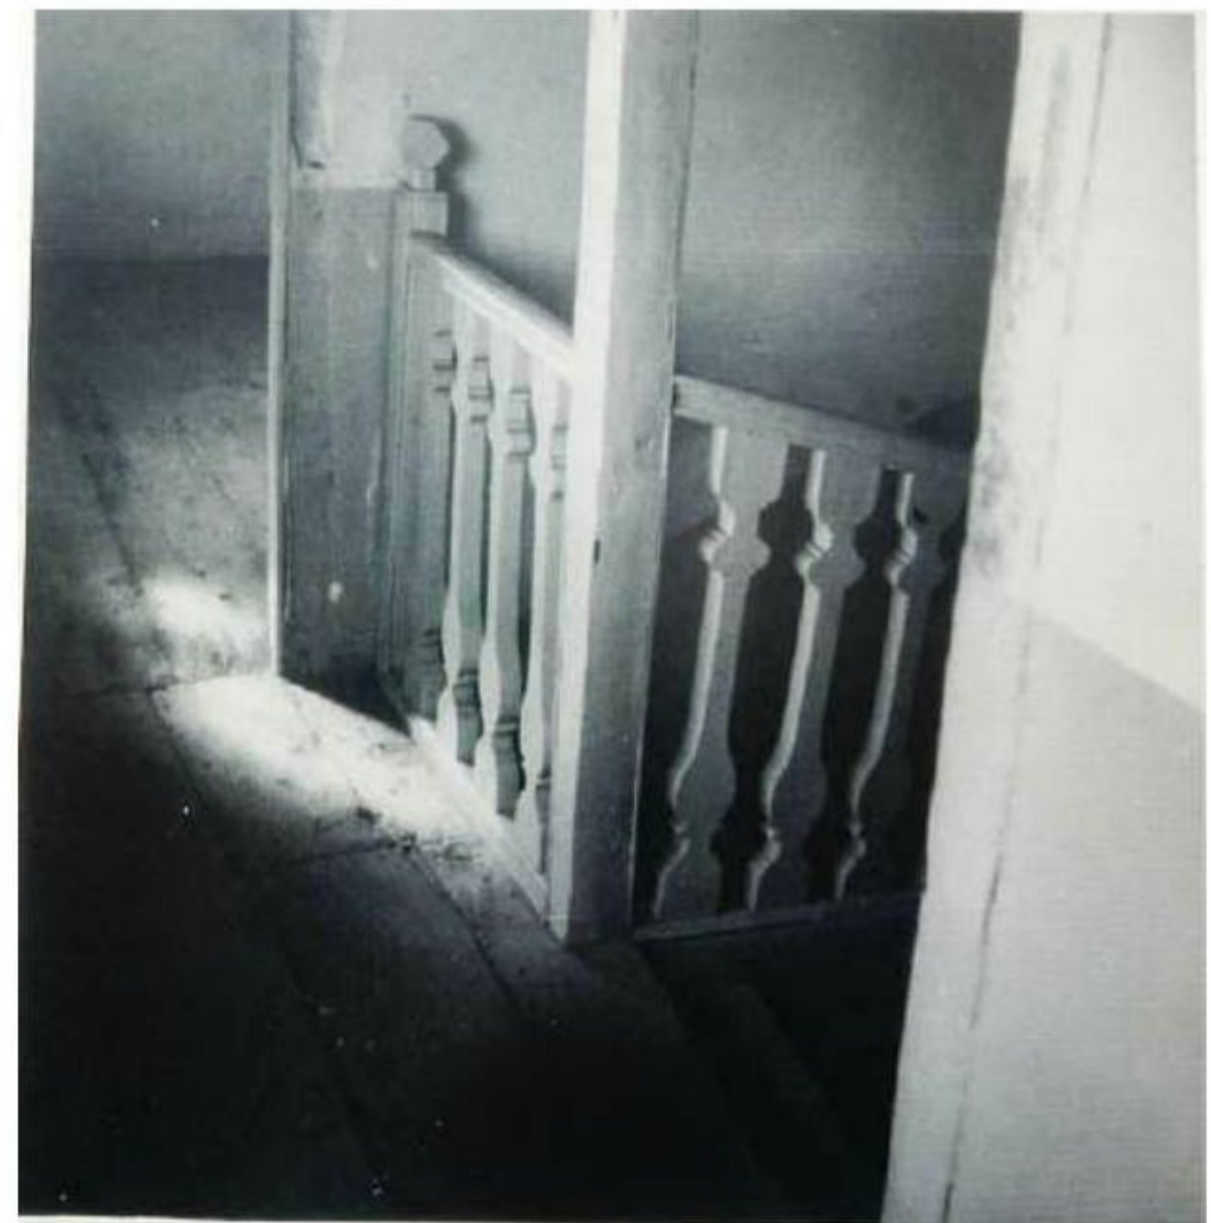
X1: Looking down the original staircase from the first-floor landing (F1). The door opening ahead is into F2. The attic stairs ascend to the right from the quarter landing in front of the doorway (out of shot)

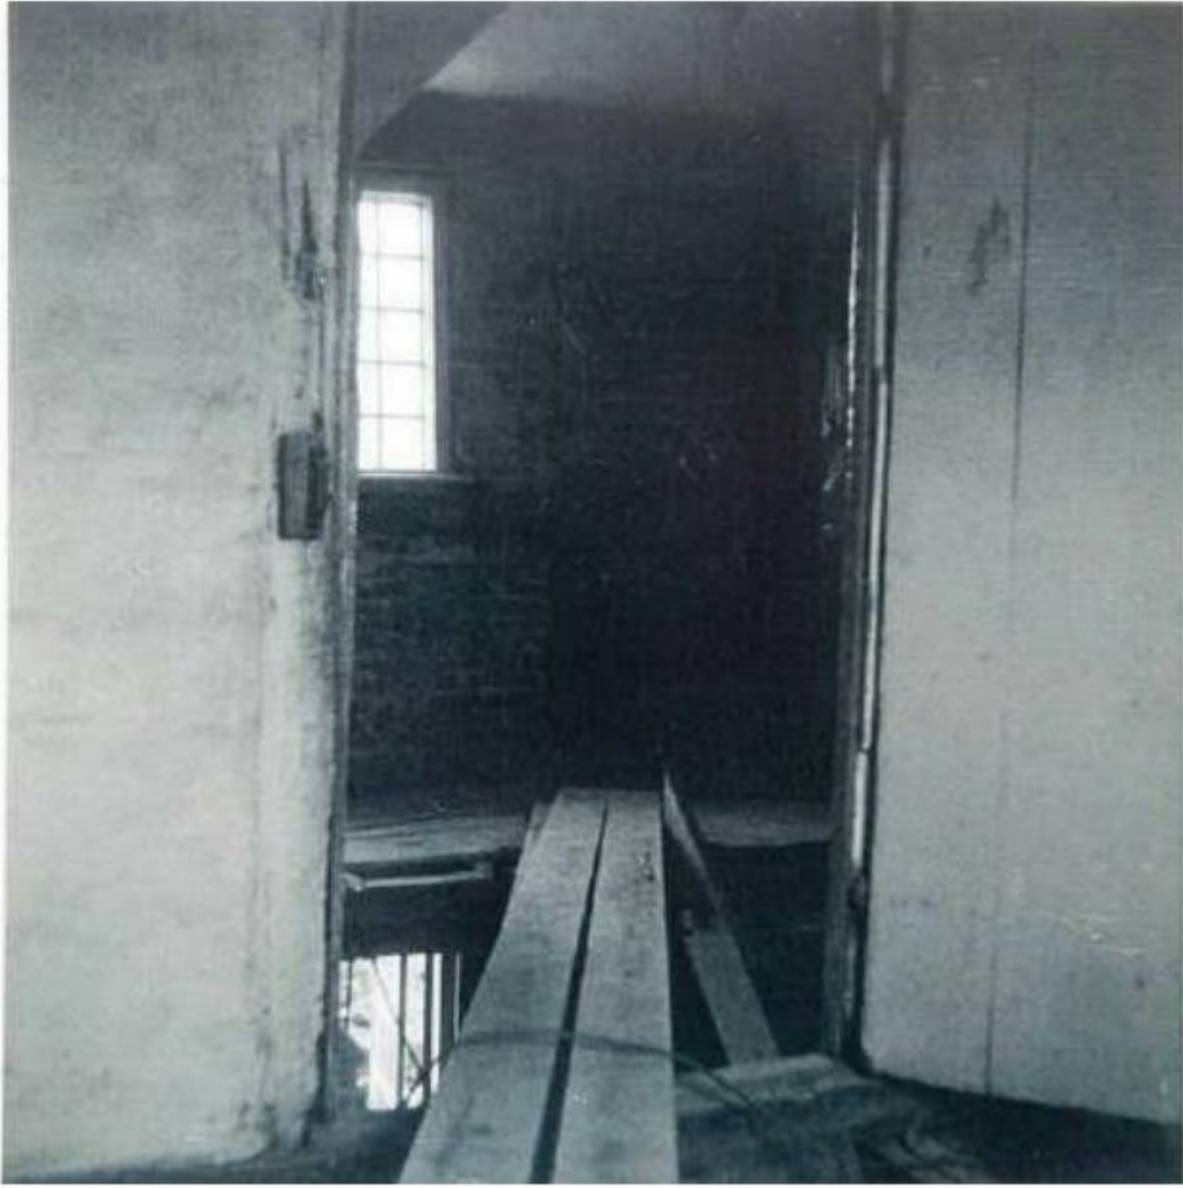
H2: Looking down from F2 into central bay: new staircase, or a temporary one, can be seen against new blockwork wall

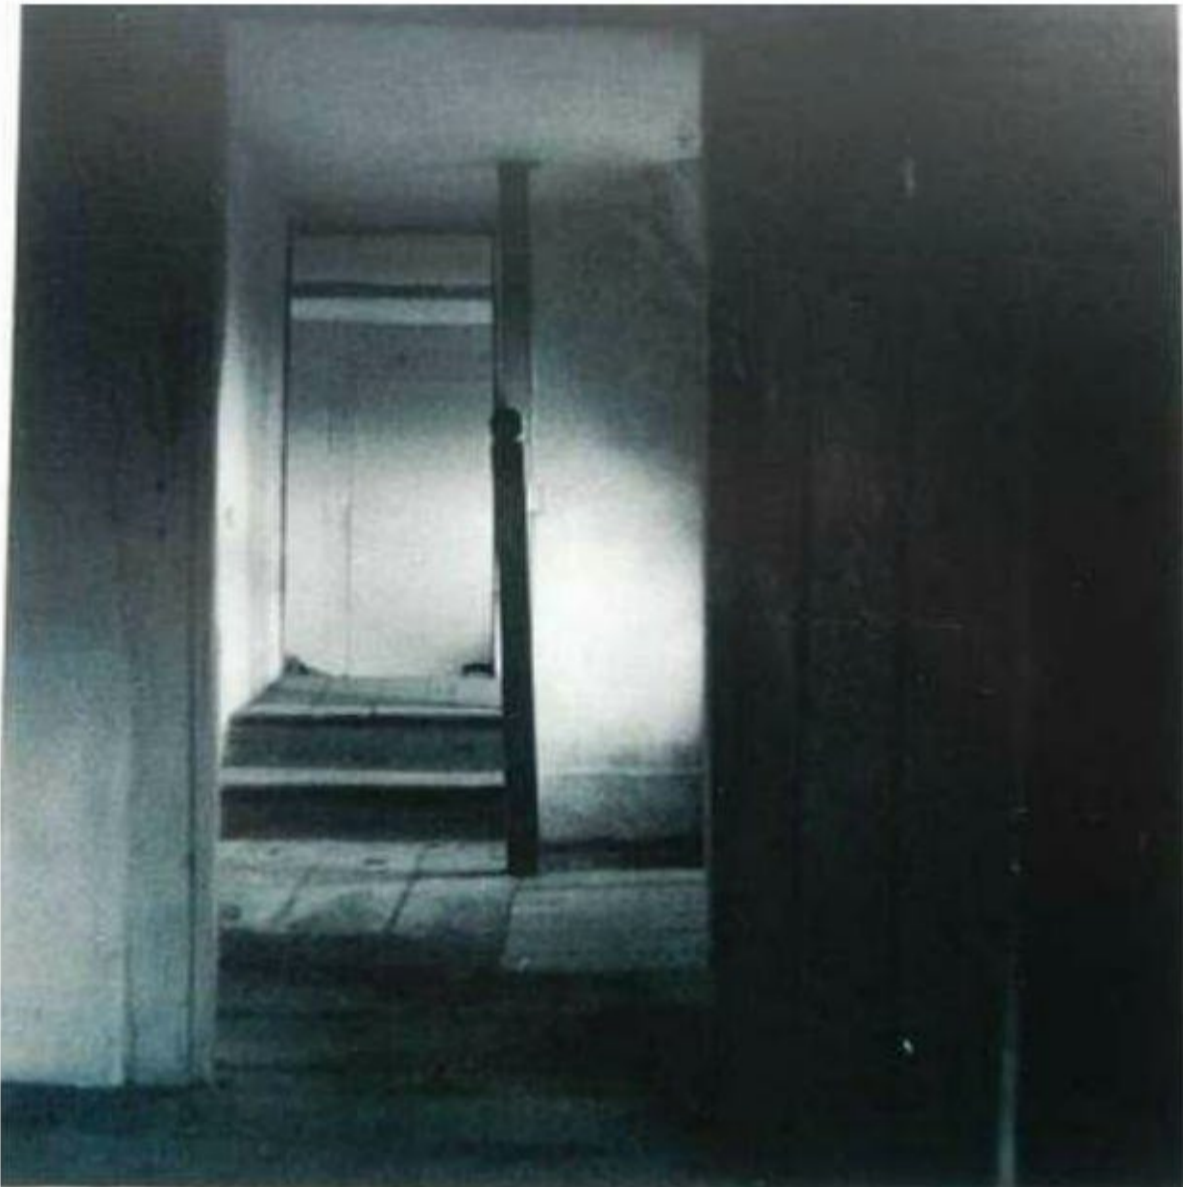
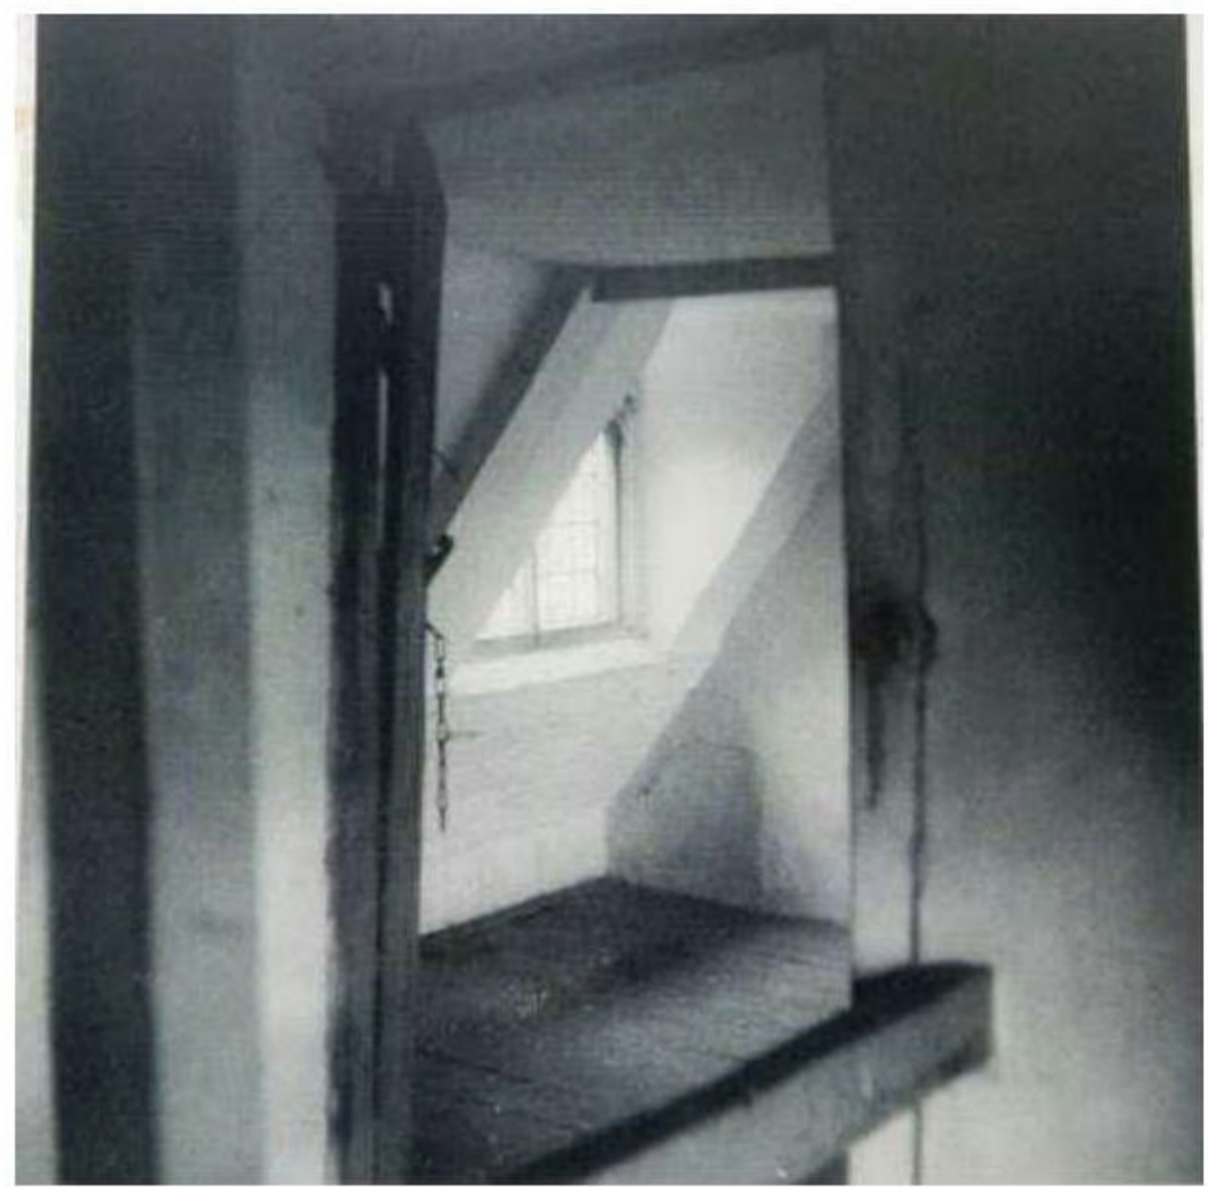
K2: S1, looking NE

J2: S1, looking NE

- 3.1.24 The second-floor landing (S1; **Plates 37 & 38**) looks much as it did in 1956, with an original newel with barrel-shaped finial and plain handrail (with replaced stick balusters) at the stair head (cf **Plate 37** with **Photos J2 & K2**). From the landing, there are two steps up to the door into the northern room and then two steps down from there into the room. This is presumably to allow for headspace and the height of the attic door beneath.
