# St. Mary the Virgin Church, Hook

## Arboricultural Method Statement

*October 2022*

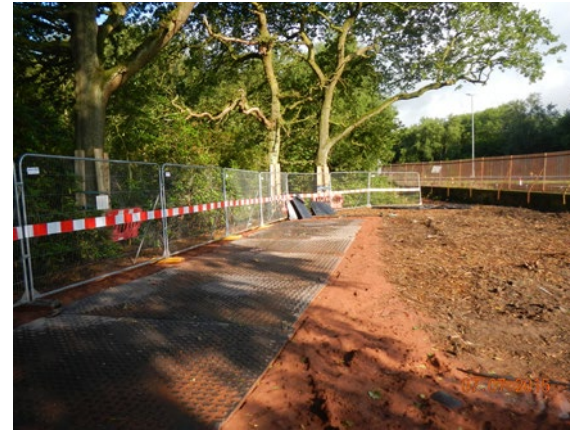
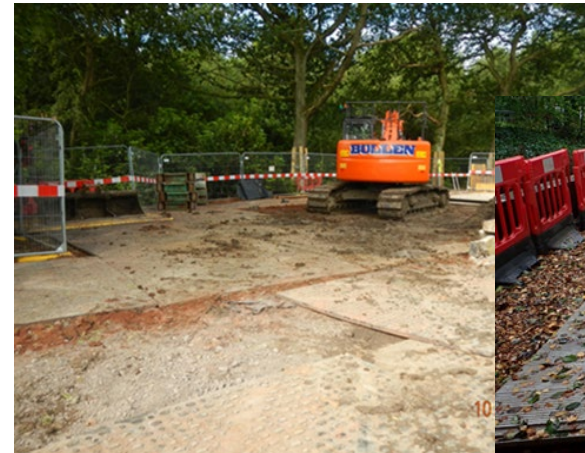
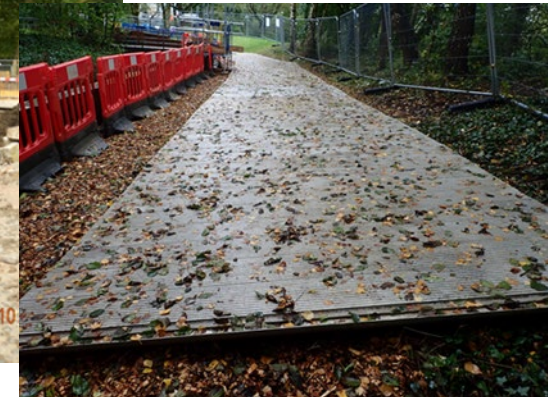
### Actions

- The following applies to plywood (other systems follow a similar installation procedure).
- Existing grass/turf to remain.
- A wood chip compressible layer is to be spread across the working area to create a level working surface to a depth of 150 mm.
- Plywood boards laid over. This surface will be retained through the works to form a working surface.
- Once the works are complete, the woodchip can be left as a soil ameliorant.

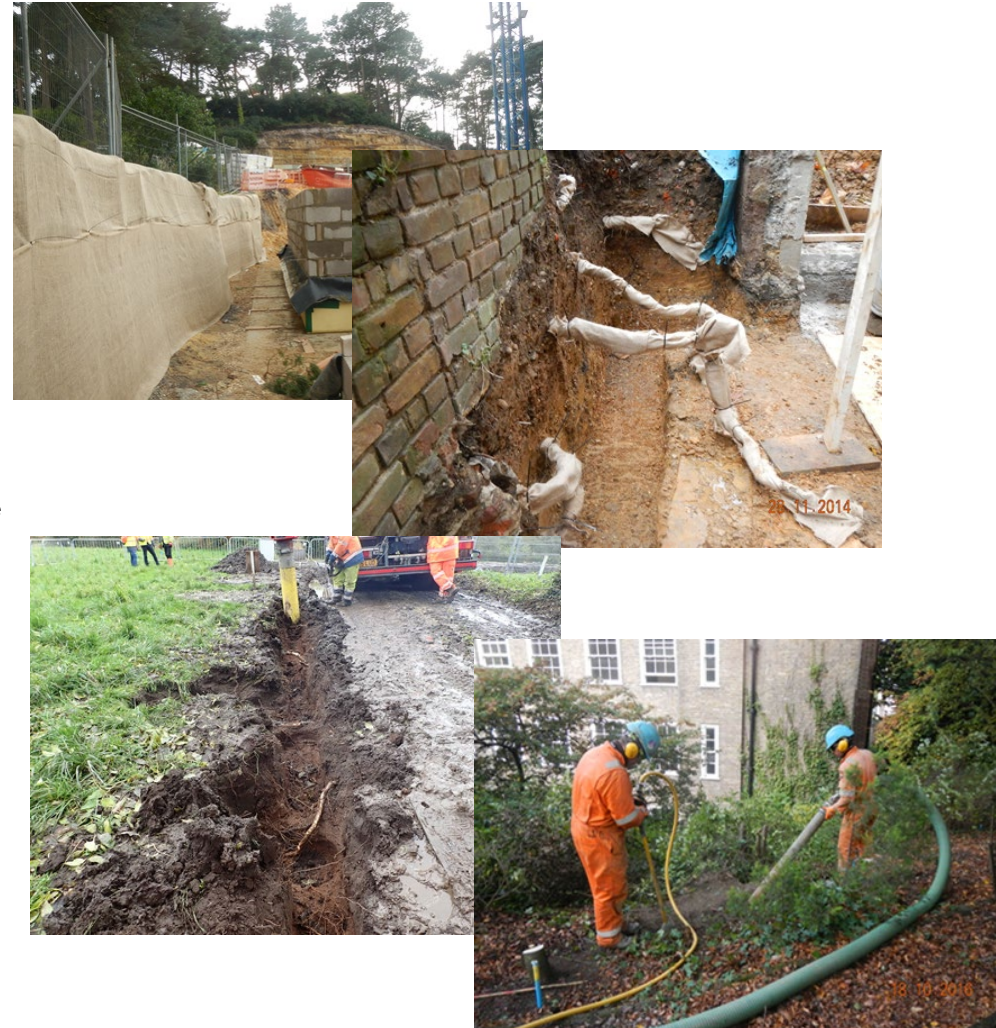
### Foundation Excavation – Concrete Plinth

- The works area is to be marked out.
- Any hard surface broken out by hand working;
- Using either Hydro Vacuum & Suction Excavation, Pneumatic Vacuum & Suction Excavation or Clay-Spade Assisted Suction Excavation, the foundation will be excavated.
- In all cases: Roots <25mm Ø are to be cut at the excavation face with secateurs. Roots >25mm Ø are to be assessed by the Arboricultural Consultant. Findings and decision on root retention/severance to be reported to the LPA.
- Exposed roots to be kept moist with hessian sacking/terram.
- The foundation pit to be lined with a visqueen liner.
- Site inspections to be reported to the development team and the LPA.
