Heritage Impact Assessment for
Refurbishment Works at
The Old Rectory, Clyst St Lawrence, CULLOMPTON,
Devon, EX15 2NW

ref: md22 0411rev Initial

1.00 Introduction

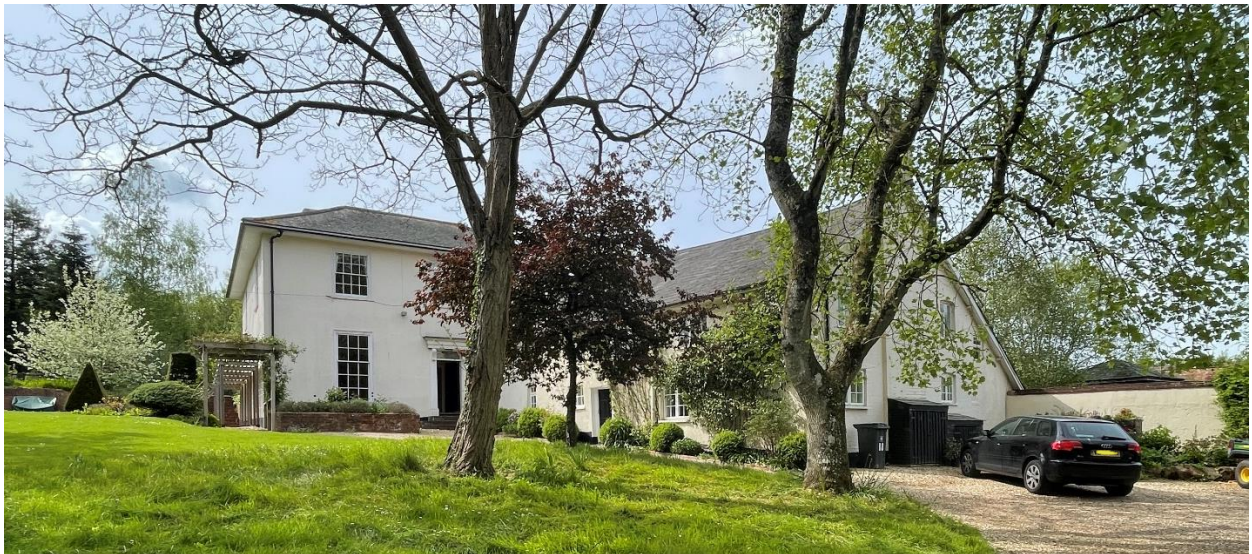
For identification purposes, the property is described in two parts, namely:

- The Tudor Wing (the eastern section)
- The Georgian Wing (the western section)

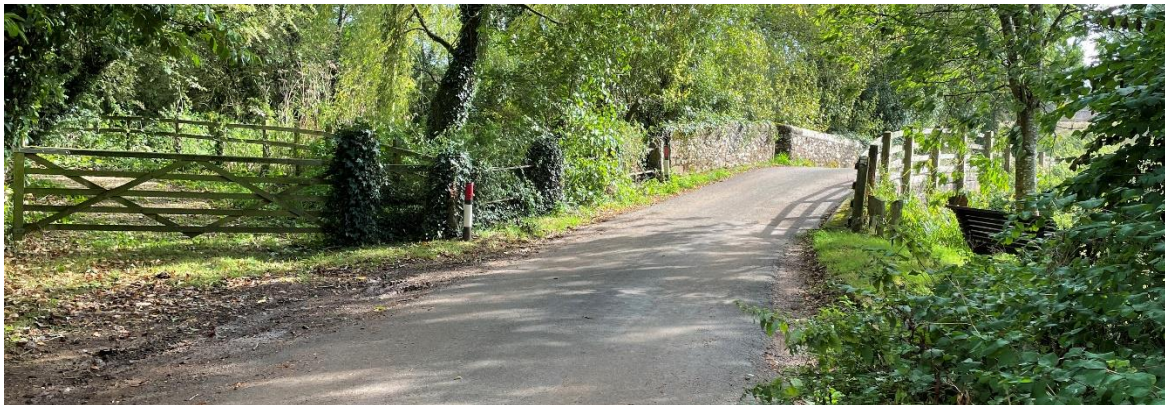
Photographs:

Small road bridge over the River Clyst. Probably C18. Local stone rubble laid to rough courses and larger and neater stone blocks towards the base, some conglomerate ashlar dressings and some brick rebuilding. 2-span bridge of segmental arches springing from vertical abutments. The voussoirs on the upstream (north) side are conglomerate ashlar but they have been replaced with brick on one arch of the downstream side. The other downstream arch now has a C20 concrete lintel. The central pier has a pointed cutwater upstream which rises to the parapet and providing a small refuge. The parapet has rounded conglomerate stone coping. The downstream side parapet has been removed and replaced with C20 tubular steel railings. The road ramps over the bridge.

The road bridge, located just to the East of the application site, contains many original features and is worthy of preservation. The bridge also supports a public highway.

Although the proposed works are extremely unlikely to physically impact on the bridge, the risk is deemed medium as any impact could have severe consequences.

The road bridge is also located within a flood zone and this will need to be considered.

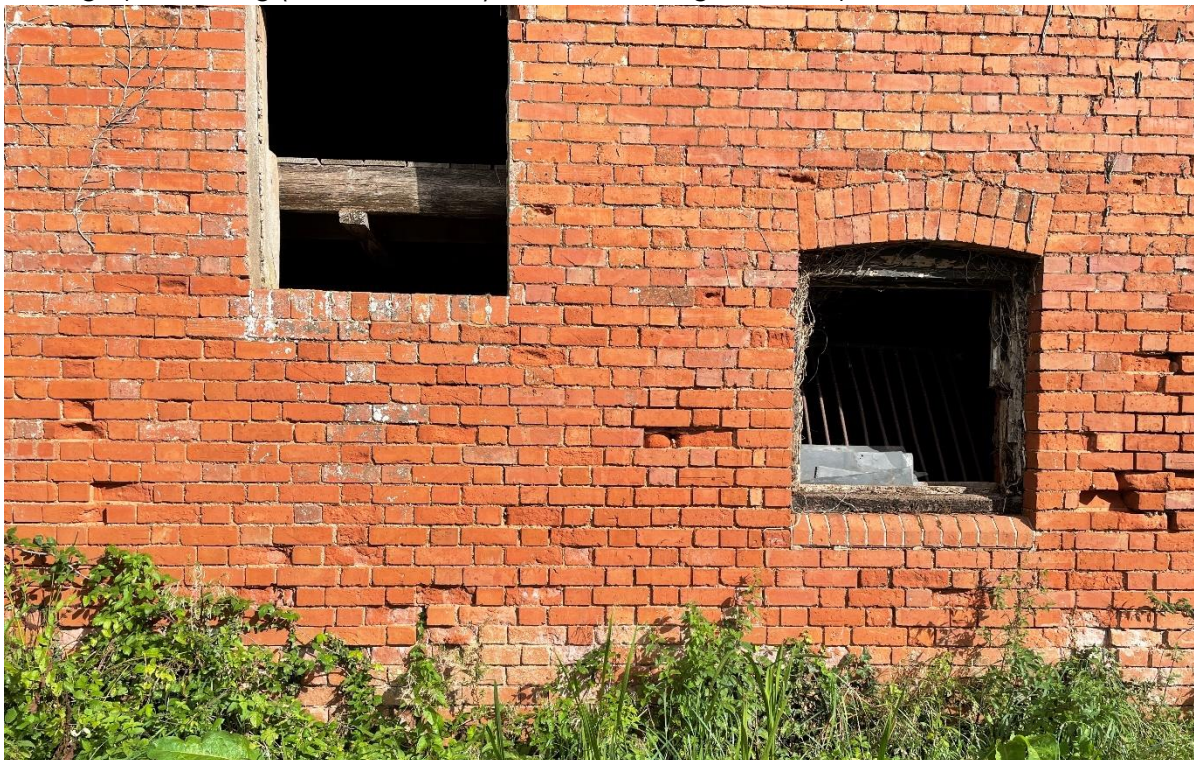
Photograph showing (more common) Flemish bonding on nearby barn:

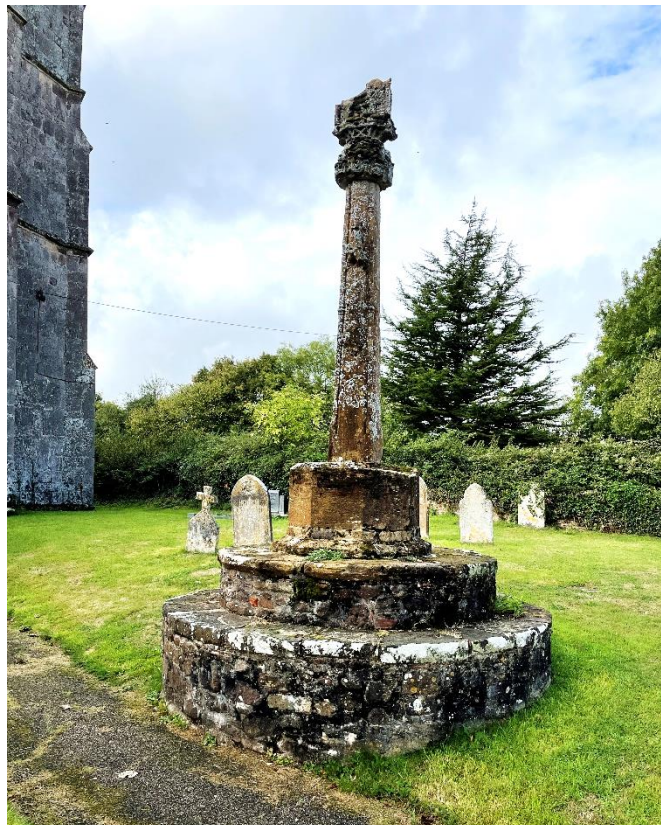
2.07iv Churchyard Cross (06) (right)

This scheduled monument is a free-standing structure set within the churchyard and is believed to be the only one in Devon with a bracketed niche on the shaft.

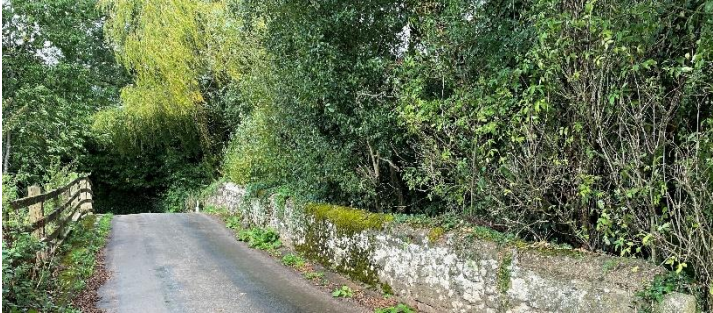
The Site is surrounded with dense vegetation, including nearby trees. The following photographs show the Site's visibility in early autumn, while the trees were still in leaf:

photo (left), looking west, over the bridge (02) towards the Site

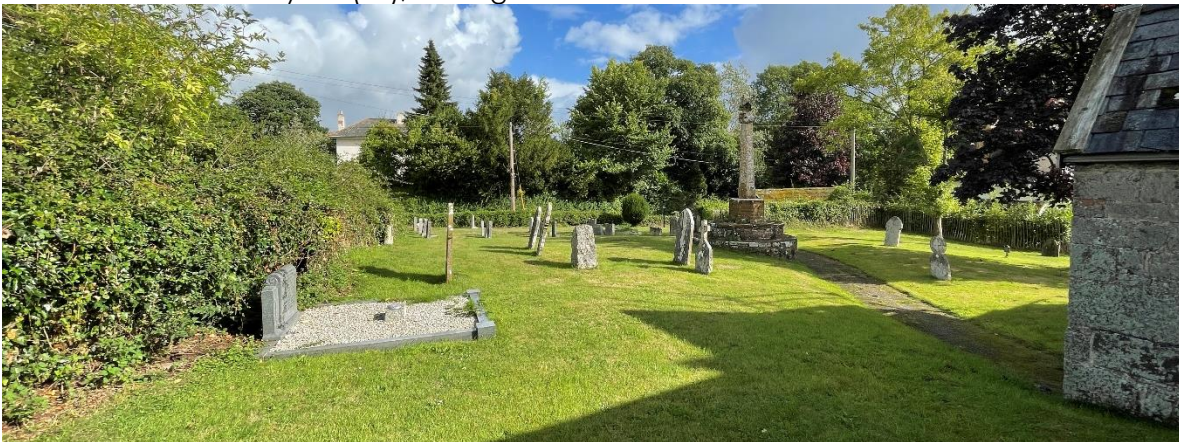
View from the Churchyard (07), looking north towards the Site:

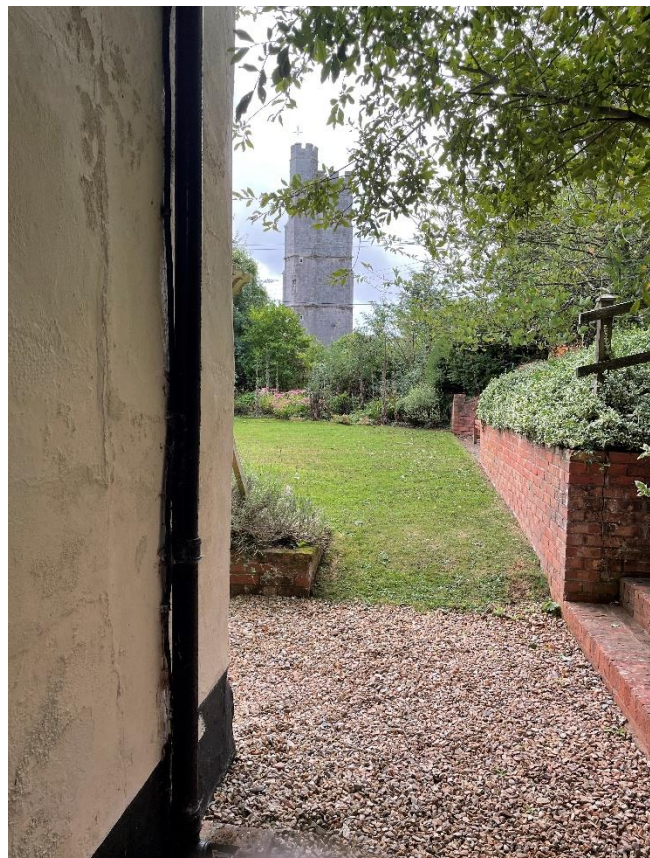
Return view from the Site, looking south towards the Church (07):
