Helmingham Hall Proposals

November 2022

Ben Pentreath

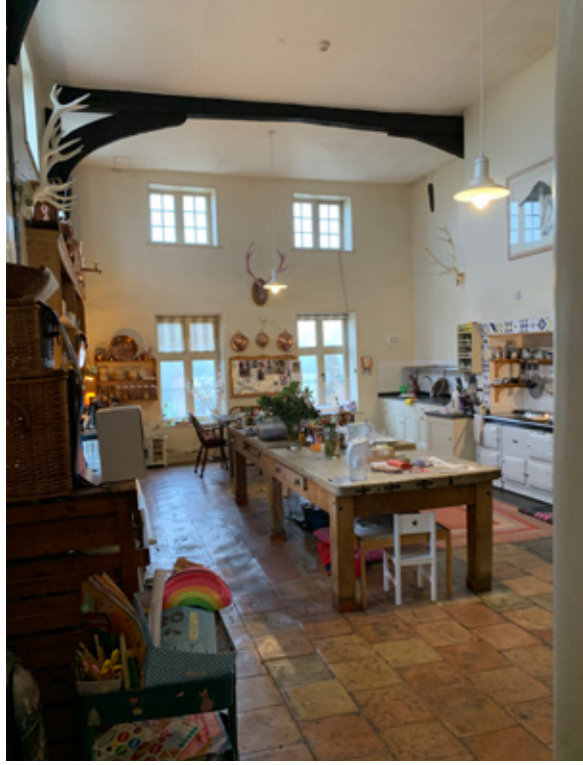
Kitchen facing east

North elevation - We propose opening up three blind windows internally. The windows are present on the exterior and have been blocked off internally at some point in the 20th century. We would also like to adapt one of the windows to form a door giving access from the kitchen onto the terrace. This would be done by carefully matching the historic window/door between the sitting room and small dining room on the east front.

East elevation - There is some damp along the floor line beneath the windows. We propose stripping off the plaster to investigate the cause of the damp and re-plastering in a breathable lime plaster.

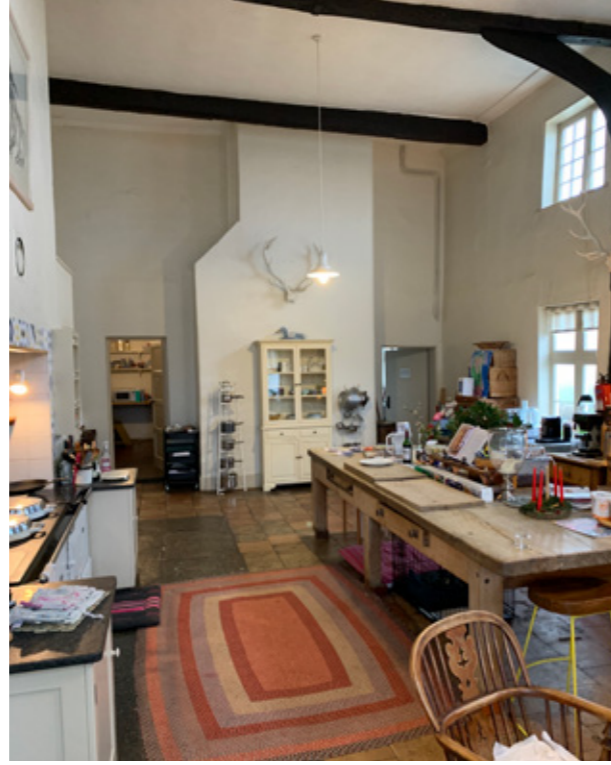
Kitchen facing west

West Elevation – we propose carefully removing the plaster in the centre of the chimney breast to reveal the historic fire chamber. The fireplace would then be reinstated with a simple, flat early 18th century style chimneypiece in stone. The design is similar to the current fireplace in the small dining room.

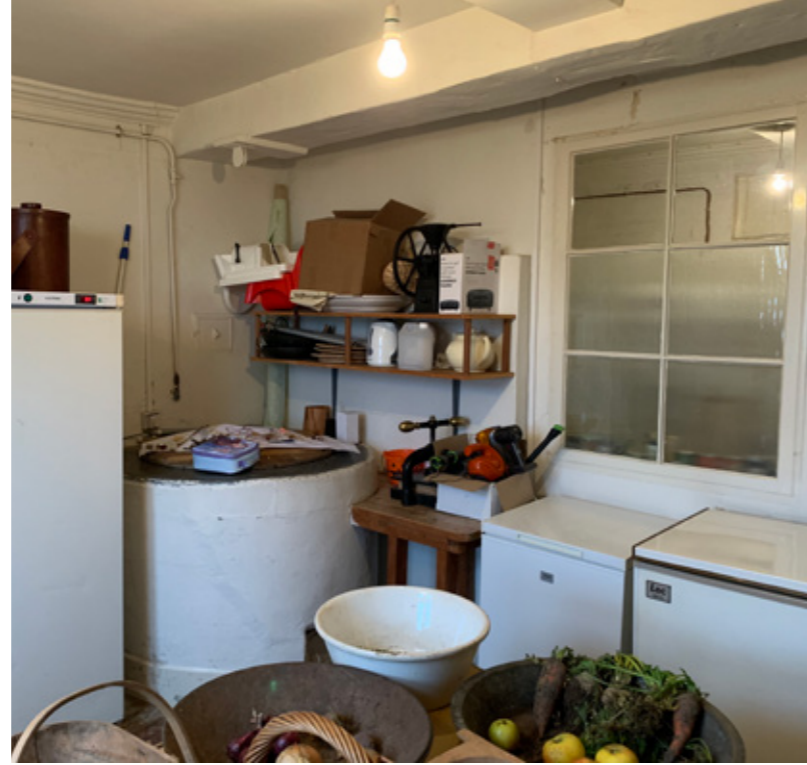
Historic copper in south-east corner of prep kitchen

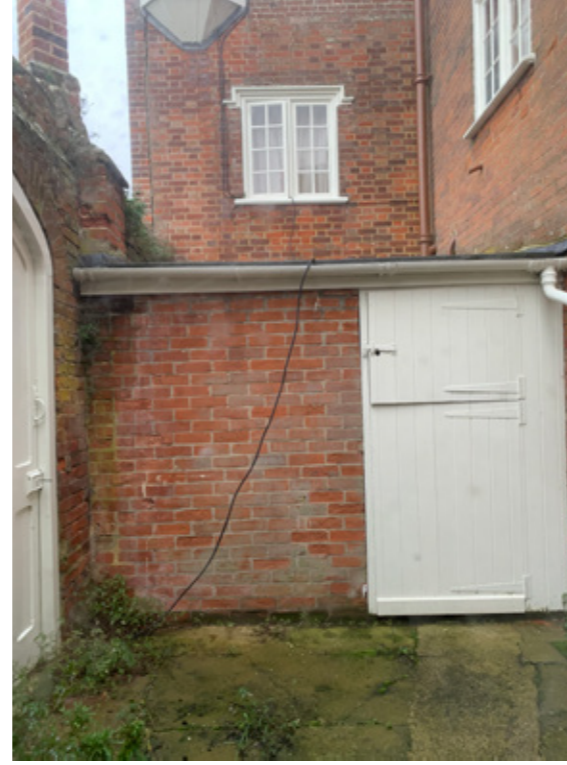
Courtyard outer wall by Nash to the left, with Salvin's new range visible on the right and 20th century infill to the centre.

We can see from the 1950s plan that this yard had a brick floor and small coal enclosure along the north wall. At some point during the second half of the 20th century a larger enclosure with a mono-pitch roof was added to the eastern half. This structure is of poor quality with an asphalt roof, on chipboard sheets and the wall is built in stretcher bond. The brick floor has been replaced with concrete, now in a poor state of repair. A flimsy partially glazed screen of 20th century construction divides the yard from GF08.

We propose removing the modern lean-to structure and repairing the brick pier of Nash's courtyard wall to the north, which it currently adjoins. We plan to remove the concrete floor and replace this with a reclaimed brick floor to match GF4 and GF8. On the north wall, we plan to add an identical casement window to balance the one lighting the Butler's pantry on the other side of the courtyard door. The Butler's pantry was probably added in the 1950s, as it doesn't appear in an old black and white photo of the house. Adding a new window in this location will create a more balanced composition externally as well as affording views into the park.

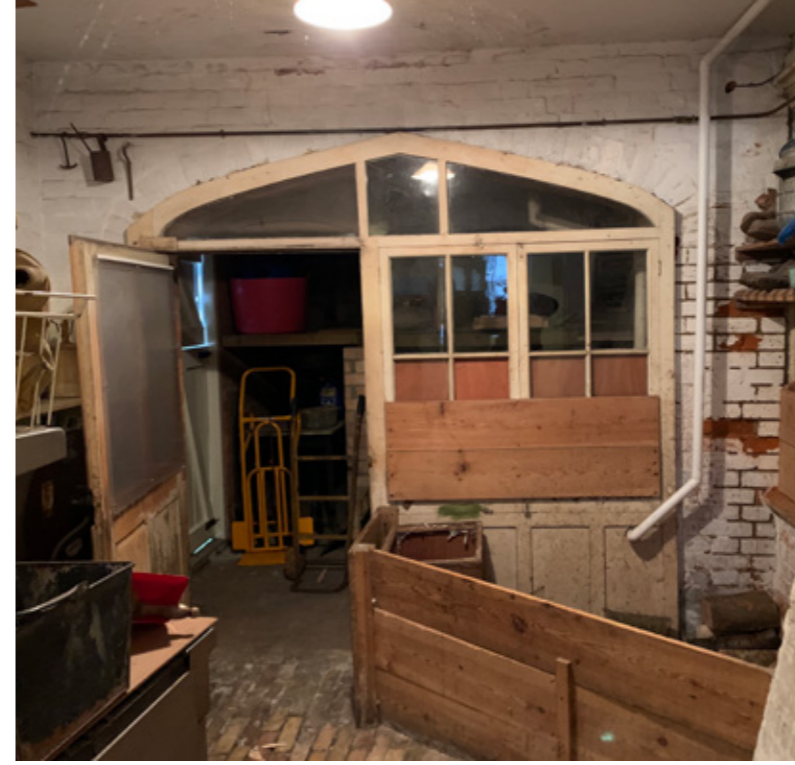
Arch from Salvin's remodelling once allowed access to external courtyard, now internal due to 20th century extension.

A new glazed screen door is proposed in the arch between the glass house and GF8.

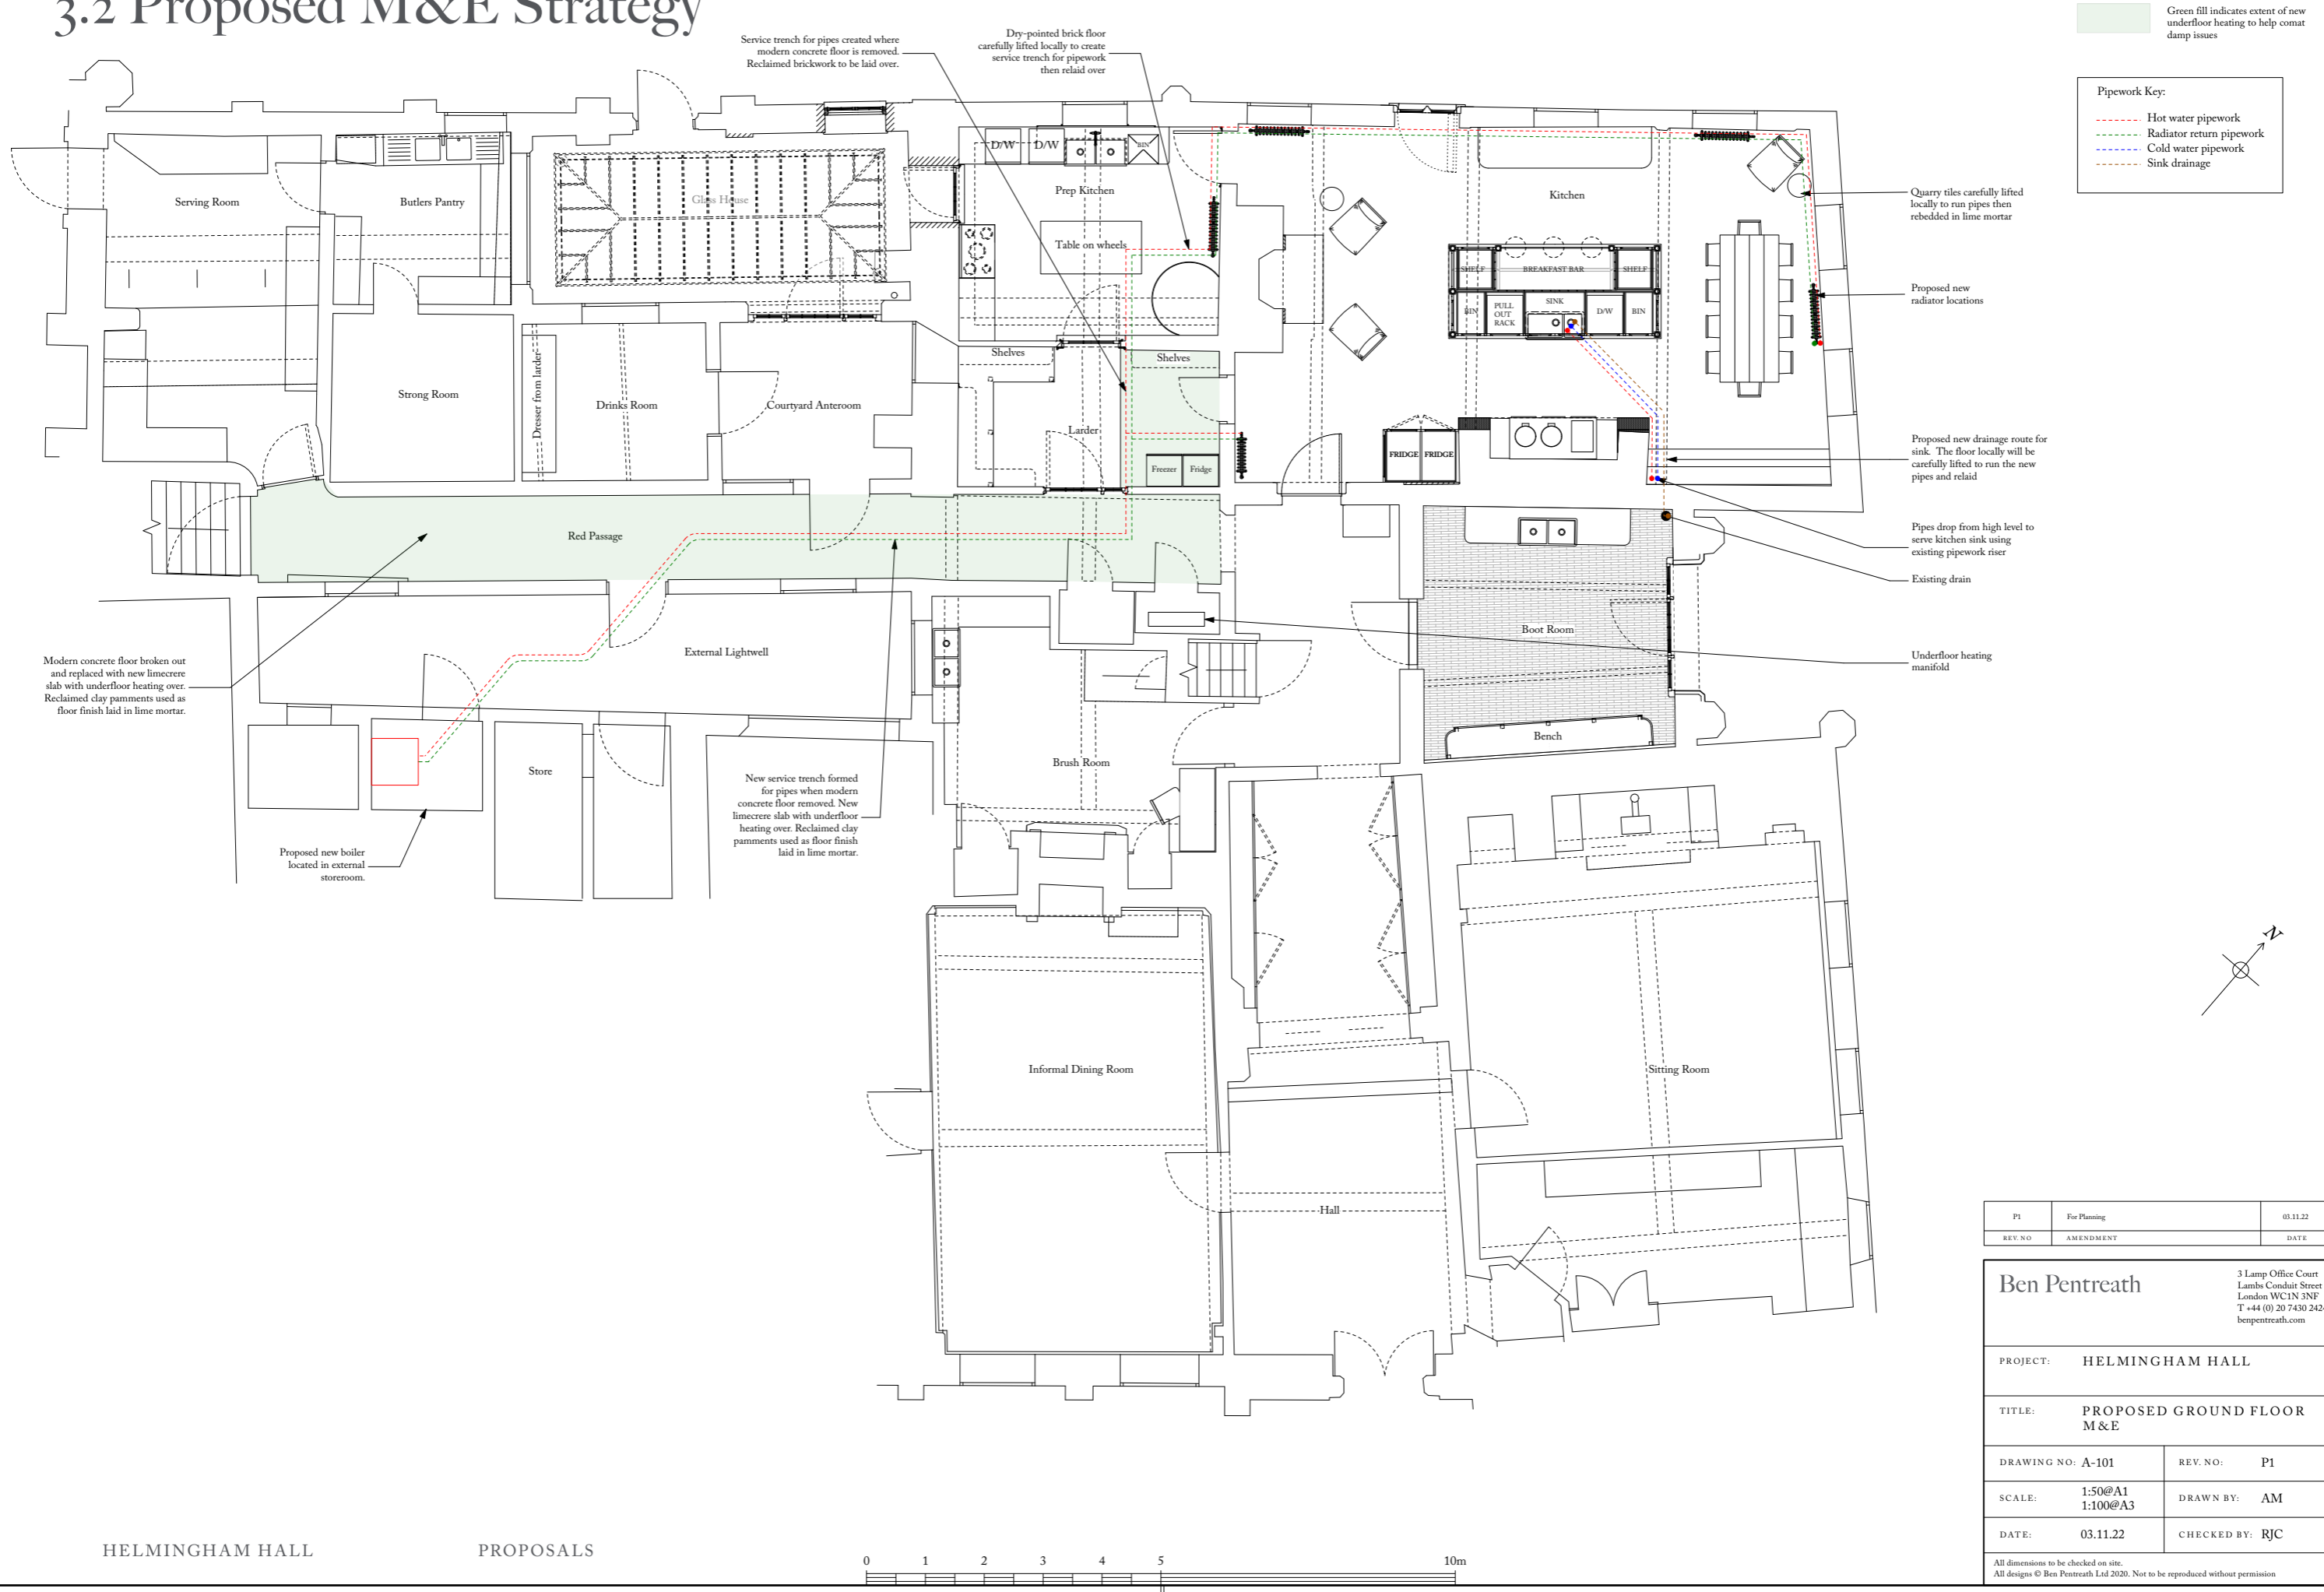
3.2 Proposed M&E Strategy

Green fill indicates extent of new underfloor heating to help comat damp issues

Modern concrete floor broken out and replaced with new limecrete slab with underfloor heating over. Reclaimed clay pammments used as floor finish laid in lime mortar.

Currently there is a convoluted system of surface-run pipes with a number of independent hot water cylinders and boilers scattered around the wing. Some of the wiring too, appears to date from the 1950s and will need replacing. We intend to rationalise the mechanical and electrical services in the service wing and consolidate the heating and hot water into a single location in a storeroom off the internal light well. We have an M&E consultant who specialises in re-servicing listed buildings doing a feasibility study.

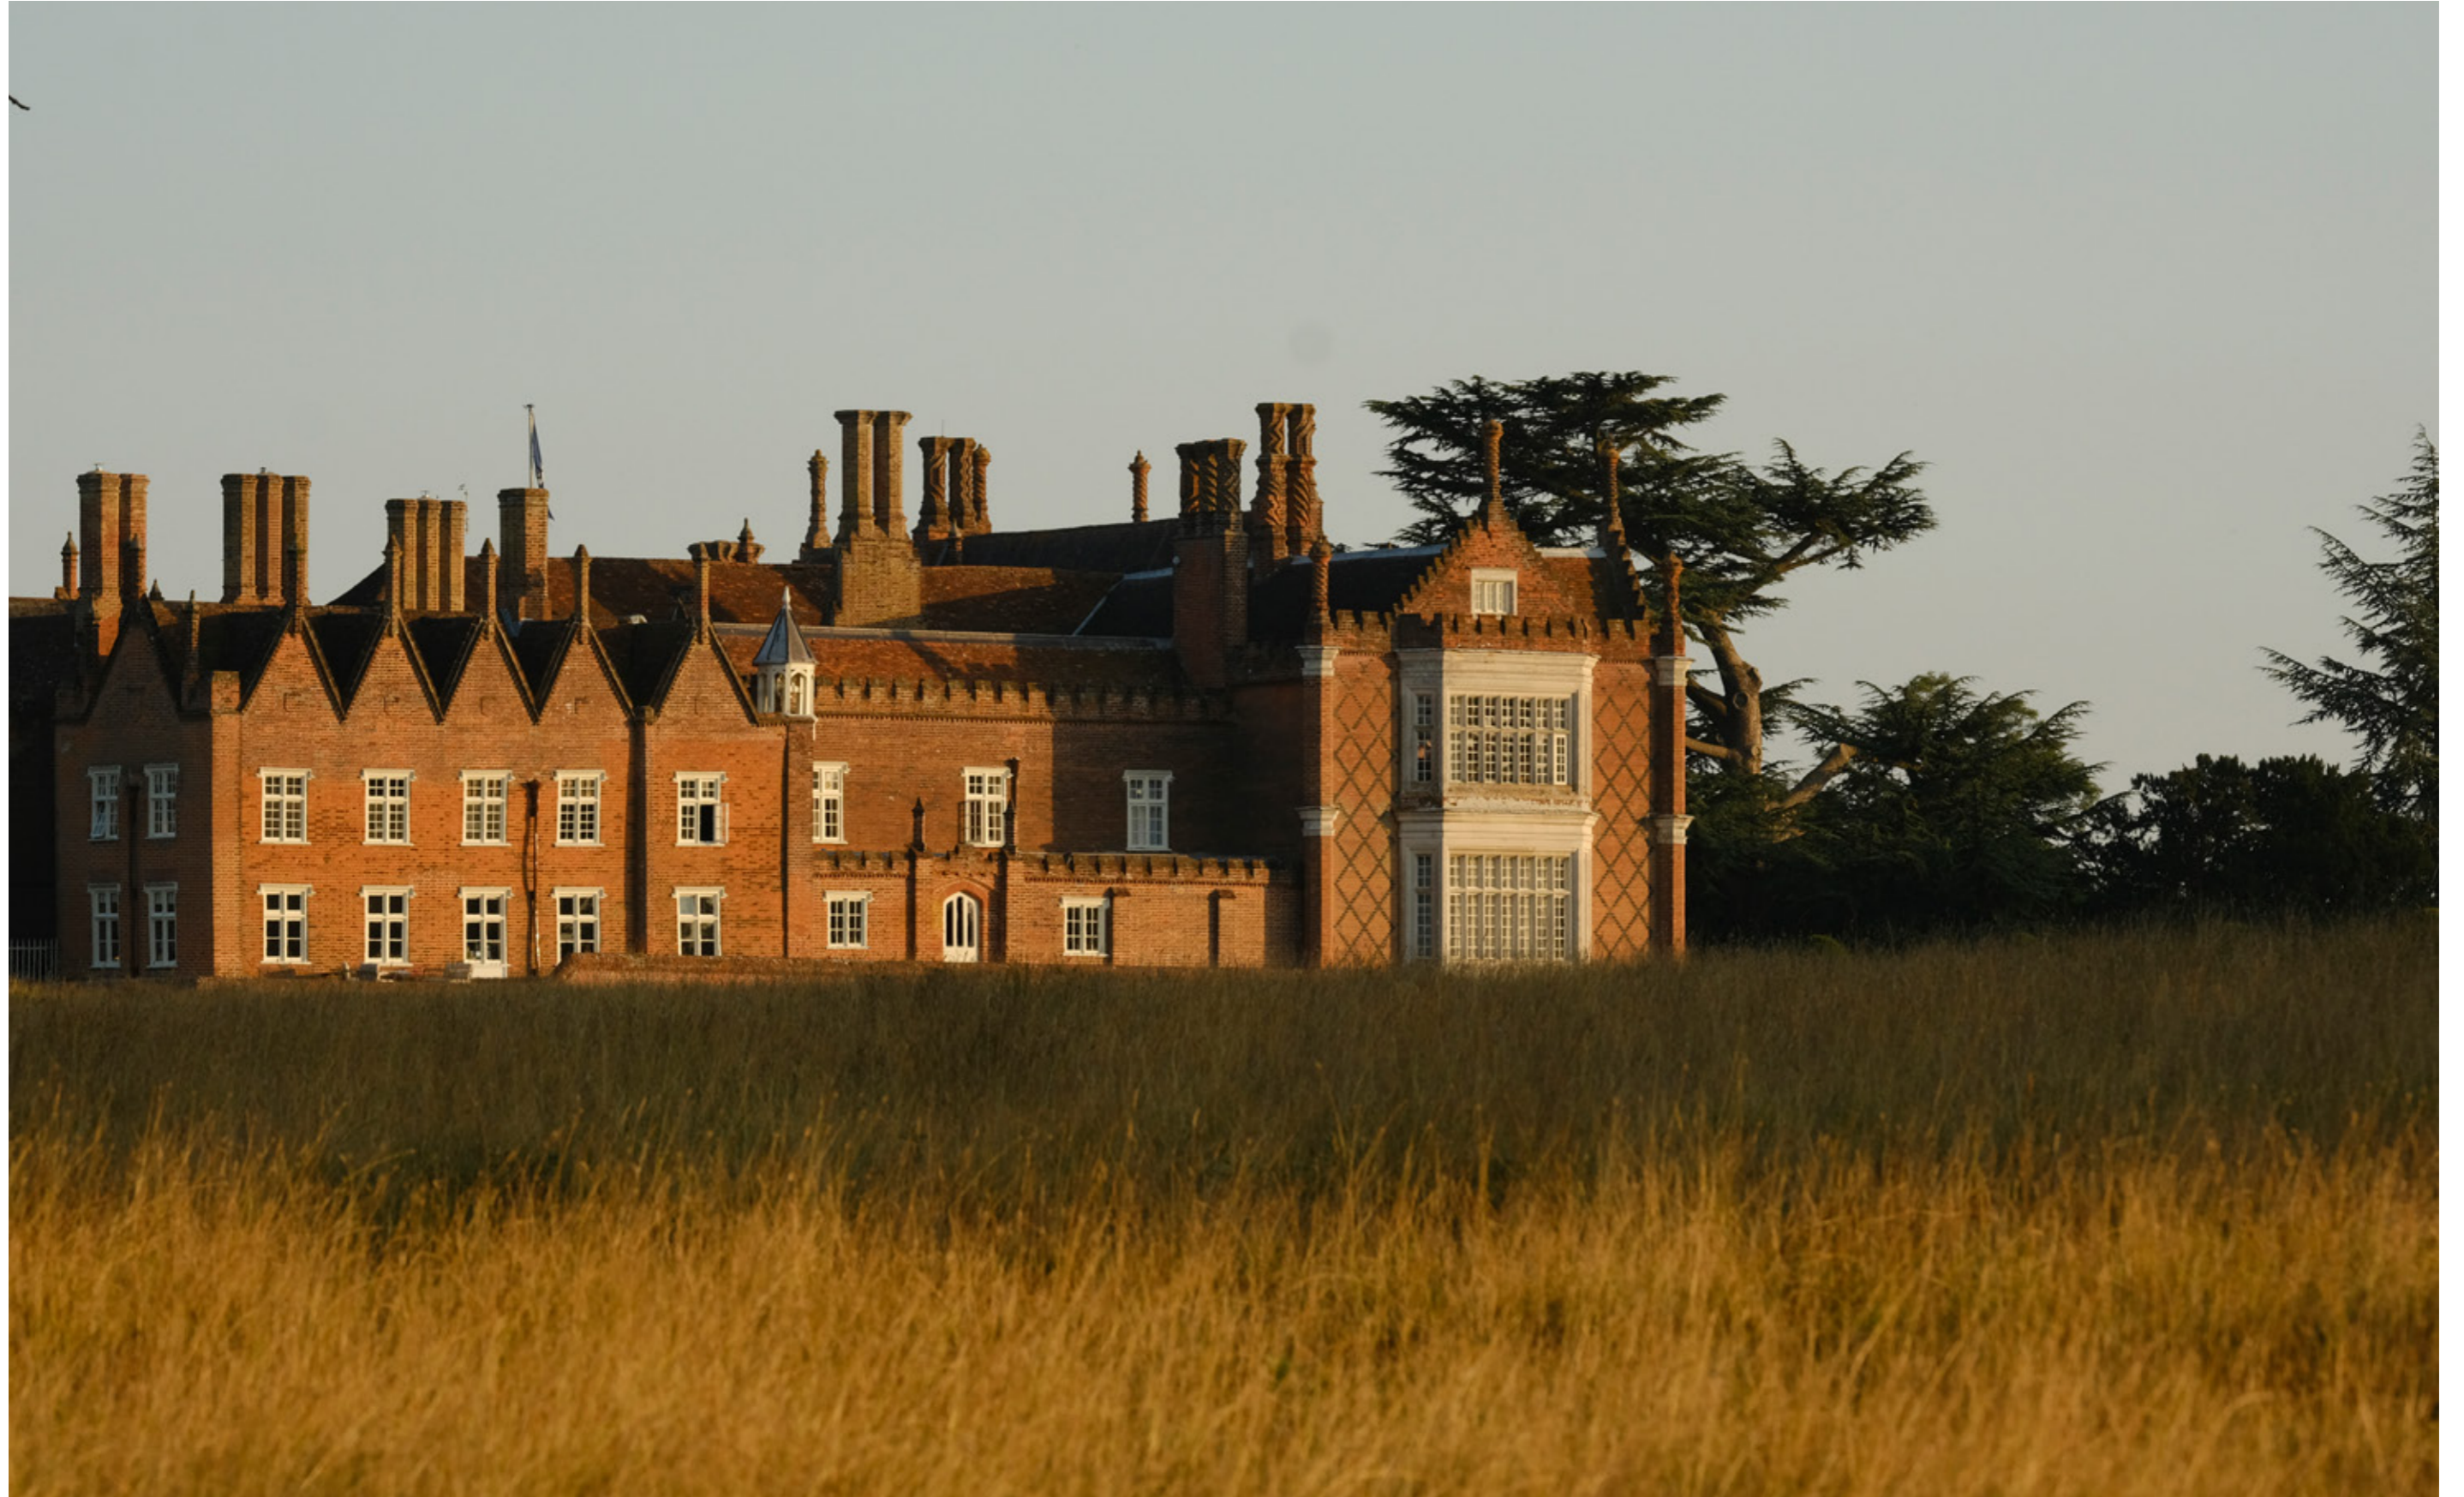
A view toward the north front, demonstrating the discreet nature of the proposed kitchen window-door and glass house window, door and roof.

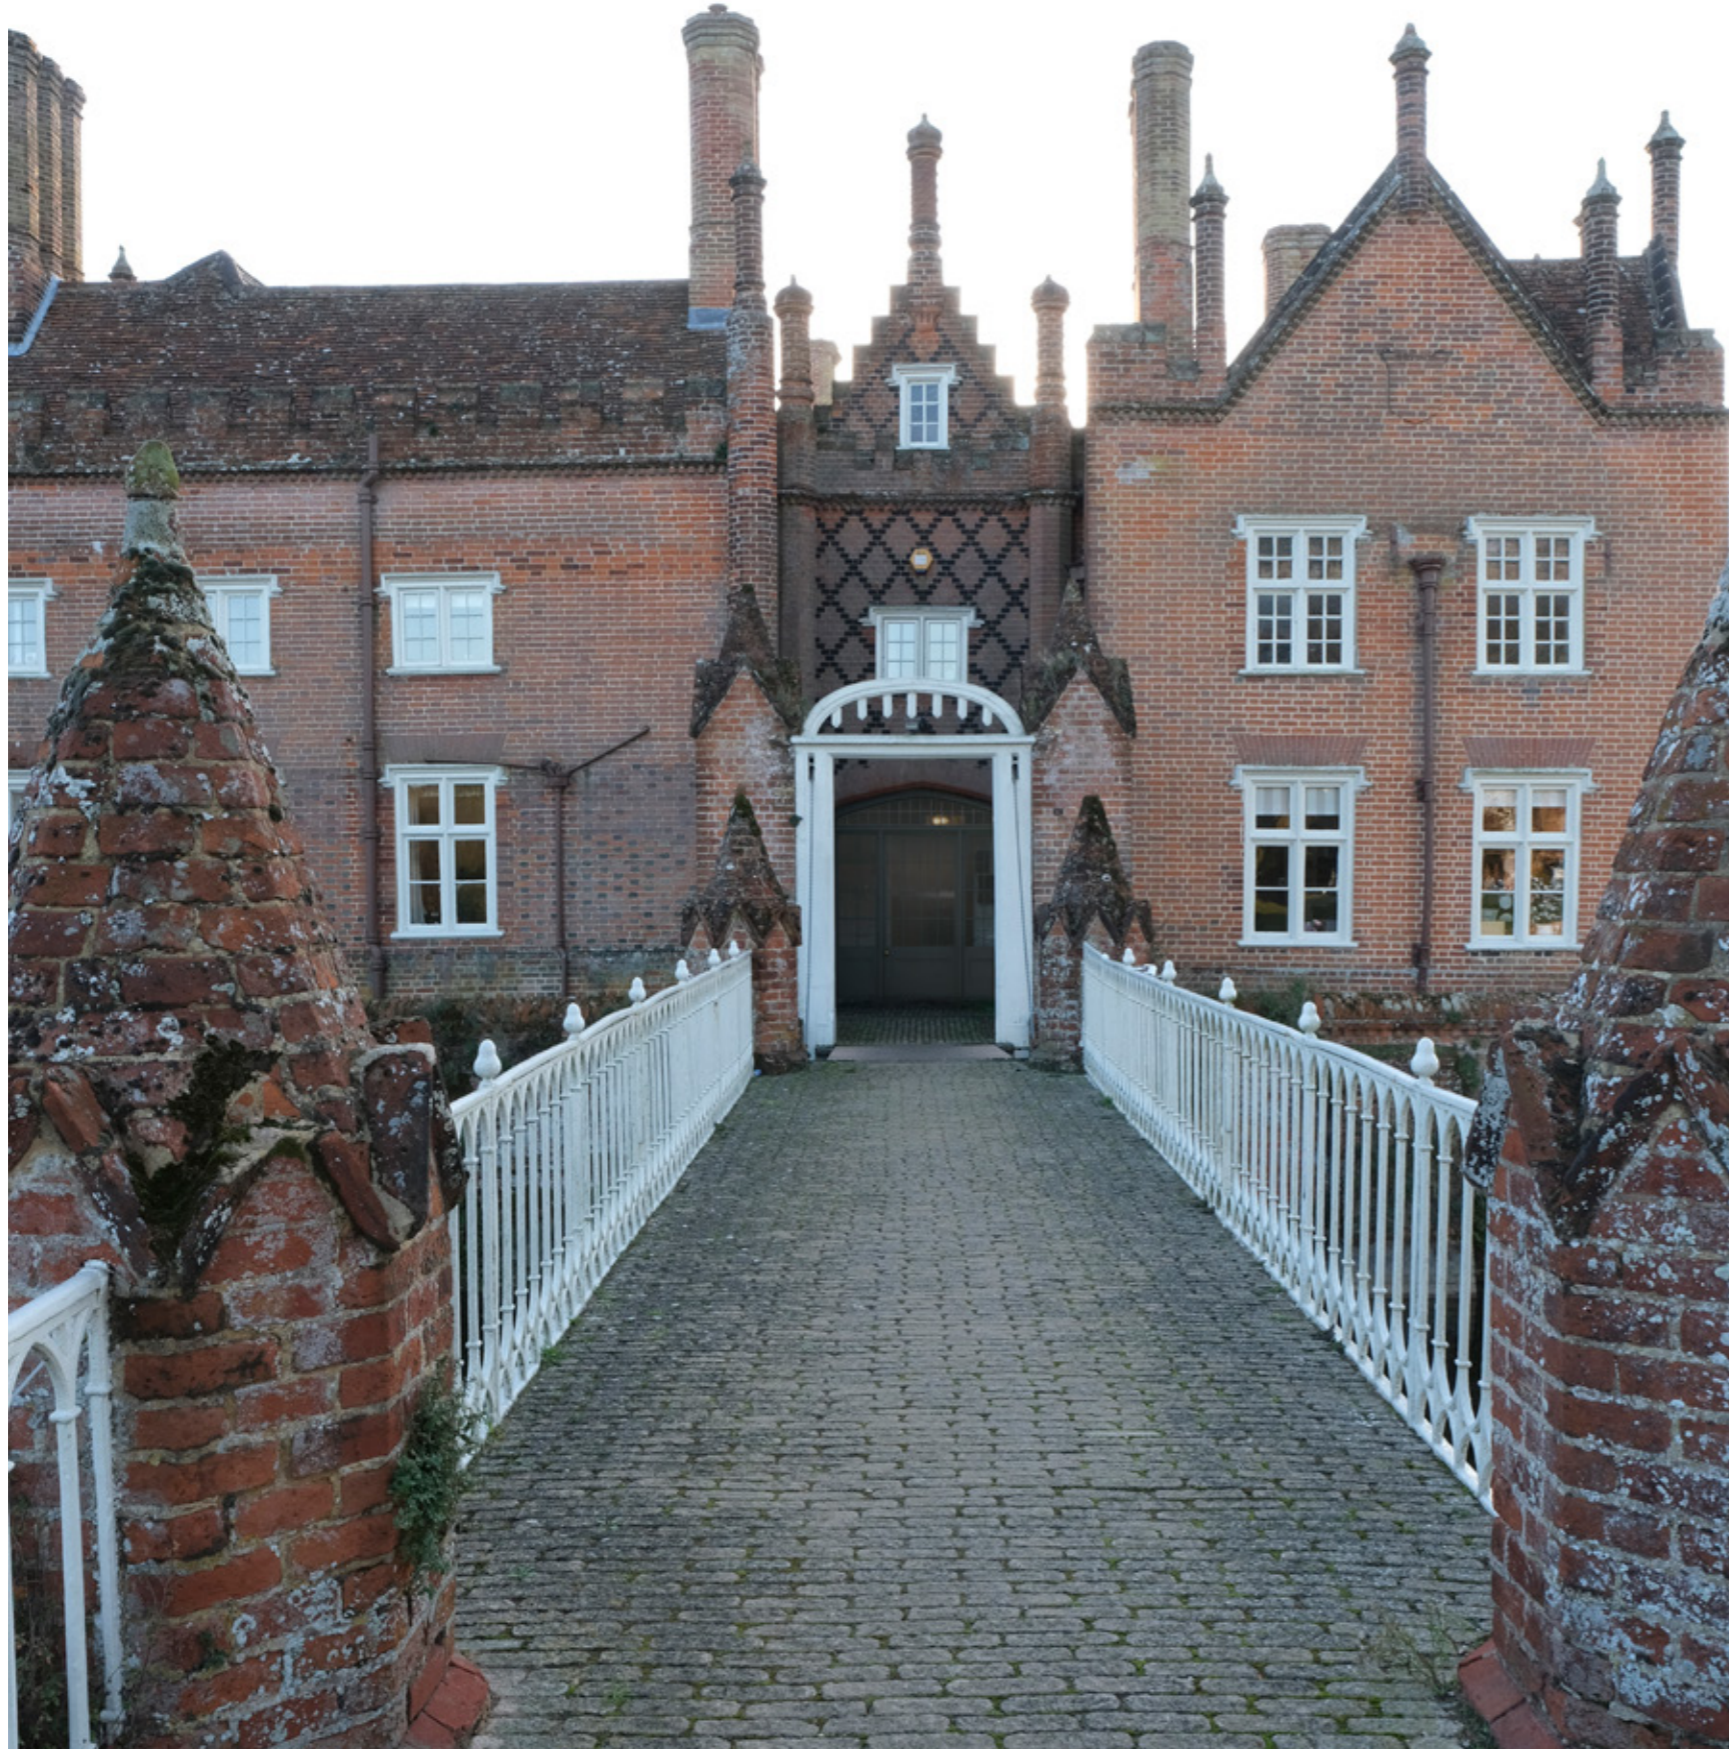
The proposed boot room glazed screen will appear completely recessive to the surrounding historic brickwork and arch.
