4.0 THE HERITAGE ASSET AND ITS SIGNIFICANCE

SECTION 5.0

HERITAGE IMPACT ASSESSMENT

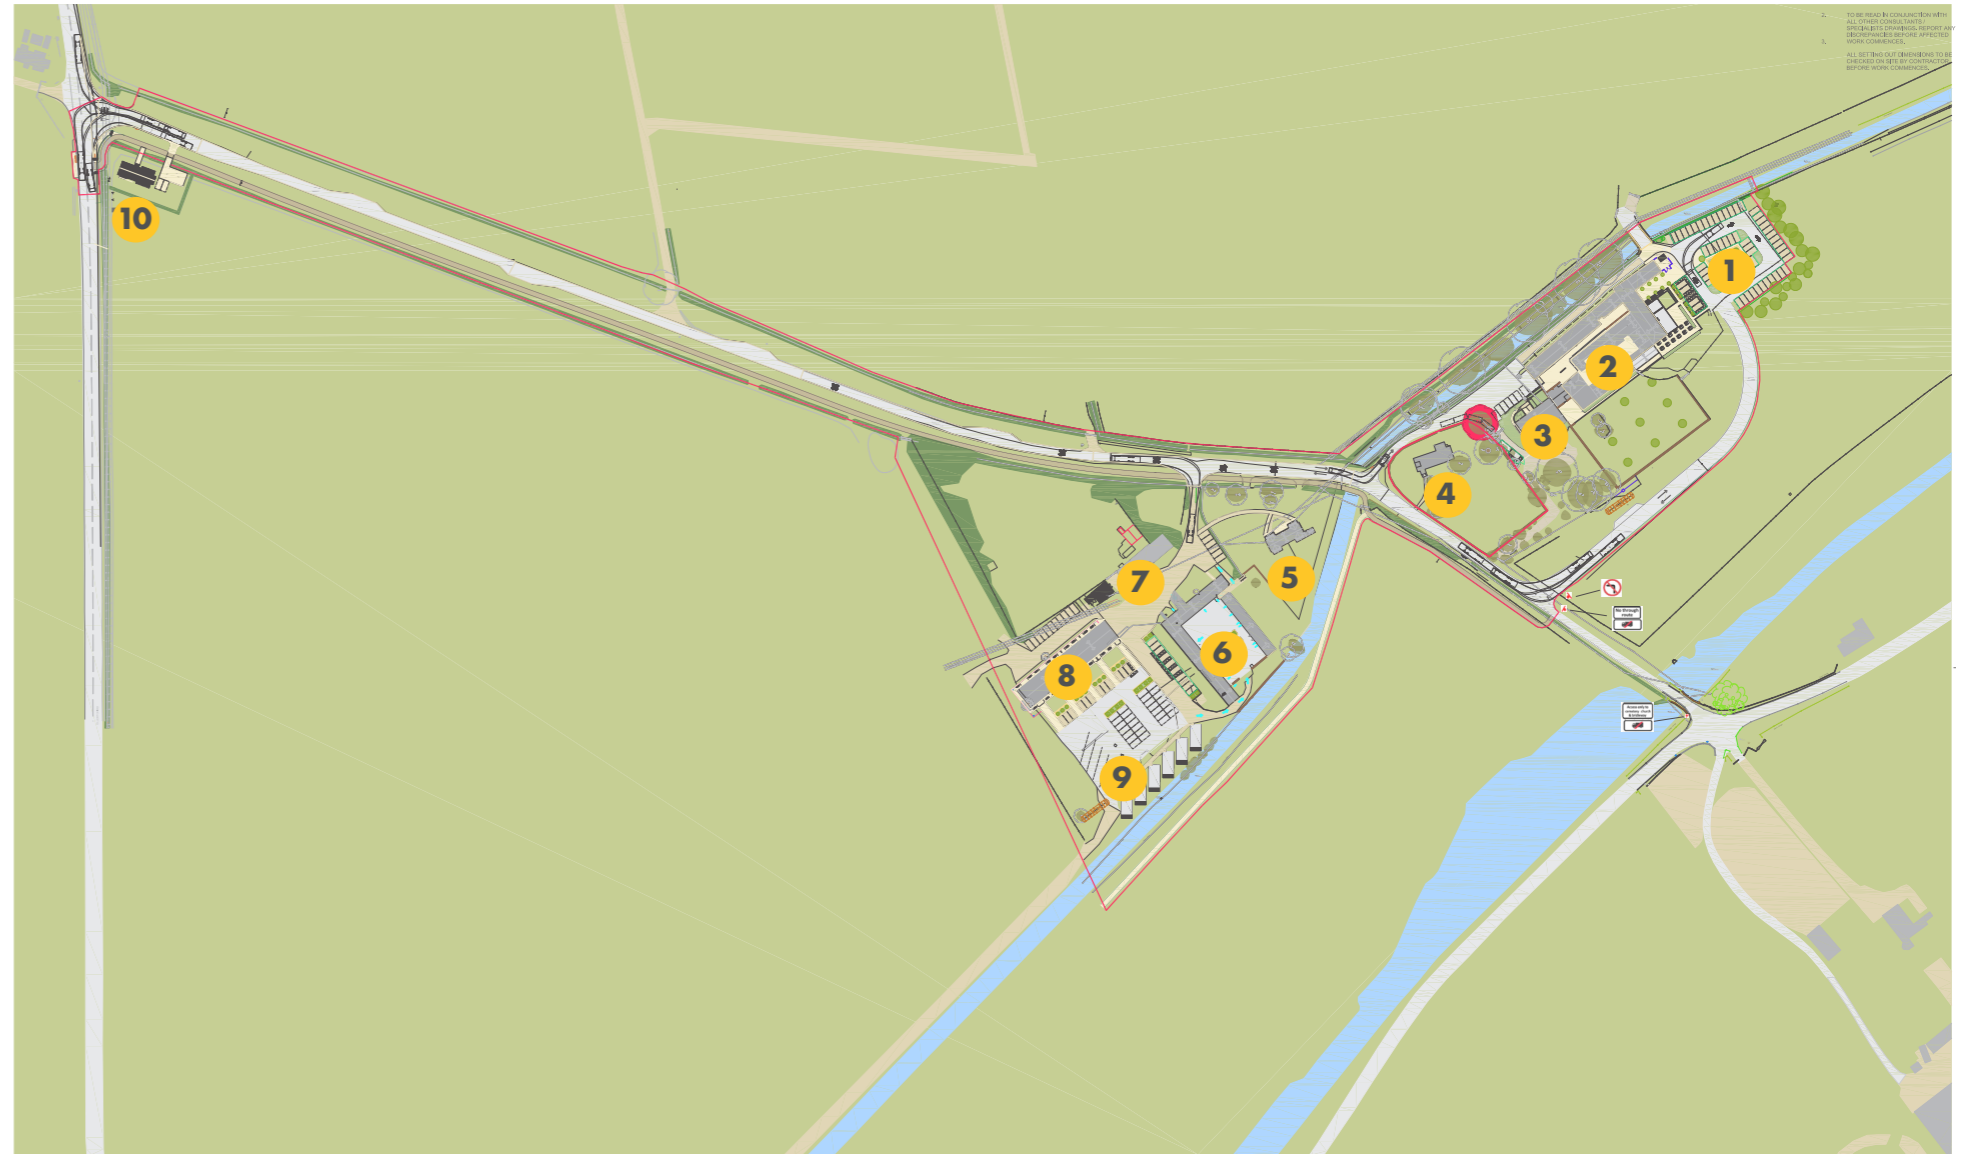
There are 3 no new buildings to be located on the site which are numbered 8,9 and 10 on the map adjacent.

- 1** New Carpark
- 2** East Barns - Restoration of existing barns with small addition and rearrangement.
- 3** Manor House - Restoration of the existing fabric with minor changes to the fabric.
- 4** Church is outside the scope of works
- 5** Cottages - Renewed doors and windows .
- 6** West Barns - Restoration of existing barns with small additions and rearrangement.
- 7** West Barns 2 - Restoration of existing barns with small additions and rearrangement.
- 8** West Barns 3 - New Build
- 9** Pod Cabins - New Build
- 10** Gate House - New Build

The location of the existing buildings requires the creation of new car parking to either end of the site, making use of existing areas of hand standing. It is proposed that access routes across the site are to be improved and rationalised to increase connectivity and help to unify the site for a single use.

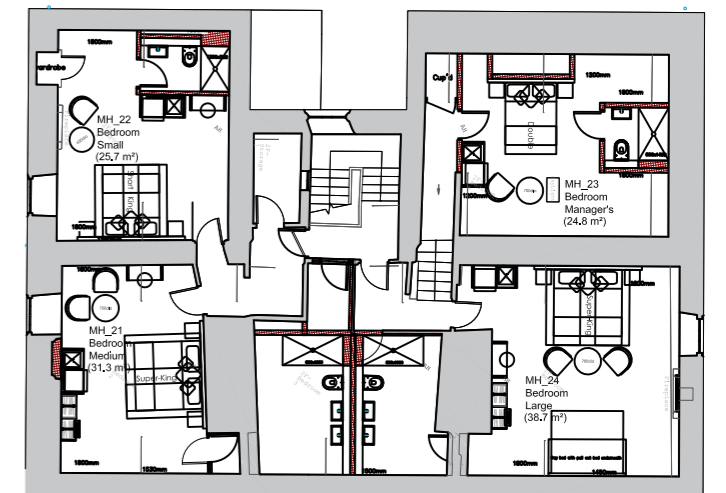
Proposed Second Floor Plan

All rooms at second floor level will be renovated into bedrooms with ensuite facilities.
