## 5.0 PROPOSED SCHEME

### 5.4 MANOR HOUSE

#### REMOVAL/REPAIRS FLOOR PLANS

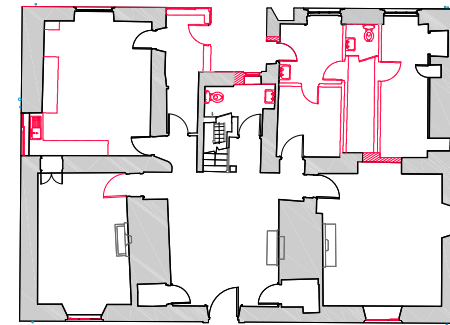
Proposed Basement Plan

The proposed modifications to the existing structure involve the removal of the later addition partitions installed to create bedrooms, WC's and En-suites to take the building back to its earlier layout and to improve the legibility of the historic floor plan.

The later addition lobby to the north -west elevation is also to be removed to improve the arrival experience and to improve the legibility of the historic fabric.

The later addition timber framed windows to the south-east elevations are to be removed and replaced with new windows that better reflect the proportions of the Georgian extension.

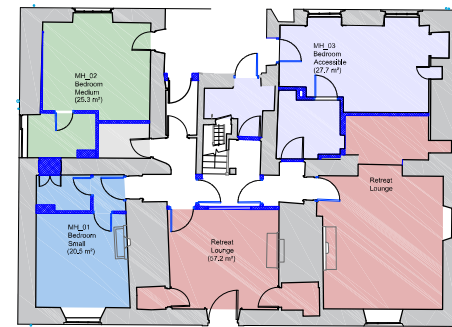
Proposed Basement Plan

The adjacent plans illustrate the proposed new interventions required to bring the building back into use as hotel bedrooms and a retreat area.

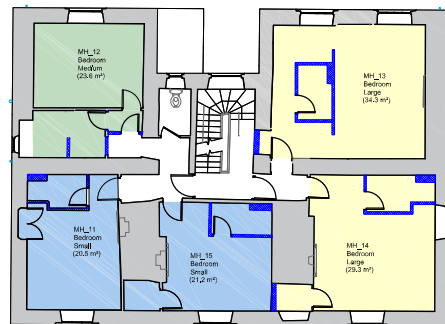
Proposed Ground Floor Plan

To the ground floor, a lobby is to be formed within the existing entrance area to create a protected stair core to provide a safe means of escape from the upper floor levels. The two existing ground floor living rooms are to be utilised as the shared Retreat area where guest can relax, play board games and enjoy afternoon tea.

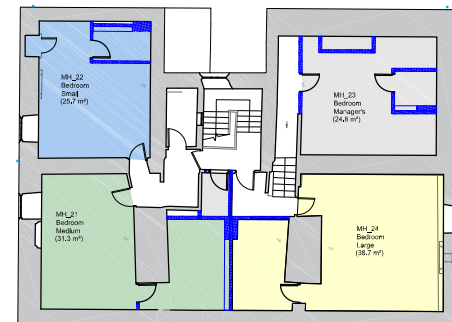
Proposed First Floor Plan

The remaining rooms are retained in their historic form with new en-suite bathrooms installed to serve each bedroom. In the most prominent room on the first floor level where existing details are present, the en-suite bathroom has been designed as a bathroom 'pod' sitting centrally within the space to ensure that the intervention does not conflict with the existing features.

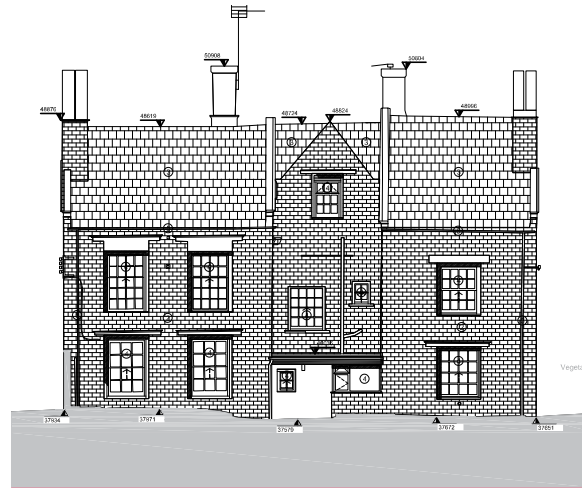
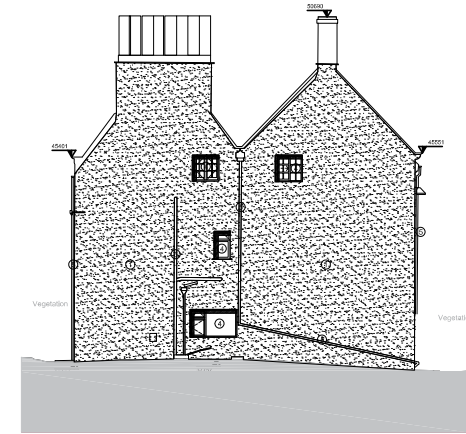
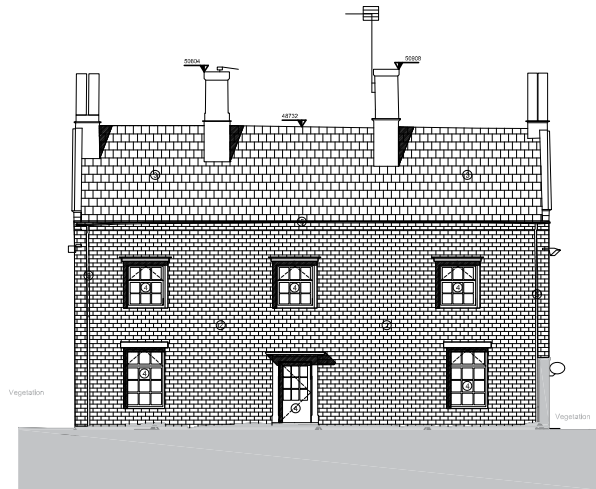
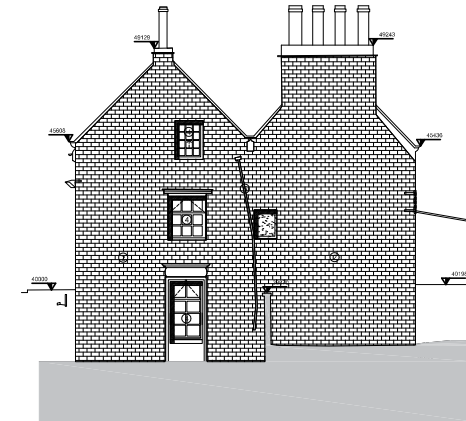
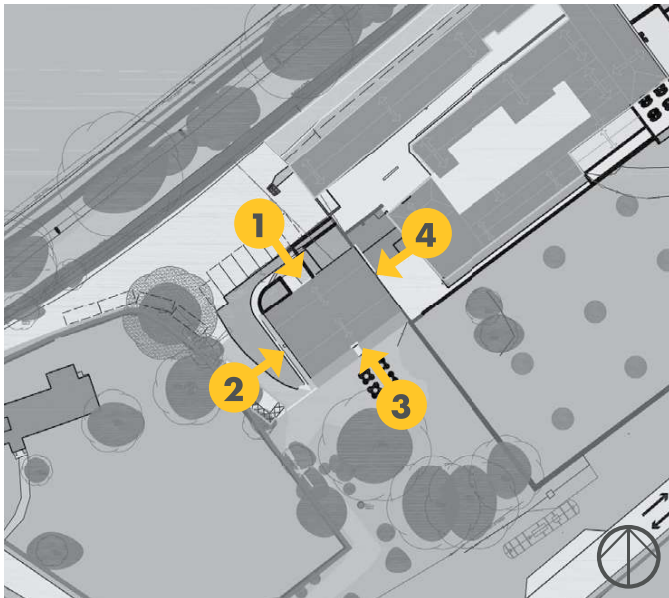
The existing elevation to the north-west is the primary elevation of the original single pile wing. The windows to this elevation are much bigger in size and proportion, giving a reduced solid to void ration when compared to the south-east elevation. Changes that have occurred when the building was extended are still visible to the stair core where the window positions have been altered at this time.

The elevation to the south-west has been rendered in a cement render system, likely due to its exposure to the westerly wind and rain. Later interventions to the kitchen at ground floor have created a horizontal proportioned window which is incongruous with the vertical proportions of windows to the rest of the building.

The south-east elevation has a more Georgian proportion with a greater solid to void ratio and smaller windows. The original windows have been replaced with new timber framed windows in the 1960's/70's which do not suit the proportions of the building generally.

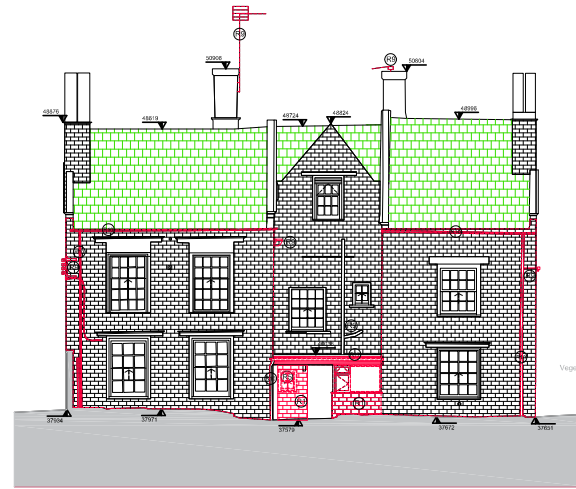
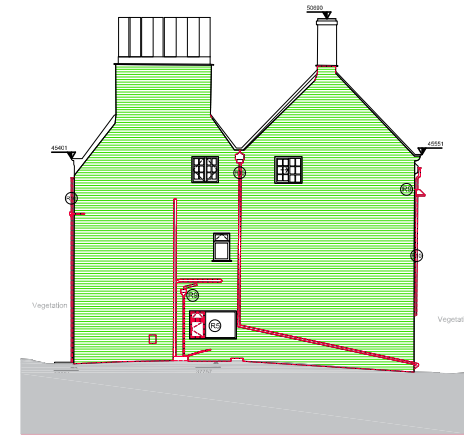
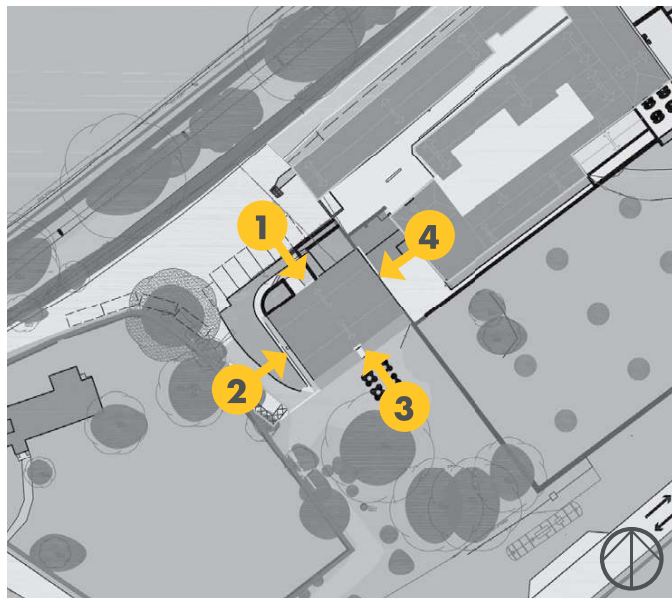
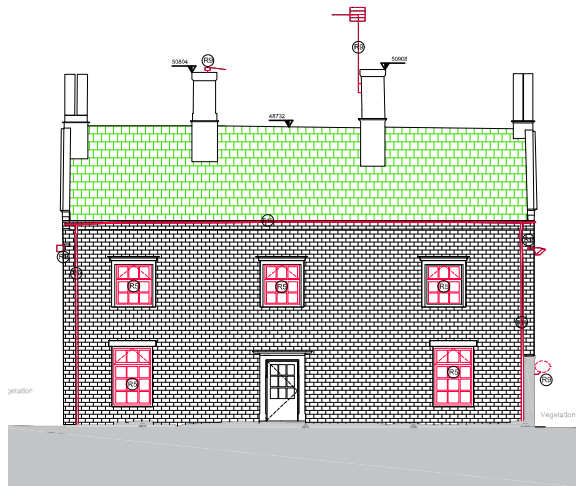
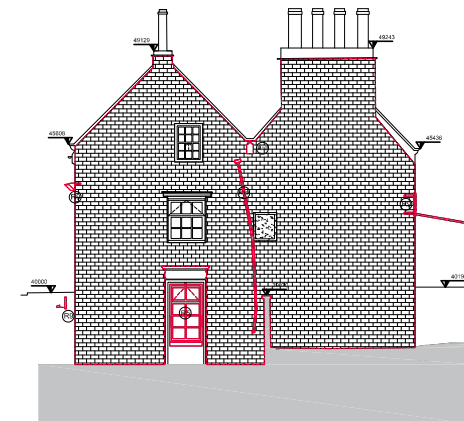
The proposed works to the elevations involve the removal of the later addition porch to the north-west elevation added to the rear of the stair core. All of the existing rainwater goods are in very poor condition and are to be removed and replaced with new.

The cement render to the south-west elevation is damaging the building fabric by preventing the fabric from breathing. The cement render is therefore to be removed and the condition of the stonework behind assessed and repaired if possible.

The later addition timber framed windows to the south-east elevation are to be removed and replaced with new Georgian style slimline double glazed sash windows.

The former door opening to the north-east elevation at ground floor level is to be reinstated to provide direct access to the garden from the retreat lounge.

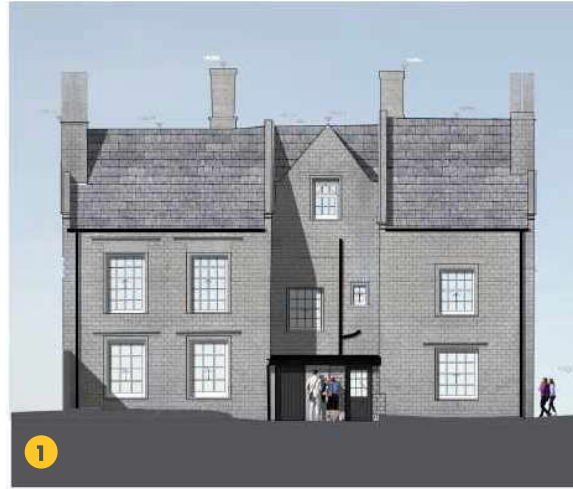
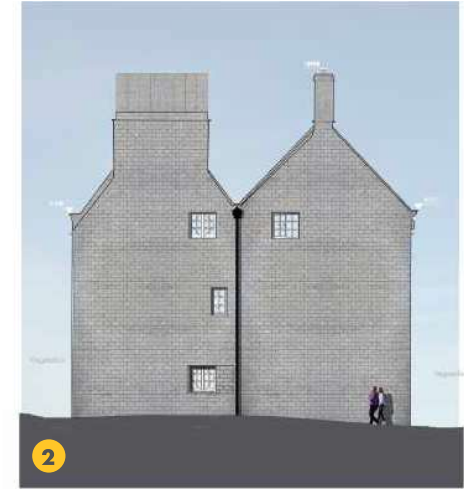
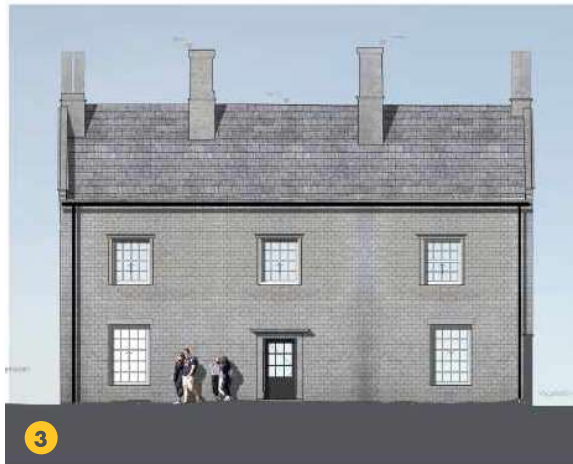
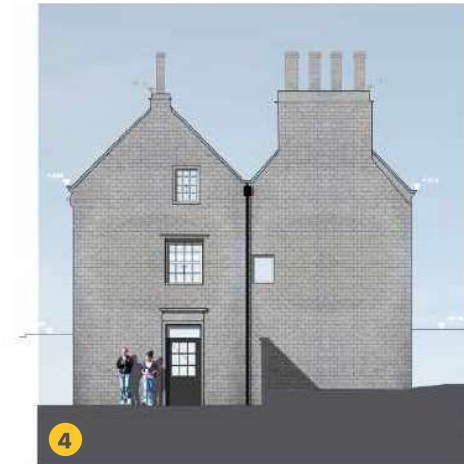
The adjacent elevations show the proposed modifications to the elevational treatment.

The existing porch is to be replaced with a new roof, recessed from the primary frontage to reduce its prominence. This will create an area where guests can shelter upon arriving at Manor House from the rain.

The windows to the south-west elevation are to be replaced to the ground floor with horizontal sliding sash to better reflect the proportions of the original building.

To the south-east elevation, new sliding sash windows are proposed to replace the existing later addition windows to better reflect the Georgian proportions of the later wing.

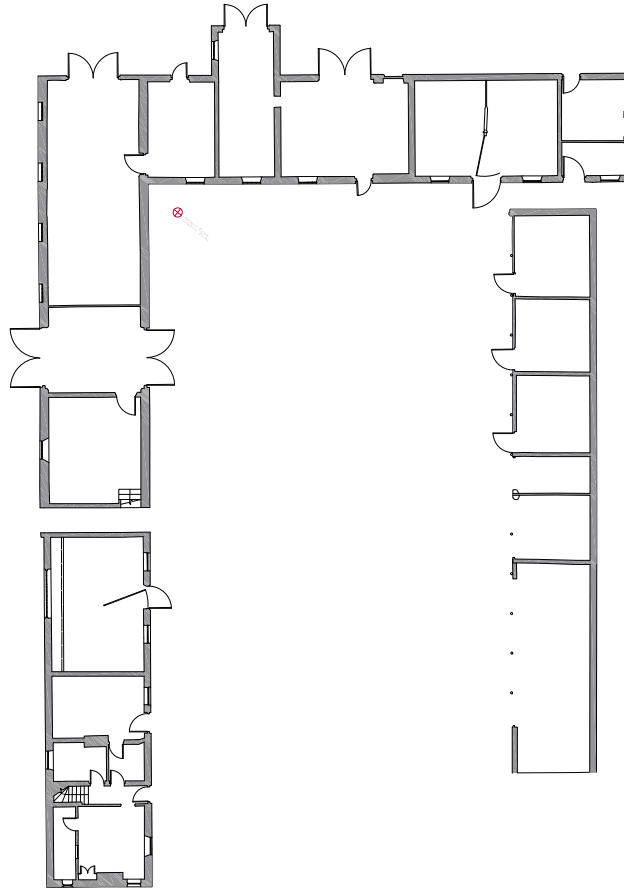
EXISTING GROUND FLOOR PLAN

The existing buildings to the West Barns complex comprise of a two storey L-shaped barn configuration to the north west and south west with a single storey stable block to the north east creating a courtyard configuration.

The single storey stable block has been adapted over the years with the installation of blockwork walls to separate the stables. The original cast iron columns, timber roof trusses and frame and timber soffit to the underside of the roof are still in-situ and are of reasonable condition.

The two storey L-shaped barn is separated into a more cellular arrangement at ground floor level whilst the first floor level comprises of three large open barn lofts with large barn doors providing access for the movement of goods, hay, etc.

To the south-east of the L-shaped building is a two storey two bedroomed dwelling.

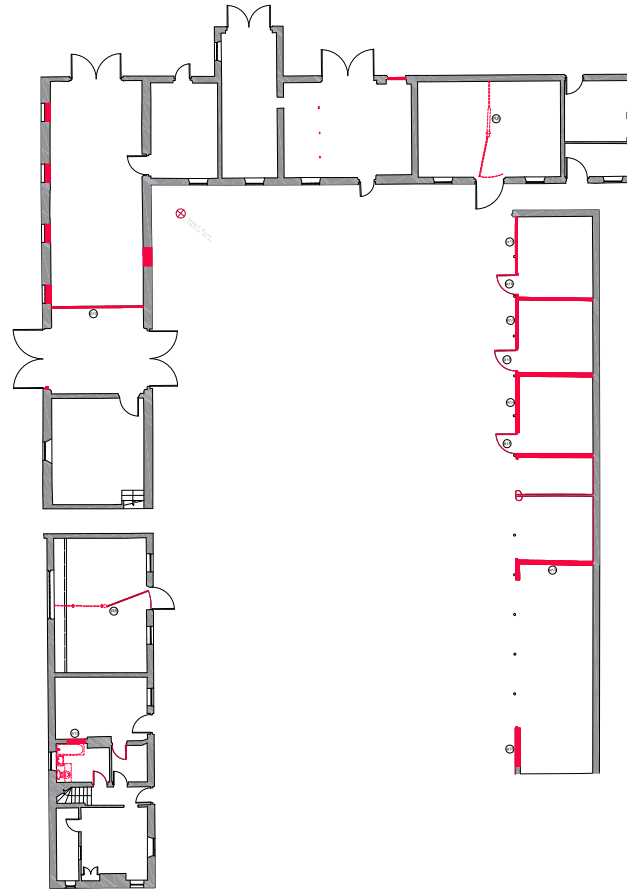
DEMOLITION GROUND FLOOR PLAN

The proposed removal and repair works are relatively limited to the West Barns to ensure that the character of the buildings is retained where possible.

The later addition blockwork stables within the stable block are to be removed to open up the stables and to reveal their original structure. The cast iron columns, timber frame and trusses are to be retained and repaired and the brickwork walls retained and repointed.

To the ground floor of the two storey L-shaped barn, dividing partitions are to be removed internally to open up the barns and to provide greater flexibility of the accommodation. Windows that have previously been bricked up are to be opened up again to provide daylight and natural ventilation to the bedrooms.

New door openings are to be created between the barns and the 2 storey dwelling to provide a more flexible layout.

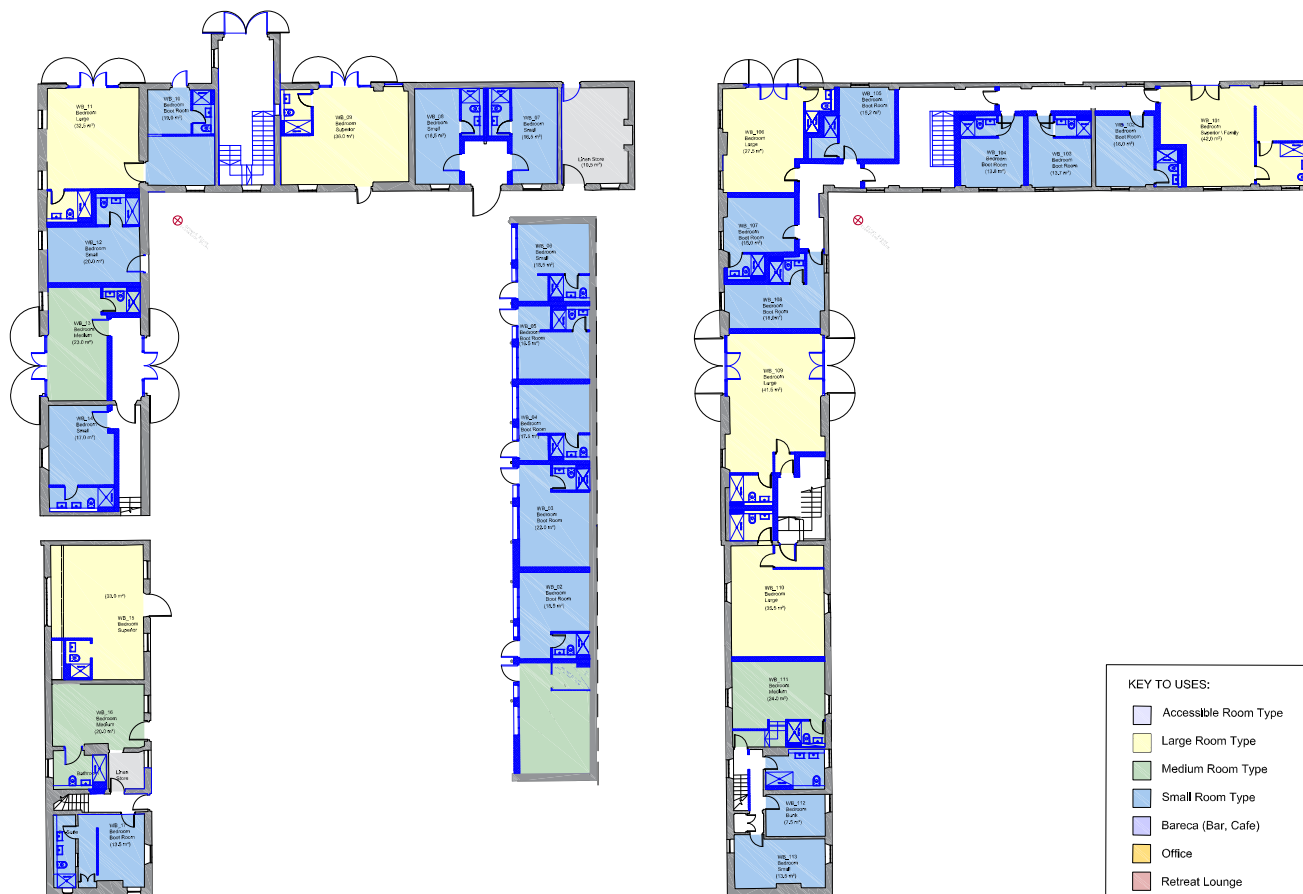
PROPOSED GROUND FLOOR PLAN

The bedroom configuration enables the retention of the existing barn doors which are to be pinned back with the openings infilled with a lightweight glass infill. The ground floor bedrooms optimise the use of the existing timber doors to provide access to the individual bedrooms where possible.

The stable block is redeveloped as bedroom accommodation with the existing structure used to determine the layout to create a layout that responds directly to the existing fabric. New timber and glass infills are created to provide direct access to each bedroom from the courtyard.

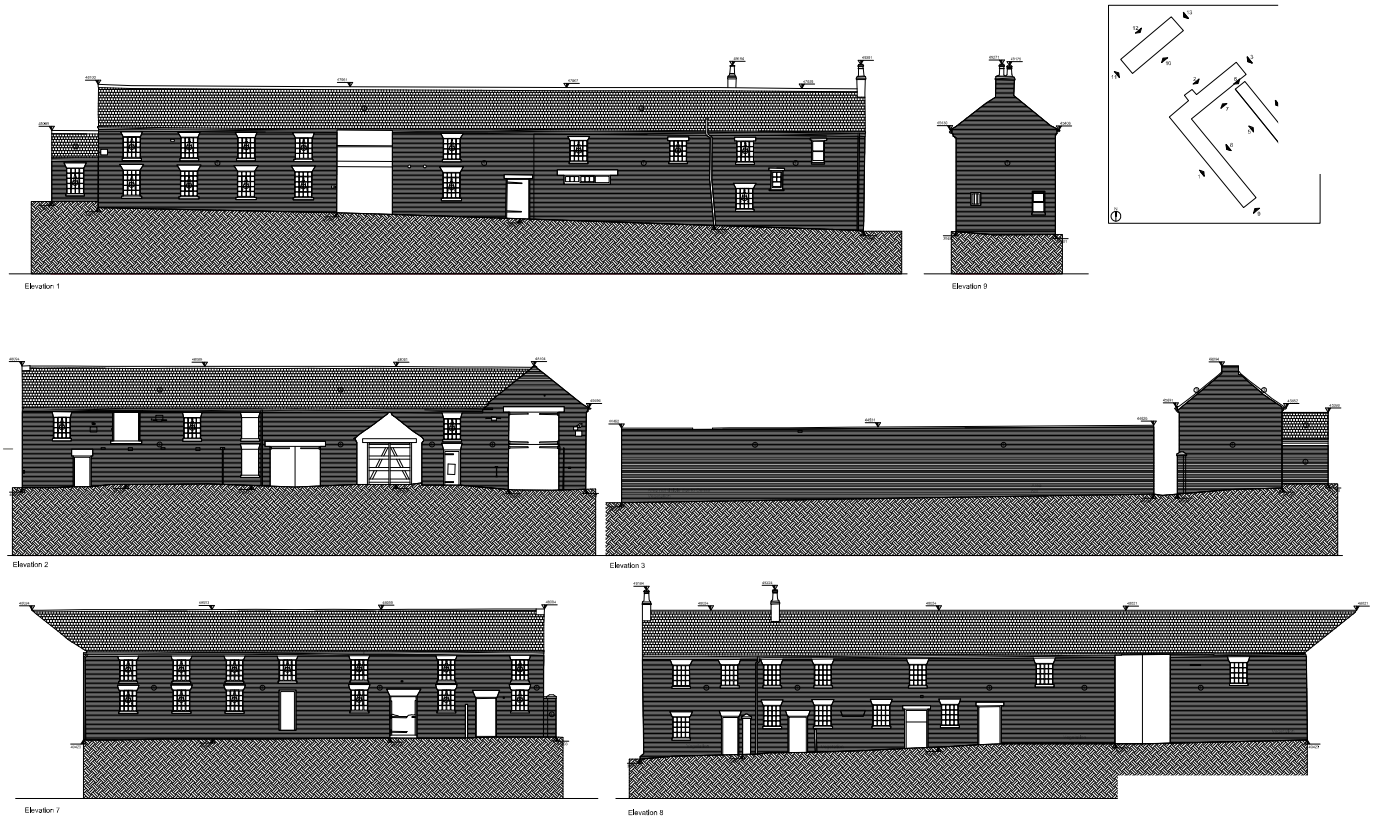
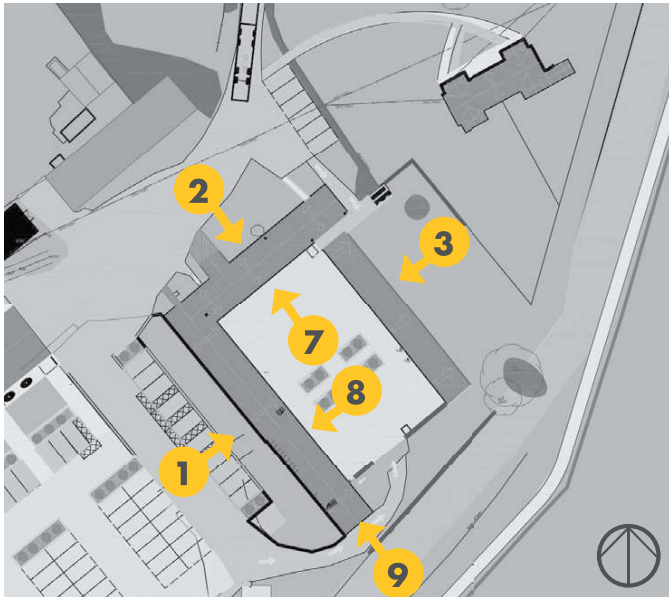
The existing two storey barn buildings comprise of solid brickwork walls with stone lintels and cills to doors and windows with terracotta pan tile roof throughout. A number of door and window openings have been bricked up over the years to adapt the buildings to the changing needs of the farm. Existing windows are generally single glazed steel framed windows which are generally in a poor condition. Existing barn doors have been retained in some instances.

Rainwater goods generally are either PVC or asbestos and in very poor condition.

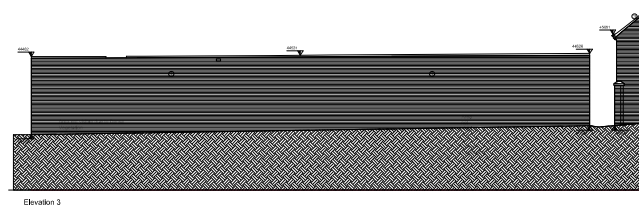
The existing stable block comprises of cast iron columns supporting a timber roof structure with a corrugated asbestos roof finish. The external walls are of solid brickwork construction with the elevation facing the courtyard. Later addition blockwork walls have been constructed to separate the stables.

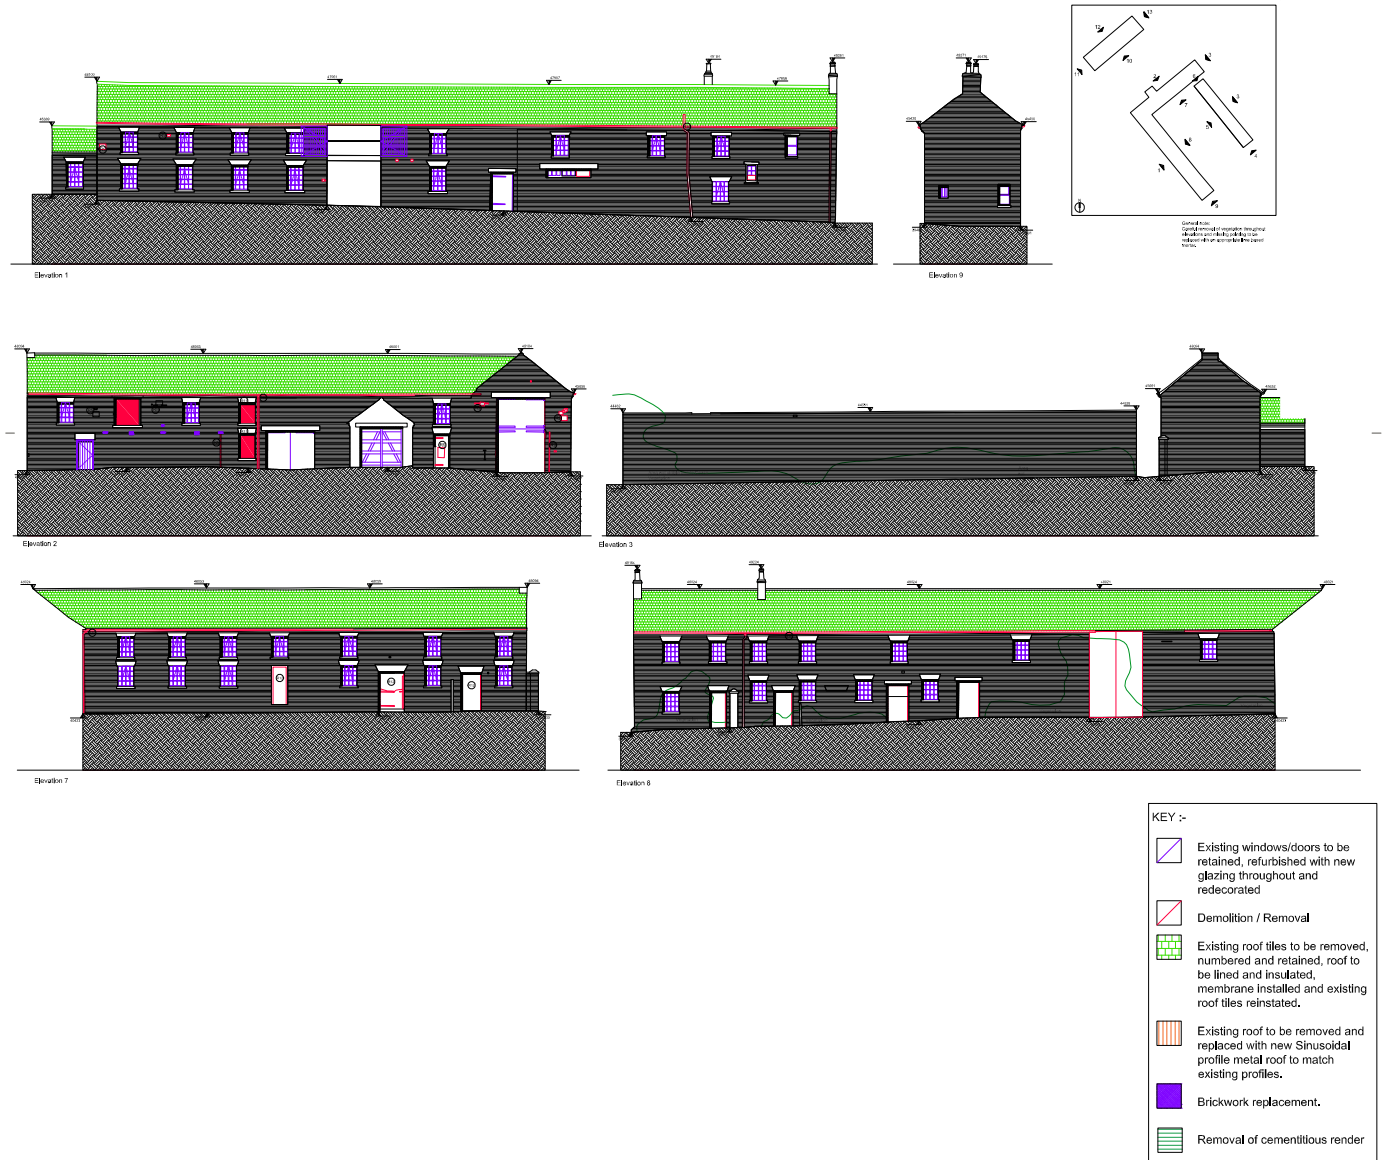
The existing single glazed steel windows have suffered from exposure to water and a lack of ongoing maintenance over the years and have substantially degraded. The design of the windows and the height in relation to the internal floor level also provides a health and safety risk due to the lack of barrier loading which would require internal balustrades to be installed to many of the windows.

In order to improve the thermal, acoustic and barrier loading performance of the windows, it is proposed that the existing steel windows are carefully removed and replaced with new slimline metal framed double glazed windows. By improving the thermal performance of the roof and windows, it allows the brickwork walls internally to be left exposed, thus retaining the agricultural character of the buildings and allowing the timber trusses to be left exposed.

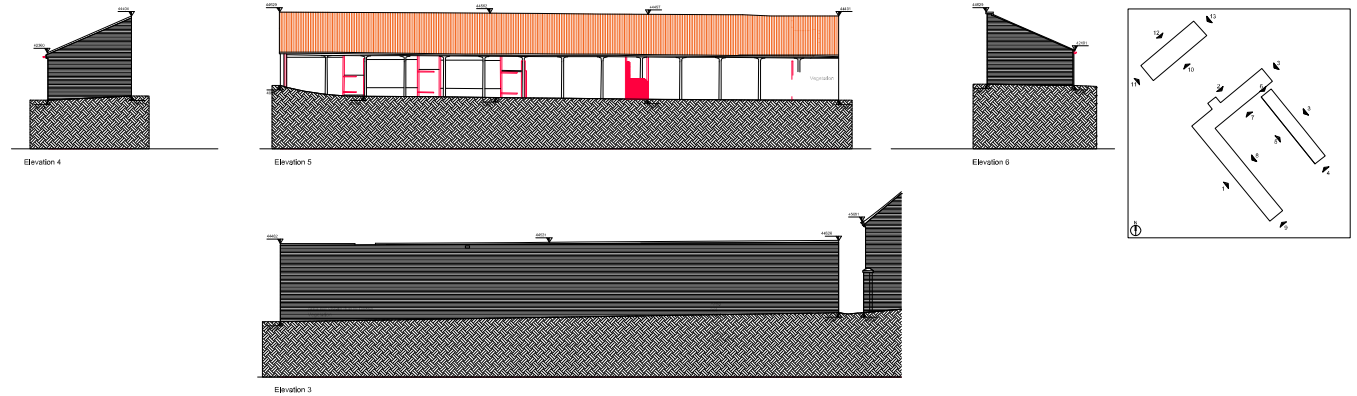
The proposed works to the existing stable block is to remove the existing corrugated asbestos roof ready for replacement.

The existing cast iron columns and roof structure are to be retained, repaired and restored. The diagonally laid timber roof lining to the ceilings are to be retained and repaired where required.

The existing blockwork walls and low quality timber doors to the stable block are to be carefully removed to reveal the original stable block structure.

Existing asbestos rainwater goods are to be removed.

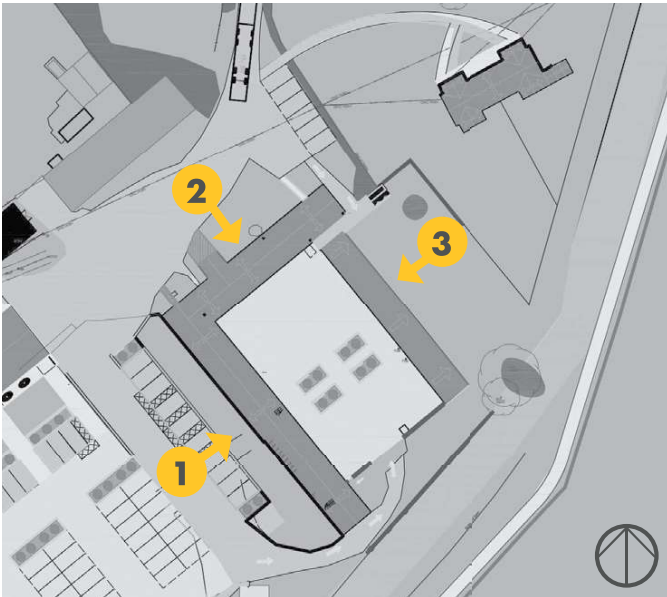
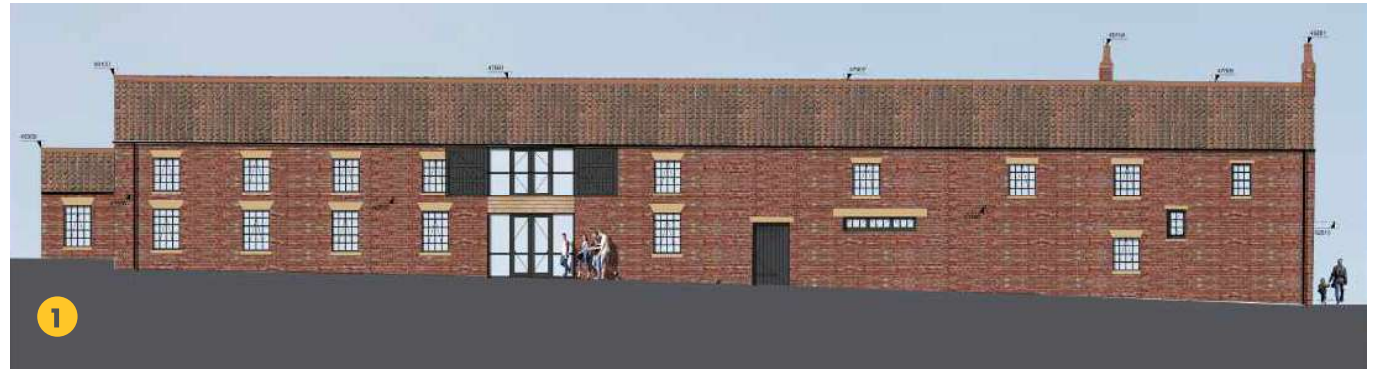
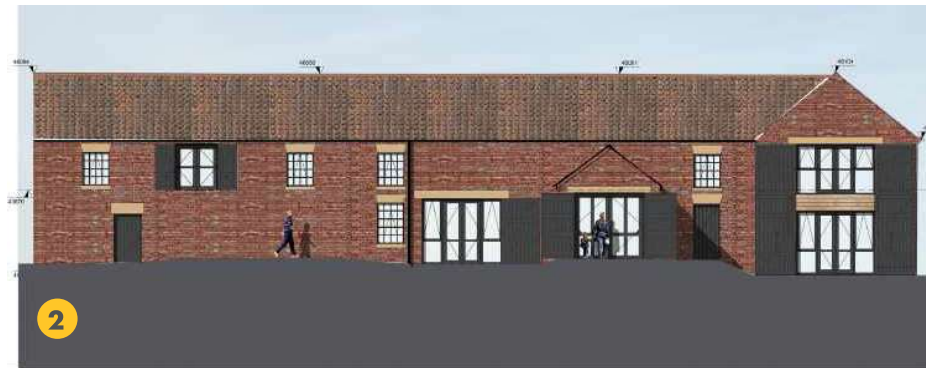
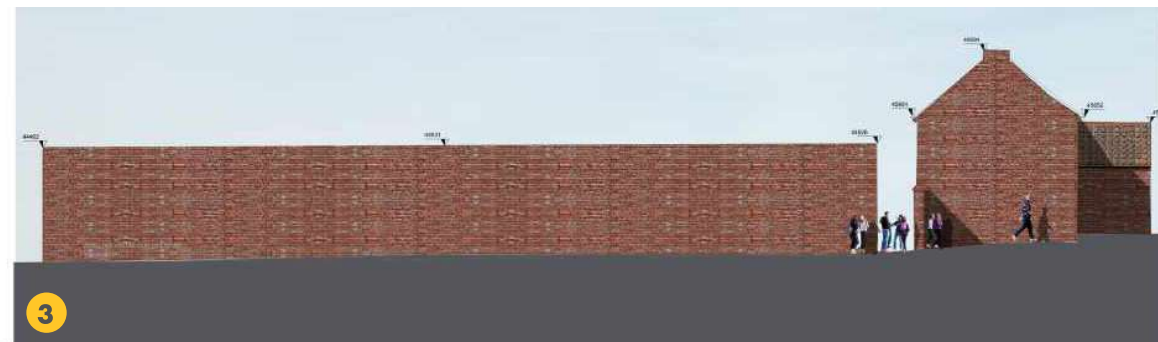
The existing brickwork walls are to be re-pointed where required using a lime mortar and existing stone lintels and cills retained and repaired to bring the buildings back into use.

The existing pan tile roof is to be relaid with insulation and breathable membrane to improve the thermal performance whilst retaining the historic character both internally and externally. Rainwater goods are to be replaced throughout with cast iron gutters and downpipes.

Existing barn doors are to be retained and repaired and pinned back to allow the infill of the barn door bays with lightweight glass and timber frames with horizontal timber cladding used at first floor level to clearly denote the infill as a new intervention.

Existing windows are to be replaced with new double glazed steel framed windows with the same design and detailing as existing to improve thermal, acoustic and barrier loading performance.

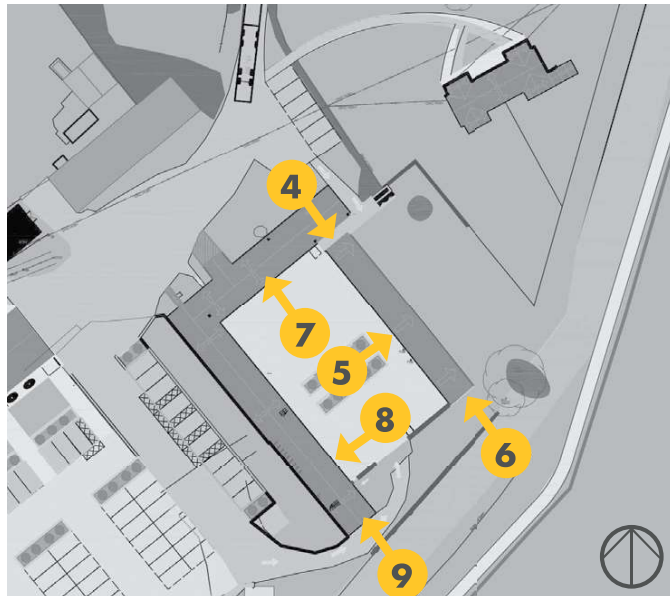
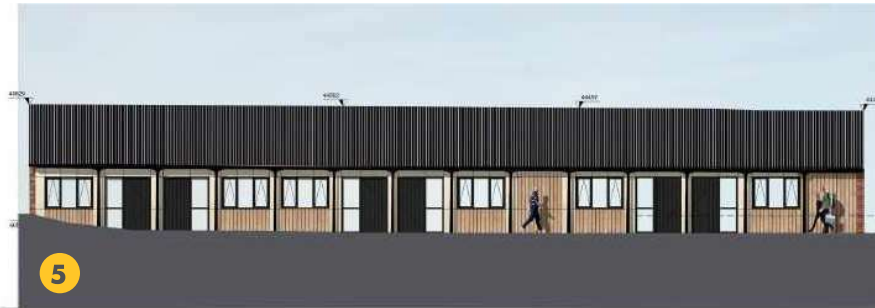
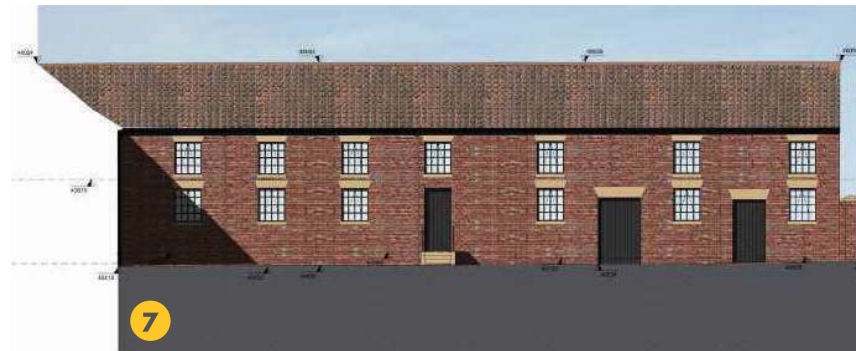
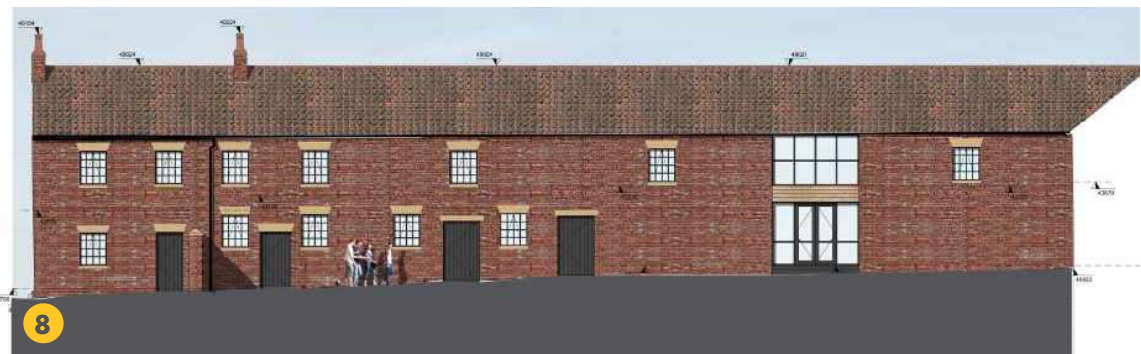
The stable block open elevation to the courtyard is to be infilled with a contemporary, lightweight infill that is set back from the cast iron columns to allow them to be fully visible externally. Vertical timber cladding, painted black timber doors and window frames and a marine ply infill panel to accentuate the cast iron columns and to accommodate the nominal changes in dimensions to the column setting out. A concrete plinth is provided at the base to prevent water damage to the timber cladding.

New semi-circular cast iron rainwater goods are to be provided throughout. The existing corrugated asbestos roof finish to the stable block is to be removed and replaced with an insulated sinusoidal roof finish to reflect the agricultural character of the buildings across the Manor Farm site.

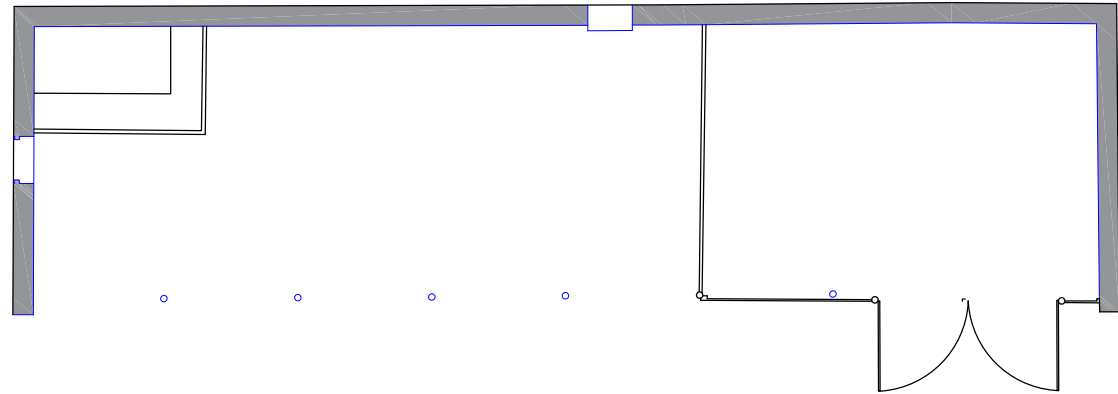
Existing Ground Floor Plan

The existing West Barn 2 is an existing barn with solid stonework walls to three sides and an open frontage to the south east elevation with cast iron columns supporting the timber roof structure and trusses. Later metal cladding and metal steel framed doors have been added to create an enclosure to the northern end of the building.

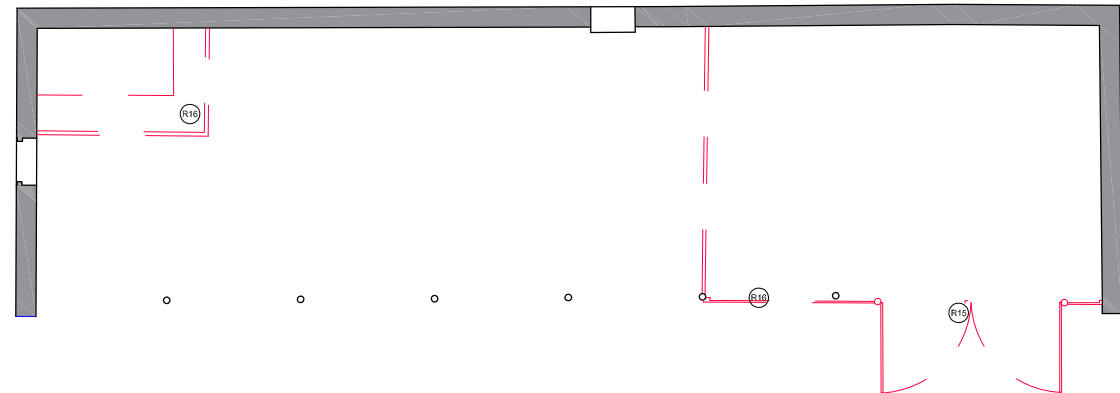
Ground Floor Plan

The existing stonework walls to the three sides, the cast iron columns and the timber roof structure are to be retained and repaired where required. The later addition metal clad enclosures are to be removed to expose the original structure.

Existing rainwater goods, where in situ are severely degraded and are to be removed and replaced with new cast iron goods throughout.

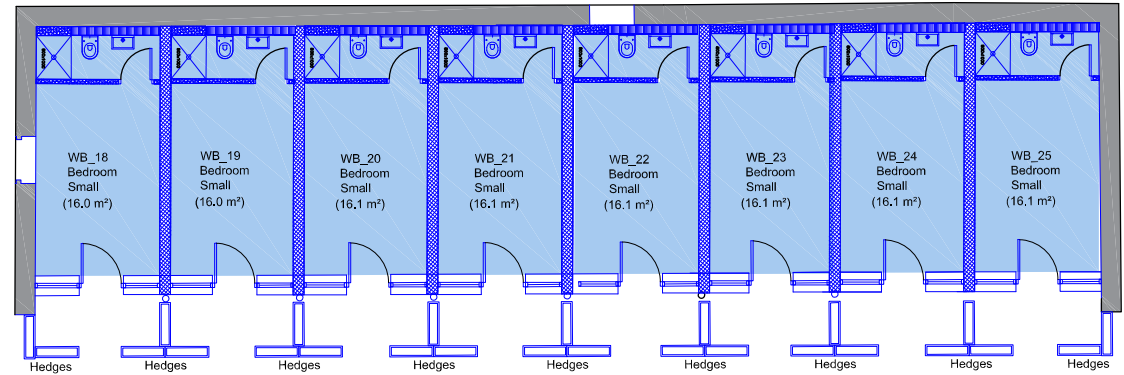
Proposed Ground Floor Plan

The proposed redevelopment will convert the single storey stone barn into 8 'Boot Room' bedrooms with En-suite bathrooms to the rear. The rooms are divided to respond to the structural grid of the existing building. The open elevation is to be infilled using a lightweight timber framed system which is set back from the cast iron column line to allow the columns to be clearly visible externally.

To protect privacy to each room, a small outdoor space is to be formed using free standing planters.

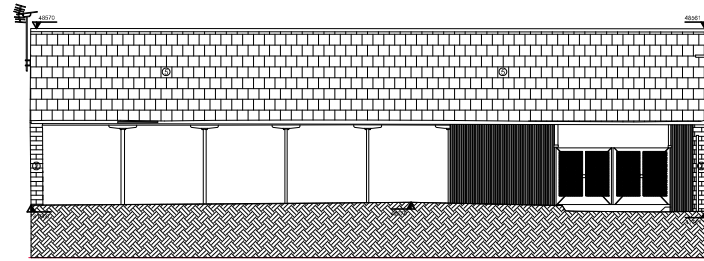
Elevation 10

The existing stonework walls are to be retained and repointed where required. The later addition corrugated metal and steel framed compounds are to be removed to expose the original timber and cast iron columns throughout.

The existing slates are to be carefully removed from the roof and stored for relaying following the installation of new insulation and breathable membrane to improve thermal performance.

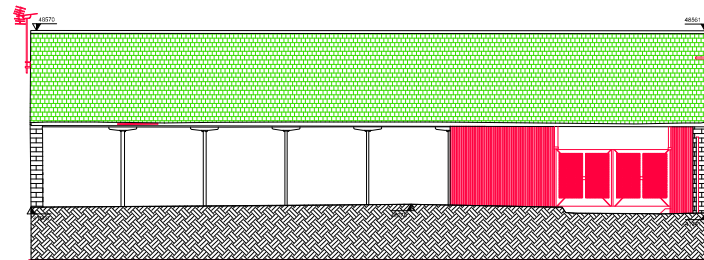
Elevation 10

The infill elevation is set back from the cast iron columns to enable them to be clearly legible externally. The materials and design continues the materials utilised on the Stable block with vertical timber cladding used at low level for privacy with windows above. Marine plywood is used as an infill material behind the existing cast iron columns to further emphasise the columns and to accommodate any variation in dimensional set-out.

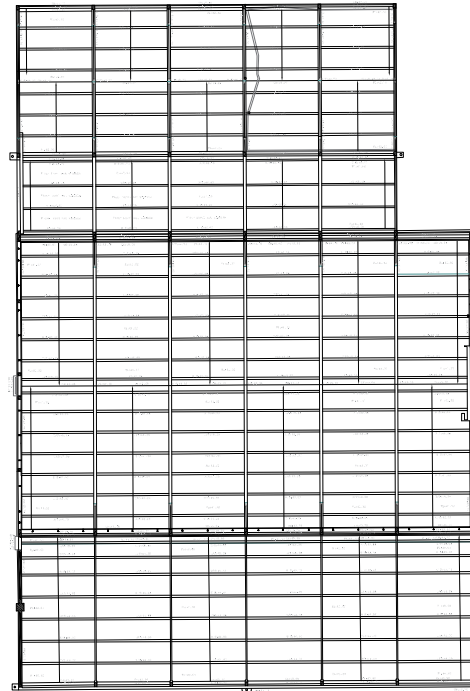
Existing Ground Floor Plan

The building is of low quality and is not considered to be of significant historical value to the site and the Listed West Barns complex.

The existing barn comprises of a concrete and steel frame construction with asbestos cladding at first floor level and roof level and steel cladding infills to the ground floor level.

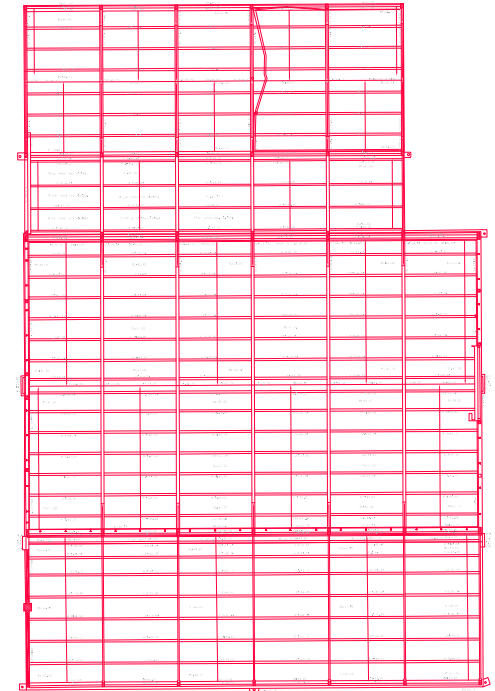
Ground Floor Plan

The proposals are to demolish the existing building in its entirety whilst retaining the concrete floor slab to provide a base for the car parking area.

The proposals will demolish this existing low quality barn to free up this area of the site to accommodate additional new build accommodation.

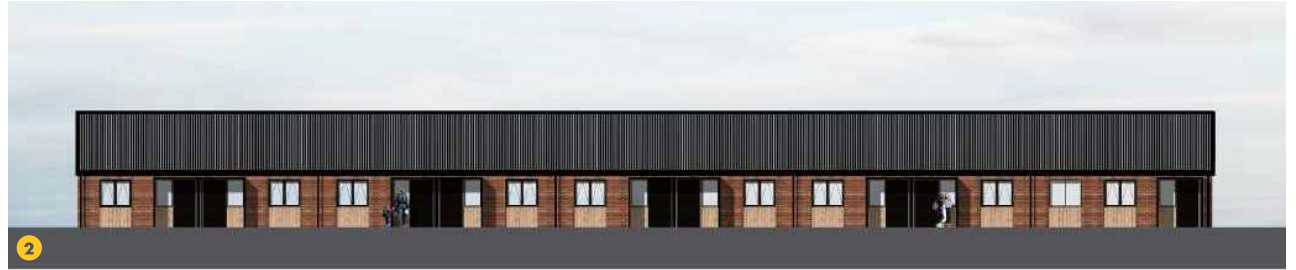
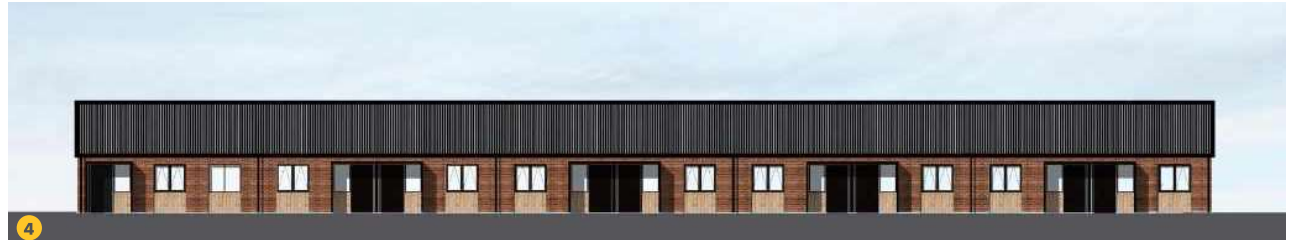
The proposed new build barn comprises of brickwork elevations with vertical timber infill panels beneath the windows to reflect the style of the new infills within the existing buildings to create a consistency in materials and character. The roof is to be Sinusoidal metal cladding with black roof trims to reflect the agricultural character of the site.

Canopies project out from the main building form to mark the entrances to each room and to provide shelter from the elements due to the exposed location.

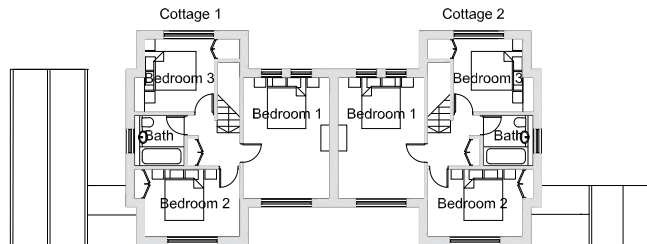
First Floor Plan  
Cottage 1 = 47,0m<sup>2</sup>  
Cottage 2 = 47,0m<sup>2</sup>

The existing two storey semi-detached dwellings were built in the 1950's/1960's and reflect the style and proportions of the time. The houses comprise of a symmetrical arrangement with a main block running in a north east to south west orientation and a projecting gable to each dwelling to the front and rear elevations. The houses provide 3 bedrooms and will be utilised as family holiday accommodation to cater for larger scale groups on the site.

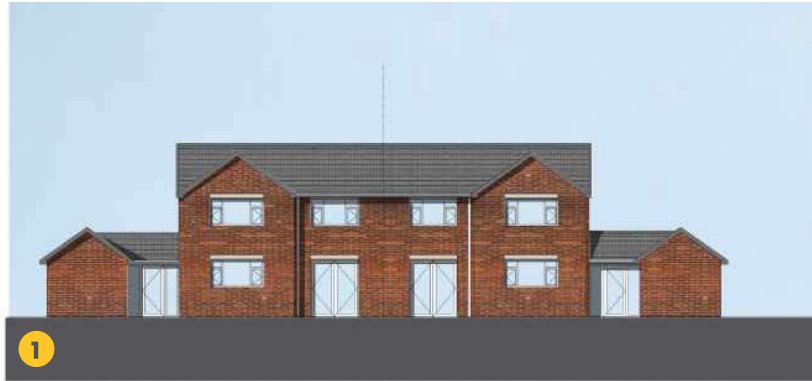
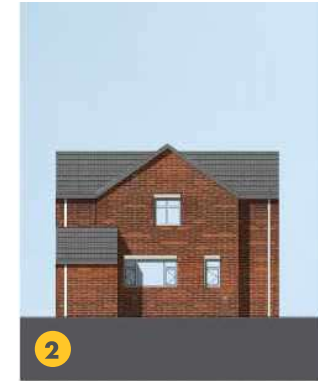
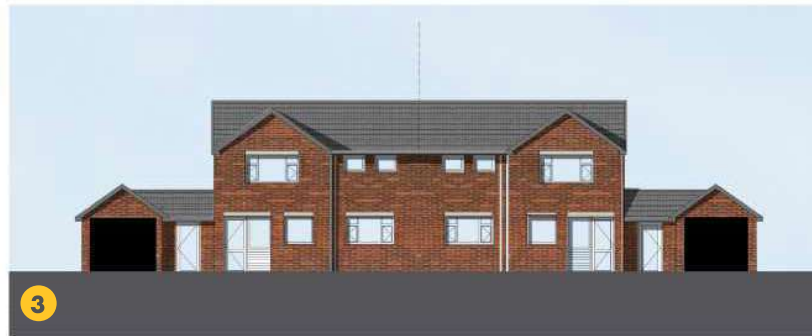
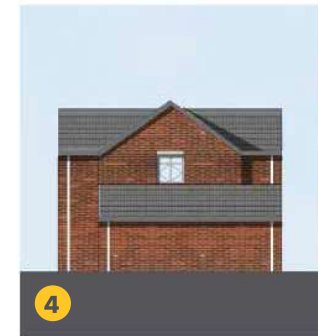
#### PROPOSED ELEVATIONS

The modifications proposed to the Cottages are to replace all of the timber framed single glazed windows and doors with new double glazed windows to improve the thermal performance. The two existing windows to the Living Rooms to the rear of the properties are to be removed and the cills dropped to form two double door openings to provide direct access to the garden from the Living area.

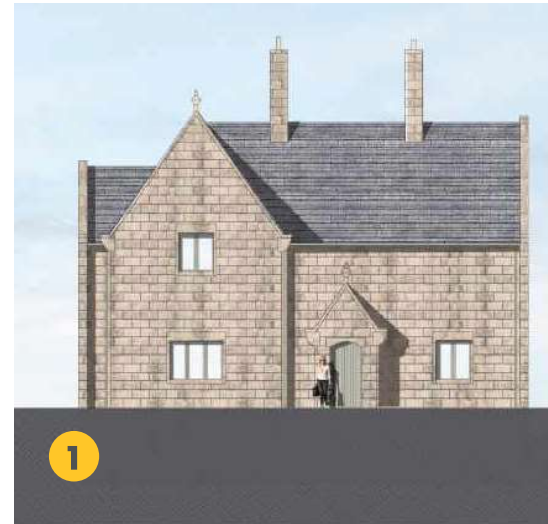
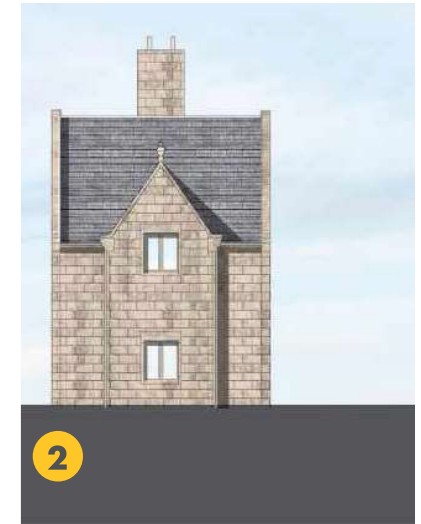
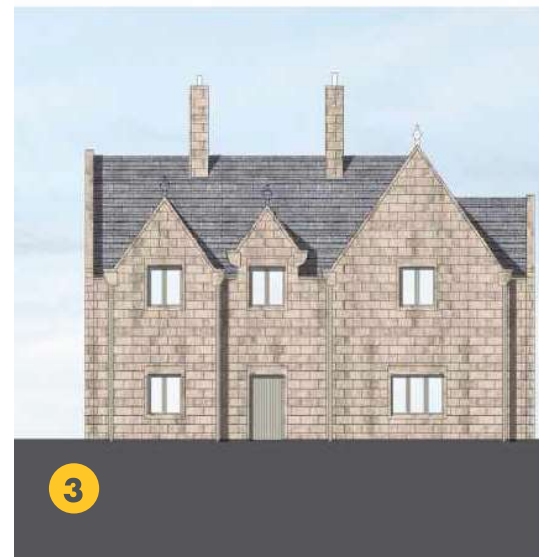
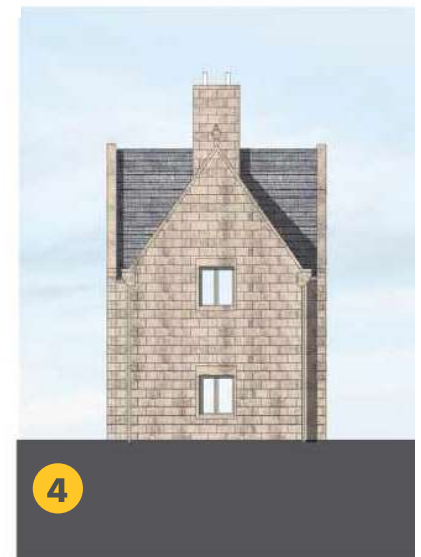
#### PROPOSED ELEVATIONS

The proposed design is of a scale, detail and proportion that reflects the gatehouse located directly opposite the site with steeply pitched roofs, stone facades and detailing and a slate roof.
