PROPOSED SOUTH (FRONT) ELEVATION

THIS DRAWING TO BE READ IN CONJUNCTION WITH
DRAWING No 23/1511/001 TOGETHER WITH REPORT,
DETAILS ETC PREPARED BY THE MORTON PARTNERSHIP

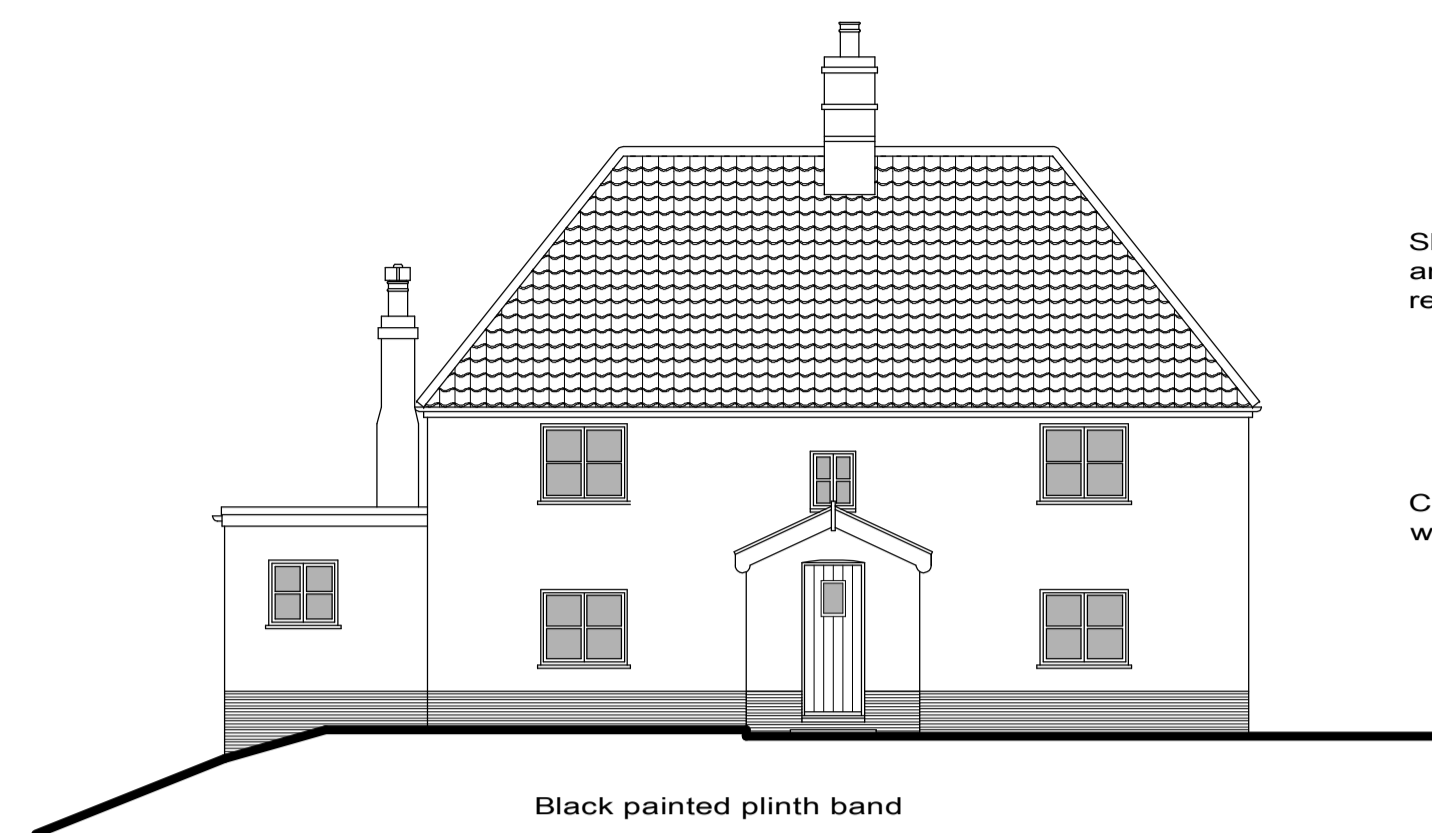
Slipped or damaged clay pantiles and ridge/hip tiles to be reset or else replaced as necessary

Cement/lime render with colour wash finish

Black painted plinth band

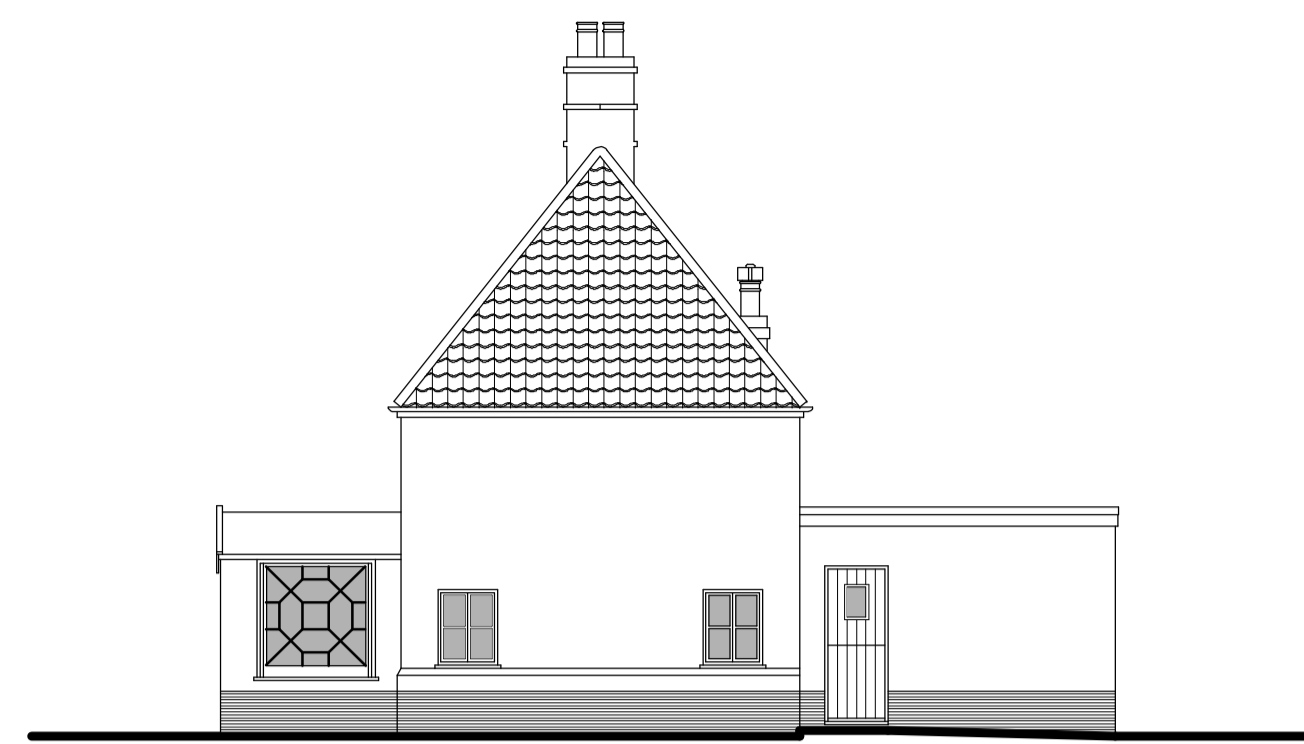
PROPOSED EAST ELEVATION

Slipped or damaged clay pantiles and ridge/hip tiles to be reset or else replaced as necessary

Where collapsed walls on part east and north elevations to be rebuilt using blockwork. Walls to be finished with cement/lime render with colour wash finish. Remain parts of walls to be finished as noted elsewhere.

Black painted plinth band

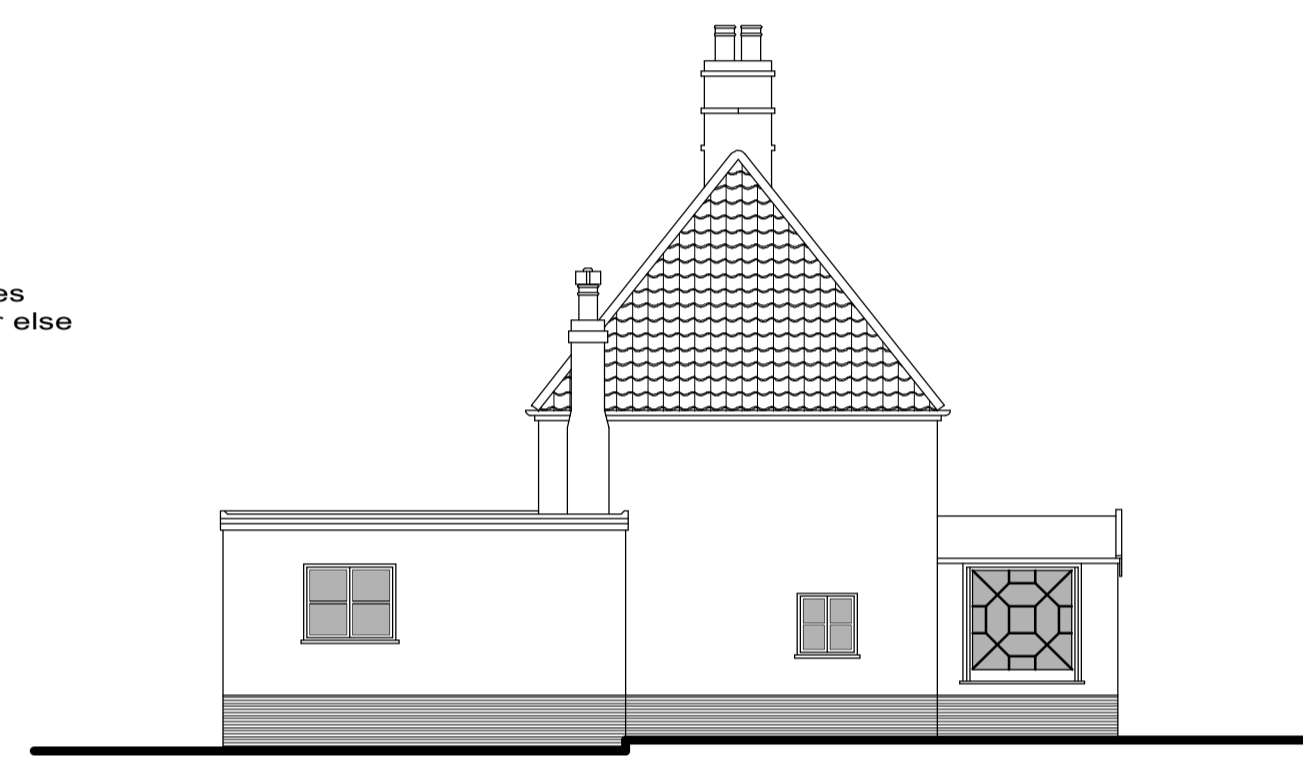
PROPOSED WEST ELEVATION

Slipped or damaged clay pantiles and ridge/hip tiles to be reset or else replaced as necessary

Cement/lime render with colour wash finish

Black painted plinth band
