# whitworth

COUSENS FARM, MICKFIELD  
OUTLINE HERITAGE STATEMENT revision C

This statement has been prepared in support of a pre application enquiry to Mid Suffolk District Council for alterations and extensions to Cousens Farm.

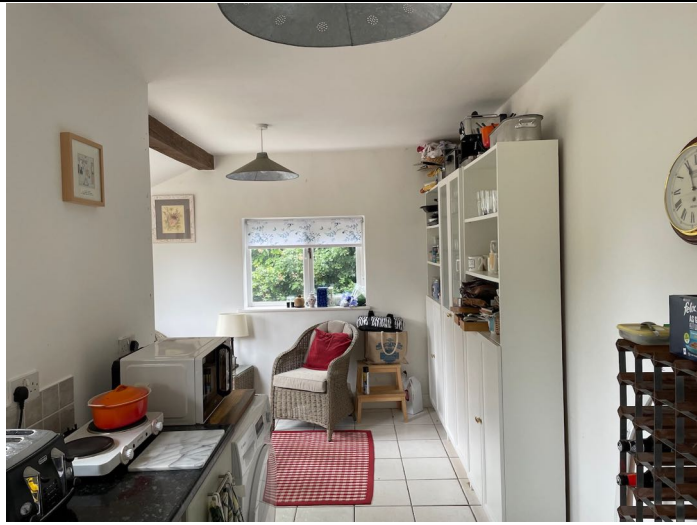
1

Item	Form internal partitions in the lean to extension on the South elevation
		Significance	<b>Low</b>
		Risk	<b>Low</b>
		Benefit	<b>High</b>
		Mitigation	The internal partitions will be in a 20th century addition to the property and will not involve the loss of any historic fabric or change in the external appearance or character of the property

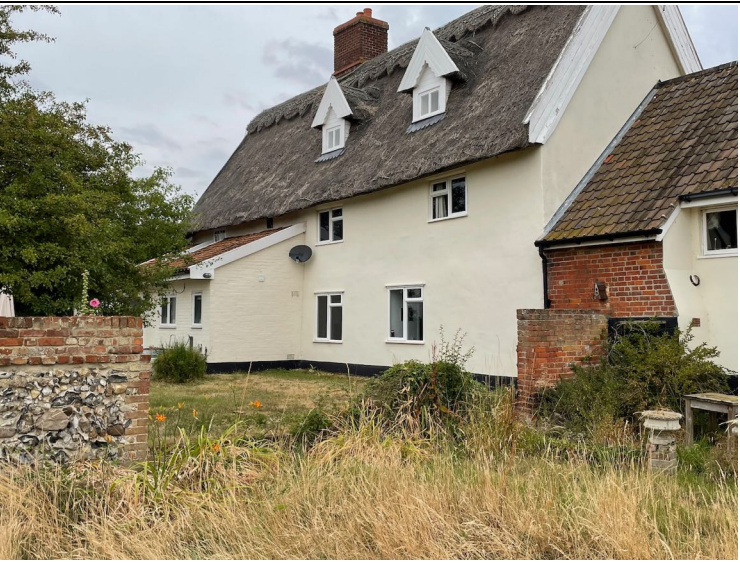
2

Item	Construct a single story garden room
		Significance	<b>Low</b>
		Risk	<b>Medium</b>
		Benefit	<b>High</b>
		Mitigation	<p>The proposed garden room will be sited on the South facing elevation to the size and proportions shown on drawing 02. This will be of single Storey design in the style of the bottom photograph. The sighting of the garden room will cover the two modern ground floor windows shown in the centre of the photograph to the left.</p> <p>The access to the garden room will be through an existing window opening shown in the centre photograph, this will involve cutting through the timber soleplate although this is a modern 20th century replacement and construction of the garden room will not involve the loss of any historic fabric within the building.</p> <p>The garden room will change the character of this elevation although being of single Storey construction the change will be minimised and will provide considerable benefits to the occupants by providing a room with views of the gardens.</p>

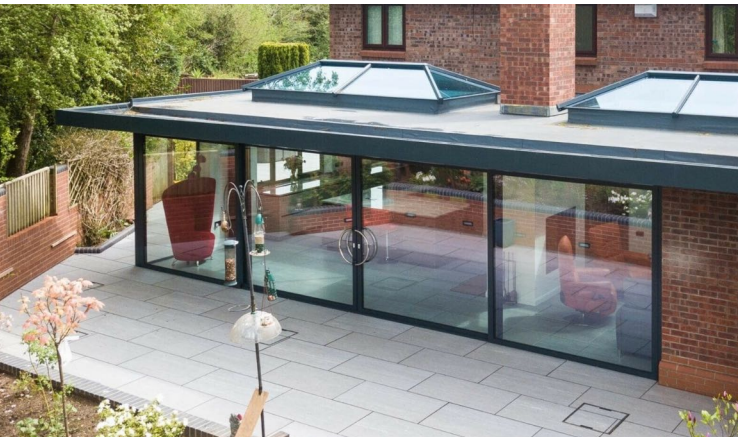
<p>Style of proposed garden room</p>

The design of the garden room will use traditional materials but will clearly be a modern element on the historic building and will be read as an addition. The remaining works are designed to follow the character of the traditional farm setting using materials matching the existing.

Garden room – Oak frame with lead covered roof  
Porch – rendered walls, softwood window and clay tile roof  
New windows – painted softwood  
Stable roof – softwood trusses finished with clay tiles

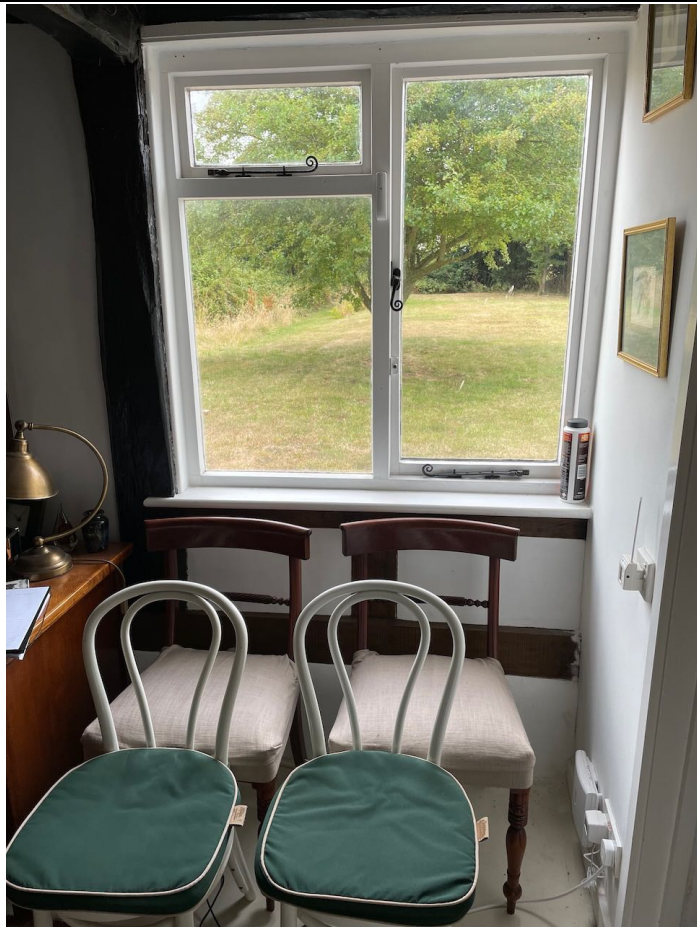
Replacement sole plate where the door opening will be formed

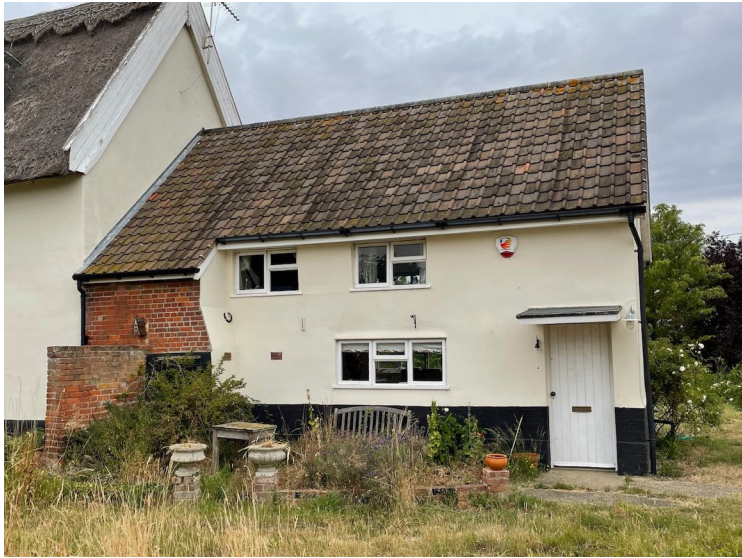
3

Item	Construct a boot room on the South elevation of the rear wing
		Significance	<b>Low</b>
		Risk	<b>medium</b>
		Benefit	<b>High</b>
		Mitigation	<p>The boot room shown on drawing 02 will give definition to the entrance to the property. The front door on the north elevation is not visible when approaching the property from the driveway and is rarely used. Constructing the boot room will give a focal point for visitors and also enable the hallway to be increased in size which is currently very limited. The proposed boot room will be of a traditional design and construction with rendered walls and a tiled roof. A small section of the brick wall to the left of the current entrance door will be removed to open the porch into the existing hallway.</p> <p>Investigation into the wall construction shows a simple timber frame above the brick plinth, there are no substantial timbers within that area of wall proposed to be removed, and no infill to the wall panels.</p>

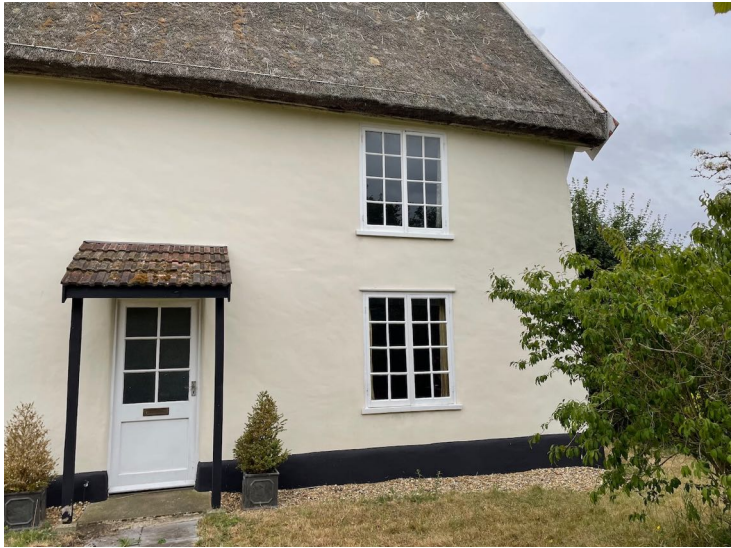
4

Item	Demolish the lean to porch on the principal north elevation and replace the entrance door
		Significance	<b>Low</b>
		Risk	<b>Low</b>
		Benefit	<b>Medium</b>
		Mitigation	The existing canopy and entrance door are 20th century elements and do not follow the character of the original building, in particular the glazing pattern of the entrance door. Removing the canopy and fitting a new door will remove this modern element and enhance the character of the property.
5

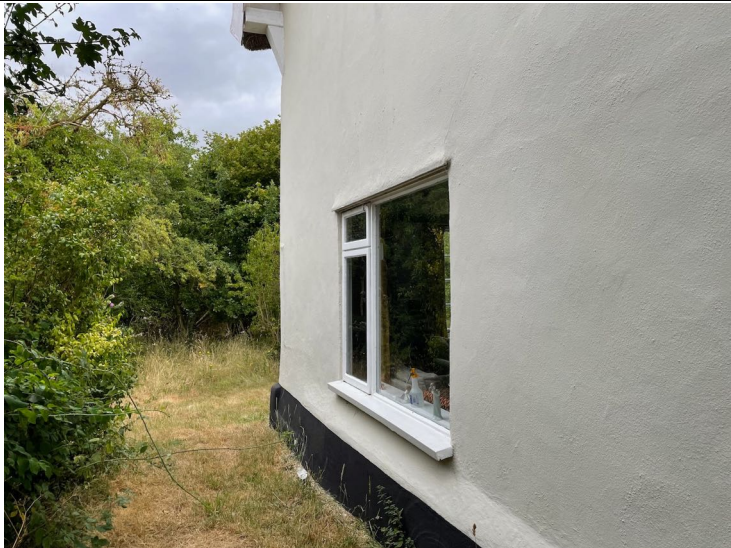
Item	Replace the ground floor window on the West Gable
		Significance	<b>Low</b>
		Risk	<b>Low</b>
		Benefit	<b>High</b>
		Mitigation	The existing window is a modern storm proof design, the proposed replacement window will have flush casements and glazing bars to match the pattern of the attic window on this elevation shown in the lower photograph and windows on the front elevation which will enhance the character of the property. There are very limited views of this window due to the close proximity of the boundary hedge

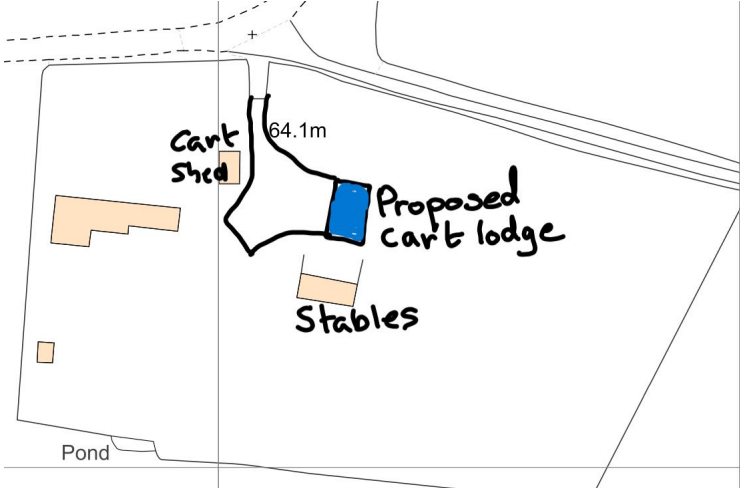
<p>Proposed layout</p>

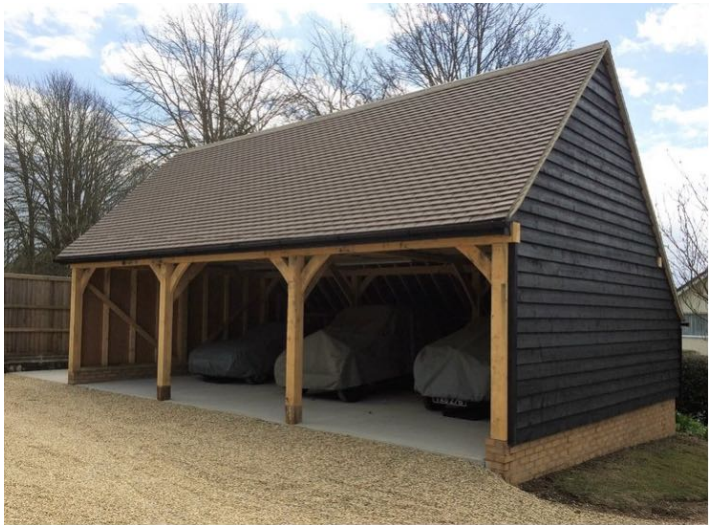
<p>Style of proposed cart lodge</p>	Item	Re configure the layout of the driveway and construct a 3 Bay cart lodge
		Significance	<b>Low</b>
		Risk	<b>Low</b>
		Benefit	<b>High</b>
		Mitigation	The finish of the driveway will remain in gravel. The design of the cart lodge will be similar to the photograph on the left taking the form of a traditional outbuilding. The sighting of the cart lodge is sufficiently far from the house that it will not have a negative impact on the setting of the property.

Cart lodge – timber boarded walls and clay tile roof

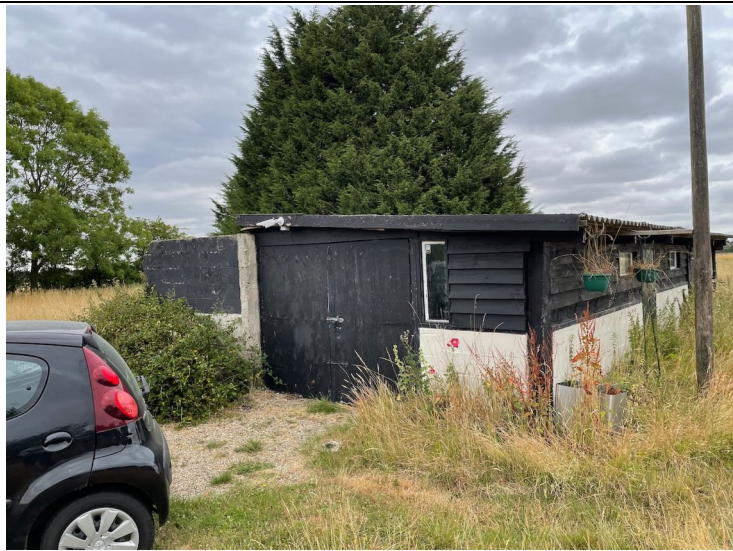
8

Item	Repair and upgrade the stable building with a new pitched roof
		Significance	<b>Low</b>
		Risk	<b>Low</b>
		Benefit	<b>High</b>
		Mitigation	The existing stable building is constructed from a mix of concrete block work and timber framing with a shallow pitched roof. The design of the building is not in keeping with the character of the house or farm setting. Repairing the building and fitting a tiled pitched roof will enhance the character of the setting.
9

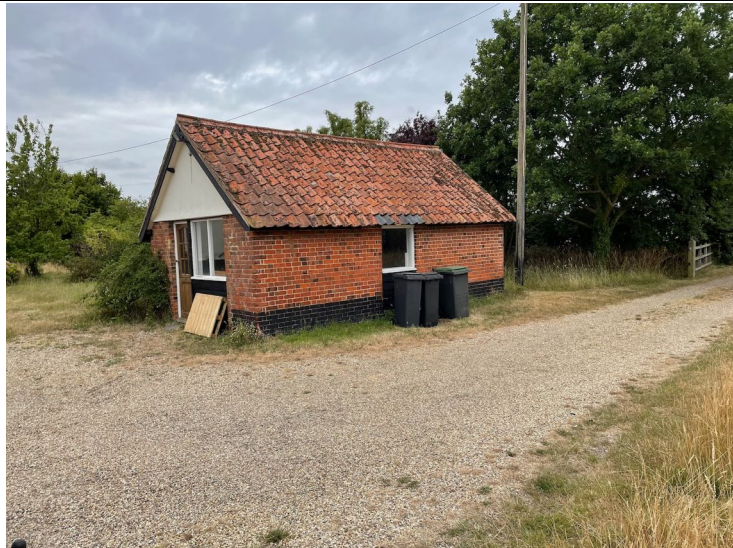
Item	Fit new Windows in outbuilding
		Significance	<b>Low</b>
		Risk	<b>Low</b>
		Benefit	<b>Medium</b>
		Mitigation	The existing building has been altered with the size of the brickwork opening reduced on the South Gable where the entrance door currently is. The former doorway on the east elevation shown by the bins has been partially blocked up and a window fitted. The joinery is all 20th century and not to a traditional design or detailing. Replacing the windows with the more traditional design will enhance the character of the building without the loss of any historic fabric. The proposal is to replace the window and door on the south gable and fully glaze the opening.

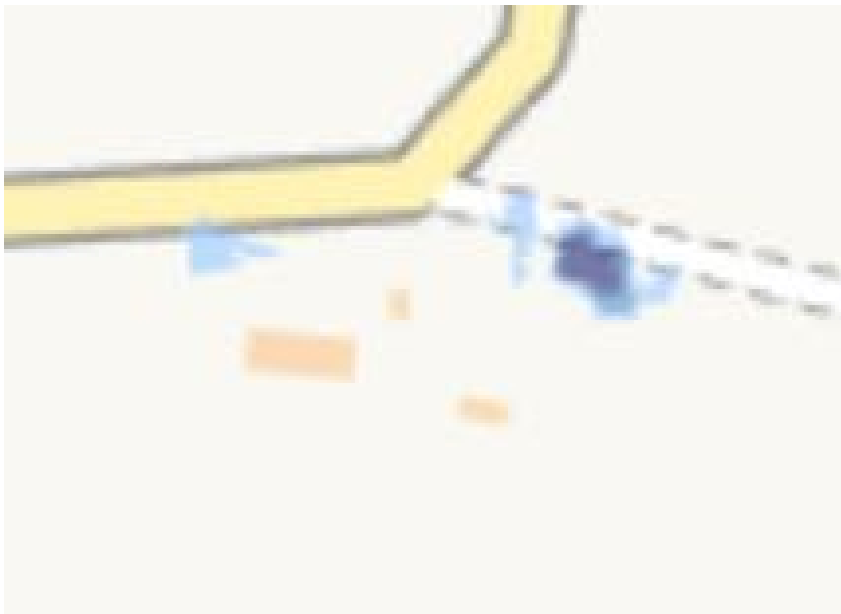
The above surface water flood risk map taken from the .Gov website shows two areas to the north on the site that could be liable to flooding from surface water, the risk is assessed as being 0.1%.

These areas are not in close proximity to either the extension or the proposed cart lodge and therefore do not represent a risk to the development.
